**FOUNDATION INVESTIGATION REPORT  
HIGHWAY 401 – HIGHWAY 15 INTERCHANGE IMPROVEMENTS  
HIGH FILL EMBANKMENTS  
KINGSTON, ON**

**Agreement No. 4015-E-0013  
G.W.P. 4059-11-00**

**GEOCRES Number: 31C-251**

**File No. 12093**

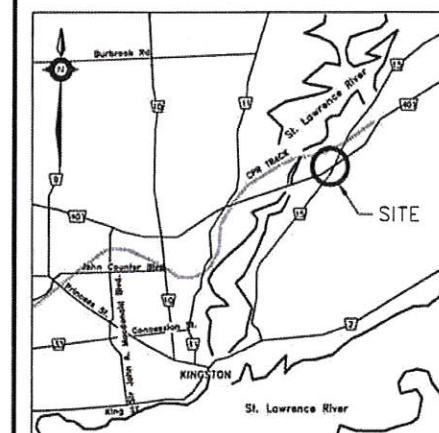
HIGHWAY 401 &  
HIGHWAY 15 INTERCHANGE  
N/S-W RAMP  
BOREHOLE LOCATIONS AND SOIL STRATA

NO	ELEVATION	NORTHING	EASTING
16-01	112.7	4 905 471.5	310 335.
16-02	105.7	4 905 509.1	310 362.
16-03	106.2	4 905 454.2	310 285.

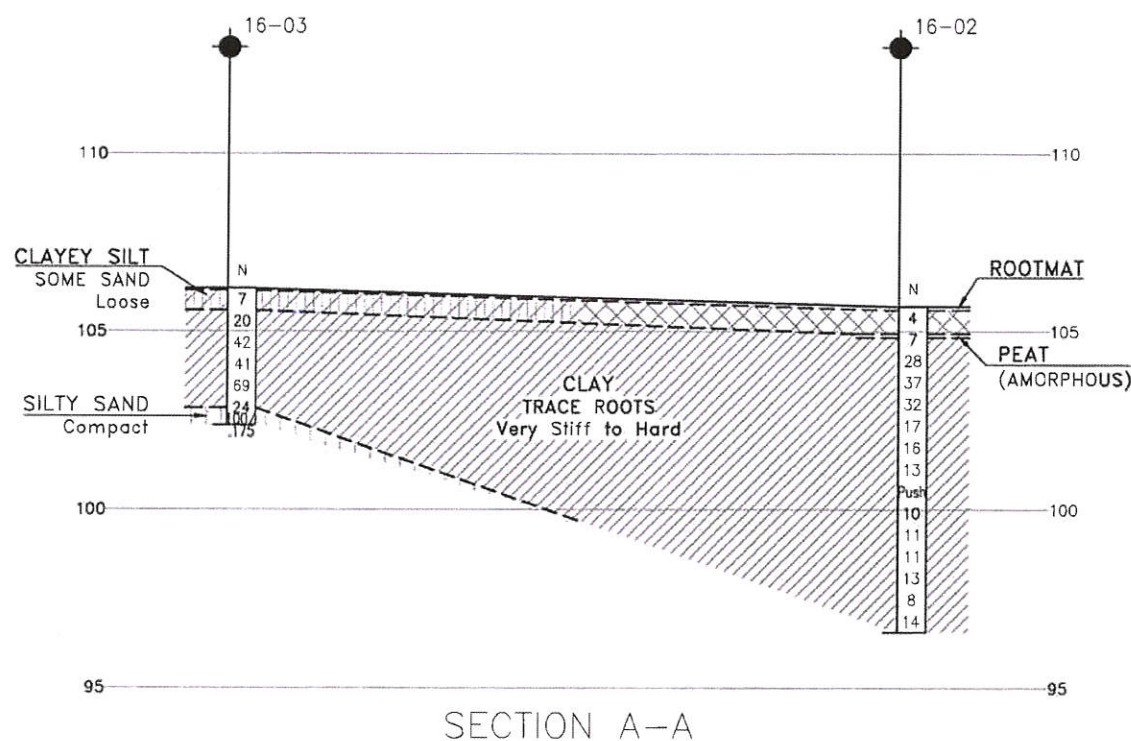
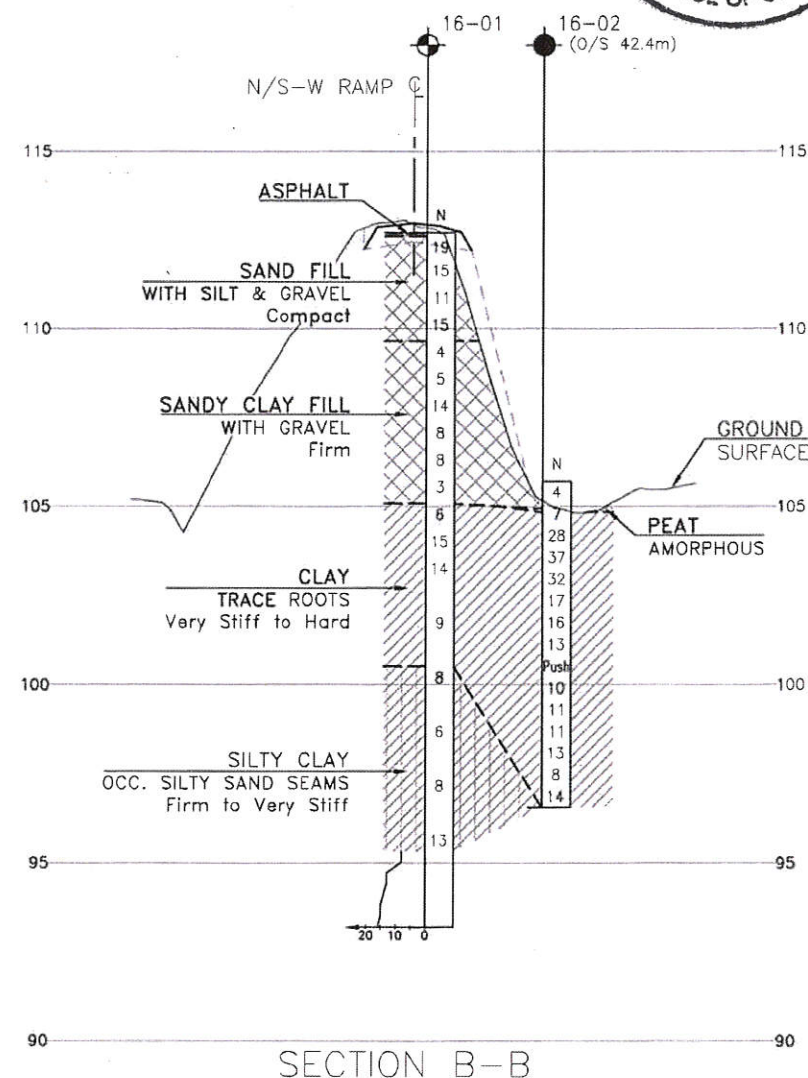
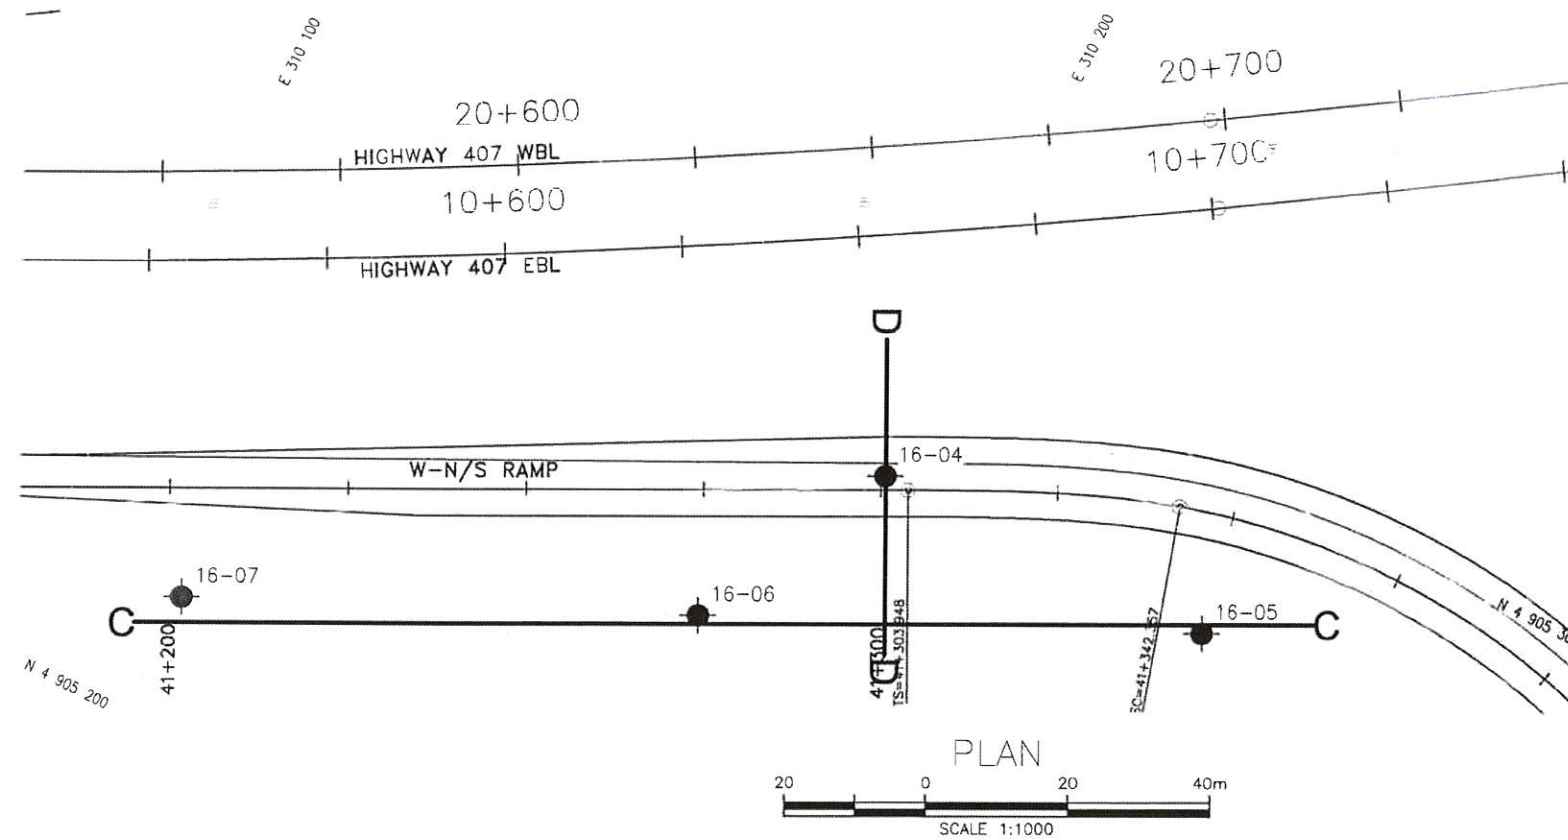
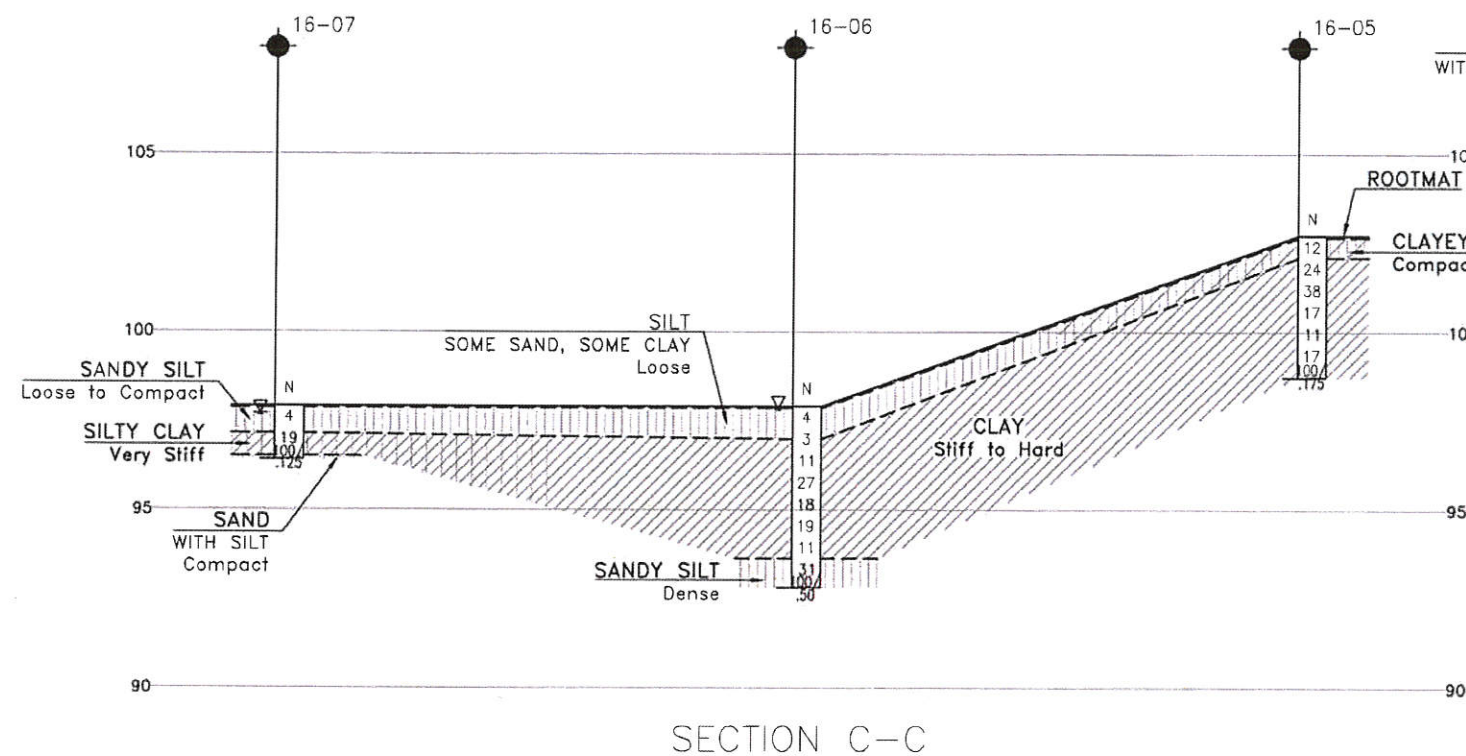
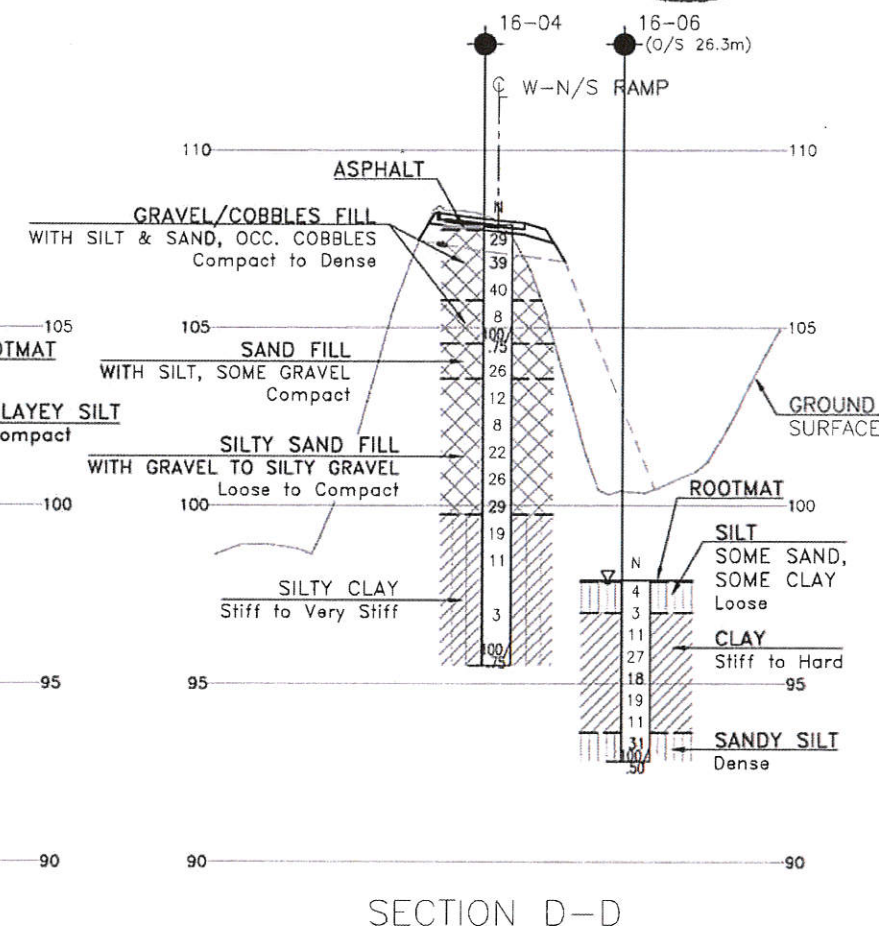
approximate locations of the boreholes are shown on the Borehole Location Plans and Soil Strata Drawings provided in Appendix A.

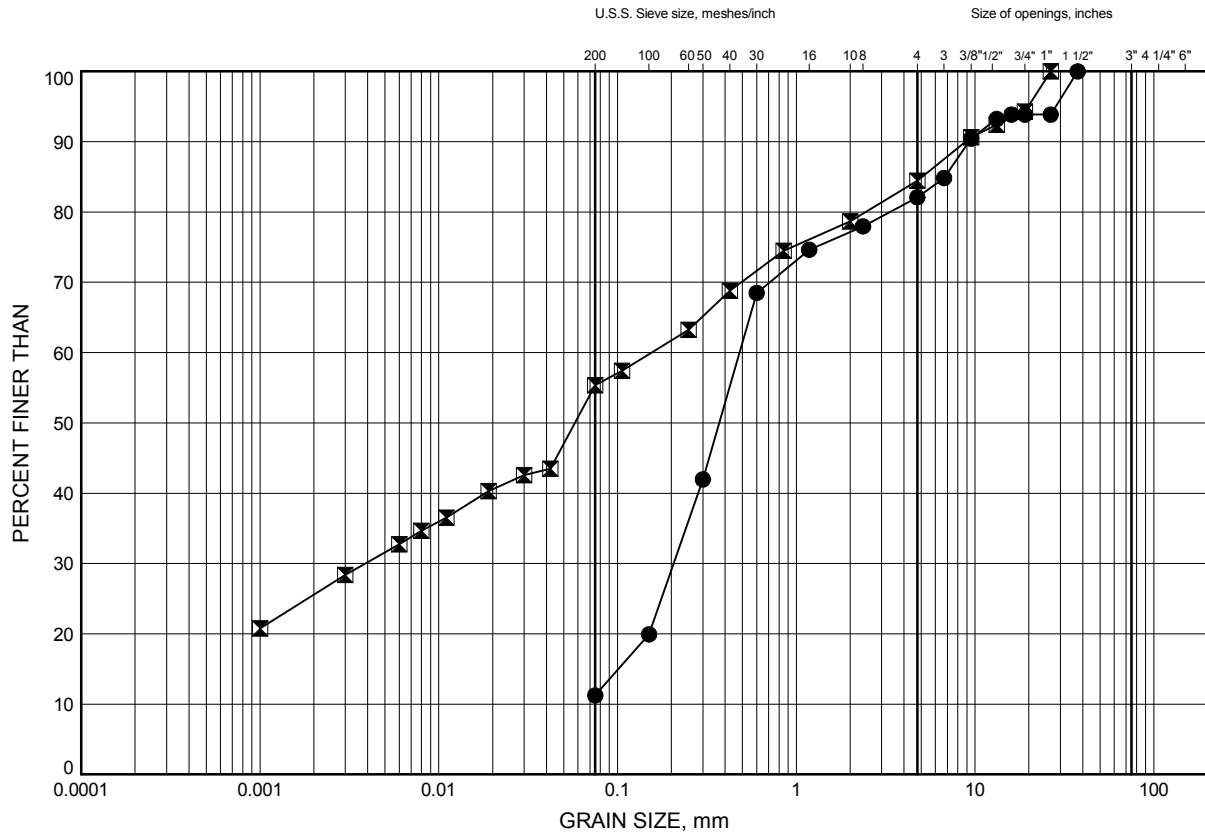
FIGURE C1

The SPT N-value for the granular embankment fill ranged from 11 to 19 blows per 0.3 m penetration, indicating a compact state. The colour of the granular fill is brown. The moisture content of the granular fill ranged from 3% to 7%. The results of grain size analysis conducted on one sample of the granular fill material are presented on Figure C1 in Appendix C. The results are summarized in the following table.

The results of grain size analysis conducted on one sample of the sandy clay fill are presented on Figure C1 in Appendix C. The results are summarized in the following table.

**Granular and Embankment Fill**

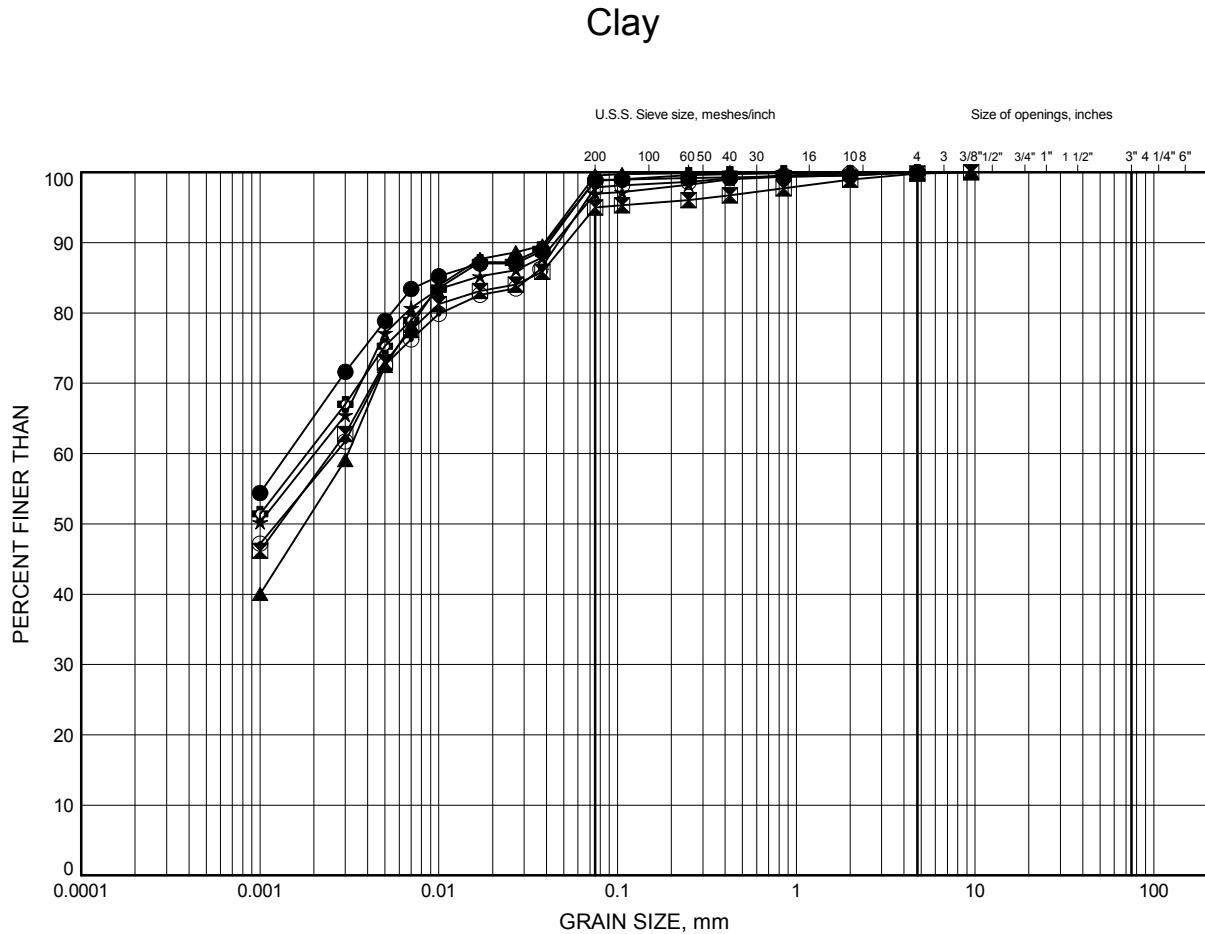
FIGURE C2

The results of grain size analyses conducted on eight samples of the clay are presented on Figure C2 and Figure C3 in Appendix C. The results are summarized in the following table.

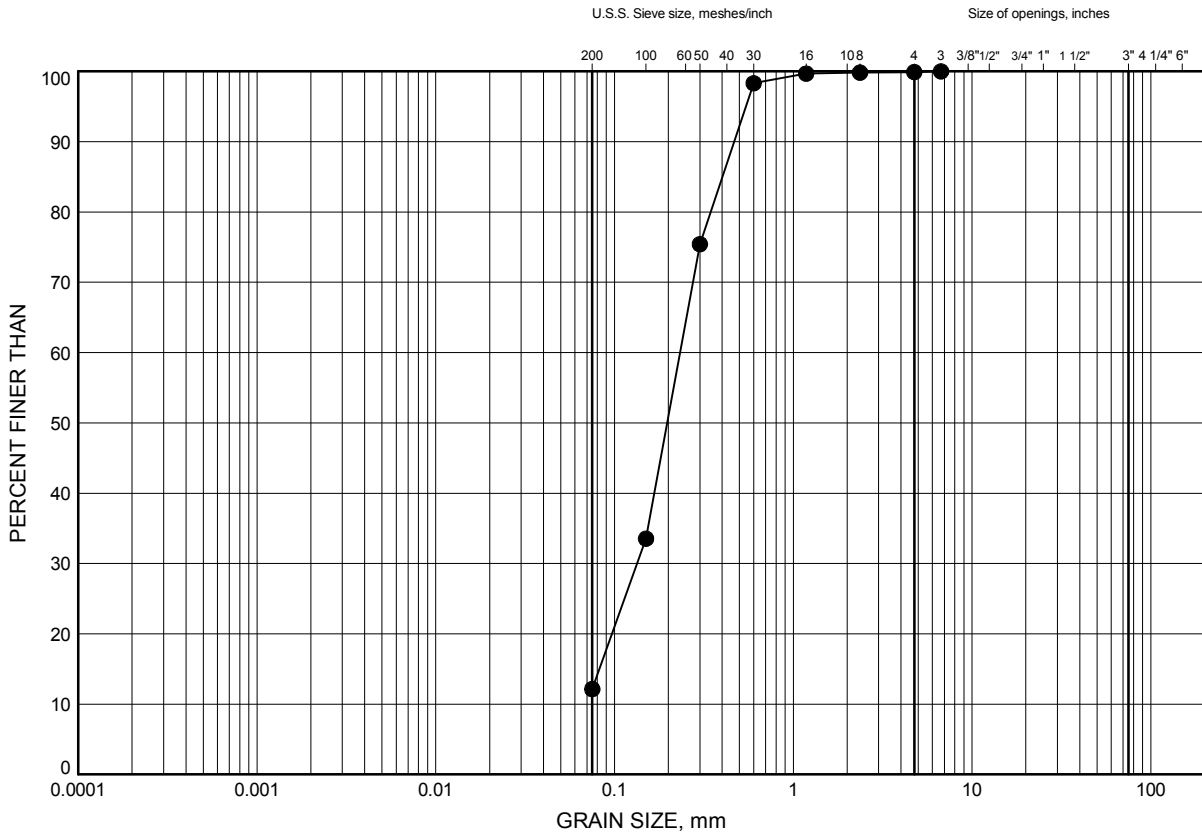
FIGURE C4

Grain size analysis conducted on a sample of the soil are presented on Figure C4 in Appendix C. These results are summarized in the following table.

Silty Sand

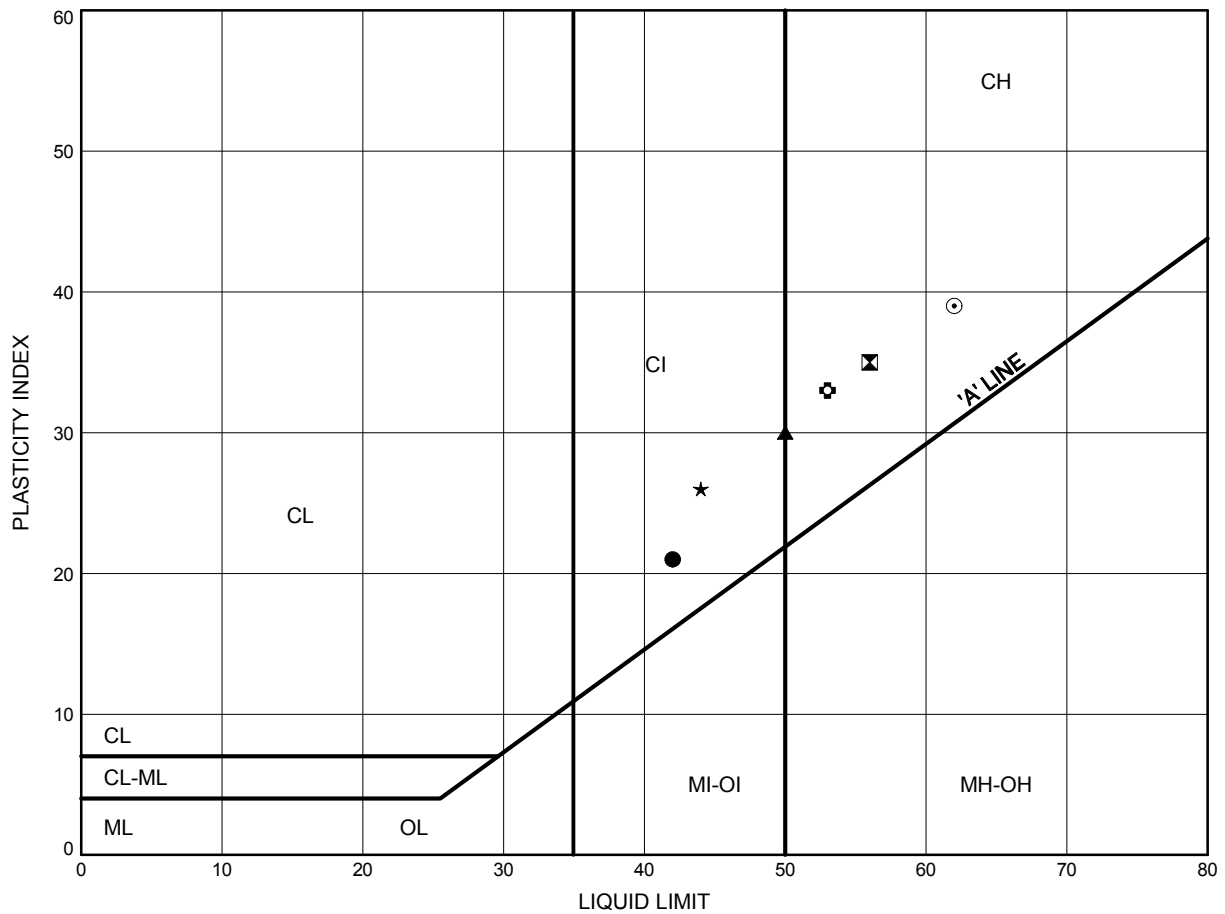
FIGURE C5

Atterberg limit testing was carried out on a sample of the sandy clay fill. The liquid limit was 42% and the plasticity index was 21%. The sample can be classified as clay of intermediate plasticity (CI). The results are presented on Figure C5 in Appendix C and summarized in the table below.

NS - W Ramp, Highway 15/401 Interchange  
**ATTERBERG LIMITS TEST RESULTS**

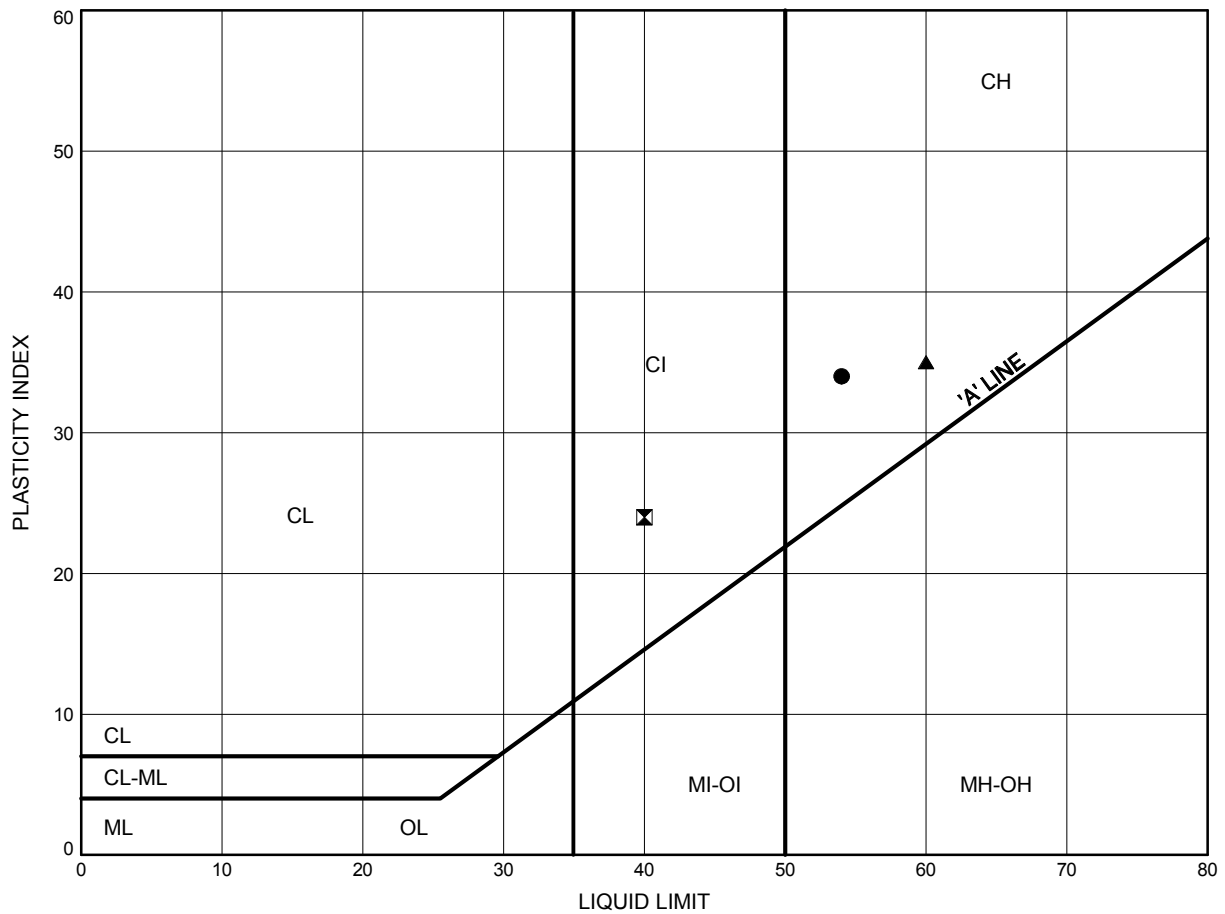
FIGURE C6

Atterberg limit testing was carried out on eight samples of the clay. The clay can be classified as clay of intermediate to high plasticity (CI to CH). The results are presented on Figure C5 and Figure C6 in Appendix C and summarized in the table below.

NS - W Ramp, Highway 15/401 Interchange  
**ATTERBERG LIMITS TEST RESULTS**

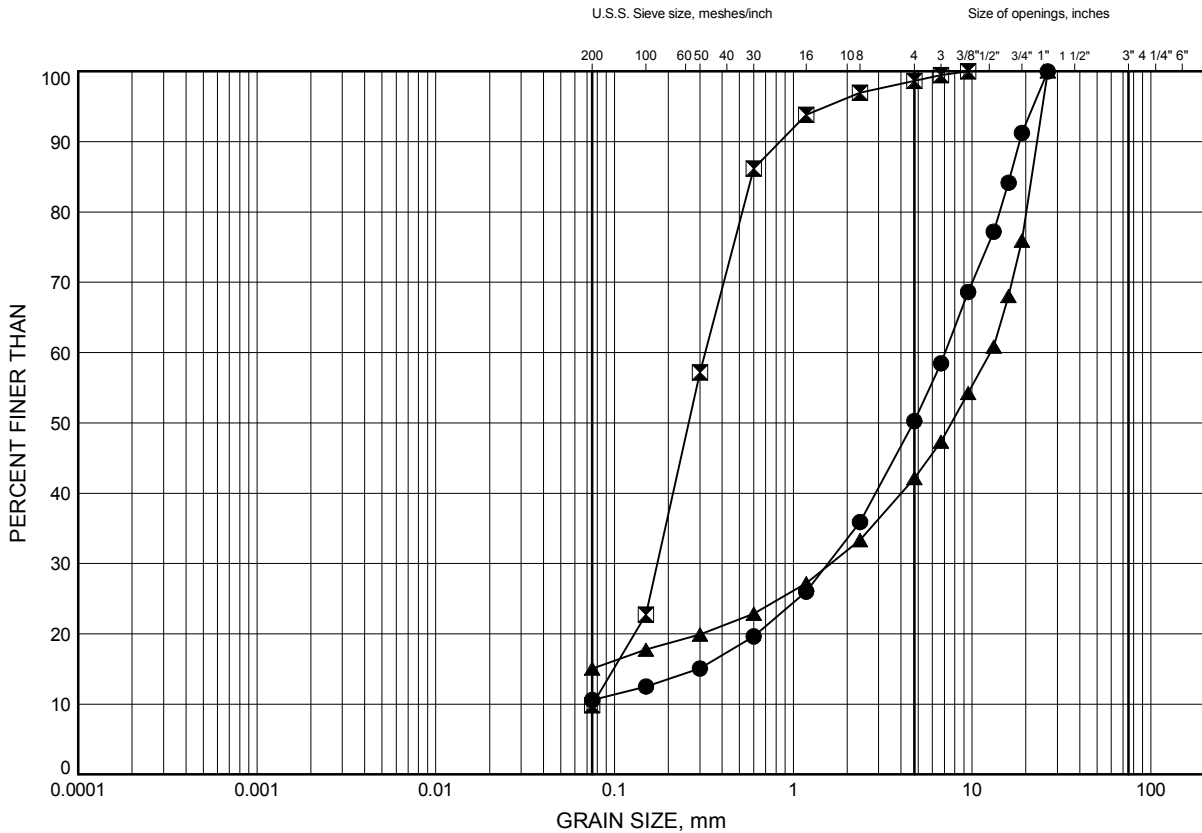
FIGURE C7

The results of grain size analysis conducted on three samples of the embankment fill are presented on Figure C7 in Appendix C. The results are summarized in the following table.

**Granular and Embankment Fill**

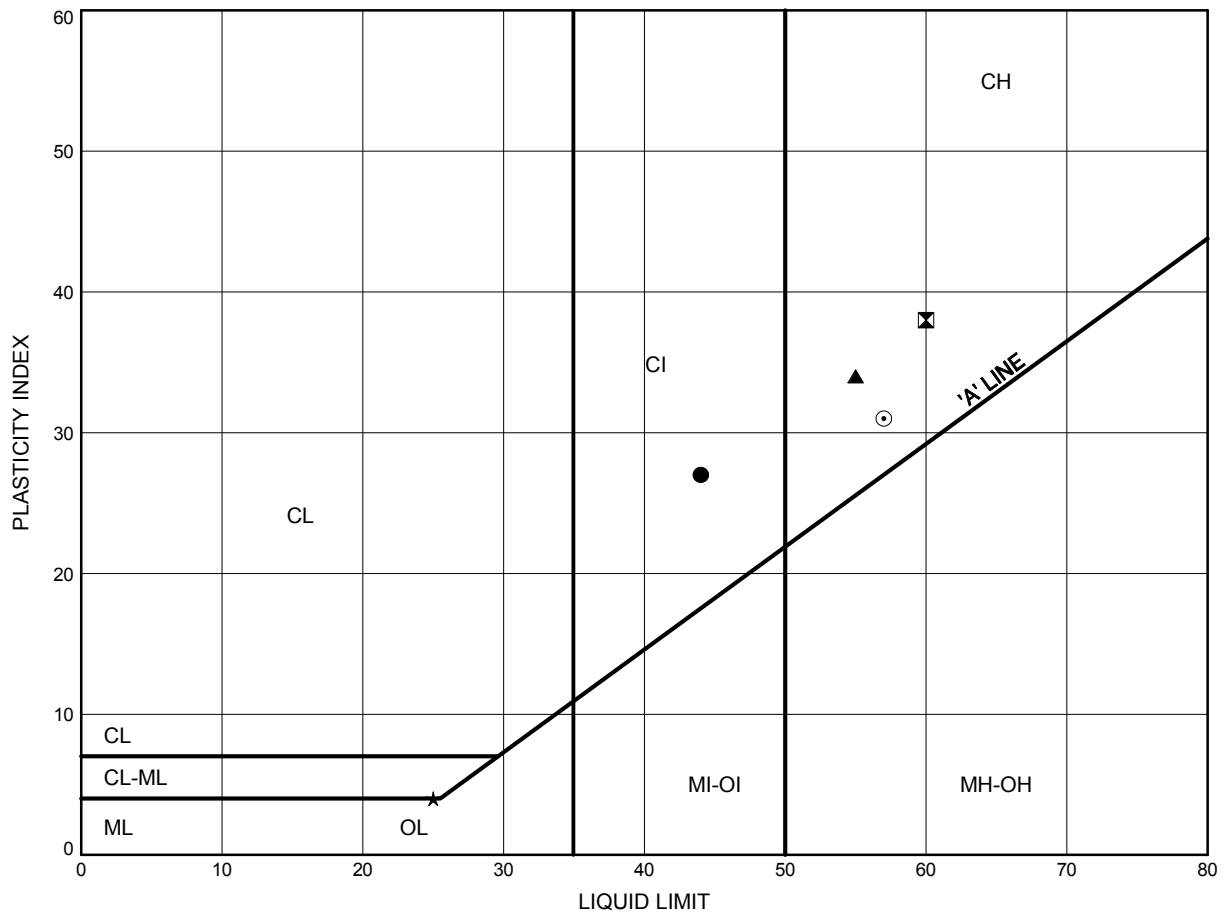
FIGURE C10

W- NS Ramp, Highway 15/401 Interchange  
**ATTERBERG LIMITS TEST RESULTS**

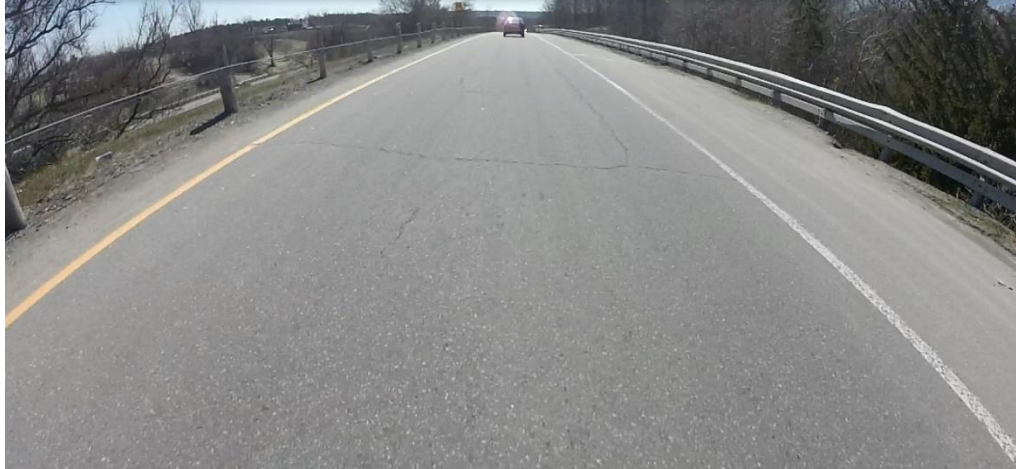
**Photo 1: N/S-W Ramp – looking west towards Borehole 16-1**

The N/S-W ramp is approximately parallel to the Highway 401 westbound lanes. The easternmost portion of the ramp, from the intersection with Highway 15 to approximately 100 m west of the intersection is on a fill section up to approximately 8 m high. The north side of the embankment is sloped at approximately 2H:1V and is vegetated with wild grasses and brush. This embankment slope wraps around the northwest corner of the intersection with Highway 15 and extends up the west side of Highway 15, with a decreasing height. A residential property is located in the northwest quadrant of the intersection at the toe of slope. The south side of the N/S-W ramp embankment slopes down to Highway 401 at approximately 3H:1V and is vegetated with wild grasses and brush. West of this fill section, the ramp extends through a rock cut section. No evidence of settlement or stability concerns were noted.

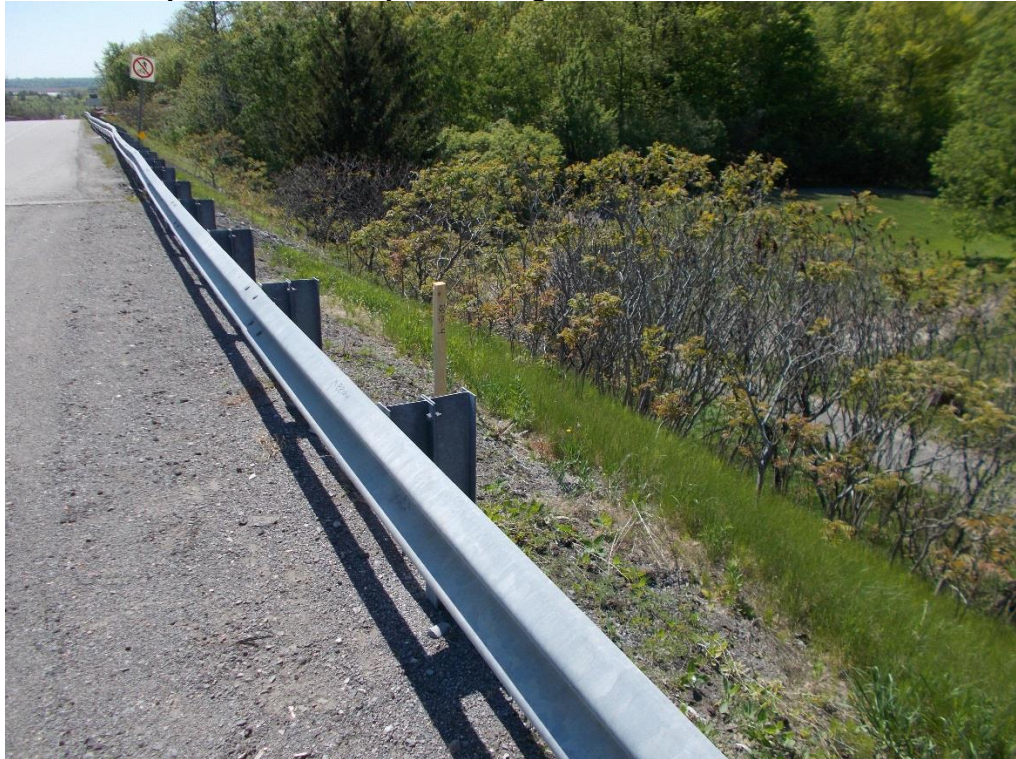
**Photo 2: N/S-W Ramp north side slope– looking west**

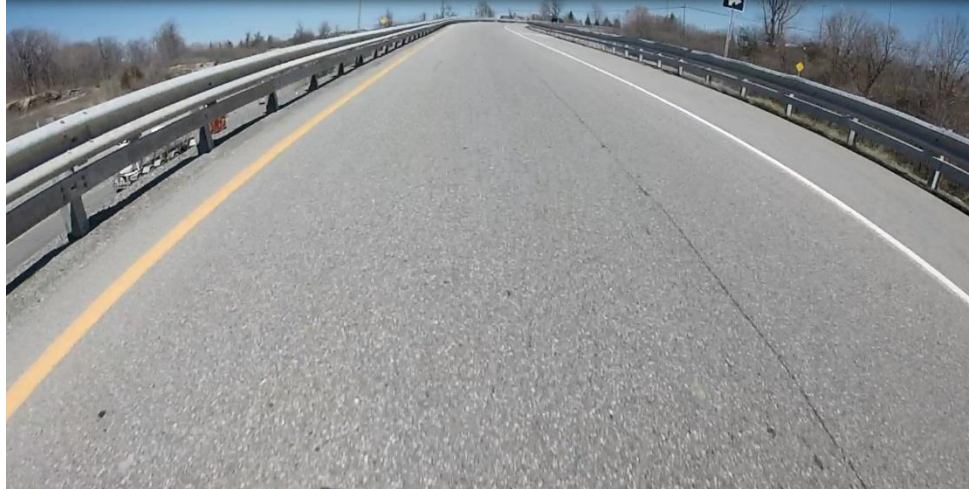
**Photo 3: W-N/S Ramp – looking east towards Borehole 16-4**

The W-N/S ramp starts approximately parallel to the Highway 401 eastbound lanes and then turns away to meet Highway 15 at a signalized intersection. An existing park and ride lot is present at the southwest corner of the intersection of the ramp and Highway 15. A motel and commercial properties are present on the west side of Highway 15 south of the park and ride lot. The ramp is located on a fill embankment up to 8 m high. The existing slopes are graded at approximately 1.5H:1V and covered with rock fill. Wild grasses, brush and small trees are present at the toe of slope. A small area with stagnant surface water is also present at the toe of slope on the south side. No evidence of settlement or stability concerns were noted.

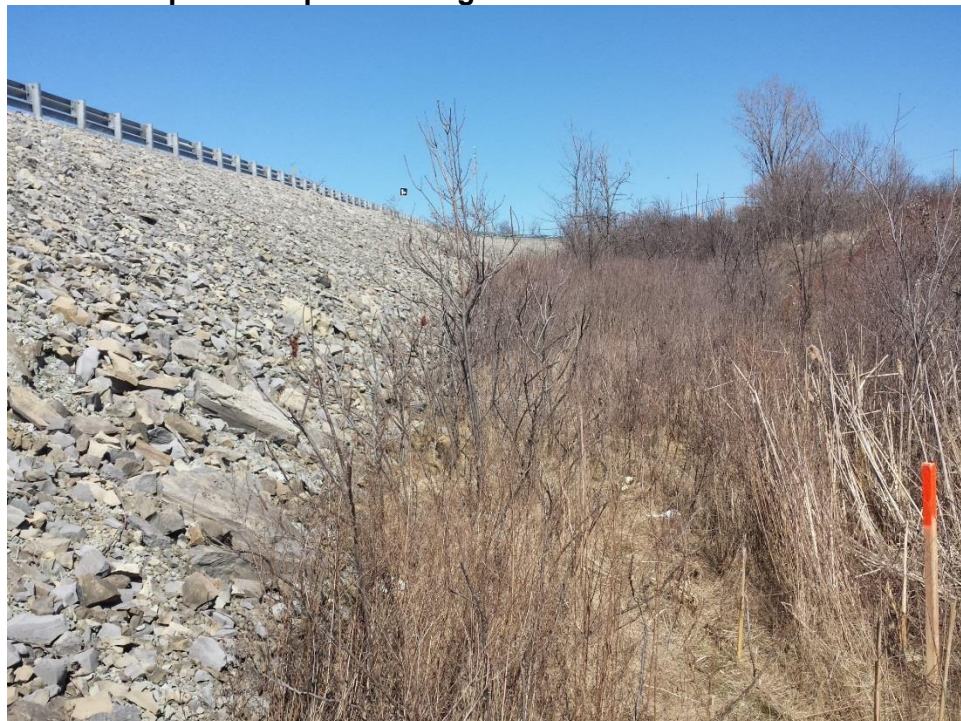
**Photo 4: W-N/S Ramp side slope – looking east at Borehole 16-7**

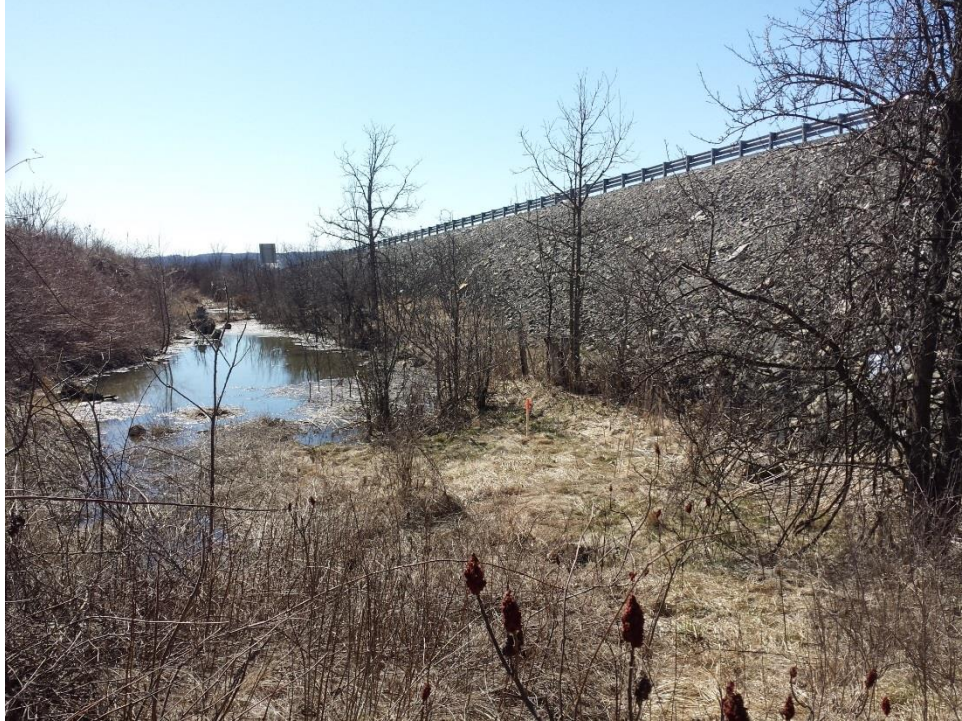
**Photo 5: W-N/S Ramp side slope – looking west at Borehole 16-6**

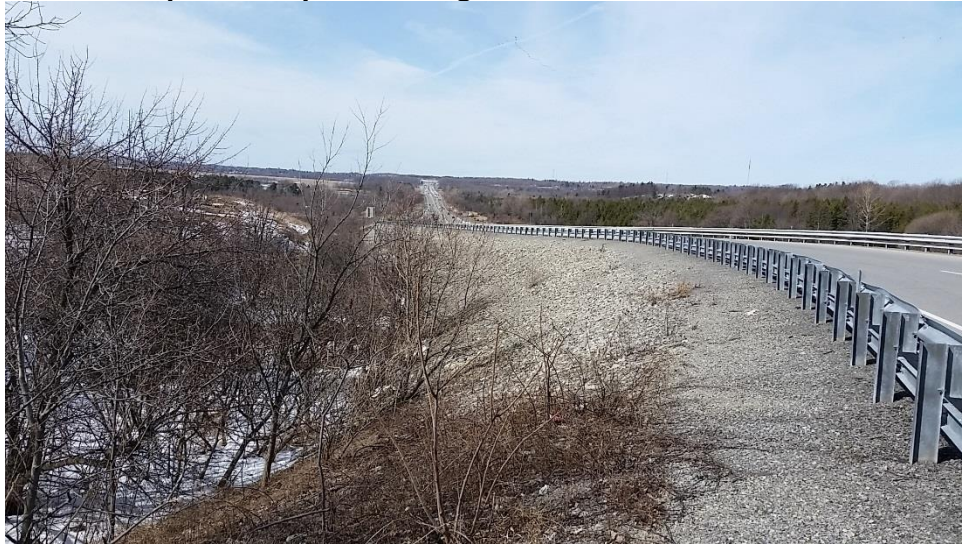
**Photo 6: W-N/S Ramp side slope – looking west from crest of embankment**
