# Part A - Foundation Investigation Report

**HIGHWAY 17 WIDENING  
AREA 1 (STA. 10+400 – 10+600), AREA 2 (STA. 11+050 – 11+160)  
AREA 3 (STA. 11+525 – 11+600), AREA 4 (STA. 12+350 – 12+480)  
TOWNSHIP OF DAMBROSSIO  
AREA 7 (STA. 16+700 – 16+825)  
TOWNSHIP OF LALIBERT  
DISTRICT OF ALGOMA  
BETWEEN WHITE RIVER AND WAWA, ONTARIO**

AGREEMENT NO. 5017-E-0043  
WORK ITEM: #5  
GWP 5031-18-00

GHD Ref.: 11185012-500

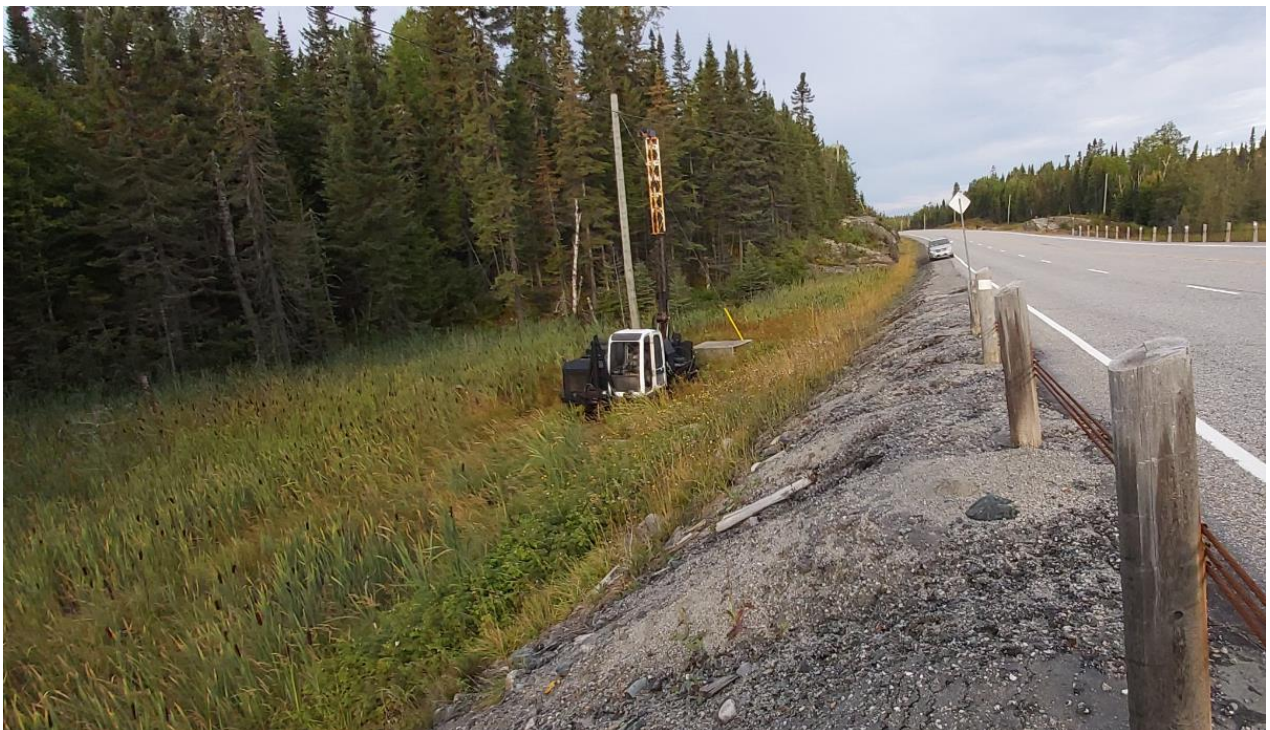
**Photo 6 – Highway 17 - Area 1 – Drilling at BH-19-1-01 - Looking West**

Drilling started in Area 1 using an Acker Soil Sentry track-mounted drilling rig equipped with hollow stem augers. Rock coring was carried out using swivel-type double tube core barrels. The drilling equipment was owned and operated by a specialist drilling contractor known as Tetry Environmental Drilling (Tetry) of Timmins, Ontario. In the time between September 03, 2019 and September 13, 2019, Tetry completed four (4) boreholes in Area 1, and was later replaced by Marathon Underground Constructors Corp. (Marathon) of Greely, Ontario. The remaining boreholes in Area 1 and all boreholes in Area 2, Area 3 and Area 4 were completed by Marathon using CME 55 track mounted drilling rig equipped with hollow stem augers and capable of rock coring.

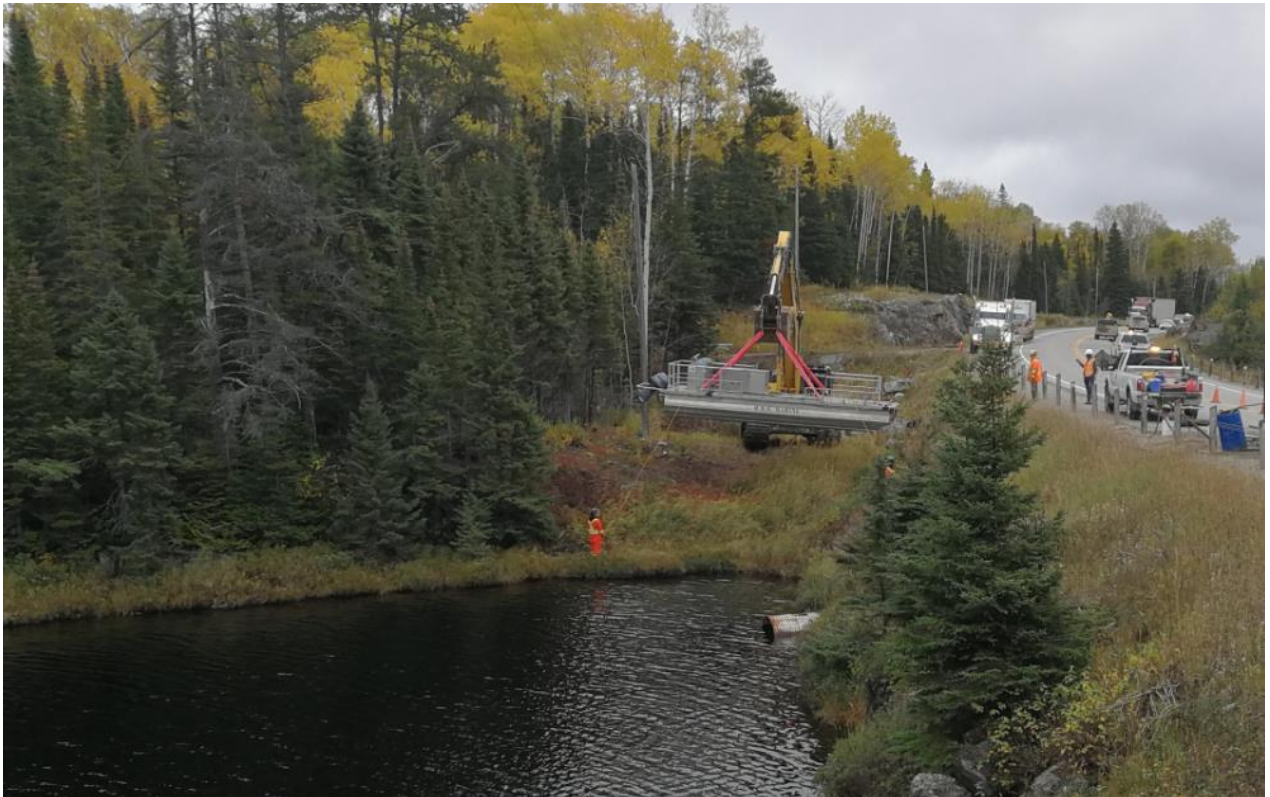
**Photo 13 – Highway 17 - Area 4 – Boat Unloading and Setup – Looking East**

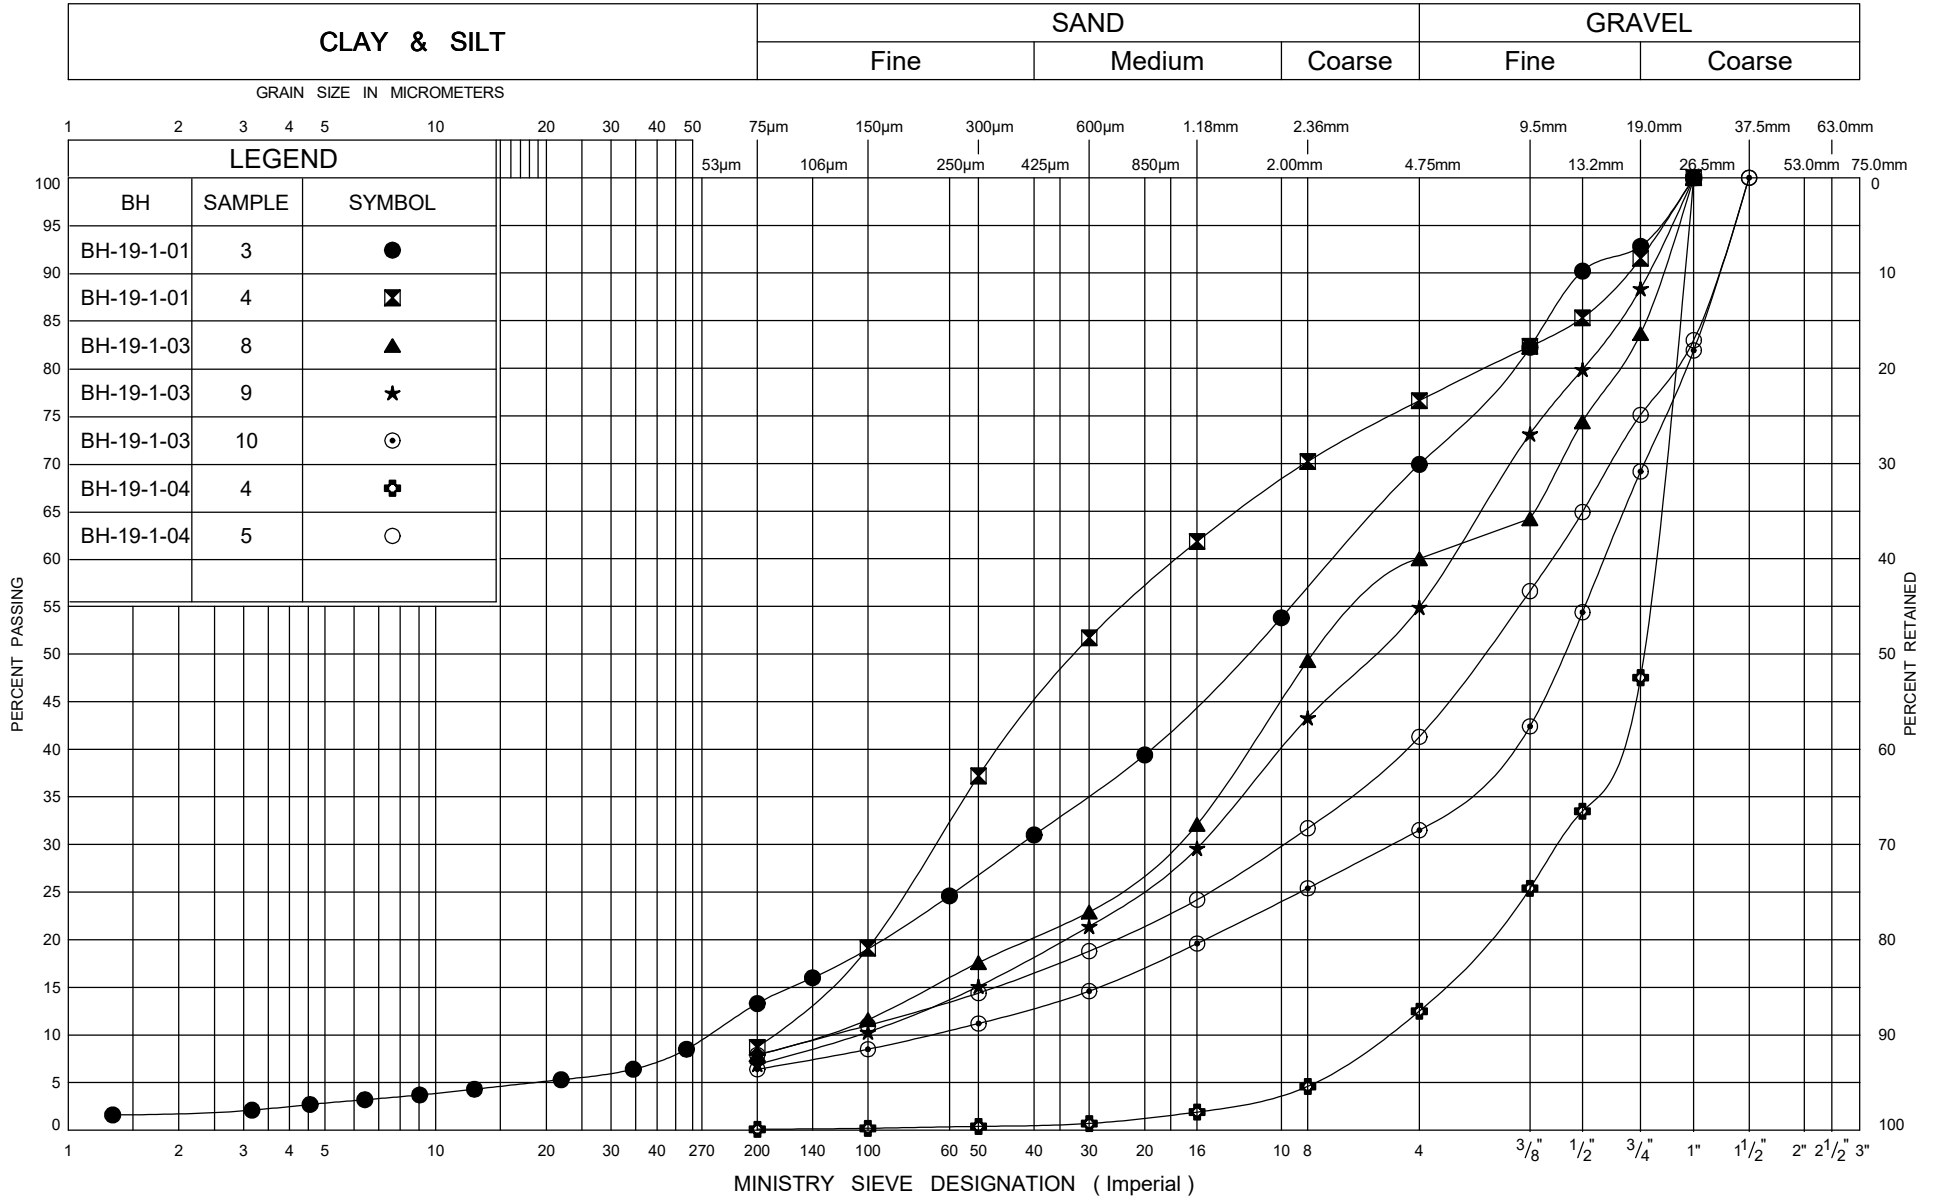
FIG No.:	GSA-1-1
Agreement No.:	5017-E-0043
Work Item No.:	5
G.W.P. No.:	5031-18-00

## GRAIN SIZE DISTRIBUTION

Gravelly with Sand / Sand and Gravel / Sandy Gravel, Trace Silt, Trace Clay

The SPT "N"-values in the sand with gravel /sand and gravel/ sandy gravel layer ranged from 15 blows/300 mm to greater than 100 blows/300 mm, indicating a "compact" to "very dense" state of relative density. In BH-19-1-02, drilling in the upper part of the sand and gravel layer was found to be difficult because of the presence of a higher proportion of gravel and cobbles.

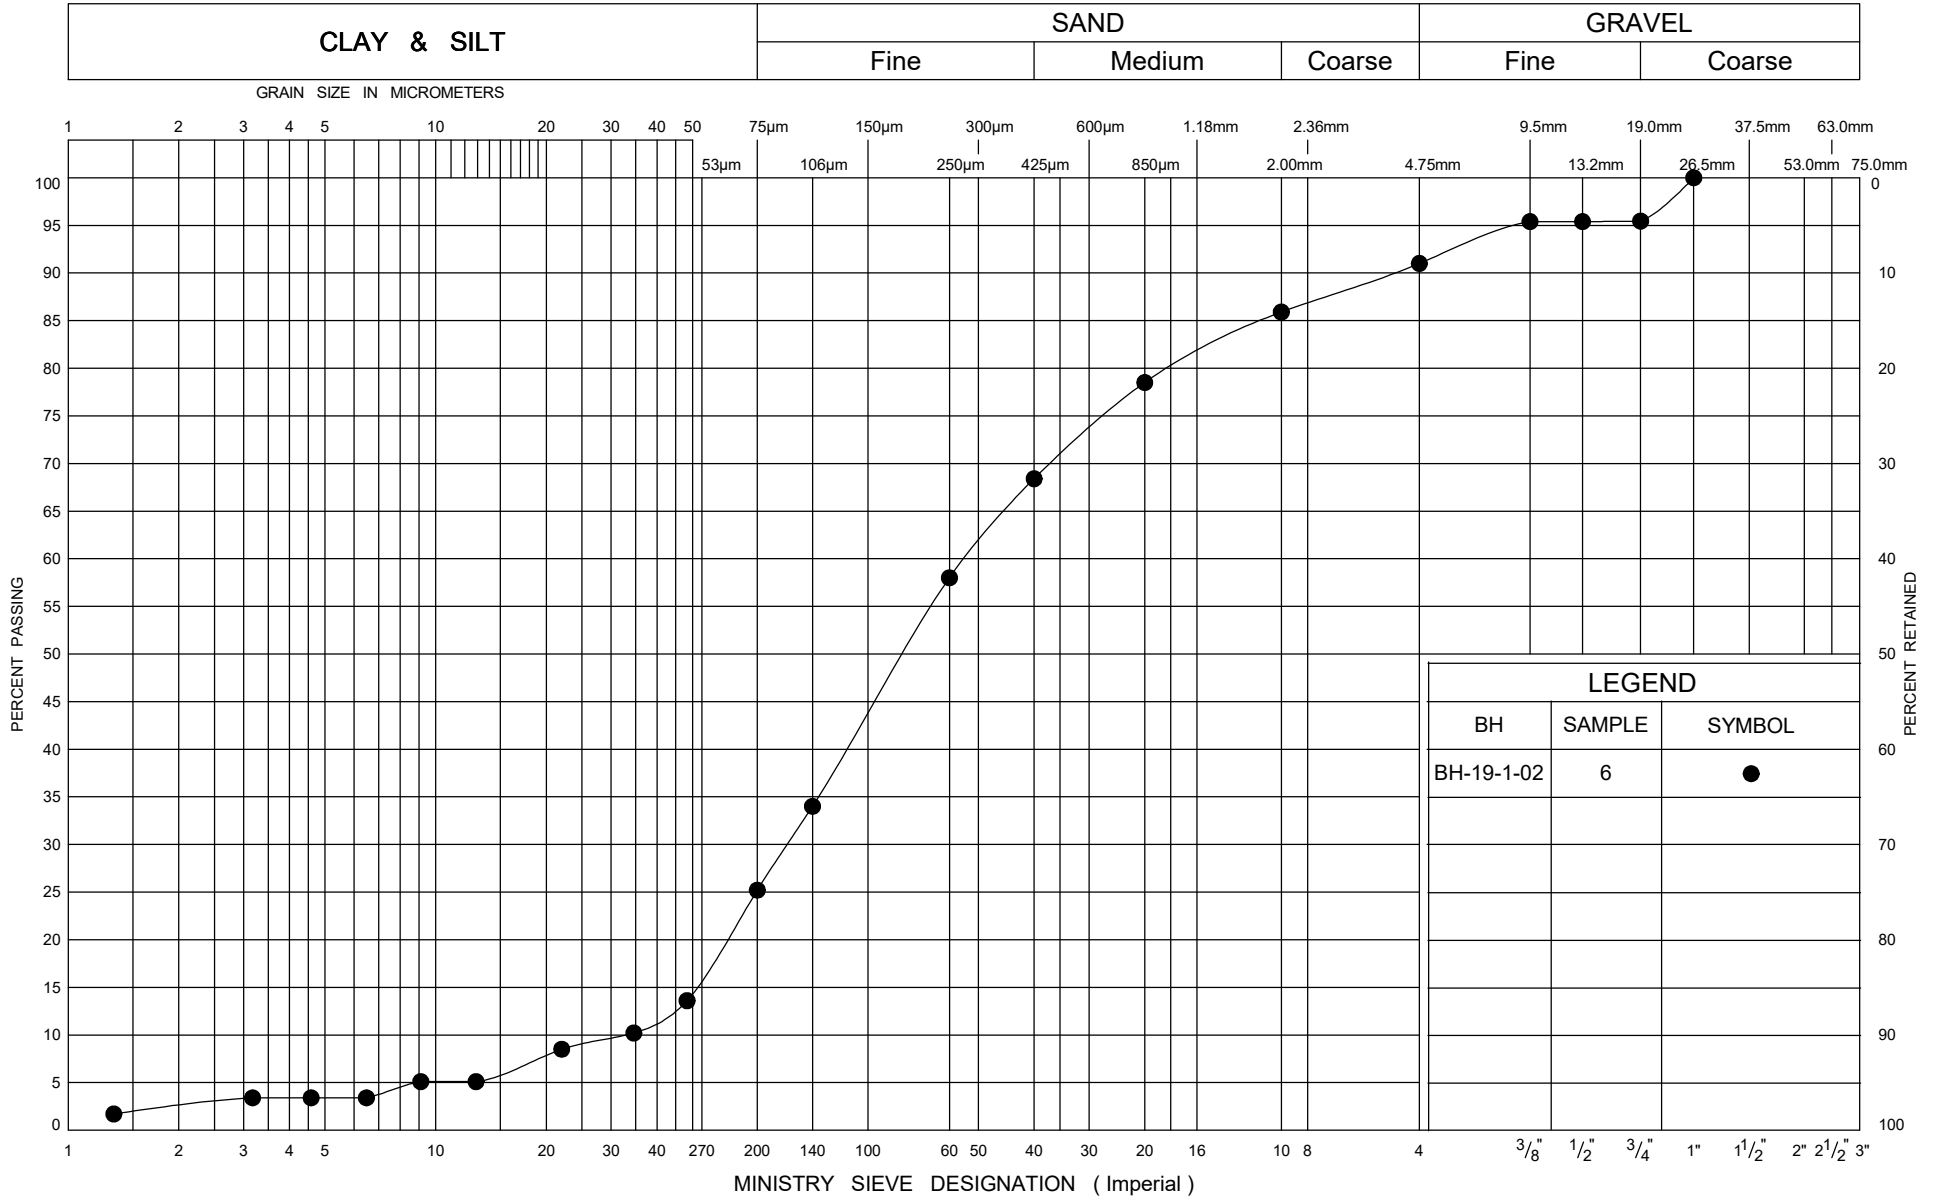
FIG No.:	GSA-1-2
Agreement No.:	5017-E-0043
Work Item No.:	5
G.W.P. No.:	5031-18-00

**GRAIN SIZE DISTRIBUTION**  
Sand with Silt, Trace Gravel, Trace Clay

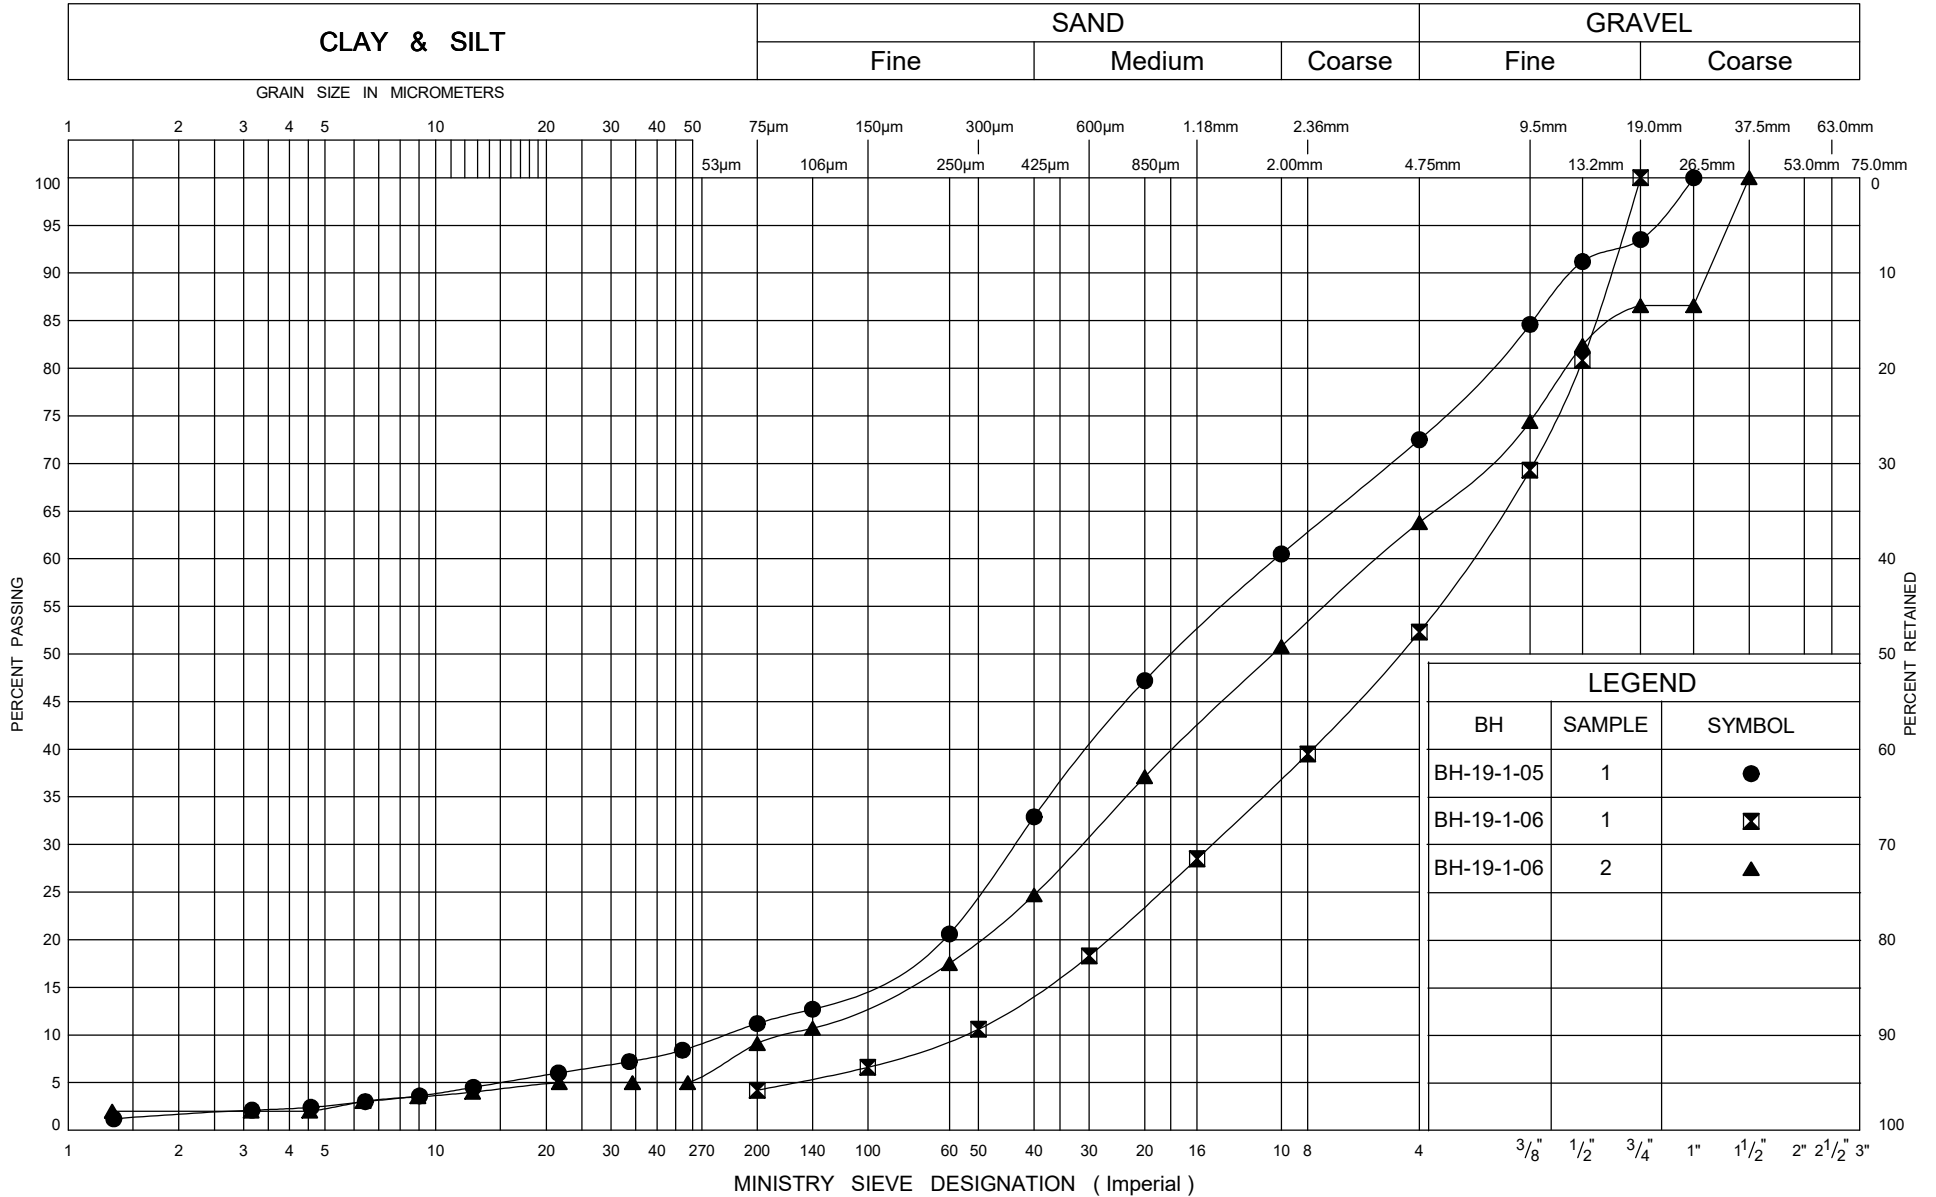
FIG No.:	GSA-1-3
Agreement No.:	5017-E-0043
Work Item No.:	5
G.W.P. No.:	5031-18-00

## GRAIN SIZE DISTRIBUTION

Fill - Sand with Gravel to Sand and Gravel, Trace Silt, Trace Clay, Trace Cobbles

A fill material was encountered beneath the asphalt layer. The fill consisted of sand with gravel to sand and gravel, with trace silt and trace clay. Cobbles and a higher proportion of gravel were also encountered in the upper part of the fill. The fill was brown in color and was dry to moist at the time of drilling. The thickness of the granular fill ranged from 0.6 m to 1.2 m, extending to El. 440.5 m.

Moisture content tests conducted on samples of the fill gave values from 4% to 13%. The high moisture content values correspond to the lower part of the fill with an increased amount of silt.

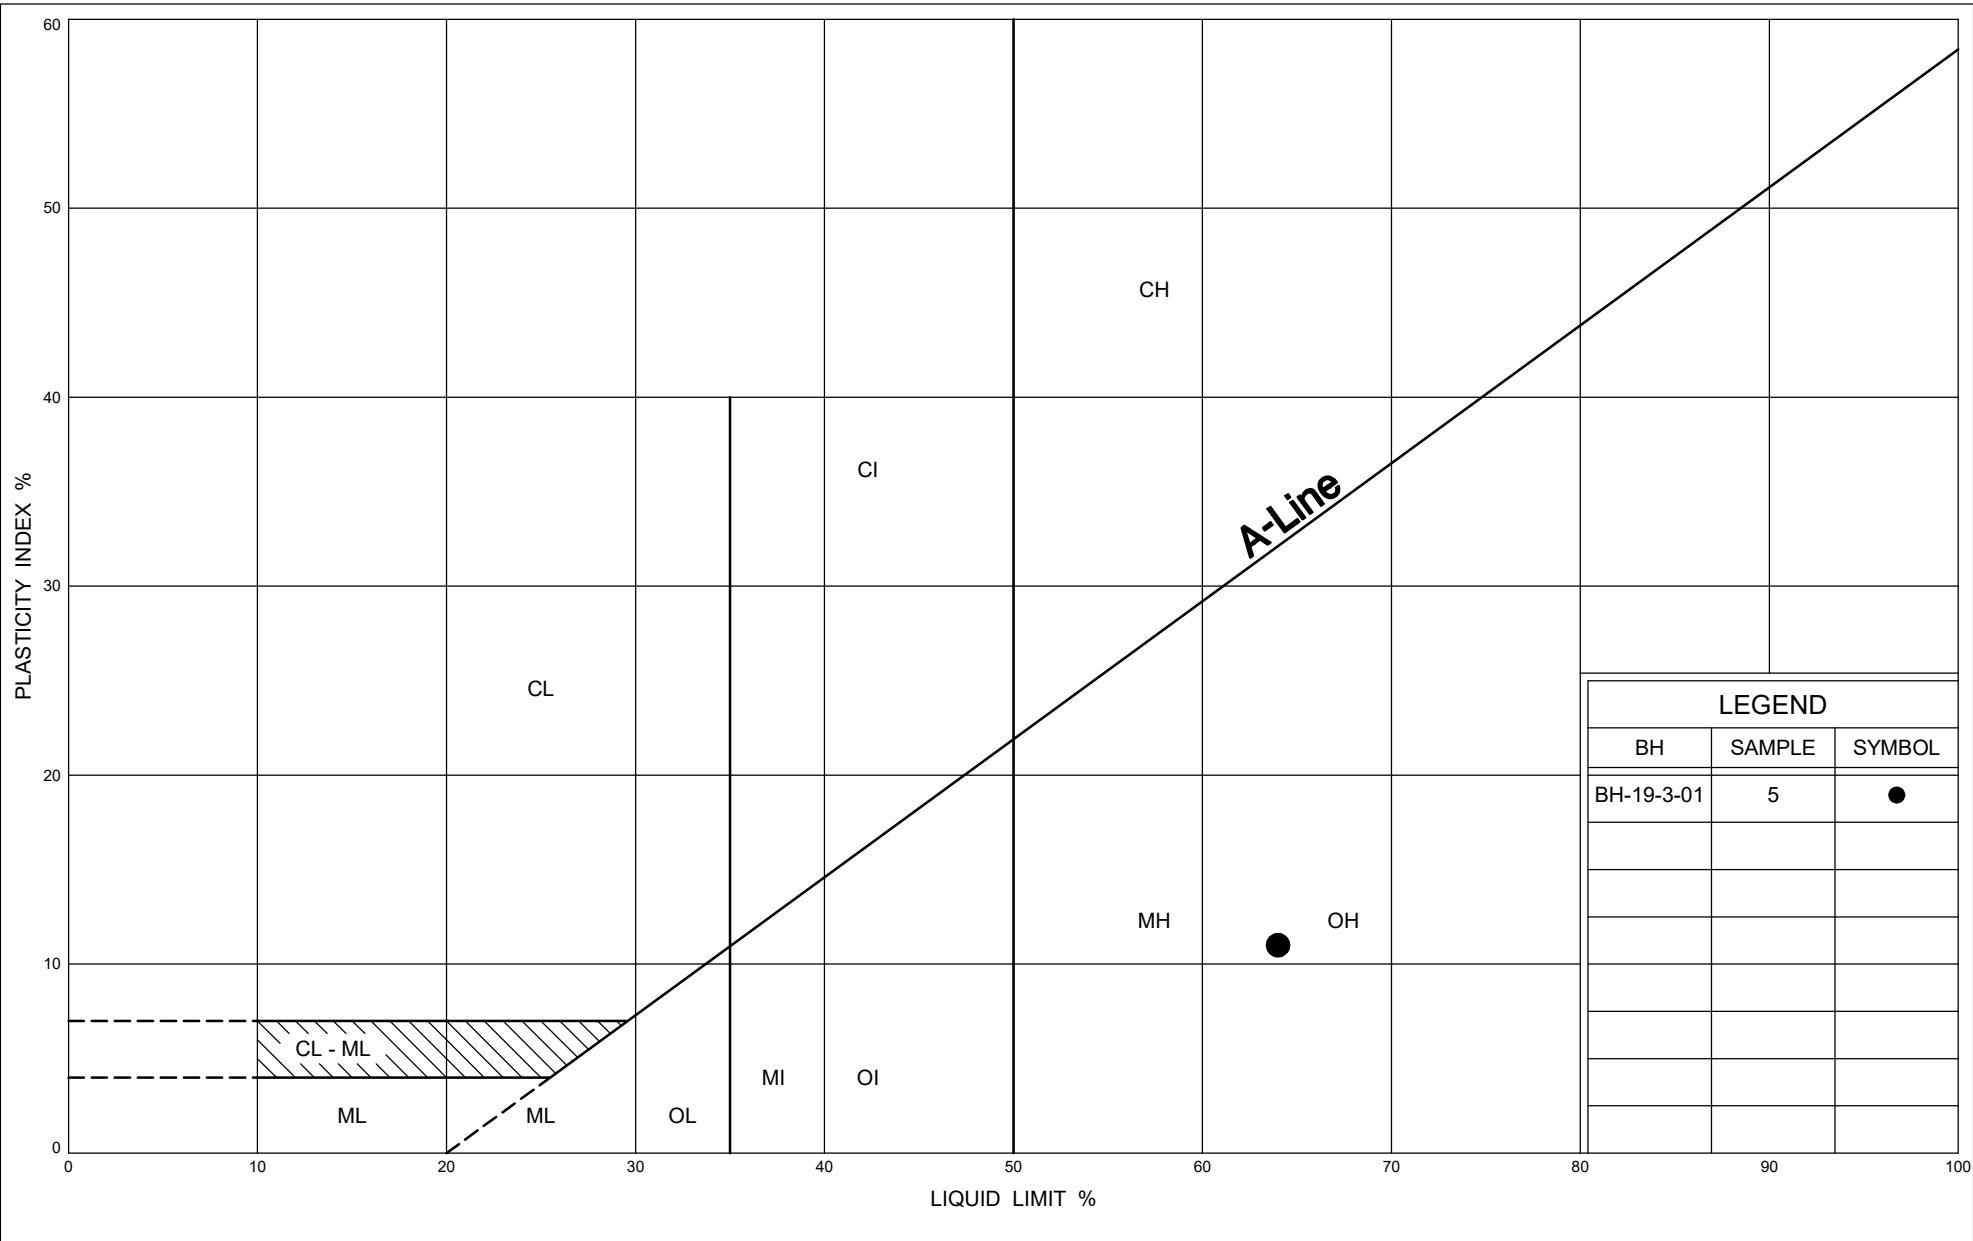
FIG No.:	PC-3-1
Agreement No.:	5017-E-0043
Work Item No.:	5
G.W.P. No.:	5031-18-00

PLASTICITY CHART  
Silty Clay

The moisture content of the silty clay deposit was 144%.

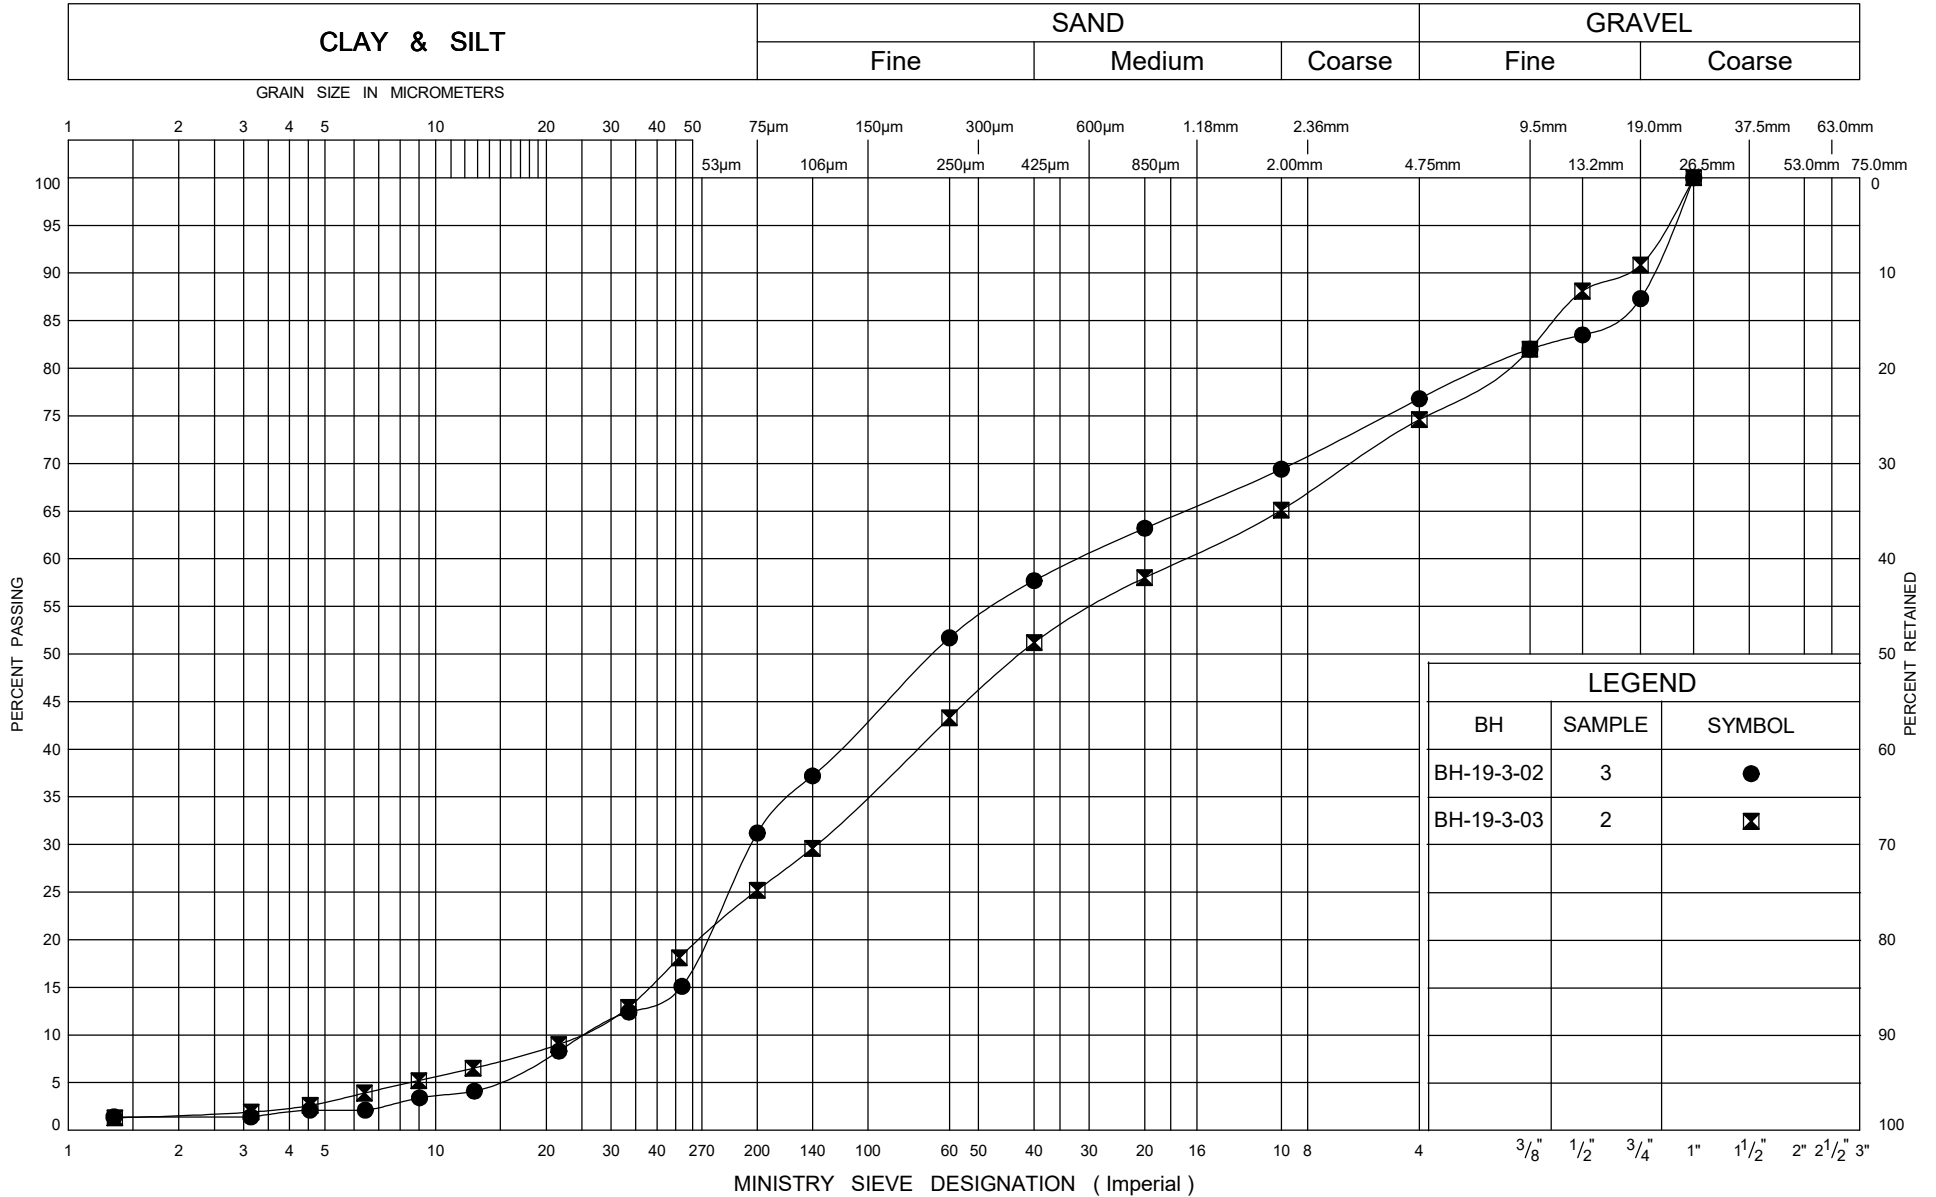
FIG No.:	GSA-3-2
Agreement No.:	5017-E-0043
Work Item No.:	5
G.W.P. No.:	5031-18-00

**GRAIN SIZE DISTRIBUTION**  
Silty Sand with Gravel, Trace Clay

The SPT "N"-values within the silty sand ranged from 4 blows/300 mm to 18 blows/300 mm, suggesting "very loose" to "compact" soil relative density.

The moisture content of samples from the silty sand was in the range of 14.6% to 23%.

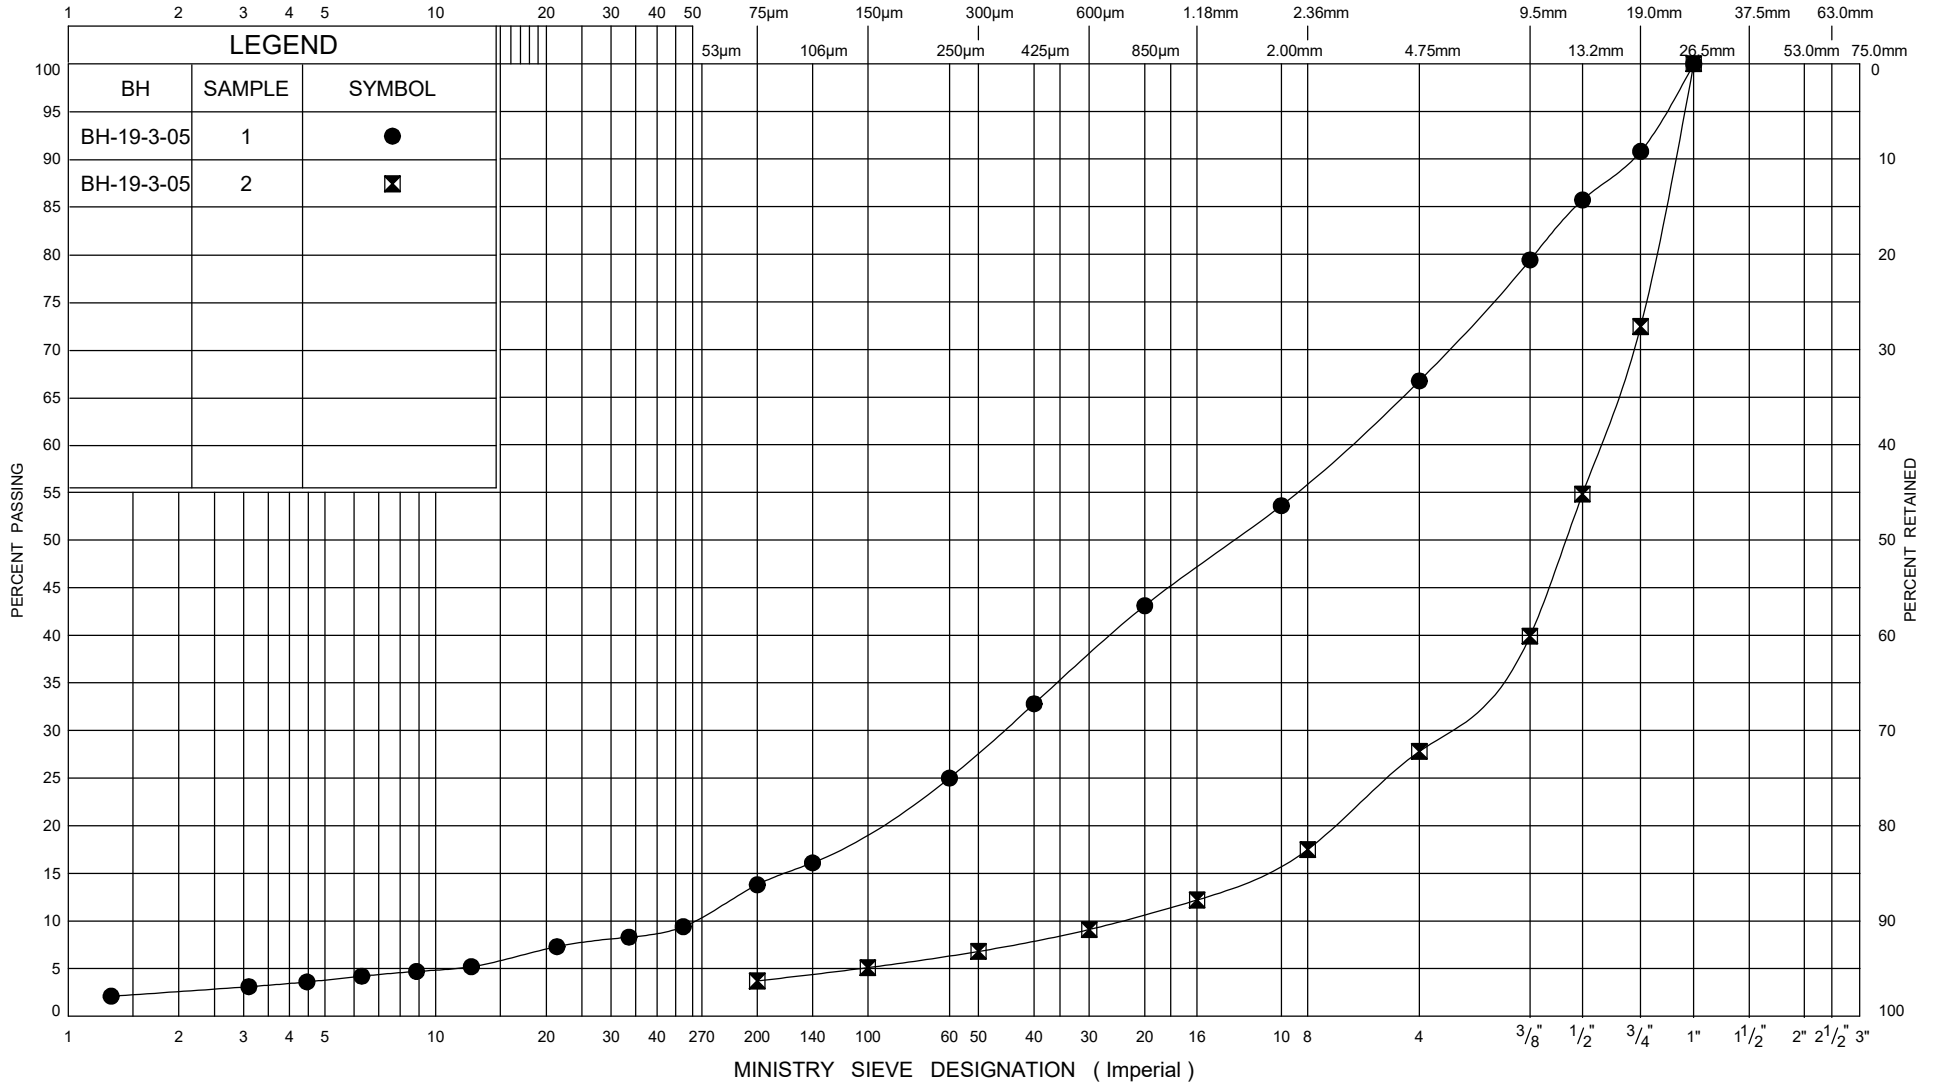
FIG No.:	GSA-3-4
Agreement No.:	5017-E-0043
Work Item No.:	5
G.W.P. No.:	5031-18-00

## GRAIN SIZE DISTRIBUTION

Fill - Gravelly Sand to Sandy Gravel, Some Silt, Trace Clay, Trace Cobbles

A fill material was encountered beneath the asphalt layer. The fill consisted of gravelly sand to sand and gravel, with some silt, trace clay and cobbles. It was brown to grey in color and was dry to moist. The thickness of the fill ranged from 0.8 m to 1 m, extending to El. 463.4 m.

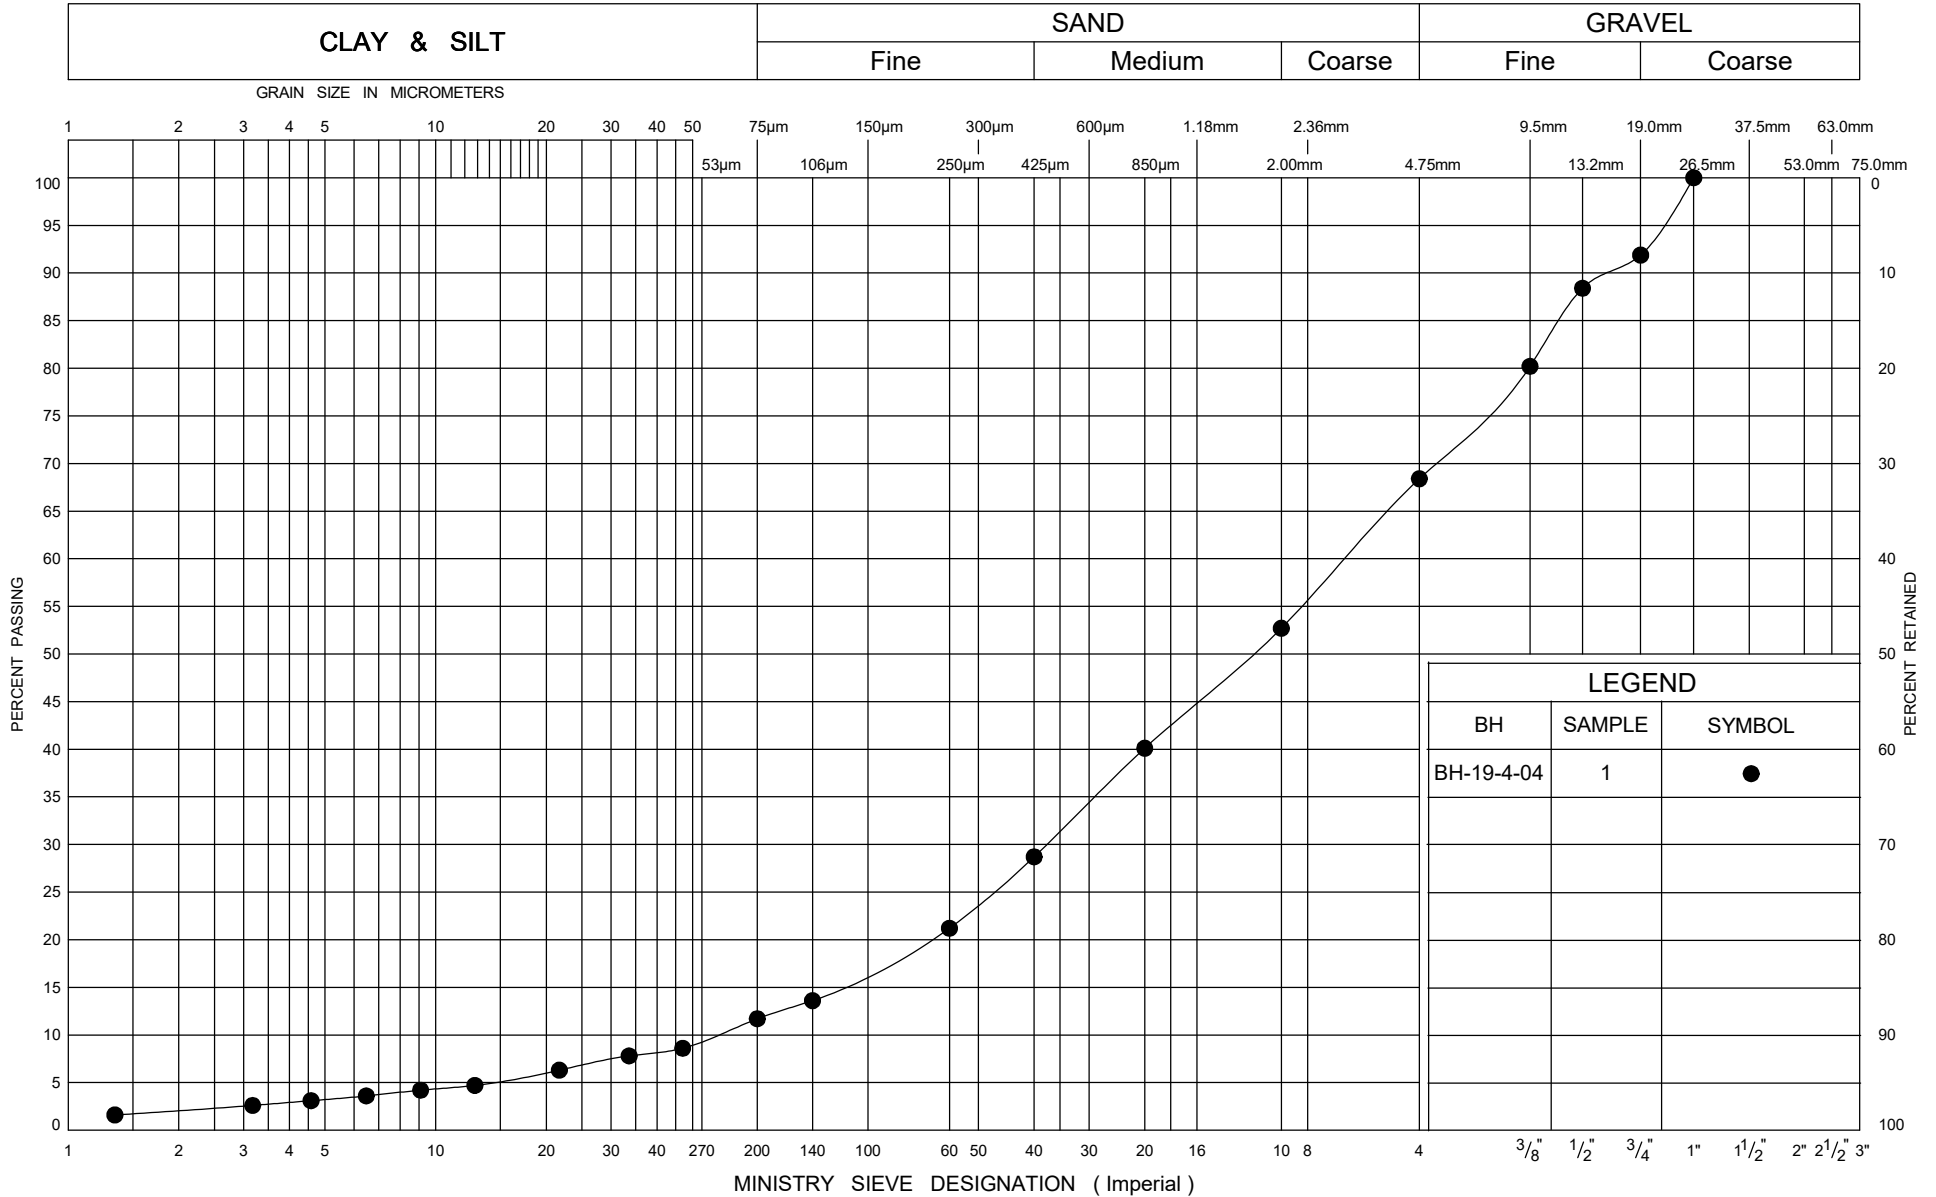
FIG No.:	GSA-4-3
Agreement No.:	5017-E-0043
Work Item No.:	5
G.W.P. No.:	5031-18-00

GRAIN SIZE DISTRIBUTION

Fill - Gravelly Sand, Some Silt, Trace Clay, Trace Cobbles

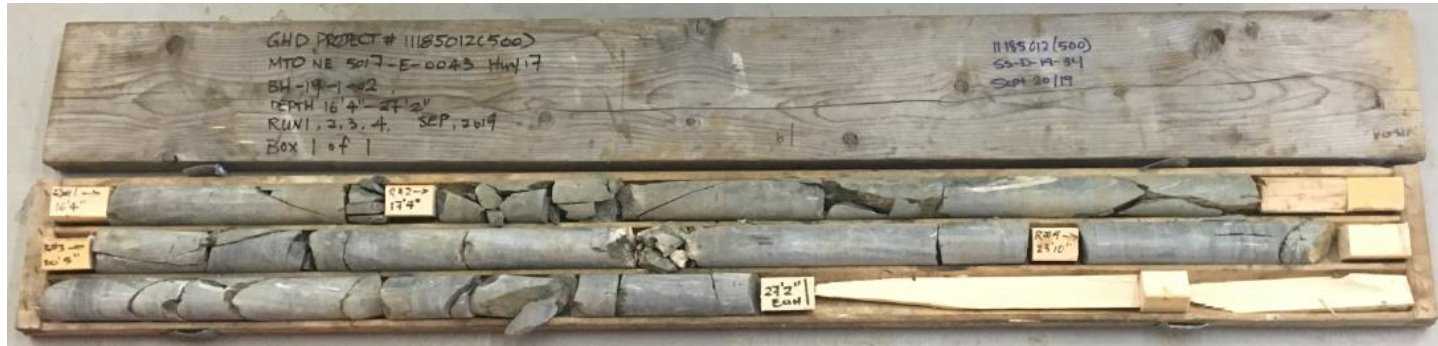
Photo 19 – Highway 17 - Area 1 - BH-19-1-02, R1 = 5.0 m – 5.4 m, R2 = 5.4 m – 6.2 m, R3 = 6.2 m – 7.3 m, and R4 = 7.3 m – 8.3 m

The bedrock encountered in all three boreholes was described to be Greenstone. It was dark green to black in color, fine to medium grained, weakly to moderately foliated, and consisted of quartz and plagioclase crystals in a fine matrix of dark minerals. The rock cores were slightly weathered and moderately to well fractured, and were medium to hard (based on geological hammer and knife test).

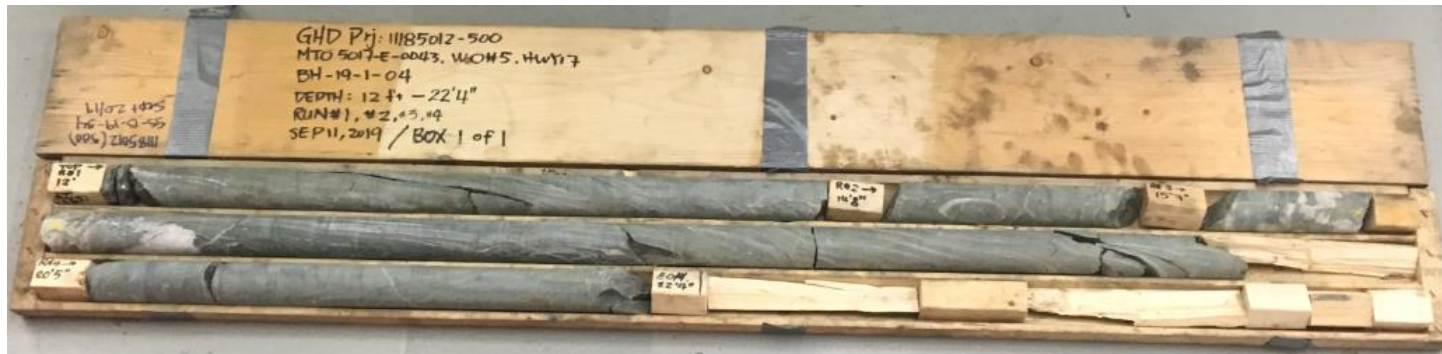
Photo 20 – Highway 17 – Area 1 - BH-19-1-04, R1 = 3.7 m – 4.4 m, R2 = 4.4 m – 4.7 m, R3 = 4.7 m – 6.2 m, and R4 = 6.2 m – 6.8 m

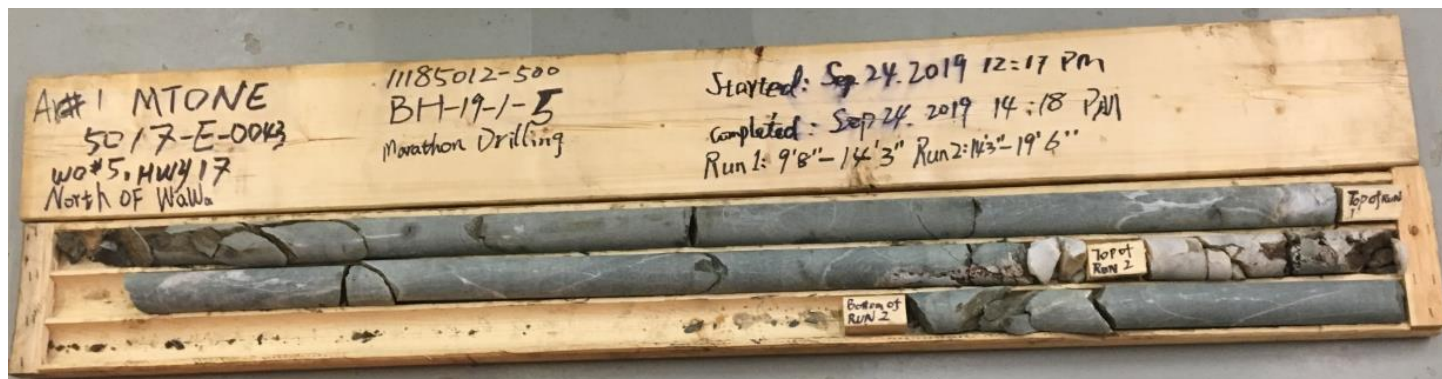
Photo 21 – Highway 17 – Area 1 - BH-19-1-05, R1 = 2.9 m – 4.3 m, and R2 = 4.3 m – 5.9 m

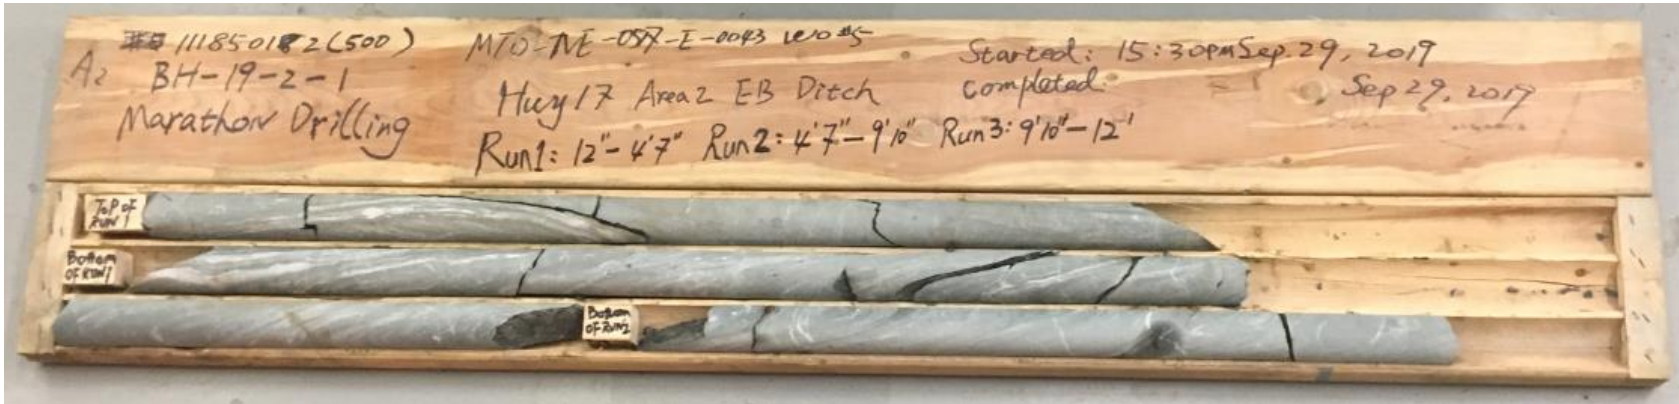
Photo 22 – Highway 17 - Area 2 - BH-19-2-01, R1 = 0.3 m – 1.4 m, R2 = 1.4 m – 3.0 m, R3 = 3.0 m – 3.7 m

The bedrock encountered in the two boreholes was described to be Greenstone, and was the same as the type of rock exposed at road cuts and surface exposures in the area. It was dark green to black in color, fine to medium grained, weakly to moderately foliated, and consisted of quartz and plagioclase crystals in a fine matrix of dark minerals. The rock cores were slightly weathered and moderately to highly fractured, and were medium to hard (based on geological hammer and knife test).

Measured Core Recovery (REC) in BH-19-2-01 ranged from 98% to 100%. In BH-19-2-02, the REC was in the range of 93% to 100%. The Rock Quality Designation (RQD) values ranged from 67% to 81% in BH-19-2-01, and 33% to 90% in BH-19-2-02. Based on the RQD values, the quality of the rock mass near BH-19-2-01 was described to be “fair” to “excellent”, while the quality of the rock mass around BH-19-2-02 was “poor” to “good”. Especially, the core run corresponding to the upper part of the bedrock in BH-19-2-02 was highly fractured, and indicated a “very poor” rock mass quality.

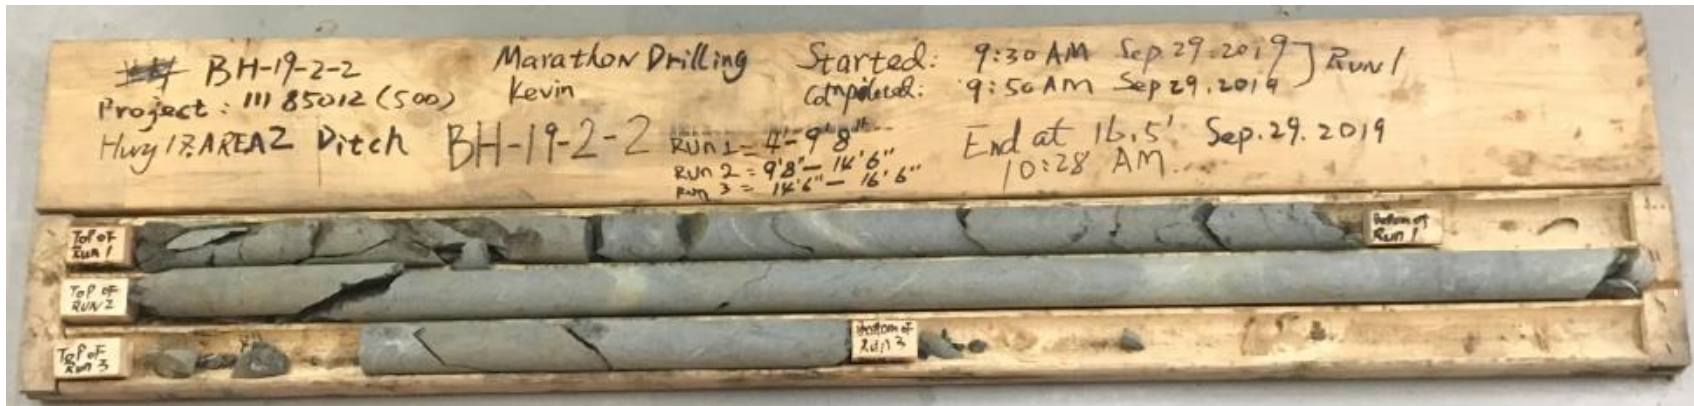
Photo 23 – Highway 17 – Area 2 - BH-19-2-02, R1 = 1.4 m – 2.9 m, R2 = 2.9 m – 4.4 m, R3 = 4.4 m – 5.0 m
