# Part A - Foundation Investigation Report

**HIGHWAY 17 WIDENING  
AREA 1 (STA. 10+400 – 10+600), AREA 2 (STA. 11+050 – 11+160)  
AREA 3 (STA. 11+525 – 11+600), AREA 4 (STA. 12+350 – 12+480)  
TOWNSHIP OF DAMBROSSIO  
AREA 7 (STA. 16+700 – 16+825)  
TOWNSHIP OF LALIBERT  
DISTRICT OF ALGOMA  
BETWEEN WHITE RIVER AND WAWA, ONTARIO**

AGREEMENT NO. 5017-E-0043  
WORK ITEM: #5  
GWP 5031-18-00

GHD Ref.: 11185012-500

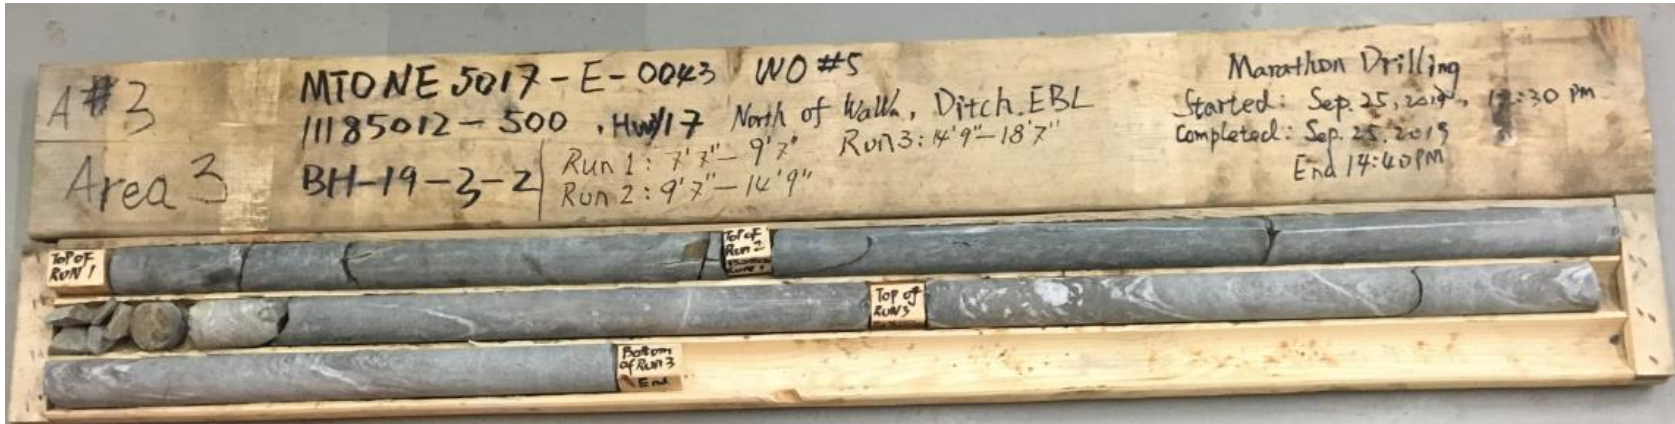
Photo 24 – Highway 17 - Area 3 - BH-19-3-02, R1 = 2.3 m – 2.8 m, R2 = 2.8 m – 4.5 m, R3 = 4.5 m – 5.7 m

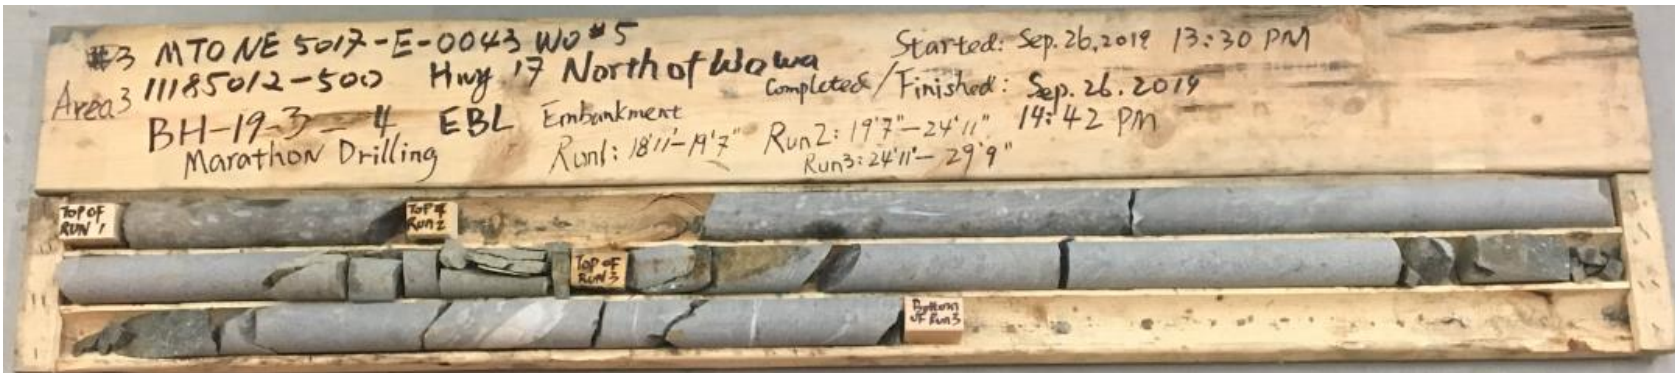
Photo 25 – Highway 17 – Area 3 - BH-19-3-04, R1 = 5.8 m – 6.1 m, R2 = 6.1 m – 7.6 m, R3 = 7.6 m – 9.1 m

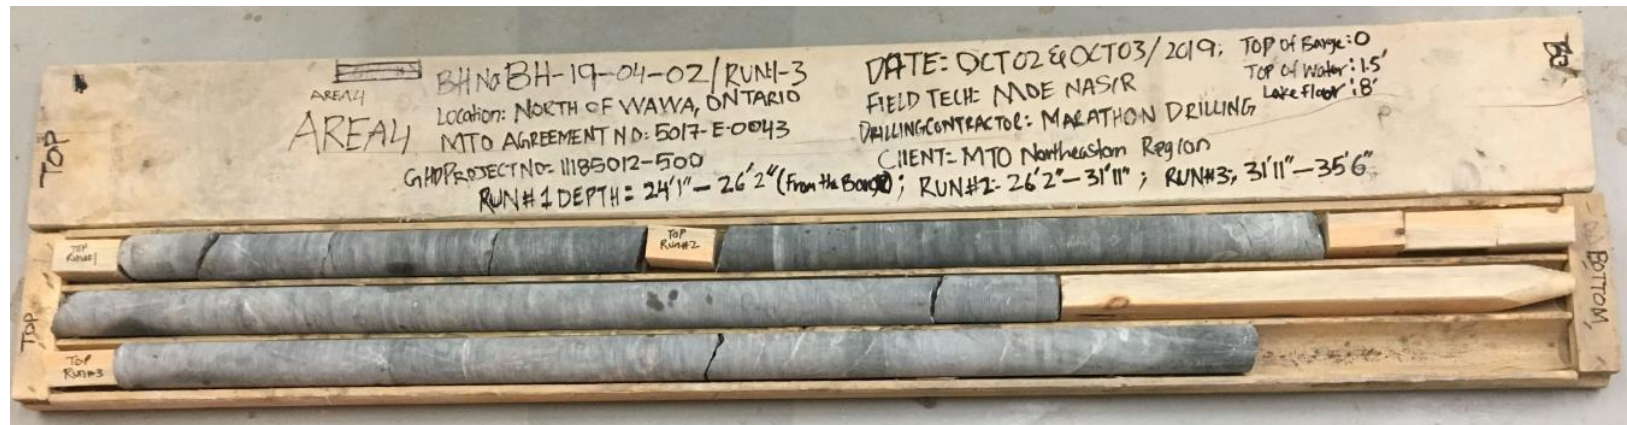
**Photo 25 – Highway 17 – Area 4 - BH-19-4-02, R1 = 7.2 m – 7.8 m, R2 = 7.8 m – 9.8 m, R3 = 9.8 m – 10.8 m**

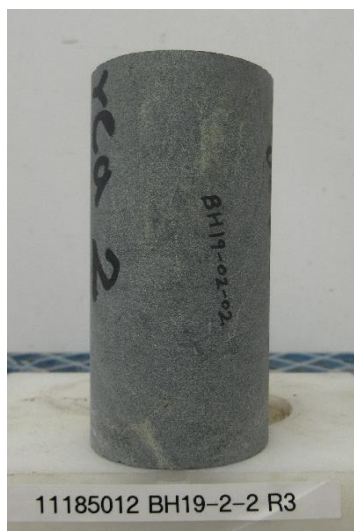
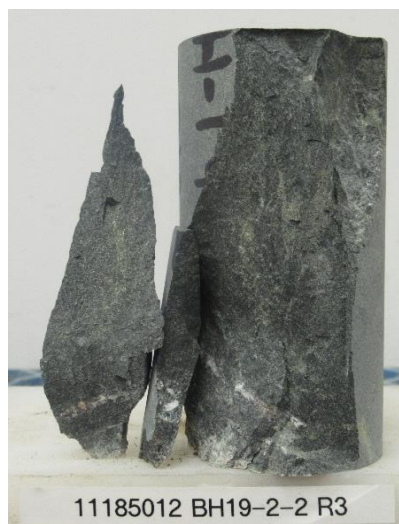
Initial Specimen Parameters	
Diameter, cm	4.7
Height, cm	10.0
Height-to-Diameter Ratio	2.1
Volume, cm <sup>3</sup>	174.3
Mass, g	526.8
Bulk Density, kg/m <sup>3</sup>	3023
Moisture Condition	As Received
Moisture Content, %	-----

Maximum Applied Load, kN	346.3
Compressive Strength, MPa	199.3

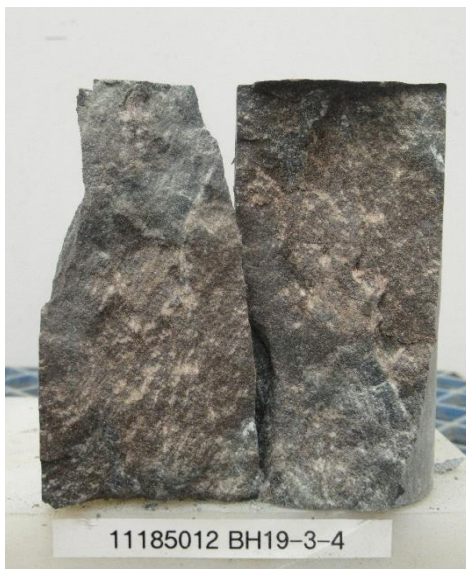
Initial Specimen Parameters	
Diameter, cm	4.7
Height, cm	9.8
Height-to-Diameter Ratio	2.1
Volume, cm <sup>3</sup>	170.6
Mass, g	487.1
Bulk Density, kg/m <sup>3</sup>	2855
Moisture Condition	As Received
Moisture Content, %	----

Maximum Applied Load, kN	136.4
Compressive Strength, MPa	78.6

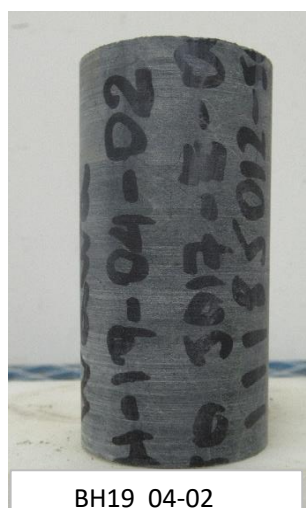
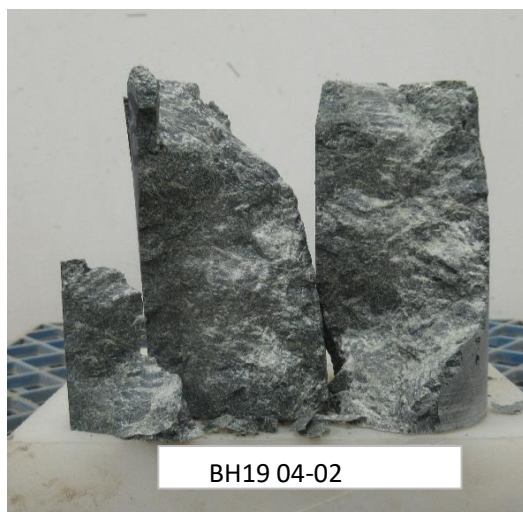
BH19 04-02

Initial Specimen Parameters	
Diameter, cm	4.7
Height, cm	10.0
Height-to-Diameter Ratio	2.1
Volume, cm <sup>3</sup>	176.9
Mass, g	534.1
Bulk Density, kg/m <sup>3</sup>	3019
Moisture Condition	As Received
Moisture Content, %	-----

Maximum Applied Load, kN	210.9
Compressive Strength, MPa	119.5
