**PRELIMINARY FOUNDATION INVESTIGATION REPORT
HIGHWAY 401 WIDENING, HIGHWAY 16 TO MAITLAND ROAD
MAITLAND ROAD U/P REPLACEMENT, SITE NO. 16X-0126/B0
GWP 4024-20-00 / ASSIGNMENT NO. 4019-E-0010.2**

SITE NO. 16X-0126/B0

Geocres No.: 31B12-001

March 2024
Thurber File No.: 29381

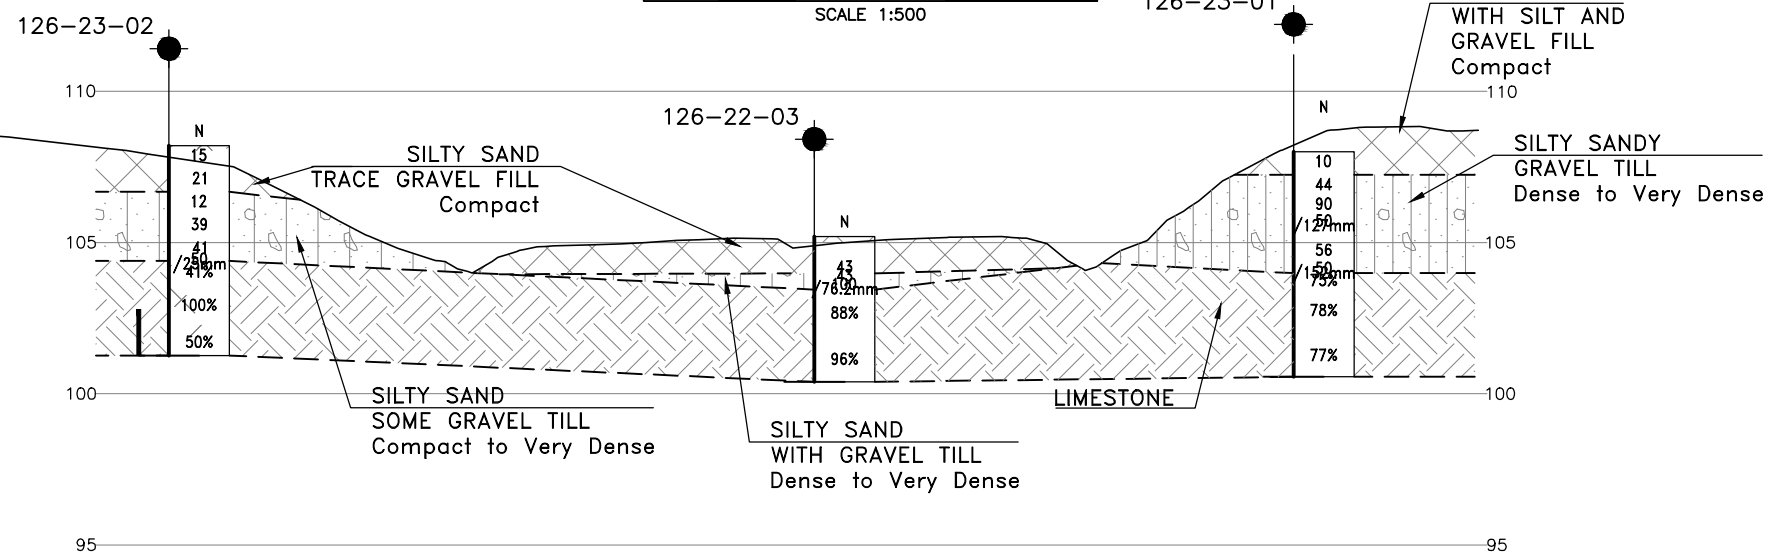
HIGHWAY 401
MAITLAND ROAD
BRIDGE REPLACEMENT
BOREHOLE LOCATIONS AND SOIL STRATA

PROFILE ALONG PROPOSED MAITLAND ROAD

Details of the encountered soil stratigraphy are presented on the Record of Borehole sheets included in Appendix B and the Borehole Location and Soil Strata Drawing included in Appendix A. A general description of the stratigraphy based on the conditions encountered in the boreholes is given in the following sections. However, the factual data presented on the Borehole Records takes precedence over the Soil Strata Drawing and the general description. It must be recognized that the soil and groundwater conditions may vary between and beyond borehole locations. Soil classification is in accordance with ASTM D2487. Description of cohesive soils and secondary components are described as outlined in the MTO Guideline for Foundation Engineering Services Manual (April 2022).

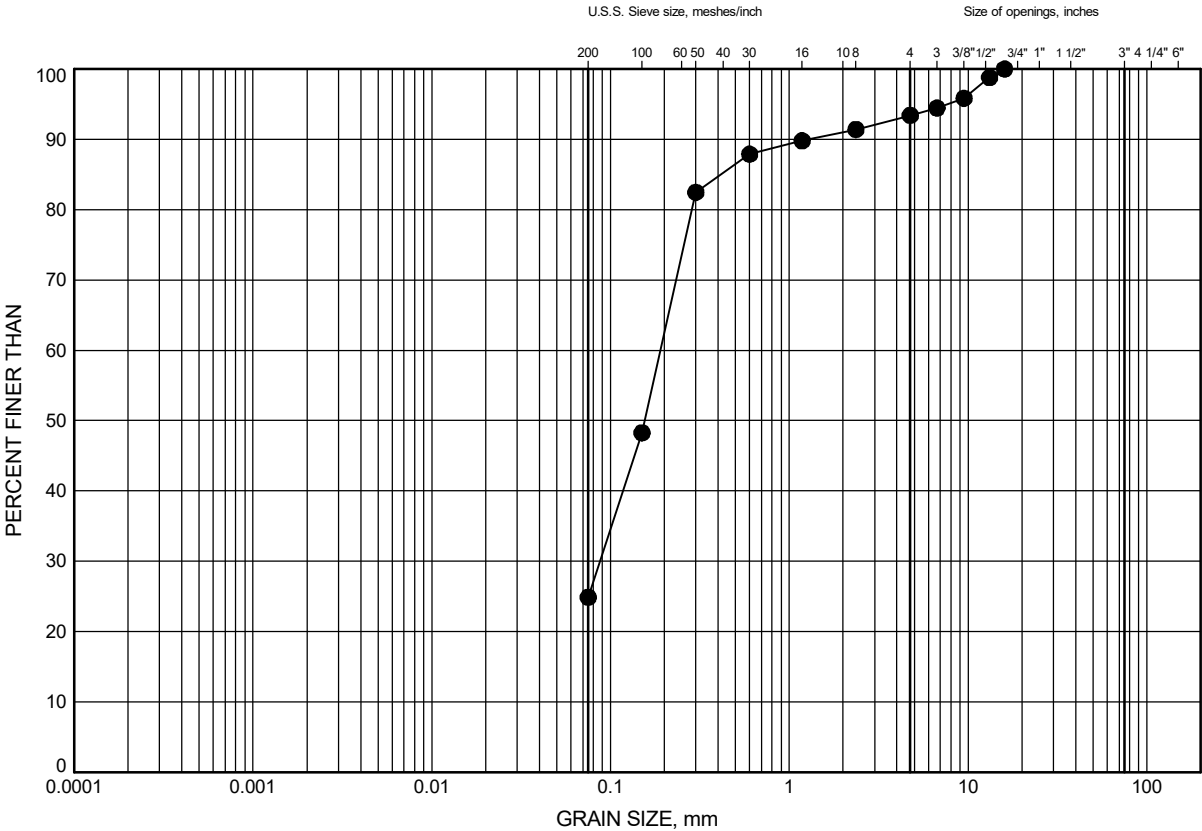
GRAIN SIZE DISTRIBUTION

FILL: Silty Sand trace Gravel

The recorded moisture contents within the fill ranged from 5 to 21%. The results of gradation analyses completed on one sample of the silty sand fill are illustrated on Figure C1 of Appendix C. The results of the tests are summarized below and on the Record of Boreholes sheets in Appendix B.

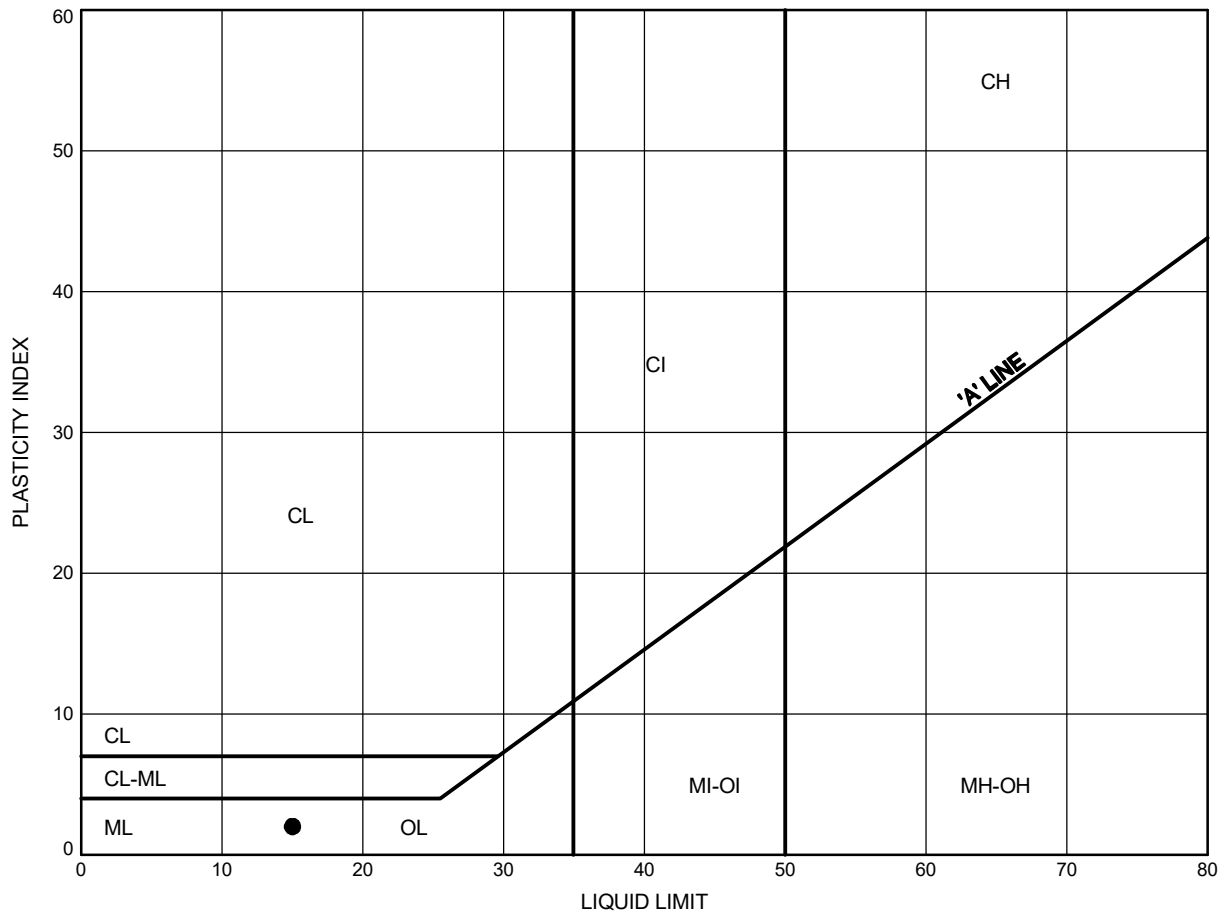
FIGURE C2

GLACIAL TILL

The recorded moisture content of samples of the glacial till ranged from 1 to 18%. Results of Atterberg Limit testing carried out on the fines portion of one sample of the glacial till are illustrated in Figure C2 of Appendix C. The results of this test are summarized below and on the Record of Borehole sheet in Appendix B. The laboratory results indicate that the fines portion exhibit low plastic behaviour (ML).

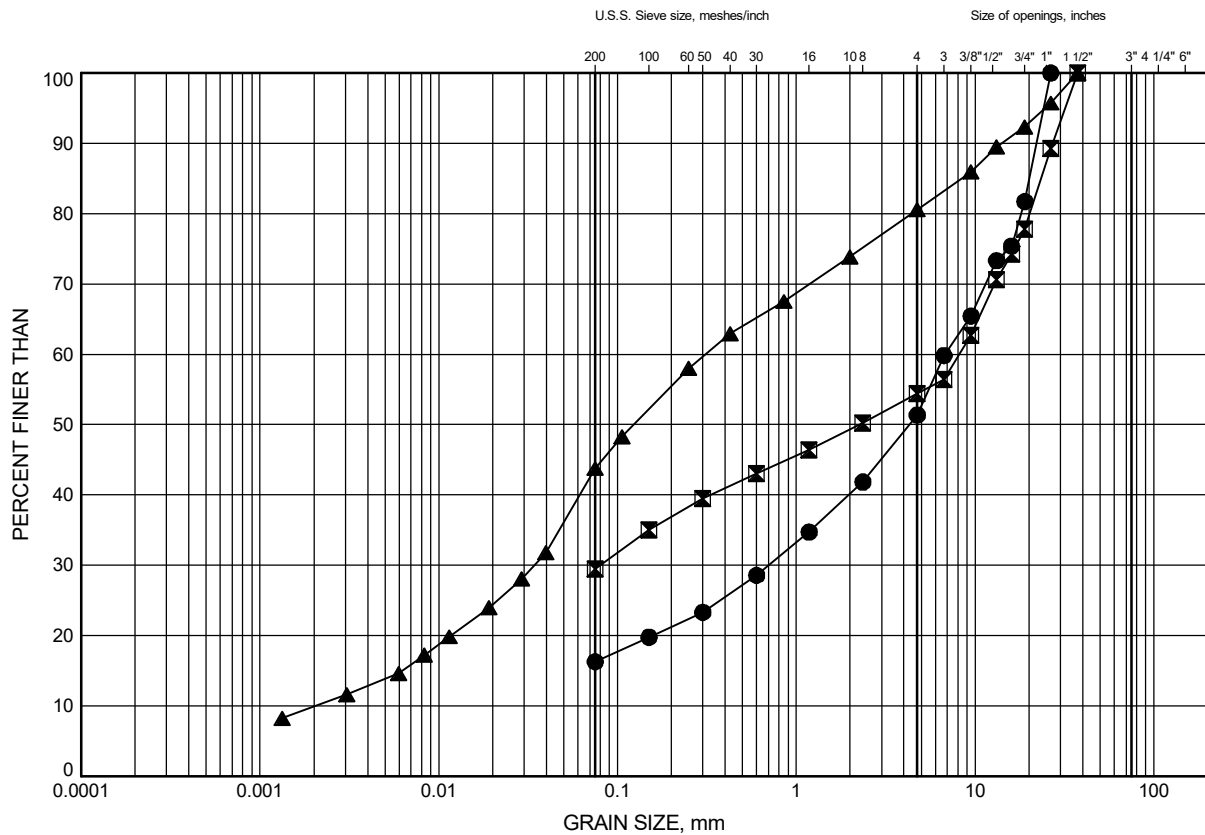
GRAIN SIZE DISTRIBUTION

GLACIAL TILL

The results of gradation analyses completed on three samples of the glacial till are illustrated on Figure C3 of Appendix C. The results of the tests are summarized below and on the Record of Boreholes sheets in Appendix B.

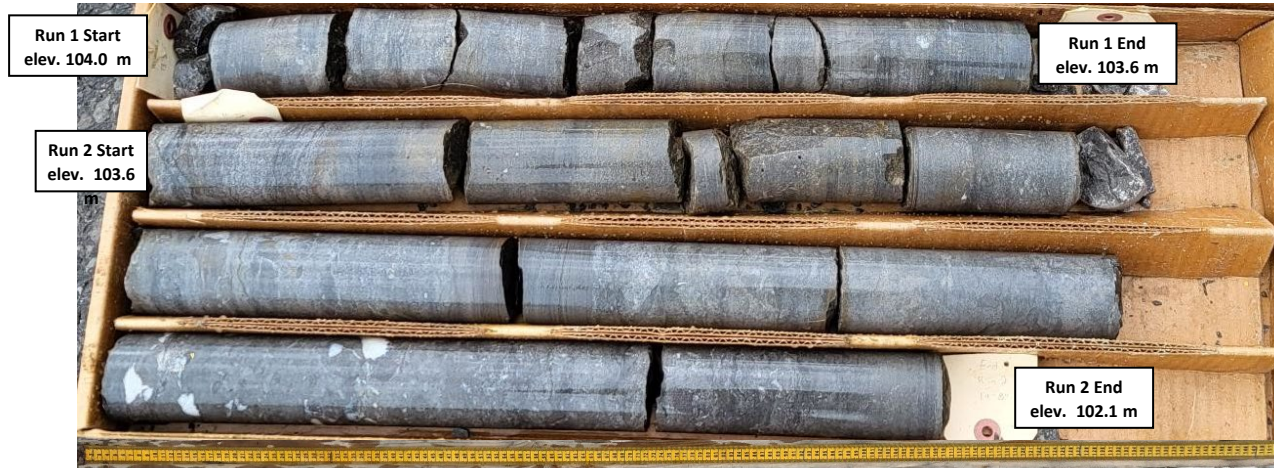
Borehole 126-23-01
Runs 1 to 2
Depth 4 to 5.9 m
Elevation 104.0 to 102.1 m
Wet Sample

The rock core quality and strength are summarized in Table 5-2 below. Based on the RQD, the bedrock quality is classified as fair to excellent (CFEM, 2006). The result of an unconfined compressive strength test (UCS) was 149 MPa, indicating that the tested sample of bedrock is very strong (CFEM, 2006). The results of the UCS testing are included in Appendix C.

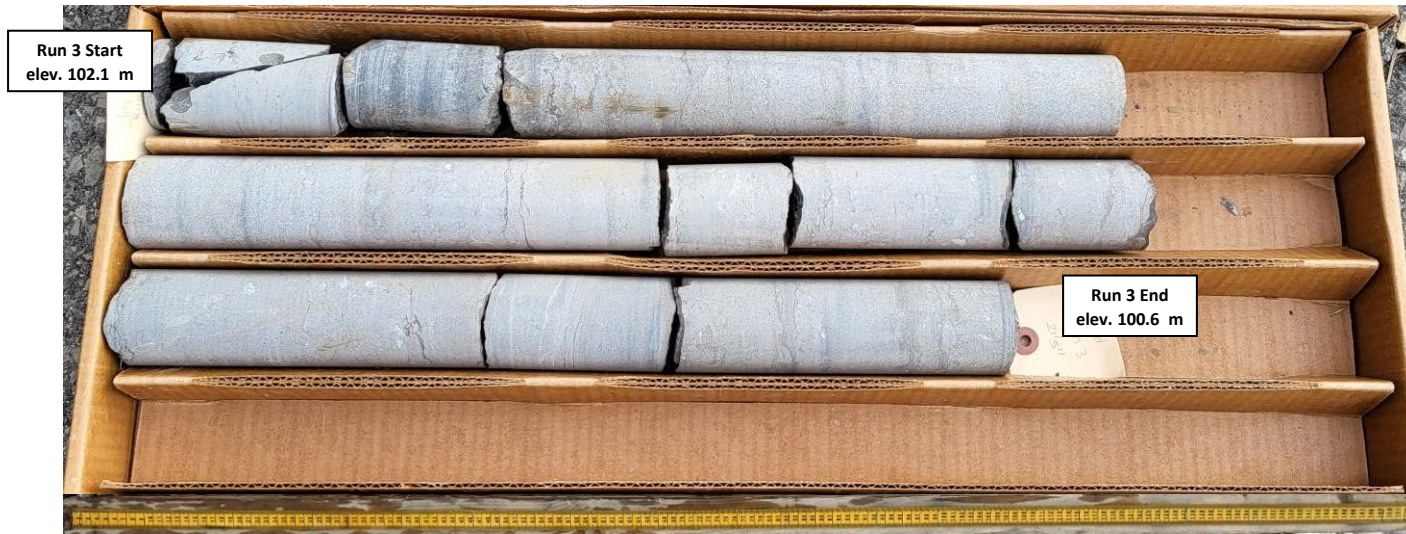
Borehole 126-23-01
Runs 3
Depth 5.9 to 7.4 m
Elevation 102.1 to 100.6 m
Dry Sample

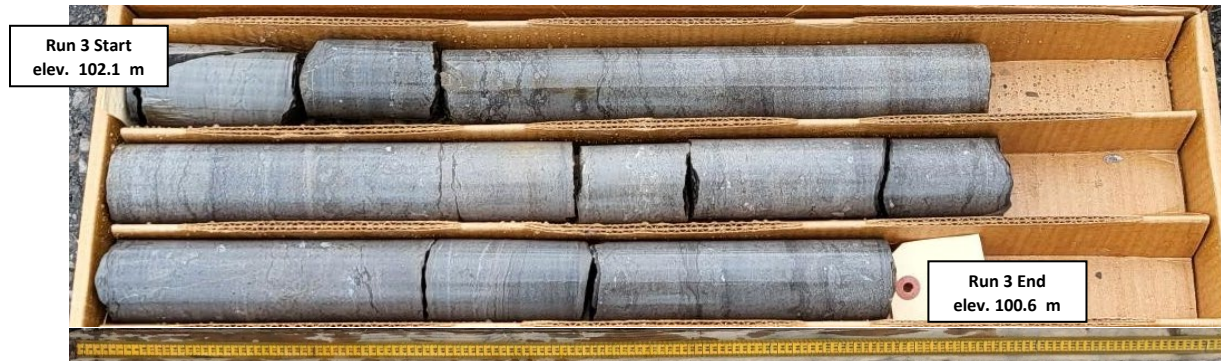
Borehole 126-23-01
Runs 3
Depth 5.9 to 7.4 m
Elevation 102.1 to 100.6 m
Wet Sample

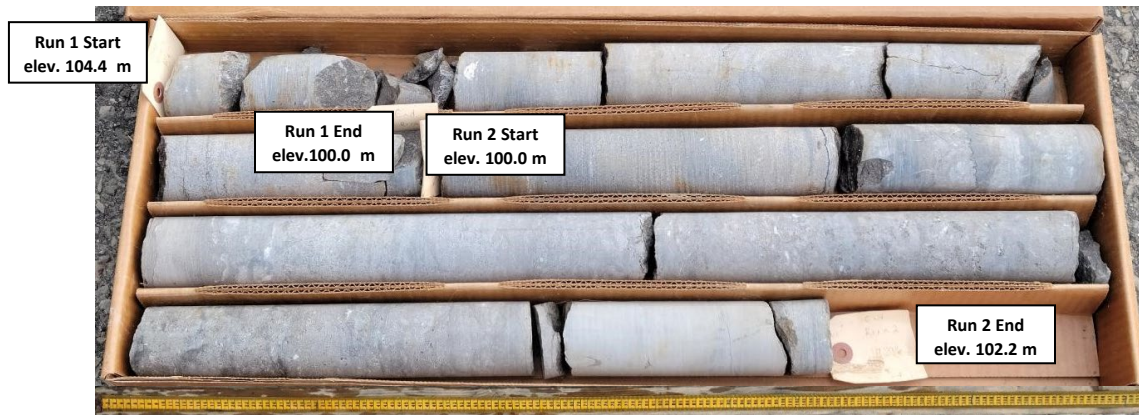
Borehole 126-23-02
Runs 1 to 2
Depth 3.8 to 6.0 m
Elevation 104.4 to 102.2 m
Dry Sample

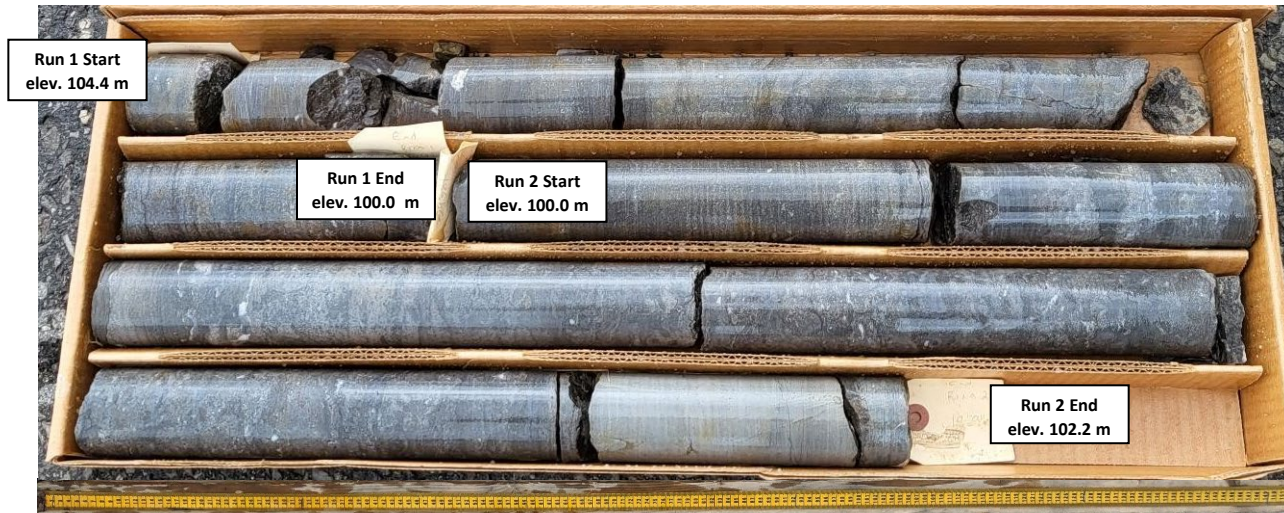
Elevation 104.4 to 102.2 m

Wet Sample

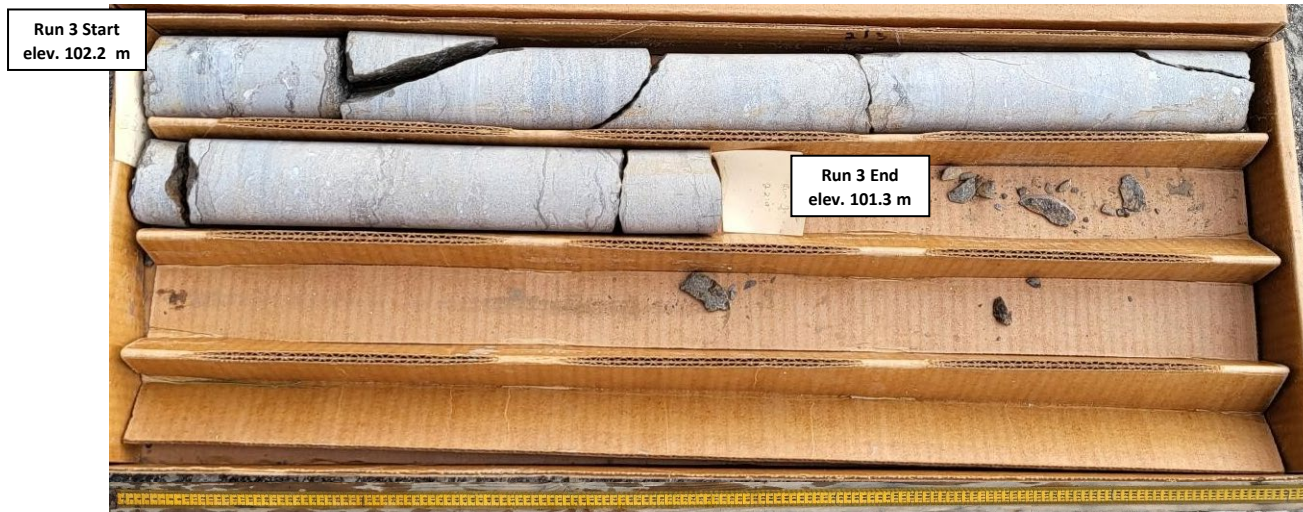
Borehole 126-23-02
Runs 3
Depth 6.0 to 6.9 m
Elevation 102.2 to 101.3 m
Dry Sample

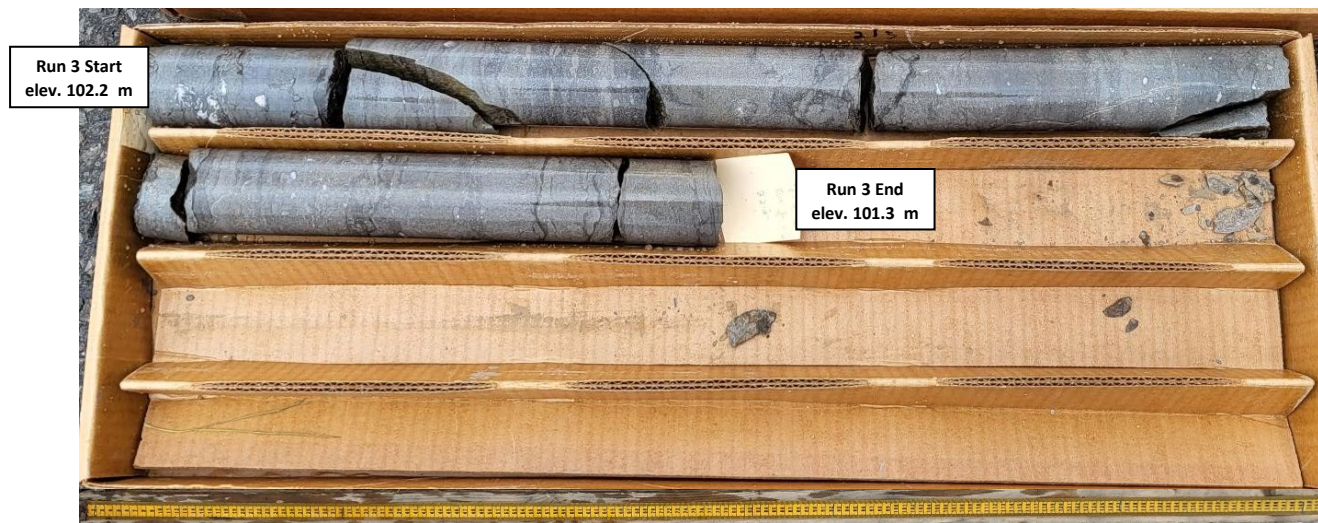
Borehole 126-23-02
Runs 3
Depth 6.0 to 6.9 m
Elevation 102.2 to 101.3 m
Wet Sample

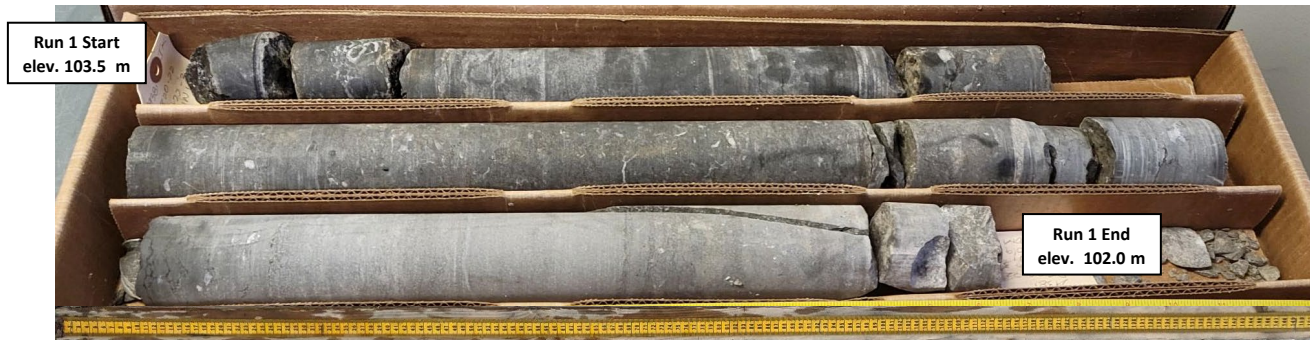
Borehole 126-23-03

Elevation 103.5 to 102.0 m

Dry Sample

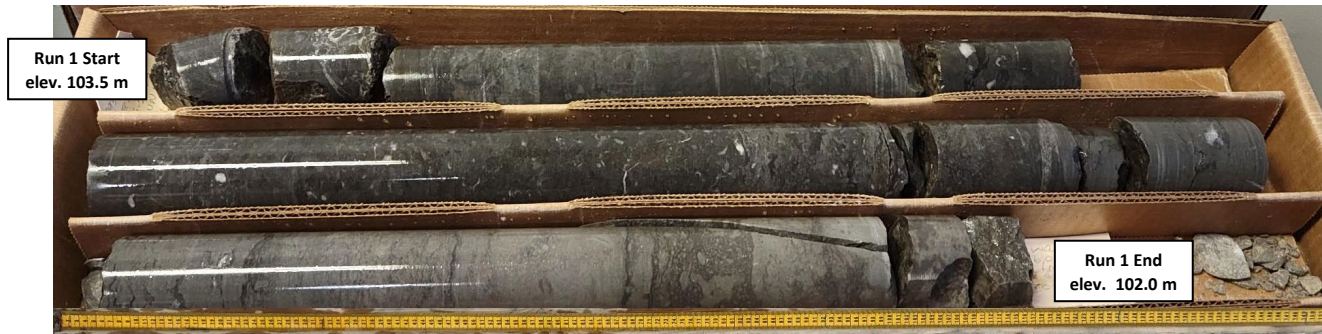
Borehole 126-23-03

Elevation 103.5 to 102.0 m

Wet Sample

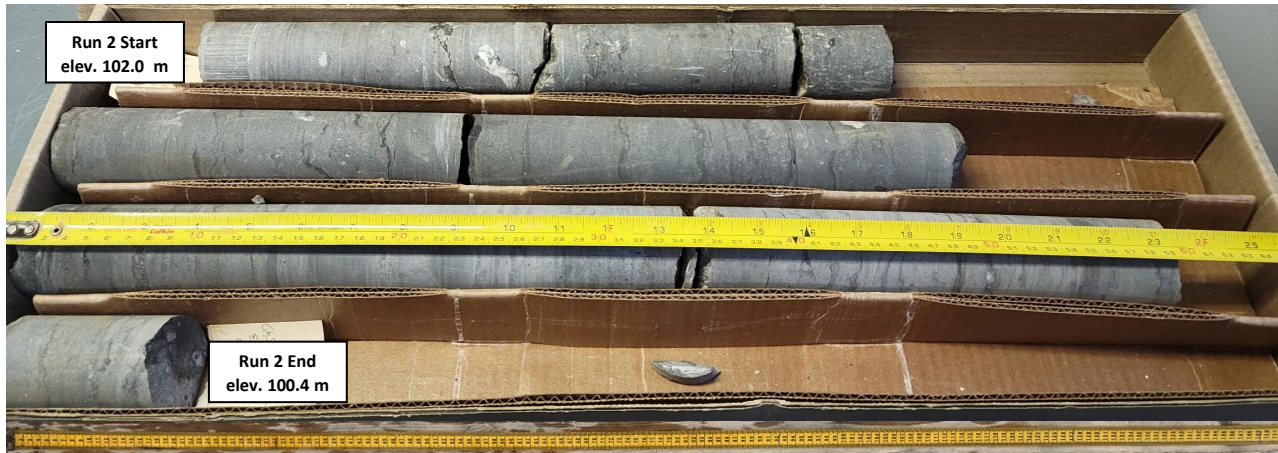
Borehole 126-23-03

Elevation 102.0 to 100.4 m

Dry Sample

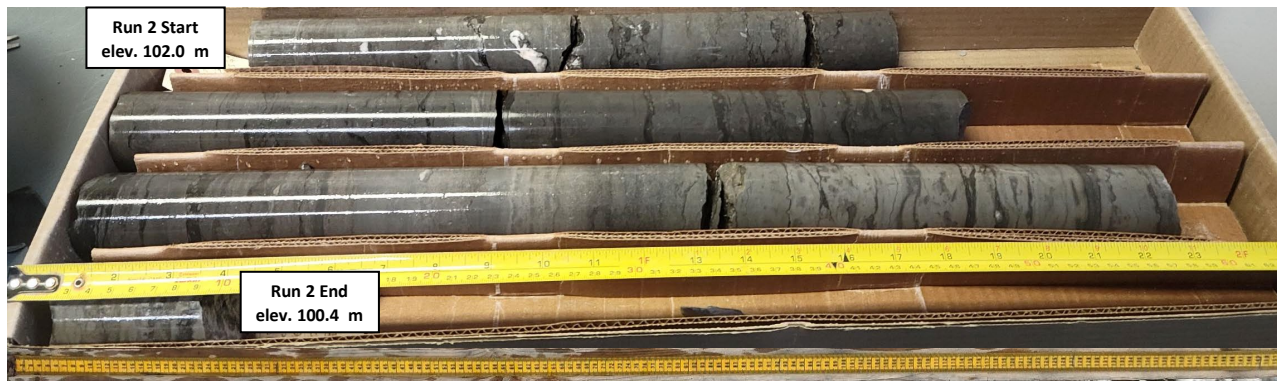
Borehole 126-23-03

Elevation 102.0 to 100.4 m

Wet Sample
