**PRELIMINARY FOUNDATION INVESTIGATION REPORT
HIGHWAY 401 WIDENING, HIGHWAY 16 TO MAITLAND ROAD
HIGHWAY 401 STA. 13+075 CULVERT REHABILITATION
SITE NO. 16X-0250/C0
GWP 4024-20-00 / ASSIGNMENT NO. 4019-E-0010.2**

January 2023
Thurber File No.: 29381

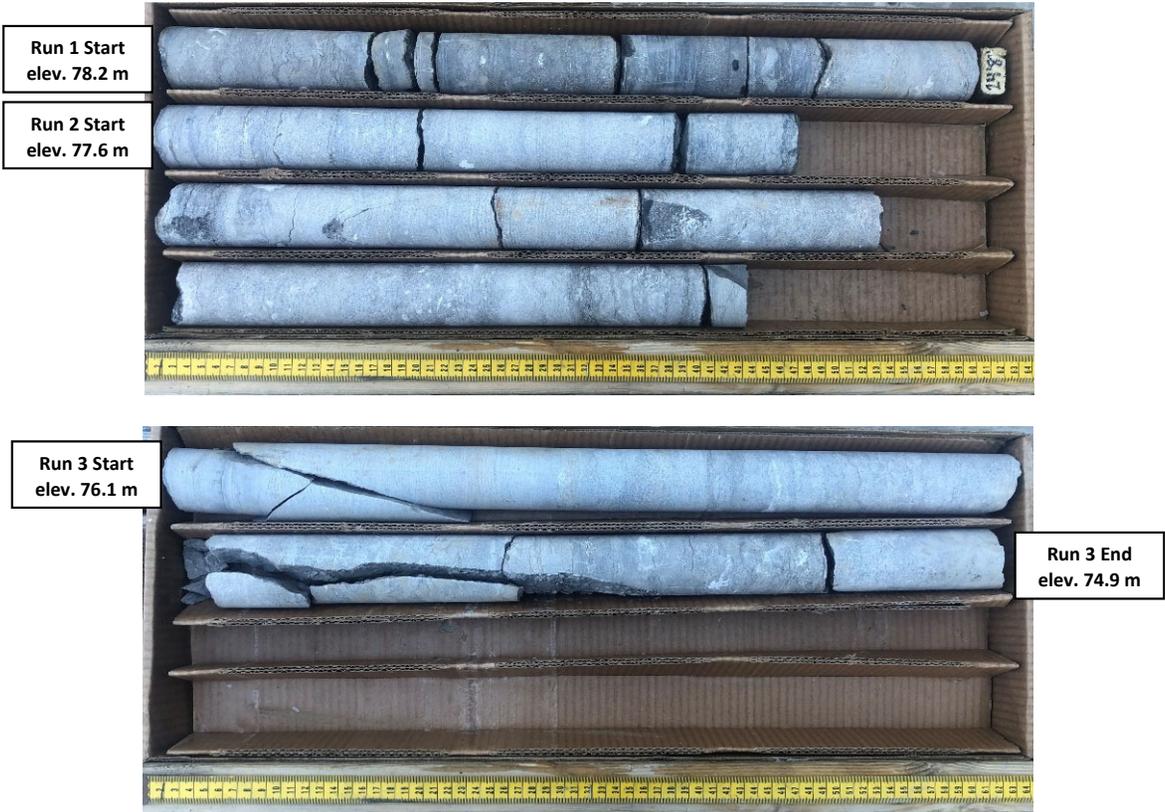
Borehole 250-21-1
Run 1 to 3 (of 3)
Elevation 78.2 m to 74.9 m
Dry

The bedrock encountered in the current investigation consisted of fresh, very strong, grey interbedded dolostone and sandstone. The RQD ranged from 58% to 82%, the Solid Core Recovery (SCR) ranged from 96% to 100%, and the Total Core Recovery (TCR) ranged from 96% to 100%. Photographs of the bedrock cores are provided in Appendix C. Unconfined compressive strength (UCS) testing was carried out on one sample of the bedrock from Borehole 250-21-1. The result of 182 MPa indicates a very strong rock; test details are in Appendix C

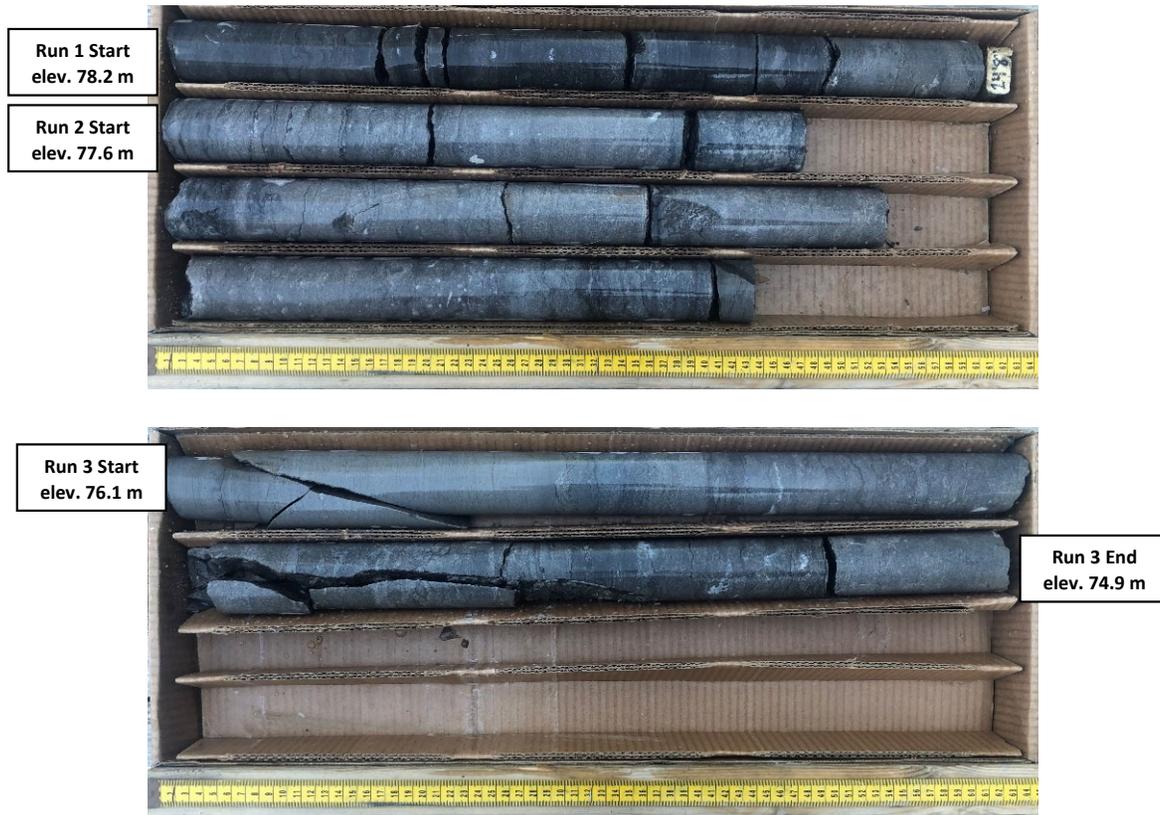
Borehole 250-21-1
Run 1 to 3 (of 3)
Elevation 78.2 m to 74.9 m
Wet

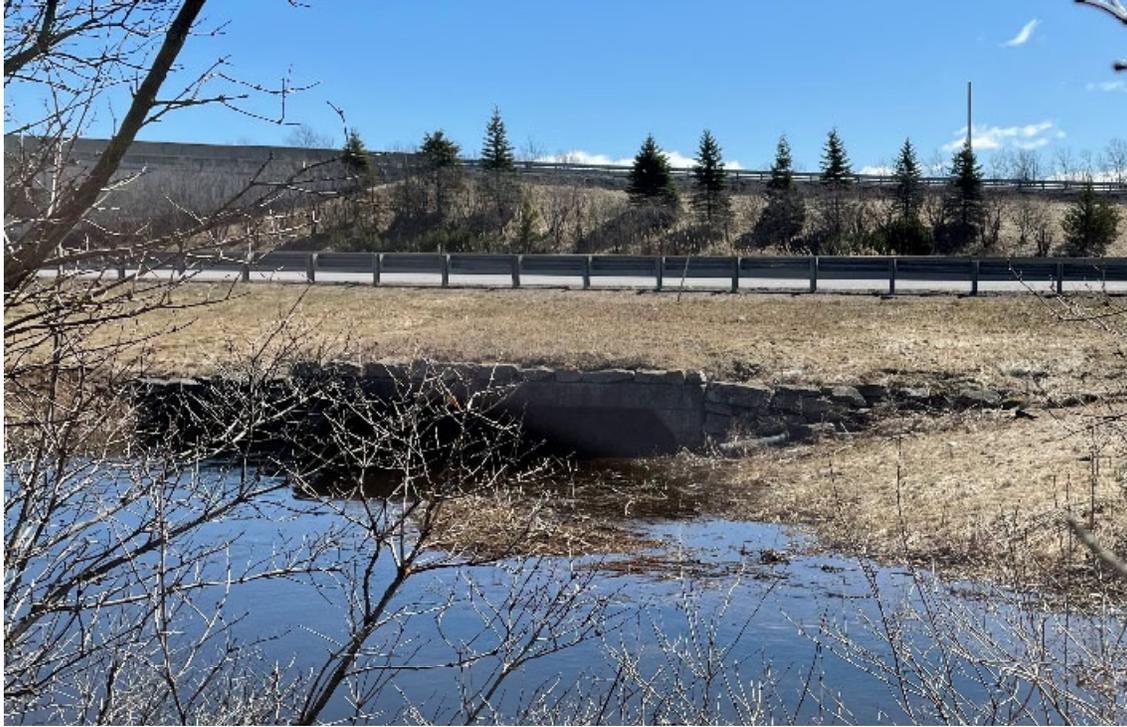
Photo 1. Looking south at culvert inlet (2021/03/29).

Based on the available project background documents including the photos and recent documented inspection records, the culvert consists of a cast-in-place, single span concrete culvert with open footings, constructed in 1961. The culvert is approximately 53.1 m long, has a total internal span width of 6.0 m, and an overall approximate internal height of 1.8 m above the stream bed. Structural culvert (Site No. 16-259) is located approximately 10 m downstream from the culvert outlet.
