**PRELIMINARY FOUNDATION INVESTIGATION REPORT
HIGHWAY 401 WIDENING, HIGHWAY 16 TO MAITLAND ROAD
HIGHWAY 401W-416N RAMP REHABILITATION, SITE NO. 16X-0306
GWP 4024-20-00 / ASSIGNMENT NO. 4019-E-0010.2**

March 2023
Thurber File No.: 29381

HIGHWAY 401
401W - 416N RAMP
BRIDGE REHABILITATION
BOREHOLE LOCATIONS AND SOIL STRATA

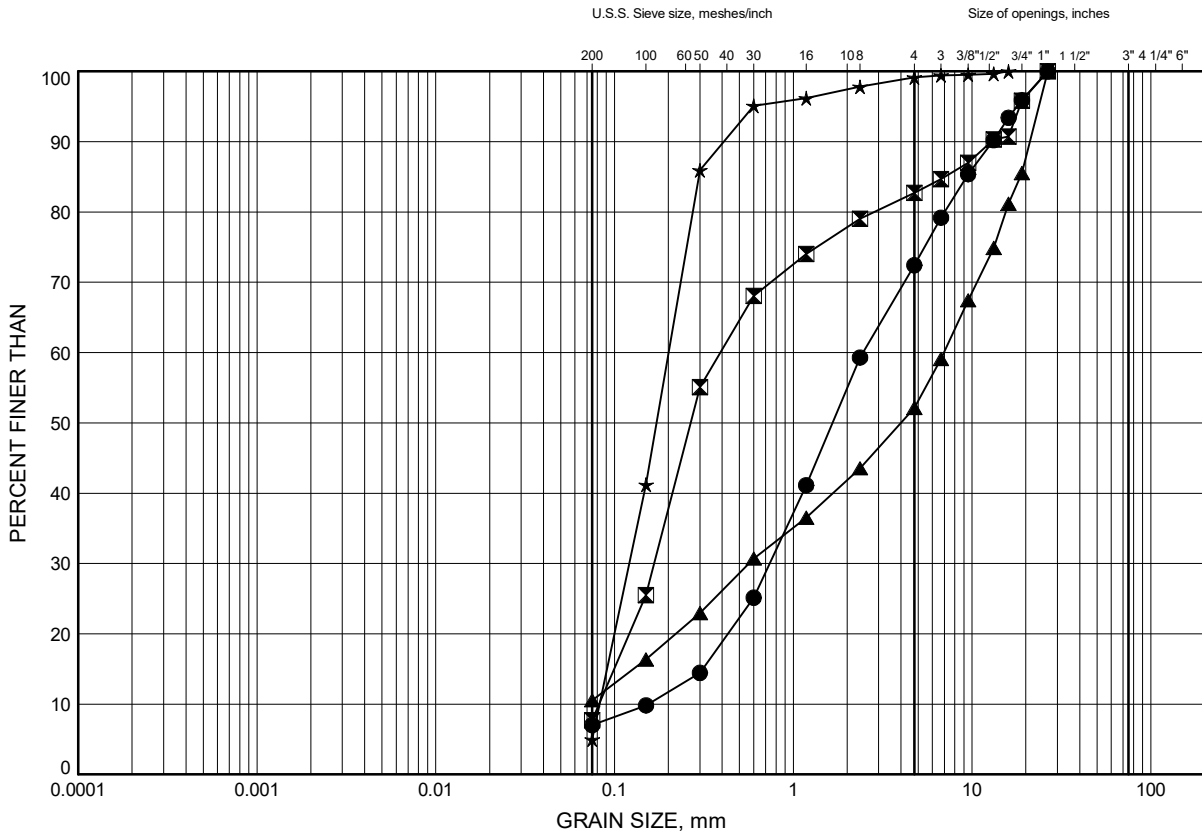
FIGURE C1

EMBANKMENT FILL

The moisture content of the fill samples tested ranged from about 2 to 9%, and one moisture content of 17% in Borehole 306-21-2. The results of grain size analysis testing conducted on four samples of the embankment fill are summarized below and are illustrated on Figure C1 in Appendix C.1.

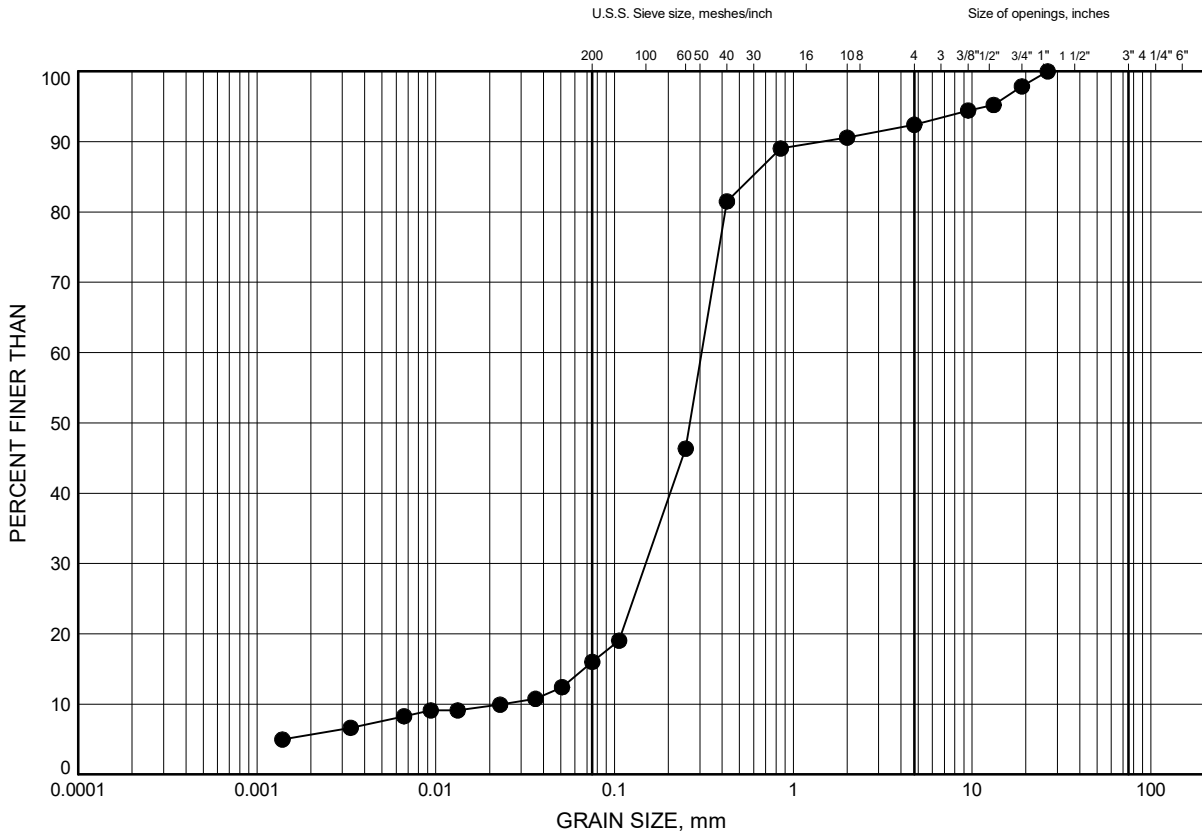
FIGURE C2

SAND

The moisture content of one sample tested was 23%. The results of a grain size analysis test conducted on a sample of this material obtained in Borehole 306-21-1 is summarized below and is illustrated on Figure C2 in Appendix C.1.

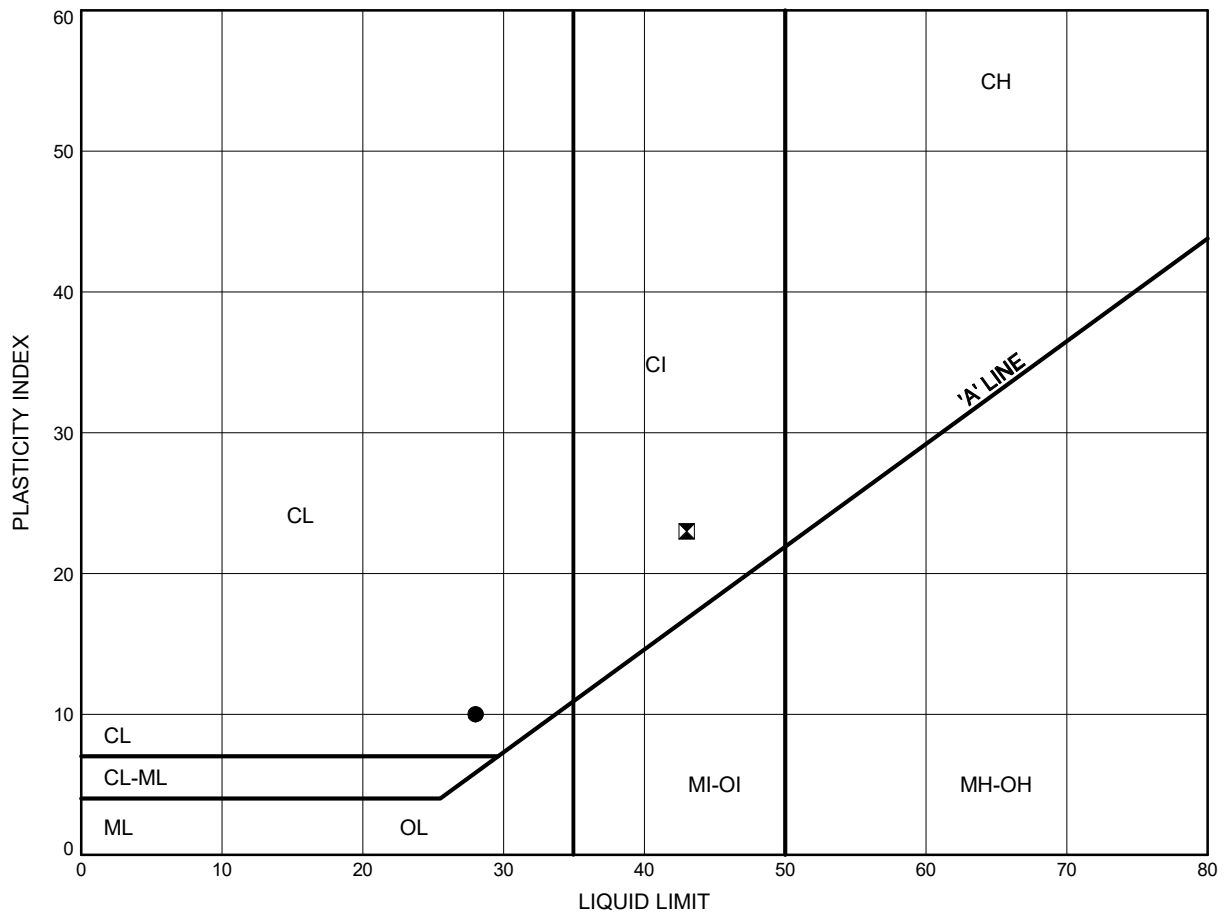
FIGURE C4

CLAYEY SILT TO SILTY CLAY

SYMBOL	BOREHOLE	DEPTH (m)	ELEV. (m)
●	306-21-1	12.5	82.3
⊠	306-21-2	9.4	86.0

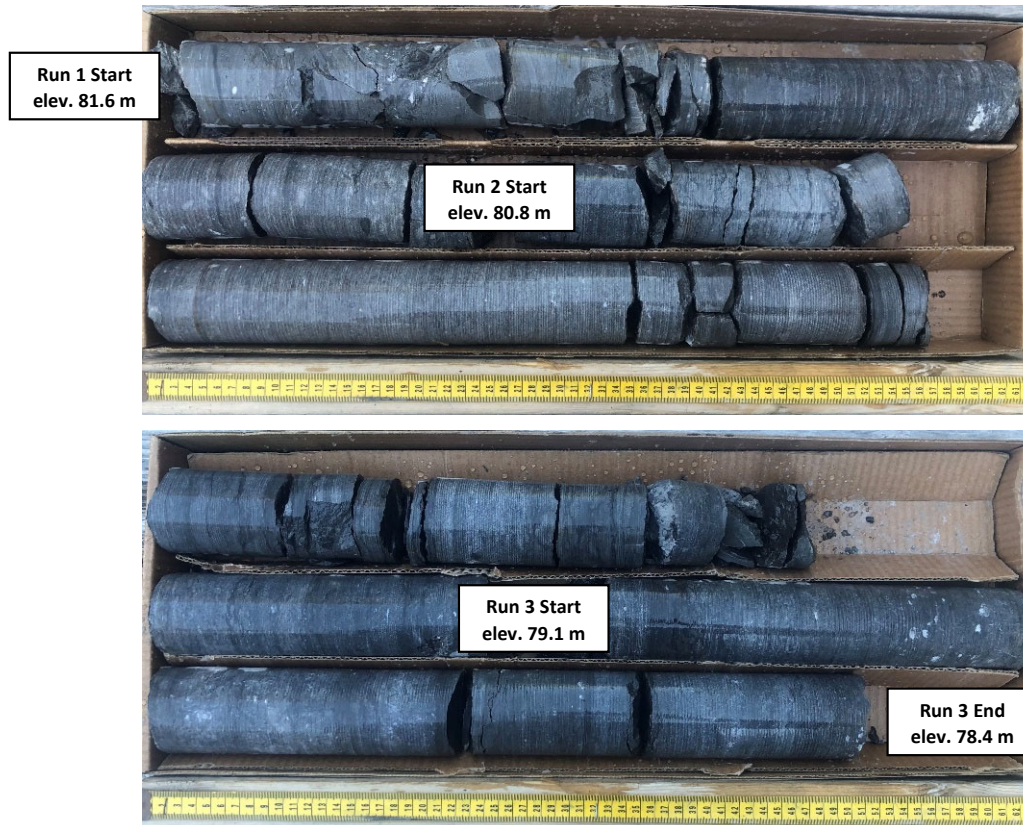
Borehole 306-21-1
Run 1 to 3 (of 3)
Elevation 81.6 m to 78.4 m
Wet

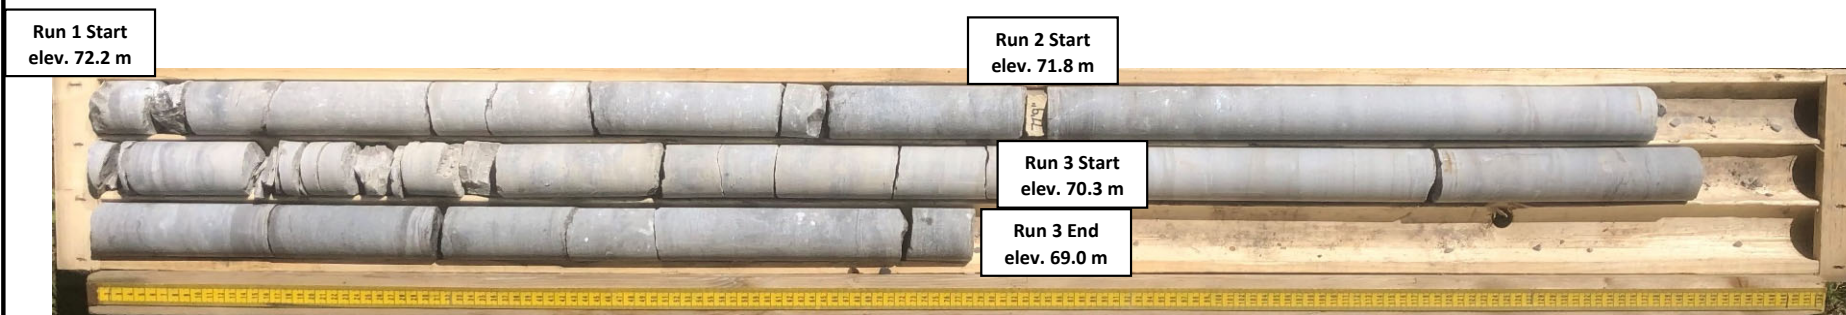
Borehole 306-21-2
Run 1 to 3 (of 3)
Elevation 72.6 m to 69.0 m
Dry

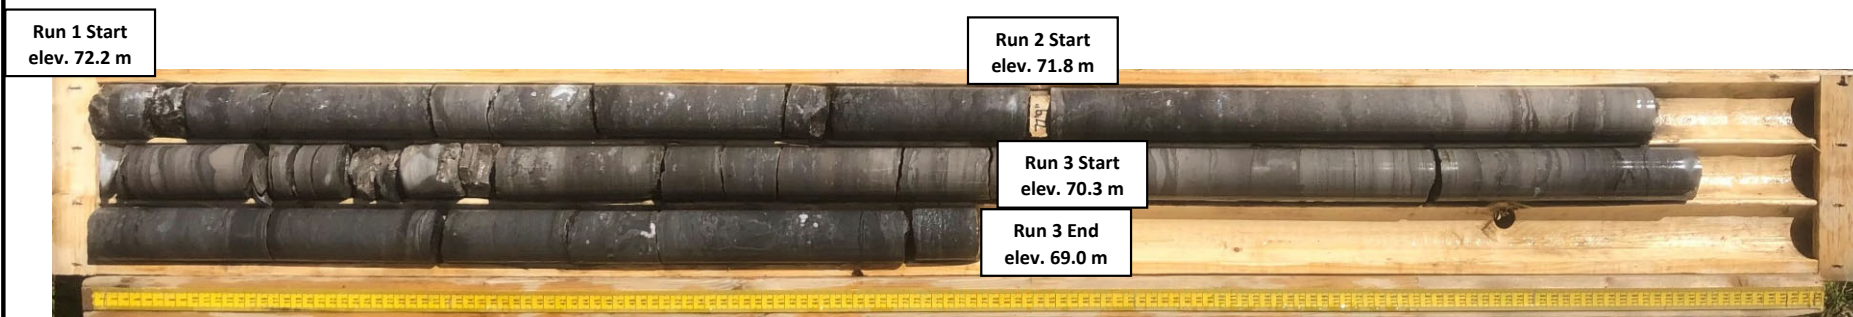
Borehole 306-21-2
Run 1 to 3 (of 3)
Elevation 72.6 m to 69.0 m
Wet

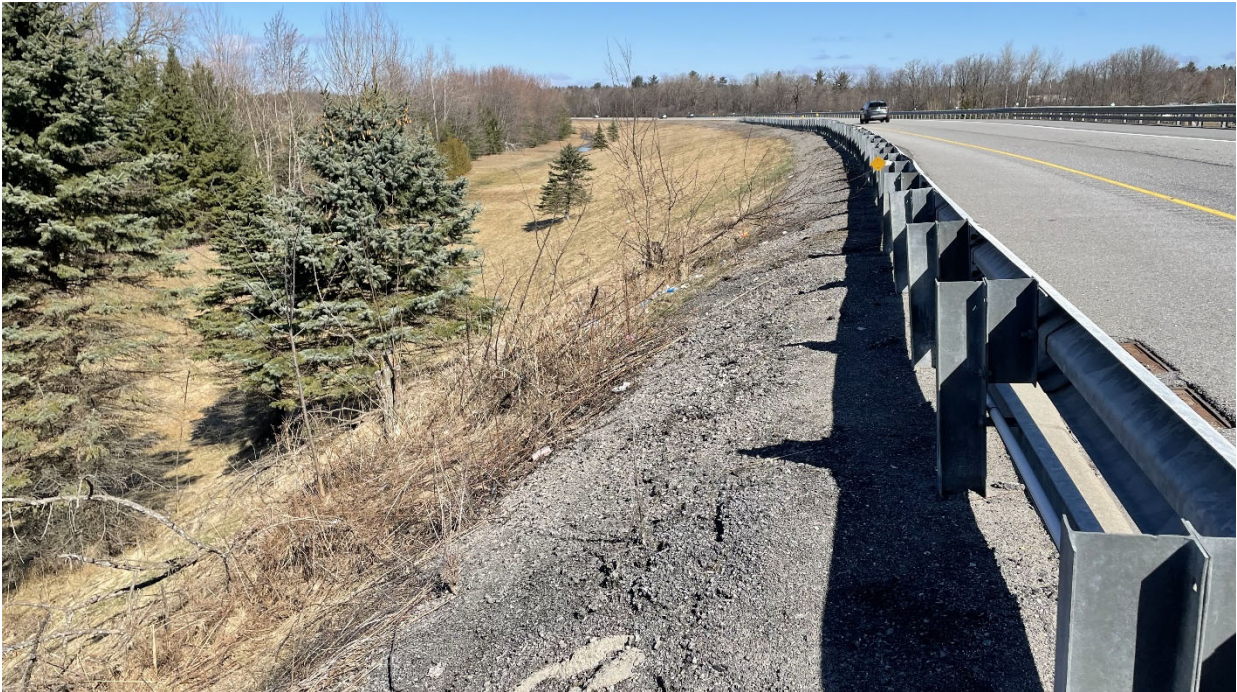
Photo 1. Looking north at northwest embankment (2021/03/29)

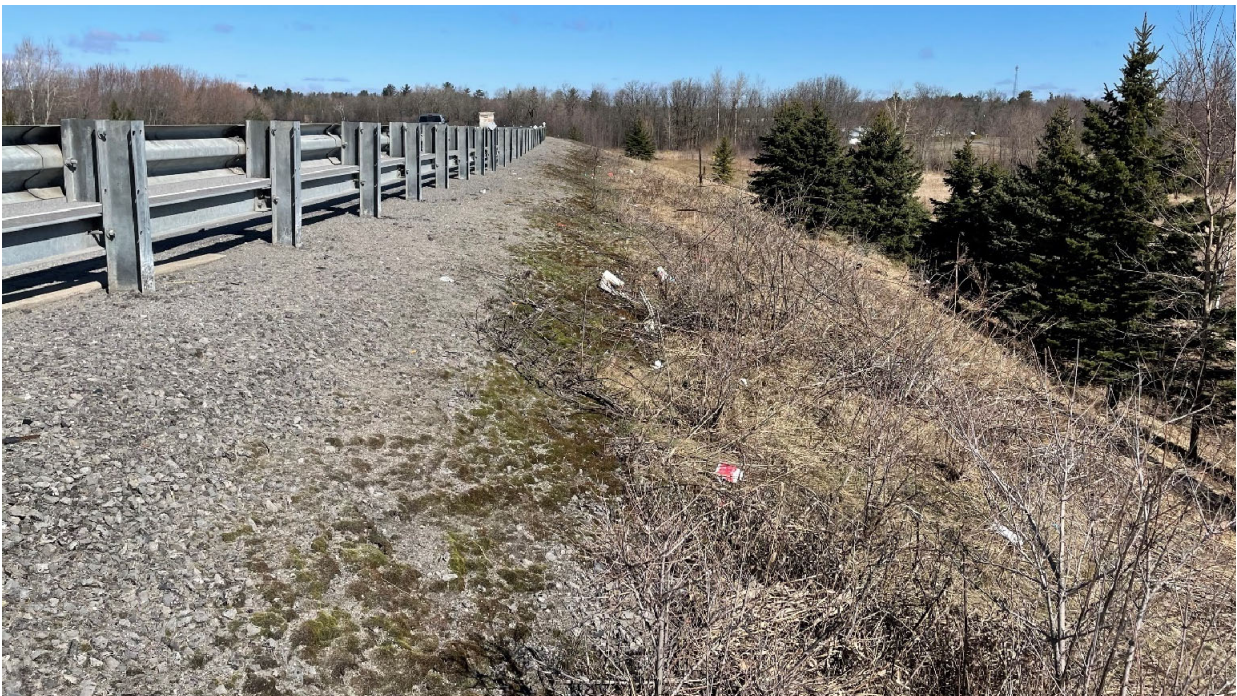
Photo 2. Looking north at northeast embankment (2021/03/29)

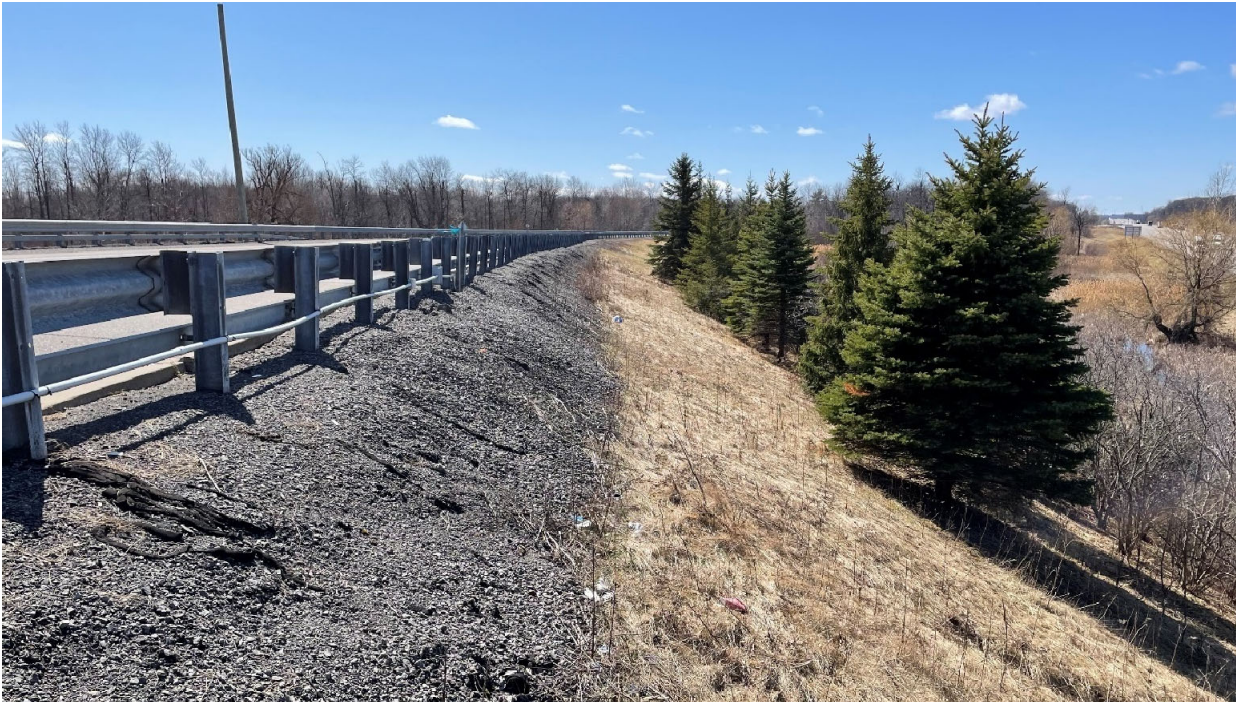
Photo 5. Looking south at southwest embankment. (2021/03/29)

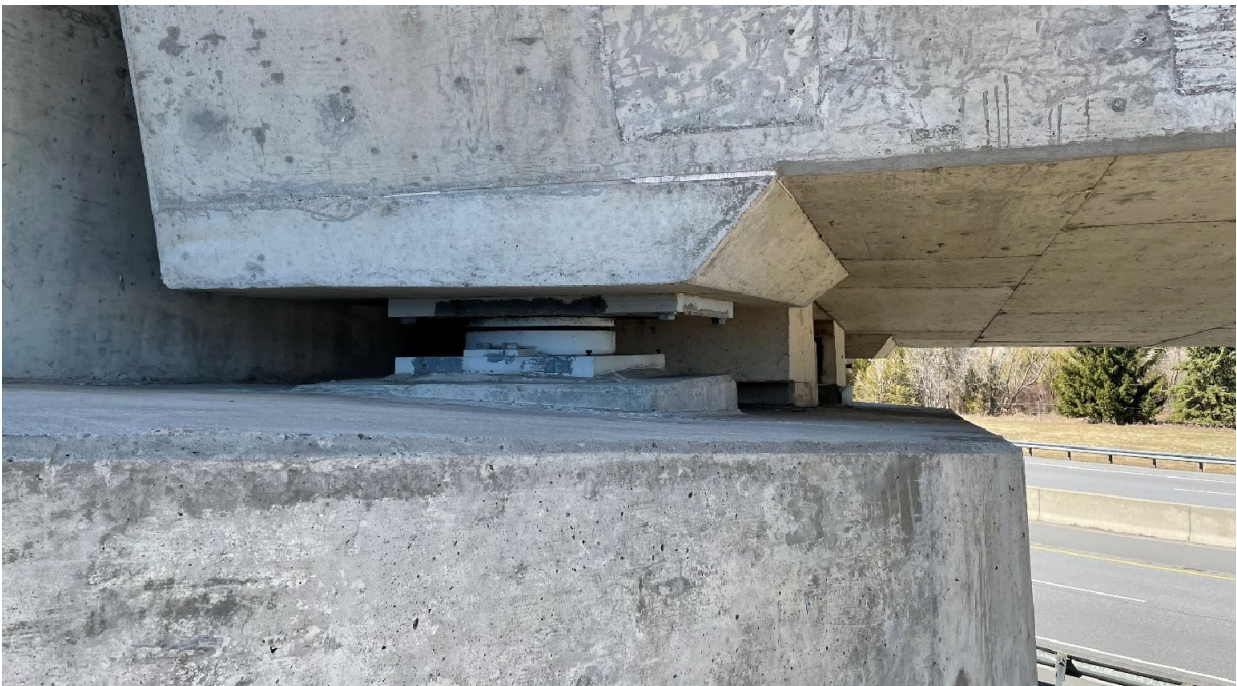
Photo 6. Looking west at south abutment bearings. (2021/03/29)
