**PRELIMINARY FOUNDATION INVESTIGATION REPORT
HIGHWAY 401 WIDENING, HIGHWAY 16 TO MAITLAND ROAD
HWY 416 SBL - CEDAR GROVE RD OVERPASS, SITE NO. 16X-0307
GWP 4024-20-00 / ASSIGNMENT NO. 4019-E-0010.2**

January 2023
Thurber File No.: 29381

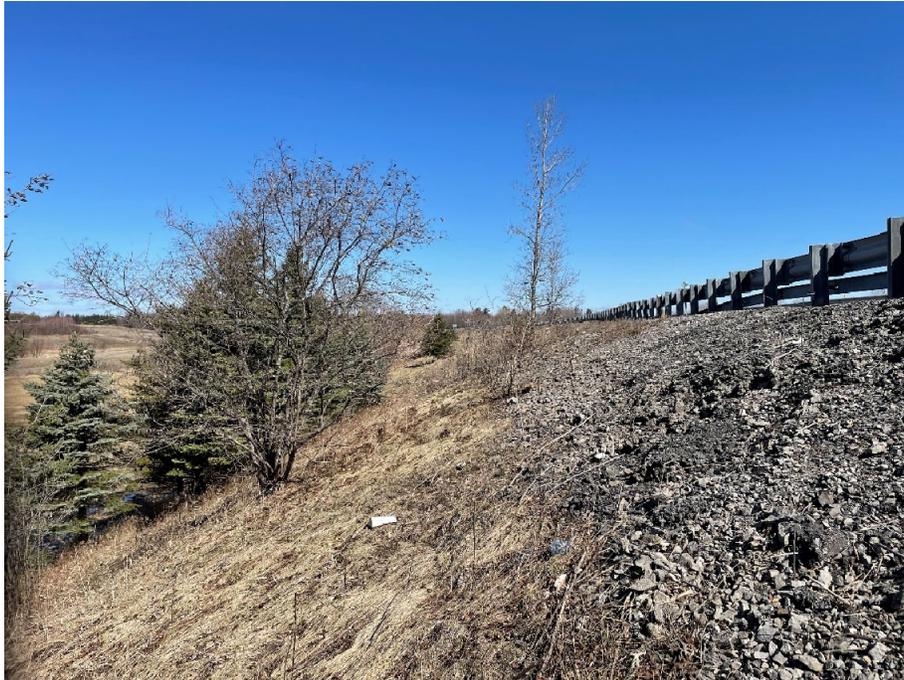
Photo 1. Looking north at the west side of the north embankment (2021/03/29)

The side slopes were observed during the current field investigation and were generally grass-covered, with bushes and small trees growing around the abutments. Rockfill material was exposed on the upper portions of the west slope of both the north and south approaches (see Photos 1 and 7 in Appendix D). At the time of the field work, the side slopes appeared to be 2H:1V in all quadrants and did not show any visible signs of distress or other performance issues. Steel beam guiderails are present along the approaches and abut the concrete barrier walls along the bridge.

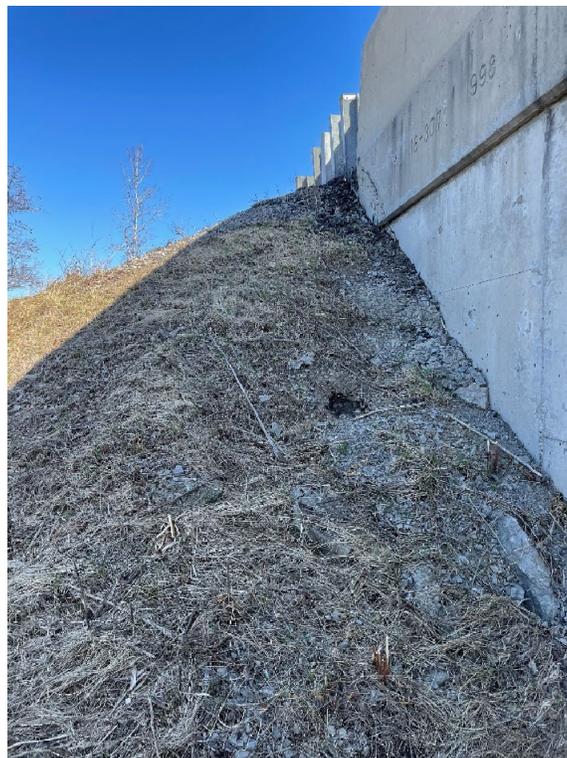
Photo 2. West side of north abutment (2021/03/29)

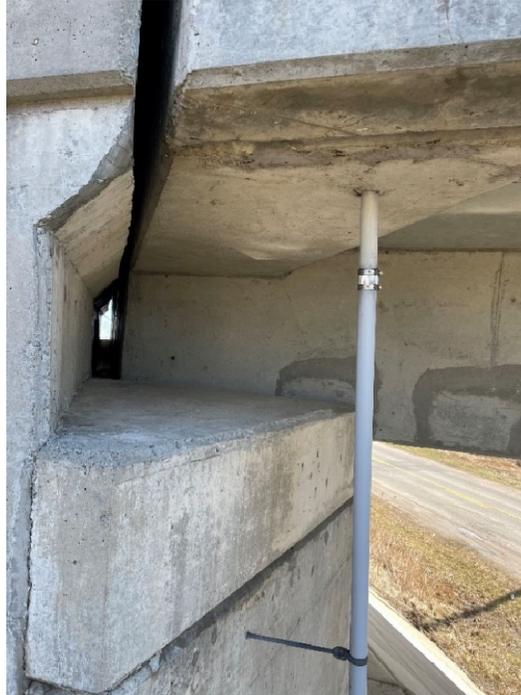
Photo 3. North deck and abutment (2021/03/29)

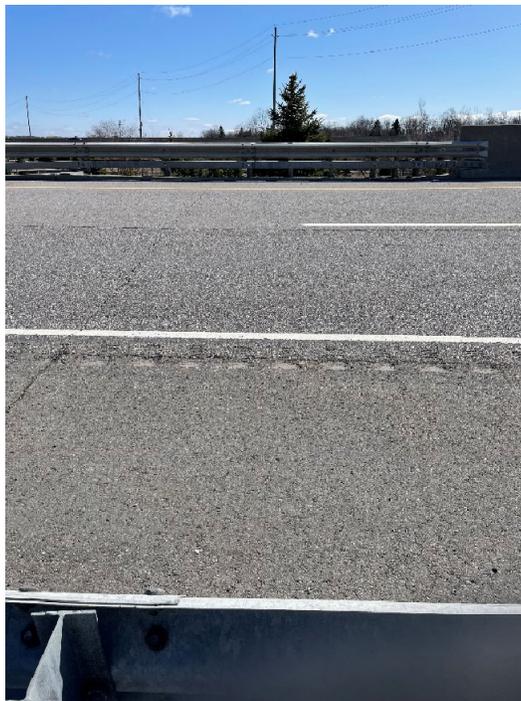
Photo 4. Asphalt paved surface of 416N-401W ramp bridge (2021/03/29)

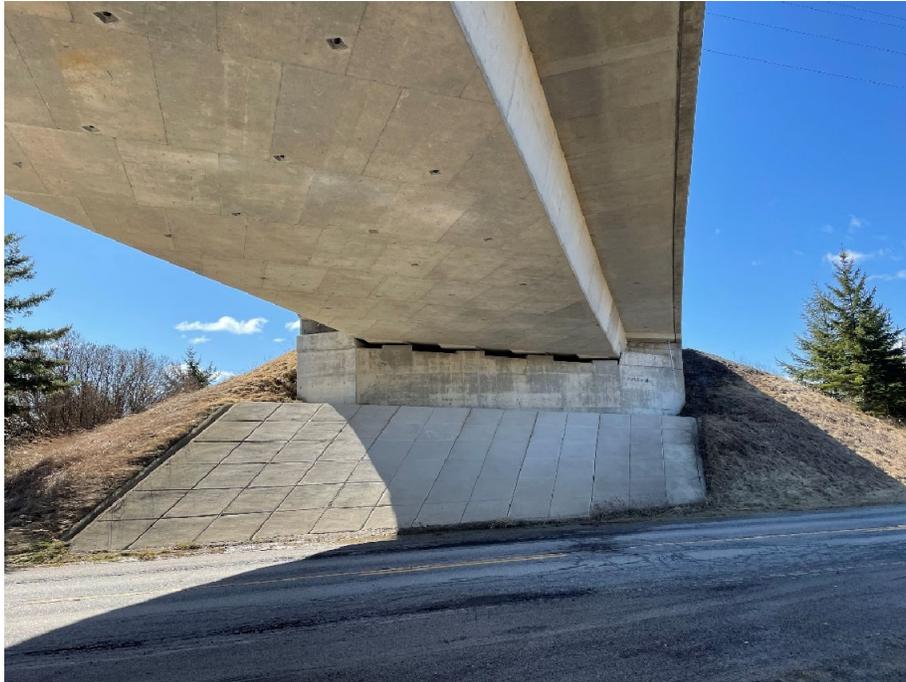
Photo 5. Looking south at south abutment (2021/03/29)

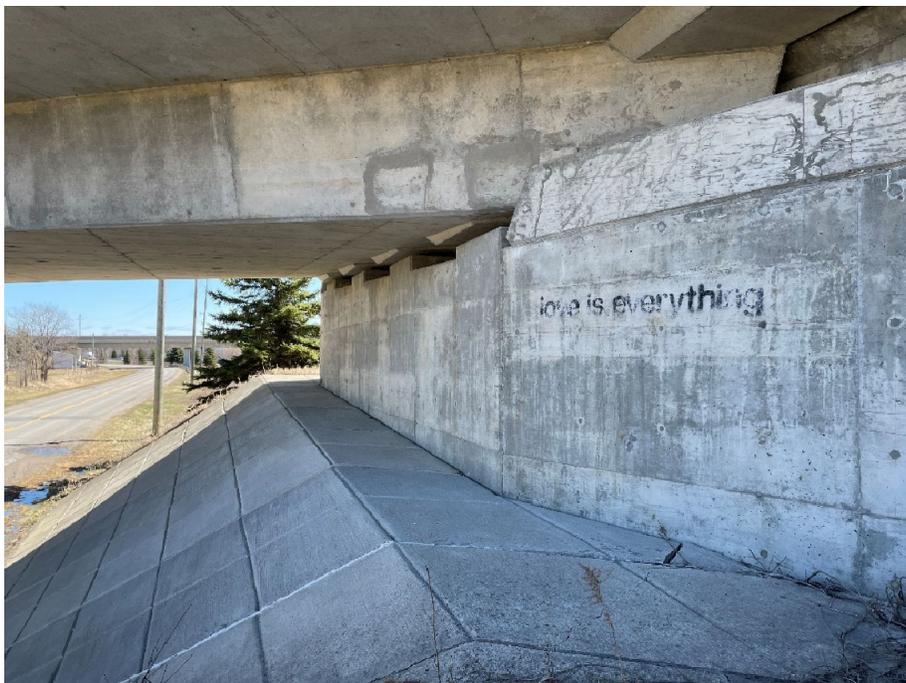
Photo 6. South deck and abutment looking east (2021/03/29)

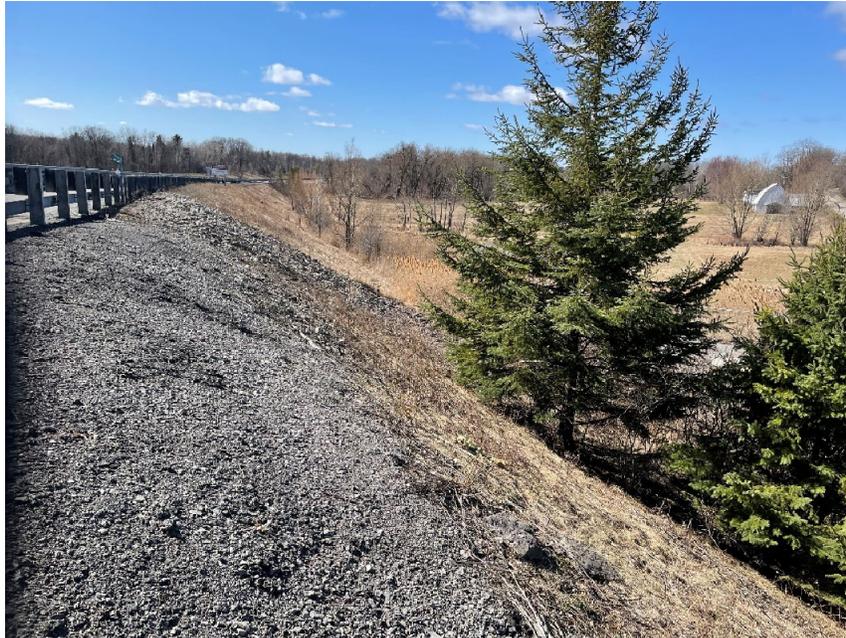
Photo 7. Looking south at the west side of the south embankment (2021/03/29)

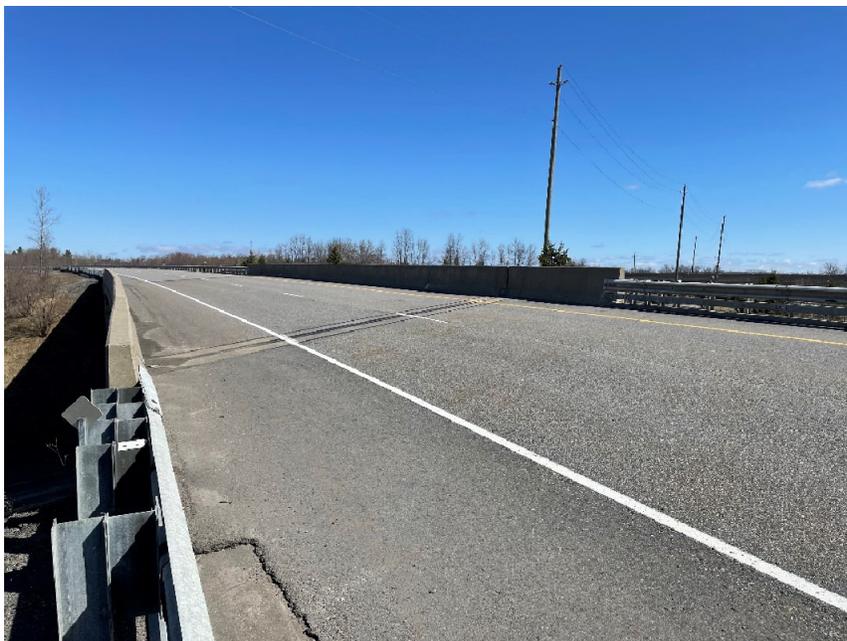
Photo 8. Looking north 416N-401W ramp bridge (2021/03/29)
