**PRELIMINARY FOUNDATION INVESTIGATION REPORT  
HIGHWAY 401 WIDENING, HIGHWAY 16 TO MAITLAND ROAD  
HIGHWAY 16 OVERHEAD AT CNR RAILWAY, SITE NO. 16X-0131  
GWP 4024-20-00 / ASSIGNMENT NO.: 4019-E-0010.2**

**SITE NO. 16X-0131/B0**

**Geocres No.: 31B12-003**

March 2024  
Thurber File No.: 29381

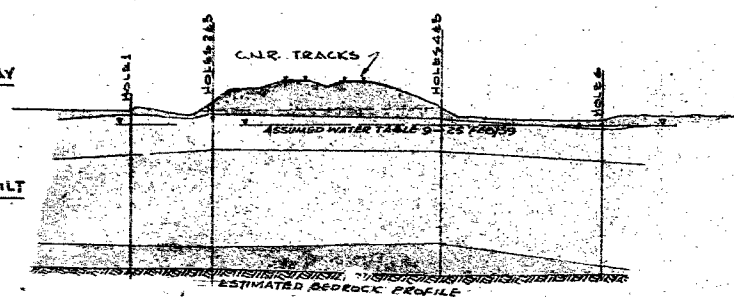
SECTION ALONG LINE HWY 16 SHOWING STRATIFICATION

NOTE: HOLES 2 & 3 AND 4 & 5 HAVE BEEN INTERPOLATED TO PRODUCE THESE RESULTS

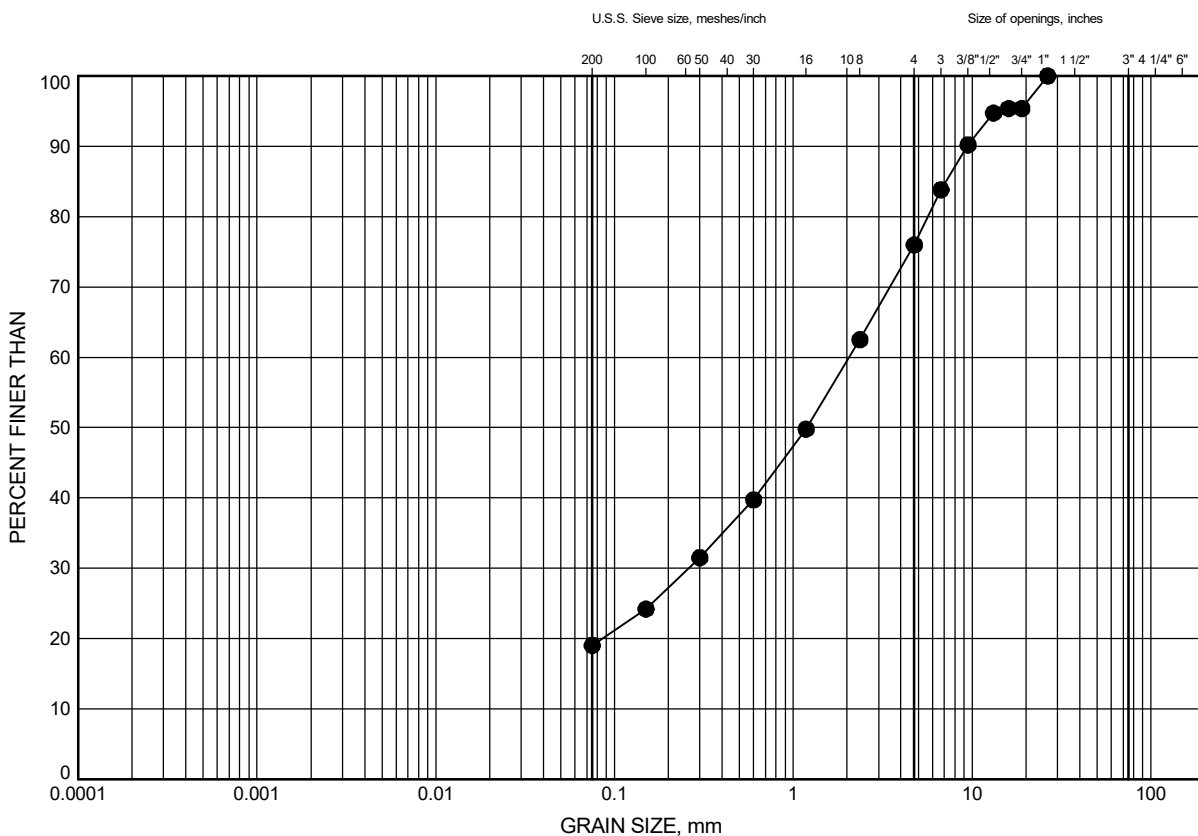
## GRAIN SIZE DISTRIBUTION

FILL: Gravelly Sand

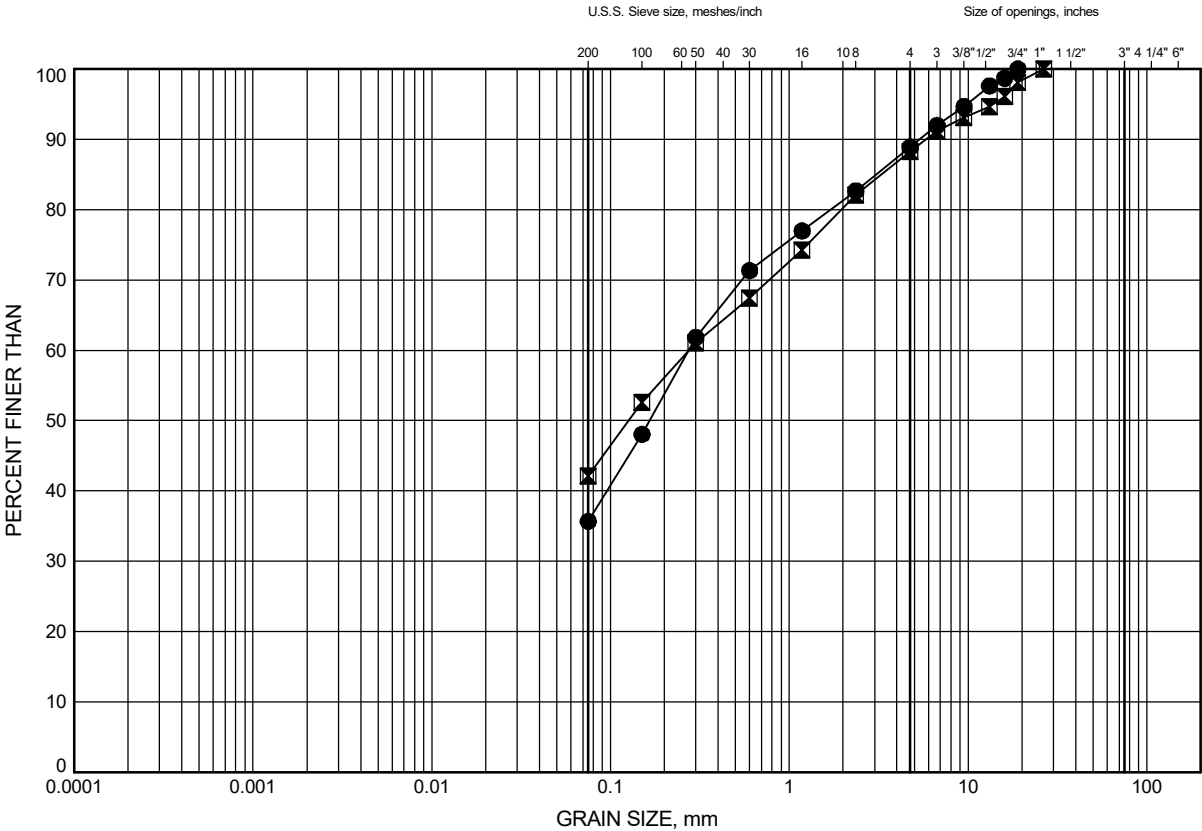
GRAIN SIZE DISTRIBUTION

FILL: Silty Sand

The recorded moisture contents of samples of the silty sand embankment fill ranged from 5% to 12%. The results of gradation analyses completed on two samples of the fill are illustrated on Figure C2 of Appendix C. The results of the tests are summarized below and on the Record of Borehole sheets in Appendix B.

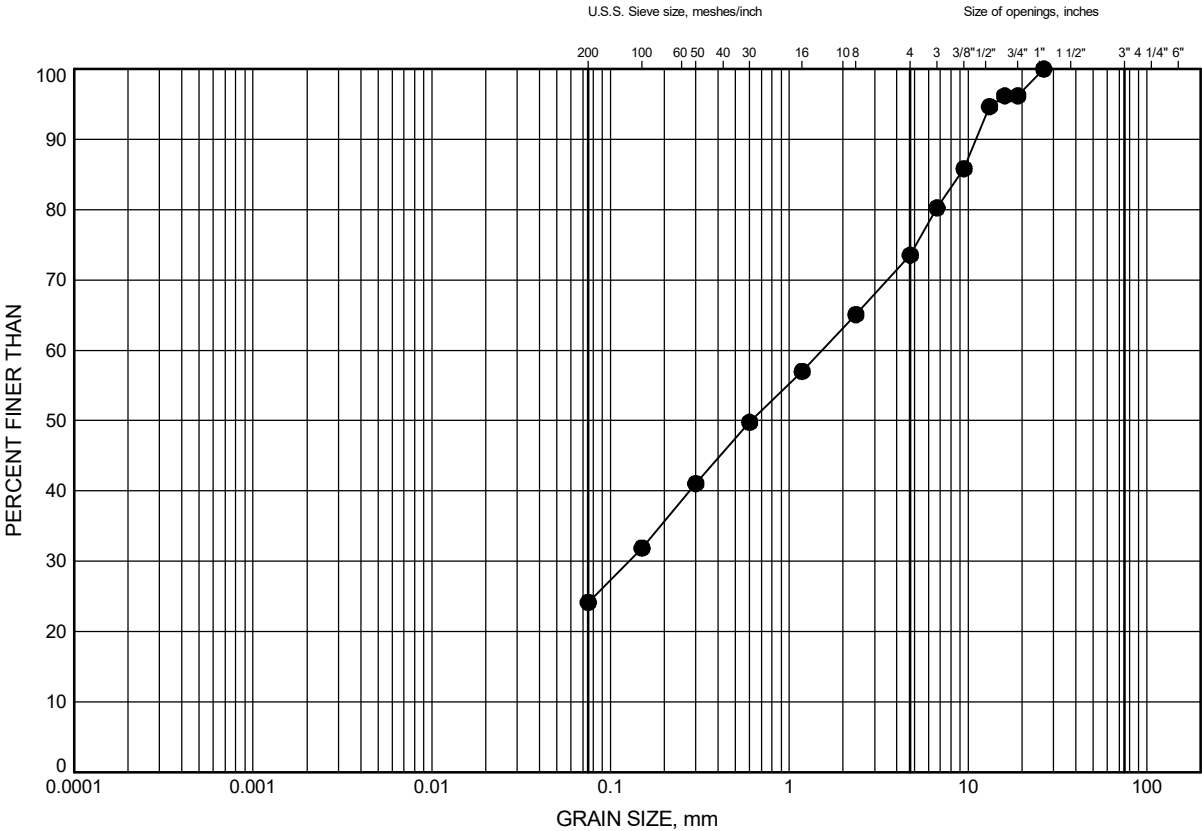
GRAIN SIZE DISTRIBUTION

FILL: Gravelly Silty Sand

The recorded moisture contents ranged from 3% to 5%. The results of a gradation analysis completed on one sample of the fill are illustrated on Figure C3 of Appendix C. The results of the tests are summarized below and on the Record of Borehole sheet in Appendix B.

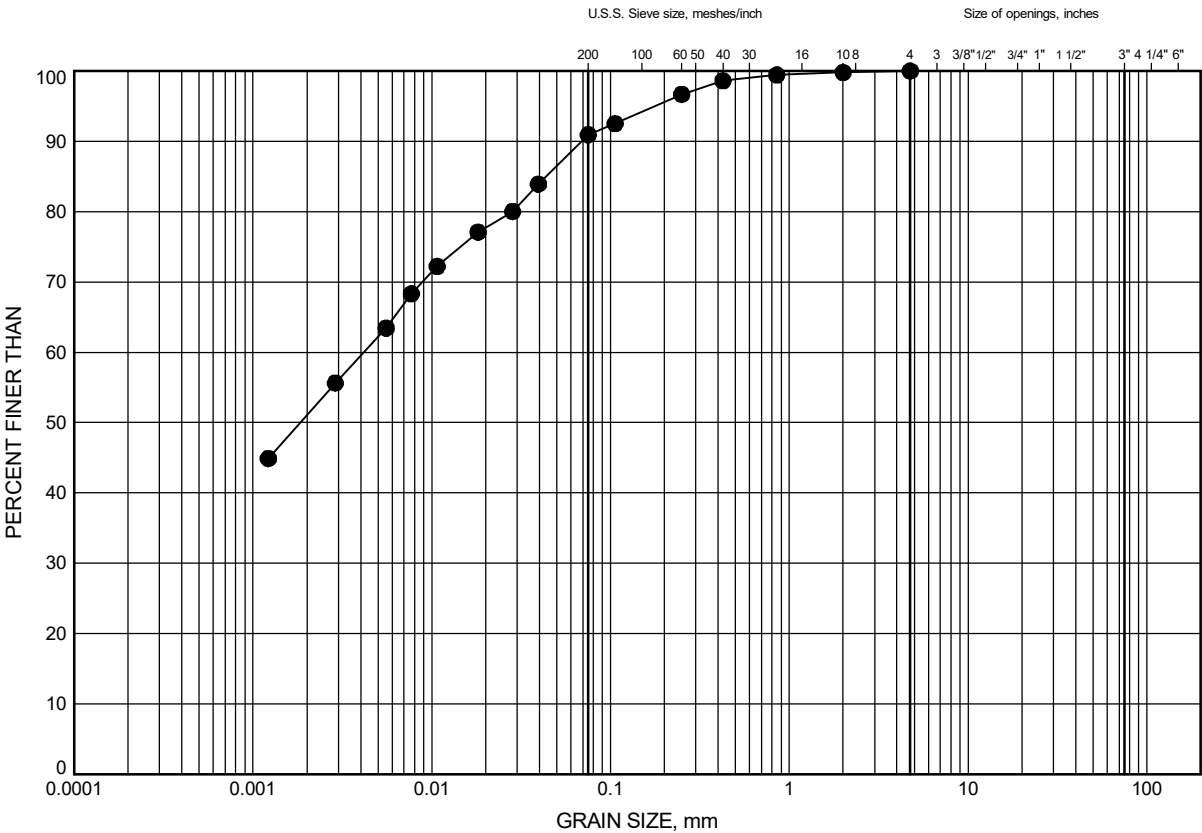
GRAIN SIZE DISTRIBUTION

FILL: Clay

The recorded moisture contents ranged from 27 to 33%. The results of a gradation analysis completed on one sample of the fill are summarized in the table below and on the Record of Borehole sheet in Appendix B, and are illustrated on Figure C4 of Appendix C.

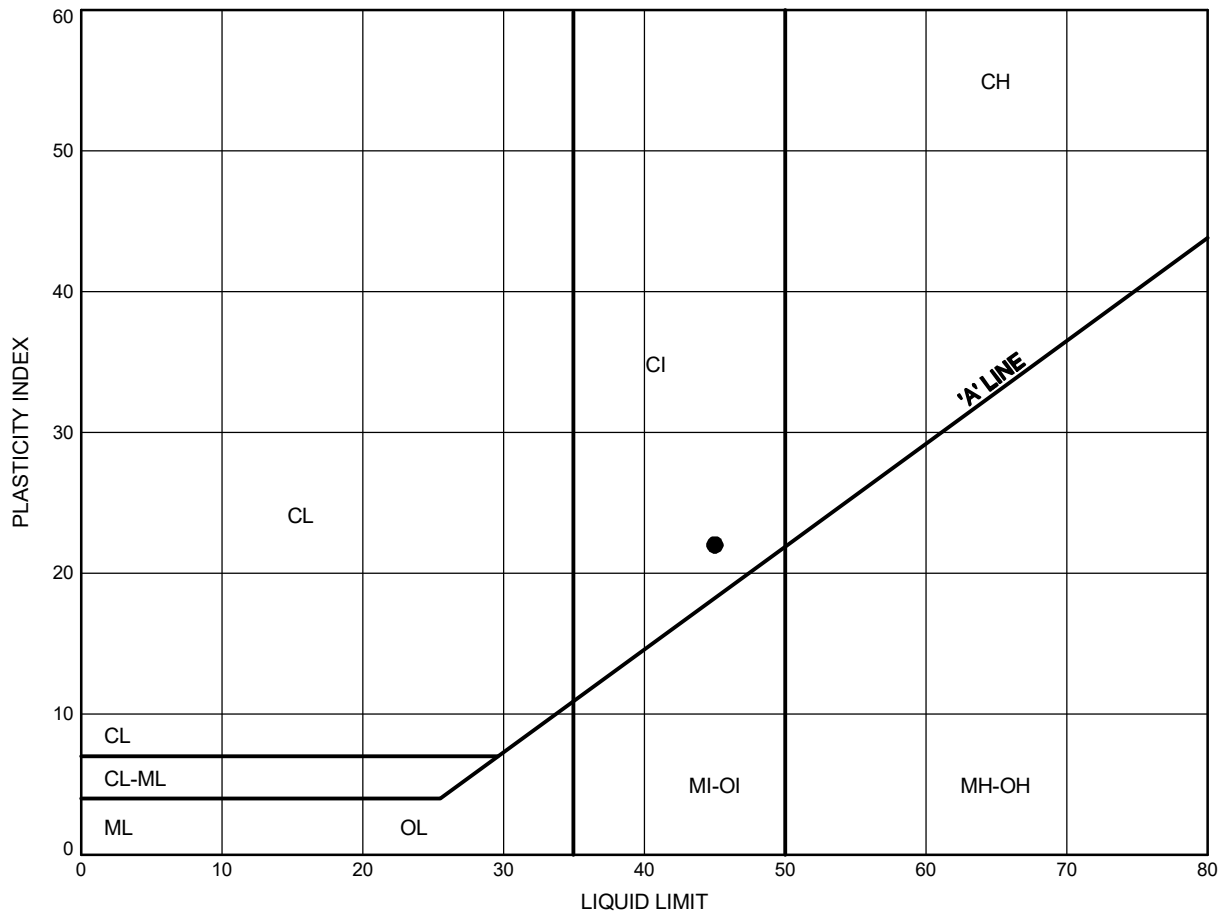
FIGURE C5

FILL: Clay

SYMBOL	BOREHOLE	DEPTH (m)	ELEV. (m)
●	131-22-01	6.4	85.4

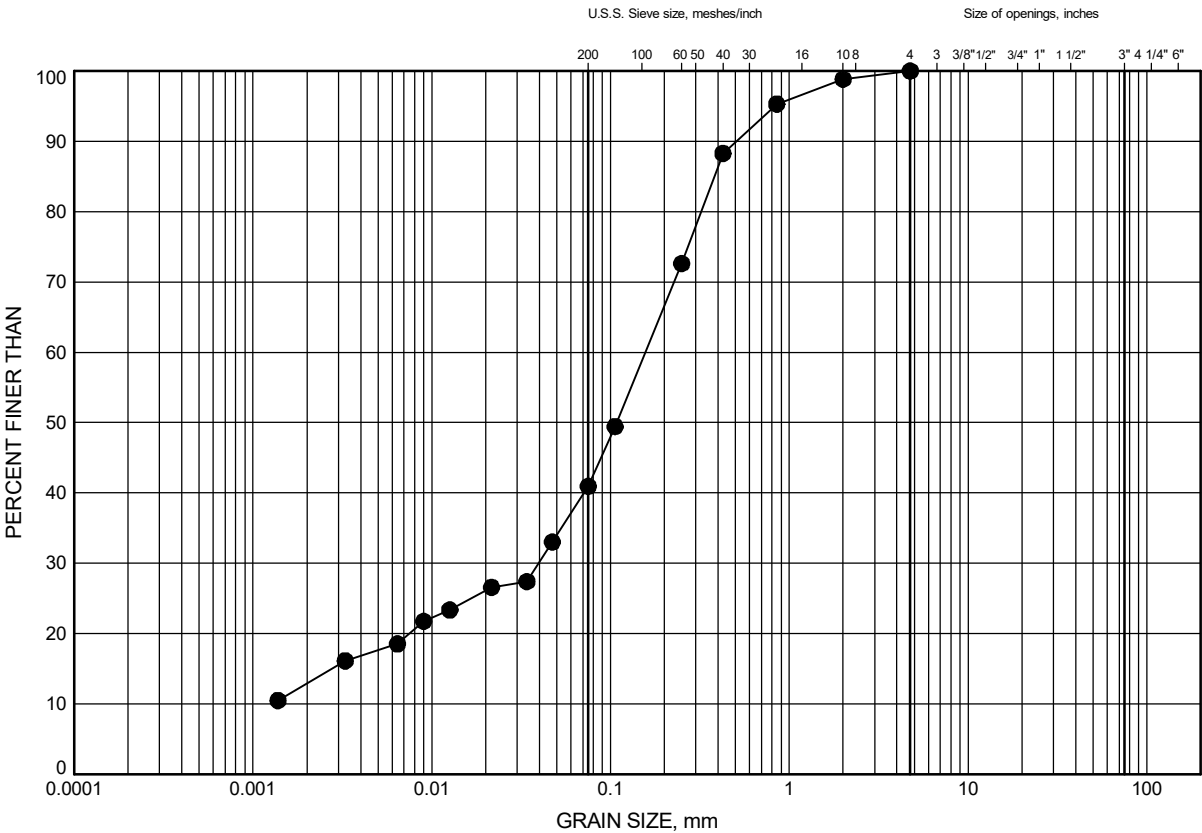
GRAIN SIZE DISTRIBUTION

Silty Sand (SM) with organics

The recorded moisture content of one sample of the deposit was 25%. The results of Atterberg Limit testing conducted on the fines portion sample from Borehole 131-22-02 indicate a non-plastic material. The results of a gradation analysis completed on the sample of the deposit are illustrated on Figure C6 of Appendix C. The results of the tests are summarized below and on the Record of Borehole sheet in Appendix B.

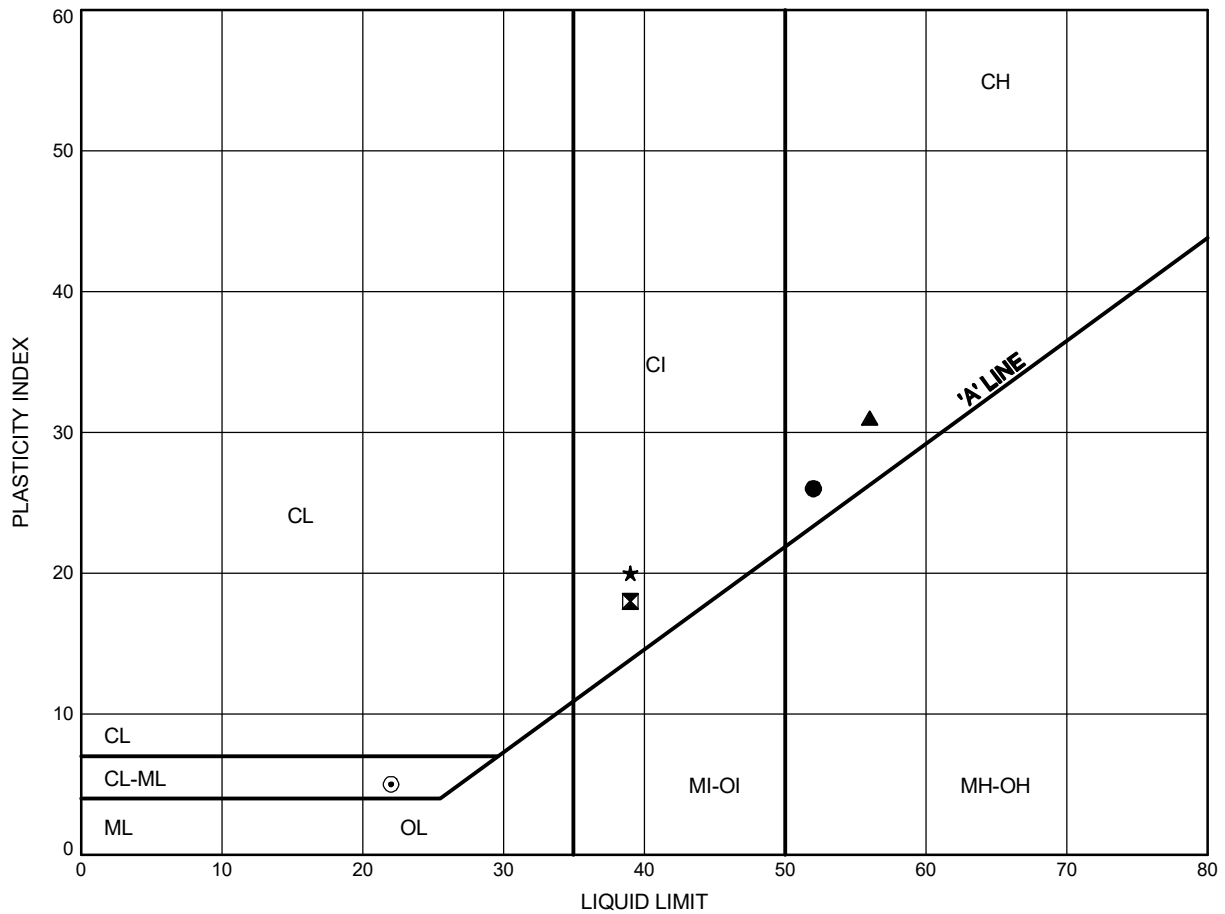
FIGURE C7

Clay (CH) to Silty Clay (CI)

SYMBOL	BOREHOLE	DEPTH (m)	ELEV. (m)
●	131-22-01	12.5	79.3
⊠	131-22-01	17.7	74.1
▲	131-22-02	13.3	79.1
★	131-22-02	17.1	75.3
⊙	131-22-02	21.6	70.8

Recorded moisture contents ranged from 14% to 43%. Atterberg Limit testing was completed on five samples of the deposit. Results are illustrated in Figure C7 of Appendix C. The results of these tests are summarized below and on the Record of Borehole sheets in Appendix B. The laboratory results indicate that the clay to silty clay generally exhibits intermediate to high plastic behaviour (CI to CH). One sample towards the bottom of the deposit in Borehole 131-22-02 (elev. 70.8 m) exhibited low plasticity (CL-ML).

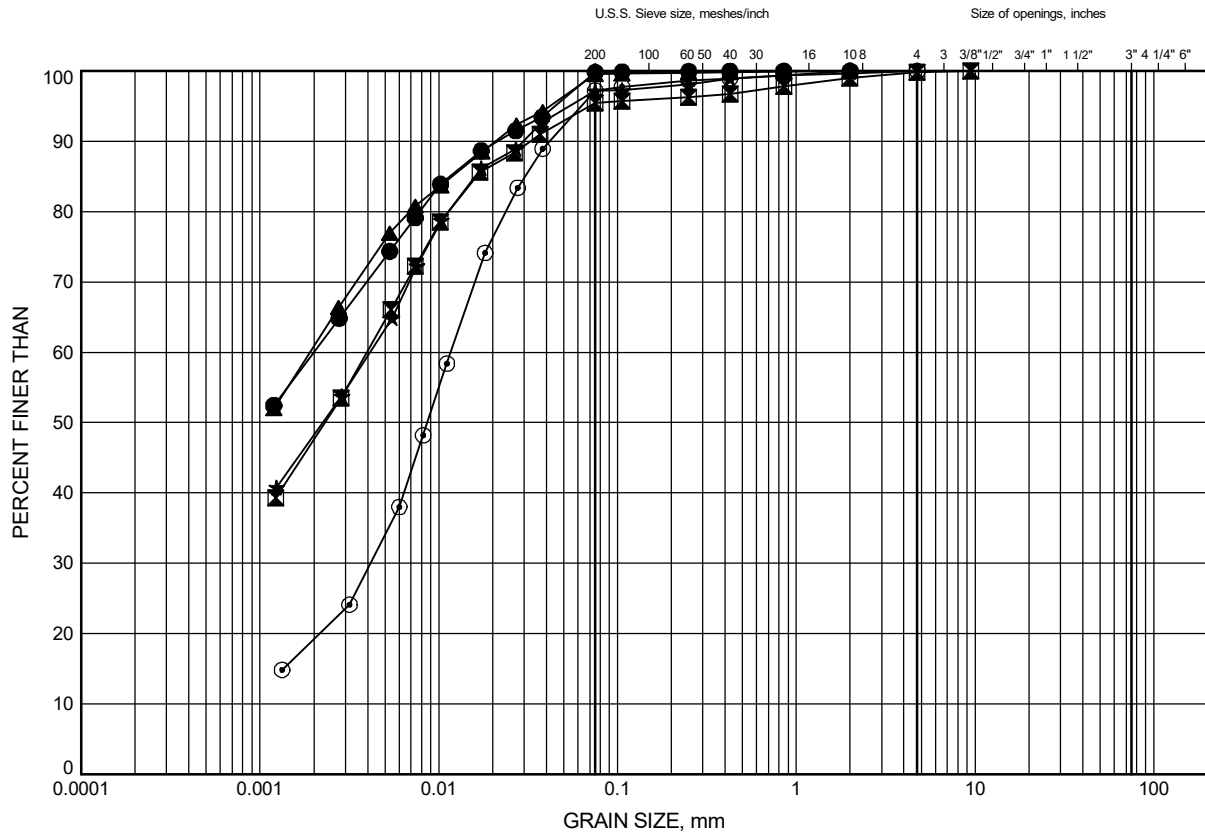
# GRAIN SIZE DISTRIBUTION

Clay (CH) to Silty Clay (CI)

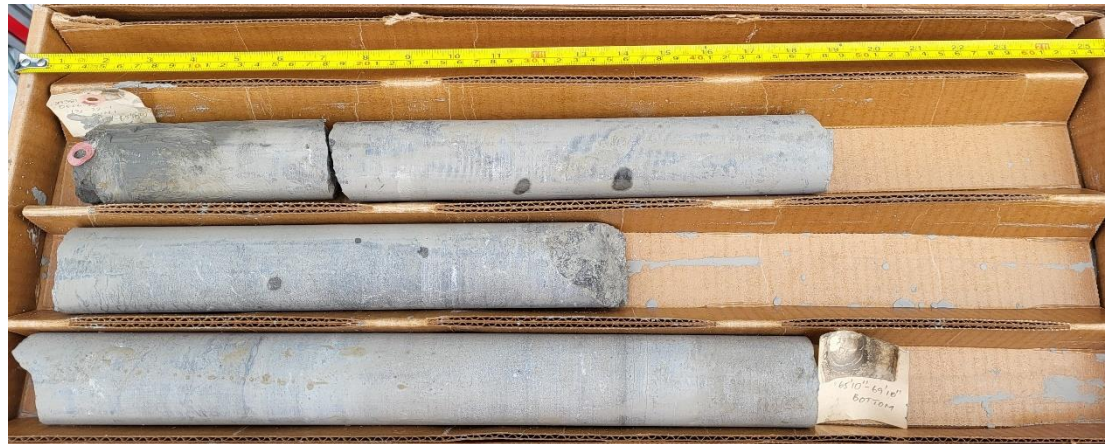
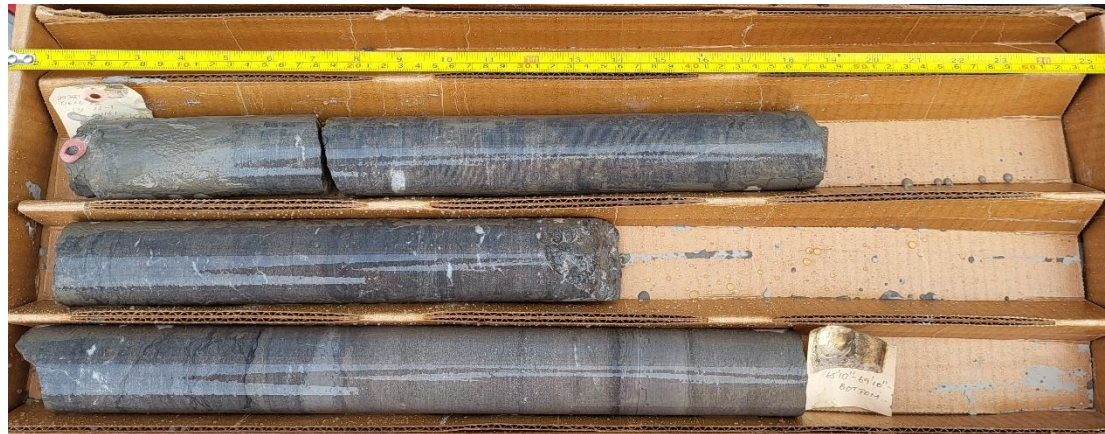
# Borehole 131-22-01

Run 1 Start  
elev. 71.7 m

Run 1 End  
elev. 70.5 m

Bedrock was proven by coring in both boreholes. The depth to bedrock from the existing road grade ranged from 20.1 m to 22.7 m (elev. 71.7 m to 69.7 m). The bedrock encountered consisted of fresh, fine-grained, grey dolostone. Quartz inclusions were noted in Borehole 131-22-02. In general, the discontinuities were rough, undulating bedding joints. Bedrock logs are provided in Appendix B, and photographs of the bedrock cores are provided in Appendix C. The rock core quality and strength are summarized in Table 5-1.

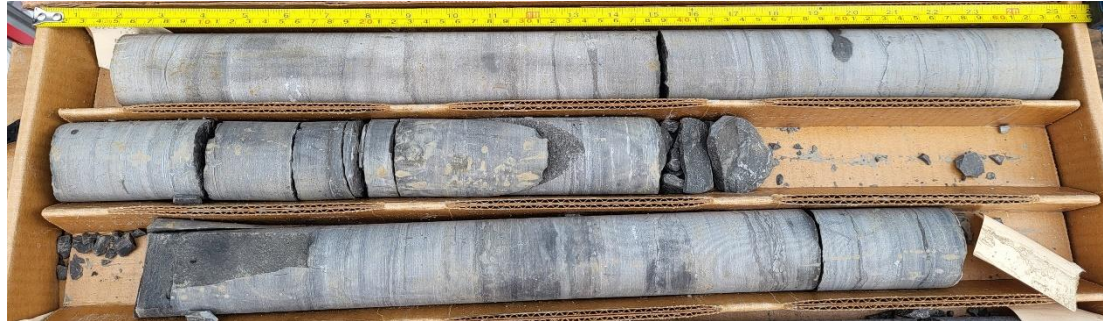
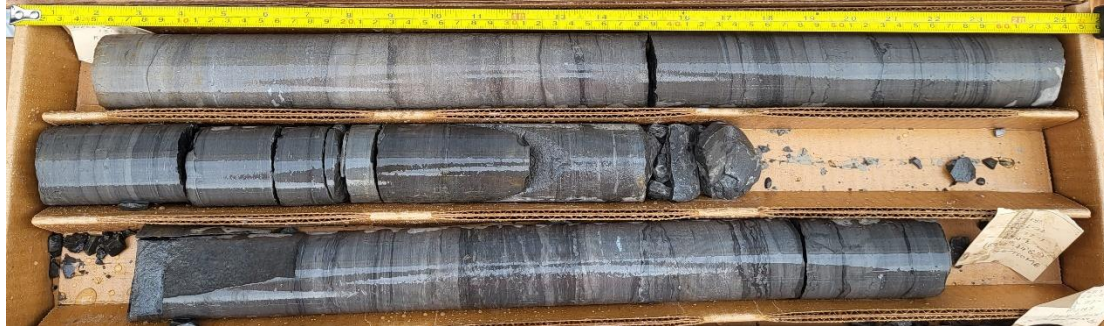
Run 2 Start  
elev. 70.5 m

Run 2 End  
elev. 69.0 m

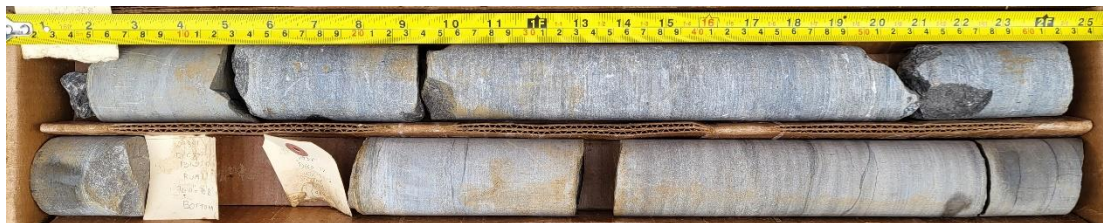
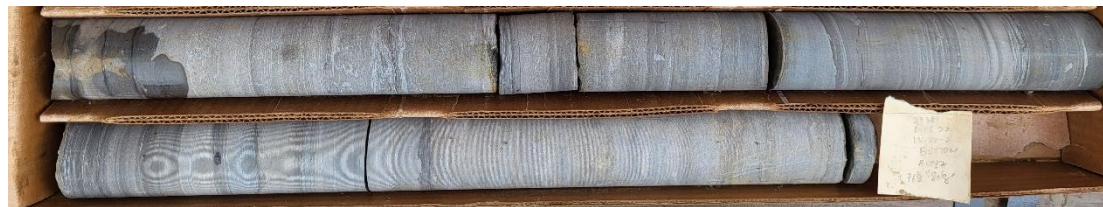
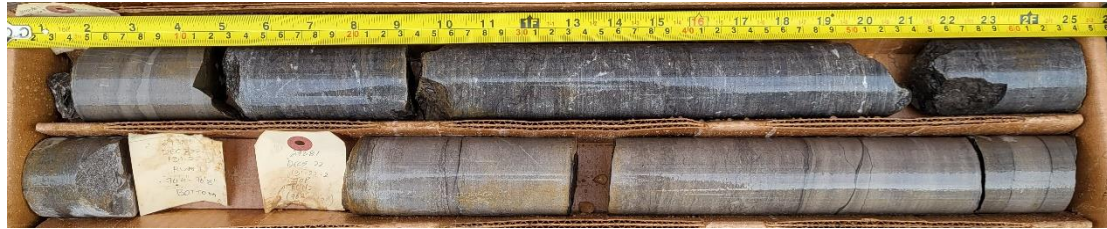
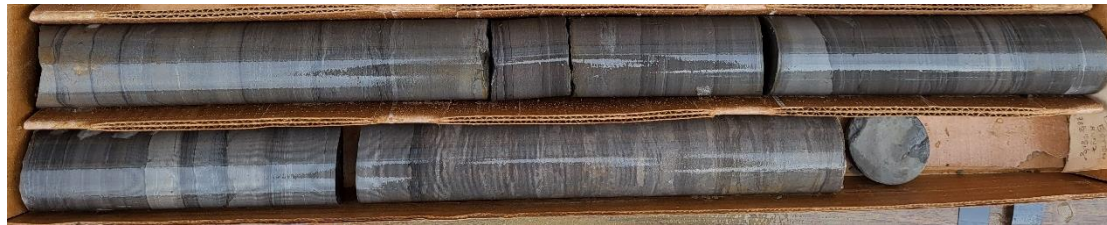
# Borehole 131-22-02

Run 1 Start  
elev. 69.7 m

Run 2 End  
elev. 67.5 m

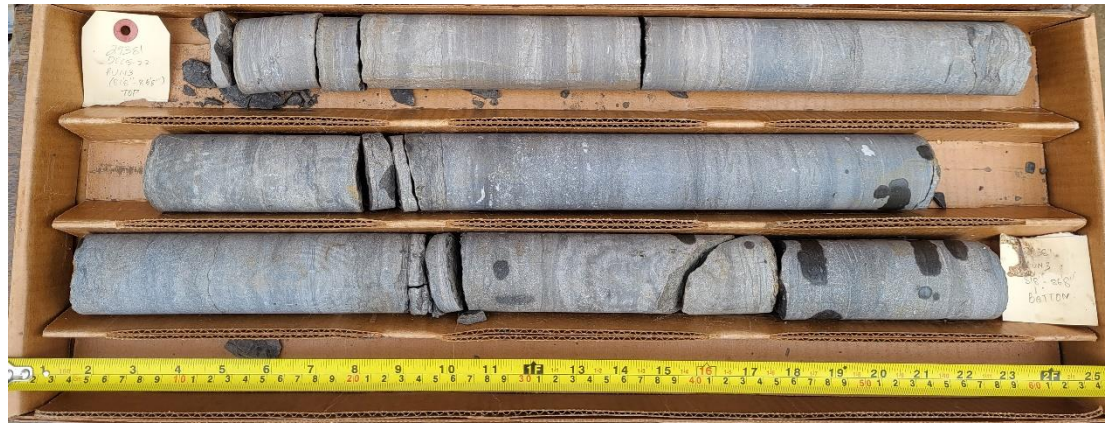
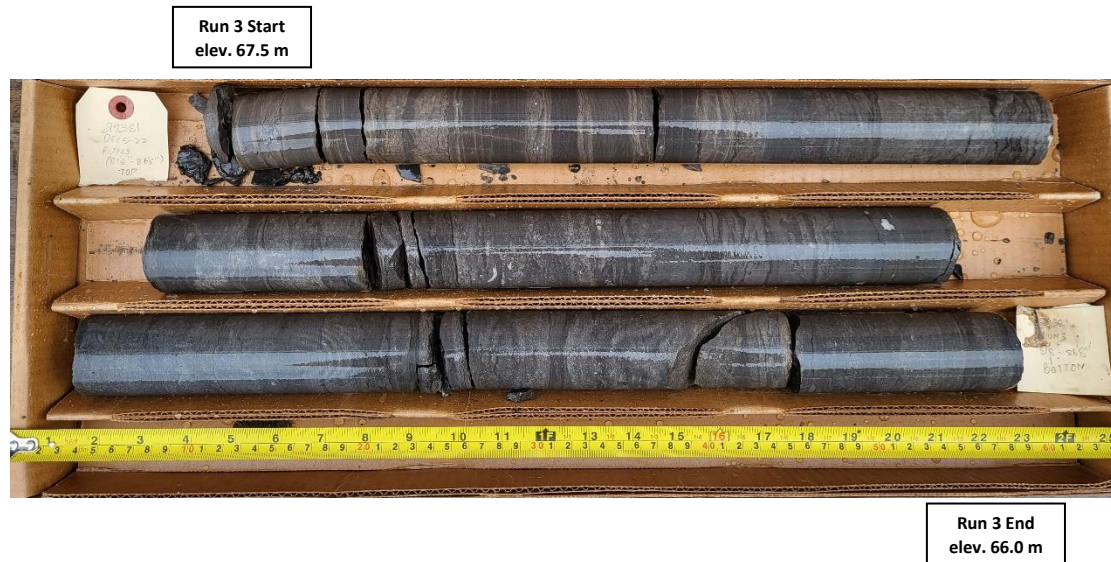
# Borehole 131-22-02

Run 3 Start  
elev. 67.5 m

Run 3 End  
elev. 66.0 m

Elevation 67.5 m to 66.0 m
