**PRELIMINARY FOUNDATION INVESTIGATION REPORT  
HIGHWAY 401 WIDENING, HIGHWAY 16 TO MAITLAND ROAD  
LEMMON'S CREEK CULVERT, SITE NO. 16X-0239C  
GWP 4024-20-00 / ASSIGNMENT NO.: 4019-E-0010.2**

**SITE NO. 16X-0239/C0**

Geocres No.: 31B12-004

March 2024

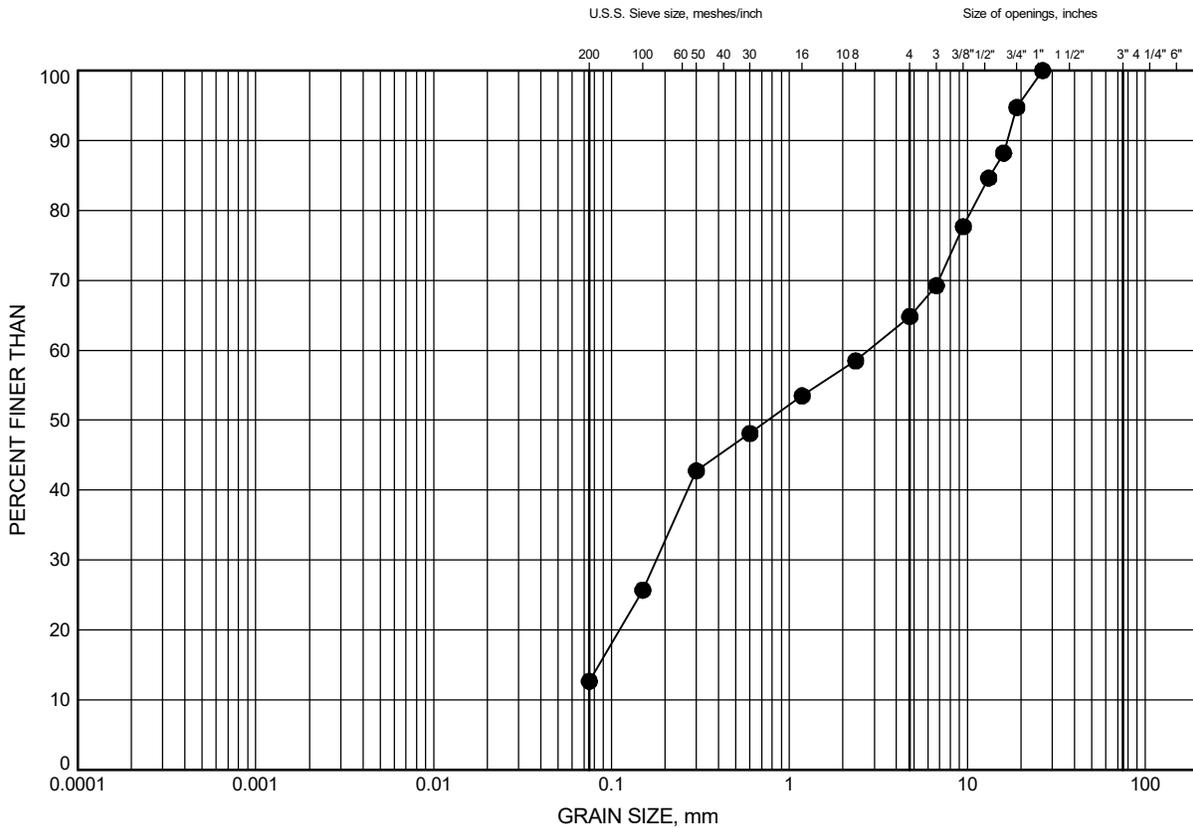
FILL: Silty Sand with Gravel

The recorded moisture contents ranged from 8 to 15%. The results of a gradation analysis completed on one sample of the fill are illustrated in Figure C1 of Appendix C. The results of the tests are summarized in the table below and on the Record of Borehole sheet in Appendix B.

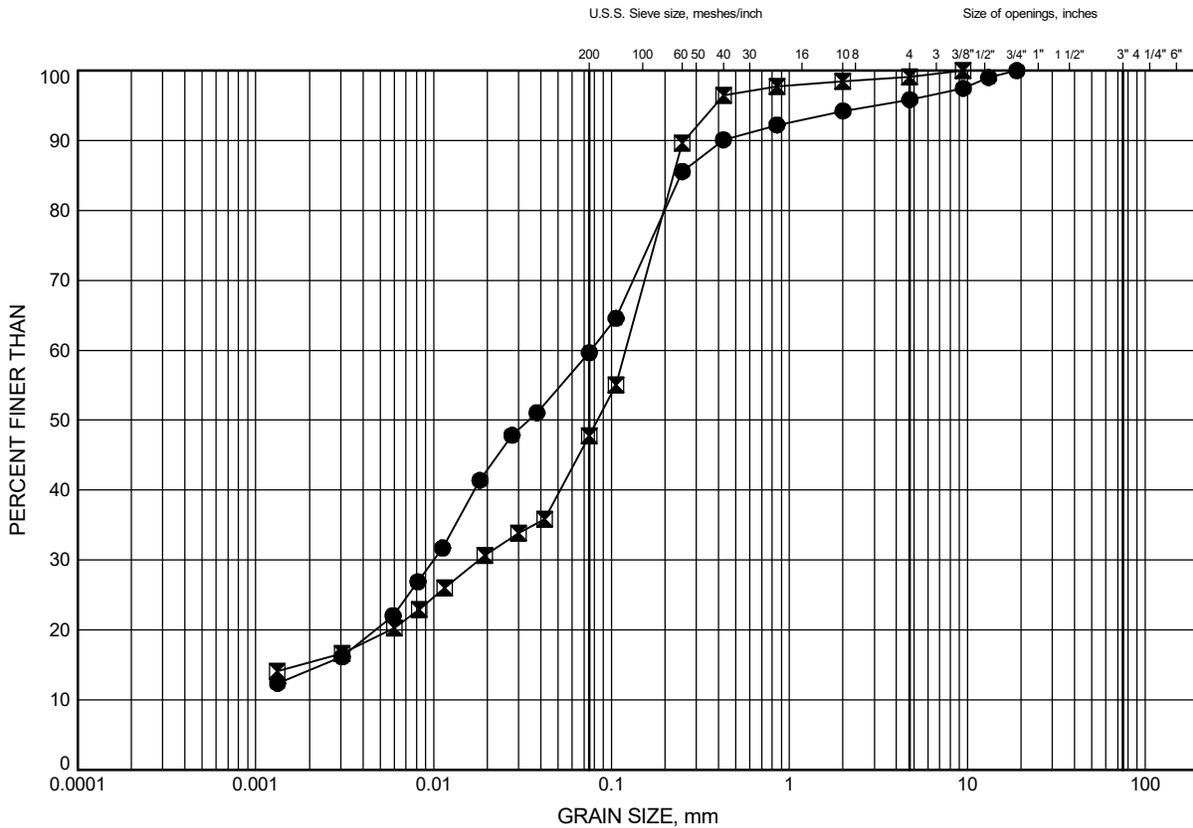
Native : Glacial Till

A deposit of glacial till consisting of sandy silt to silty sand with trace to some gravel and organics was encountered beneath the fill at both borehole locations. The glacial till was 1.9 m to 2.4 m thick (base elev. 93.6 m to 93.4 m). SPT N-values in the glacial till ranged from 4 to 8 blows per 0.3 m of penetration, indicating a loose relative density. The recorded moisture content ranged from 14 to 35%. The results of gradation analyses completed on two samples of the layer are illustrated in Figure C2 of Appendix C. The results of the tests are summarized in the table below and on the Record of Borehole sheet in Appendix B

Soil Particle	Percentage (%)
Gravel	1 – 4
Sand	36 – 51
Silt	32 – 45
Clay	15 – 16

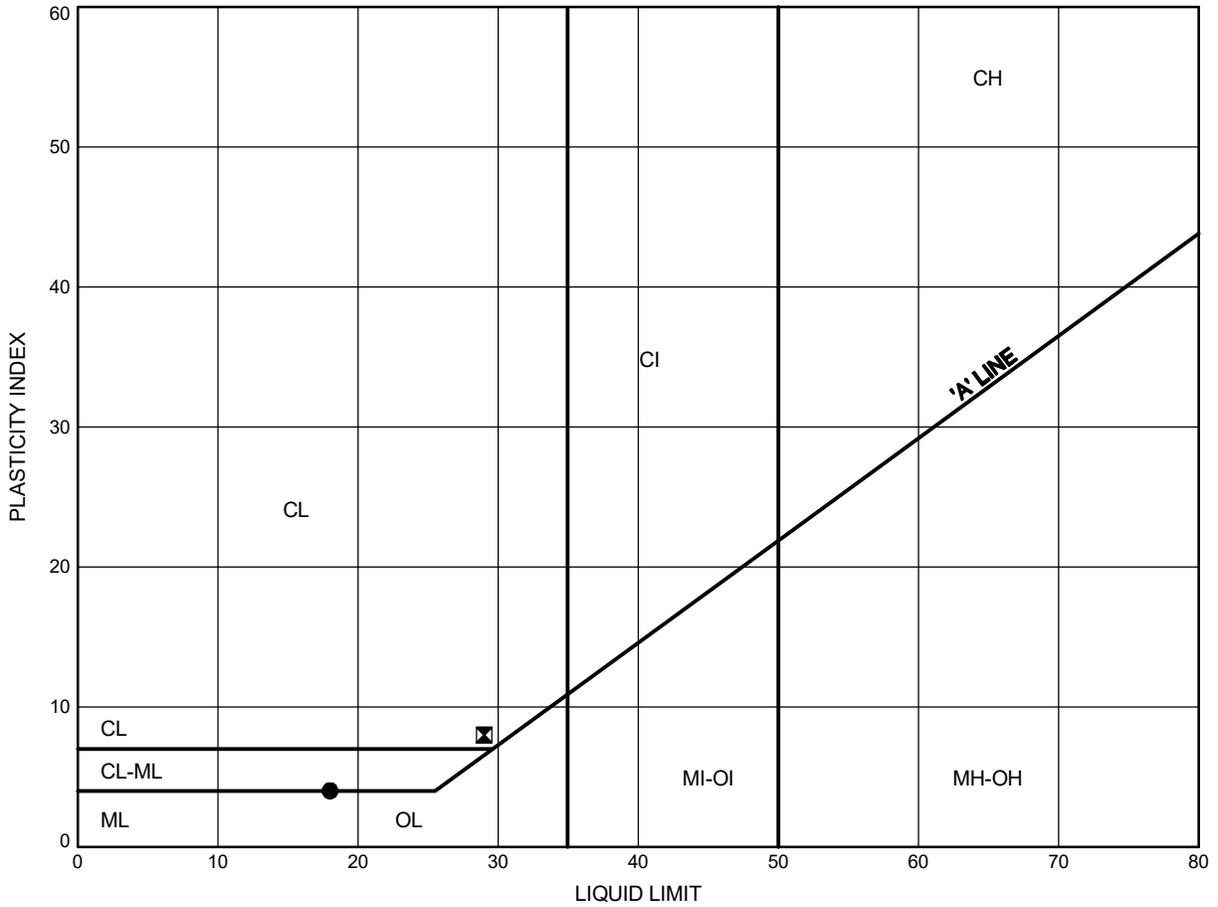
FIGURE C3

Native : Glacial Till

SYMBOL	BOREHOLE	DEPTH (m)	ELEV. (m)
●	239-23-02	1.8	94.8
⊠	239-23-02	2.6	94.0

Atterberg Limit testing was carried out on the fines portion of two samples of the till deposit obtained from Borehole 239-23-02. The results are illustrated in Figure C3 of Appendix C and are

summarized below and on the Record of Borehole sheet in Appendix B. The laboratory results indicate that the fines portion of the glacial till were generally low plasticity (CL, CL-ML).

Parameter	Value
Liquid Limit	18 – 29
Plastic Limit	14 – 21
Plasticity Index	4 – 8

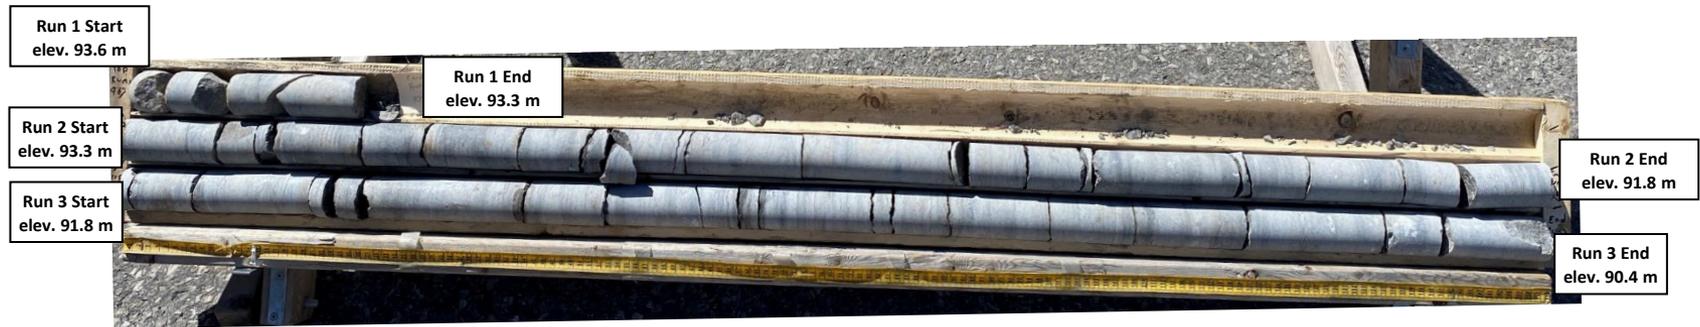
Elevation 93.6 m to 90.4 m

Dry Sample

The bedrock encountered consisted of fine grained, slightly weathered, grey, very strong limestone. Photographs of the bedrock cores are provided in Appendix C. The rock core quality is summarized in Table 5-1.

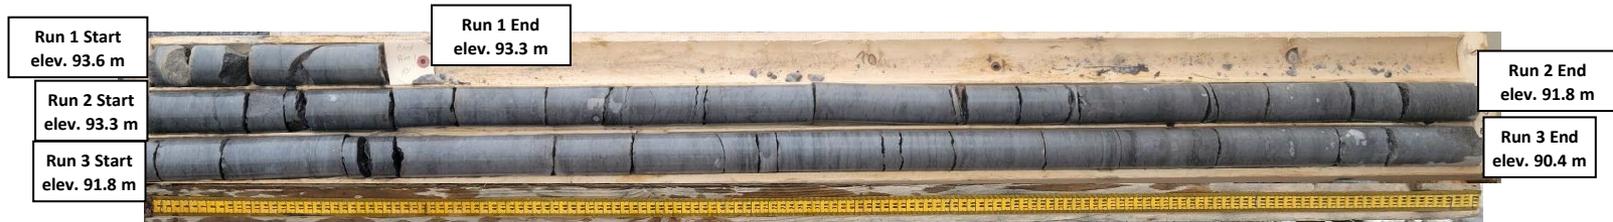
Elevation 93.6 m to 90.4 m

Wet Sample

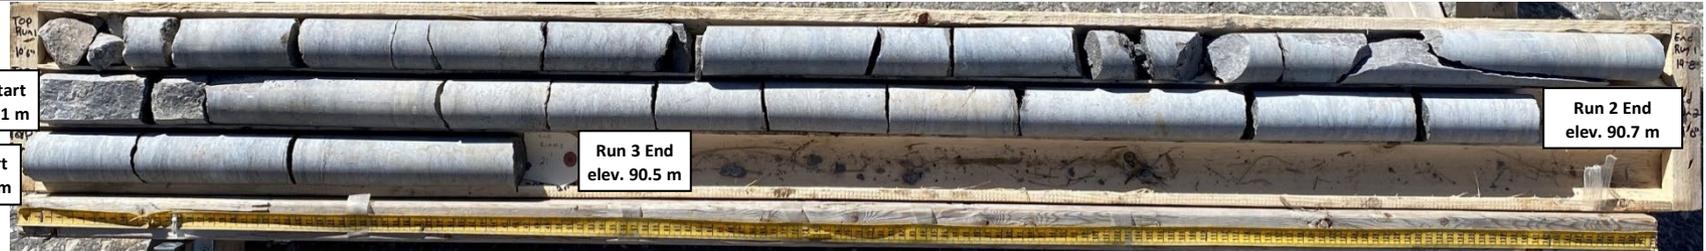
Run 3 Start  
elev. 90.7 m

Run 3 End  
elev. 90.5 m

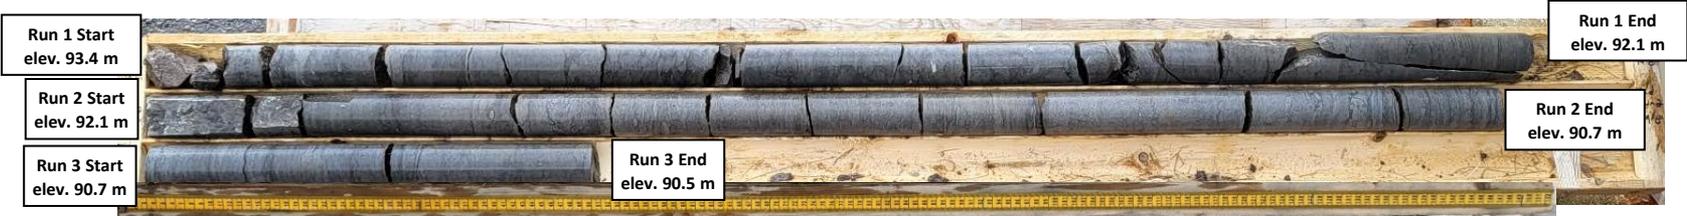
Elevation 93.4 m to 90.5 m

Wet Sample

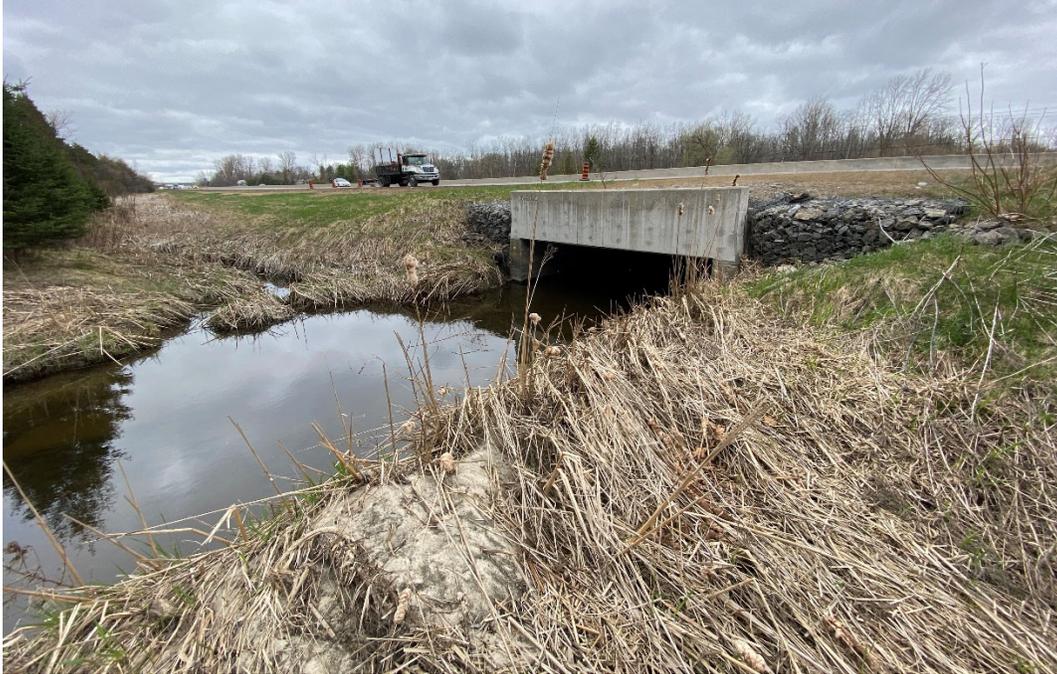
Photograph 1: Culvert Outlet – Eastbound Highway 401 *[taken April 2023]*

Based on the limited available original design drawings and OSIM report, the culvert consists of a reinforced, cast-in-place, open footing culvert. The culvert is approximately 52 m long, has a total internal span of 4.3 m, and an approximate internal height of about 1.7 m above the creek bed. The creek bed / invert of the culvert is at approximate Elevation 93.6 m. At the time of the current field investigation the creek water was about 0.6 m deep. The culvert structure includes a concrete headwall above the crown at each end and gabion baskets adjacent to the headwalls.

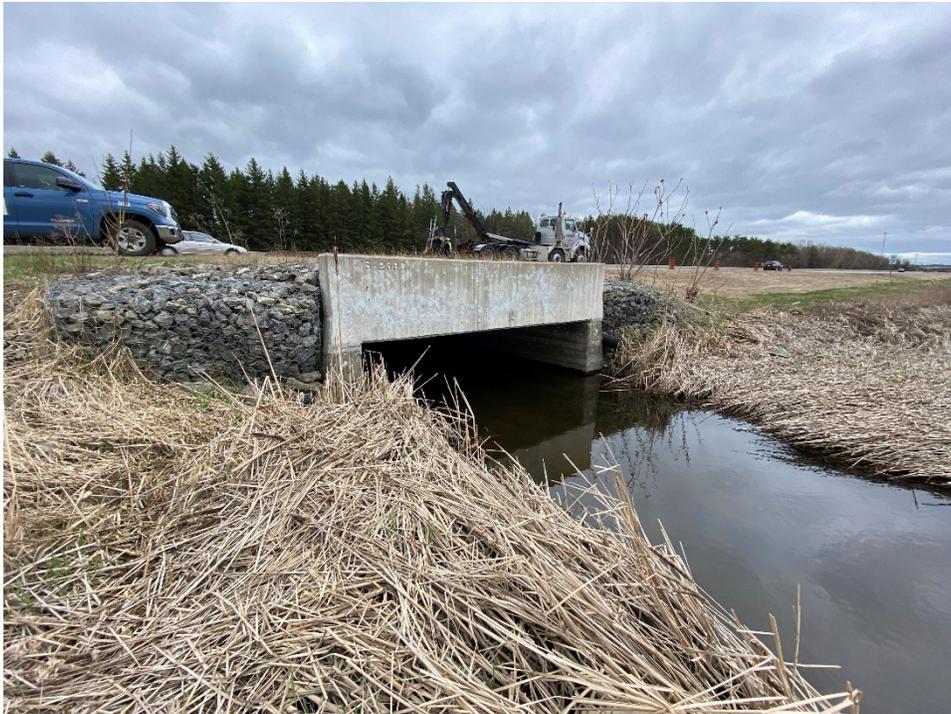
Photograph 4: Culvert Inlet Highway 401 *[taken April 2023]*
