**Foundation Investigation Report**  
Highway 7  
Culvert at Station 19+538  
Belmont Township

W.P. 84-99-00

Project No. 122410641

February 2012

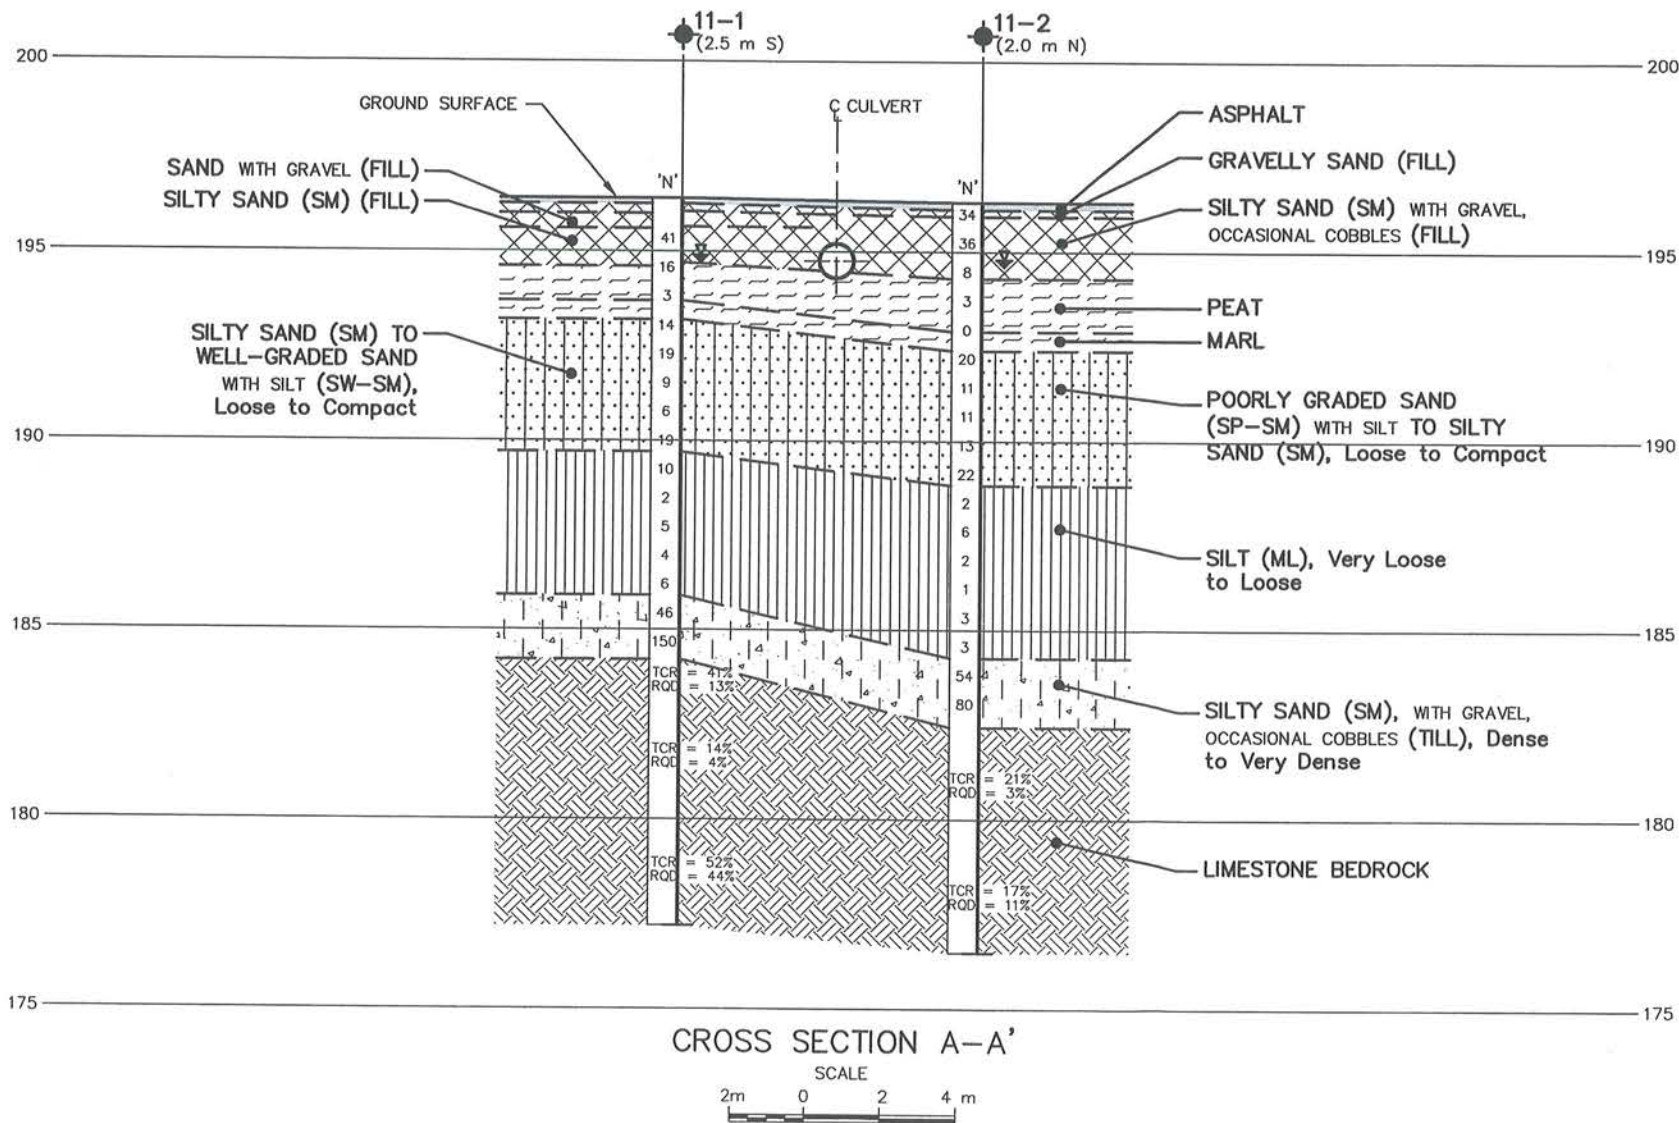
Drawing No. 1 – Borehole Location Plan and Soil Strata  
Site Photographs

HIGHWAY 7  
CULVERT AT STA 19+538  
BOREHOLE LOCATIONS & SOIL STRATA

The foundation field investigation carried out at the culvert site consisted of two boreholes within the driving lanes of Highway 7; one on either side of the culvert. The boreholes were designated as BH11-1 and BH11-2. Borehole locations are shown on the Borehole Location Plan, Drawing No.1 in Appendix A.

Descriptions of these strata are given below. A Borehole Location Plan and a Stratigraphic Section showing the soils encountered within the boreholes are provided on Drawing No. 1 in Appendix A.

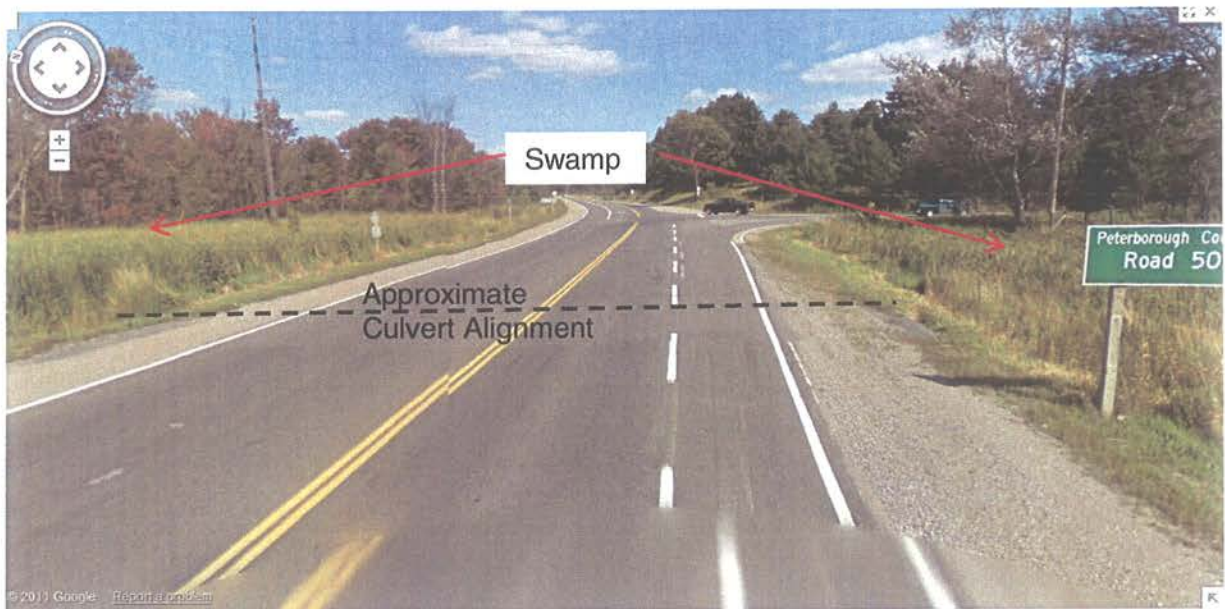
**Photo No. 1: Looking east along Highway 7 at culvert site**

At the investigation site, Highway 7 crosses a swamp which includes cattails on both sides of the road. See photographs in Appendix A.

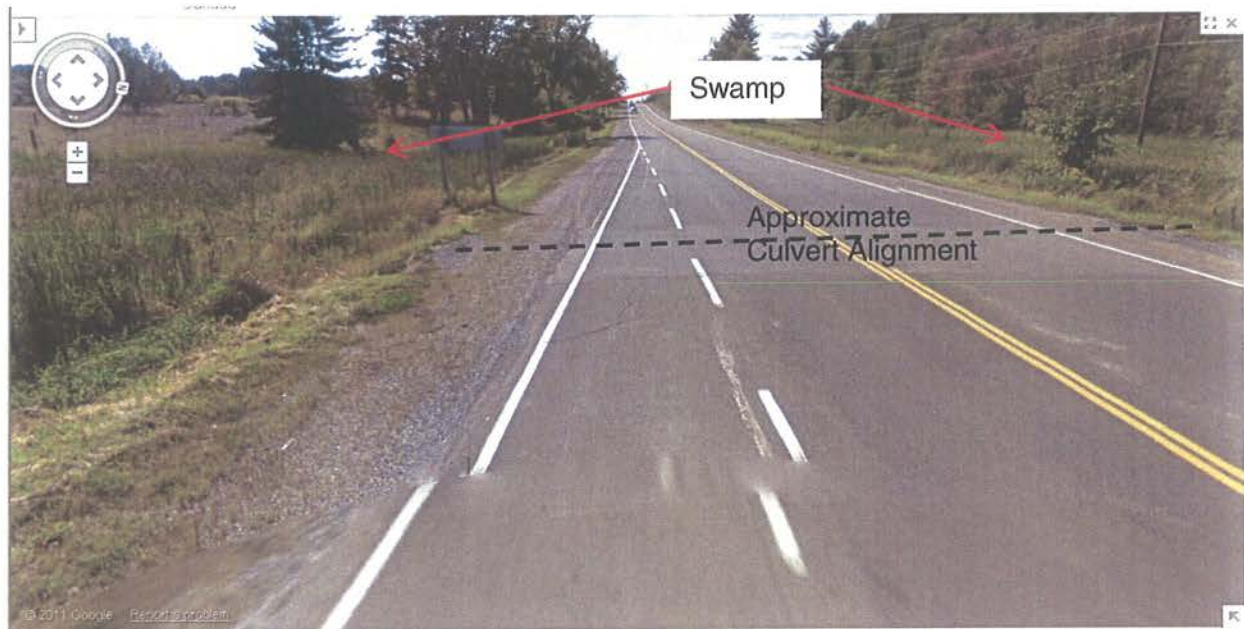
**Photo No. 2: Looking west along Highway 7 at culvert site**

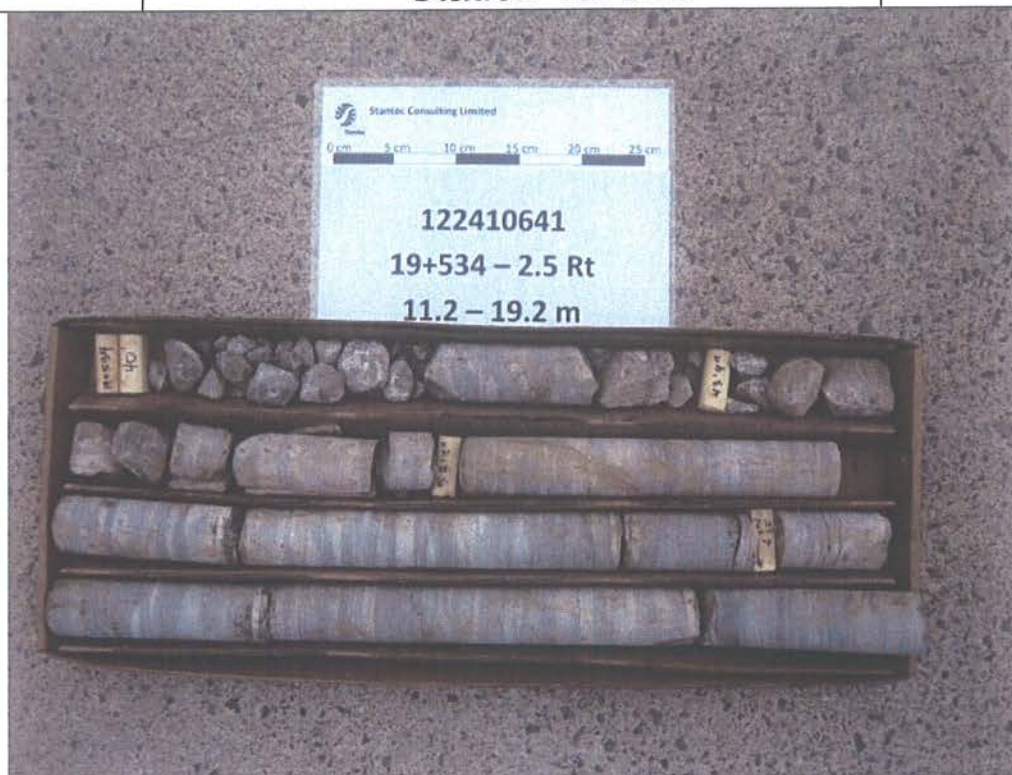
Photo No.: 1

Borehole: BH11-1

Depth: 12.2 to 19.2 m

The total core recovery (TCR) of the rock ranged between 14 and 52% (with average of 29%). The rock quality designation (RQD) ranged between 3 and 44% (with average of 15%), indicating a very poor to poor rock mass quality. The bedrock was friable to slightly weathered with joint spacing ranging from close to moderate and joint orientation predominantly flat. A detailed description of the rock core is provided in Field Core Logs along with rock core photographs in Appendix B.

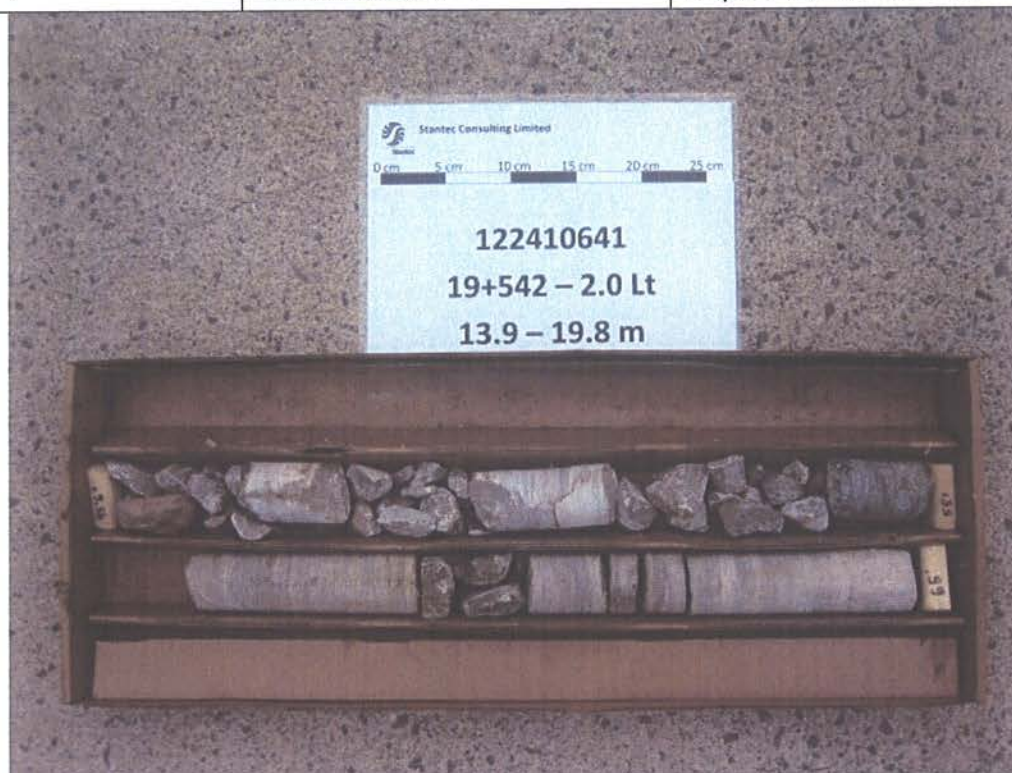
Photo No.: 2

Borehole: BH11-2

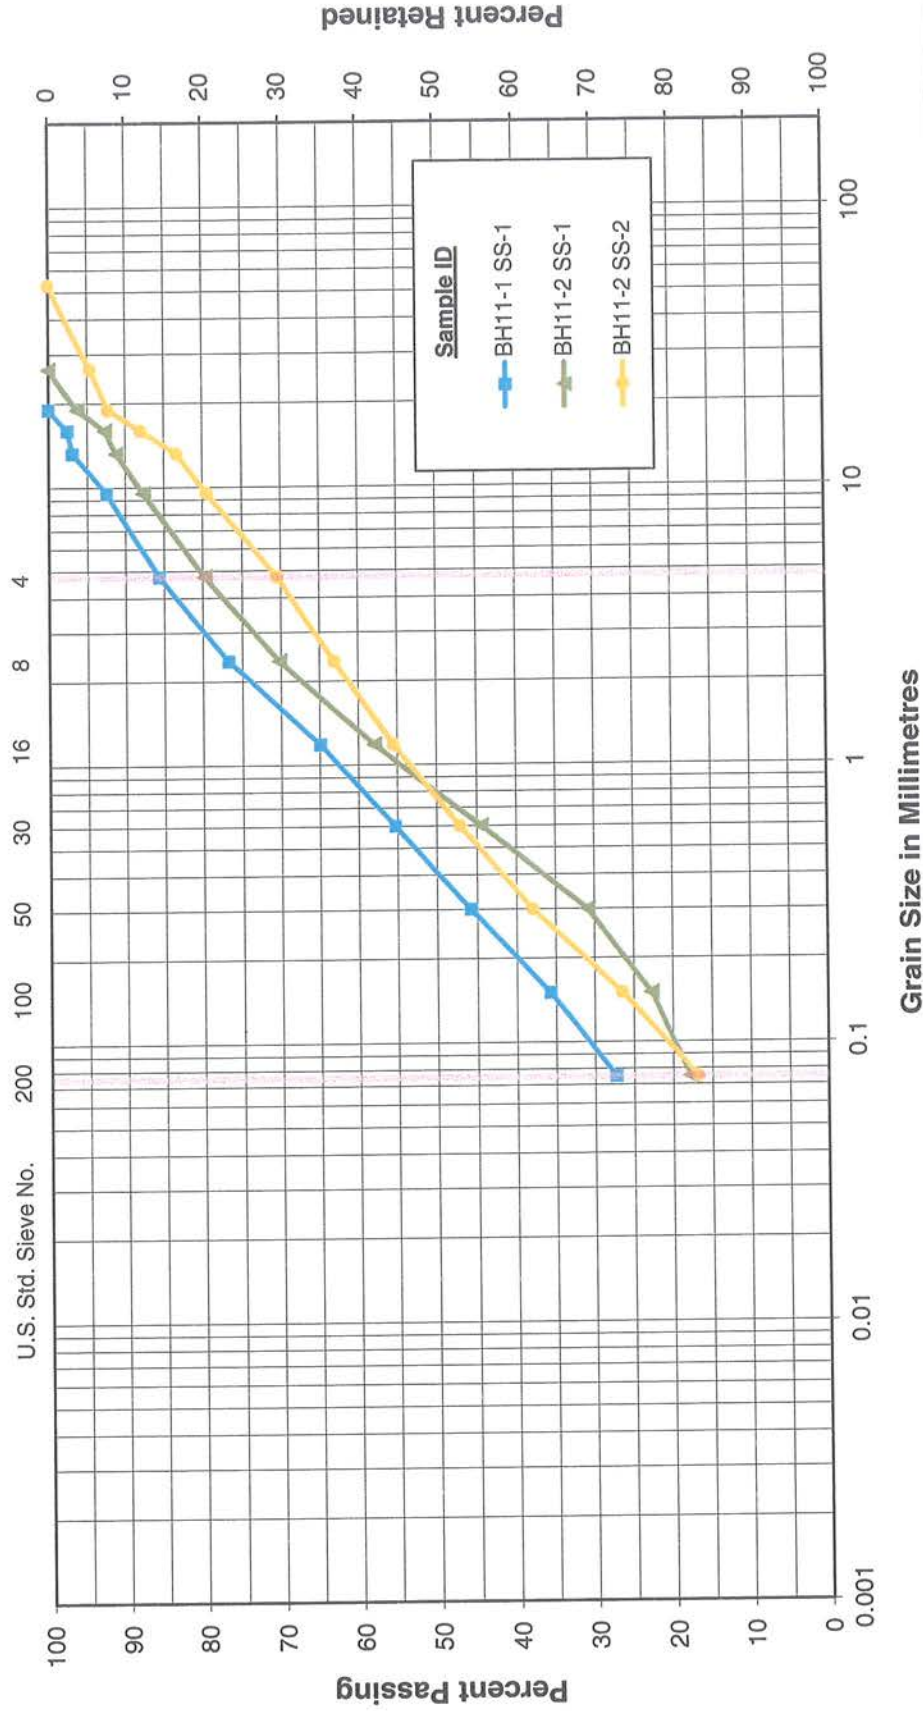
# GRAIN SIZE DISTRIBUTION

This material can be classified as silty sand (SM) to silty sand with gravel (SM). The grain size distribution curves are shown on Figure 1 in Appendix C.

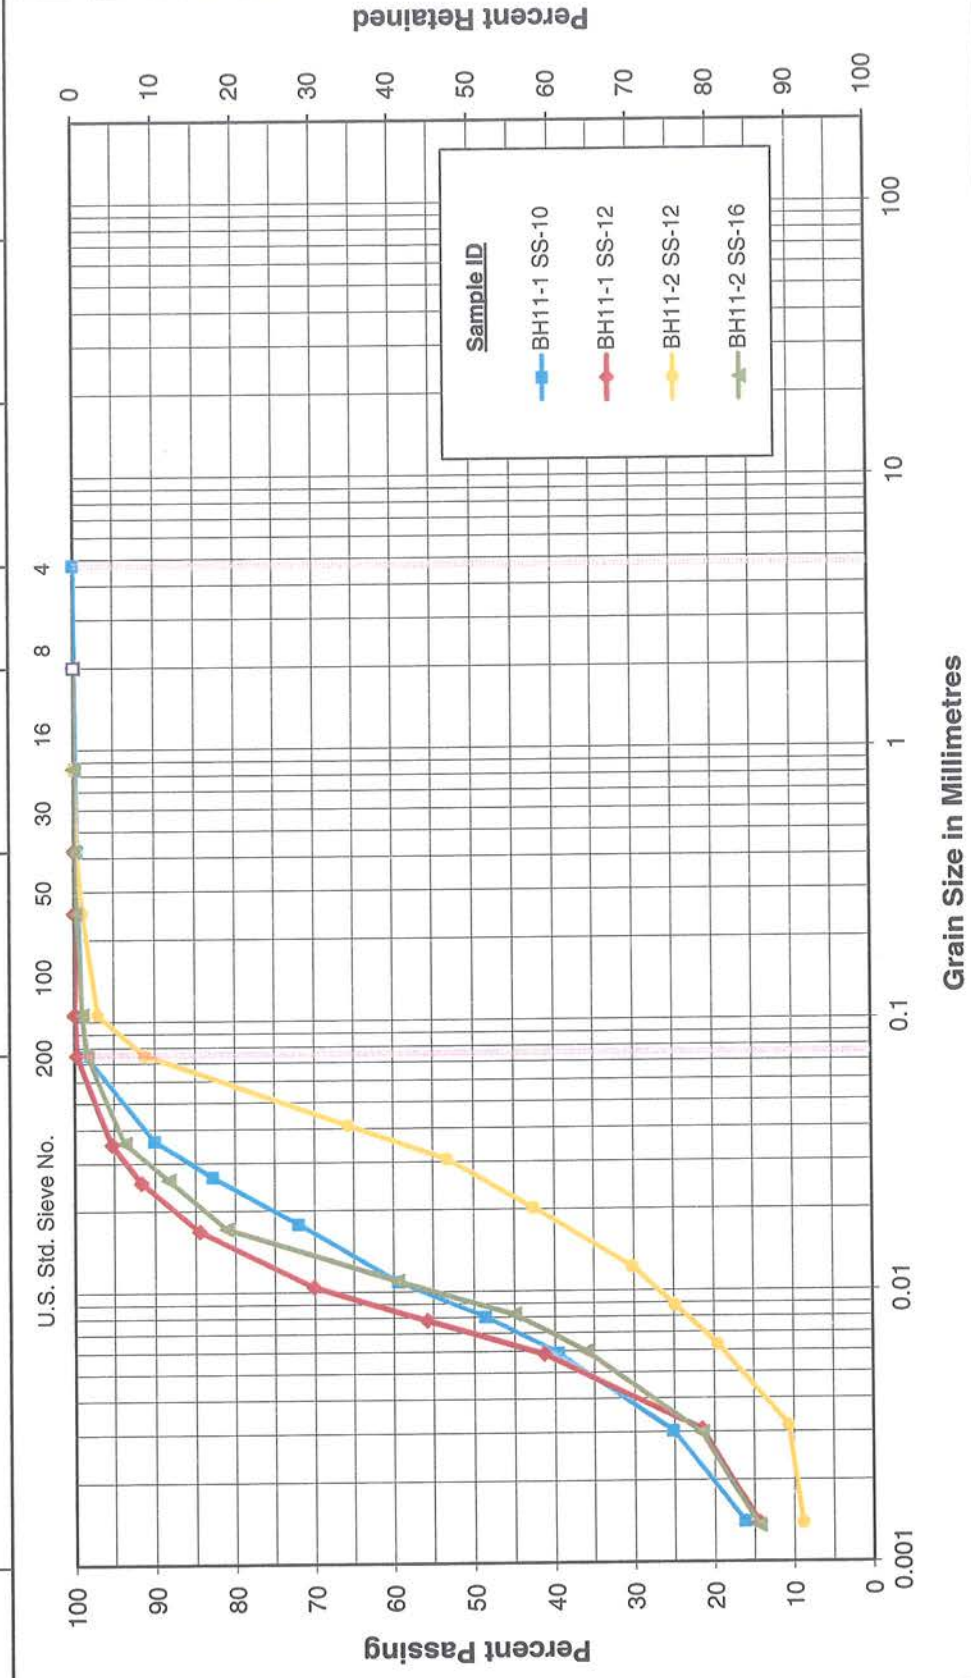
Figure No. 3

**GRAIN SIZE DISTRIBUTION**  
Silt (ML) to Silty Clay (CL-ML)

The grain size distribution plots of representative samples obtained from this deposit are shown in Figure 3.

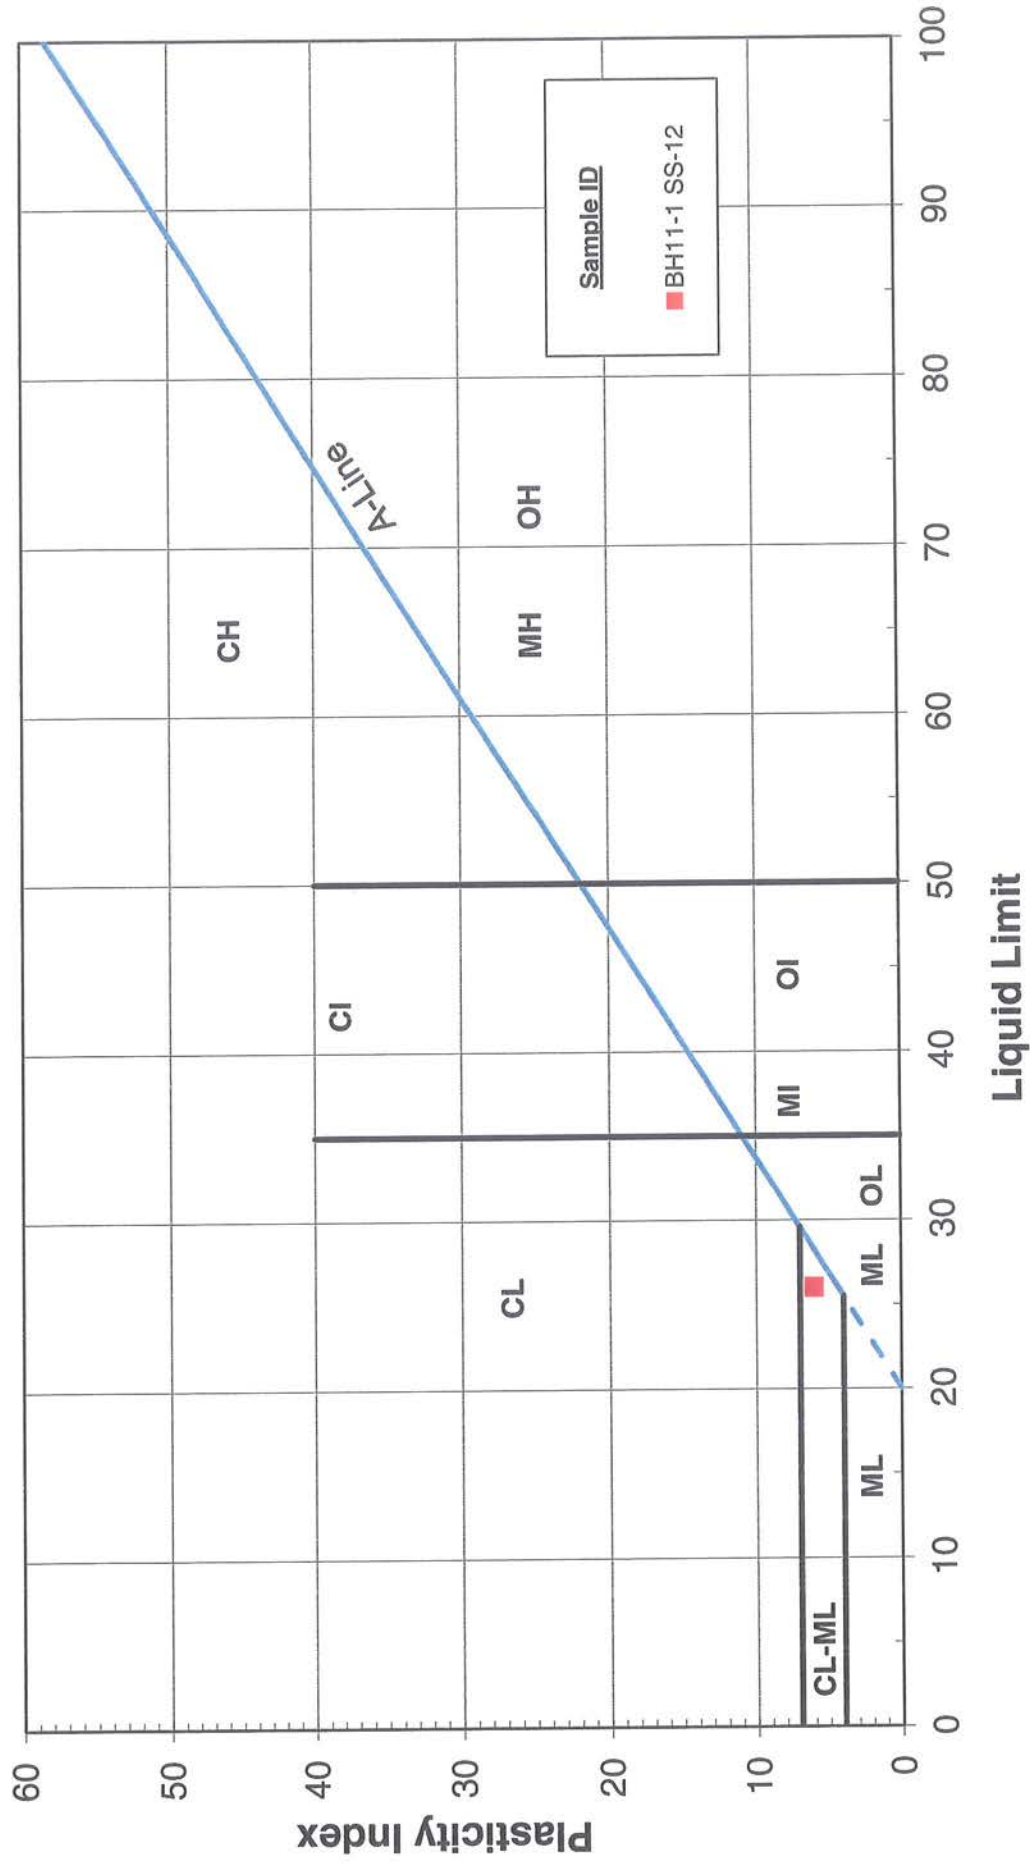
Figure No. 4

# PLASTICITY CHART

Four Atterberg Limits tests were carried out on representative samples from this deposit. Three samples were non-plastic while one sample had low plasticity (plasticity index = 6%). The plasticity chart is provided in Figure 4 in Appendix C.

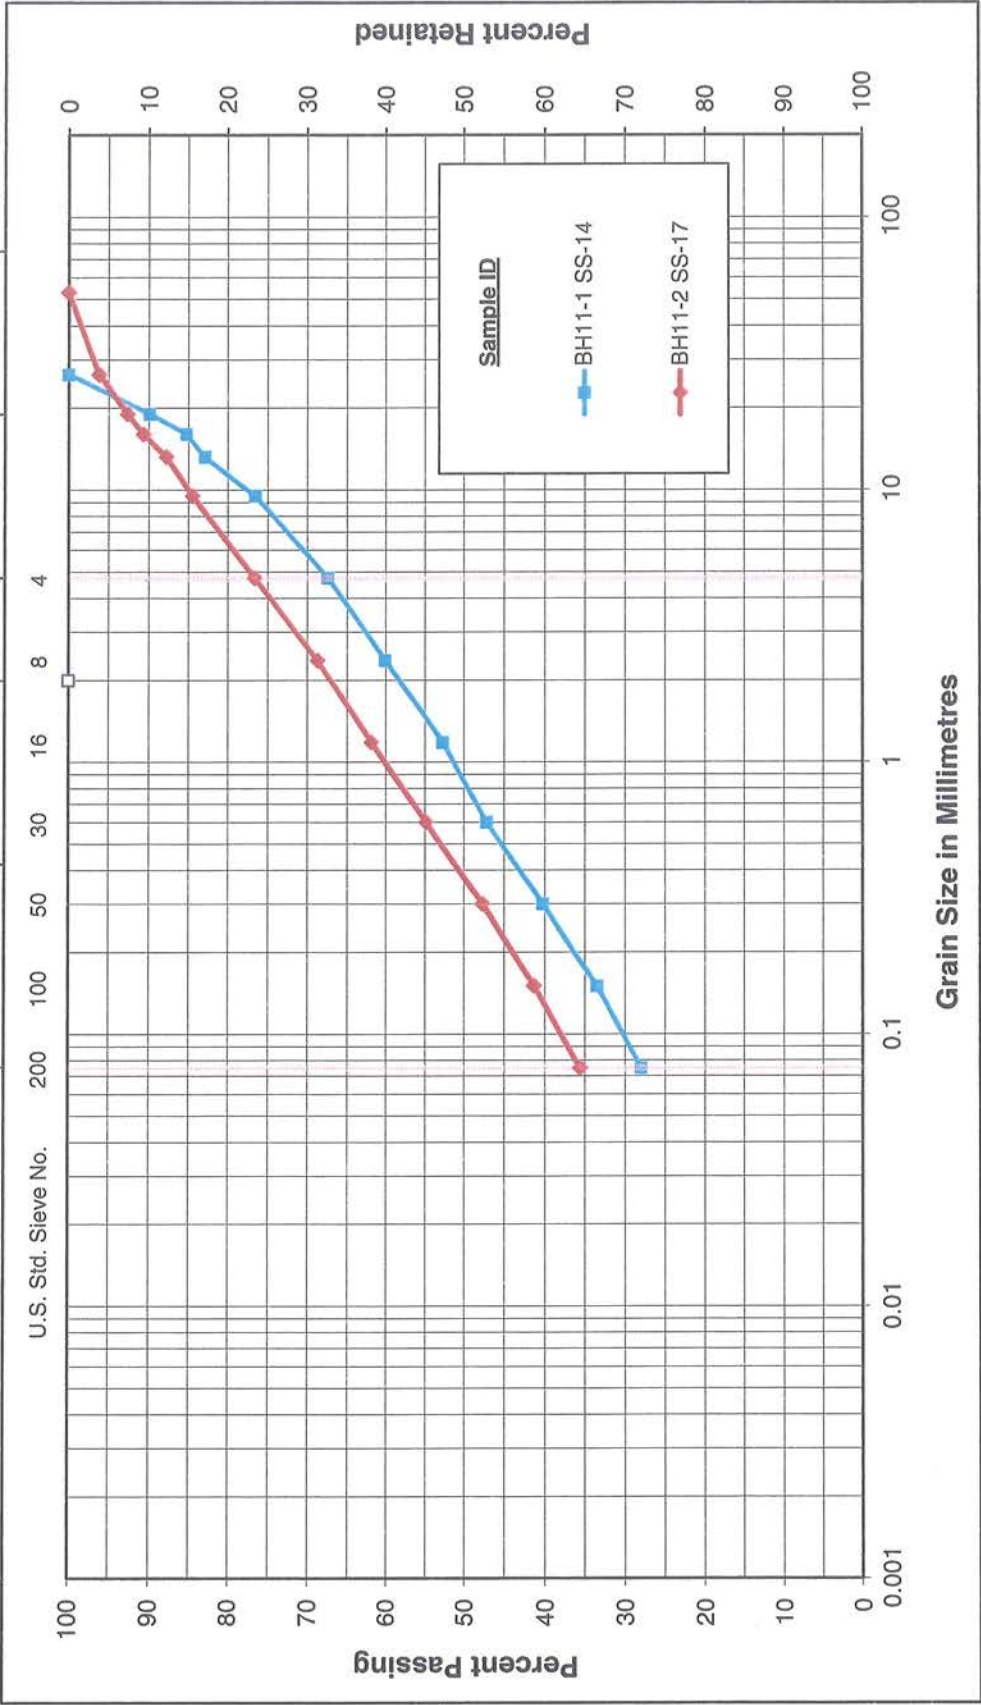
Figure No. 5

**GRAIN SIZE DISTRIBUTION**  
Silty Sand with Gravel (SM), TILL

The material of this deposit can be classified as silty sand with gravel (SM). The grain size distribution plots of representative samples obtained from this deposit are shown in Figure 5.
