Foundation Investigation Report

Highway 24
Alder Creek Culvert
Partial Replacement and Rehabilitation
Station 11+650
Township of North Dumfries
Site No. 33-489/C

G.W.P. 3055-03-00

May 2011

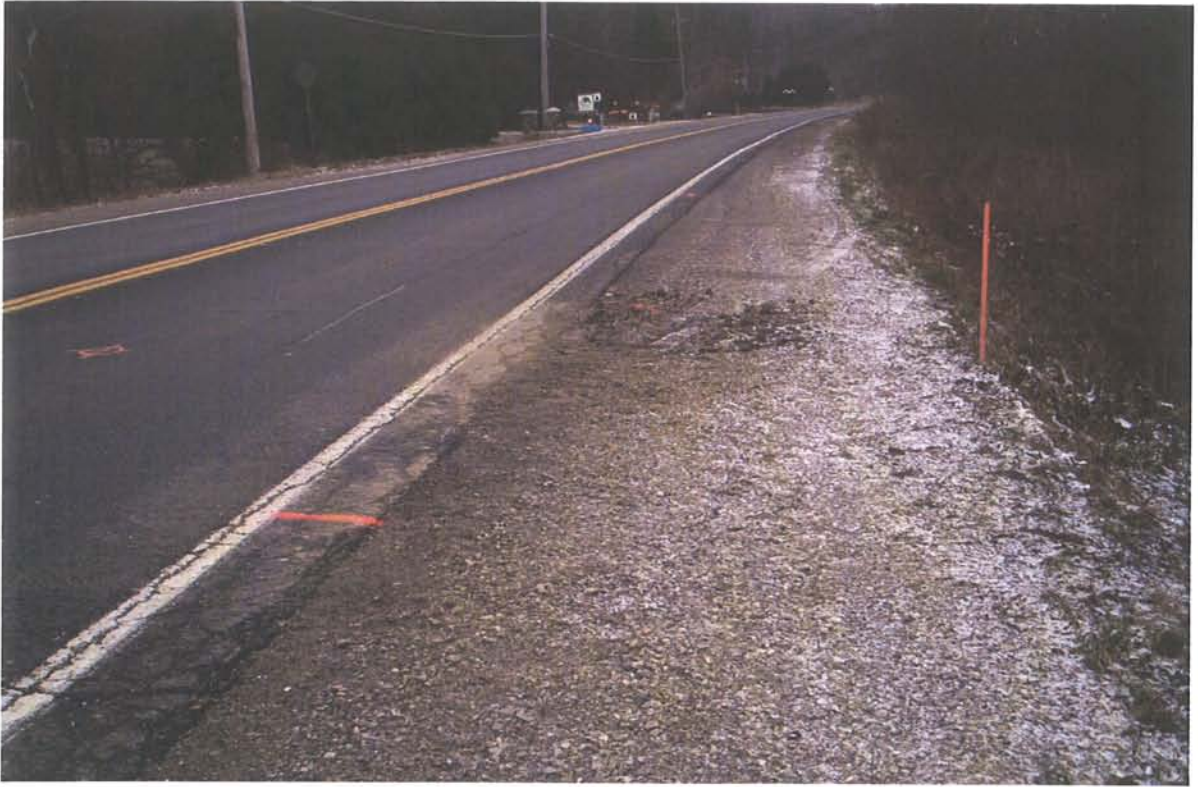
It is noted that Highway 24 runs approximately north-south at the project location with chainage increasing from south to north. In the vicinity of the culvert, Highway 24 has a two lane rural cross-section with approximately 3 m wide shoulders (see Photo 1 in Appendix A).

Photo No. 1: Hwy 24 looking south at culvert site.

The area between Highway 24 and the recreational trail is covered with brush and small trees (see Photos No 1 and 3 in Appendix A).

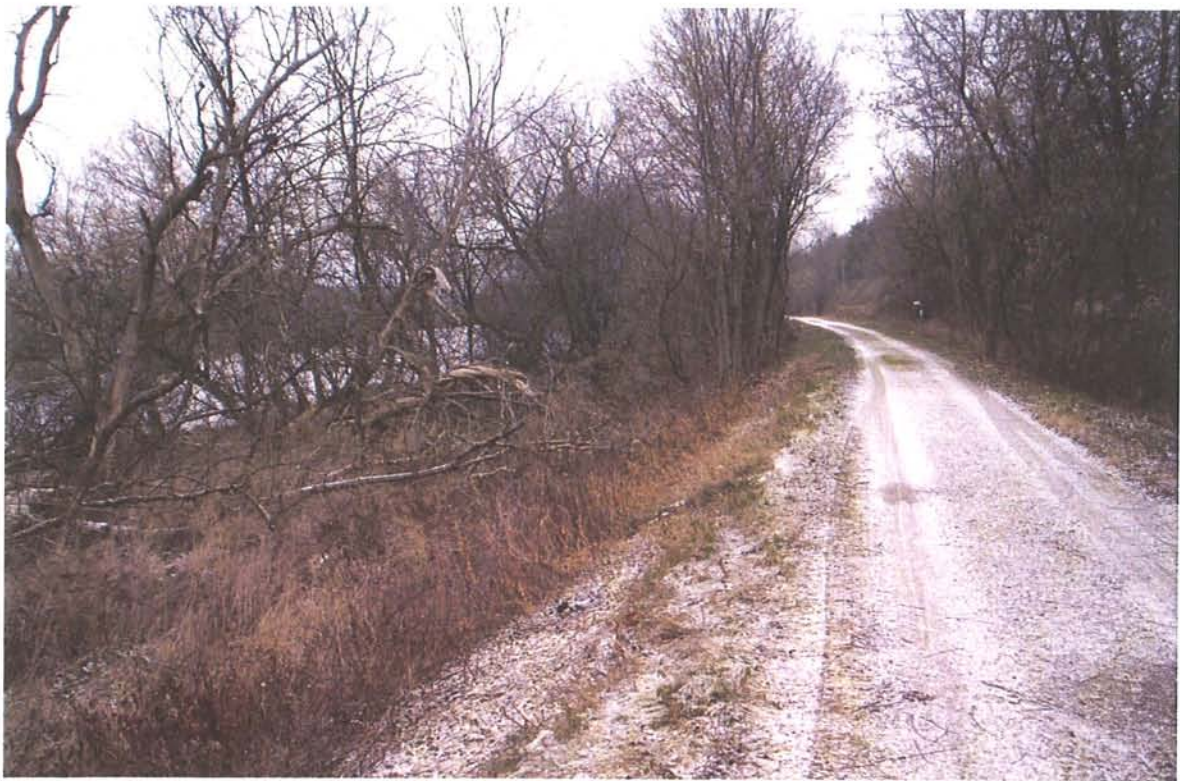
Photo No. 2: Recreational trail looking north at culvert site.

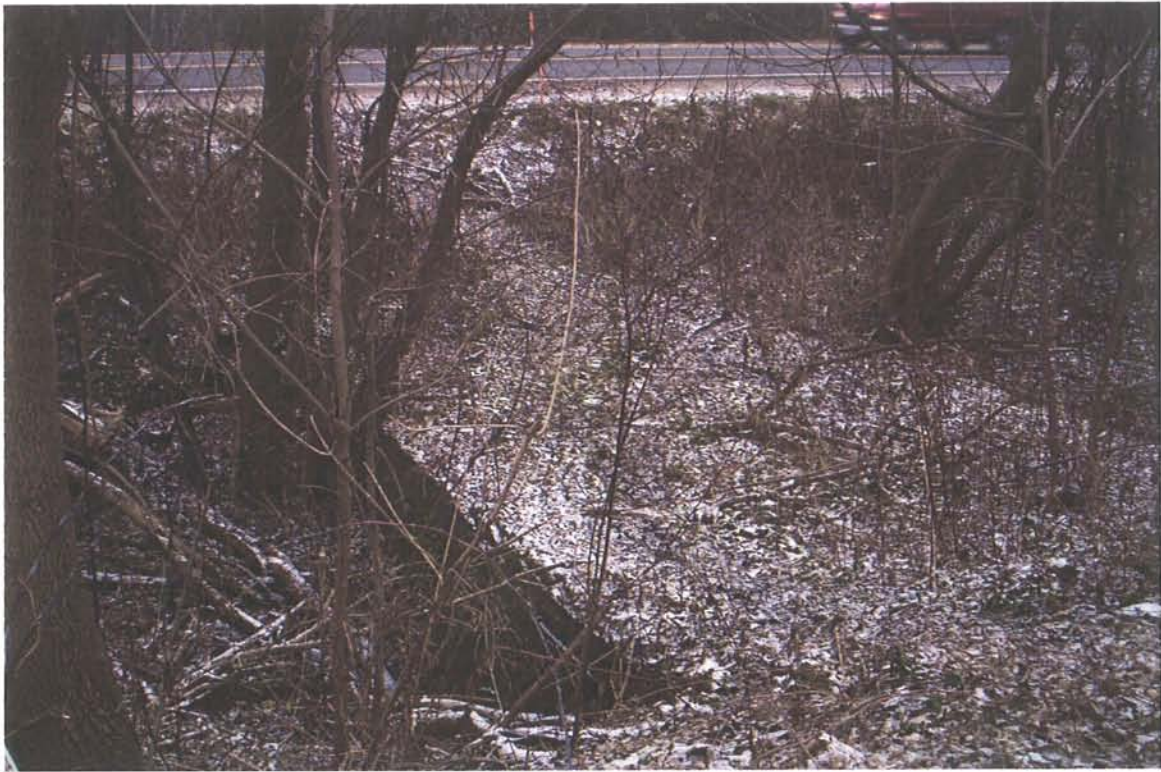
Photo No. 3: View from recreational trail toward Hwy 24 with exposed culvert section in between.

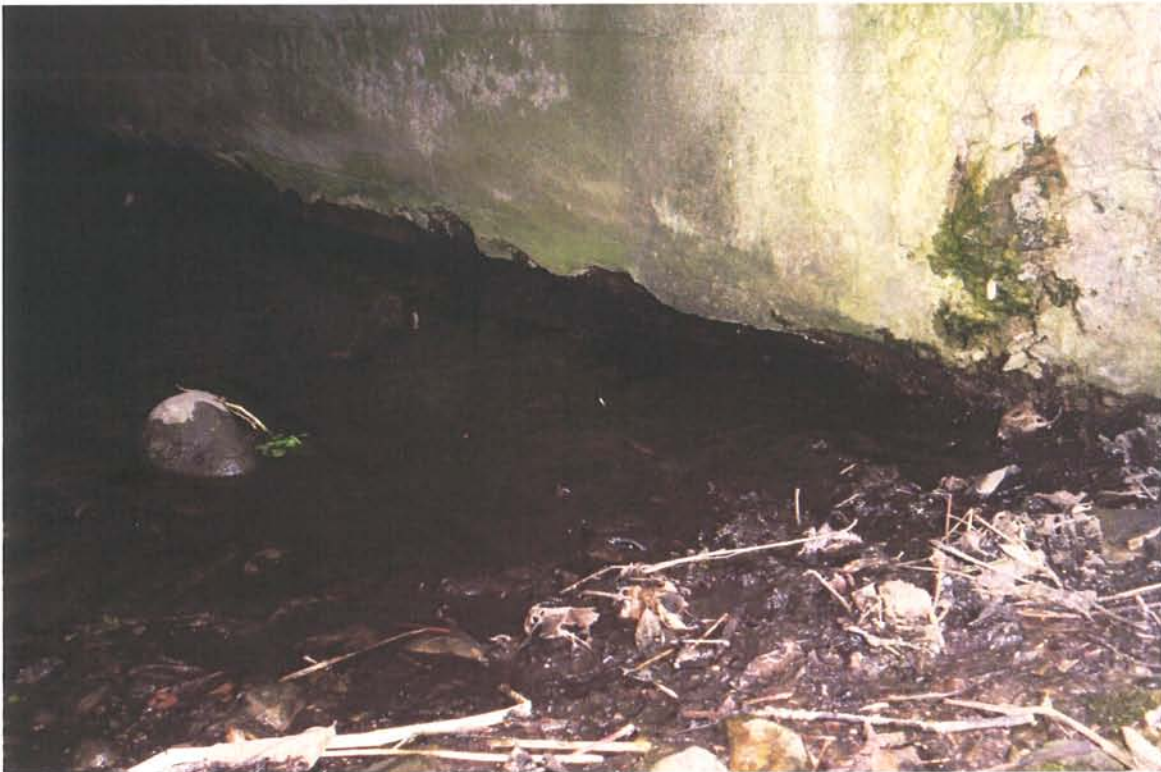
The outlet of the culvert is visible at the base of the trail embankment on the west side, approximately 2.1 m below the trail surface (see Photo 4 in Appendix A). Signs of erosion and concrete deterioration of the underside of the culvert are visible on the south side of the outlet. A concrete headwall is present at the outlet.

Photo No. 4: Culvert outlet with signs of erosion and deterioration at the south side.
