**FINAL  
PRELIMINARY FOUNDATION INVESTIGATION REPORT  
HIGHWAY 401 WIDENING, HIGHWAY 16 TO MAITLAND ROAD  
HIGHWAY 401 UNDERPASS AT HIGHWAY 16, SITE NO. 16X-0130/B0  
GWP 4024-20-00 / ASSIGNMENT NO.: 4019-E-0010.2**

**SITE NO. 16X-0130/B0**

Geocres No.: 31B-112

November 2023  
Thurber File No.: 29381

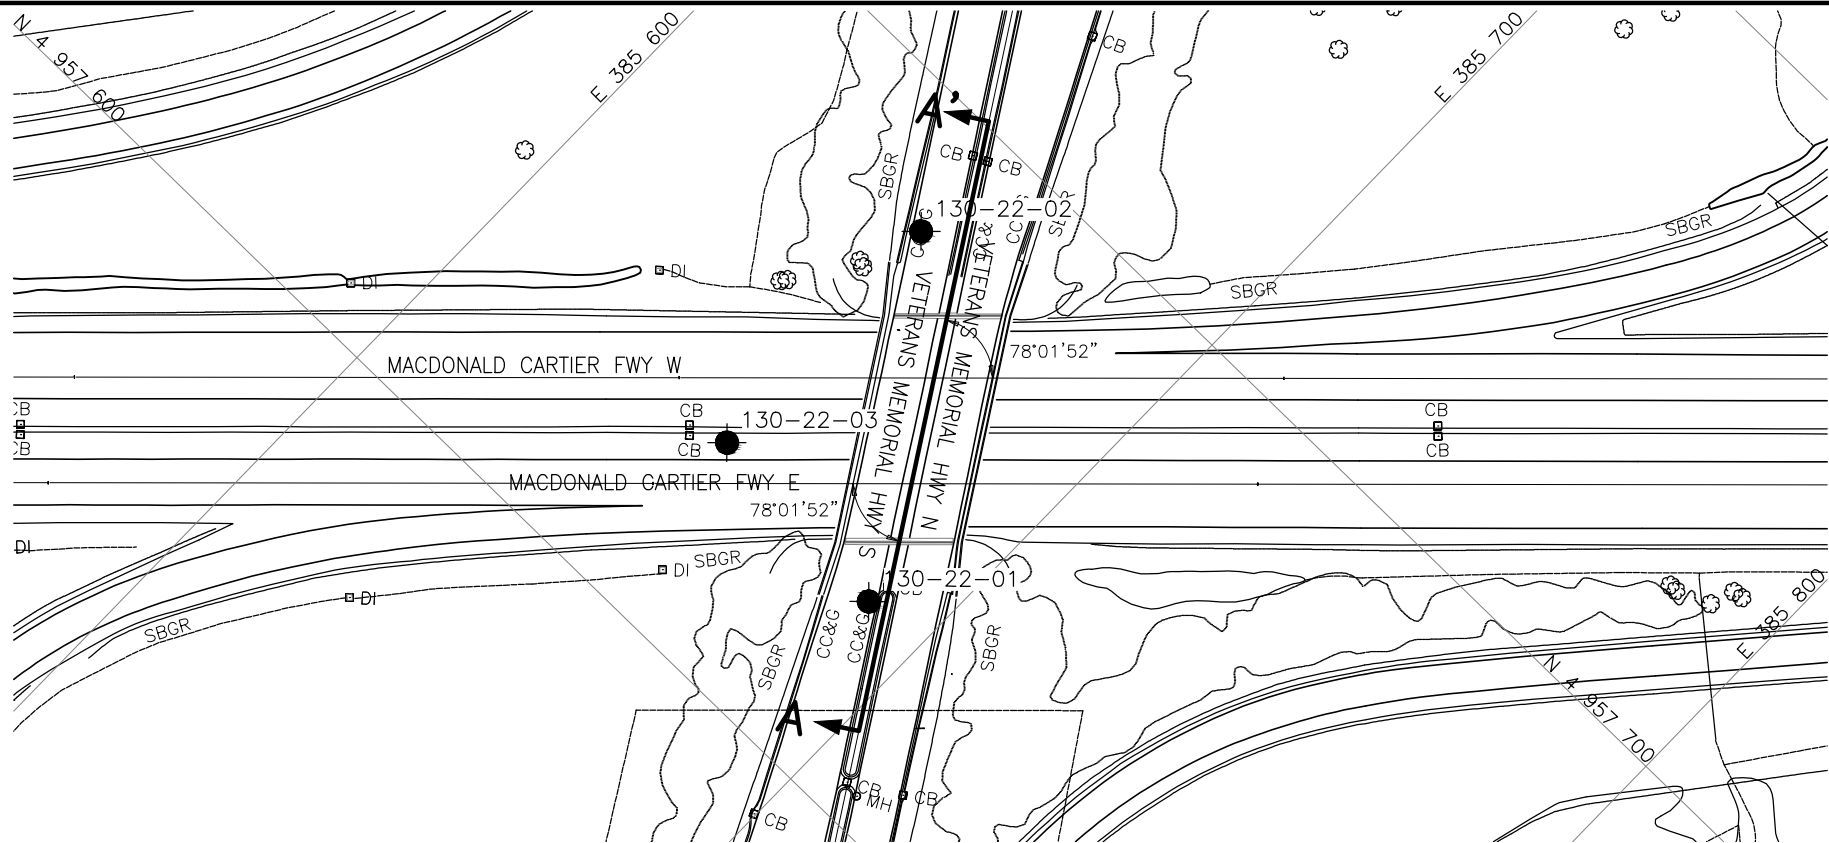
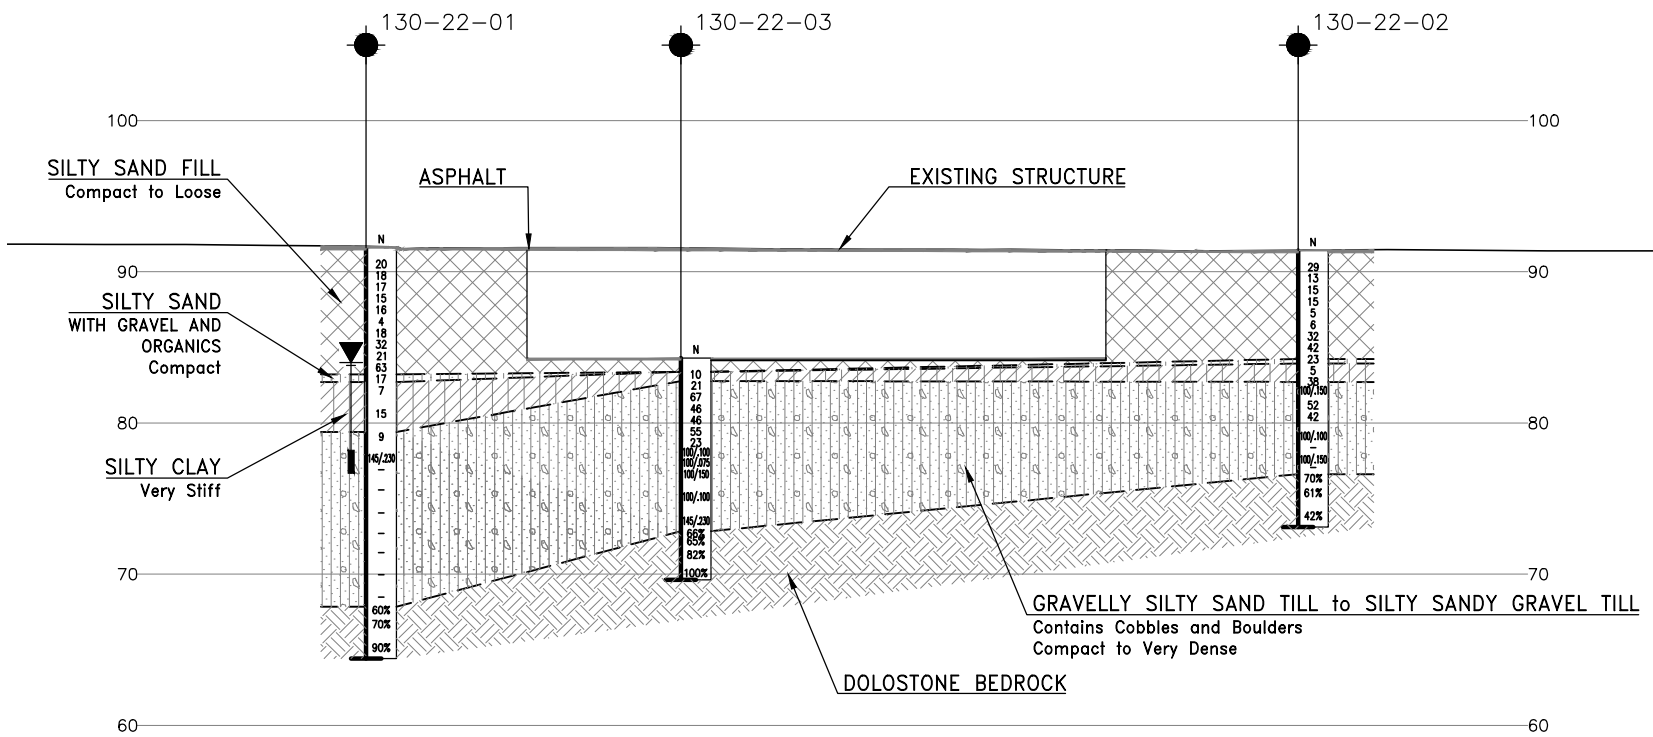
HIGHWAY 401  
HIGHWAY 16 UNDERPASS  
BRIDGE REPLACEMENT  
BOREHOLE LOCATIONS AND SOIL STRATA

PLAN

SECTION A-A'

Details of the encountered soil stratigraphy are presented on the Record of Borehole sheets included in Appendix B and on the Borehole Location and Soil Strata Drawing included in Appendix A. A general description of the stratigraphy, based on the conditions encountered in the boreholes, is given in the following sections. However, the factual data presented on the Record of Borehole sheets takes precedence over this general description for interpretation of the site conditions. It must be recognized that the soil and groundwater conditions will vary between and beyond borehole locations. Soil classification is in accordance with ASTM D 2487. Description of cohesive soils and secondary components are described as outlined in the MTO Guideline for Foundation Engineering Services Manual (April 2022).

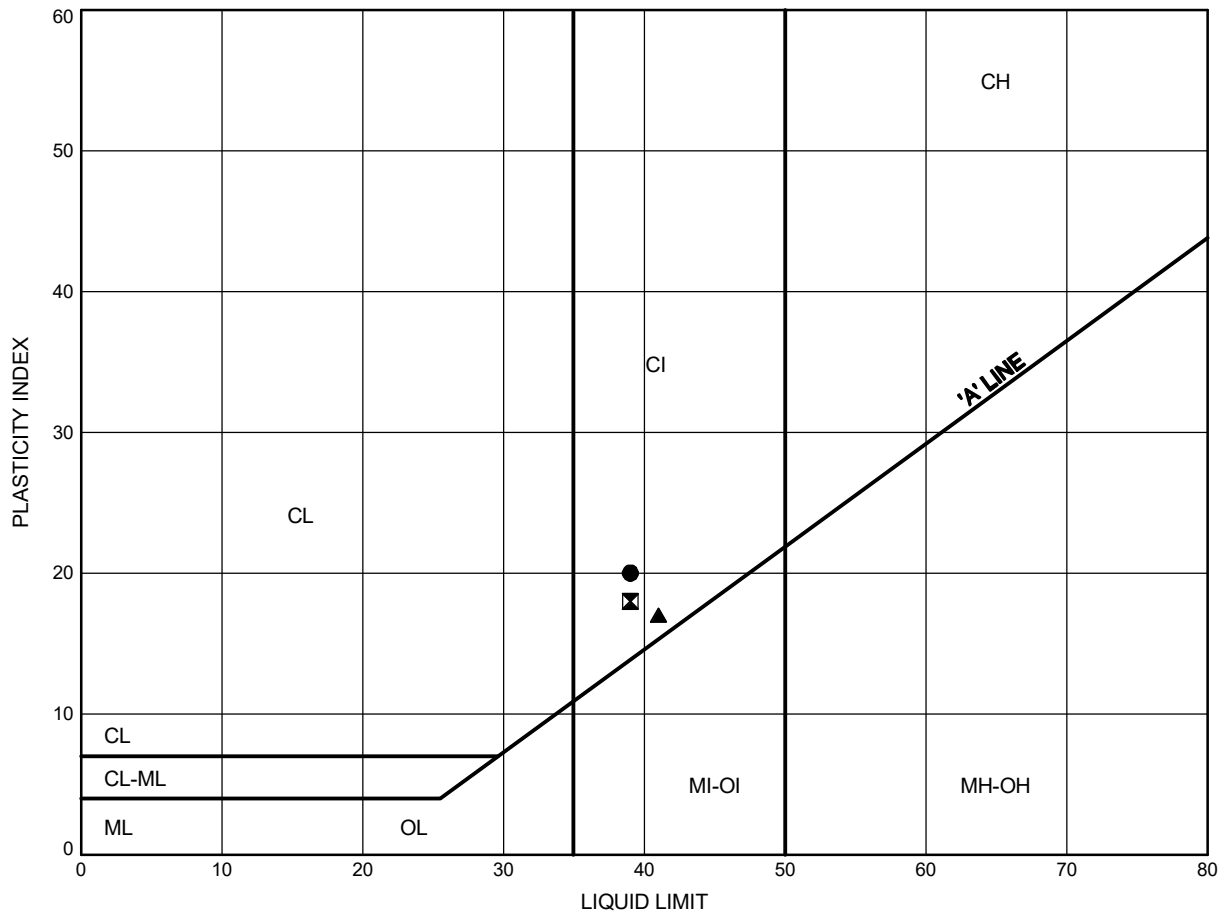
FIGURE C4

Silty Clay (CI)

SYMBOL	BOREHOLE	DEPTH (m)	ELEV. (m)
●	130-22-01	11.0	80.6
⊠	130-22-02	7.9	83.5
▲	130-22-03	1.1	83.2

Recorded moisture contents ranged from 25 to 37%. Atterberg Limit testing was completed on three samples of the layer. Results are illustrated in Figure C4 of Appendix C. The results of these tests are summarized below and on the Record of Borehole sheets in Appendix B. The laboratory results indicate that the silty clay exhibits intermediate plastic behaviour (CI).
