**PRELIMINARY FOUNDATION INVESTIGATION REPORT
HIGHWAY 401 WIDENING, HIGHWAY 16 TO MAITLAND ROAD
EDWARD STREET UNDERPASS, SITE NO. 16X-0128/B0
GWP 4024-20-00 / ASSIGNMENT NO. 4019-E-0010.2**

Geocres No.: 31B-111

September 2023
Thurber File No.: 29381

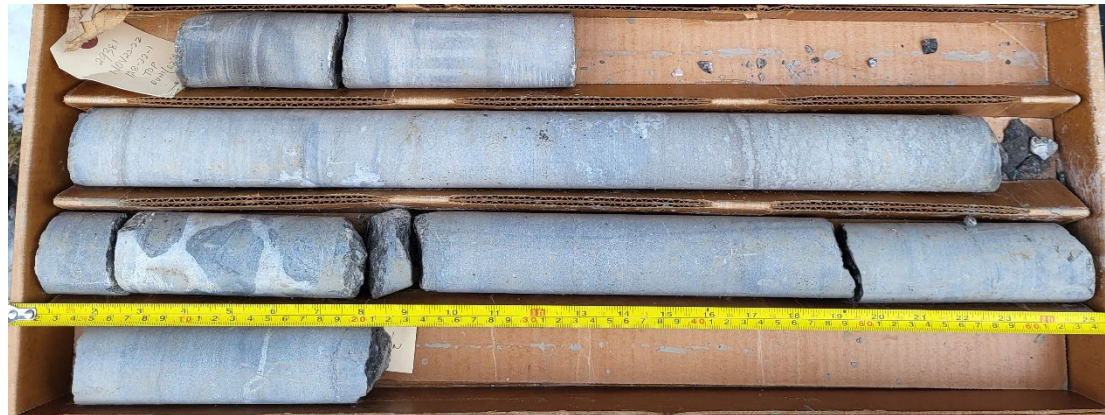
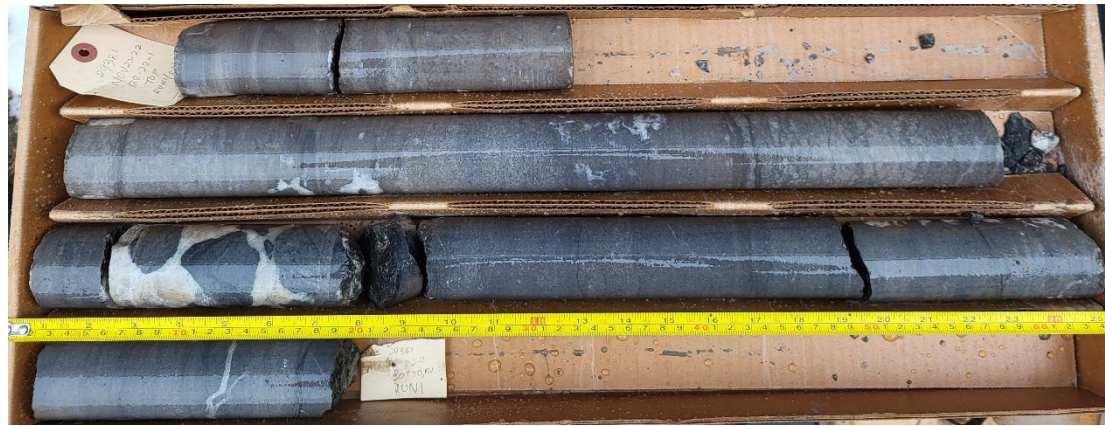
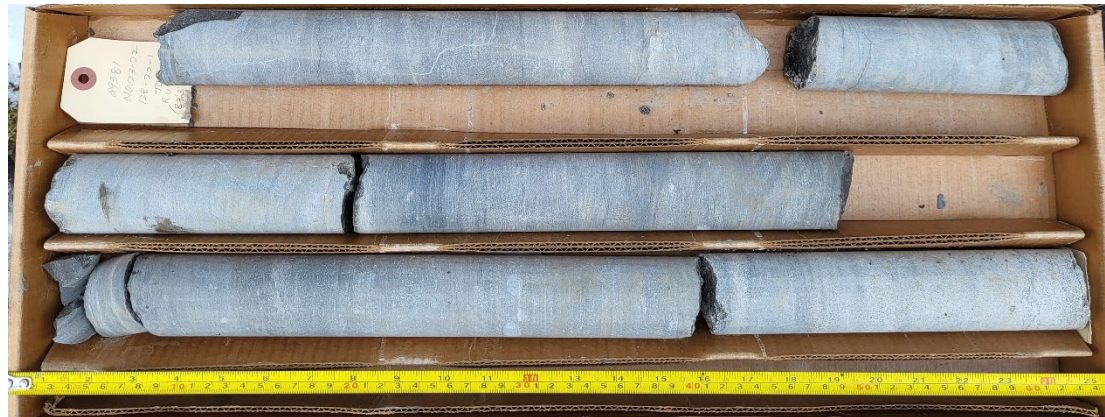
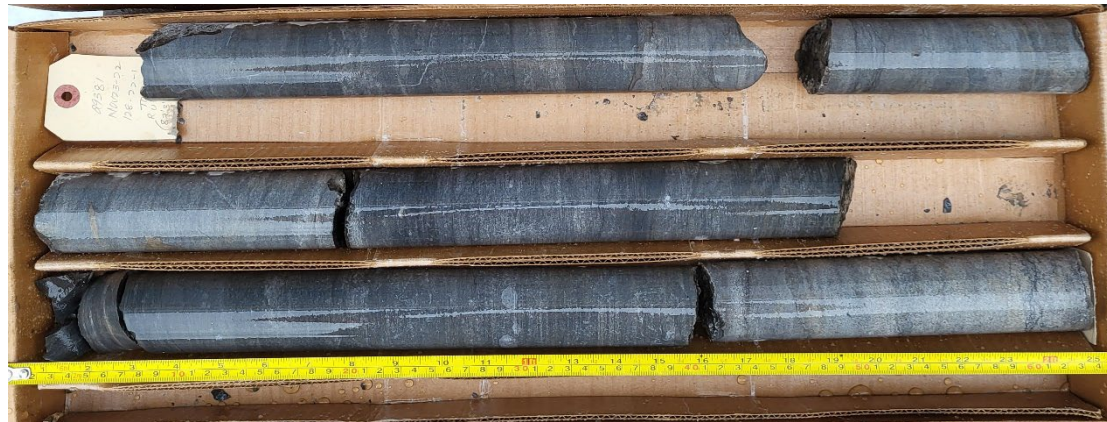
Borehole 128-22-01

Dry Sample

Wet Sample

All rock cores were photographed and their total core recovery (TCR), solid core recovery (SCR) and rock quality designation (RQD) were measured. One sample of intact rock core was submitted for Unconfined Compressive Strength (UCS) testing.

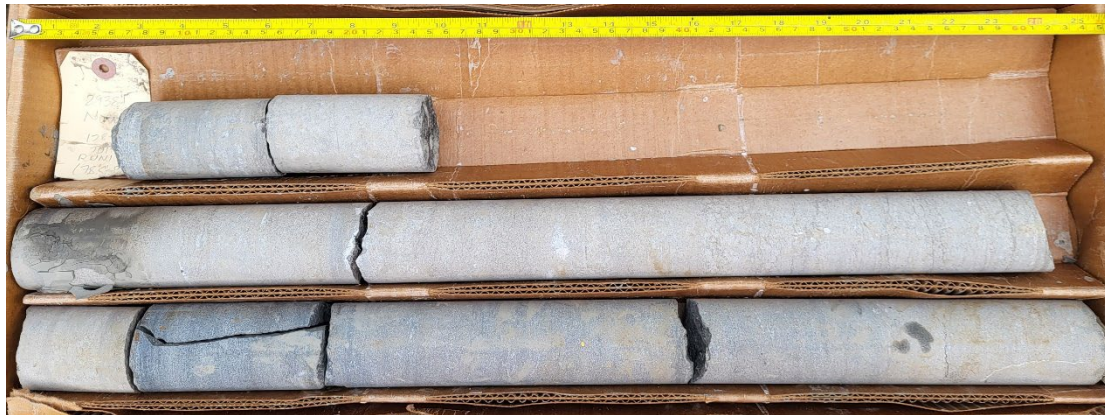
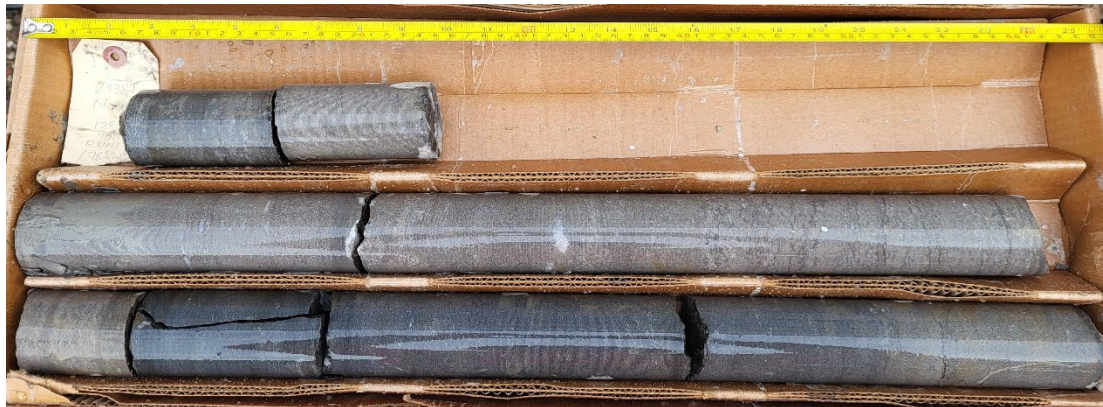
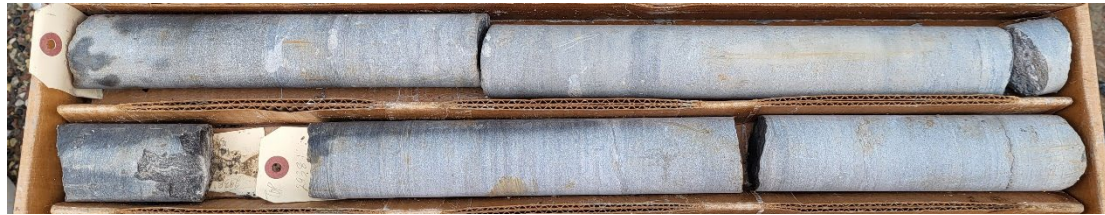
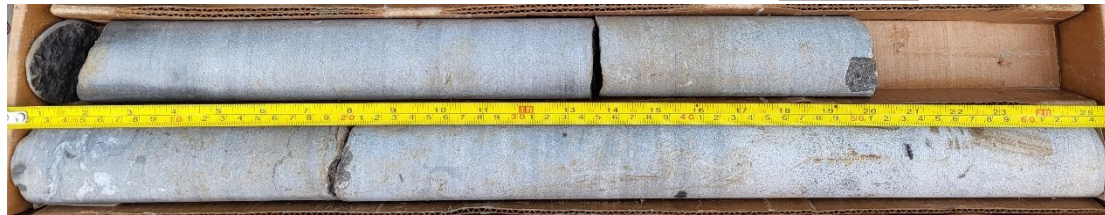
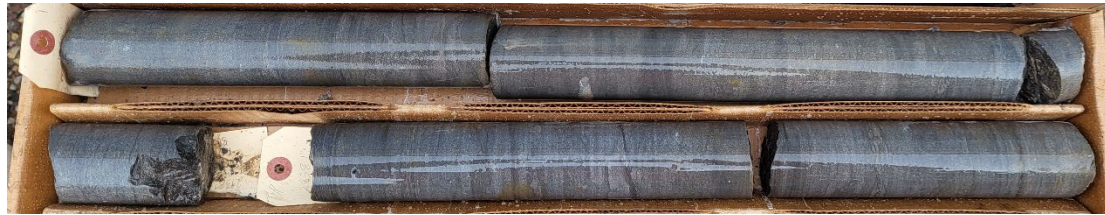
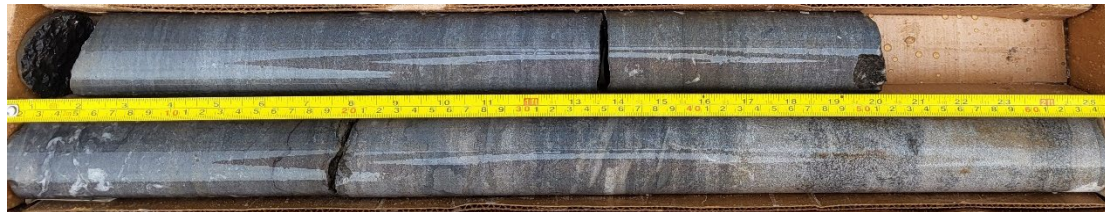
Dry Sample

Wet Sample

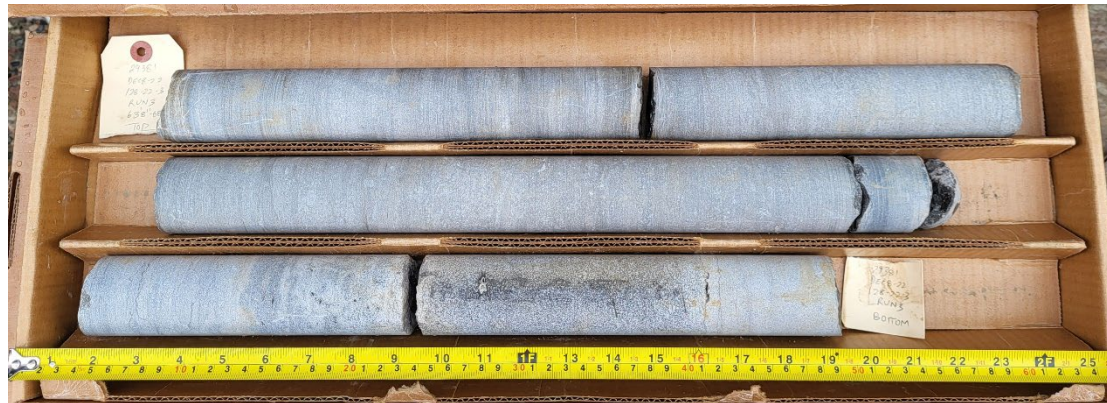
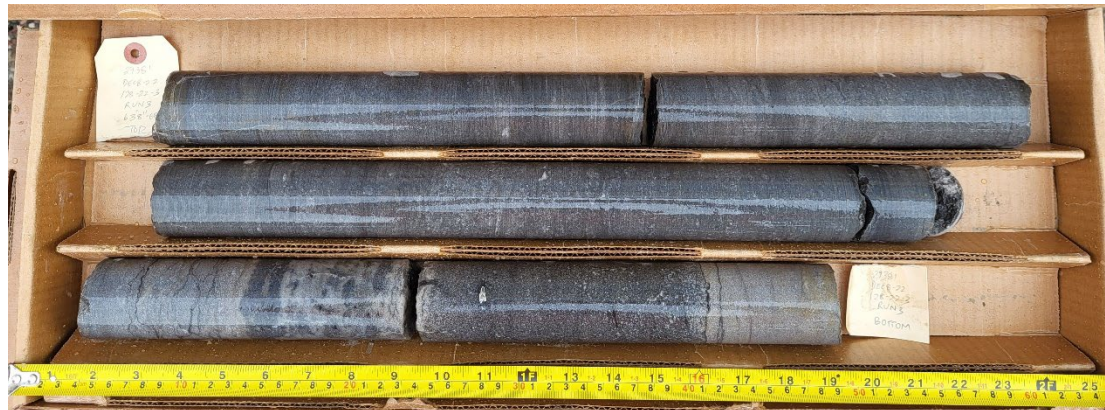
Borehole 128-22-03

Dry Sample

Wet Sample

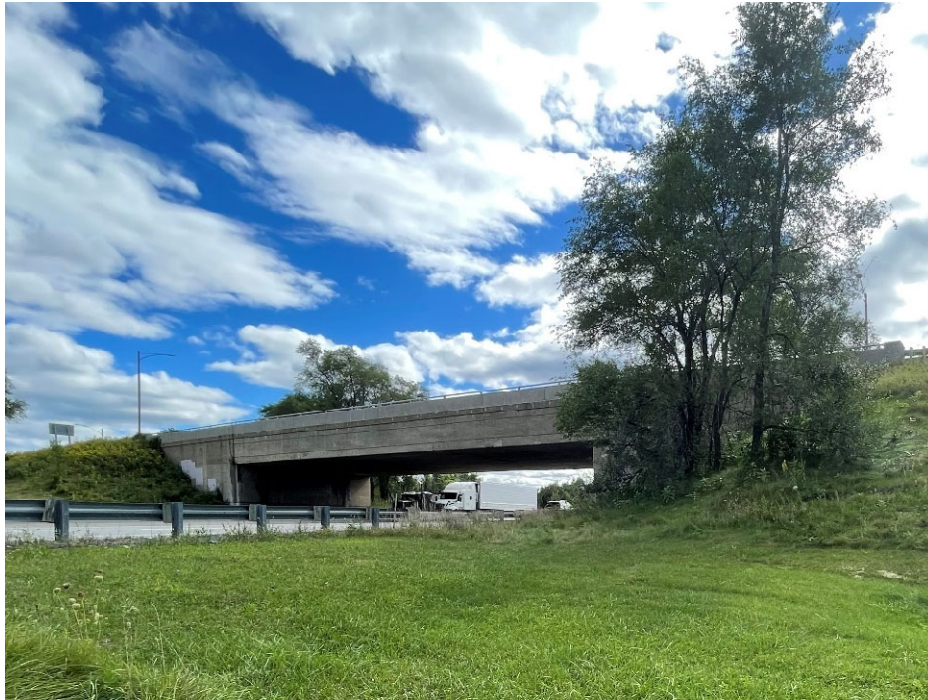
Photo 1: Looking southwest at bridge (2022/09/01)

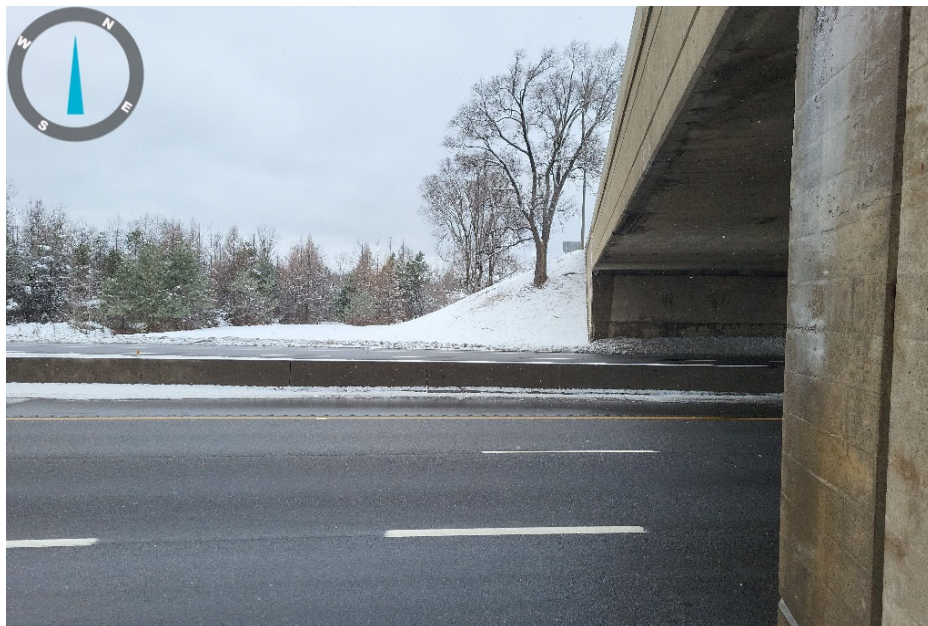
Photo 2: Looking north along west side of bridge (2022/12/19)

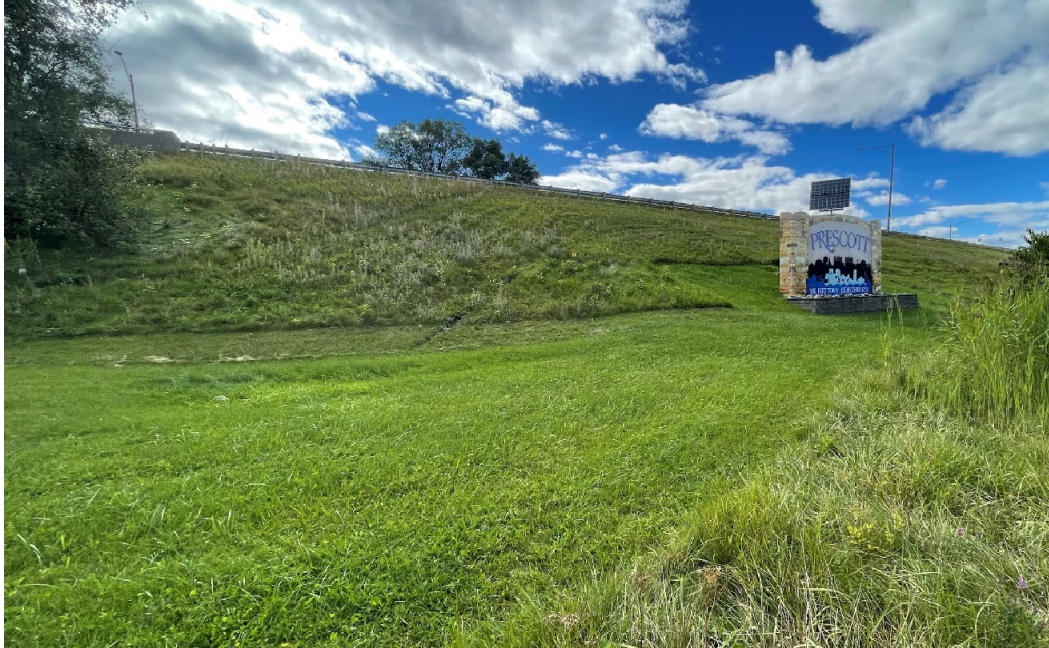
Photo 5: Looking west at northeast embankment side slope (2022/09/01)

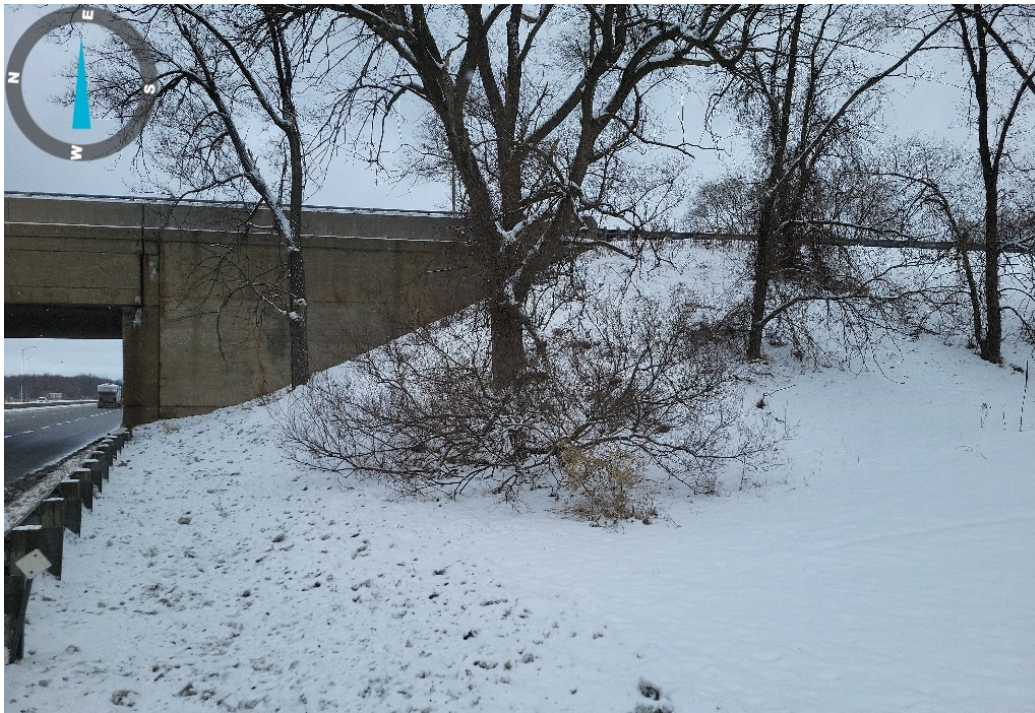
Photo 6: Looking east at southwest embankment side slope (2022/12/19)

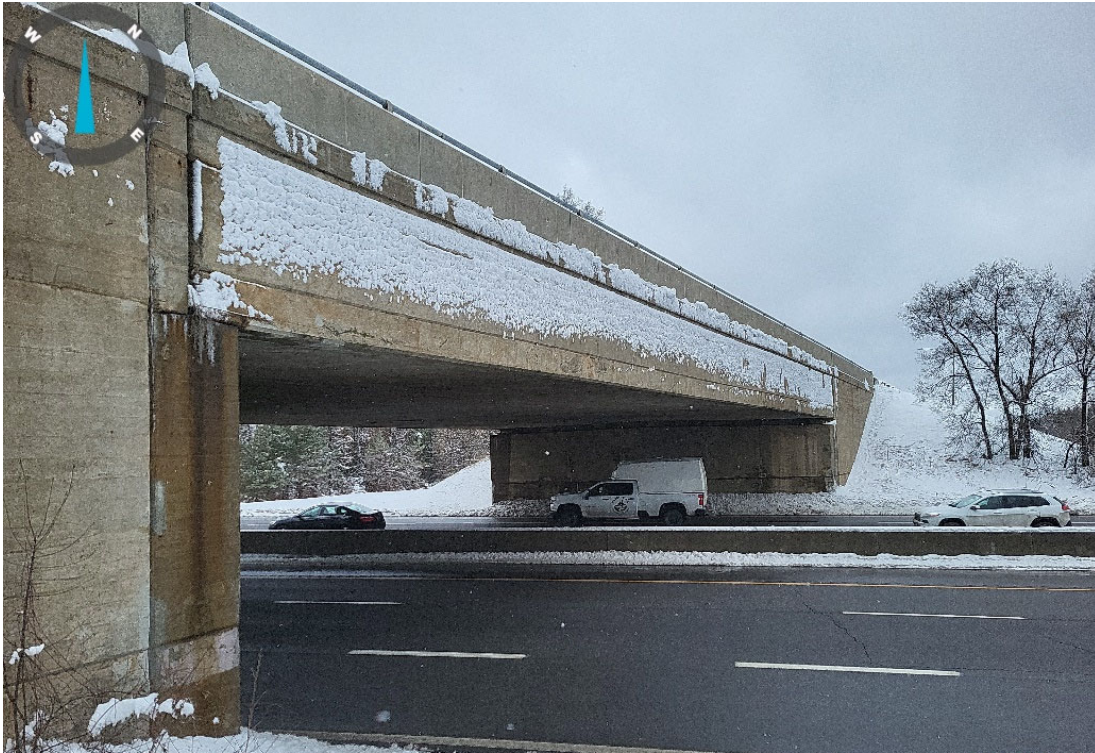
Photo 7: Looking north from east side of bridge (2022/12/19)
