**PRELIMINARY FOUNDATION INVESTIGATION REPORT
HIGHWAY 401 WIDENING, HIGHWAY 16 TO MAITLAND ROAD
CPR OVERHEAD, SITE NO. 16X-0129
GWP 4024-20-00, ASSIGNMENT NO.: 4019-E-0010.2**

SITE NO. 16X-0129/B0

October 2023
Thurber File No.: 29381

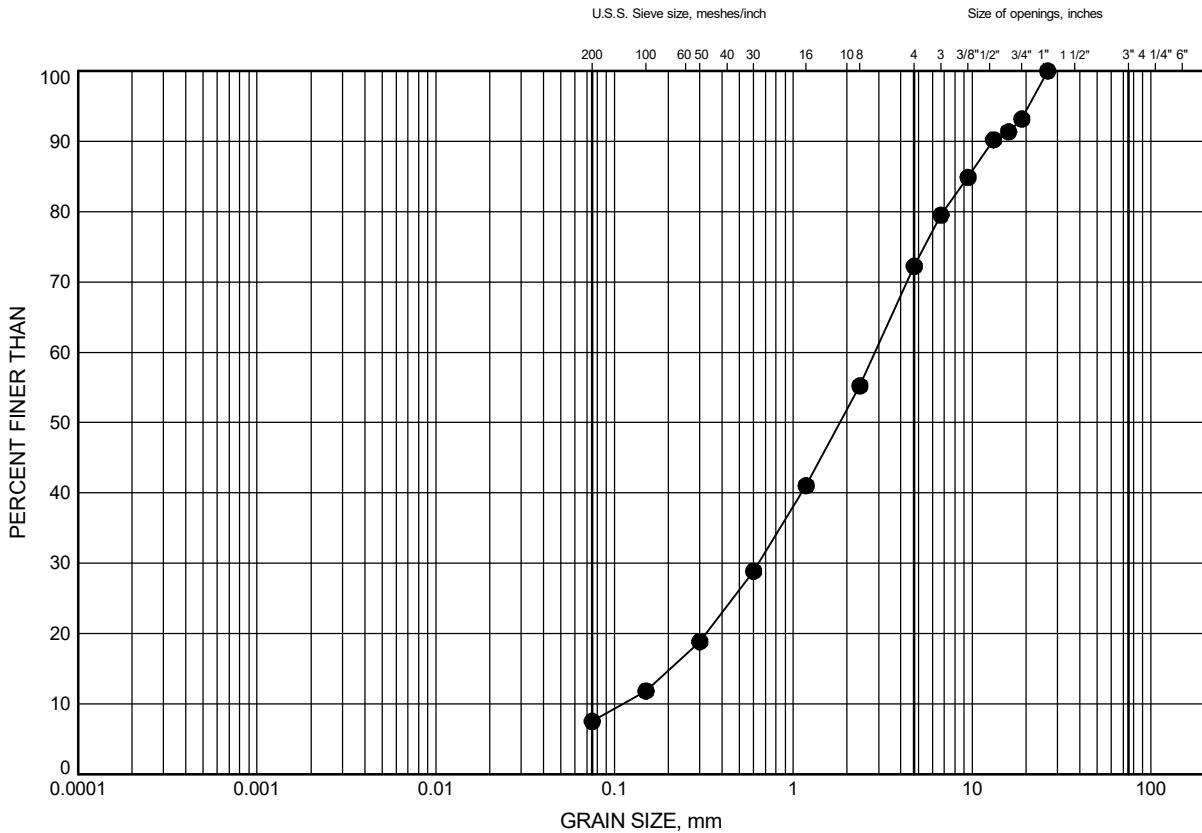
FILL: Gravelly Sand

GRAIN SIZE DISTRIBUTION

The recorded moisture content of a sample of the gravelly sand fill was 2%. The results of a gradation analysis completed on the sample are illustrated on Figure C1 of Appendix C. The results of the test are summarized below and on the Record of Borehole sheets in Appendix B.

Soil Particle	Percentage (%)
Gravel	28
Sand	65
Silt	7
Clay

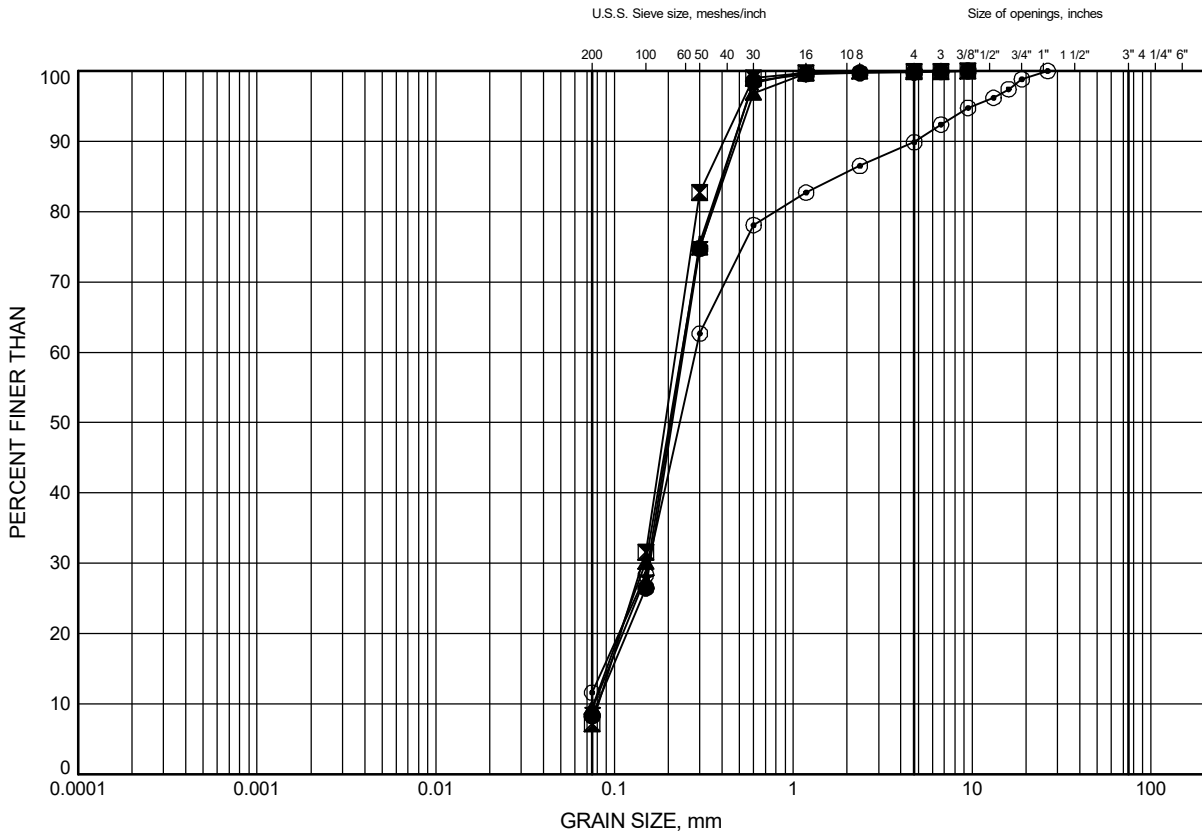
FILL: Sand

GRAIN SIZE DISTRIBUTION

The recorded moisture content of samples of the sand fill ranged from 4 to 20%. The results of gradation analyses completed on five samples of the fill are illustrated on Figure C2 of Appendix C. The results of the tests are summarized below and on the Record of Borehole sheets in Appendix B. The results from the gradation analysis carried out on a sample from the lower portion of the east embankment (Borehole 129-22-02) contained some gravel.

Soil Particle	Percentage (%)
Gravel	0 – 10
Sand	78 – 93
Silt	7 – 12
Clay

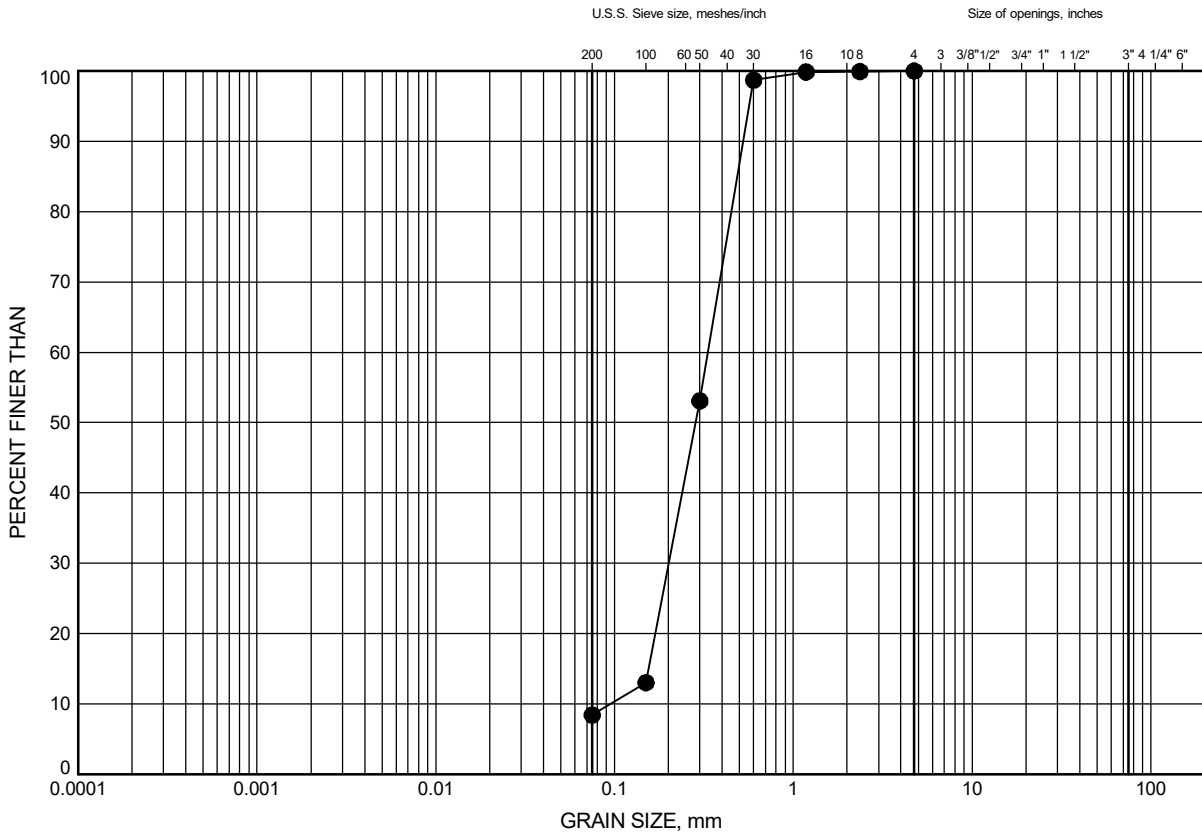
Sand (SP-SM)

GRAIN SIZE DISTRIBUTION

The recorded moisture content of samples of the native sand ranged from 18 to 22%. The results of a gradation analysis completed on one sample of the layer are illustrated on Figure C3 of Appendix C. The results of the tests are summarized below and on the Record of Borehole sheet in Appendix B.

Soil Particle	Percentage (%)
Gravel	0
Sand	92
Silt	8
Clay

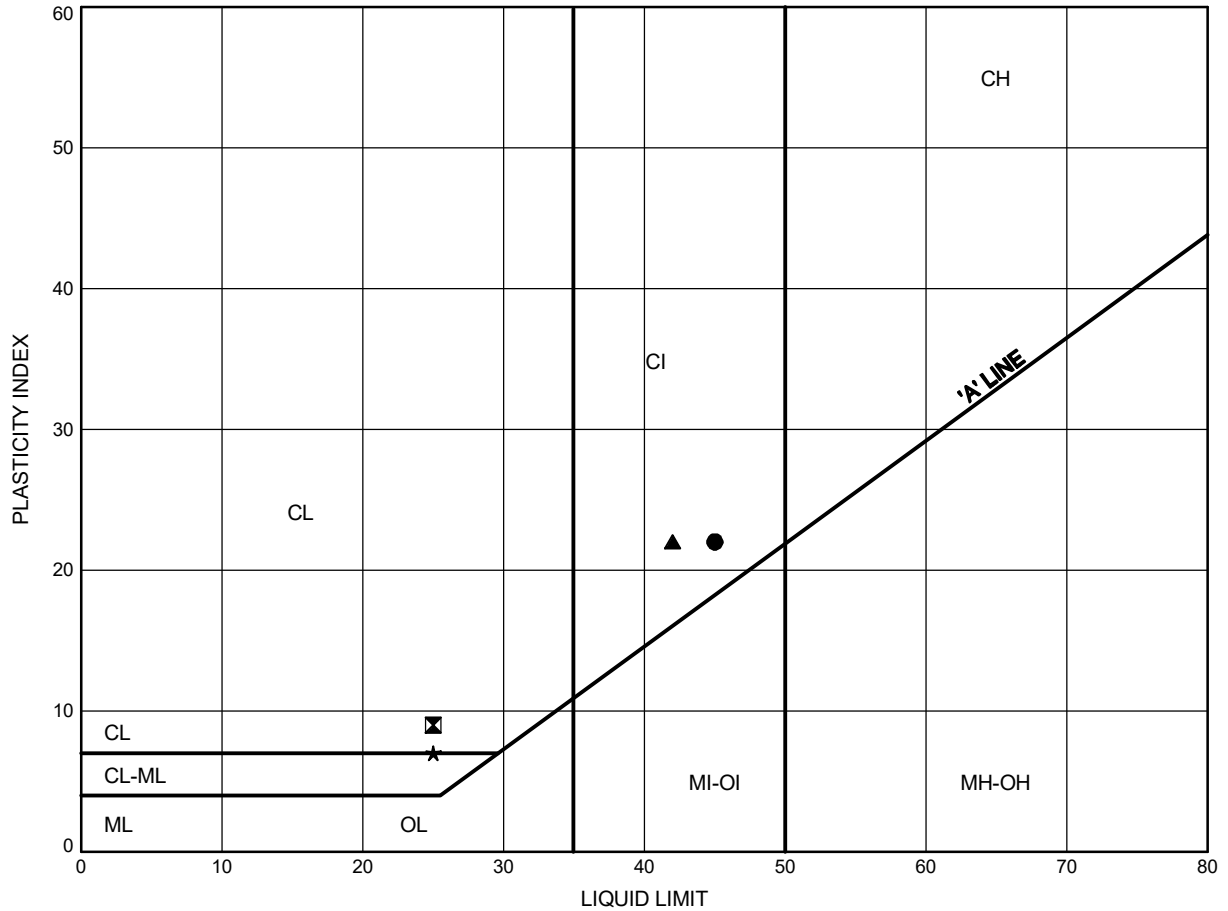
Silty Clay (CI) to Clayey Silt (CL to CL-ML)

GRAIN SIZE DISTRIBUTION

SYMBOL	BOREHOLE	DEPTH (m)	ELEV. (m)
●	129-22-01	17.1	79.3
⊠	129-22-01	21.6	74.8
▲	129-22-02	12.5	84.0
★	129-22-02	20.1	76.4

Recorded moisture contents ranged from 16 to 41% and generally decreased with depth. Atterberg Limit testing was completed on four samples of the layer. Results are illustrated in Figure C4 of Appendix C. The results of these tests are summarized below and on the Record of Borehole sheets in Appendix B. The laboratory results indicate that the silty clay to clayey silt generally ranged in plasticity from intermediate (CI) to low (CL) with depth.

Parameter	Value
Liquid Limit	25 – 45
Plastic Limit	16 – 23
Plasticity Index	7 – 22

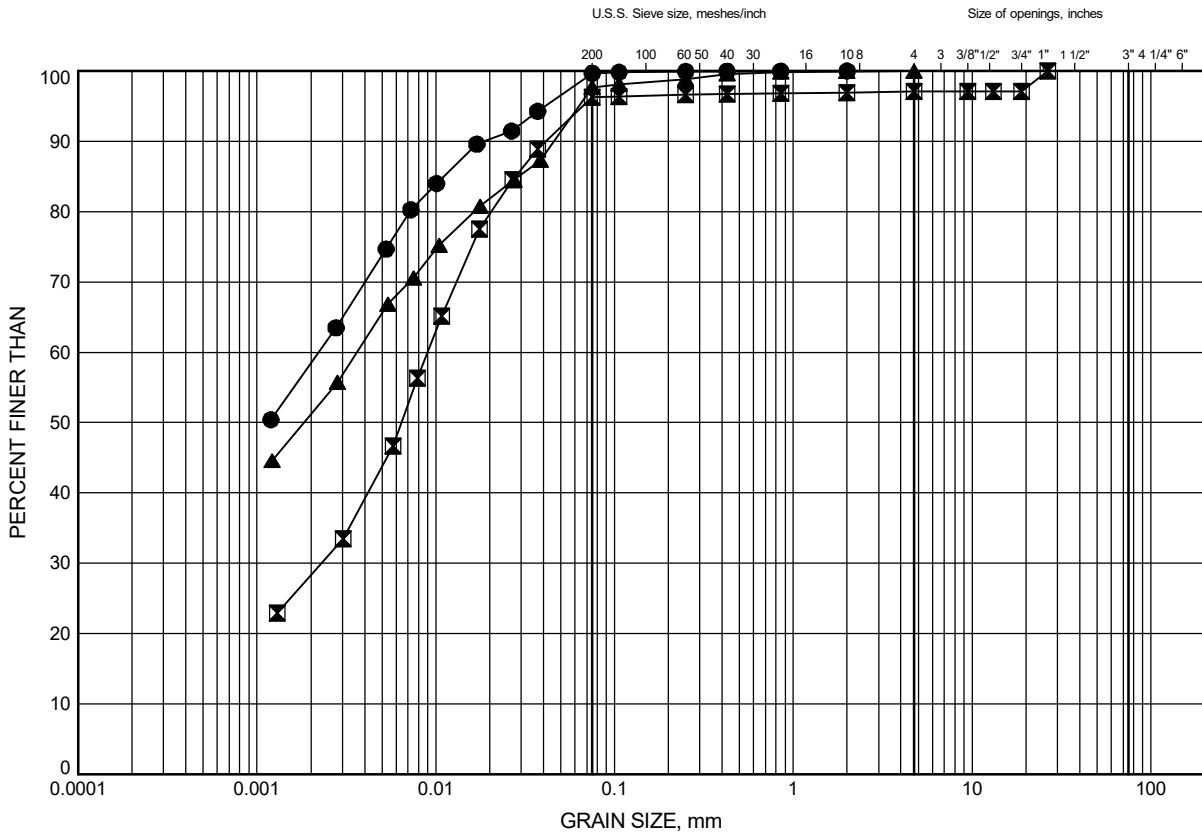
Silty Clay (CI) to Clayey Silt (CL to CL-ML)

GRAIN SIZE DISTRIBUTION

The results of gradation analyses completed on three samples of the layer are illustrated on Figure C5 of Appendix C. The results of the tests are summarized below and on the Record of Borehole sheets in Appendix B.

Soil Particle	Percentage (%)
Gravel	0 – 3
Sand	0 – 2
Silt	41 – 68
Clay	28 – 59

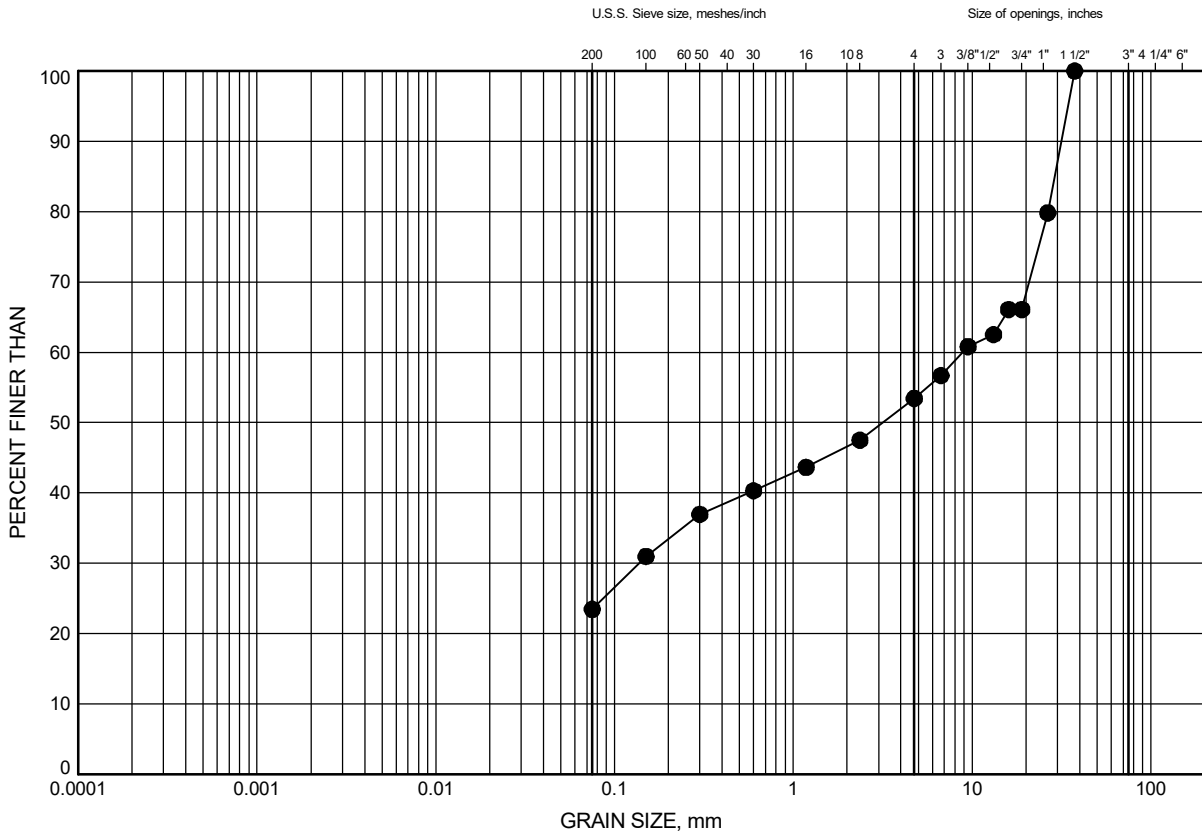
GLACIAL TILL: Sandy Gravel (GM)

GRAIN SIZE DISTRIBUTION

The recorded moisture content of samples of the deposit recovered with a split-spoon sampler ranged from 1% to 8%. The results of a gradation analysis completed on a sample obtained from the upper portion of the deposit in Borehole 129-22-02 are illustrated on Figure C6 of Appendix C. The results of the tests are summarized above and on the Record of Borehole sheet in Appendix B.

Soil Particle	Percentage (%)
Gravel	47
Sand	30
Silt	23
Clay

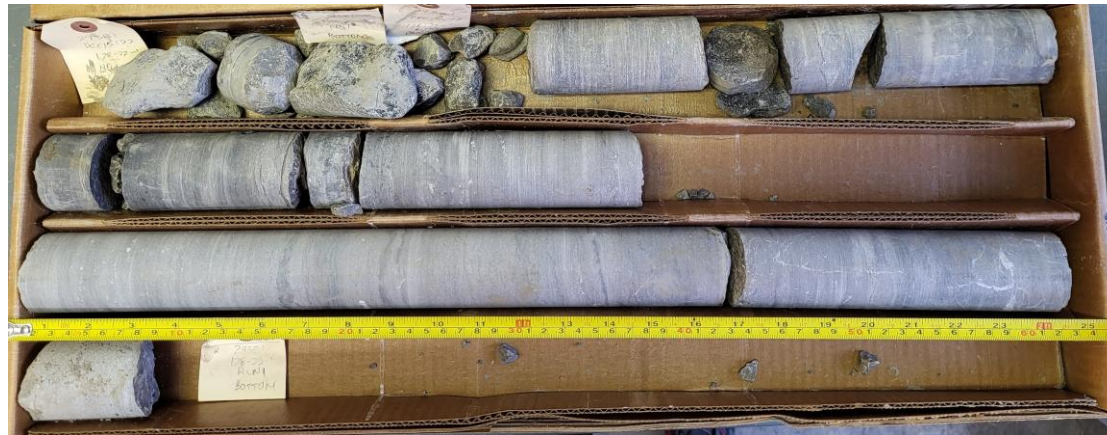
Borehole 129-22-01

NQ1 – Cobbles and Boulders
elev. 71.2 m to 70.5 m

Run 1 Start
elev. 70.5 m

Run 1 End
elev. 69.1 m

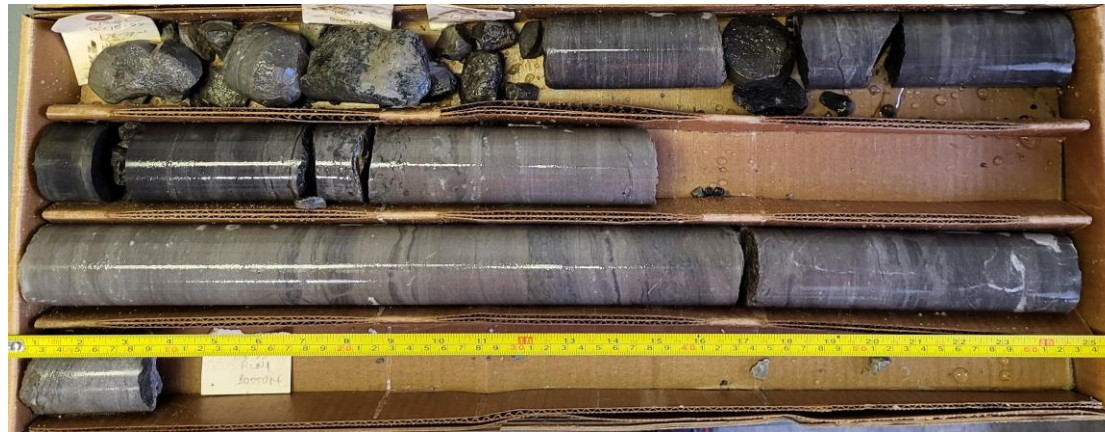
Borehole 129-22-01

NQ1 – Cobbles and Boulders
elev. 71.2 m to 70.5 m

Run 1 Start
elev. 70.5 m

Run 1 End
elev. 69.1 m

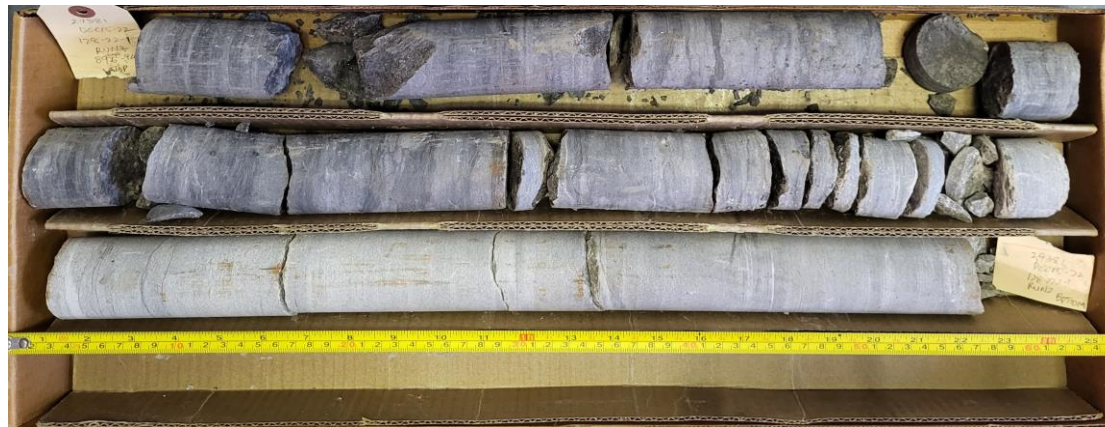
Borehole 129-22-01

Dry Sample

Run 2 Start
elev. 69.1 m

Run 2 End
elev. 67.5 m

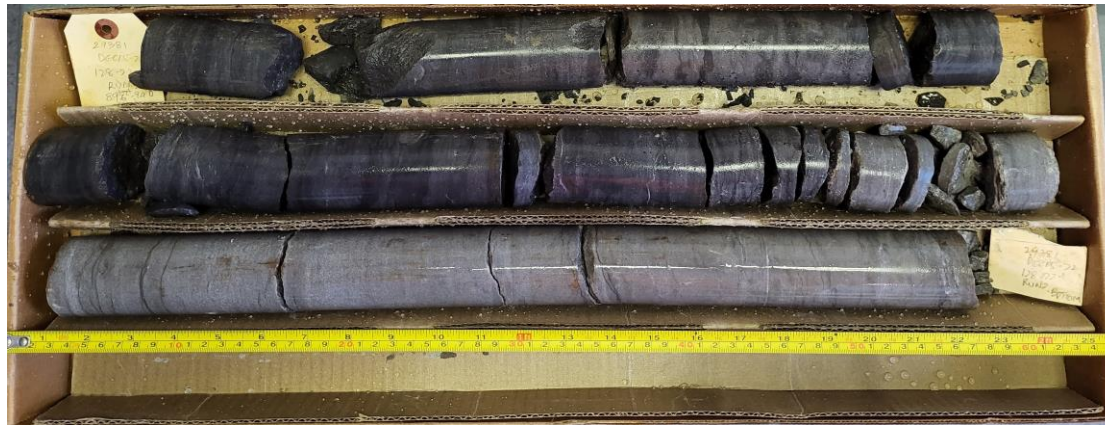
Wet Sample

Run 2 Start
elev. 69.1 m

Run 2 End
elev. 67.5 m

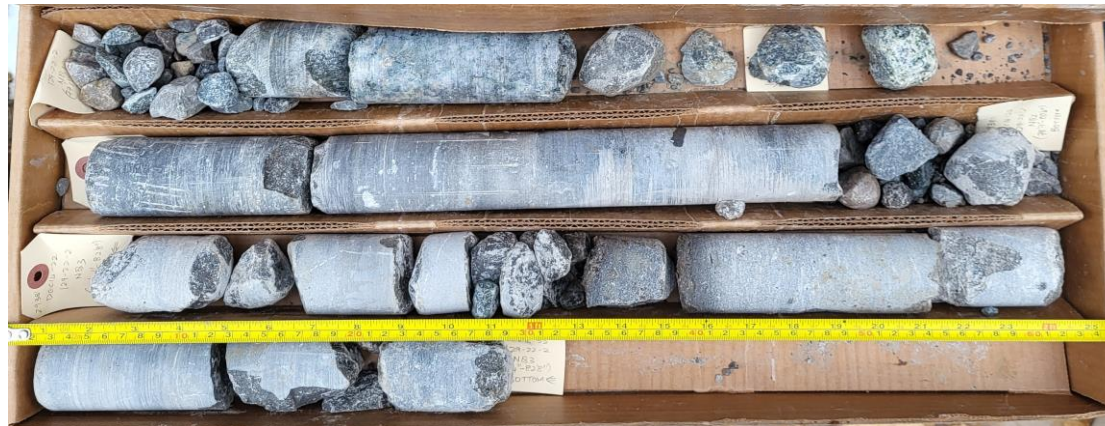
Borehole 129-22-02
NQ1, NQ2, and NQ3 – Cobbles and Boulders
Depth 23.5 m to 25.2 m
Elevation 73.0 m to 71.3 m
Dry Sample

NQ1, NQ2, and NQ3 – Cobbles and Boulders Start
elev. 73.0 m

NQ1, NQ2, and NQ3 – Cobbles and Boulders End
elev. 71.3 m

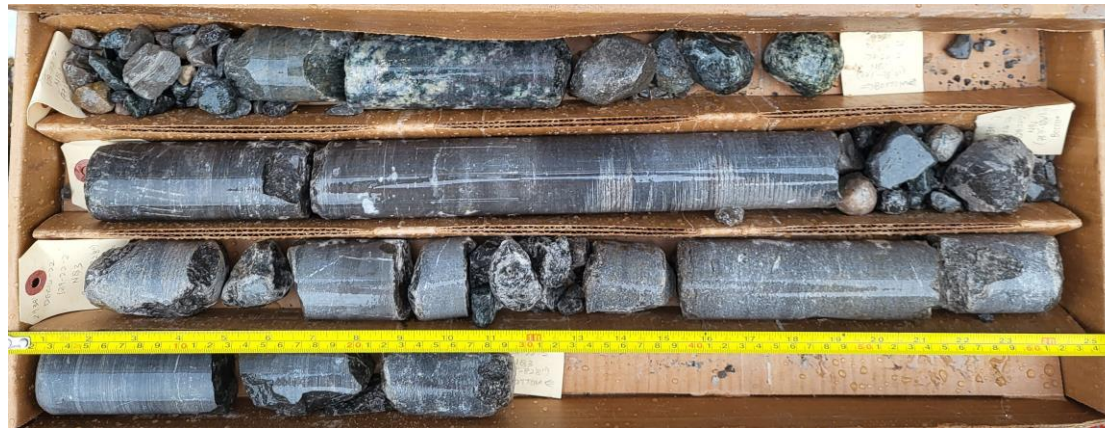
Borehole 129-22-02
NQ1, NQ2, and NQ3 – Cobbles and Boulders
Depth 23.5 m to 25.2 m
Elevation 73.0 m to 71.3 m
Wet Sample

NQ1, NQ2, and NQ3 – Cobbles and Boulders Start
elev. 73.0 m

NQ1, NQ2, and NQ3 – Cobbles and Boulders End
elev. 71.3 m

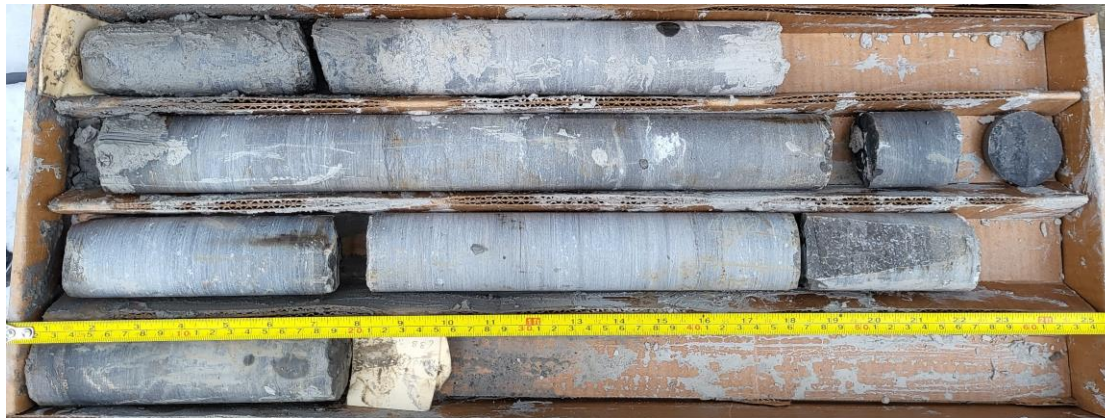
Depth 25.2 m to 26.8 m
Elevation 71.3 m to 69.7 m
Dry Sample

Run 1 Start
elev. 71.3 m

Run 1 End
elev. 69.7 m

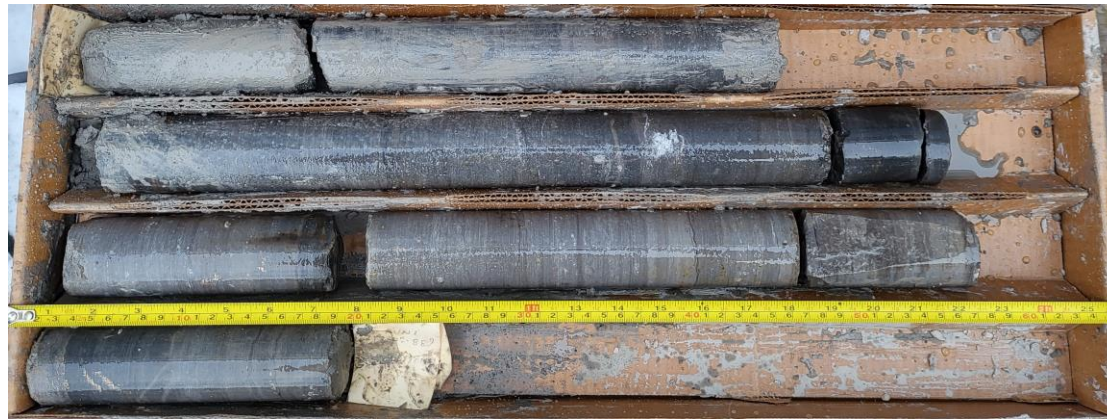
Wet Sample

Run 1 Start
elev. 71.3 m

Run 1 End
elev. 69.7 m

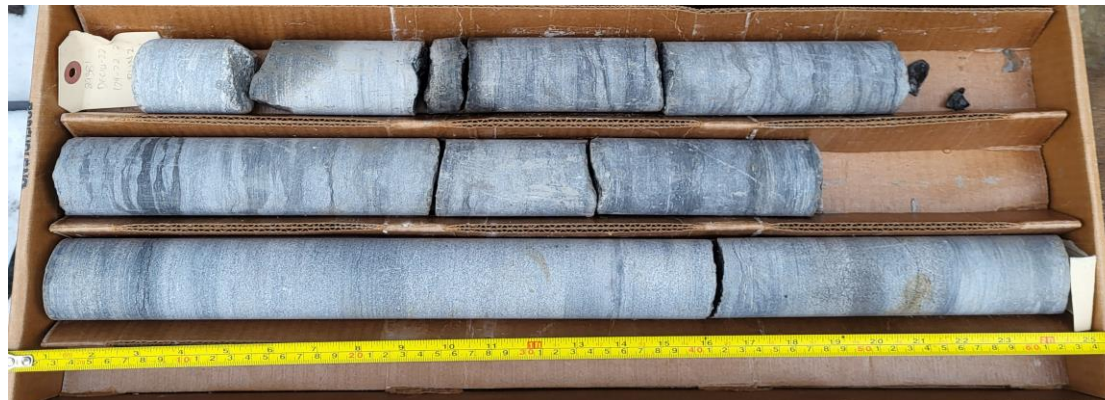
Dry Sample

Run 2 Start
elev. 69.7 m

Run 2 End
elev. 68.2 m

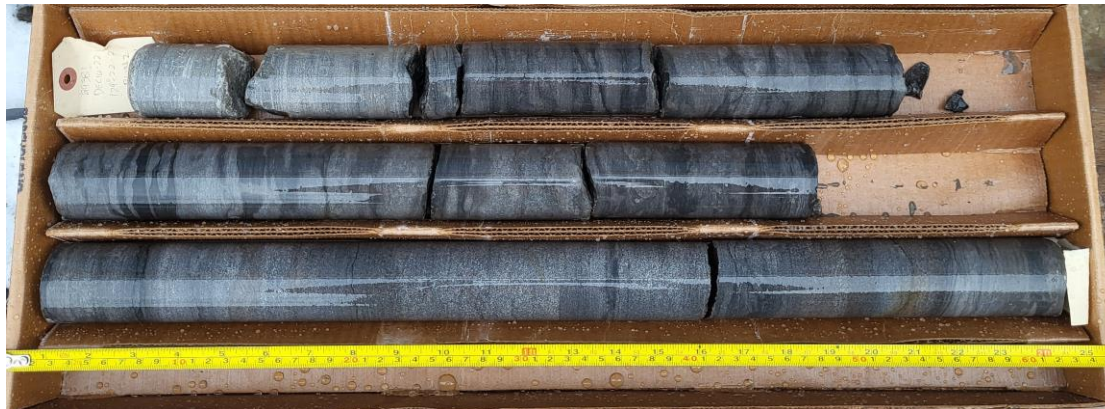
Wet Sample

Run 2 Start
elev. 69.7 m

Run 2 End
elev. 68.2 m

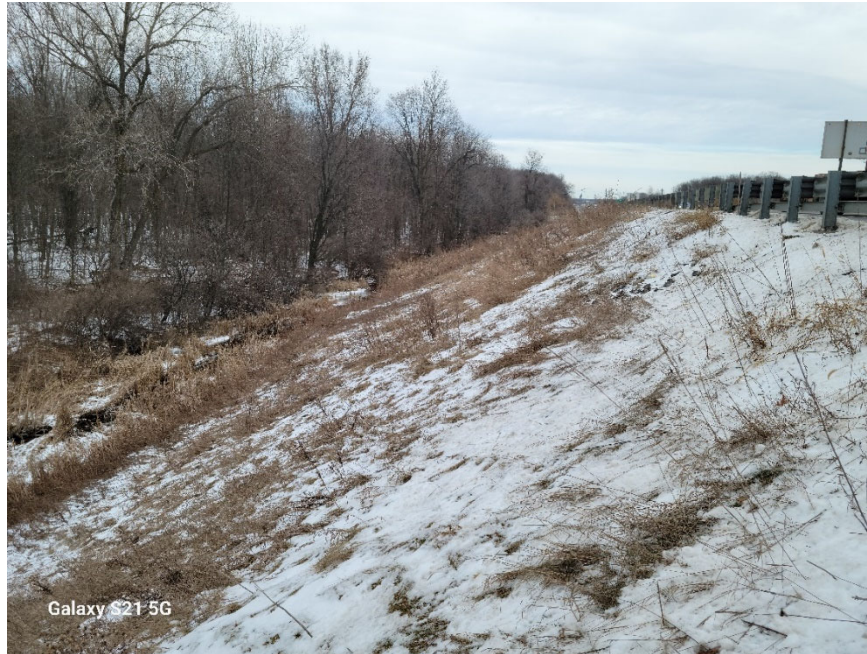
Photograph 1: Looking east at the east embankment, north slope.
[taken on December 18, 2022]

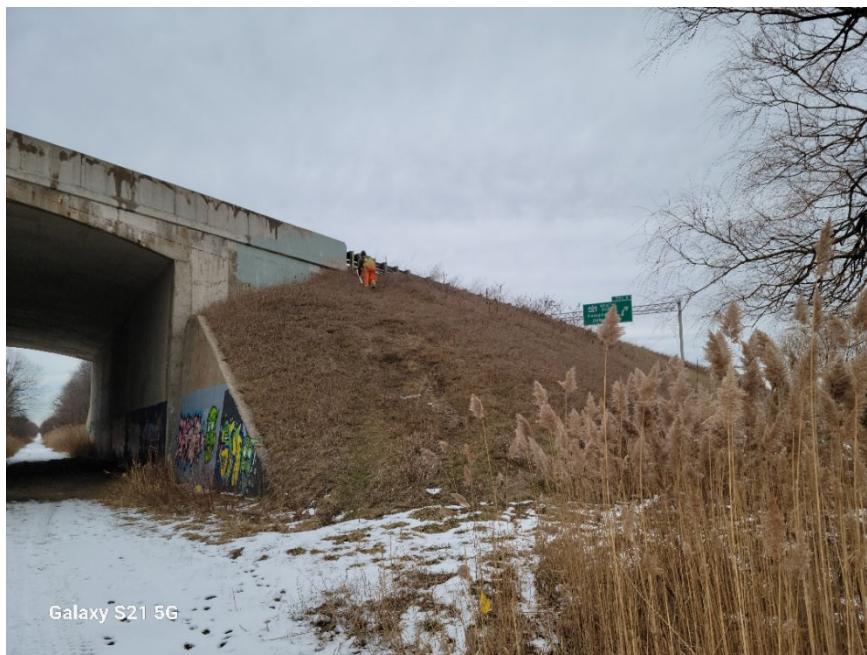
Photograph 2: Looking north at the east embankment, south slope.
[taken on December 18, 2022]

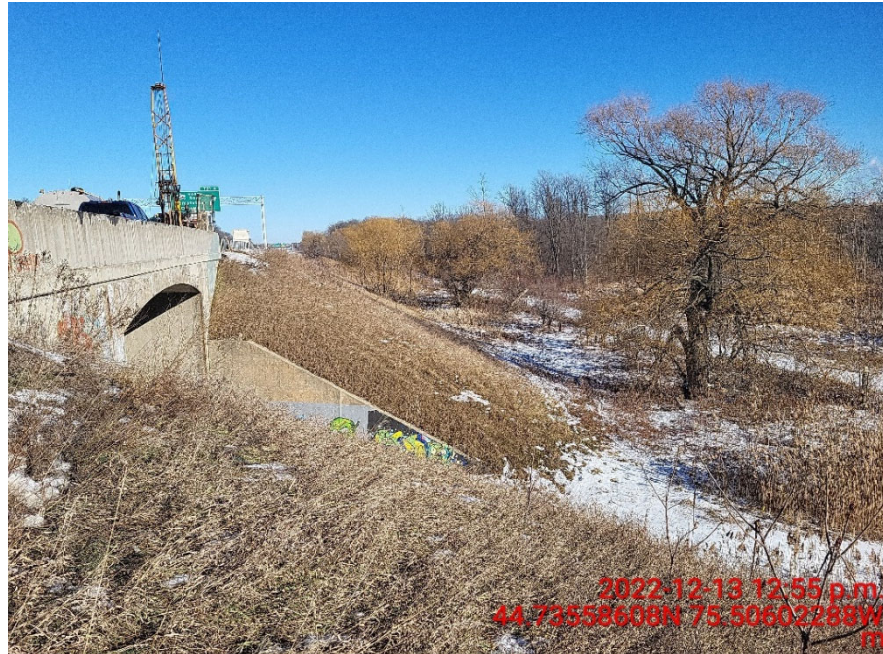
Photograph 3: Looking east at the east embankment, south slope.
[taken on December 13, 2022]

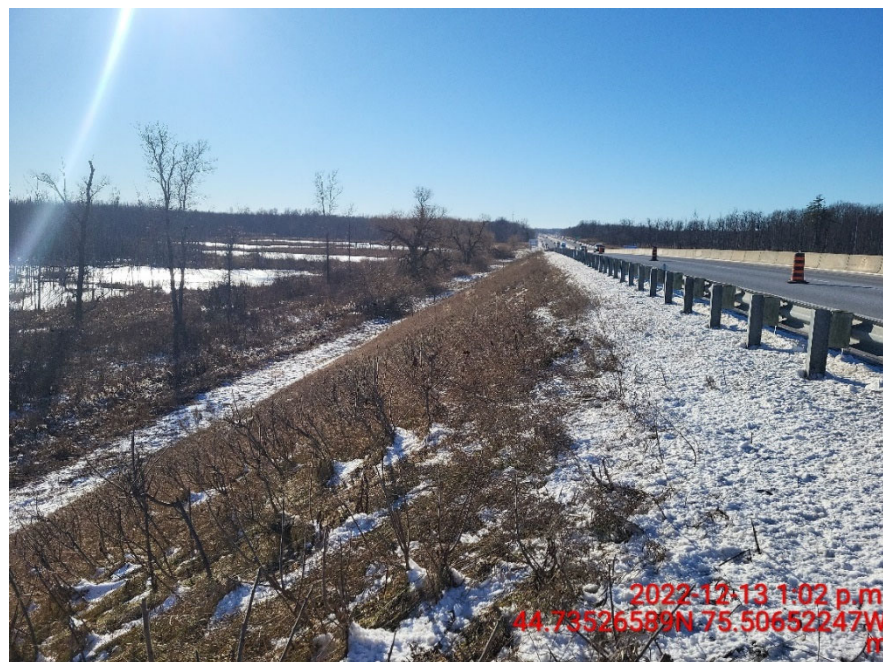
Photograph 4: Looking west at the west embankment, south slope.
[taken on December 13, 2022]

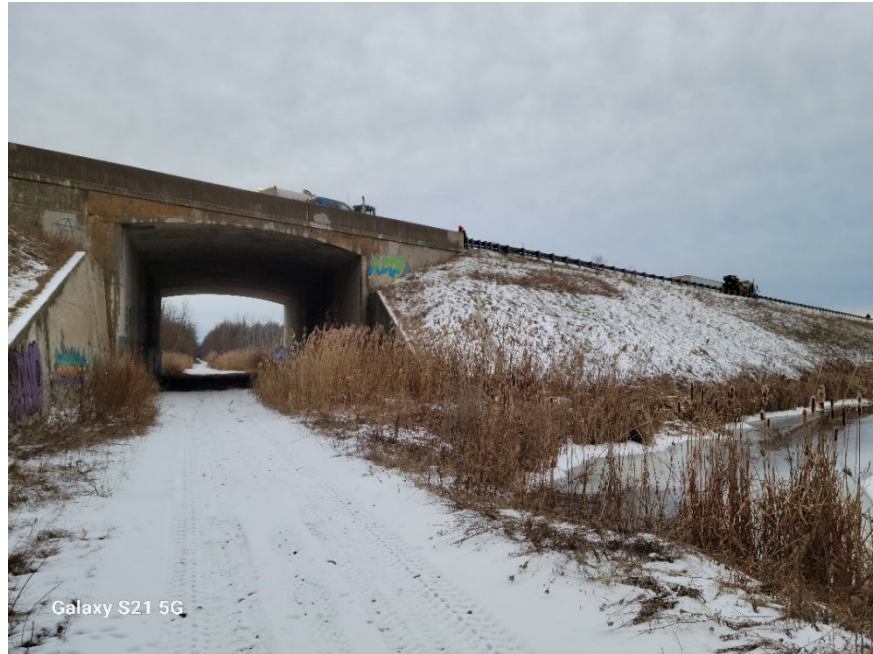
Photograph 5: Looking north at the Highway 401 overhead at CPR
[taken on December 18, 2022]

The CPR overhead structure is skewed at approximately 30 degrees and has a span of approximately 11 m. The rails have been removed and the ground surface of the former rail line now has a granular surface. CAD drawings provided by AECOM indicate an unpaved path located in the southeast quadrant parallels the eastbound embankment toe. The drawings also indicate two centreline culverts located at approximately 22 m and 93 m from the west and east abutments, respectively.

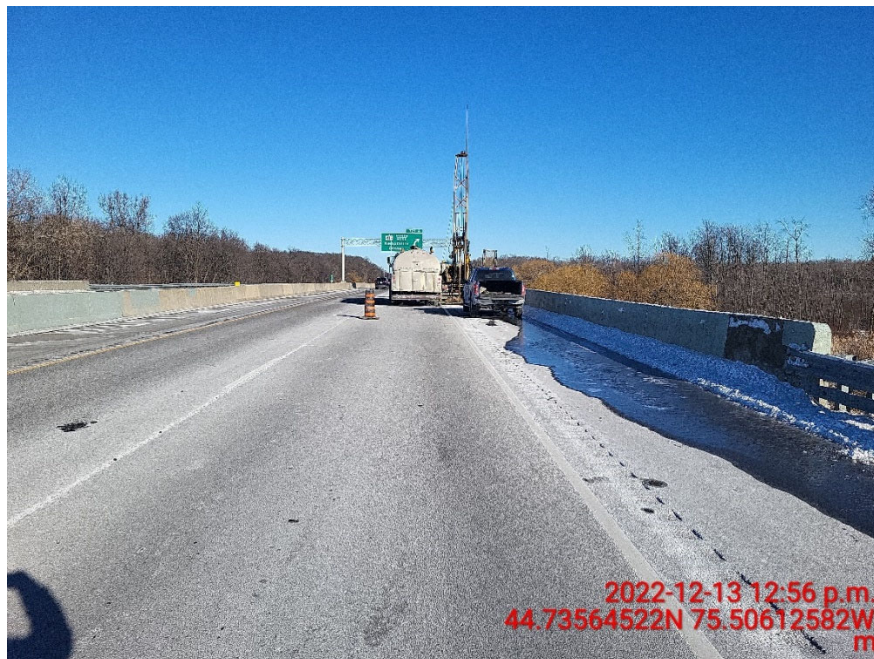
Photograph 6: Looking east across the bridge deck, eastbound Highway 401 lanes.
[taken on December 13, 2022]

At the CPR overhead, Highway 401 has two through lanes in each direction. The outside and median shoulders are fully paved. Concrete jersey barriers are present along the median and concrete barrier wall along the outside shoulders. In the area of the structure the Highway 401 median is approximately 9 m wide from edge of lane to edge of lane. Galvanized W-beam guiderails supported on metal posts extend beyond the concrete barrier walls up to about 1.1 km from the abutments. Concrete wingwalls are present at all four quadrants. The embankment side slopes are inclined at approximately 2.1H:1V and are vegetated with grasses and some shrubs. No signs of global instability of the embankment were noted during the field investigation.
