**FOUNDATION DESIGN REPORT
EMBANKMENT GRADE RAISES AND WIDENING
PROPOSED RECONSTRUCTION OF HIGHWAY 400 NBL
FROM 1.2 KM SOUTH OF MUSKOKA ROAD INTERCHANGE
NORTHERLY 22.7 KM, HUNTSVILLE AREA
G.W.P. 152-98-00**

GEOCRES NO. 31D-407

**Project: SPT1117
November 11, 2004**

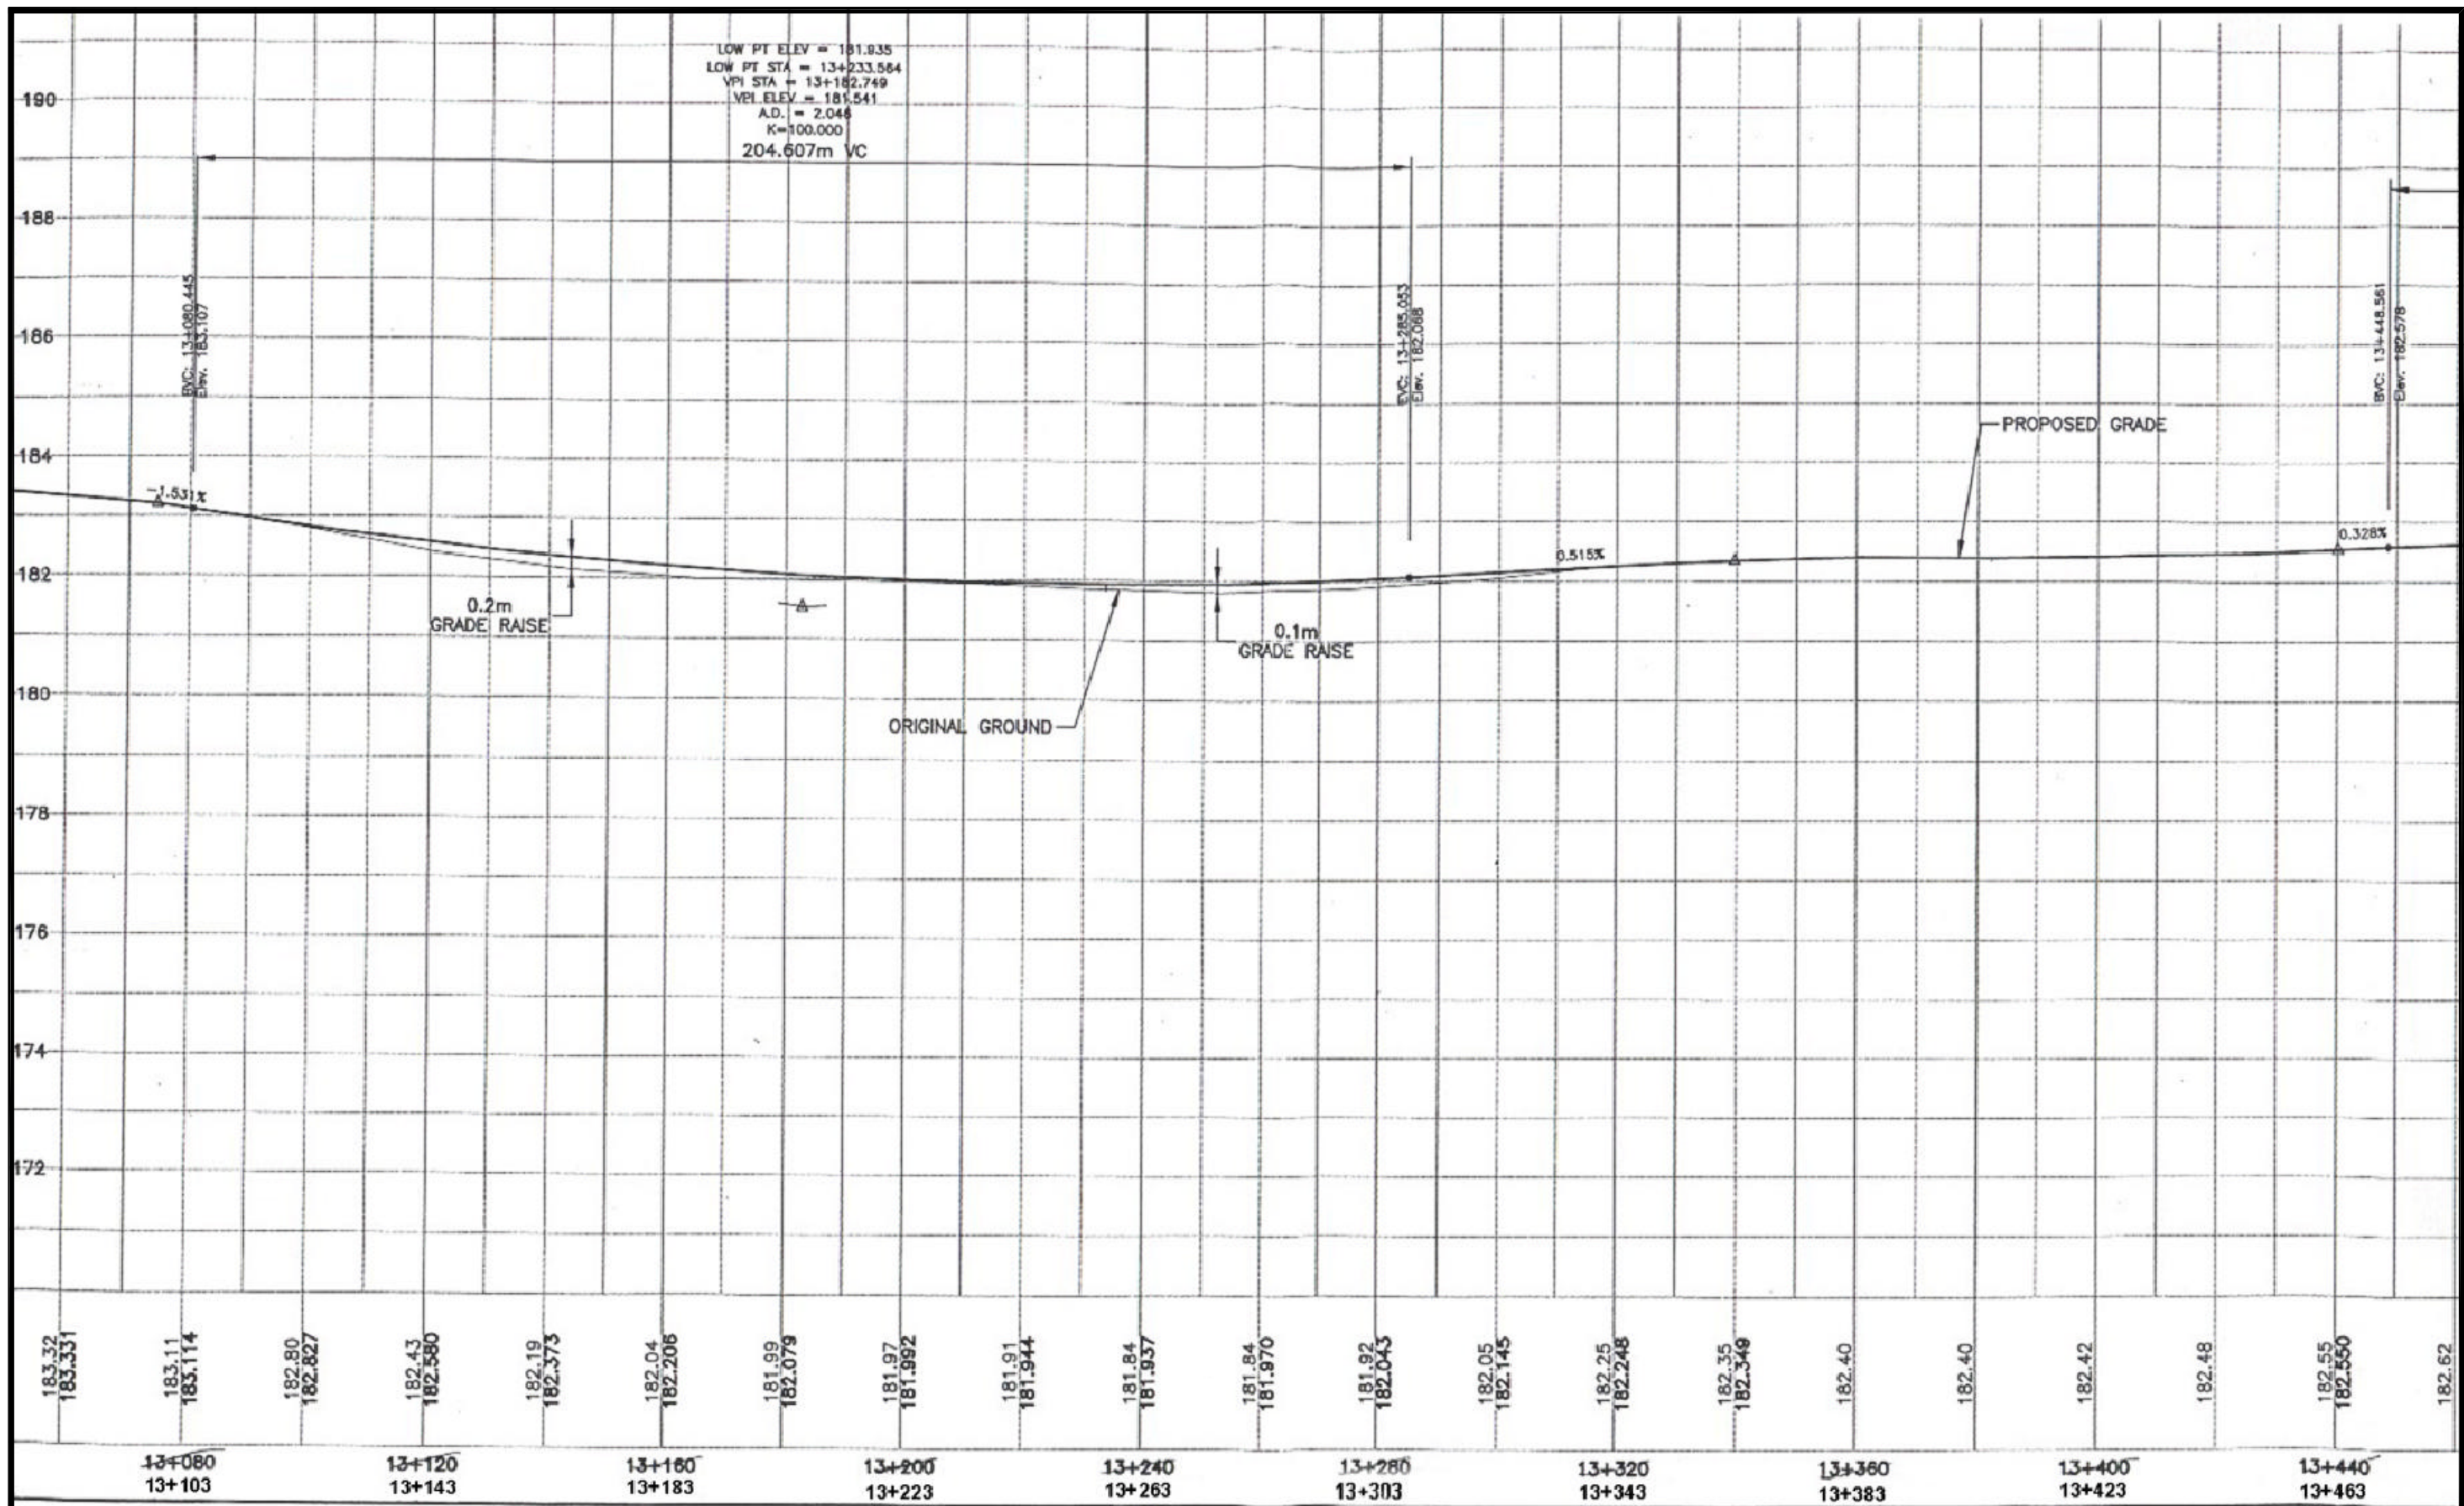
FIGURE G1-1

STATION BASED ON MEDIAN CL CHAINAGE

0.20 m GRADE RAISE

In this section, the height of the embankments generally range from about 1.0 m at Station 13+370 to 2.1 m at about Station 13+100 m but is generally between 1.2 and 1.5 m above the adjacent (original) grades. While the proposed embankment loading (i.e. up to 200 mm of asphalt) is very unlikely to cause any instability, this aspect was checked for completeness, as well as to obtain an opinion on the previous conditions (when the

Our analysis shows that based on available field and laboratory test data, the proposed 200 mm re-surfacing between Stations 13+130 and 13+200 is likely to cause a settlement of about 40 mm which should take place within the next ten years. In addition, a combination of secondary settlement and residual settlement (i.e. due to 1989 re-surfacing) can be expected to be of the order of 30 mm, bringing the total to 70 mm. While this

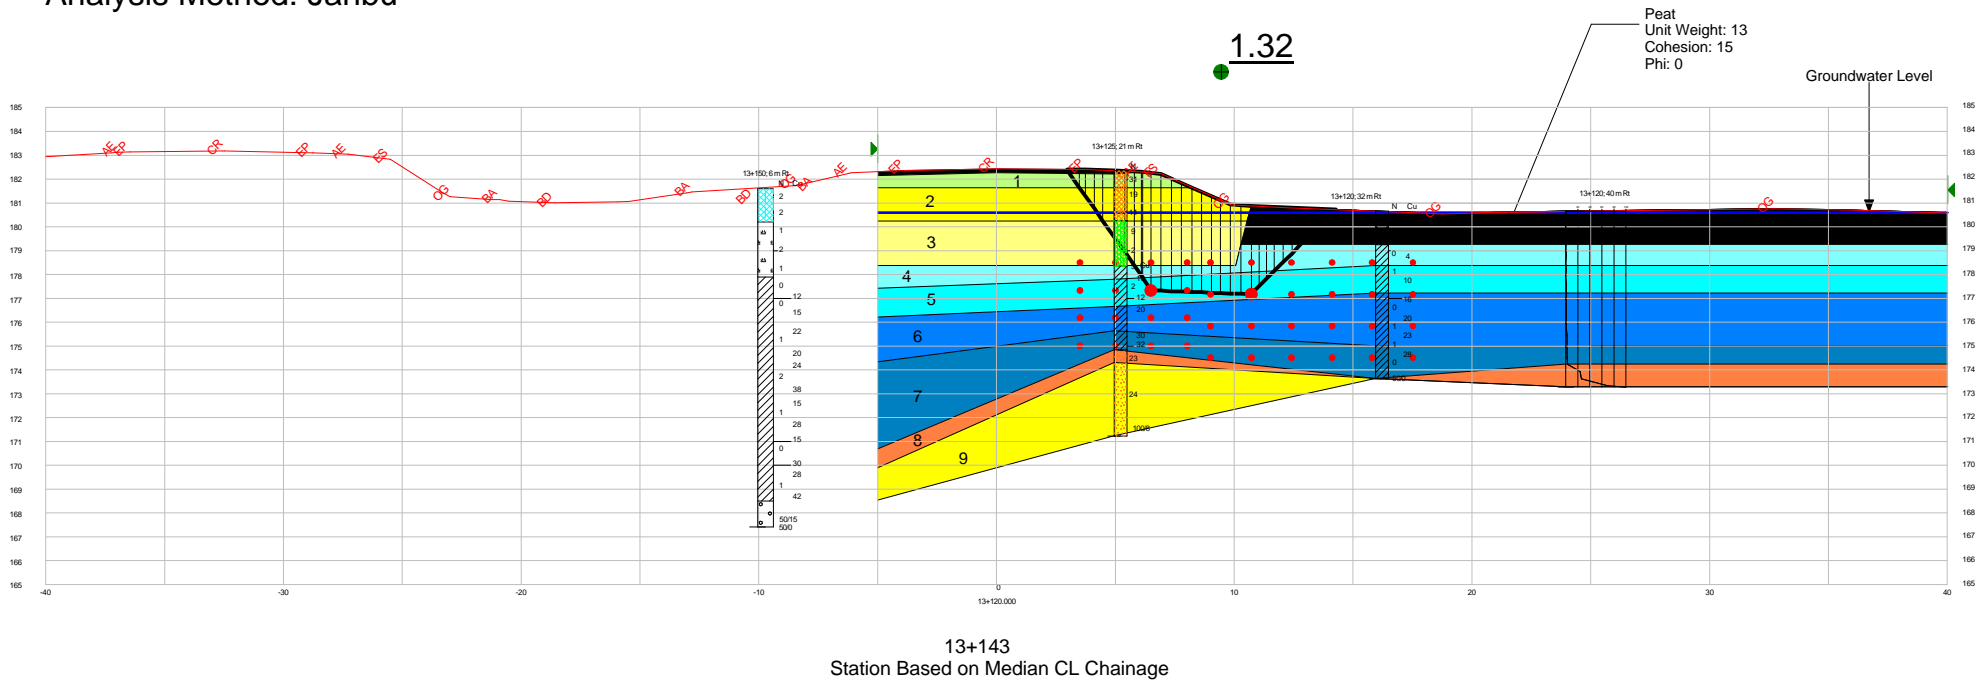
Highway 400 NBL, Twp of Baxter
Station 13+143 (Existing Embankment Height)

Drained Case (Long-Term)

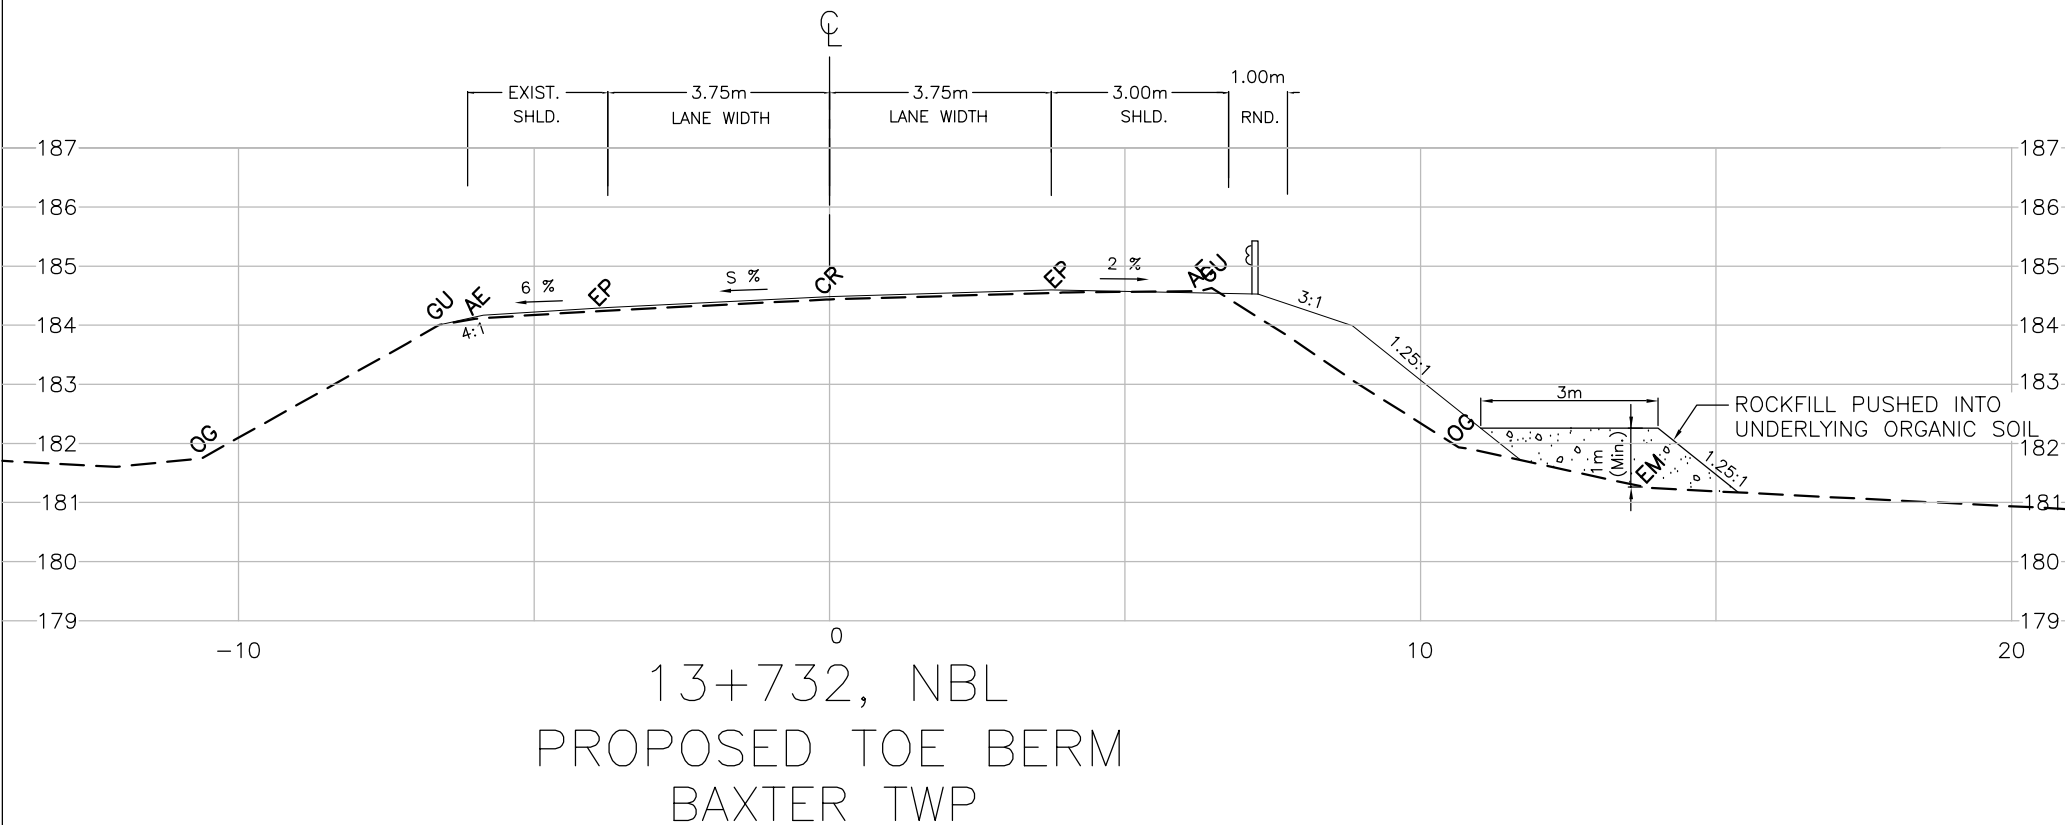
STATION BASED ON MEDIAN CL CHAINAGE

0.05 m GRADE RAISE

A section was presented to us at Station 13+732 (Figure G2-2). At this section, the embankment is relatively high (i.e. 3.6 m high) while the subsurface conditions as

The situation is somewhat more complicated in the section where shoulder widening is anticipated (see Figure G2-2 in Appendix G2). Here the widening is expected to cause a settlement of the order of 70 mm at the outer edge of the widened shoulder. In anticipation of this, consideration may be given to raising the grade at the outer edge of the widened shoulder by about this amount, decreasing to zero at a point about 4 m to the west of this point.

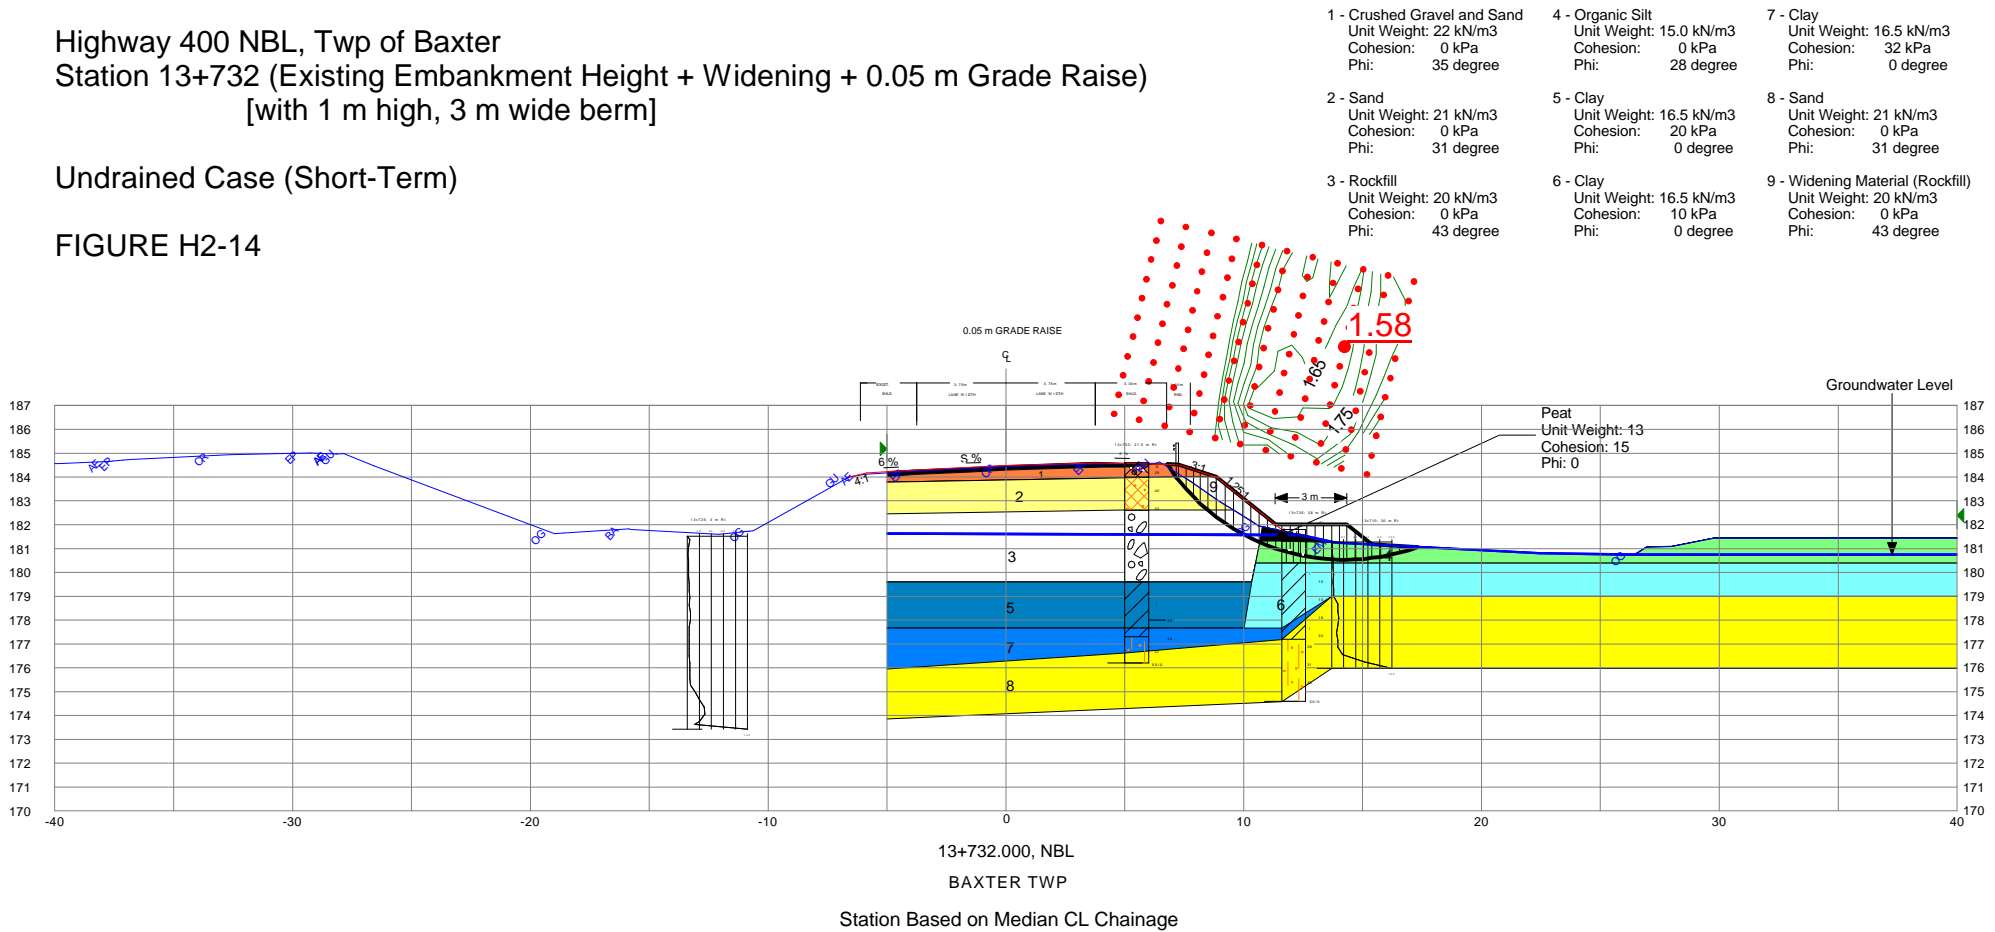
FIGURE H2-14

Highway 400 NBL, Twp of Baxter
Station 13+732 (Existing Embankment Height + Widening + 0.05 m Grade Raise)
[with 1 m high, 3 m wide berm]

Undrained Case (Short-Term)

represented by the findings of Boreholes 13+725 (28 m Rt) and 13+733 (21.5 m Rt) show representative conditions for the general swampy areas in this section. An analysis based on the findings of these boreholes indicates a factor of safety of about 1.3 for the original short (undrained) and long-term (drained) conditions. In this section, a 0.05 m grade raise is contemplated and this is not likely to change the stability conditions. In addition to this, however, a widening of the right (east) shoulder is planned. This is planned to be 3H:1V in the upper granular pavement section and 1.25H:1V side slopes for the lower part, which will consist of rock fill. The analysis with this configuration yielded a safety factor of about 1.1 for both the short and the long-term for shallow failures and about 1.2 for relatively deeper seated failures. The figures for the shallow seated failures are considered unacceptable and to remedy this situation it is suggested that a 1.0 m high (over the o.g. level) and a minimum 3.0 m long rock fill berm (beyond the toe of the final configuration) be placed (see Figure G2-3). Rock fill berm should be placed before widening. From the stability point of view, the existing peat/organic silt need not be removed provided rock fill is pushed into it. However, MTO will likely require that all organic soils be removed from beneath the toe berm as well as the widening. The removal of the organic soils must be carried out in a manner so as not to cause a failure of the existing embankment. For this purpose, the excavation should be carried out in sufficiently narrow sections (i.e. no wider than 3 m sections) perpendicular to the roadway (i.e. perpendicular to the longitudinal direction). Excavation and backfilling of each section should be carried out concurrently and under water. Rock fill placed below groundwater table may be end dumped. The rock fill should be placed according to OPSS 206.07.08 and current MTO practice. This operation should be carried along the entire length of proposed widening prior to its implementation. With this approach, the safety factors reach to about 1.5 or more, a figure which is considered acceptable (see Appendix H2).

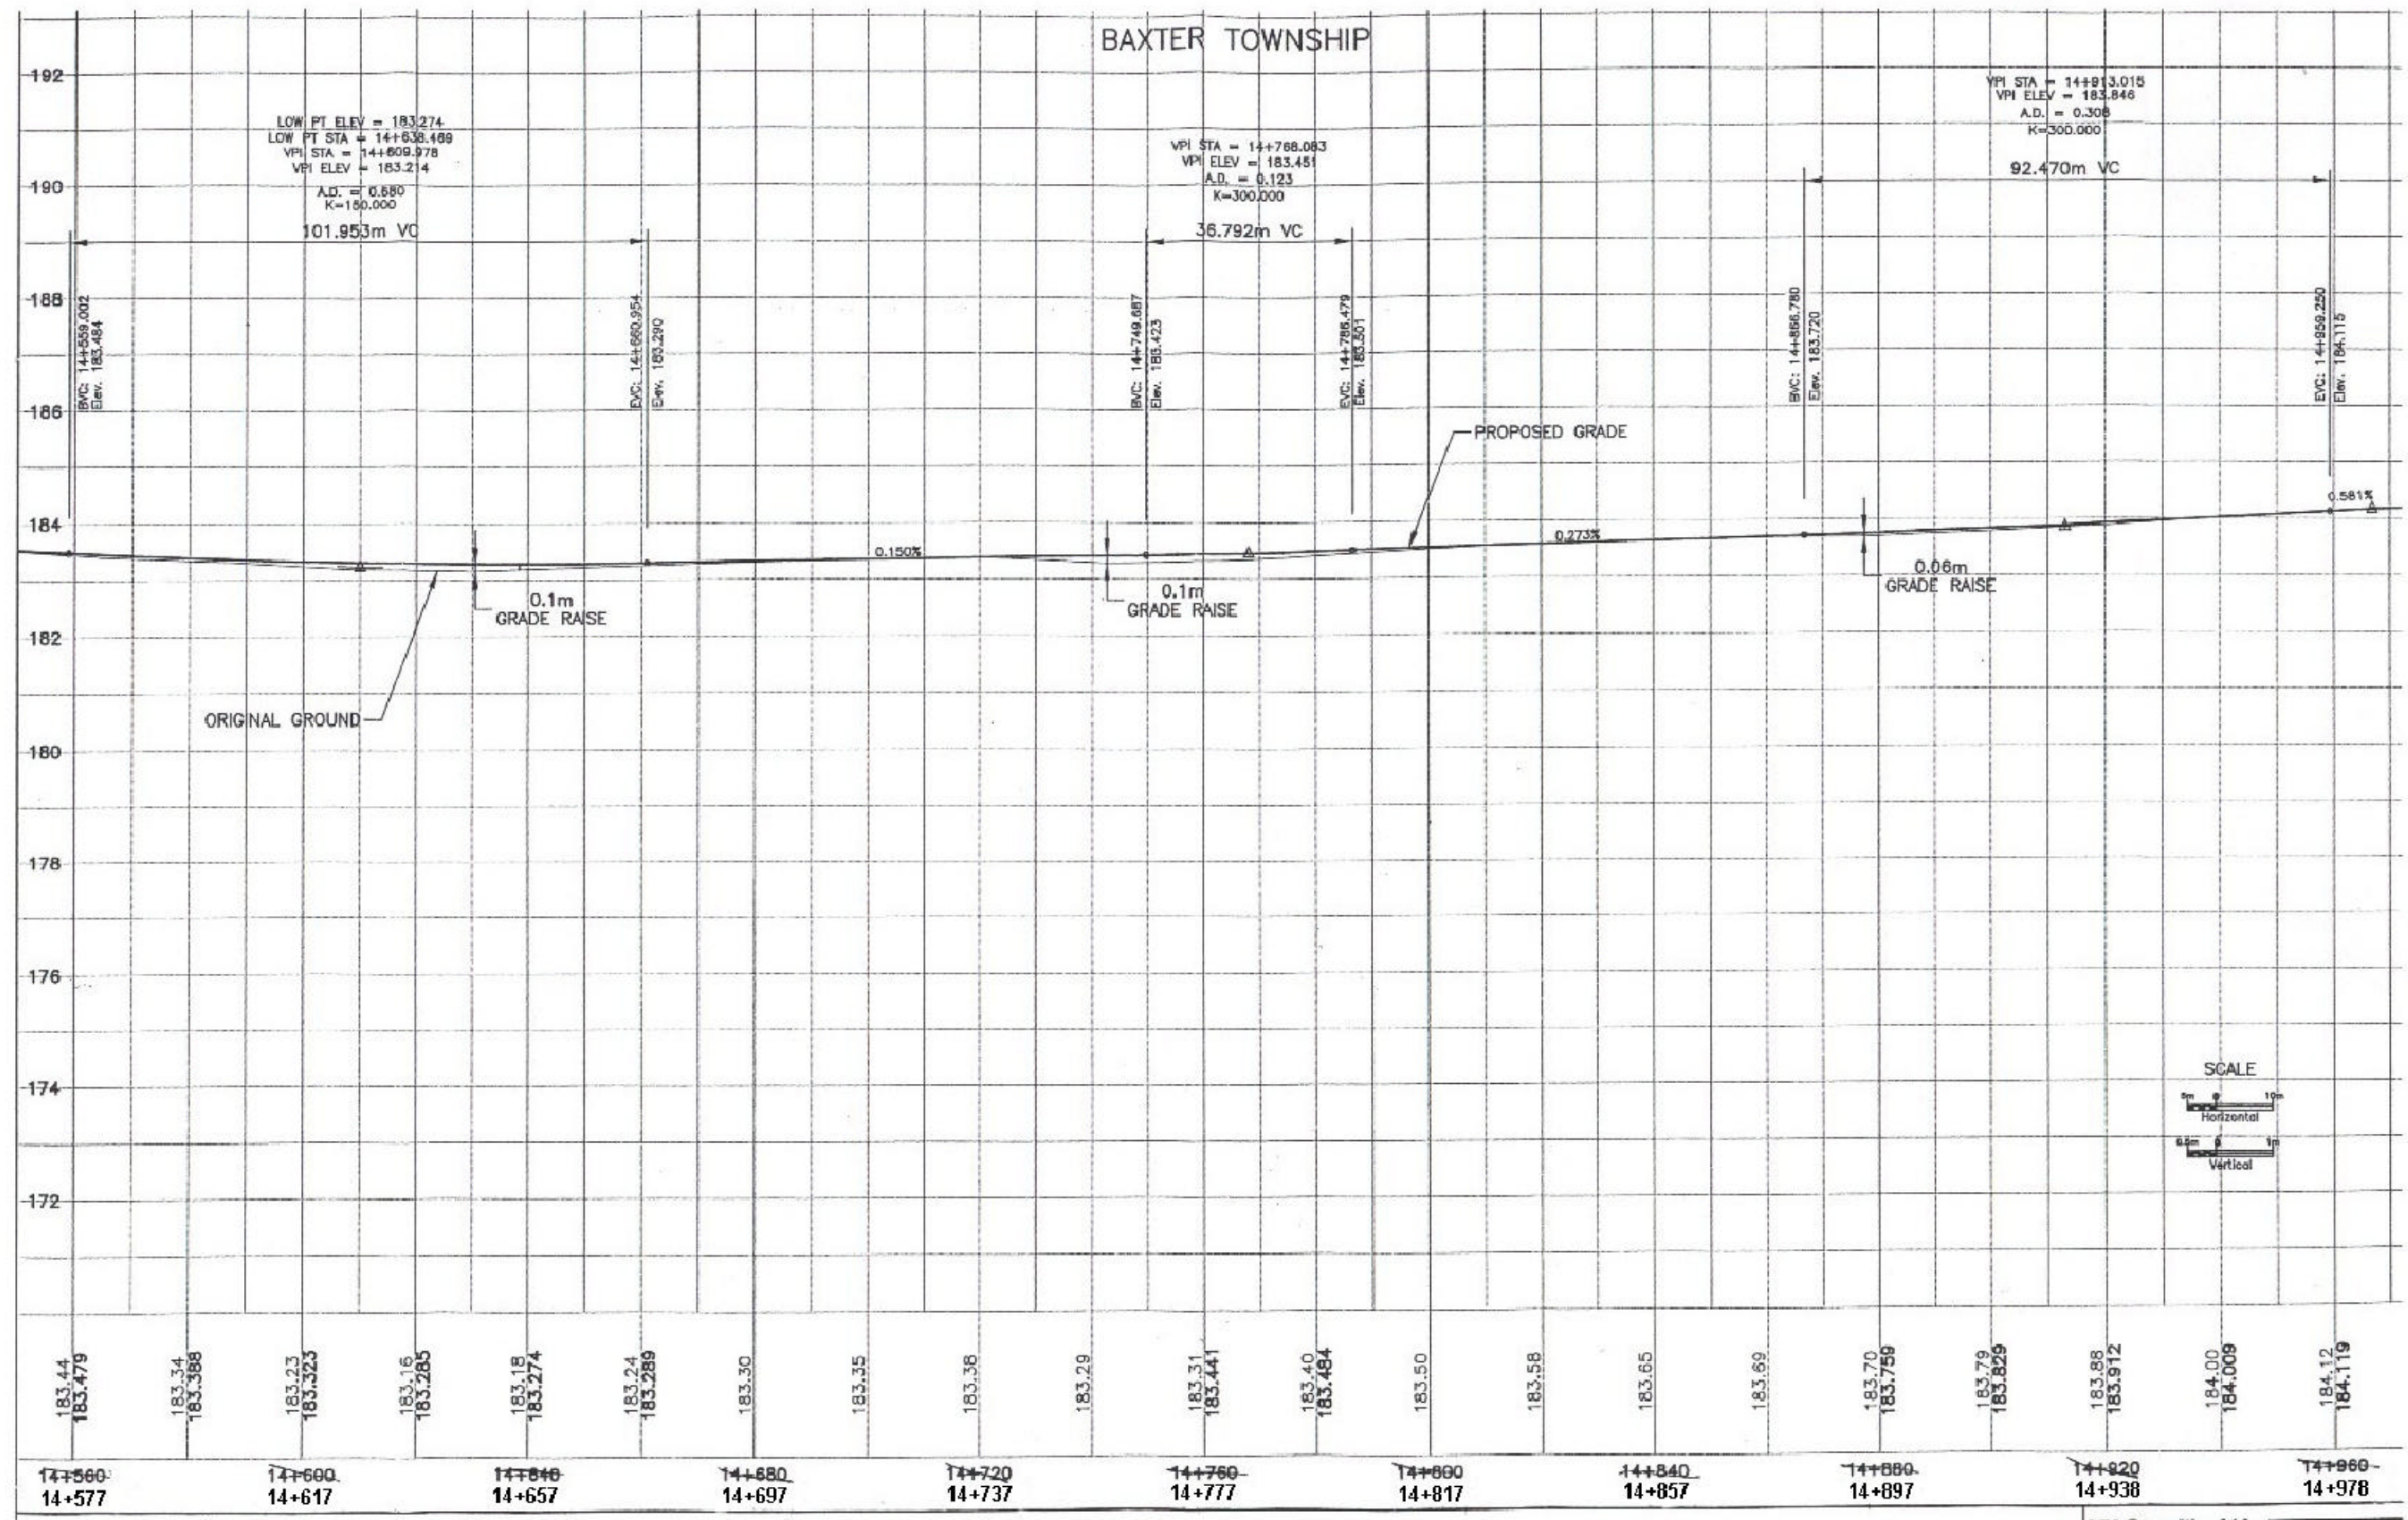
FIGURE G3-1

STATION BASED ON MEDIAN CL CHAINAGE

As was mentioned before in this section, the height of the embankment in the middle swampy sections (i.e. typically between Stations 14+550 and 14+700) is 1.2 to 1.5 m high. A foundation stability analysis was conducted to gauge available approximate safety factors when the embankments were first built (probably some 28 years ago). Slope stability analysis by the computer program Slope/W using Bishop's simplified method, using assumed and/or measured soil properties yielded safety factors in the order of between 1.7 and 3.5. Large scale horizontal deformations of the foundation soils are unlikely to have occurred with safety factors of these magnitudes when the embankments were first built. For this purpose, the section provided to us (i.e. at Station 14+647) was utilized and it was assumed that all organic soils under the footprint of the embankment were removed, as evidenced by the findings of Borehole 14+660 (24 m Rt) and that the embankment fill consists of mainly rockfill as indicated by the same borehole. The results of the analyses are given in Figures H3-1, H3-2, H3-3 and H3-4 in Appendix H3.

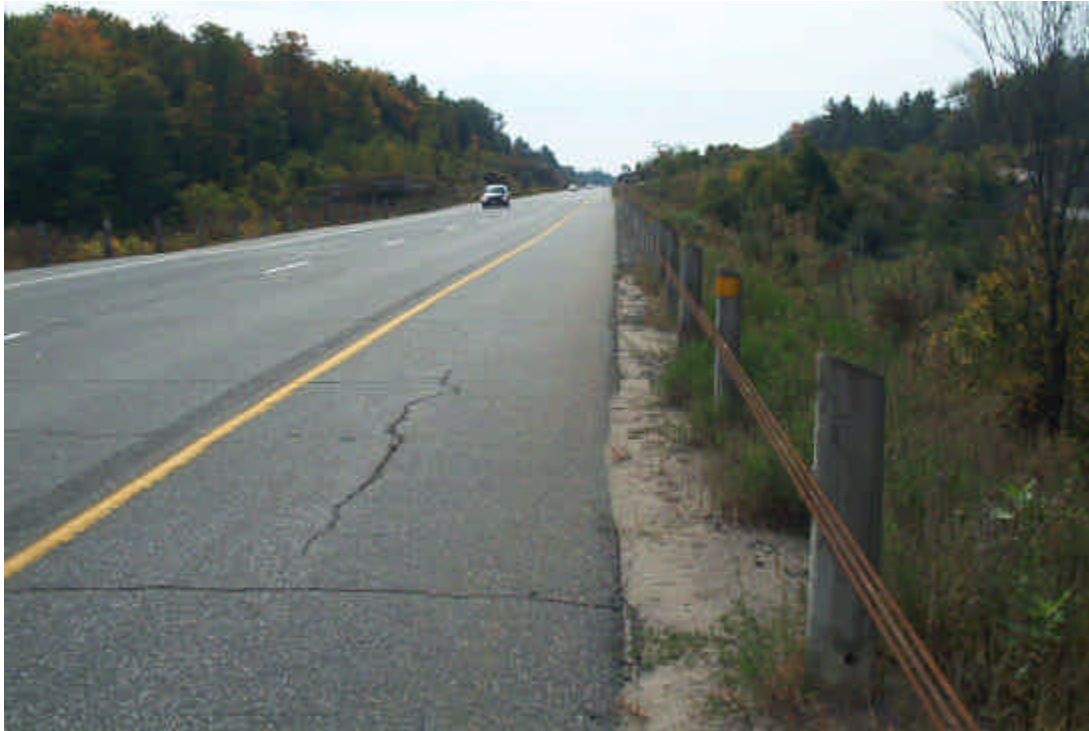
Photograph I-2 Pavement condition at about Station 11+800 (left shoulder)

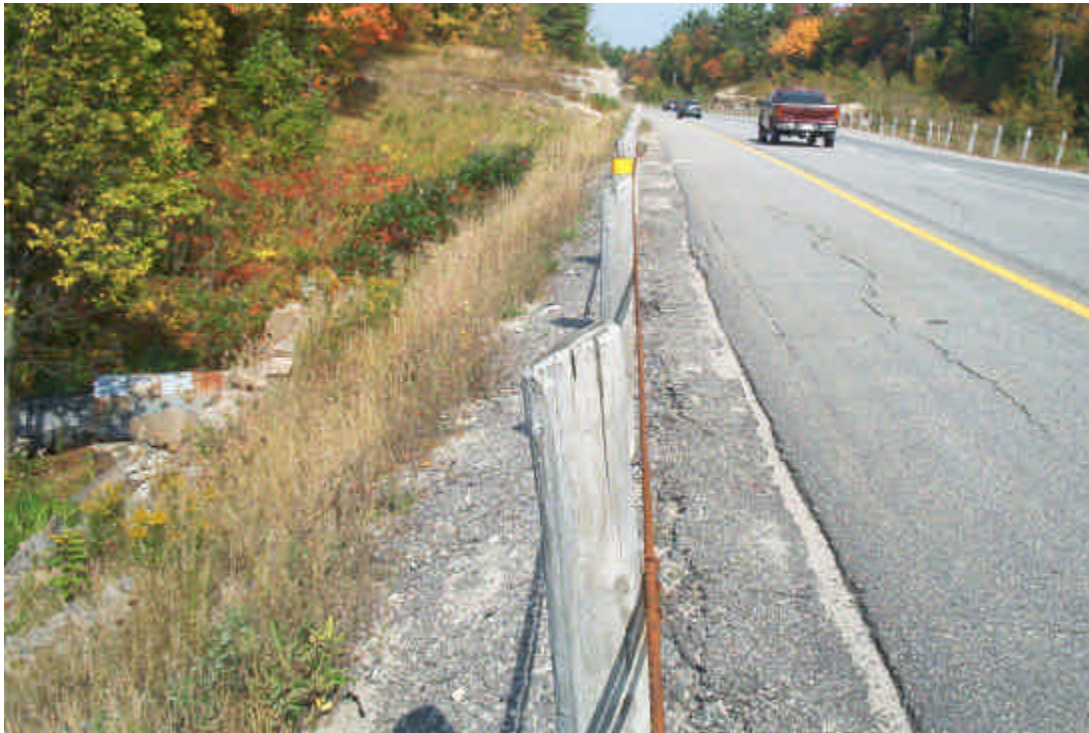
Photograph I-6 Cracks on Left Shoulder
