FOUNDATION INVESTIGATION AND DESIGN REPORT

**Construction of new concrete fish ladder at the outlet of the existing Heyrock
Creek Culvert, Highway 21, Bluewater Municipality**

Agreement No. 3015-E-0017

GWP 3186-15-00

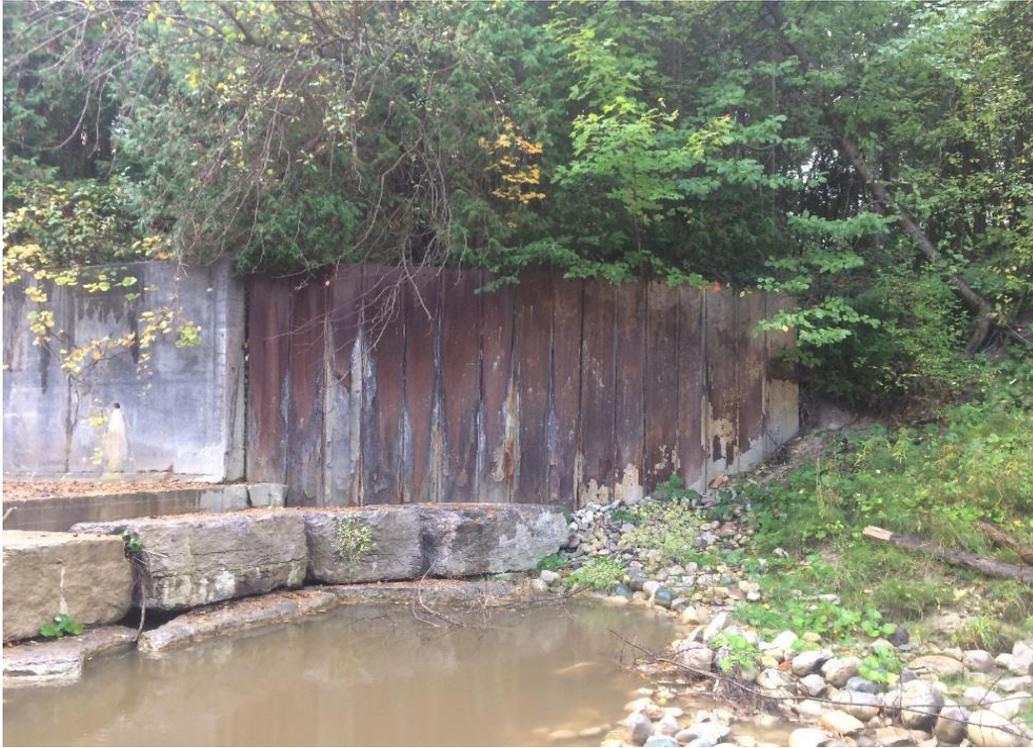
Photo 5: Heyrock Creek Culvert Outlet – South Side Retaining Wall

The general, site conditions in the immediate vicinity of the culvert were assessed during the site reconnaissance in October 24, 2016. On the inlet (east) side of the culvert, the embankments, although steep, were noted in an overall stable configuration with no obvious indications of recent slope movement. On the outlet (west) side of the culvert, the embankments exhibit signs of progressive slope movements behind the existing sheet pile walls at the downstream ends of the wing walls. Depressions in the soils of up to 1m were observed behind the sheet pile walls on both sides of the creek. Localized slope instability was noted to have occurred at the west end of the north sheet pile wall as well, also leaving a similar depression. Both sheet pile walls were noted in general deteriorating condition due to corrosion, bowed in the center and leaning toward the creek. Based on visual observation, the culvert and wing walls appeared to be in satisfactory condition with minor indications of age related deterioration. The floor of the culvert and spillway were noted generally intact. Photographs of the soil instabilities are presented in Appendix A.

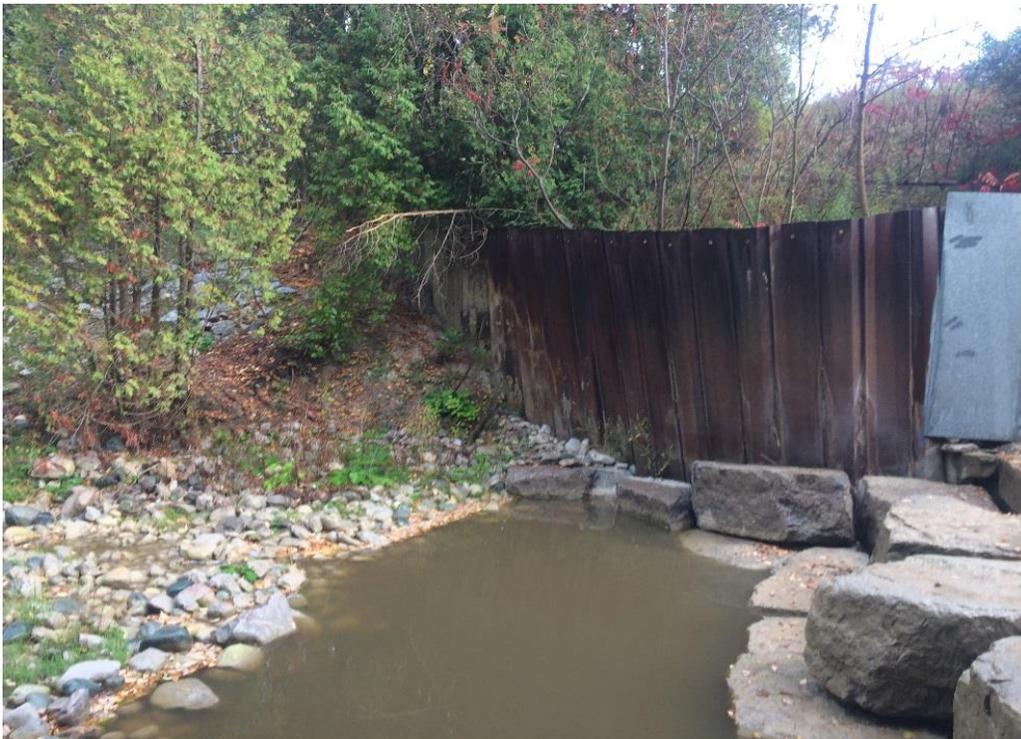
Photo 6: Heyrock Creek Culvert Outlet – North Side Retaining Wall

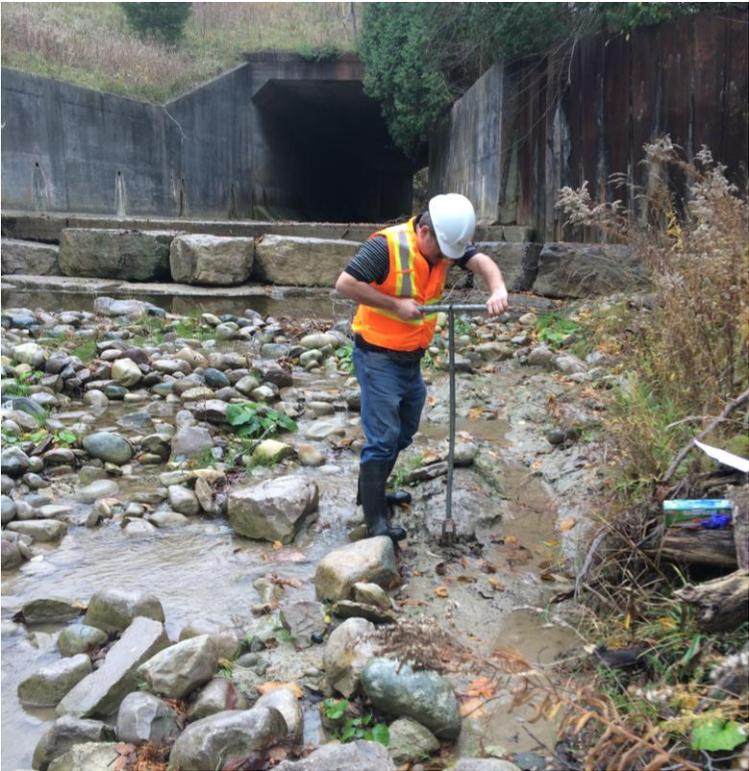
Photo 10: Probe hole using 'T' bar

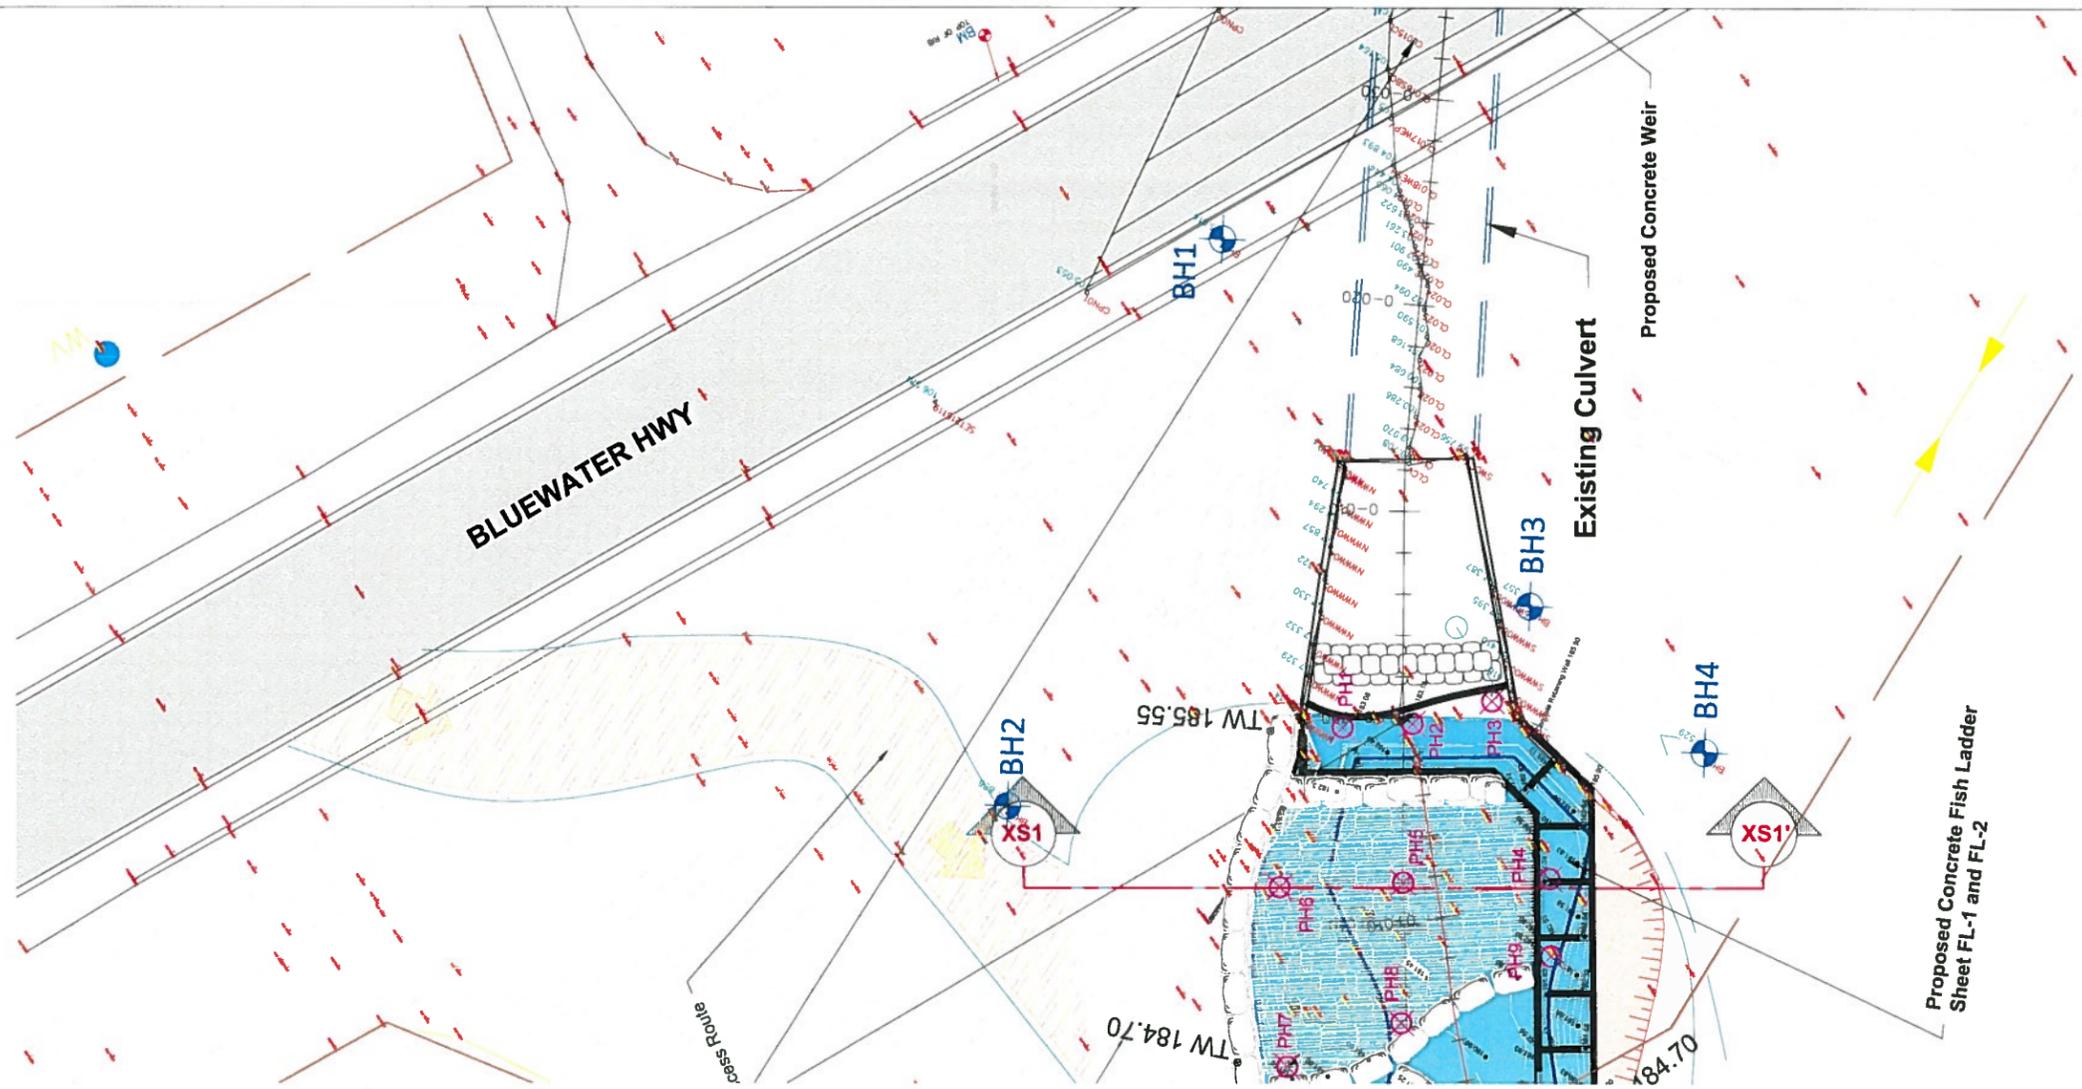
NOTE: THE PLAN AND PROFILE ARE PROVIDED BY MTO/ PARSONS.

A borehole location plan and stratigraphic section are provided in Appendix C. It should be noted that the stratigraphic boundaries indicated on the borehole log and stratigraphic section are inferred from semi-continuous sampling, observations of drilling progress and results of Standard Penetration Tests. These boundaries typically represent transitions from one soil type to another and should not be interpreted as exact planes of geological change. Furthermore, subsurface conditions may vary between and beyond the borehole locations.

The subsurface conditions observed during advancing of probe holes (PH1 to PH9) are summarized in the table below. The probe hole locations are shown on the Drawing 1 in Appendix C.

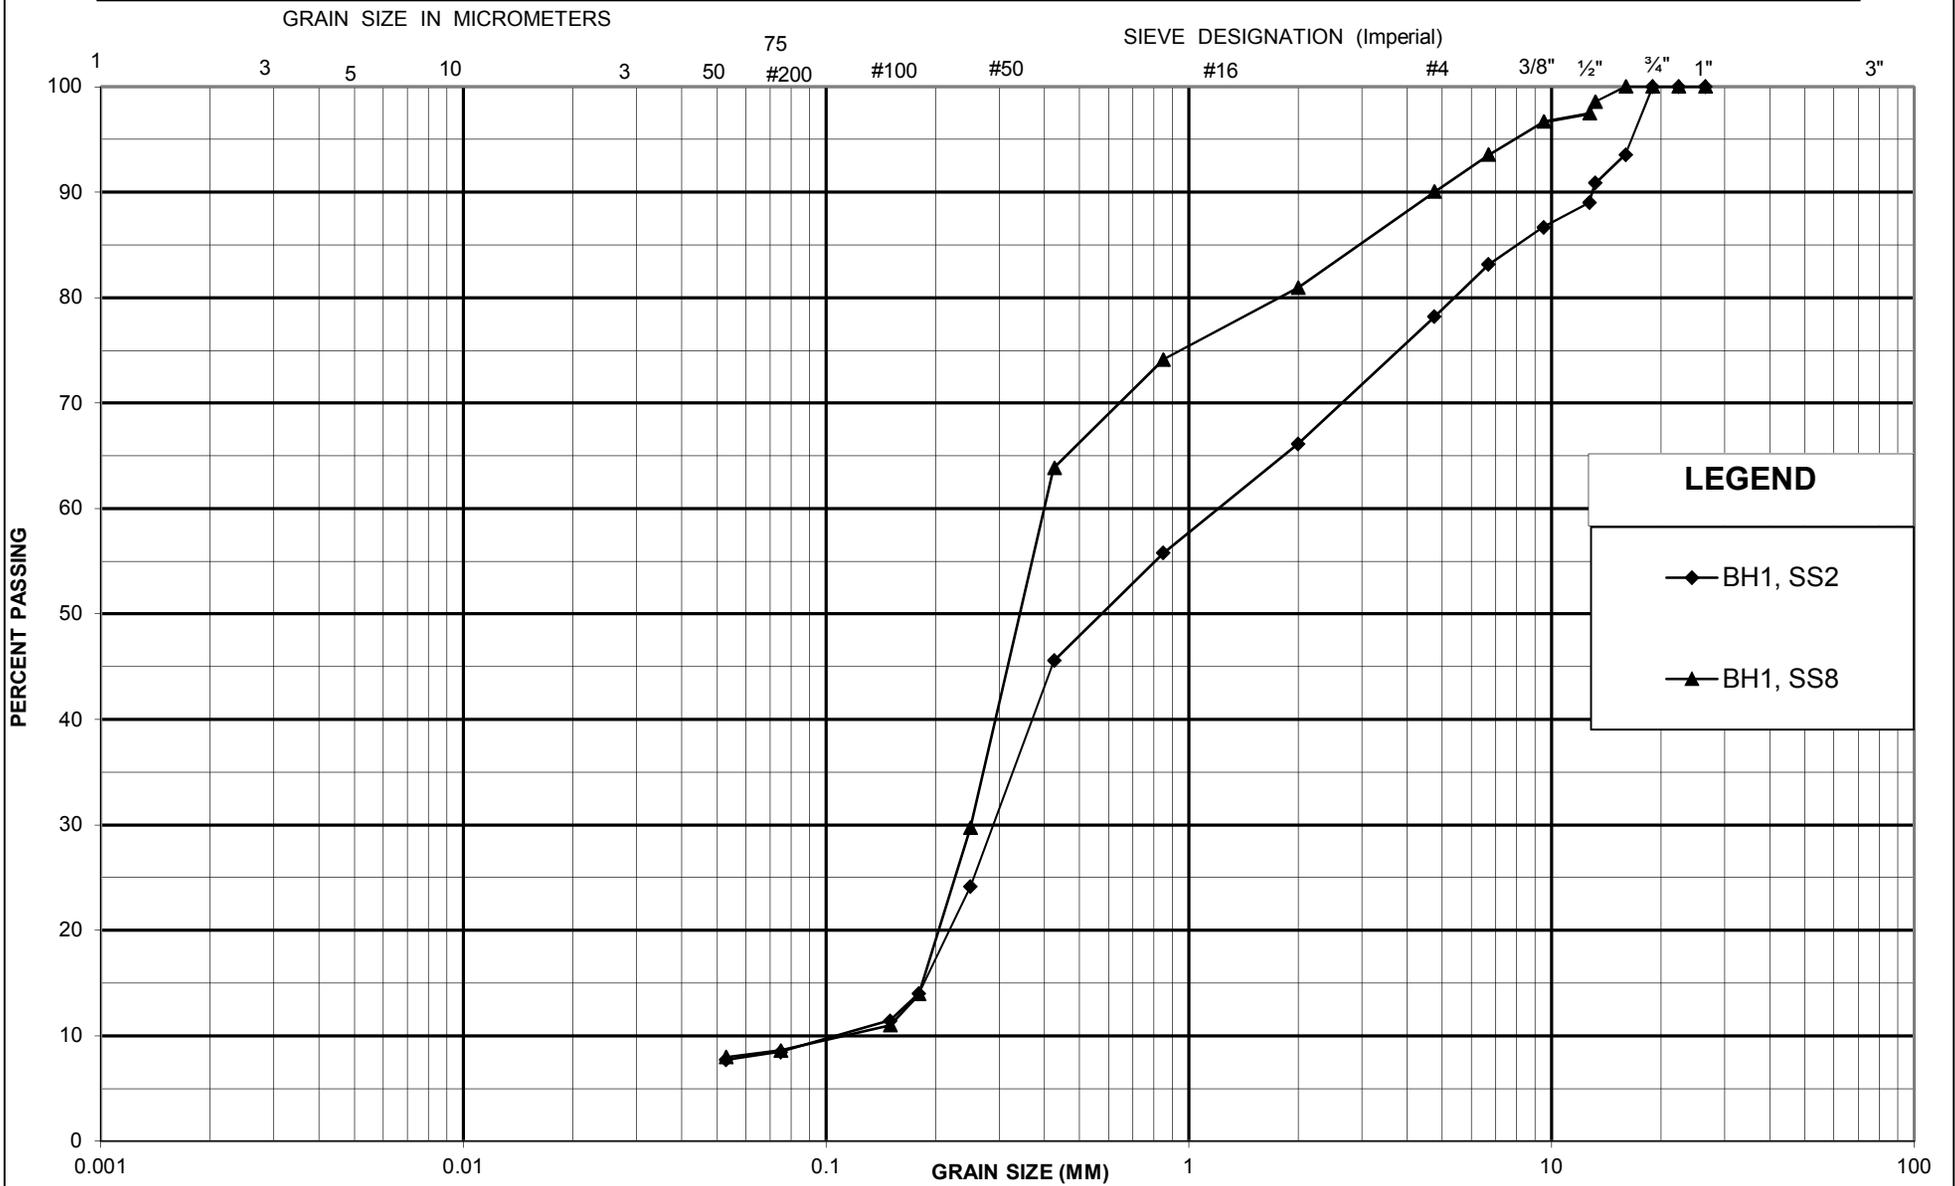
FIGURE No. 1
 GWP : 3186-15-00
 DATE November, 2016

GRAIN SIZE DISTRIBUTION
FILL: GRAVELLY SAND TO SAND

The results of the moisture content and grain size distribution tests are provided on the record of borehole sheets in Appendix D. The results of the grain size distribution tests are also provided on Figure 1 in Appendix E.

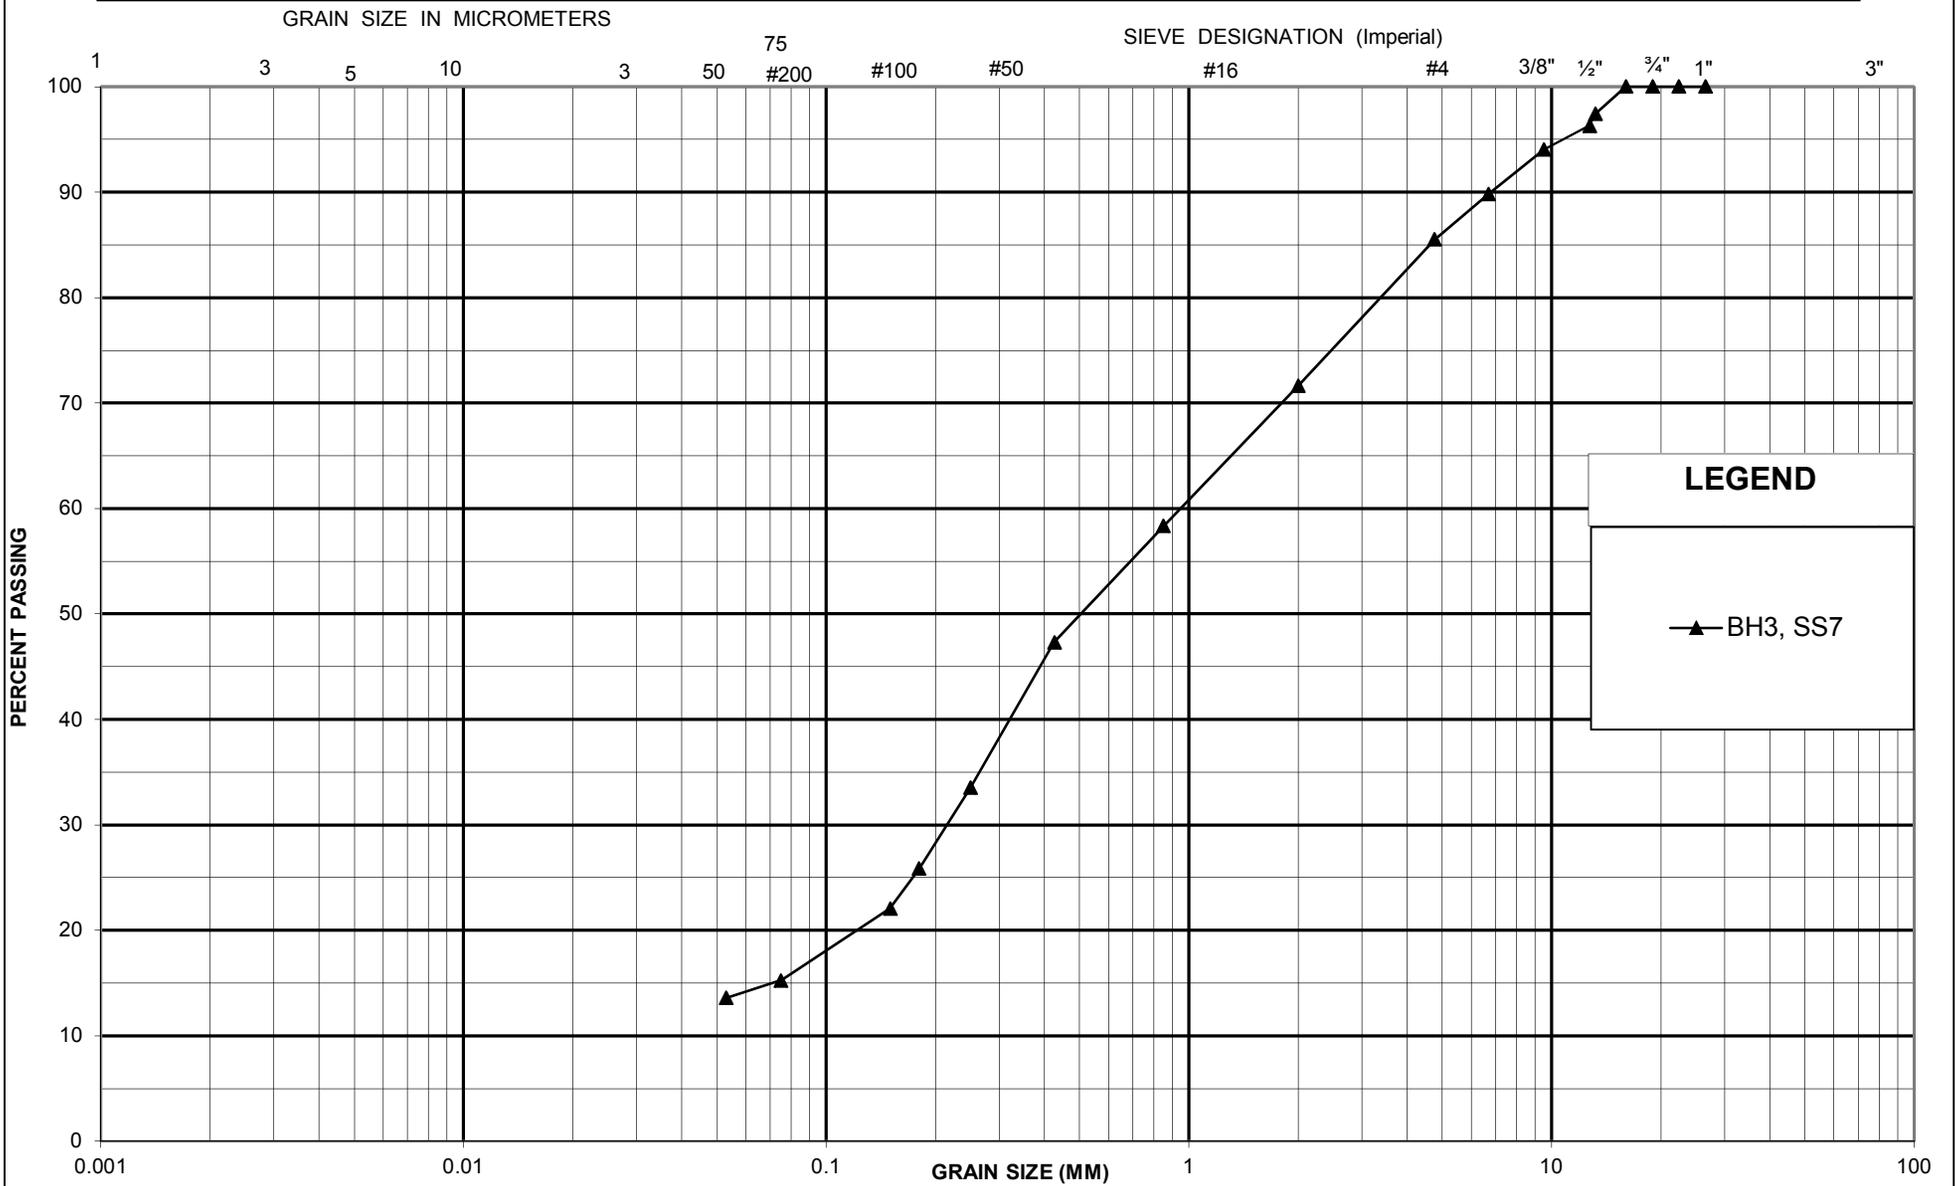
FIGURE No. 6

GRAIN SIZE DISTRIBUTION
GRAVELLY SAND

The results of the moisture content and grain size distribution tests are provided on the record of borehole sheets in Appendix D. The results of the grain size distribution tests are also provided on Figure 5 and 6* in Appendix E.

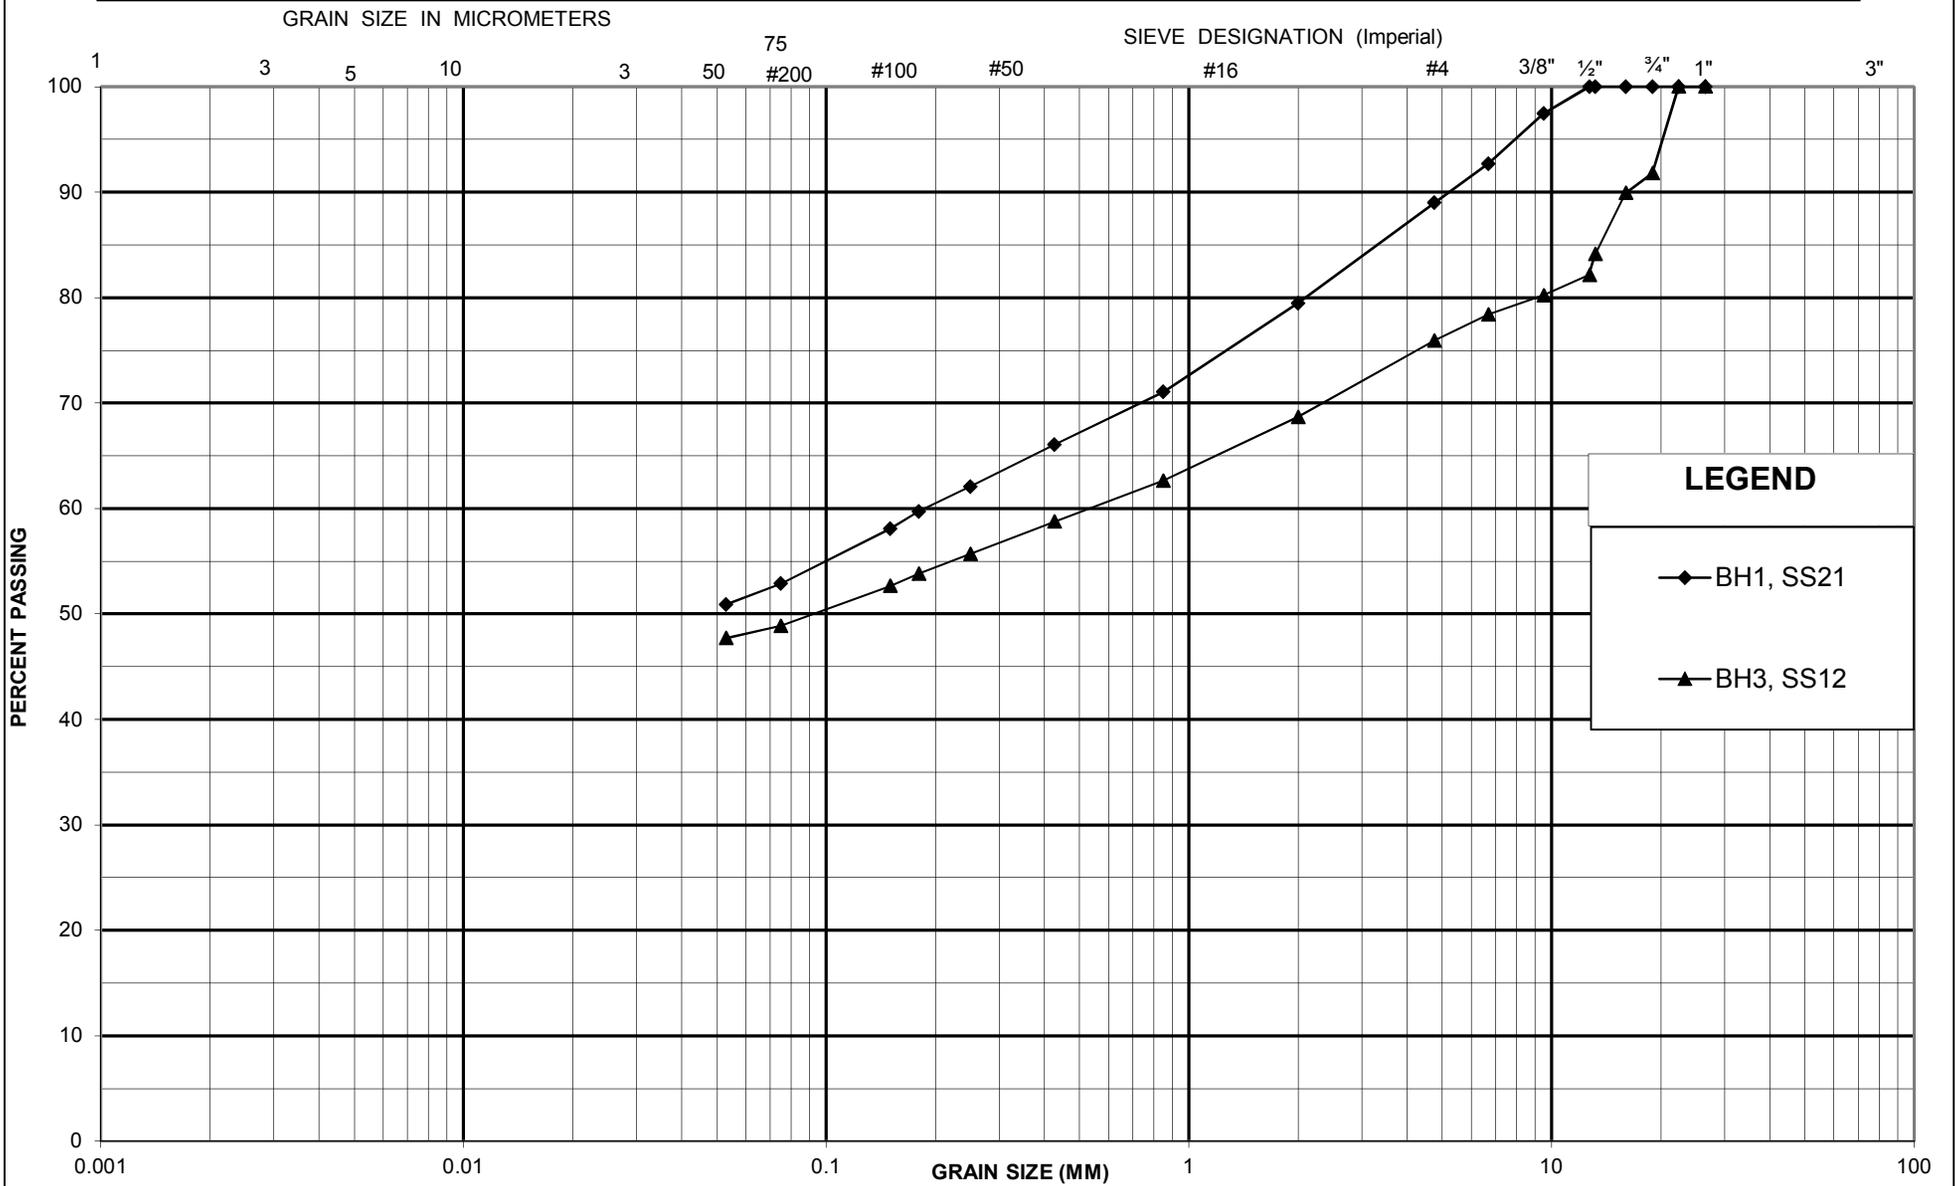
FIGURE No. 7

GRAIN SIZE DISTRIBUTION
SANDY SILT (TILL)

The results of the moisture content and grain size distribution tests are provided on the record of borehole sheets in Appendix D. The results of the grain size distribution tests are also provided on Figure 7 in Appendix E.

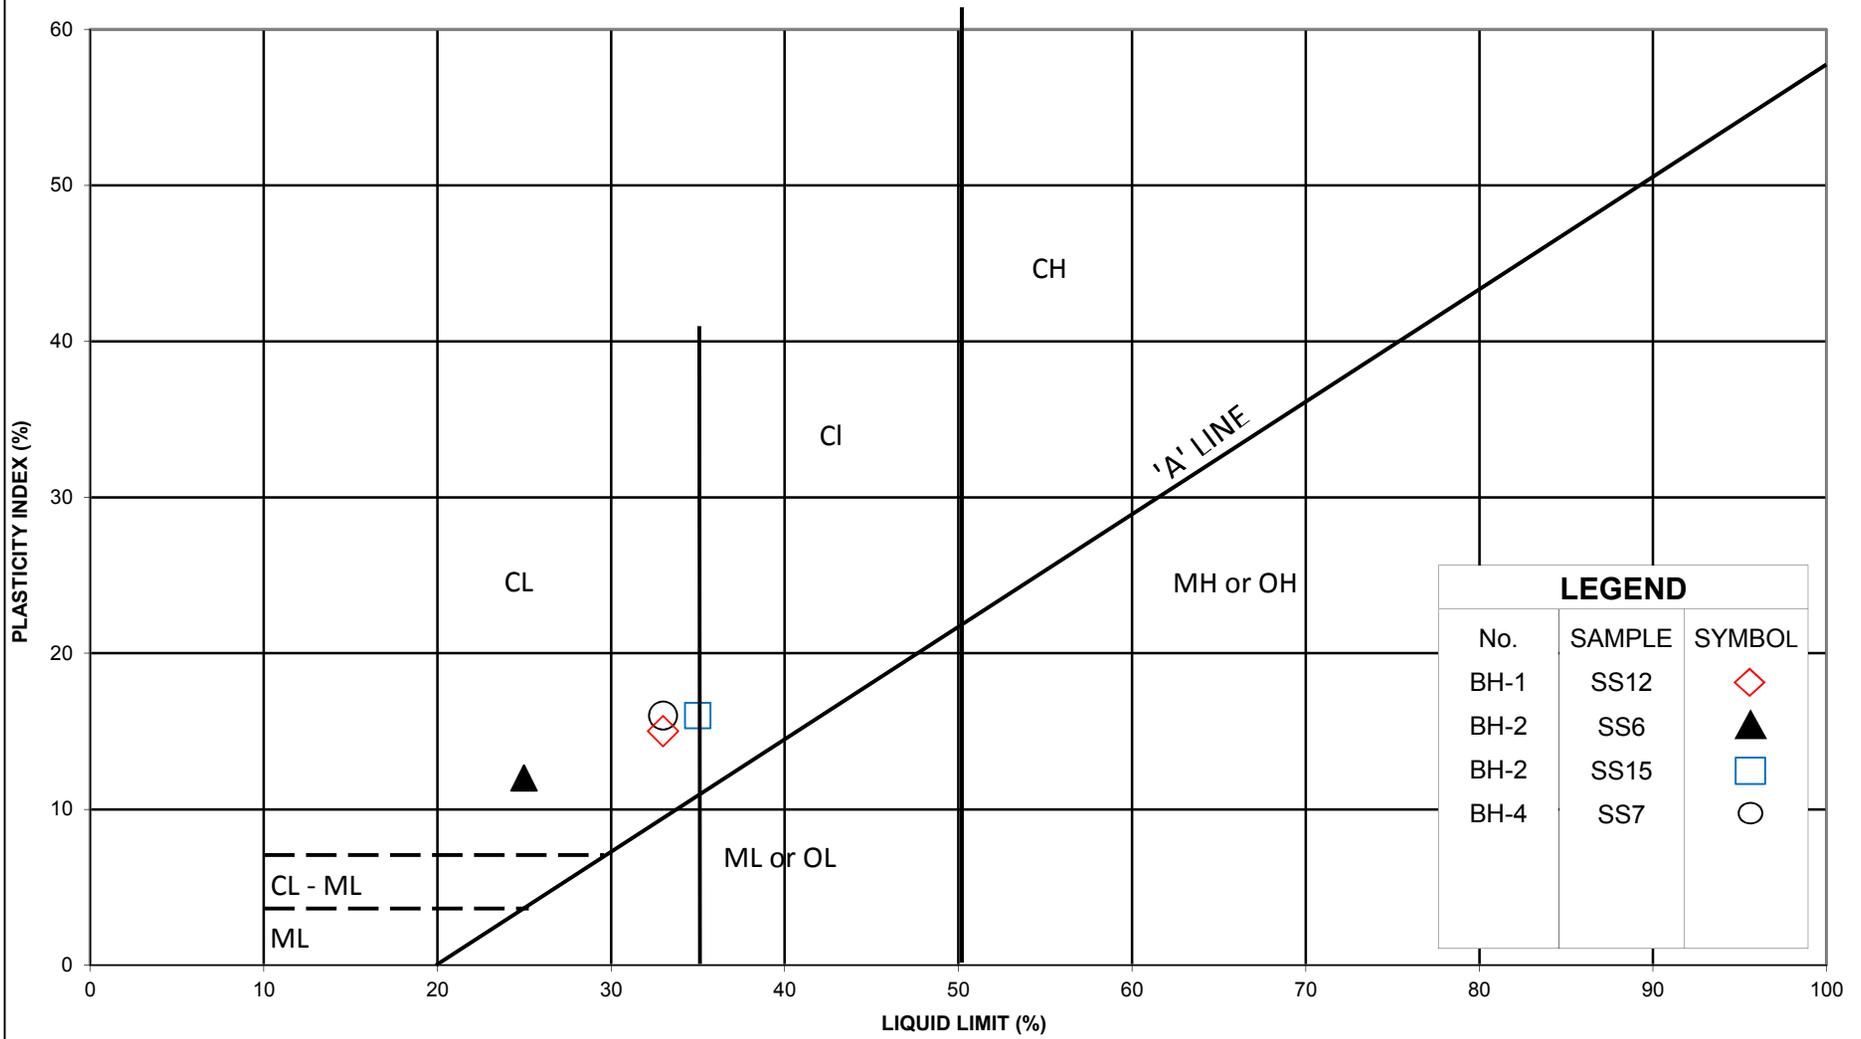
FIGURE NO.: 9
GWP: 3186-15-00
DATE: November 2016

PLASTICITY CHART
Clayey Silt (Upper)

The results of the moisture content, grain size distribution and Atterberg Limits tests are provided on the record of borehole sheets in Appendix D. The results of the grain size distribution tests and Atterberg Limits tests are also provided on Figure 4 and 9, respectively, in Appendix E.

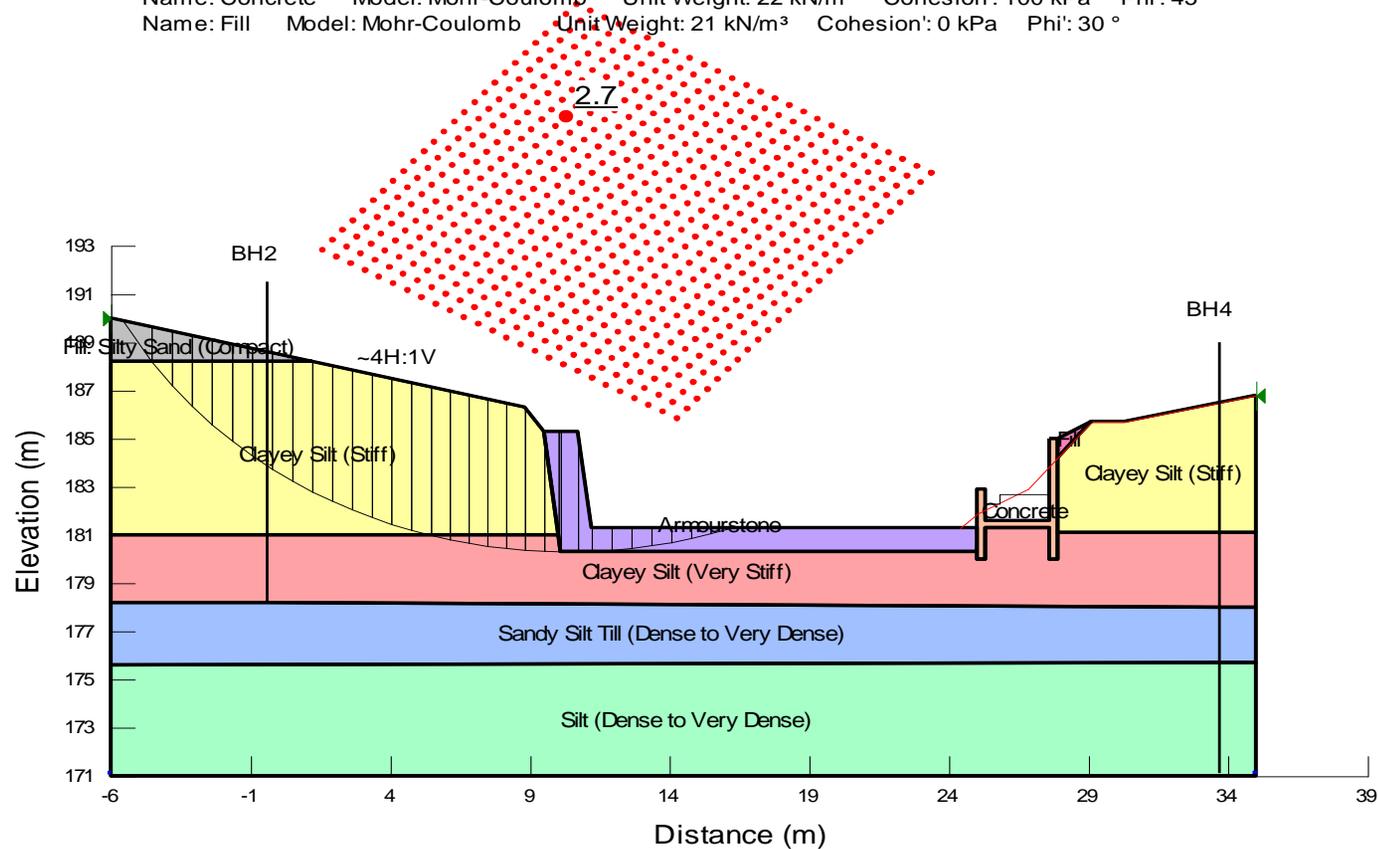
Name: Fill: Silty Sand (Compact) Model: Mohr-Coulomb Unit Weight: 21 kN/m³ Cohesion: 0 kPa Phi: 32 °
 Name: Clayey Silt (Stiff) Model: Undrained (Phi=0) Unit Weight: 19 kN/m³ Cohesion: 60 kPa
 Name: Clayey Silt (Very Stiff) Model: Undrained (Phi=0) Unit Weight: 20 kN/m³ Cohesion: 120 kPa
 Name: Sandy Silt Till (Dense to Very Dense) Model: Mohr-Coulomb Unit Weight: 21 kN/m³ Cohesion: 0 kPa Phi: 32 °
 Name: Silt (Dense to Very Dense) Model: Mohr-Coulomb Unit Weight: 20 kN/m³ Cohesion: 0 kPa Phi: 30 °
 Name: Armourstone Model: Mohr-Coulomb Unit Weight: 18 kN/m³ Cohesion: 0 kPa Phi: 38 °
 Name: Concrete Model: Mohr-Coulomb Unit Weight: 22 kN/m³ Cohesion: 100 kPa Phi: 45 °
 Name: Fill Model: Mohr-Coulomb Unit Weight: 21 kN/m³ Cohesion: 0 kPa Phi: 30 °

Figure 1: Slope stability analysis for retaining wall – undrained static conditions

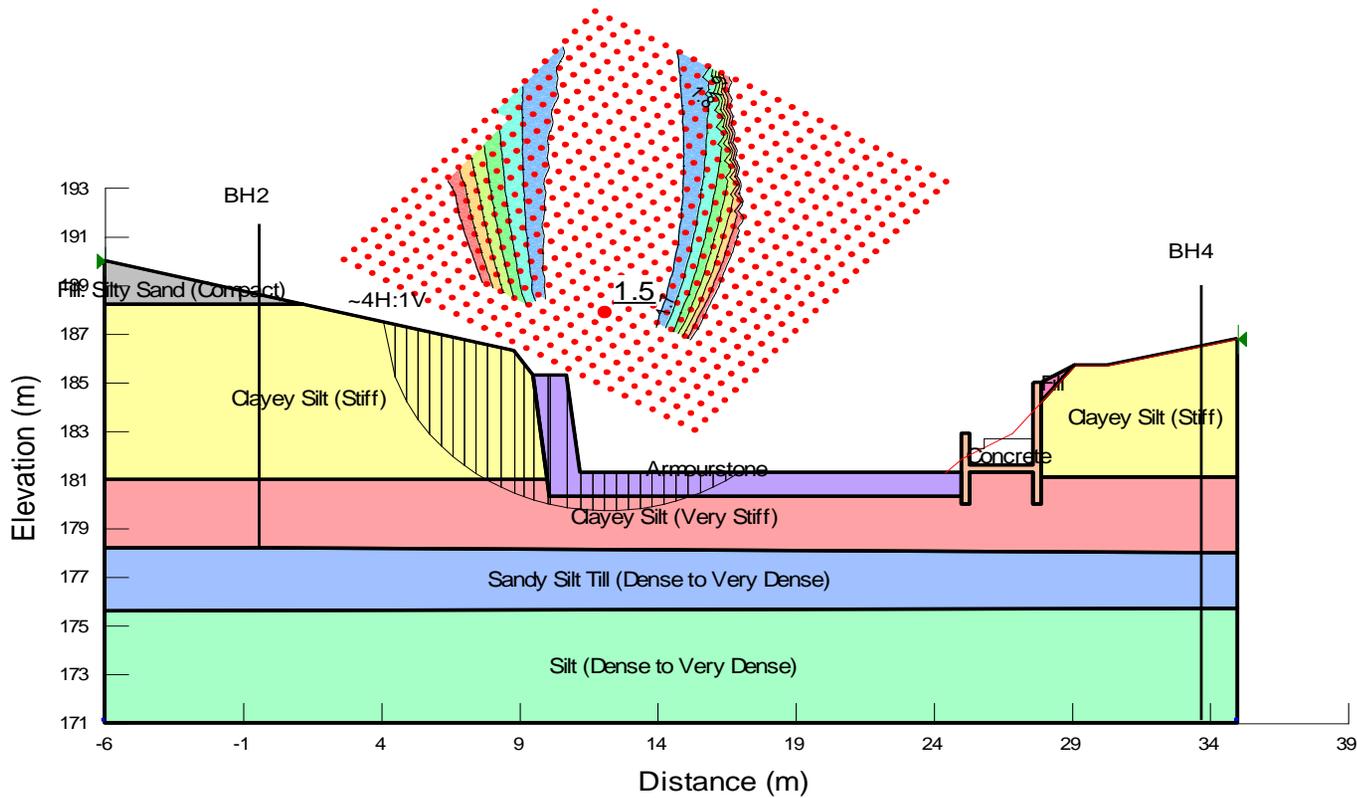
- Name: Fill: Silty Sand (Compact) Model: Mohr-Coulomb Unit Weight: 21 kN/m³ Cohesion: 0 kPa Phi: 32 °
- Name: Clayey Silt (Stiff) Model: Mohr-Coulomb Unit Weight: 19 kN/m³ Cohesion: 0 kPa Phi: 29 °
- Name: Clayey Silt (Very Stiff) Model: Mohr-Coulomb Unit Weight: 20 kN/m³ Cohesion: 0 kPa Phi: 31 °
- Name: Sandy Silt Till (Dense to Very Dense) Model: Mohr-Coulomb Unit Weight: 21 kN/m³ Cohesion: 0 kPa Phi: 32 °
- Name: Silt (Dense to Very Dense) Model: Mohr-Coulomb Unit Weight: 20 kN/m³ Cohesion: 0 kPa Phi: 30 °
- Name: Armourstone Model: Mohr-Coulomb Unit Weight: 18 kN/m³ Cohesion: 0 kPa Phi: 38 °
- Name: Concrete Model: Mohr-Coulomb Unit Weight: 22 kN/m³ Cohesion: 100 kPa Phi: 45 °
- Name: Fill Model: Mohr-Coulomb Unit Weight: 21 kN/m³ Cohesion: 0 kPa Phi: 30 °

Figure 2: Slope stability analysis for retaining wall – drained static conditions

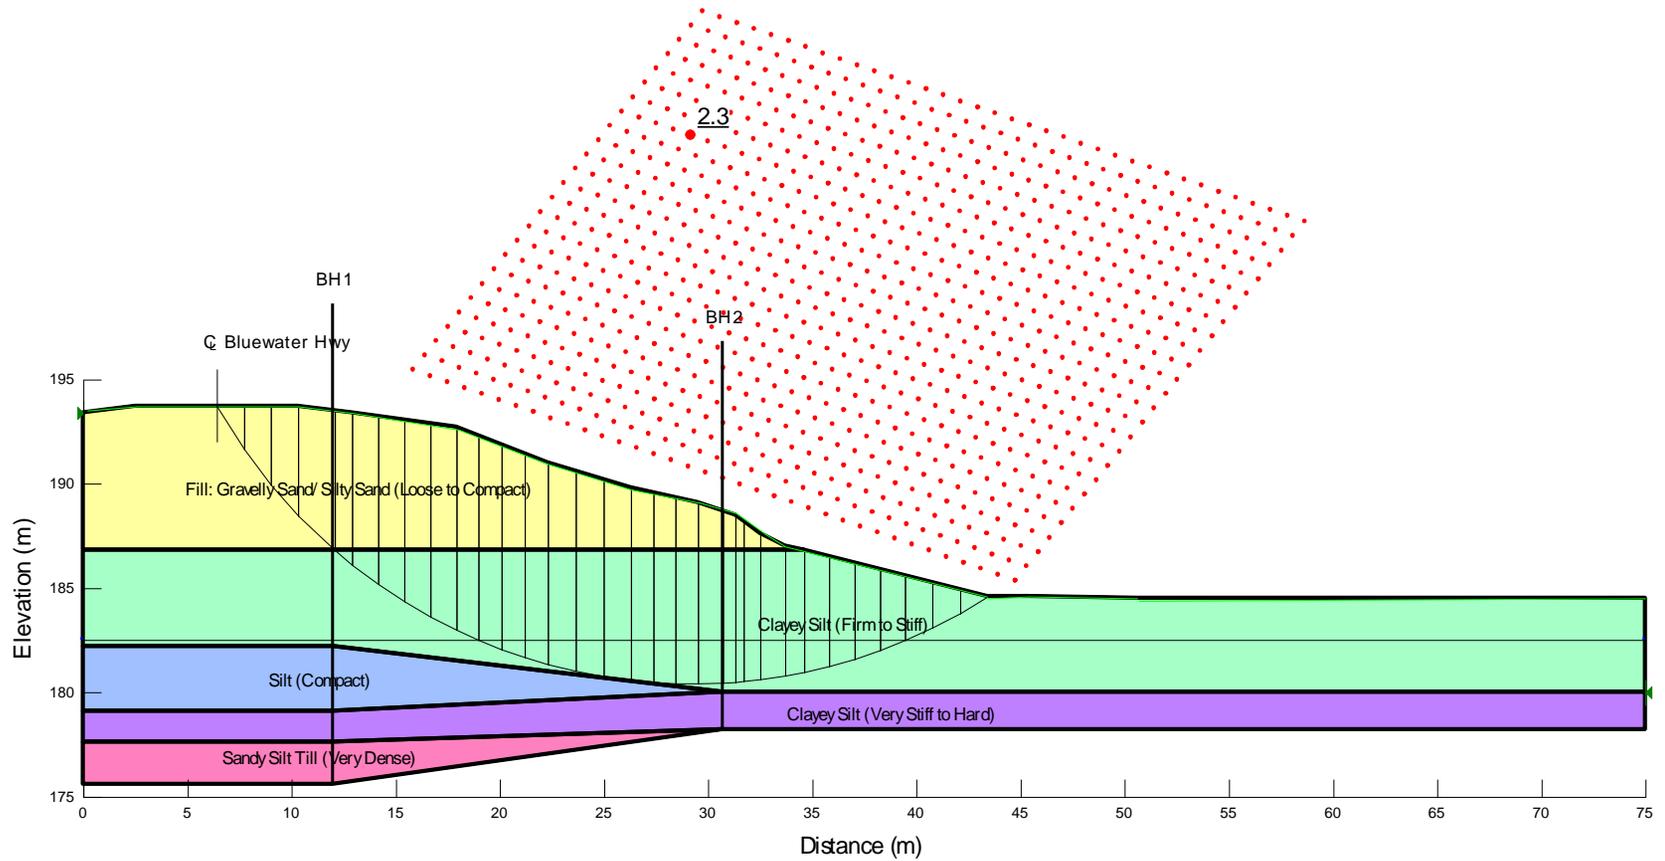
Name: Fill: Gravelly Sand/ Silty Sand (Loose to Compact) Model: Mohr-Coulomb Unit Weight: 19 kN/m³ Cohesion: 0 kPa Phi: 32 °
 Name: Silt (Compact) Model: Mohr-Coulomb Unit Weight: 20 kN/m³ Cohesion: 0 kPa Phi: 29 °
 Name: Clayey Silt (Firm to Stiff) Model: Undrained (Phi=0) Unit Weight: 19 kN/m³ Cohesion: 60 kPa
 Name: Clayey Silt (Very Stiff to Hard) Model: Undrained (Phi=0) Unit Weight: 20 kN/m³ Cohesion: 120 kPa
 Name: Sandy Silt Till (Very Dense) Model: Mohr-Coulomb Unit Weight: 21 kN/m³ Cohesion: 0 kPa Phi: 32 °

Figure 3: Slope stability analysis for embankment slope – undrained static conditions

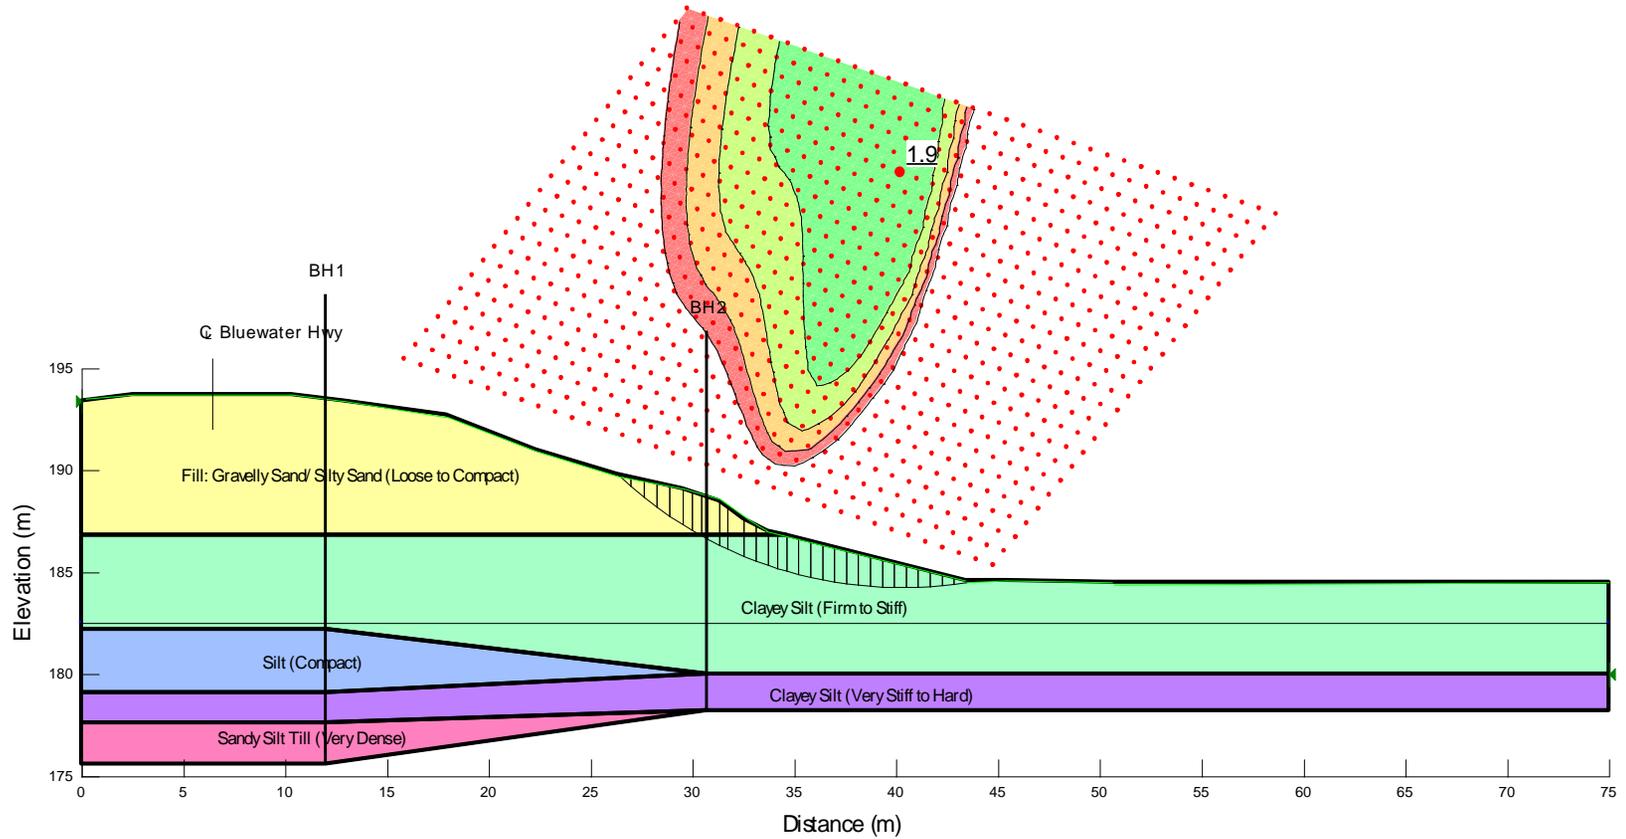
Name: Fill: Gravelly Sand/ Silty Sand (Loose to Compact) Model: Mohr-Coulomb Unit Weight: 19 kN/m³ Cohesion': 0 kPa Phi': 32 °
 Name: Silt (Compact) Model: Mohr-Coulomb Unit Weight: 20 kN/m³ Cohesion': 0 kPa Phi': 29 °
 Name: Clayey Silt (Firm to Stiff) Model: Mohr-Coulomb Unit Weight: 19 kN/m³ Cohesion': 0 kPa Phi': 29 °
 Name: Clayey Silt (Very Stiff to Hard) Model: Mohr-Coulomb Unit Weight: 20 kN/m³ Cohesion': 0 kPa Phi': 31 °
 Name: Sandy Silt Till (Very Dense) Model: Mohr-Coulomb Unit Weight: 21 kN/m³ Cohesion': 0 kPa Phi': 32 °

Figure 4: Slope stability analysis for embankment slope – drained static conditions

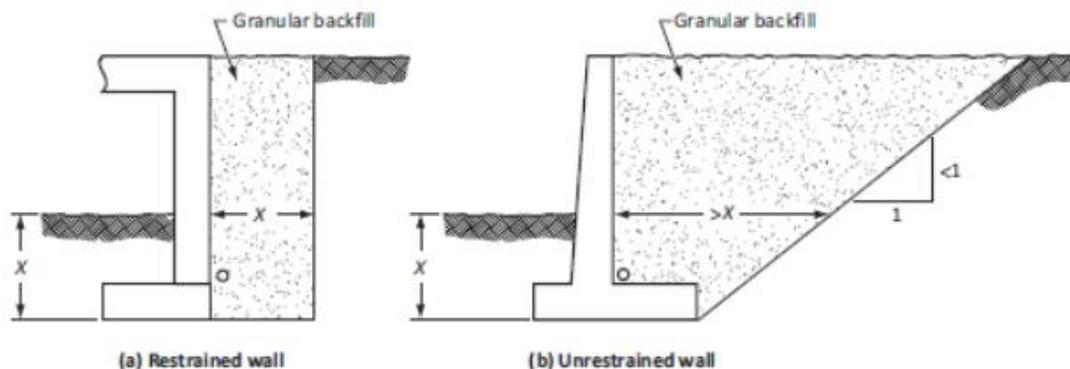
Figure C6.20
Backfill for frost protection
 (See Clause C6.12.1.)
