### **FOUNDATION INVESTIGATION REPORT**

**Construction of new concrete fish ladder at the outlet of the existing Heyrock  
Creek Culvert, Highway 21, Bluewater Municipality**

**Agreement No. 3015-E-0017**

January 11, 2017

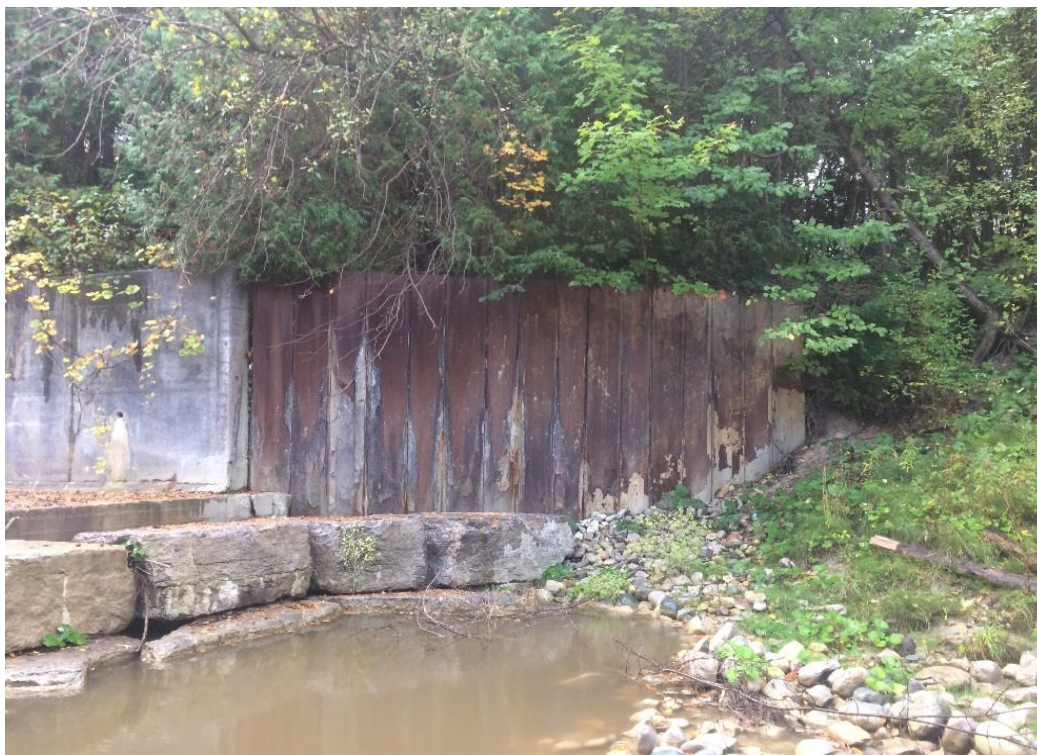
Photo 5: Heyrock Creek Culvert Outlet – South Side Retaining Wall

The general, site conditions in the immediate vicinity of the culvert were assessed during the site reconnaissance in October 24, 2016. On the inlet (east) side of the culvert, the embankments, although steep, were noted in an overall stable configuration with no obvious indications of recent slope movement. On the outlet (west) side of the culvert, the embankments exhibit signs of progressive slope movements behind the existing sheet pile walls at the downstream ends of the wing walls. Depressions in the soils of up to 1m were observed behind the sheet pile walls on both sides of the creek. Localized slope instability was noted to have occurred at the west end of the north sheet pile wall as well, also leaving a similar depression. Both sheet pile walls were noted in general deteriorating condition due to corrosion, bowed in the center and leaning toward the creek. Based on visual observation, the culvert and wing walls appeared to be in satisfactory condition with minor indications of age related deterioration. The floor of the culvert and spillway were noted generally intact. Photographs of the soil instabilities are presented in Appendix A.

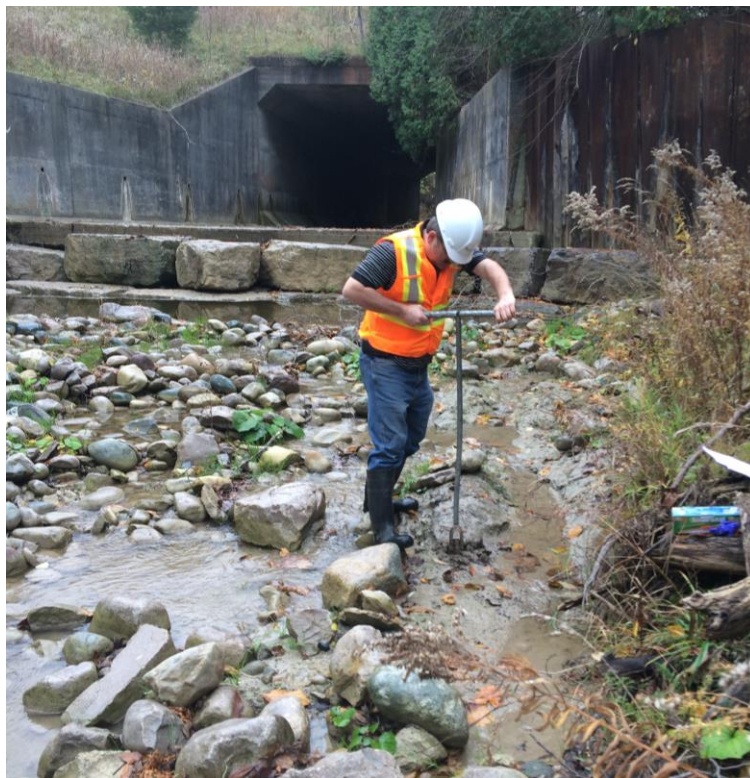
Photo 10: Probe hole using 'T' bar

The subsurface conditions observed during advancing of probe holes (PH1 to PH9) are summarized in the table below. The probe hole locations are shown on the Drawing 1 in Appendix C.

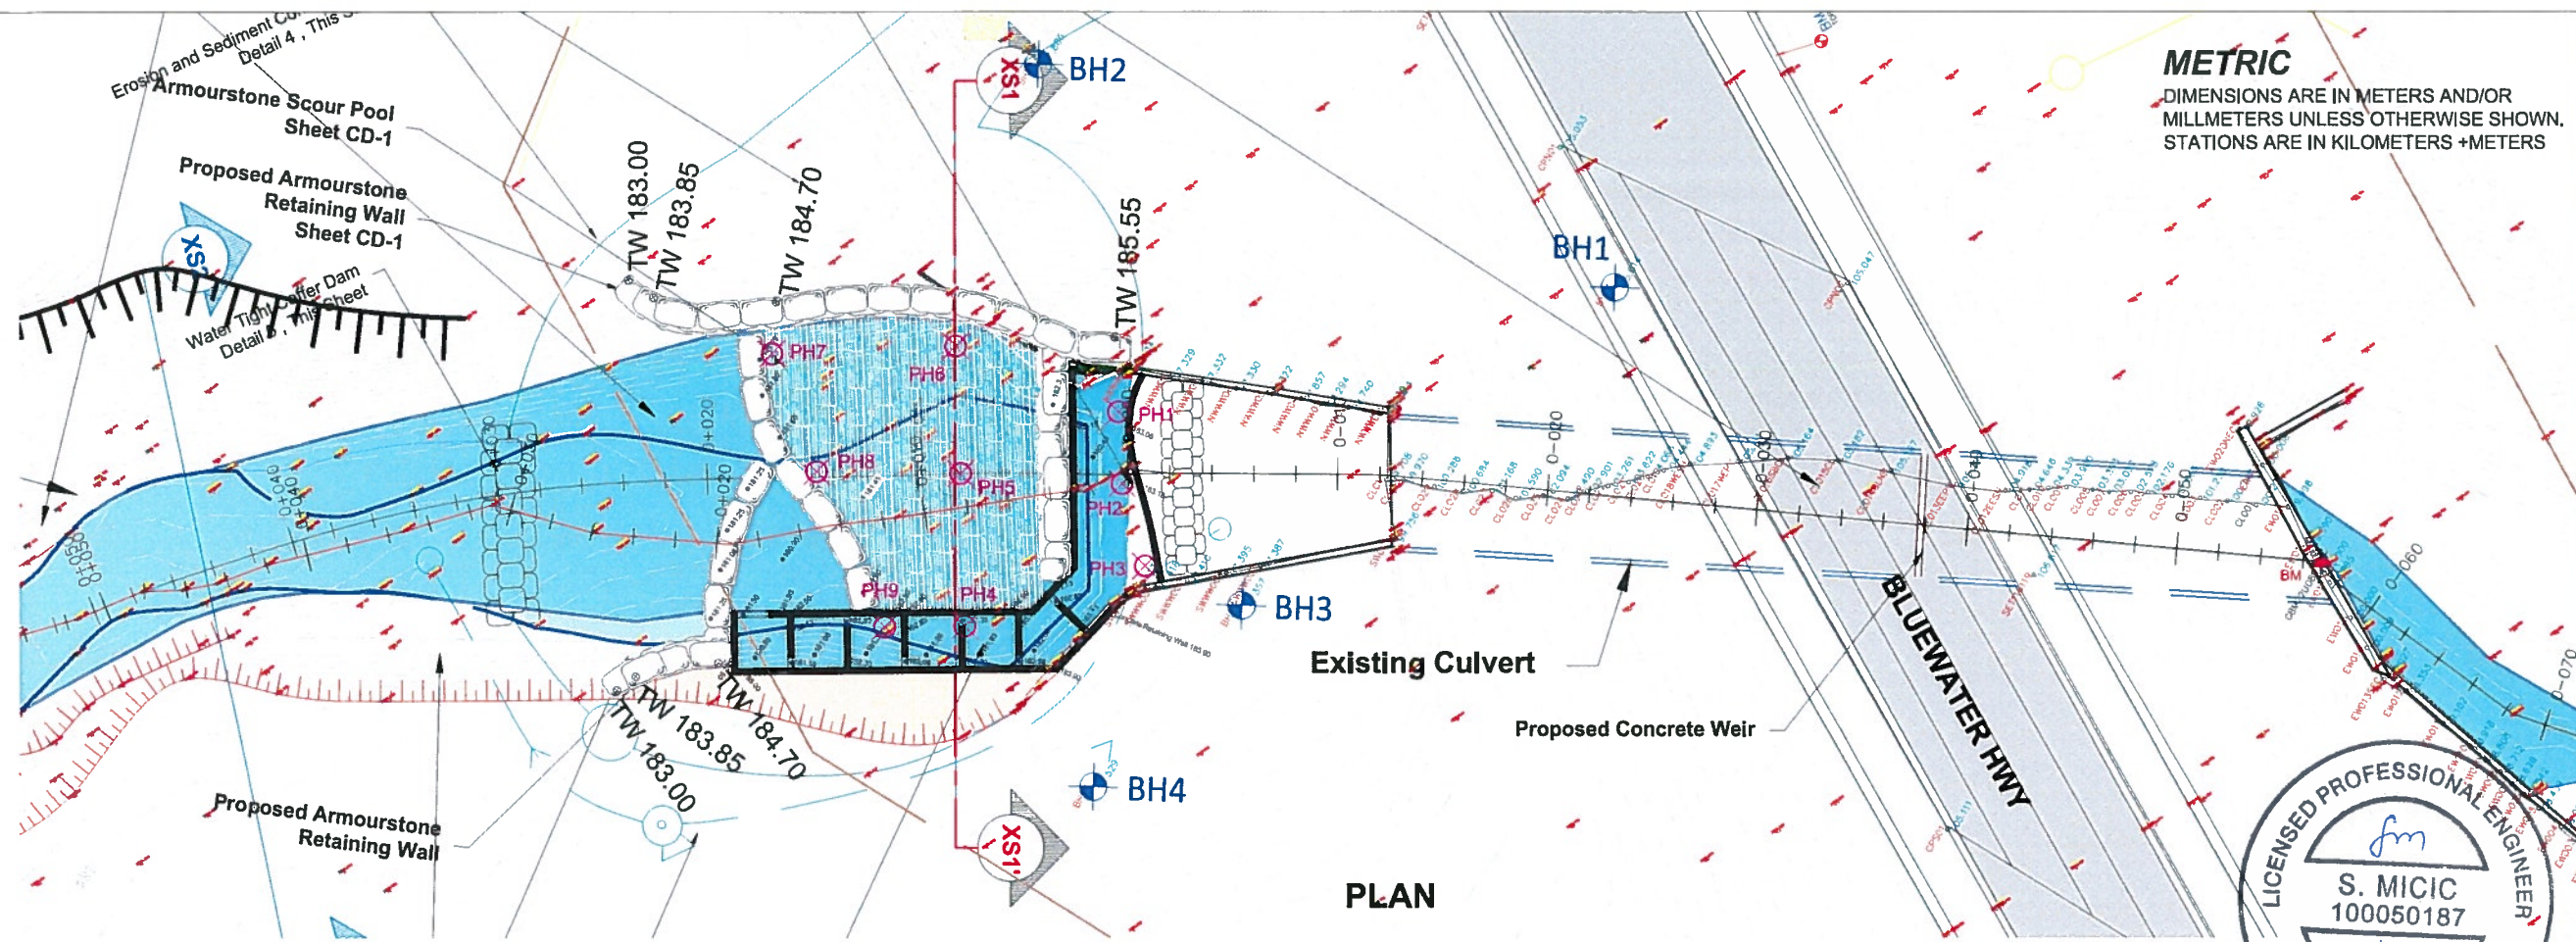
DATE	BY	DESCRIPTION			
15/12/2016	SM	SUBMISSION FOR MTO REVIEW			
		GEOCRES NO. 40P5-21			
		PROJECT NO. ADM-00235197-B0			
SUBM'D	SM	CHECKED	SM	DATE	15/12/2016
DRAWN	SH	CHECKED	SG	APPROVED	DWG. 1

A borehole location plan and stratigraphic section are provided in Appendix C. It should be noted that the stratigraphic boundaries indicated on the borehole log and stratigraphic section are inferred from semi-continuous sampling, observations of drilling progress and results of Standard Penetration Tests. These boundaries typically represent transitions from one soil type to another and should not be interpreted as exact planes of geological change. Furthermore, subsurface conditions may vary between and beyond the borehole locations.

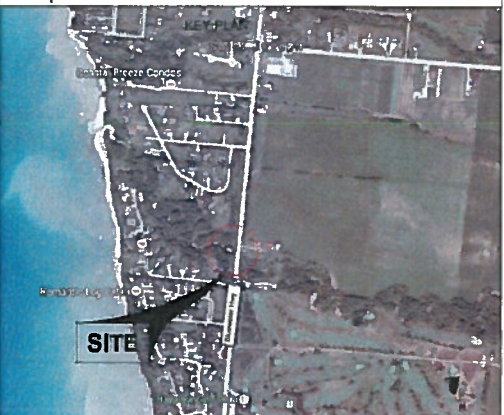
04/01/2017	SM	SUBMISSION FOR MTO REVIEW	
DATE	BY	DESCRIPTION	
		GEOCRES NO. 40P5-21	
		PROJECT NO. ADM-00235197-B0	
SUBM'D SM	CHECKED SM	DATE	04/01/2017
DRAWN SH	CHECKED SG	APPROVED	DWG. 2

CONSTRUCTION OF CONCRETE FISH  
LADDER AT OUTLET OF THE EXISTING  
HEYROCK CREEK CULVERT  
BOREHOLE LOCATION PLAN AND PROFILE

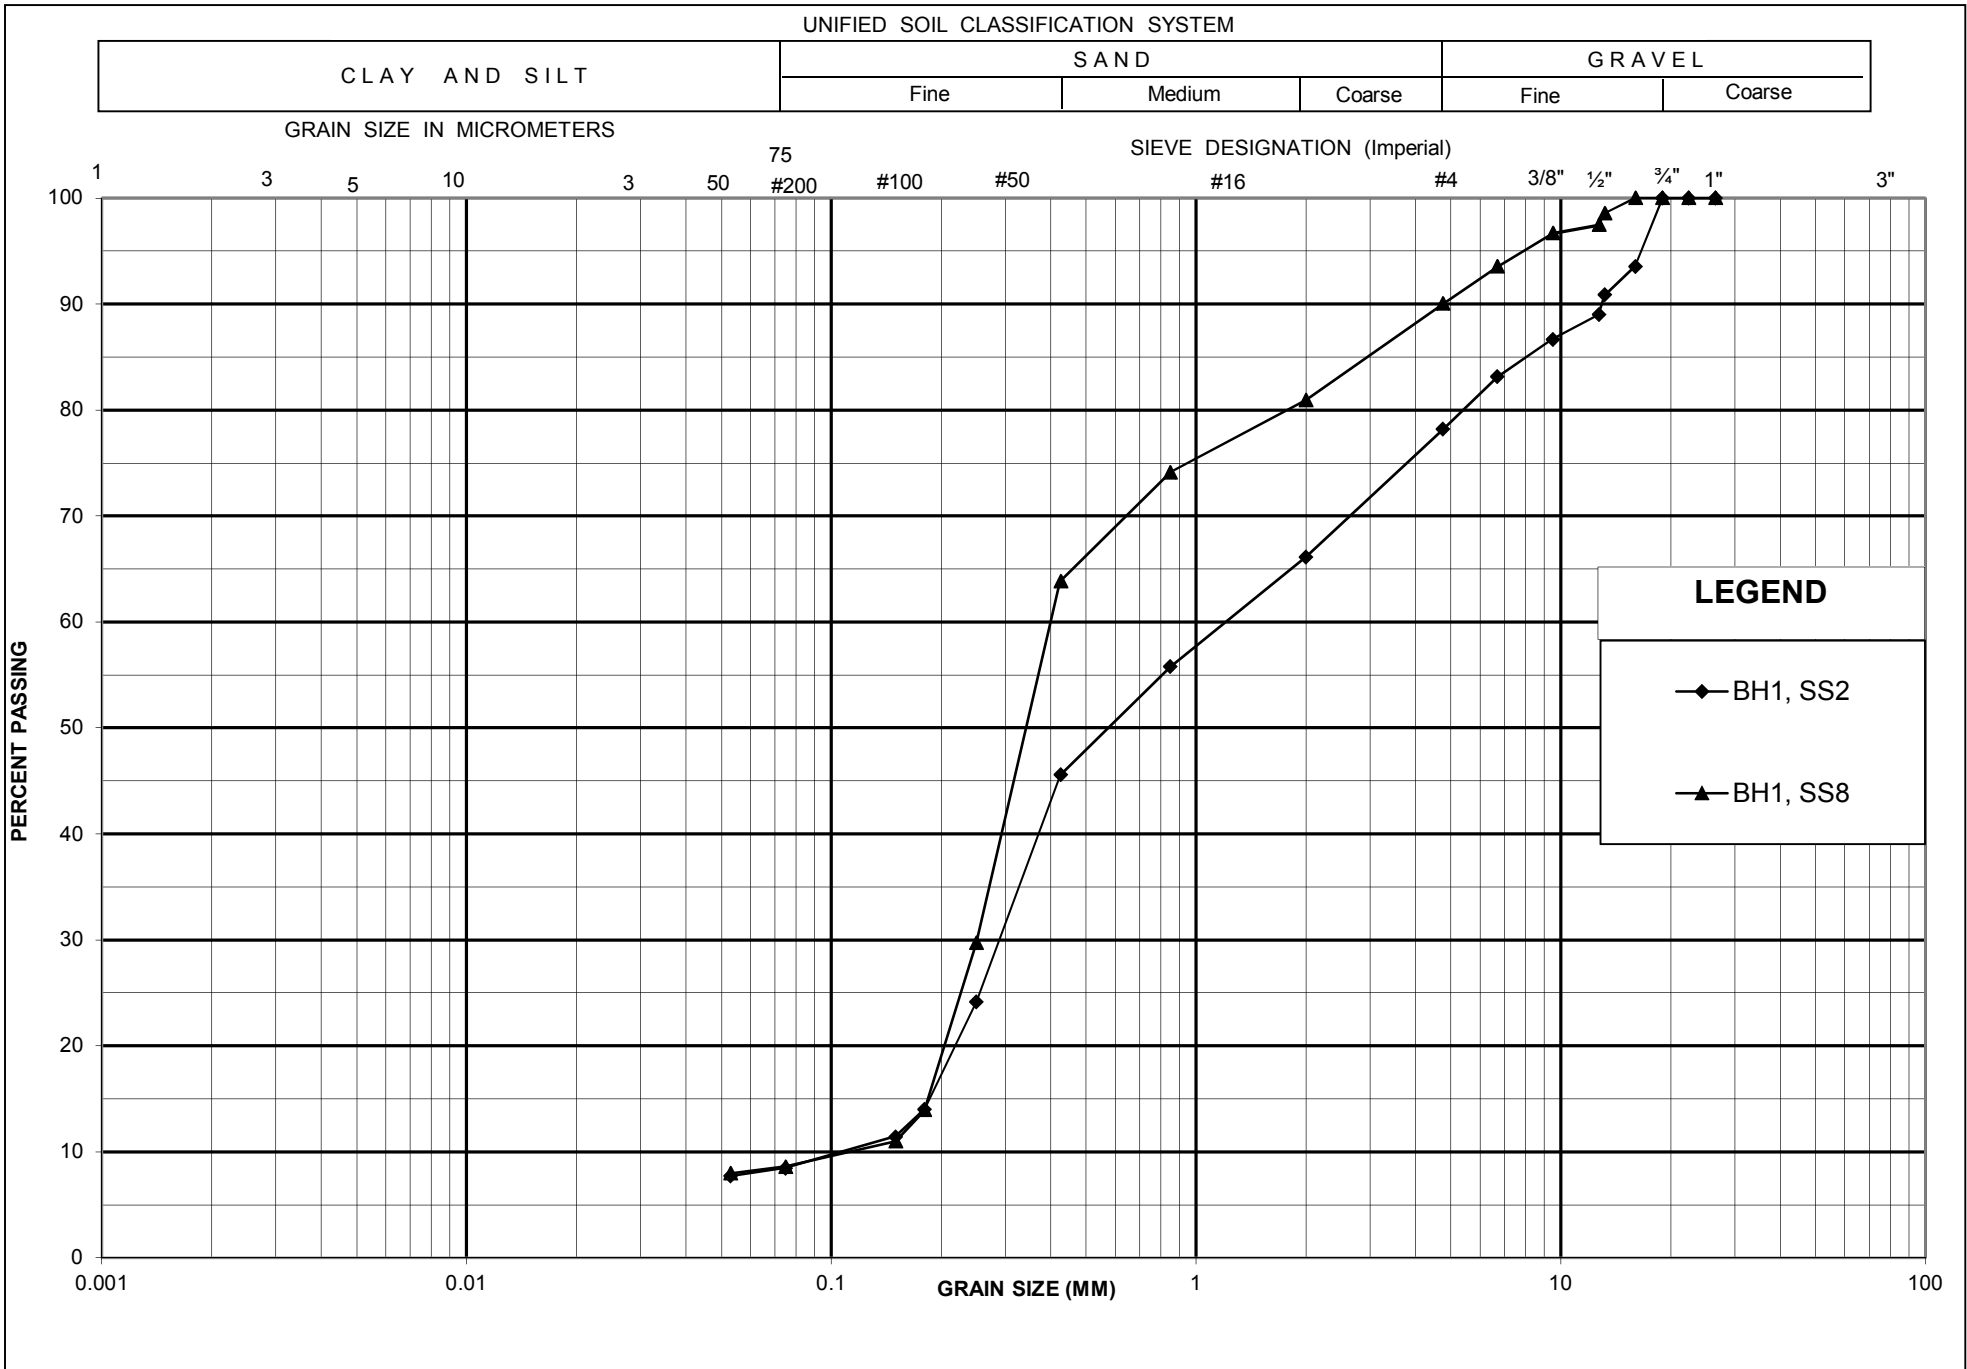
The composition of this fill layer is sand and gravel and trace silt. The material is brown in color, and moist. The SPT "N" values within this layer ranged from 4 to 28 blows per 300 mm penetration, suggesting very loose to compact, but generally very loose to loose in compactness condition.

The results of the moisture content and grain size distribution tests are provided on the record of borehole sheets in Appendix D. The results of the grain size distribution tests are also provided on Figure 1 in Appendix E.

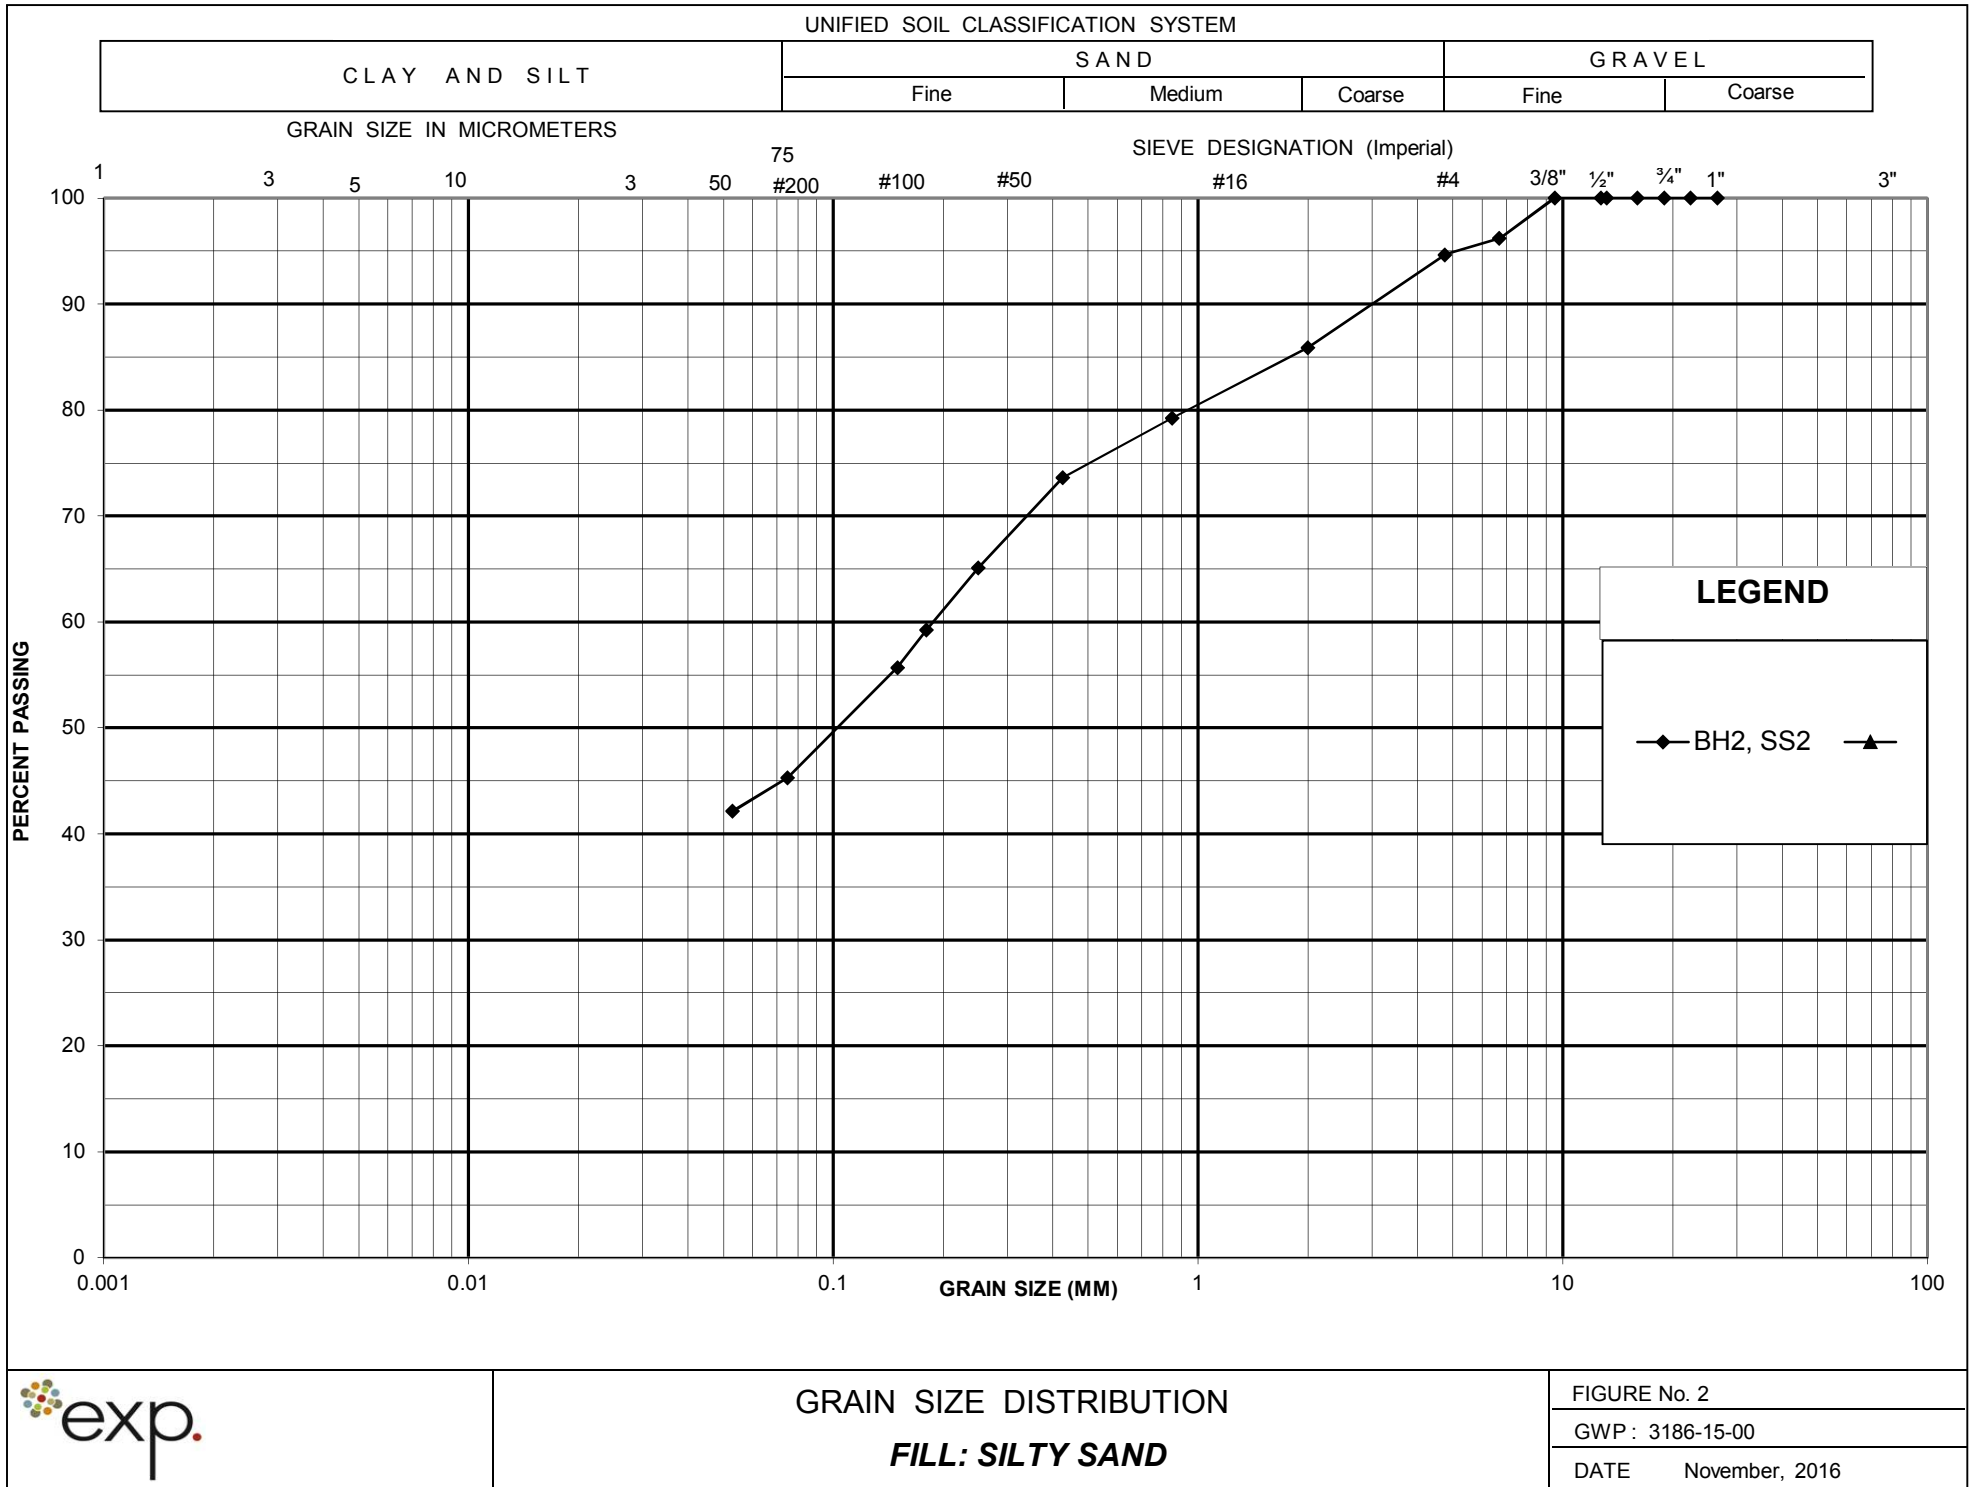
The composition of this fill layer is silt and sand, trace to some clay, trace gravel trace topsoil. The material is brown in color, and moist. The SPT "N" values within this layer ranged from 10 to 17 blows per 300 mm penetration, suggesting compact in compactness condition.

The results of the moisture content and grain size distribution tests are provided on the record of borehole sheets in Appendix D. The result of the grain size distribution test is also provided on Figure 2 in Appendix E.

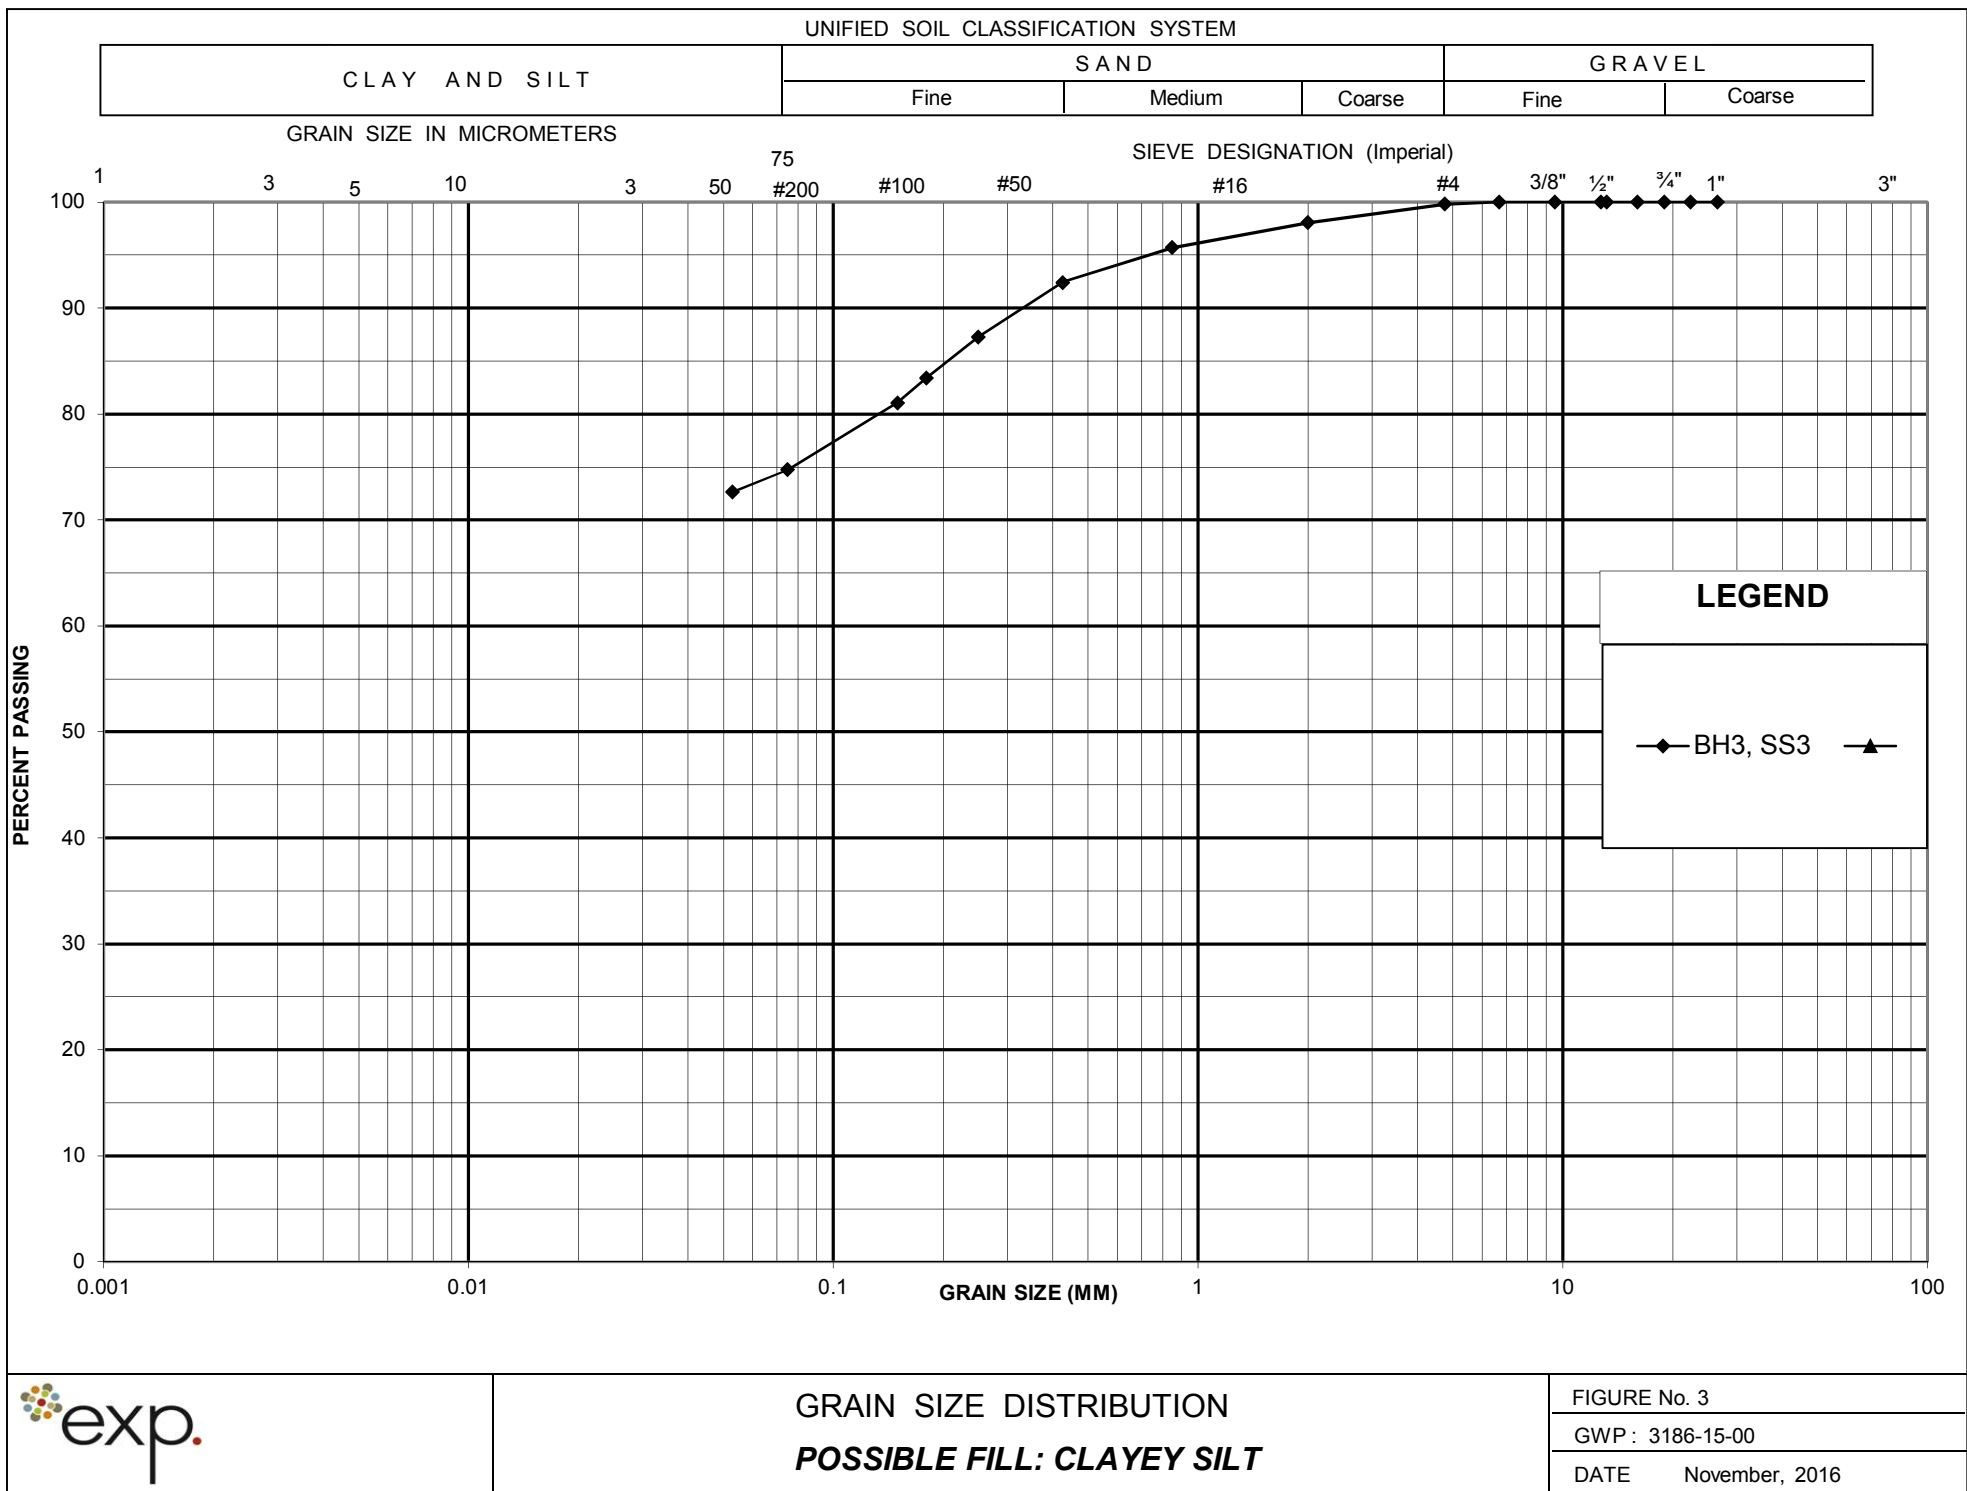
The composition of this layer is clay and silt, trace to some sand and trace gravel. The material is grey in color, and moist. The SPT "N" values within this layer was 7 blows per 300 mm penetration, suggesting firm in consistency.

The results of the moisture content and grain size distribution tests are provided on the record of borehole sheets in Appendix D. The result of the grain size distribution test is also provided on Figure 3 in Appendix E

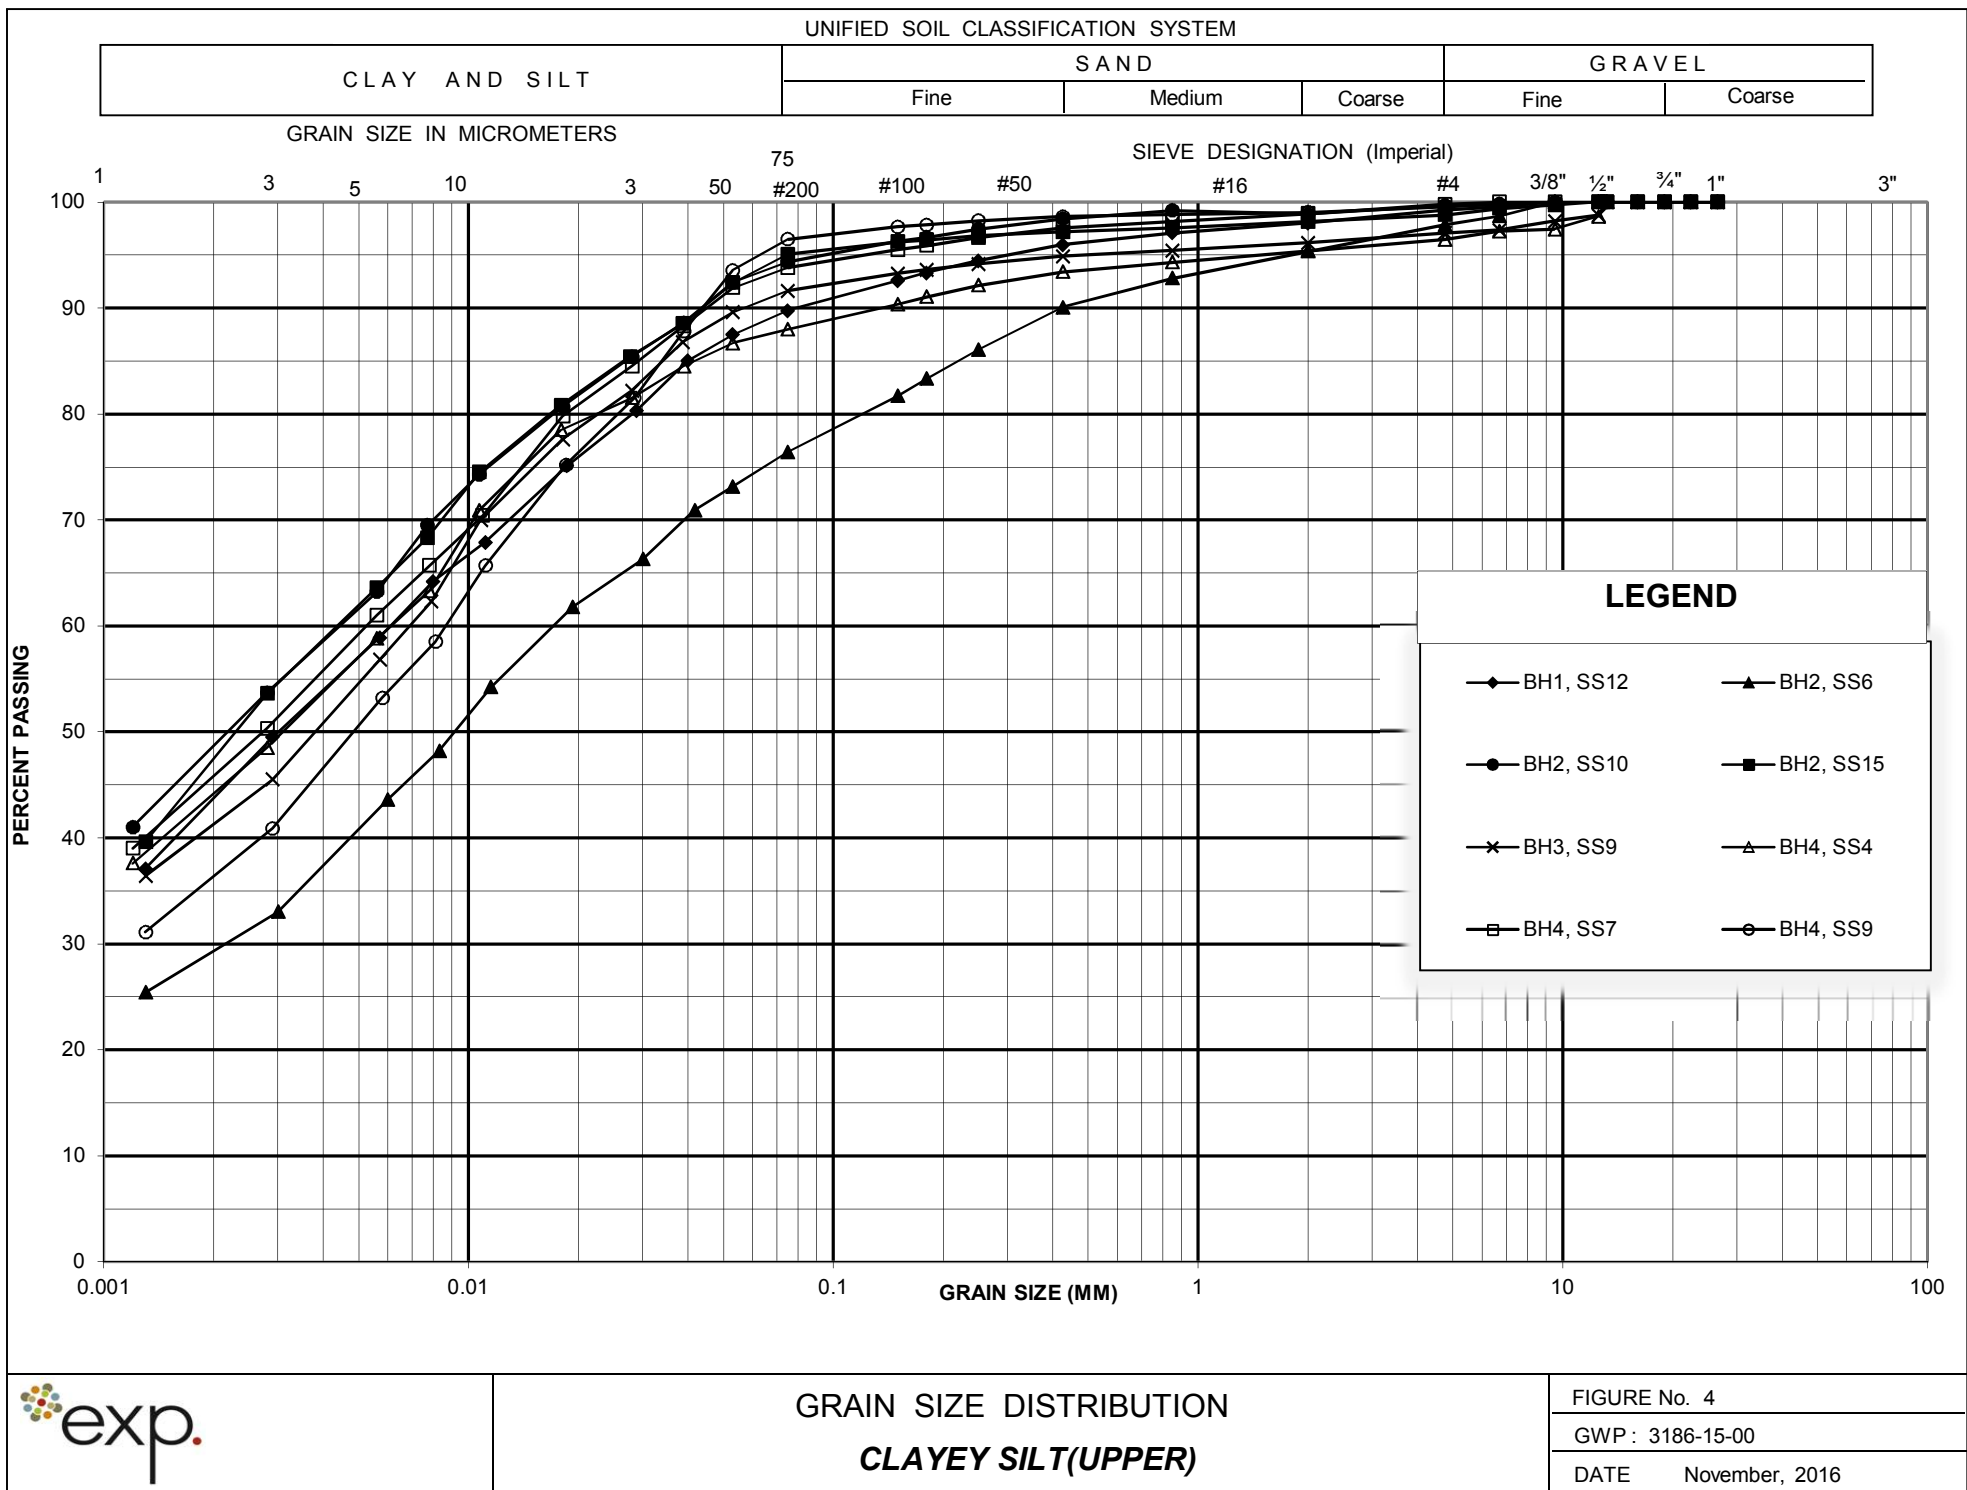
The composition of this layer is clay and silt, trace to some sand and trace gravel. The material is brown to grey in color, and moist. The SPT "N" values within this layer ranged from 9 to 44 blows per 300 mm penetration, suggesting stiff to hard generally stiff to very stiff in consistency. One SPT "N" value within this layer in BH 2 recorded to be 100 blows per 76 mm penetration, this could be influence of refusal (possible boulder) encountered.

The results of the moisture content, grain size distribution and Atterberg Limits tests are provided on the record of borehole sheets in Appendix D. The results of the grain size distribution tests and Atterberg Limits tests are also provided on Figure 4 and 9, respectively, in Appendix E.

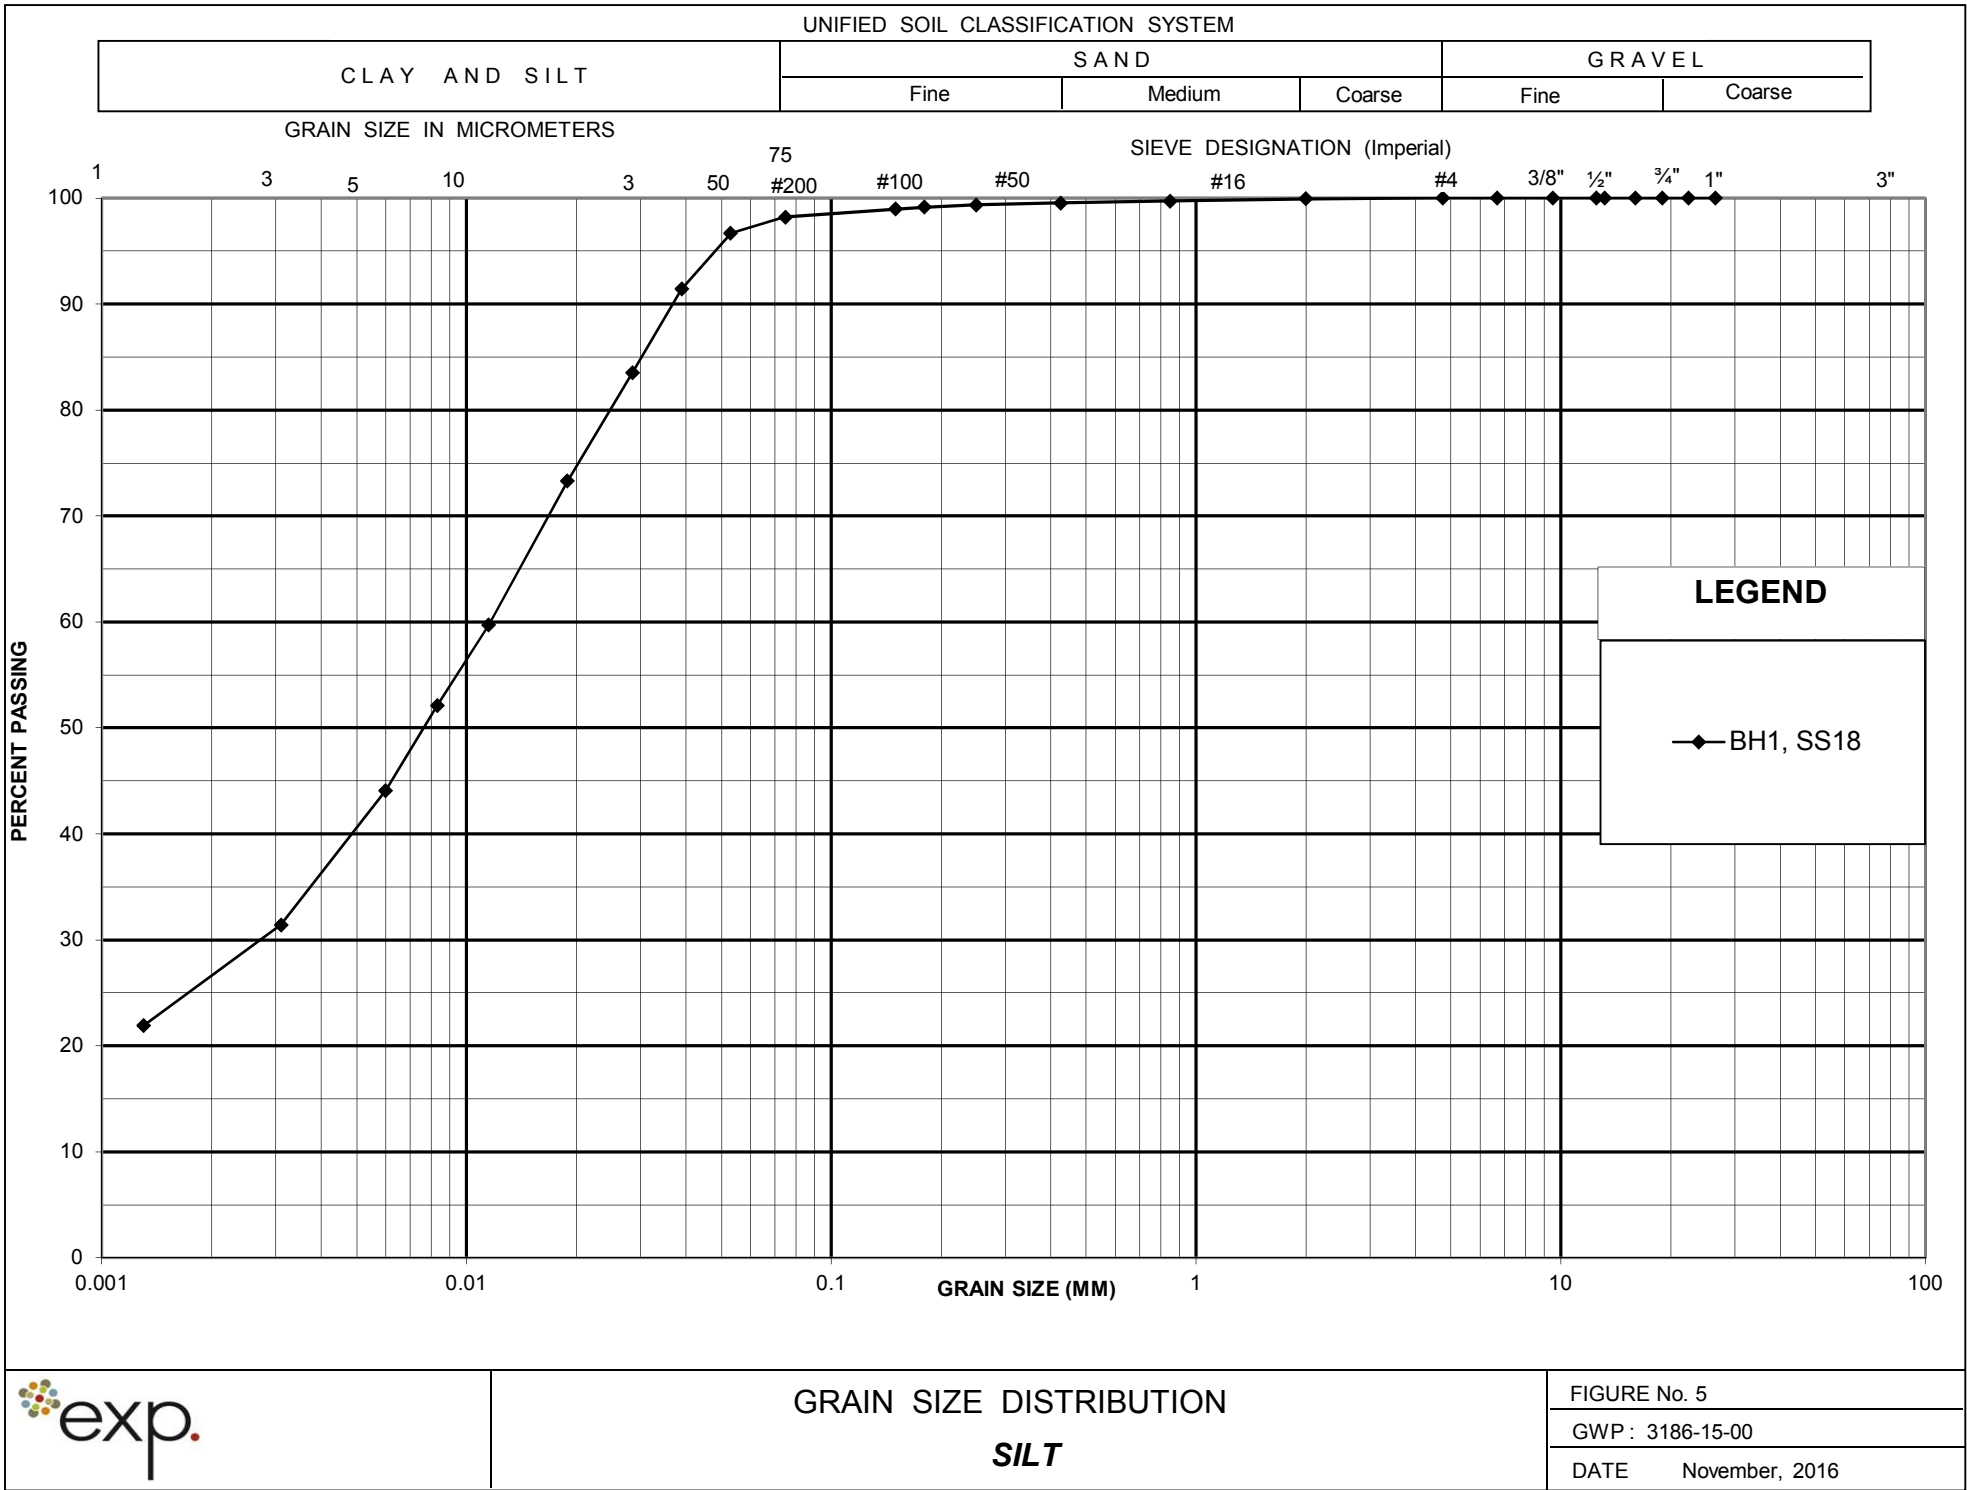
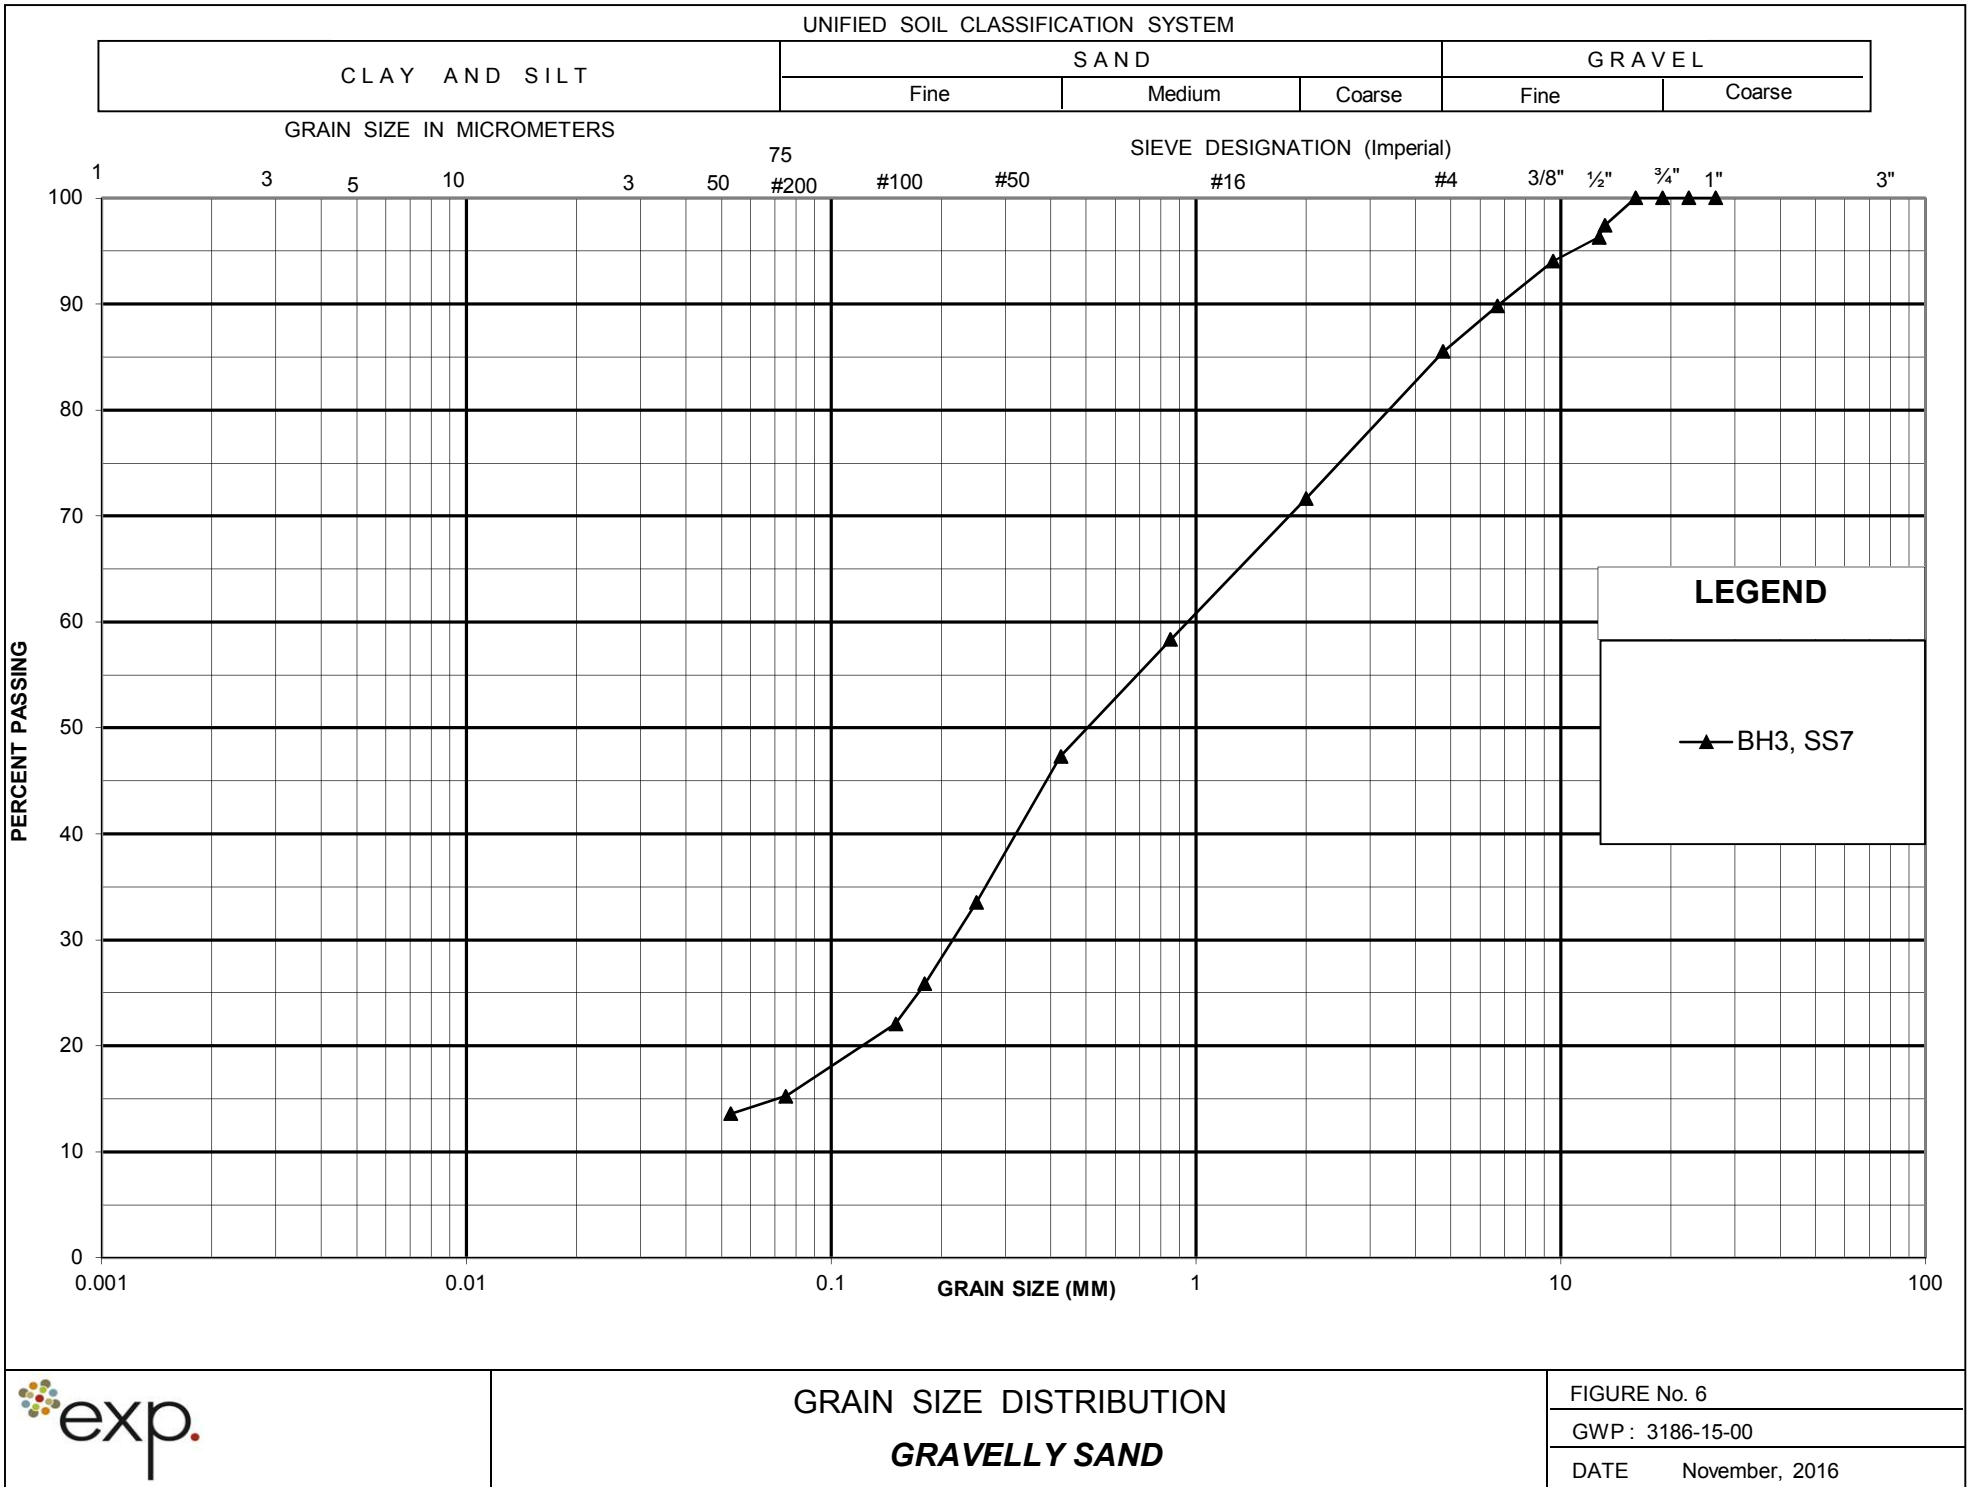
The composition of this layer is silt, trace to some clay, trace sand and trace to some gravel. Occasional gravelly sand layer was encountered in BH 3 within this layer\*. The material is grey in color, and moist to wet. The SPT "N" values within this layer ranged from 19 to 53 blows per 300 mm penetration, suggesting compact to very dense in compactness condition.

The results of the moisture content and grain size distribution tests are provided on the record of borehole sheets in Appendix D. The results of the grain size distribution tests are also provided on Figure 5 and 6\* in Appendix E.
