### **FOUNDATION INVESTIGATION REPORT**

**Construction of new concrete fish ladder at the outlet of the existing Heyrock  
Creek Culvert, Highway 21, Bluewater Municipality**

**Agreement No. 3015-E-0017**

January 11, 2017

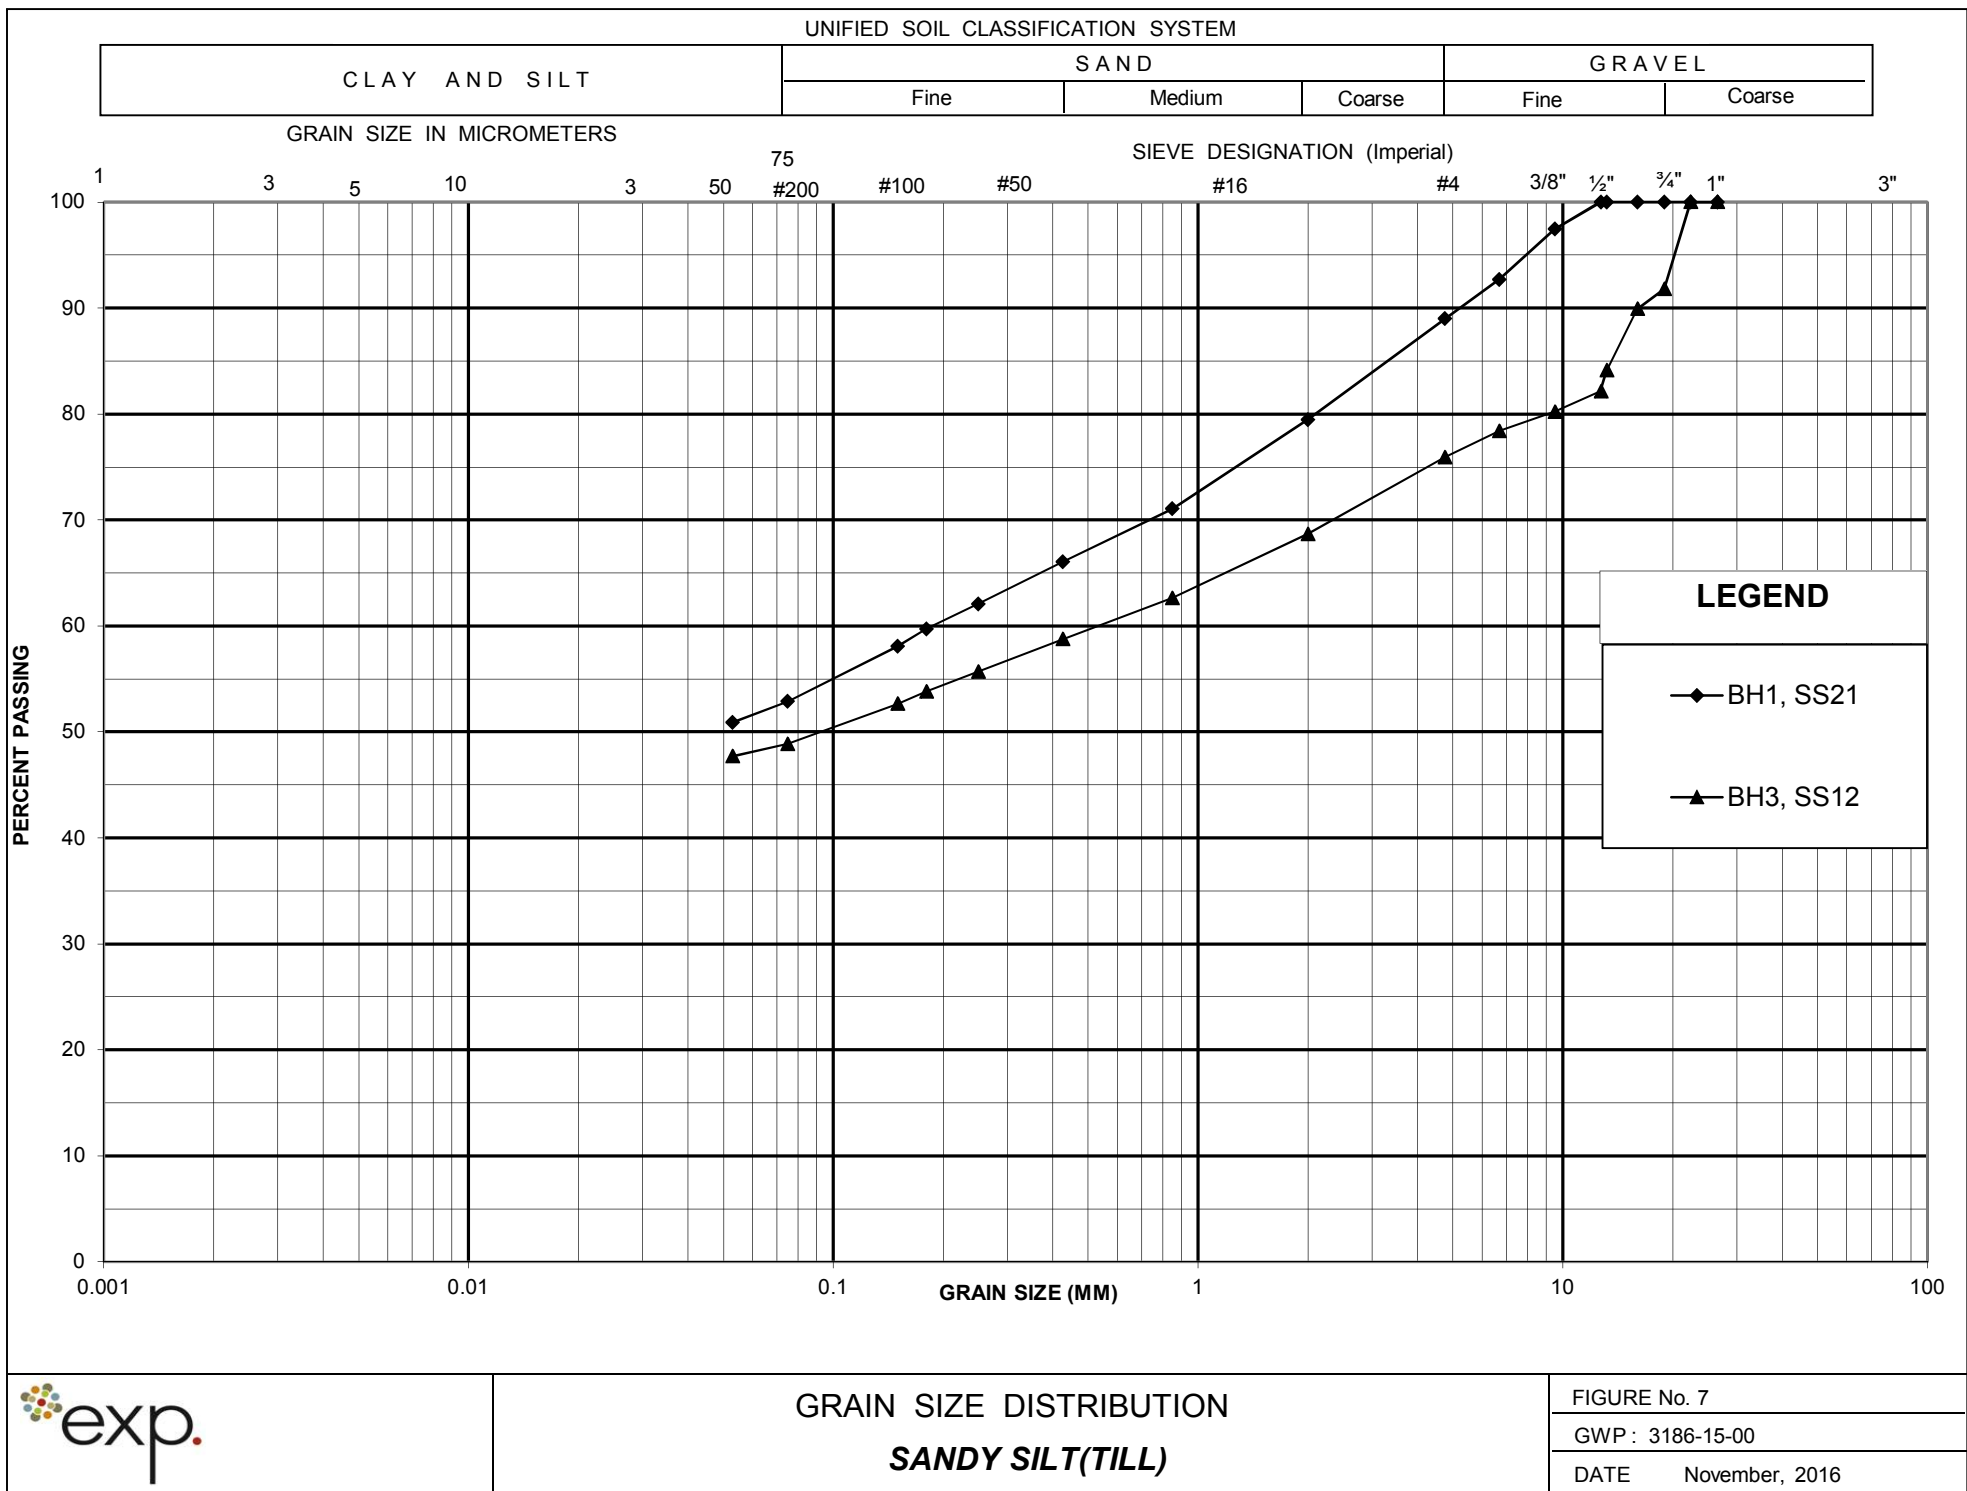
The composition of this layer is sand and silt, trace to some gravel and trace to some clay. The material is grey in color, and moist. The SPT “N” values within this layer ranged from 37 to 106 blows per 300 mm, suggesting dense to very dense in compactness condition.

The results of the moisture content and grain size distribution tests are provided on the record of borehole sheets in Appendix D. The results of the grain size distribution tests are also provided on Figure 7 in Appendix E.

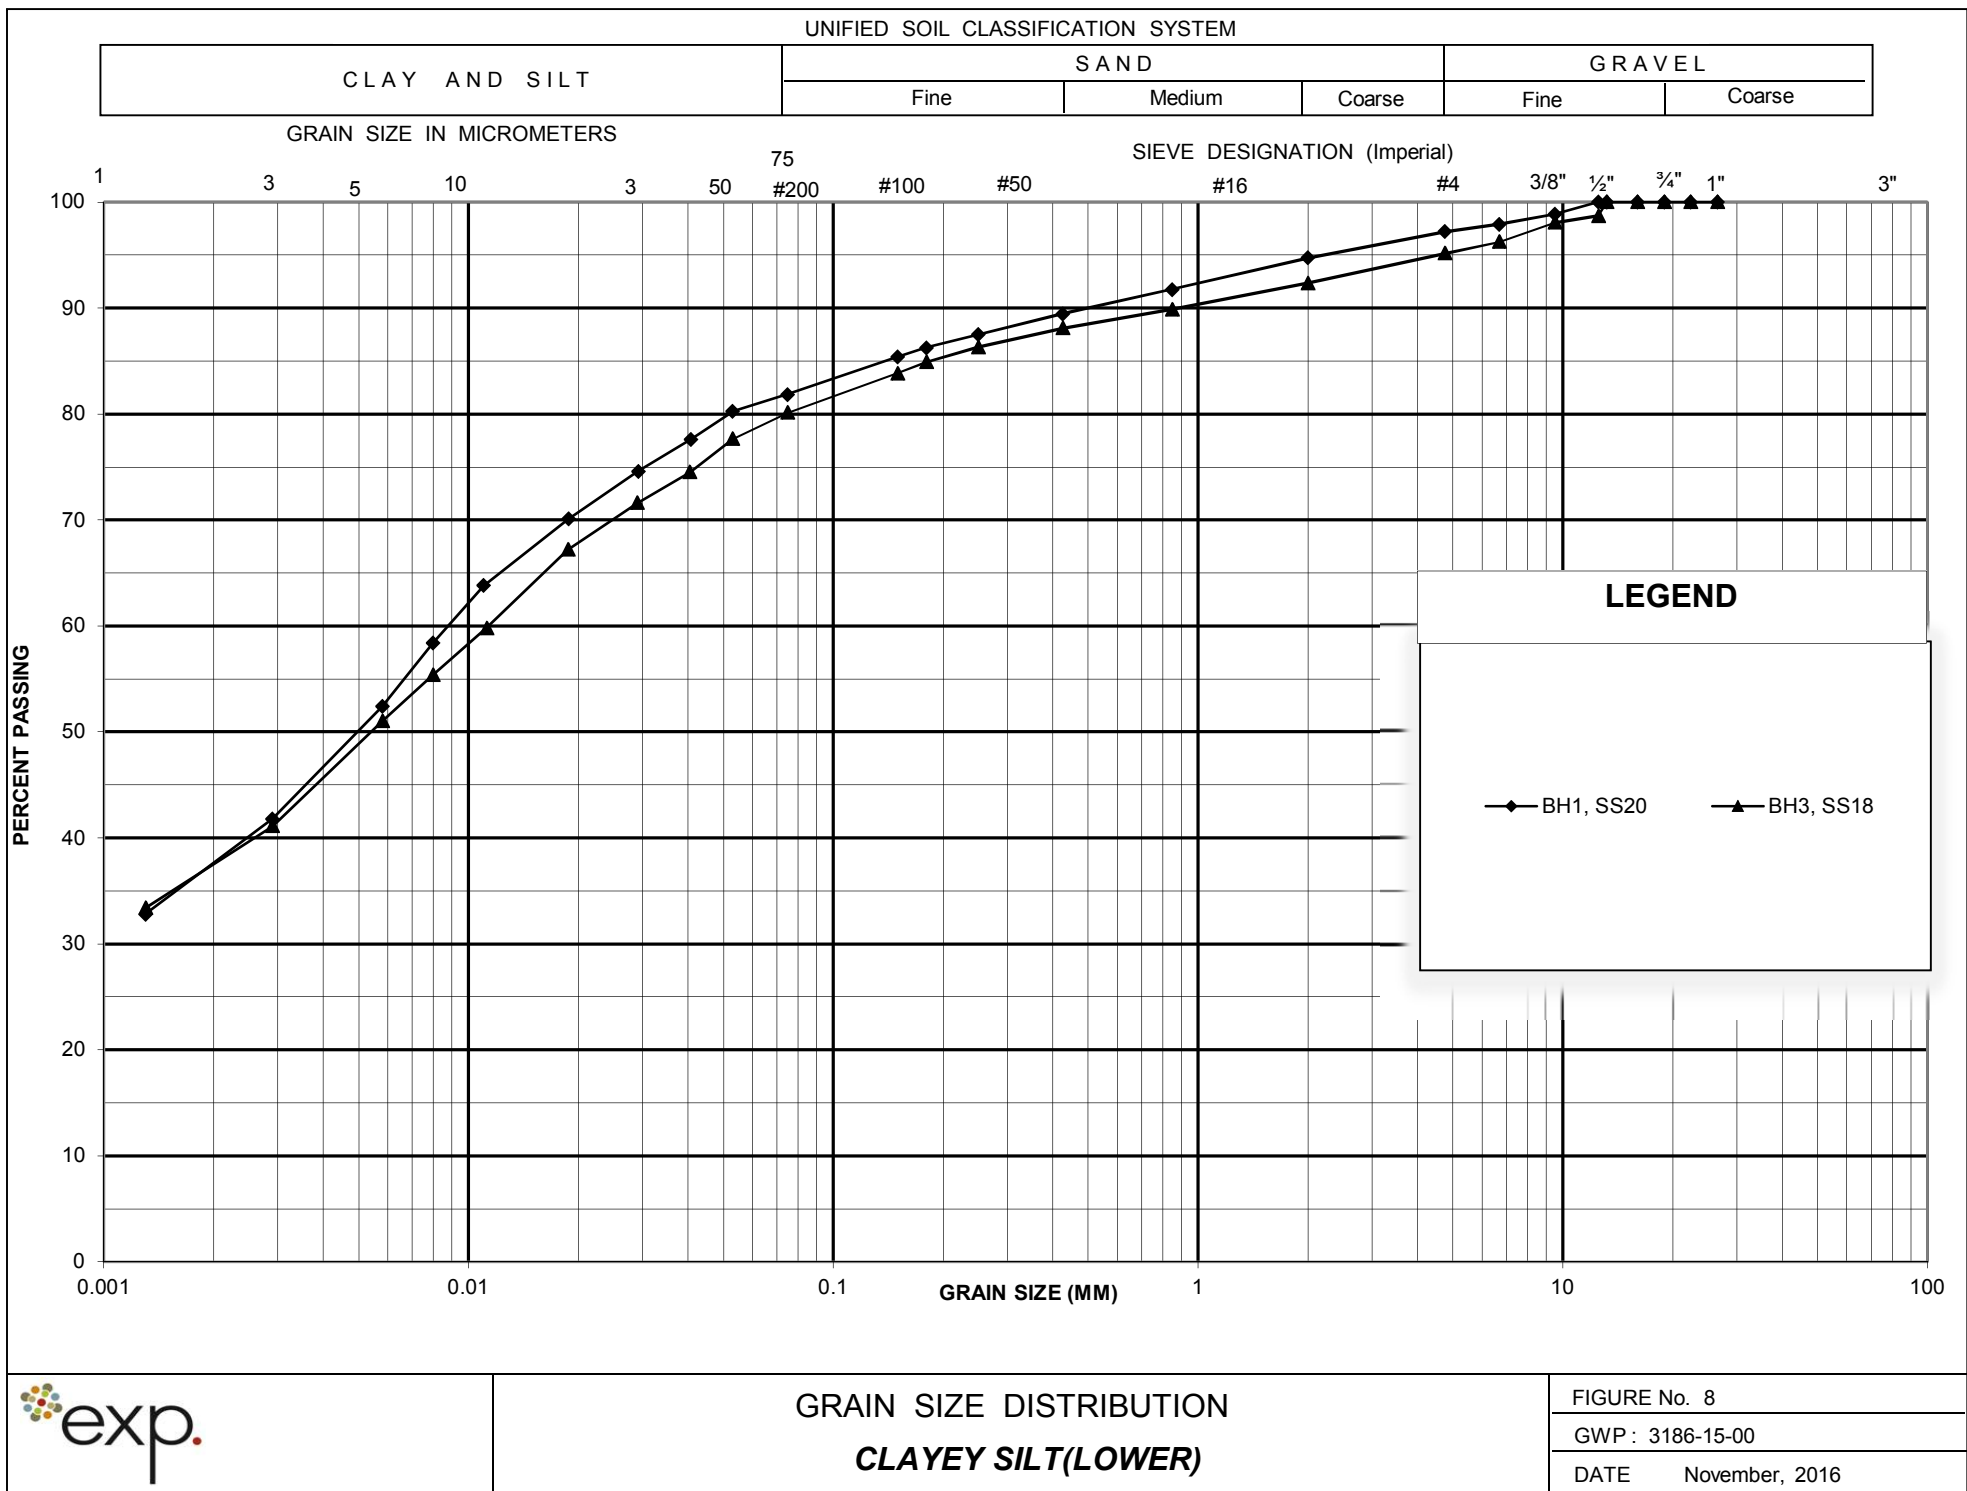
The composition of this layer is clay and silt, trace to some sand and trace gravel. The material is grey in color, and moist. The SPT “N” values within this layer ranged from 19 to 56 blows per 300 mm penetration, suggesting very stiff to hard in consistency.

The results of the moisture content, grain size distribution and Atterberg Limits tests are provided on the record of borehole sheets in Appendix D. The results of the grain size distribution tests and Atterberg Limits tests are also provided on Figure 8 and 10, respectively, in Appendix E.

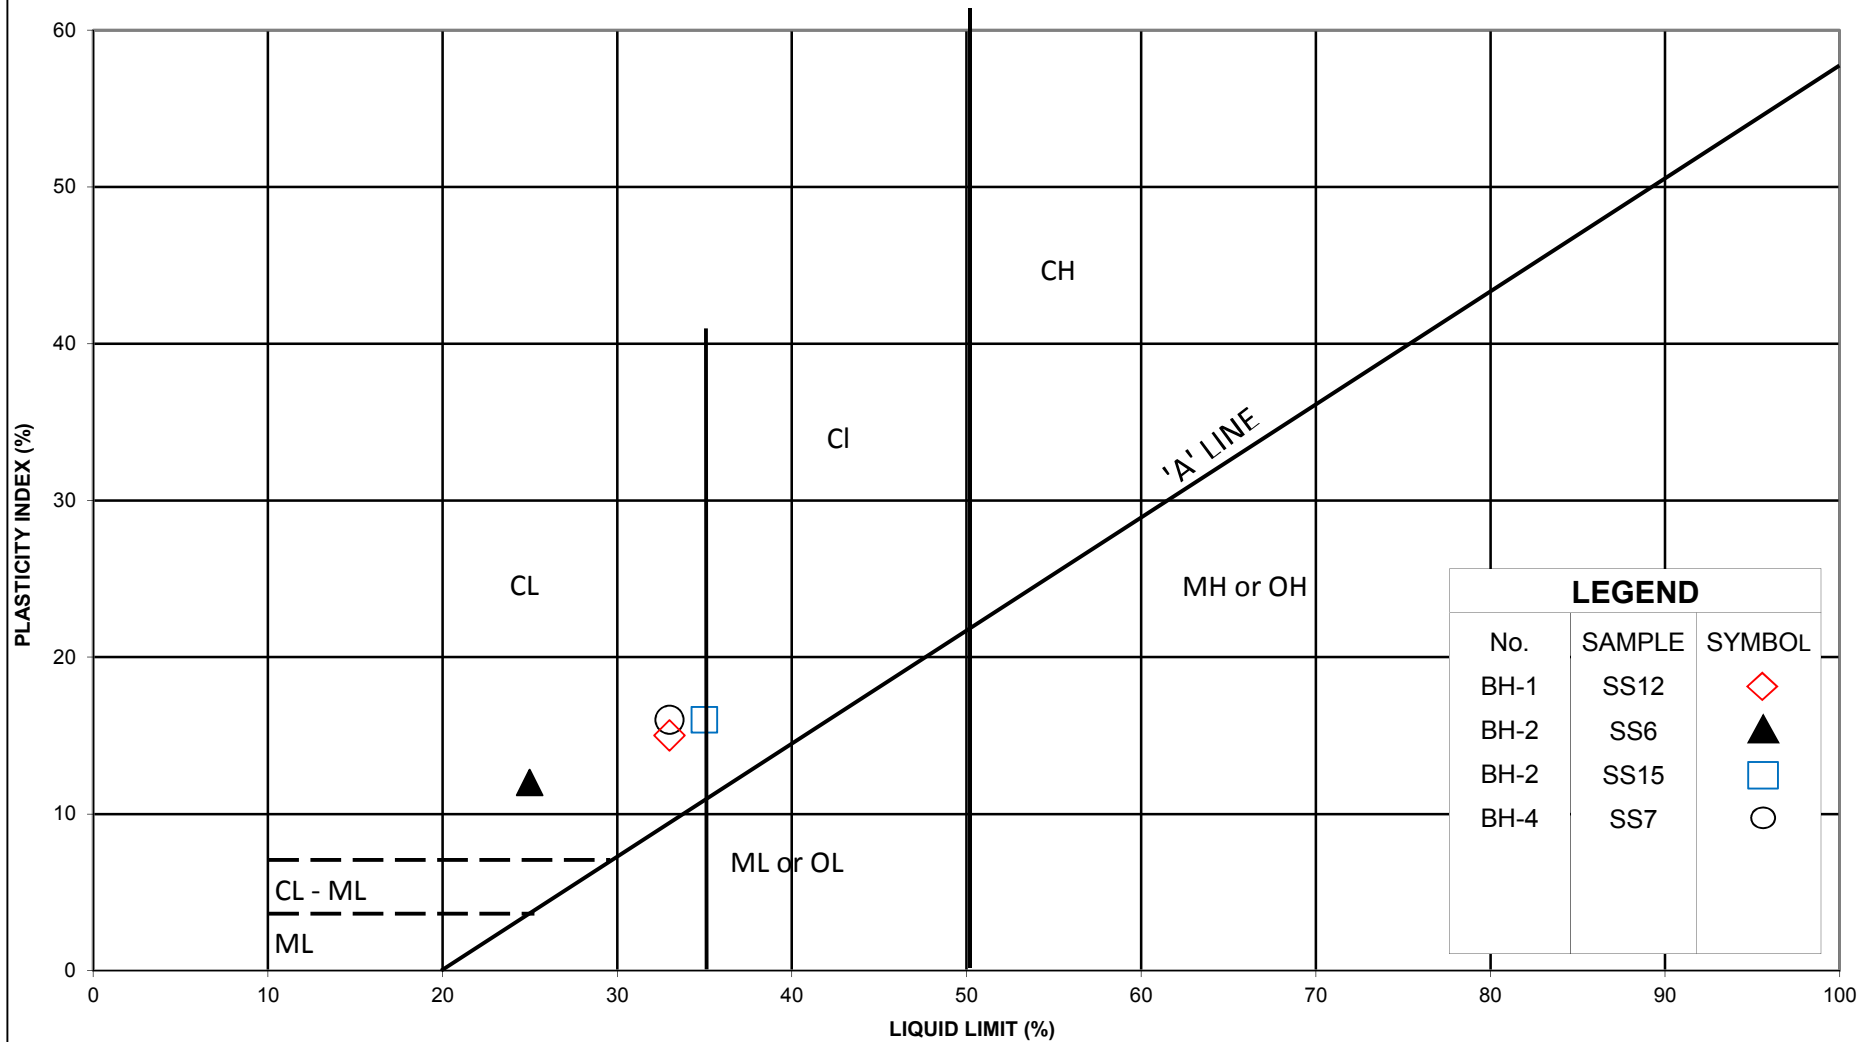
The results of the moisture content, grain size distribution and Atterberg Limits tests are provided on the record of borehole sheets in Appendix D. The results of the grain size distribution tests and Atterberg Limits tests are also provided on Figure 4 and 9, respectively, in Appendix E.
