FOUNDATION INVESTIGATION REPORT

Culvert Replacement, Highway 3, 1.89 km east of Haldimand Road 55, Jarvis

Foundation Investigation and Design Report for Culvert Replacement

Highway 3, 1.89 km East of Haldimand Road 55

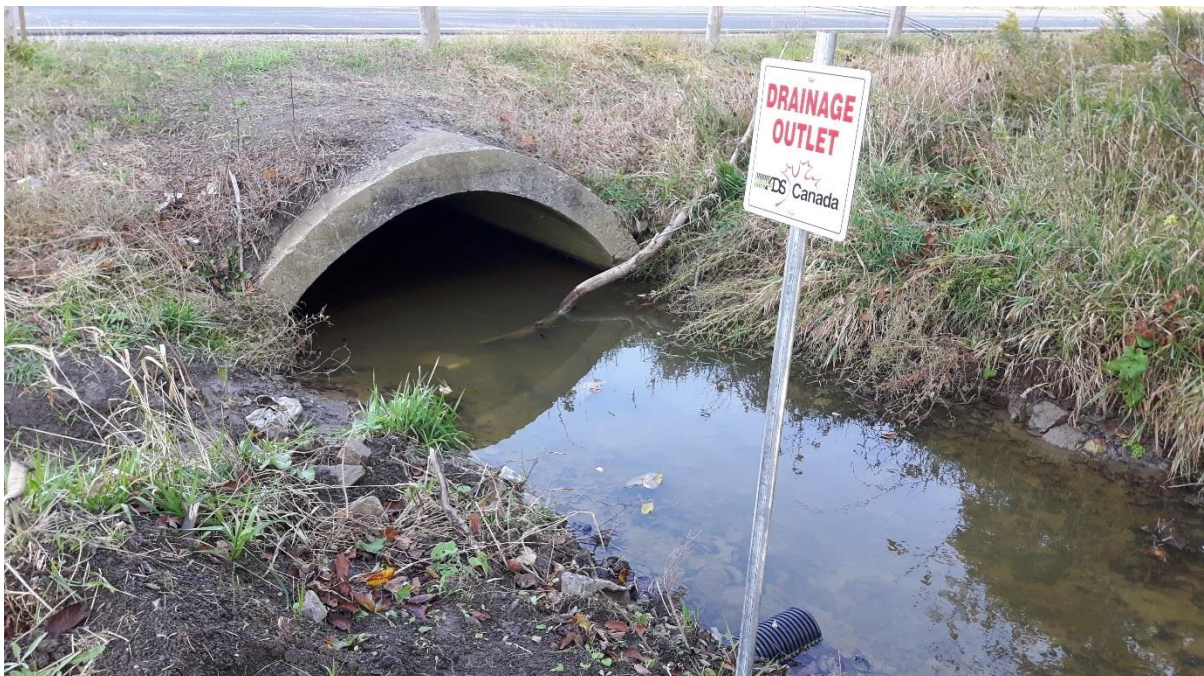
Photo 2: Looking north at culvert from south of Highway 3

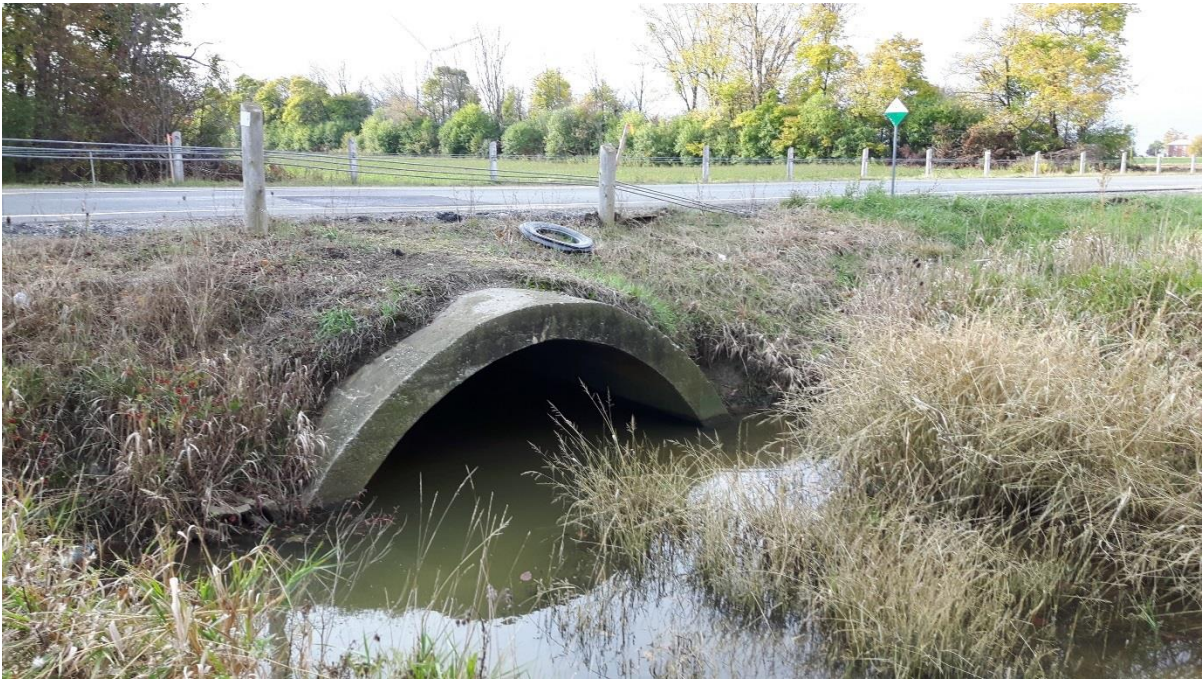
Photo 5: Looking south at culvert from north of Highway 3

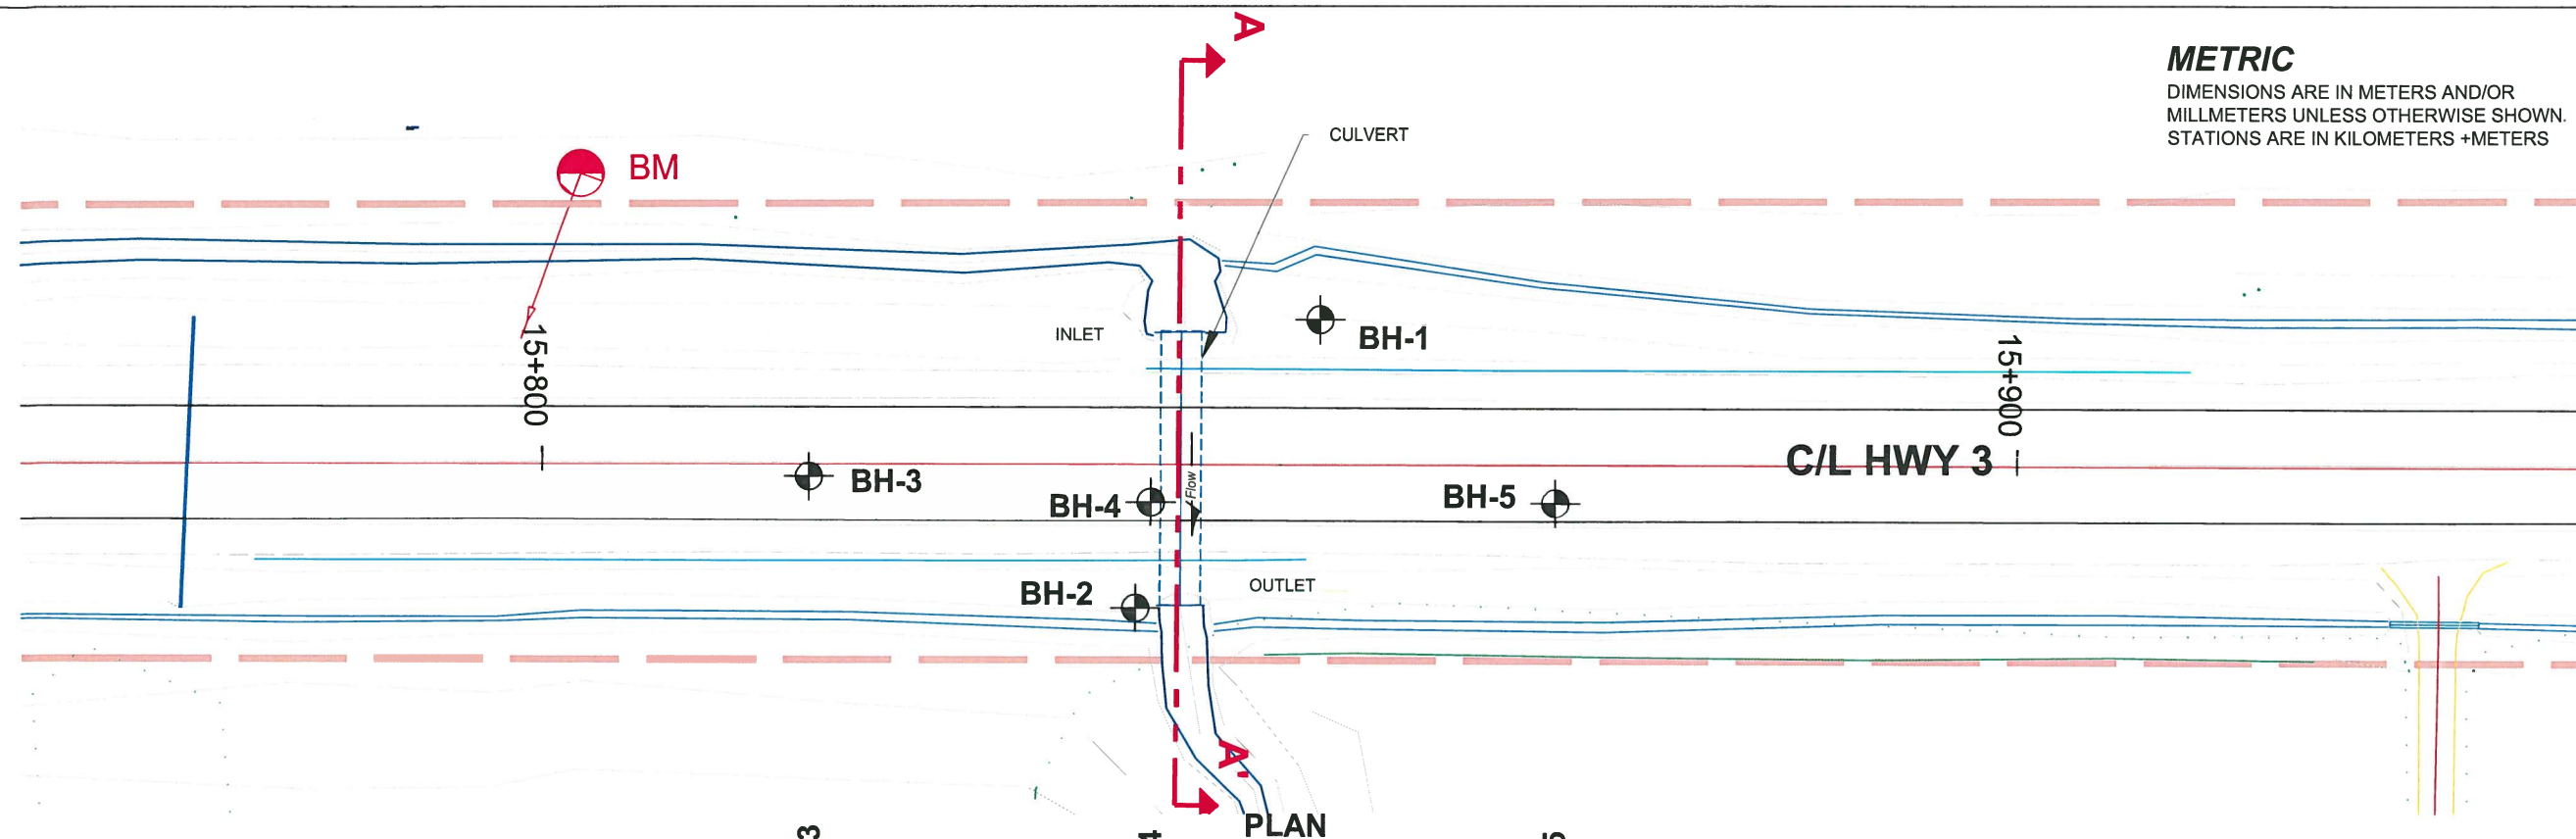
18/01/2017	SM	SUBMISSION FOR MTO REVIEW	
DATE	BY	DESCRIPTION	
		GEOCRES NO. 4016-27	
		PROJECT NO. ADM-00235197-C0	
SUBM'D SM	CHECKED SM	DATE	18/01/2017
DRAWN SH	CHECKED SG	APPROVED SG	DWG. 1

CULVERT REPLACEMENT
HWY 3, JARVIS
BOREHOLE LOCATION PLAN AND PROFILE

PROFILE ALONG C/L HWY 3

The existing culvert is an arch concrete rigid framed structure and is assumed to have an open footing foundation, but inspection was not possible due to the presence of water. It is assessed that the culvert has a span of approximately 2.8 m and rise of 1.5 m. The culvert is approximately 18.4 m long. The existing culvert is intended to be replaced with a new culvert along the same alignment. Select photographs of the site and existing culvert are presented in Appendix A. The site plan and cross-section profiles for the culvert alignment are shown on Drawings 1 and 2 in Appendix B.

A borehole location plan and stratigraphic section are provided in Appendix B. It should be noted that the stratigraphic boundaries indicated on the borehole log and stratigraphic section are inferred from semi-continuous sampling, observations of drilling progress and results of Standard Penetration Tests. These boundaries typically represent transitions from one soil type to another and should not be interpreted as exact planes of geological change. Furthermore, subsurface conditions may vary between and beyond the borehole locations.

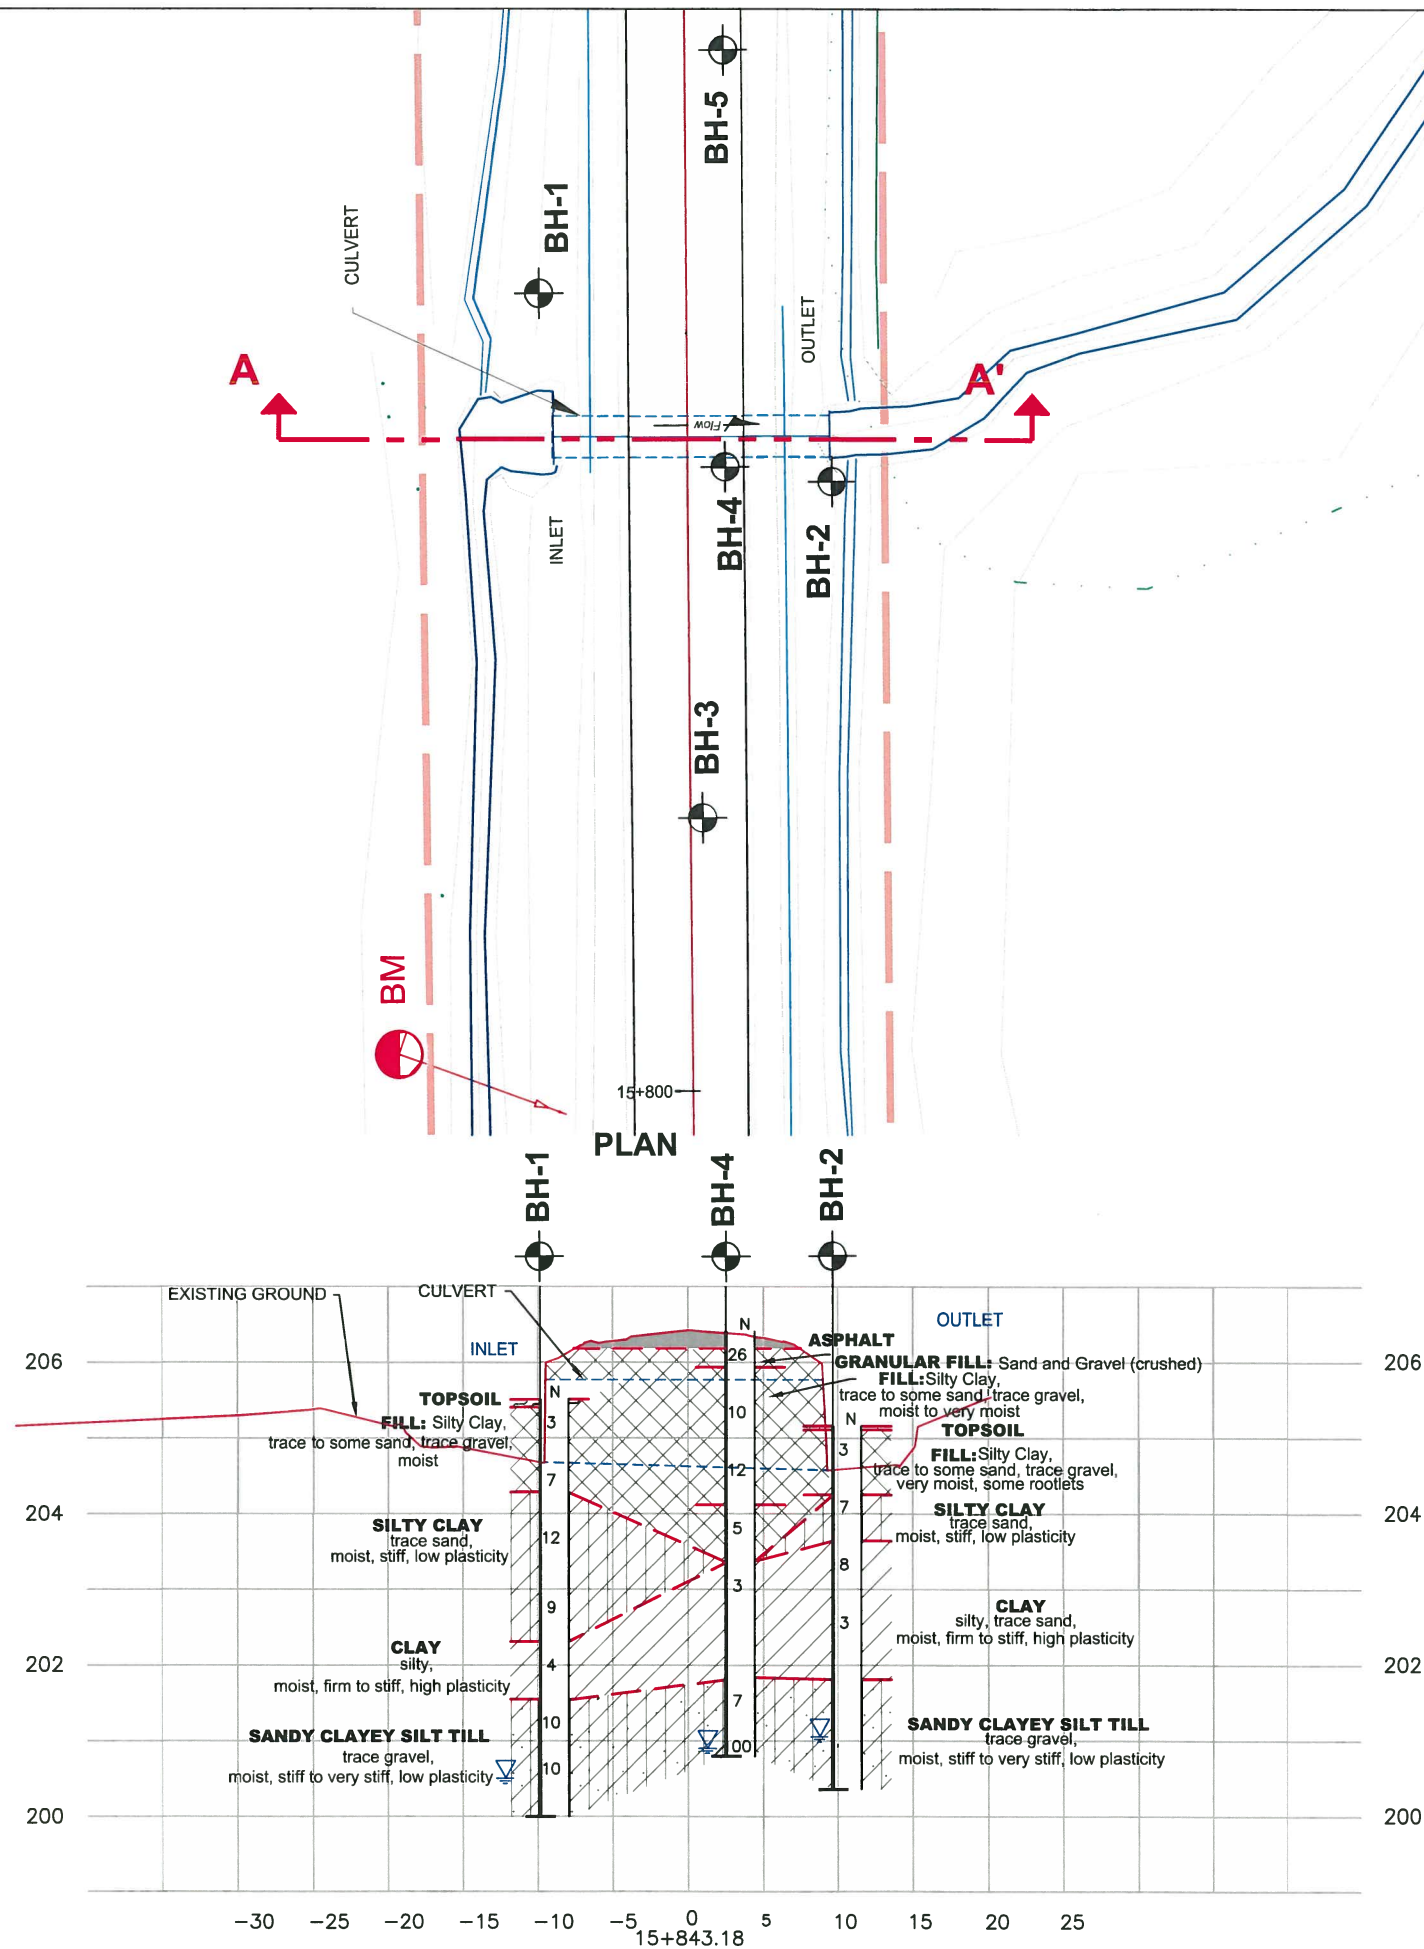
**CULVERT REPLACEMENT
HWY 3, JARVIS
BOREHOLE LOCATION PLAN
AND SECTION A-A'**

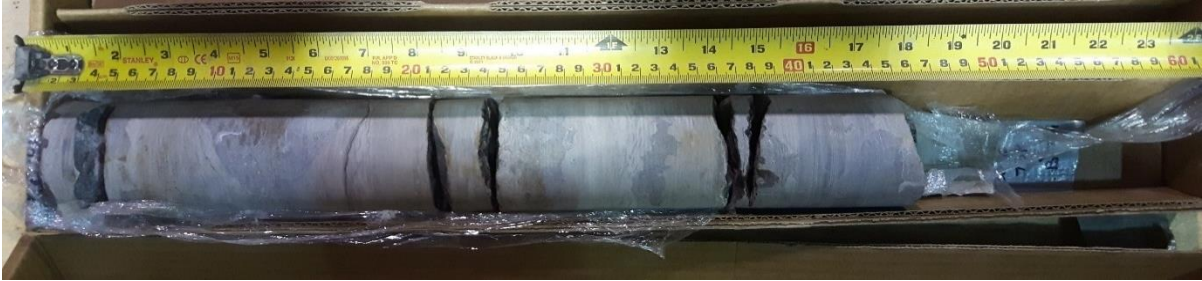
Sample Elevation: 199.58 – 199.17 m)

Recovery 100%, RQD 70% (fair quality)

Photo 1. Core Sample for BH3 from Elevation 199.58 m to 199.17 m

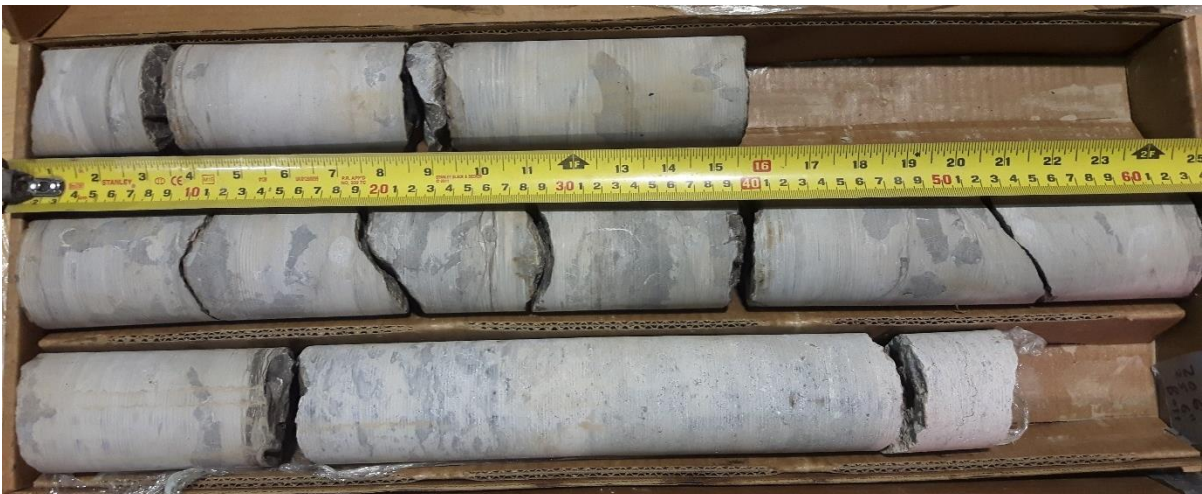
Sample Elevation: (199.17 – 197.65 m)

Recovery 100%, RQD 68% (fair quality)

Photo 2. Core Sample for BH3 from Elevation 199.17m to 197.65 m

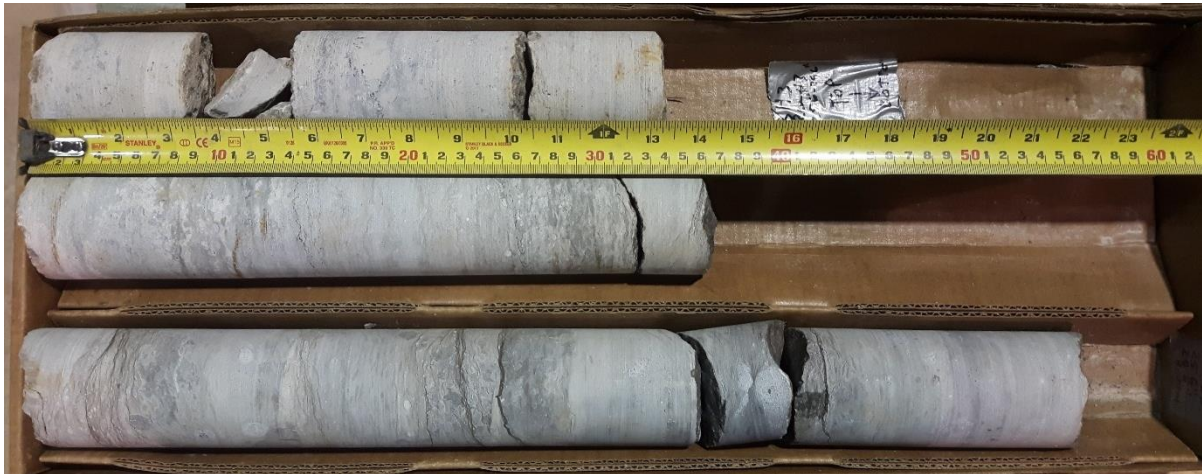
Sample Elevation: (197.65 – 196.43 m)

Recovery 100%, RQD 77% (good quality)

Photo 3. Core Sample for BH3 from Elevation 197.65 m to 196.43 m

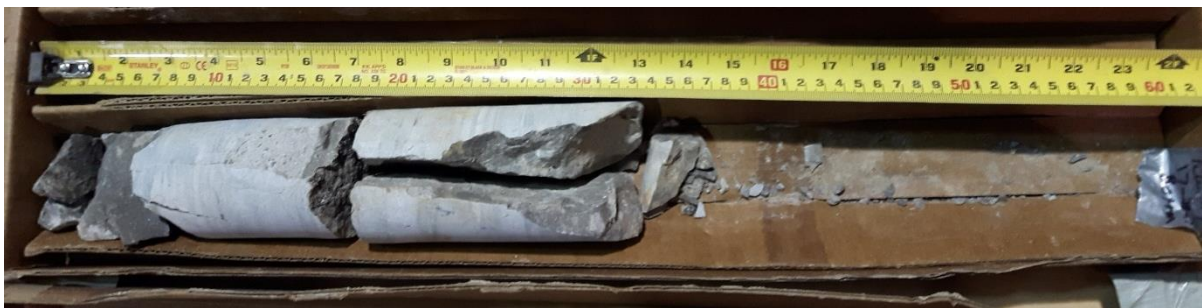
Sample Elevation: (199.77 – 199.36 m)

Recovery 100%, RQD 0% (very poor quality)

Photo 4. Core Sample for BH1 from Elevation 199.77 m to 199.36 m
