**FOUNDATION INVESTIGATION REPORT
GROUND MOUNTED SIGN SUPPORTS
HIGHWAY 401/COUNTY ROAD 30
BRIGHTON, ON
AGREEMENT 4017-E-0047
ASSIGNMENT 4**

Geocres No.: 31C-281

September 2019
Thurber File No.: 24731

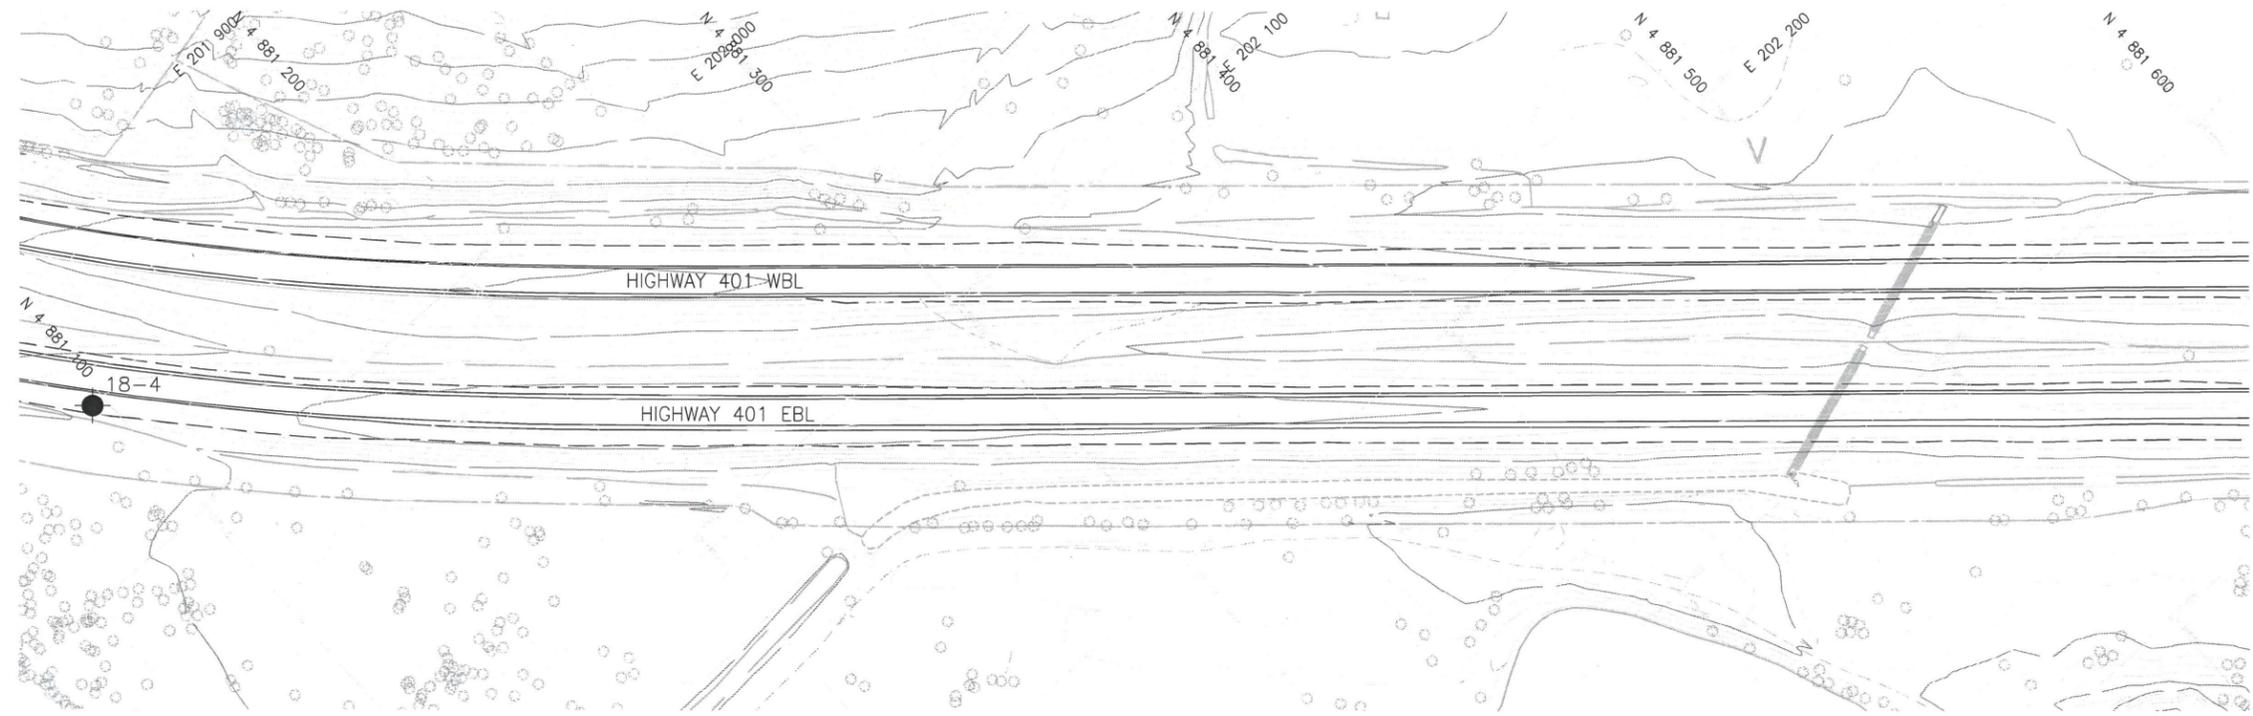
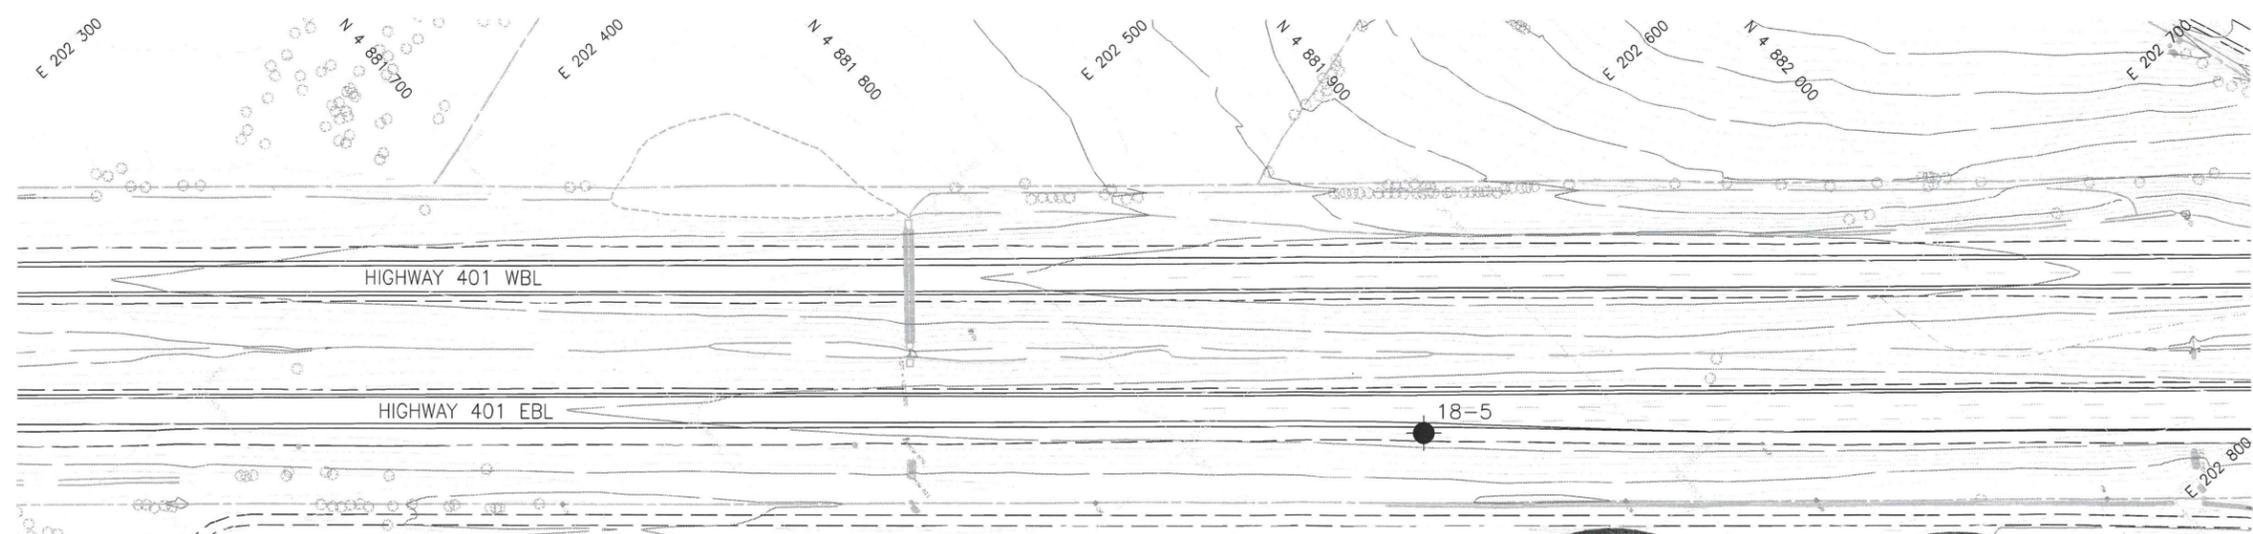
CONT No
WP No
HIGHWAY 401
COUNTY ROAD 30
GROUND MOUNTED SIGN SUPPORTS
BOREHOLE LOCATIONS PLAN

NO	ELEVATION	NORTHING	EASTING
18-4	200.7	4 881 096.1	201 956.5
18-5	202.5	4 881 854.1	202 642.3

The northing, easting and elevation of the boreholes are shown on the Borehole Location Drawing No. 1 in Appendix A, the individual Record of Borehole sheets in Appendix B and in Table 3-1. The termination depth of each of the boreholes is also provided in Table 3-1 below. The site is within MTM Zone 9.

Details of the soil stratigraphy encountered in the boreholes are presented on the Record of Borehole sheets in Appendix B. A Borehole Location Plan is presented on Drawing No. 1 in Appendix A. An overall description of the stratigraphy is given in the following sections; however, the factual data presented on the Borehole Records governs any interpretation of the site conditions.

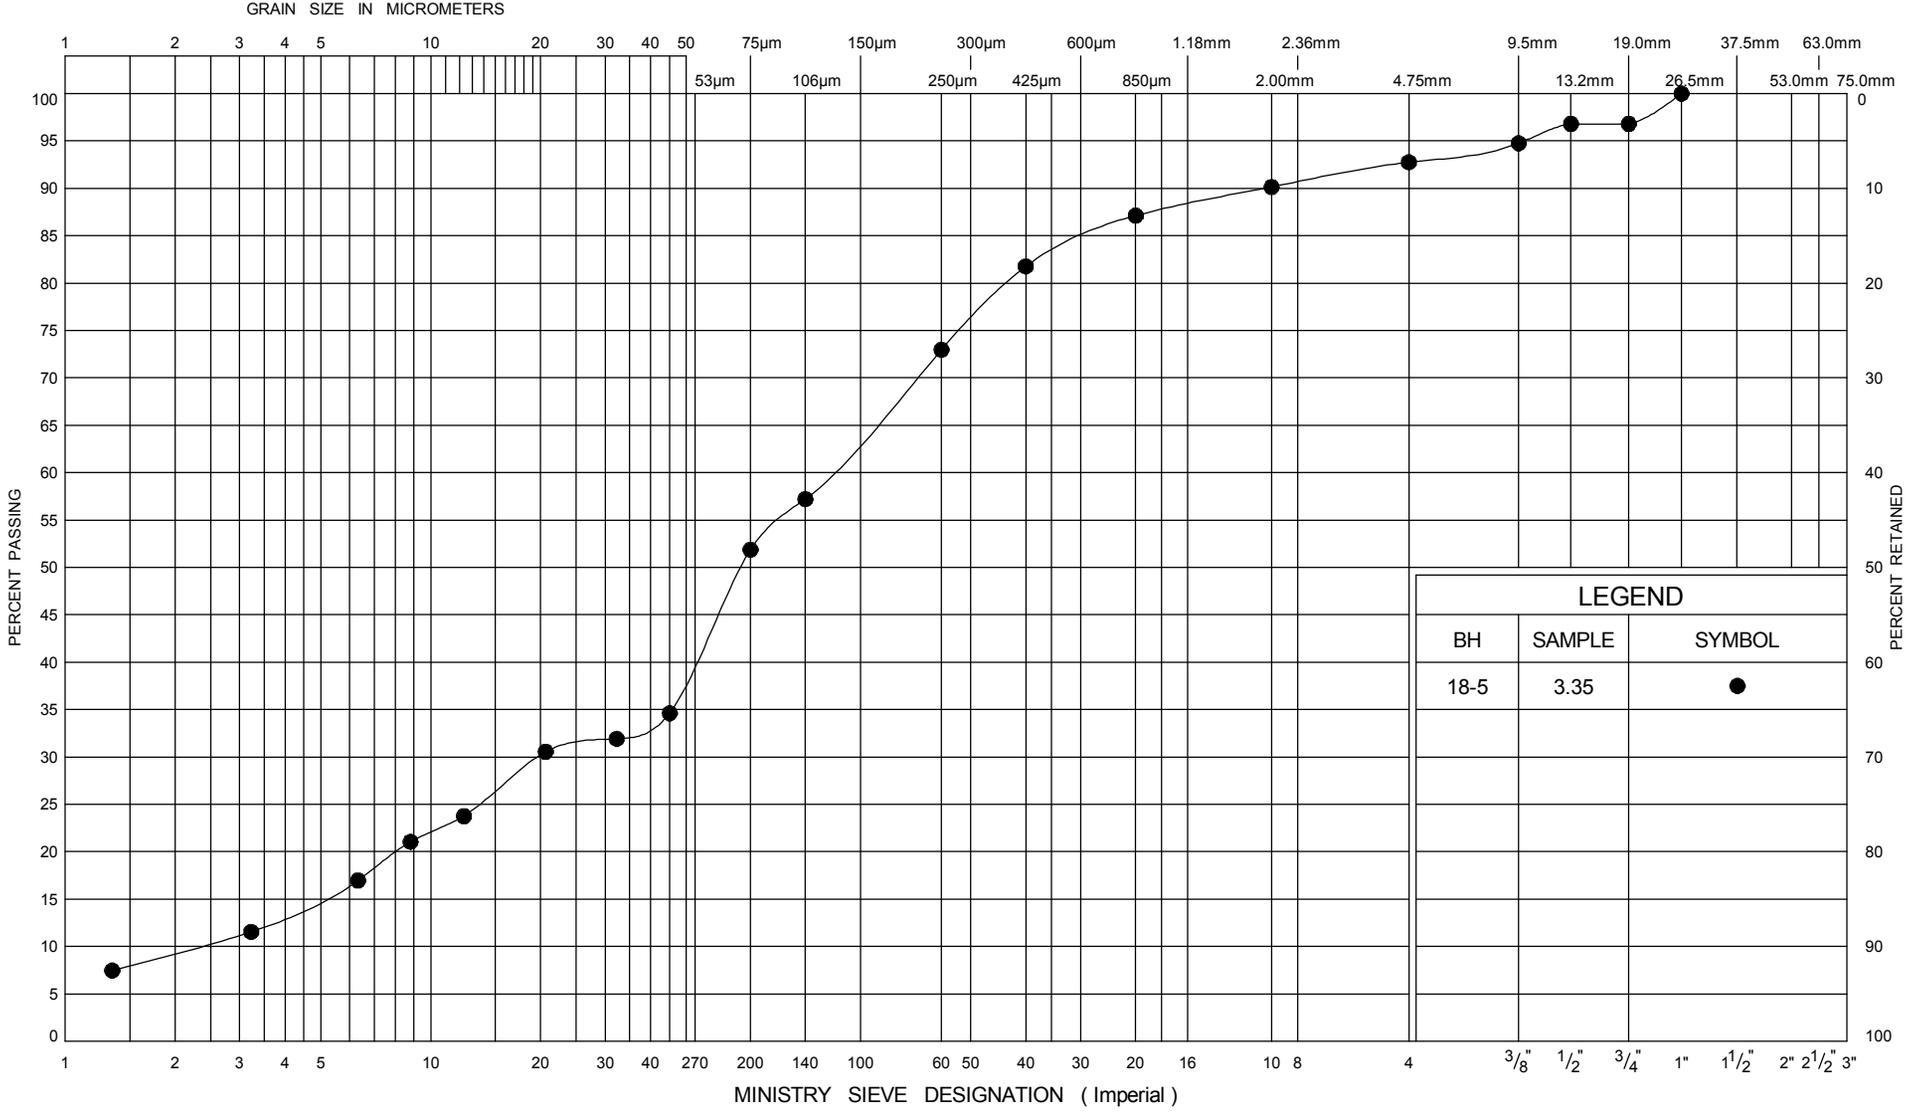
FIG No C2

LEGEND		
BH	SAMPLE	SYMBOL
18-5	3.35	●

GRAIN SIZE DISTRIBUTION
Sandy Silt (ML)

Recorded moisture contents of the sandy silt typically ranged from 12 to 15%. A moisture content of 26% was recorded in an upper sample containing organics. The results of grain size analysis conducted on one sample of the sandy silt indicated this material to consist of 7% gravel, 41% sand, 43% silt and 9% clay. These results are illustrated on Figure C2 in Appendix C.

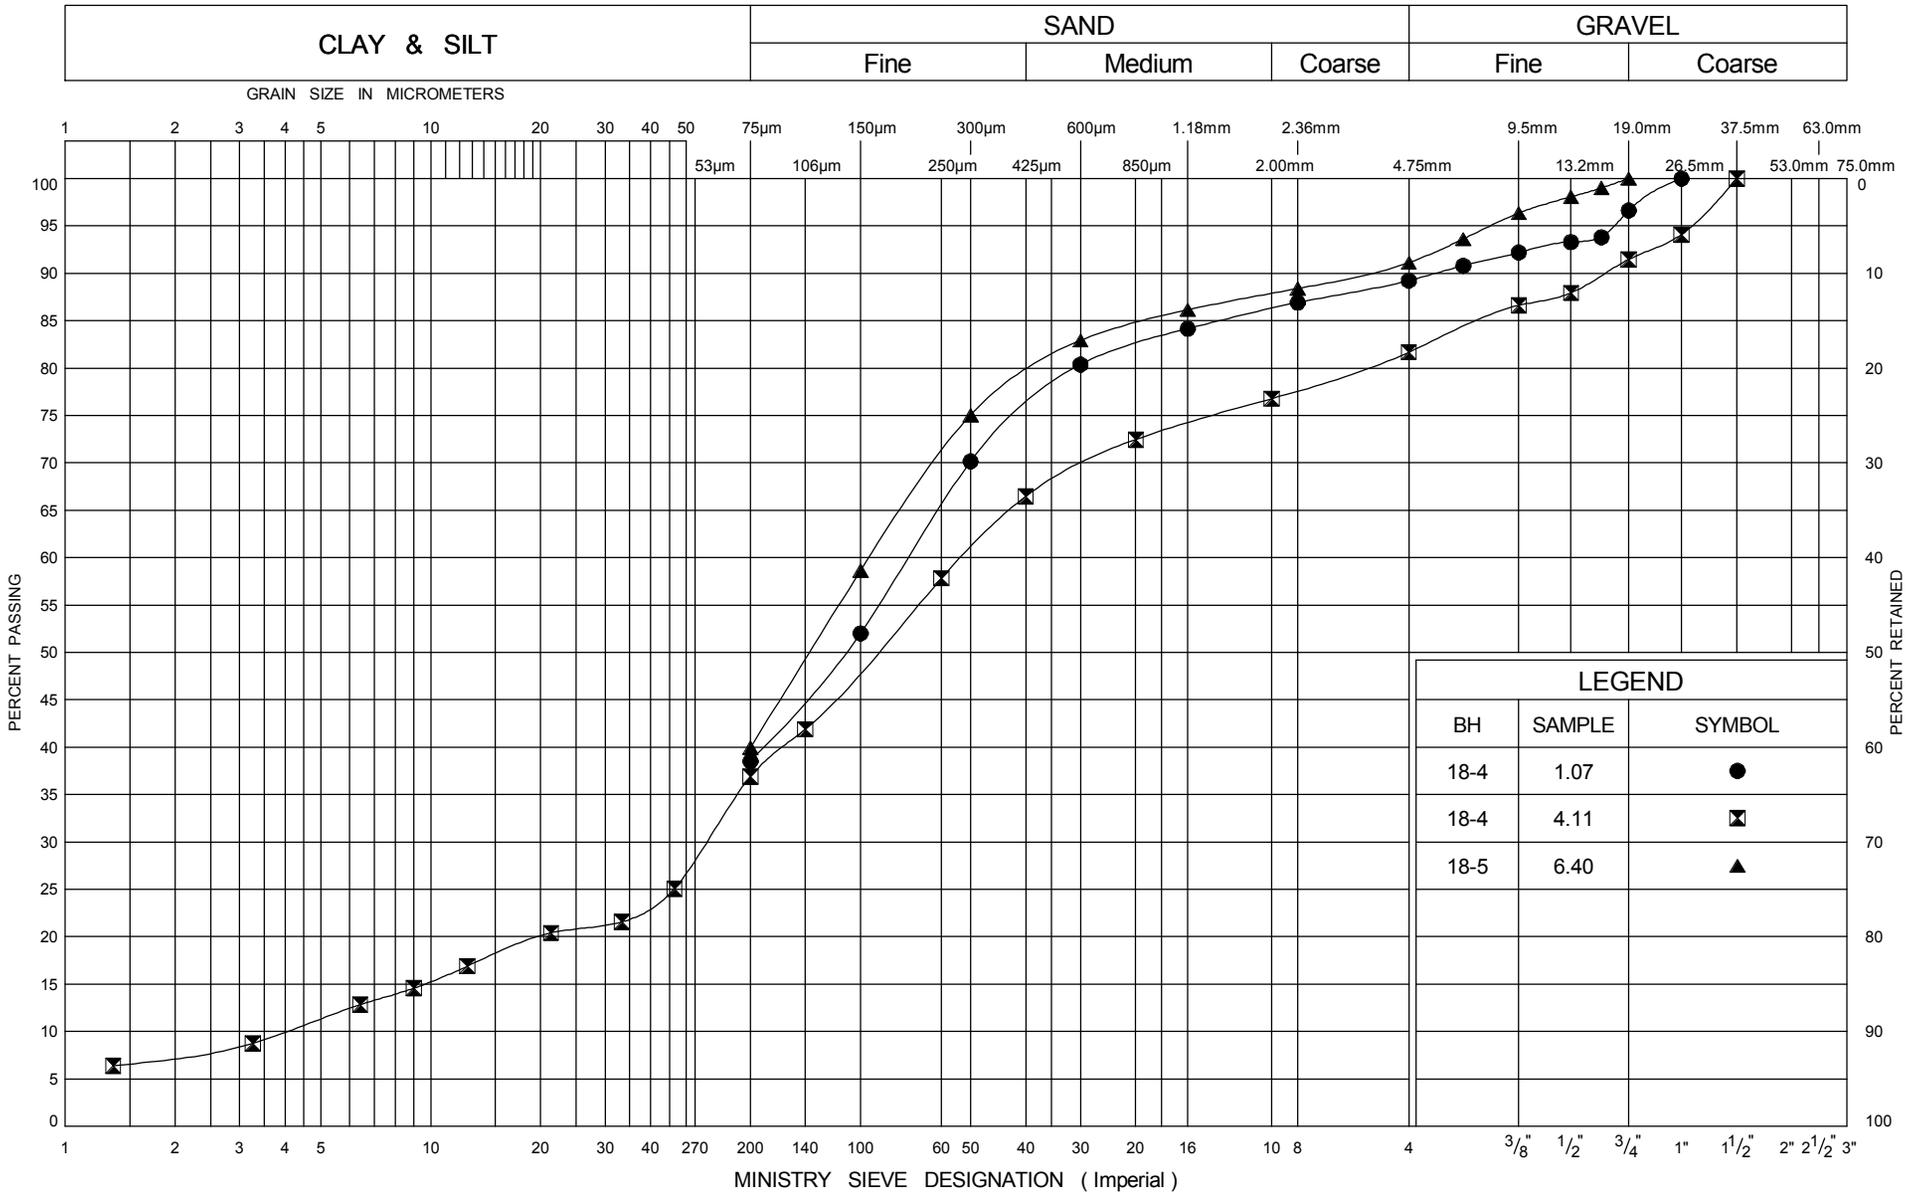
FIG No C3
 W P -
 Hwy 401/CR30 Signs

LEGEND		
BH	SAMPLE	SYMBOL
18-4	1.07	●
18-4	4.11	⊠
18-5	6.40	▲

GRAIN SIZE DISTRIBUTION

Silty Sand TILL

Recorded moisture contents ranged from 7 to 13%. The results of grain size analyses conducted on three samples of the silty sand till are summarized in the Table 5-1 below and are illustrated on Figure C3 in Appendix C.

Soil Particle	Percentage (%)	
Gravel	9 – 18	
Sand	45 – 51	
Silt	29	38 – 40
Clay	8

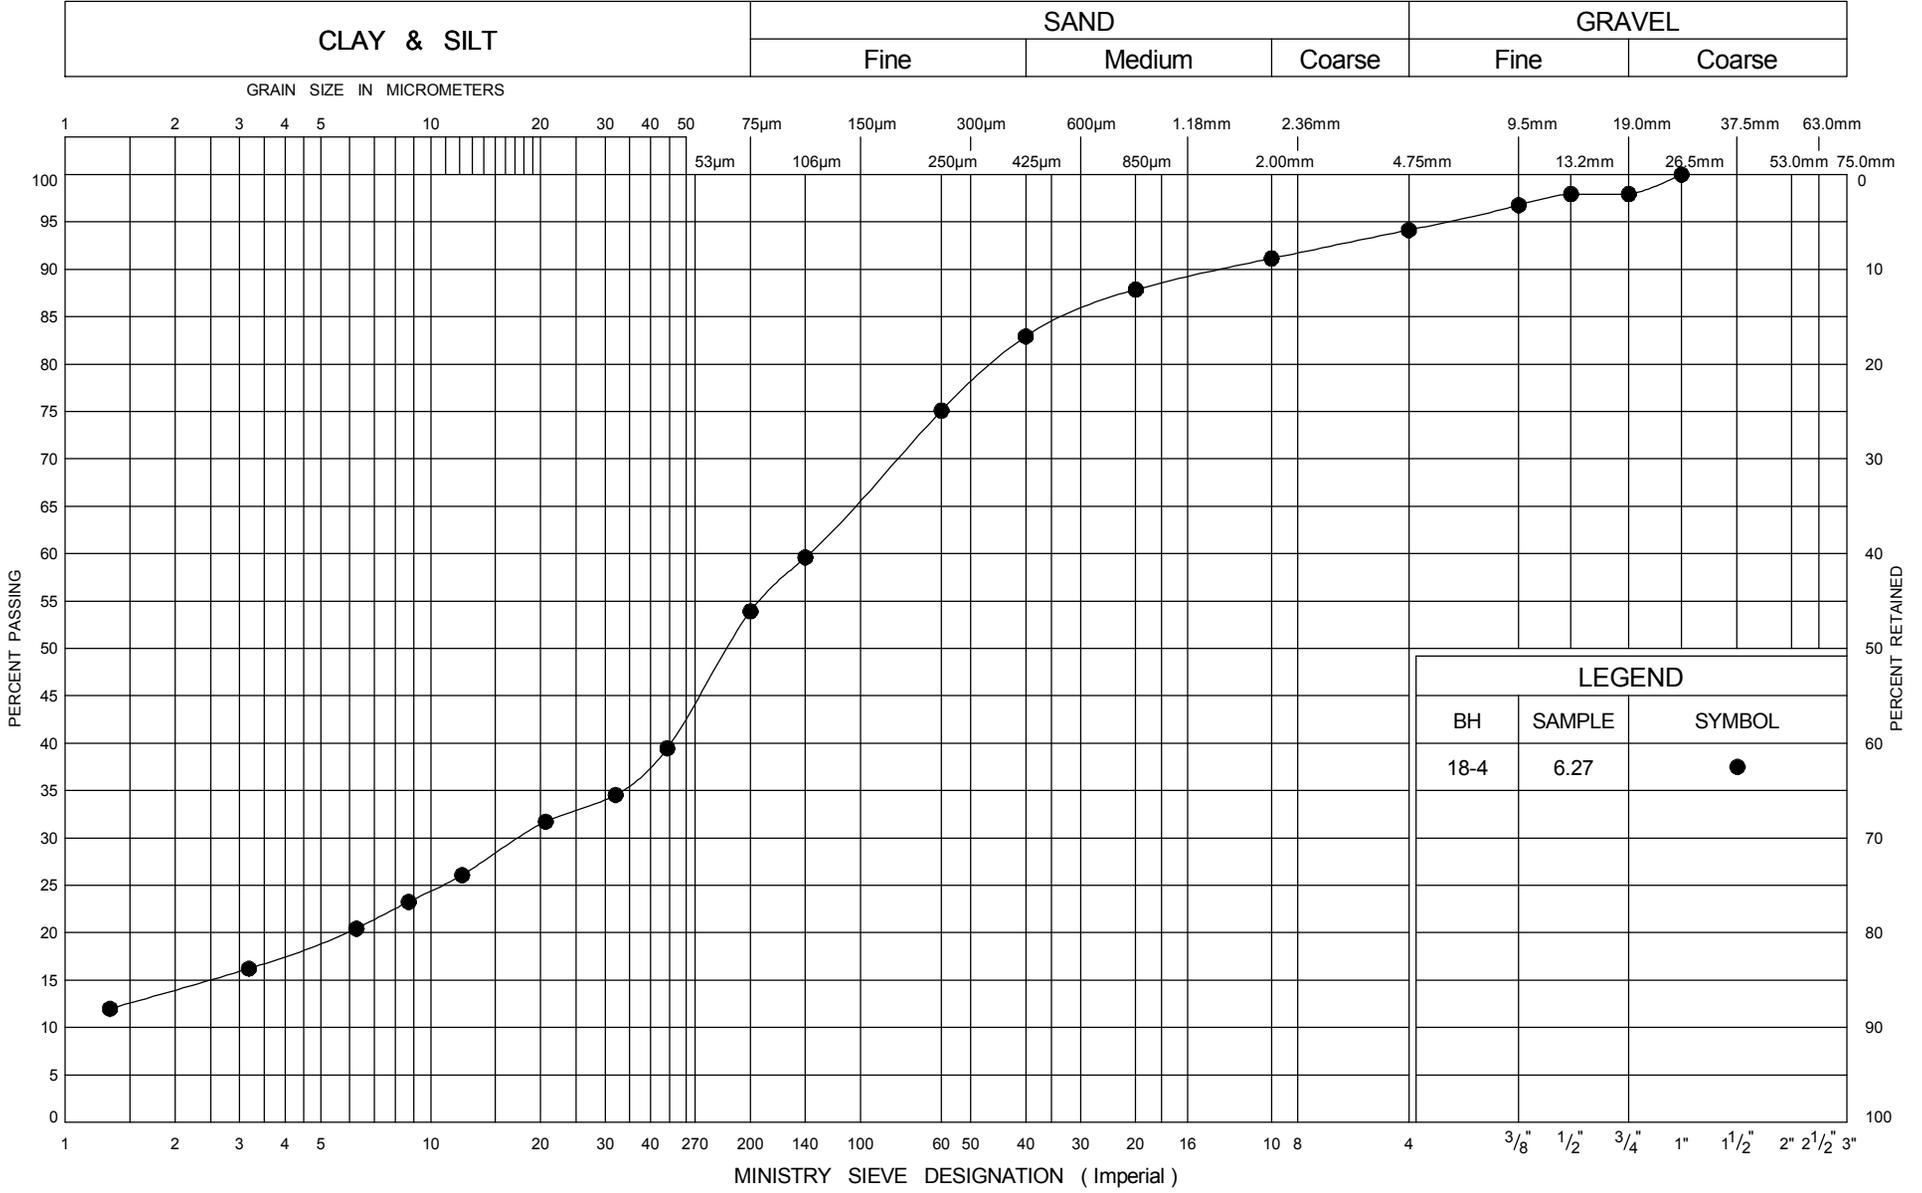
FIG No C4
 W P -
 Hwy 401/CR30 Signs

GRAIN SIZE DISTRIBUTION

Sandy Silty Clay TILL

Recorded moisture contents were 6 and 9%. The results of grain size analysis conducted on one sample of the sandy silty clay indicated this material to consist of 6% gravel, 40% sand, 40% silt and 14% clay. These results are illustrated on Figure C4 in Appendix C.

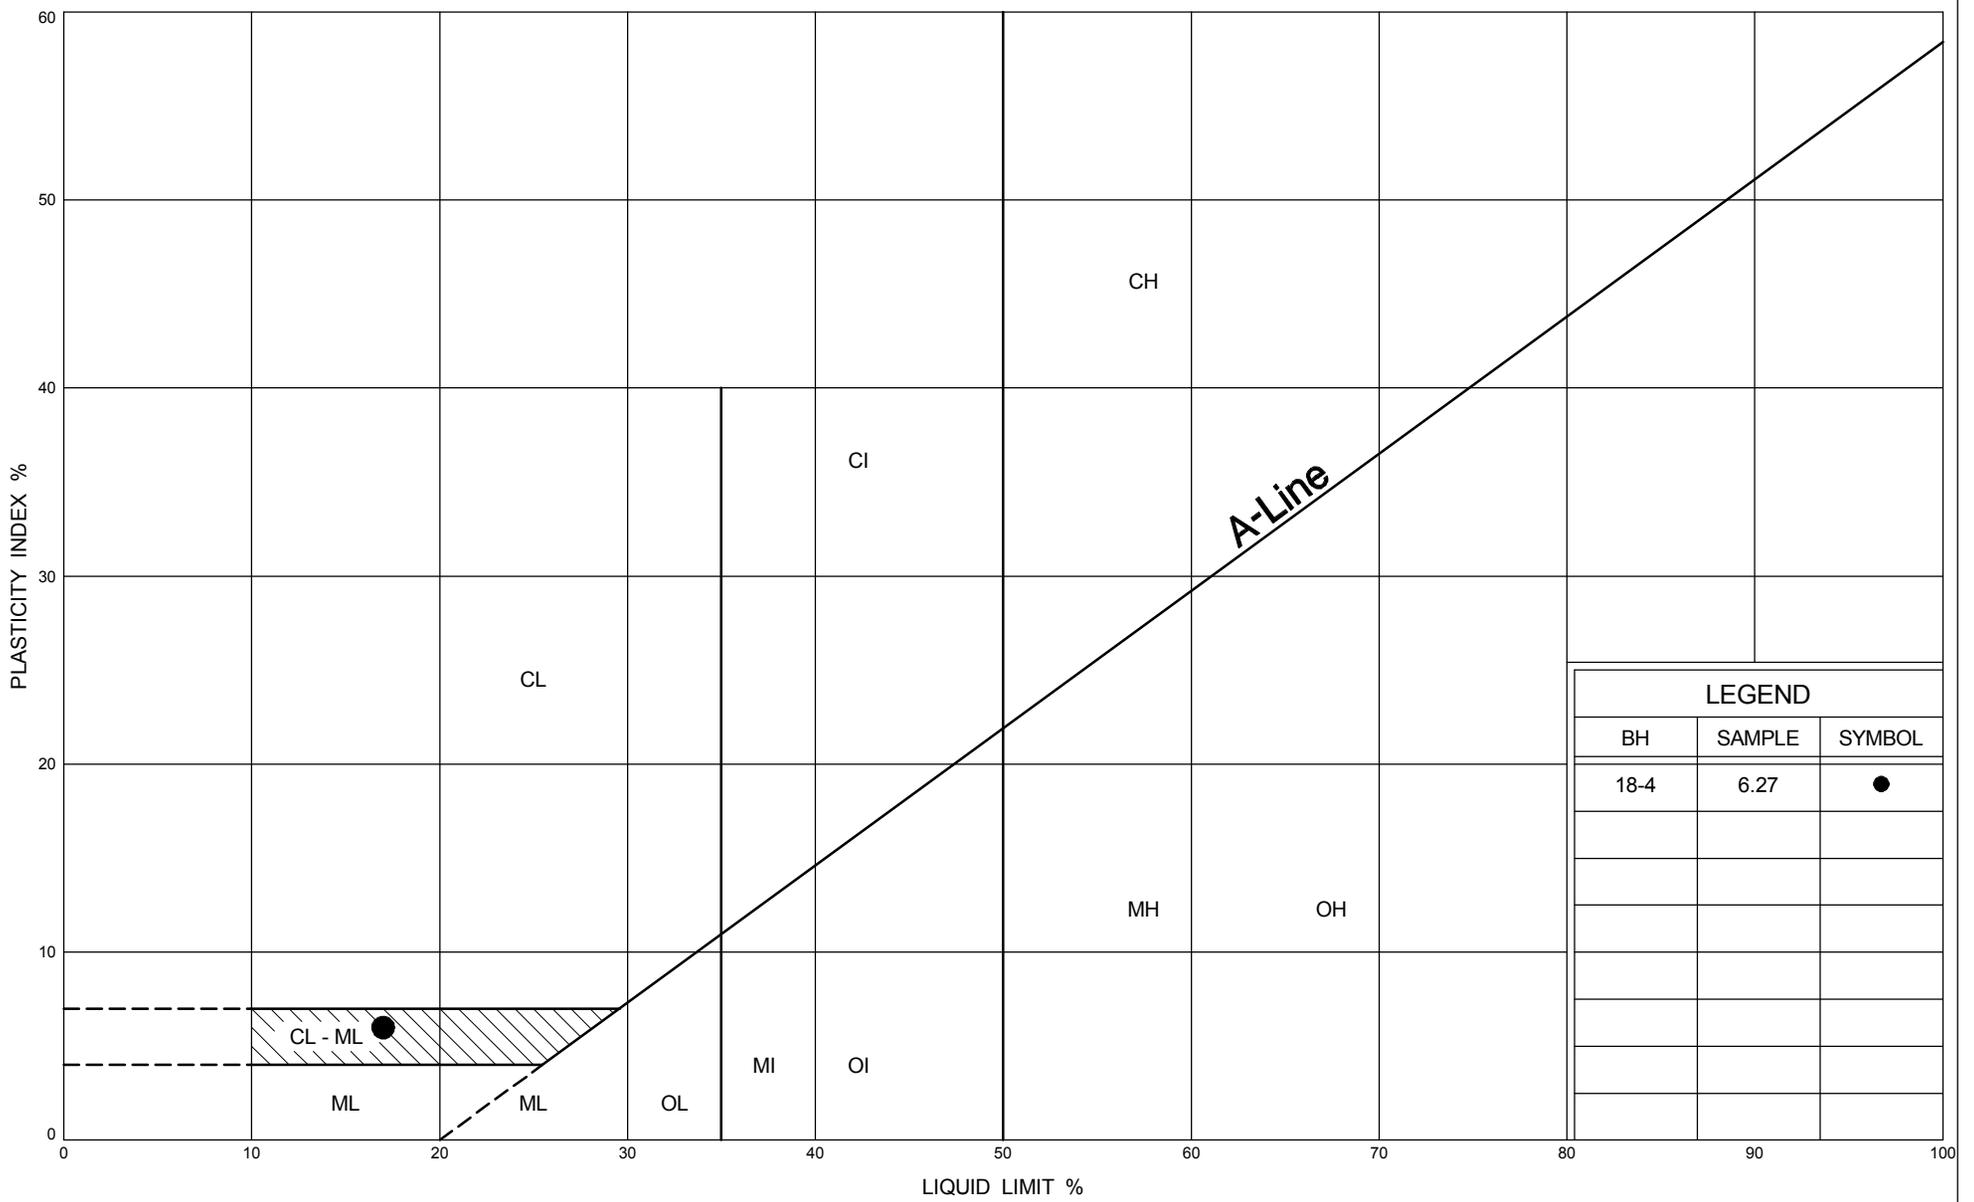
FIG No C5
 W P -
 Hwy 401/CR30 Signs

LEGEND		
BH	SAMPLE	SYMBOL
18-4	6.27	●

PLASTICITY CHART

An Atterberg Limit test was completed on a sample of the sandy silty clay and indicated that the fines have a low plasticity (CL-ML). This result is illustrated on Figure C5 in Appendix C.
