**FINAL**  
**FOUNDATION INVESTIGATION AND DESIGN REPORT**  
**HIGHWAY 11 UNDERPASS STRUCTURE**  
**MUSKOKA RD 14/FRASERBURG RD, DISTRICT OF MUSKOKA**  
**AGREEMENT NO. 5017-E-0003**  
**Site No.: 42X-0189**

**G.W.P. 5138-13-00**

Geocres No.: **31E-391**

February 2019  
Thurber File: 20244

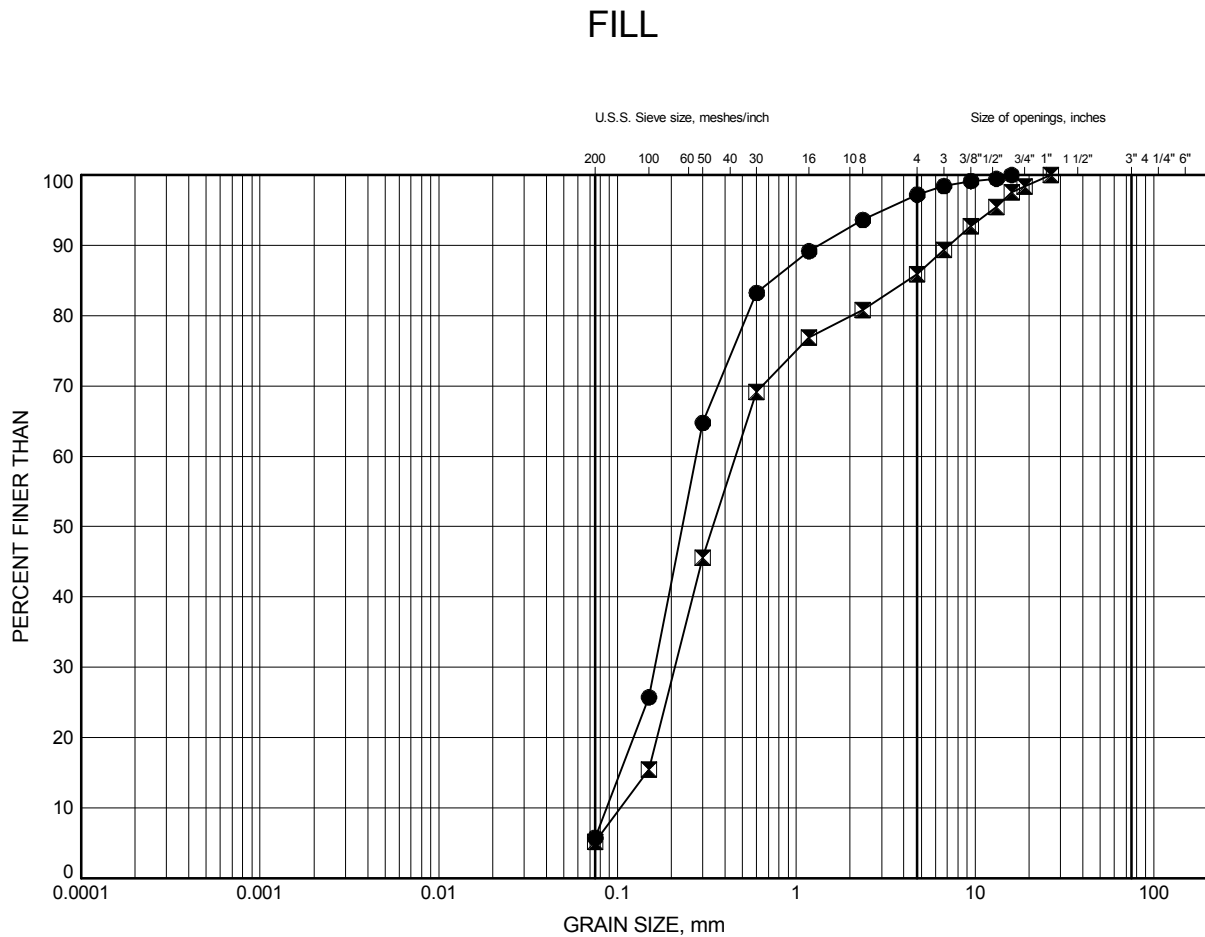
FIGURE C1

Recorded moisture contents ranged from 3 to 14%. The results of grain size analyses conducted on two samples of the sand fill are summarized below and are illustrated on Figure C1 in Appendix C.

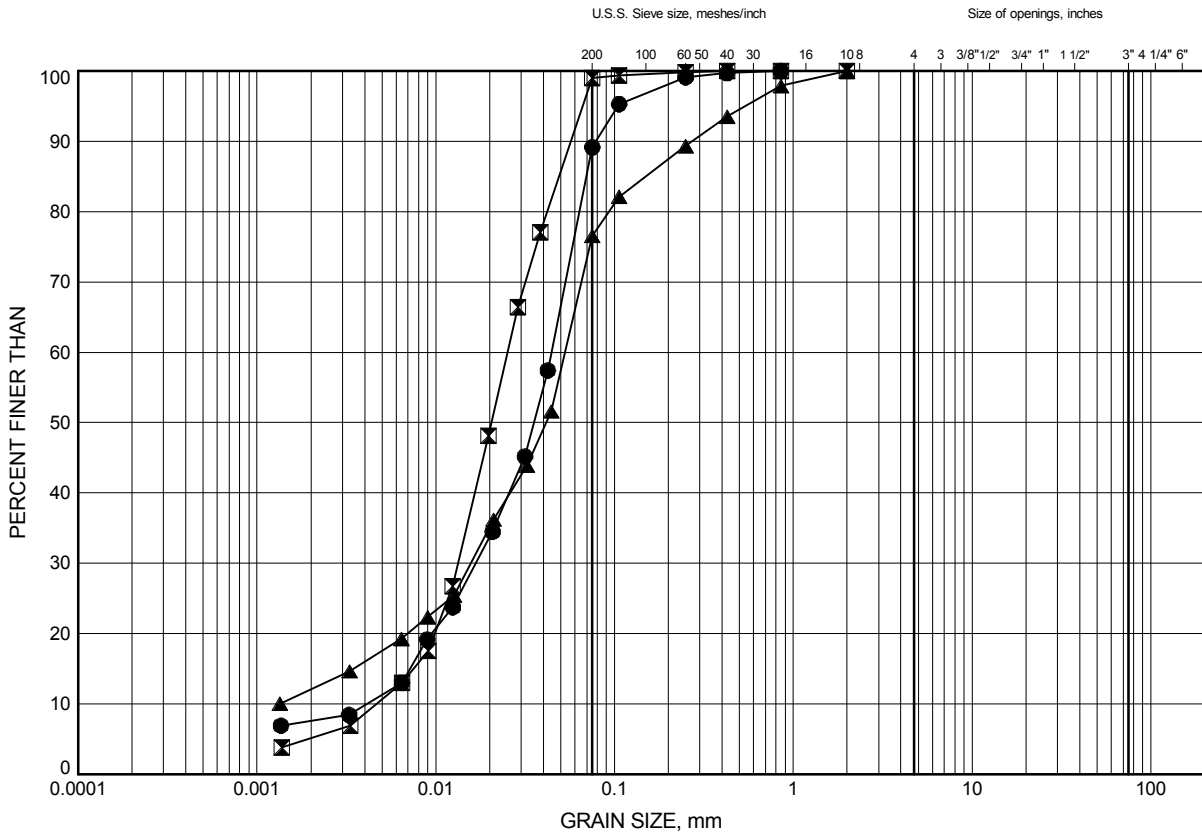
FIGURE C2

Recorded moisture contents ranged from 18 to 25%. One moisture content as high as 137% was recorded in Borehole 18-2 within the sample containing wood fragments. Atterberg Limits testing on two samples indicated that this material was non-plastic. The results of grain size analyses conducted on two samples of the silt are summarized below and illustrated on Figure C2 in Appendix C.

### SILT (ML) / LOWER SILT (ML)

Recorded moisture contents ranged from 19 to 30%. Atterberg Limits testing on one sample indicated that this material was non-plastic. The results of a grain size analysis conducted on one sample of the lower silt are summarized below and illustrated on Figure C2 in Appendix C.

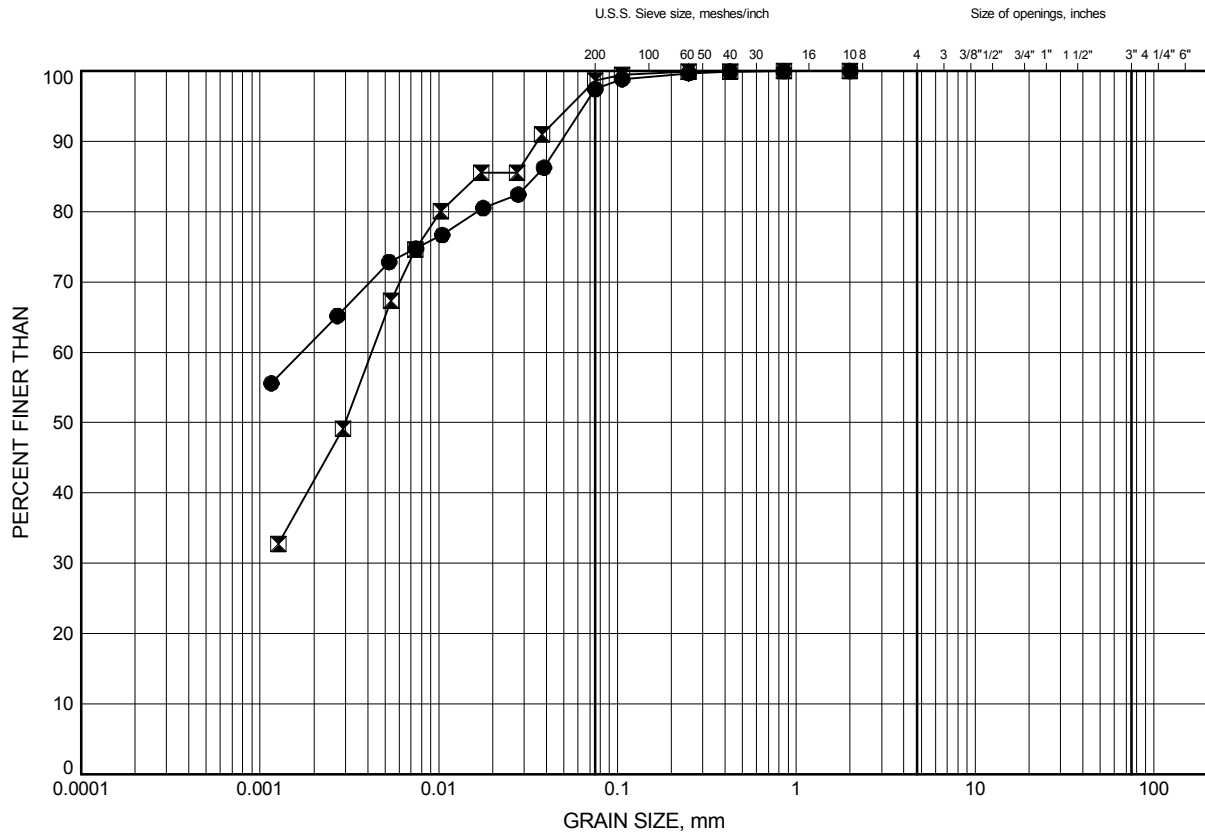
FIGURE C3

Recorded moisture contents ranged from 32 to 59%. The results of grain size analyses conducted on two samples of the clay are summarized below and illustrated on Figure C3 in Appendix C.

### CLAY (CL-CH)

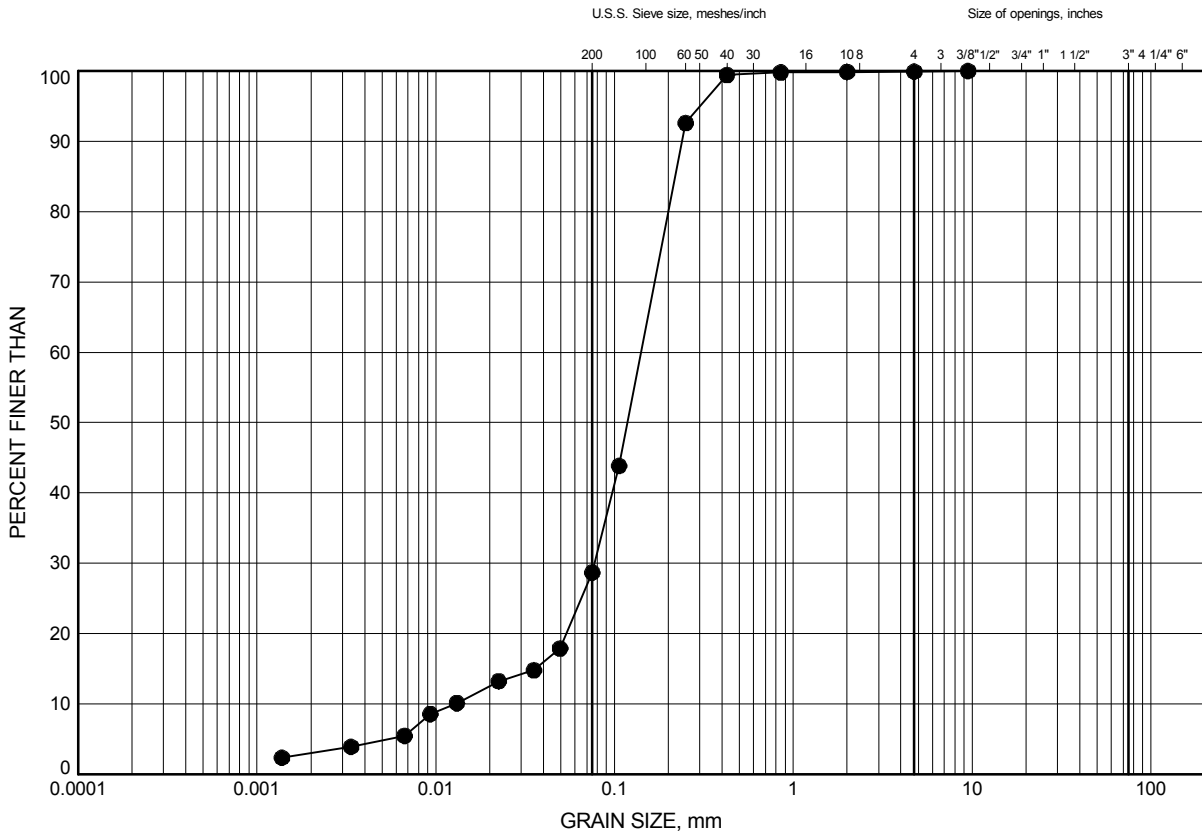
FIGURE C4

The recorded moisture contents ranged from 16 to 44%. The results of a grain size analysis conducted on one sample of the silty sand are summarized below and illustrated on Figure C4 in Appendix C.

### SILTY SAND (SM)

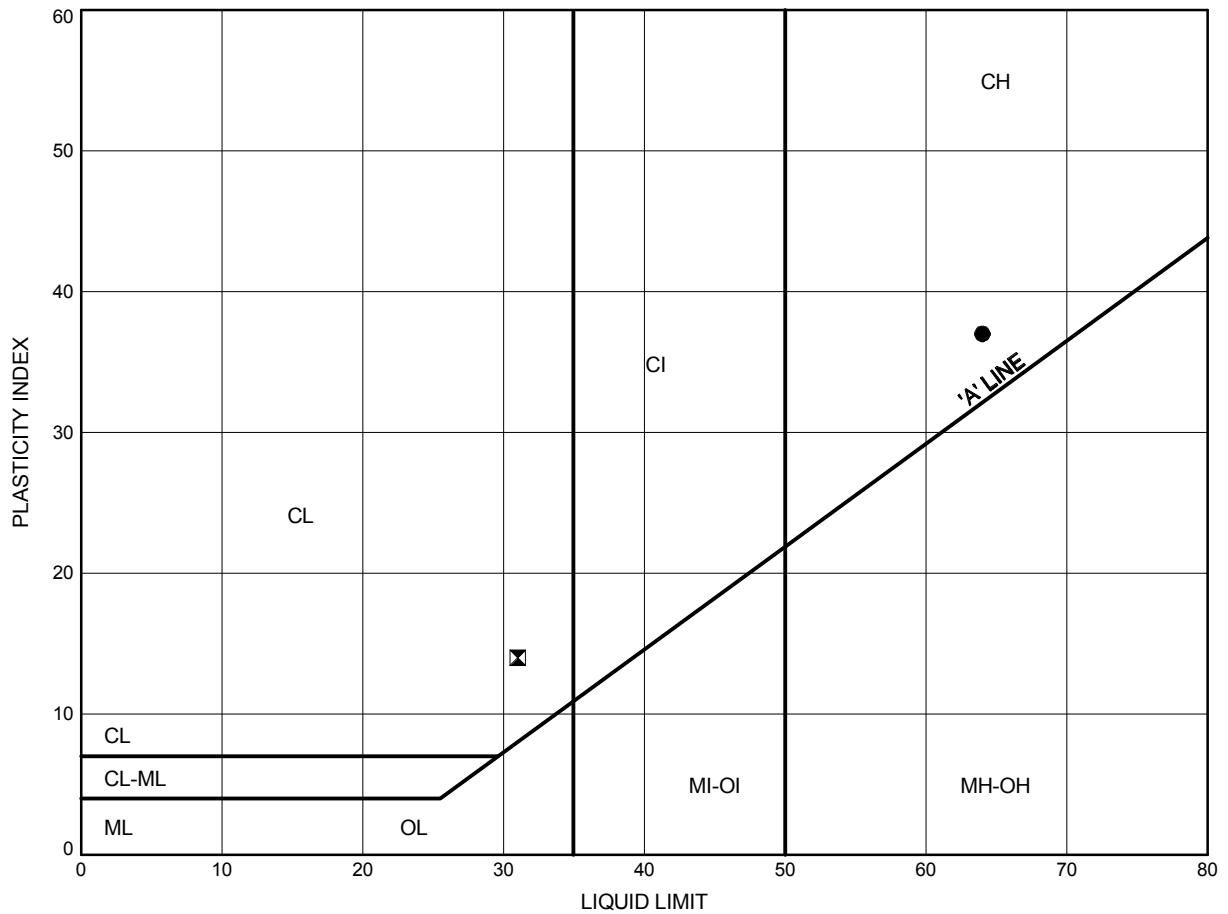
FIGURE C5

## CLAY (CL-CH)

SYMBOL	BOREHOLE	DEPTH (m)	ELEV. (m)
●	18-1	7.9	253.0
⊠	18-2	12.5	247.0

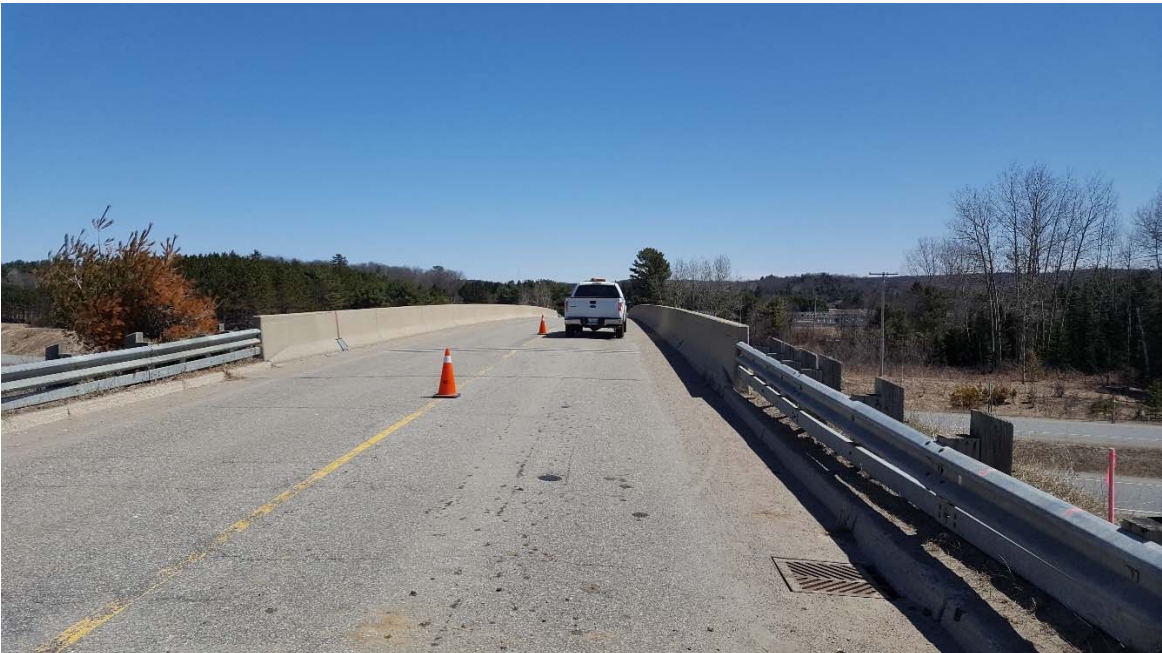
**Photo 2. Muskoka Road 14 (Fraserburg Road) Underpass Structure from west (April 29<sup>th</sup>, 2018)**
