# FOUNDATION INVESTIGATION REPORT

PROPOSED REHABILITATION OF  
DUFFERIN STREET OVERPASS HWY 401  
EB & WB EXPRESS, TORONTO, ONTARIO

MINISTRY OF TRANSPORTATION, ONTARIO

WSP PROJECT NO.: 19M-01243-00

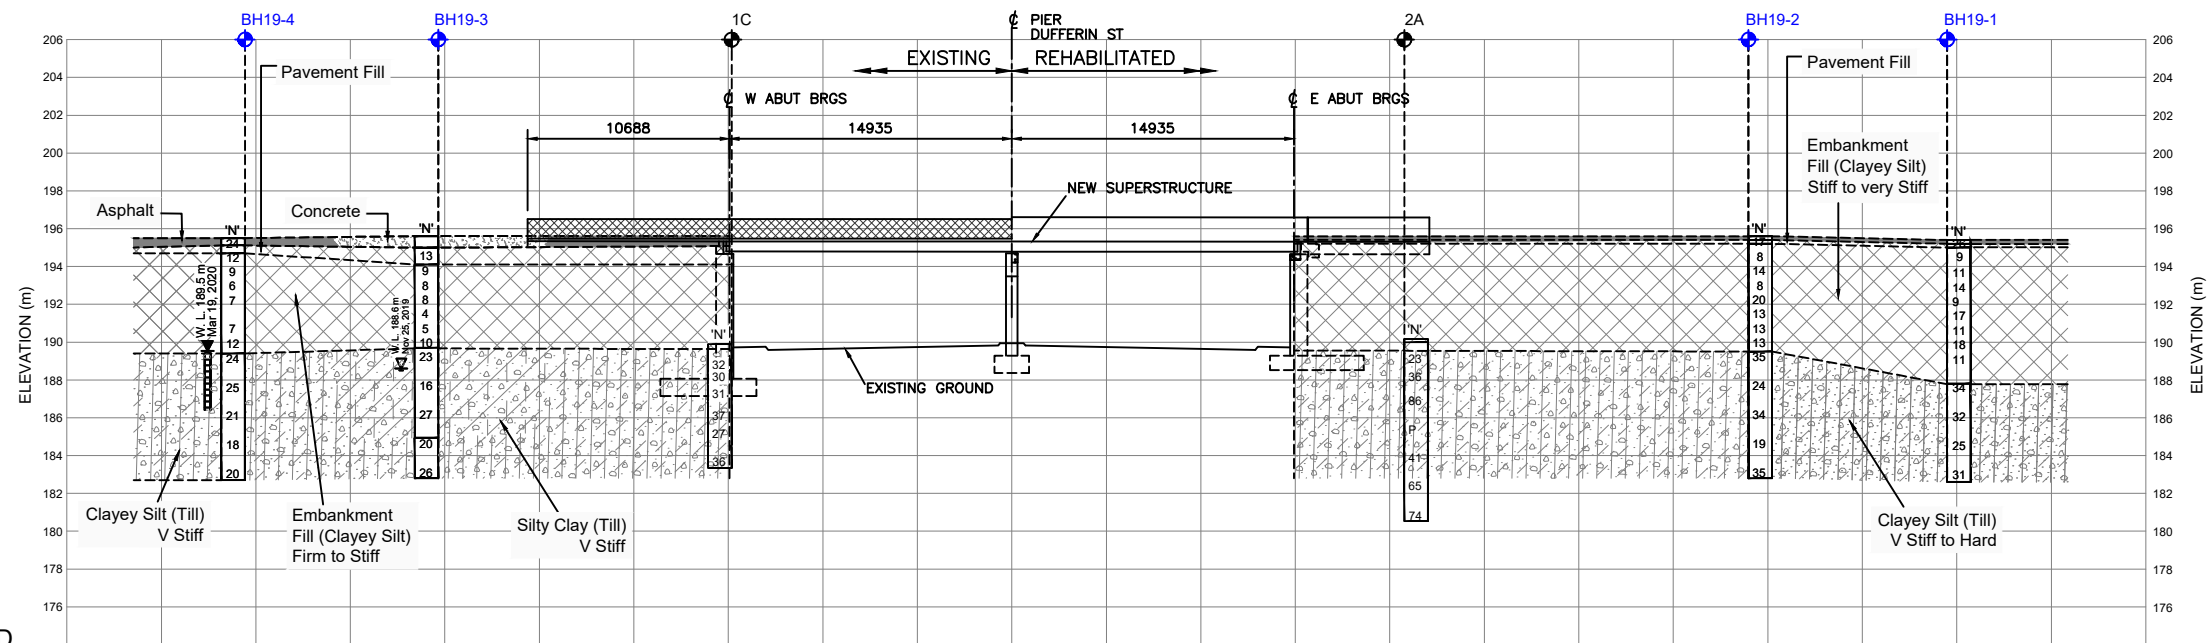
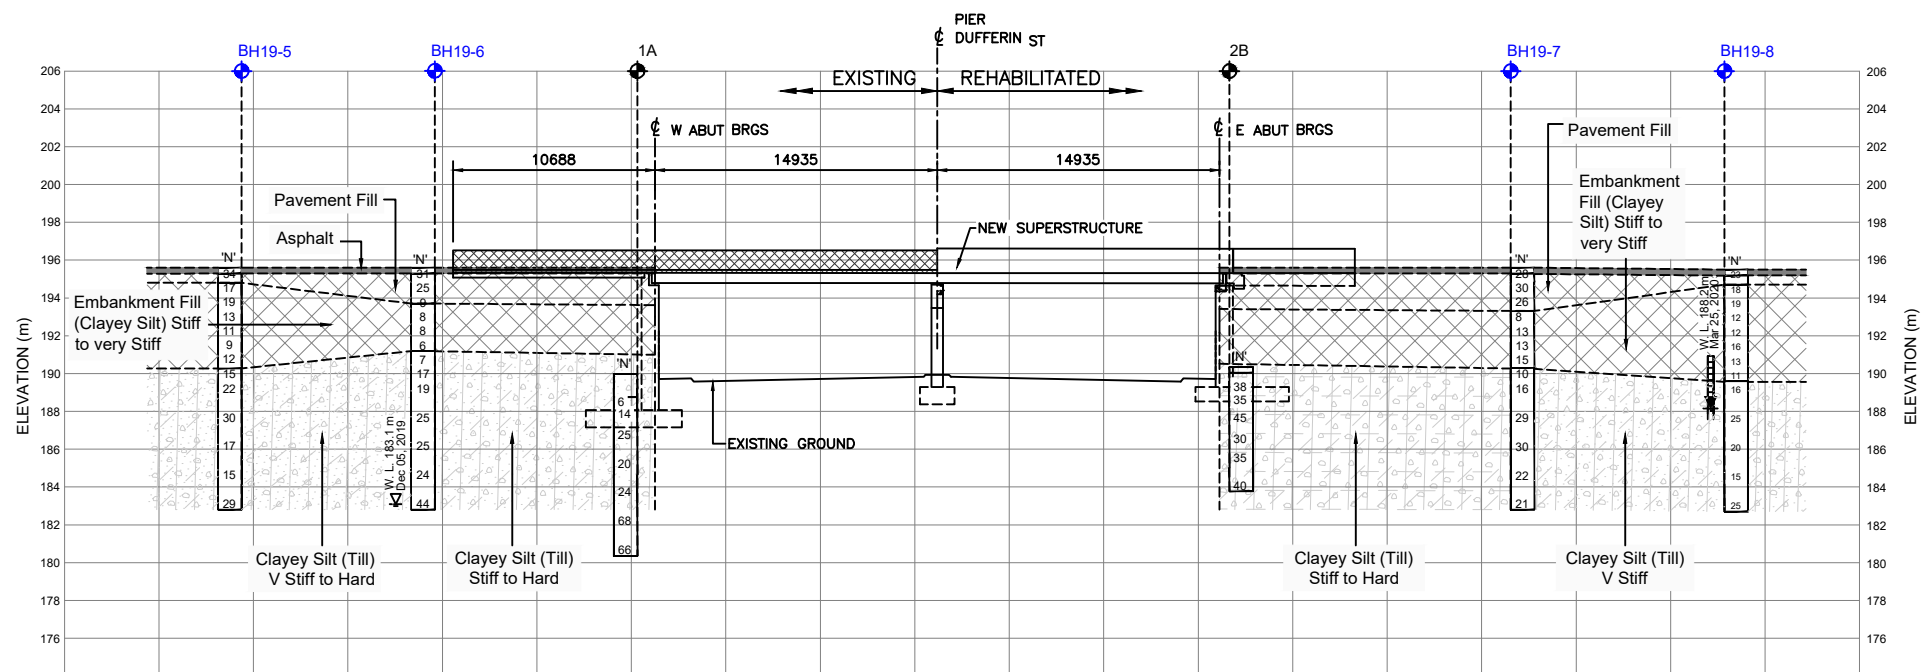
**Drawings 1 & 2** show key plans with longitudinal profiles for EB and WB structures (projected along the centrelines of the Hwy 401 cores at the proposed structure rehabilitation). The inferred stratigraphic profiles at the structure locations are based on the borehole data. The soil descriptions are based on visual and tactile observations and complemented by the results of field and laboratory soil test results.

The boundaries between soil strata have been established only at Borehole locations. Between Boreholes the boundaries are assumed from geological evidence.

For further information, historic borehole logs from GEOCRETS NO. 30M011-081, namely 1A, 2B, 1C and 2A have been presented along side the current boreholes in **Drawings 1 & 2**. It is to be noted that the historic borehole locations are approximate and that the surface elevation of these boreholes have been assumed to be with respect to the same elevation datum to that of the current boreholes. Further, construction activities over the ensuing years may have masked the nature of surficial deposits identified in the historic borehole logs.

The site of the proposed bridge rehabilitation is located at the Dufferin Overpass of Highway 401 EB/WB Express, North York, Ontario. The key plan of the site is shown on **Drawings 1 & 2**. Highway 401 EB & WB Express lanes are operationally, a four-lane and a five-lane roadway respectively with paved shoulders. Both Express lanes are bounded by the collector lanes laterally at each end. The highway runs approximately in an east-west direction over Dufferin Street. The posted regulatory speed limit is 100km/hr. There are industrial/commercial density of businesses located within the vicinity of the site. The existing bridges with abutment walls and pier are shown in Photos C1-2 and C1-3. A site reconnaissance visit was carried out on 1st November 2019.

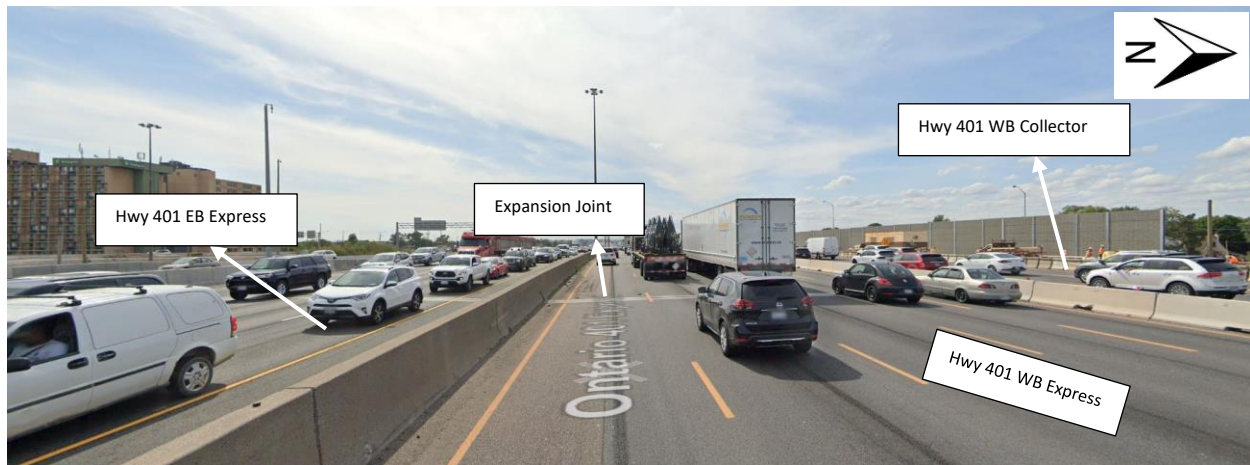
Photo C1-1 Looking towards West at Dufferin Street Overpass Highway 401 Express (November 2019)

Existing express lanes on Dufferin Street overpass at Highway 401 can be seen in Photo C1-1. Night work at boreholes BH 19-3 and BH19-4 with associated traffic control setup is shown in Photos C2-1 and C2-2 in **Appendix C**.

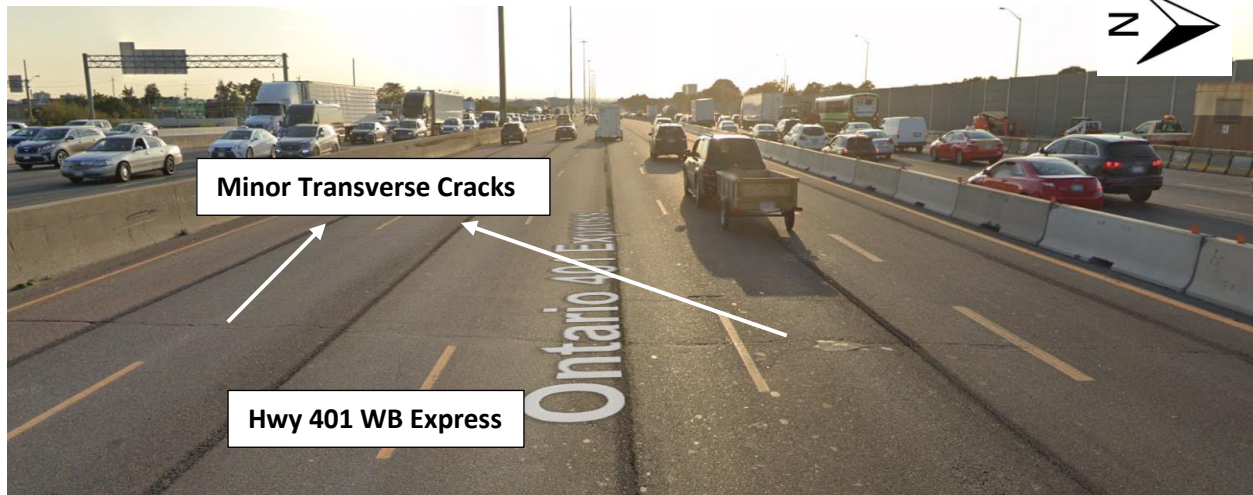
Photo C1-4 Looking towards West : Dufferin Street Overpass (November 2019)

There are minor transverse cracks on the highway (Photo C1-4). Also, there are no visible/observable signs of differential settlement between the approach slab and the approach embankment at each abutment. The embankment side slopes at the east and west approach embankments are well vegetated and green showing no sign of erosional activities.

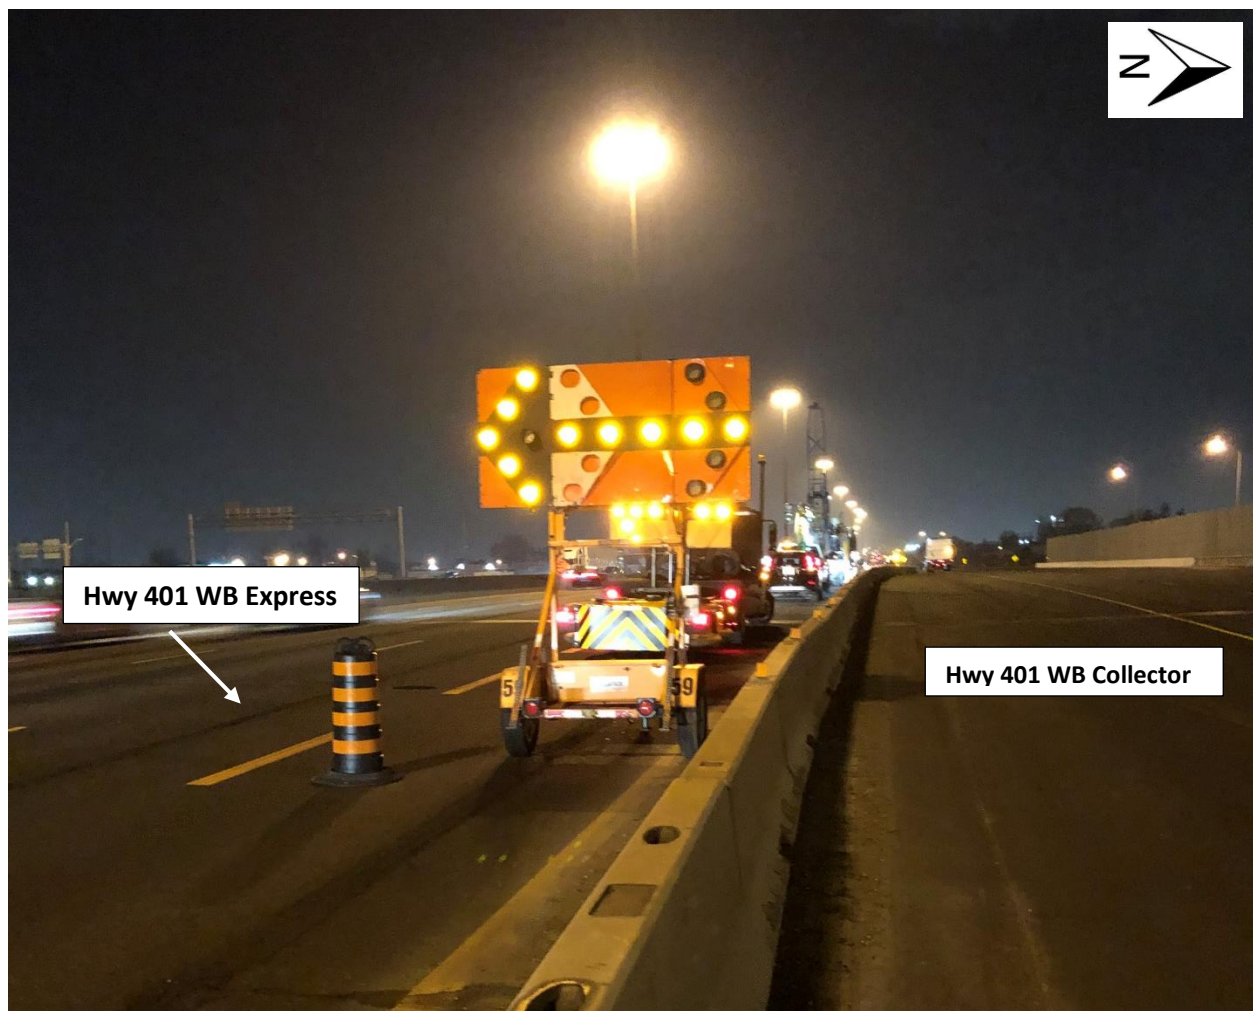
Photo C2-1: Looking towards West at Dufferin street Overpass on Highway 401 WB Express. – Traffic Control Set-up (November 2019)

The traffic set-up indicated a single lane closure with traffic cones and electronic signboards in accordance with TL-29 Right Lane Closure, MTO Book 7 (Photos C2-1 and C2-2 in **Appendix C**).

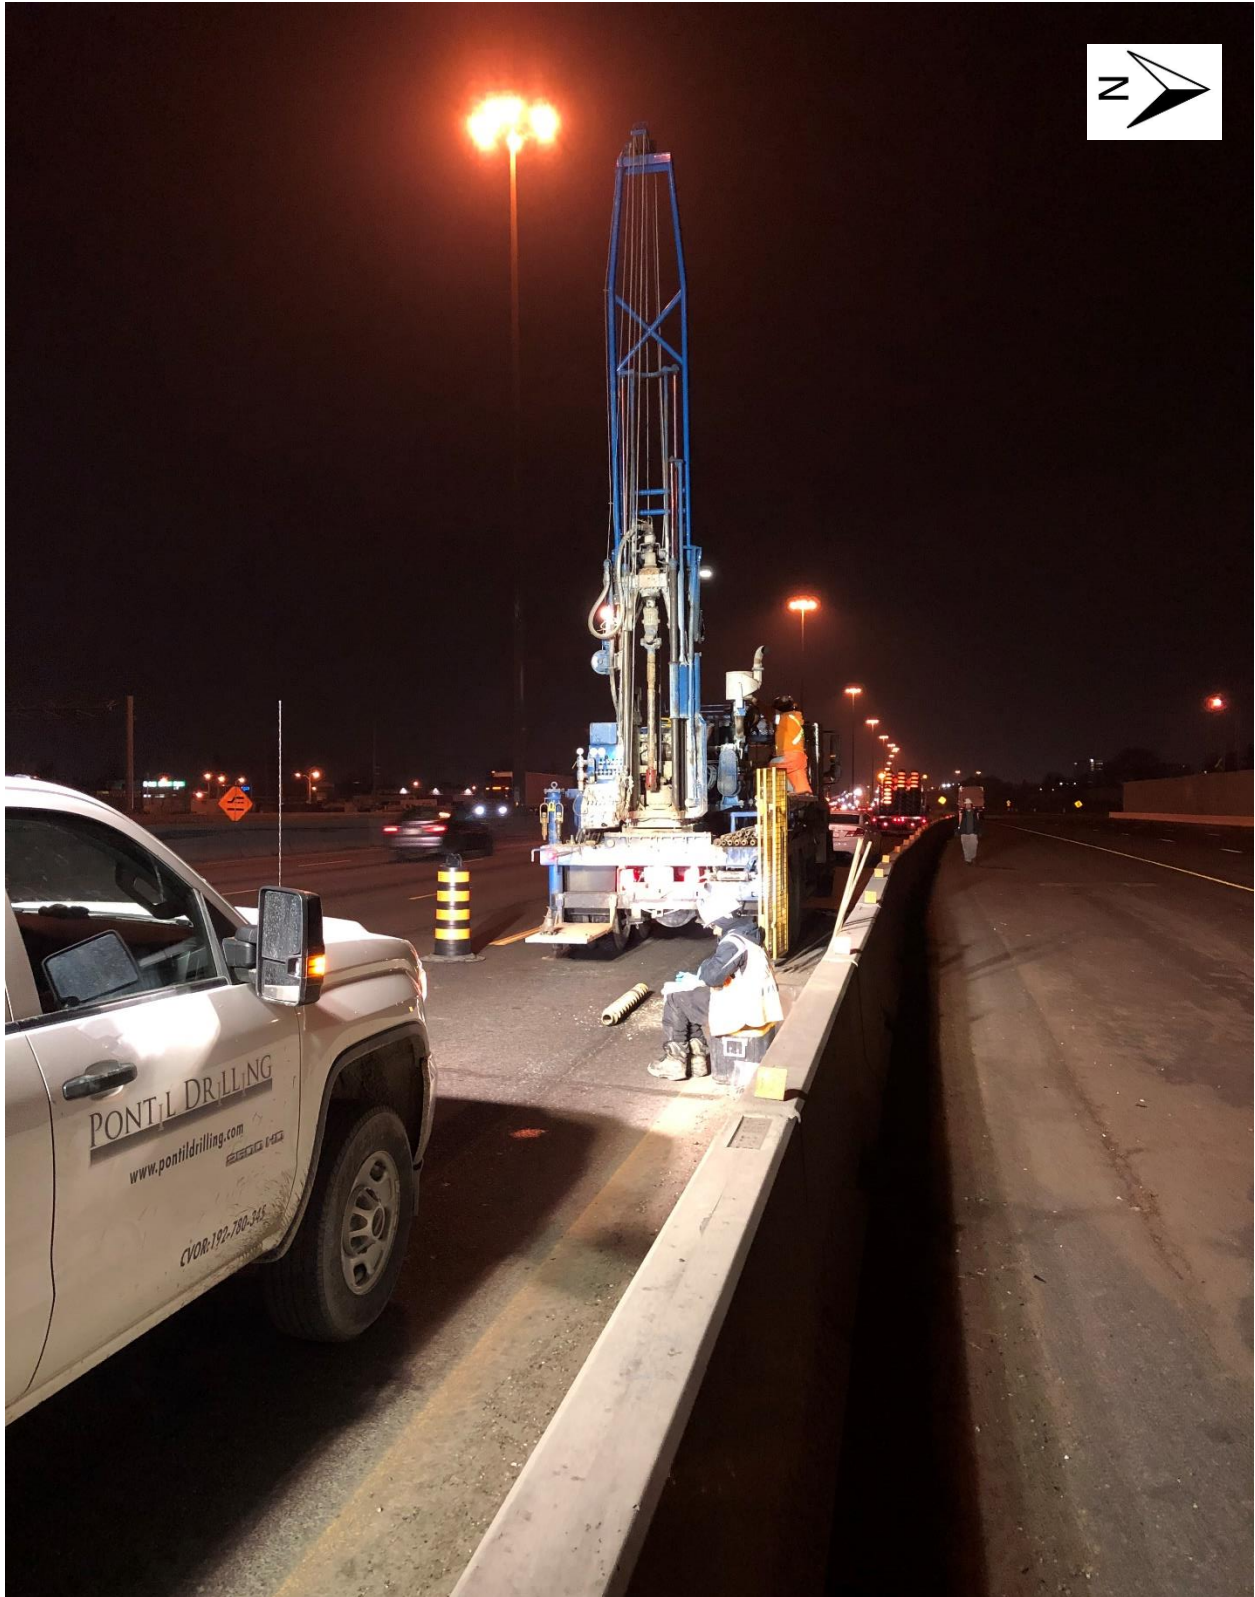
Photo C2-2: Looking towards West at Dufferin street Overpass on Highway 401 WB Express. – Traffic Control Set-up (November 2019)
