**FINAL  
FOUNDATION INVESTIGATION AND DESIGN REPORT  
REPLACEMENT OF THE HIGHWAY 401 OVERPASS AT  
CHOATE ROAD  
NORTHUMBERLAND COUNTY – PORT HOPE, ONTARIO  
ASSIGNMENT NO.: 4019-E-0021  
GWP 4068-14-00**

**SITE NO. 21X-0230/B0  
GEOCRES NO.: 30M16-075**

**Report  
to  
MCINTOSH PERRY | LEA JOINT VENTURE**

August 2023  
Thurber File No.: 33099

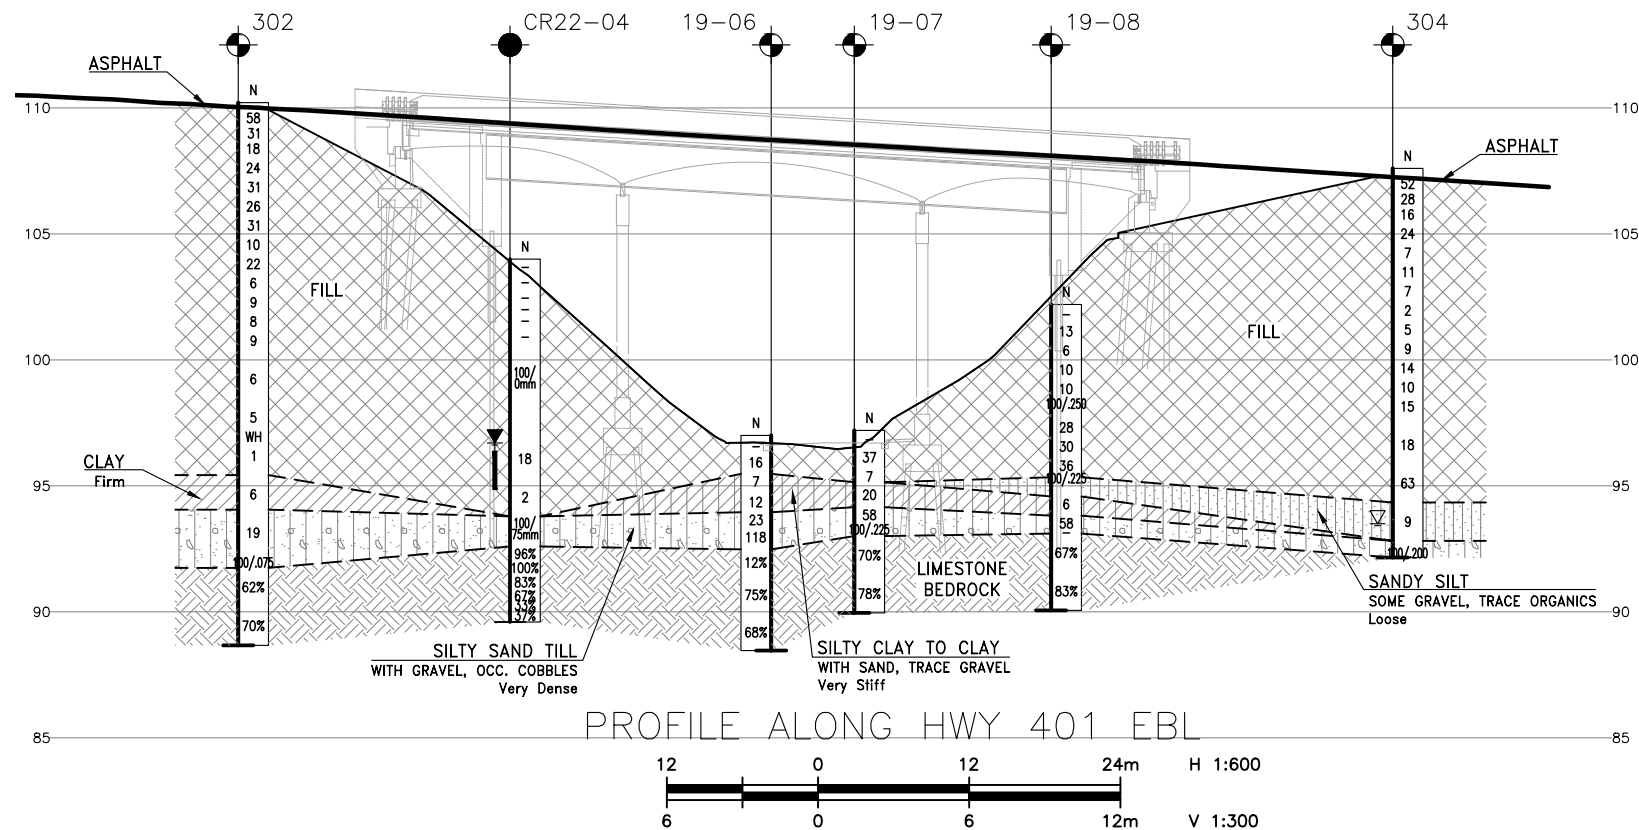
REVISIONS	DATE	BY	DESCRIPTION
DESIGN	CM	CHK -	CODE
DRAWN	AN	CHK CM	SITE
LOAD	DATE	OCT 2022	
STRUCT	DWG	2

HIGHWAY 401  
CHOATE ROAD OVERPASS  
BRIDGE REPLACEMENT  
BOREHOLE LOCATIONS AND SOIL STRATA

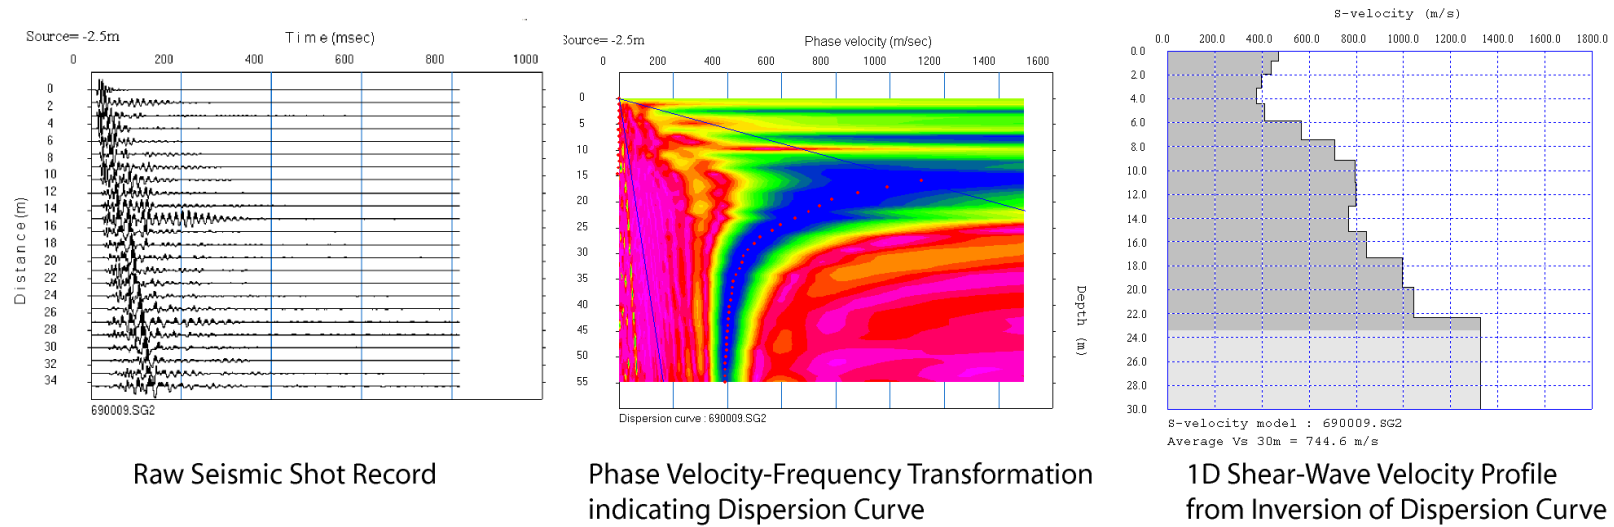
**Figure 3: Example of a typical MASW shot record, phase velocity/frequency curve and resulting 1D shear-wave velocity model.**

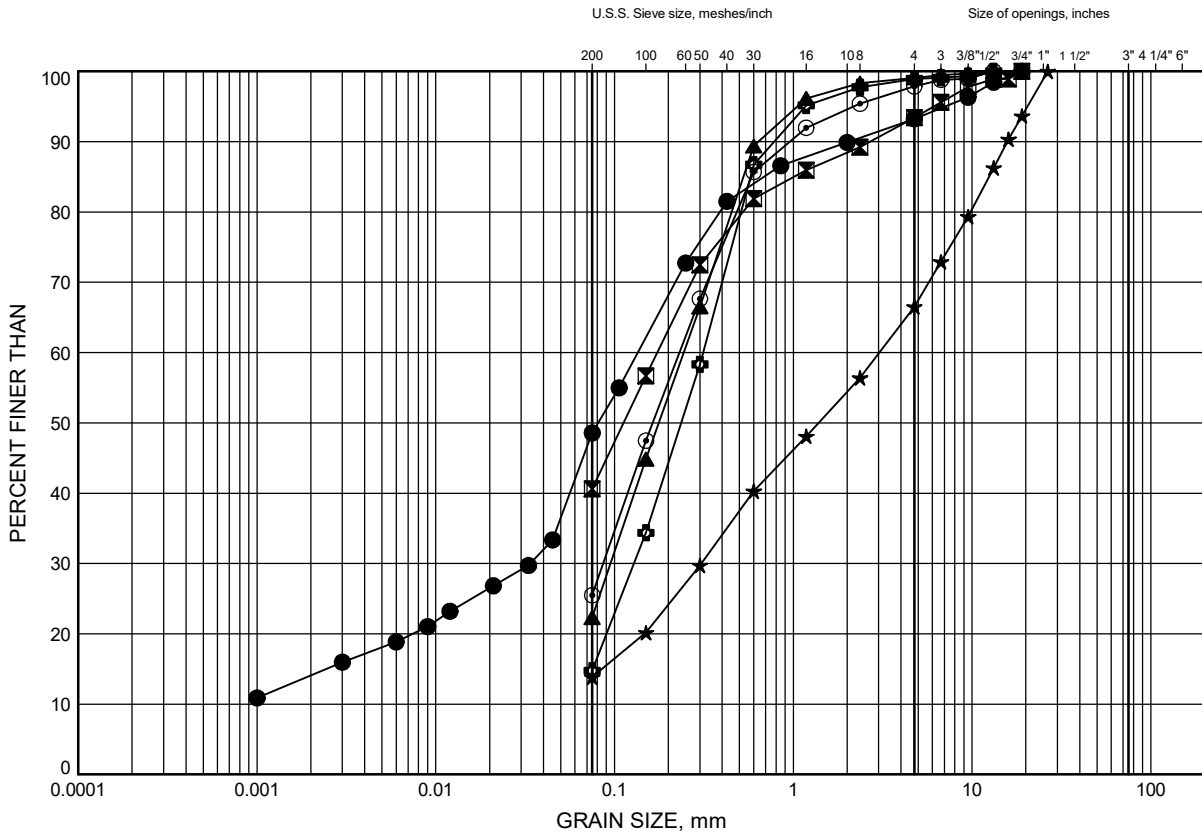
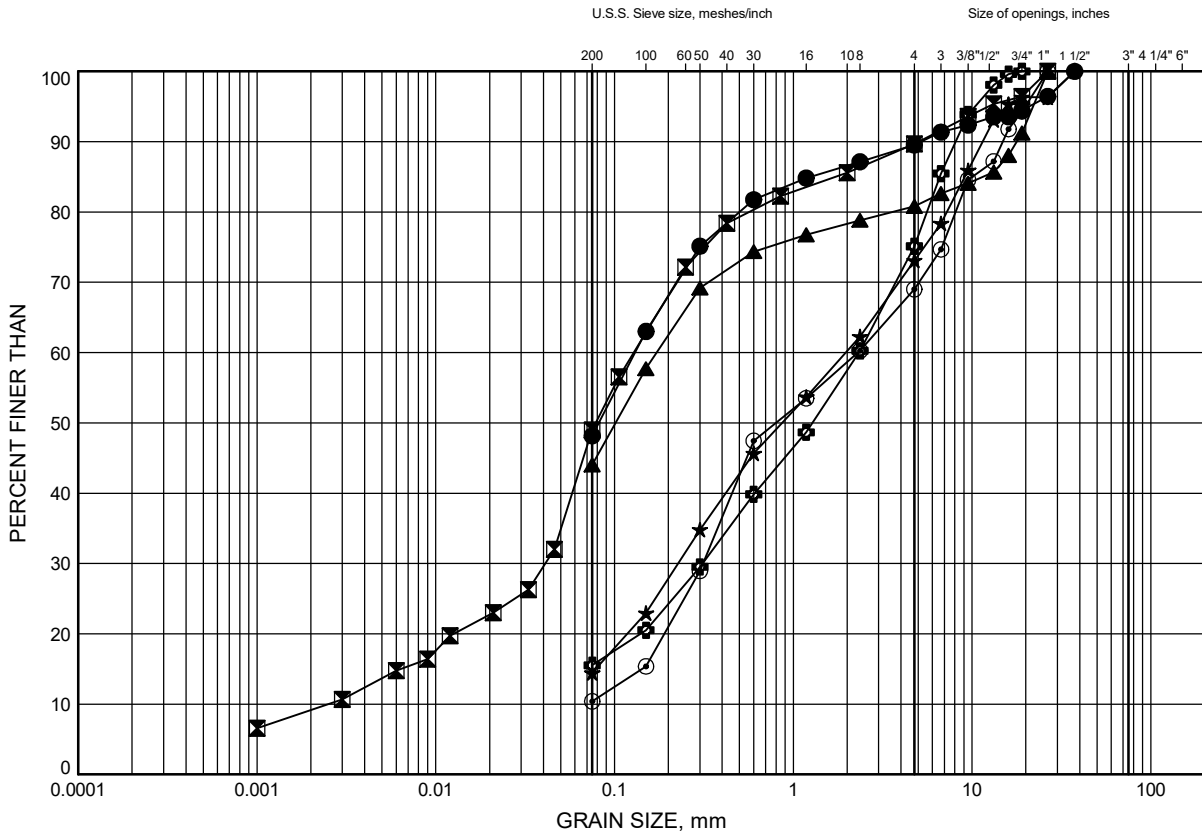
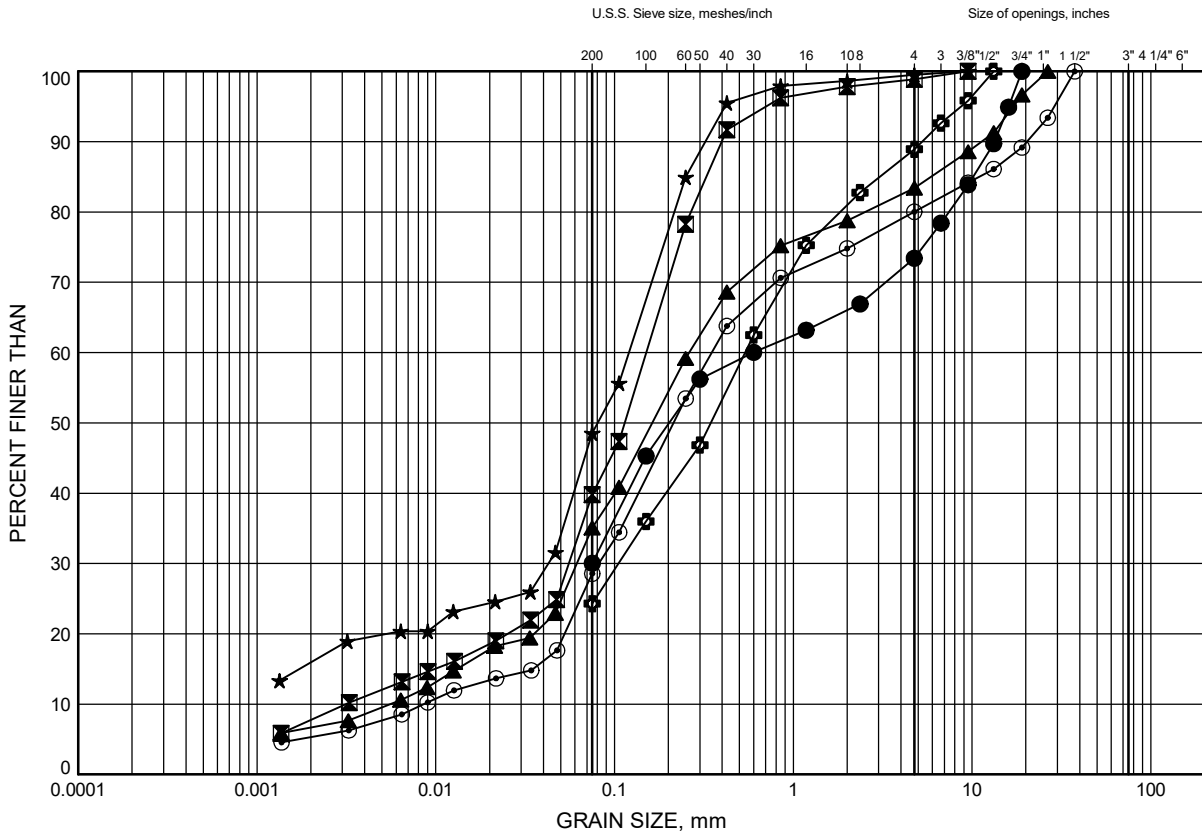
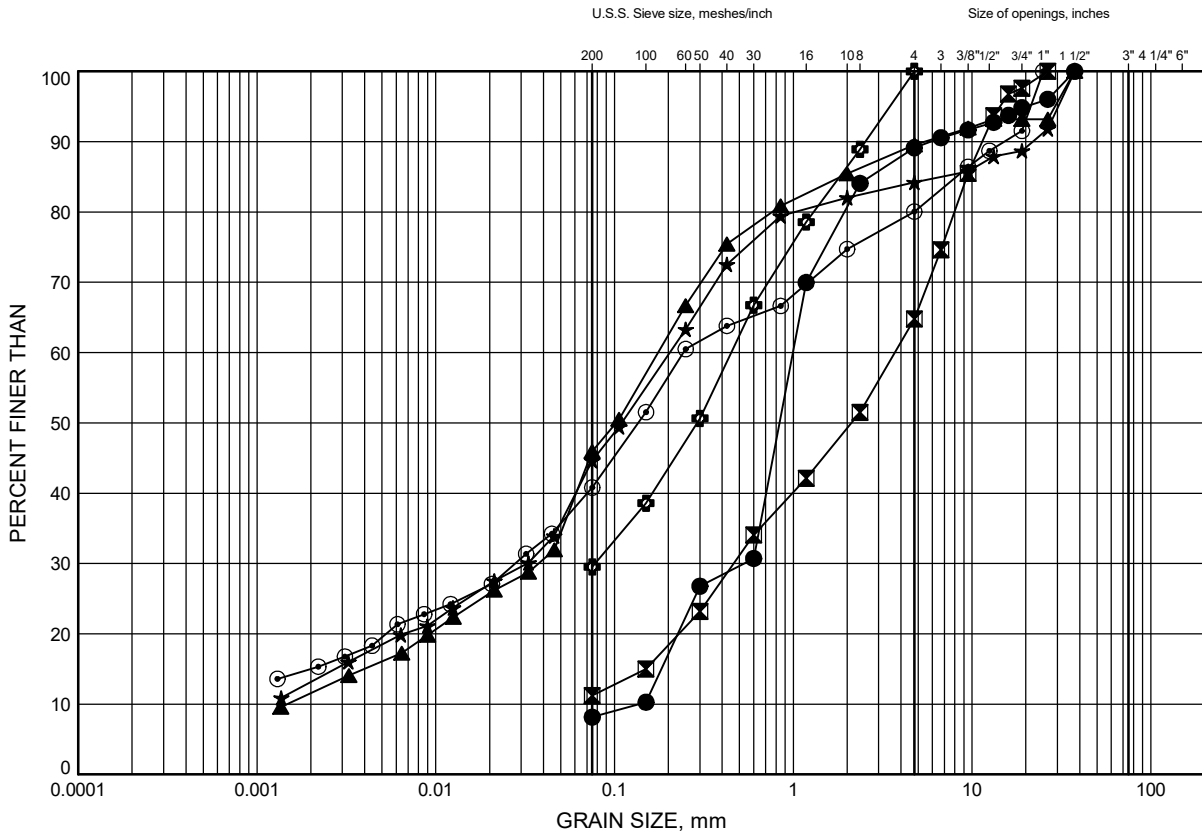
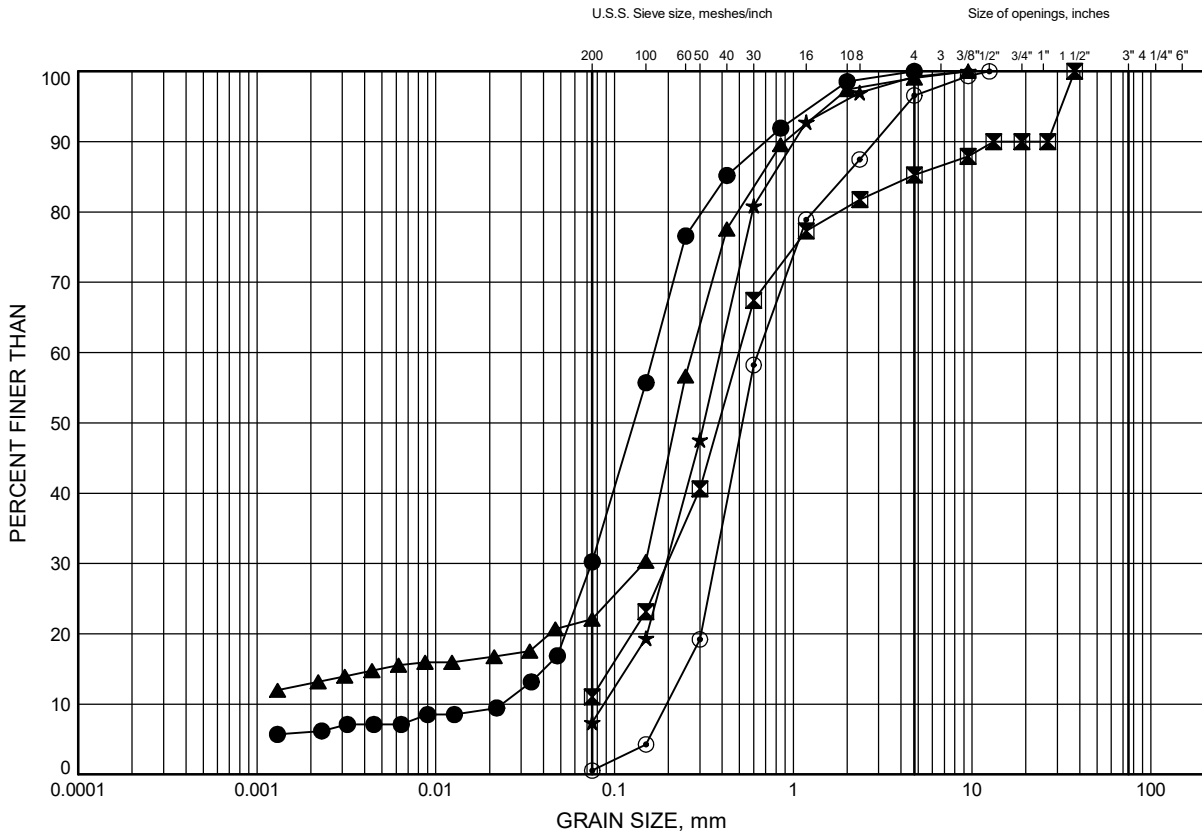
## Granular Fill - Sand

The moisture content of the samples tested ranged from 1% to 28%. A single moisture content of 56% was noted in the surficial granular fill in Borehole 19-05; organics were noted within this sample. The results of grain size analysis conducted on selected samples of this material are summarized in Table 6-1 and are illustrated on Figures C1 to C5 in Appendix C.

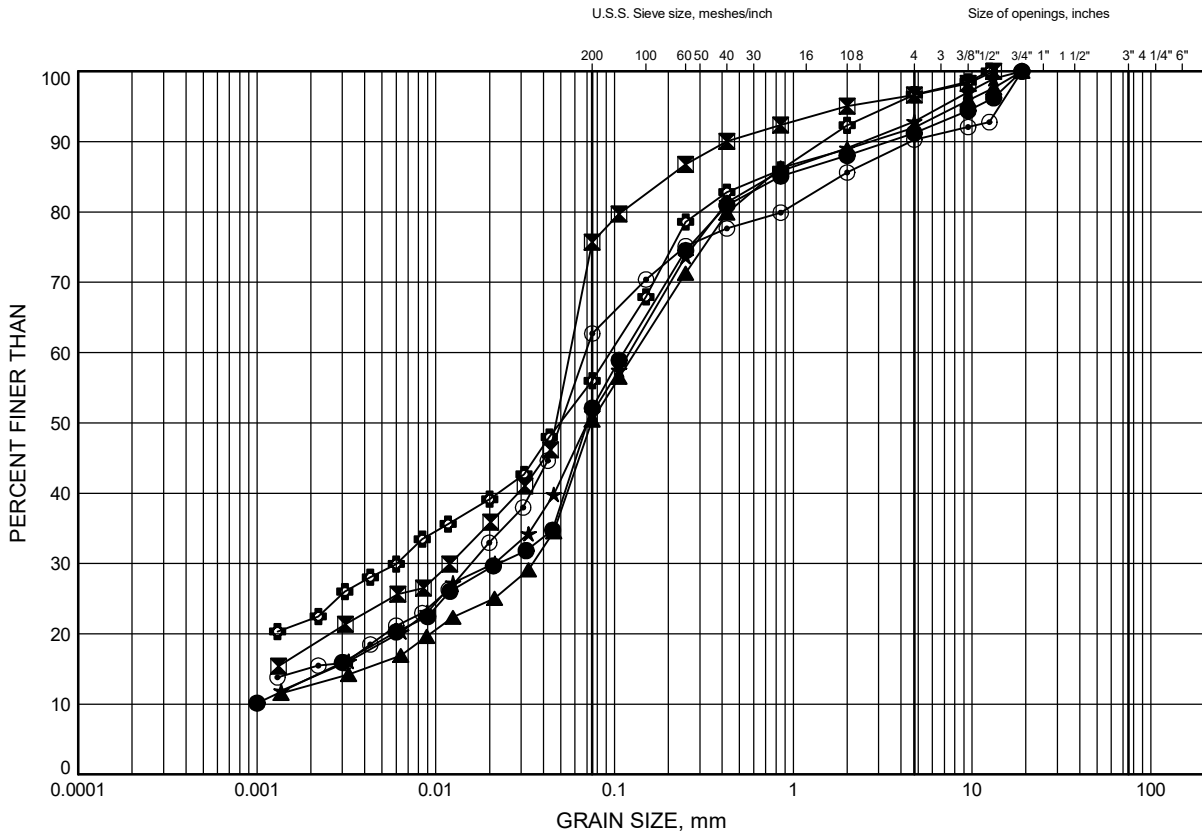
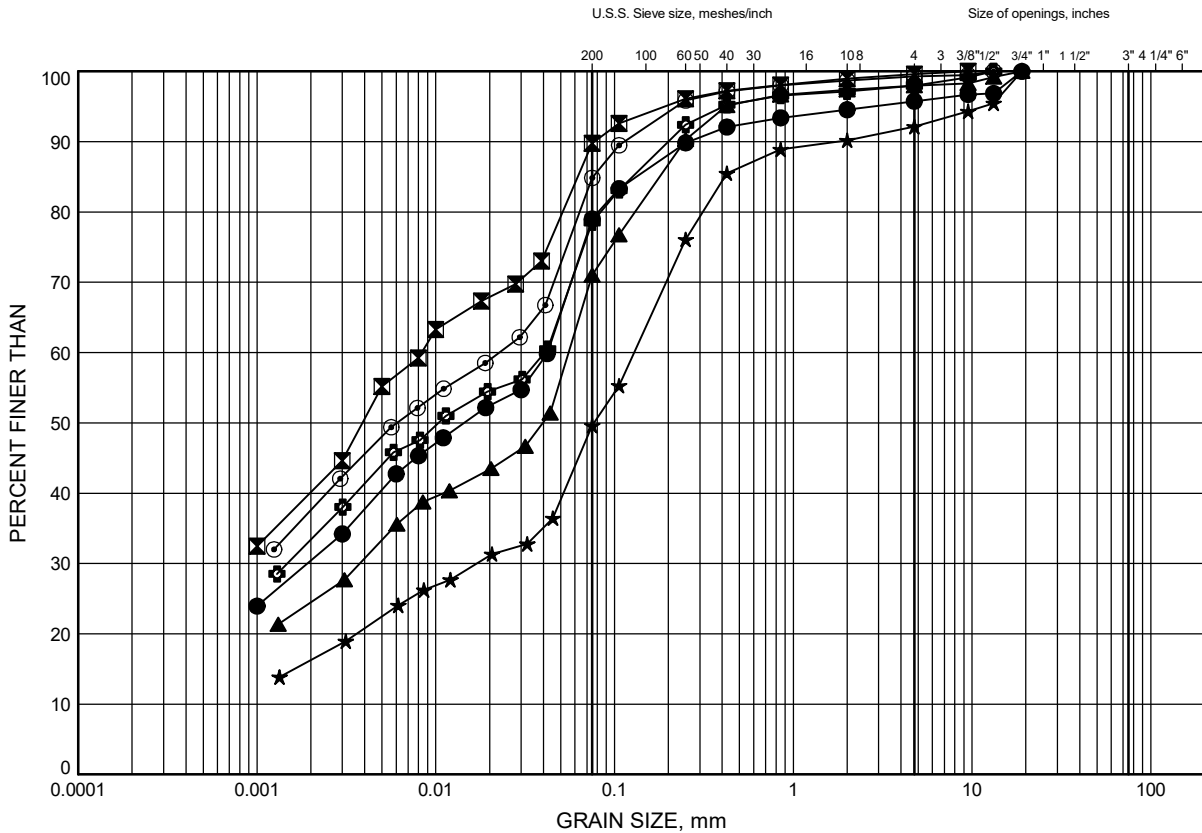
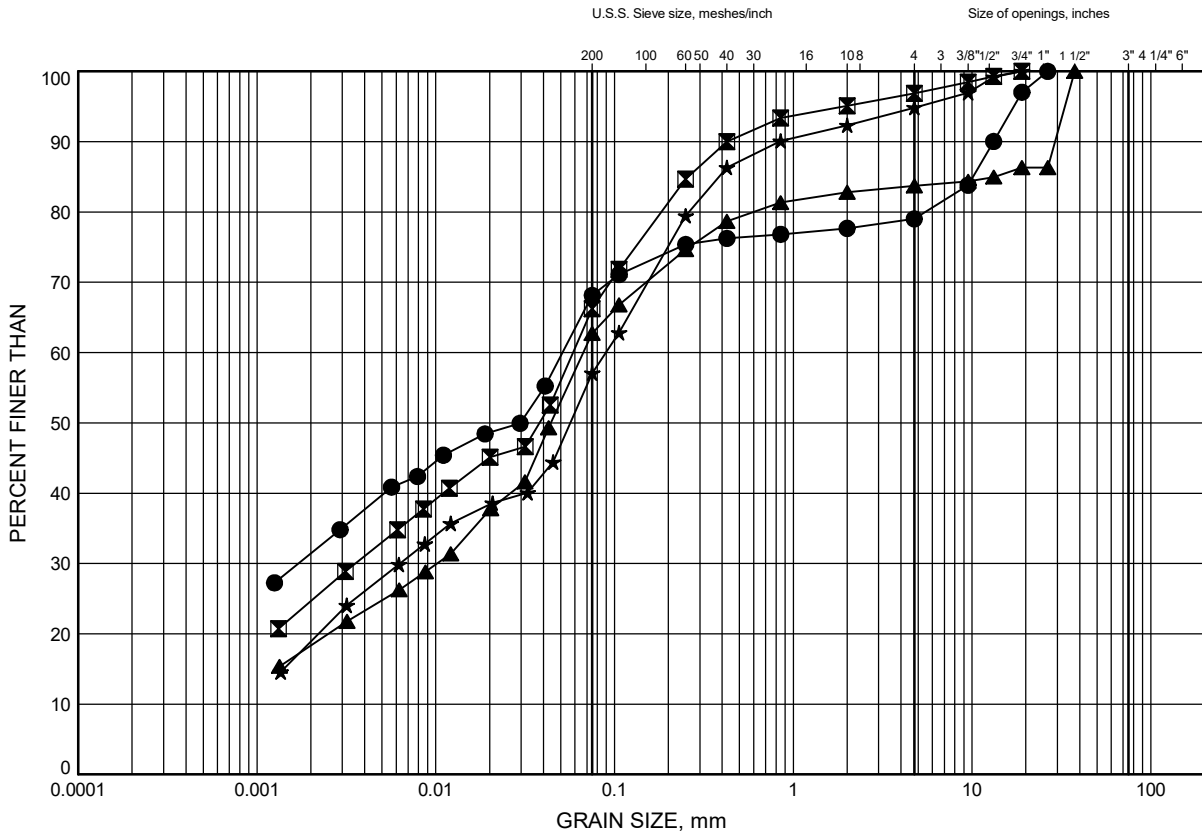
## Cohesive Fill

The moisture content of the samples tested ranged from 8% to 32%. The results of grain size analysis conducted on selected samples of this material are summarized in Table 6-2 and are illustrated in Figures C6 to C8 in Appendix C.

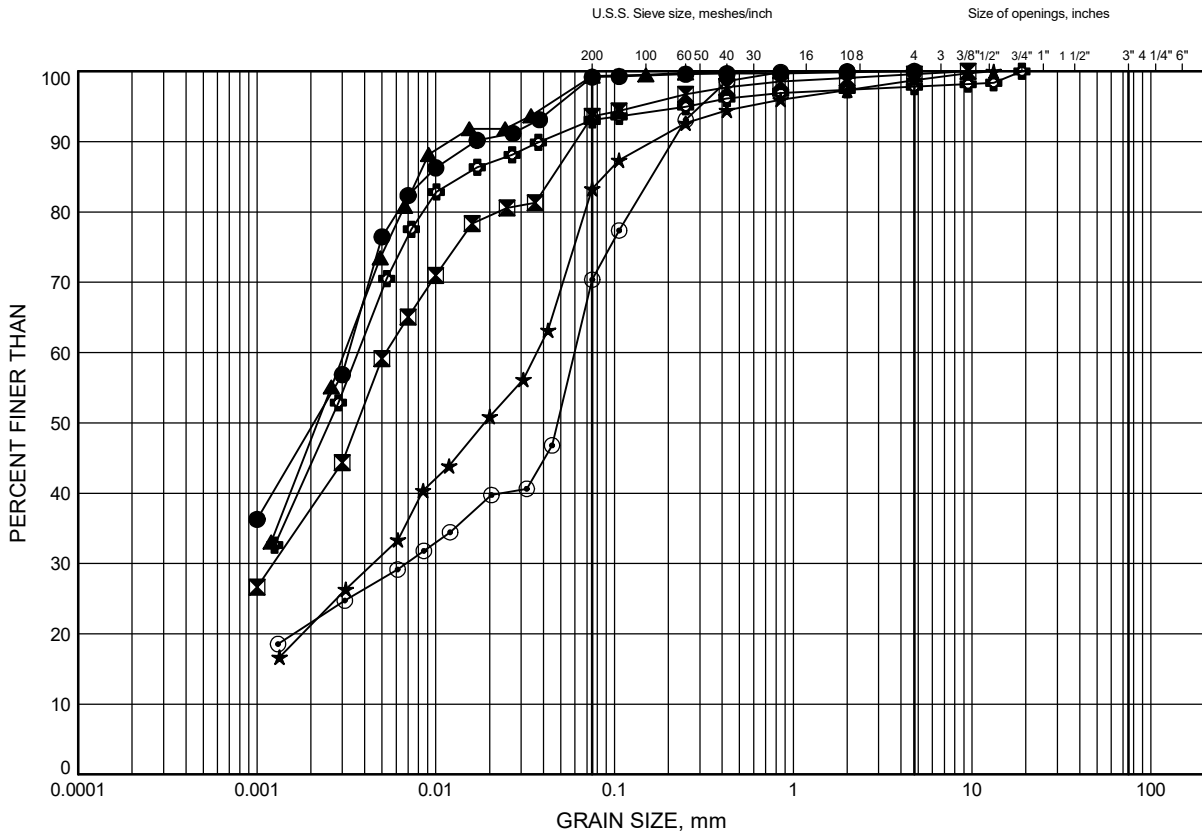
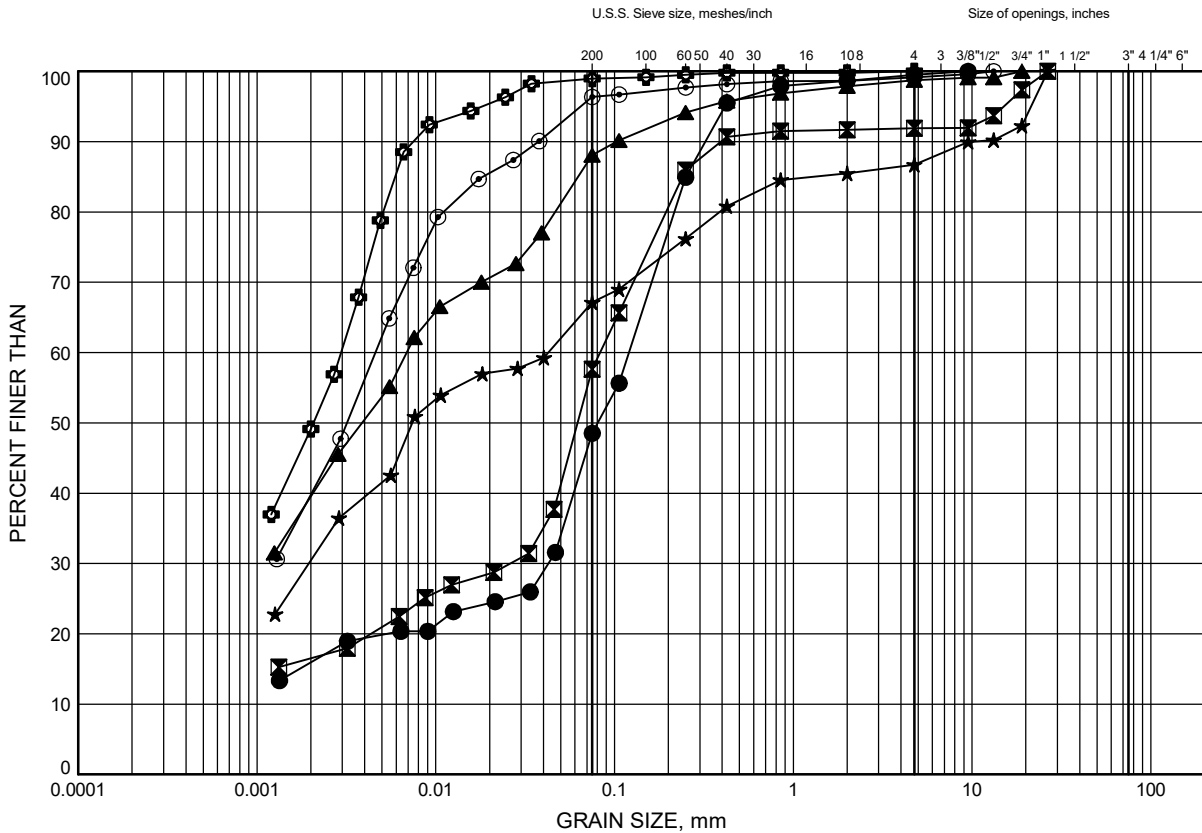
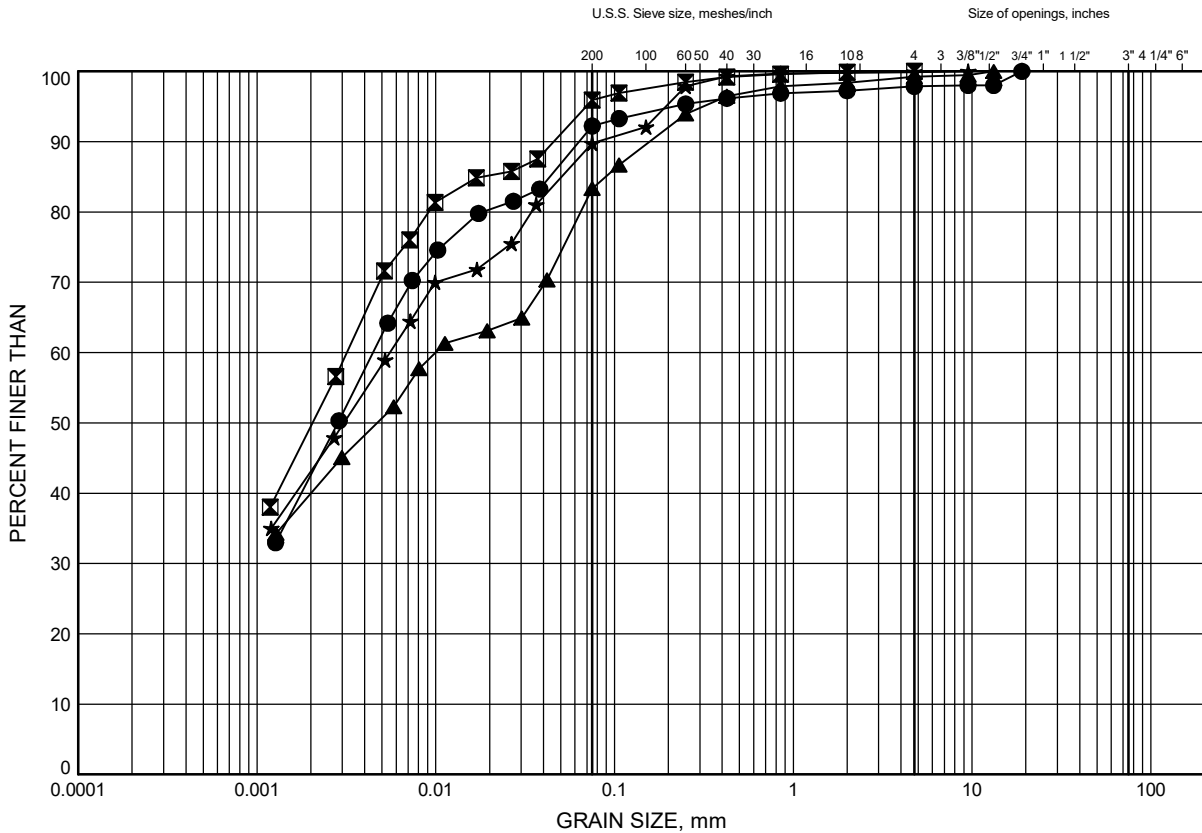
Clayey Silt (CL-ML to CL)

## Silty Clay (CI)

The moisture content of the samples tested ranged from 14% to 39%. The results of grain size analysis testing conducted on selected samples of this material are summarized in Table 6-4 and are illustrated on Figures C9 to C11 in Appendix C.

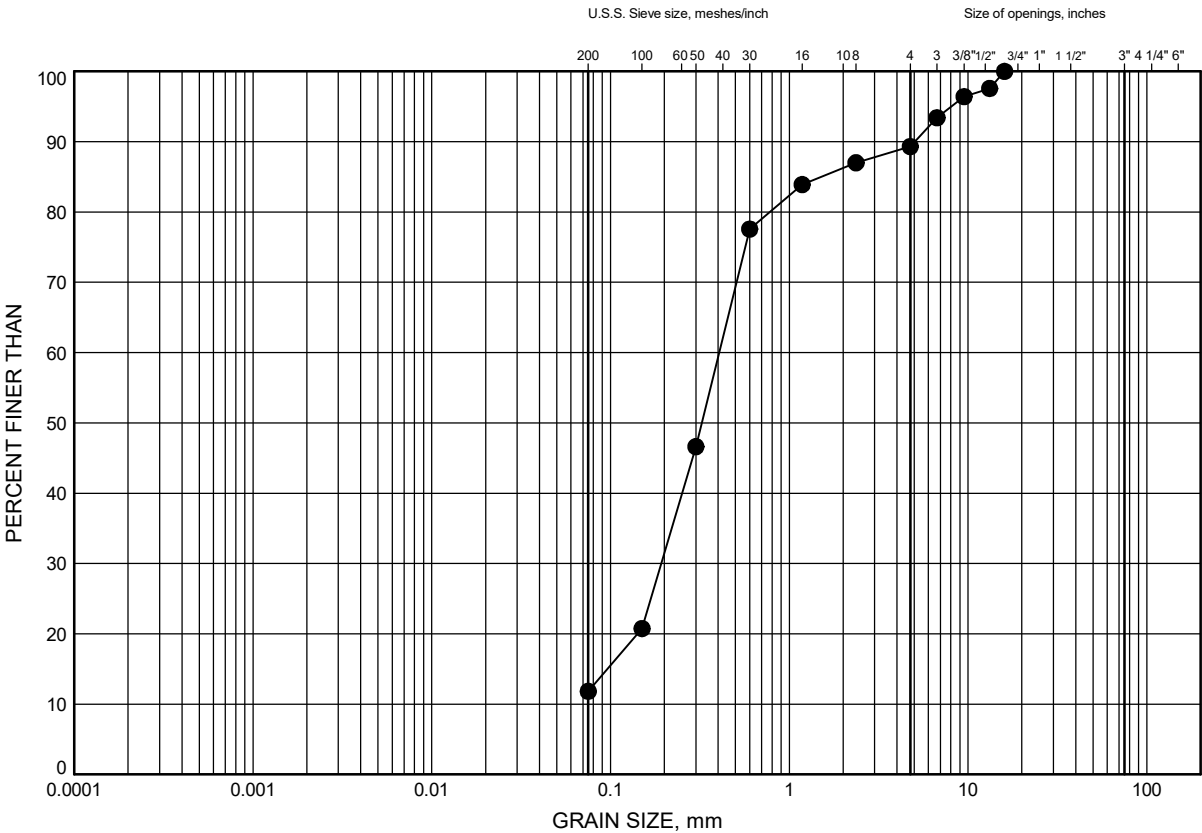
Silty Sand (SM)

The moisture content of the samples tested ranged from 11% to 15%. The results of grain size analysis conducted on one sample of this material indicates a gravel content of 11%, a sand content of 77%, and a silt and clay content of 12%. The grain size analysis results are illustrated on Figure C12 in Appendix C.

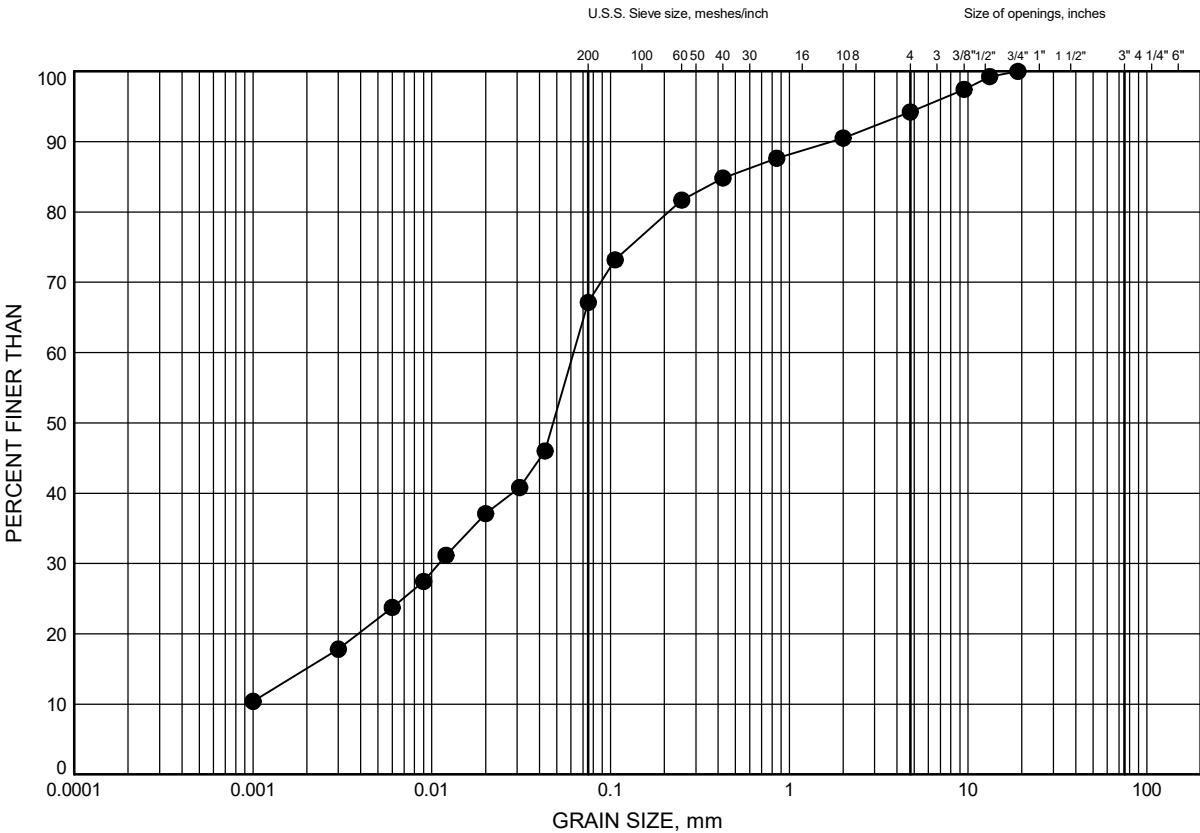
Sandy Silt (ML)

The moisture content of the samples tested ranged from 13% to 25%. The result of an organic content test on material from Borehole 19-13 indicated an organic content of 7.2% and is provided in Appendix C. The results of a grain size analysis test conducted on a sample of this material indicates a gravel content of 6%, a sand content of 27%, a silt content of 52% and clay content of 15%. The grain size analysis results are illustrated on Figure C13 in Appendix C.

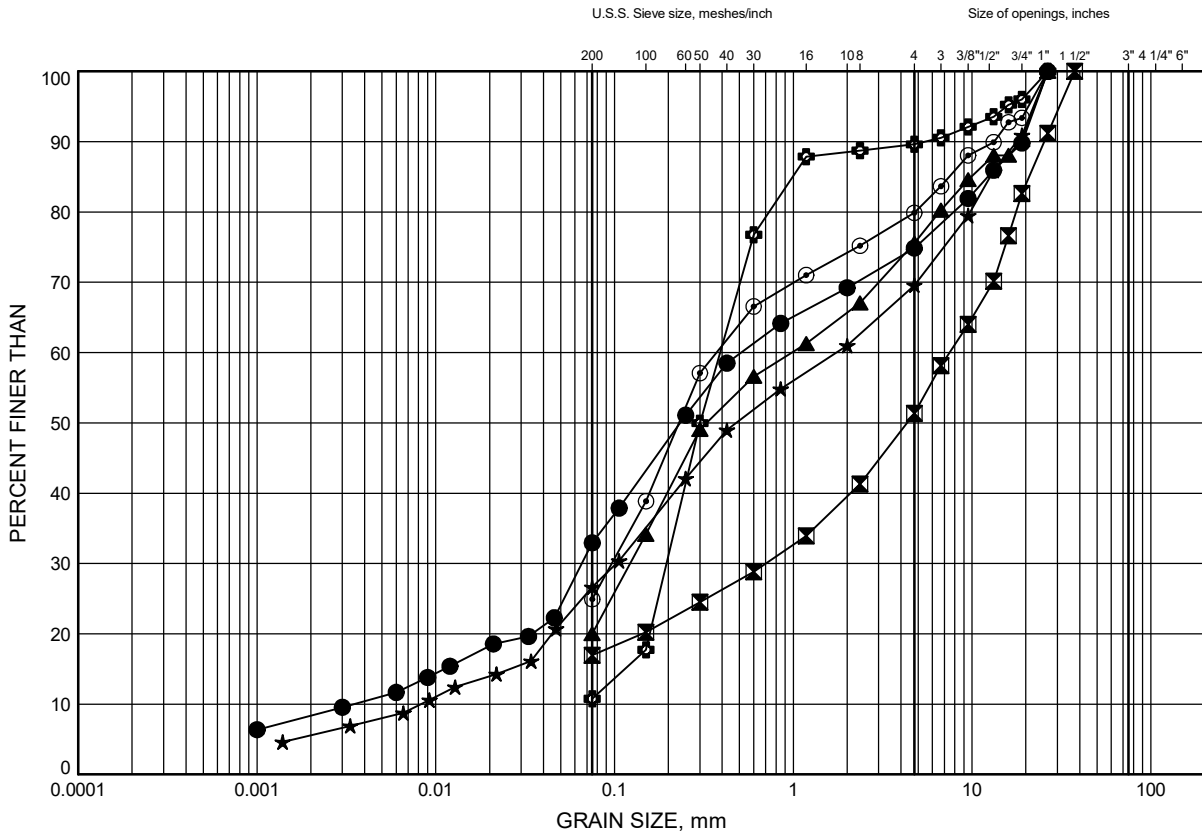
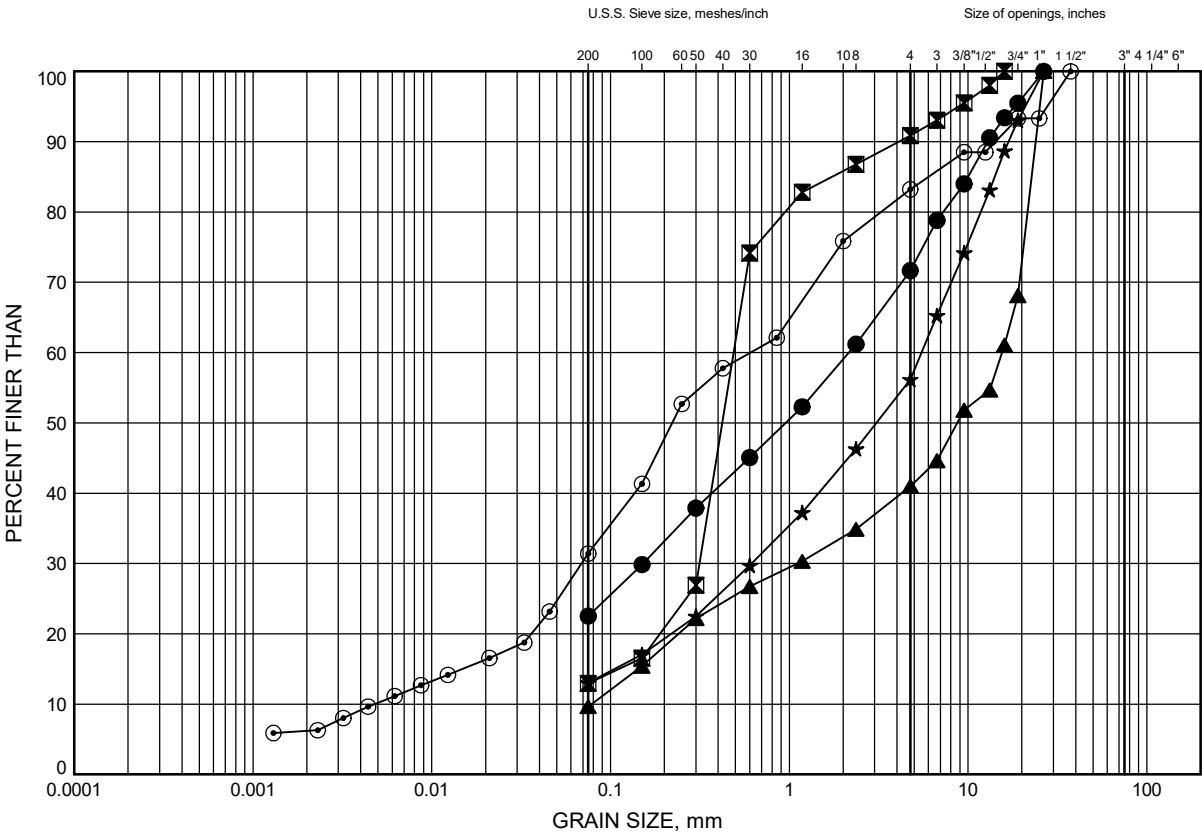
## Glacial Till

The moisture contents of the samples tested ranged from 4% to 29%. The results of grain size analysis conducted on selected samples of this material are summarized in Table 6-7 and are illustrated on Figures C14 and C15 in Appendix C.

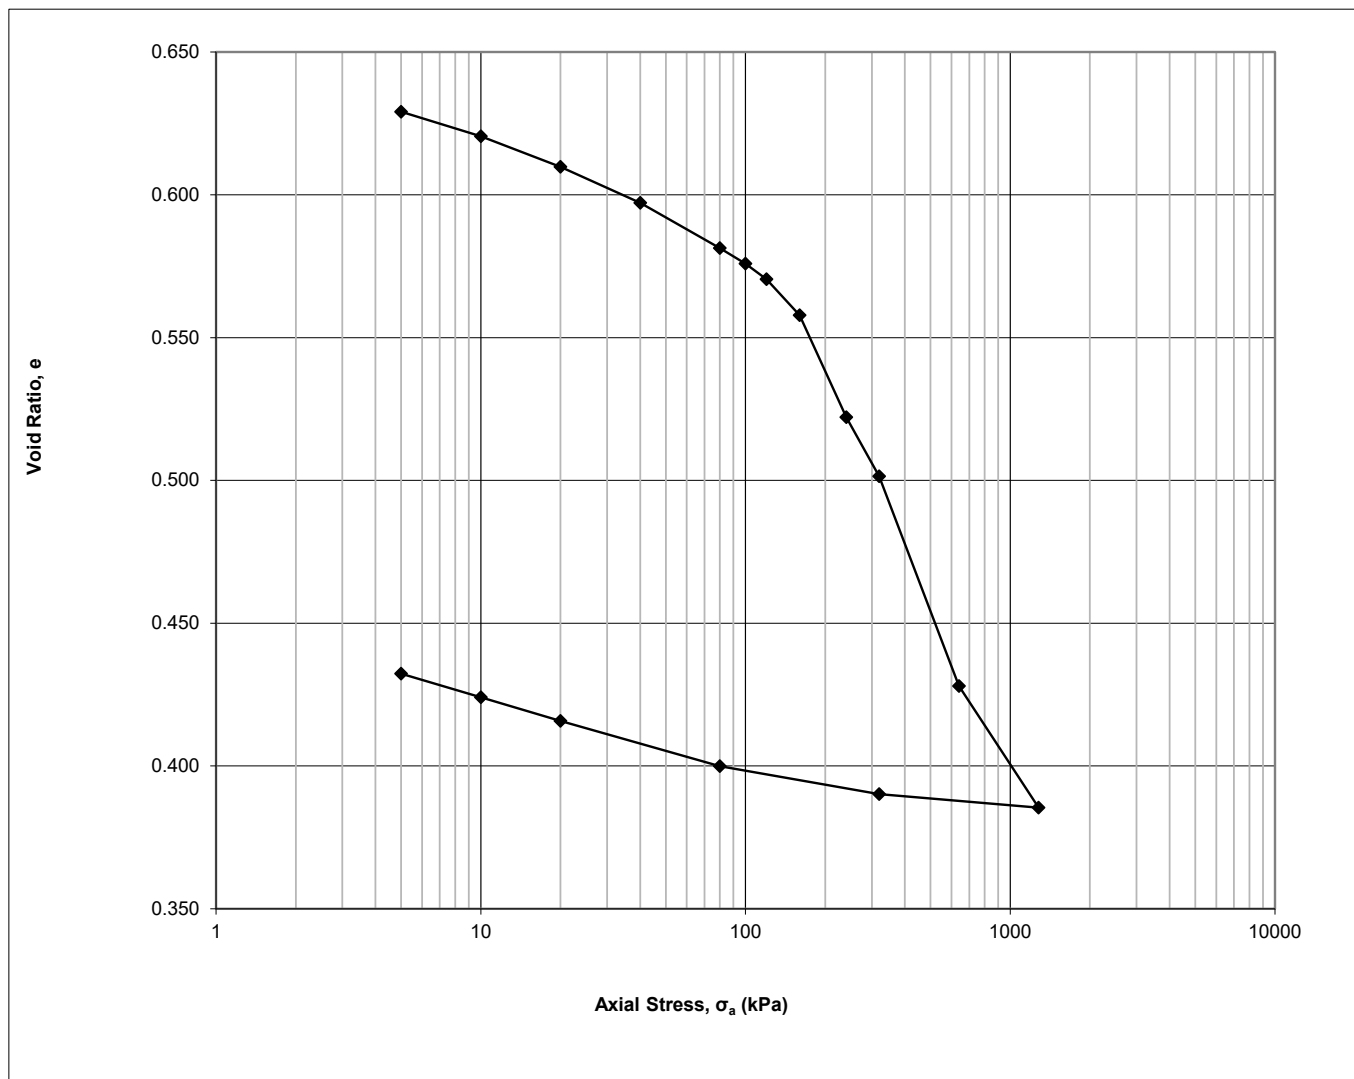
**Thurber Engineering, File# 22645**  
**122410864**  
**BH 19-01**  
**ST 1**  
**20-22 ft.**

**One-Dimensional Consolidation Test using Incremental Loading**  
**ASTM D2435/D2435M - 11**

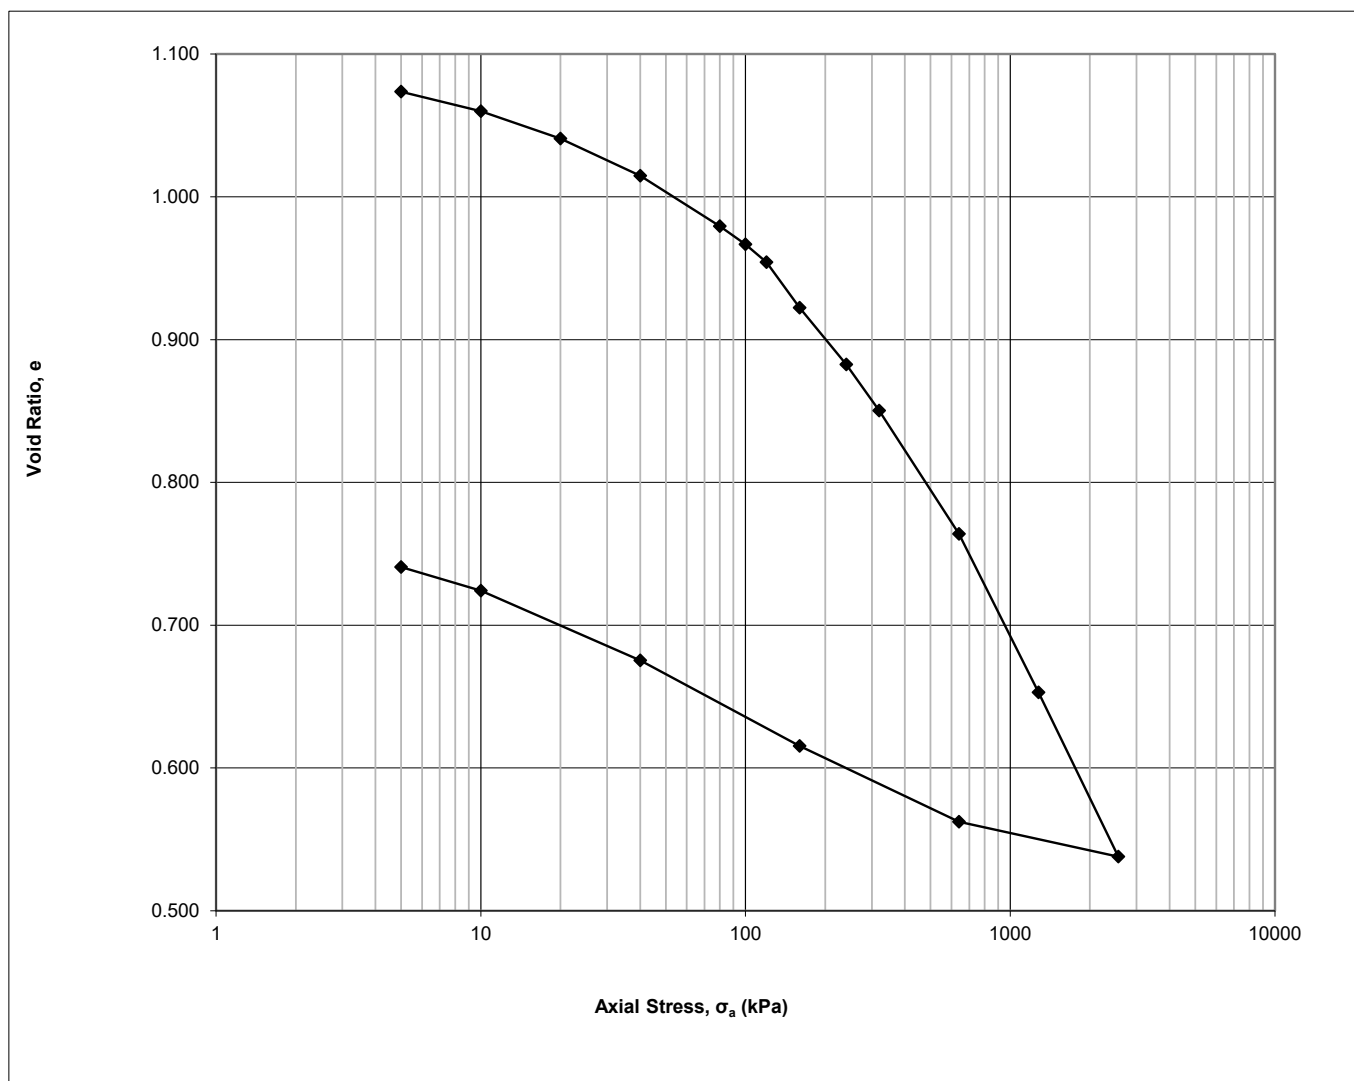
**Thurber Engineering, File# 22645**  
**122410864**  
**BH 19-11B**  
**ST 1**  
**9-11 ft.**

**One-Dimensional Consolidation Test using Incremental Loading**  
**ASTM D2435/D2435M - 11**

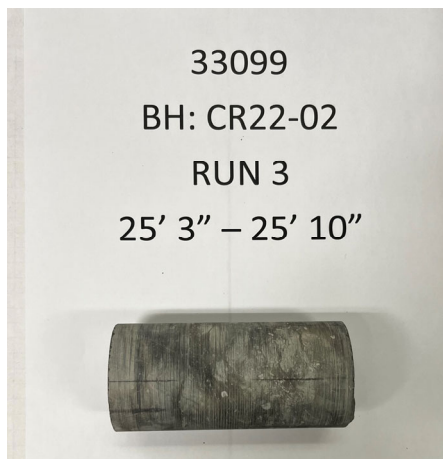
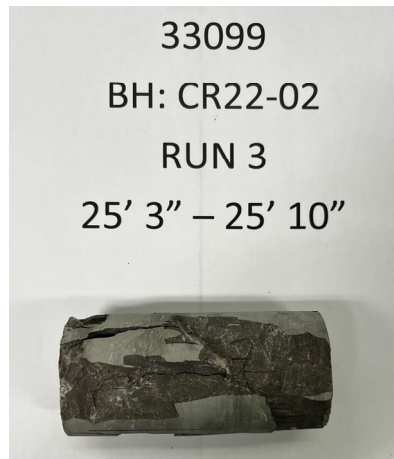
AVG. RATE OF STRAIN TO FAILURE:	0.250 MPa/s
MAXIMUM COMPRESSIVE LOAD:	204.0 kN
UNCONFINED COMPRESSIVE STRENGTH:	103.1 MPa

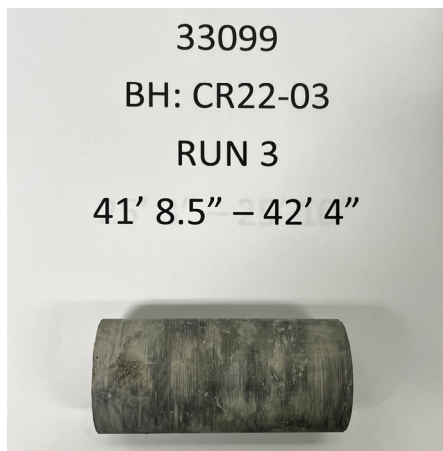
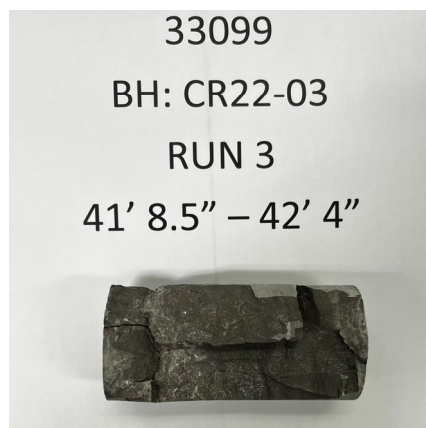
AVG. RATE OF STRAIN TO FAILURE:	0.250 MPa/s
MAXIMUM COMPRESSIVE LOAD:	185.6 kN
UNCONFINED COMPRESSIVE STRENGTH:	93.0 MPa
