**FINAL
FOUNDATION INVESTIGATION REPORT
REPLACEMENT OF THE HIGHWAY 401 OVERPASS AT
GANARASKA RIVER
NORTHUMBERLAND COUNTY – PORT HOPE, ONTARIO
ASSIGNMENT NO.: 4019-E-0021
GWP 4068-14-00**

**SITE NO. 21X-0231/B0
GEOCRES NO.: 30M16-078**

**Report
to
MCINTOSH PERRY | LEA JOINT VENTURE**

August 2023
Thurber File No.: 33099

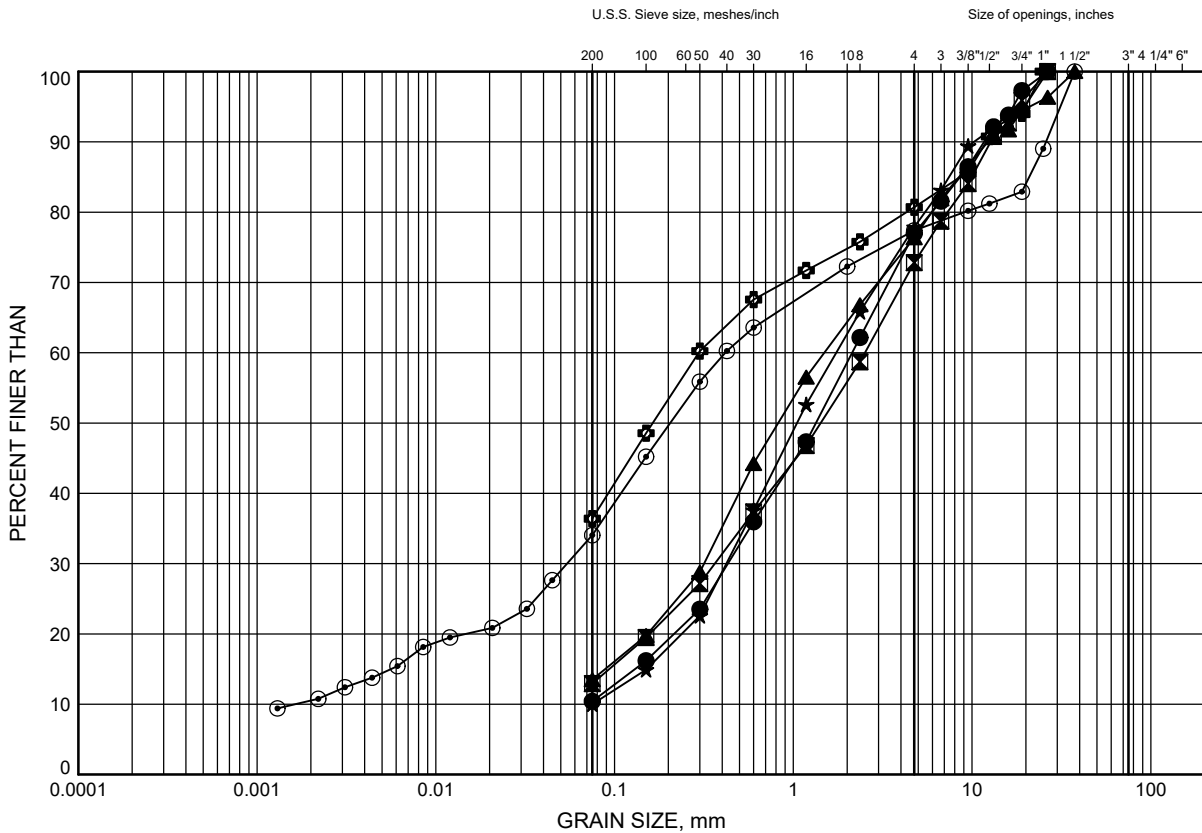
GRAIN SIZE DISTRIBUTION

FILL: Silty Sand with Gravel

The moisture content of the samples tested ranged from 1% to 32%. The results of grain size analysis conducted on seven samples of this material are summarized in Table 6-1 and are illustrated on Figures C1 and C2 in Appendix C.

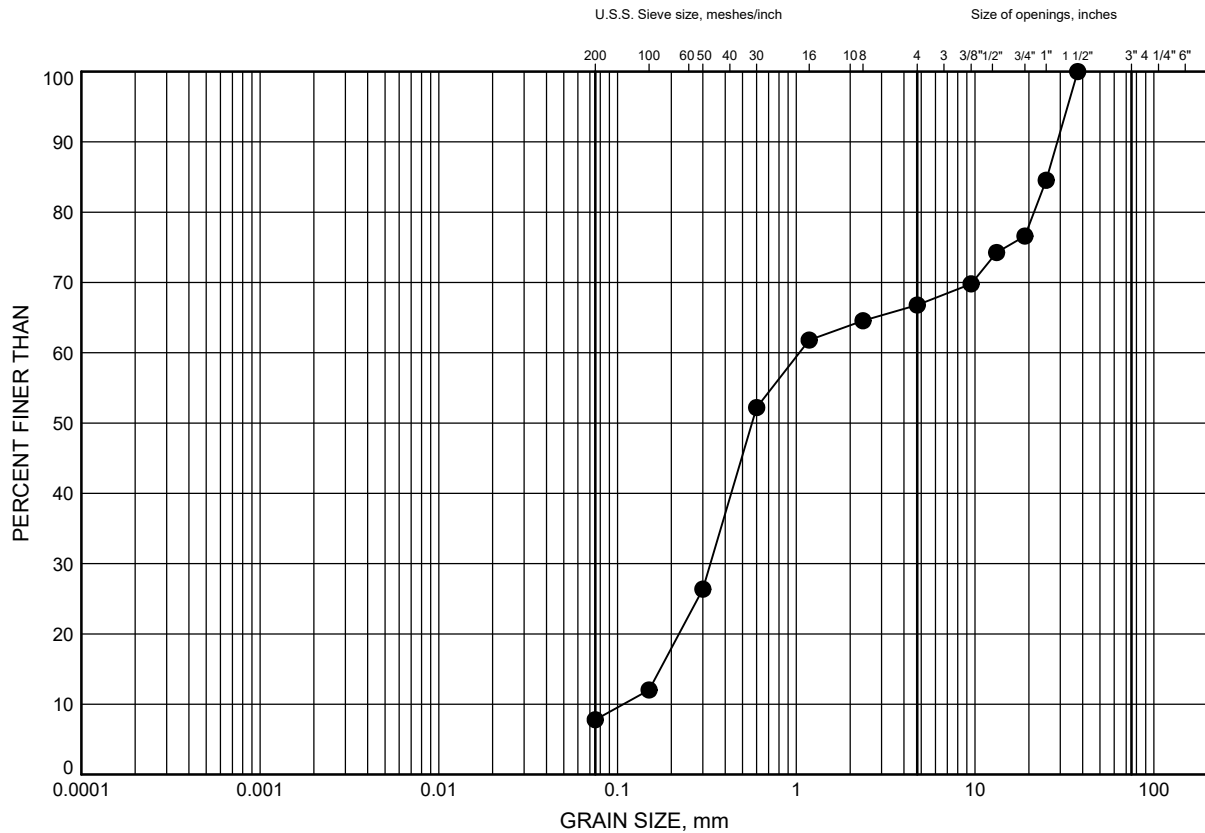
GRAIN SIZE DISTRIBUTION

FILL: Silty Sand with Gravel

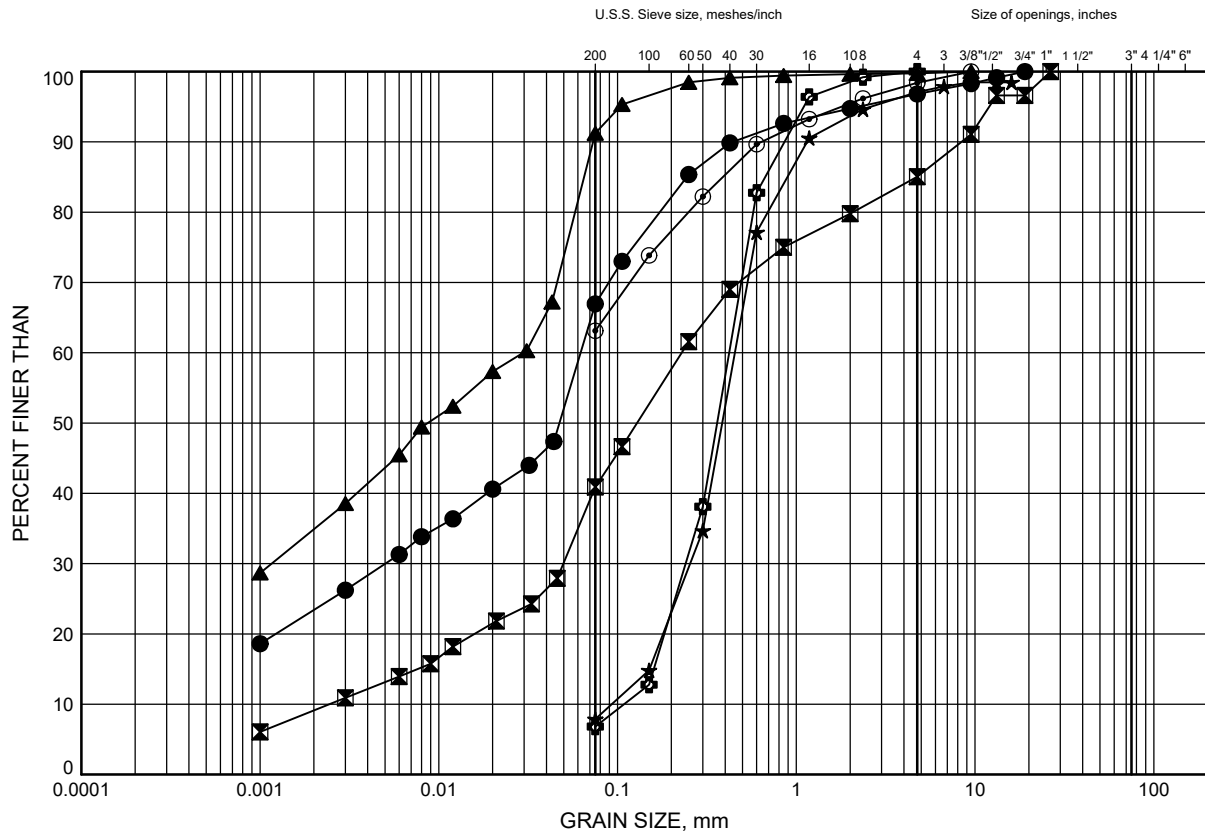
GRAIN SIZE DISTRIBUTION

FILL: Variable

The moisture content of the samples tested ranged from 3% to 67%. The results of grain size analysis conducted on seven samples of this material are summarized in Table 6-2 and are illustrated on Figures C3 and C4 in Appendix C.

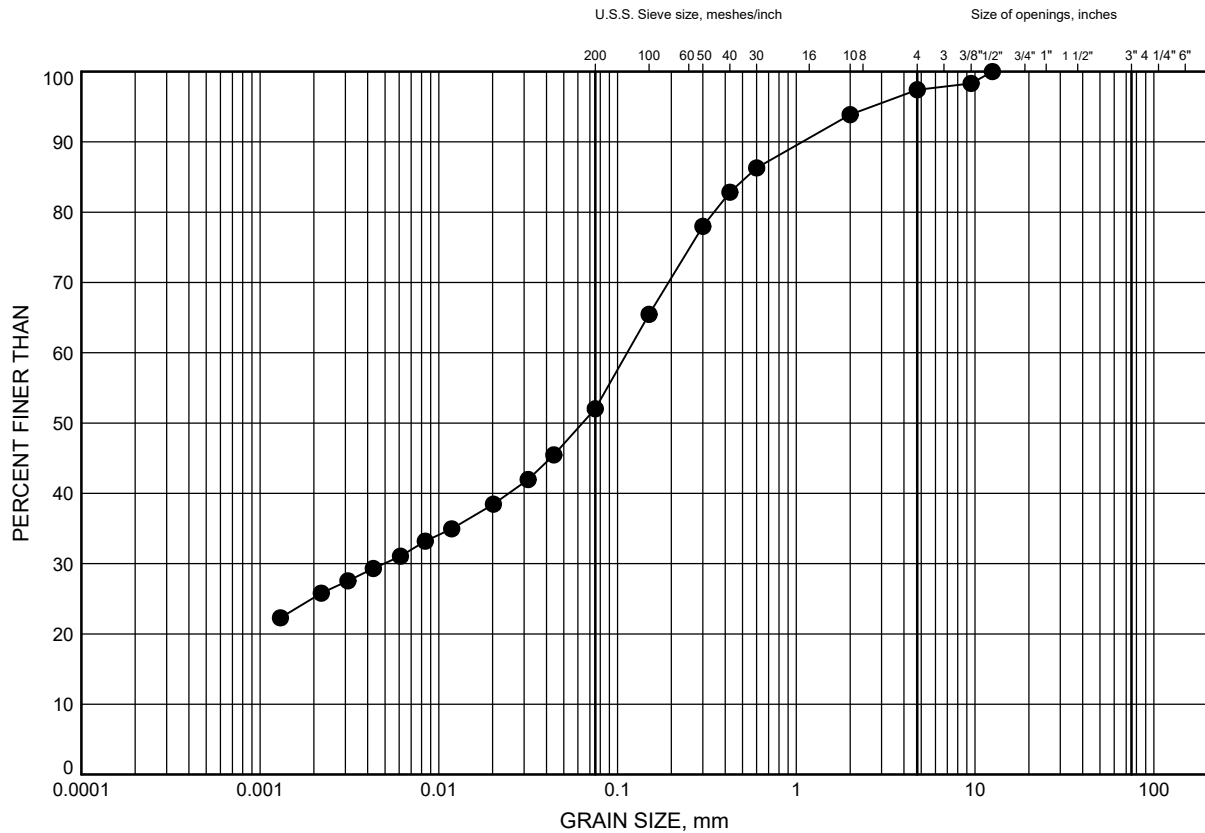
GRAIN SIZE DISTRIBUTION

FILL: Variable

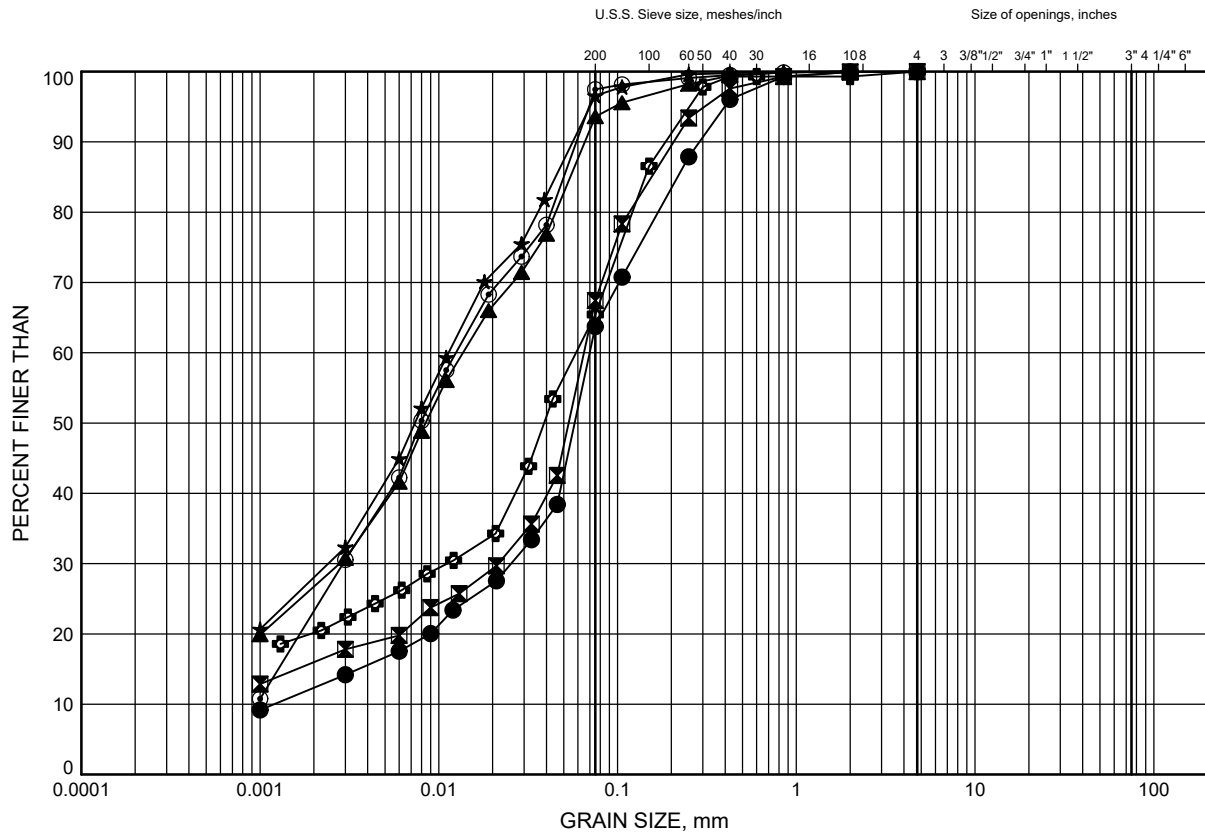
GRAIN SIZE DISTRIBUTION

Organic Silt (ML-OL to MH-OH)

The moisture content of the samples tested ranged from 14% to 99%. The results of grain size analysis testing conducted on nine samples of this material are summarized in Table 6-4 and are illustrated on Figure C5 and C6 in Appendix C.

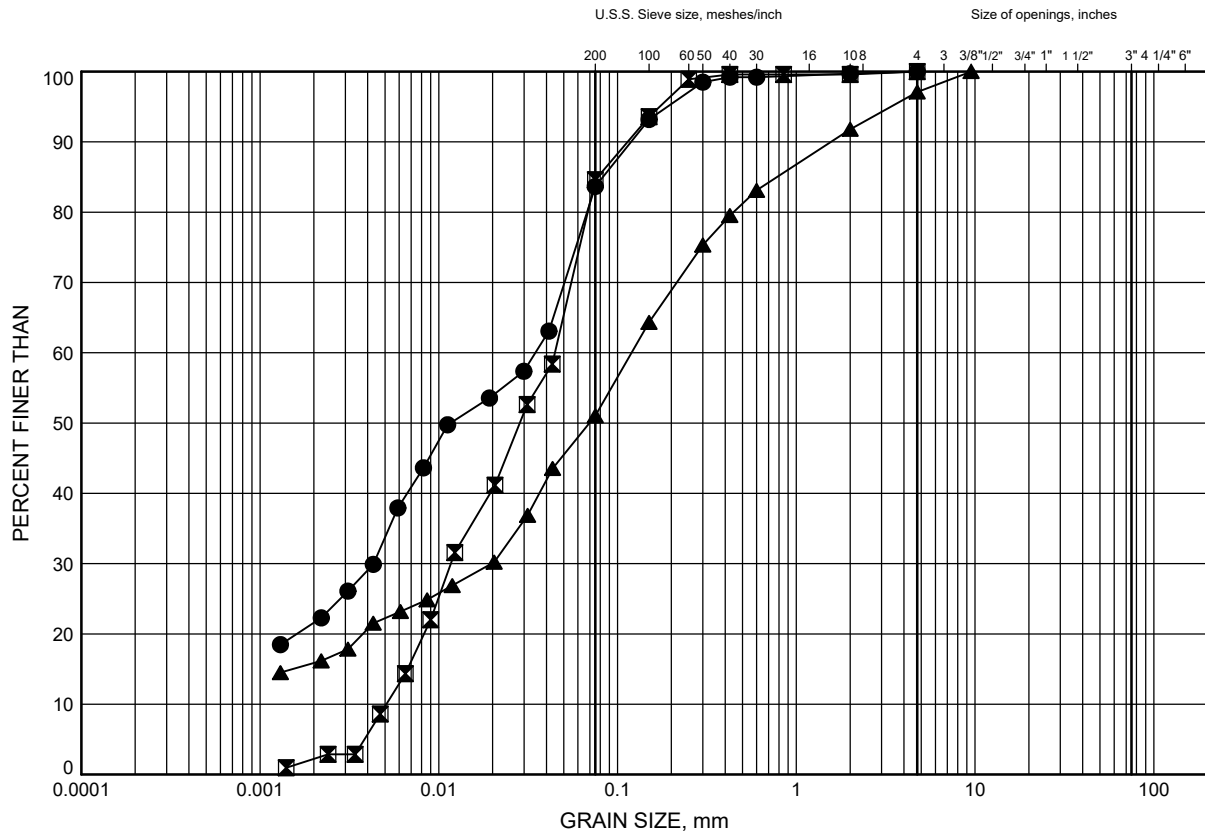
GRAIN SIZE DISTRIBUTION

Organic Silt (ML-OL to MH-OH)

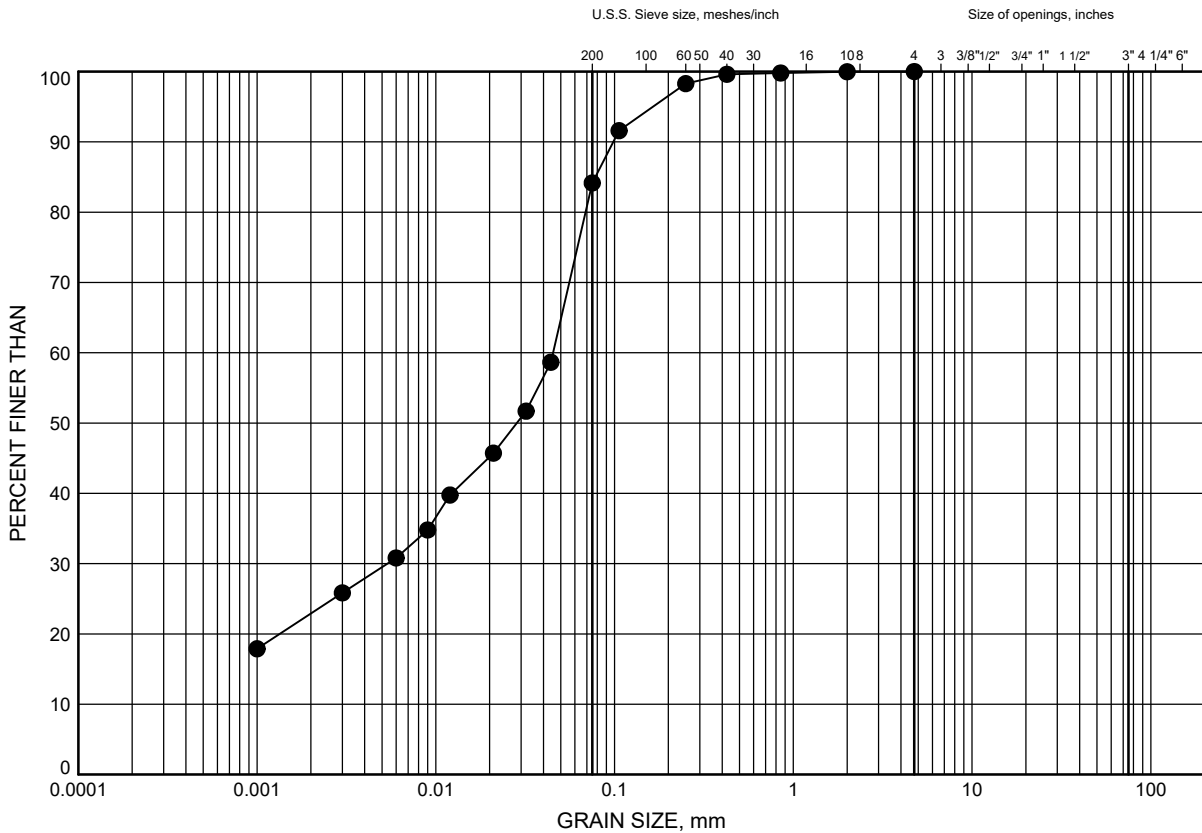
GRAIN SIZE DISTRIBUTION

Clayey Silt (CL)

The moisture content of the sample tested was 31%. The results of a grain size analysis tests indicated a gravel content of 0%, sand content of 16%, a silt content of 61% and a clay content 23%. Grain size analysis results are illustrated on Figure C7 in Appendix C.

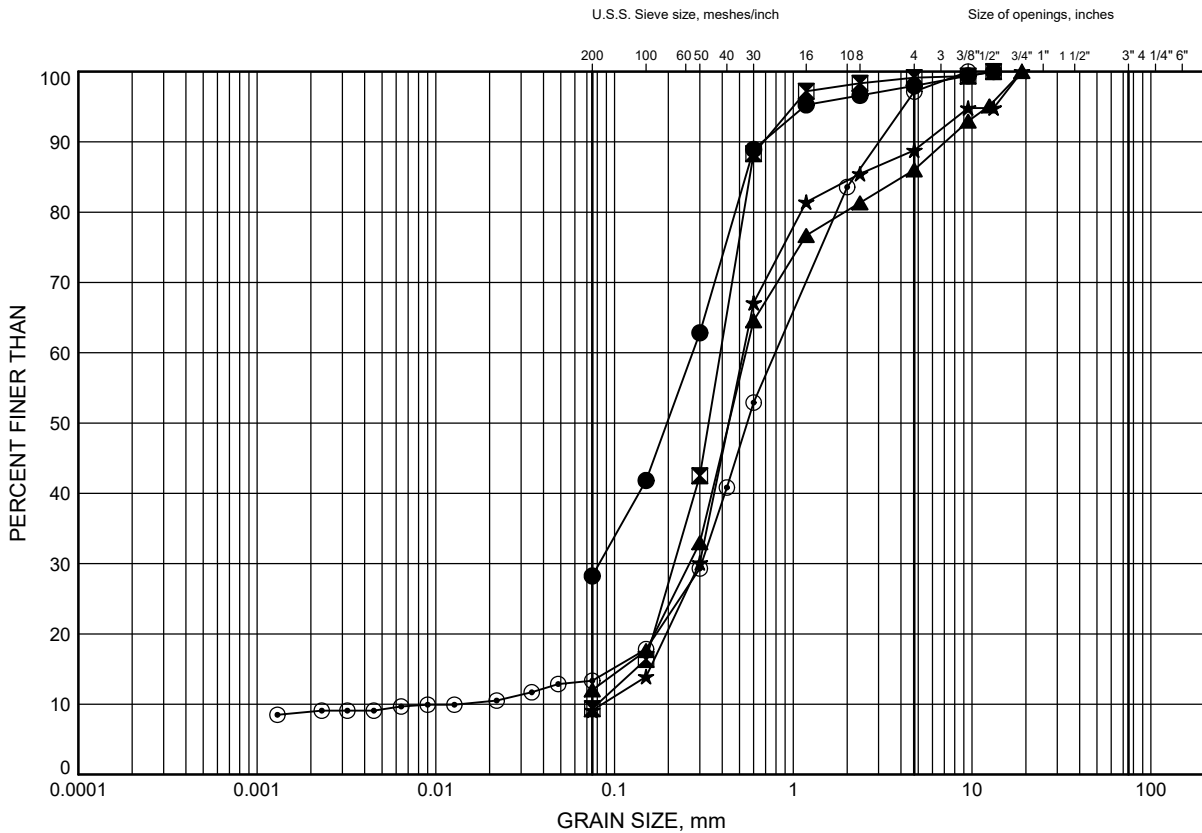
Silty Sand to Sand with silt (SM to SP-SM to SW-SM)

The moisture content of the sample tested ranged from 1% to 15%. The results of a grain size analysis testing conducted on five samples of this material are summarized in Table 6-6 and are illustrated on Figure C8 in Appendix C.

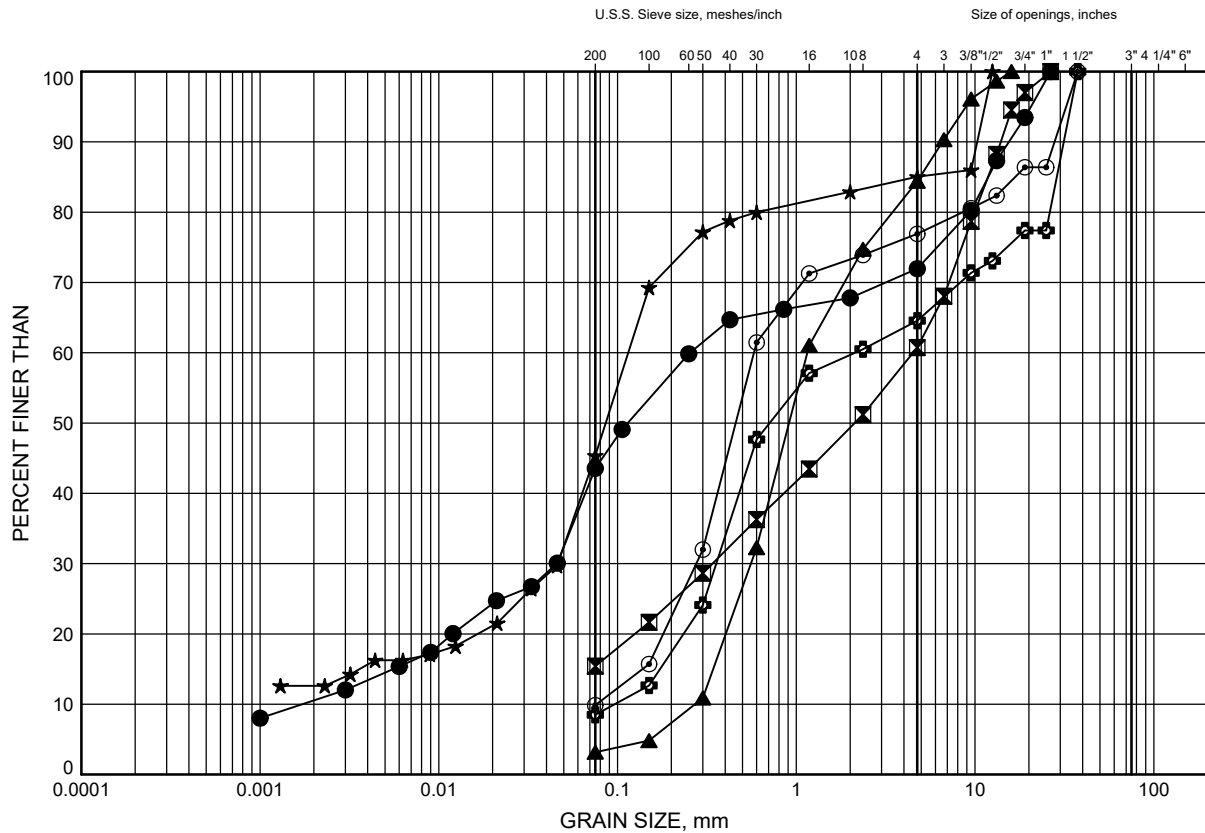
GRAIN SIZE DISTRIBUTION

Glacial Till

The moisture content of the sample tested ranged from 4% to 27%. The results of a grain size analysis testing conducted on six samples of this material are summarized in Table 6-7 and are illustrated on Figures C9 in Appendix C.

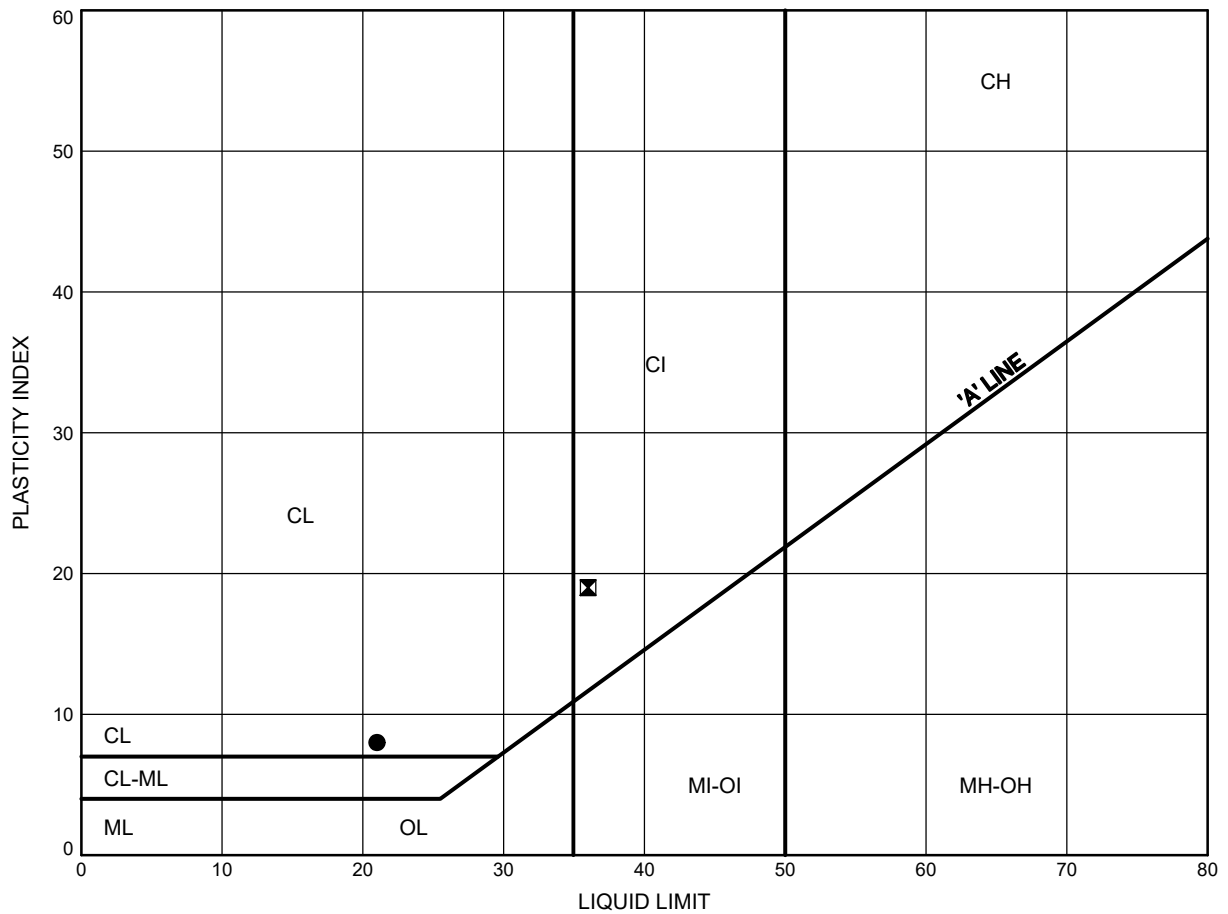
FIGURE C10

Fill: Variable

The results of Atterberg Limits testing completed on three samples of the fine-grained embankment fill are summarized in Table 6-3 and are illustrated on Figure C10 in Appendix C. It should be noted that one sample of embankment fill was found to be non-plastic.

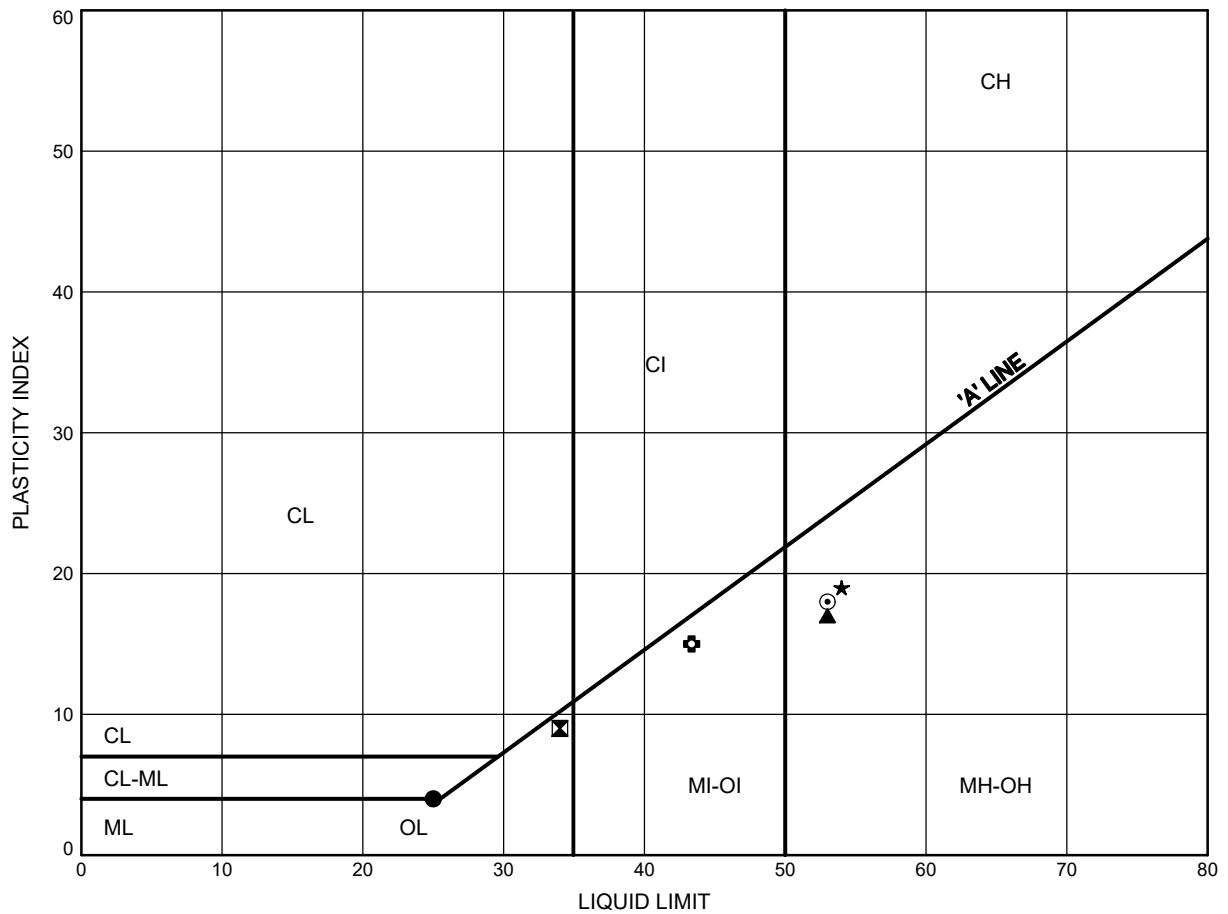
FIGURE C11

Organic Silt (ML-OL to MH-OH)

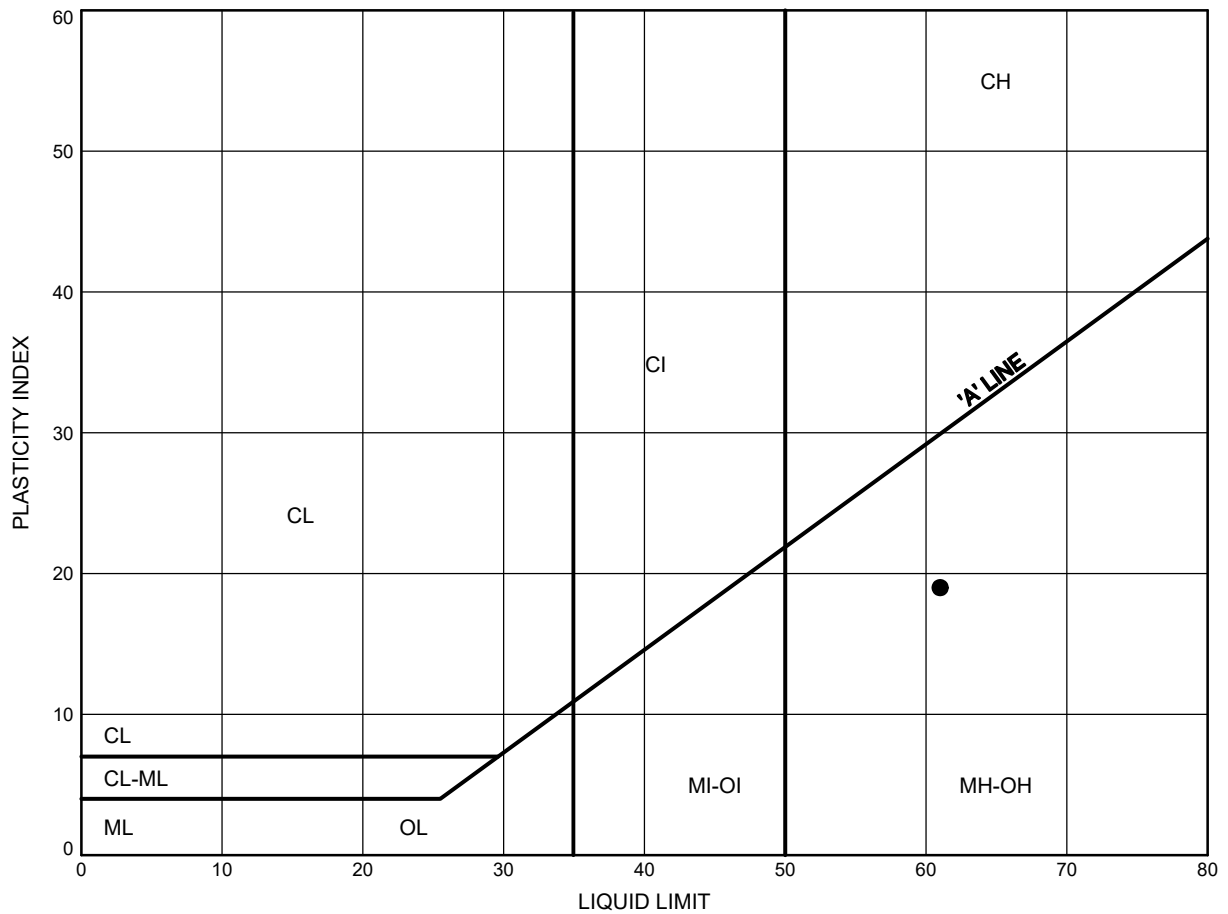
FIGURE C12

Organic Silt (ML-OL to MH-OH)

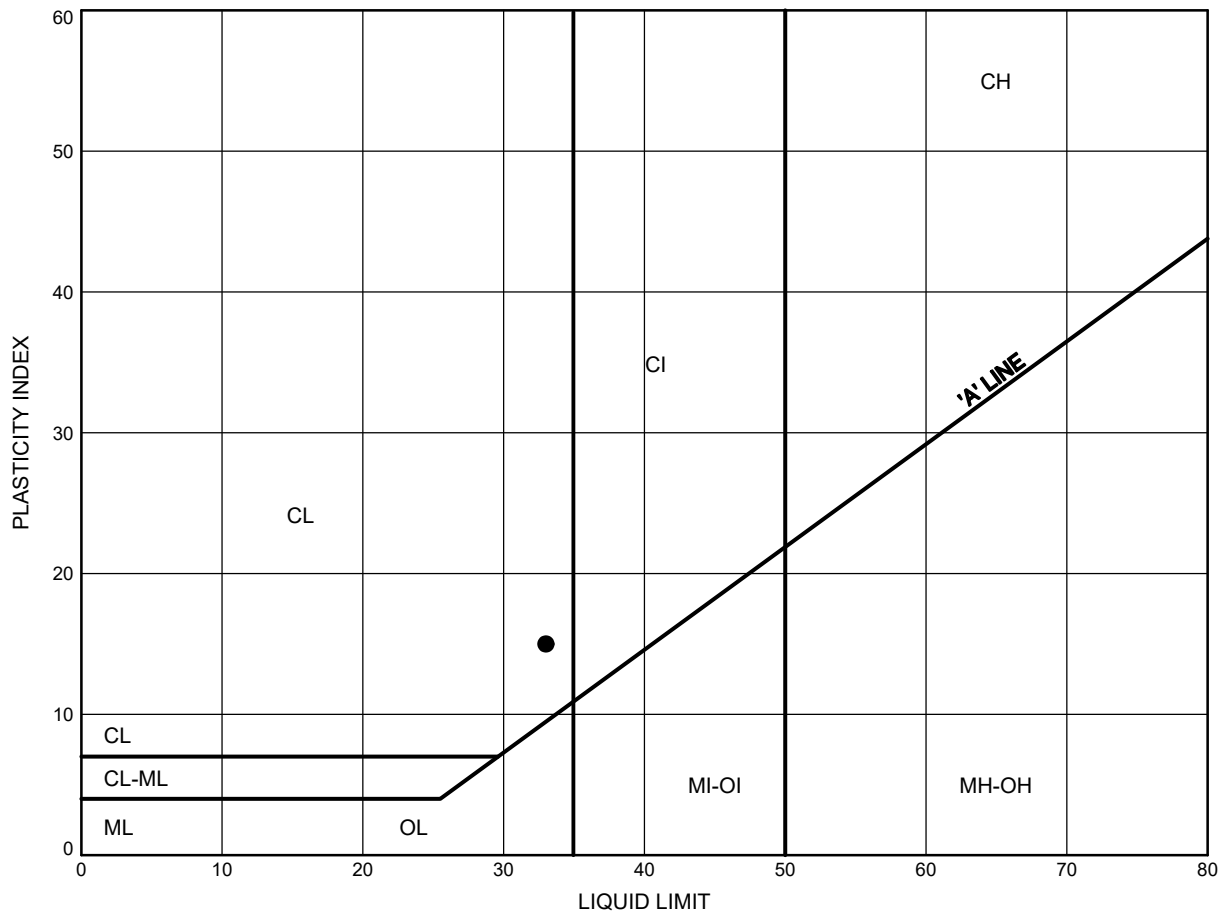
FIGURE C13

Clay (CL)

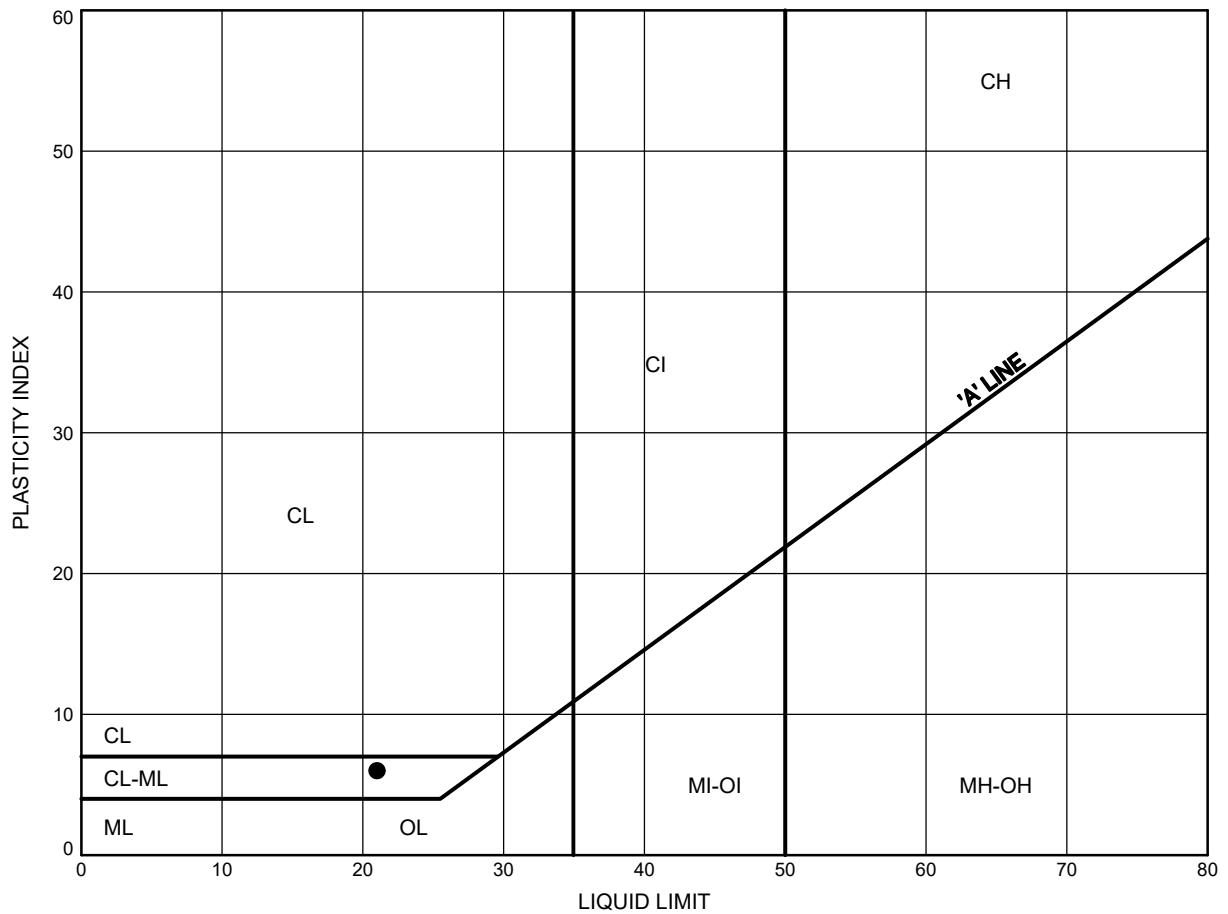
FIGURE C14

Glacial Till

The results of Atterberg Limits testing completed on two samples of the fines of this material found one sample to be non-plastic and the other to have a liquid limit of 21, a plastic limit of 15, and a plasticity index of 6, indicating silty, clayey sand (CL-ML) till in that instance. Atterberg Limit analysis results for the glacial till are illustrated on Figure C14 in Appendix C.

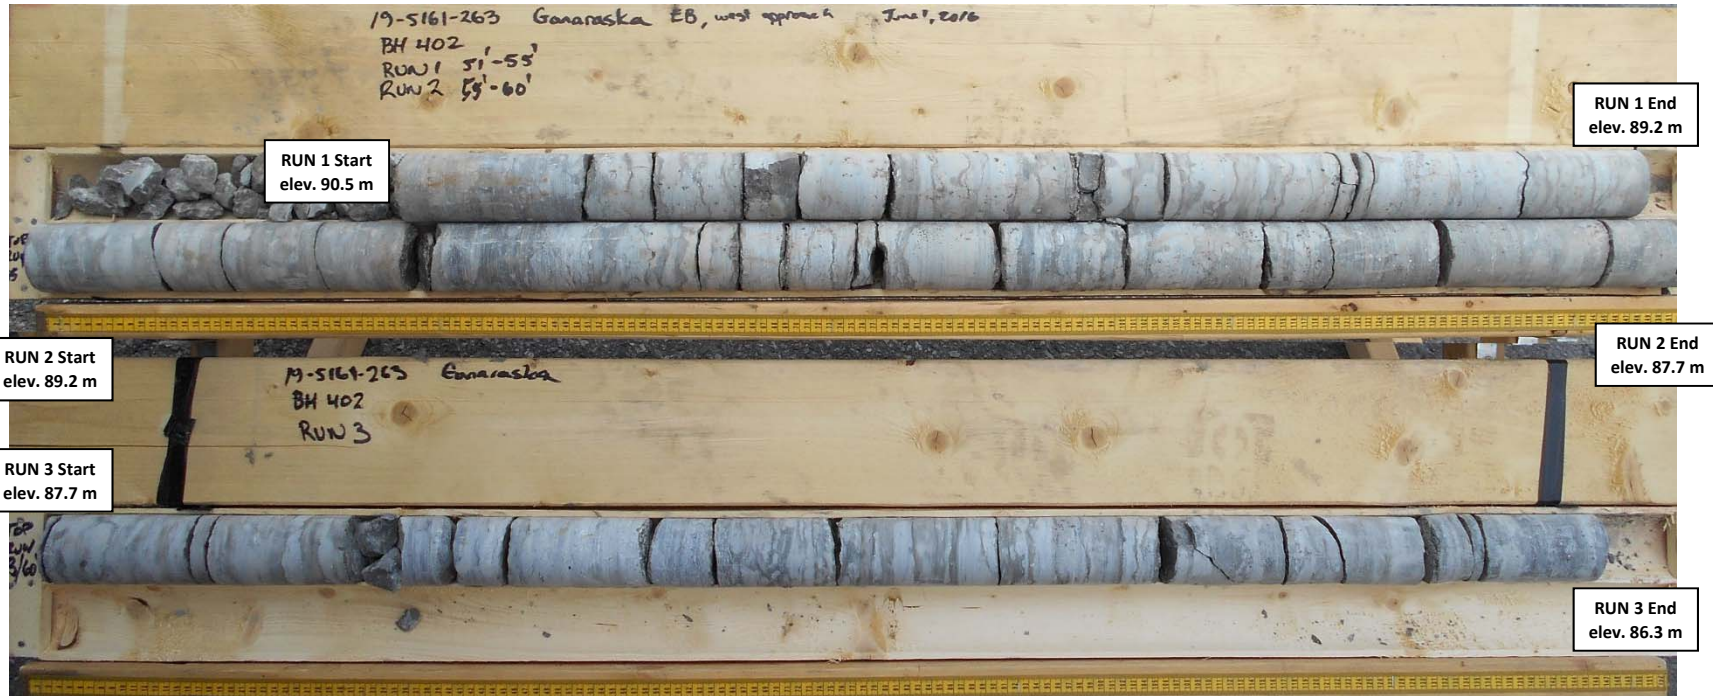
Borehole 402
RUN 1 to 3 (of 3)
Elevation 90.5 m to 86.3 m

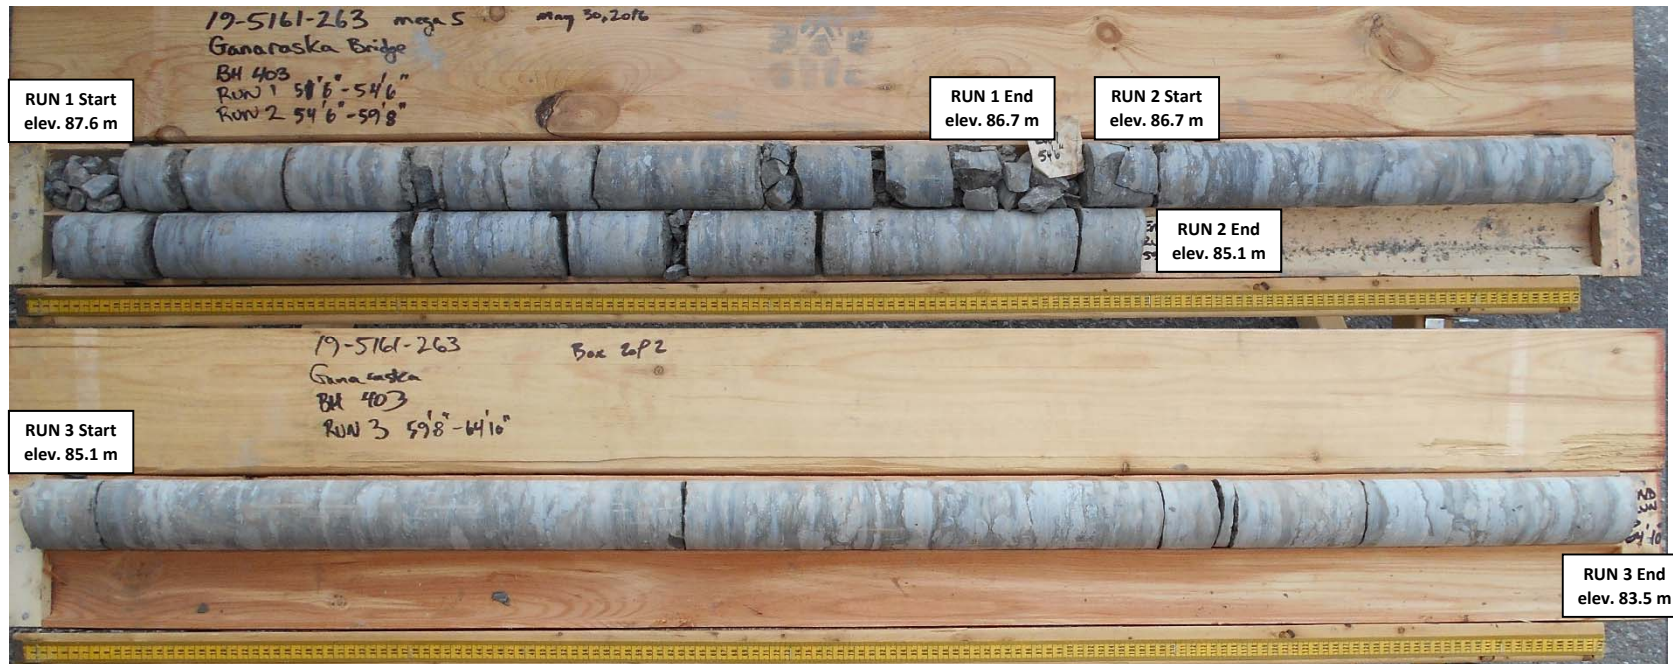
Borehole 403
RUN 1 to 3 (of 3)
Elevation 87.6 m to 83.5 m

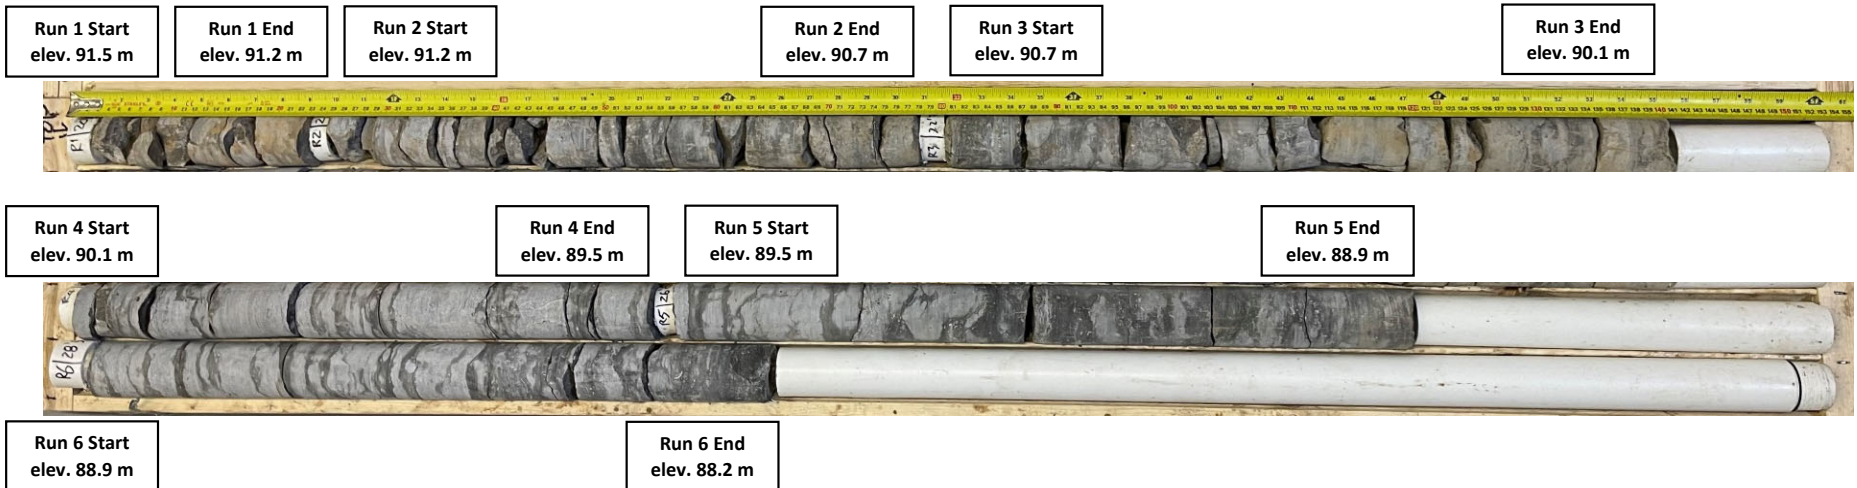
Borehole GR22-02

Runs 1 to 6

Depth 6.1 to 9.4 m

Elevation 91.5 to 88.2 m

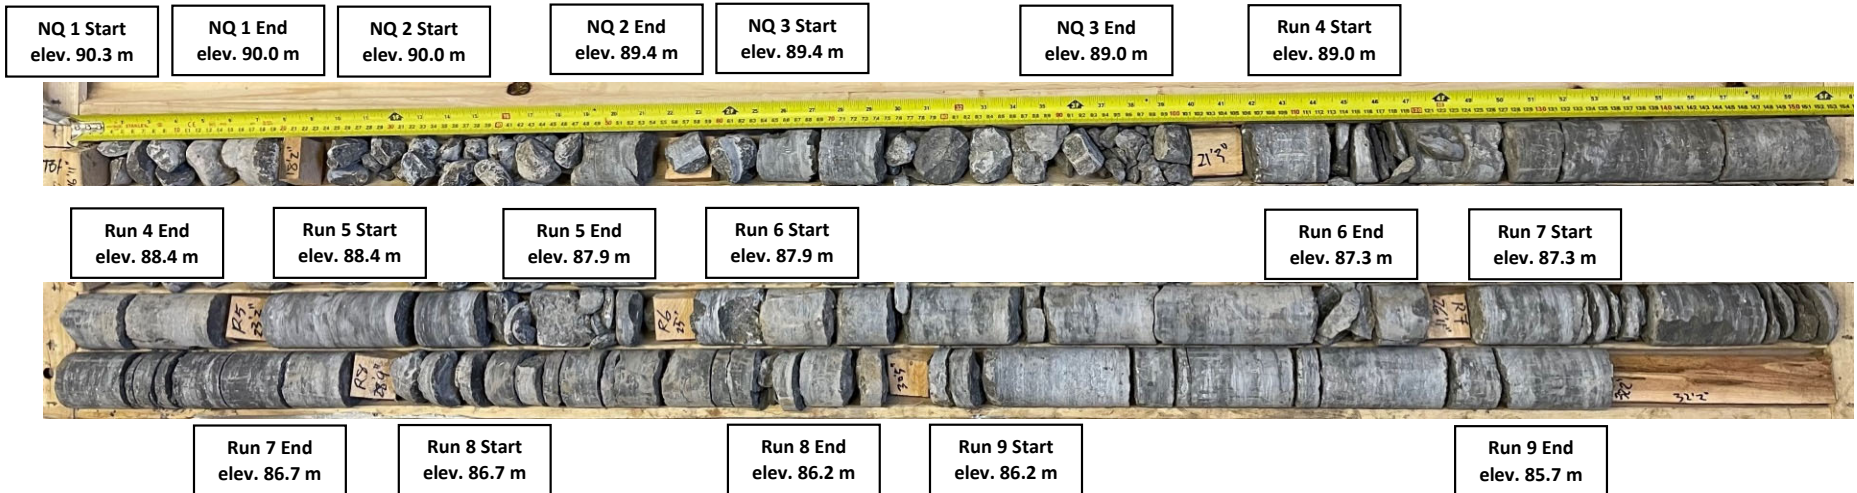
Borehole GR22-03

NQ 1 to NQ3; Runs 4 to 9
Depth 5.1 to 9.8 m
Elevation 90.3 to 85.7 m

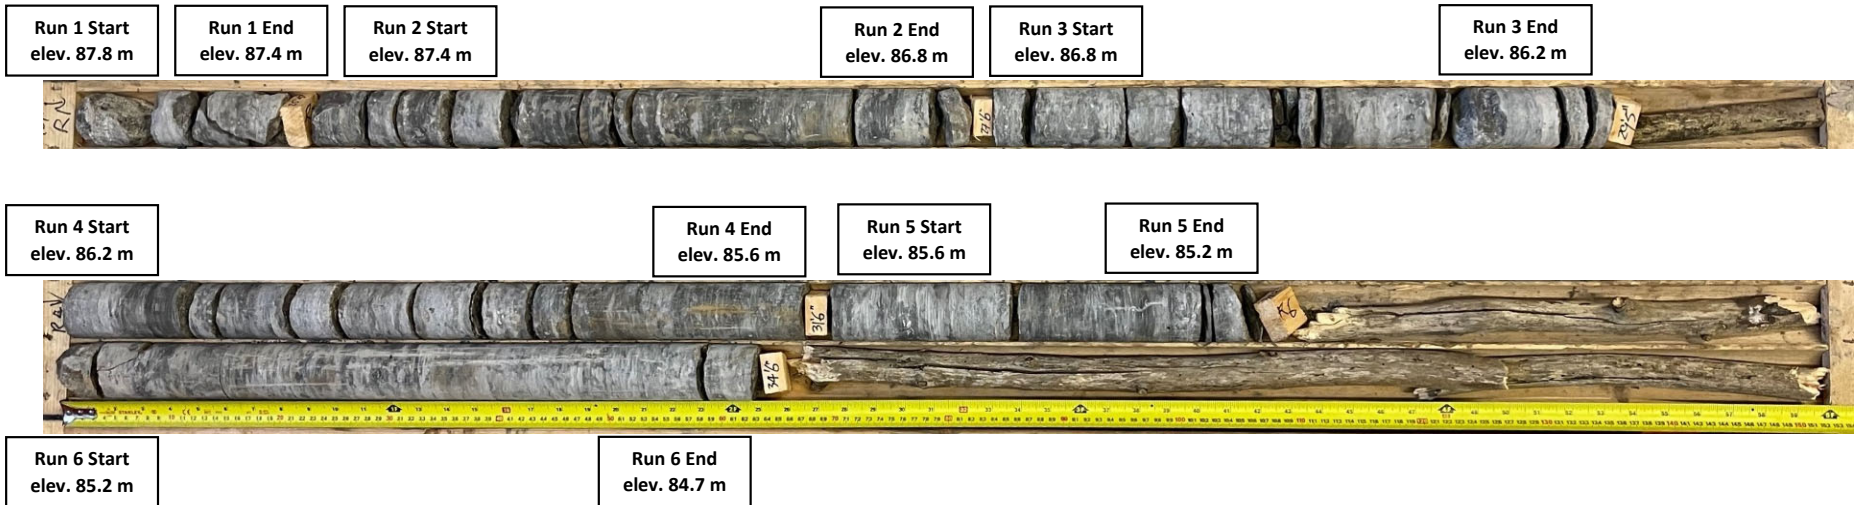
Borehole GR22-04

Runs 1 to 6

Depth 7.4 to 10.5 m

Elevation 87.8 to 84.7 m

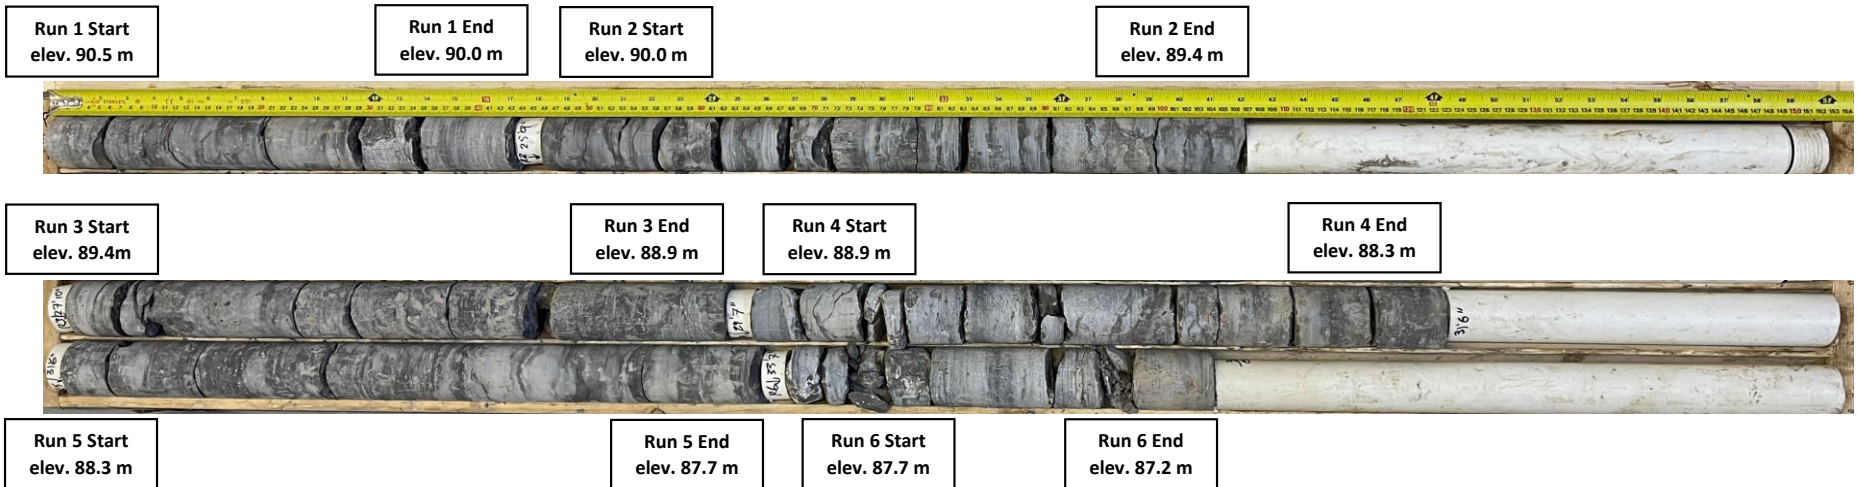
Borehole GR22-07

Runs 1 to 6
Depth 7.4 to 10.7 m
Elevation 90.5 to 87.2 m

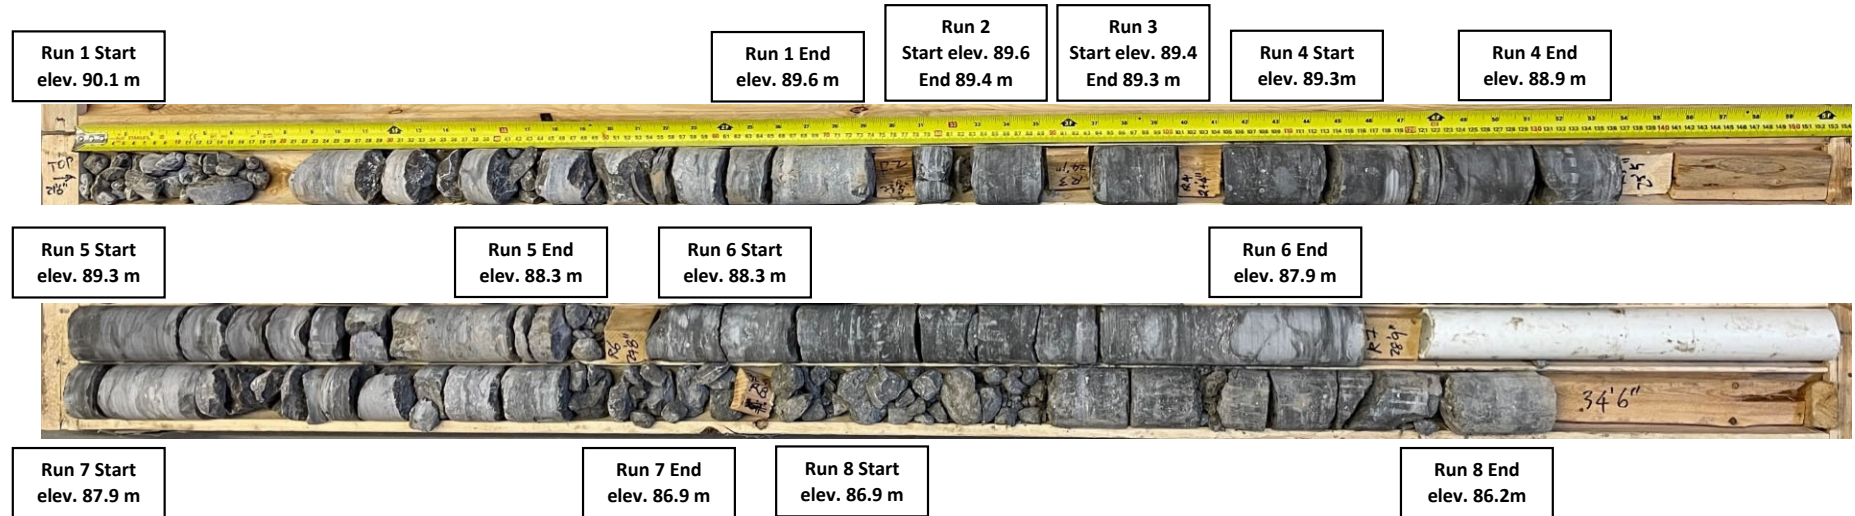
Borehole GR22-08

Runs 1 to 8
Depth 6.6 to 10.5 m
Elevation 90.1 to 86.2 m

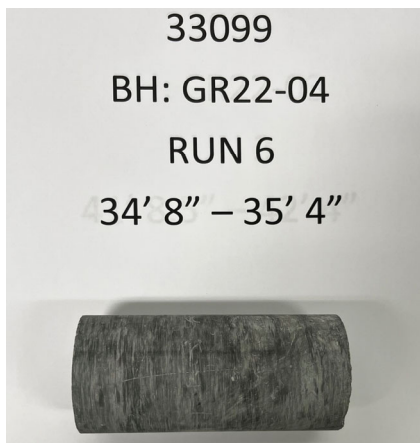
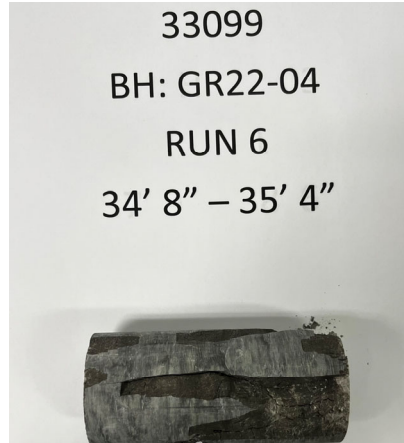
Avg. Height (cm):	10.7	Weight (g):	568.5
Avg. Diameter (cm):	5.1	Wet Density (kg/m ³):	2,653
H. to Dia. Ratio**:	2.1:1	Dry Density (kg/m ³):	2,642
Cross Sectional Area (cm ²):	20.03	Moisture Content* (%):	0.4
Sample Volume (cm ³):	214.32

AVG. RATE OF STRAIN TO FAILURE:	0.250 MPa/s
MAXIMUM COMPRESSIVE LOAD:	174.5 kN
UNCONFINED COMPRESSIVE STRENGTH:	87.1 MPa
