**FINAL
FOUNDATION INVESTIGATION REPORT
REPLACEMENT OF THE HIGHWAY 401 OVERPASS AT
GANARASKA RIVER
NORTHUMBERLAND COUNTY – PORT HOPE, ONTARIO
ASSIGNMENT NO.: 4019-E-0021
GWP 4068-14-00**

**SITE NO. 21X-0231/B0
GEOCRES NO.: 30M16-078**

**Report
to
MCINTOSH PERRY | LEA JOINT VENTURE**

August 2023
Thurber File No.: 33099

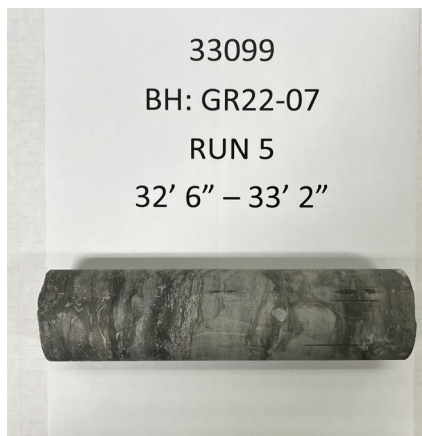
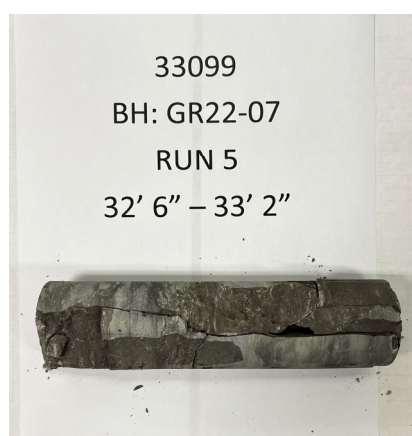
Avg. Height (cm):	18.9	Weight (g):	999.3
Avg. Diameter (cm):	5.0	Wet Density (kg/m ³):	2,650
H. to Dia. Ratio**:	3.8:1	Dry Density (kg/m ³):	2,639
Cross Sectional Area (cm ²):	19.95	Moisture Content* (%):	0.4
Sample Volume (cm ³):	377.06

AVG. RATE OF STRAIN TO FAILURE:	0.250 MPa/s
MAXIMUM COMPRESSIVE LOAD:	102.8 kN
UNCONFINED COMPRESSIVE STRENGTH:	51.5 MPa

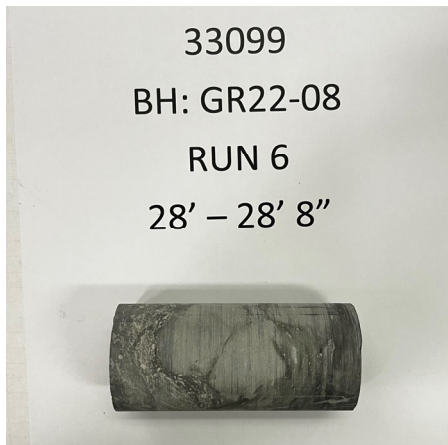
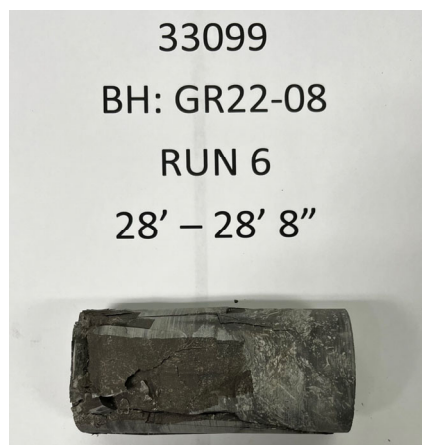
Avg. Height (cm):	10.6	Weight (g):	556.3
Avg. Diameter (cm):	5.0	Wet Density (kg/m ³):	2,652
H. to Dia. Ratio**:	2.1:1	Dry Density (kg/m ³):	2,638
Cross Sectional Area (cm ²):	19.79	Moisture Content* (%):	0.5
Sample Volume (cm ³):	209.80

AVG. RATE OF STRAIN TO FAILURE:	0.250 MPa/s
MAXIMUM COMPRESSIVE LOAD:	90.0 kN
UNCONFINED COMPRESSIVE STRENGTH:	45.5 MPa
