**FOUNDATION INVESTIGATION REPORT  
HIGHWAY 7 GRADE LOWERING FROM STN. 20+000 TO 20+450 AND  
NEW STRUCTURAL CULVERT AT STN. 20+320, SITE NO. 32-097  
MUNICIPALITY OF KAWARTHA LAKES  
AGREEMENT 4016-E-0034, ASSIGNMENT 6  
GWP 4094-17-00**

Geocres No.: 31D-746

March 2020  
Thurber File No.: 23770

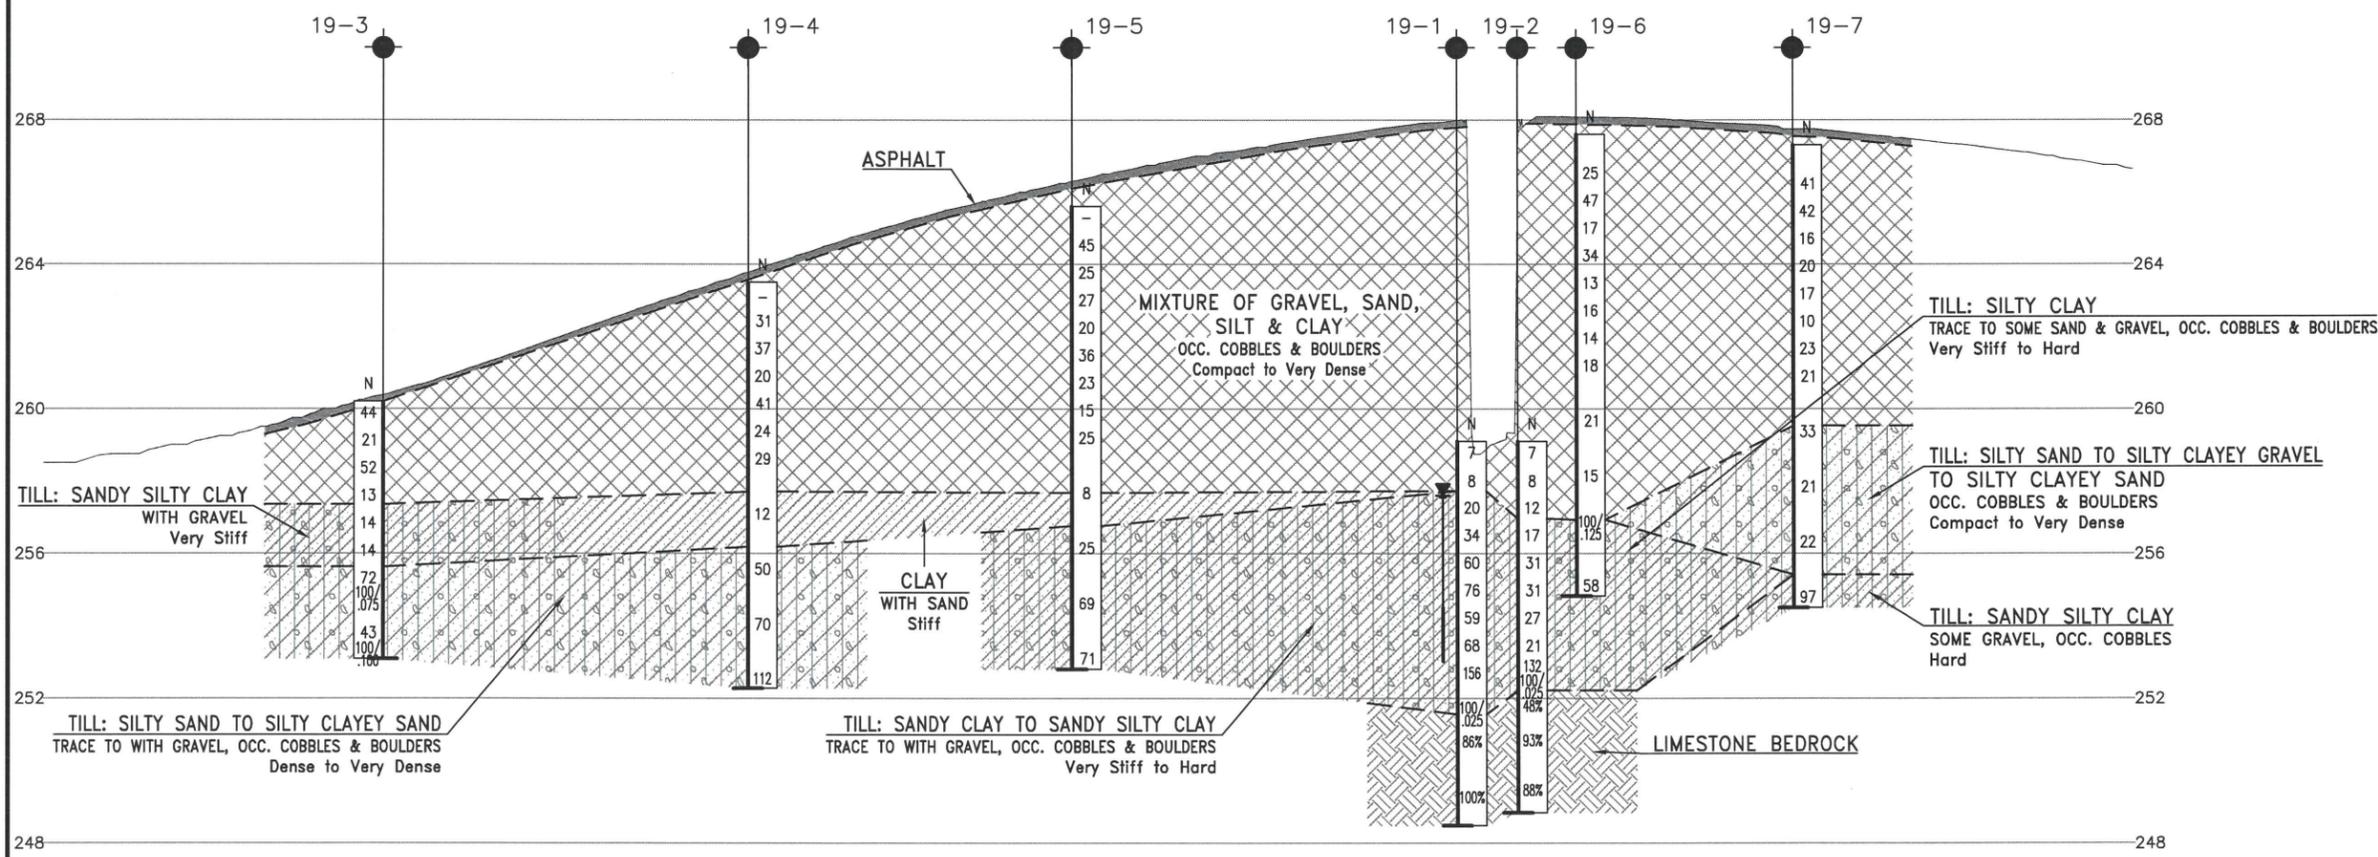
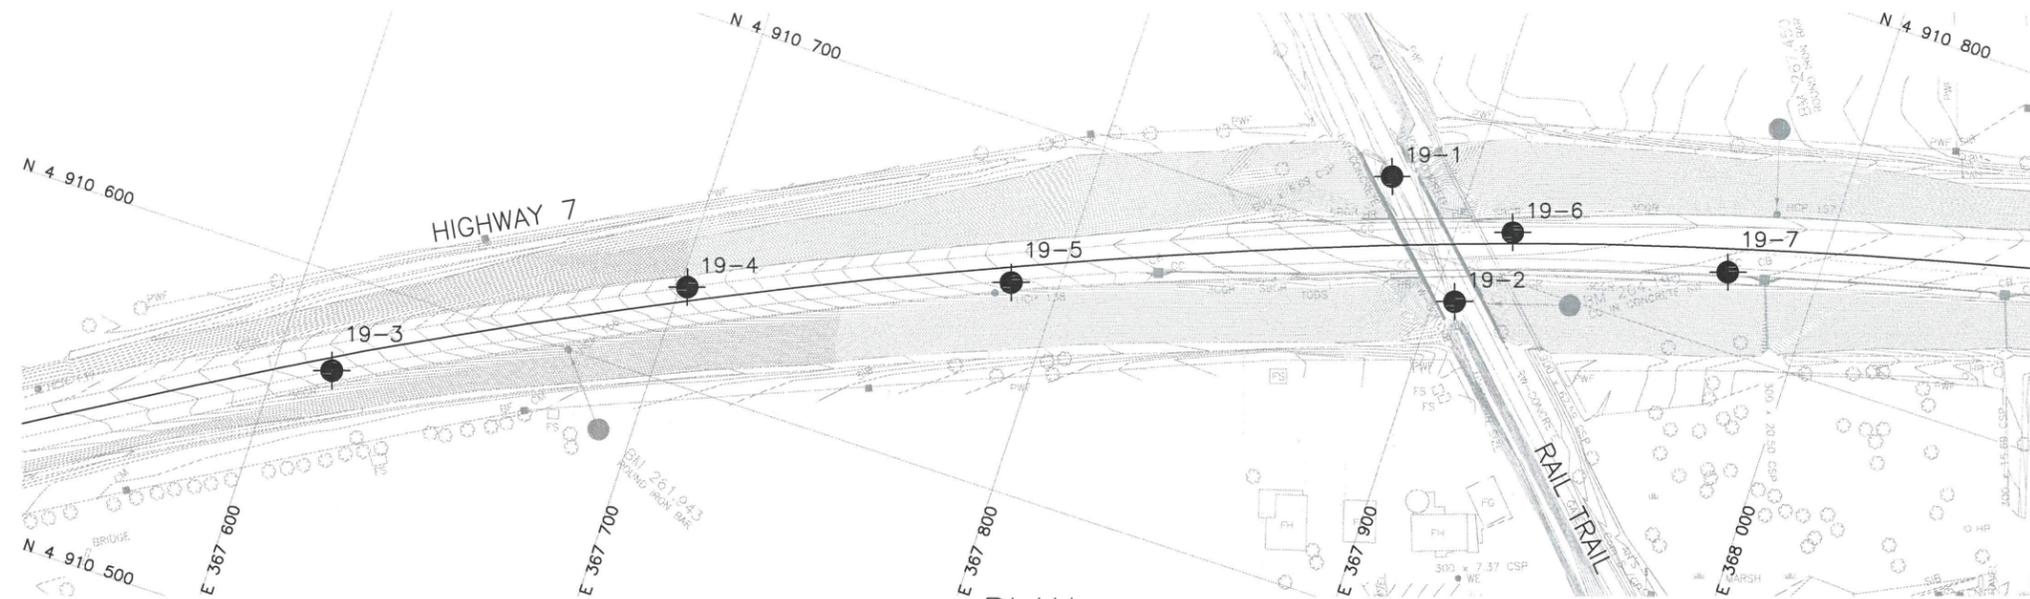
LOAD DATE MAR 2020  
STRUCT DWG 1

The northing, easting and elevation of the boreholes are shown on the Borehole Location and Soil Strata Drawing No. 1 in Appendix A, the individual Record of Borehole sheets in Appendix B, and in Table 3-1 below. The site is located within MTM Zone 10.

HIGHWAY 7  
GRADE LOWERING  
STATION 20+000 TO 20+450  
BOREHOLE LOCATIONS AND SOIL STRATA

Details of the encountered soil stratigraphy are presented on the Record of Borehole sheets included in Appendix B and the Borehole Location and Soil Strata Drawing is included in Appendix A. A general description of the stratigraphy, based on the conditions encountered in the boreholes, is given in the following sections. However, the factual data presented on the Borehole Records takes precedence over the Soil Strata Drawing and the general description. It must be recognized that the soil and groundwater conditions may vary between and beyond borehole locations.

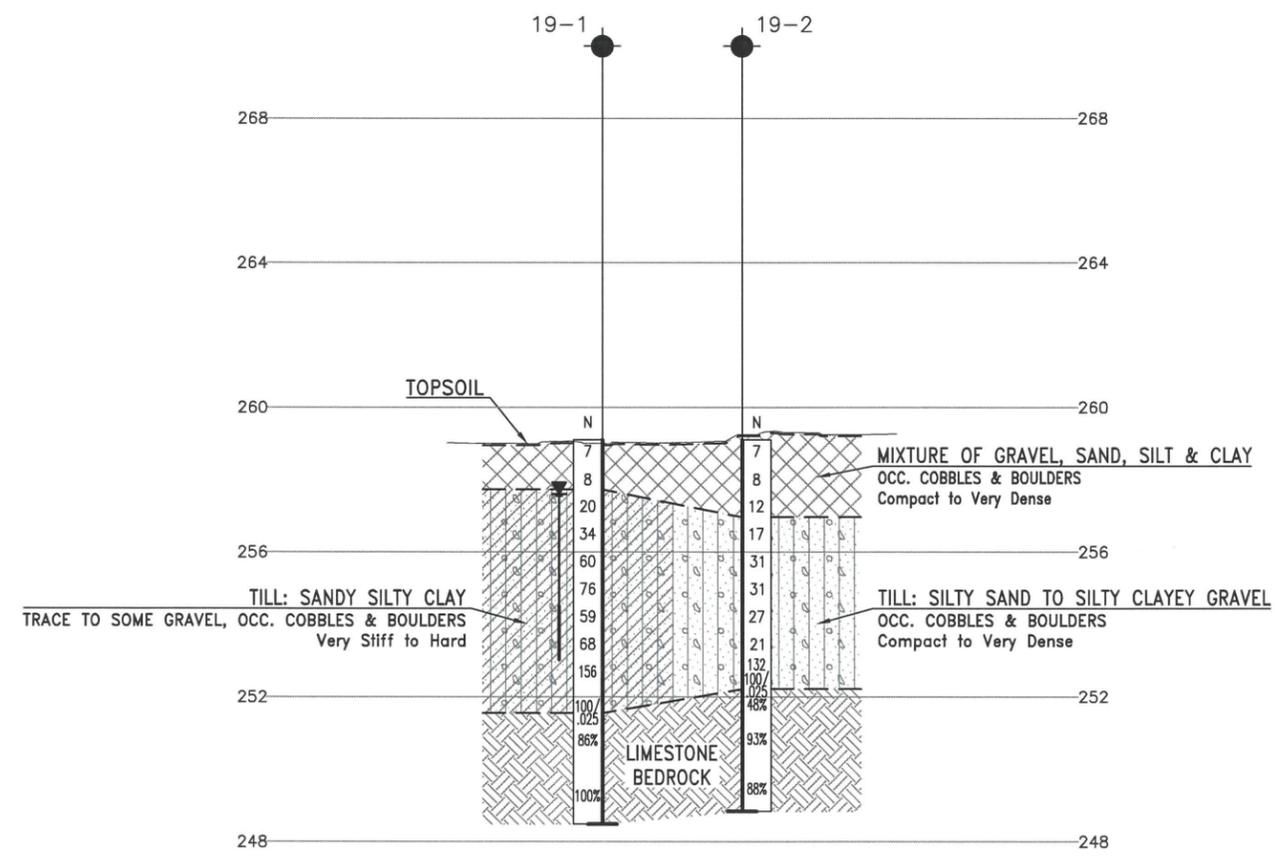
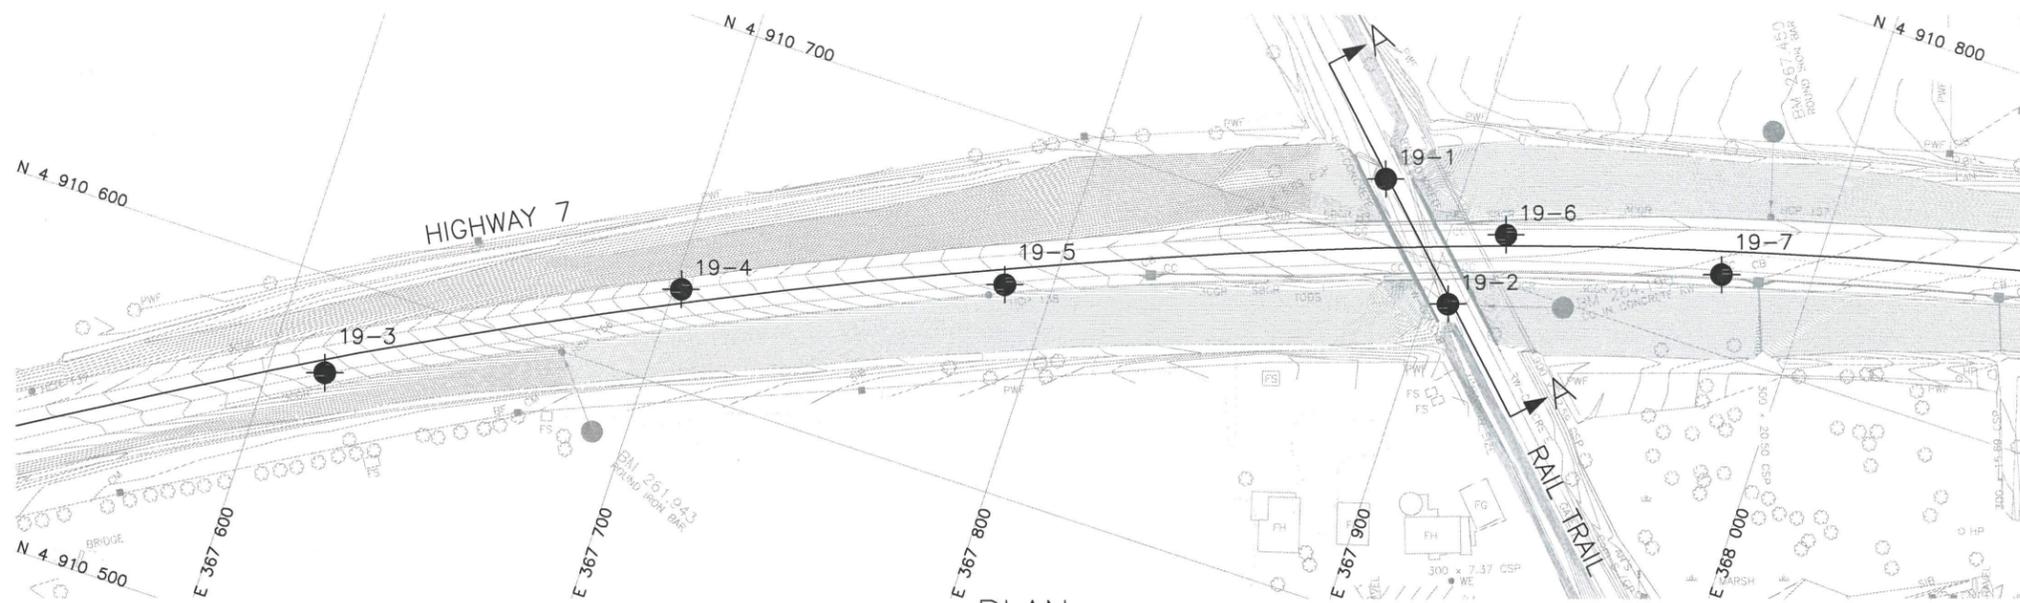
DESIGN	JG	CHK	SD	CODE	LOAD	DATE	MAR 2020
DRAWN	MFA	CHK	JG	SITE	STRUCT	DWG	2

- The boundaries between soil strata have been established only at Borehole locations. Between Boreholes the boundaries are assumed from geological evidence.
- This drawing is for subsurface information only. Surface details and features are for conceptual illustration.
- Coordinate system is MTM NAD 83 Zone 10.

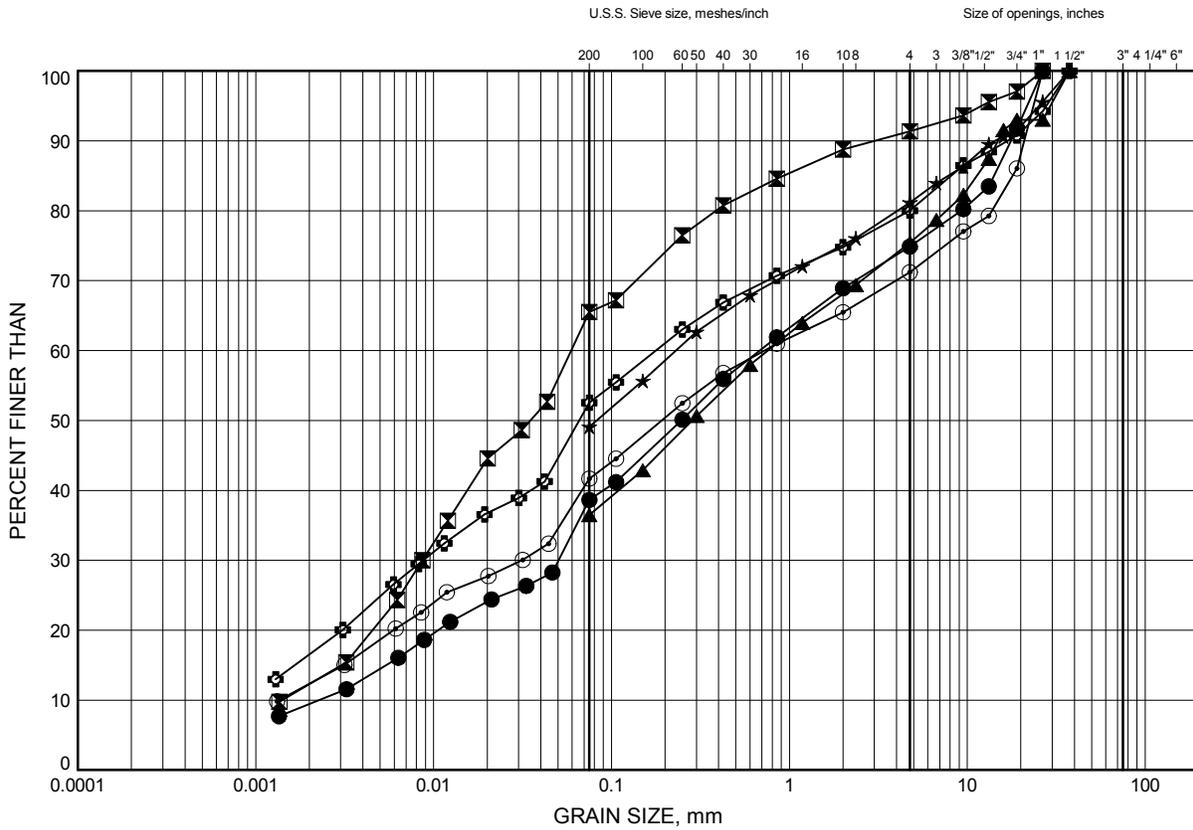
FIGURE C1

## Fill

The results of grain size distribution testing carried out on nine samples of the fill are summarized in Table 5-1 below and are illustrated on Figures C1 and C2 in Appendix C.

The results of grain size distribution testing carried out on two samples of the fill are summarized in Table 5-3 below and are illustrated on Figure C1 in Appendix C.

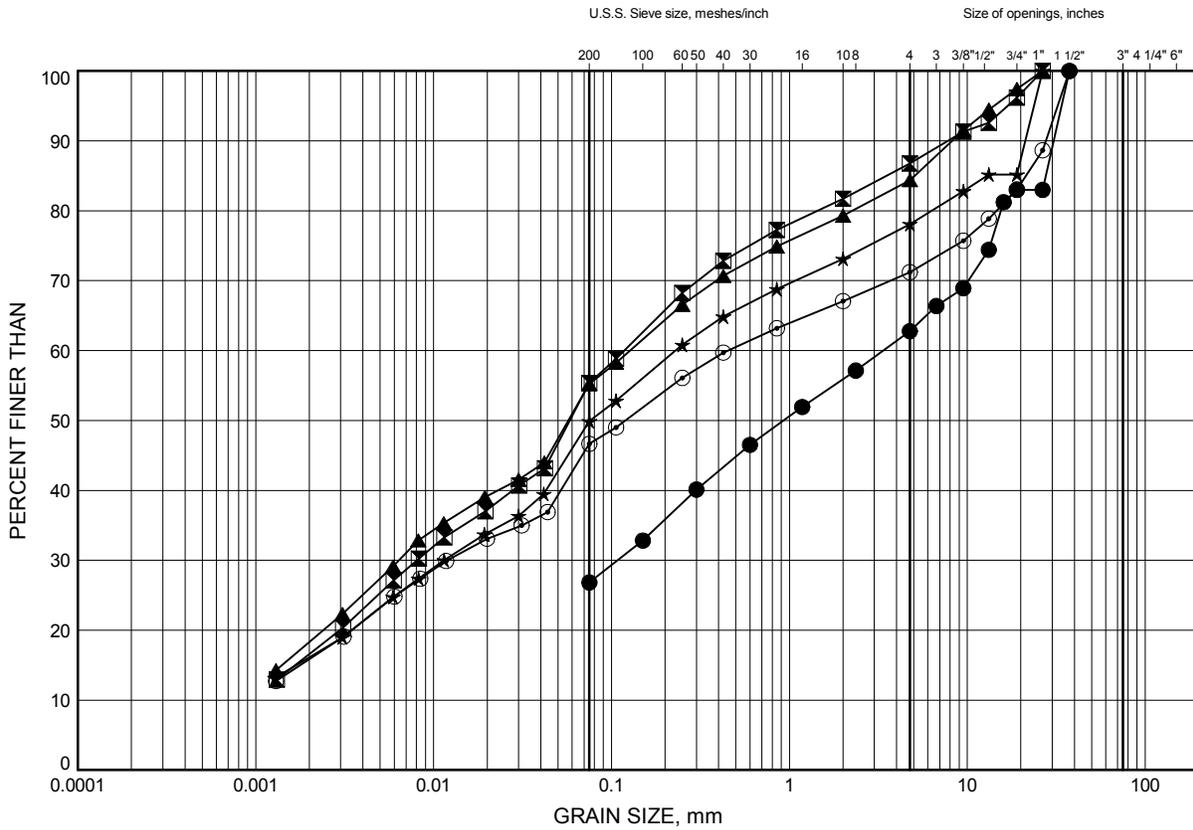
FIGURE C2

## Fill

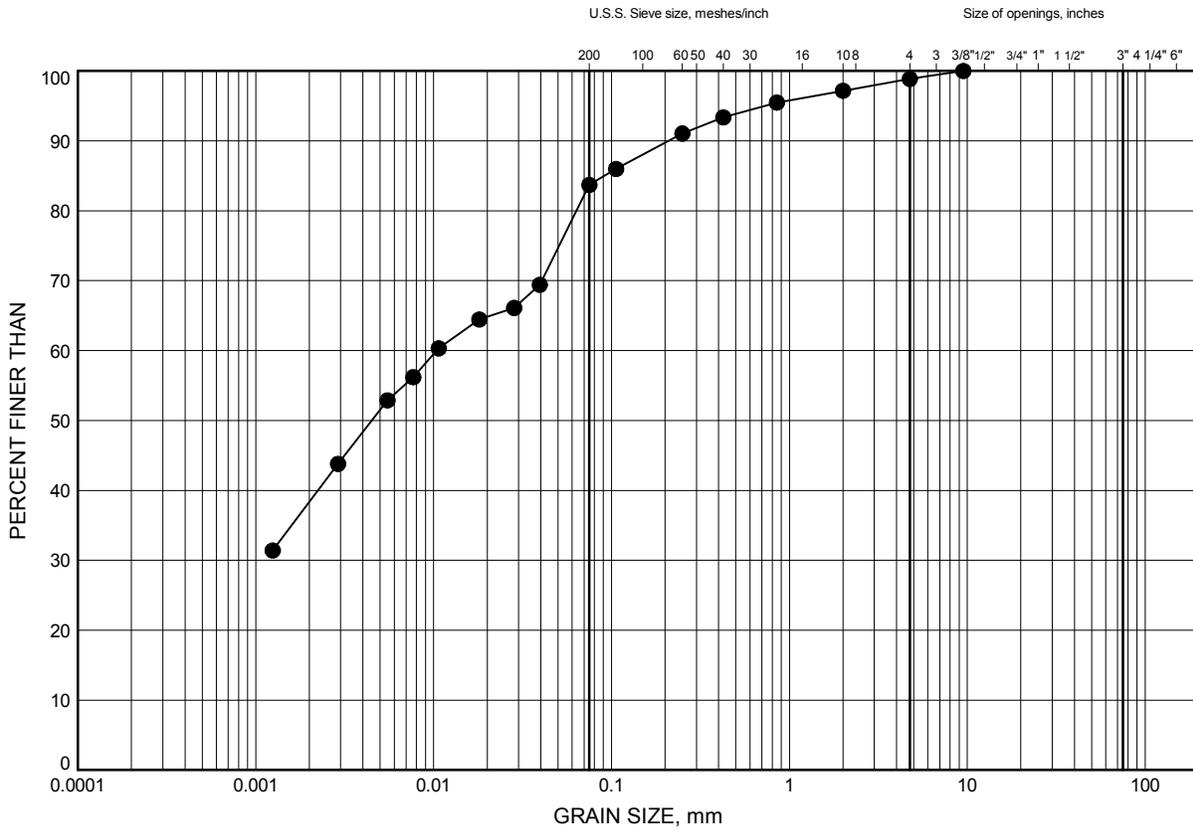
FIGURE C3

Clay (CI) with sand

The results of grain size distribution testing carried out on one sample of the clay indicated this material to consist of 1% gravel, 15% sand, 45% silt, and 39% clay. These results are illustrated on Figure C3 in Appendix C. The results of Atterberg limit testing conducted on one sample of the clay are shown on Figure C8 in Appendix C and indicated this material to have a liquid limit of 42, a plastic limit of 18, and a plasticity index of 24. These results indicate that the soil is classified as clay of intermediate plasticity (CI).

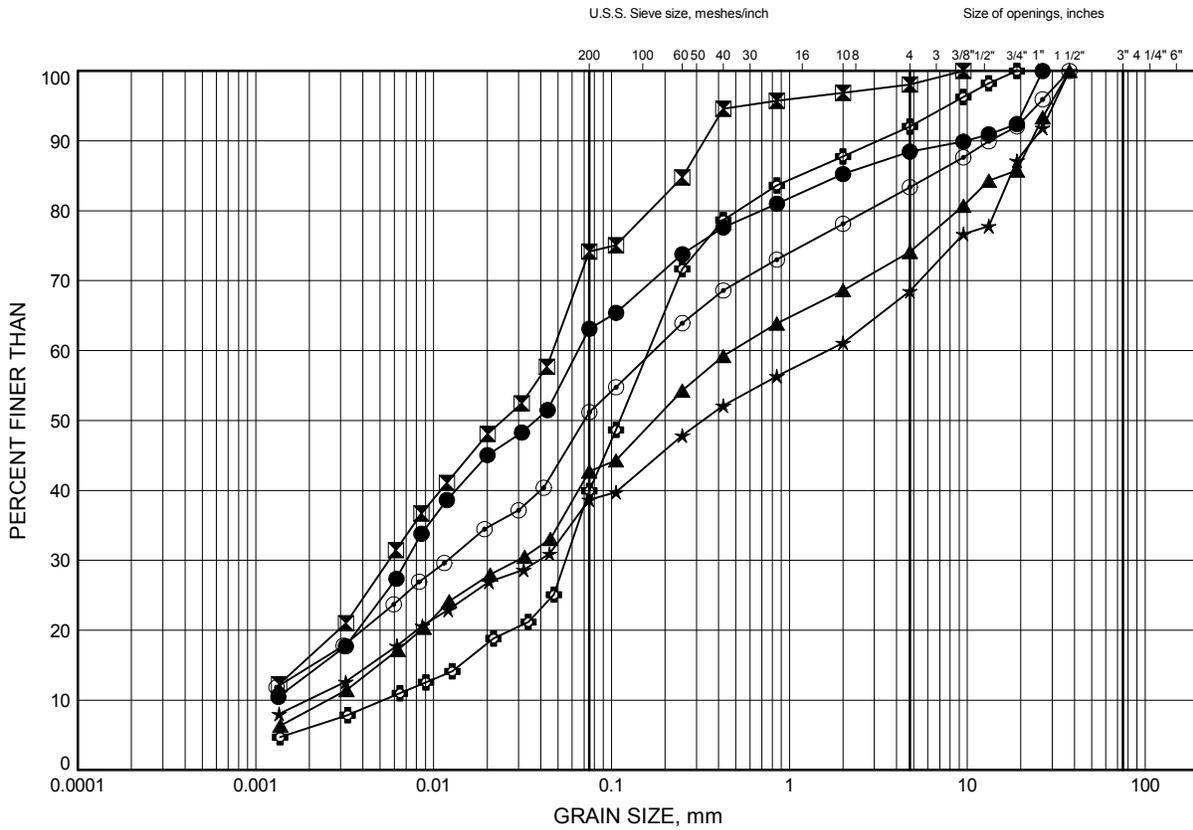
FIGURE C4

## Glacial Till

The results of grain size distribution testing carried out on 11 samples of the till are summarized in Table 5-5 below and are illustrated in Figures C4 and C5 in Appendix C.

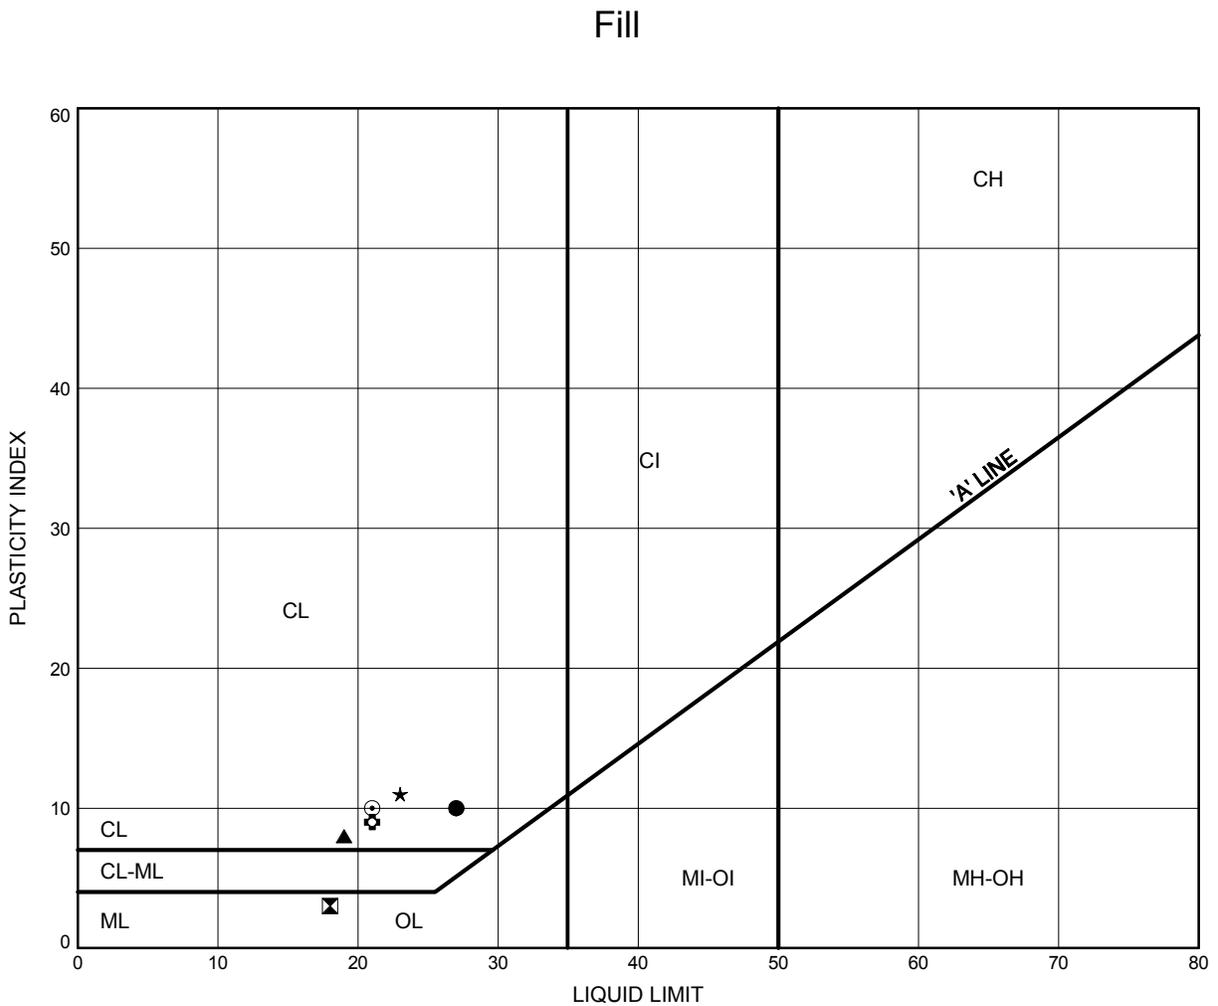
FIGURE C6

Hwy 7 Lindsay Rail Trail Culvert  
**ATTERBERG LIMITS TEST RESULTS**

SYMBOL	BOREHOLE	DEPTH (m)	ELEV. (m)
●	19-1	0.3	258.8
⊠	19-2	1.1	258.0
▲	19-5	2.6	263.0
★	19-5	6.4	259.2
⊙	19-6	4.9	262.7
⊕	19-6	7.9	259.7

The results of Atterberg limit testing carried out on six samples of the fill are summarized in Table 5-2 below and are illustrated on Figures C6 and C7 in Appendix C. These results indicate that the fines within the fill are classified as clay of low plasticity (CL).

The results of Atterberg limit testing carried out on two samples of the fill are summarized in Table 5.4 below and are illustrated on Figure C6 in Appendix C. These results indicate that the fines within the fill are classified as silt (ML) to clay of low plasticity (CL).

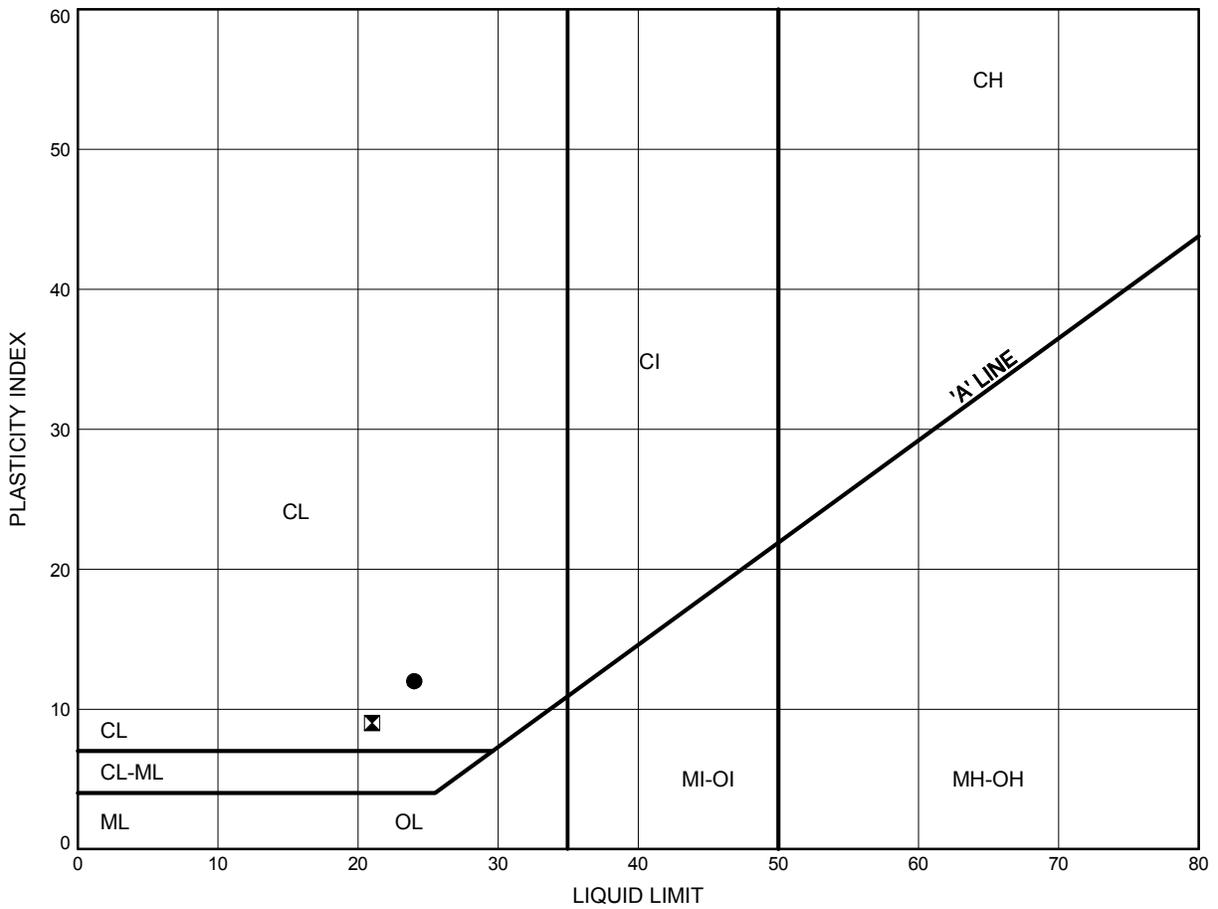
FIGURE C7

Fill

SYMBOL	BOREHOLE	DEPTH (m)	ELEV. (m)
●	19-7	3.4	263.9
⊠	19-7	6.4	260.9

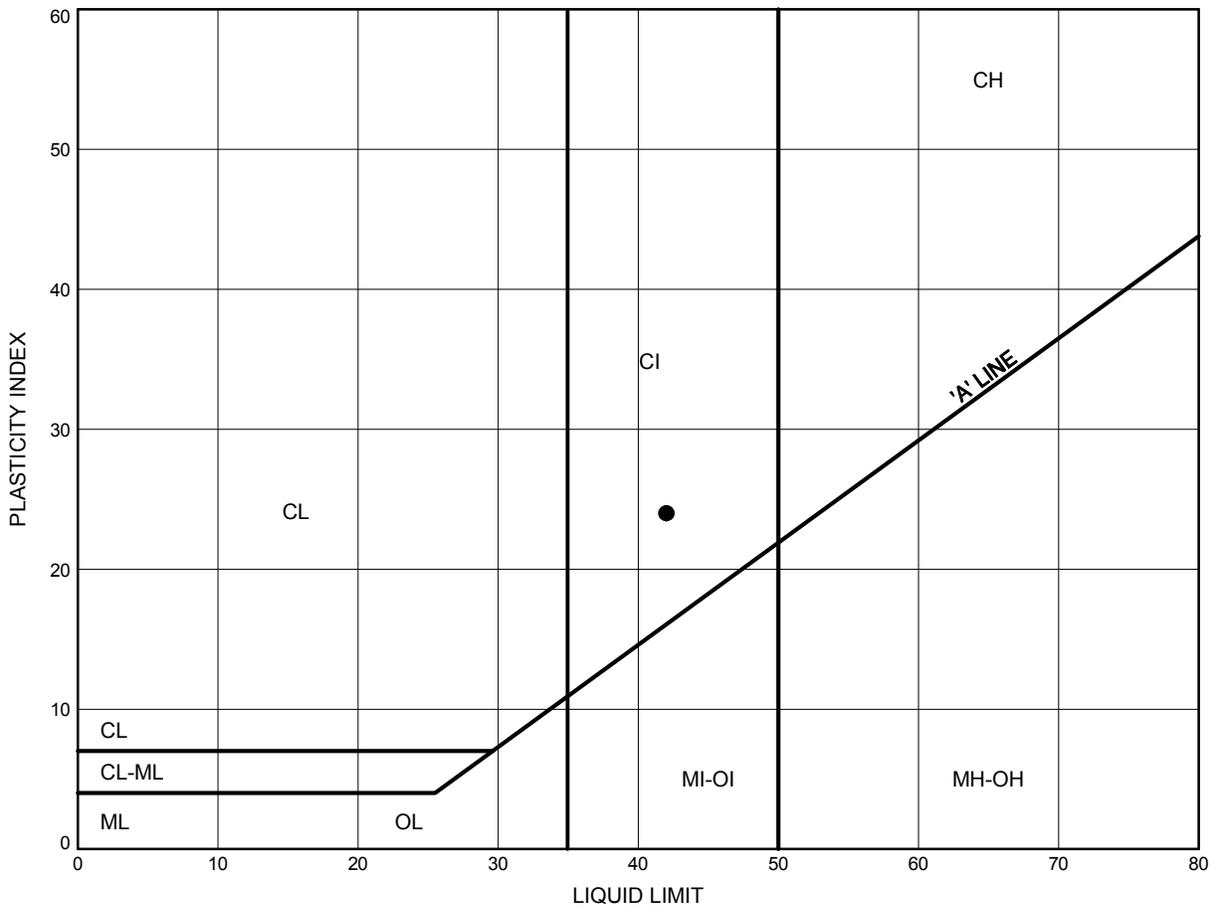
FIGURE C8

Clay (CI) with sand

SYMBOL	BOREHOLE	DEPTH (m)	ELEV. (m)
●	19-4	6.4	257.1

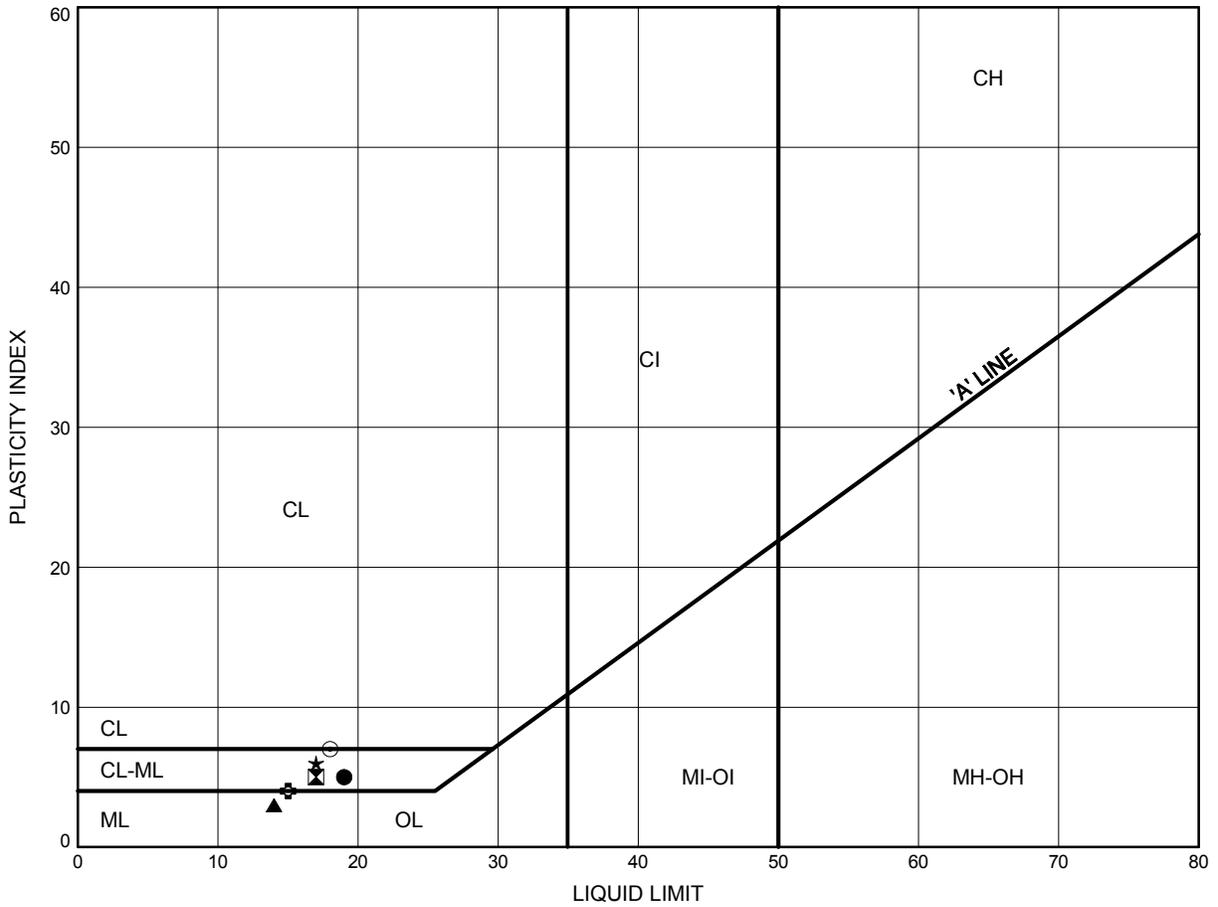
FIGURE C9

Glacial Till

SYMBOL	BOREHOLE	DEPTH (m)	ELEV. (m)
●	19-1	2.6	256.5
⊠	19-1	5.6	253.5
▲	19-2	3.4	255.7
★	19-2	5.6	253.5
⊙	19-3	3.4	256.8
⊕	19-4	7.9	255.6

The results of Atterberg limit testing carried out on 10 samples of the till are summarized in Table 5-6 below and are illustrated on Figures C9 and C10 in Appendix C. These results indicate that the fines within the till are classified as silt (ML) to silty clay (CL-ML) to clay of low plasticity (CL). Testing on one sample from Borehole 19-3 (SS9) indicated that the soil was non-plastic.

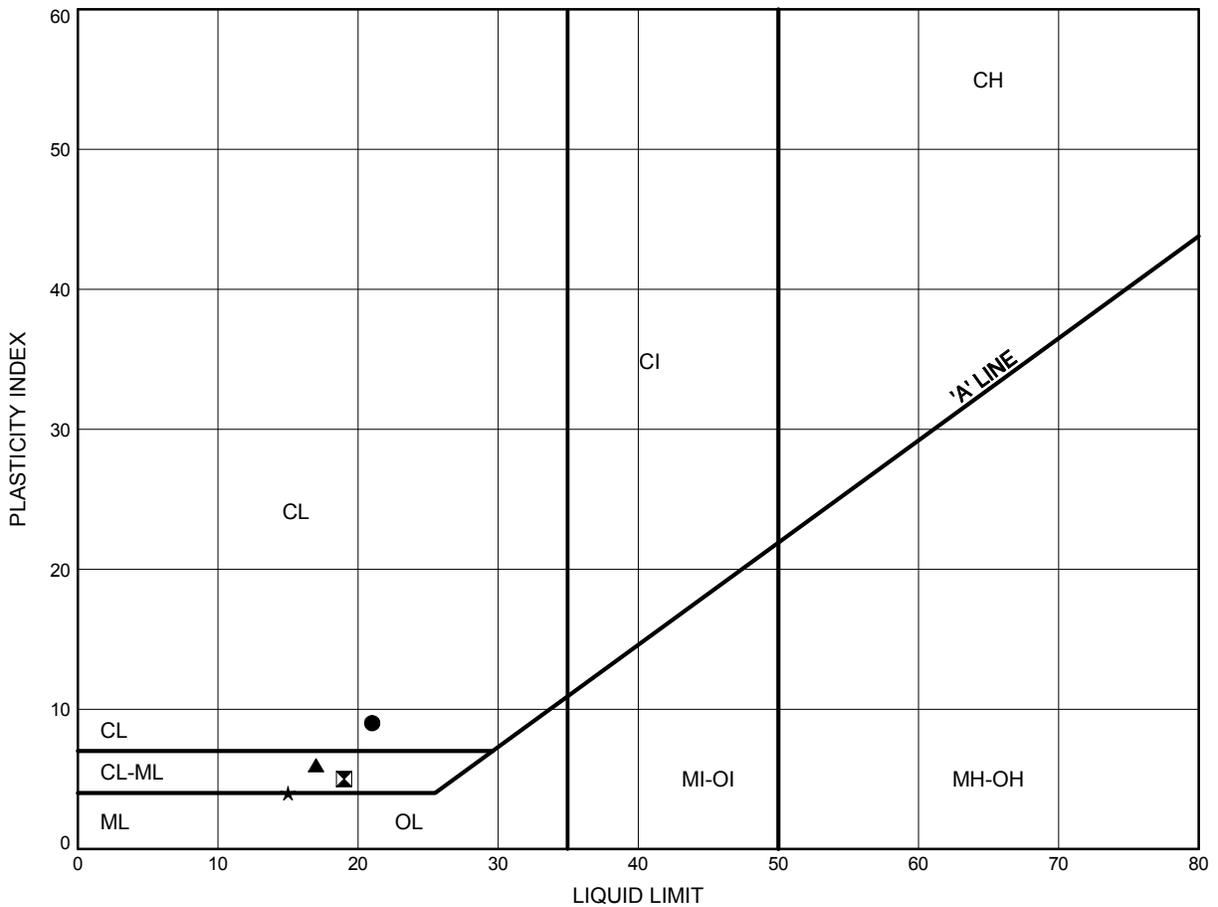
FIGURE C10

Glacial Till

SYMBOL	BOREHOLE	DEPTH (m)	ELEV. (m)
●	19-5	12.5	253.1
⊠	19-6	12.5	255.1
▲	19-7	11.0	256.3
★	19-7	12.5	254.8

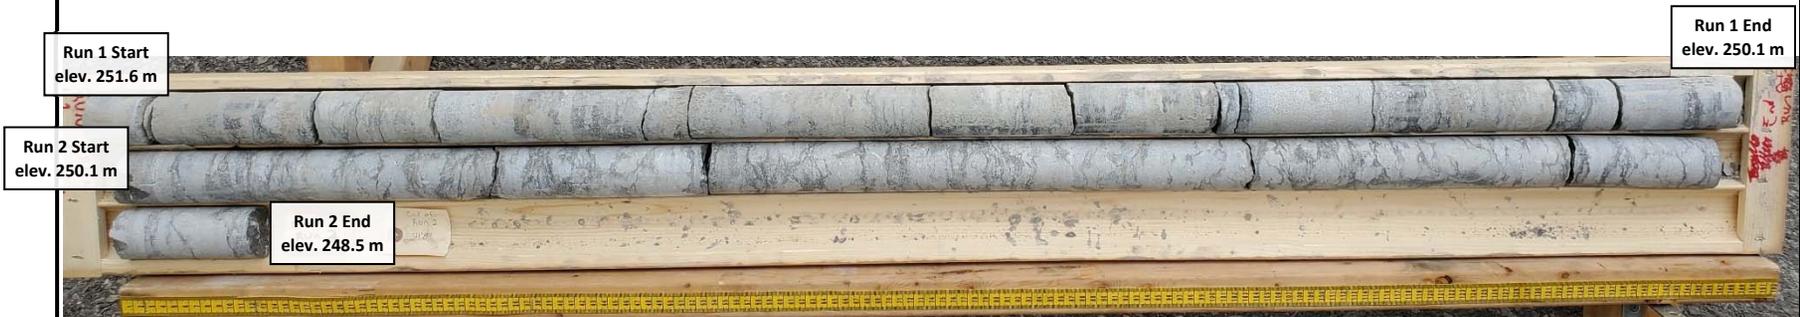
**Borehole 19-1**  
**Run 1 to 2 (of 2)**  
**Elevation 251.6 m to 248.5 m**

Bedrock was encountered and proven by coring in Boreholes 19-1 and 19-2. A summary of the bedrock surface information is provided in Table 5- below:

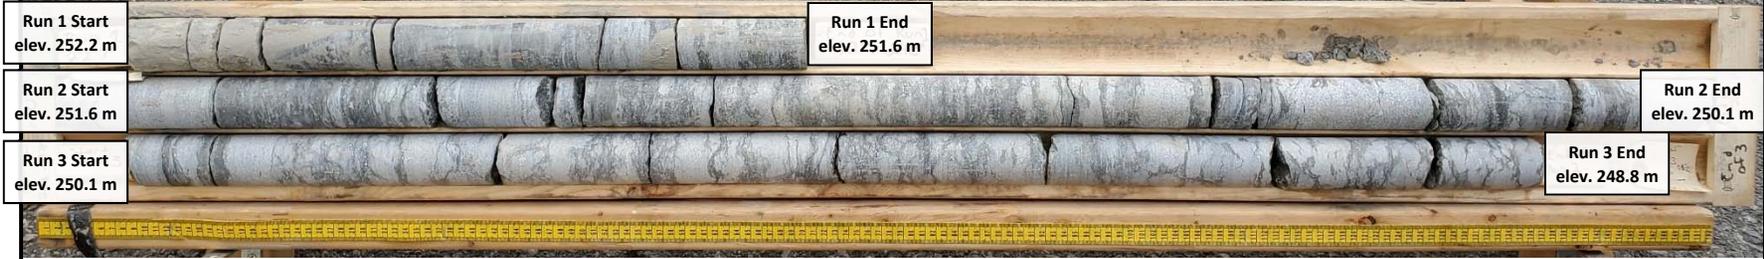
**Borehole 19-2**  
**Run 1 to 3 (of 3)**  
**Elevation 252.2 m to 248.8 m**
