# Foundation Investigation & Design Report

*Replacement of Structural Culvert 29X-0229/C0*

*Highway 41, Grattan, Ontario*

*MTO GWP 4123-17-00; Agreement Number 4021-E-0021-04*

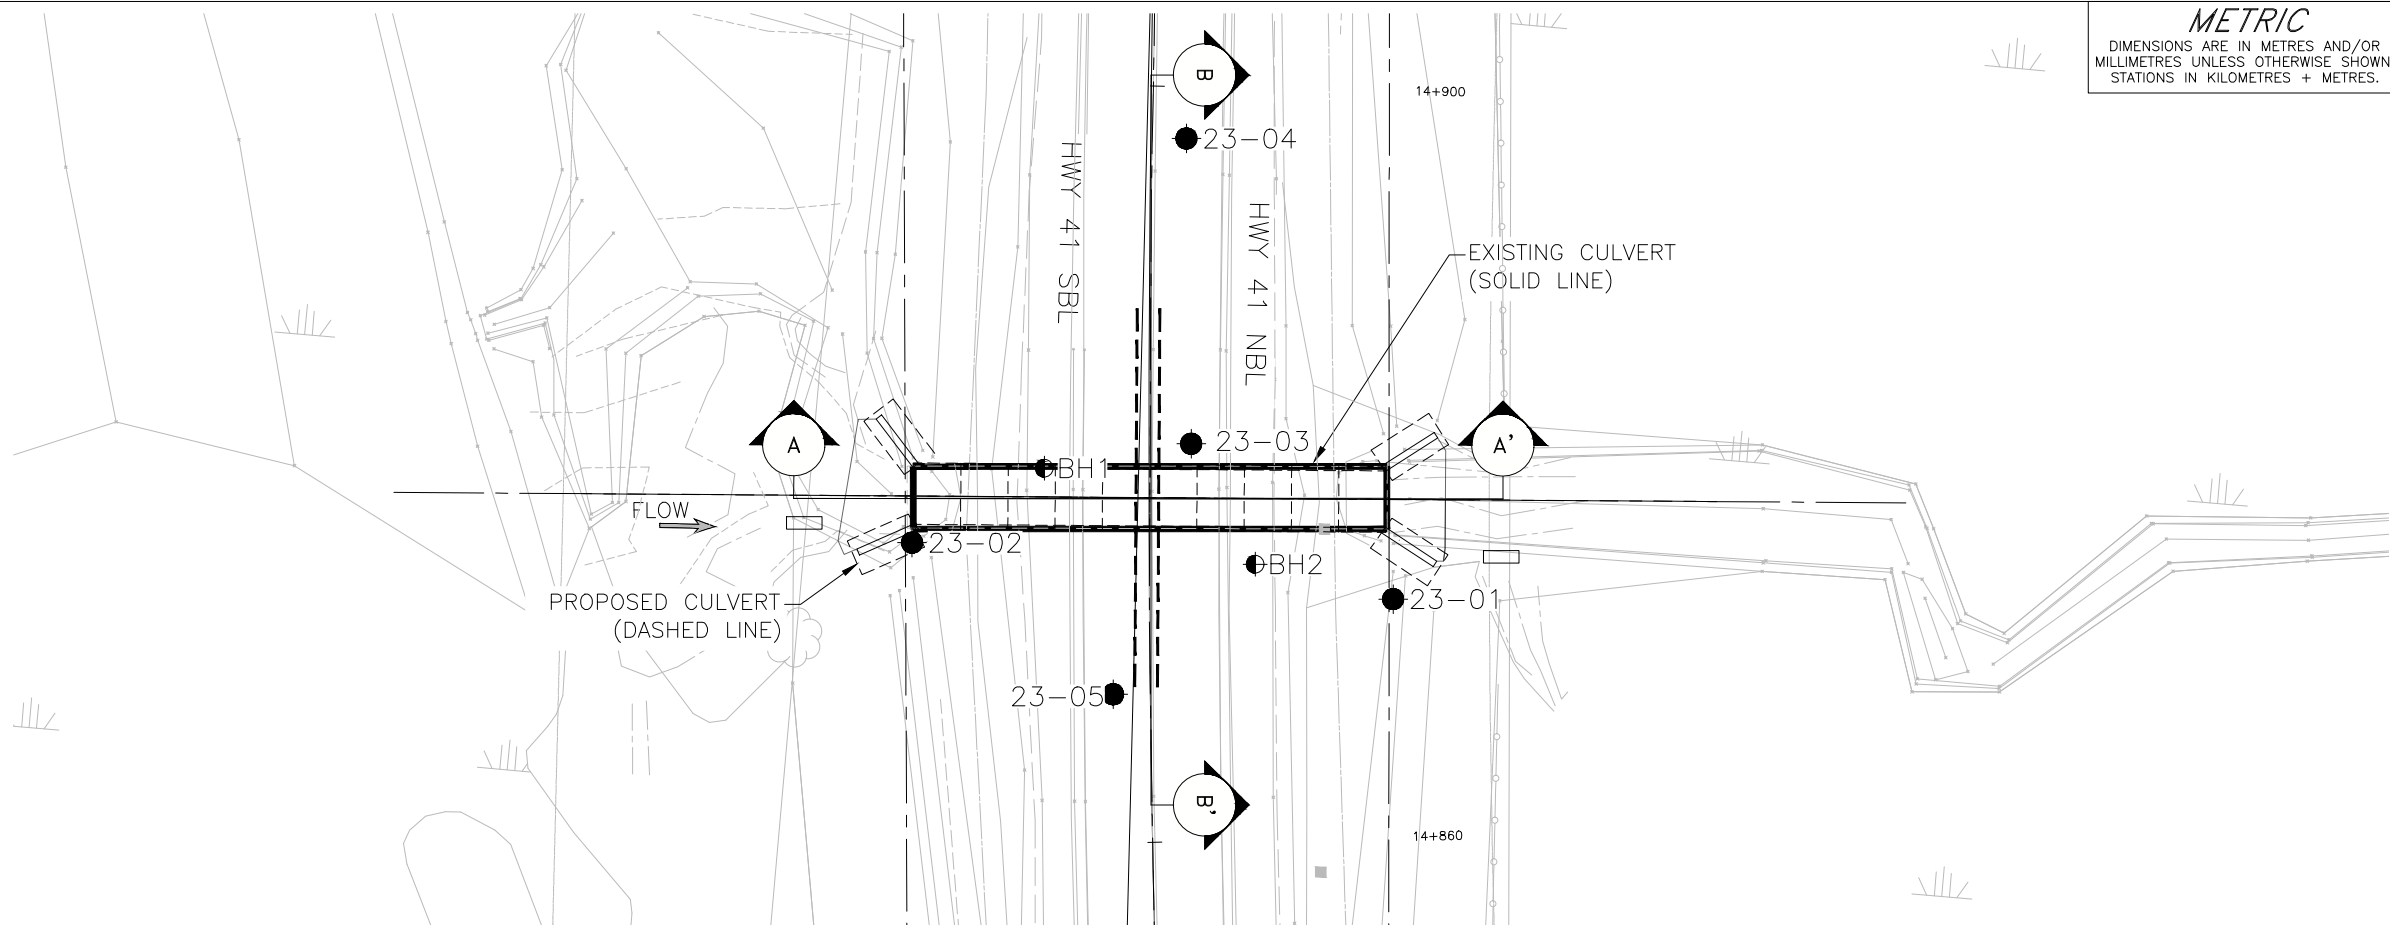
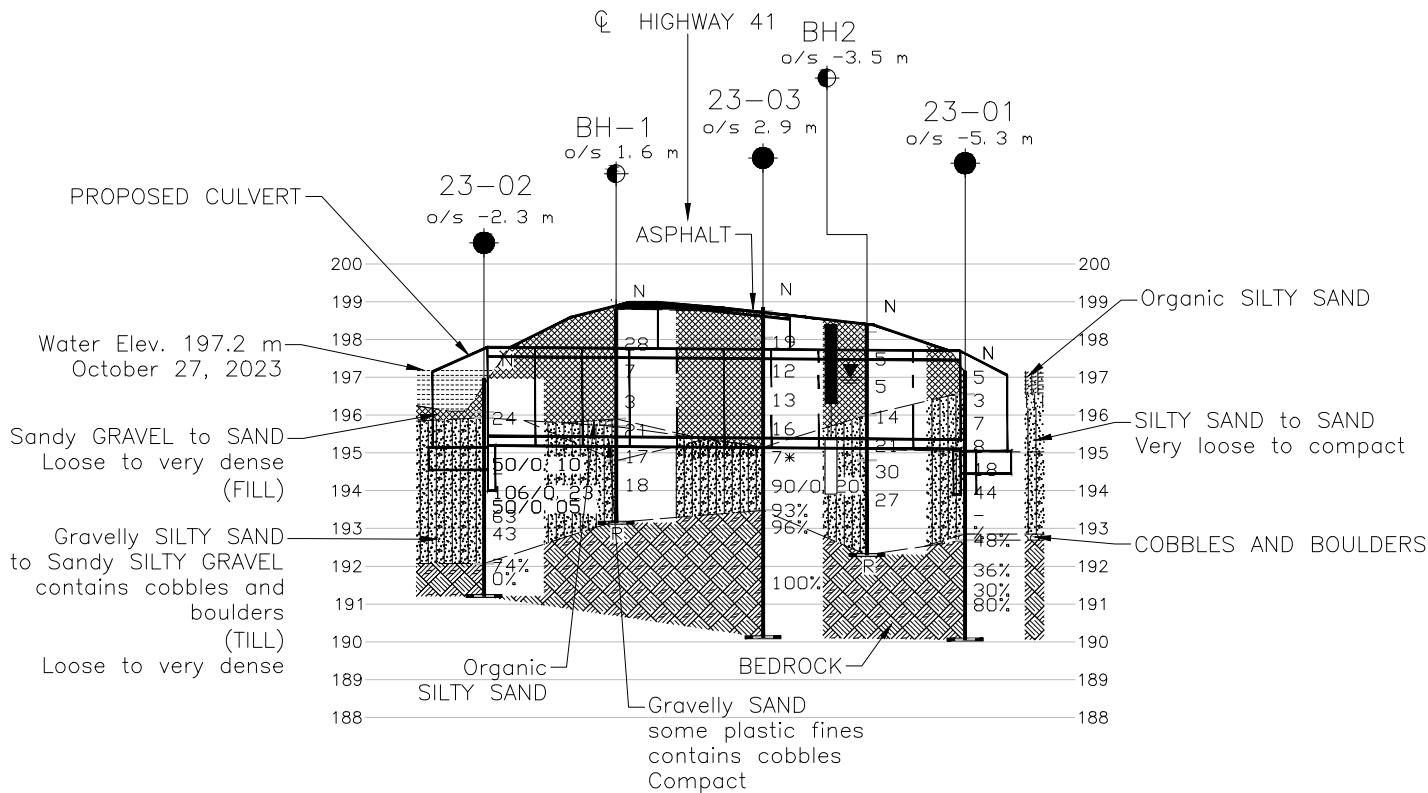
HIGHWAY 41  
REPLACEMENT OF CULVERT 29X-0229/C0  
BOREHOLE LOCATIONS AND SOIL  
STRATA

A copy of the borehole locations and Record of Boreholes relevant to the current investigation are provided for reference in Appendix C and the Soil Strata have been incorporated into Drawings 1 and 2. The results of the 2021 investigation have also been incorporated into the following description of the subsurface conditions.

The stratigraphic boundaries shown on the Record of Borehole sheets and on the interpreted stratigraphic sections in Drawings 1 and 2, are inferred from observations of the drilling progress and noncontinuous sampling and therefore, represent transitions between soil types rather than exact planes of geological change. The subsoil conditions will vary between and beyond the borehole locations.

PLAN

CROSS-SECTION A-A'

The subsurface soil, bedrock and groundwater conditions encountered in the boreholes and the results of in-situ testing from the current investigation are shown on the Records of Borehole, and Drillhole sheets presented in Appendix A. The results of the laboratory testing carried out during the investigation are presented on the Record of Borehole sheets as well as in Figures B1 to B4 in Appendix B. The borehole locations and the interpreted stratigraphic profiles projected along the existing culvert alignment, and parallel to the centerline of Highway 41, are provided in Drawings 1 to 2, respectively.

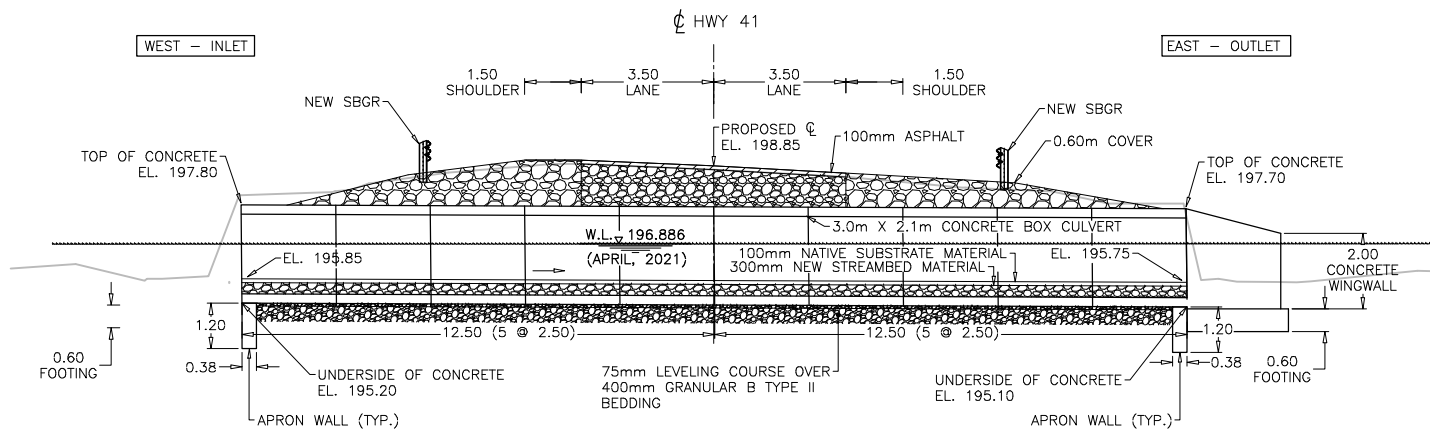
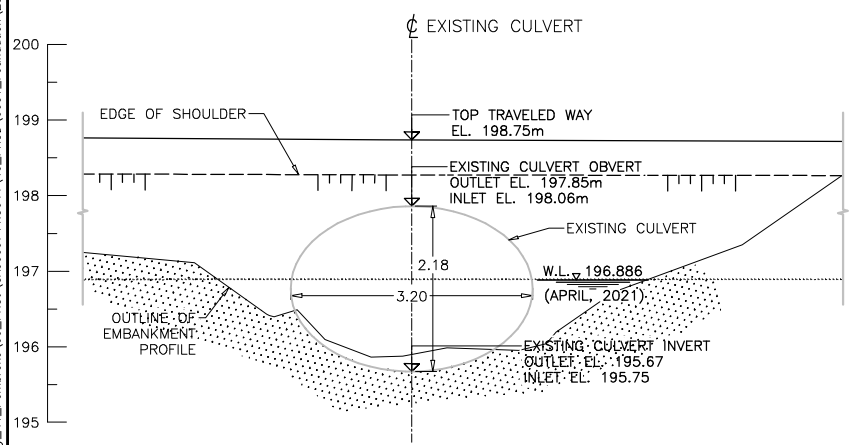
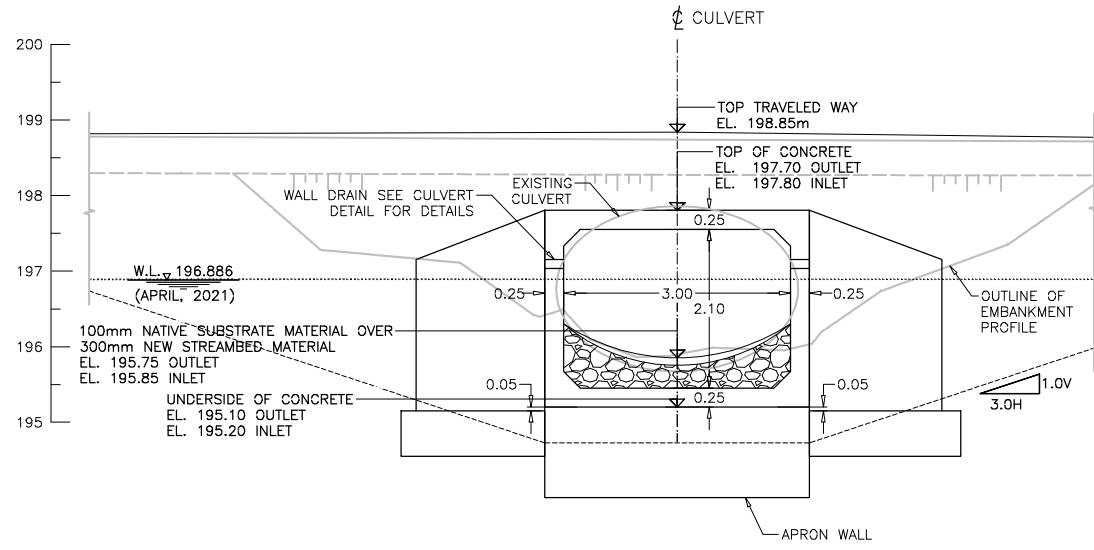
**Drawings 1 and 2 Borehole Locations and Soil Strata  
Preliminary General Arrangement Drawing; dated  
January 2022**

PLAN  
SCALE 1:100

LONGITUDINAL SECTION  
SCALE 1:100

EAST ELEVATION - EXISTING  
SCALE 1:50  
(WEST ELEVATION SIMILAR)

EAST ELEVATION  
SCALE 1:50  
(WEST ELEVATION SIMILAR)

This section of the report provides foundation recommendations for the detailed design of the replacement of Culvert 29X-0229/C0. The guidance provided herein is based on an interpretation of the factual data obtained from the 2023 investigation completed by WSP supplemented with data from the 2021 investigation at the site completed by Ainley and a review of the design information in the Preliminary General Arrangement (GA) drawing prepared by Ainley Group Consulting Engineers and Planners Ltd. (Ainley). A copy of the GA drawing is provided in the Drawings Appendix.

The preliminary GA drawing dated January 2022 indicates that the replacement culvert is to be approximately 25 m long and installed along the existing culvert alignment and that the existing highway platform grade will be maintained (i.e., no grade raise). To prevent erosion and undermining, concrete wing-walls and cut-off-walls are proposed at the inlet and outlets of the new culvert. It is anticipated that the culvert will be replaced via open-cut excavations in multiple stages, with the use of temporary protection systems along Highway 41. It is understood that to accommodate the proposed staging, Highway 41 will be reduced to one lane during construction and traffic will be controlled with temporary signalling.

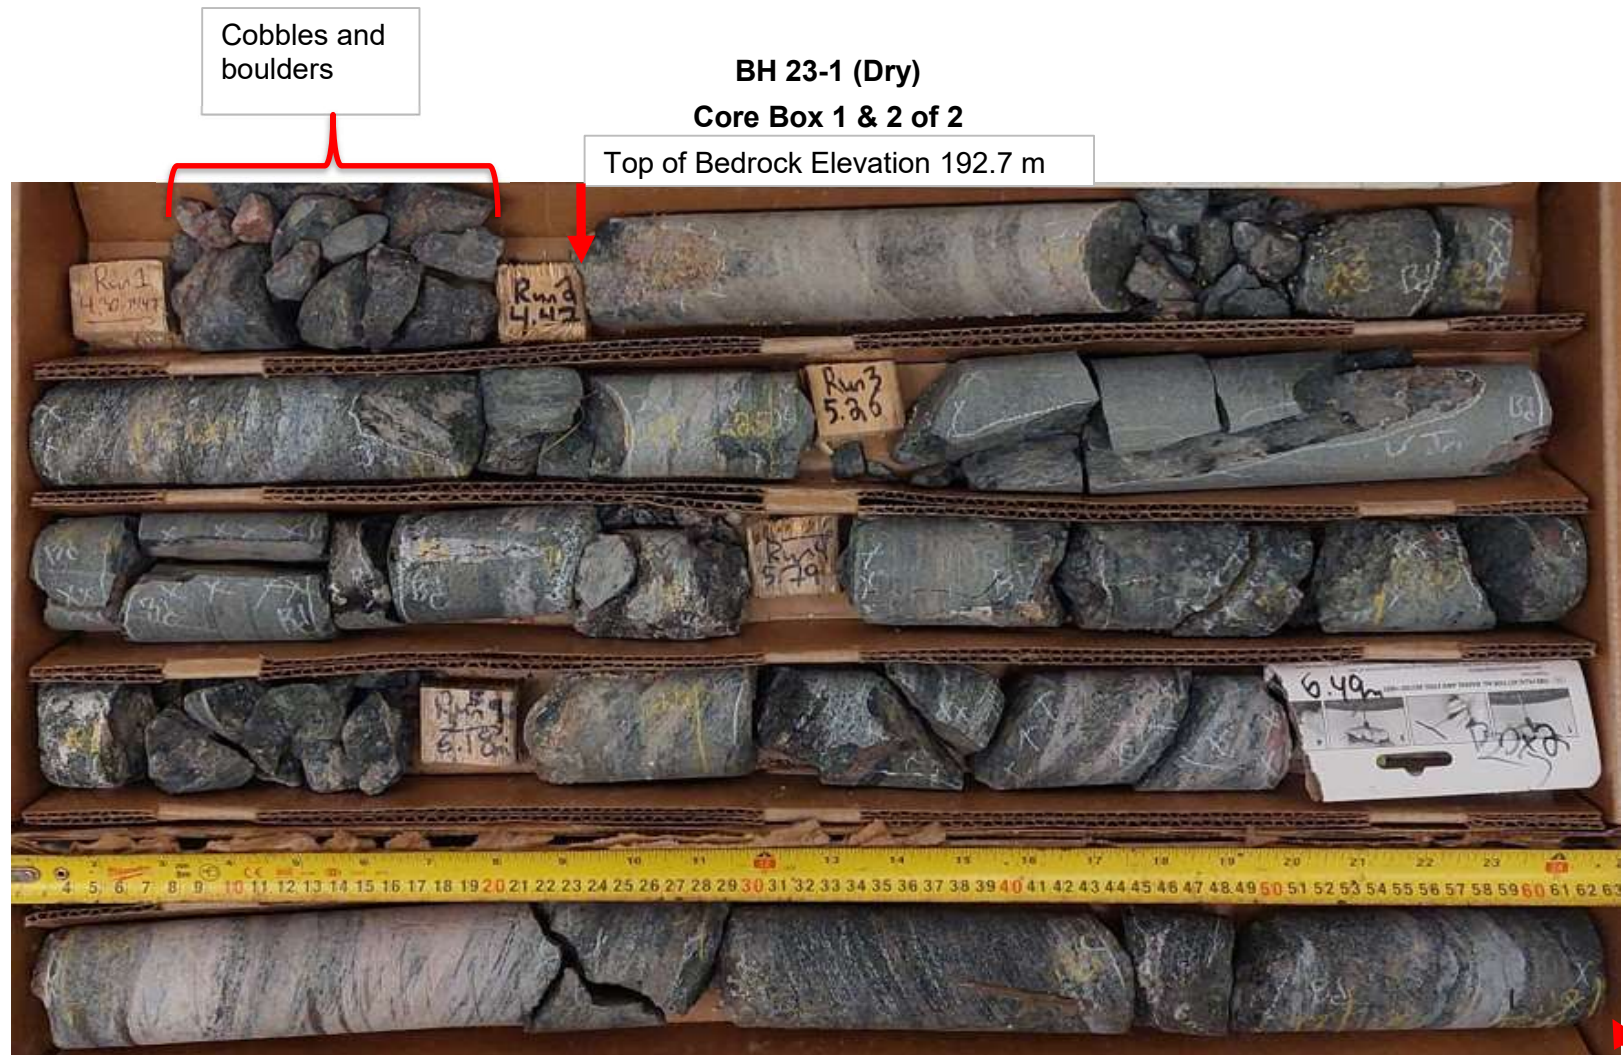
**Figure A1**

Cobbles and  
boulders

**BH 23-1 (Dry)**  
**Core Box 1 & 2 of 2**

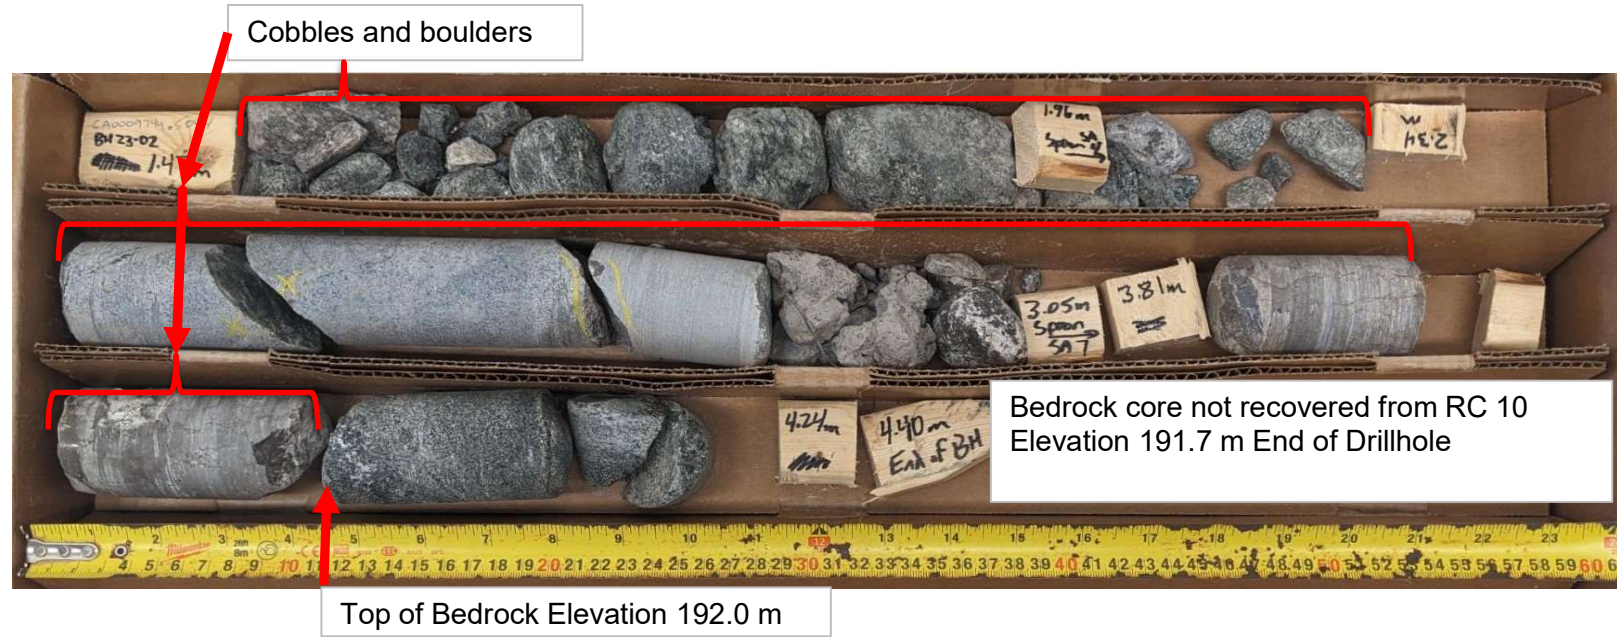
**Figure A3**

BH 23-2 (Wet)  
Core Box 1 of 1

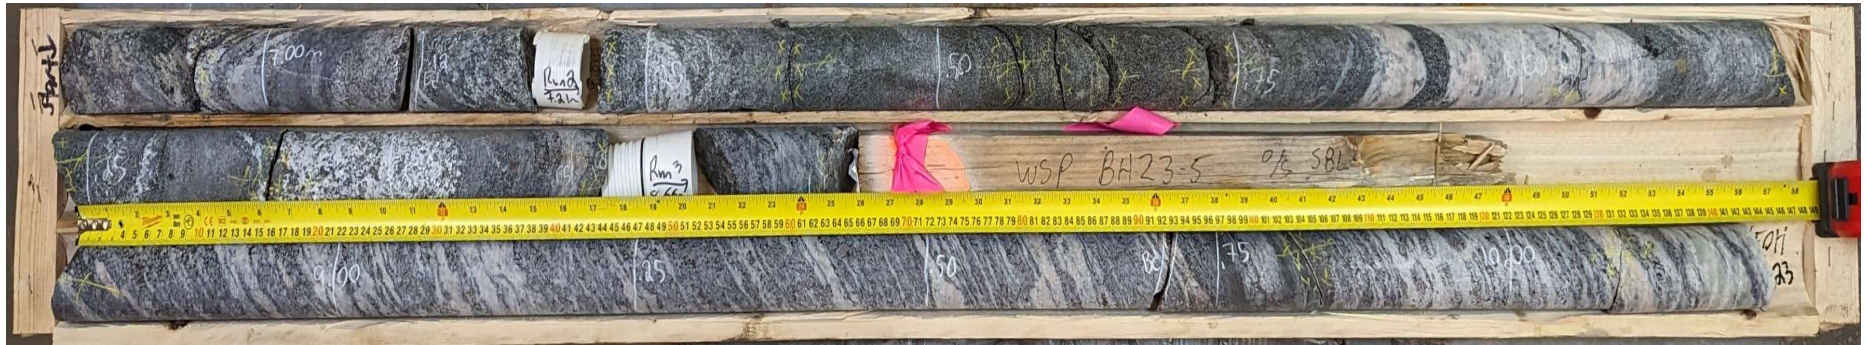
**BH 23-5 (Dry)**  
**Core Box 1 of 1**

Top of Bedrock Elevation 192.3 m

Elevation 188.9 m  
 End of Drillhole

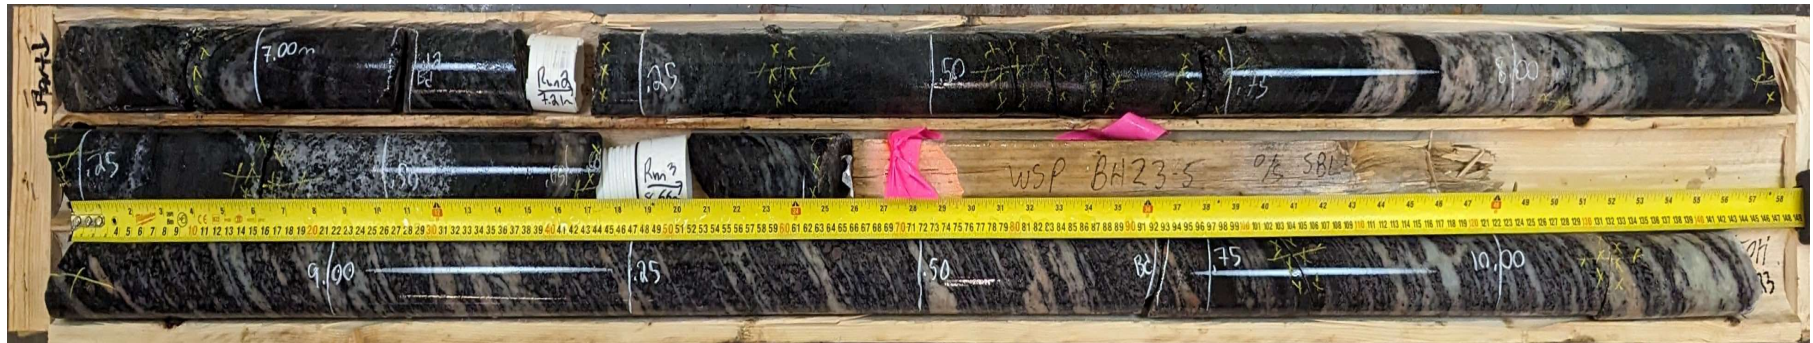
**BH 23-5 (Wet)**  
**Core Box 1 of 1**

Top of Bedrock Elevation 192.3 m

Elevation 188.9 m  
 End of Drillhole

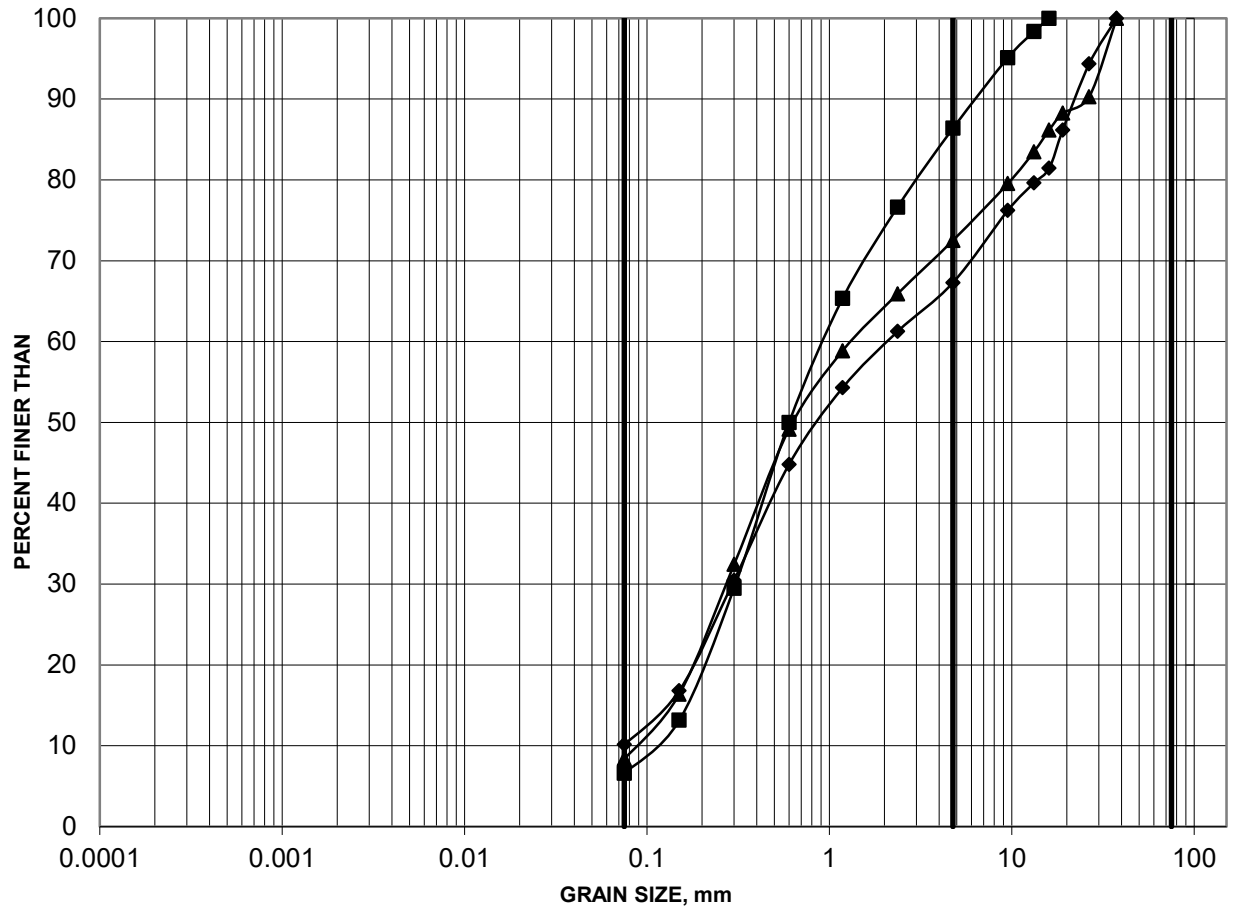
FIGURE B1

Gravelly SAND, to SAND, some gravel (FILL) (SP-SM)

Borehole	Sample	Depth (m)	Constituents (%)			
			Gravel	Sand	Silt	Clay
■ 23-03	4	2.30-2.90	14	79	7	
◆ 23-04	2	0.80-1.40	33	57	10	
▲ 23-05	2	0.80-1.40	27	65	8

Fill layers comprised of sandy gravel (base/sub-base layers of pavement structure) and sand with varying amounts of gravel and silt (embankment fill) were encountered below the asphalt at Boreholes 23-02 to 23-05 and at the ground surface of Boreholes BH1 and BH2. The top of this layer was encountered at elevations ranging from 198.4 m to 199.0 m. The total thickness of this layer ranges from about 2.3 m to 3.6 m. The SPT N-values recorded in the fill layers ranges from 5 to 51 blows per 0.3 m of penetration but more typically 7 to 19 blows per 0.3 m indicating a loose to compact state of compactness. The measured water content of 13 samples tested range from 1% to 15%. The results of grain size analysis testing carried out on three samples of fill materials are provided in Figure B1 in Appendix B.

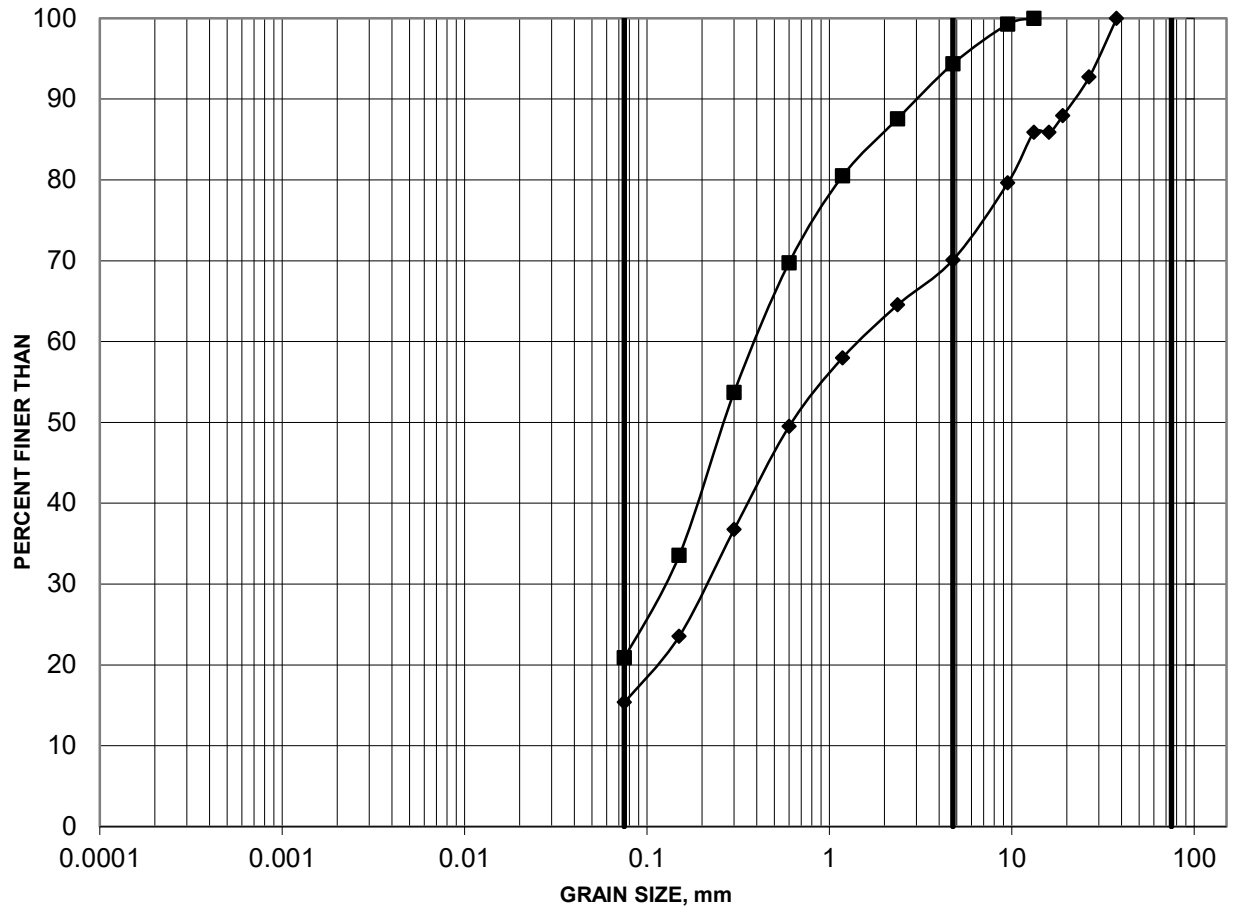
FIGURE B2

## Gravelly SILTY SAND to SILTY SAND (SM)

Borehole	Sample	Depth (m)	Constituents (%)			
				Gravel	Sand	Silt	Clay
■	23-01	3	1.22-1.83	6	73	21	
◆	23-04	5	3.00-3.70	30	55	15

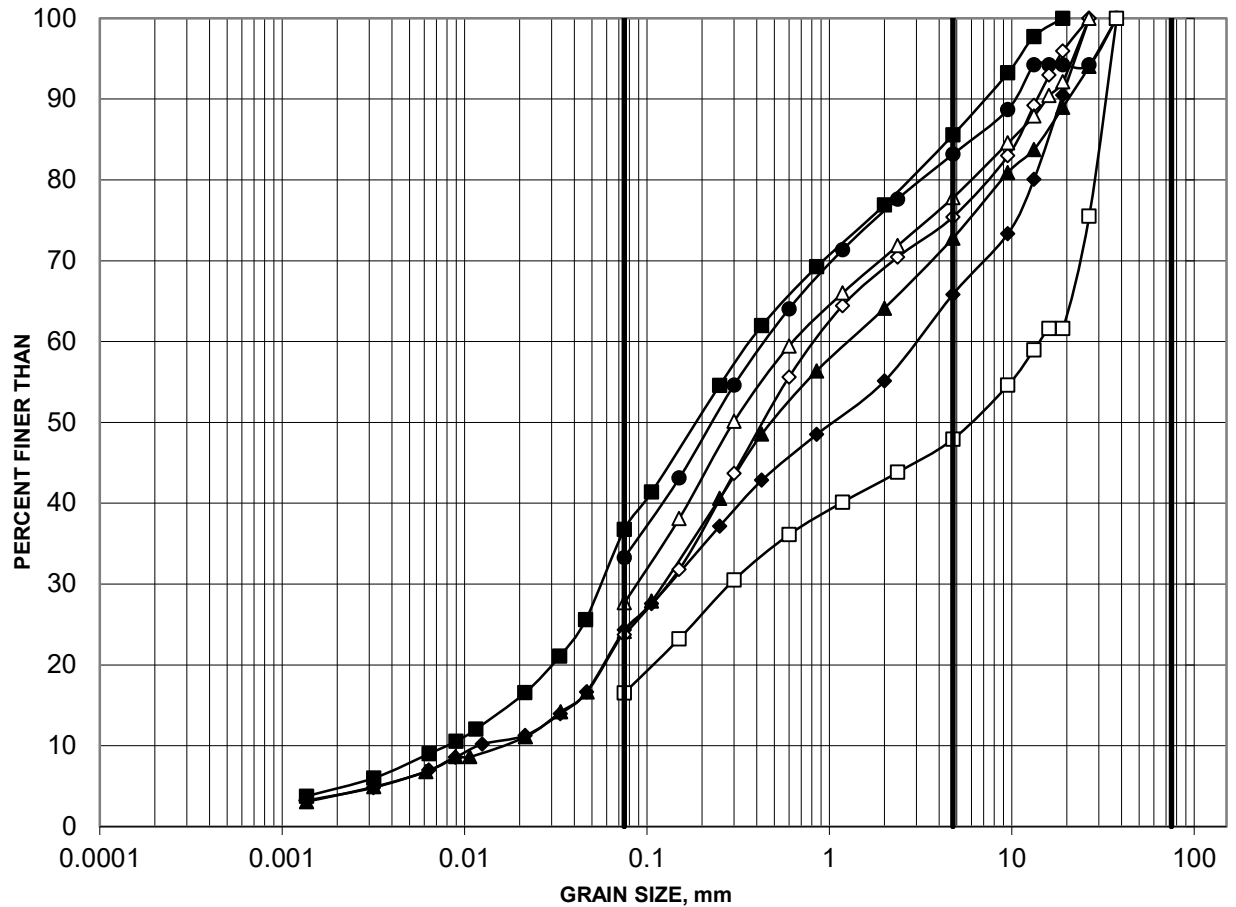
FIGURE B3

SILTY SAND, some gravel to Sandy SILTY GRAVEL (TILL) (SM to GM)

Borehole	Sample	Depth (m)	Constituents (%)			
				Gravel	Sand	Silt	Clay
■	23-01	5	2.44-3.05	14	49	32	5
◆	23-02	4	2.01-2.34	34	42	20	4
▲	23-02	7	3.05-3.66	27	49	20	4
●	23-03	6	3.80-4.40	17	50		33
□	23-04	7B	4.90-5.10	52	31		17
◇	23-05	5	3.00-3.70	25	51		24
△	23-05	8	5.30-5.90	22	50		28

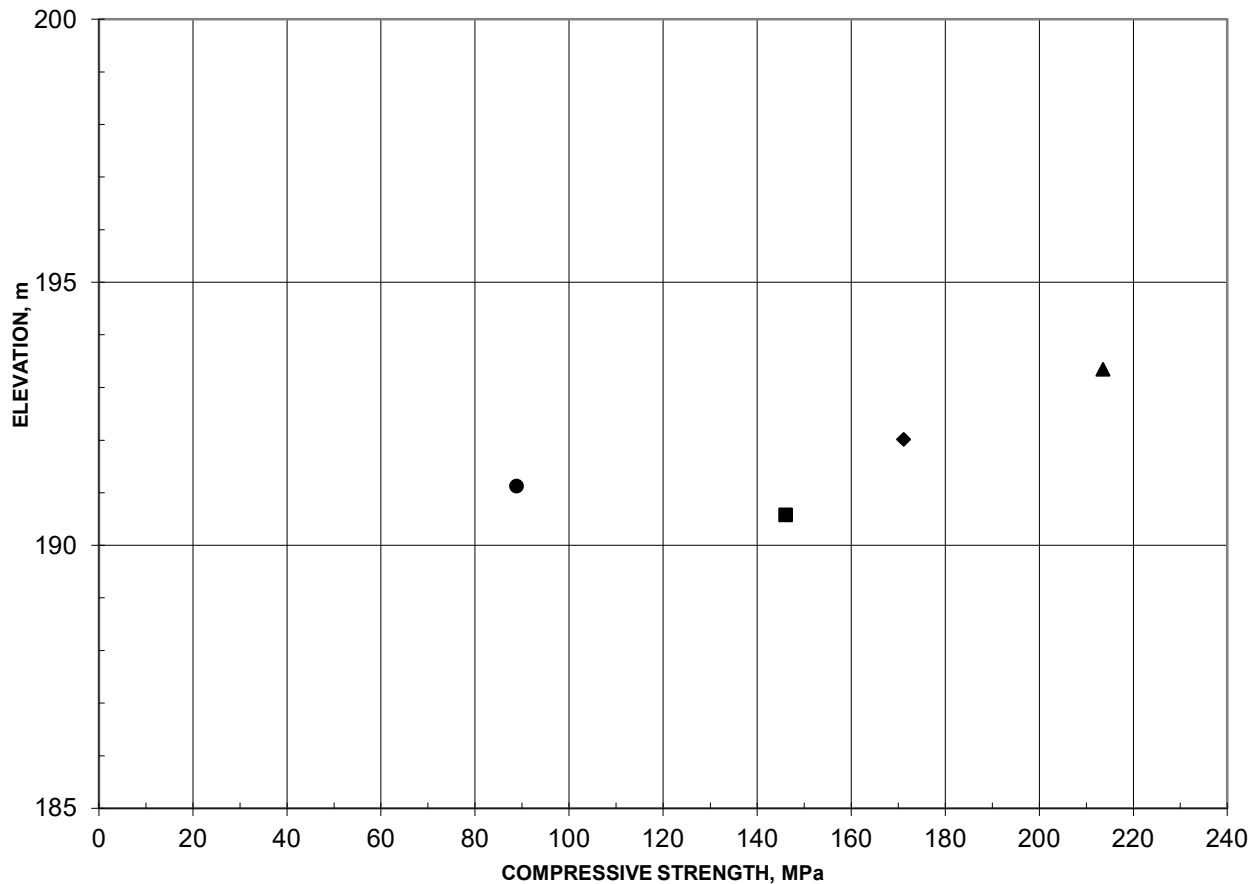
**FIGURE B4**

**ASTM D7012 - Method C**  
**UNCONFINED UNIAXIAL COMPRESSIVE STRENGTH OF ROCK CORE**  
**SUMMARY OF LABORATORY TEST RESULTS**

Borehole	Depth (m)	L/D	Bulk Density (kg/m <sup>3</sup> )	Lithology	UCS (MPa)	Failure Type
■	23-01 RC1	6.6	3	2649	Granitic Gneiss	146	1
◆	23-03 RC1	6.8	2.2	2817	Granitic Gneiss	171	1
▲	23-04 RC1	5.5	2.5	2568	Granitic Gneiss	214	1
●	23-05 RC1	8.0	2.3	2590	Granitic Gneiss	89	1

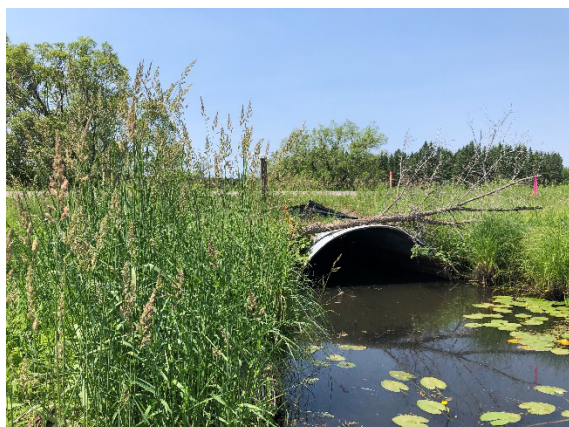
Photograph 5: Culvert 29X-0229 east opening, June 2023

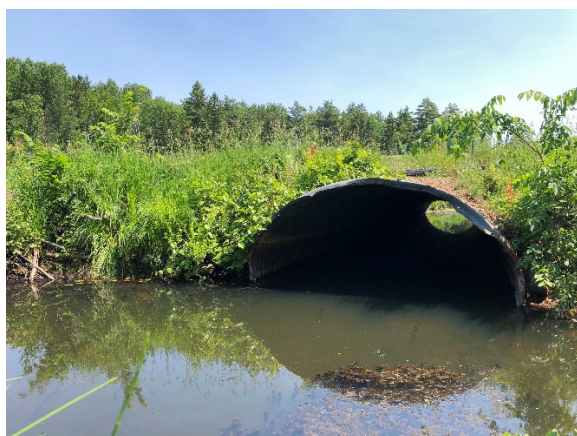
Photograph 7: Culvert 29X-0229 west opening, June 2023

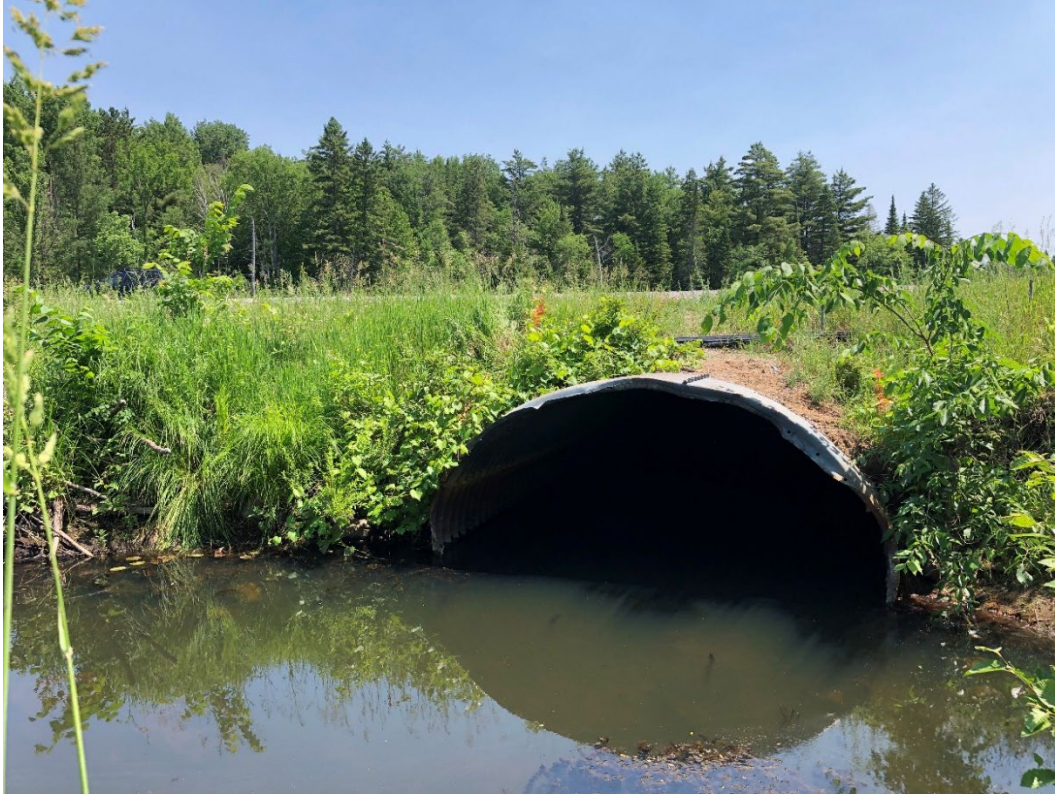
*Photograph 1: Looking east toward existing culvert inlet; March 13, 2024*

Site photographs showing the general conditions of the site at the time of the 2023 investigation are presented in Appendix F.
