# Foundation Investigation Report

*Replacement of Structural Culvert 29X-0229/C0*

*Highway 41, Grattan, Ontario*

*MTO GWP 4123-17-00; Agreement Number 4021-E-0021-04*

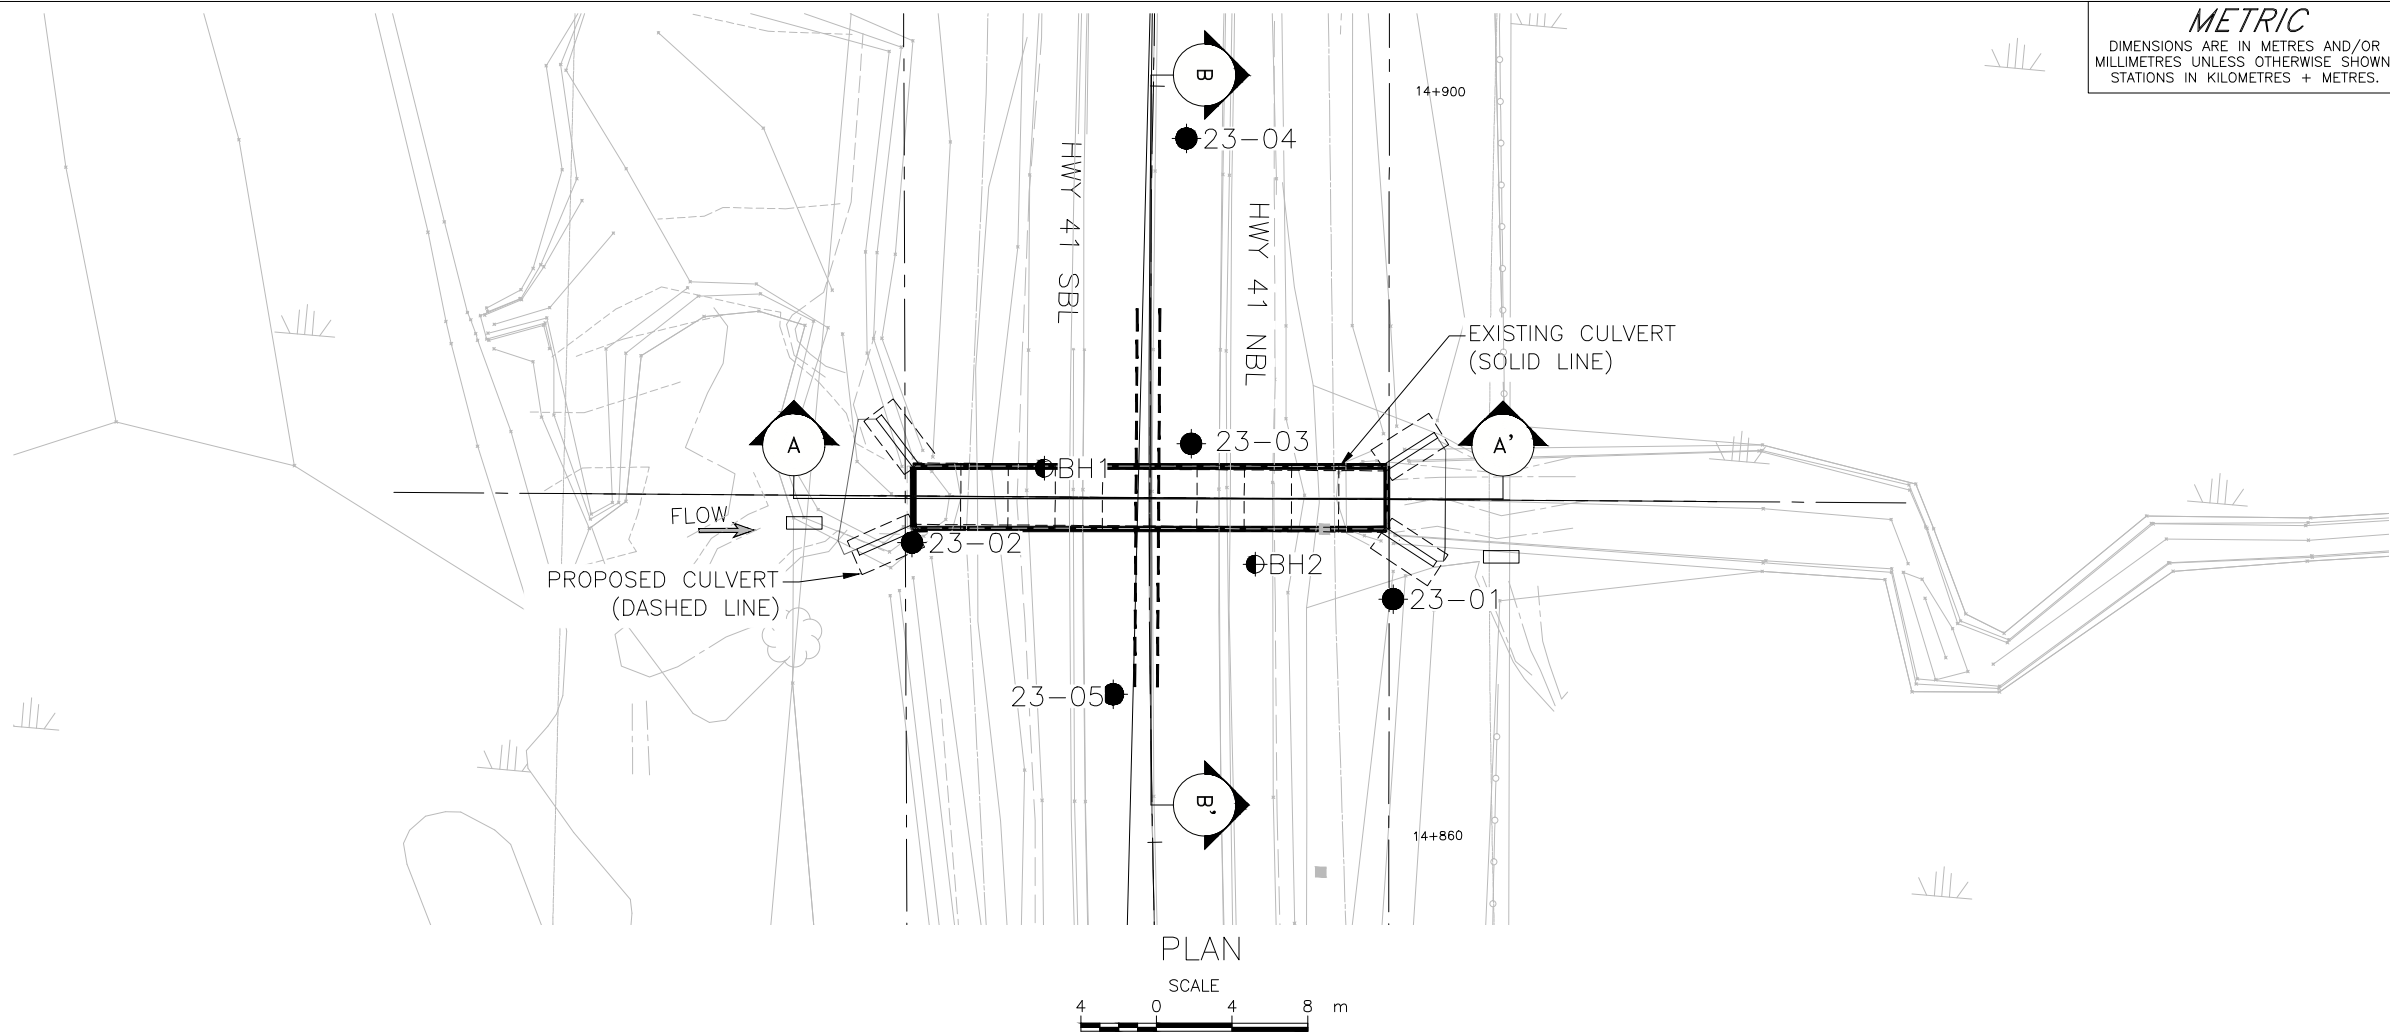
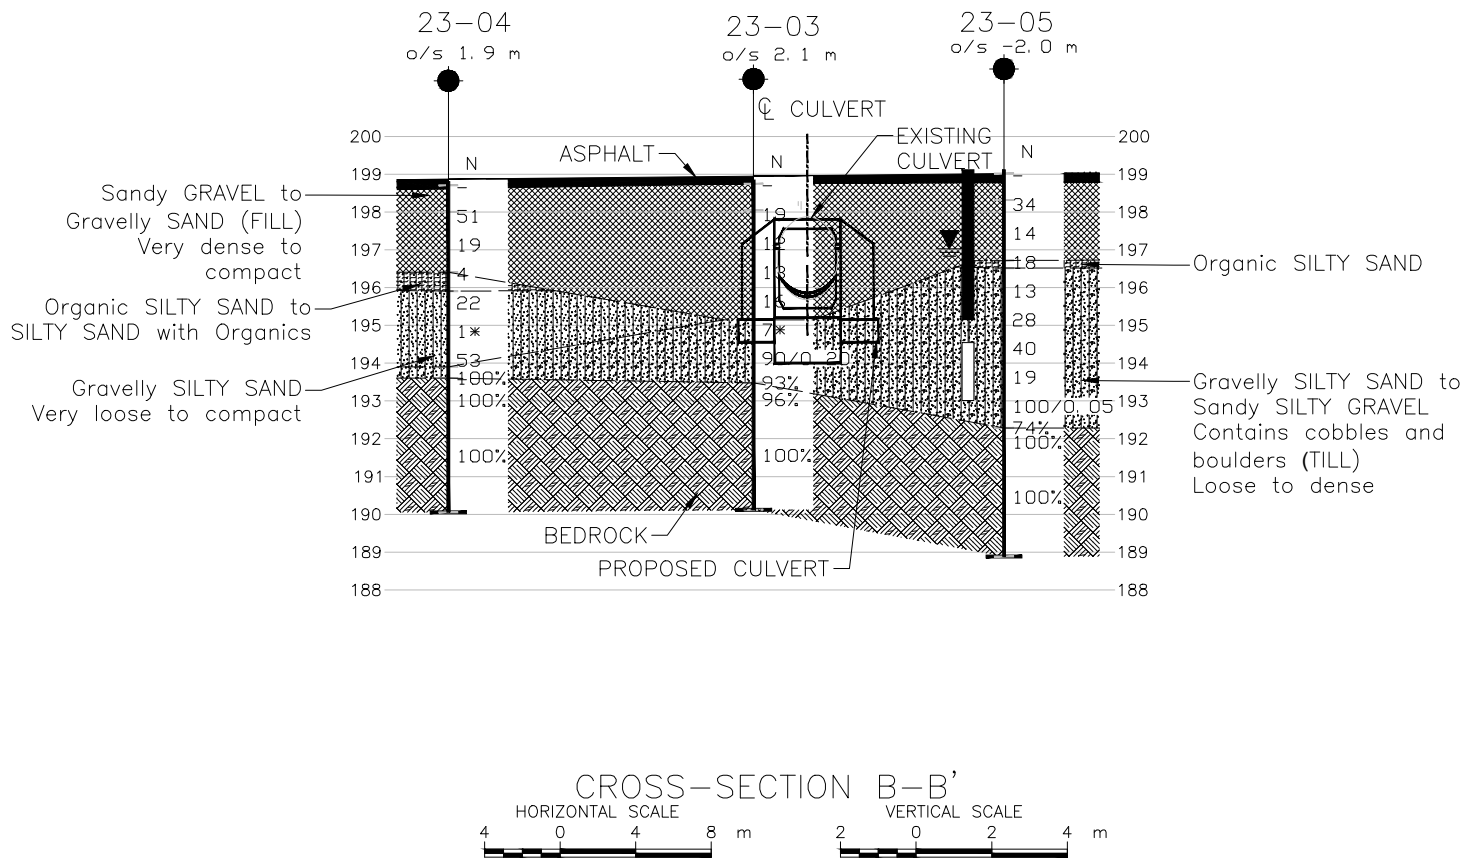
NO.	DATE	BY	REVISION
Geocres No. 31F06-001			
HWY. 41		PROJECT NO. CA0009744.5044	
SUBM'D. BW		DIST. EASTERN	
DRAWN: SA		DATE: 6/27/2024	
CHKD: KCP		SITE: 29X-0229/C0	
APPD: JPD		DWG. 2

HIGHWAY 41  
REPLACEMENT OF CULVERT 29X-0229/C0  
BOREHOLE LOCATIONS AND SOIL  
STRATA

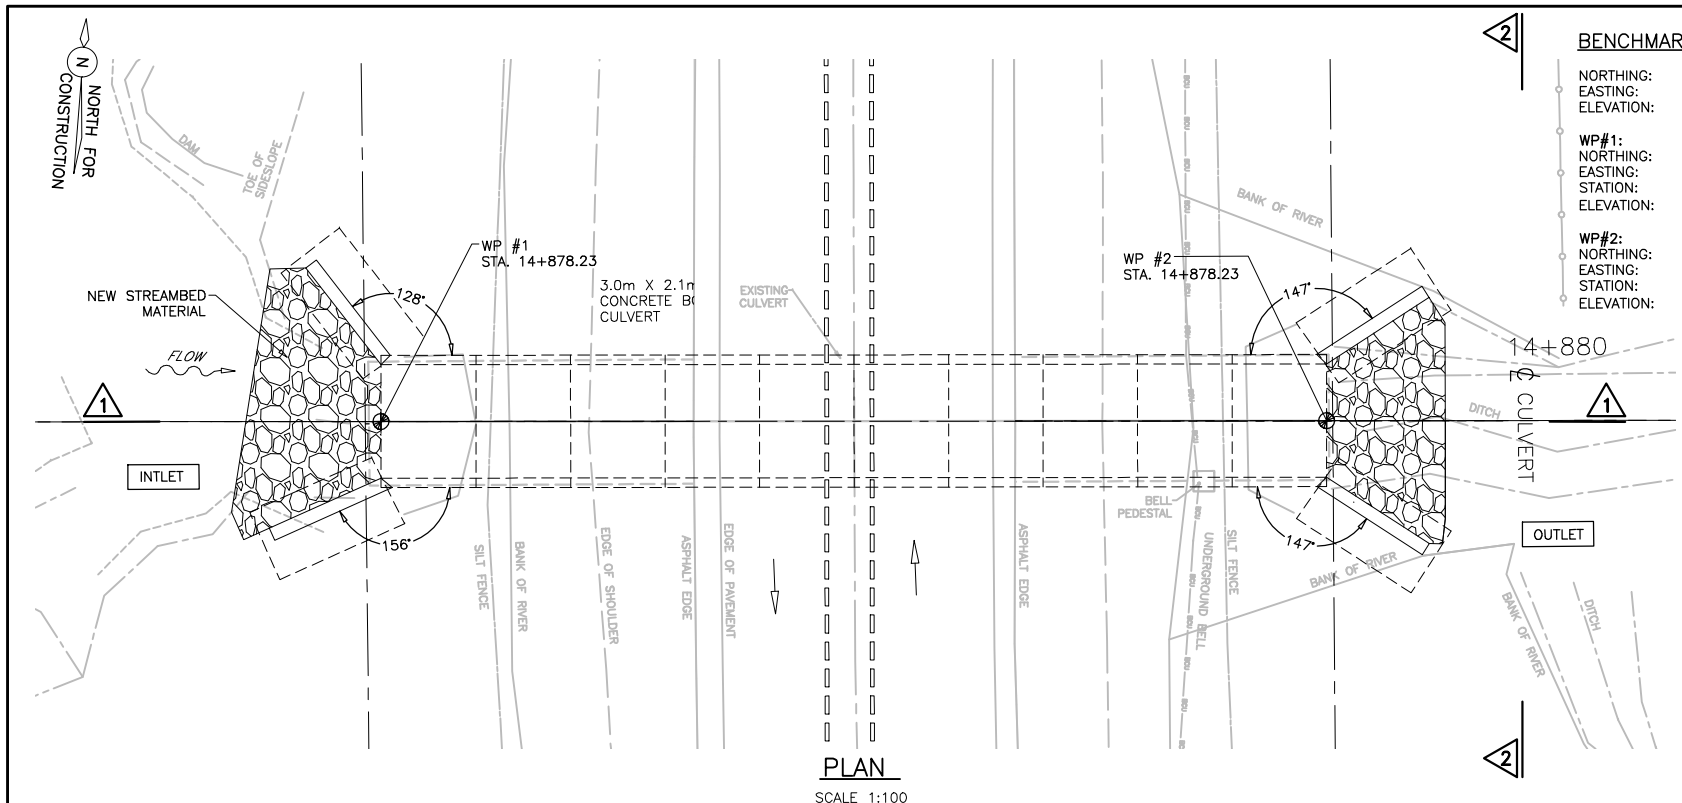
PLAN  
SCALE 1:100

HIGHWAY 41  
CULVERT REPLACEMENT  
SITE No. 29X-0229/C0

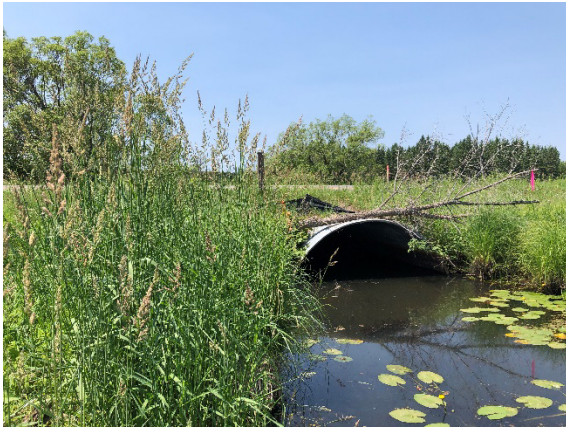
Photograph 5: Culvert 29X-0229 east opening, June 2023

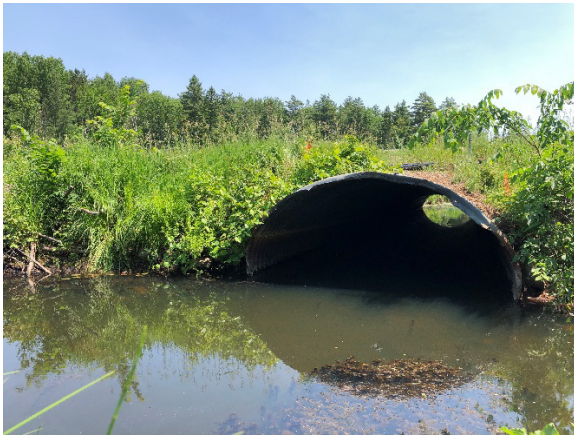
Photograph 7: Culvert 29X-0229 west opening, June 2023
