THURBER ENGINEERING LTD.

**FINAL
FOUNDATION INVESTIGATION AND DESIGN REPORT
HIGHWAY 17, FROM THE EAST JUNCTION OF SUDBURY RR 55 19.5KM TO
KUKAGAMI RD
EMBANKMENT FROM STA. 13+110 TO 13+179, AWREY TWP
ASSIGNMENT NO. 5019-E-0012
GWP 5168-16-00**

May 2021
Thurber File No.: 28408

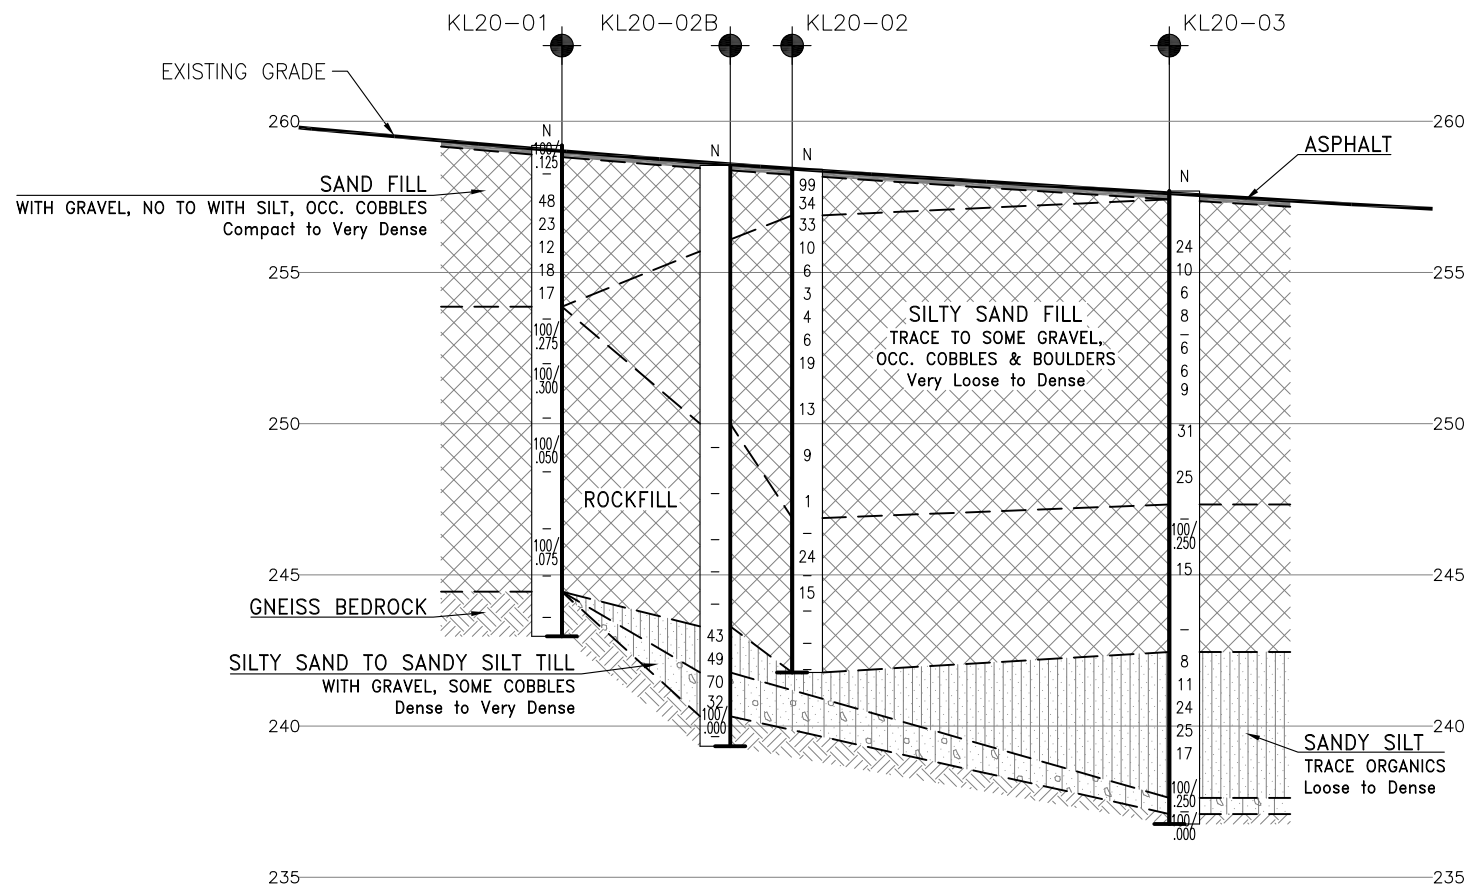
PROFILE A-A

HIGHWAY 17
KUKAGAMI SLOPE
INSTABILITY
BOREHOLE LOCATIONS AND SOIL STRATA

Details of the encountered soil stratigraphy are presented on the Record of Borehole sheets included in Appendix B and the Borehole Location and Soil Strata Drawing included in Appendix A. A general description of the stratigraphy, based on the conditions encountered in the boreholes advanced during the current investigation, is given in the following paragraphs. However, the factual data presented on the Record of Borehole sheets takes precedence over this general description for interpretation of the site conditions. It must be recognized that the bedrock elevation, soil and groundwater conditions will vary between and beyond the borehole locations.

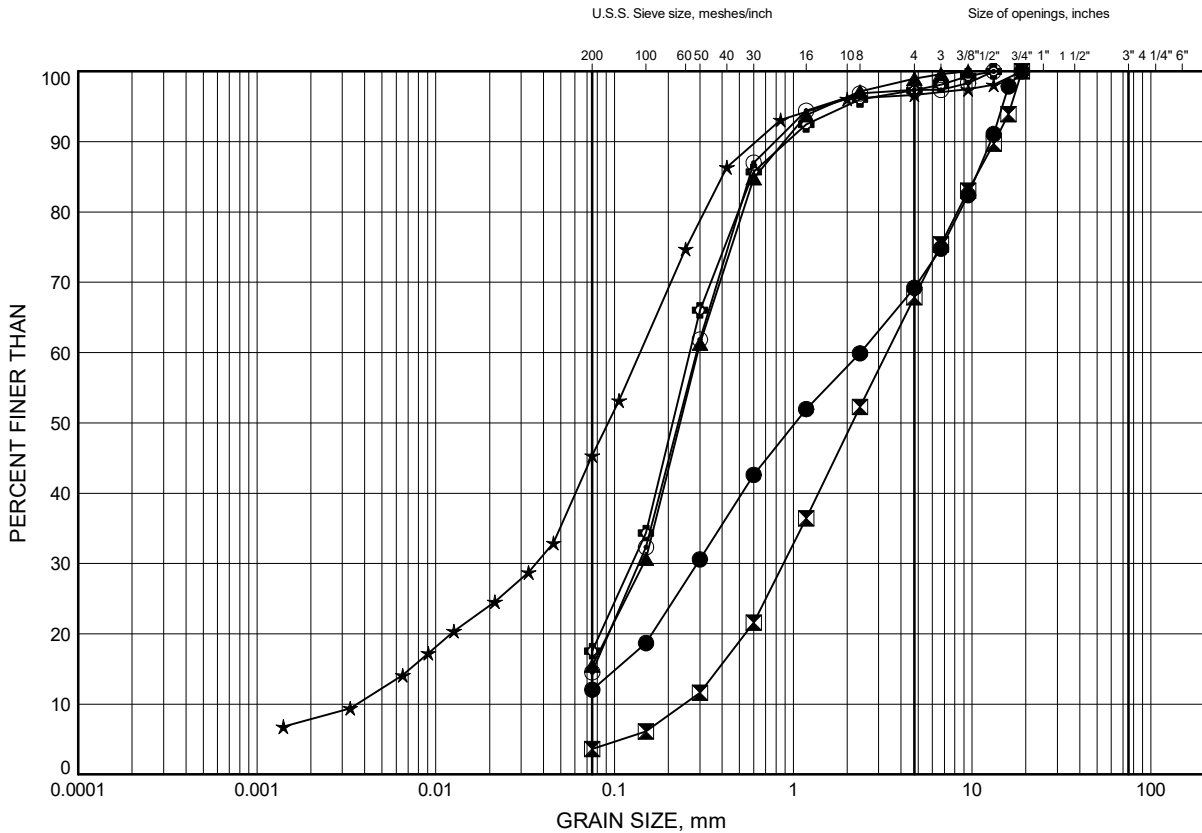
FIGURE C1

Sand with Silt and Gravel to Sand with Gravel to Silty Sand Fill

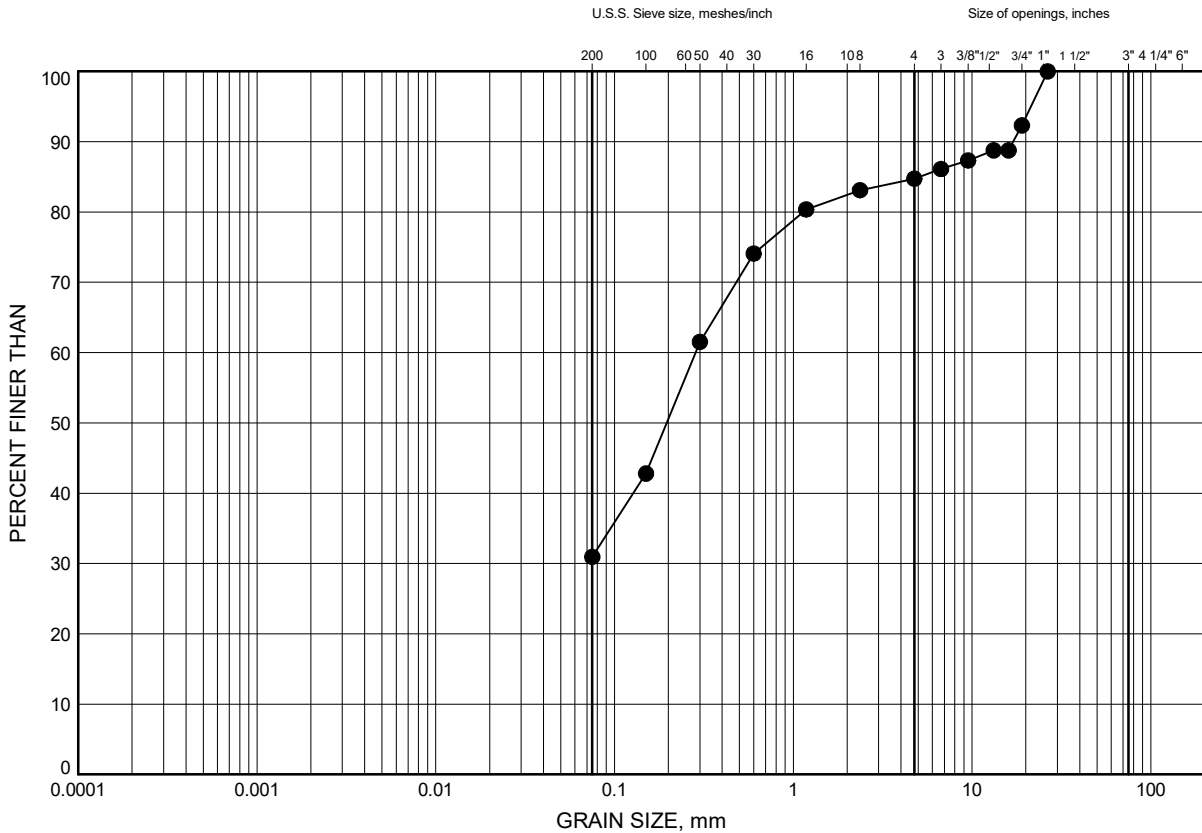
FIGURE C2

Sand with Silt and Gravel to Sand with Gravel to Silty Sand Fill

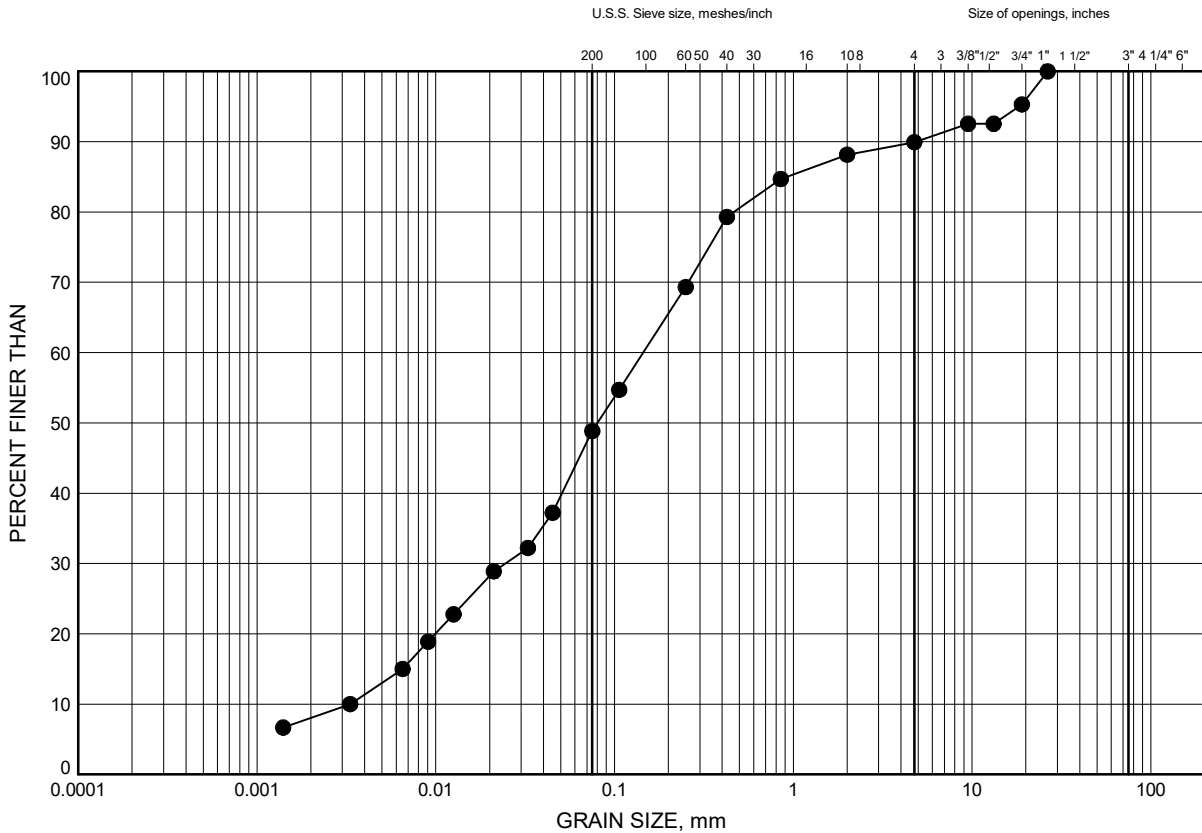
FIGURE C3

Rockfill

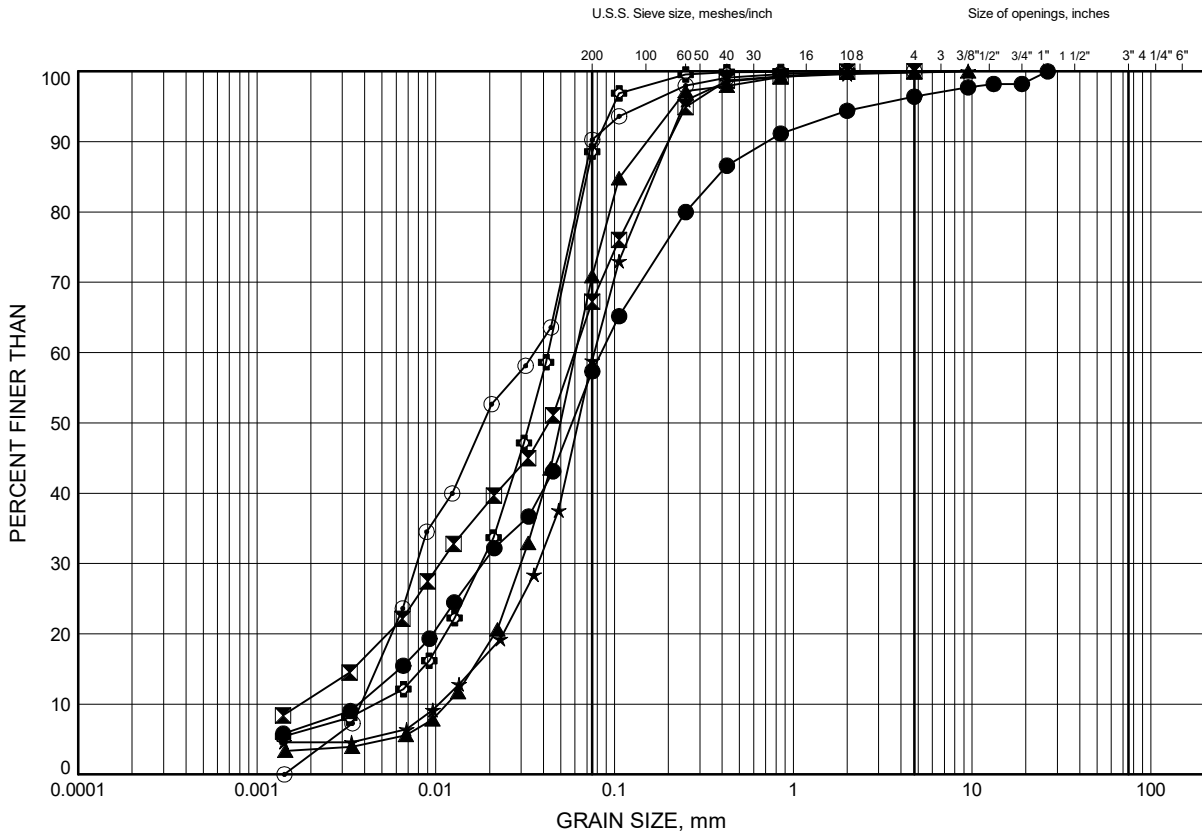
FIGURE C4

Sandy Silt (SM) to Silty Sand (ML)

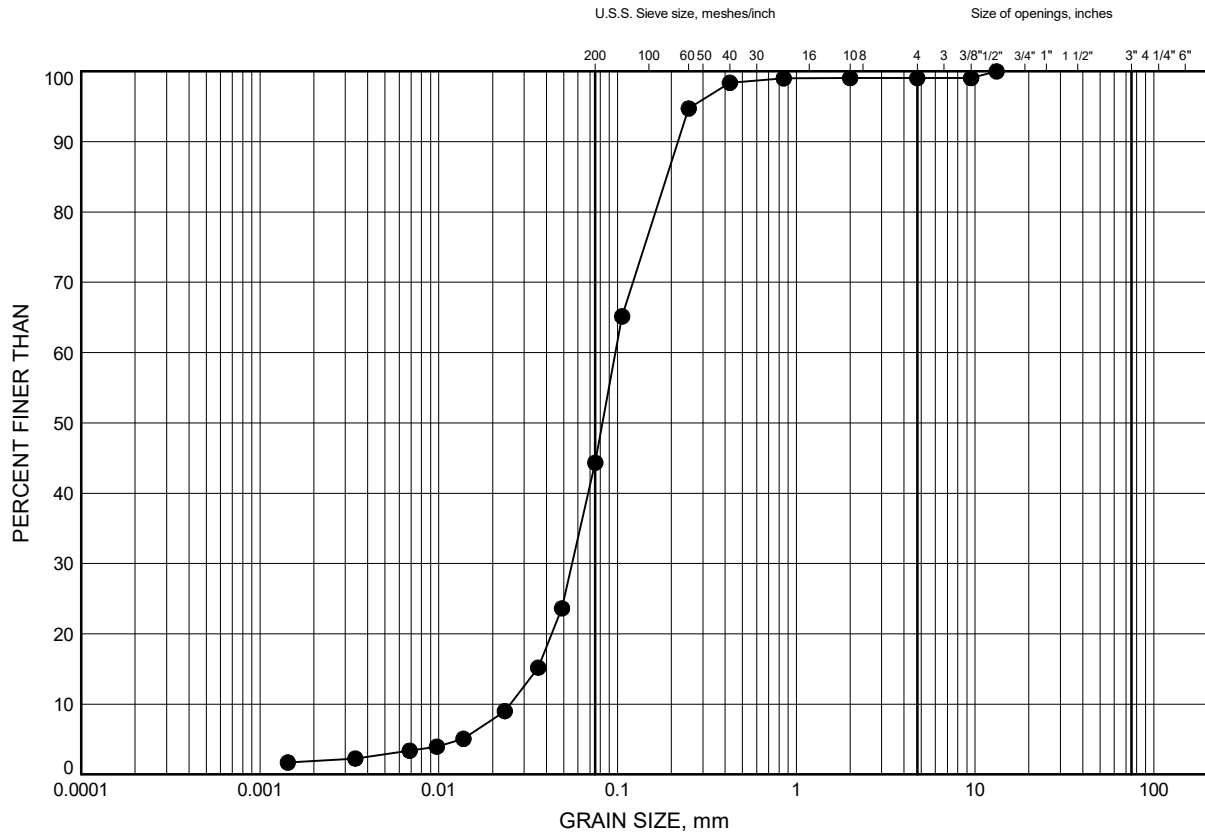
FIGURE C5

Sandy Silt (SM) to Silty Sand (ML)

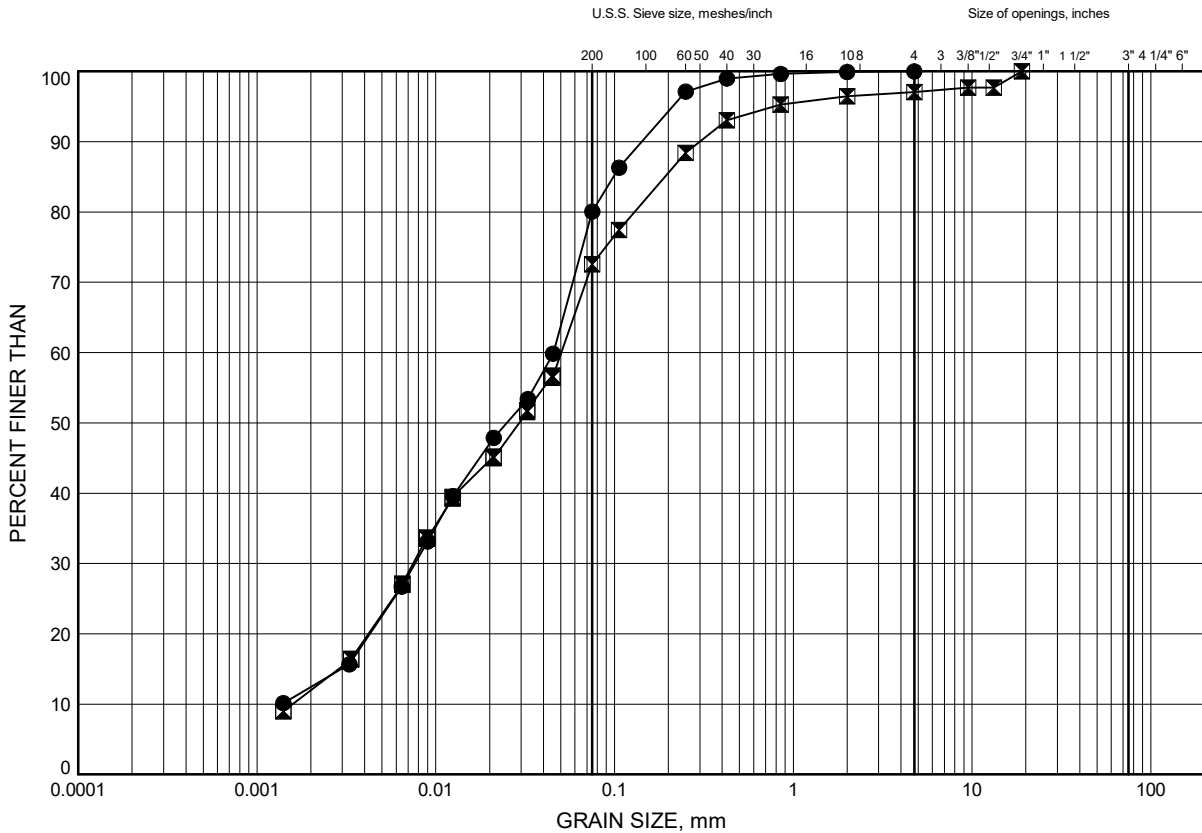
FIGURE C6

Clayey Silt (MI)

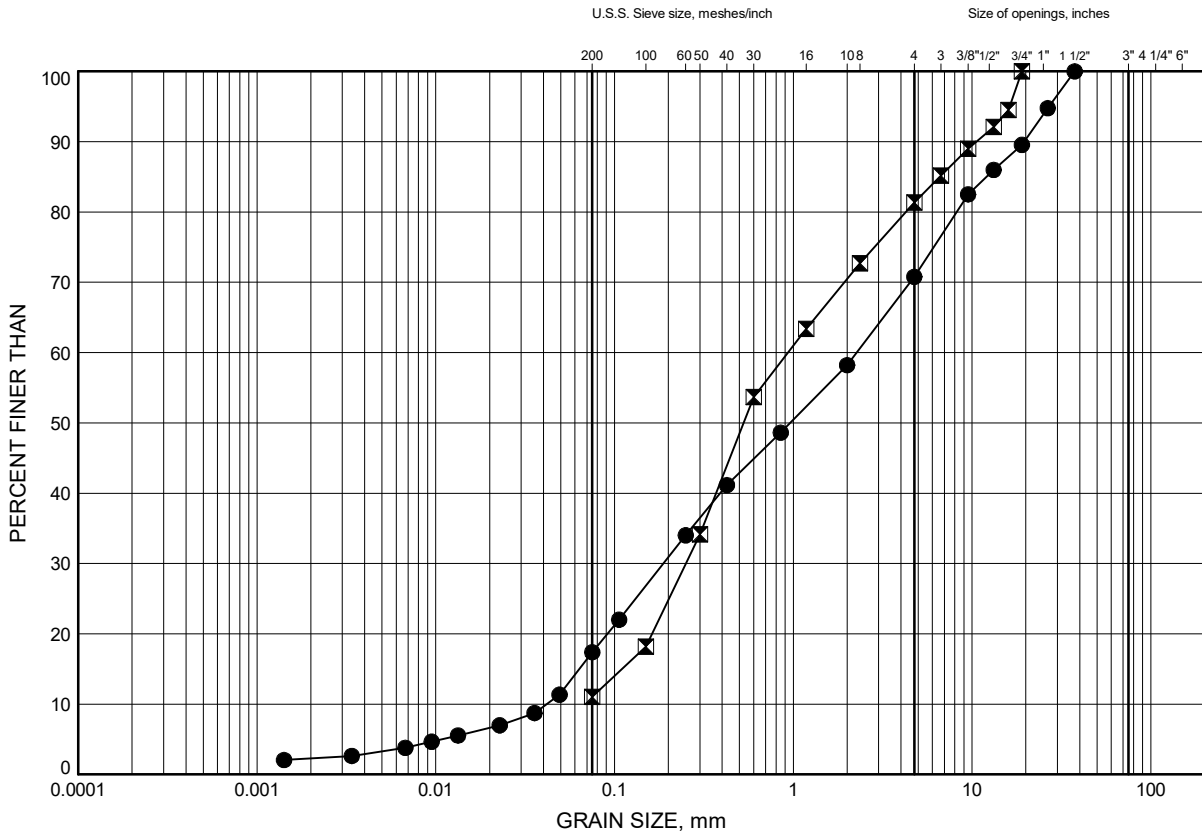
FIGURE C7

Silty Sand (SM) to Sand (SP-SM) Till

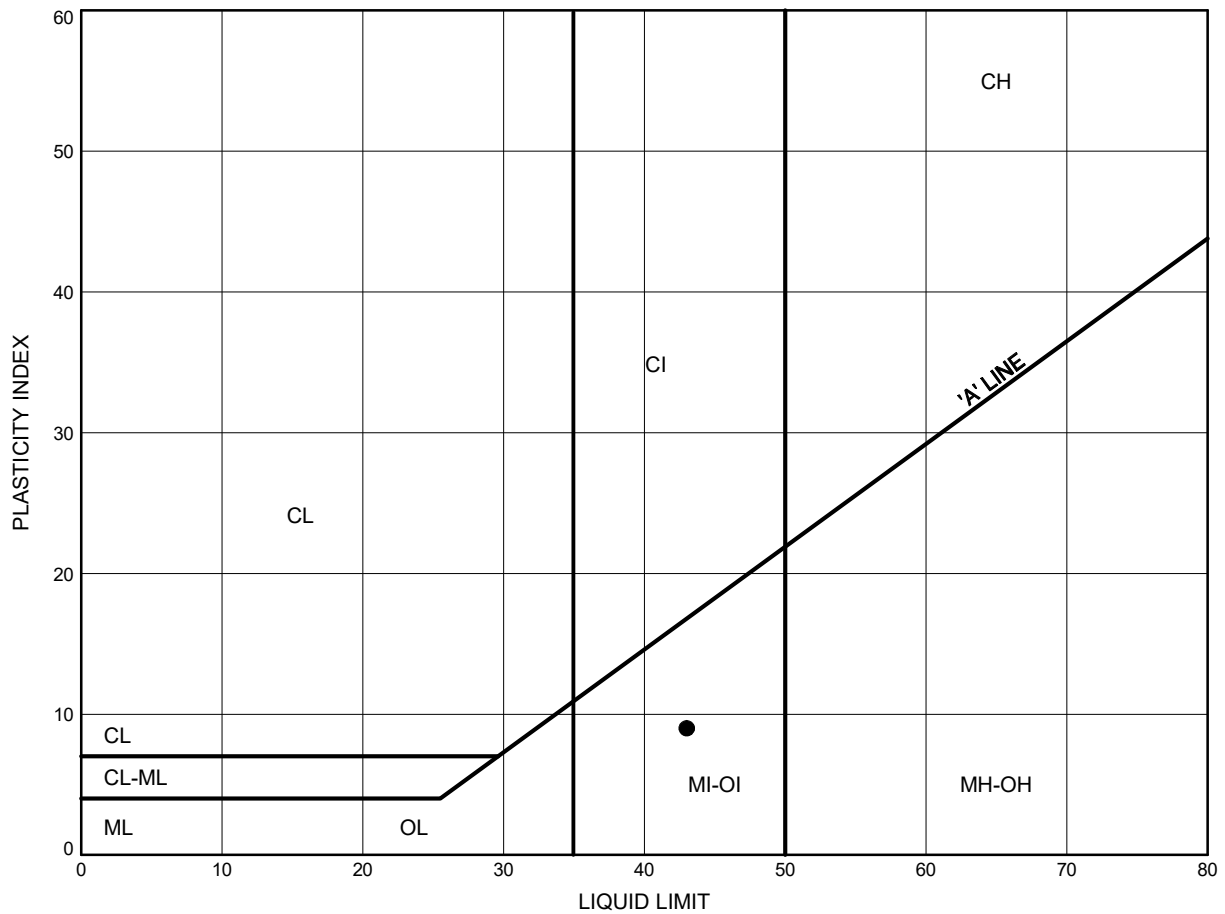
FIGURE C8

Clayey Silt (MI)

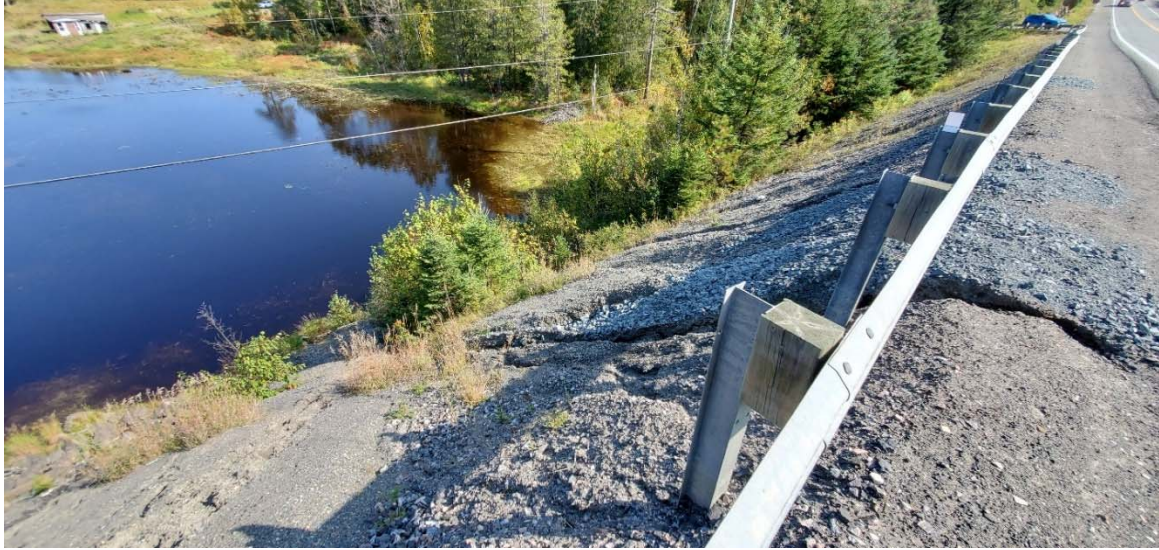
Photo 1: Looking northeast along north embankment slope. Granular slope, erosion gullies, localized crushed rock repairs, vegetation at the east end of embankment and body of water at embankment toe. Photo taken near location of culvert crossing. [taken September 2020]

Photographs showing the existing conditions of the embankment slope and the surrounding area at the time of the field visits are included in Appendix D for reference.

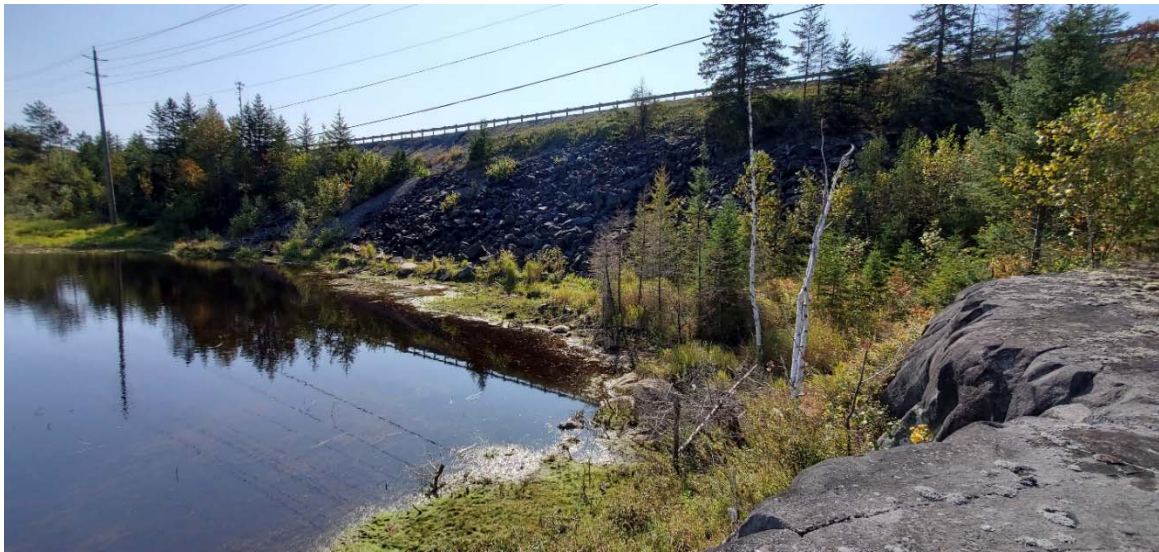
Photo 2: Looking southeast along north embankment slope. Large rocks present along slope. Exposed bedrock present in near side of photo (west end of body of water) [taken September 2020]

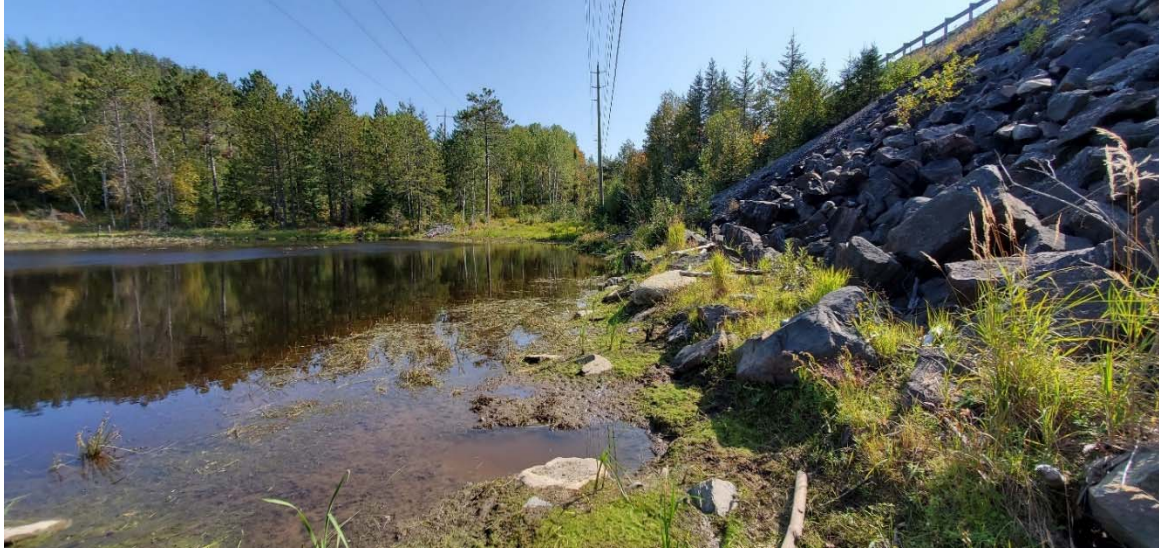
Photo 3: Looking eastward along north embankment toe. Water at toe of rock lined slope. Utility lines overhead and Buried Bell utility. [taken September 2020]

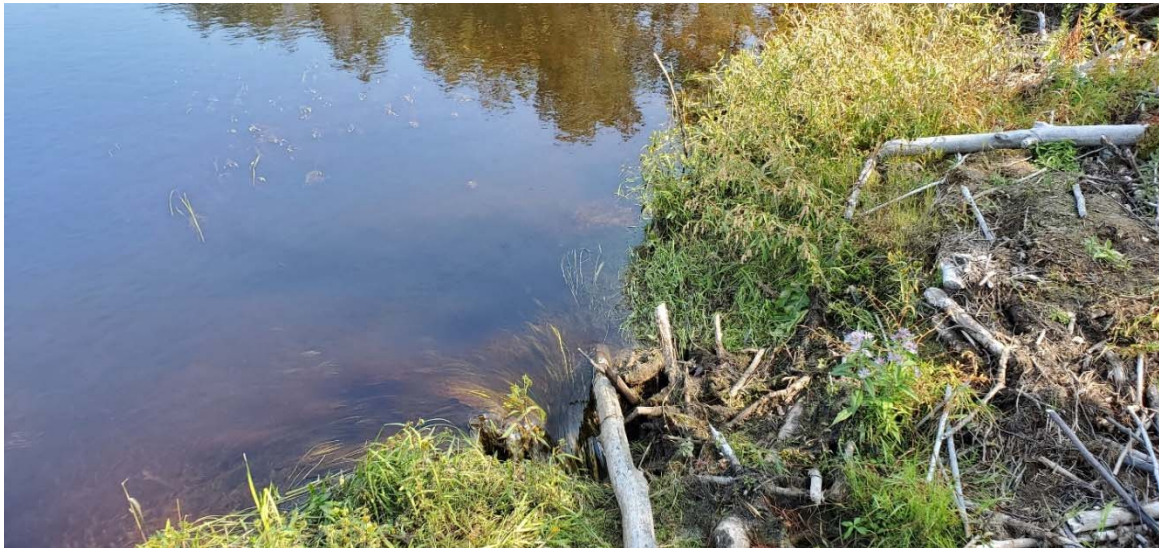
Photo 4: Presumed location of north end of culvert. Water vortex entering under pile of wooded debris. [taken September 2020]

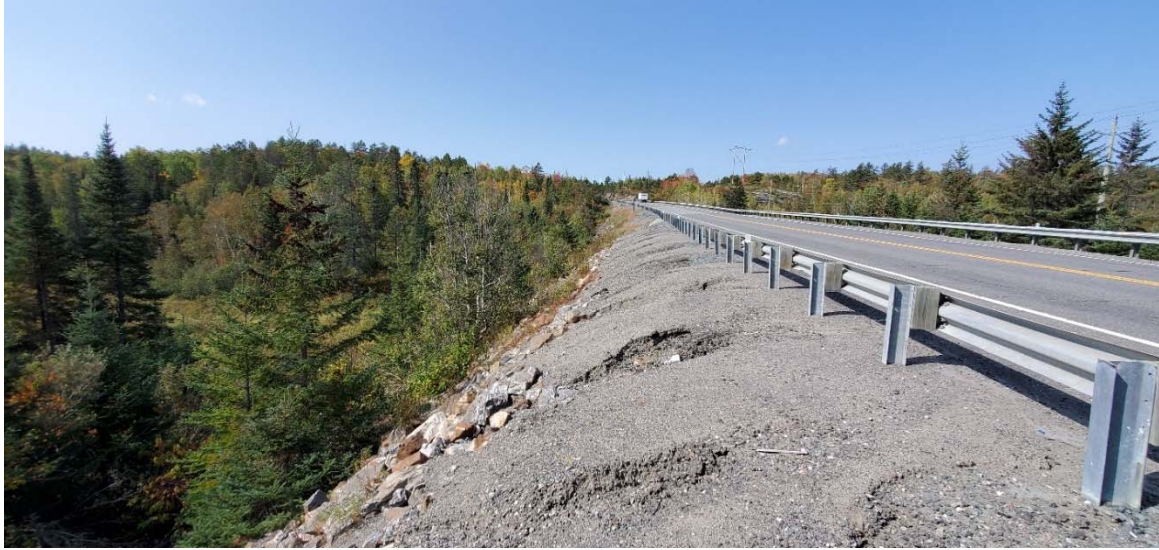
Photo 5. Looking westward along south slope, similar conditions as noted along the north slope. [taken September 2020]

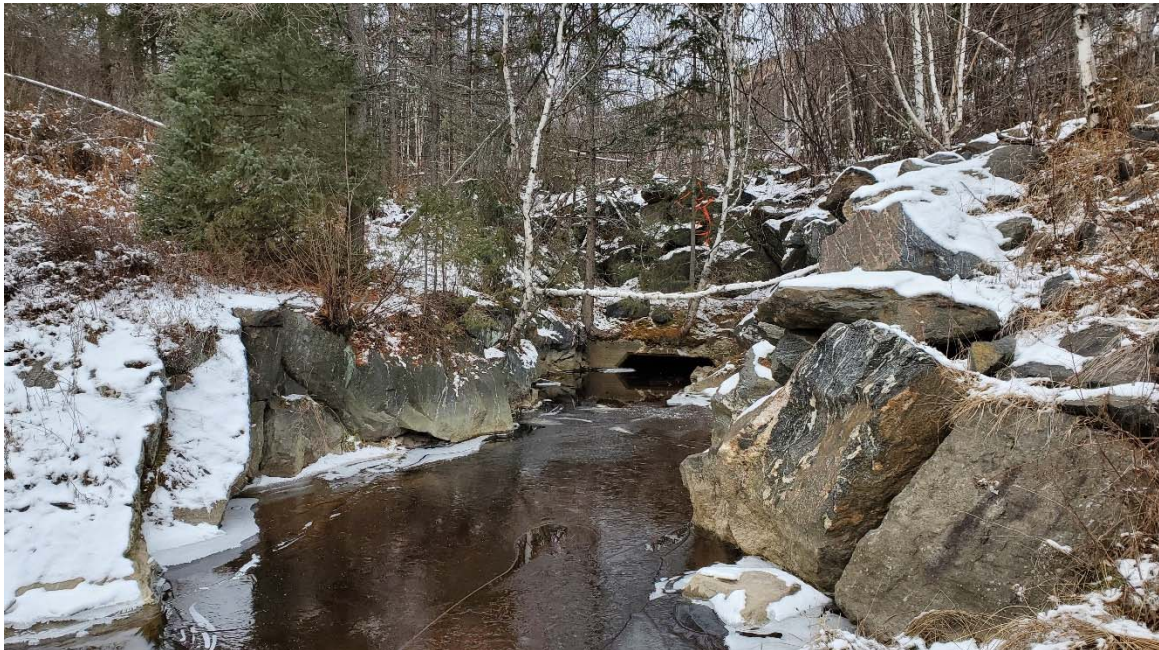
Photo 6. Looking north at culvert outlet, showing bedrock on west side. [taken December 2020]

A 1.8 m by 1.4 m by 59.7 m reinforced box culvert is present crossing underneath the embankment and is indicated to be near Sta. 13+140 as shown on the drawings provided to the Design Team. The culvert alignment bends to the east just prior to the outlet. It is understood that the invert elevation is at approximate elevation 242.3 m and 242.2 m at the inlet and outlet, respectively. At the time of the investigation the inlet was below water level and could not be observed. A bedrock outcrop was noted to the west of the existing culvert outlet.

The culvert outlet was observed during the December 2020 field investigation. A bedrock outcrop was noted to the west of the existing culvert (see Photo 6 in Appendix D).

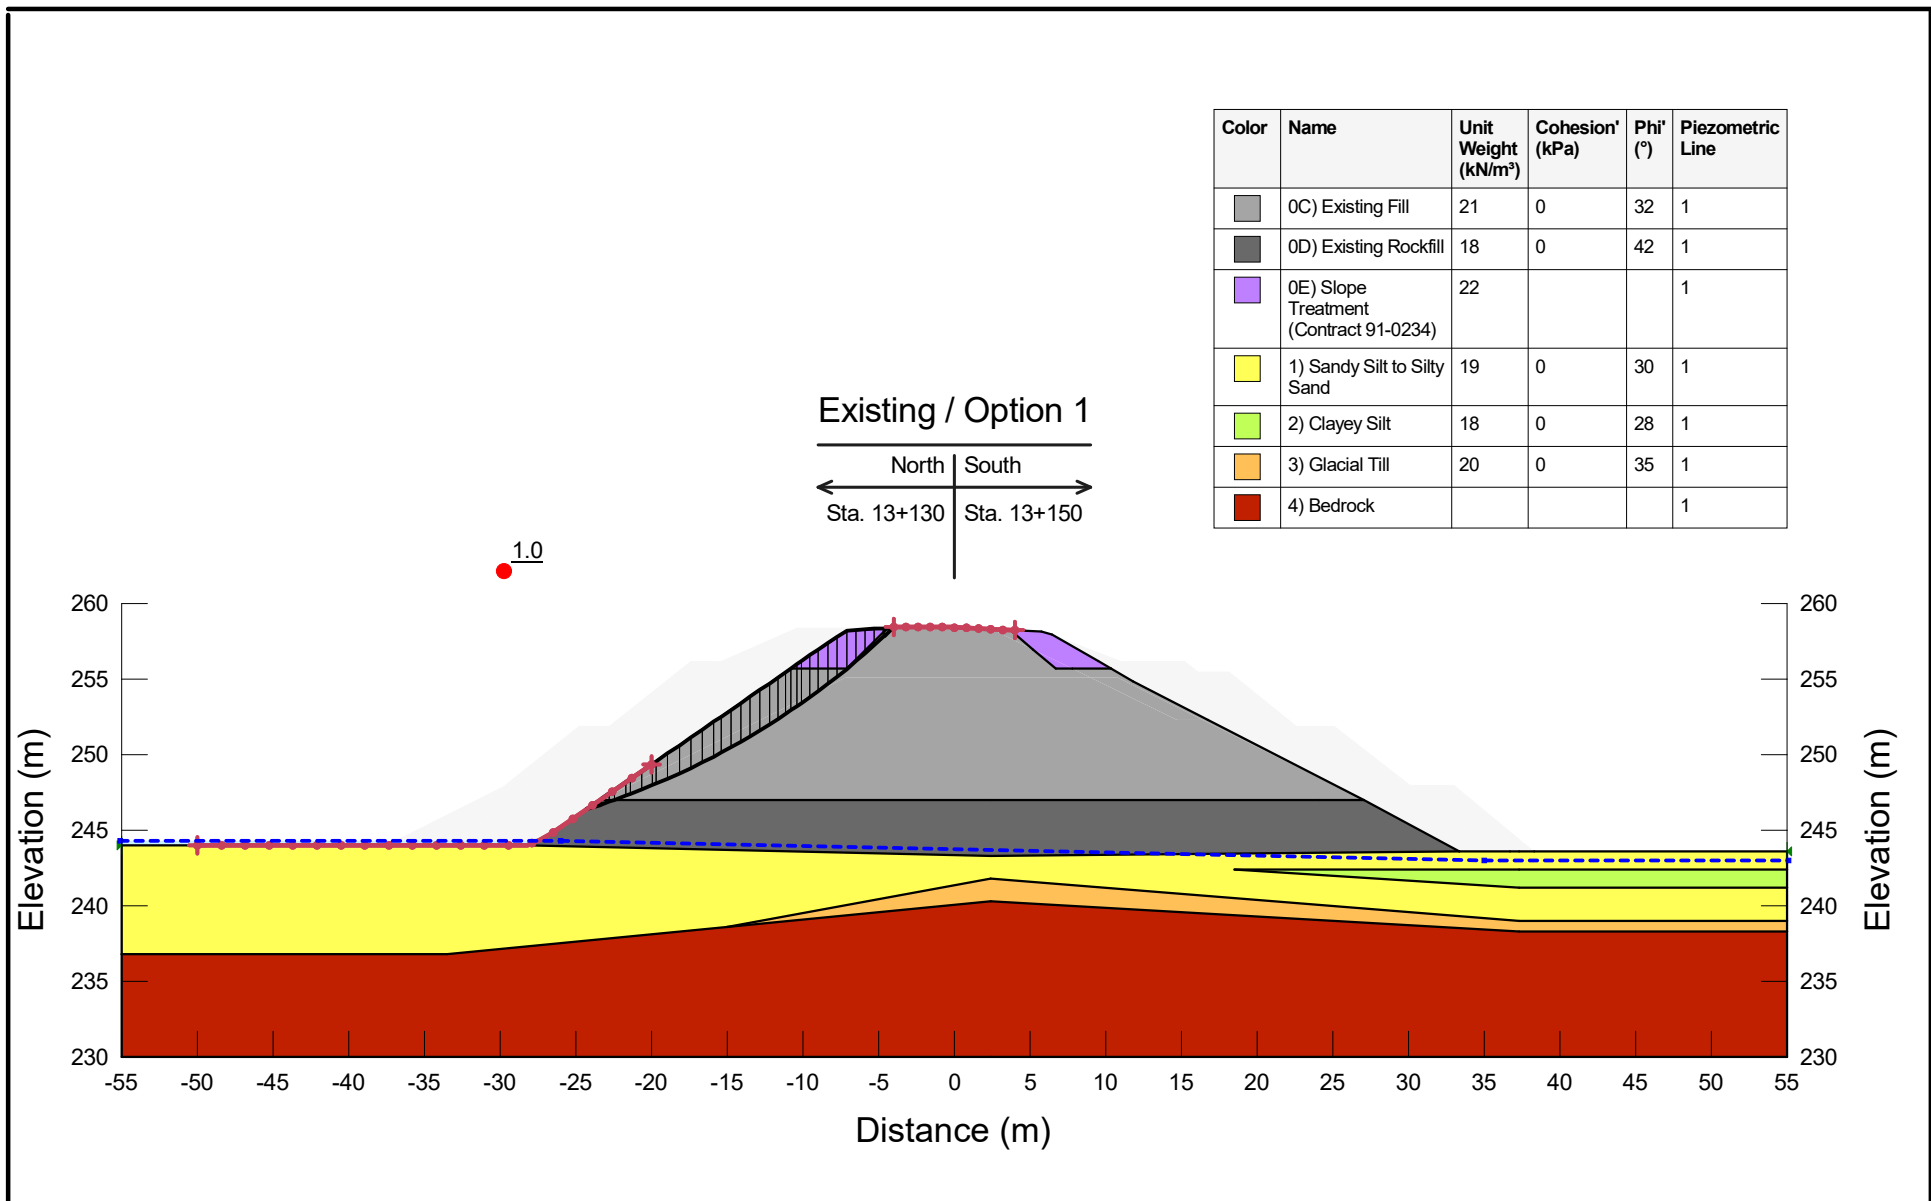
Figure F1

Analysis Title:
1N - Existing

Method: Morgenstern-Price, Half-Sine
Minimum Slip Surface Depth: 2 m
Center: (-39.838674, 295.70371) m w/ Radius: 51.708172 m
PWP Conditions from: Piezometric Line
Horz Seismic Coef.: 0 g

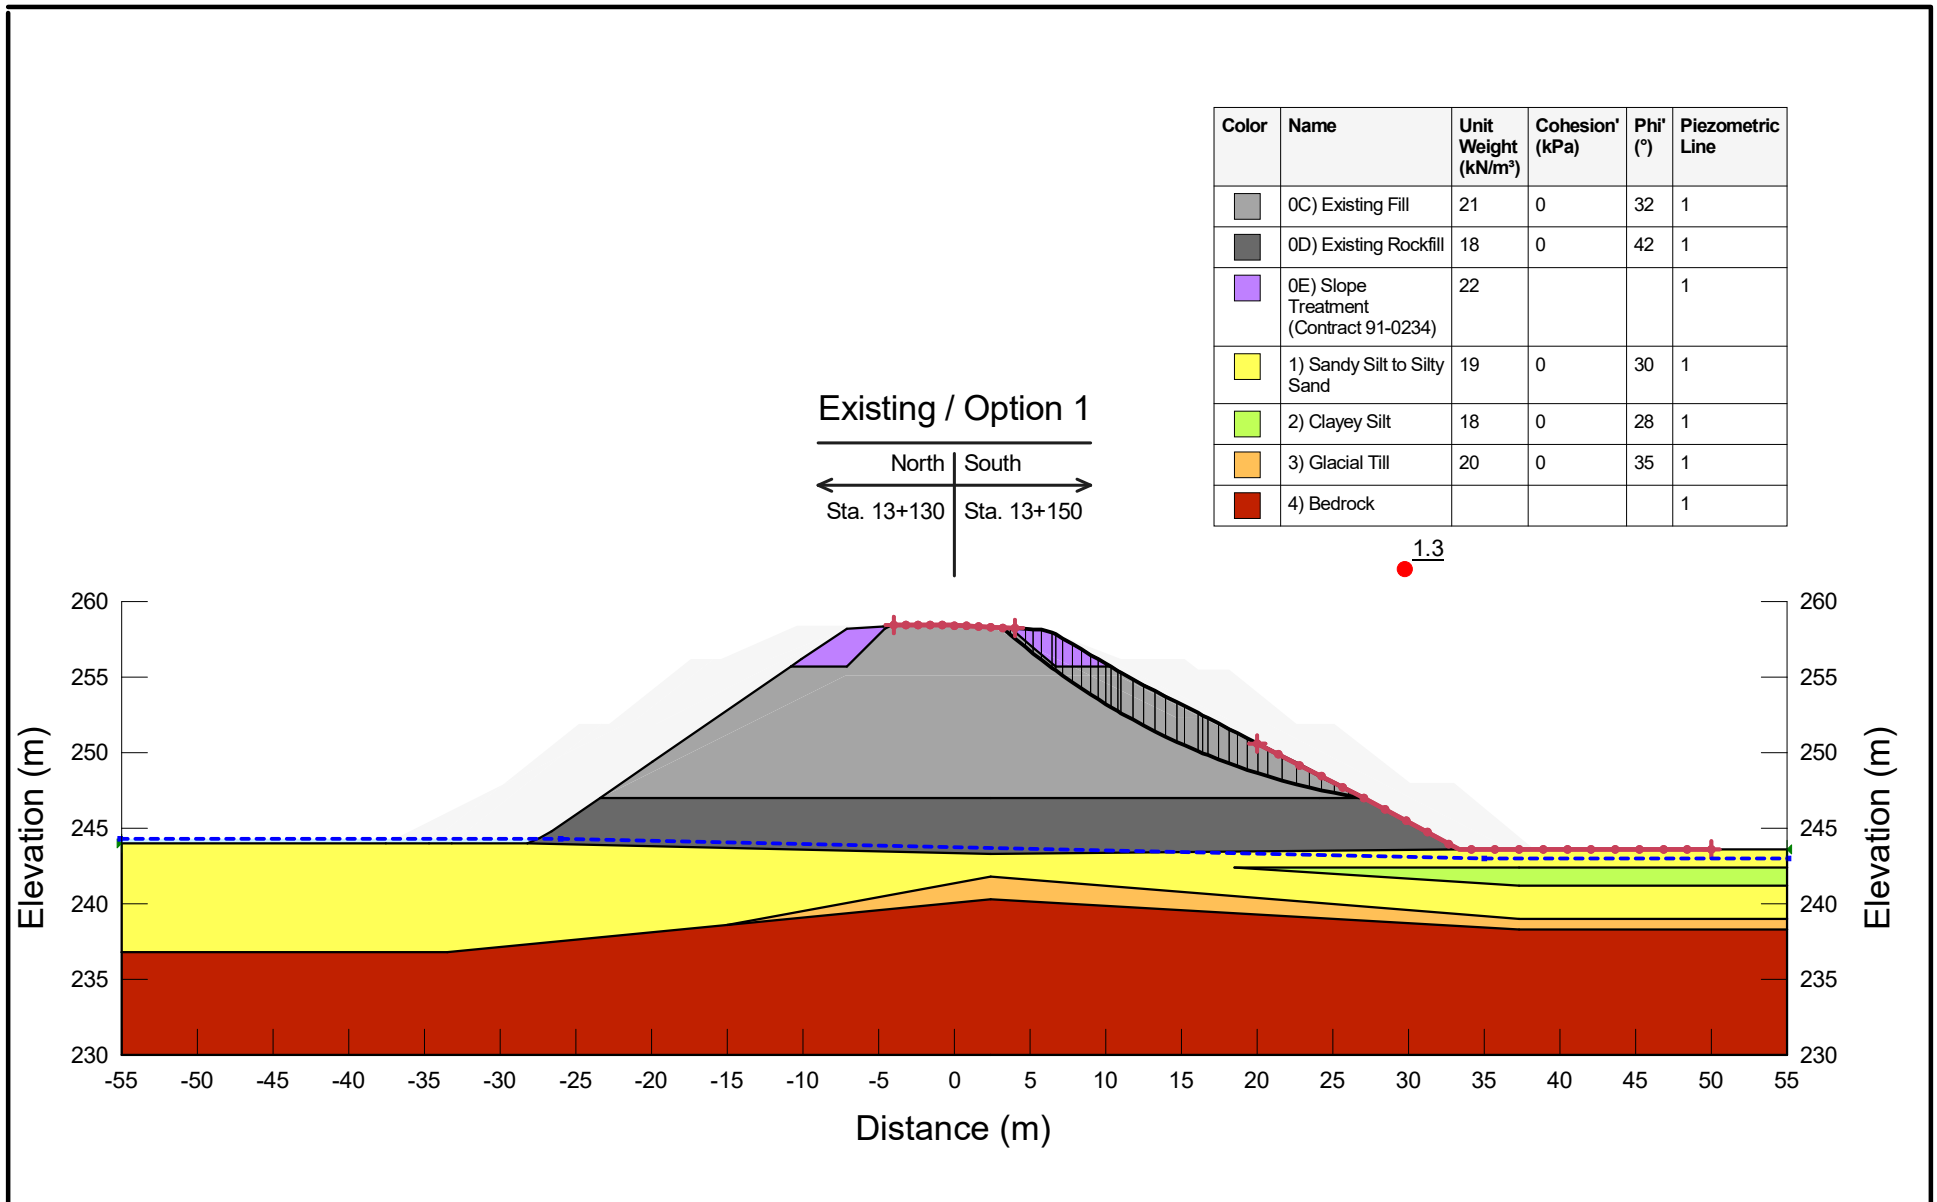
Figure F2

THURBER	Project Name: Highway 17 Instability			Analysis Details: Method: Morgenstern-Price, Half-Sine Minimum Slip Surface Depth: 2 m Center: (34.07839, 292.70469) m w/ Radius: 46.251114 m PWP Conditions from: Piezometric Line Horz Seismic Coef.: 0 g
	Analysis Title: 1S - Existing			
	Project No.: 28408	Seismic Coeff.: H: 0g, V: 0g	Prepared by: DP/SP	
	Date: 05/27/2021	Scale: 1:500	Reviewed by: FG

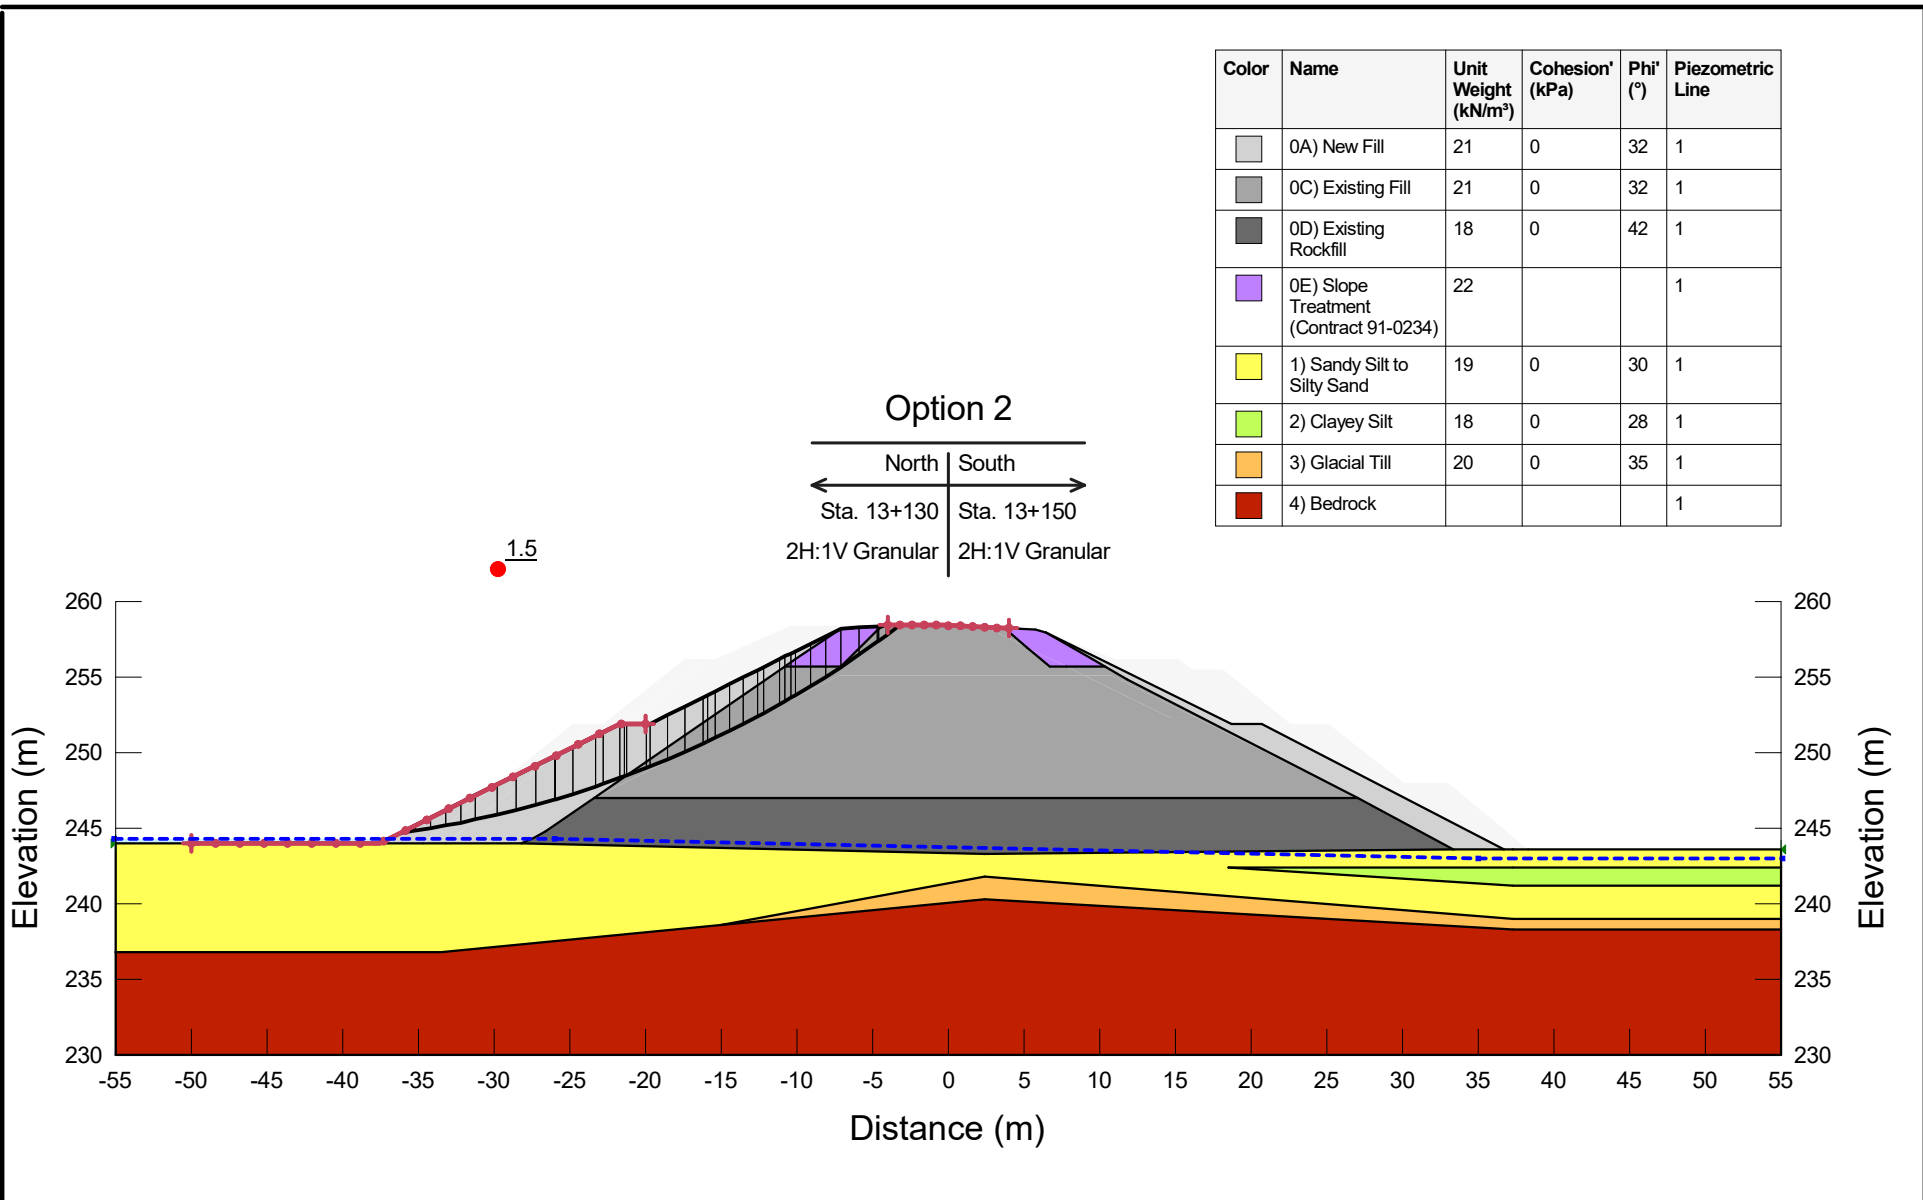
Project Name: Highway 17 Instability		Analysis Details: Method: Morgenstern-Price, Half-Sine Minimum Slip Surface Depth: 2 m Center: (-46.119011, 315.02381) m w/ Radius: 71.027208 m PWP Conditions from: Piezometric Line Horz Seismic Coef.: 0 g	
	Analysis Title: 2N - 2H:1V Granular			
	Project No.: 28408	Seismic Coeff.: H: 0g, V: 0g	Prepared by: DP/SP	
	Date: 05/27/2021	Scale: 1:500	Reviewed by: FG	
				Figure F3
