THURBER ENGINEERING LTD.

**FINAL
FOUNDATION INVESTIGATION AND DESIGN REPORT
HIGHWAY 17, FROM THE EAST JUNCTION OF SUDBURY RR 55 19.5KM TO
KUKAGAMI RD
EMBANKMENT FROM STA. 13+110 TO 13+179, AWREY TWP
ASSIGNMENT NO. 5019-E-0012
GWP 5168-16-00**

May 2021
Thurber File No.: 28408

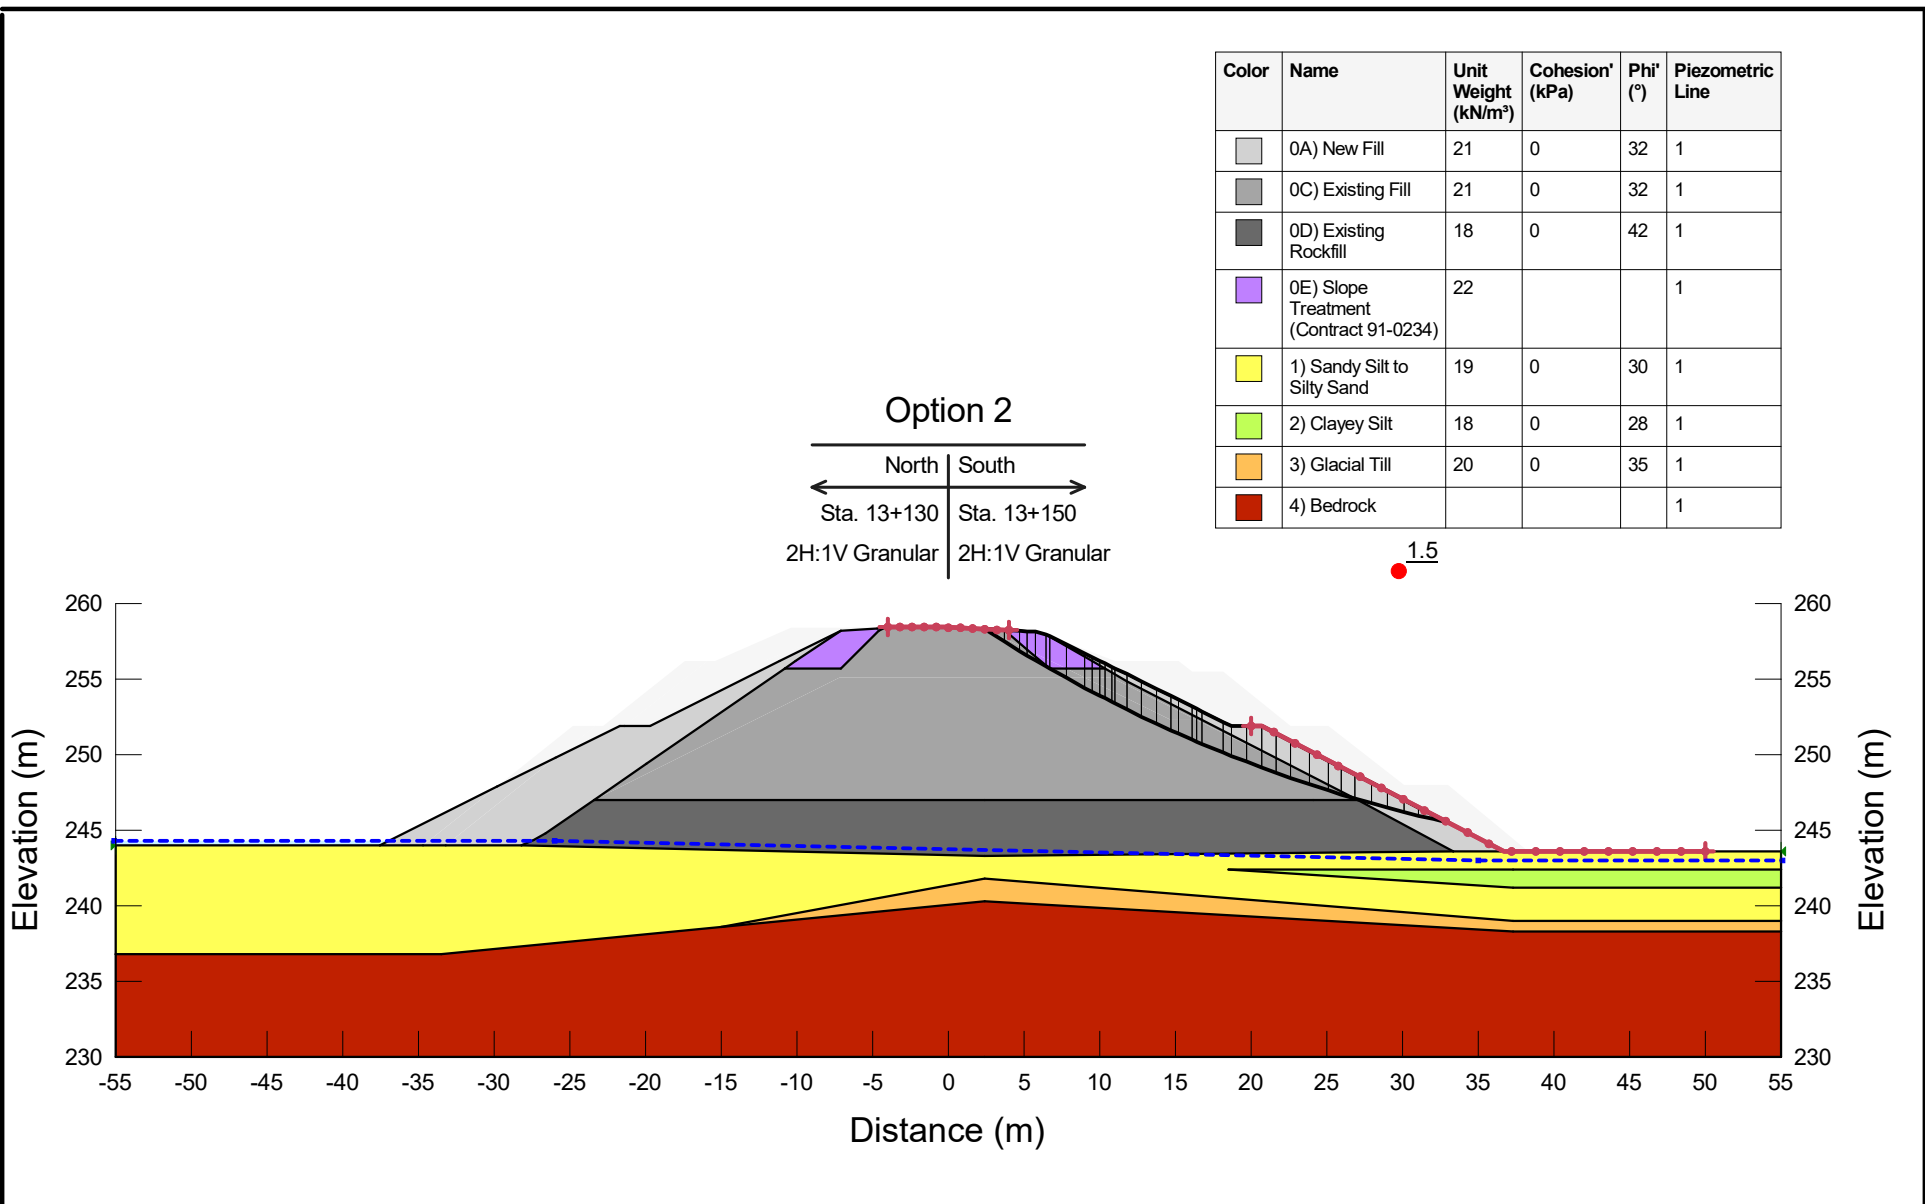
THURBER	Project Name: Highway 17 Instability		Analysis Details: Method: Morgenstern-Price, Half-Sine Minimum Slip Surface Depth: 2 m Center: (53.659336, 337.83473) m w/ Radius: 94.61399 m PWP Conditions from: Piezometric Line Horz Seismic Coef.: 0 g	
	Analysis Title: 2S - 2H:1V Granular			
	Project No.: 28408	Seismic Coeff.: H: 0g, V: 0g		Prepared by: DP/SP
	Date: 05/27/2021	Scale: 1:500		Reviewed by: FG
	Figure F4

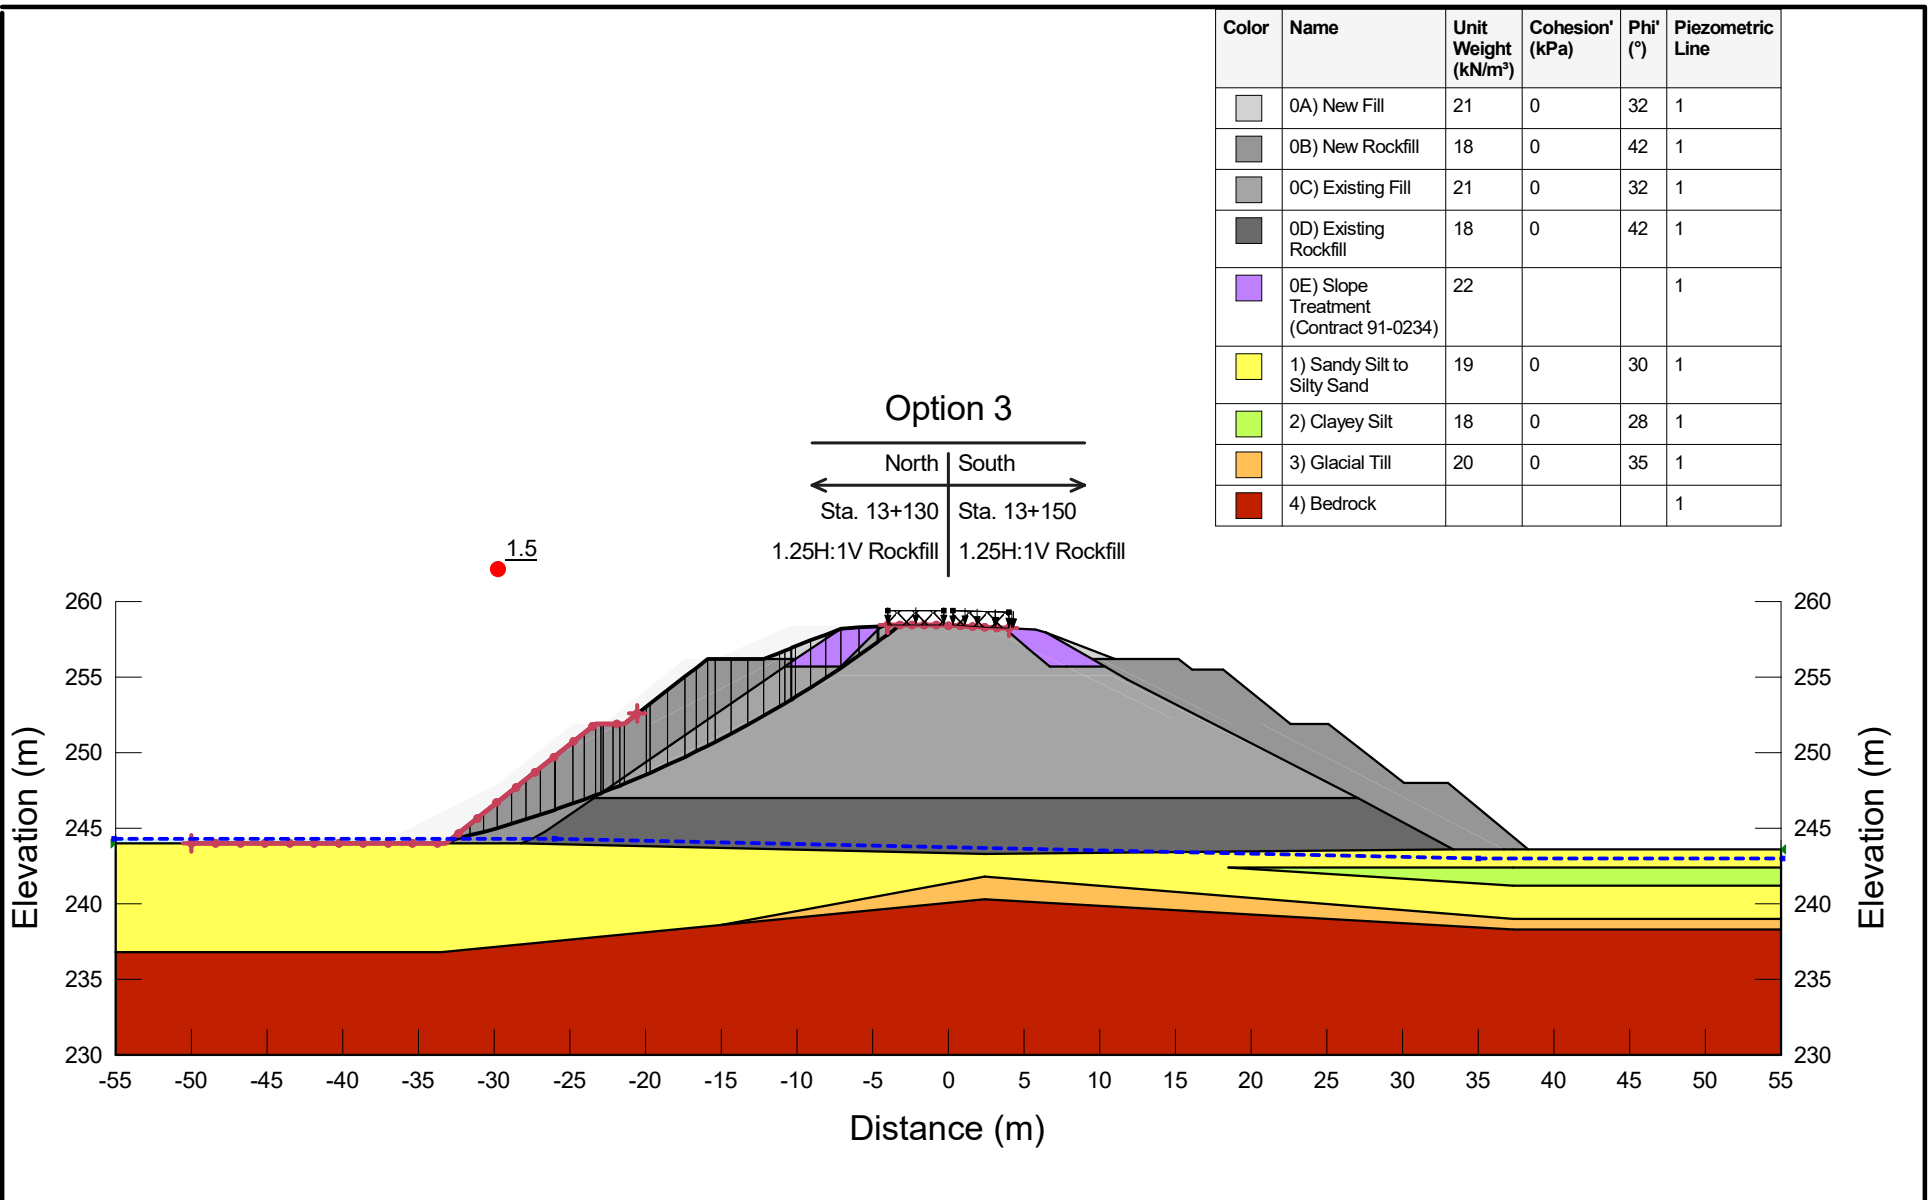
THURBER	Project Name: Highway 17 Instability		Analysis Details: Method: Morgenstern-Price, Half-Sine Minimum Slip Surface Depth: 2 m Center: (-51.580695, 321.32163) m w/ Radius: 79.347399 m PWP Conditions from: Piezometric Line Horz Seismic Coef.: 0 g Surcharge (Unit Weight): 18 kN/m³	
	Analysis Title: 3N - 1.25H:1V Rockfill (traffic)			
	Project No.: 28408	Seismic Coeff.: H: 0g, V: 0g	Prepared by: DP/SP	
	Date: 05/27/2021	Scale: 1:500	Reviewed by: FG	
		Figure F6

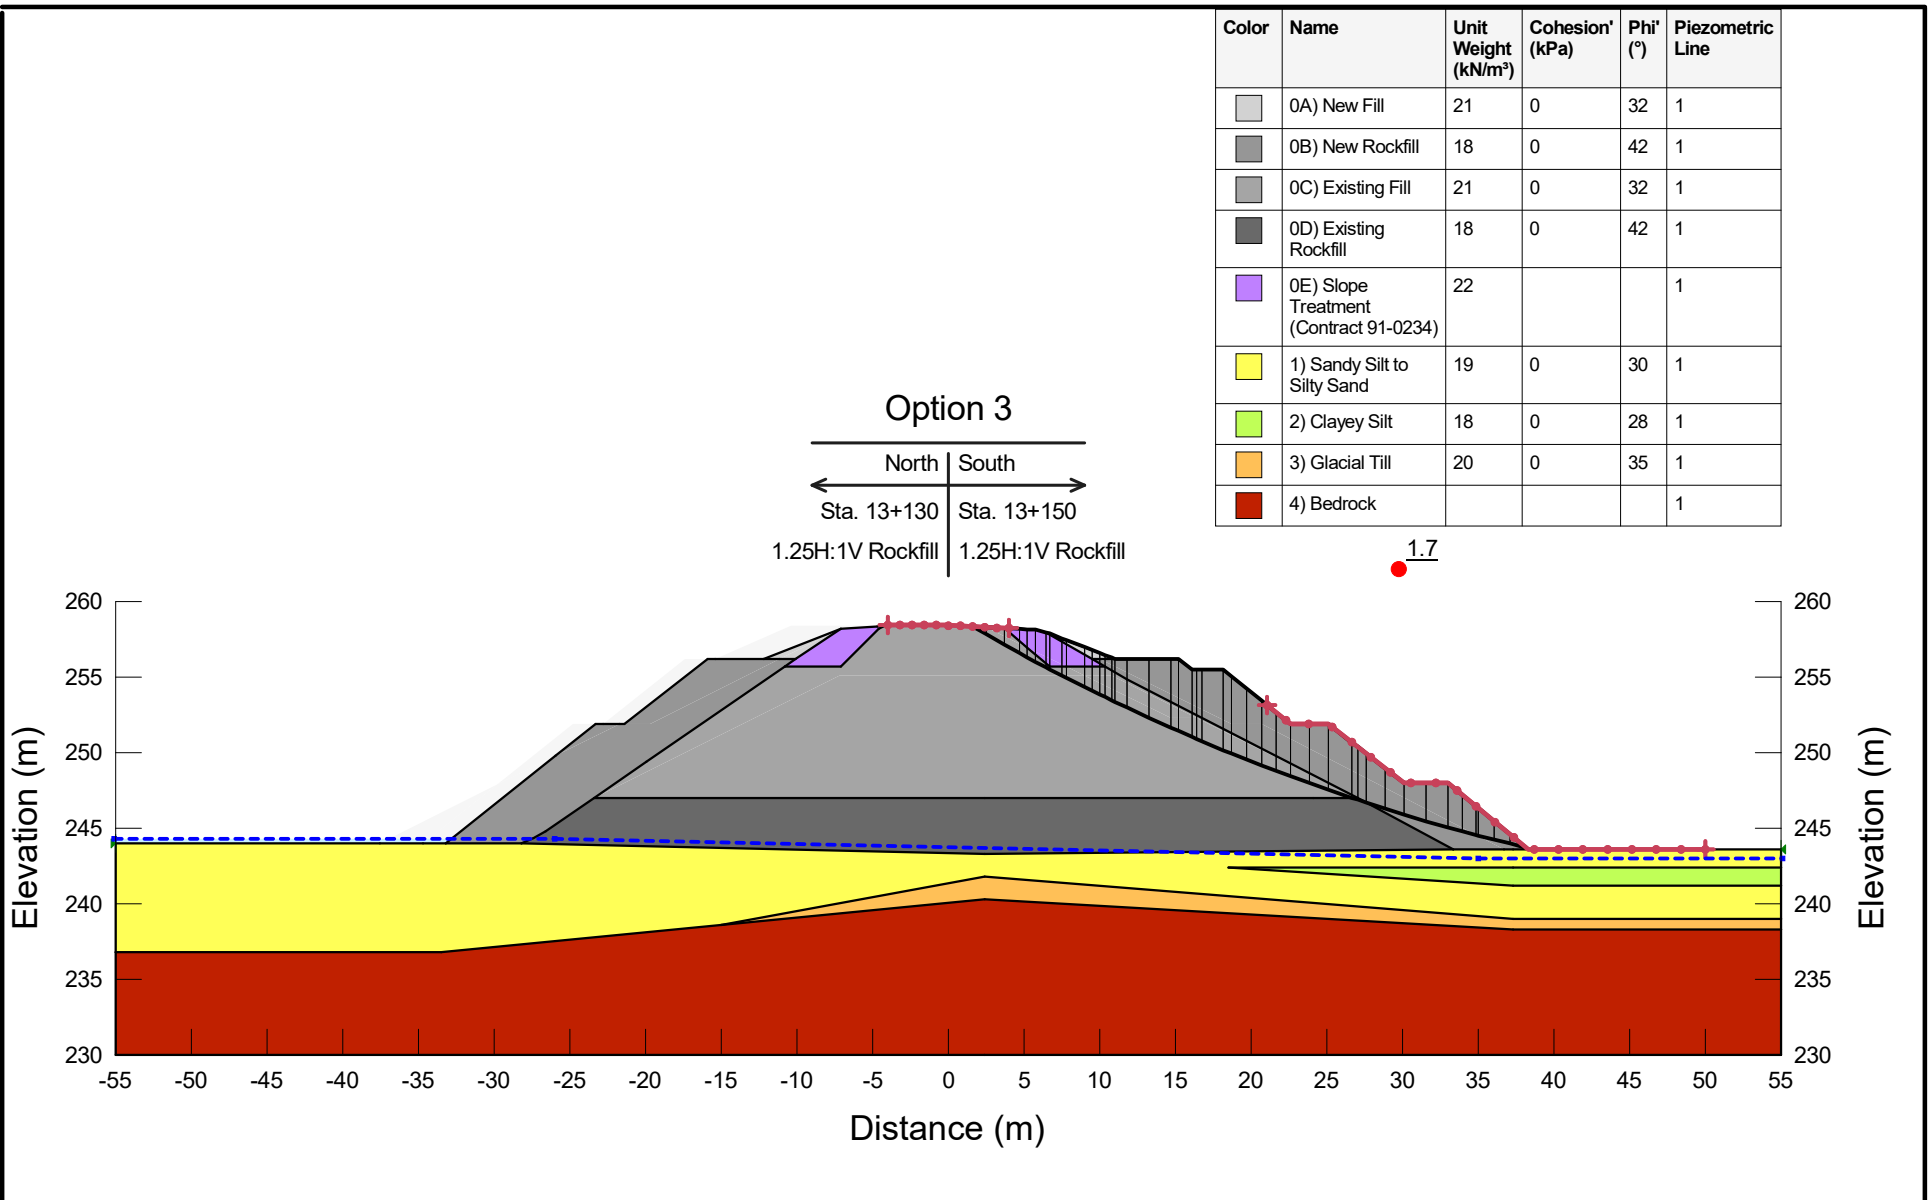
Project Name: Highway 17 Instability		Analysis Details: Method: Morgenstern-Price, Half-Sine Minimum Slip Surface Depth: 2 m Center: (69.265462, 374.48444) m w/ Radius: 134.411 m PWP Conditions from: Piezometric Line Horz Seismic Coef.: 0 g	
	Analysis Title: 3S - 1.25H:1V Rockfill			
	Project No.: 28408	Seismic Coeff.: H: 0g, V: 0g	Prepared by: DP/SP	
	Date: 05/27/2021	Scale: 1:500	Reviewed by: FG	
				Figure F8

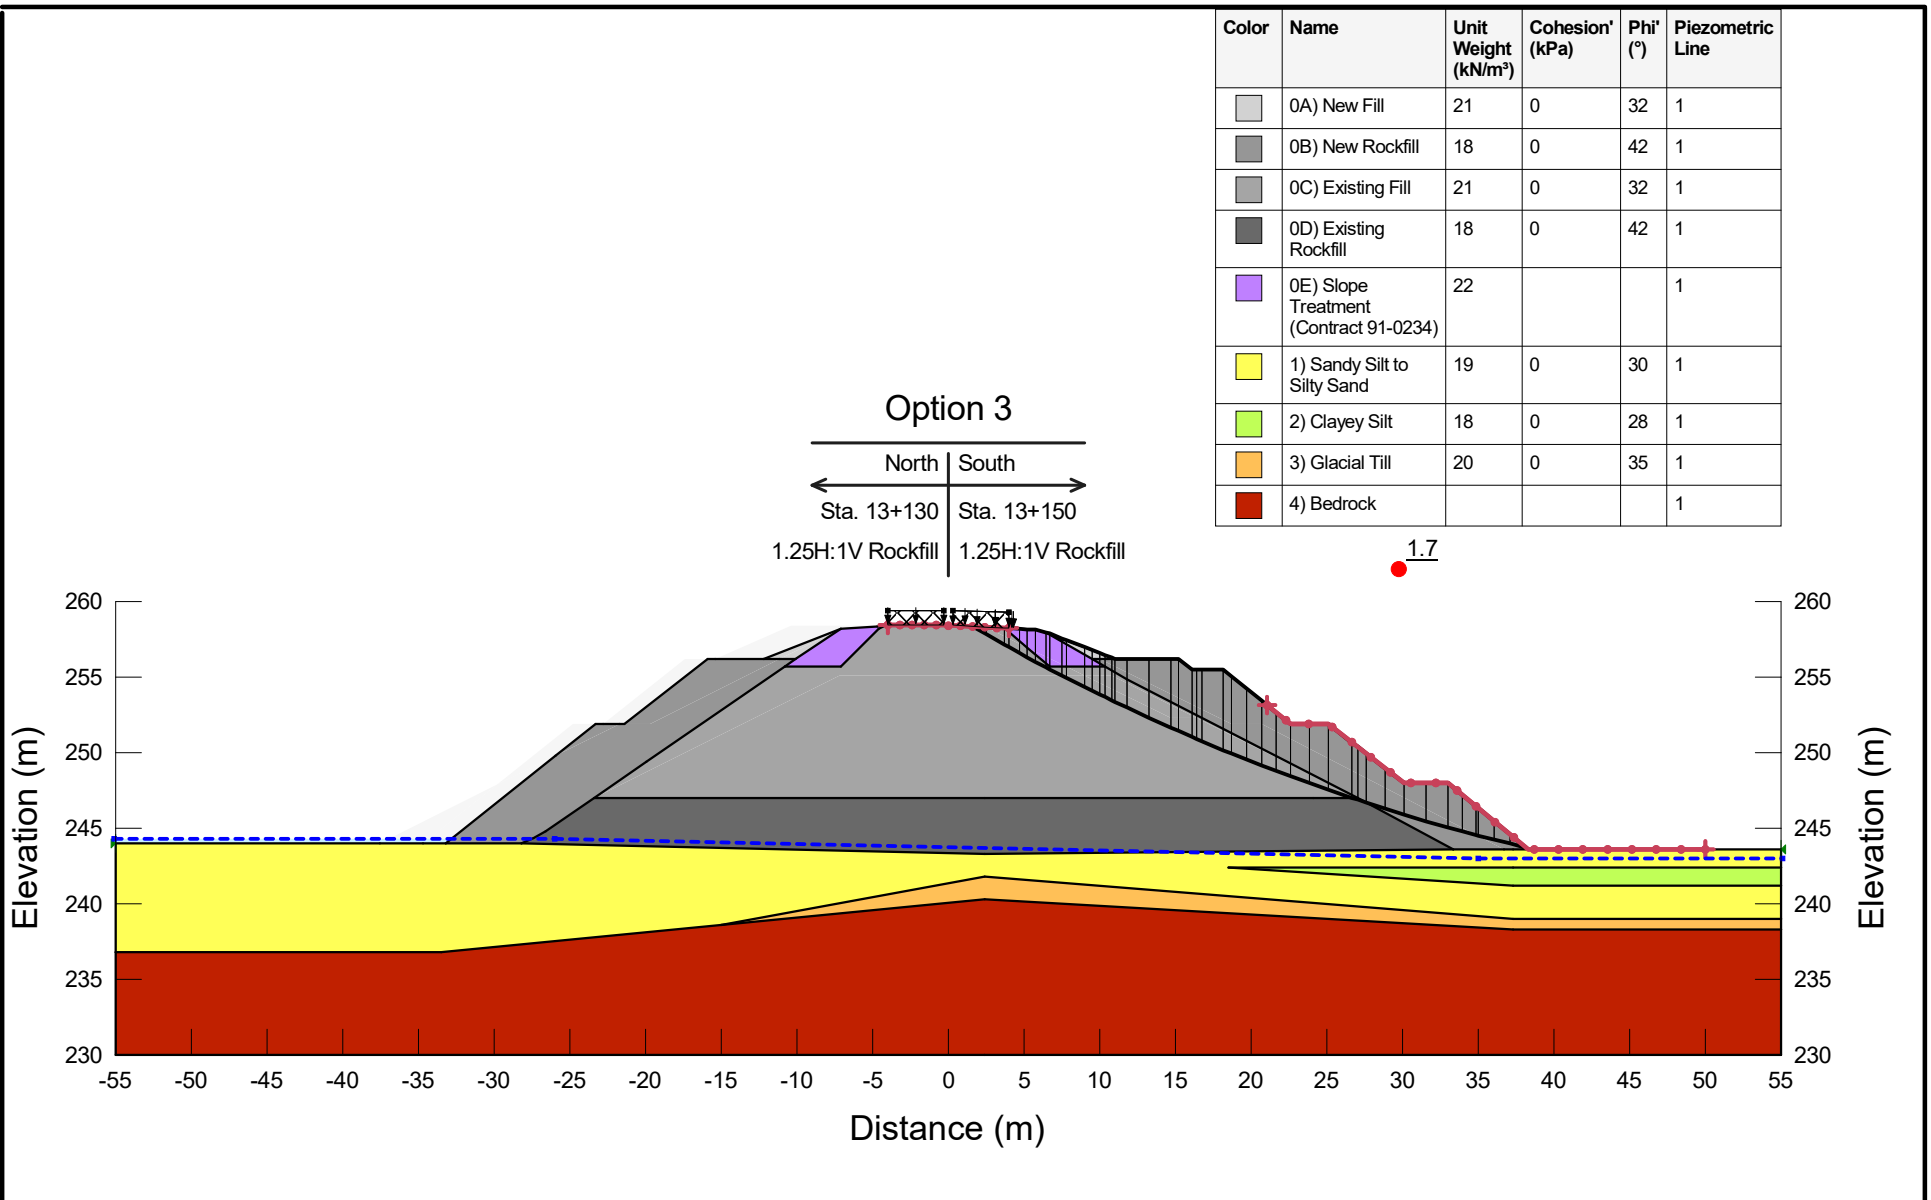
Figure F9

Project Name: Highway 17 Instability		Analysis Details: Method: Morgenstern-Price, Half-Sine Minimum Slip Surface Depth: 2 m Center: (69.265462, 374.48444) m w/ Radius: 134.411 m PWP Conditions from: Piezometric Line Horz Seismic Coef.: 0 g Surcharge (Unit Weight): 18 kN/m³	
	Analysis Title: 3S - 1.25H:1V Rockfill (Traffic)			
	Project No.: 28408	Seismic Coeff.: H: 0g, V: 0g	Prepared by: DP/SP	
	Date: 05/27/2021	Scale: 1:500	Reviewed by: FG

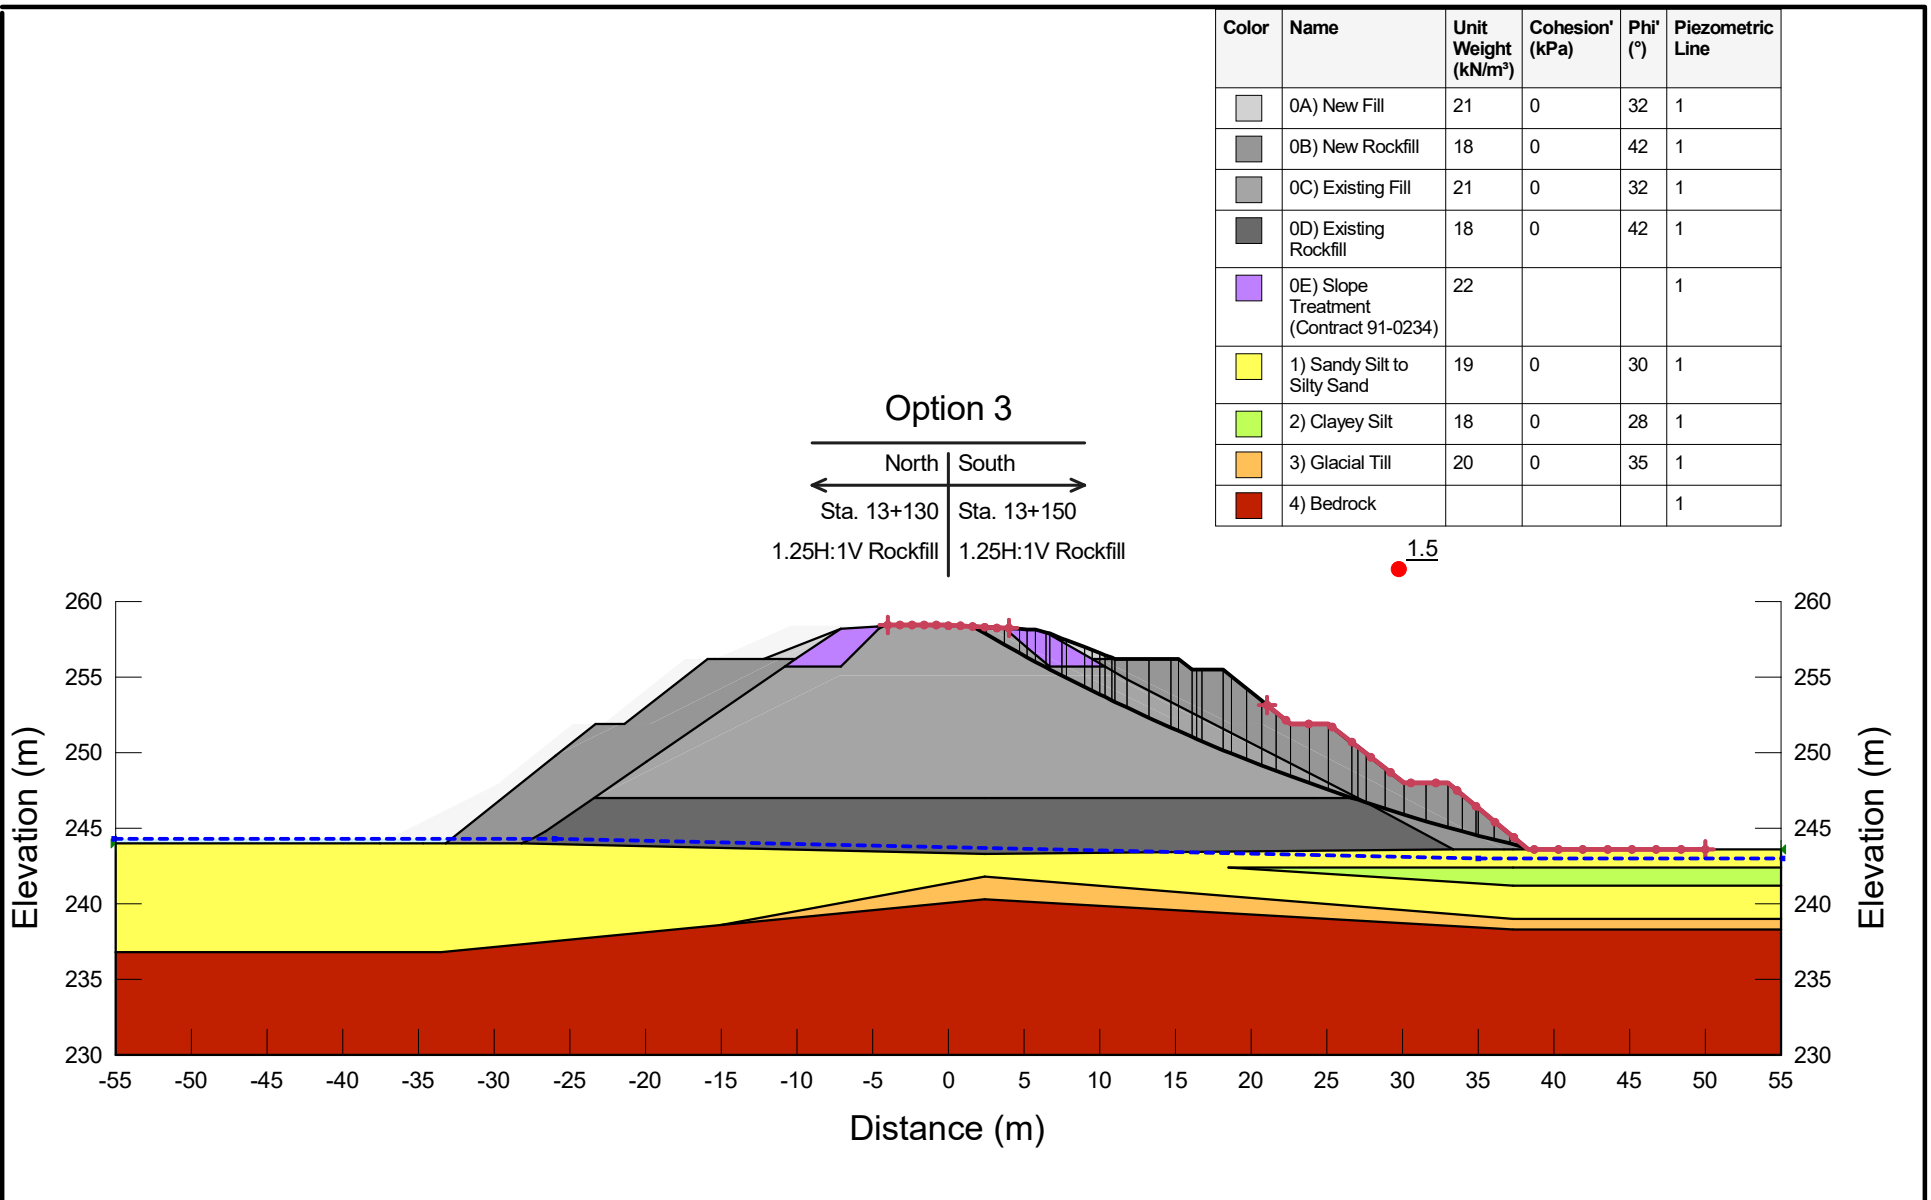
Project Name: Highway 17 Instability		Analysis Details: Method: Morgenstern-Price, Half-Sine Minimum Slip Surface Depth: 2 m Center: (69.265462, 374.48444) m w/ Radius: 134.411 m PWP Conditions from: Piezometric Line Horz Seismic Coef.: 0.05 g
	Analysis Title: 3S - 1.25H:1V Rockfill (Seismic)		
	Project No.: 28408	Seismic Coeff.: H: 0.05g, V: 0g	Prepared by: DP/SP
	Date: 05/27/2021	Scale: 1:500	Reviewed by: FG
			Figure F10

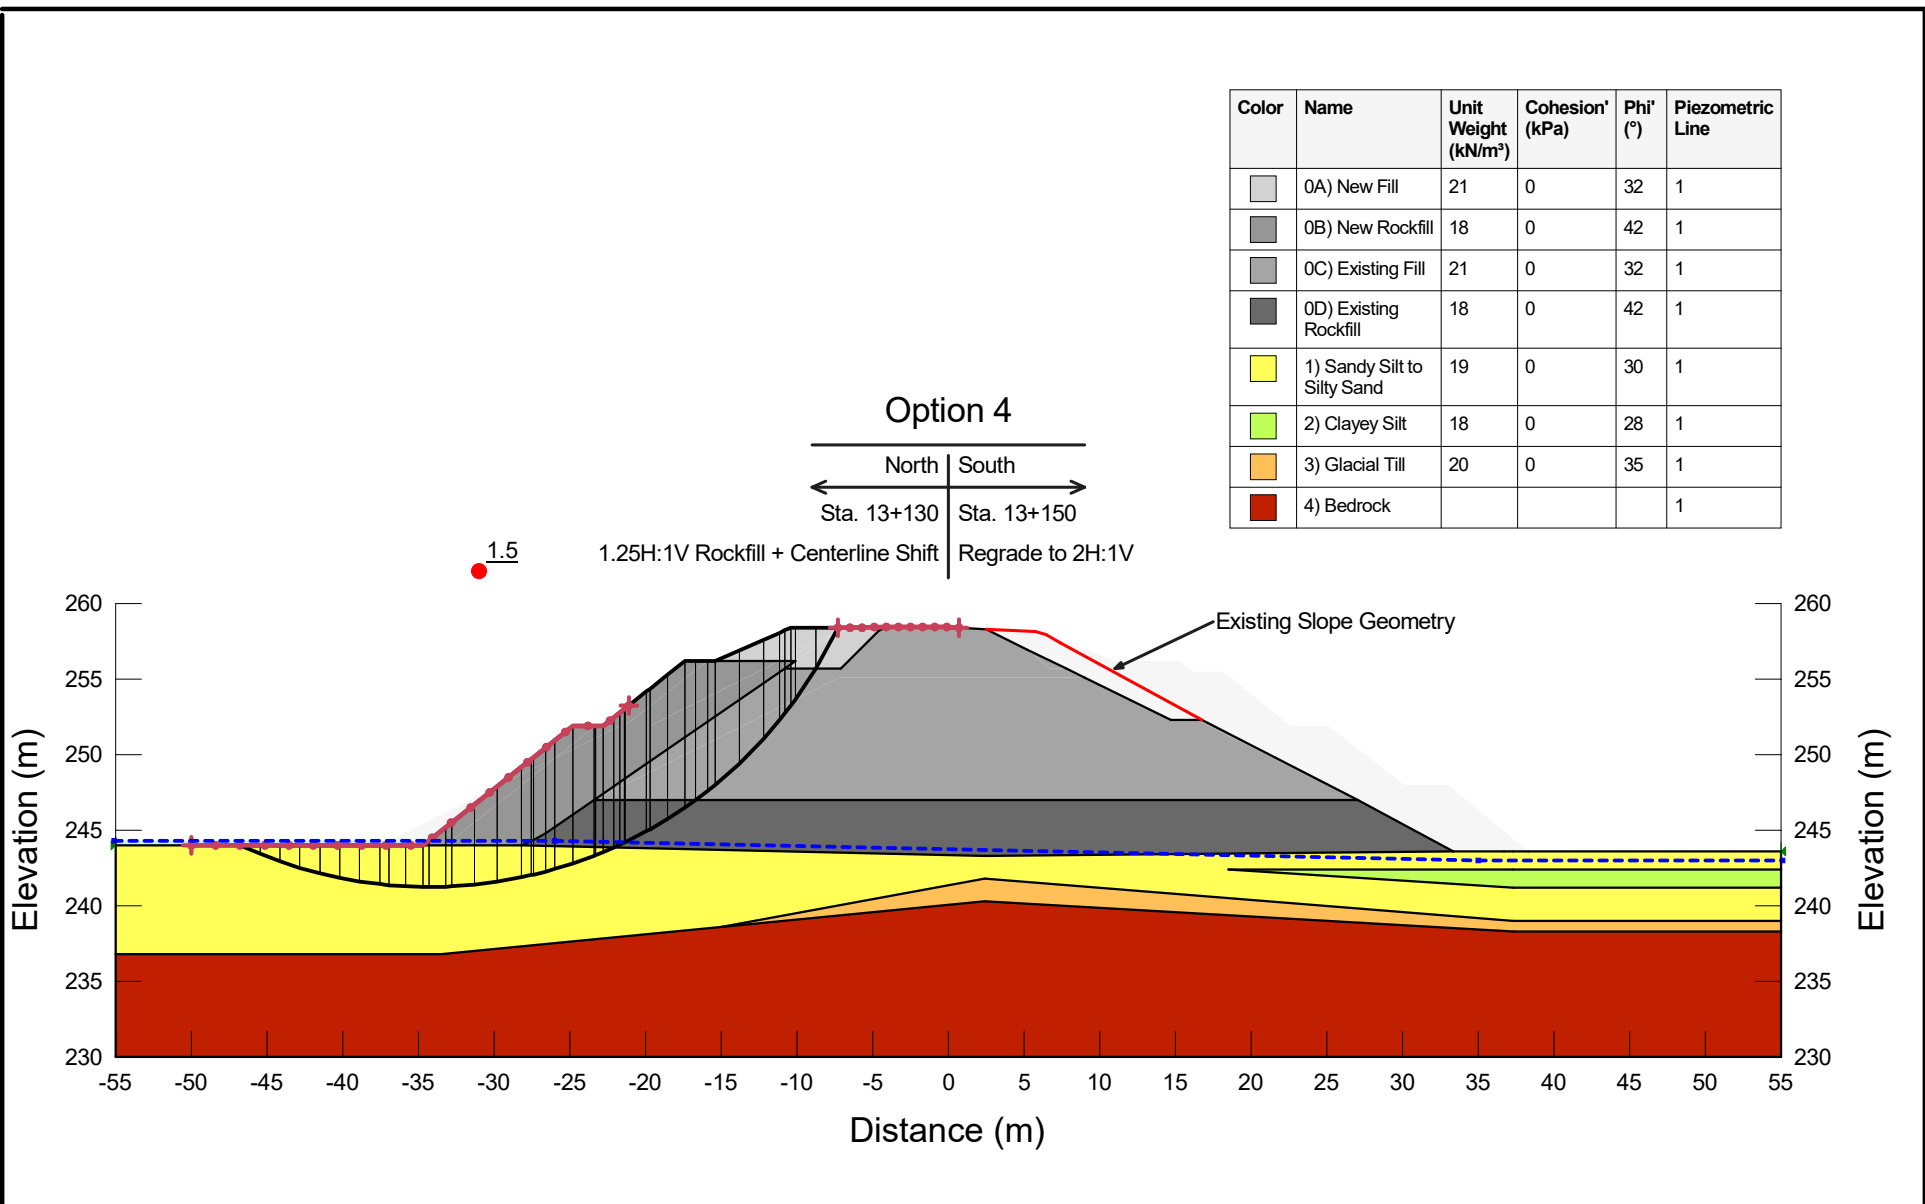
Figure F11

Analysis Title:
4N - 1.25H:1V Rockfill (North), Regrade South

Method: Morgenstern-Price, Half-Sine
 Minimum Slip Surface Depth: 2 m
 Center: (-34.286586, 271.052) m w/ Radius: 29.798928 m
 PWP Conditions from: Piezometric Line
 Horz Seismic Coef.: 0 g

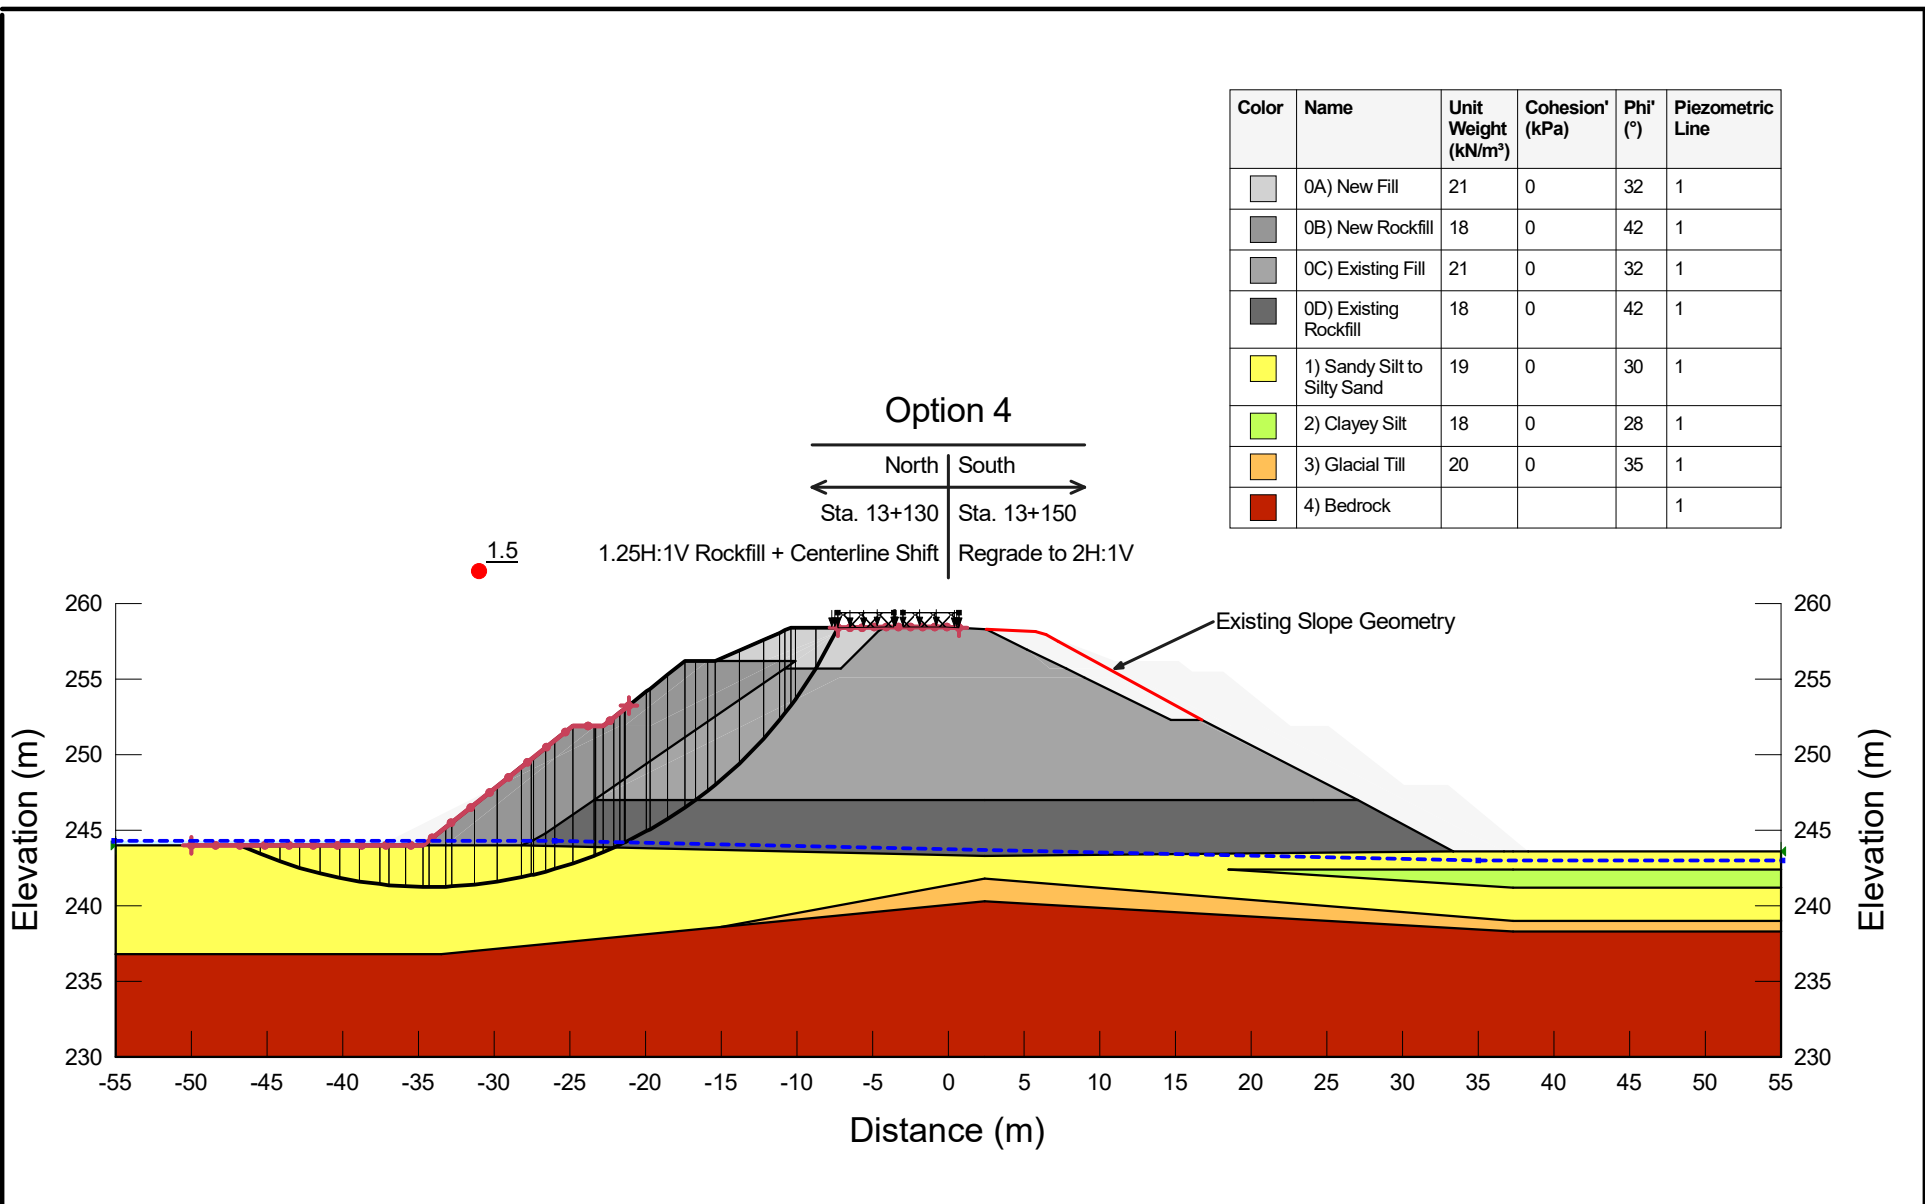
Figure F12

Analysis Title:
4N - 1.25H:1V Rockfill (North), Regrade South (Traffic)

Method: Morgenstern-Price, Half-Sine
 Minimum Slip Surface Depth: 2 m
 Center: (-34.286586, 271.052) m w/ Radius: 29.798928 m
 PWP Conditions from: Piezometric Line
 Horz Seismic Coef.: 0 g
 Surcharge (Unit Weight): 18 kN/m³

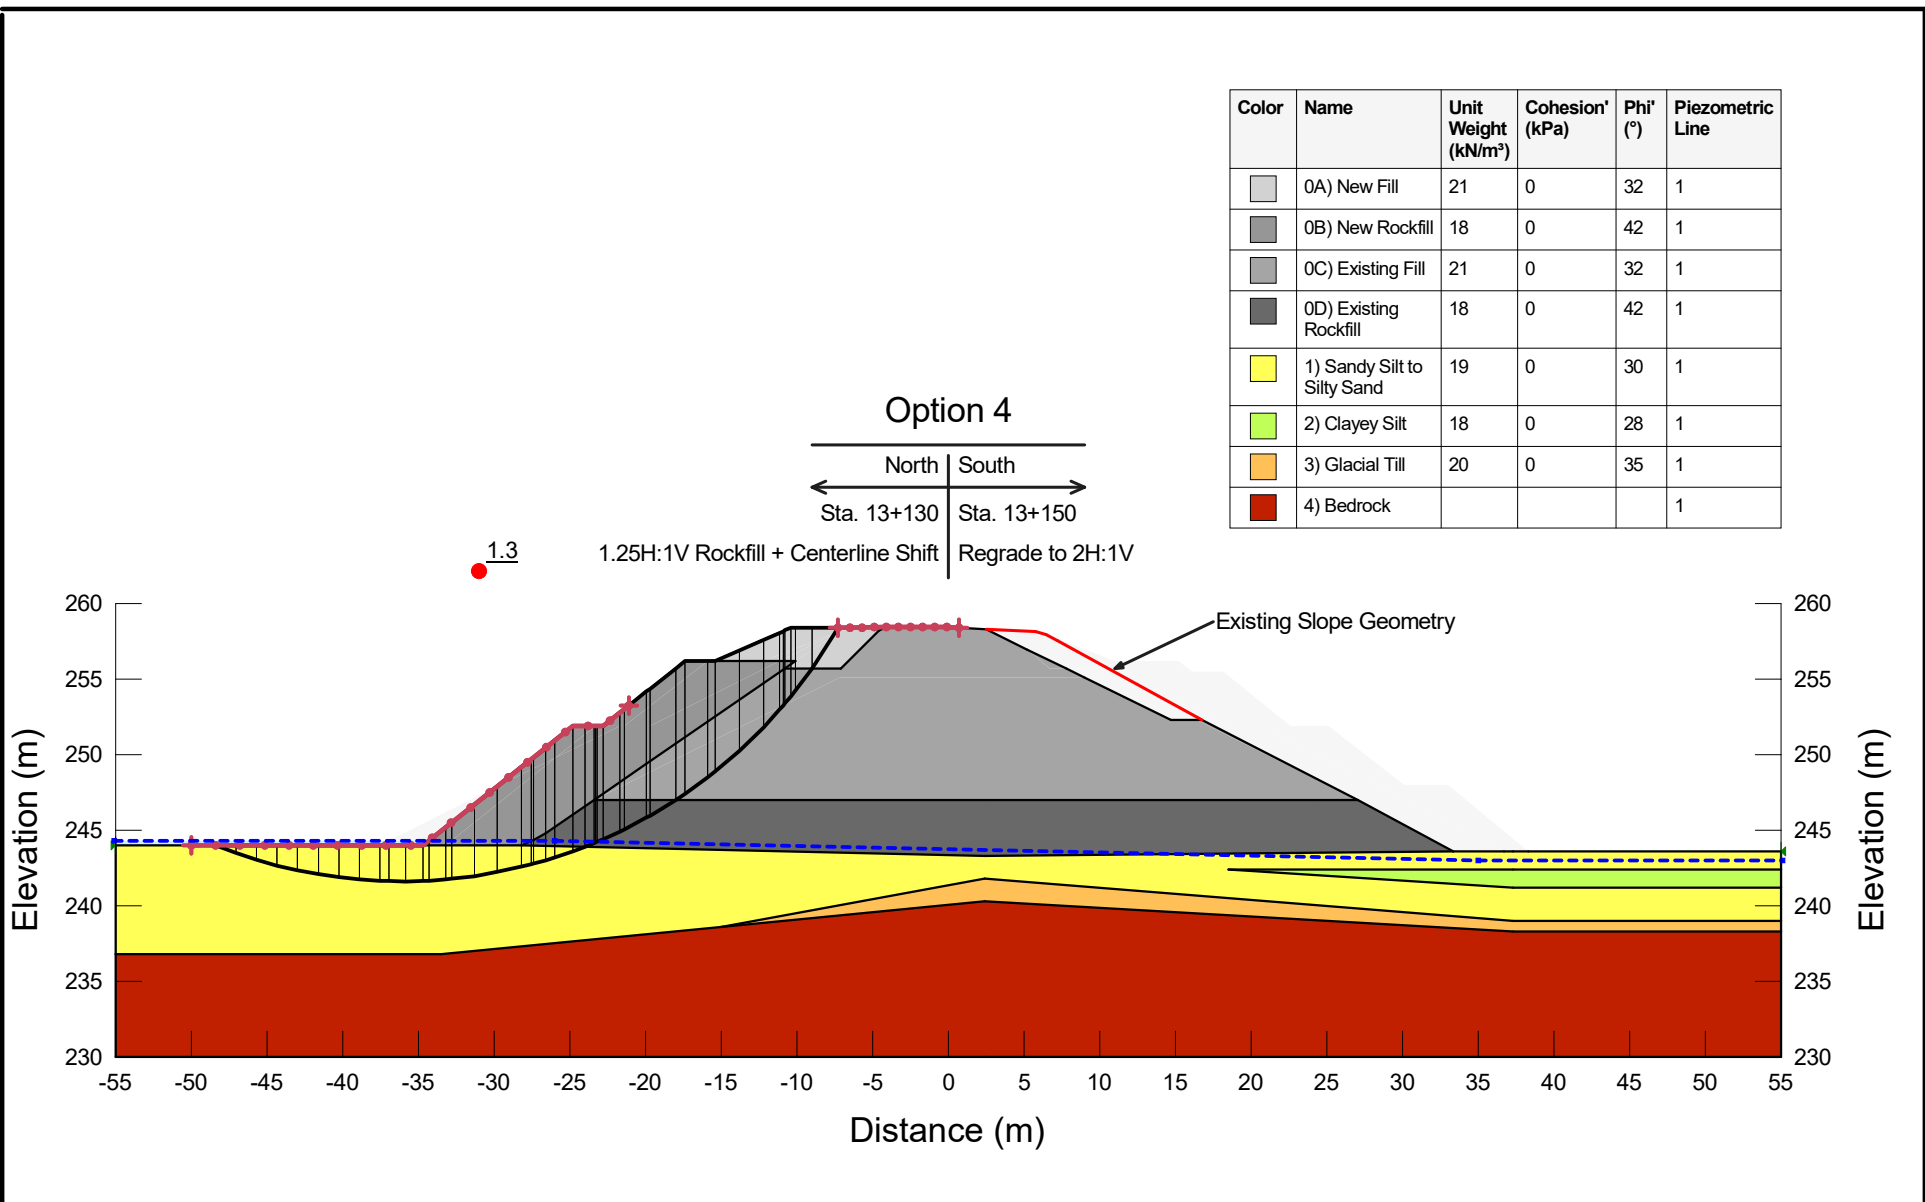
Project Name: Highway 17 Instability		
Analysis Title: 4N - 1.25H:1V Rockfill (North), Regrade South (Seismic)		
Project No.: 28408	Seismic Coeff.: H: 0.05g, V: 0g	Prepared by: DP/SP
Date: 05/27/2021	Scale: 1:500	Reviewed by: FG

Analysis Details:	
Method: Morgenstern-Price, Half-Sine	
Minimum Slip Surface Depth: 2 m	
Center: (-36.082571, 274.68765) m w/ Radius: 33.064239 m	
PWP Conditions from: Piezometric Line	
Horz Seismic Coef.: 0.05 g	
Figure F13

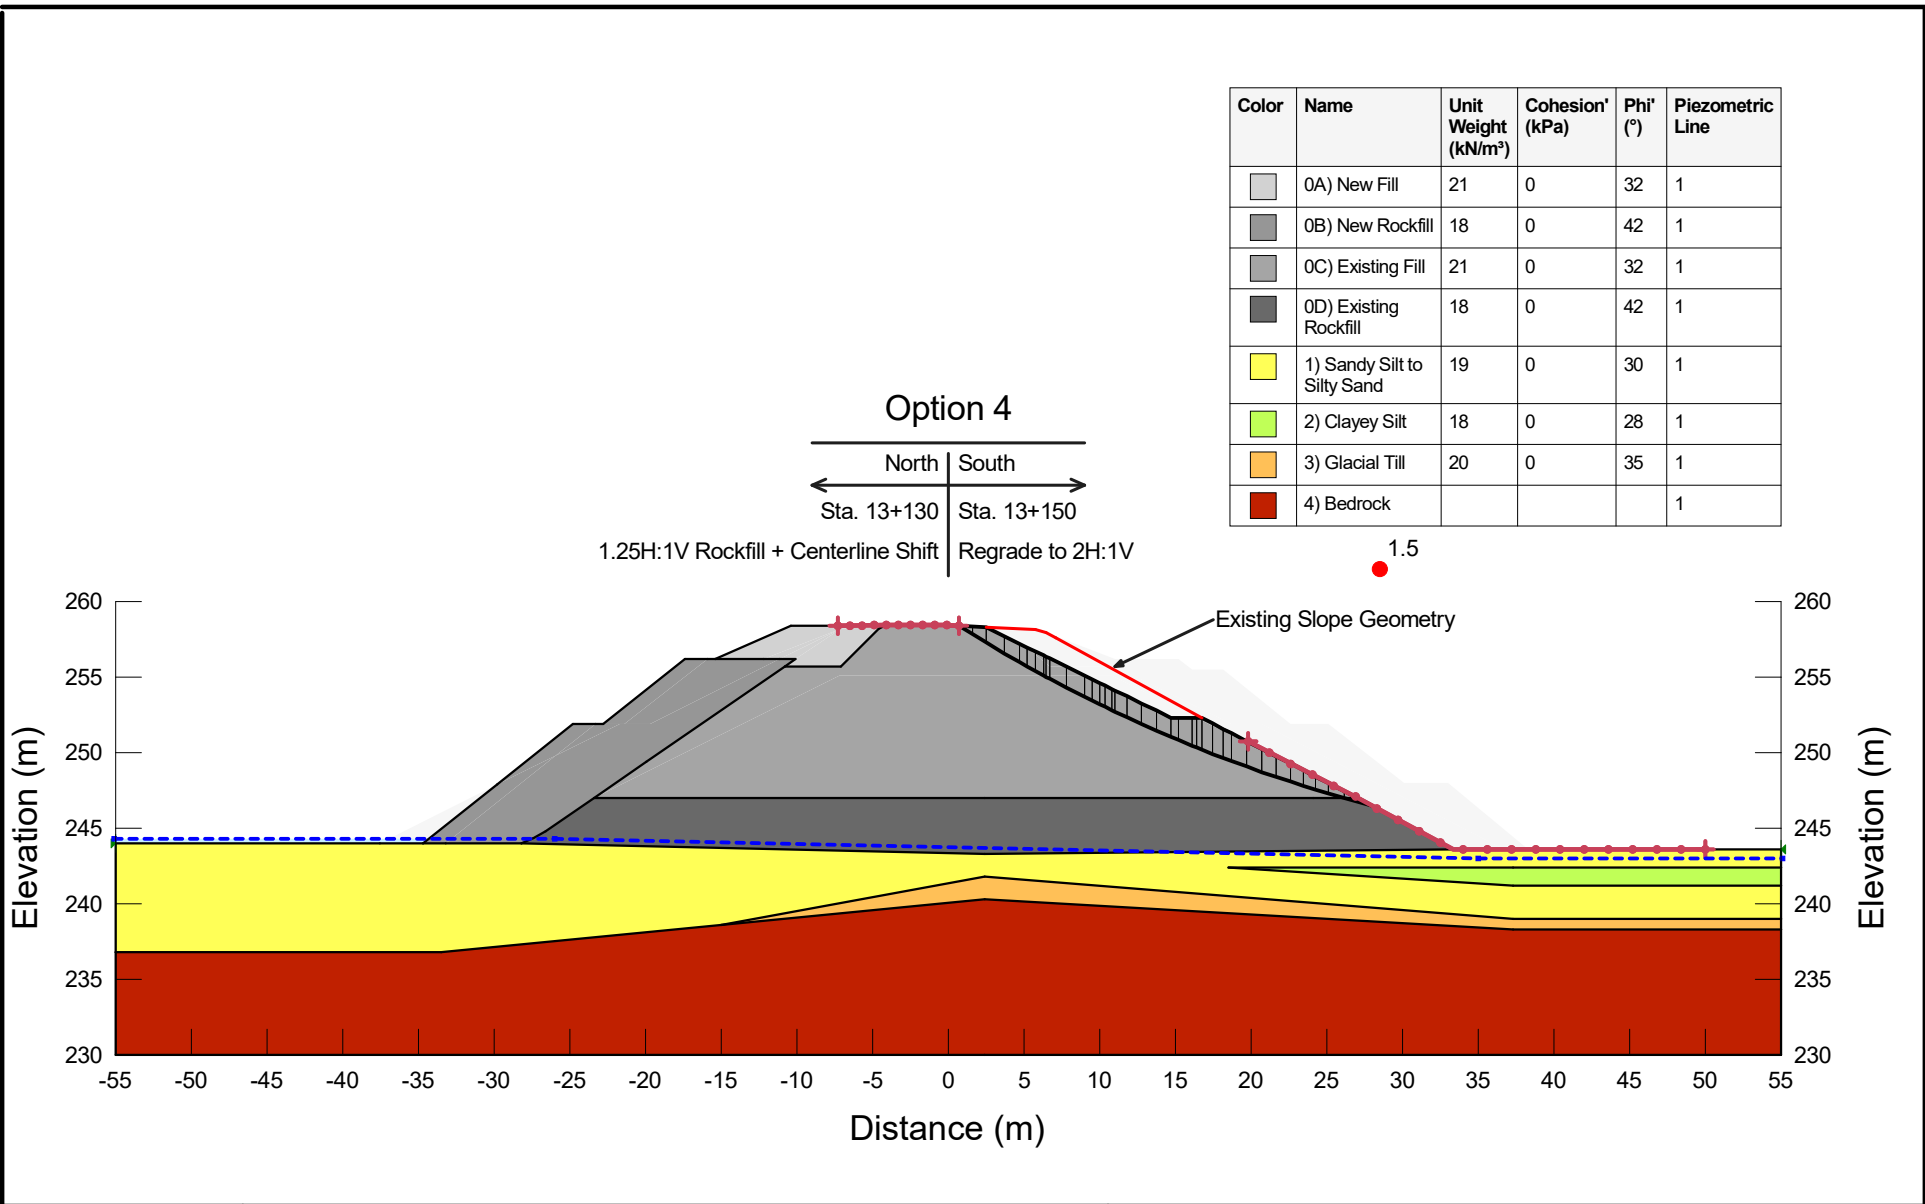
Project Name: Highway 17 Instability			Analysis Details: Method: Morgenstern-Price, Half-Sine Minimum Slip Surface Depth: 2 m Center: (52.646634, 340.34517) m w/ Radius: 97.031177 m PWP Conditions from: Piezometric Line Horz Seismic Coef.: 0 g
	Analysis Title: 4S - 1.25H:1V Rockfill (North), Regrade South			
	Project No.: 28408	Seismic Coeff.: H: 0g, V: 0g	Prepared by: DP/SP	
	Date: 05/27/2021	Scale: 1:500	Reviewed by: FG	
				Figure F14
