THURBER ENGINEERING LTD.

**FINAL
FOUNDATION INVESTIGATION AND DESIGN REPORT
HIGHWAY 17, FROM THE EAST JUNCTION OF SUDBURY RR 55 19.5KM TO
KUKAGAMI RD
EMBANKMENT FROM STA. 13+110 TO 13+179, AWREY TWP
ASSIGNMENT NO. 5019-E-0012
GWP 5168-16-00**

May 2021
Thurber File No.: 28408

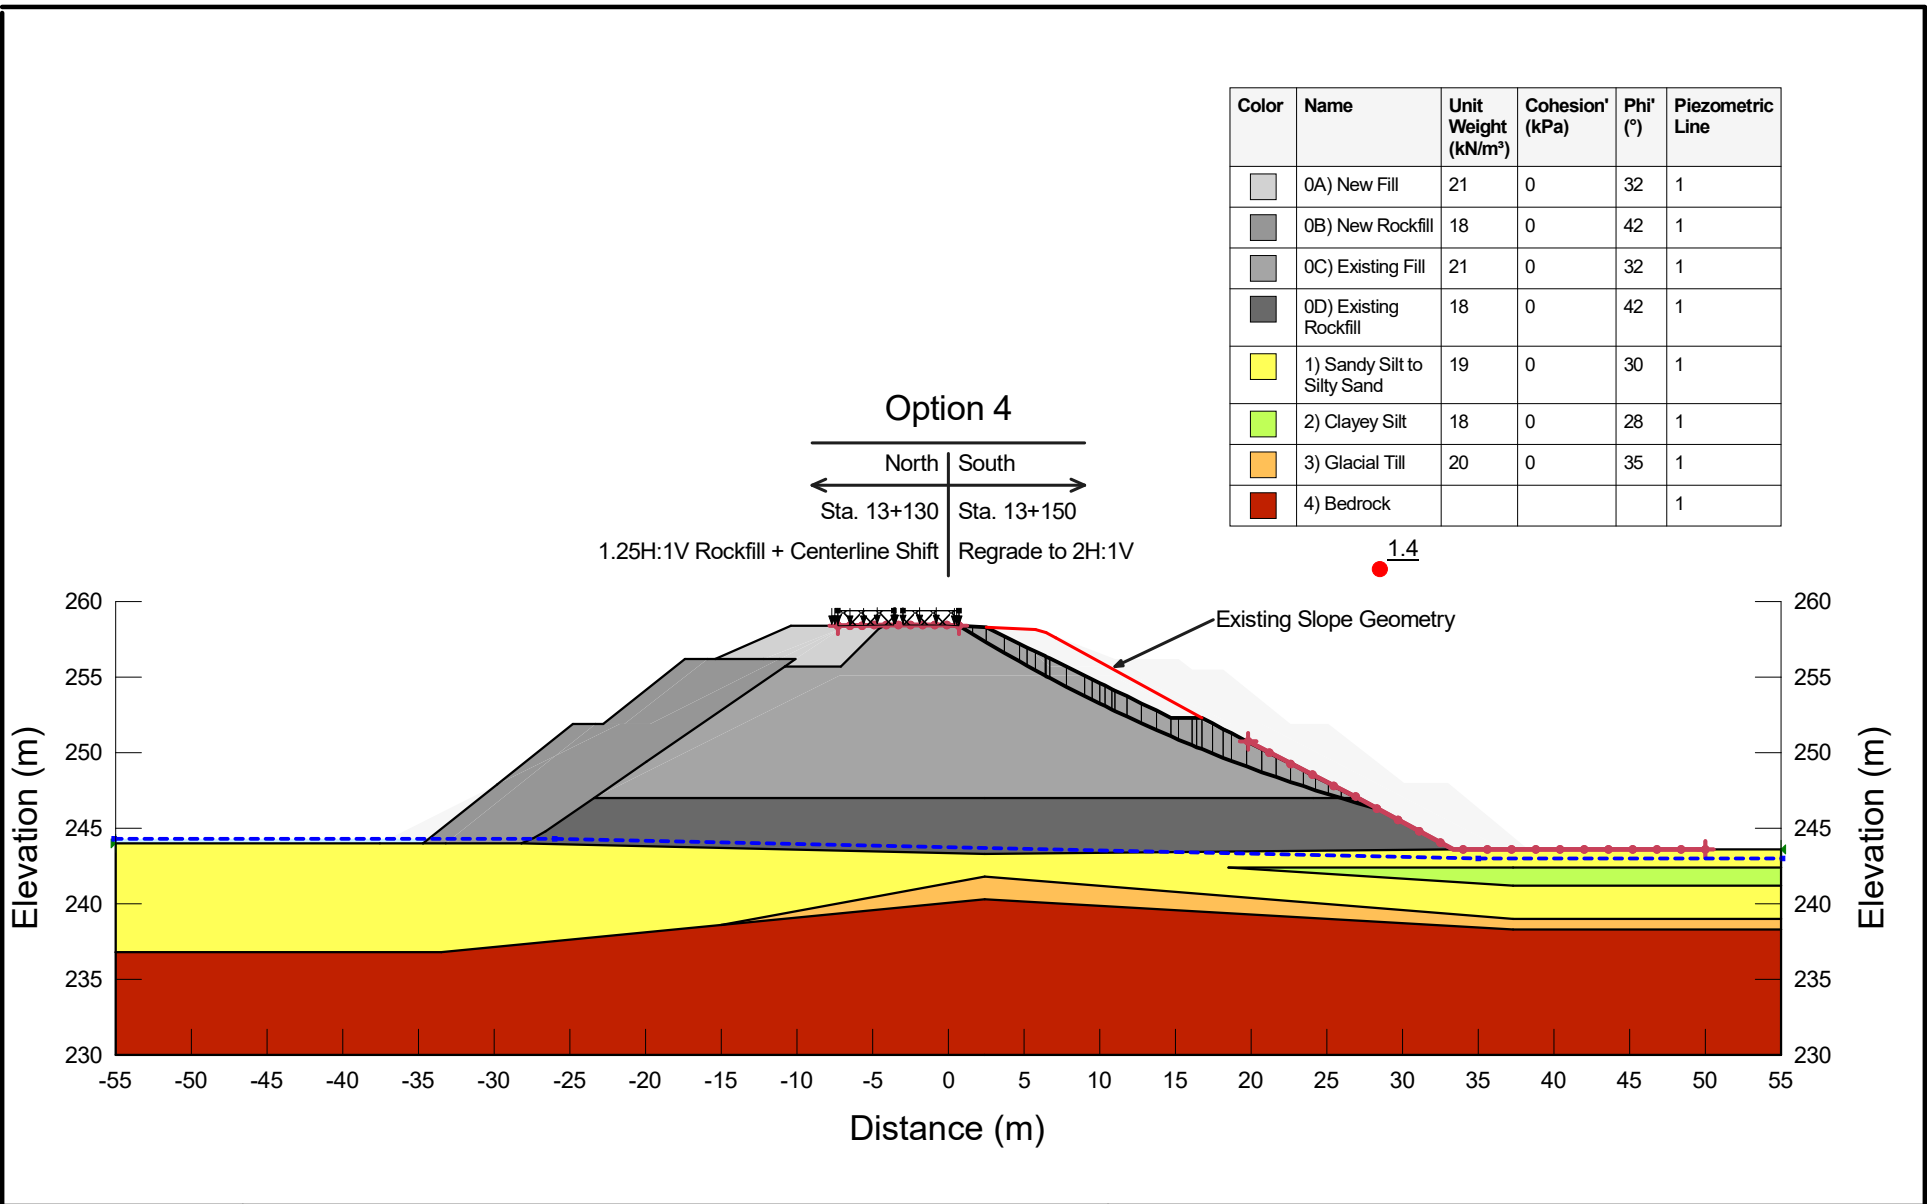
Figure F15

Analysis Title:
4S - 1.25H:1V Rockfill (North), Regrade South (Traffic)

Method: Morgenstern-Price, Half-Sine
 Minimum Slip Surface Depth: 2 m
 Center: (56.227089, 347.75212) m w/ Radius: 105.20831 m
 PWP Conditions from: Piezometric Line
 Horz Seismic Coef.: 0 g
 Surcharge (Unit Weight): 18 kN/m³

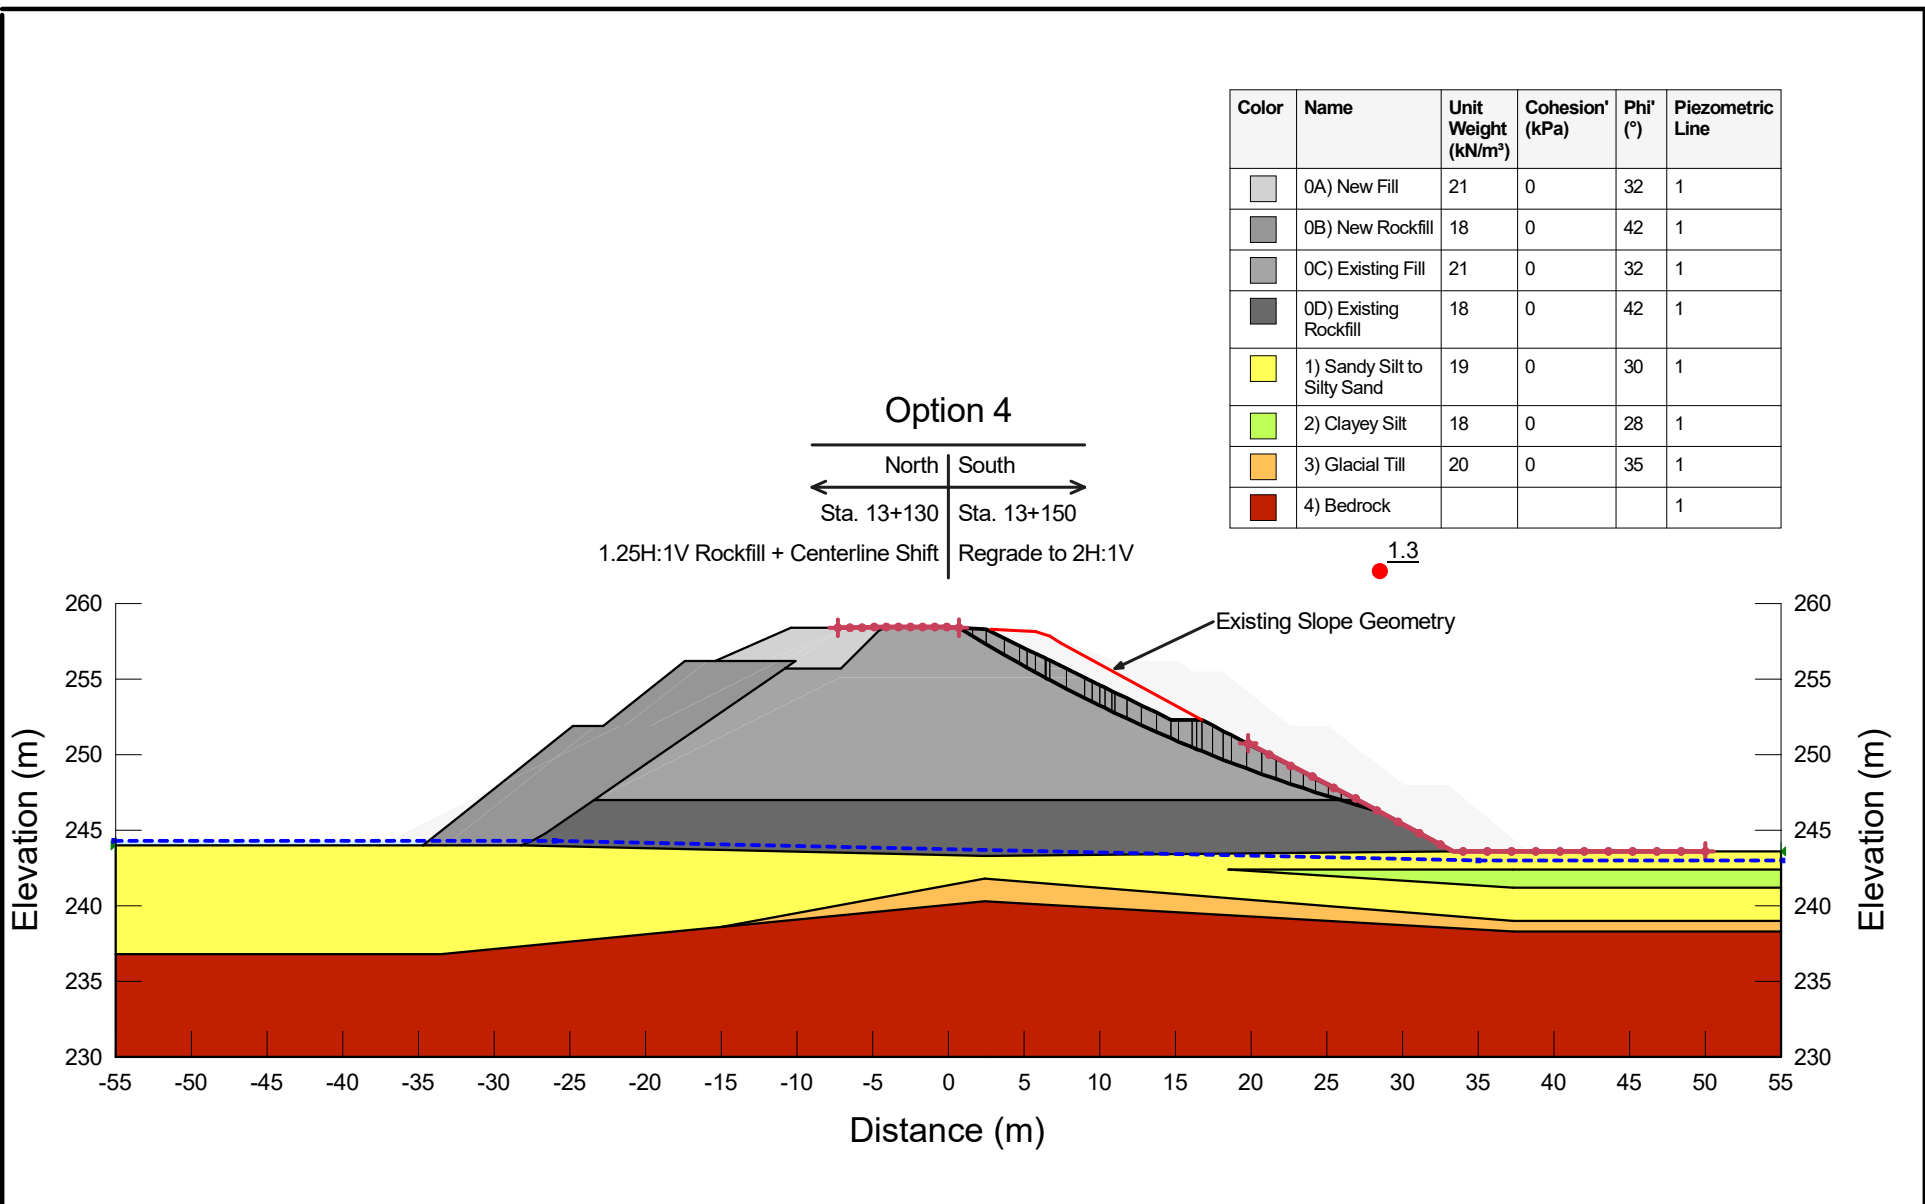
Project Name: Highway 17 Instability		
Analysis Title: 4S - 1.25H:1V Rockfill (North), Regrade South (Seismic)		
Project No.: 28408	Seismic Coeff.: H: 0.05g, V: 0g	Prepared by: DP/SP
Date: 05/27/2021	Scale: 1:500	Reviewed by: FG

Analysis Details:	
Method: Morgenstern-Price, Half-Sine	
Minimum Slip Surface Depth: 2 m	
Center: (56.227089, 347.75212) m w/ Radius: 105.20831 m	
PWP Conditions from: Piezometric Line	
Horz Seismic Coef.: 0.05 g	
Figure F16
