**FINAL
FOUNDATION INVESTIGATION REPORT
HIGHWAY 144 MCKEOWN CREEK CULVERT REHABILITATION (47X-0249/C0)
MCKEOWN TOWNSHIP, ONTARIO
ASSIGNMENT NO.: 5021-E-0039
GWP 5183-16-00**

GEOCRES NO.: 42A04-001

Client Name: AECOM Canada Ltd.

Date: December 13, 2024

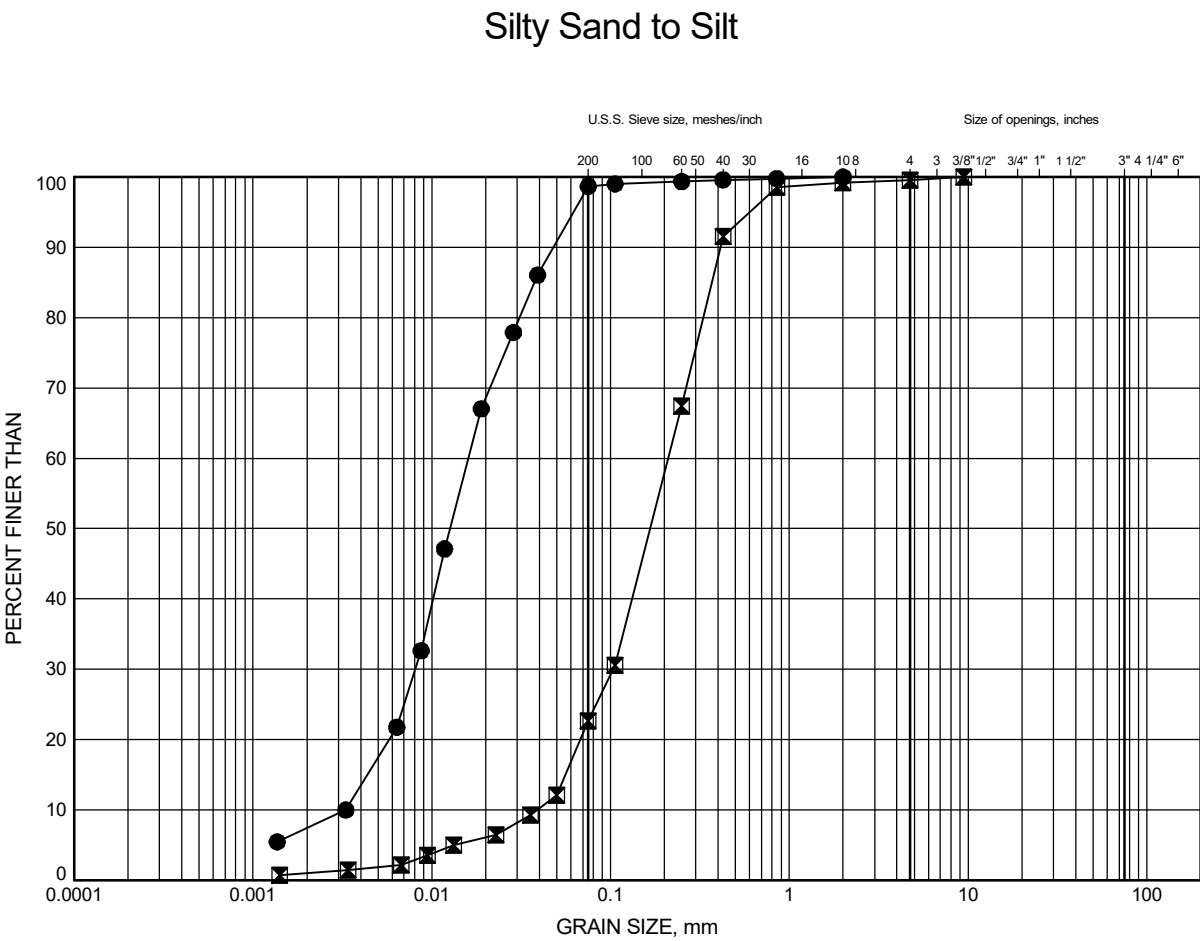
FIGURE C1

Highway 144 Culvert (47X-0249/C0)
GRAIN SIZE DISTRIBUTION

The recorded moisture contents ranged from 19 to 52%. The results of gradation analyses completed on two samples of the silt to silty sand are illustrated on Figure C1 of Appendix C. The results of the tests are summarized in the table below and on the Record of Borehole sheets in Appendix B.

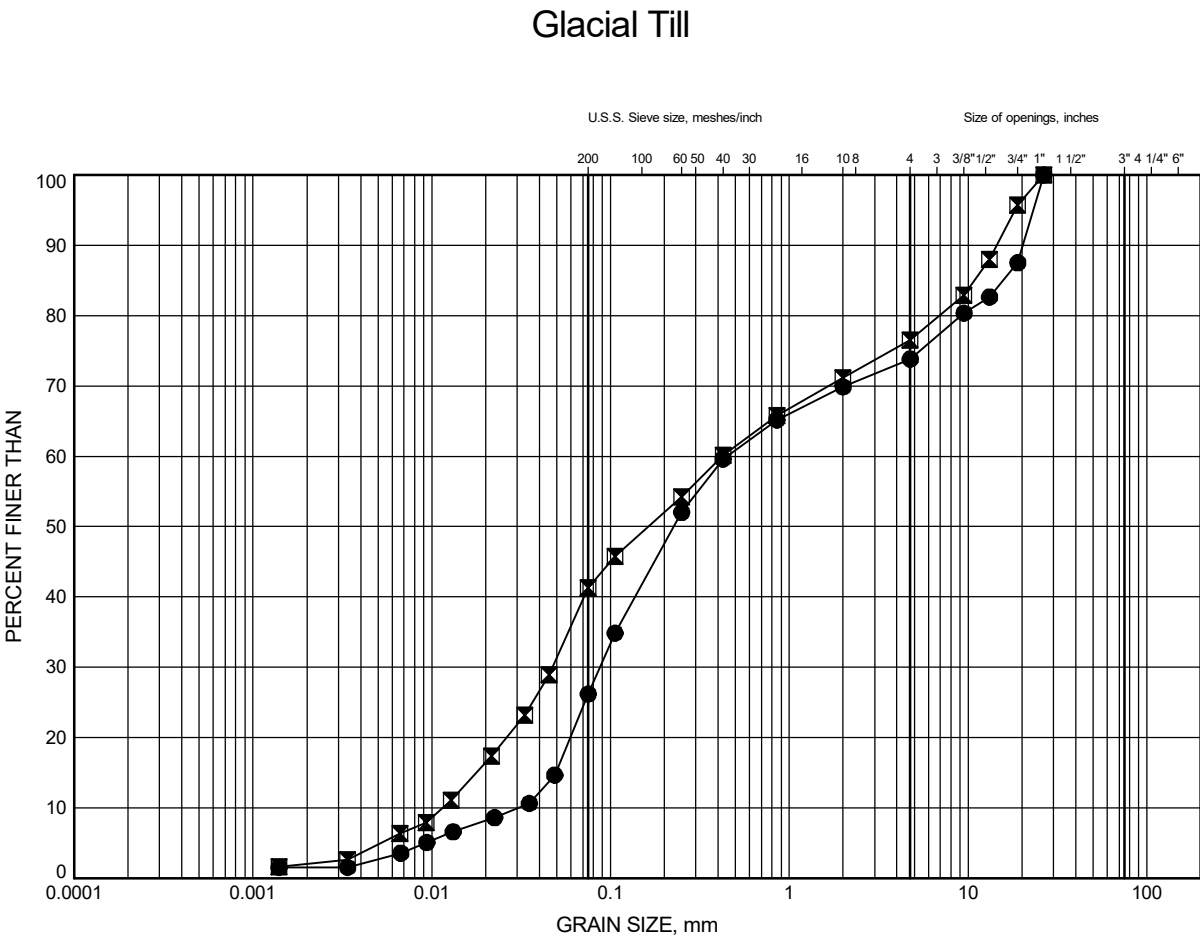
FIGURE C2

GRAIN SIZE DISTRIBUTION

The recorded moisture contents in the till ranged from 7 to 16%. The results of gradation analyses completed on two samples of the till are illustrated on Figure C2 of Appendix C. The results of

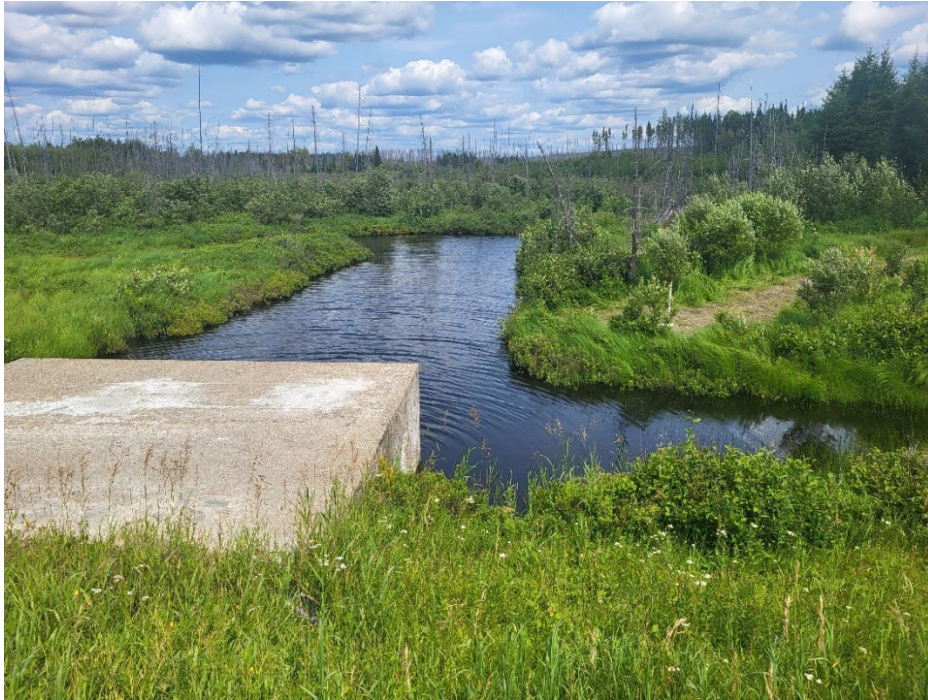
Photo 1: Culvert outlet, looking east (*taken July 2024*).

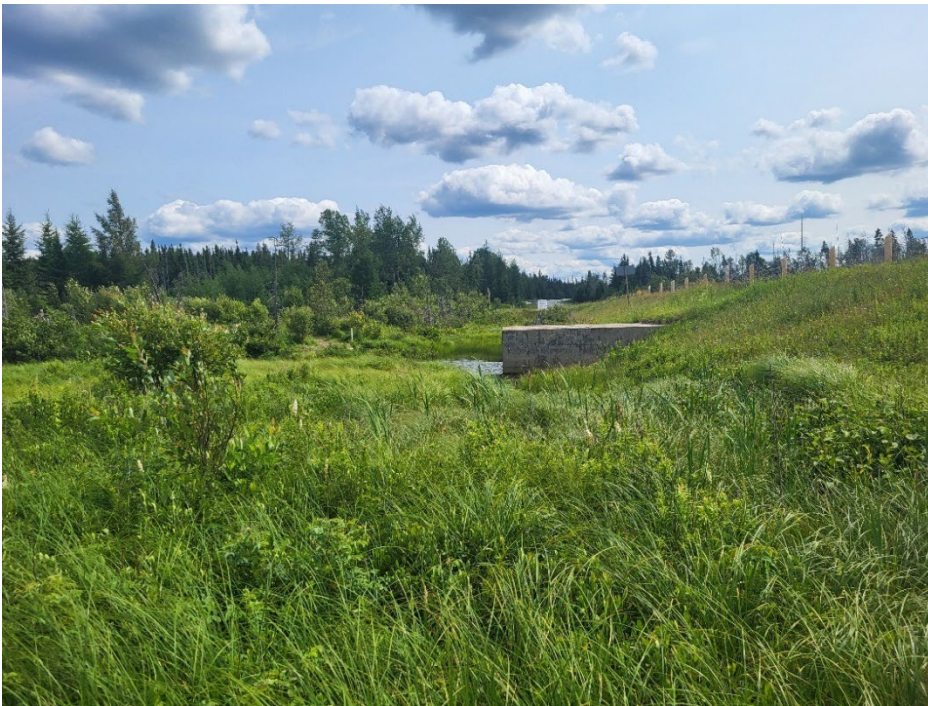
Photo 2: East embankment condition, looking south (*taken July 2024*).

Embankment slopes, in the vicinity of the culvert site, are inclined at approximately 2H:1V. The existing highway embankment side slopes at the site did not show any visible signs of global instability at the time of the investigation. Survey drawings dated January 2023 and provided by AECOM indicate that the road surface is at approximately elevation 326.8 m with a slight increase in elevation to the north.

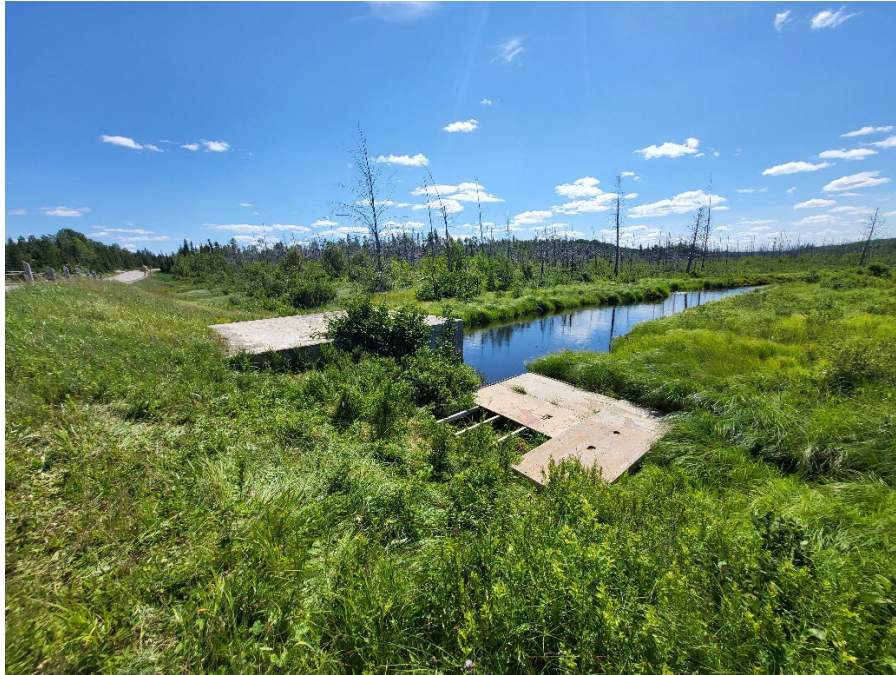
Photo 3: Culvert inlet, looking west *(taken July 2024)*.

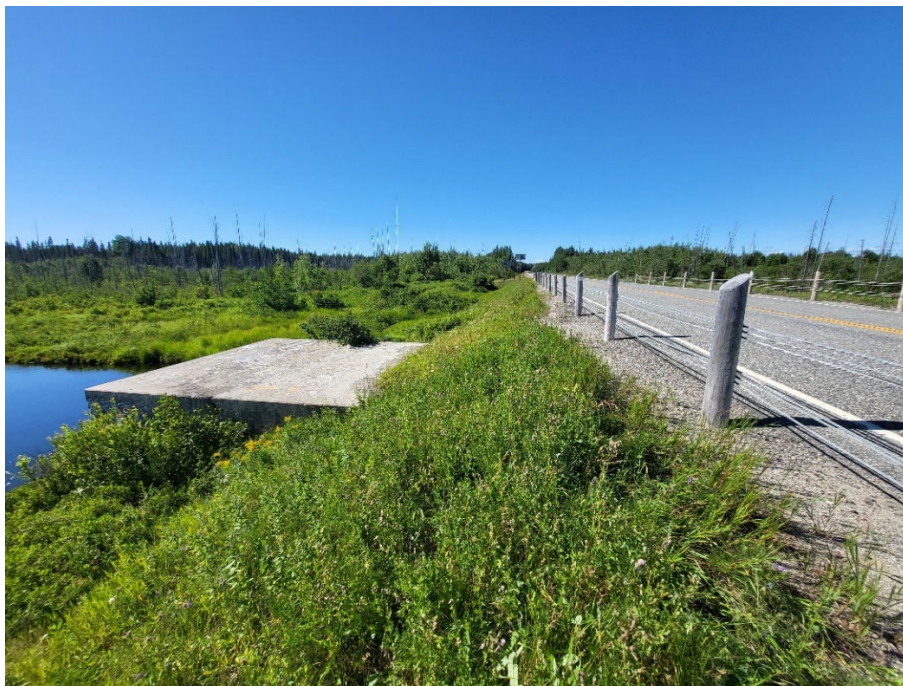
Photo 4: West embankment condition, looking north *(taken July 2024)*.
