**FINAL  
FOUNDATION INVESTIGATION REPORT  
OLD WOMAN RIVER BRIDGE  
HIGHWAY 17  
AGREEMENT NO. 5020-E-0025  
GWP 5207-18-00**

**SITE NO. 38C-0009/B0  
GEOCRES NO.: 41N00-036**

**Report  
to  
AECOM Canada Ltd.**

November 2023  
Thurber File No.: 31653

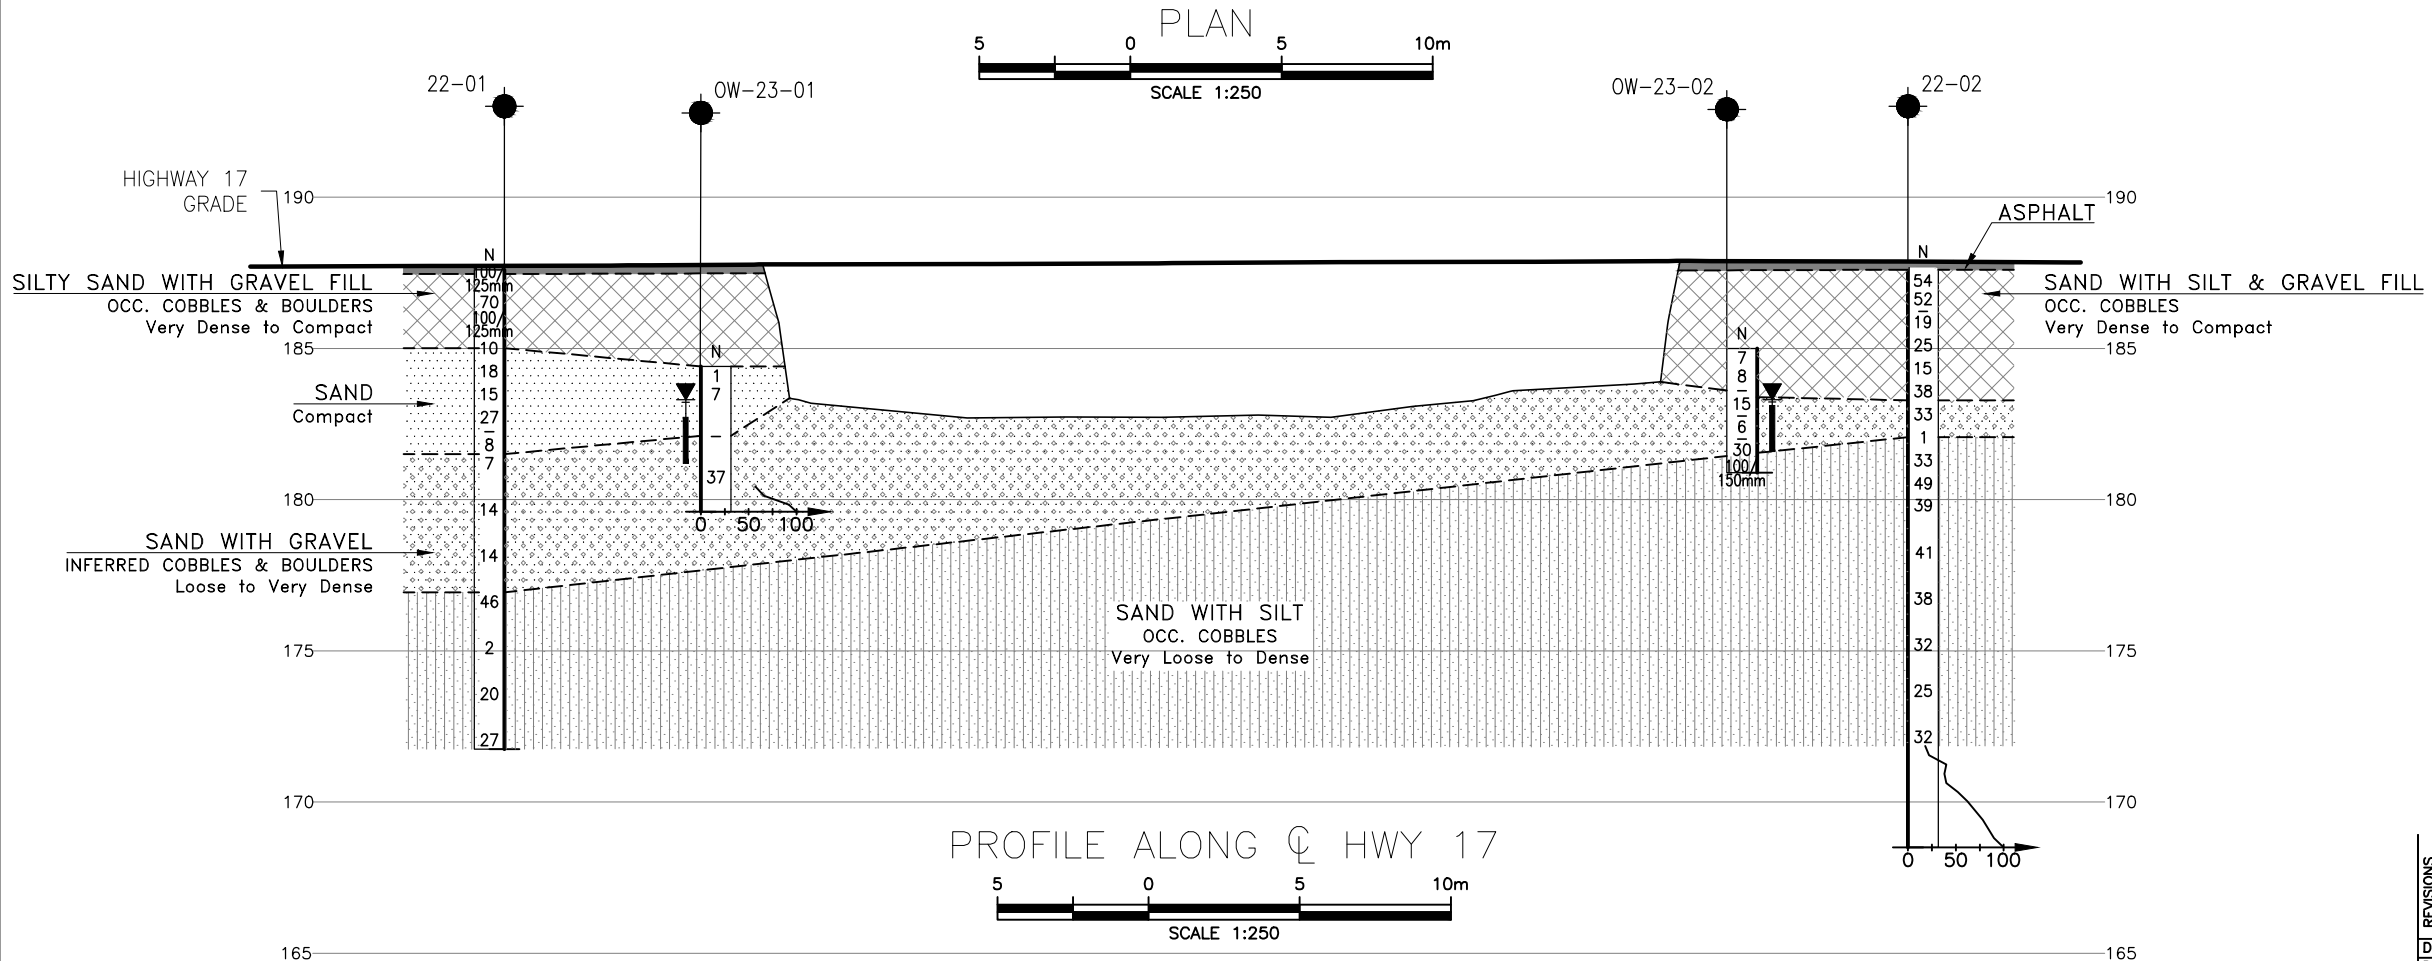
REVISIONS	DATE	BY	DESCRIPTION
DESIGN	AO	CHK	CODE
DRAWN	AN	CHK	SITE
			LOAD
			STRUCT
			DATE
			NOV 2023
			DWG F-1

Four attempts were required to advance OW-23-02. The borehole location shown was the deepest attempt and corresponds to the borehole log.

HIGHWAY 17  
OLD WOMAN RIVER BRIDGE  
LARONDE TOWNSHIP  
BOREHOLE LOCATIONS AND SOIL STRATA

- The boundaries between soil strata have been established only at Borehole locations. Between Boreholes the boundaries are assumed from geological evidence.
- This drawing is for subsurface information only. Surface details and features are for conceptual illustration.
- Coordinate system is MTM NAD 83 Zone 13.

Details of the encountered soil stratigraphy are presented on the Record of Borehole sheets included in Appendix B and on the Borehole Location and Soil Strata Drawing included in Appendix A. A general description of the stratigraphy, based on the conditions encountered in the boreholes, is given in the following paragraphs. However, the factual data presented on the Record of Borehole sheets takes precedence over this general description for interpretation of the site conditions. It must be recognized that the soil and groundwater conditions will vary between and beyond borehole locations. Soil classification is in accordance with ASTM D 2487 as per current MTO Guidelines for Foundation Engineering Services.

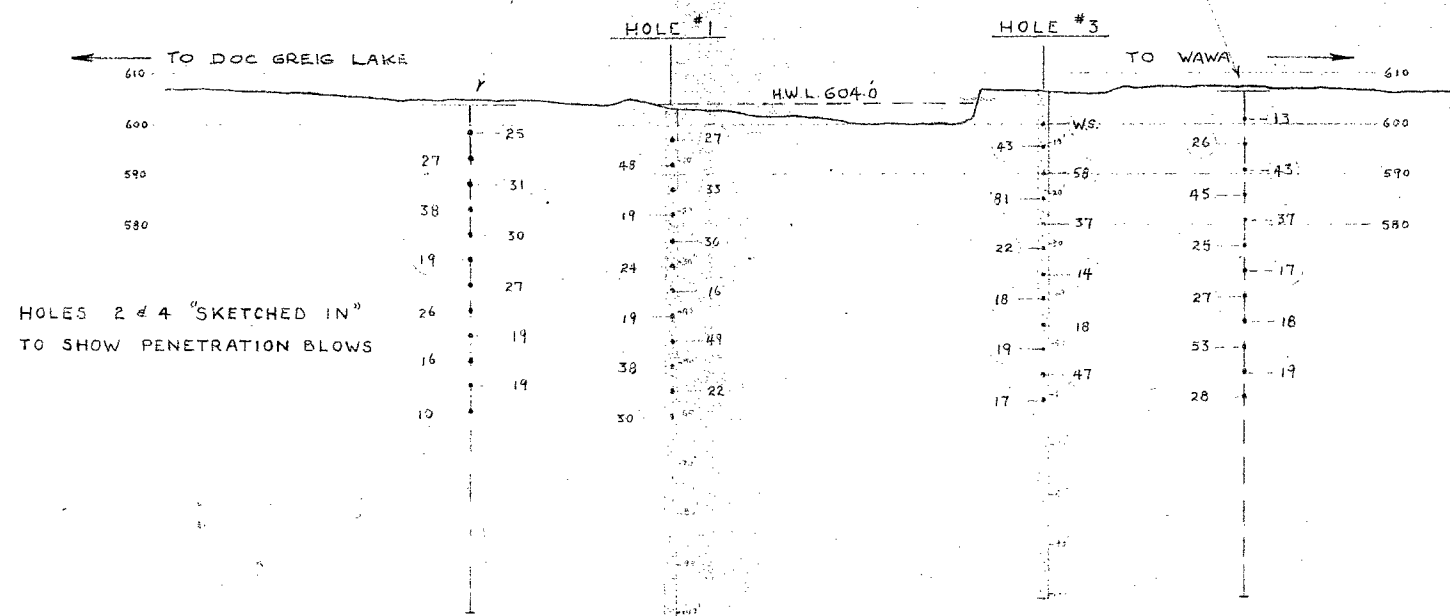
HOLES 2 & 4 "SKETCHED IN"  
TO SHOW PENETRATION BLOWS

SCALES: HOR. 1" = 20'  
VER. 1" = 20'

The coordinates of the boreholes are not provided in the historical investigation and the boreholes were advanced prior to the bridge construction. For this reason, it is difficult to know the borehole locations. Nonetheless, the historical borehole plan and borehole records are included in the report for the reference in Appendix A.

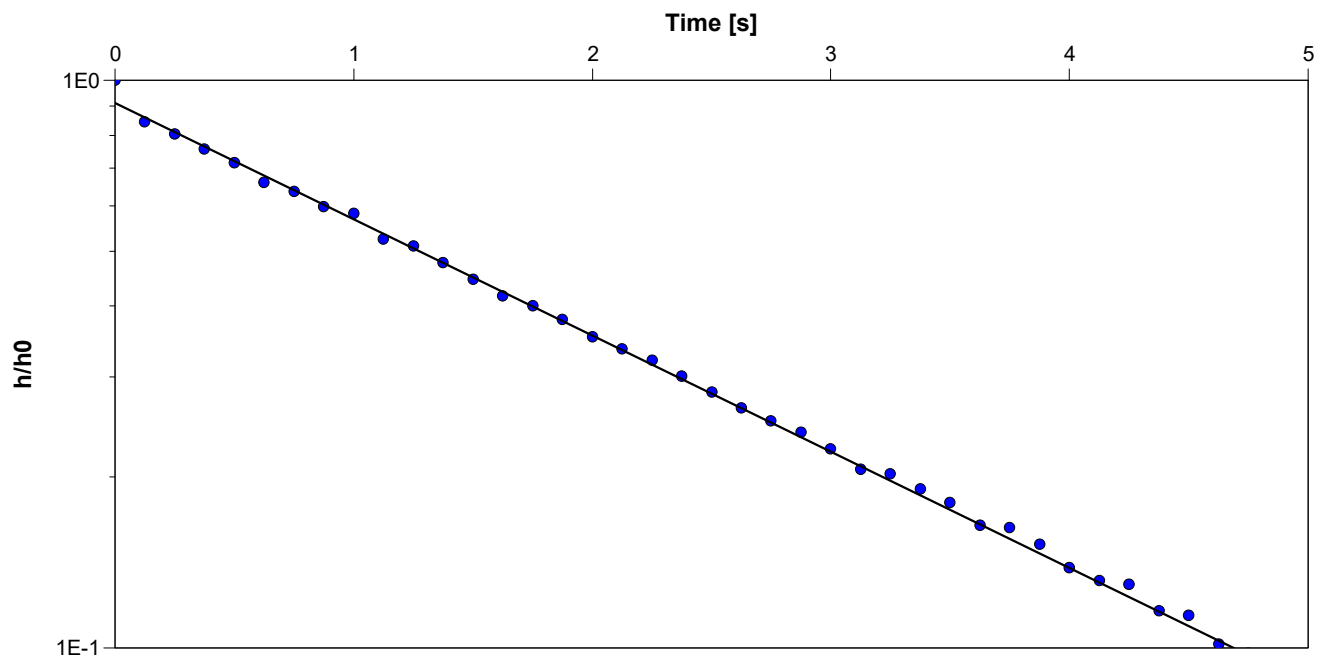
Calculation using Hvorslev

A 32 mm diameter monitoring well was installed in each of Boreholes OW-23-01 and OW-23-02 to observe the groundwater level upon completion of drilling. The details for the well are illustrated on the respective Record of Borehole sheets provided in Appendix B. The wells were decommissioned in July 2023.

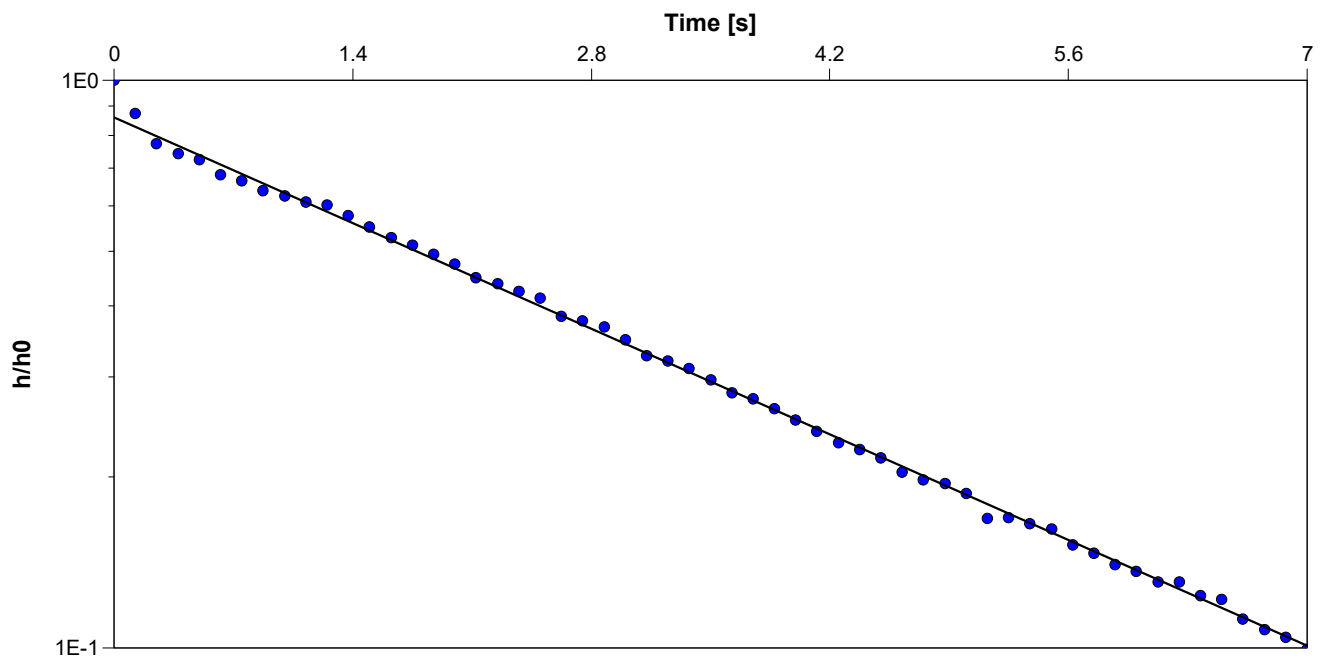
Calculation using Hvorslev

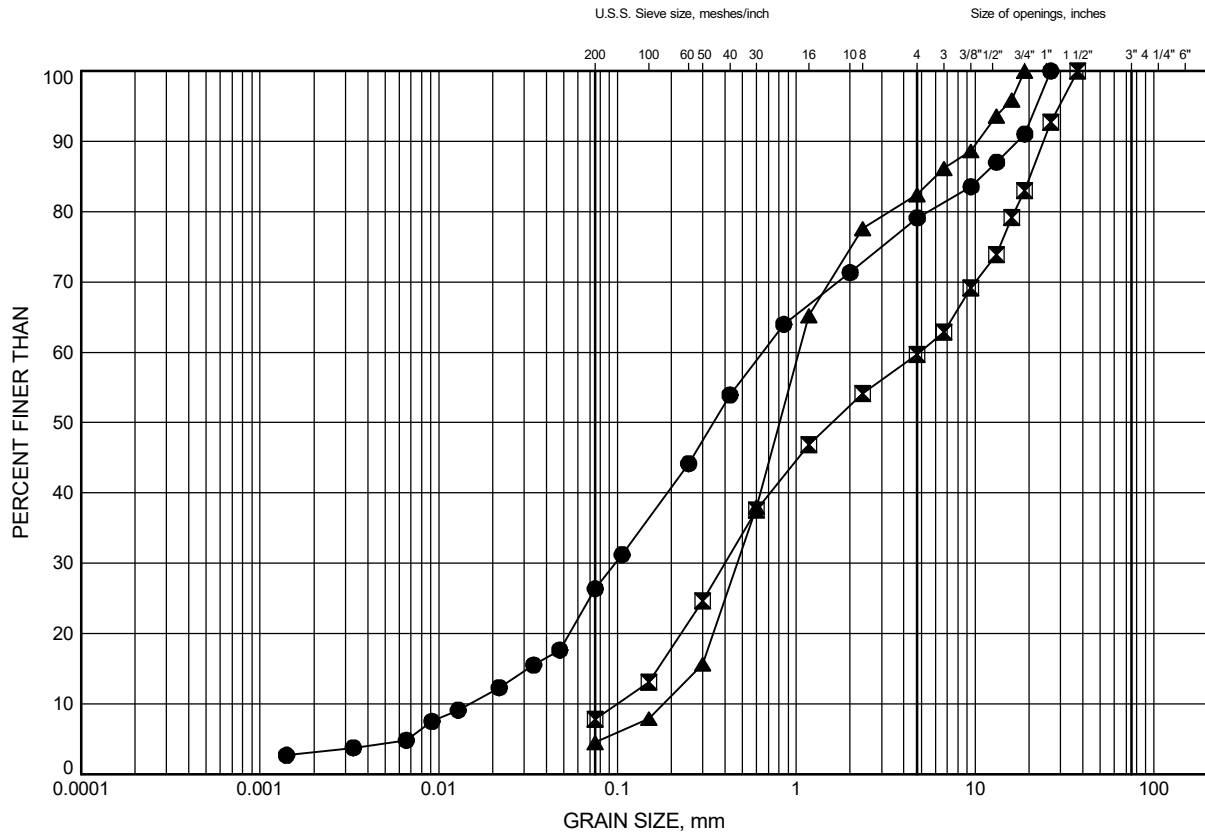
FIGURE C1

FILL: Silty Sand with Gravel to Sand with Silt and Gravel

The recorded moisture content of samples of the fill layer ranged from 4 to 16%. The results of three gradation analyses completed on samples of the fill are illustrated on Figure C1 of Appendix C. The results of the test are summarized below and on the Record of Borehole sheets in Appendix B.

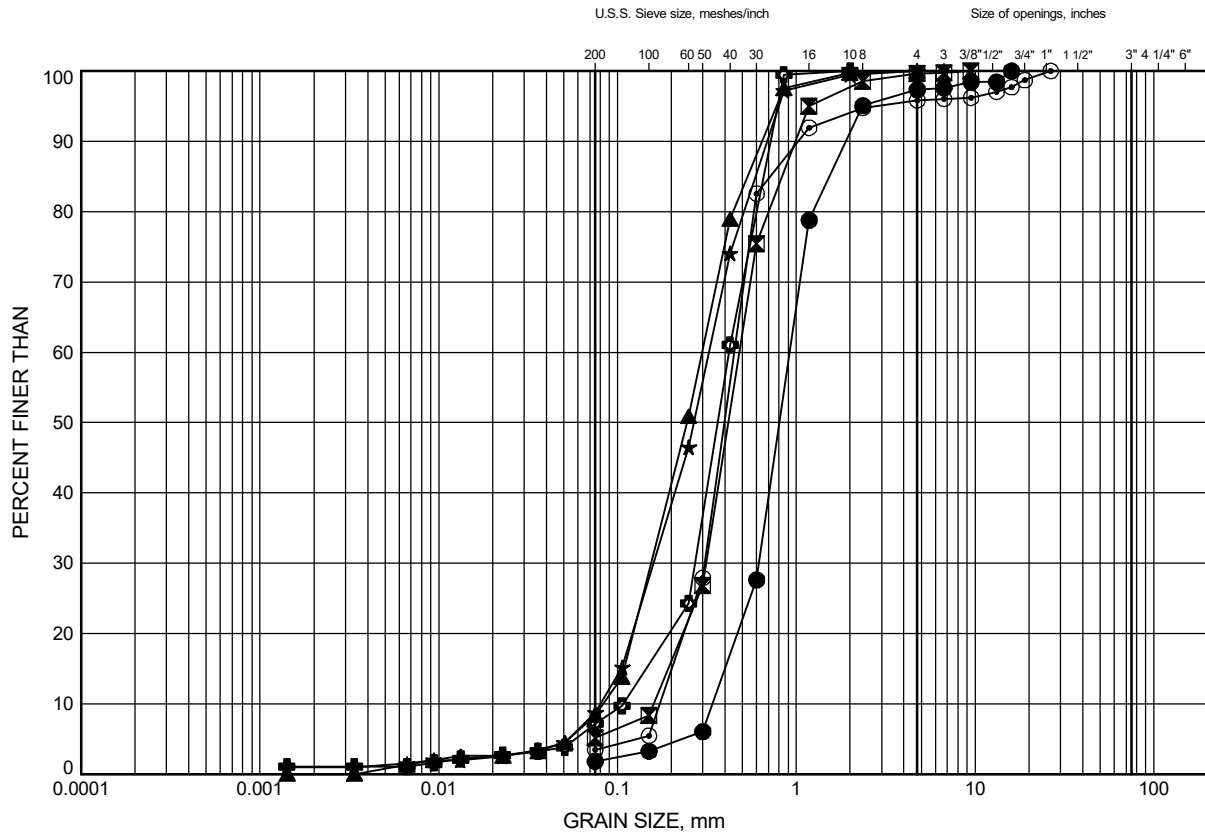
FIGURE C2

## Sand with Silt

The recorded moisture content ranged from 3 to 35% but was typically less than 23%. The results of gradation analyses completed on ten samples of the native sand illustrated on Figures C2 and C3 of Appendix C. The results of the tests are summarized below and on the Record of Borehole sheets in Appendix B.

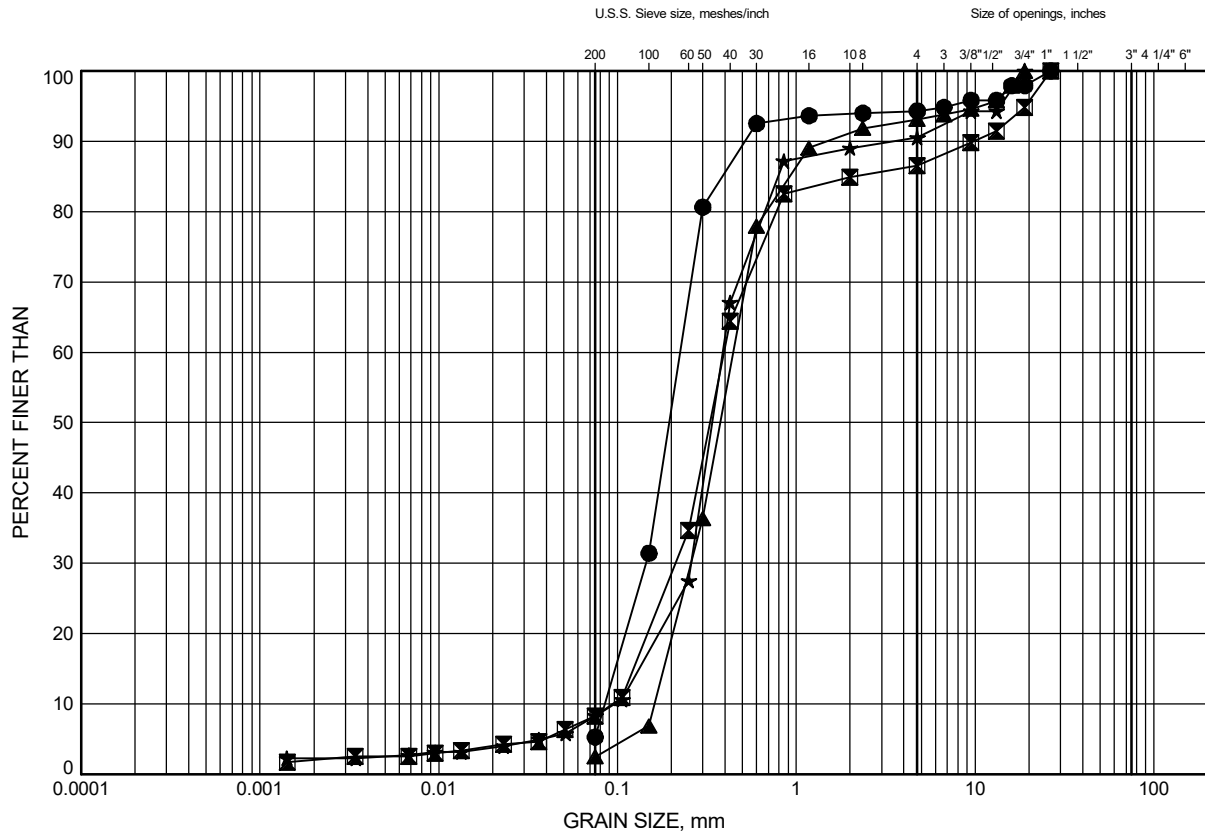
FIGURE C3

## Sand with Silt

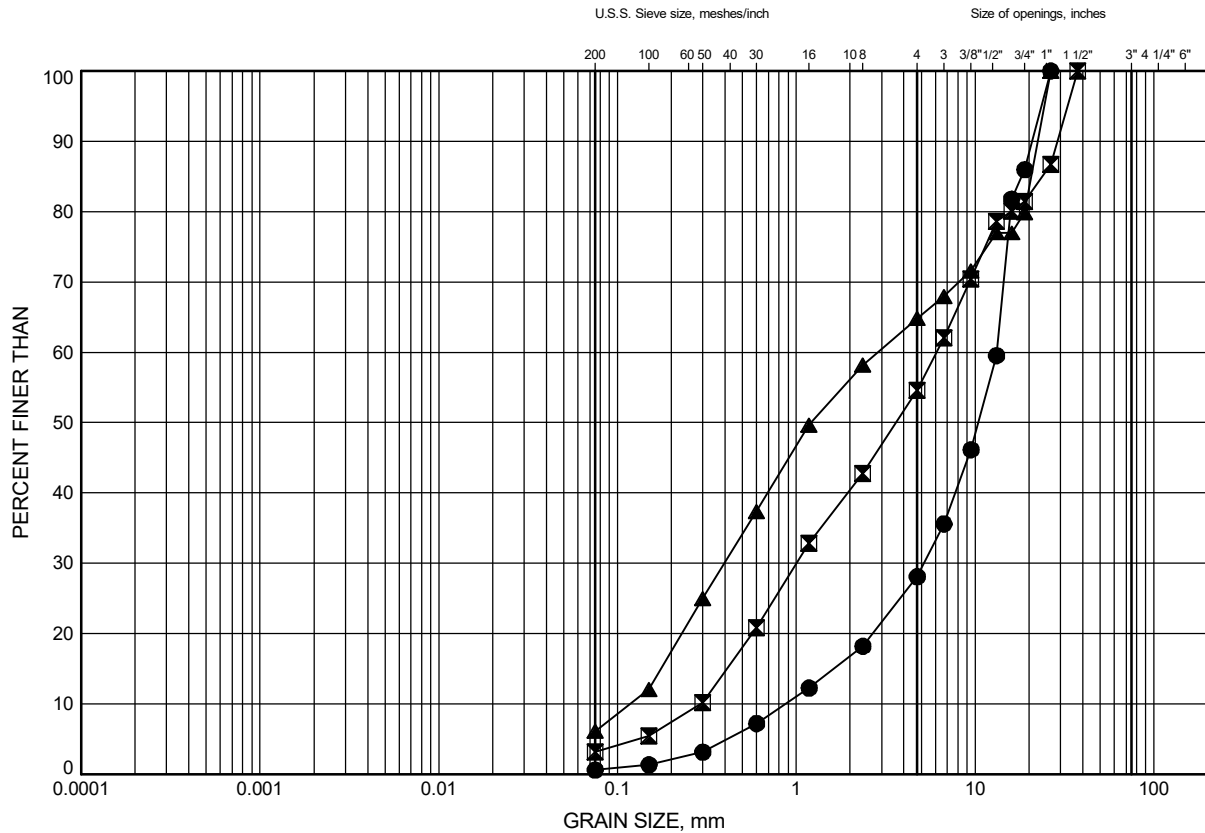
FIGURE C4

## Sand with Gravel to Gravel with Sand

Three samples from the layer in Boreholes 22-01, 22-02, and OW-23-01 had a higher gravel content. The results of gradation analyses completed on those samples are summarized below and are illustrated on Figure C4 of Appendix C. The results tests are also summarized on the Record of Borehole sheets in Appendix B

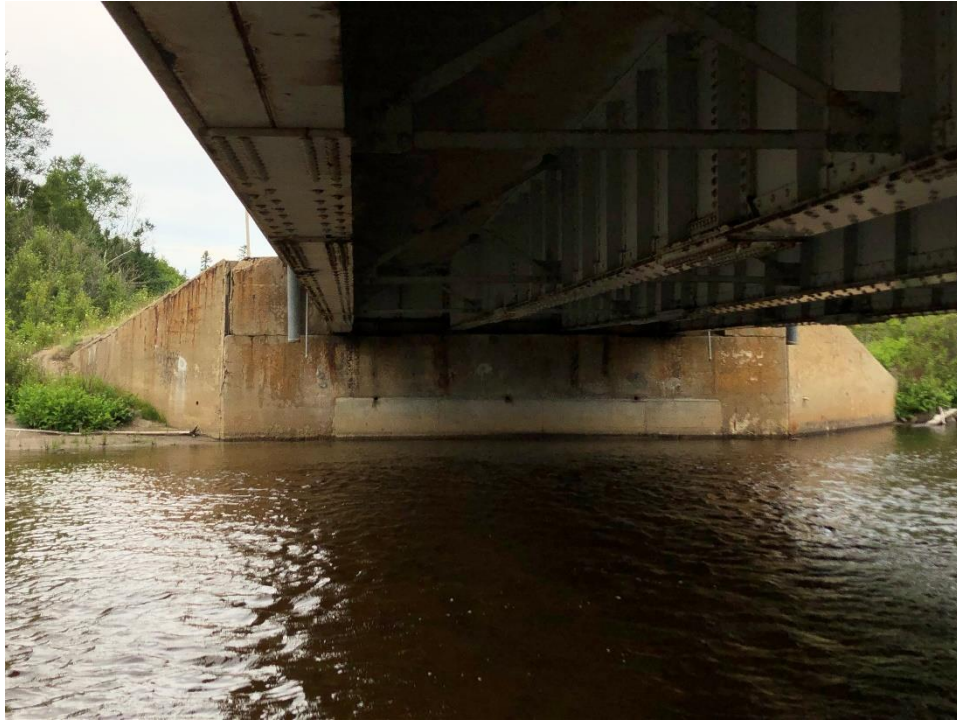
Photograph 5: Looking at north wing wall and abutment *[taken August 2022]*

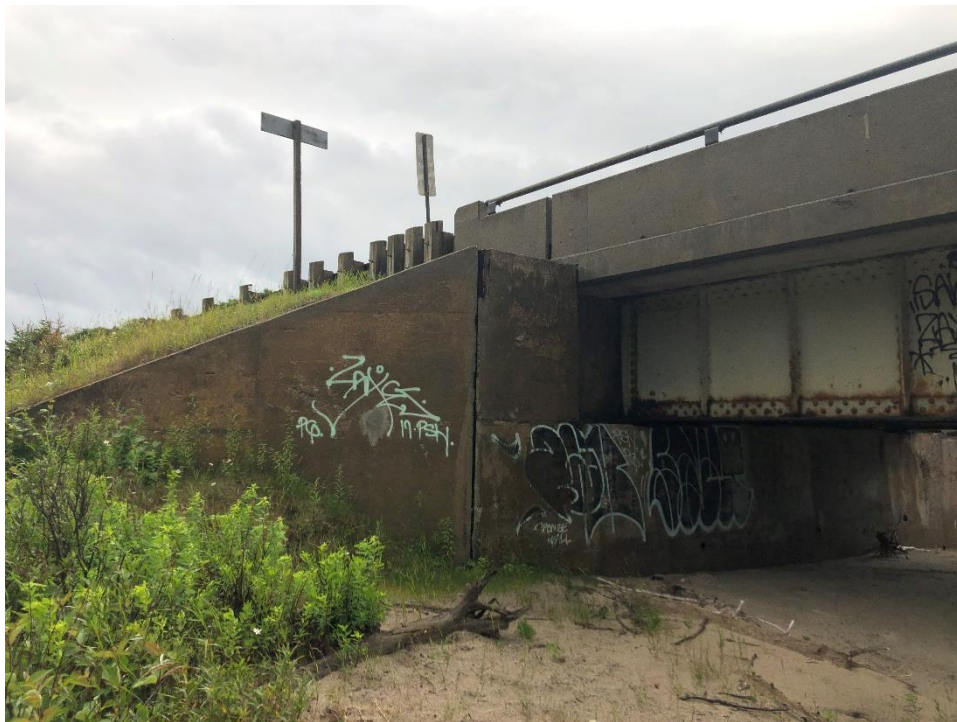
Photograph 6: Looking at south wing wall and abutment *[taken August 2022]*

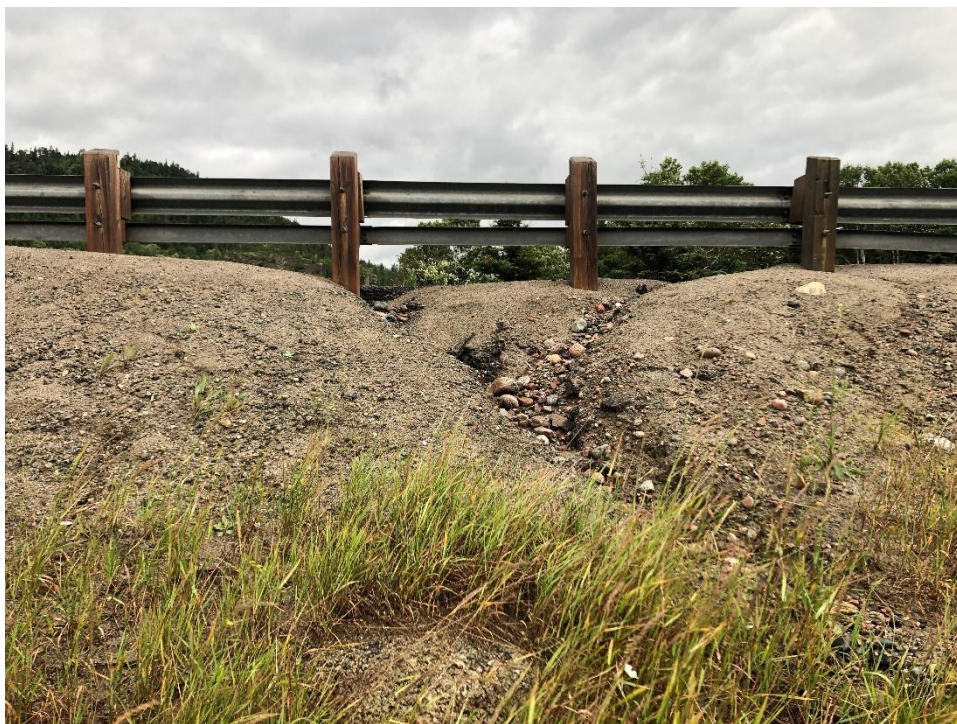
Photograph 8: Erosion at the south abutment's west side slope *[taken August 2022]*

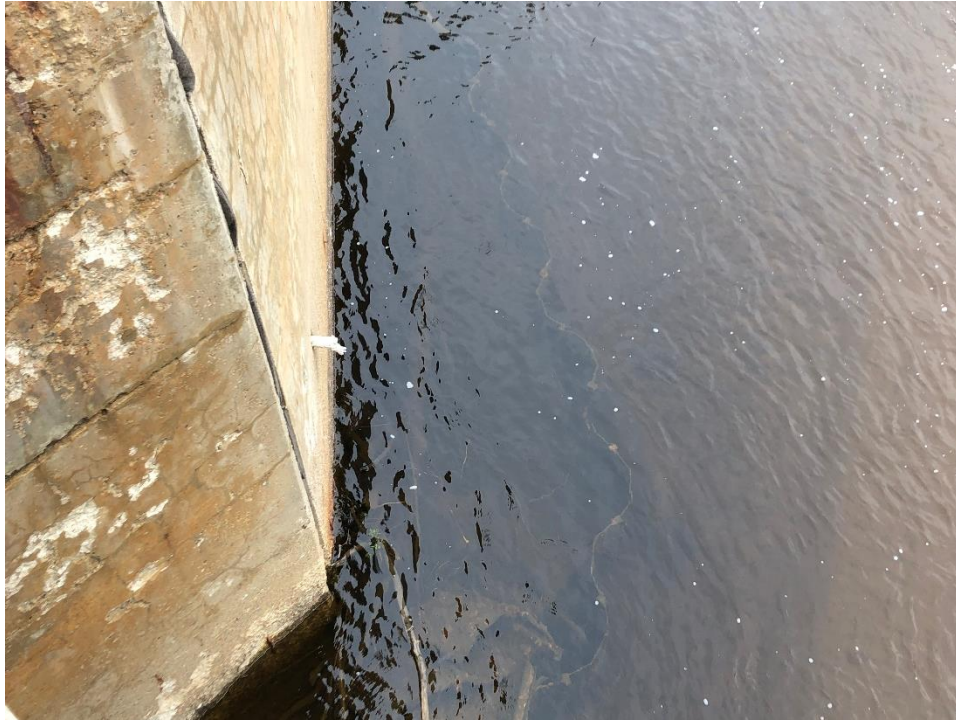
Photograph 9: Sheet piles below water at the east side of the north abutment *[taken August 2022]*

Historical construction drawings by Proctor & Redfern (W.P. 958-57) show that sheet piles were installed at each abutment to elev. 179.2 m to aid construction. Thurber observed the sheet piles in the water near the east side of the north abutment, see Photo 9 in Appendix D.

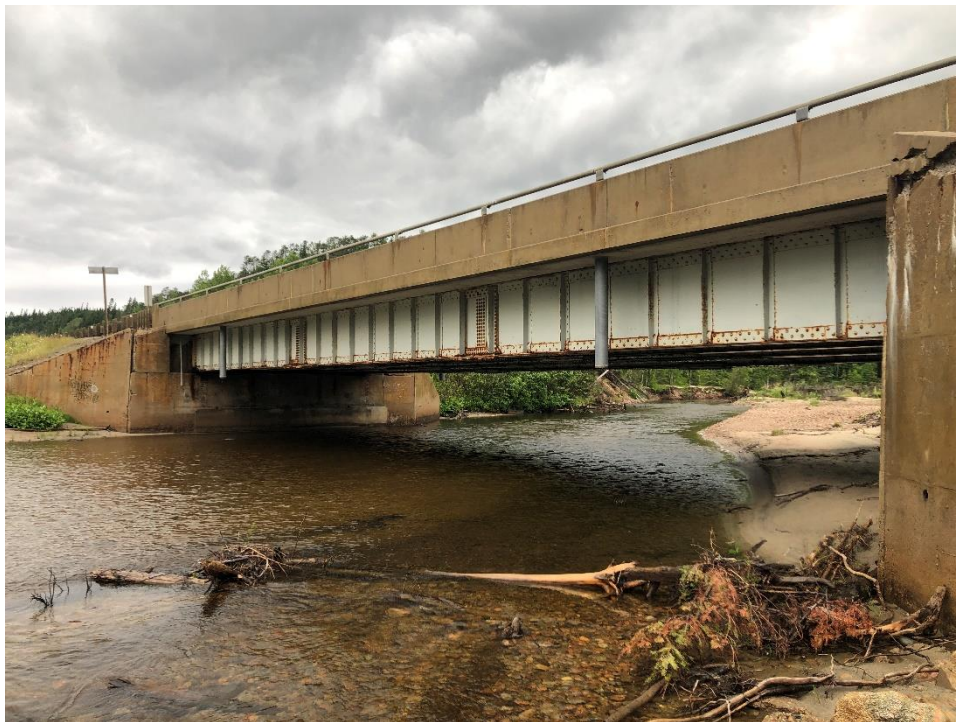
Photograph 10: Deposited sand and tree debris near the south abutment *[taken August 2022]*
