**FINAL
FOUNDATION INVESTIGATION REPORT
HIGHWAY 17 CULVERT AT STATION 14+332
DULHUT TOWNSHIP, ONTARIO
ASSIGNMENT NO.: 5020-E-0025
GWP 5207-18-00**

GEOCRES NO.: 41N00-038

Date: November 23, 2023

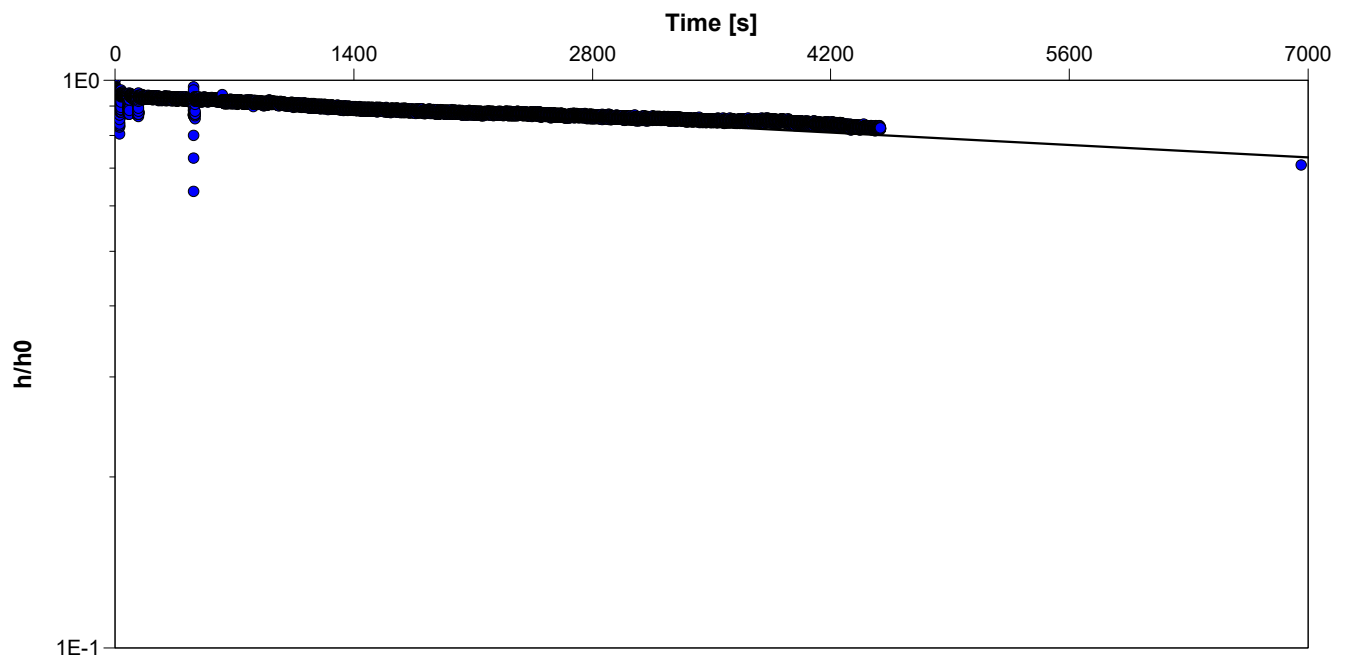
Calculation using Hvorslev

Observation Well

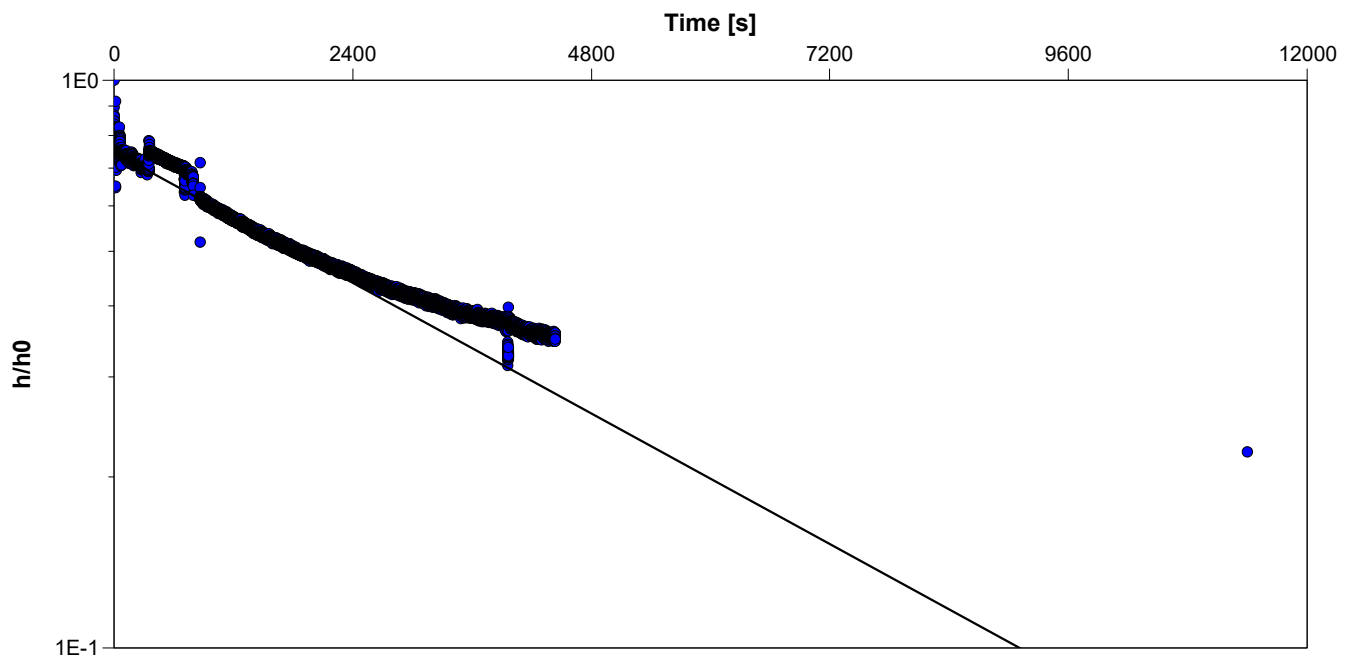
Calculation using Hvorslev

Observation Well

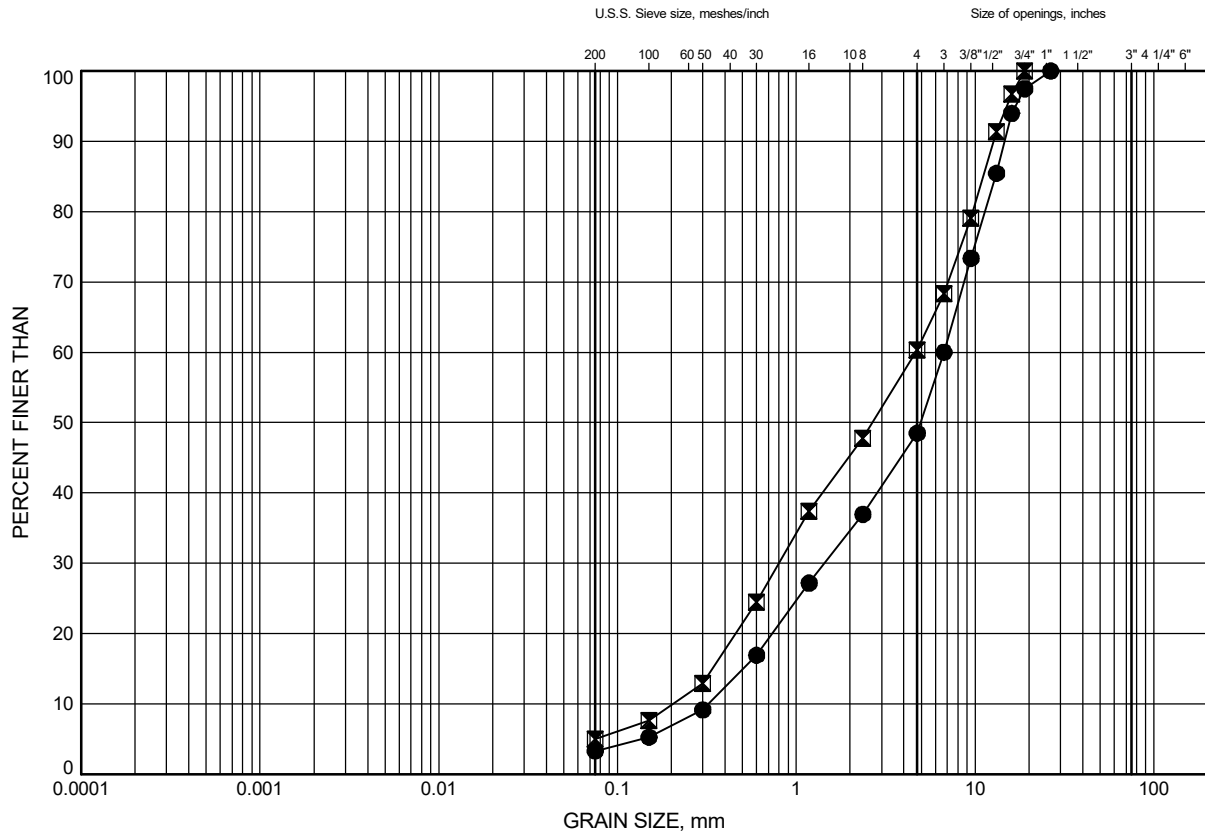
FIGURE C1

FILL: Sand and Gravel

Moisture contents ranging from 4 to 7% were recorded. The results of gradation analyses completed on two samples of the layer are illustrated in Figure C1 of Appendix C. The results of the tests are summarized in the table below and on the Record of Borehole sheets in Appendix B.

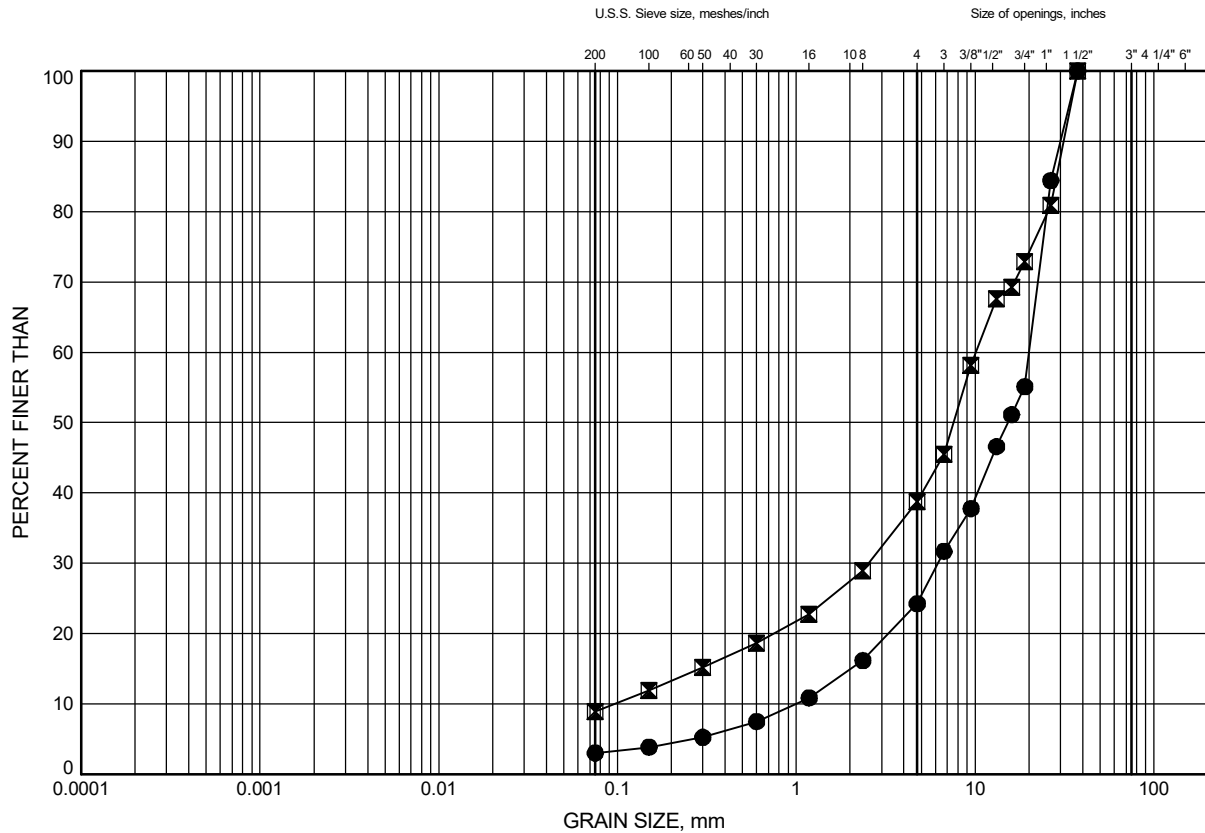
FIGURE C2

Rock Fill

The recorded moisture contents of the non-cohesive infill ranged from 1 to 6%. A limited volume of sample was obtained, and the results of gradation analyses completed on two samples of the layer are illustrated in Figure C2 of Appendix C. The results of the tests are summarized in the table below and on the Record of Borehole sheets in Appendix B.

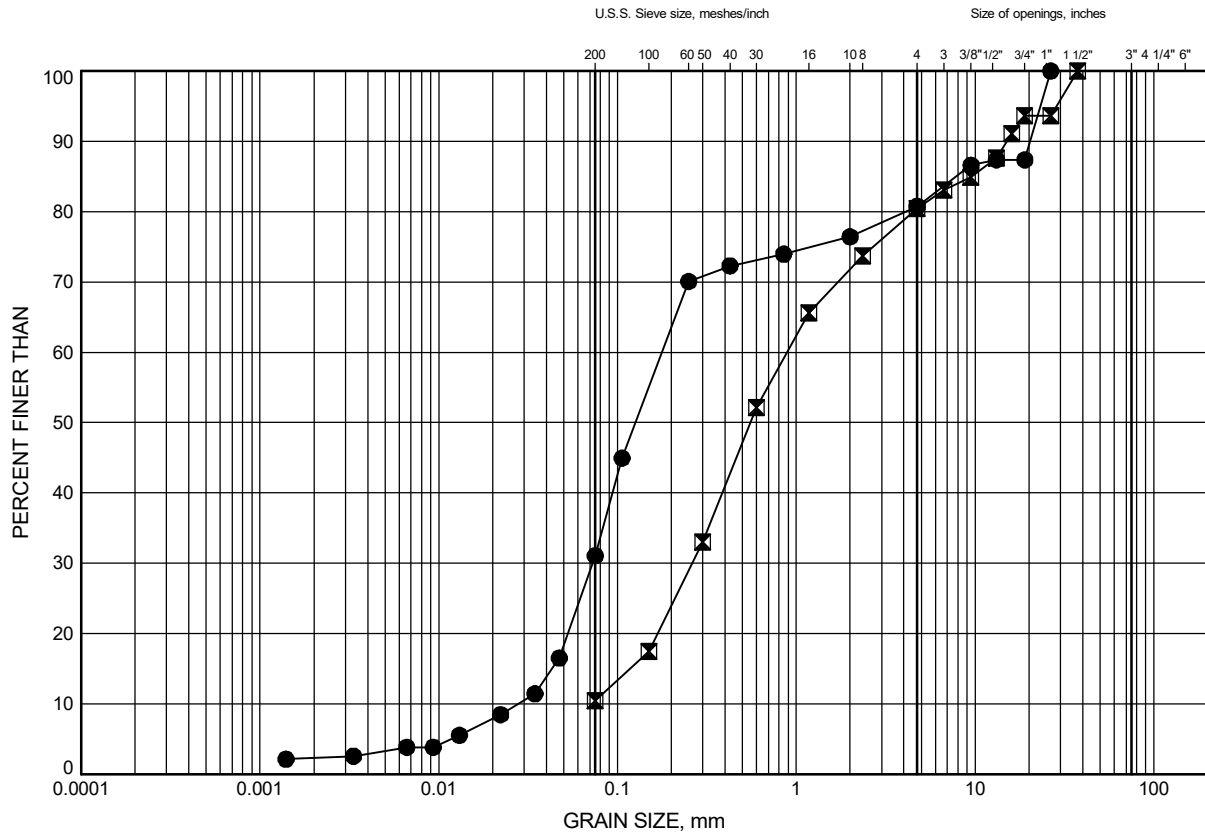
FIGURE C3

FILL: Sand to Silty Sand

The recorded moisture content ranged from 14 to 17%. The results of gradation analyses completed on two samples of the layer are illustrated in Figure C3 of Appendix C. The results of the tests are summarized in the table below and on the Record of Borehole sheets in Appendix B.

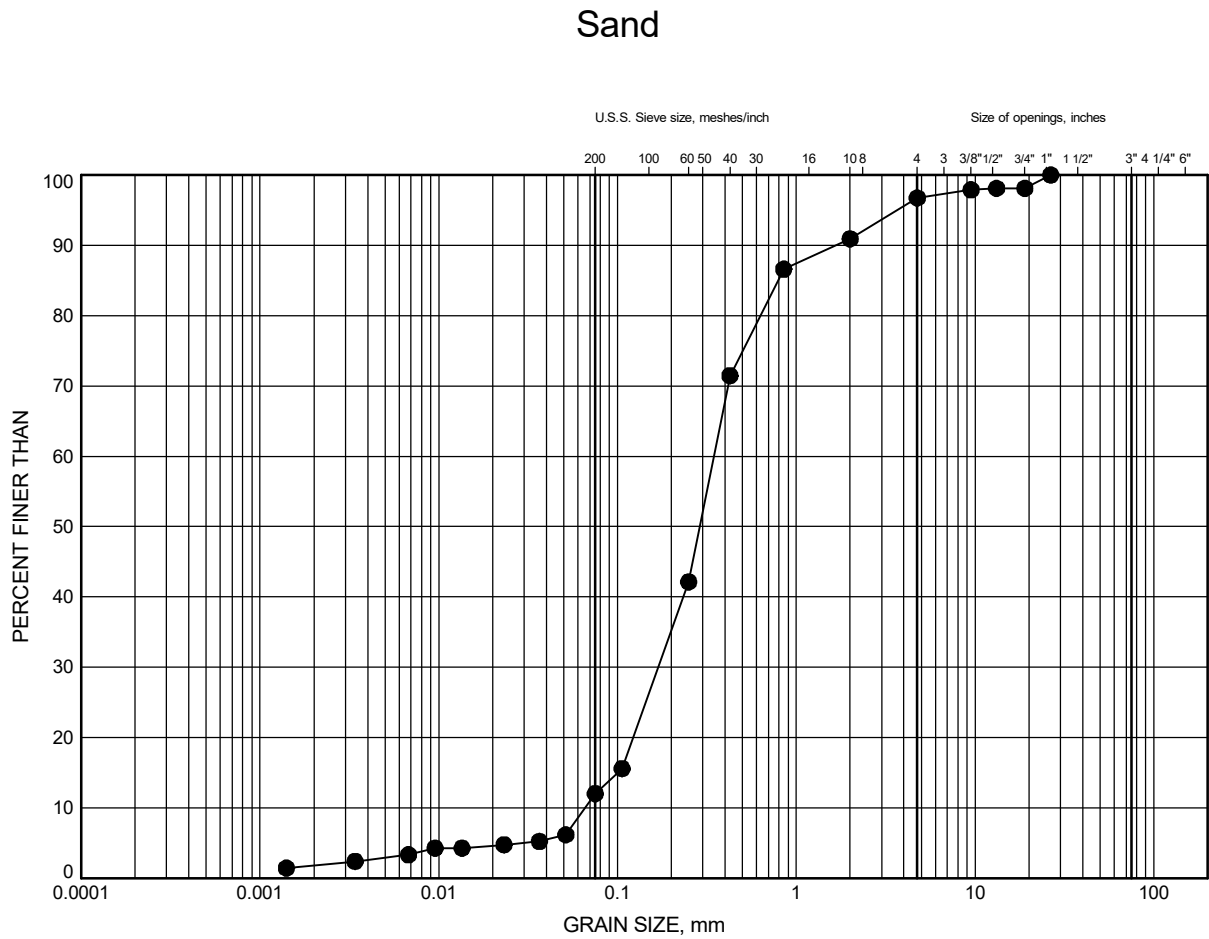
FIGURE C4

Hwy 17 Old Woman River GRAIN SIZE DISTRIBUTION

A moisture content of 16% was recorded. The results of gradation analysis completed on a sample of the layer are illustrated in Figure C4 of Appendix C. The results of the tests are summarized in the table below and on the Record of Borehole sheets in Appendix B.

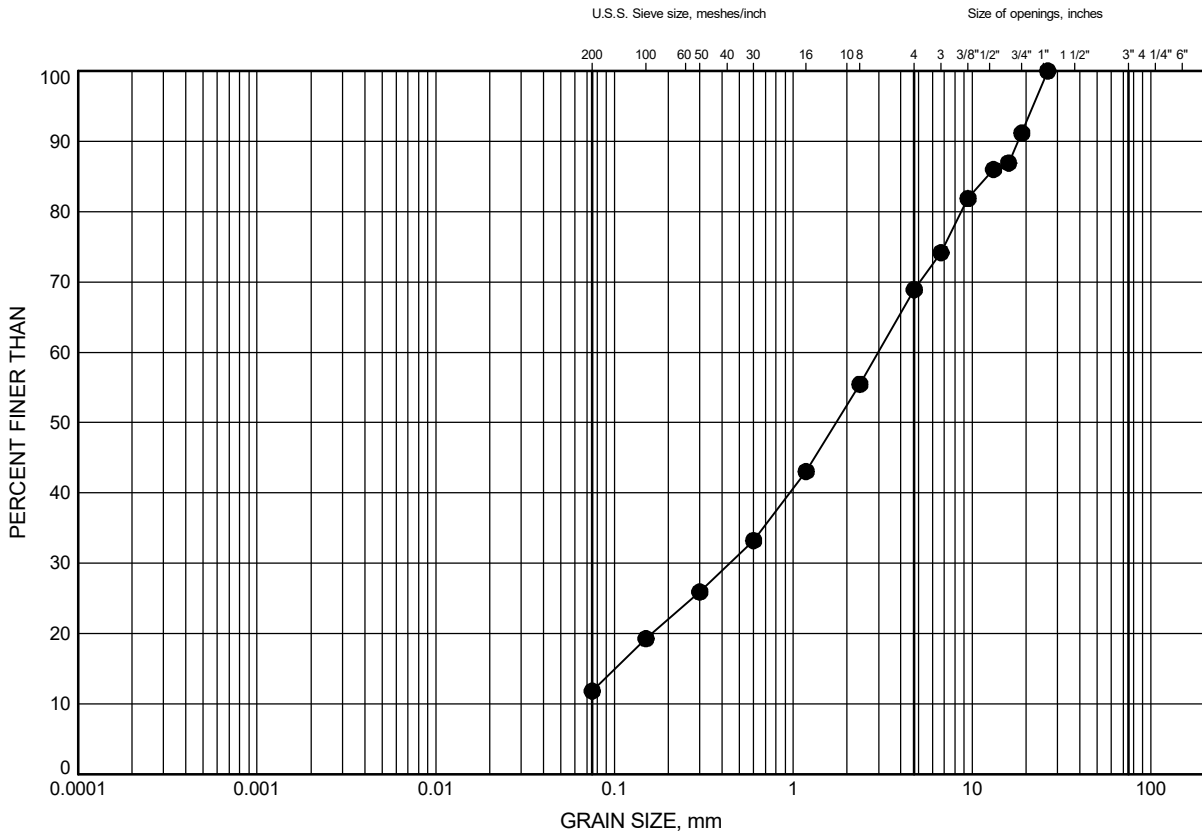
FIGURE C5

Gravelly Sand to Gravel

The moisture content of the samples tested ranged from 4 to 6%. The results of gradation analysis completed on a sample of the layer are illustrated in Figure C5 of Appendix C. The results of the tests are summarized in the table below and on the Record of Borehole sheets in Appendix B.

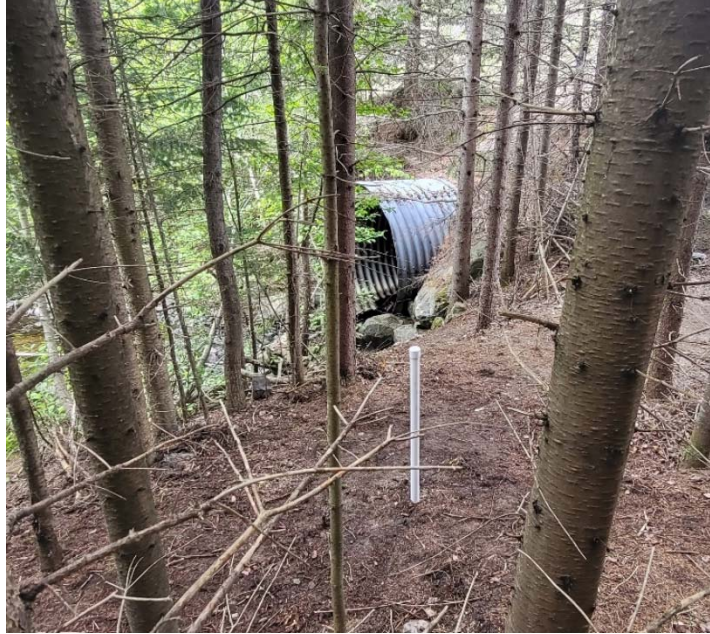
Photo 1: Culvert inlet *(taken on June 11, 2023)*

The existing culvert is reported in AutoCAD drawings provided by AECOM to be 2,400 mm diameter, 37.28 m long, corrugated steel pipe (CSP) culvert with a slight skew to the highway alignment. The culvert has a relatively flat gradient with the invert of the culvert near elevations 281.55 m and 281.20 m at the inlet and outlet, respectively. The water flows through the culvert from east to west. Approximately 0.6 m of ponded water was present at the culvert outlet and a beaver dam was present east of the culvert inlet. Ponded water, presumably due to observed beaver activity, was also observed at the culvert located approximately 90 m to the north of the site.

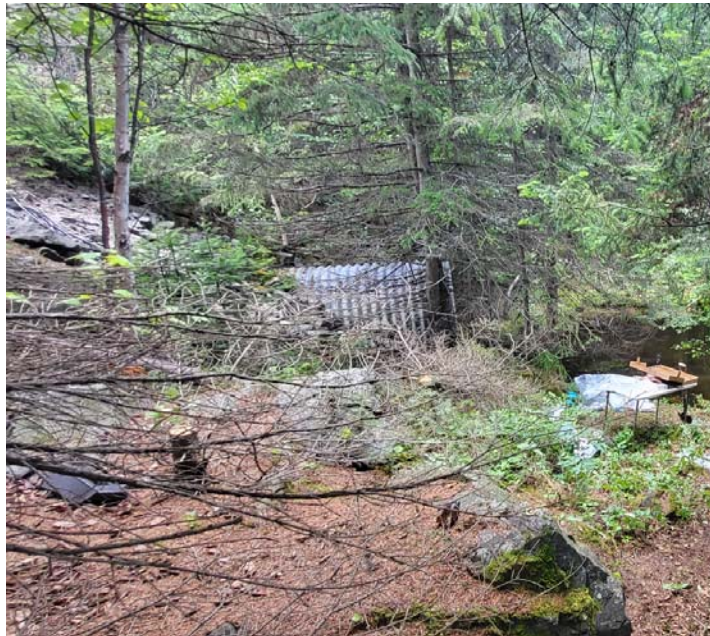
Photo 2: Culvert outlet *(taken on July 06, 2023)*

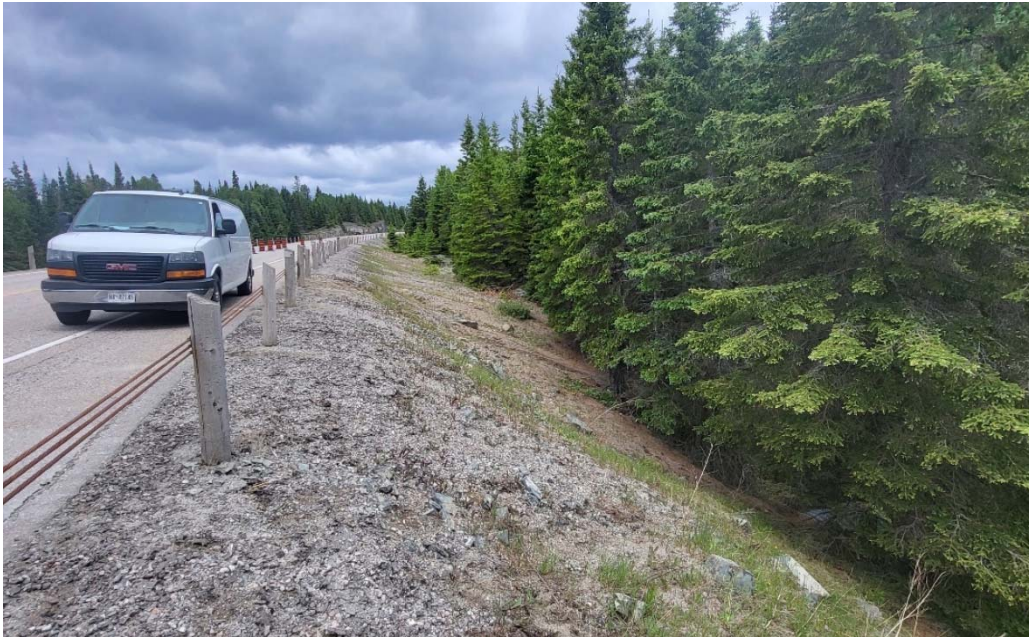
Photo 5: Looking north at the northbound embankment *(taken on June 11, 2023)*

The cover above the existing culvert is approximately 6.1 m at the highway centerline. Embankment side slopes, in the vicinity of the culvert, are generally inclined at approximately 1.9H:1V but are locally as steep as 1.3H:1V. The existing highway embankment side slopes at the culvert site did not show any visible signs of global instability at the time of the investigation.

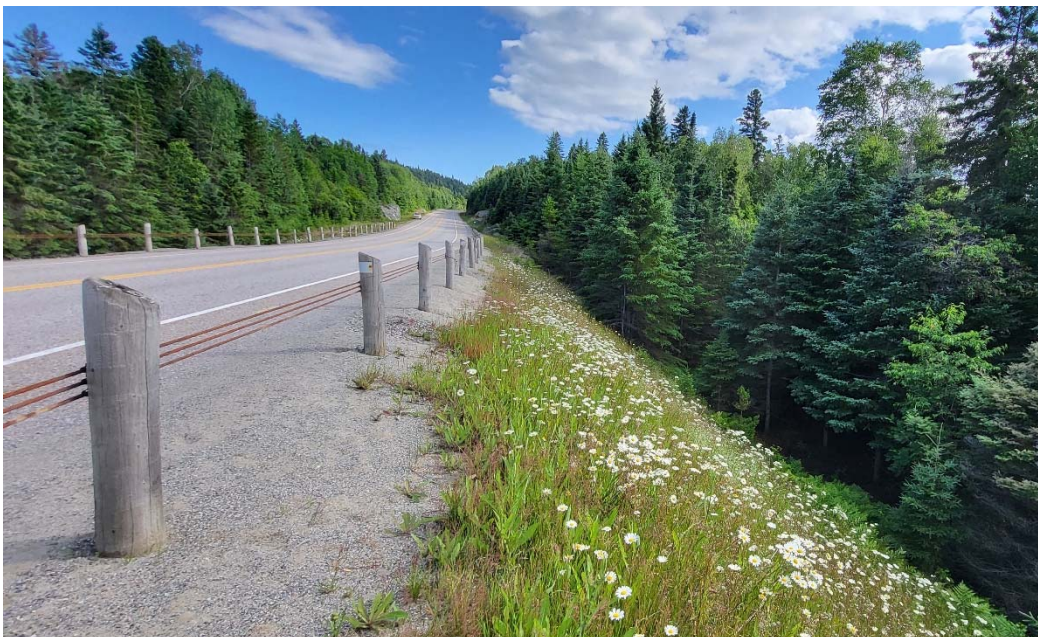
Photo 6: Looking south at the southbound embankment *(taken on July 11, 2023)*
