**FOUNDATION INVESTIGATION AND DESIGN REPORT
HIGHWAY 7289 EAST EMBANKMENT SLOPE
STA. 11+400 TO 11+900 SEGUIN TOWNSHIP
AGREEMENT NO. 5020-E-0010
GWP 5252-21-00**

GEOCRES NO.: 31E-419

April 2023

Thurber File No.: 31334

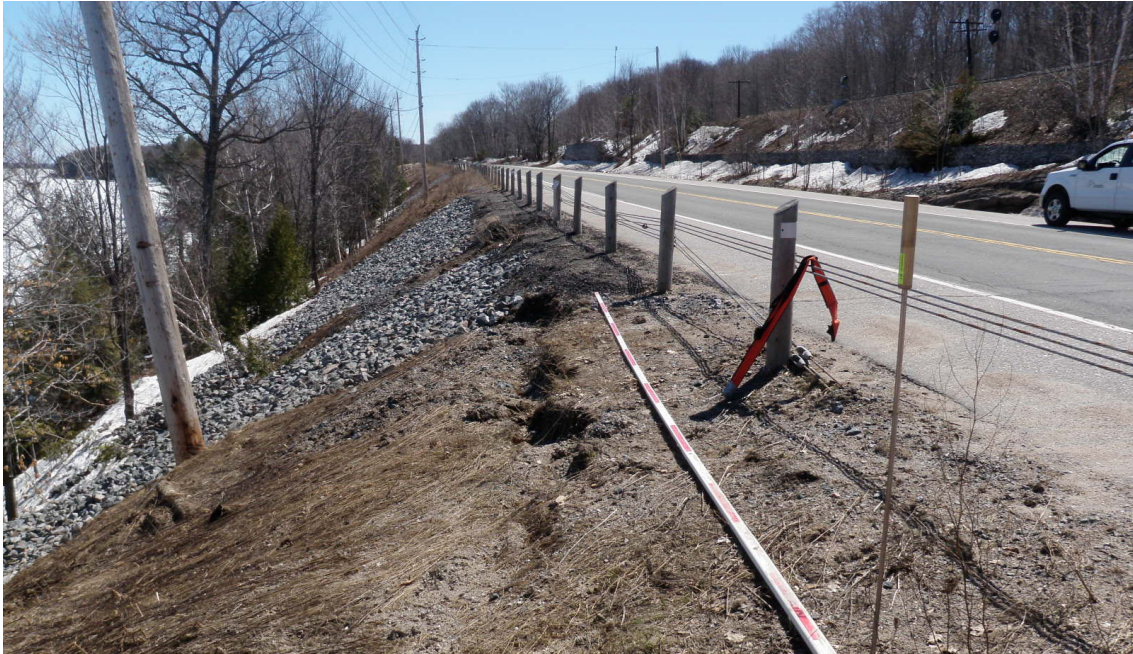
Photograph 3: New slope treatment near Sta. 11+600 (looking south)
[taken Apr. 2015]

Susceptible portions and/or locations showing visible signs of local failures have received surface treatments in an attempt to manage potential future failures. Drawings from Contract 1995-0229 (Sheets 3 to 5) show remedial treatment measures that included subexcavation and replacement of the northbound shoulder with Granular B Type II fill and a subdrain from 11+275 to 11+375, and placement of Granular B Type II fill on the exposed slope from 11+475 to 11+550. As a result of the observed failures in 2014, rock protection has been placed in many segments along the east embankment slope (see Photographs 3 and 4 in Appendix D).

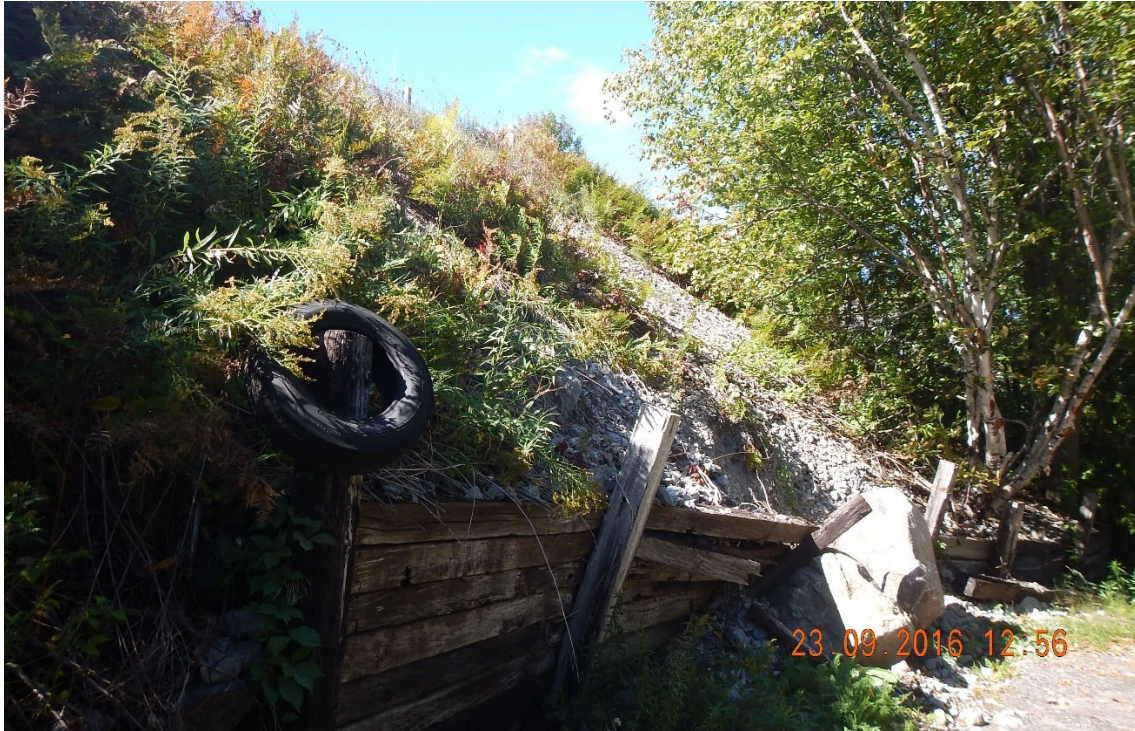
Photograph 5: Existing Timber Retaining Wall near Sta. 11+475 (looking north)
[taken Sept. 2016]

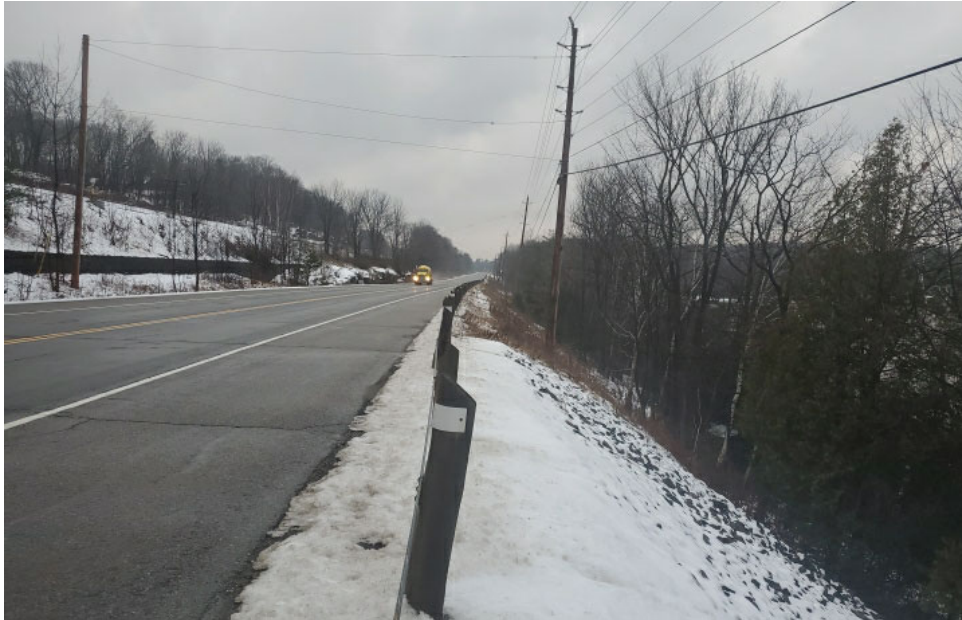
Photograph 7: Highway 7289 and east embankment slope near Sta. 11+515 (looking north)
[taken Dec. 2021]

During a site reconnaissance conducted by Thurber on December 12, 2021, no tension cracks were observed to be present in the asphalt along the existing east embankment slope, but slight to moderate tilt of guide rail posts and hydro poles on the east slope were observed within the project limits (see Photograph 7 in Appendix D). At the toe of the embankment slope, near the timber retaining wall between approximate Sta. 11+440 and 11+470, an exposed vertical slope was observed, indicating either a cut soil slope or a removed retaining wall (see Photographs 5 and 6 in Appendix D). The remaining section of the timber wall was observed to be in poor condition with significant tilt downslope.

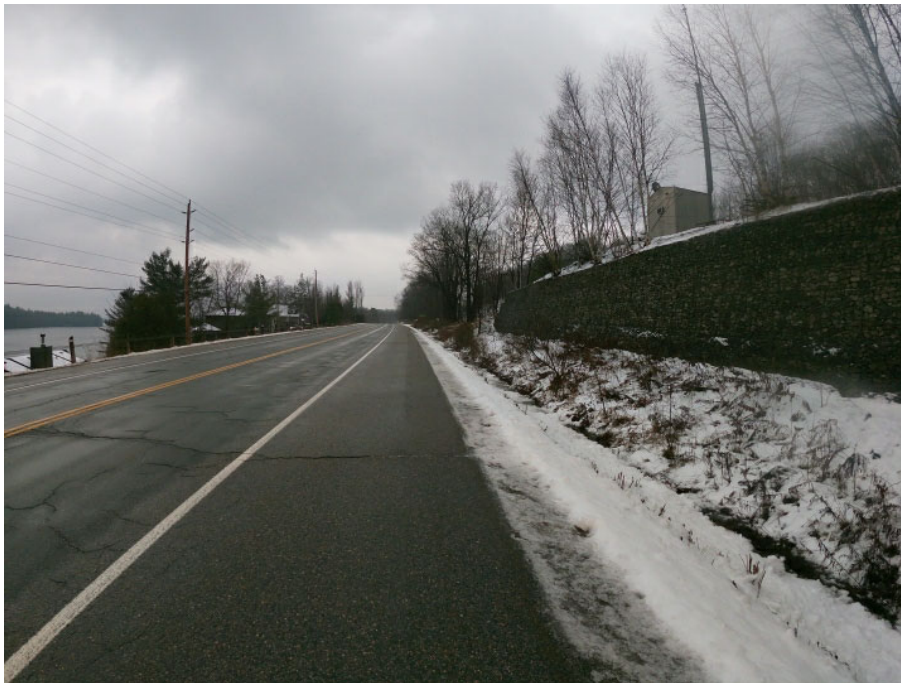
Photograph 8: West of Highway 7289 and Gabion Wall near Sta. 11+500 (looking south)
[taken Dec. 2021]

No visible signs of global instability were observed at the gabion wall and slope west of the highway alignment.
