**FOUNDATION INVESTIGATION AND DESIGN REPORT
HIGHWAY 7289 EAST EMBANKMENT SLOPE
STA. 11+400 TO 11+900 SEGUIN TOWNSHIP
AGREEMENT NO. 5020-E-0010
GWP 5252-21-00**

GEOCRES NO.: 31E-419

July 2024

Thurber File No.: 31334

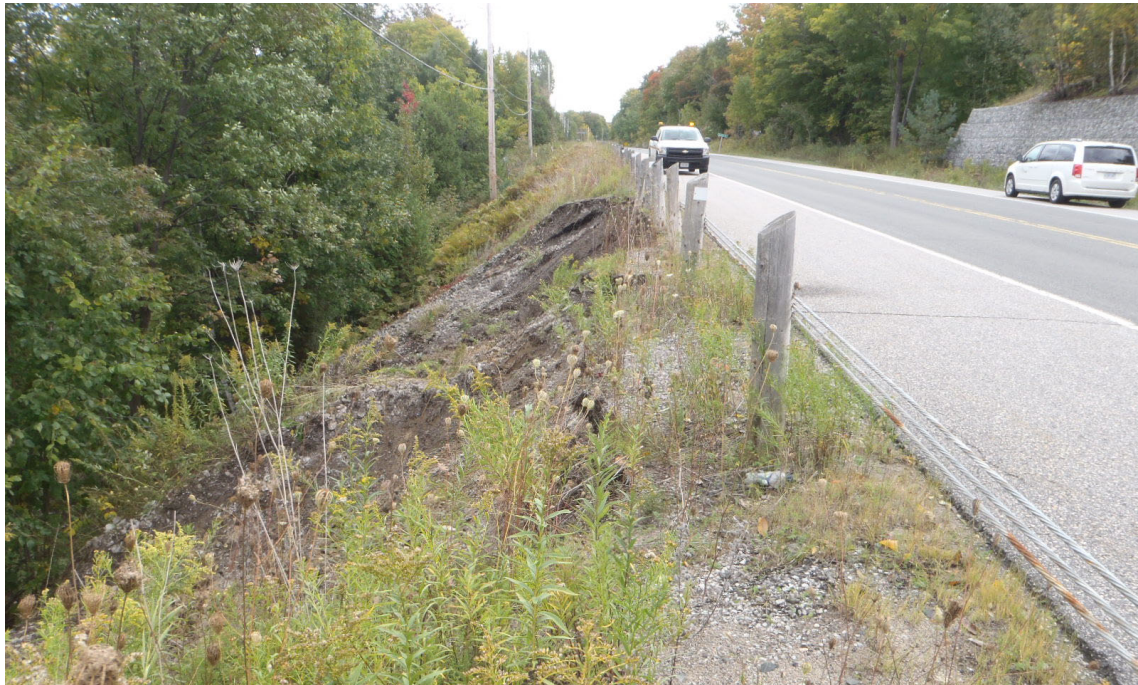
Photograph 1: Highway 7289 and east slope showing failure near Sta. 11+510 (looking south)
[taken Sept. 2014]

Localized shallow failures of the east embankment due to the steep slope and surface water infiltration have been observed over the years. Photographs 1 and 2 in Appendix D show examples of local slope failures observed in September 2014 (photographs provided by MTO). In general, the disturbed zones originated through the highway shoulder at the crest of the slope and extend down toward Lake Joseph.

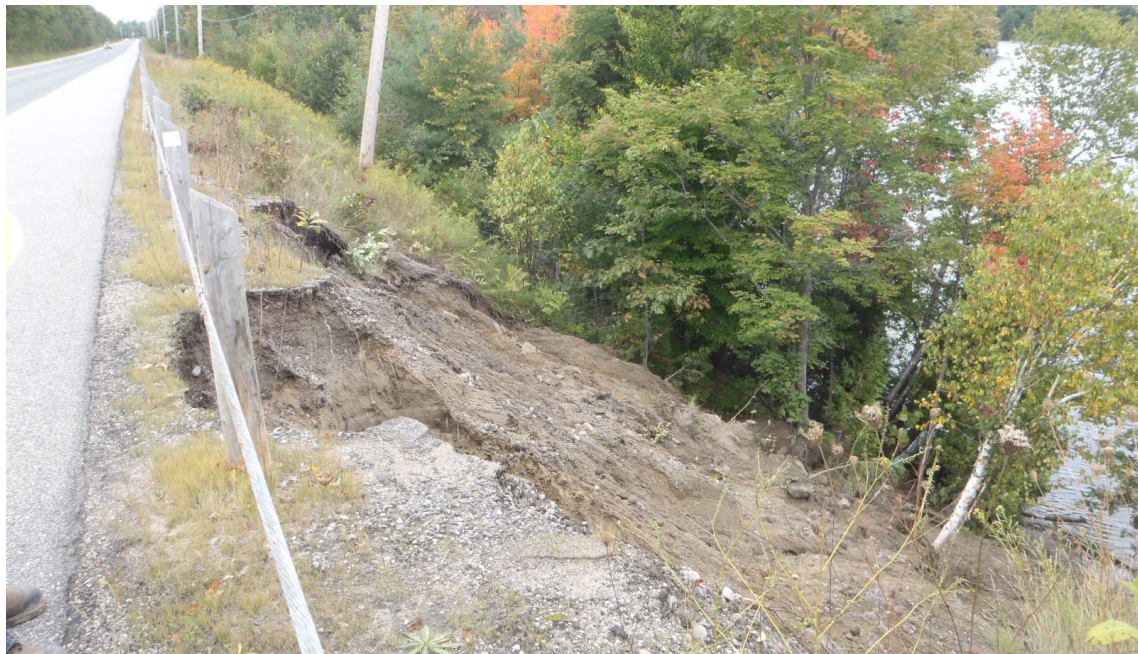
Photograph 2: Highway 7289 and east slope showing failure (looking north)
[taken Sept. 2014]

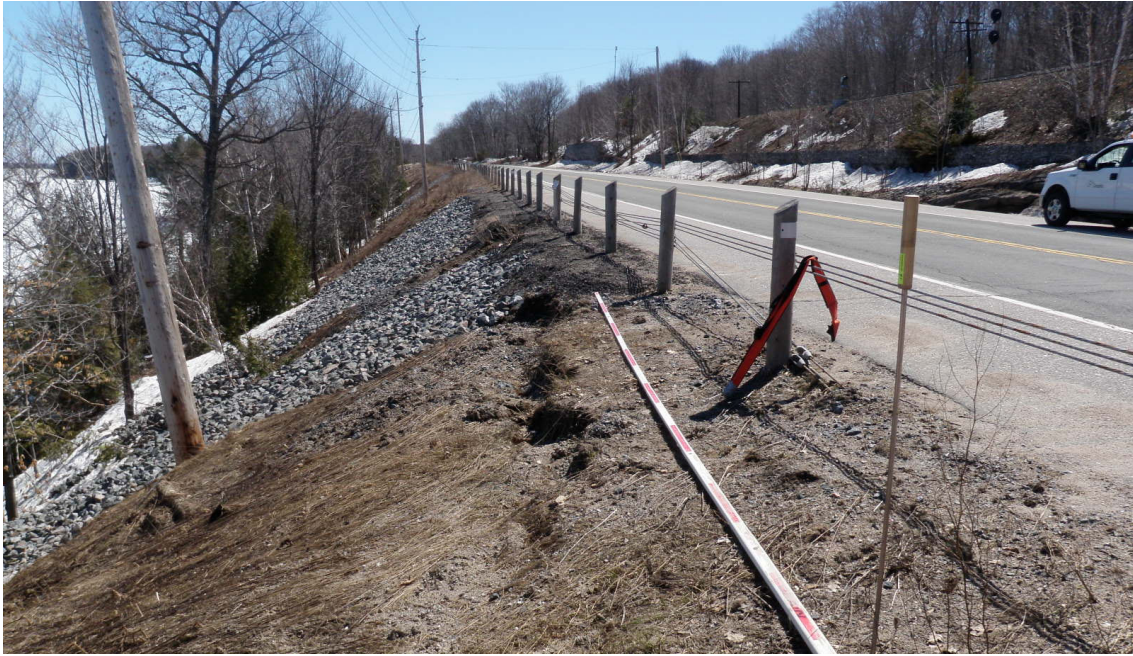
Photograph 3: New slope treatment near Sta. 11+600 (looking south)
[taken Apr. 2015]

Susceptible portions and/or locations showing visible signs of local failures have received surface treatments in an attempt to manage potential future failures. Drawings from Contract 1995-0229 (Sheets 3 to 5) show remedial treatment measures that included subexcavation and replacement of the northbound shoulder with Granular B Type II fill and a subdrain from 11+275 to 11+375, and placement of Granular B Type II fill on the exposed slope from 11+475 to 11+550. As a result of the observed failures in 2014, rock protection has been placed in many segments along the east embankment slope (see Photographs 3 and 4 in Appendix D).

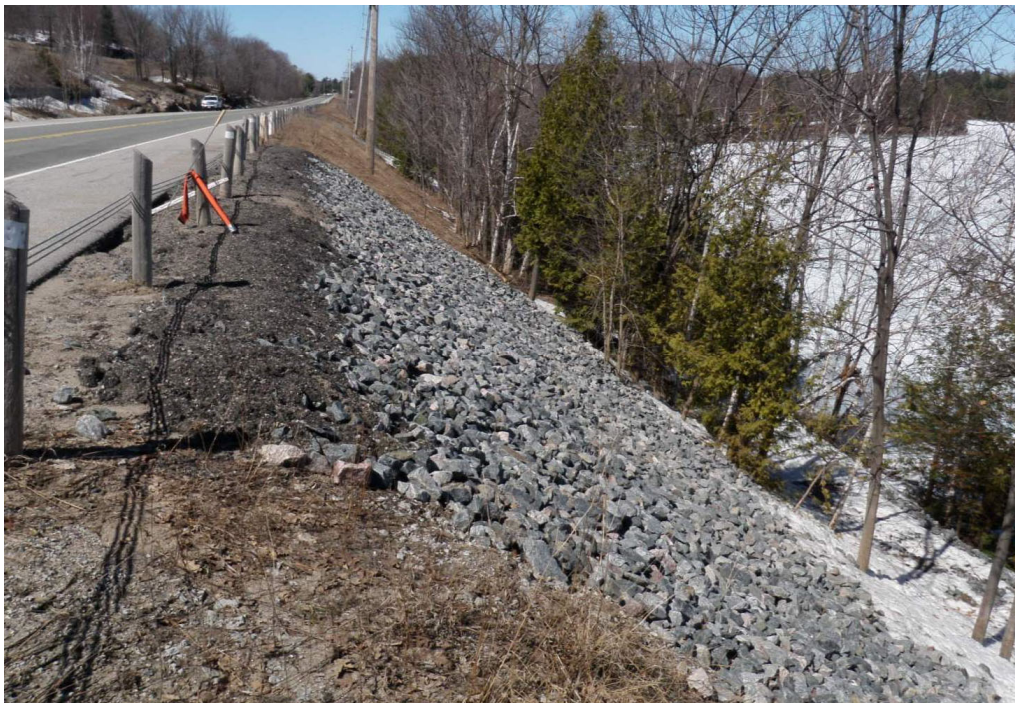
Photograph 4: New slope treatment near Sta. 11+770 (looking north)
[taken Apr. 2015]

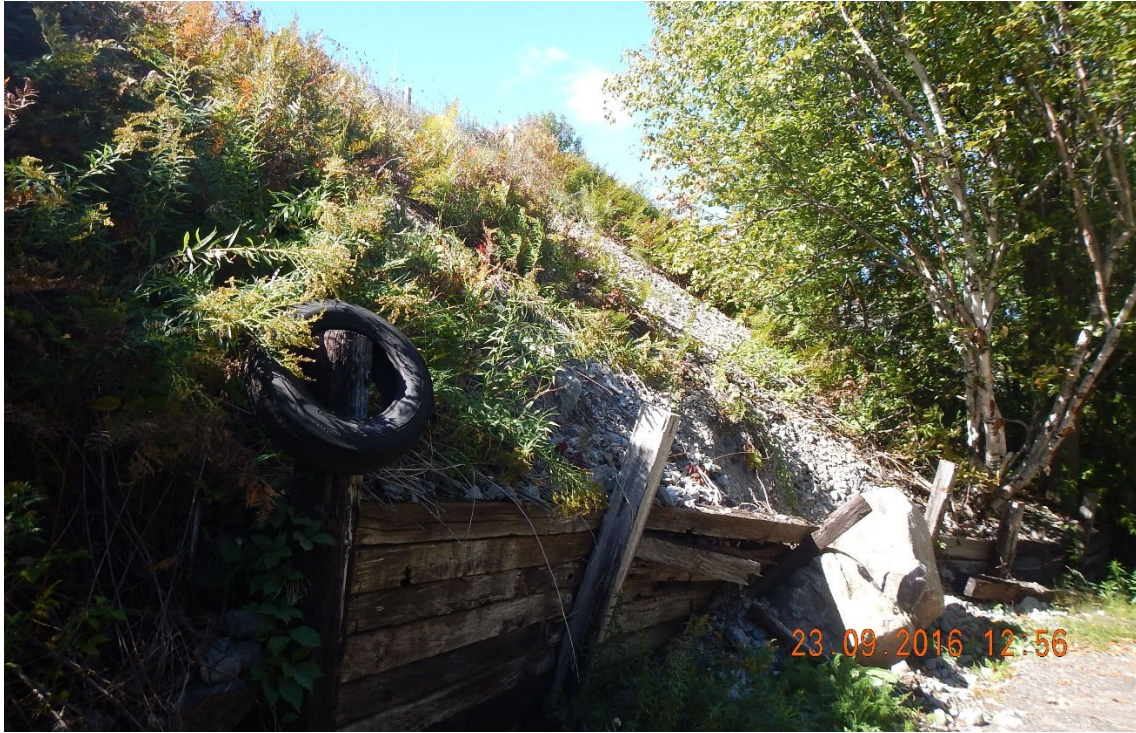
Photograph 5: Existing Timber Retaining Wall near Sta. 11+475 (looking north)
[taken Sept. 2016]

During a site reconnaissance conducted by Thurber on December 12, 2021, no tension cracks were observed to be present in the asphalt along the existing east embankment slope, but slight to moderate tilt of guide rail posts and hydro poles on the east slope were observed within the project limits (see Photograph 8 in Appendix D). At the toe of the embankment slope, near the timber retaining wall between approximate Sta. 11+440 and 11+470, an exposed vertical slope was observed, indicating either a cut soil slope or a removed retaining wall (see Photographs 5 to 7 in Appendix D). The remaining section of the timber wall was observed to be in poor condition with significant tilt downslope.

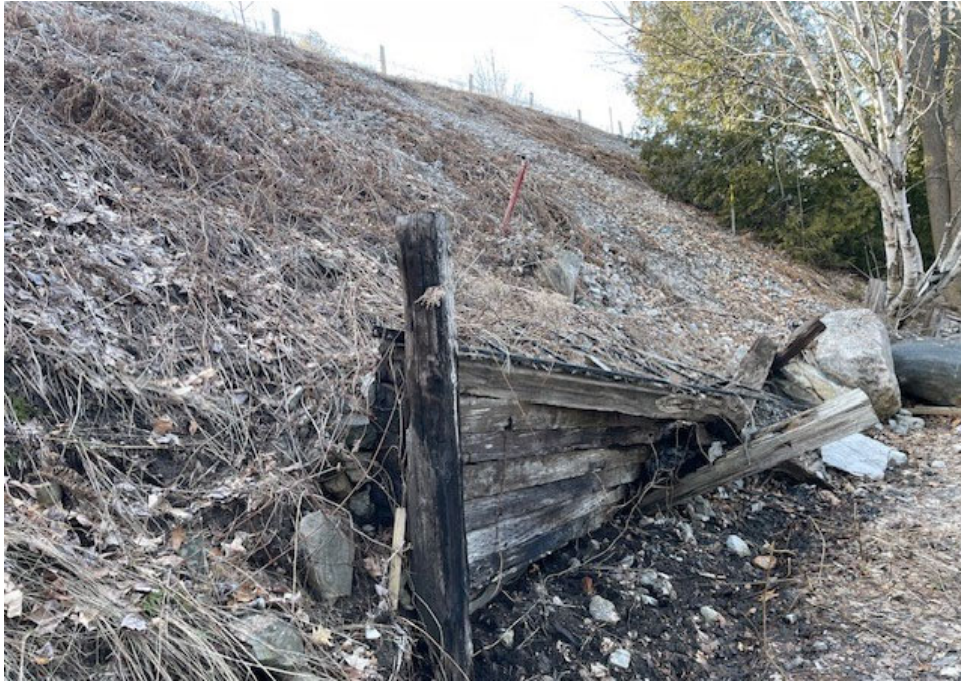
Photograph 7: Existing Timber Retaining Wall near Sta. 11+475 (looking north)
[taken Mar. 2024]

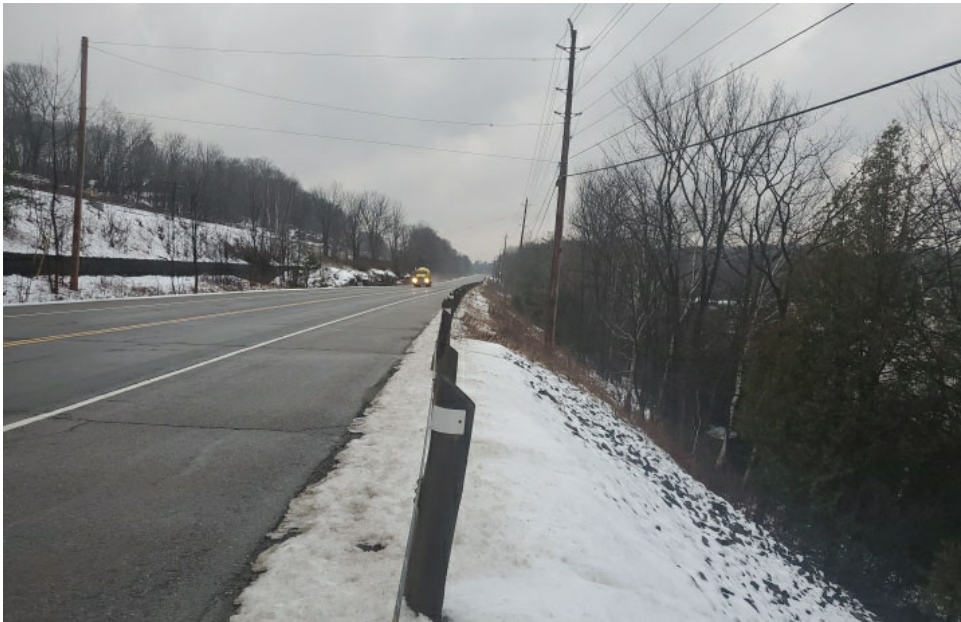
Photograph 8: Highway 7289 and east embankment slope near Sta. 11+515 (looking north)
[taken Dec. 2021]

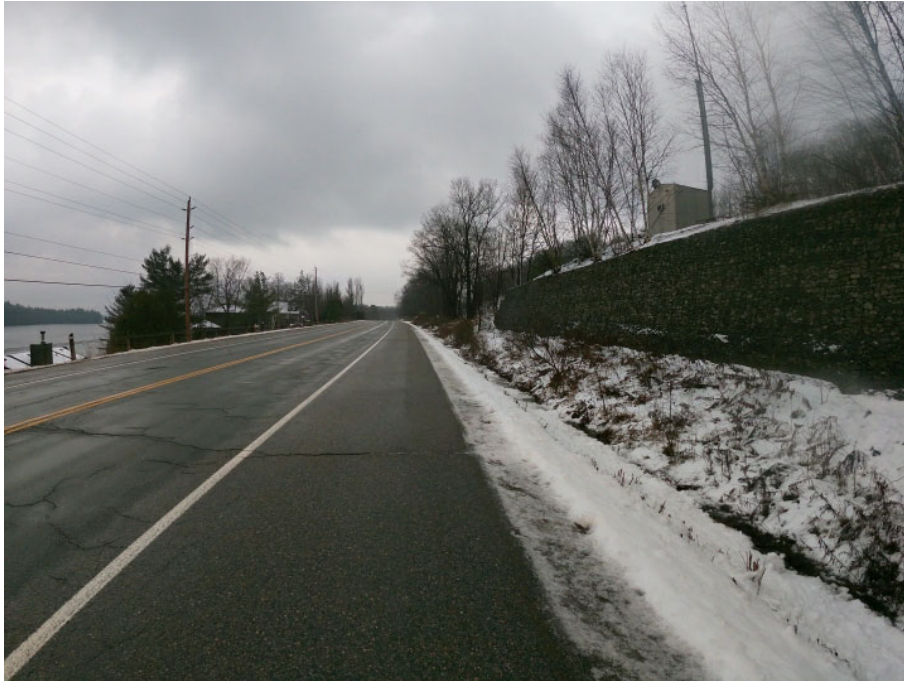
Photograph 9: West of Highway 7289 and Gabion Wall near Sta. 11+500 (looking south)
[taken Dec. 2021]

No visible signs of global instability were observed at the gabion wall and slope west of the highway alignment.
