Foundation Investigation and Design Report

Highway 17 Culvert Replacement (Culvert No.NW-867-0017-0026)

District of Thunder Bay, Ontario

Date: September 19, 2024

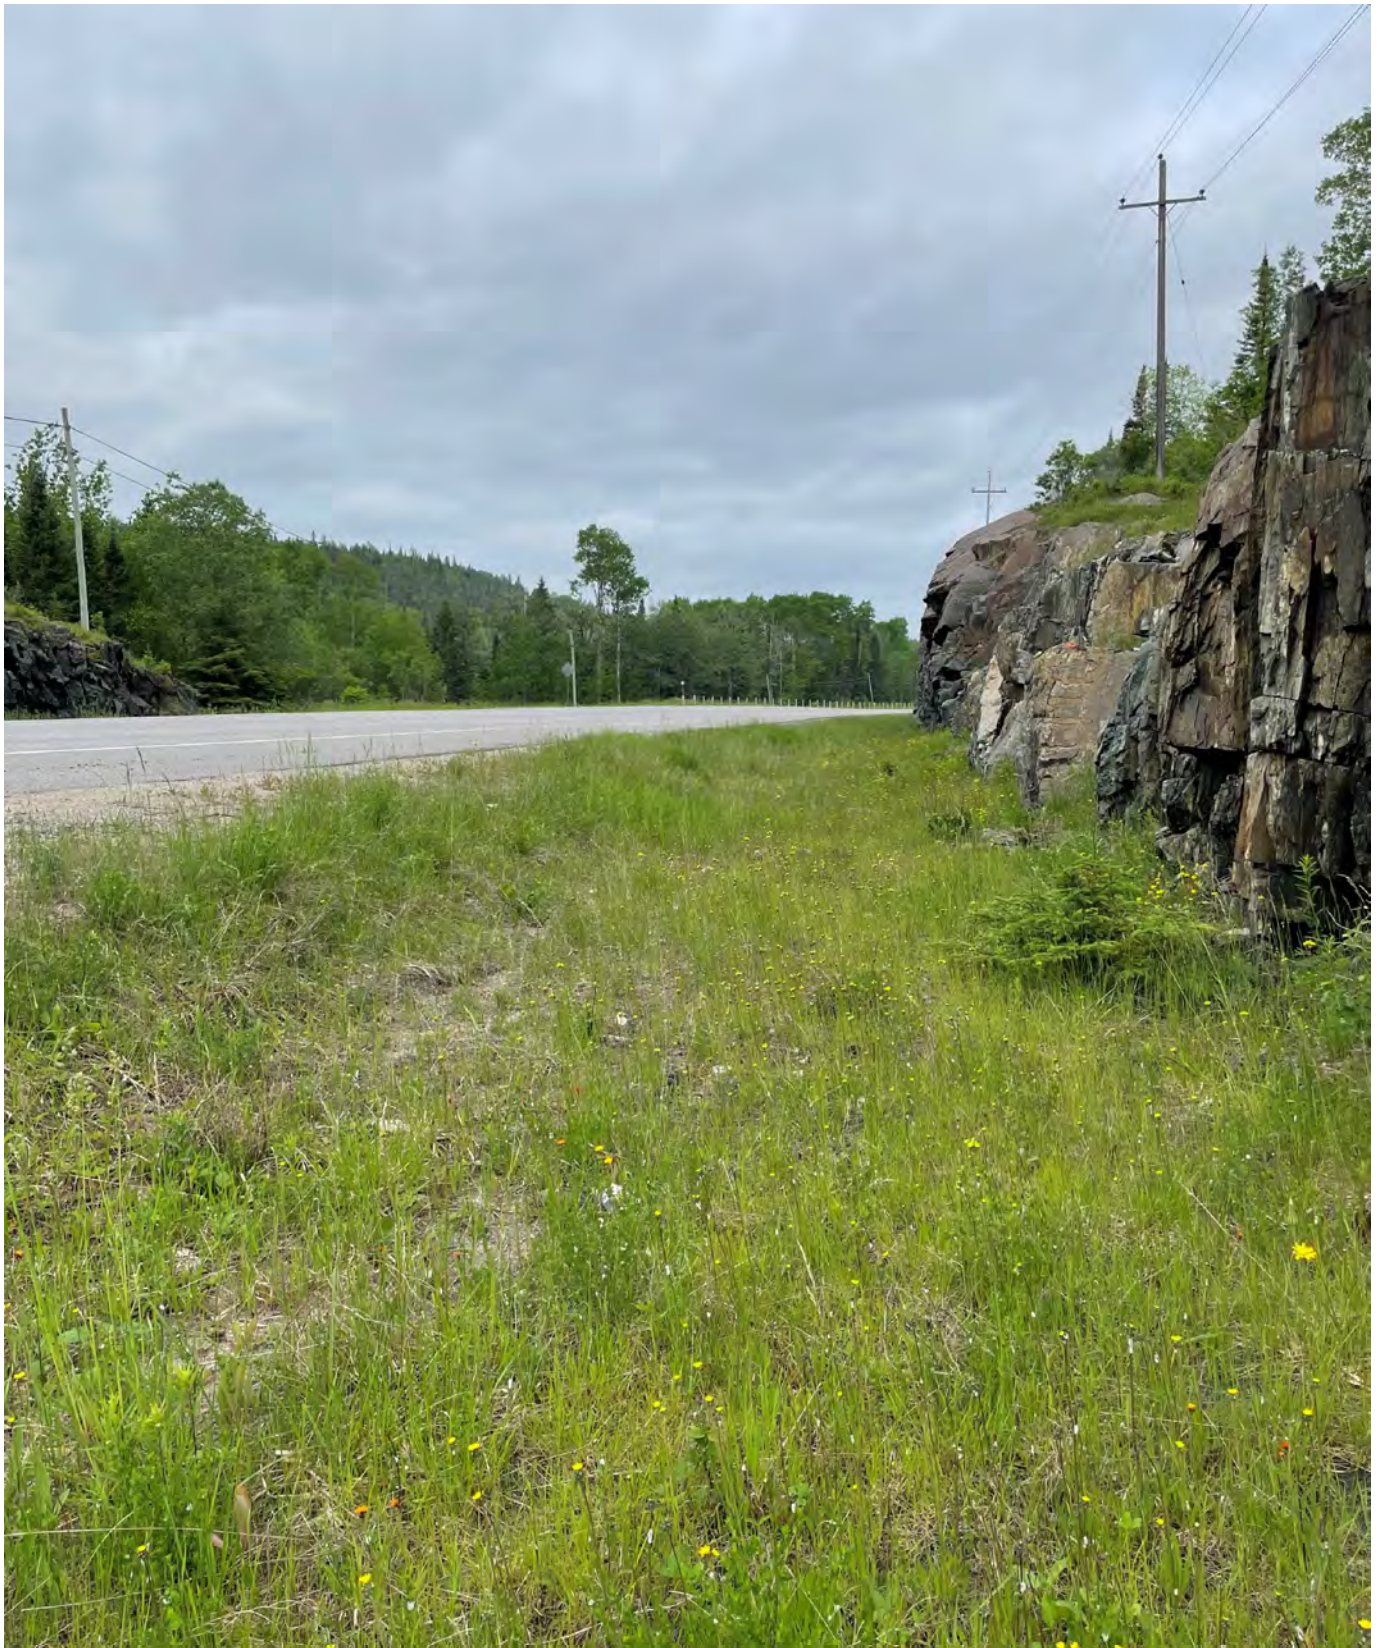
Photograph #1 – On north side of Highway 17, west of existing culvert looking west. Bedrock outcrop on both sides of the highway. (June 2024)

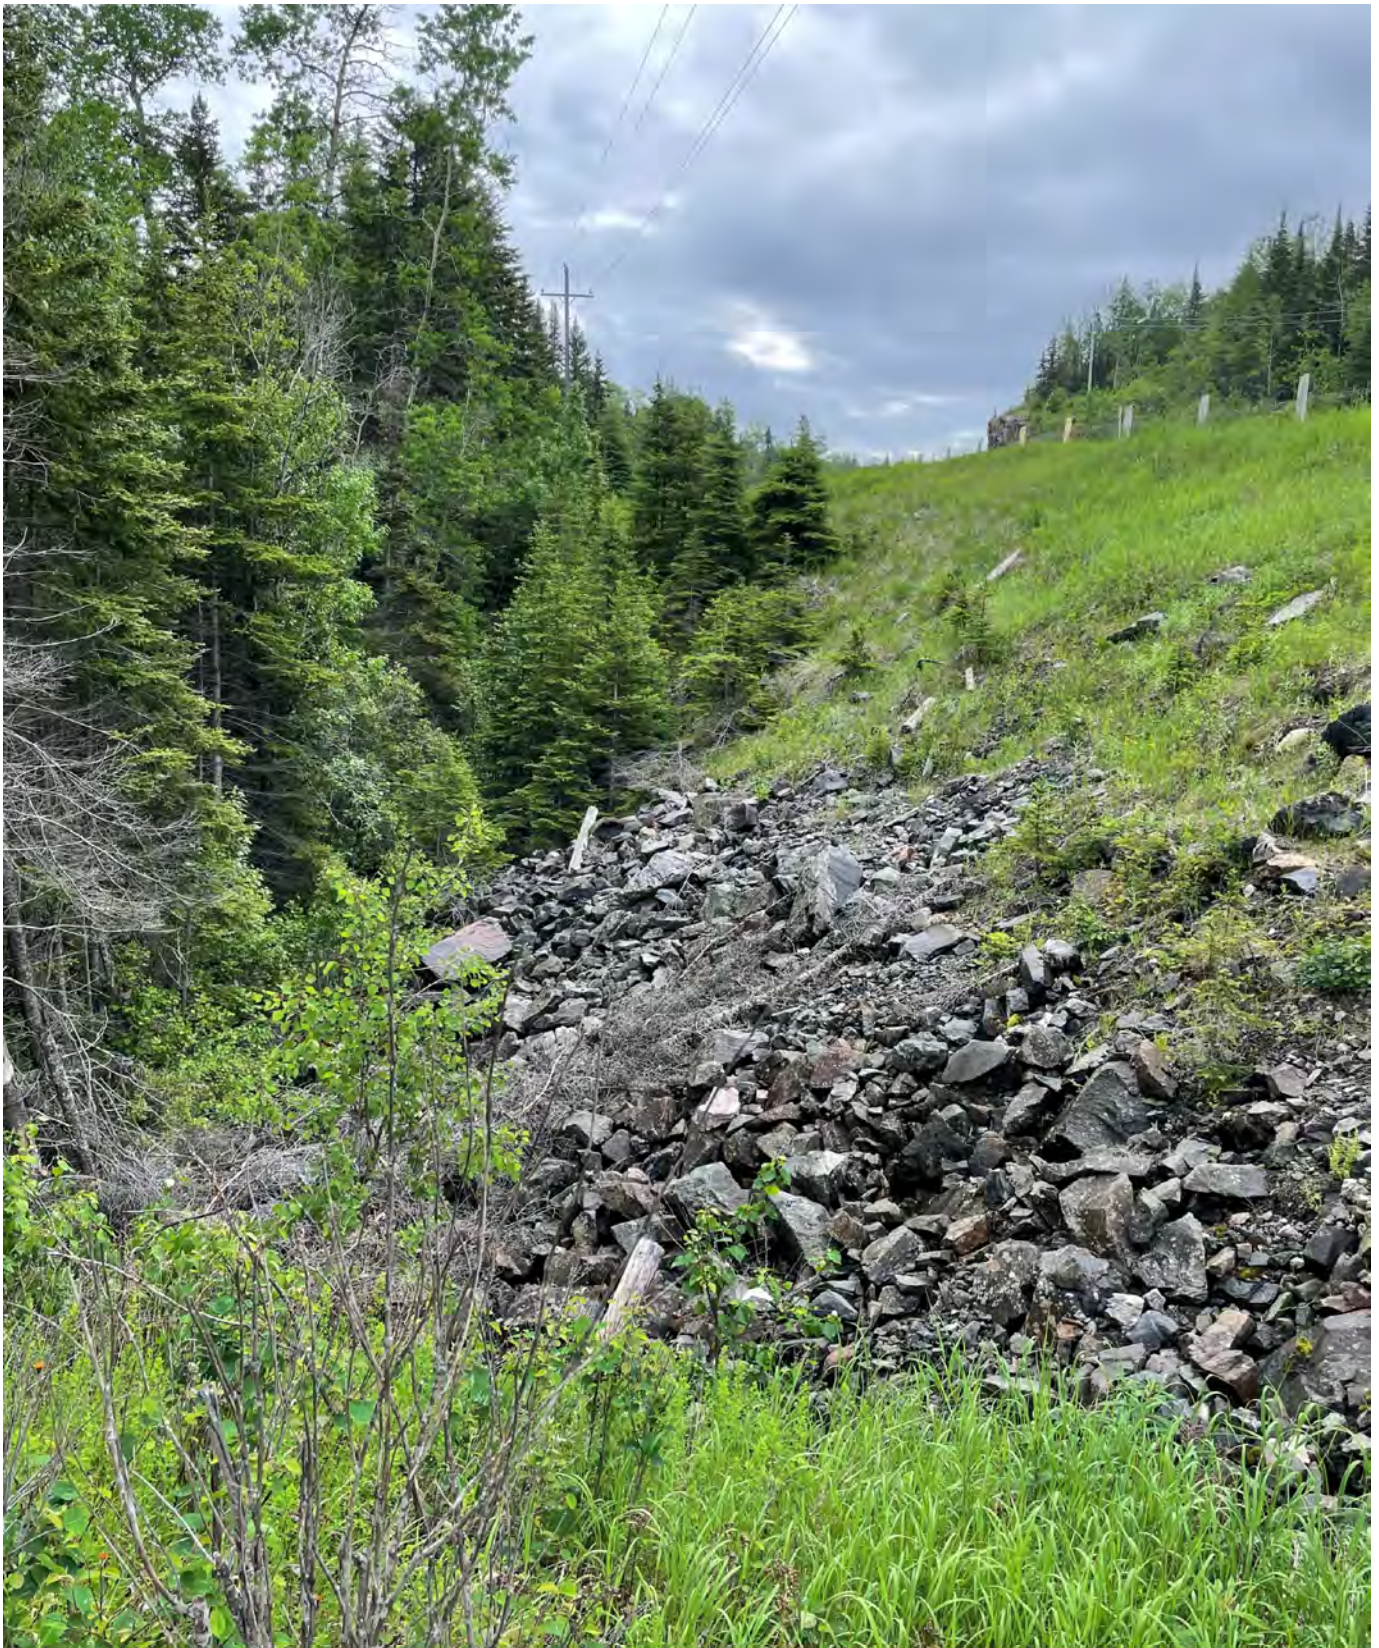
Photograph #2 – North embankment slope looking east. (June 2024)

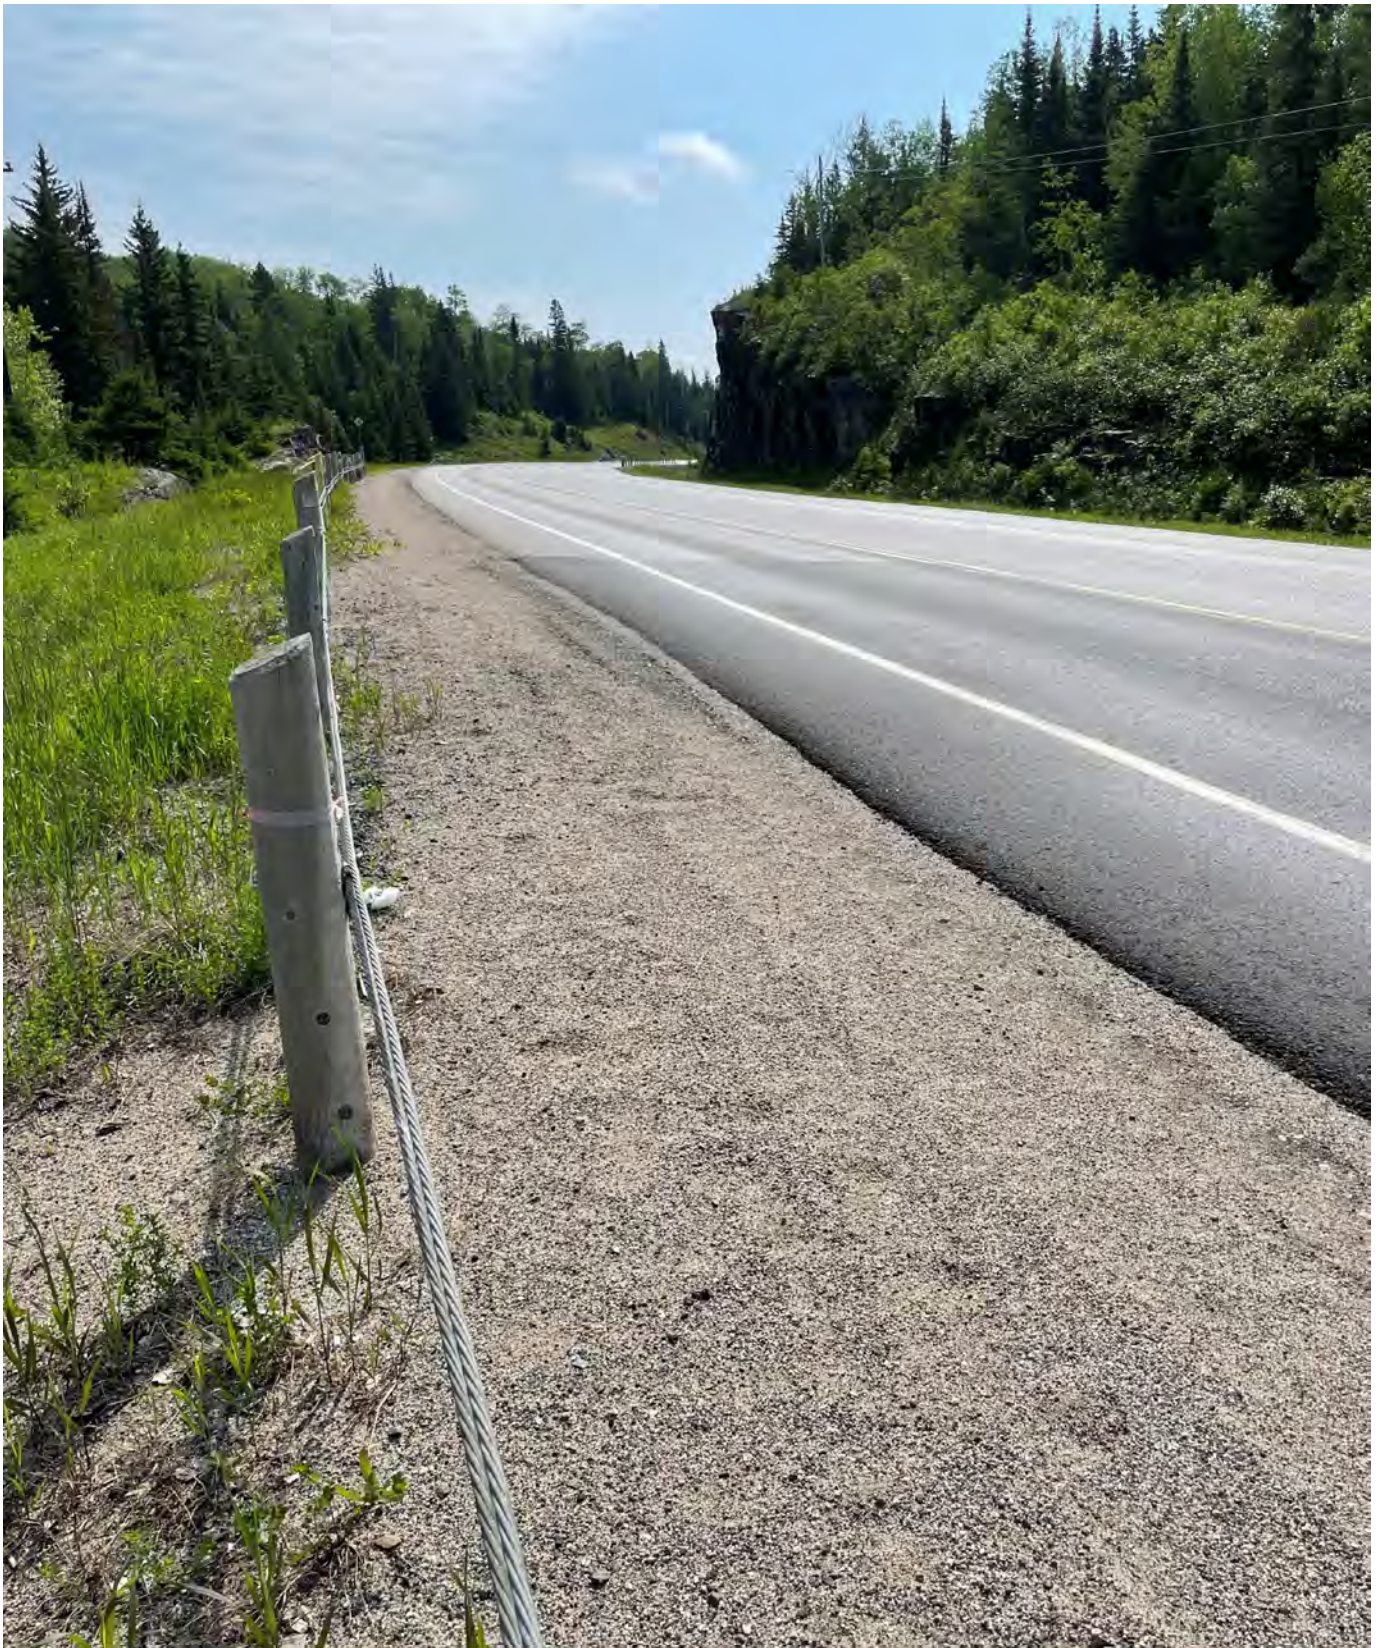
Photograph #3 – On north side of Highway 17 looking east. Note the large outcrop on south side of the highway. (June 2024)

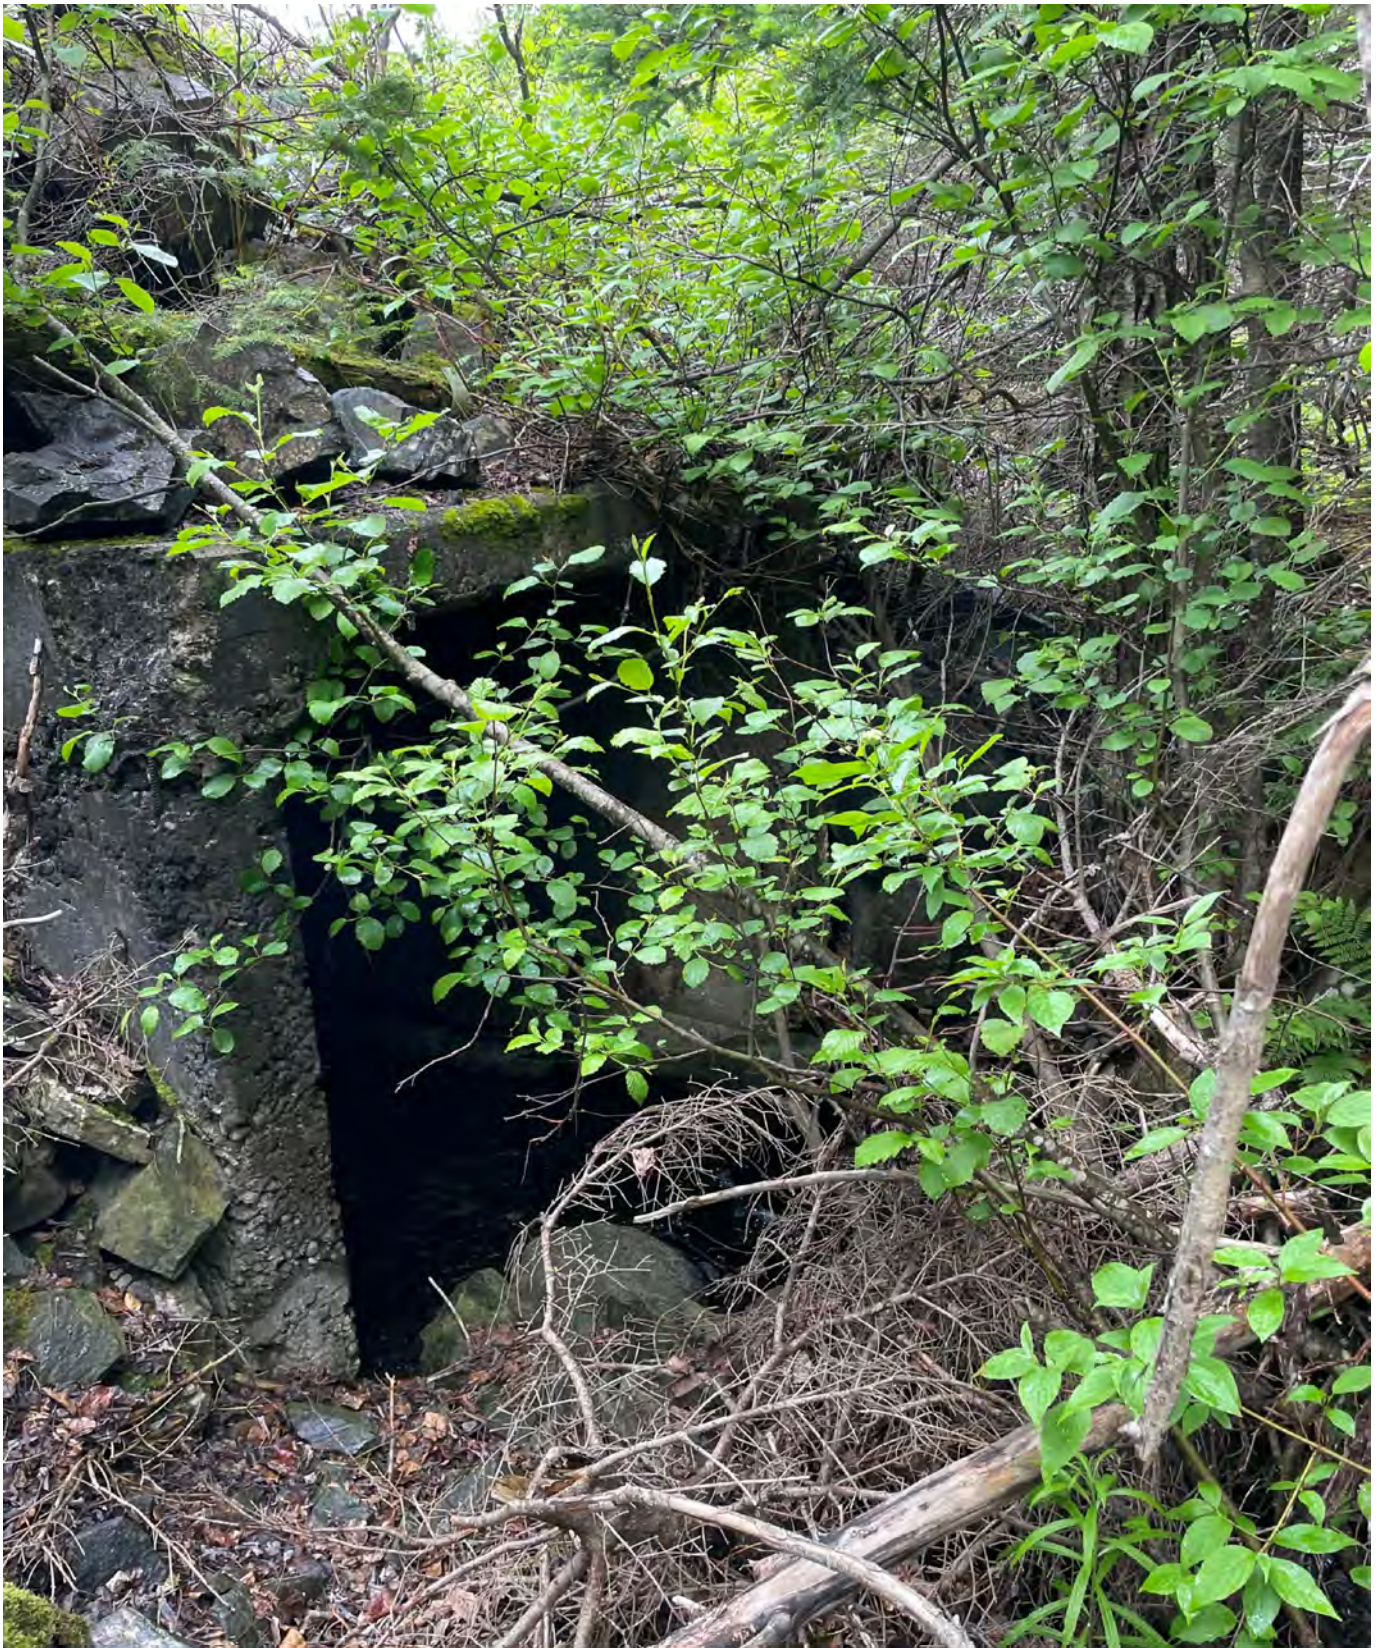
Photograph #5 – Culvert inlet obstructed with vegetation and other debris. (June 2024)

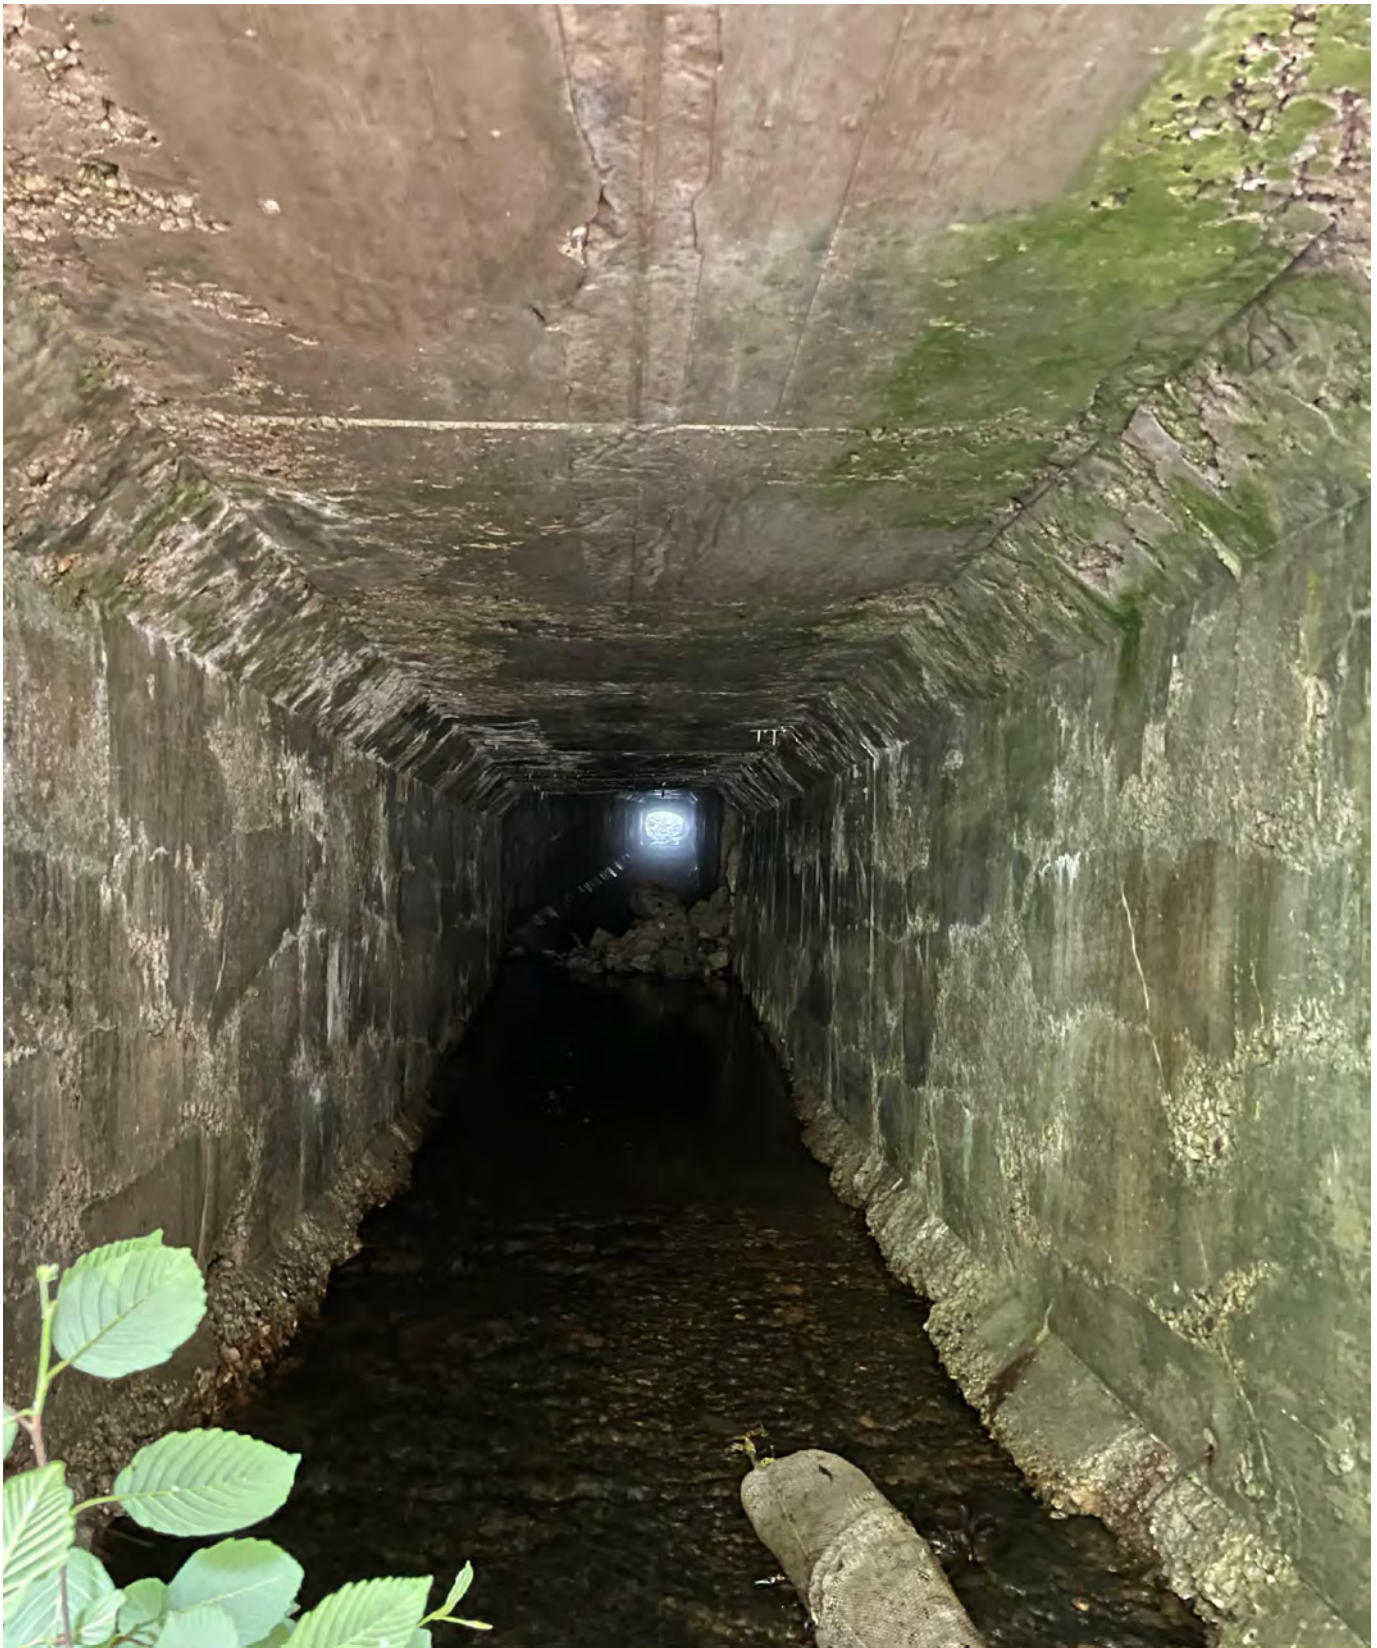
Photograph #6 – Existing culvert from inlet. (June 2024)

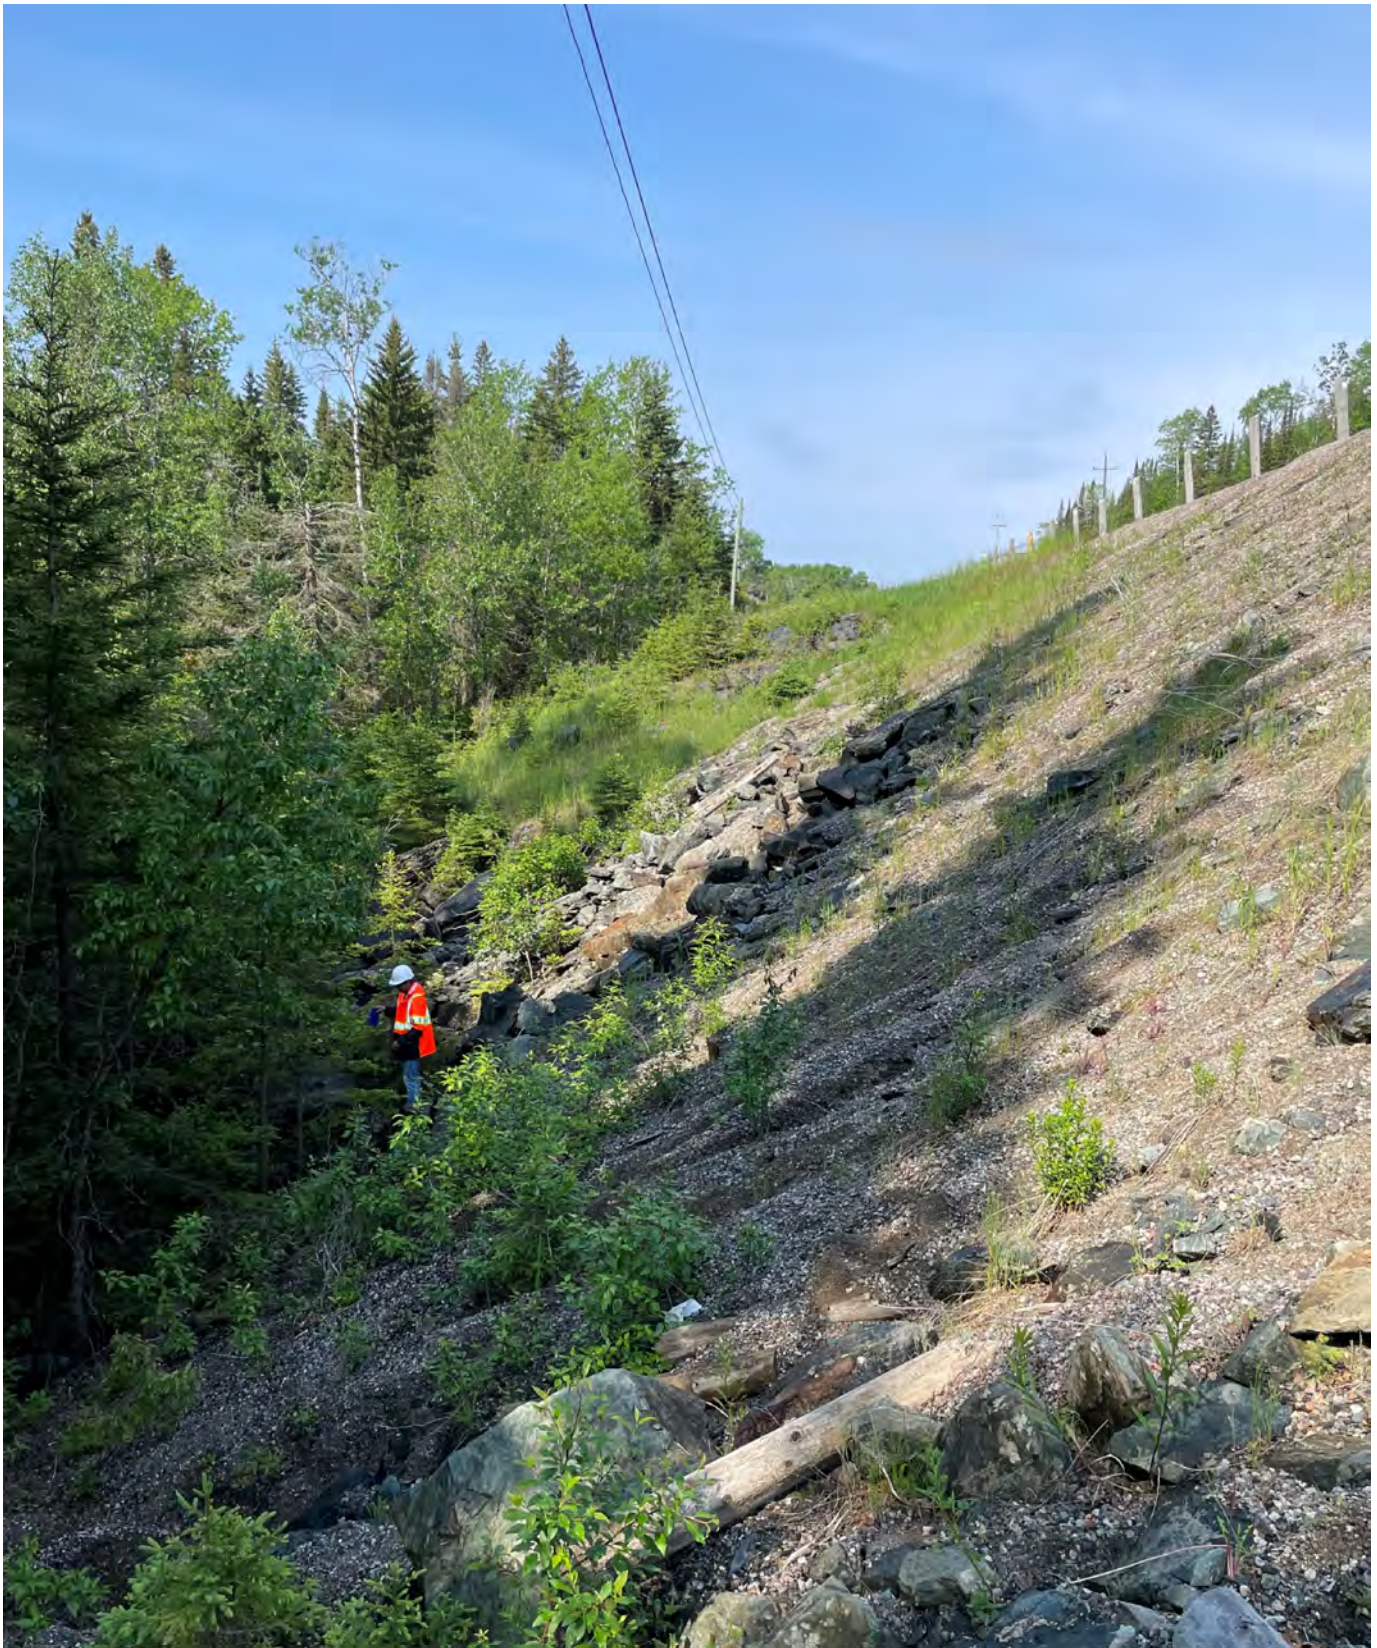
Photograph #7 – South embankment slope looking west. (June 2024)

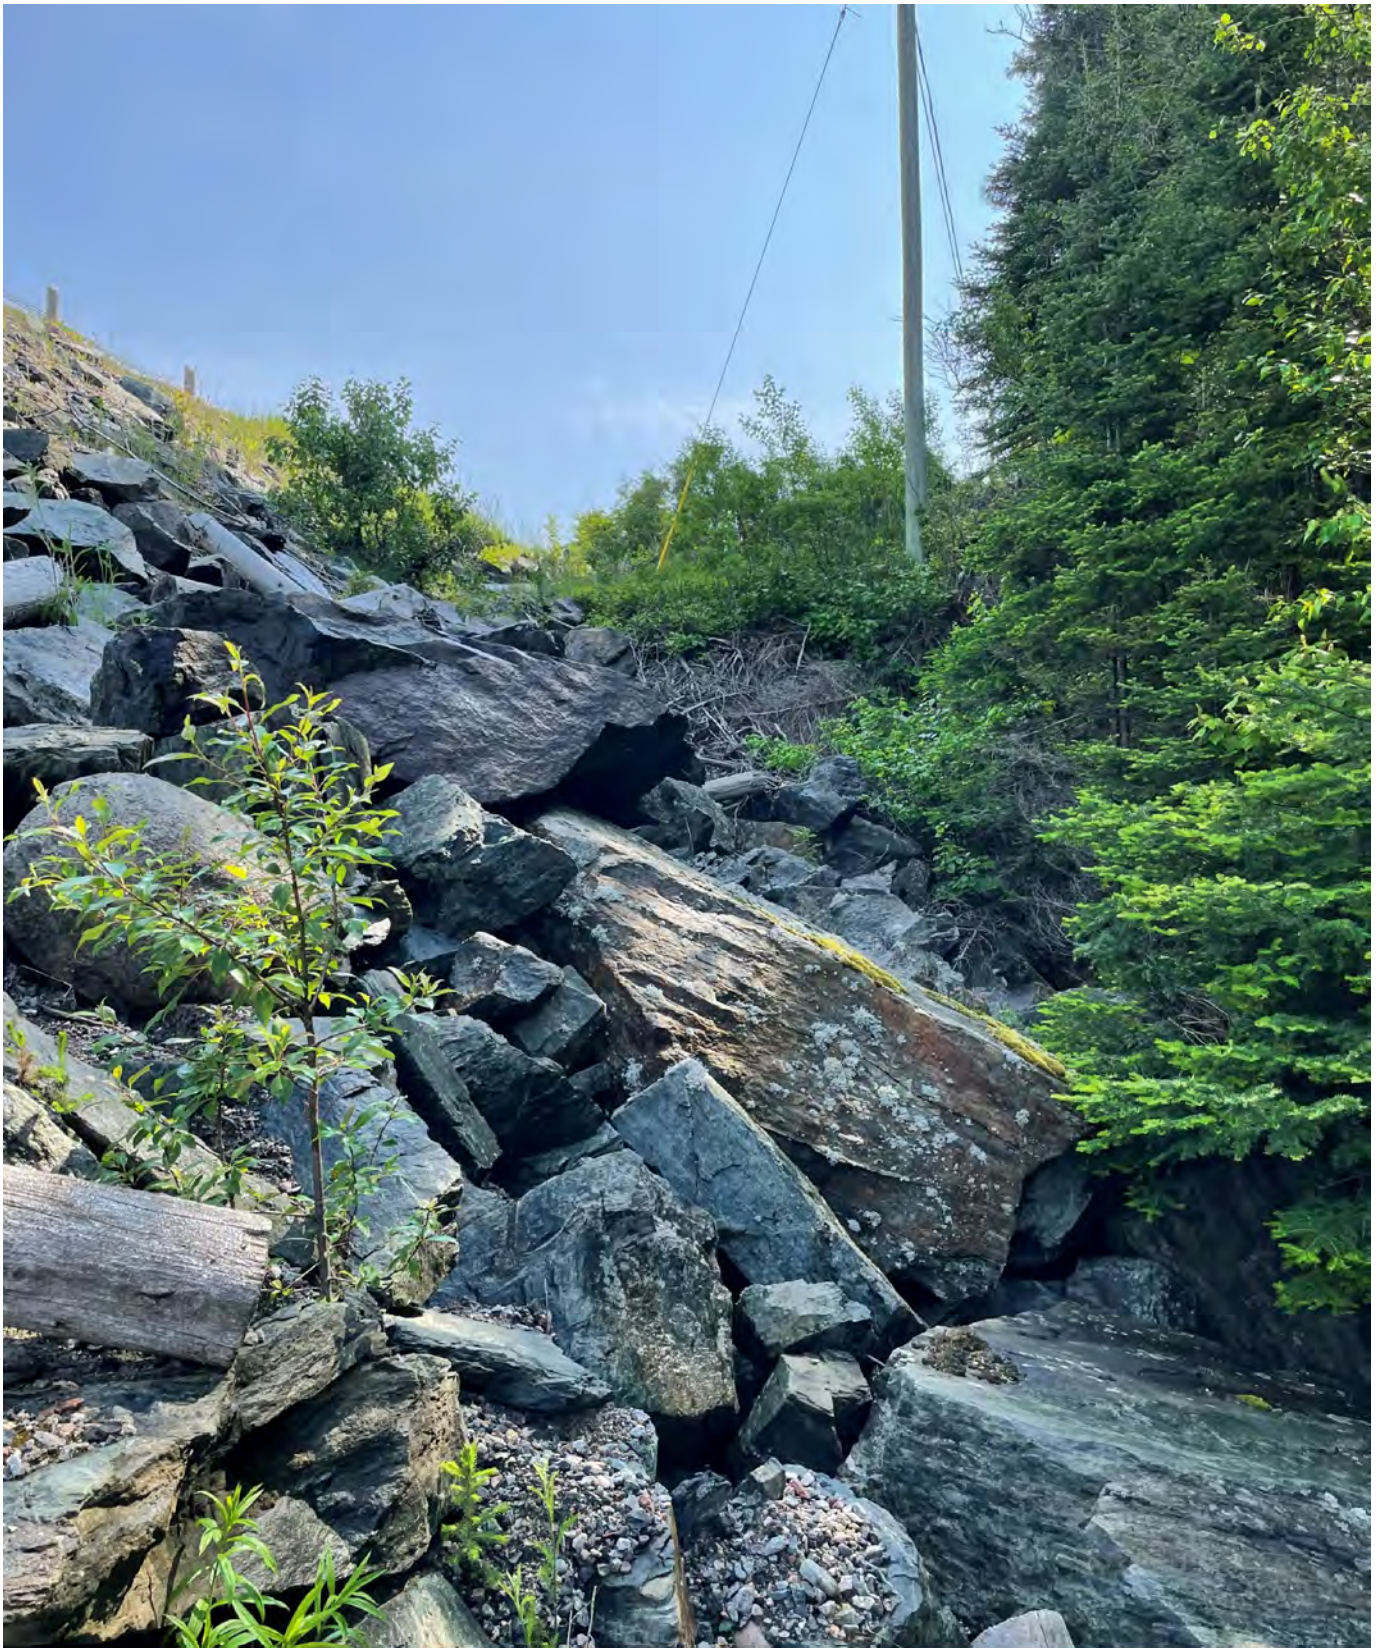
Photograph #8 – Rock fill on steep south embankment slope looking east. (June 2024)

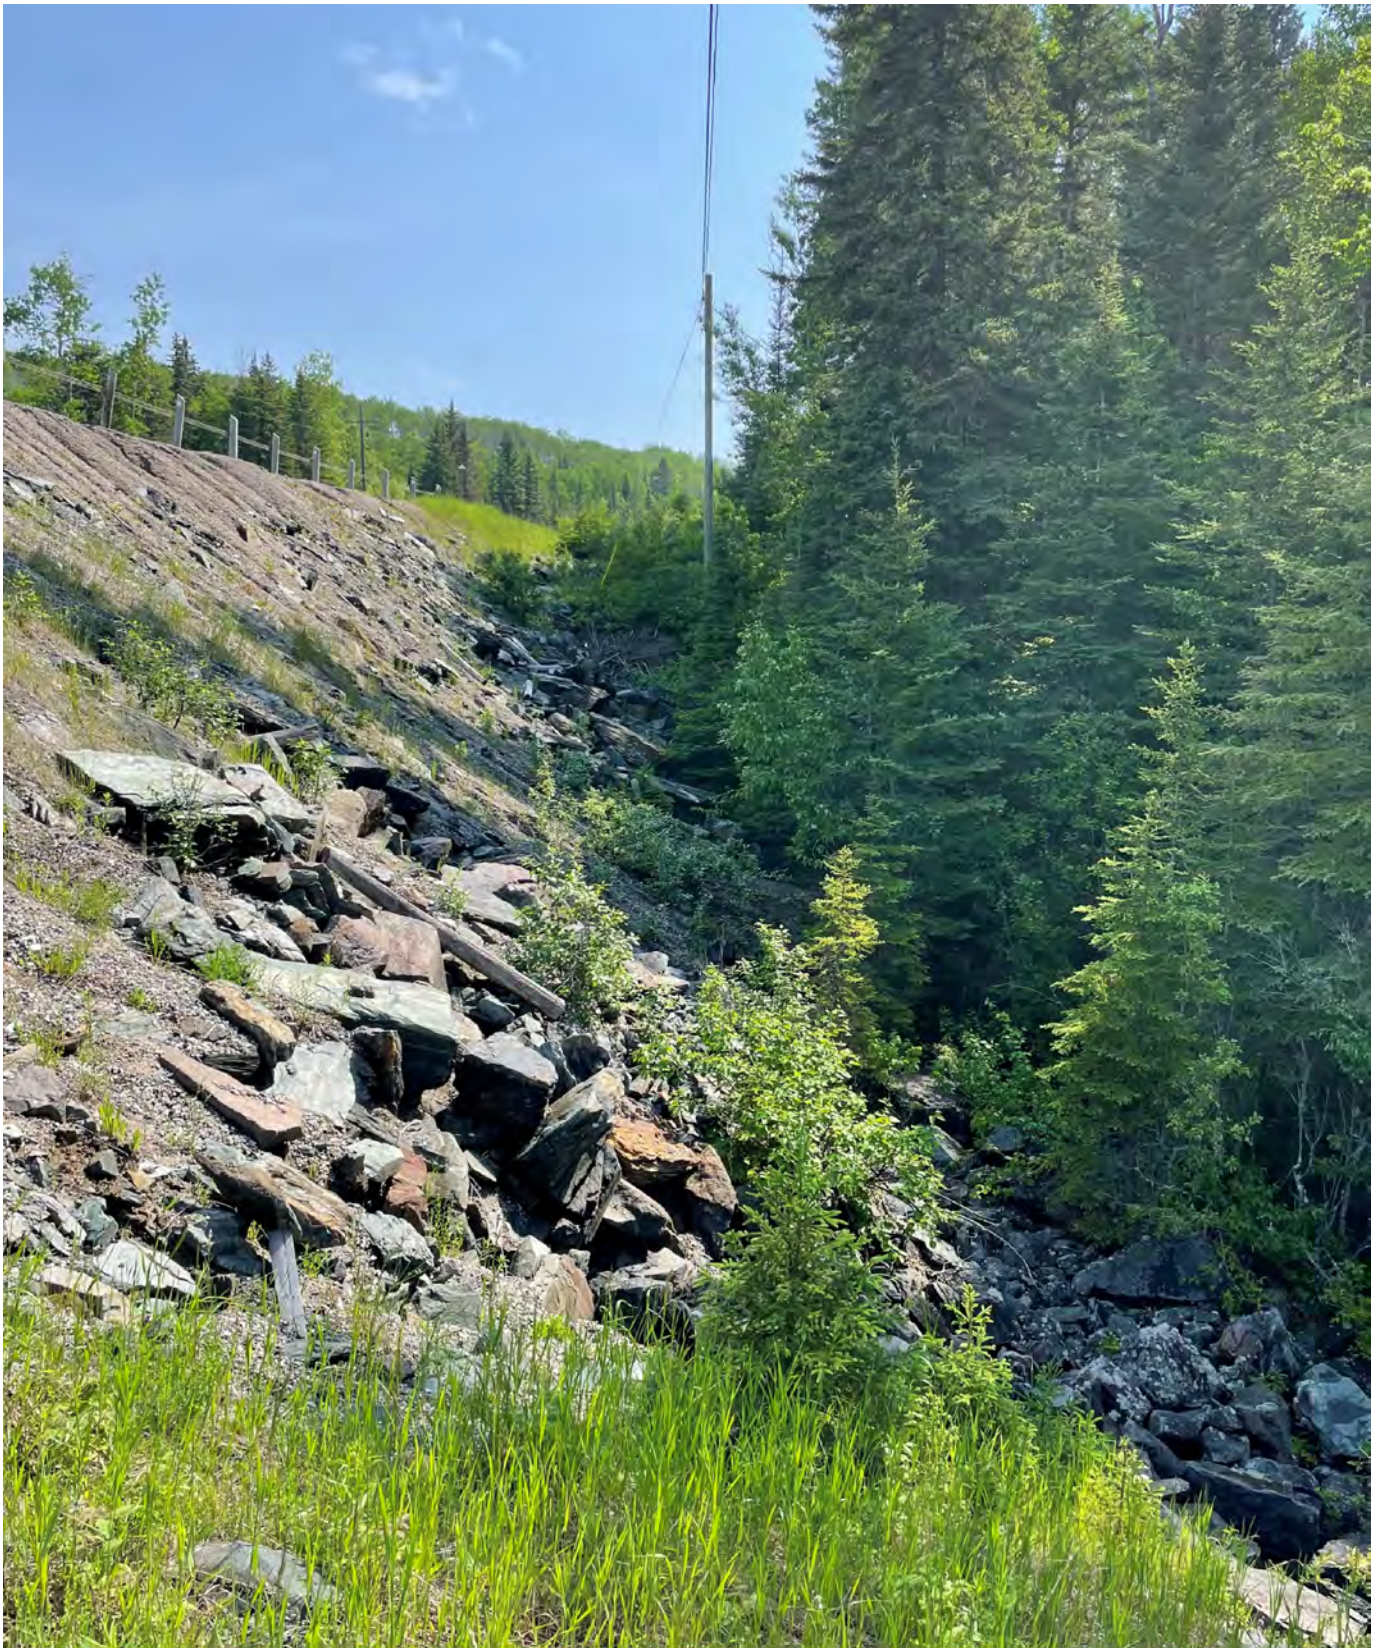
Photograph #9 – South embankment slope looking east. (June 2024)

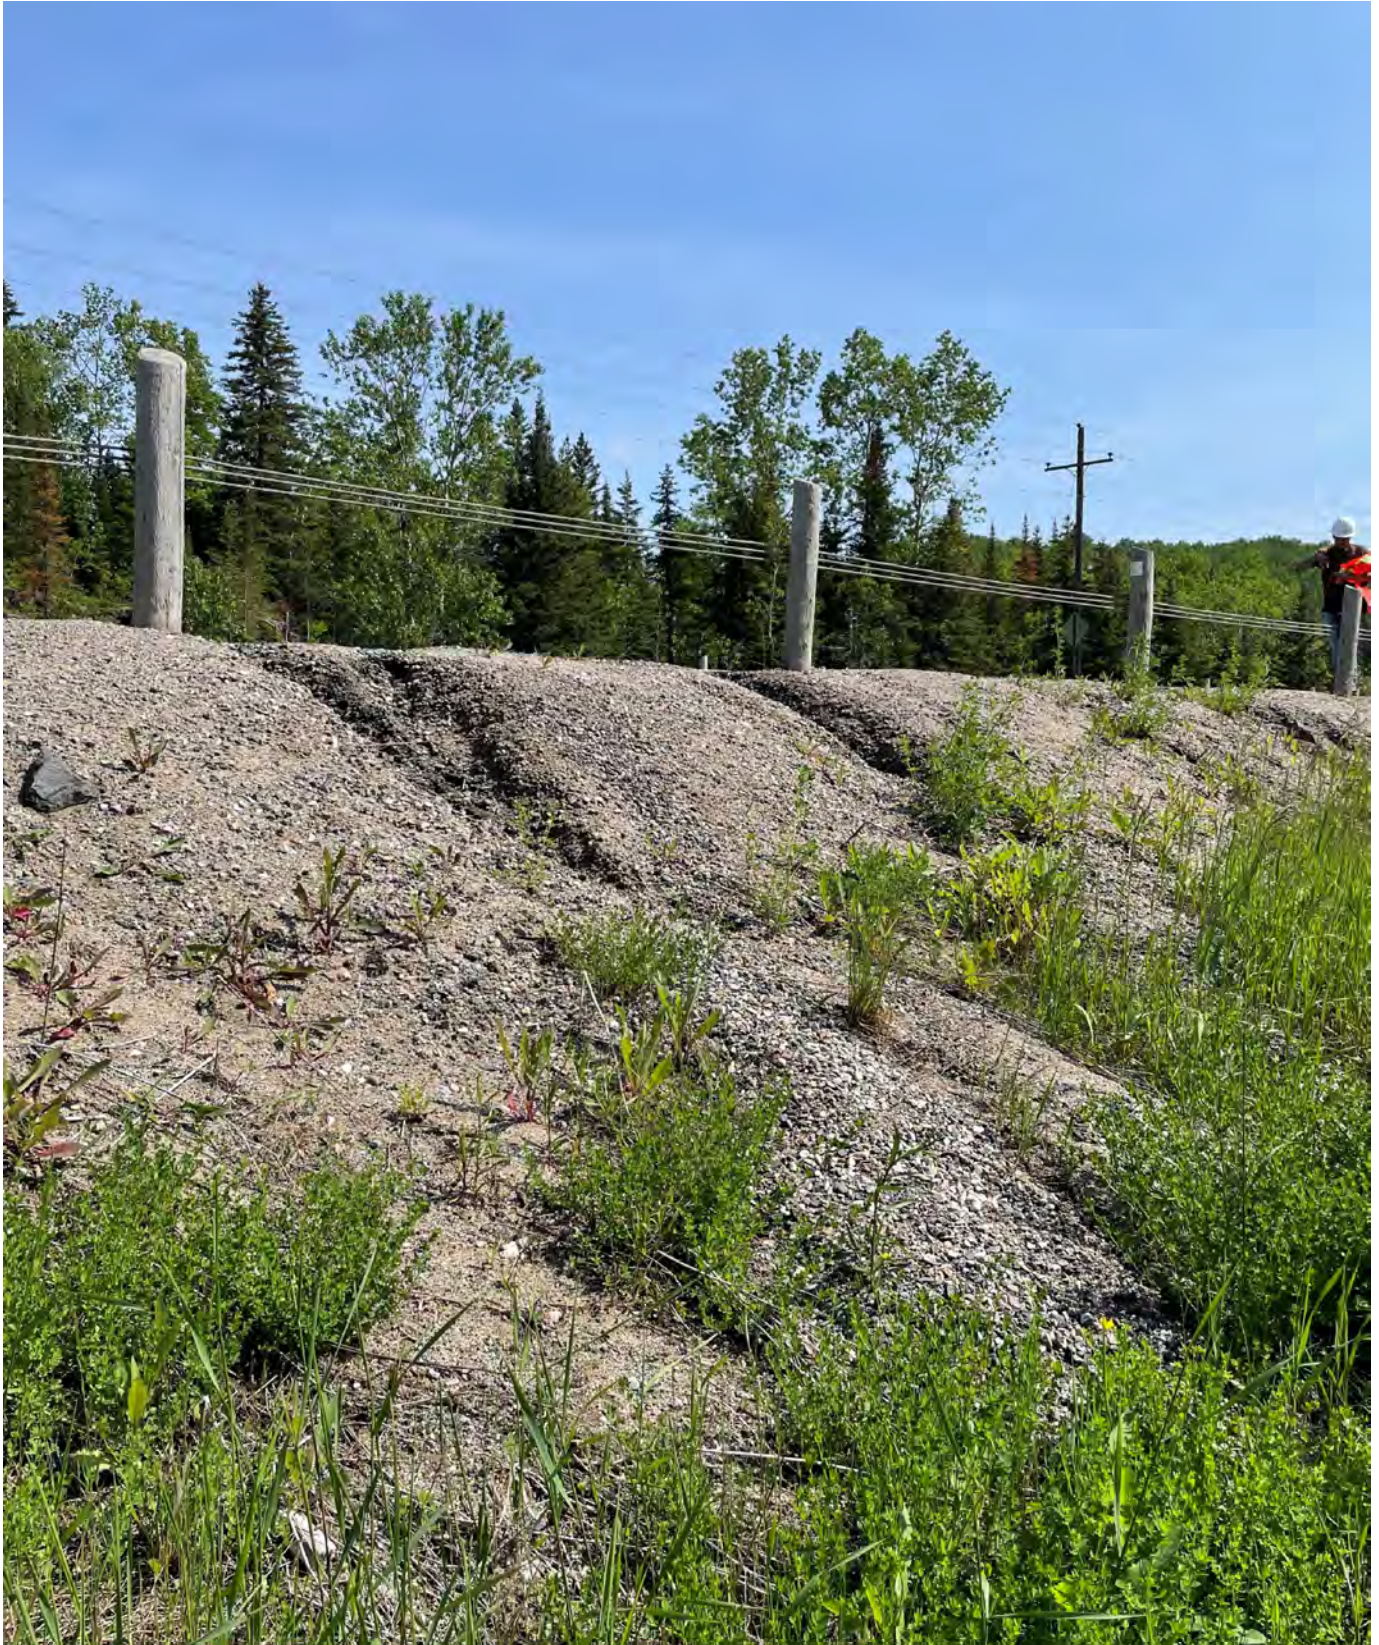
Photograph #10 – Surficial erosion at the crest of embankment beyond the south shoulder. (June 2024)

Based on visual observations, no signs of slope instability of the embankment were noted at the culvert site. Minor surficial erosions were observed along the crest of the south embankment

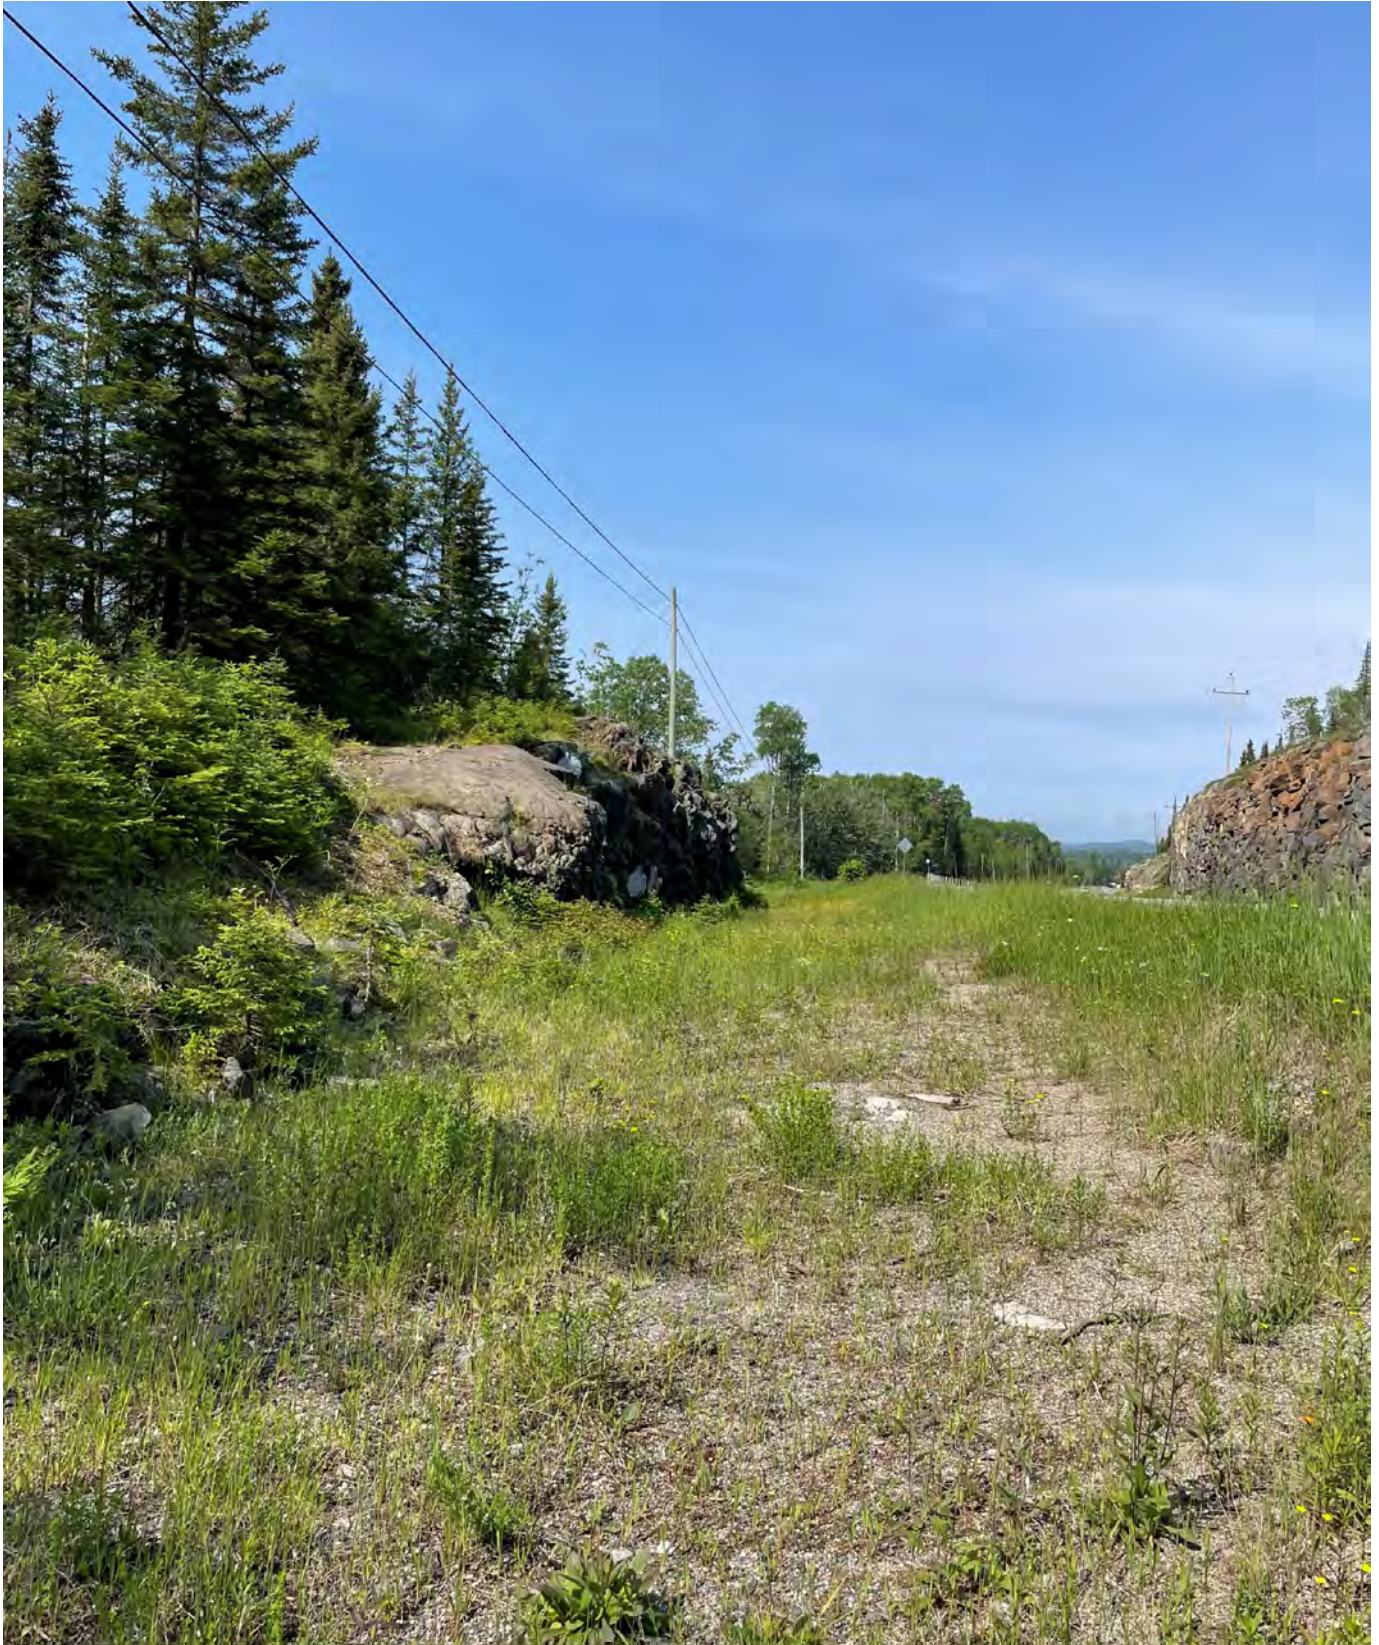
Photograph #11 – On south side of Highway17, west of existing culvert, looking west. Note the bedrock outcrops on both sides of the highway. (June 2024)
