Foundation Investigation and Design Report

Highway 17 Culvert Replacement (Culvert No.NW-867-0017-0026)

District of Thunder Bay, Ontario

Date: September 19, 2024

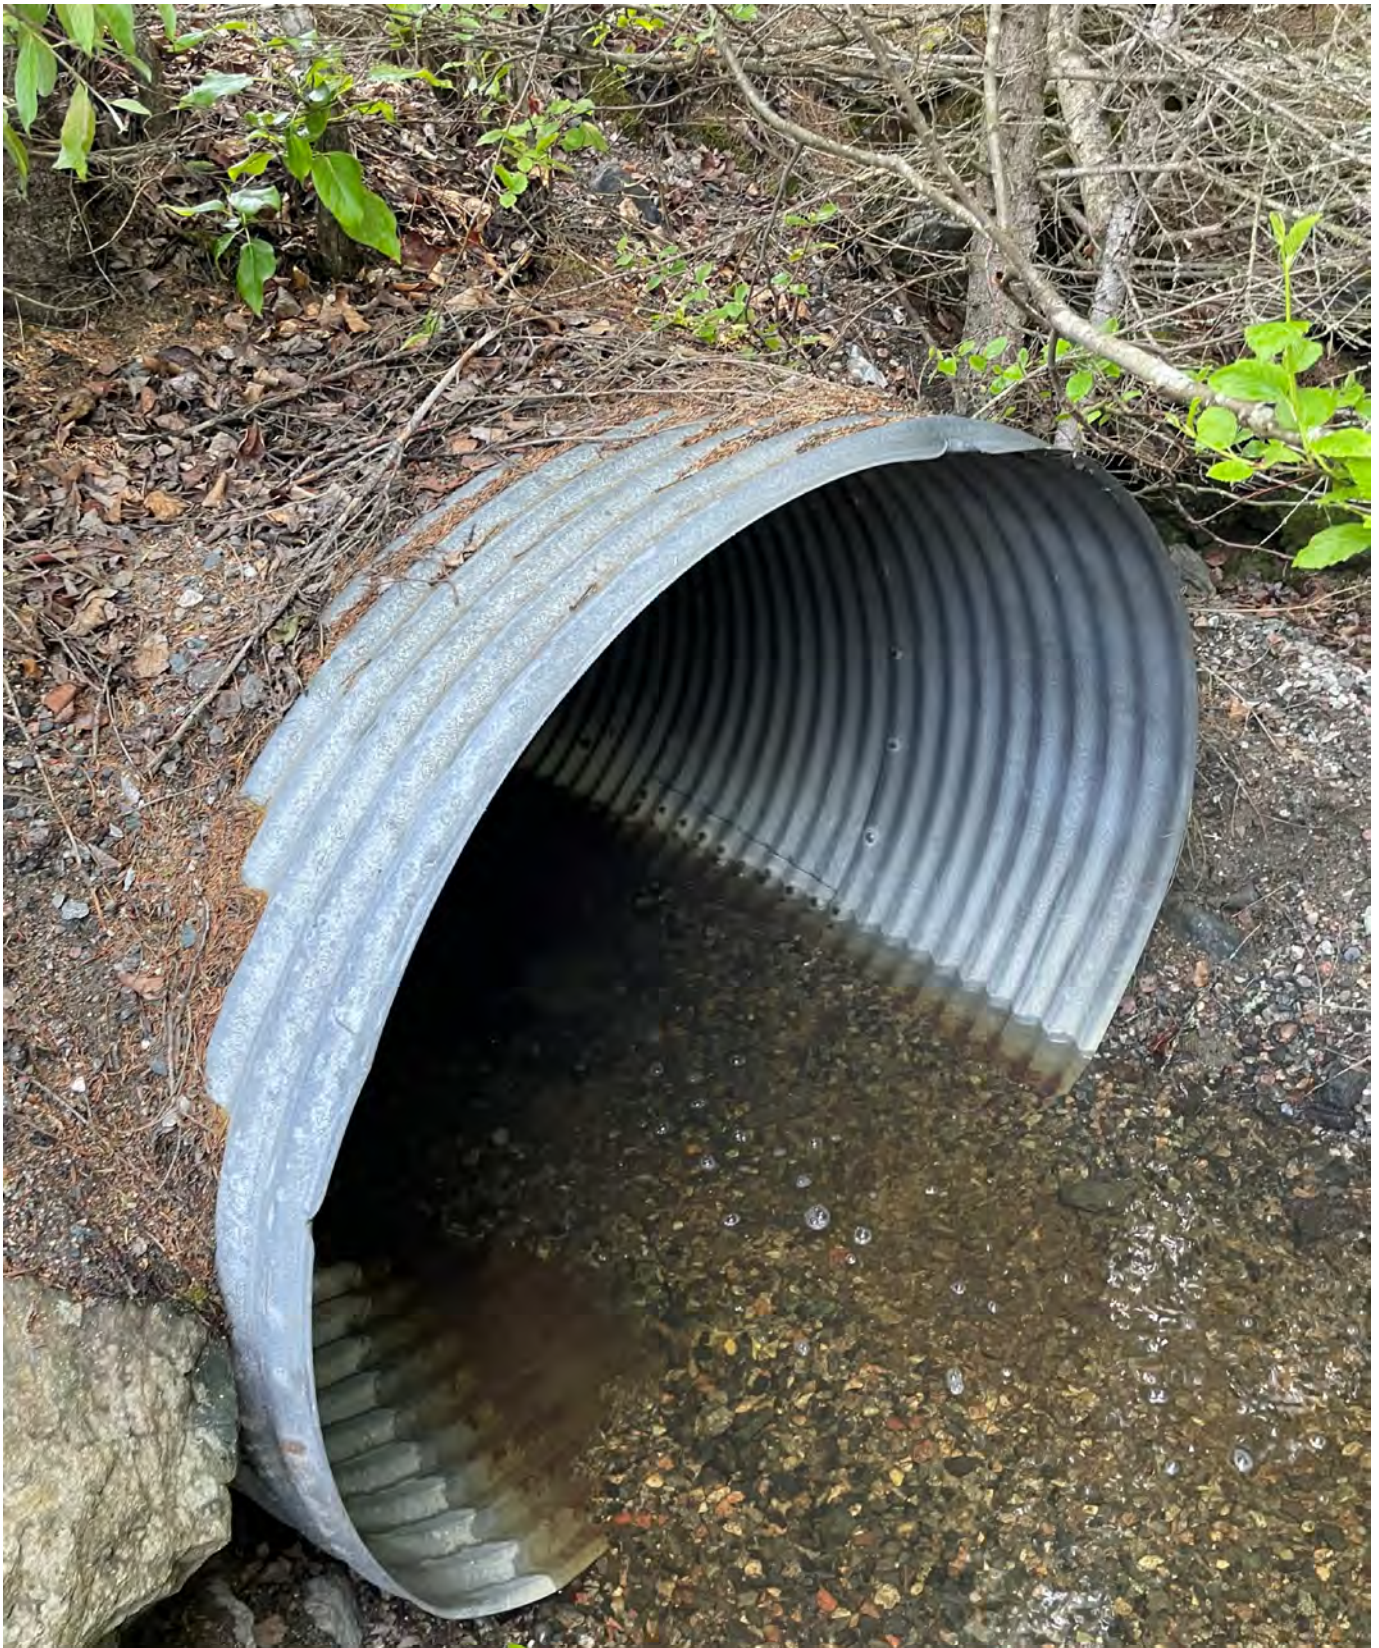
Photograph #12 – CSP extension at culvert outlet. (June 2024)

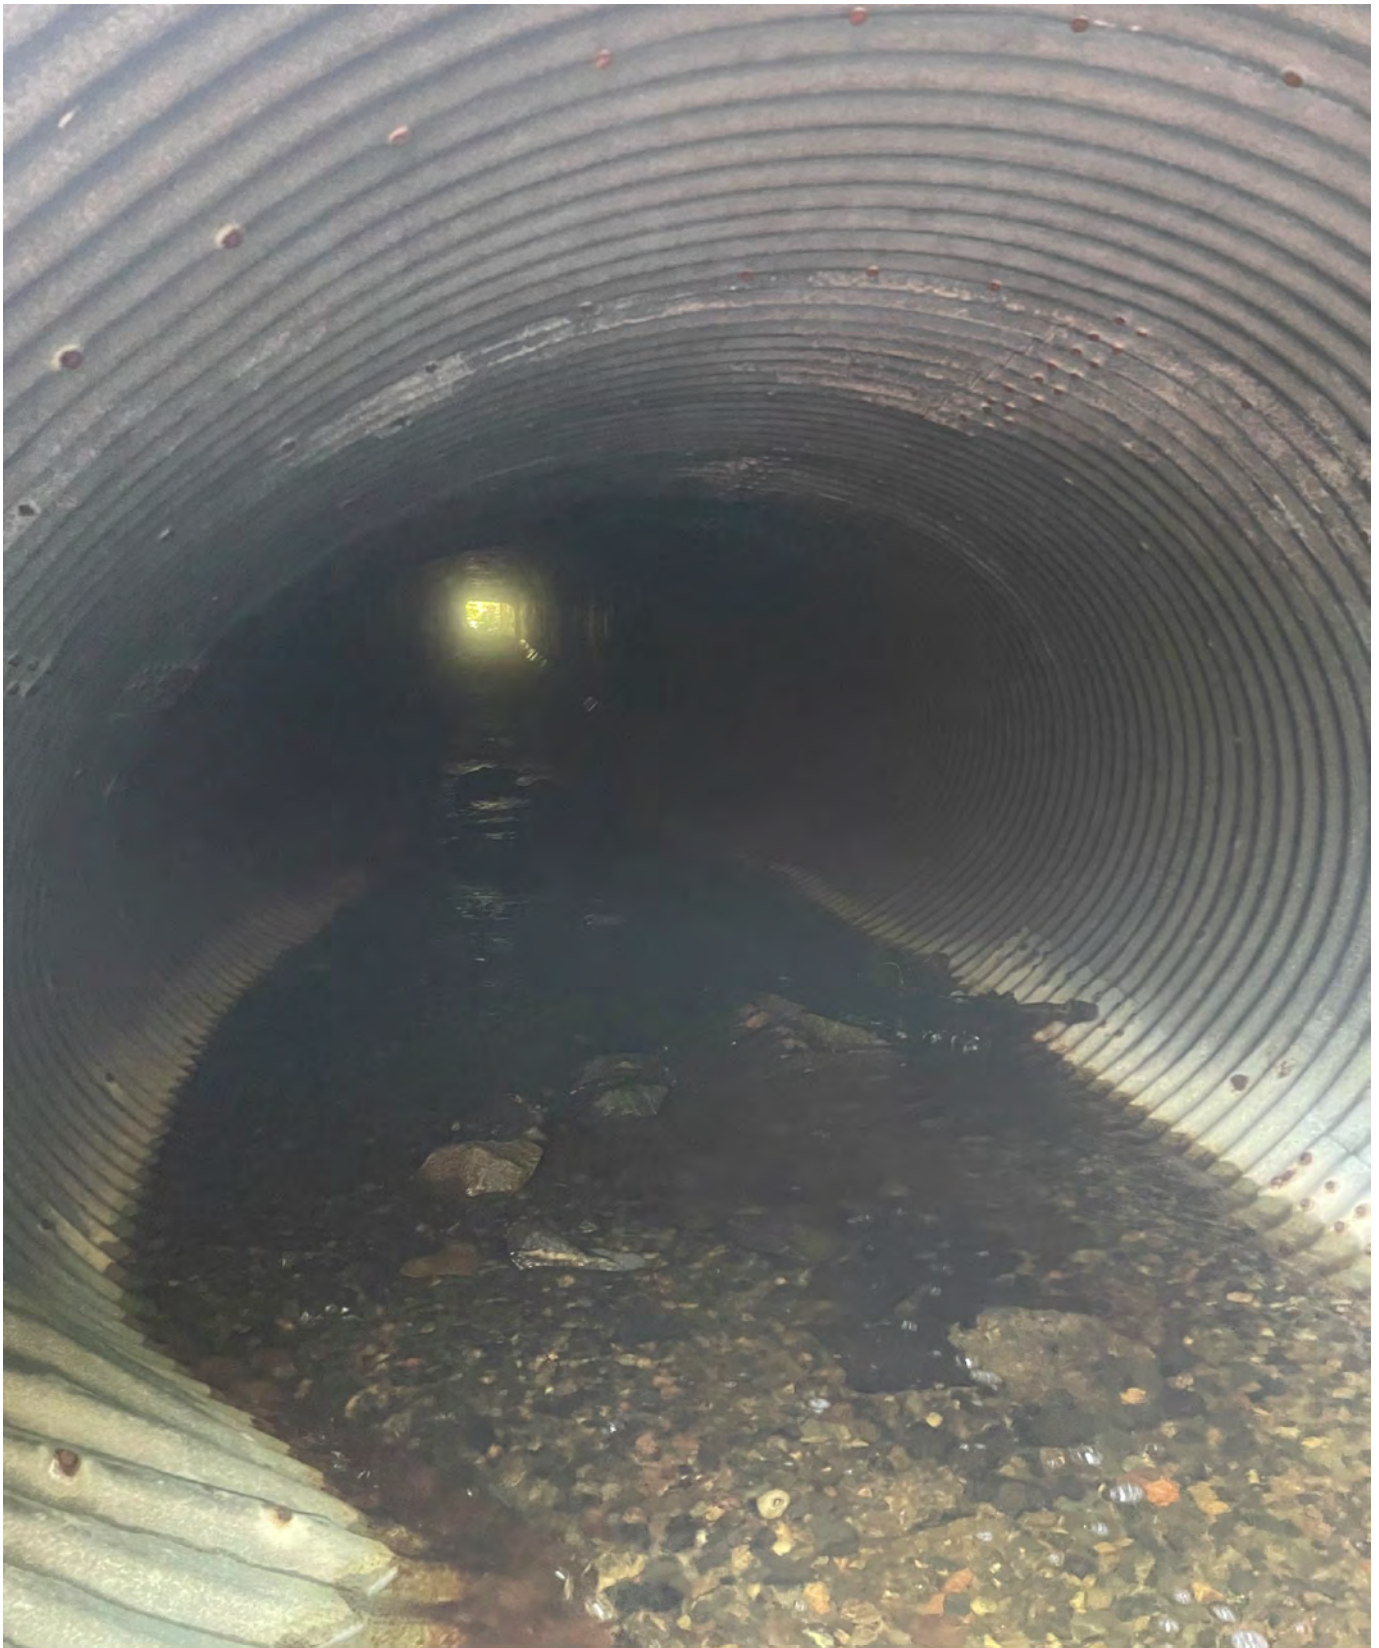
Photograph #13 – Existing culvert at outlet. (June 2024)

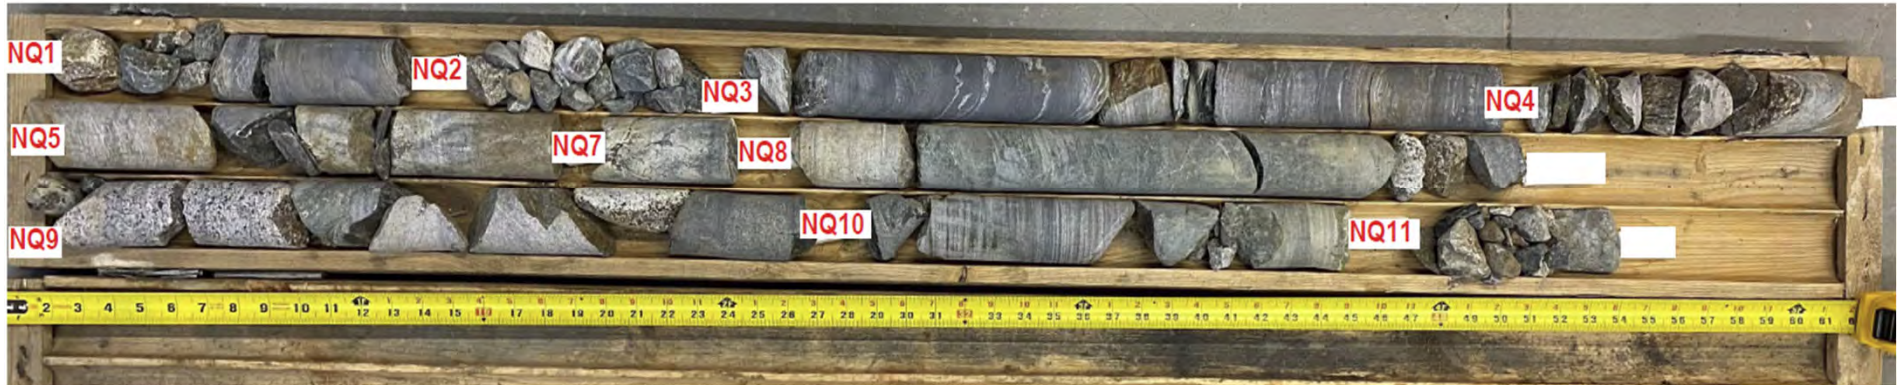
Appendix C – Rock Fill Core Photographs

RUN ID	Depth (m)	RUN ID	Depth (m)	RUN ID	Depth (m)
NQ1	2.2 – 2.6	NQ6 (No Recovery)	9.0 – 10.7	NQ11	15.2 – 16.8
NQ2	3.2 – 4.6	NQ7	10.7 – 11.5	NQ12	16.8 – 17.1
NQ3	4.6 – 6.1	NQ8	11.5 – 12.2		
NQ4	6.1 – 7.6	NQ9	12.2 – 13.7		
NQ5	7.6 – 9.0	NQ10	13.7 – 15.2

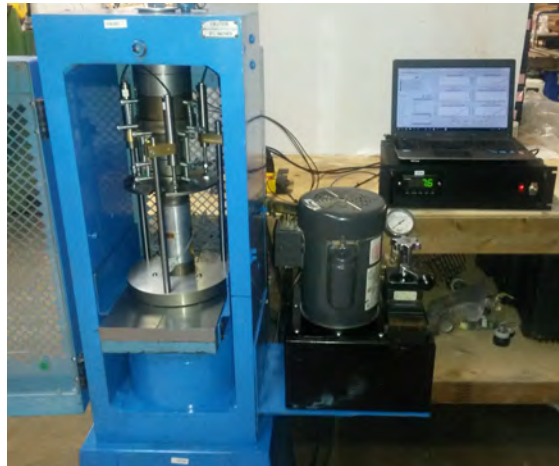
Figure 1: Forney loading frame setup for UCS testing.

This section summarizes the results of uniaxial compressive strength (UCS) testing. The testing was performed in Geomechanica Inc.'s rock testing laboratory using a 150 ton (1.3 MN) Forney loading frame equipped with pressure-compensated control valve to maintain an axial strain rate of approximately 0.05 mm/min (Figure 1). The preparation and testing procedure for each specimen included the following:

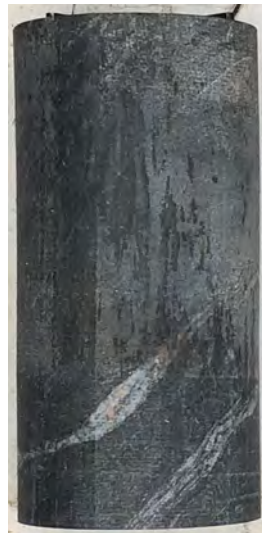
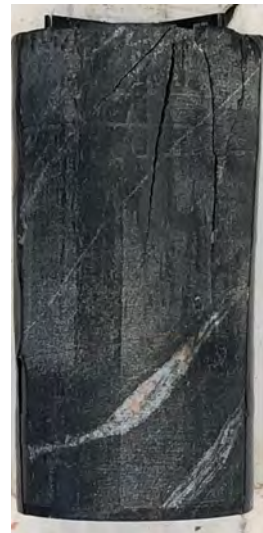
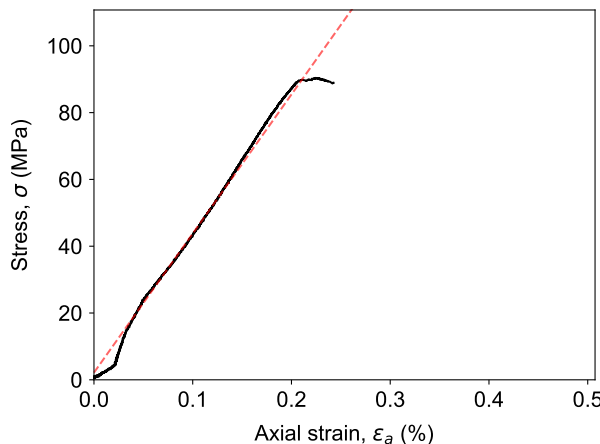
Diameter (mm) ^a	47.16	Length (mm) ^a	94.83	Bulk density ρ (g/cm ³)	2.789	UCS (MPa)	90.4	Young's modulus E (GPa) ^b	41.6	Lithology	Wacke, siltstone	Failure description ^c	1, 2	<div>Prior to testing</div>

Diameter (mm) ^a	47.16																
Length (mm) ^a	94.83																
Bulk density ρ (g/cm ³)	2.789																
UCS (MPa)	90.4																
Young's modulus E (GPa) ^b	41.6																
Lithology	Wacke, siltstone																
Failure description ^c	1, 2																
<div><div><p>^a Additional specimen measurement/details provided in accompanying summary spreadsheet.</p><p>^b Tangent modulus, calculated as the slope of the best fit line through ± 300 data points on either side of the point representing 50.0% of the peak strength.</p><p>^c Failure description: ¹ Inclined shear fracture and axial splitting failure; ² Failure partly along pre-existing structure;</p></div><div>

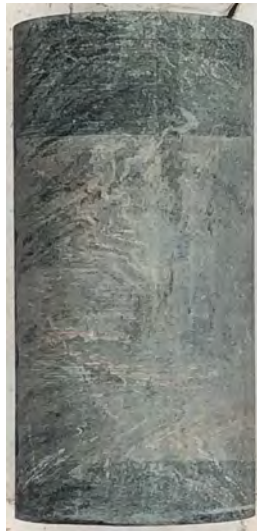
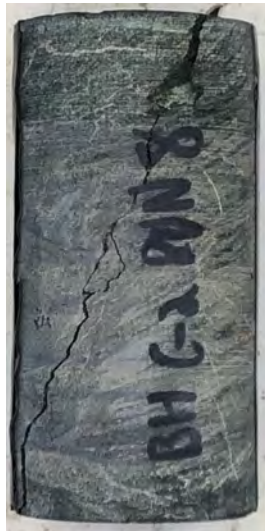
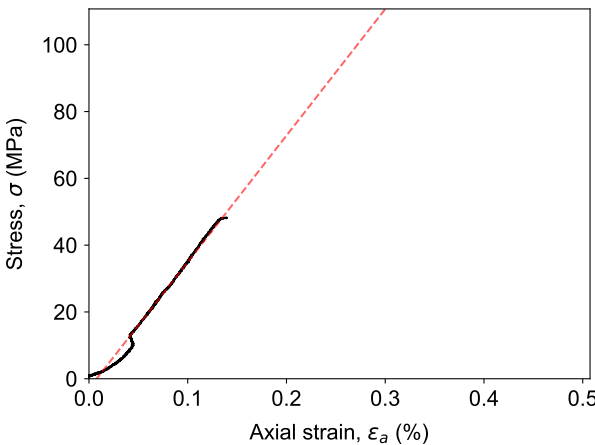
Client	Thurber Engineering Ltd.	Project	51583
Sample	BH C-2 RUN8	Depth	38'4" - 39'8"
Specimen parameters		Prior to testing	After testing
Diameter (mm) ^a	47.19

Length (mm) ^a	95.86		
Bulk density ρ (g/cm ³)	2.934		
UCS (MPa)	48.3		
Young's modulus E (GPa) ^b	37.9		
Lithology	Wacke, siltstone		
Failure description ^c	3		
^a Additional specimen measurement/details provided in accompanying summary spreadsheet.			
^b Tangent modulus, calculated as the slope of the best fit line through ±263 data points on either side of the point representing 50.0% of the peak strength.			
^c Failure description: ³ Inclined shear failure;
