## **Foundation Investigation Report Gull River Culvert Replacement**

**Highway 811, District of Thunder Bay, Ontario  
Agreement 6021-E-0005, Work Orders 1 & 23  
G.W.P. 6104-17-00, Site No. 48W-0198/C0  
Latitude: 49.404264°, Longitude: -89.590338°  
GEOCRES No. 52H05-001**

**Client Name:** HATCH

**Date:** August 1, 2024

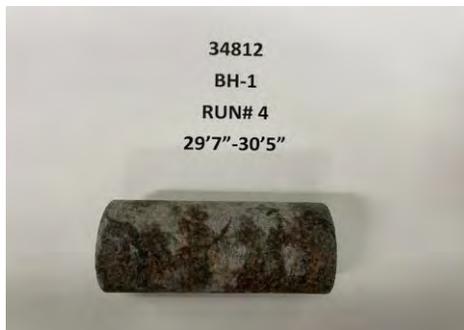
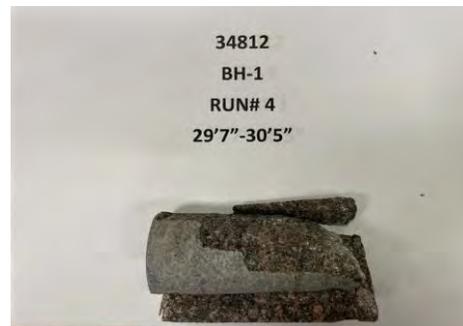
Avg. Height (cm):	10.8	Weight (g):	537.9
Avg. Diameter (cm):	4.9	Wet Density (kg/m <sup>3</sup> ):	2,641
H. to Dia. Ratio**:	2.2:1	Dry Density (kg/m <sup>3</sup> ):	2,641
Cross Sectional Area (cm <sup>2</sup> ):	18.86	Moisture Content* (%):	N/A
Sample Volume (cm <sup>3</sup> ):	203.66

AVG. RATE OF STRAIN TO FAILURE:	0.250 MPa/s
MAXIMUM COMPRESSIVE LOAD:	162.8 kN
UNCONFINED COMPRESSIVE STRENGTH:	87.1 MPa

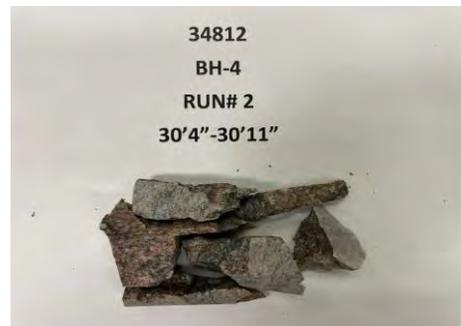
AVG. RATE OF STRAIN TO FAILURE:	0.250 MPa/s
MAXIMUM COMPRESSIVE LOAD:	382.4 kN
UNCONFINED COMPRESSIVE STRENGTH:	208.7 MPa

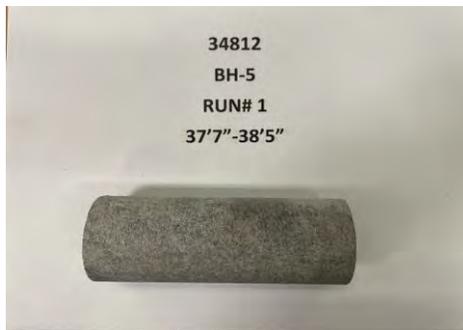
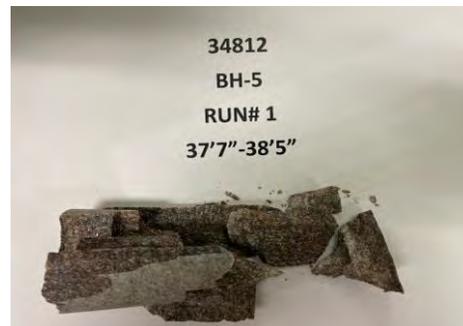
Avg. Height (cm):	13.2	Weight (g):	616.3
Avg. Diameter (cm):	4.7	Wet Density (kg/m <sup>3</sup> ):	2,640
H. to Dia. Ratio**:	2.8:1	Dry Density (kg/m <sup>3</sup> ):	2,640
Cross Sectional Area (cm <sup>2</sup> ):	17.68	Moisture Content* (%):	N/A
Sample Volume (cm <sup>3</sup> ):	233.42

AVG. RATE OF STRAIN TO FAILURE:	0.250 MPa/s
MAXIMUM COMPRESSIVE LOAD:	262.9 kN
UNCONFINED COMPRESSIVE STRENGTH:	148.4 MPa

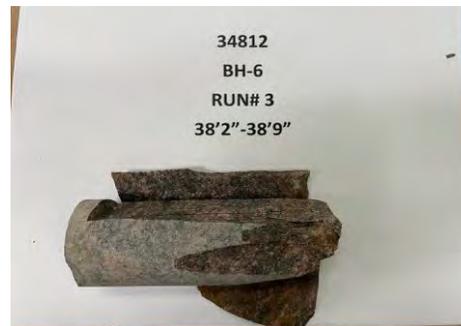
AVG. RATE OF STRAIN TO FAILURE:	0.250 MPa/s
MAXIMUM COMPRESSIVE LOAD:	125.5 kN
UNCONFINED COMPRESSIVE STRENGTH:	71.1 MPa

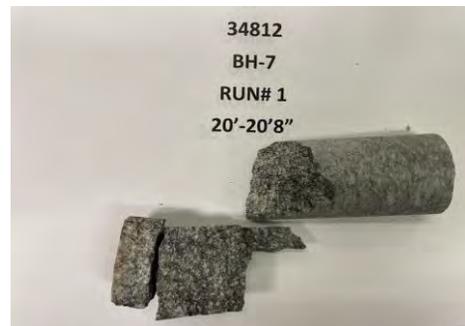
Avg. Height (cm):	11.4	Weight (g):	547.4
Avg. Diameter (cm):	4.8	Wet Density (kg/m <sup>3</sup> ):	2,654
H. to Dia. Ratio**:	2.4:1	Dry Density (kg/m <sup>3</sup> ):	2,654
Cross Sectional Area (cm <sup>2</sup> ):	18.10	Moisture Content* (%):	N/A
Sample Volume (cm <sup>3</sup> ):	206.29

AVG. RATE OF STRAIN TO FAILURE:	0.250 MPa/s
MAXIMUM COMPRESSIVE LOAD:	263.6 kN
UNCONFINED COMPRESSIVE STRENGTH:	148.8 MPa

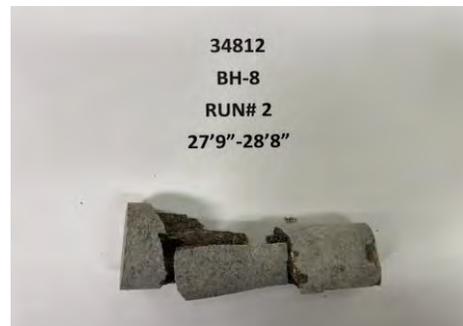
Avg. Height (cm):	11.9	Weight (g):	559.3
Avg. Diameter (cm):	4.8	Wet Density (kg/m <sup>3</sup> ):	2,597
H. to Dia. Ratio**:	2.5:1	Dry Density (kg/m <sup>3</sup> ):	2,597
Cross Sectional Area (cm <sup>2</sup> ):	18.10	Moisture Content* (%):	N/A
Sample Volume (cm <sup>3</sup> ):	215.34

AVG. RATE OF STRAIN TO FAILURE:	0.250 MPa/s
MAXIMUM COMPRESSIVE LOAD:	333.5 kN
UNCONFINED COMPRESSIVE STRENGTH:	188.2 MPa

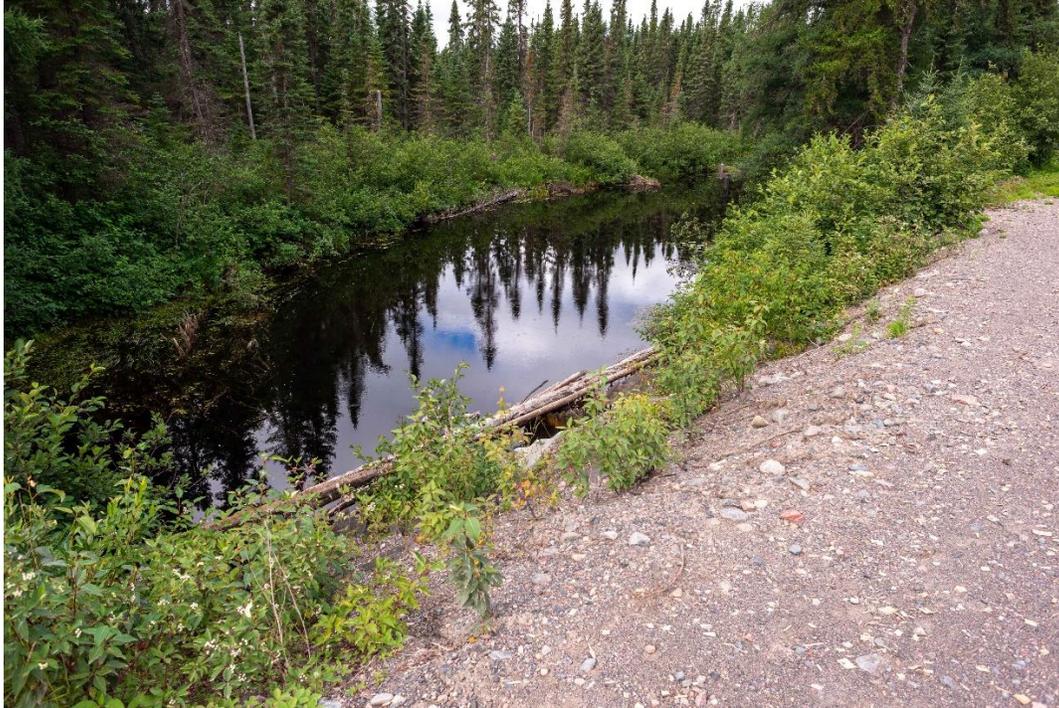
**Photo 3: Looking south towards culvert inlet (August 2022)**

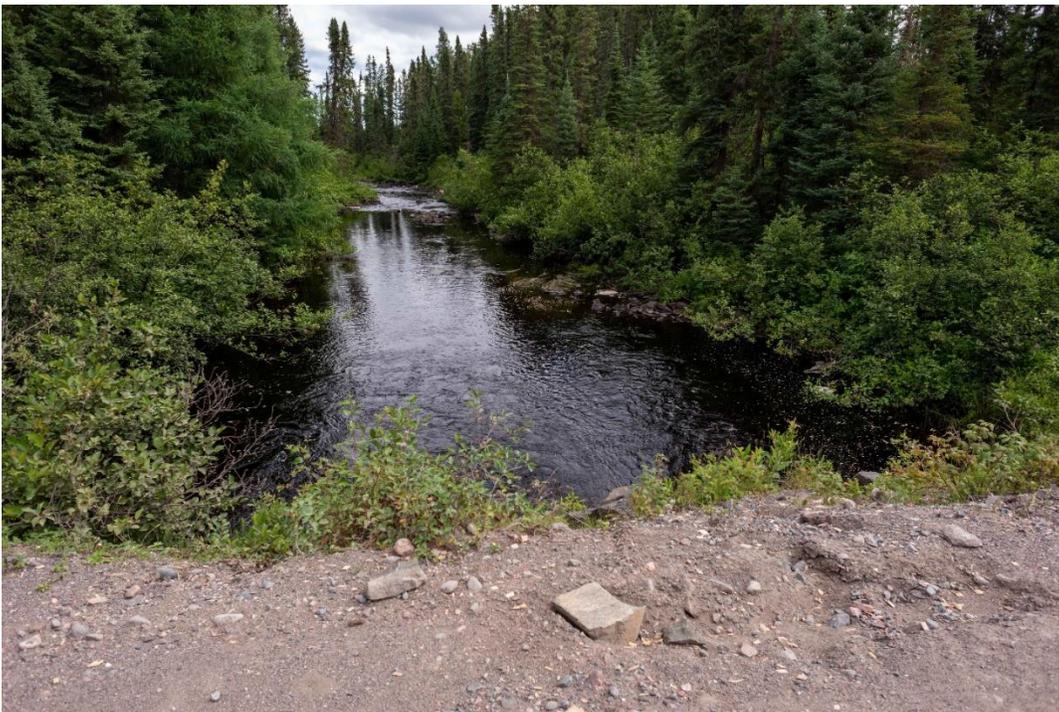
**Photo 4: Looking north towards culvert outlet (August 2022)**

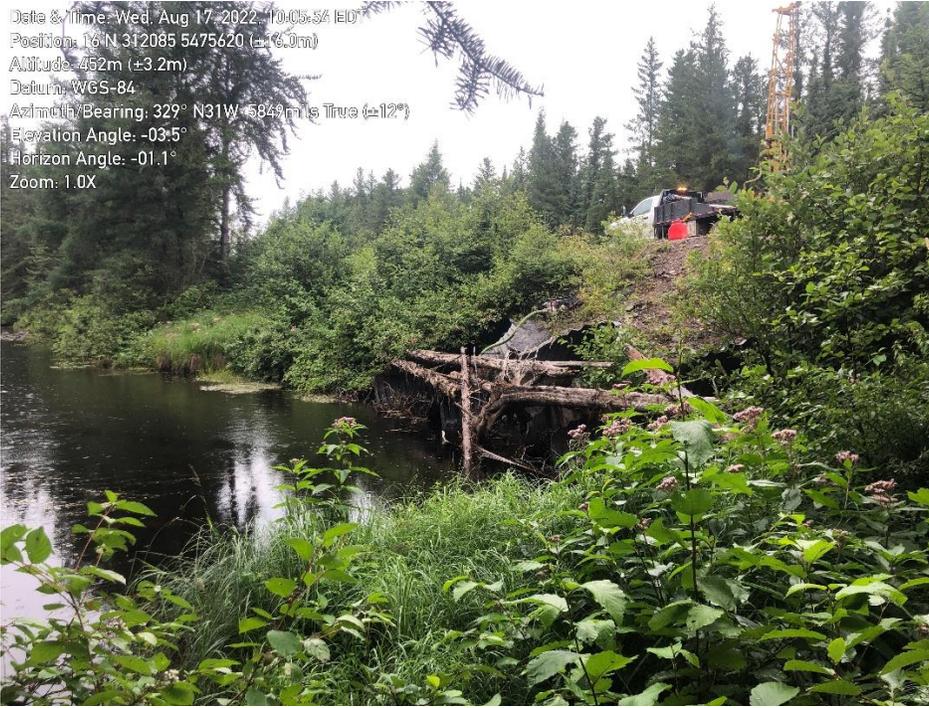
**Photo 5: Looking west at culvert inlet (August 2022)**

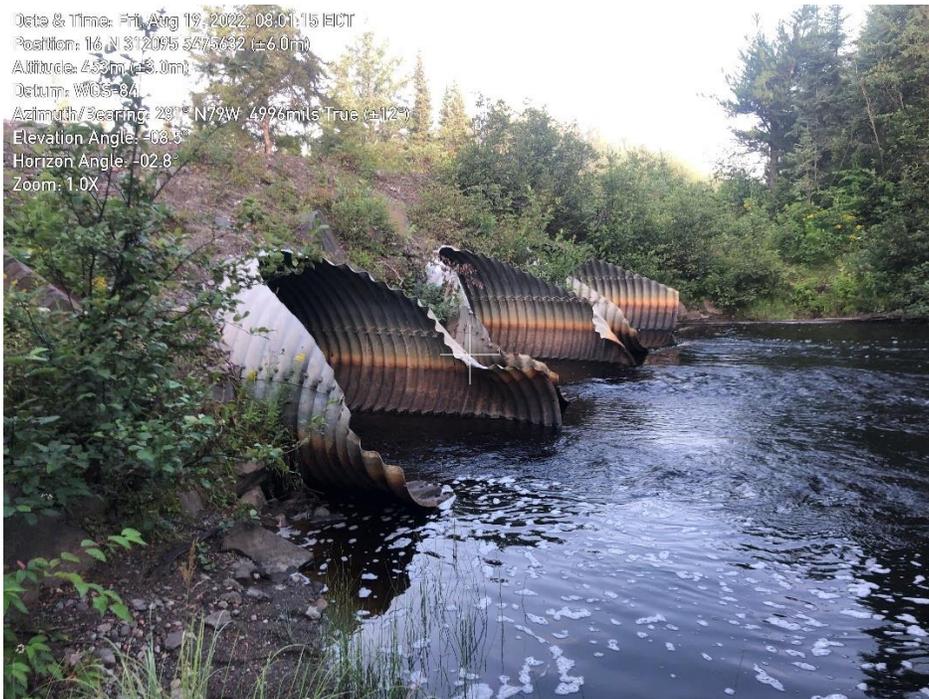
**Photo 6: Looking west at culvert outlet (August 2022)**
