Final Foundation Investigation Report (FIR)

Highway 61 Culvert Replacement

Station 14+588, Township of Blake

September 15, 2022

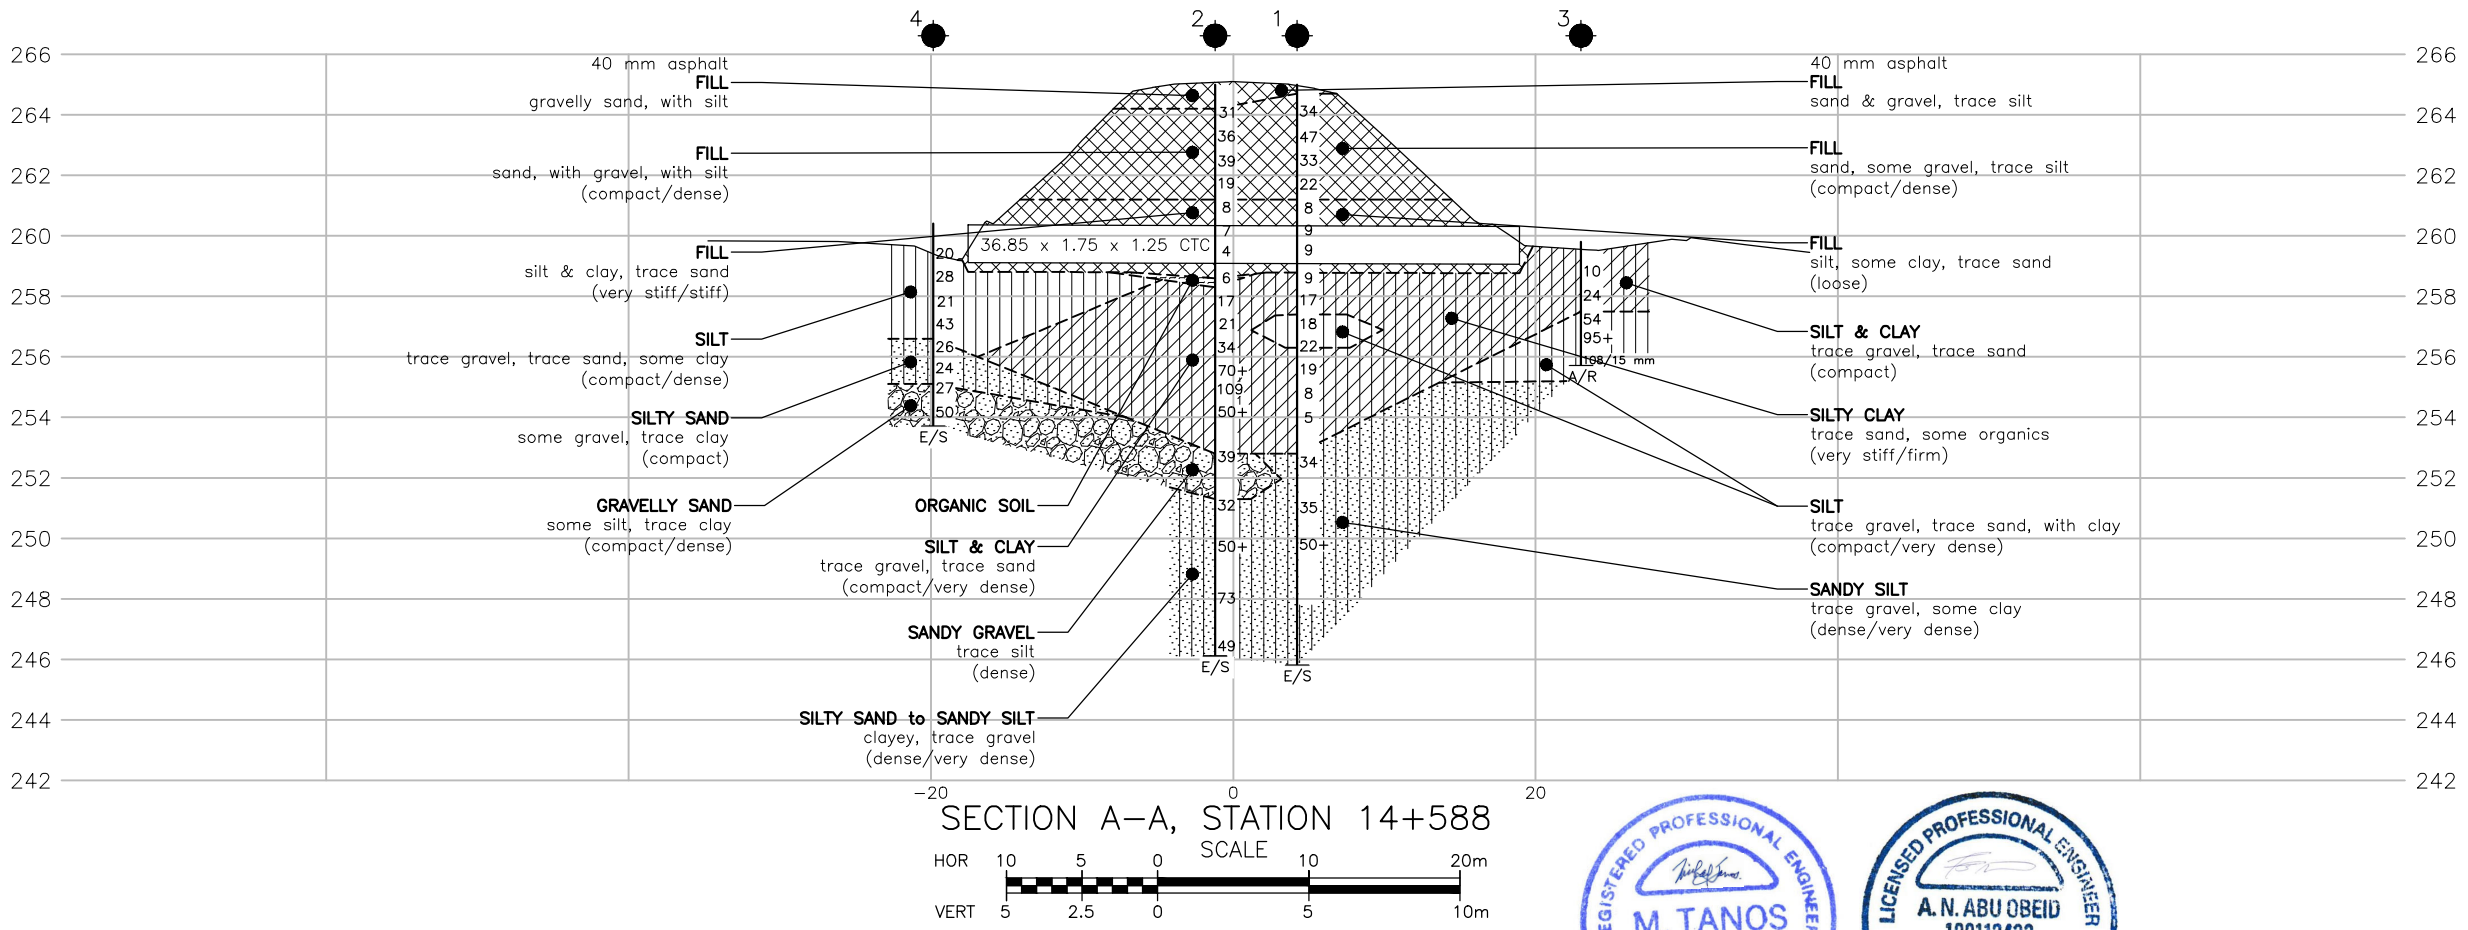
Drawing No. 2 - Borehole Location Plan & Embankment Profile

The subsurface conditions revealed by the investigation program are summarized in Table 2 below and on the stratigraphic profile presented on Drawing No. 2 (Appendix A) and on the detailed Records of Borehole Logs (Appendix B). It should be noted that the stratigraphic delineation presented on the borehole logs and soil strata plot is interpreted from the results of non-continuous sampling, response to drilling progress, recorded SPT 'N'-values, plus field observations. Typically, such boundaries represent transitions from one zone to another and are not an exact demarcation of specific geological units. Additional consideration should be given to the fact that subsurface conditions may vary markedly between adjacent boreholes and beyond any specific boring location and are shown on the drawings for illustration purposes only.

The fieldwork for this investigation included four (4) sampled boreholes (BH) were advanced. BH Nos. 1 and 2 were advanced in the roadway shoulders through the embankment. BH Nos. 3 and 4 were advanced at the inlet (Rt) and outlet (Lt) ends of the culvert, respectively. The locations of the boreholes are shown on Drawing No. 2 in Appendix C and are provided in the Table below.

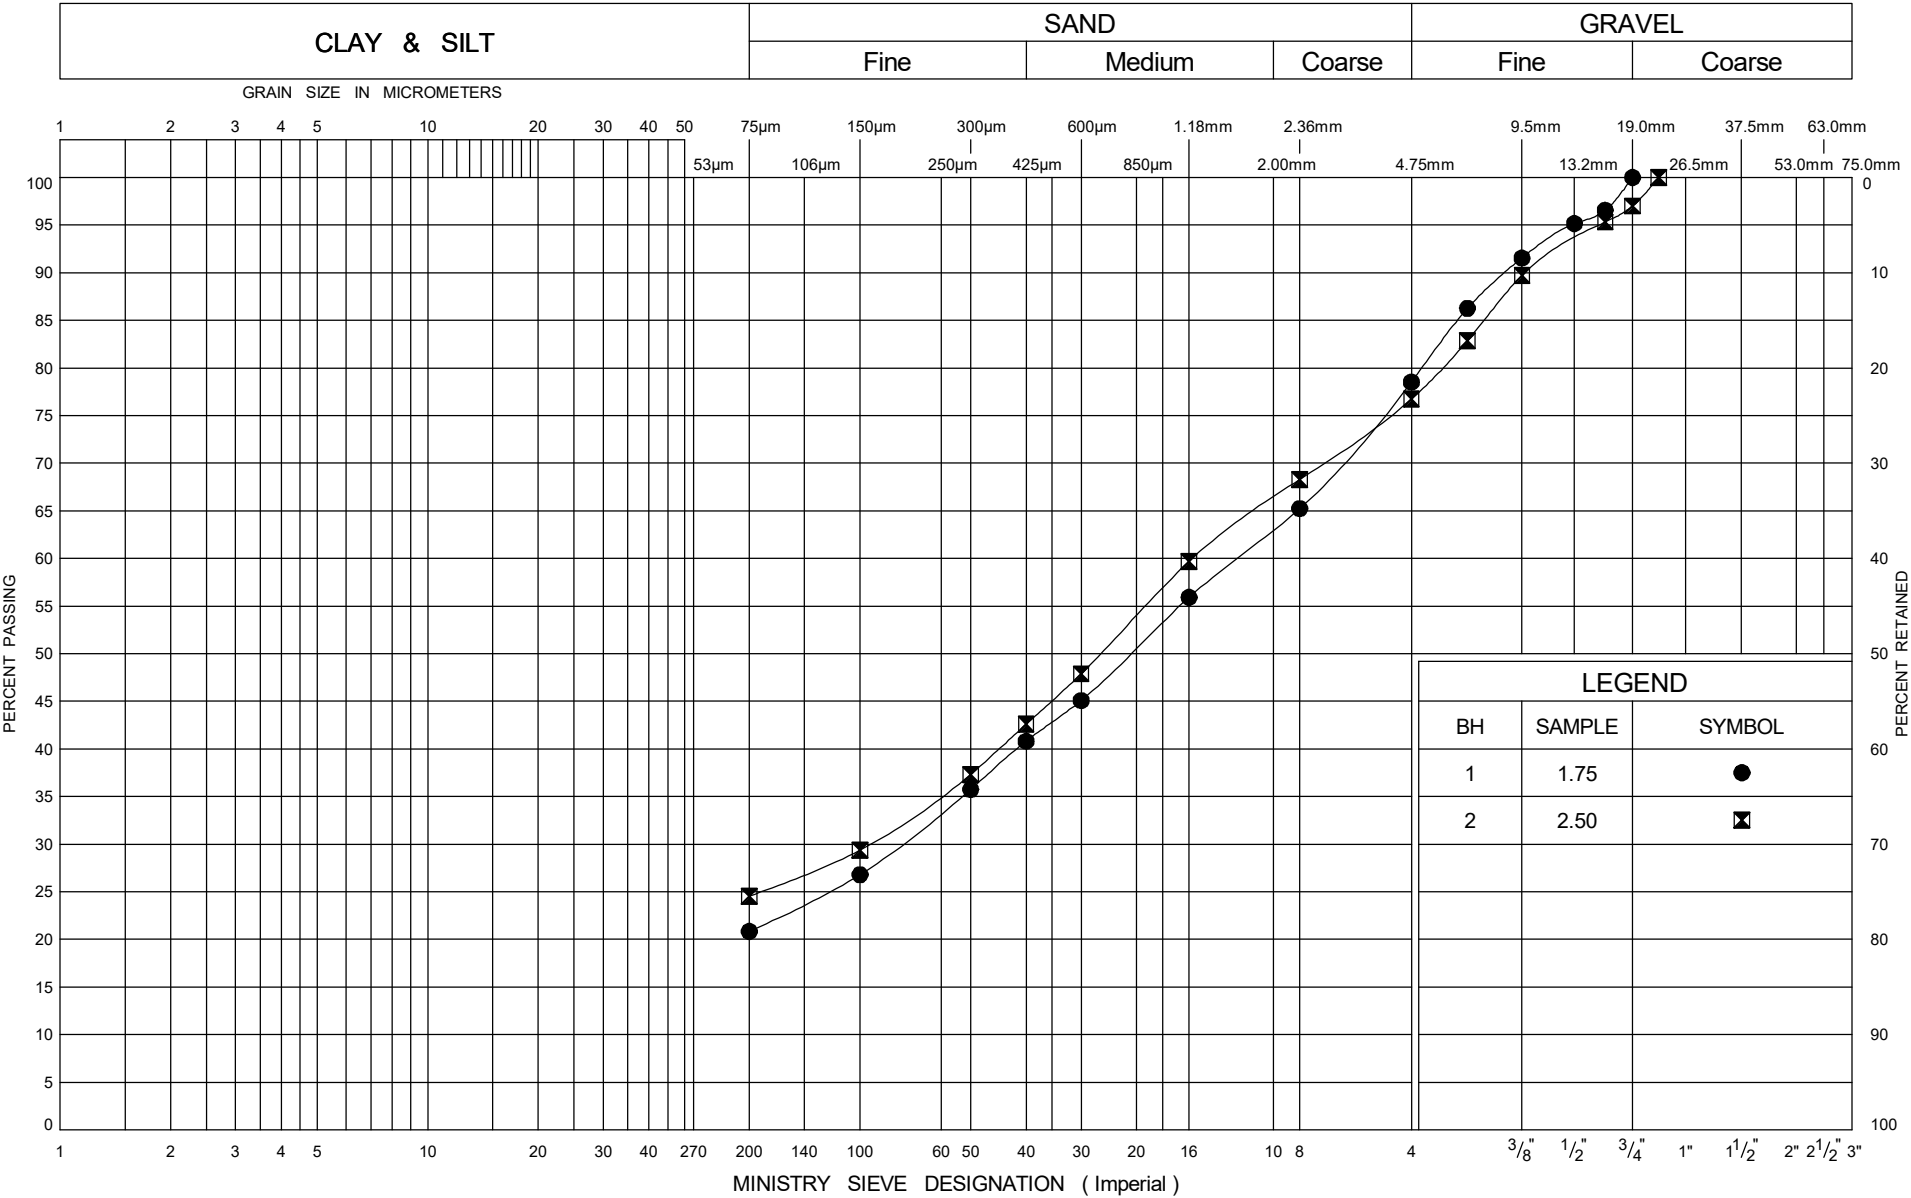
GRAIN SIZE DISTRIBUTION

The embankment fill, immediately below the pavement structure, is mainly composed of brown gravelly sand/sand with different portions of silt and clay. The gravelly sand/sand fill layer extended to approximately 3.8 m depth (El. 261.2m). This gravelly sand/sand fill layer was almost dry with approximate moisture content of 4% measured in the geotechnical laboratory. The results for grain size analyses of representative samples comprising the embankment fill are summarized in Table 3 and presented on Figure No. L-1, Appendix C.

FILL - SAND

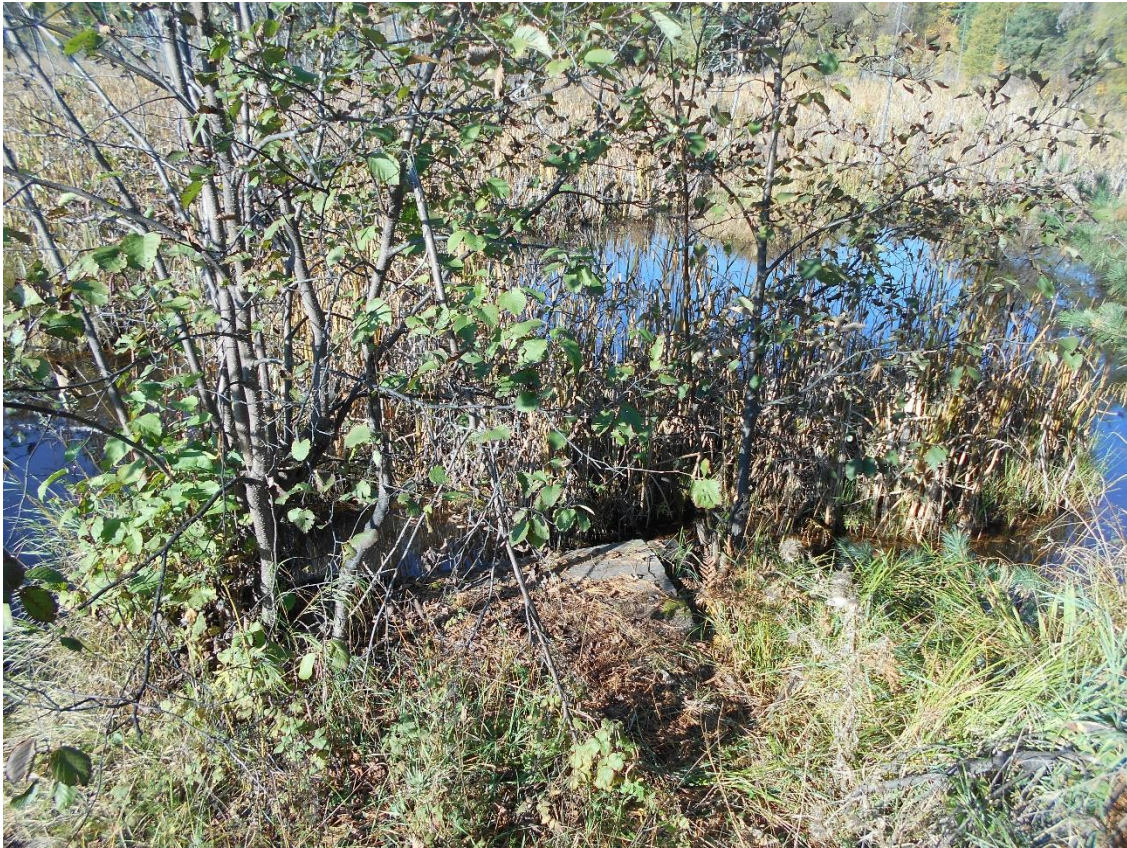
C26 - #1 – Upstream Channel Conditions

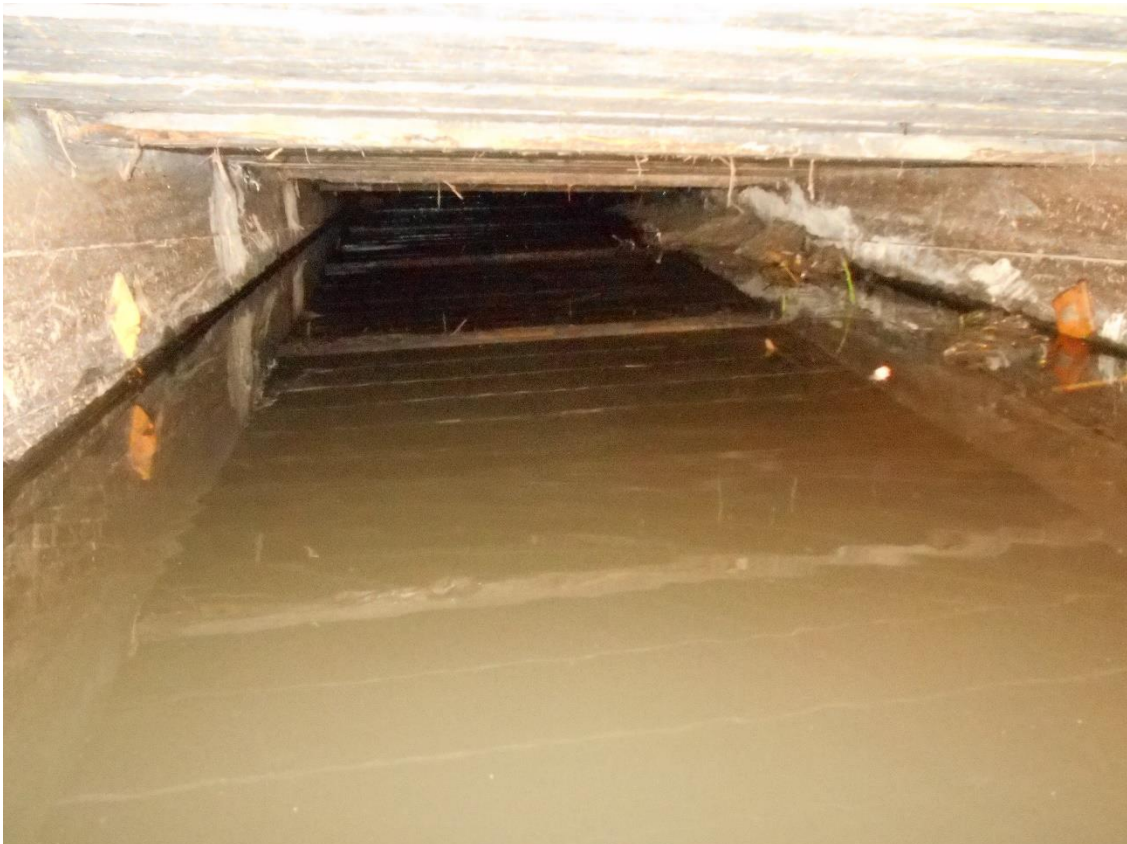
C26 - #2 – Upstream Face of the Culvert

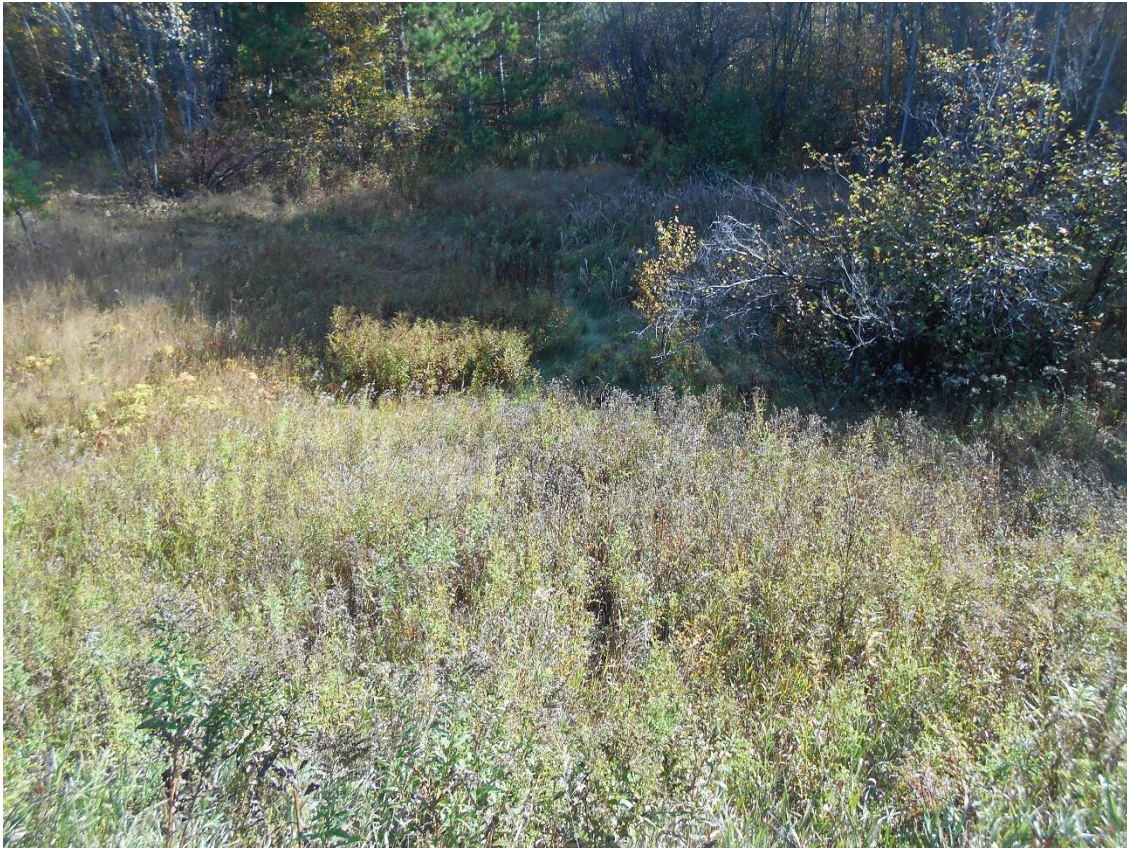
C26 - #3 – Downstream Channel Conditions

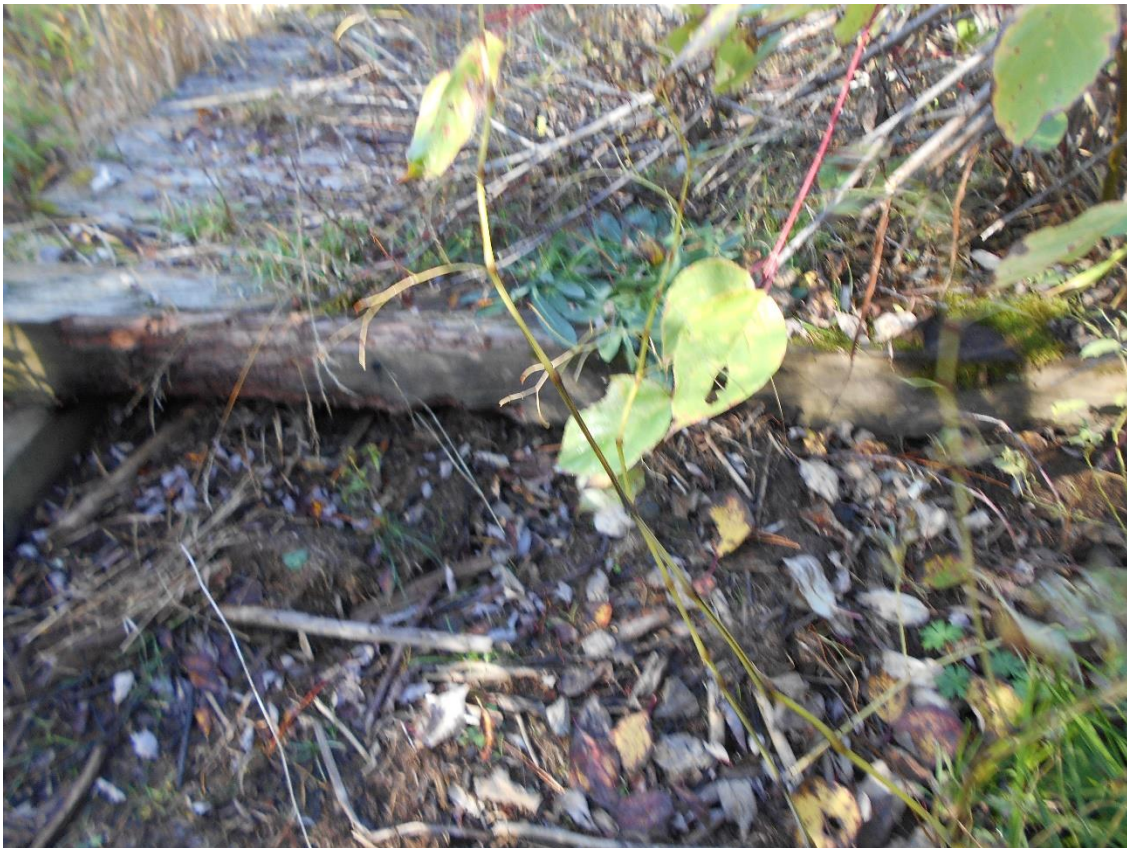
C26 - #4 – Downstream Face of the Culvert
