Final Foundation Investigation Report (FIR)

Highway 61 Culvert Replacement

Station 16+215, Township of Blake

Ontario Ministry of Transportation (MTO)

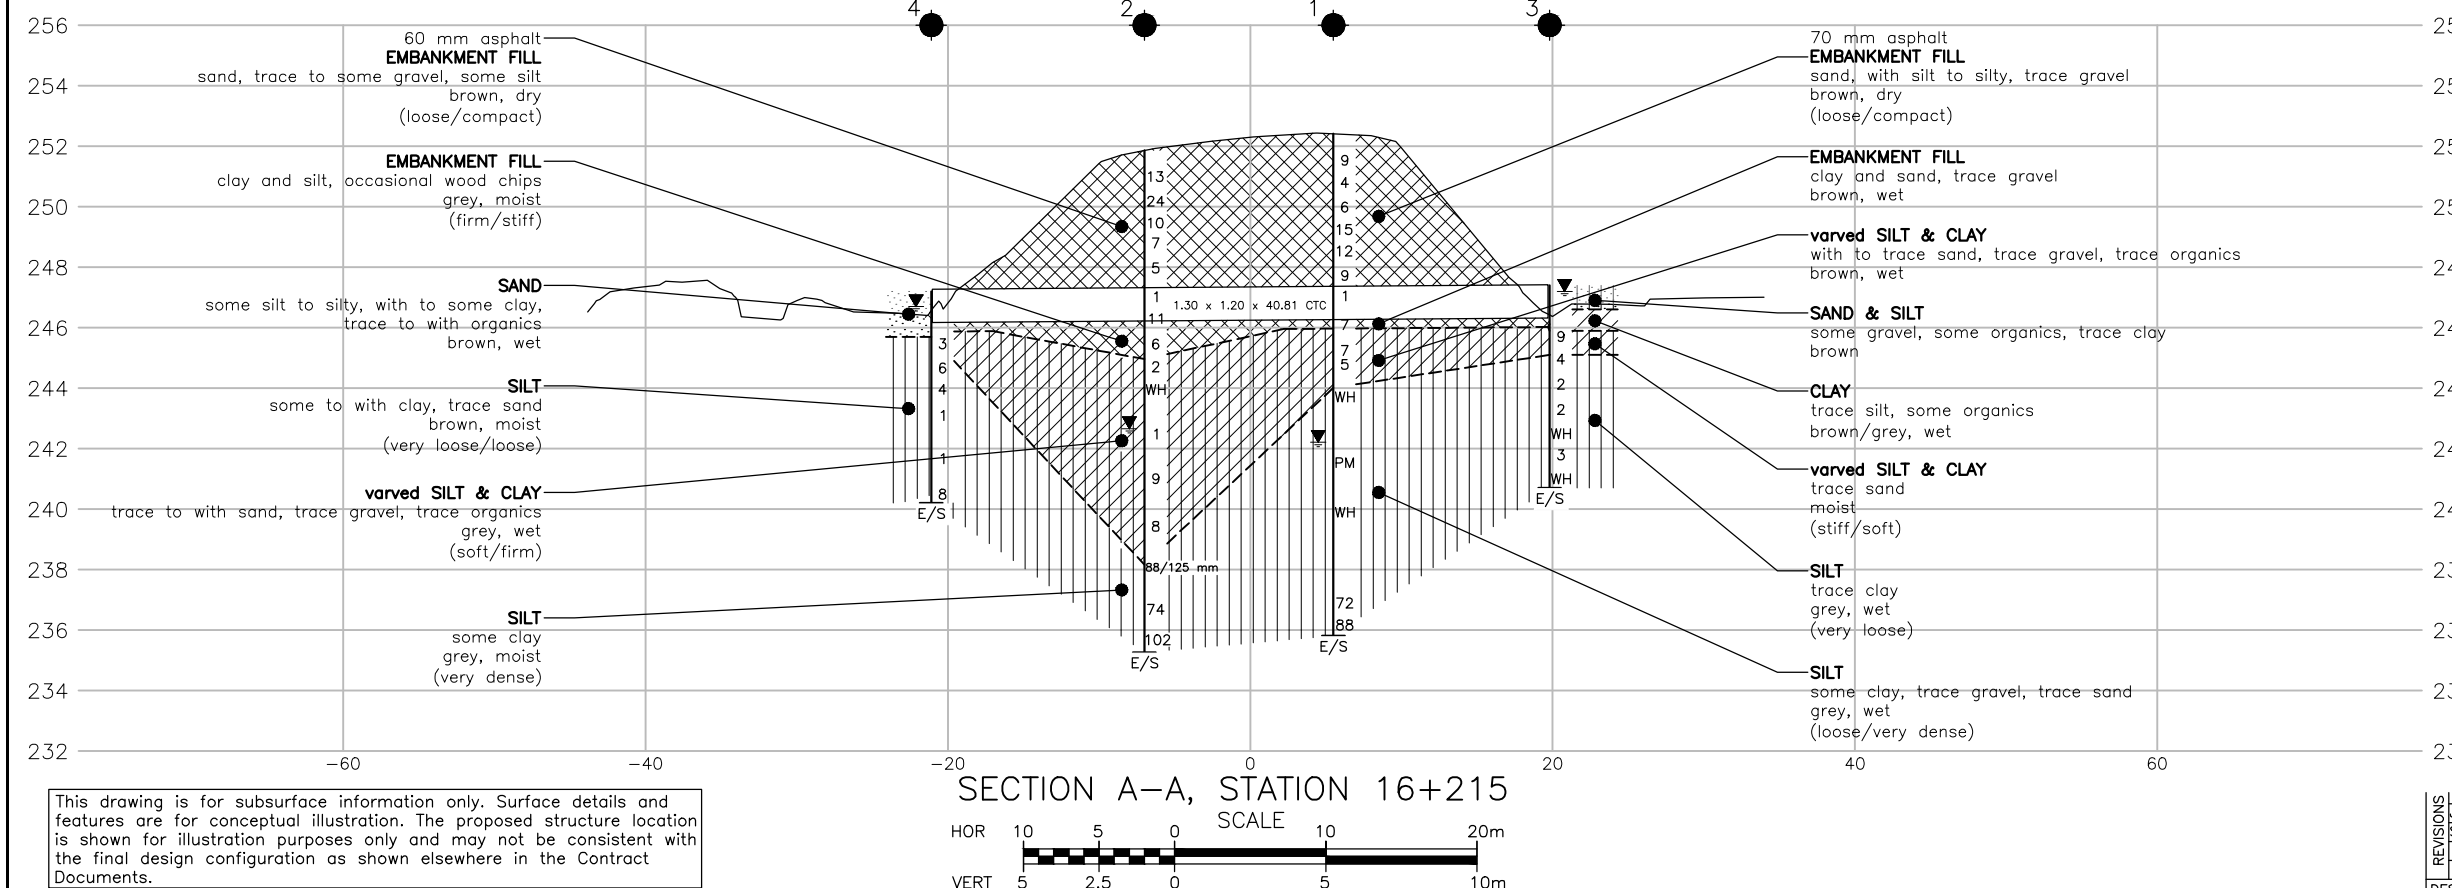
Drawing No. 2 - Borehole Location Plan & Embankment Profile

The subsurface conditions revealed by the investigation program are summarized in Table 2 below and on the stratigraphic profile presented on Drawing No. 2 (Appendix A) and on the detailed Records of Borehole Logs (Appendix B). It should be noted that the stratigraphic delineation presented on the borehole logs and soil strata plot is interpreted from the results of non-continuous sampling, response to drilling progress, recorded SPT 'N'-values, plus field observations. Typically, such boundaries represent transitions from one zone to another and are not an exact demarcation of specific geological units. Additional consideration should be given to the fact that subsurface conditions may vary markedly between adjacent boreholes and beyond any specific boring location and are shown on the drawings for illustration purposes only.

This drawing is for subsurface information only. Surface details and features are for conceptual illustration. The proposed structure location is shown for illustration purposes only and may not be consistent with the final design configuration as shown elsewhere in the Contract Documents.

The fieldwork for this investigation included four (4) sampled boreholes (BH) were advanced. BH Nos. 1 and 2 were advanced in the roadway shoulders through the embankment. BH Nos. 3 and 4 were advanced at the inlet (Rt) and outlet (Lt) ends of the culvert, respectively. The locations of the boreholes are shown on Drawing No. 2 in Appendix A and are provided in the Table below.

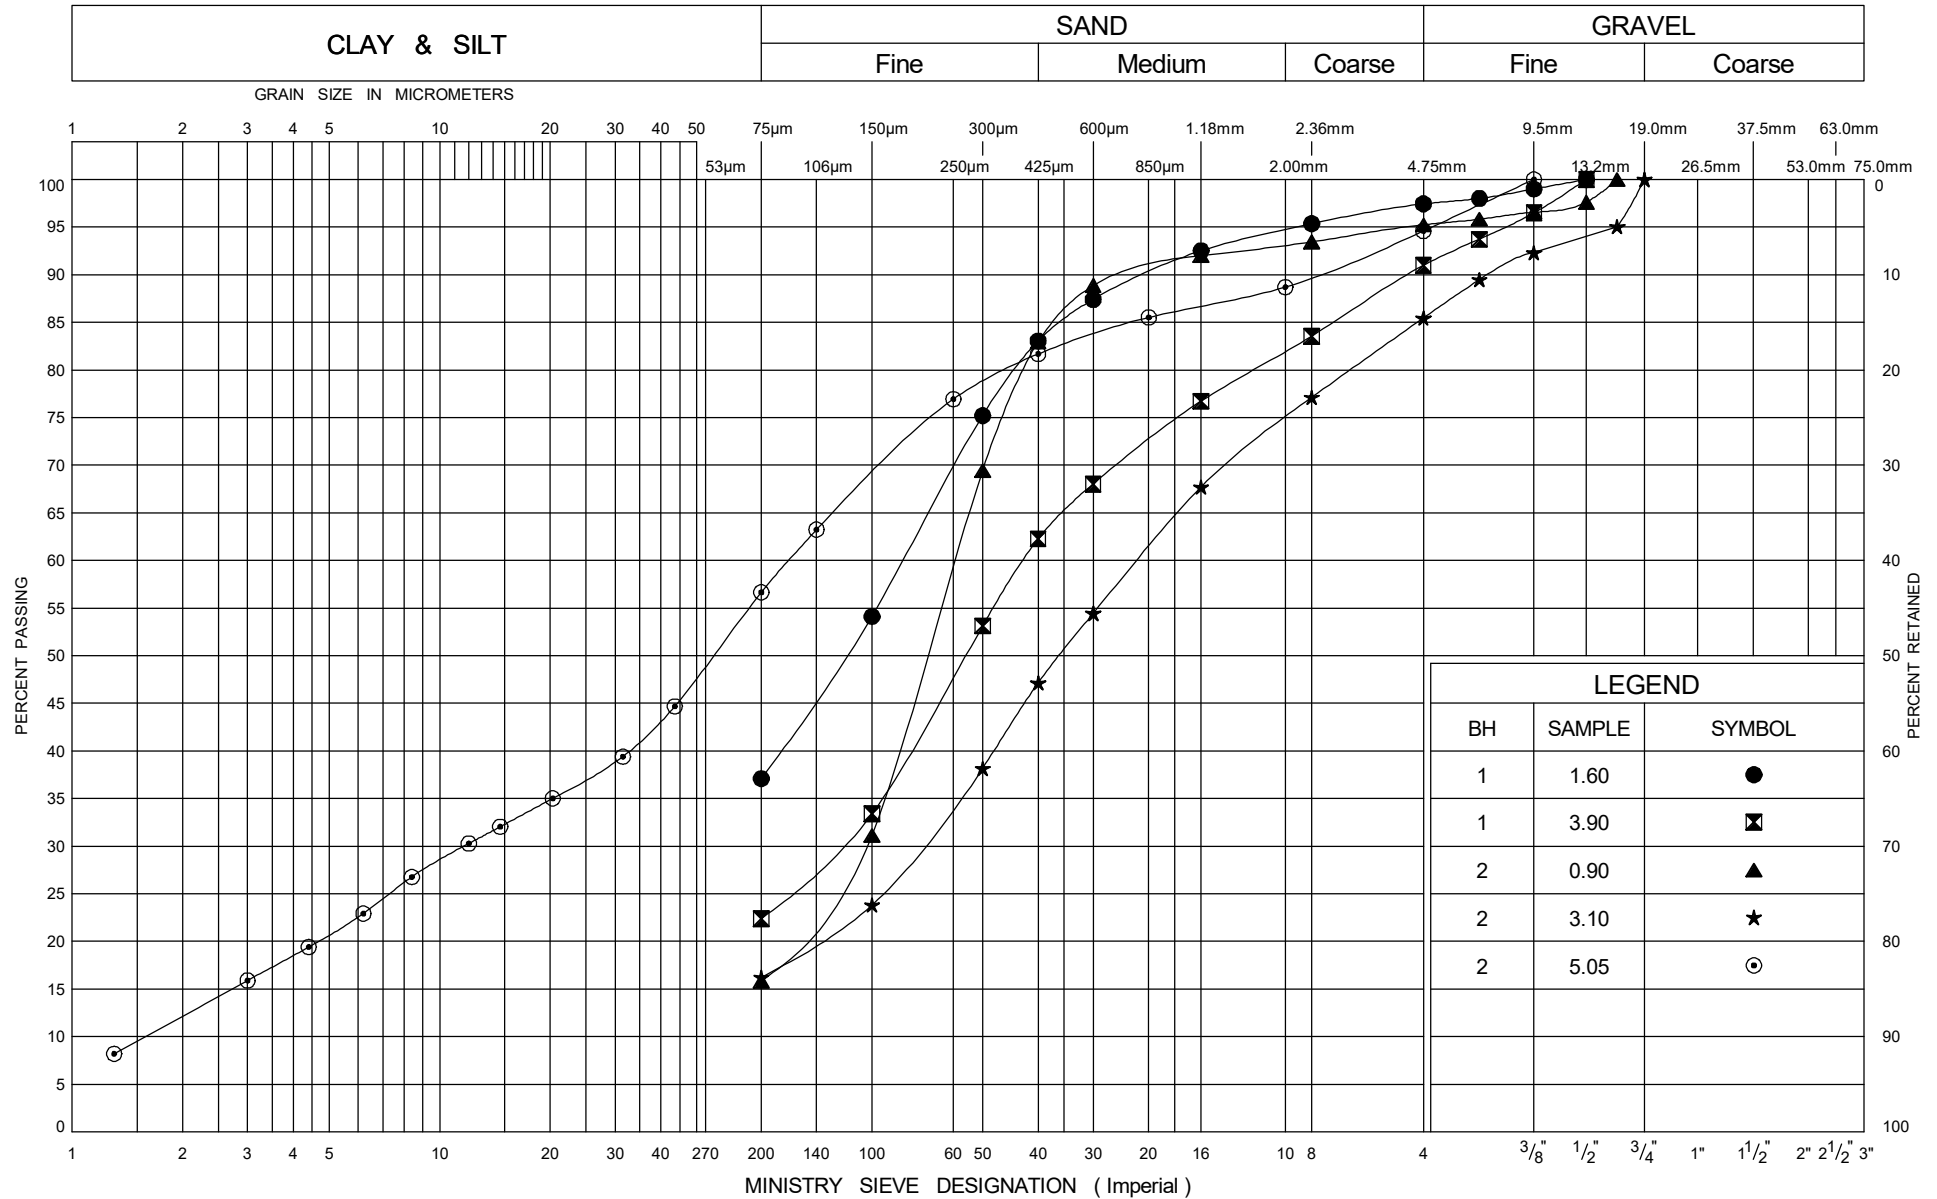
GRAIN SIZE DISTRIBUTION

FILL - SAND to SANDY SILT

The embankment fill, immediately below the asphalt layer, is mainly composed of brown sand with different portions of silt and clay. The sand fill layer extended to approximately 4.6 to 5.3 m depth. This sand fill layer was almost dry with approximate moisture content of 7 to 15% measured in the geotechnical laboratory. The results for grain size analyses of representative samples comprising the sand fill layer are summarized in Table 3 and presented on Figure No. L-1, Appendix C.

The sandy silt fill deposit was observed to be brown and moist, and was generally very loose on recorded SPT 'N' value of 1 blow/300 mm. A representative soil sample from this sandy silt fill layer was subjected to grain size analysis and the results are summarized in Table 5 and provided in Figure No. L-1, Appendix C.

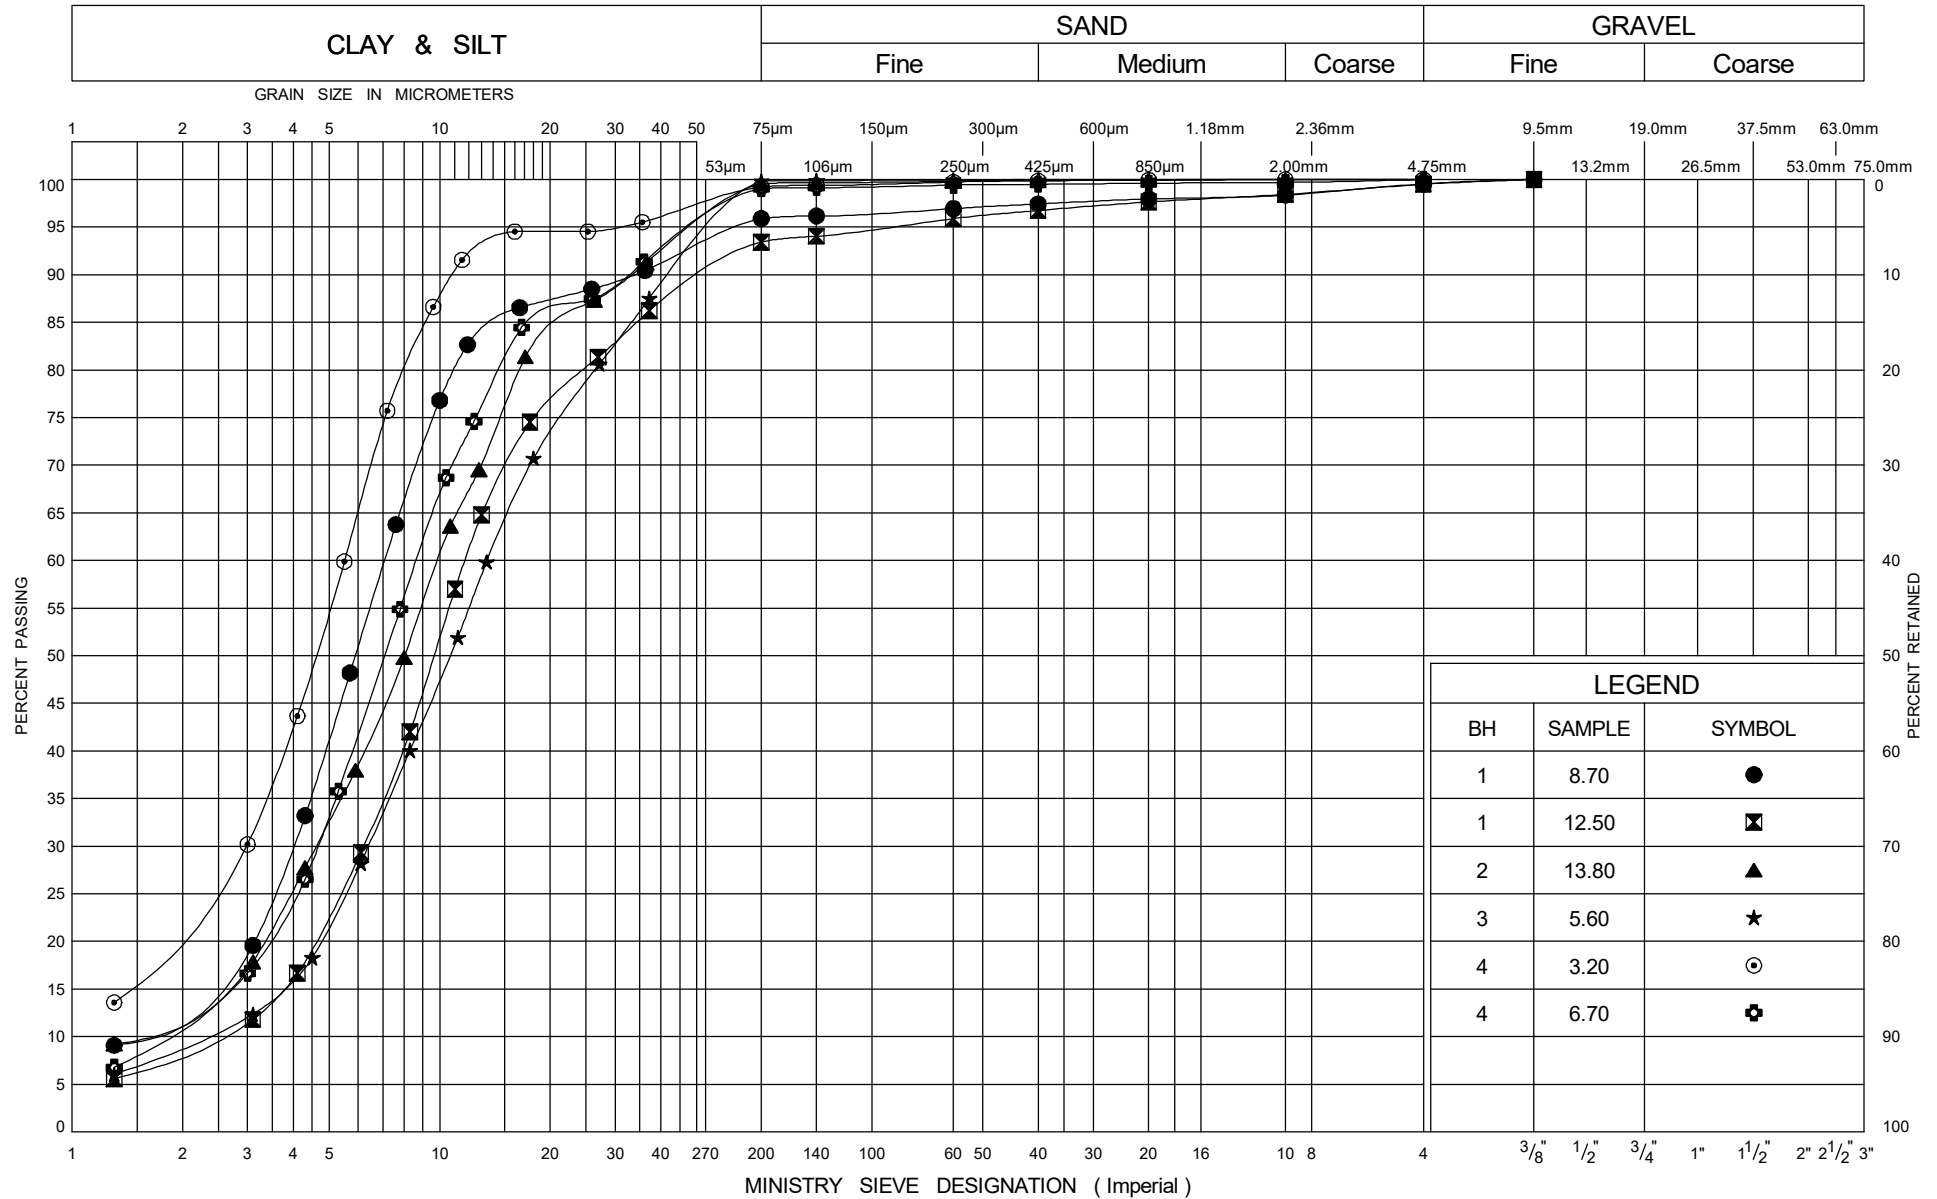
GRAIN SIZE DISTRIBUTION

SILT

The natural moisture contents measured on samples recovered from the deposit ranged from 21 to 43%. Gradation analyses and Atterberg's Limits were carried out on six (6) samples of this deposit, and the results are summarized in Table 8 and provided in Figure Nos. L-2 and L-5, Appendix C.

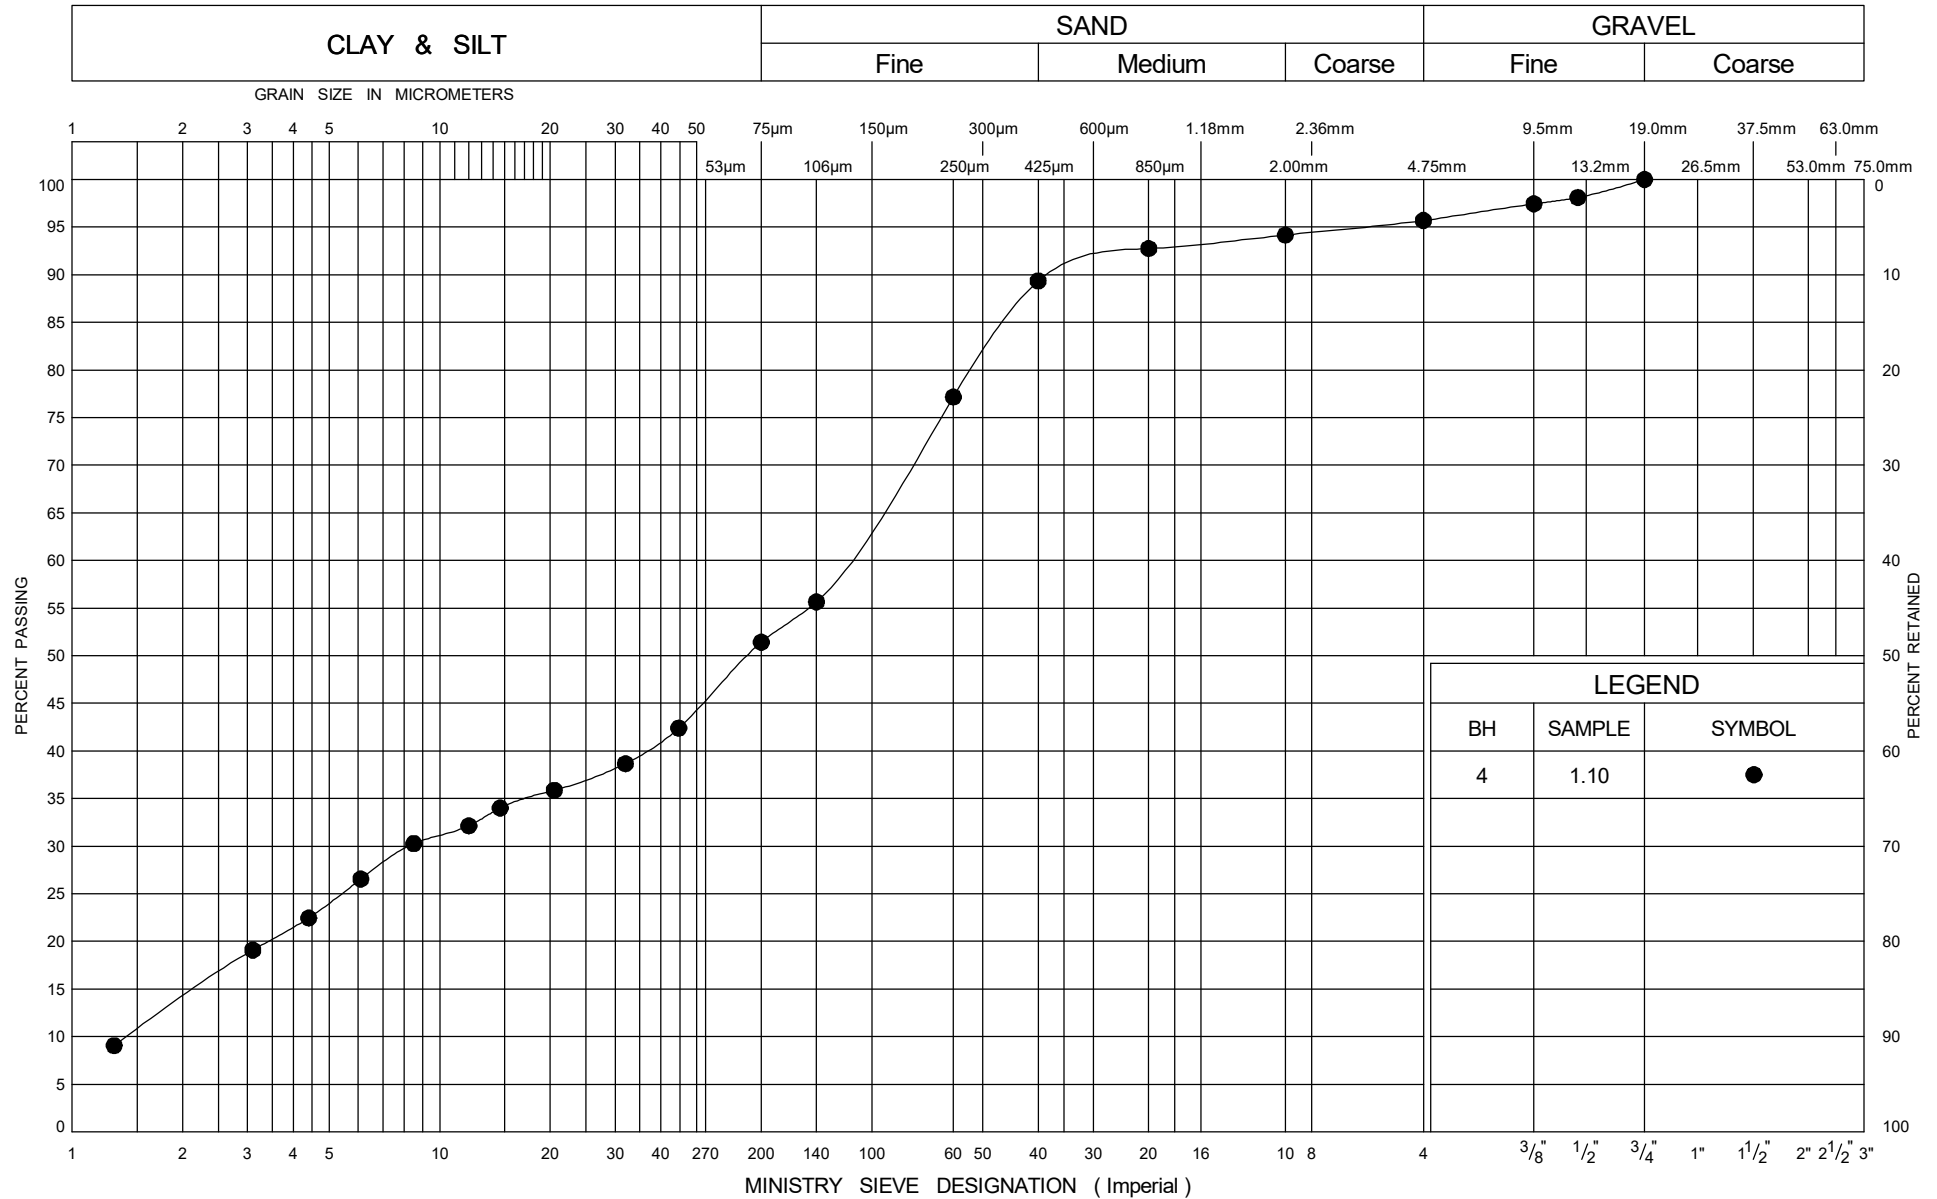
GRAIN SIZE DISTRIBUTION

SILTY SAND

The natural moisture contents measured on a sample recovered from this deposit is 48%. One gradation (hydrometer) analysis was carried out on a sample from this deposit, and the results is summarized in Table 6 and provided in Figure No. L-4, Appendix C.

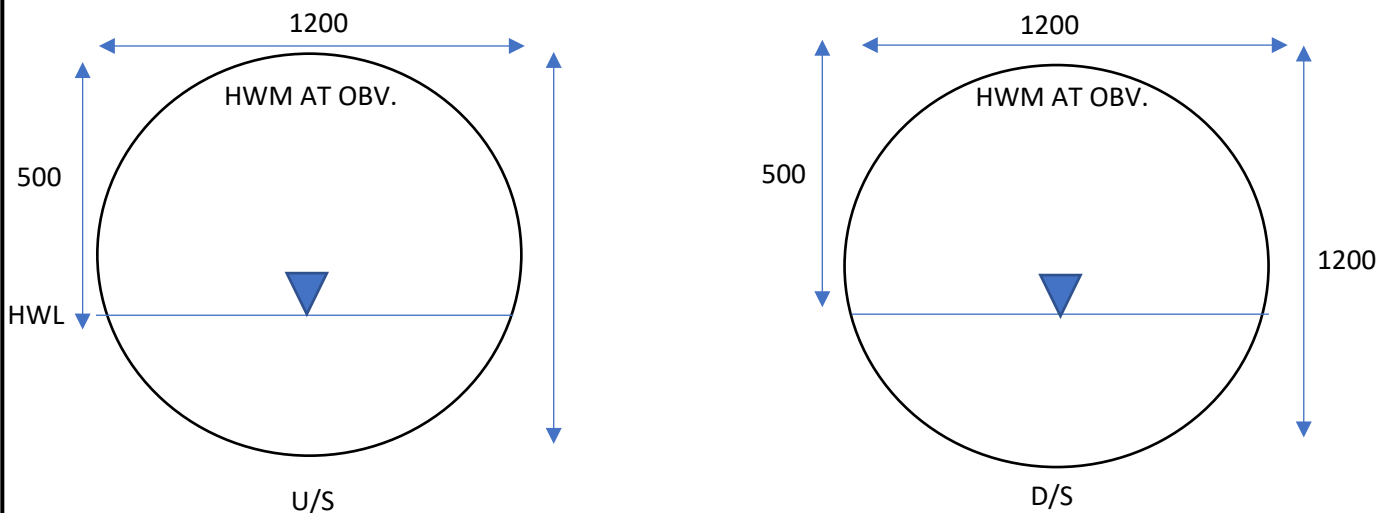
Site Sketch –

Corrugated Steel Pipe through a Creosote Timber Box Culvert (Culvert #22) @ 16+215

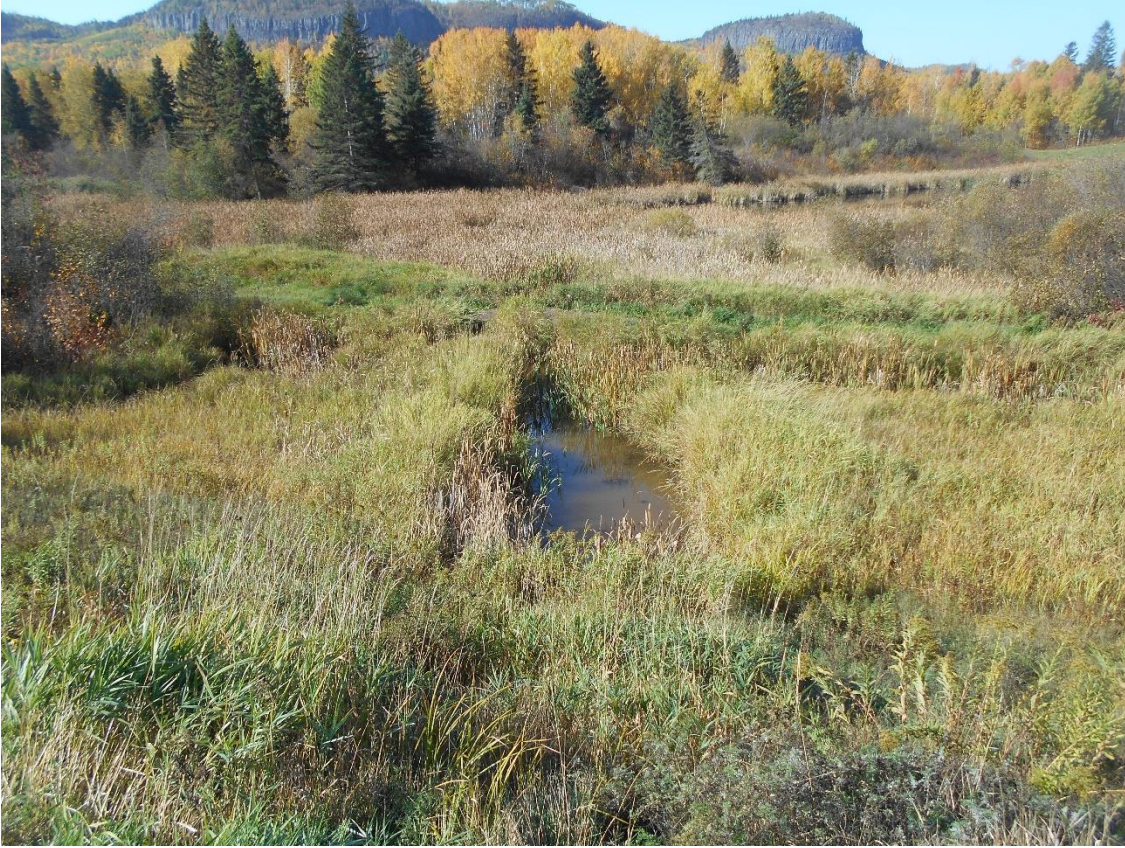
Bank Conditions (stability) – Erosion and scour holes on both ends

C22 - #3 – Downstream Channel Conditions

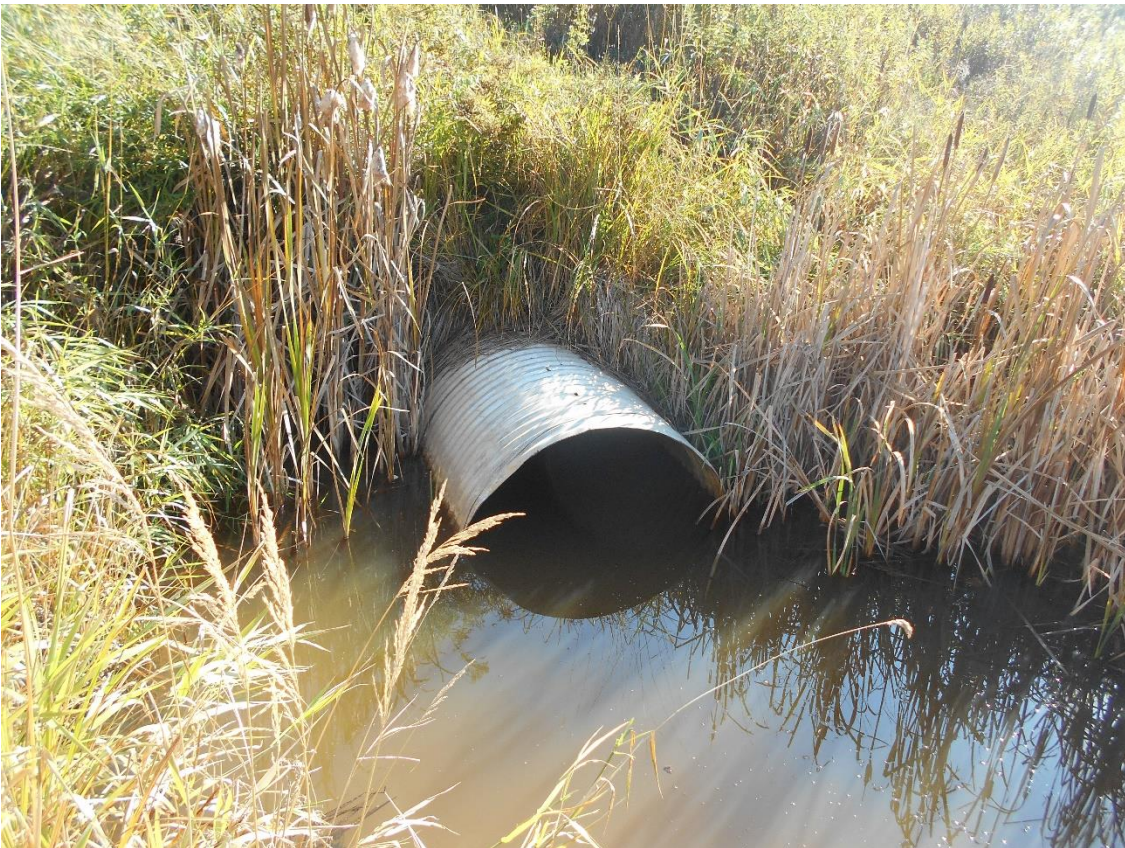
Physical Culvert Condition (rust, damage, etc.) – Damaged, rust and sagging

C22 - #4 – Downstream Face of the Culvert

Culvert Appearance (general comments) – Replace
