# Foundation Investigation Report (FIR)

Highway 61 Culvert Replacement

Station 20+200, Township of Blake

GWP 6176-15-00

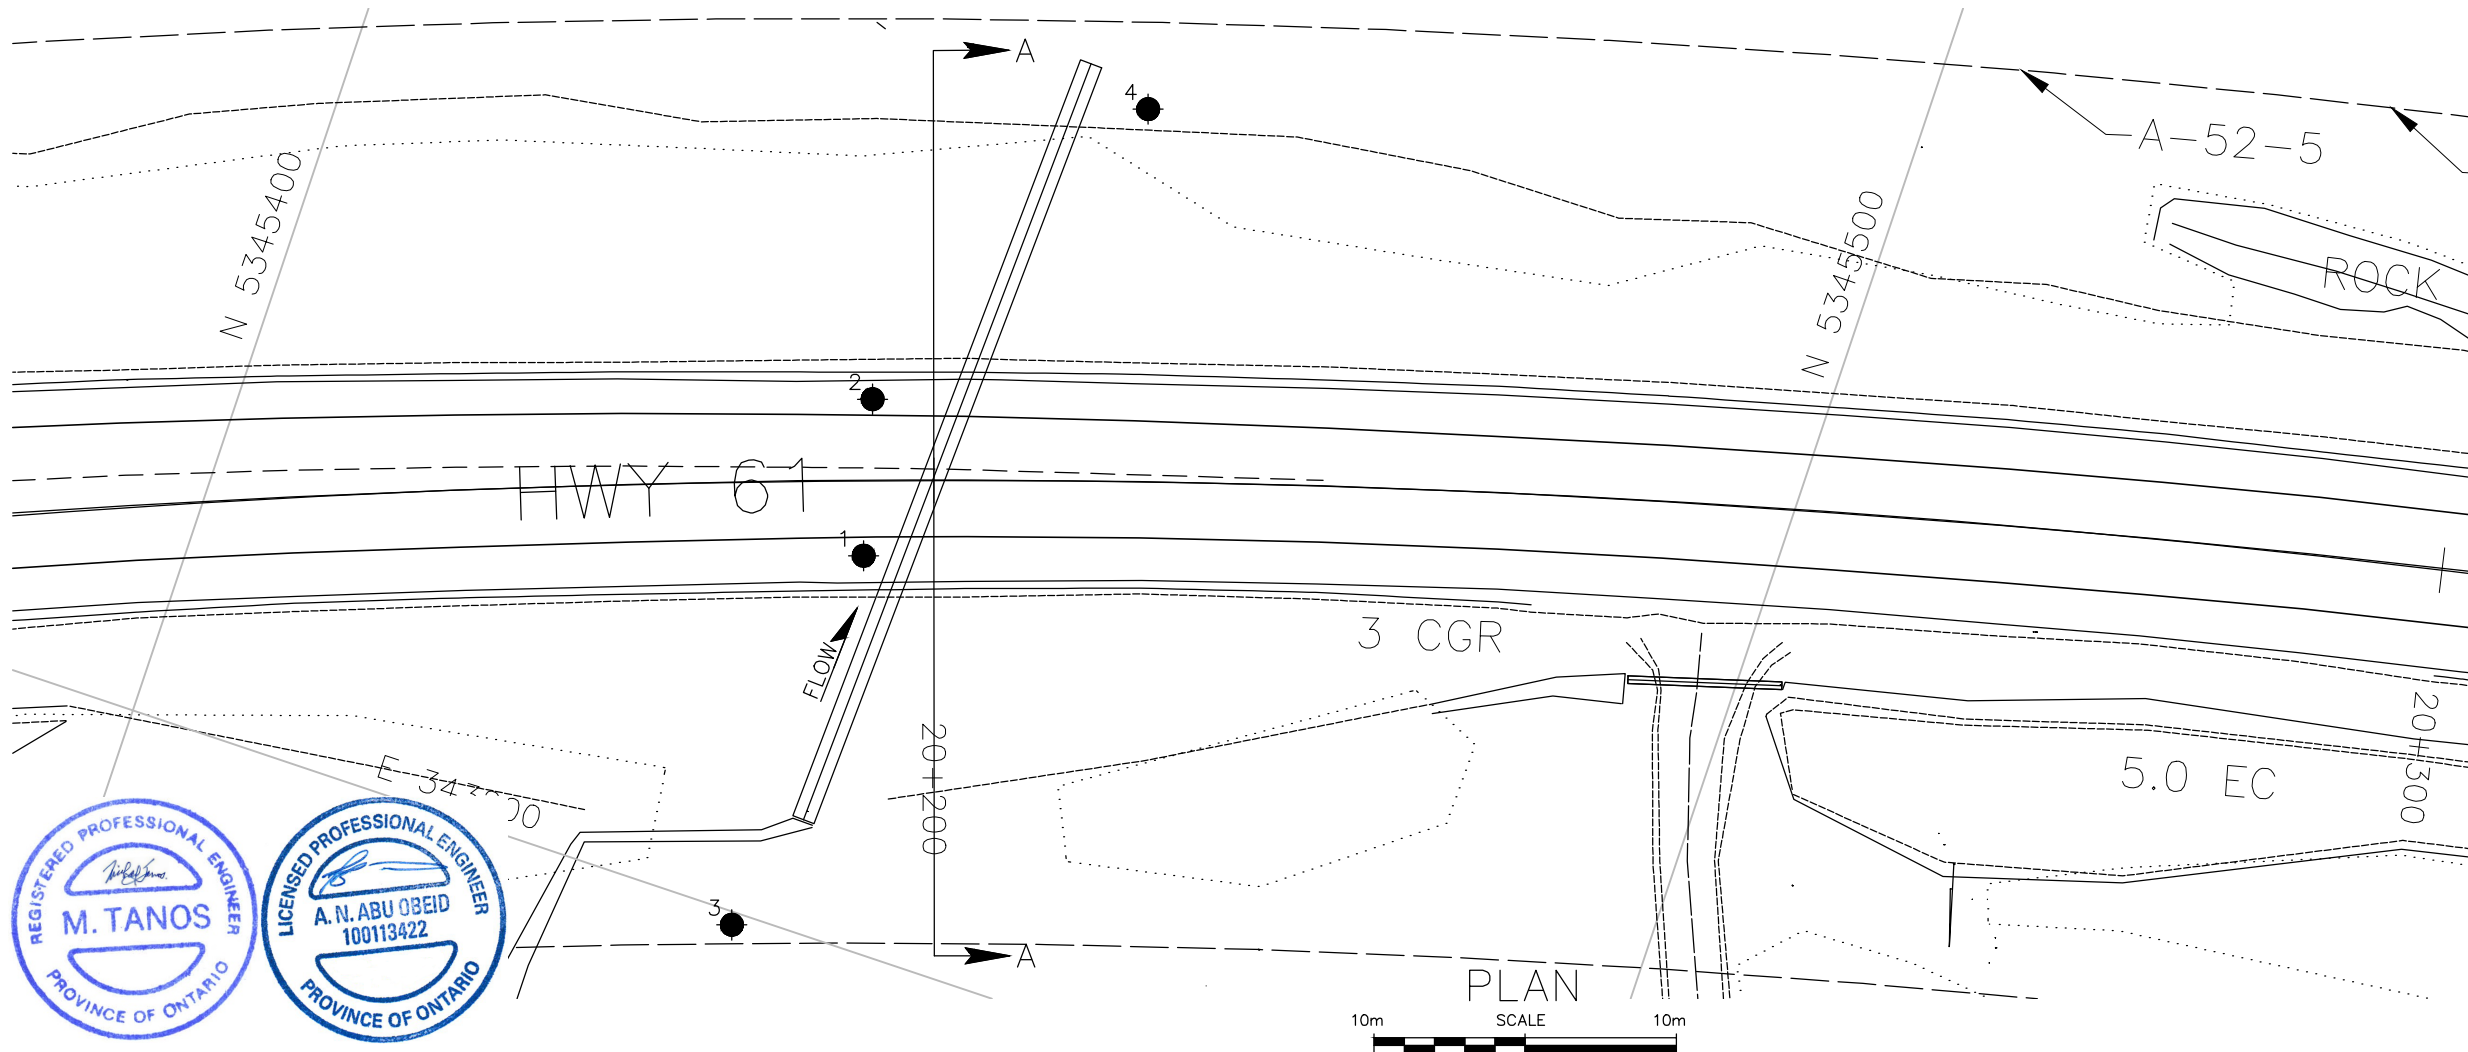
Drawing No. 2 - Borehole Location Plan & Embankment Profile

The existing culvert structure is crossing Highway 61 at almost an approximate 20° skewed alignment from east (upstream) to west (downstream). The existing culvert structure is 1400 mm wide and 1375 mm high at the upstream and 1400 mm wide and 1140 mm high at the downstream, as shown on Drawing No. 2 in Appendix A and described in detail and shown on the sketches and Figures in GF Culvert Inspection Report in Appendix D. The culvert edges extend out beyond the embankment without wing walls. The channel dimensions were described by GF in general as 1 m wide channel with banks at 2H:1V and water depth of 50 mm upstream (US) and downstream (DS). The top of the culvert elevations at the inlet and outlet are El. 226.7 and El. 225.1 m, respectively with clearance of 1325 mm and 1140 mm (i.e. dry), respectively. Flow through the culvert is from east/right (Rt) to the west/left (Lt) as shown on Drawing No. 2 in Appendix A.

The subsurface conditions revealed by the investigation program are summarized in Table 2 below and on the stratigraphic profile presented on Drawing No. 2 (Appendix A) and on the detailed Records of Borehole Logs (Appendix B). It should be noted that the stratigraphic delineation presented on the borehole logs and soil strata plot is interpreted from the results of non-continuous sampling, response to drilling progress, recorded SPT 'N'-values, plus field observations. Typically, such boundaries represent transitions from one zone to another and are not an exact demarcation of specific geological units. Additional consideration should be given to the fact that subsurface conditions may vary markedly between adjacent boreholes and beyond any specific boring location and are shown on the drawings for illustration purposes only.

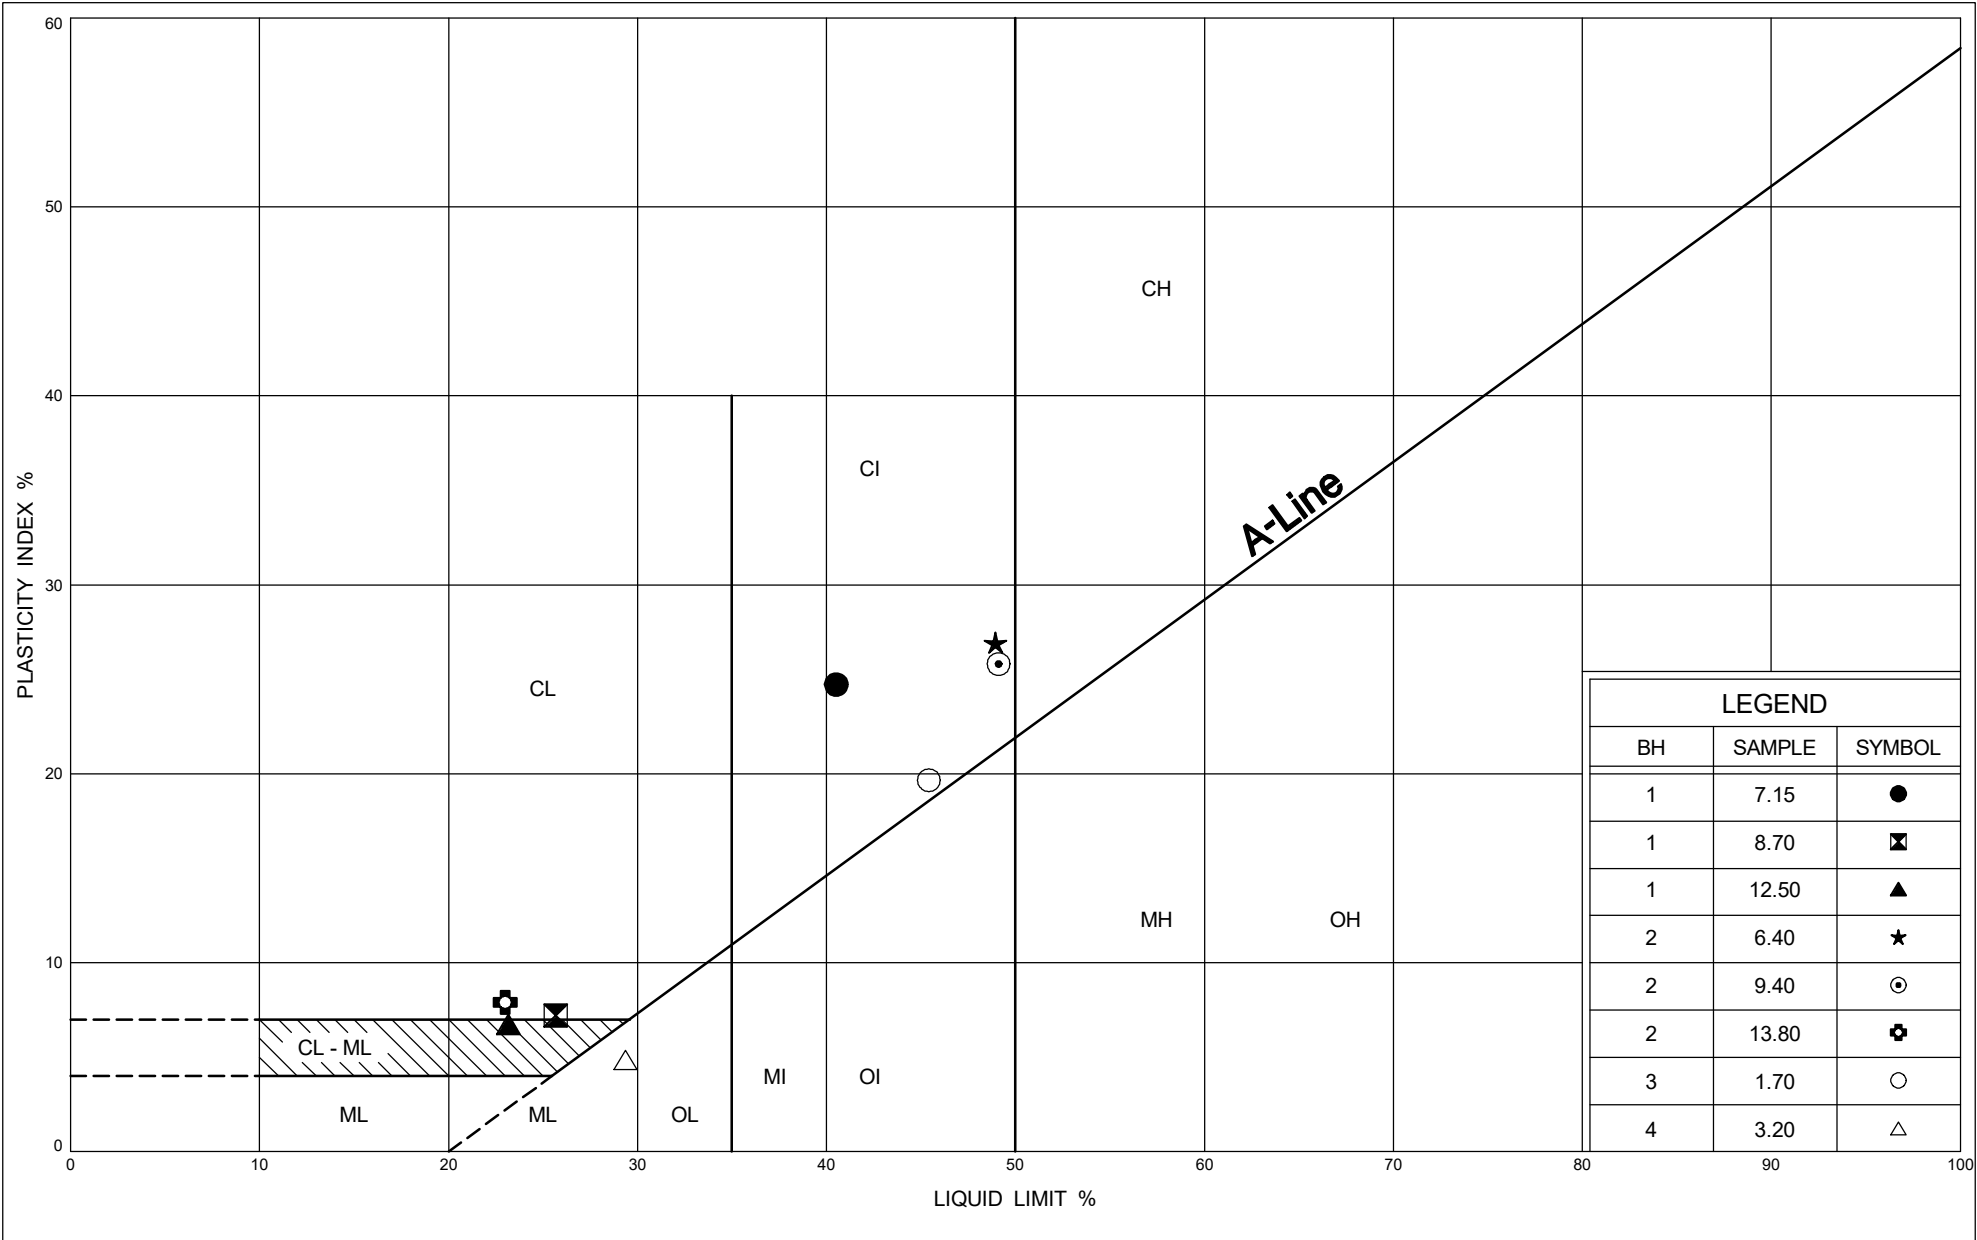
Figure No. L-5  
GWP #6176-15-00  
Highway 61, NWR

PLASTICITY CHART

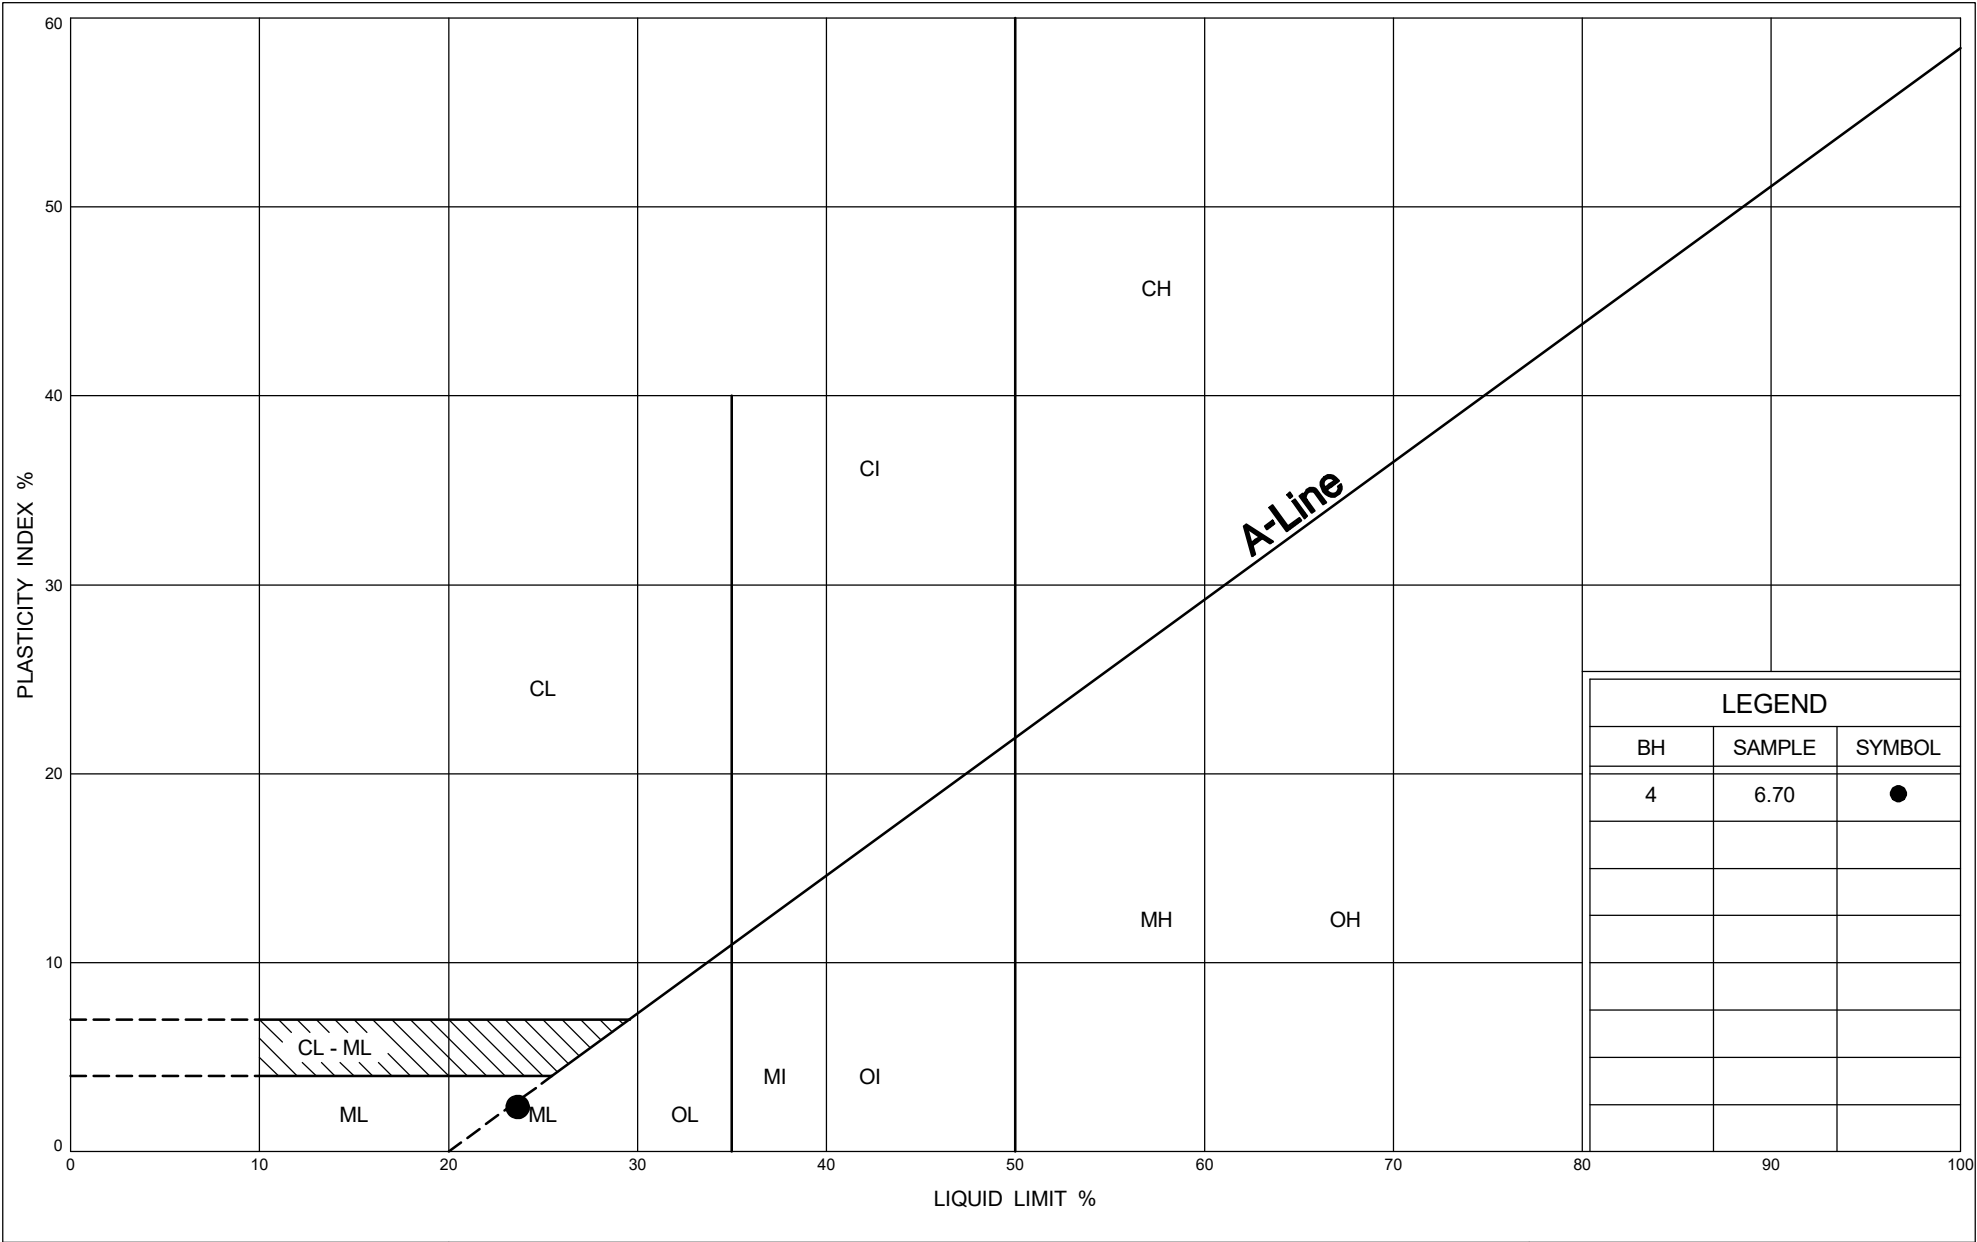
Figure No. L-6  
GWP #6176-15-00  
Highway 61, NWR

PLASTICITY CHART

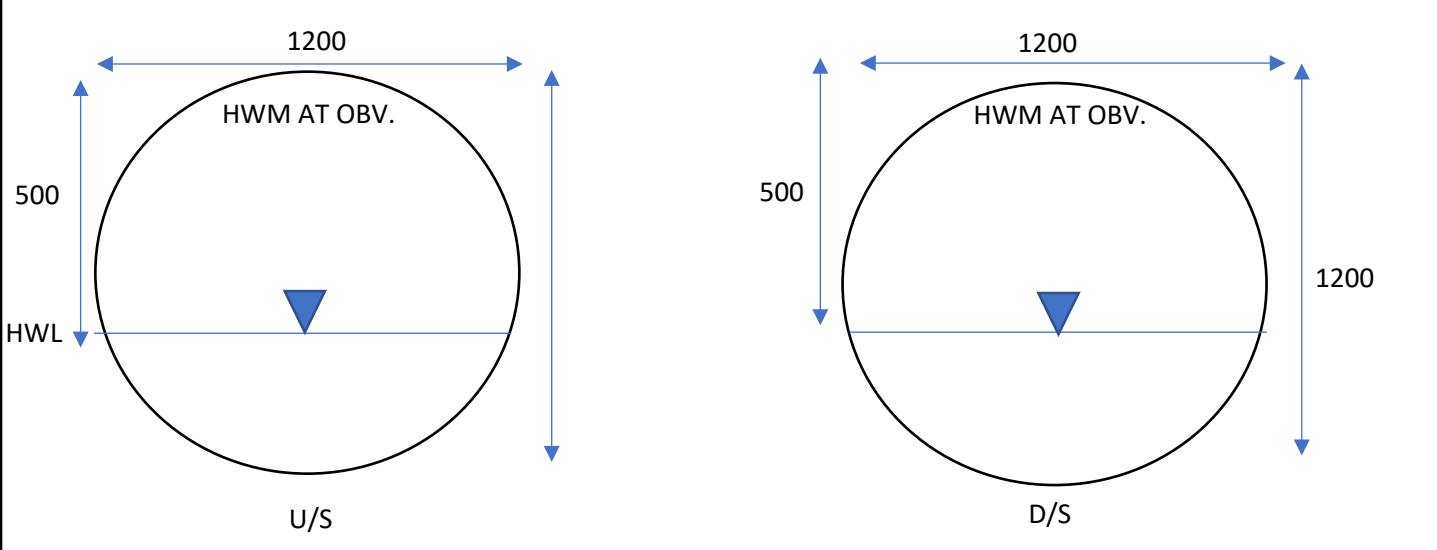
**Corrugated Steel Pipe through a Creosote Timber Box Culvert (Culvert #22) @ 16+215**

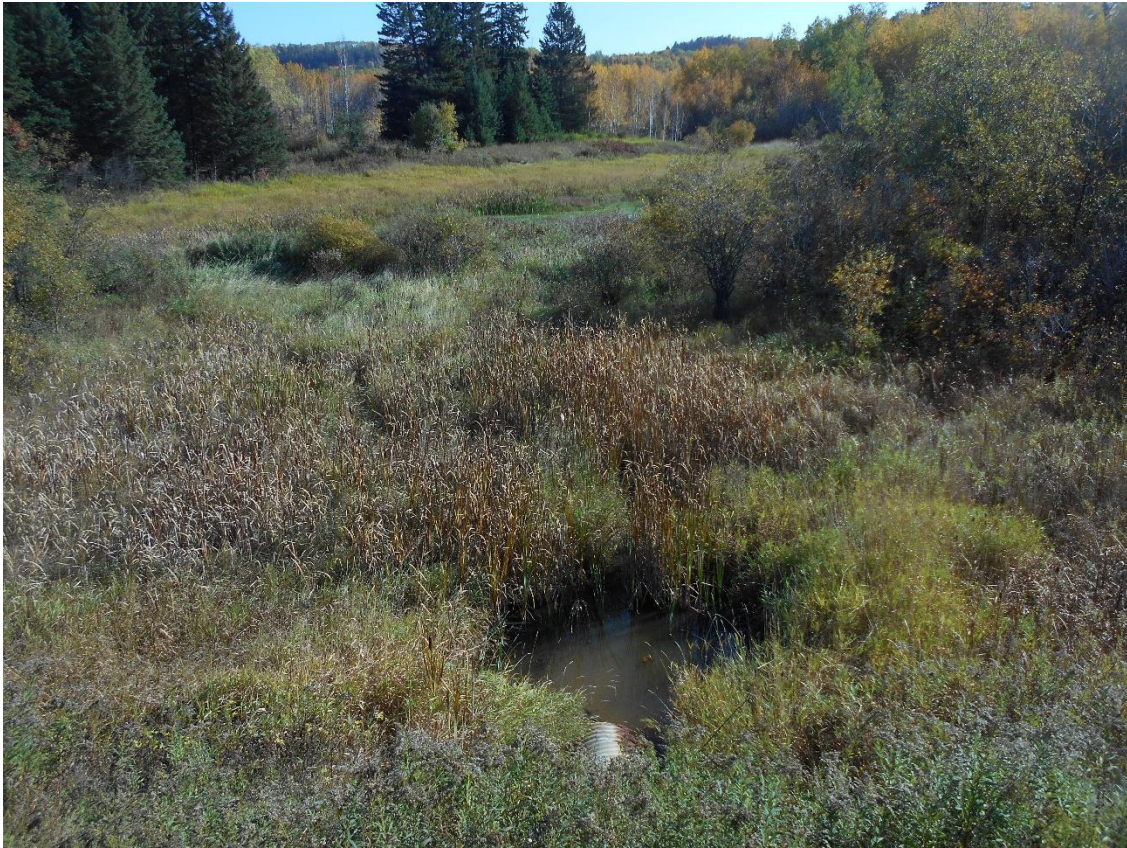
**C22 - #1 – Upstream Channel Conditions**

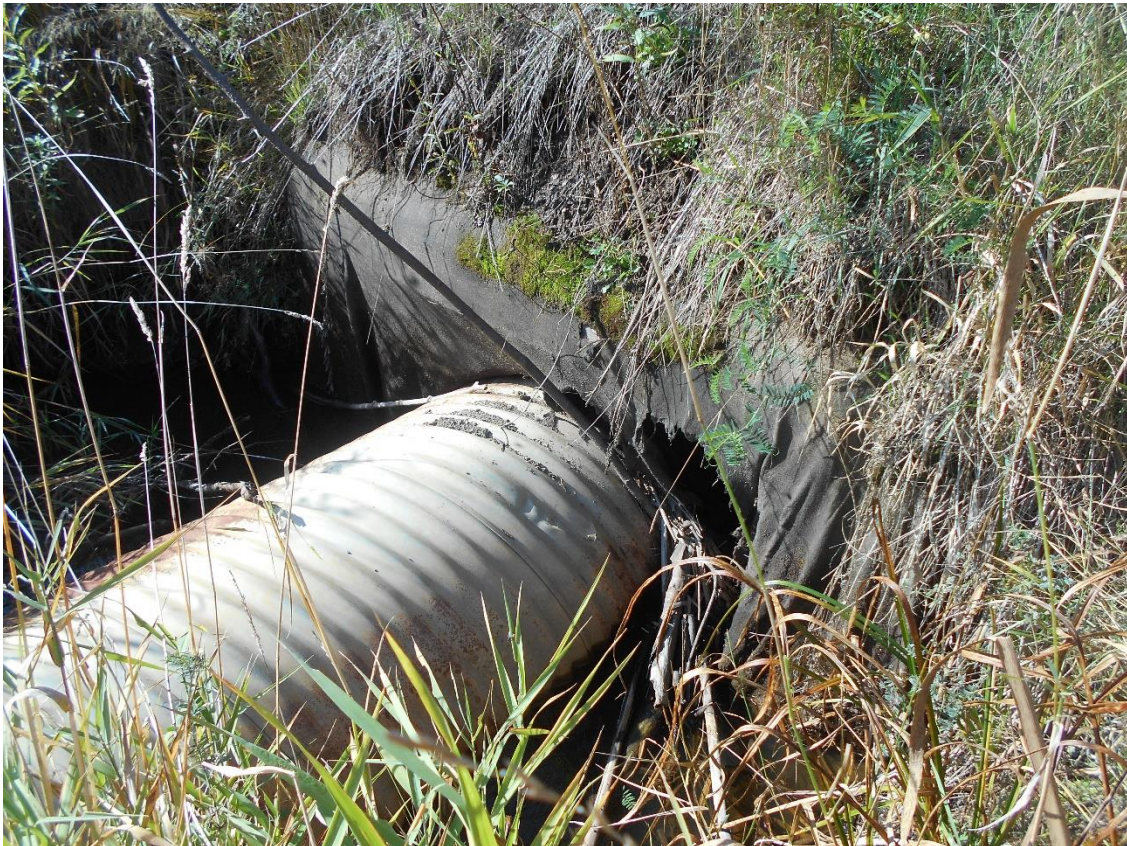
**C22 - #2 – Upstream Face of the Culvert**

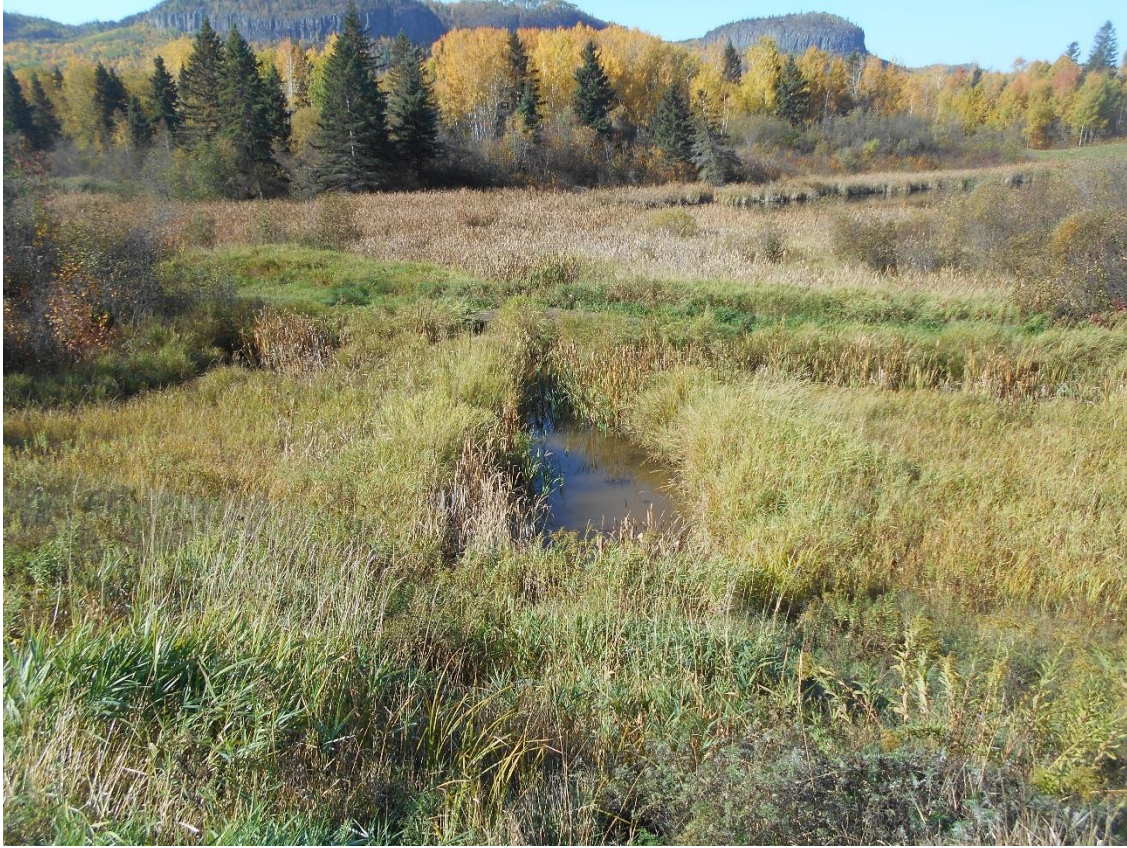
**C22 - #3 – Downstream Channel Conditions**

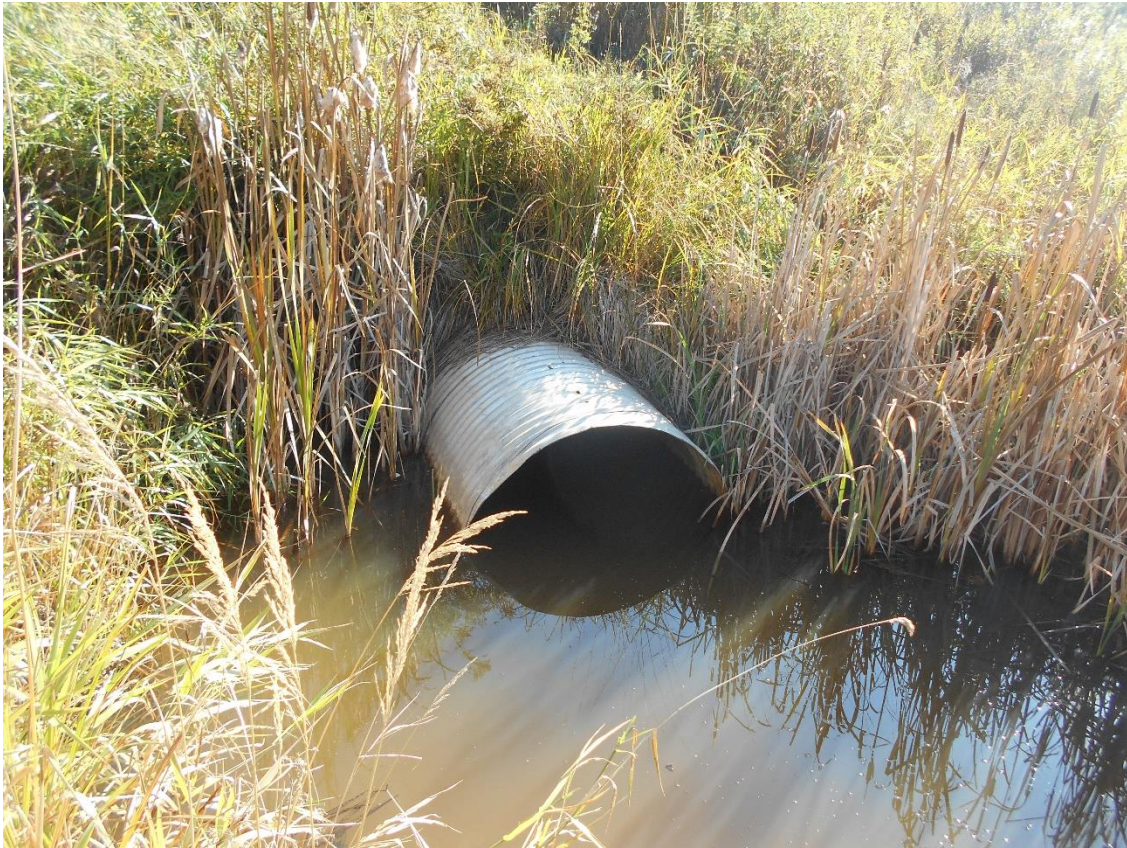
**C22 - #4 – Downstream Face of the Culvert**
