Final Foundation Investigation Report (FIR)

Highway 61 Culvert Replacement

Station 20+375, Township of Blake

September 15, 2022

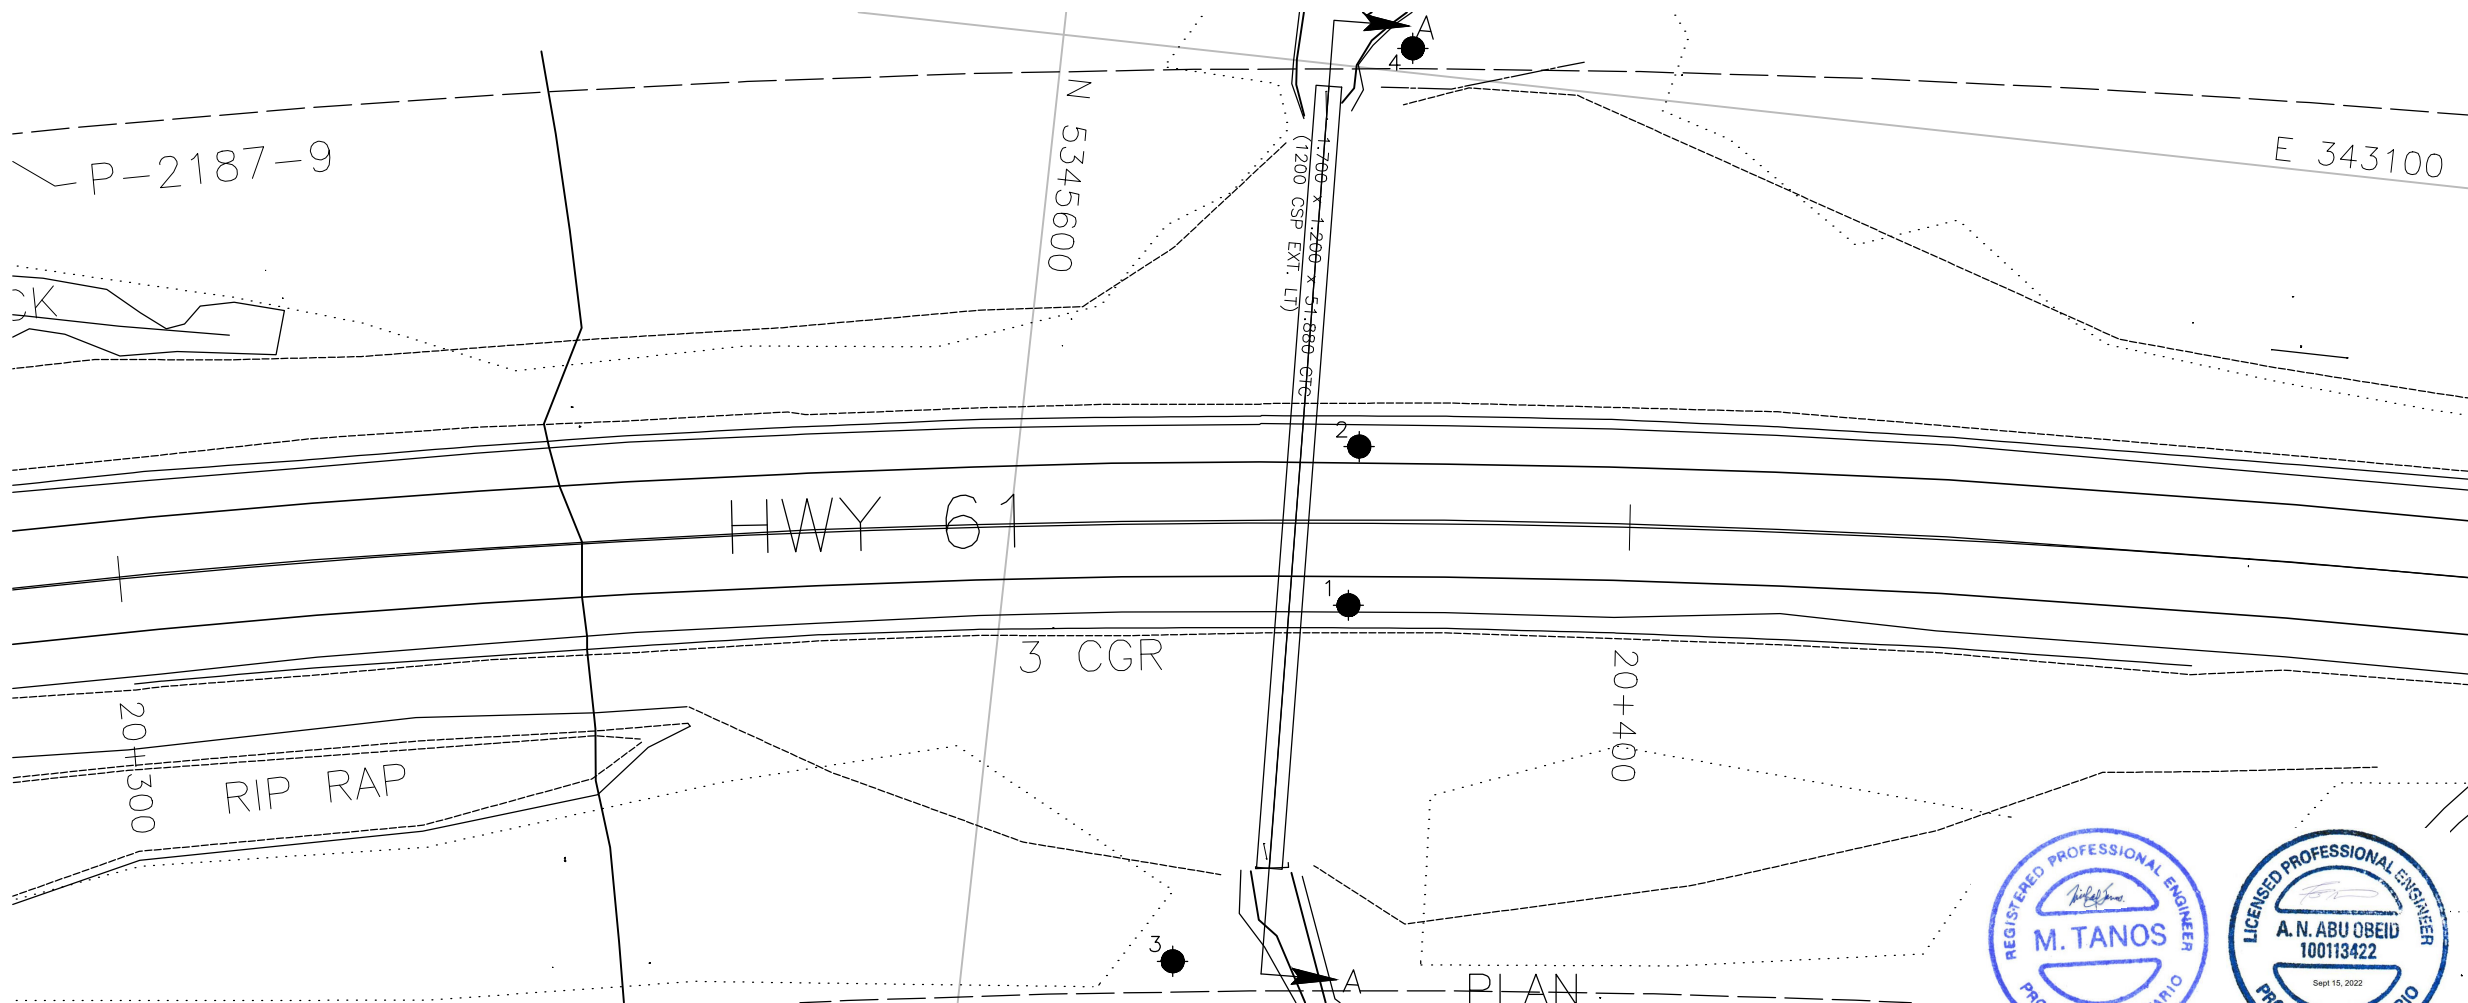
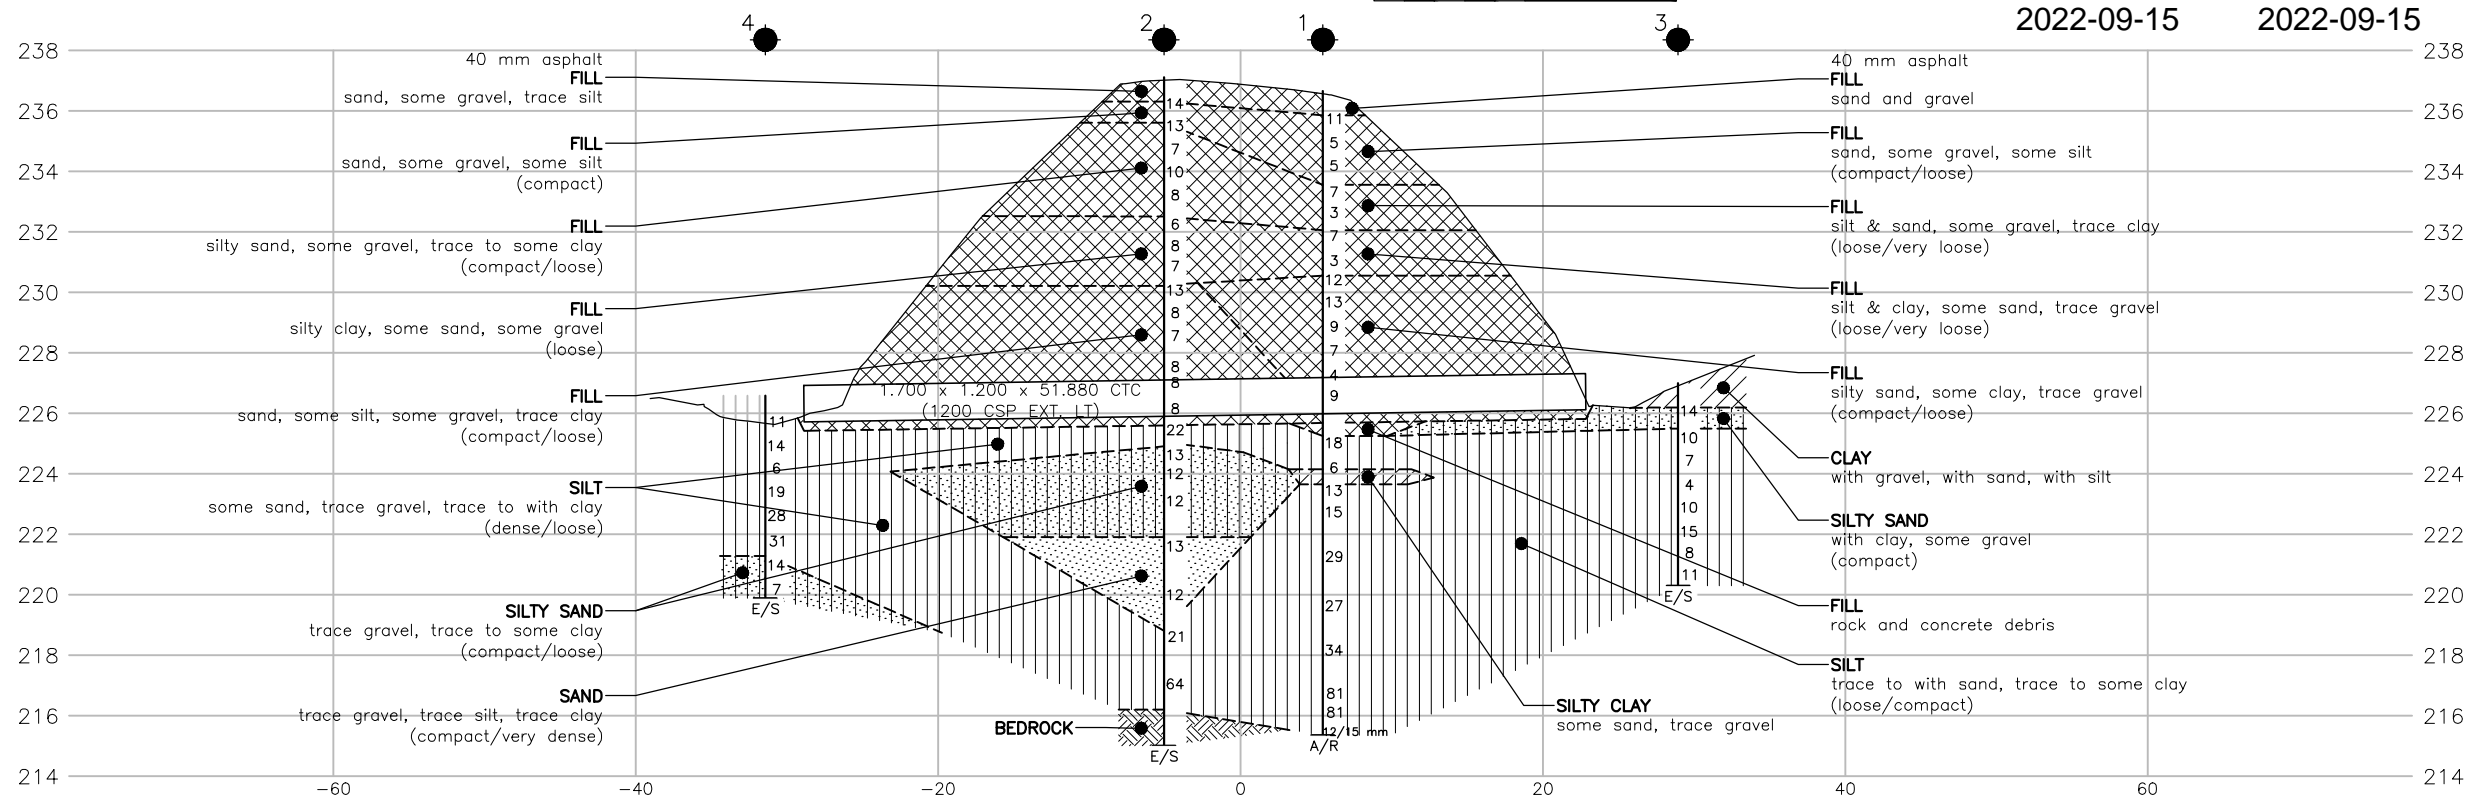
SECTION A-A, STATION 20+375

REHABILITATION OF HWY 61
CULVERT REPLACEMENT
STATION ±20+375
BOREHOLE LOCATIONS
AND SOIL STRATIGRAPHY

The existing culvert consists of two sections of undermined length. The first section (upstream) is a 1.7 m wide and 1.2 m high Creosoted Timber Culvert (CTC) at the inlet, and the second section (downstream) is a 1.2 m diameter Corrugated Steel Pipe (CSP) at the outlet extending beyond the existing embankment slope, as shown on Drawing No. 2 in Appendix A and described in detail and shown on the sketches and Figures in Gannett Fleming (GF) Culvert Inspection Report in Appendix D. The existing CTC culvert at the inlet was observed to be deteriorated and deformed. The existing CSP culvert barrel at the outlet invert is corroded and its springline is very severely corroded and damaged. The channel dimensions were described by GF in general as 2 m wide channel upstream (US) with banks at ~3H:1V and water depth of 130 mm; and 5 m wide channel downstream (DS) with banks at 3H:1V, 400 mm of water. The top of the culvert elevations at the inlet and outlet are El. 227.3 and El. 226.9 m, respectively with clearance of 1030 mm and 822 mm, respectively. Flow through the culvert is from east/right (Rt) to the west/left (Lt) as shown on Drawing No. 2 in Appendix A.

The fieldwork for this investigation included four (4) sampled boreholes (BH) were advanced. BH Nos. 1 and 2 were advanced in the roadway shoulders through the embankment. BH Nos. 3 and 4 were advanced at the inlet (Rt) and outlet (Lt) ends of the culvert, respectively. The locations of the boreholes are shown on Drawing No. 2 in Appendix A and are provided in the Table below.

The subsurface conditions revealed by the investigation program are summarized in Table 2 below and on the stratigraphic profile presented on Drawing No. 2 (Appendix A) and on the detailed Records of Borehole Logs (Appendix B). It should be noted that the stratigraphic delineation presented on the borehole logs and soil strata plot is interpreted from the results of non-continuous sampling, response to drilling progress, recorded SPT 'N'-values, plus field observations. Typically, such boundaries represent transitions from one zone to another and are not an exact demarcation of specific geological units. Additional consideration should be given to the fact that subsurface conditions may vary markedly between adjacent boreholes and beyond any specific boring location and are shown on the drawings for illustration purposes only.

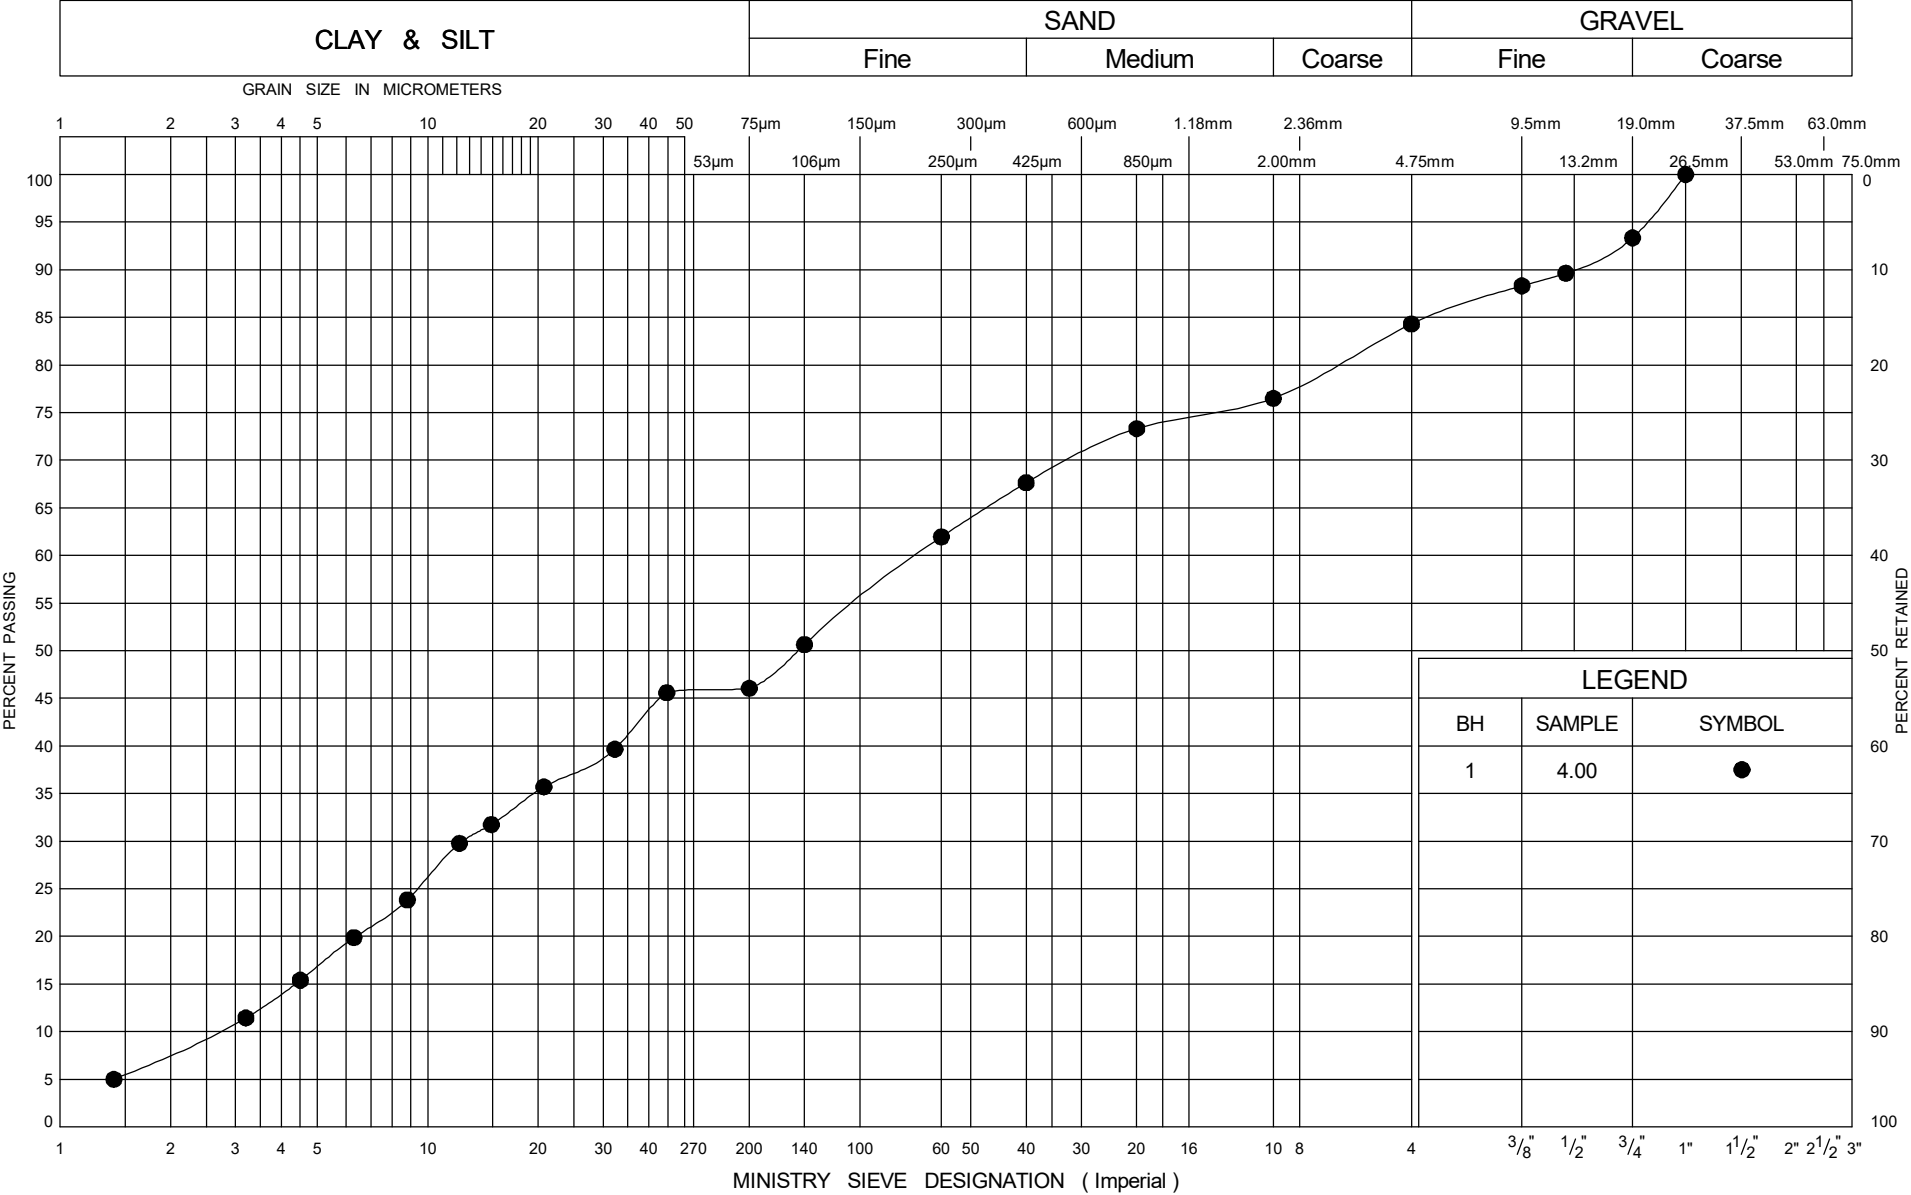
GRAIN SIZE DISTRIBUTION

FILL - SILT & SAND

The embankment fill, immediately below the pavement structure, is mainly composed of brown sand/silty sand with variable portions of gravel and clay. This fill layer was approximately 4.3 m thick and extended down to approximate El. 232.1 m in Borehole No. 1. The moisture content of this upper fill layer varied from moist near top to wet (approximately 16%) near bottom. The results for grain size analyses of representative samples of two component soil types comprising the embankment fill are summarized in Table 3 and presented on Figure Nos. L-1 and L-2 in Appendix C.

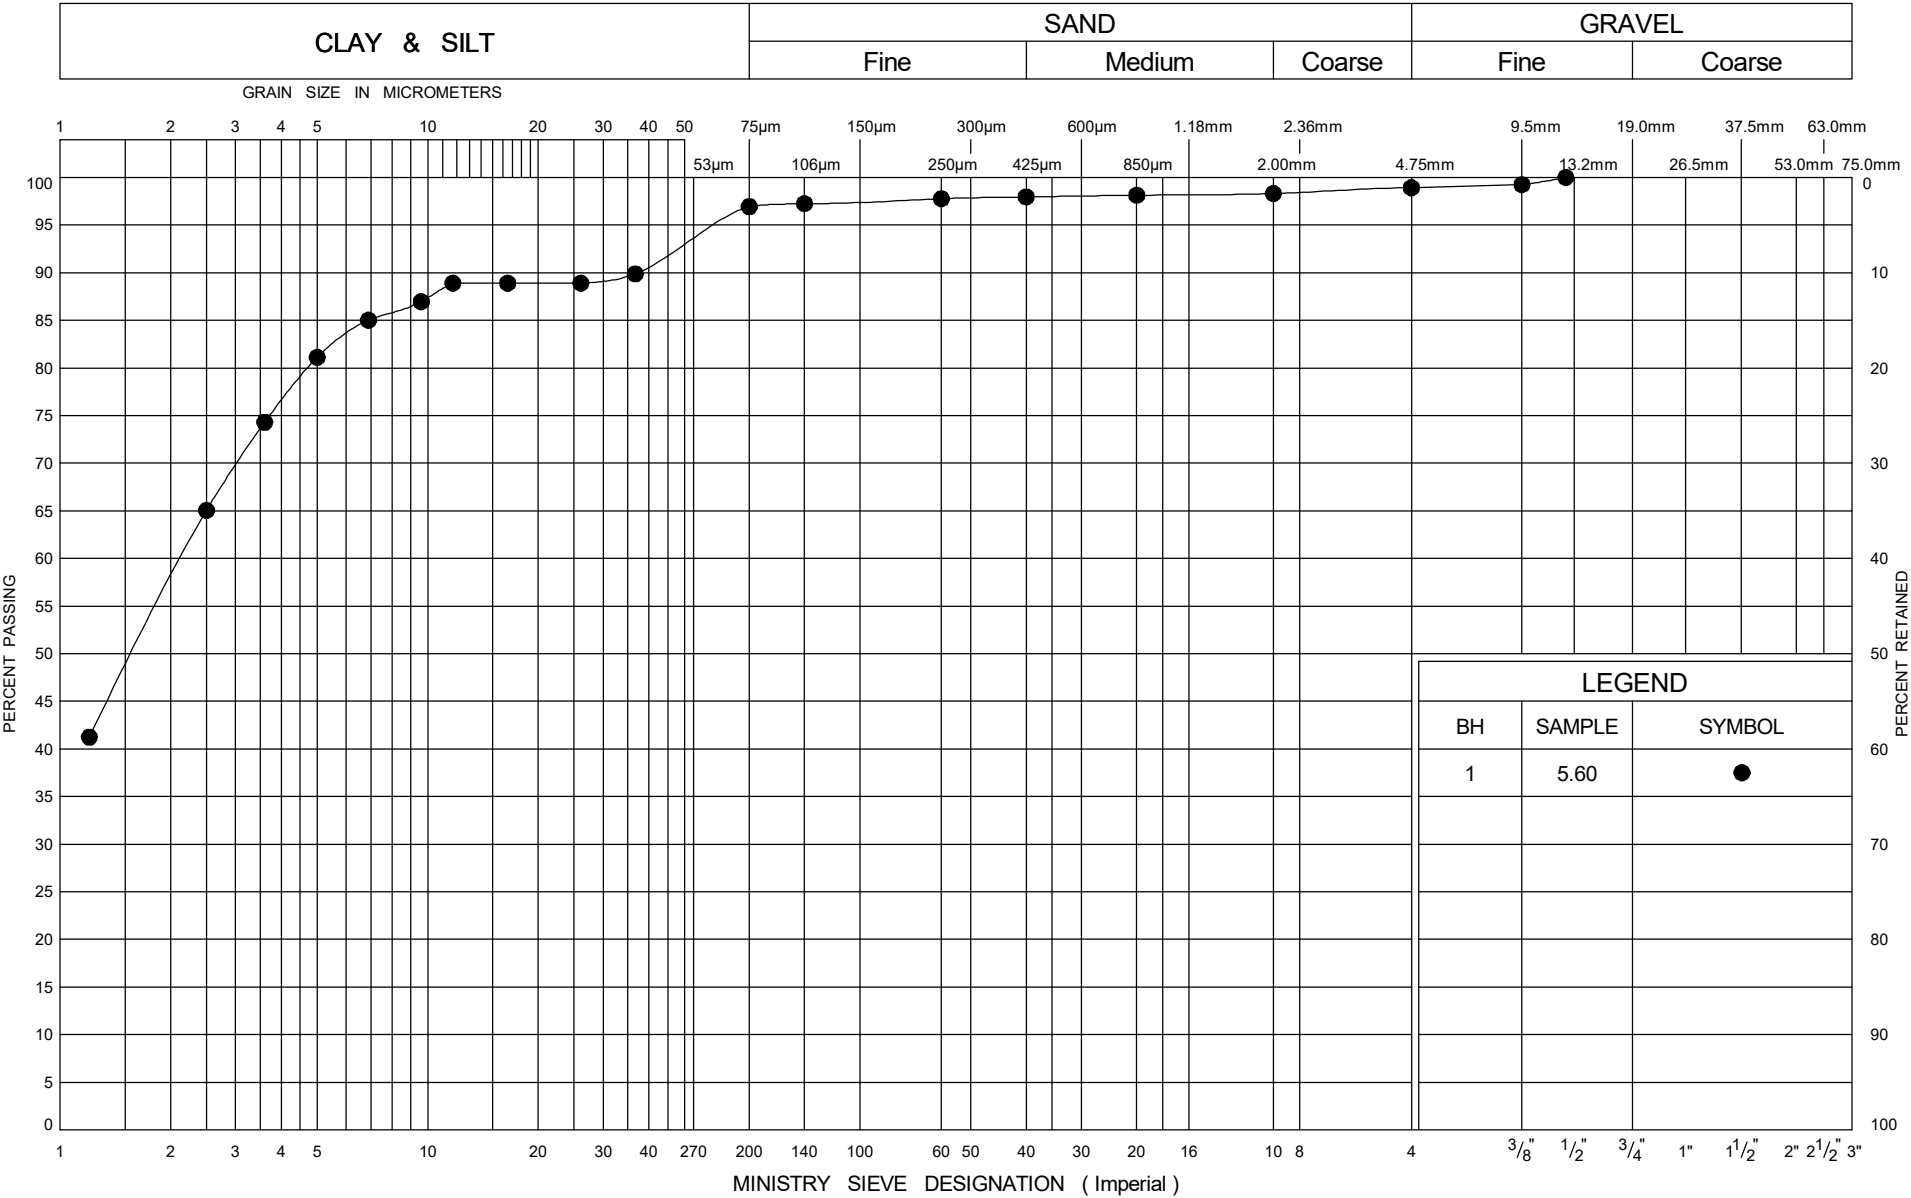
GRAIN SIZE DISTRIBUTION

FILL - SILT & CLAY

The upper sand/silty sand fill was underlain by silty clay fill approximately 1.5 m to 2.3 m thick which extended down to approximately El. 230.3 m (lowest) in Borehole No. 2. The silty clay fill included minor portions of sand and gravel. It was reddish brown in colour with its in-situ moisture content measured at approximately 40%. A representative soil sample of this layer was subjected to grain size analysis and Atterberg limits tests (Liquid Limit (LL), Plastic Limit (PL) and Plasticity Index (PI)) and the results are summarized in Table 4 and presented on Figure Nos. L-3 and L-8, Appendix C. This silty clay fill layer can be classified as clay of high plasticity (CH).

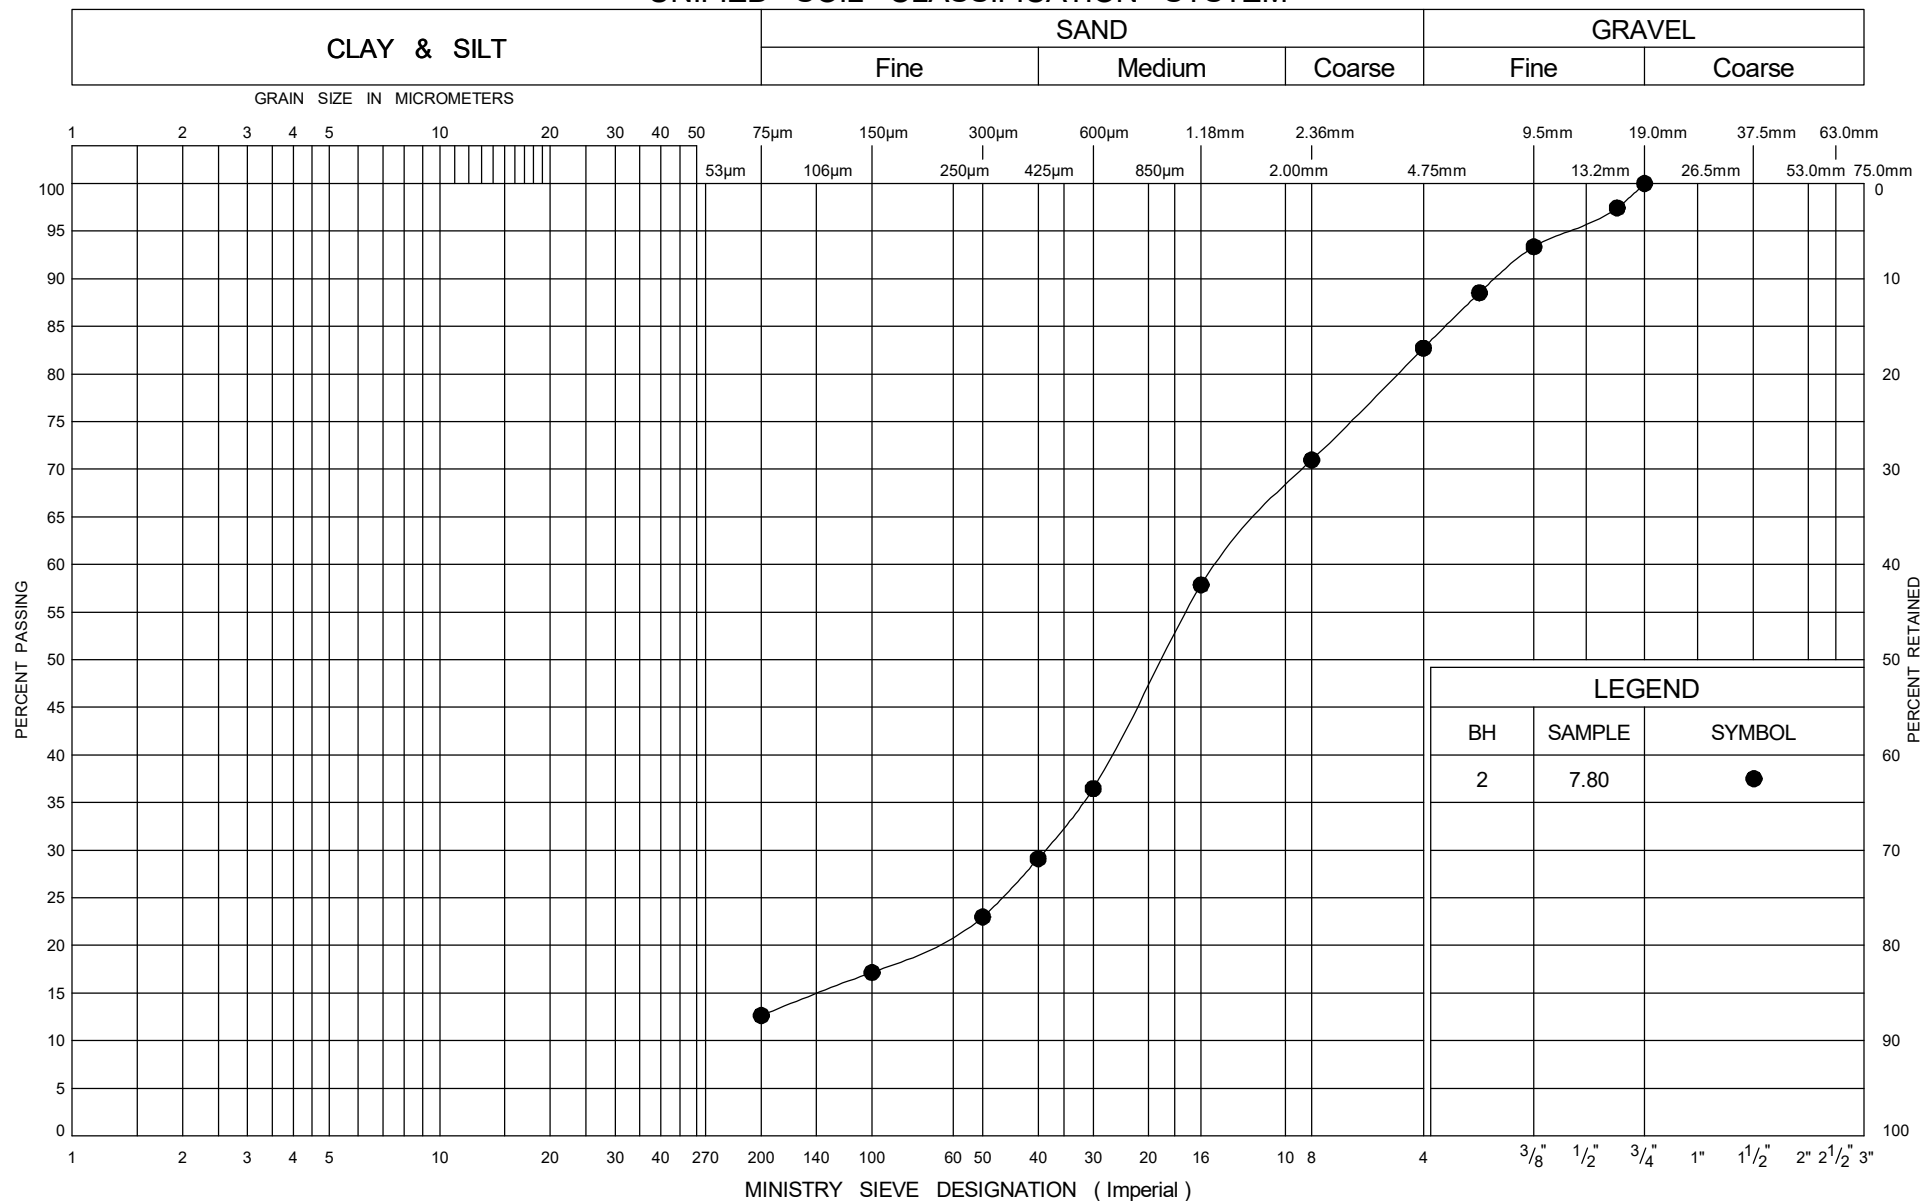
GRAIN SIZE DISTRIBUTION

FILL - SAND

Below the silty clay fill layer, another brown sand/silty sand fill layer with different portions of clay and gravel was encountered, approximately 5.3 m and 3.9 m thick, and extending down to El. 225.3 m and 226.4 m in BH No. 1 and BH No. 2, respectively. This fill layer was damp near top to moist below with average moisture content of approximately 18%. Two representative soil samples underwent grain size analyses, and the results are summarized in Table 5 and presented on Figure Nos. L-2 and L-4 in Appendix C.

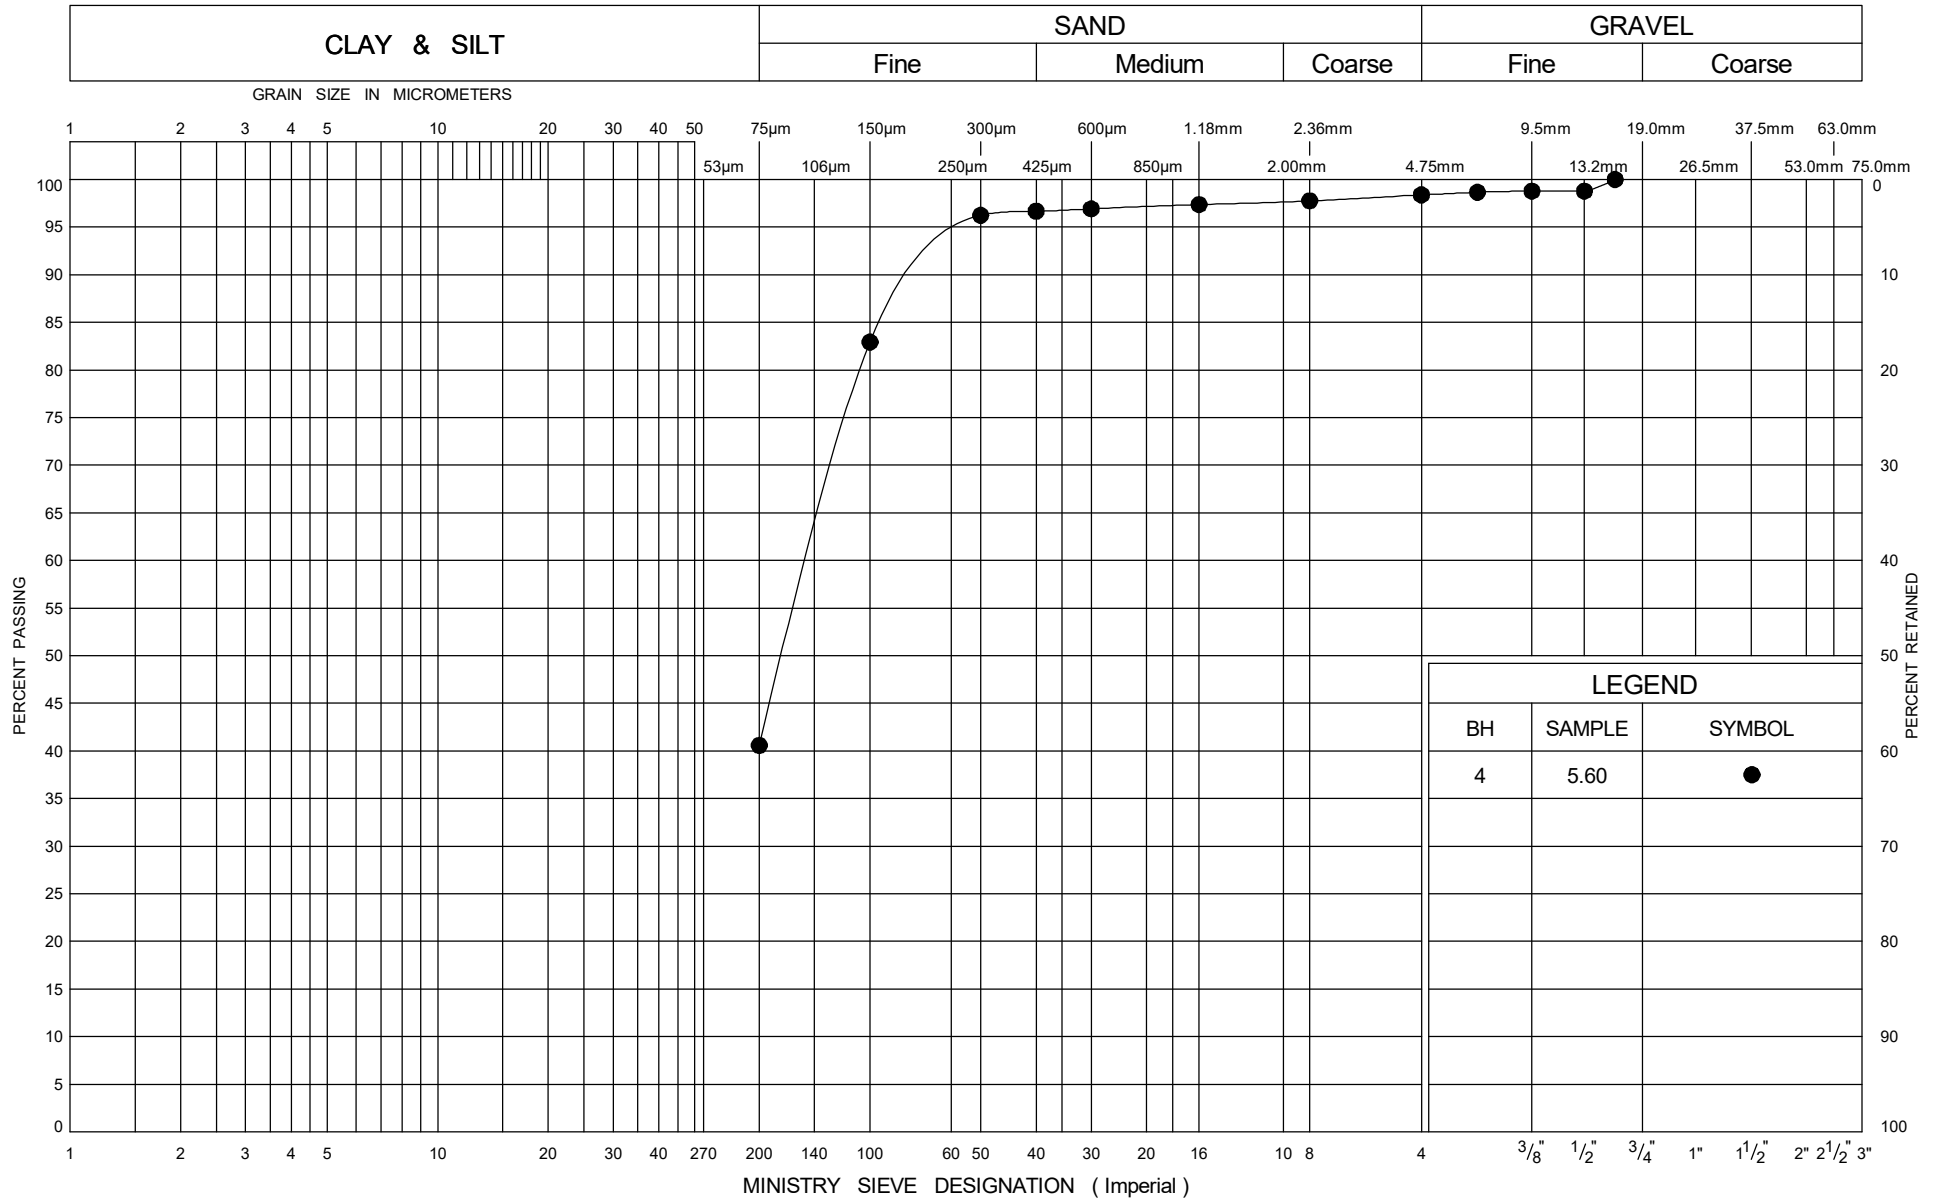
GRAIN SIZE DISTRIBUTION

SILT

The natural moisture contents measured on samples recovered from the deposit ranged from 14 to 32%. Gradation analyses and Atterberg limits tests were carried out on four samples of this deposit, and the results are summarized in Table 6 and provided in Figure Nos. L-5, L-6, L-7, and L-8, Appendix C.

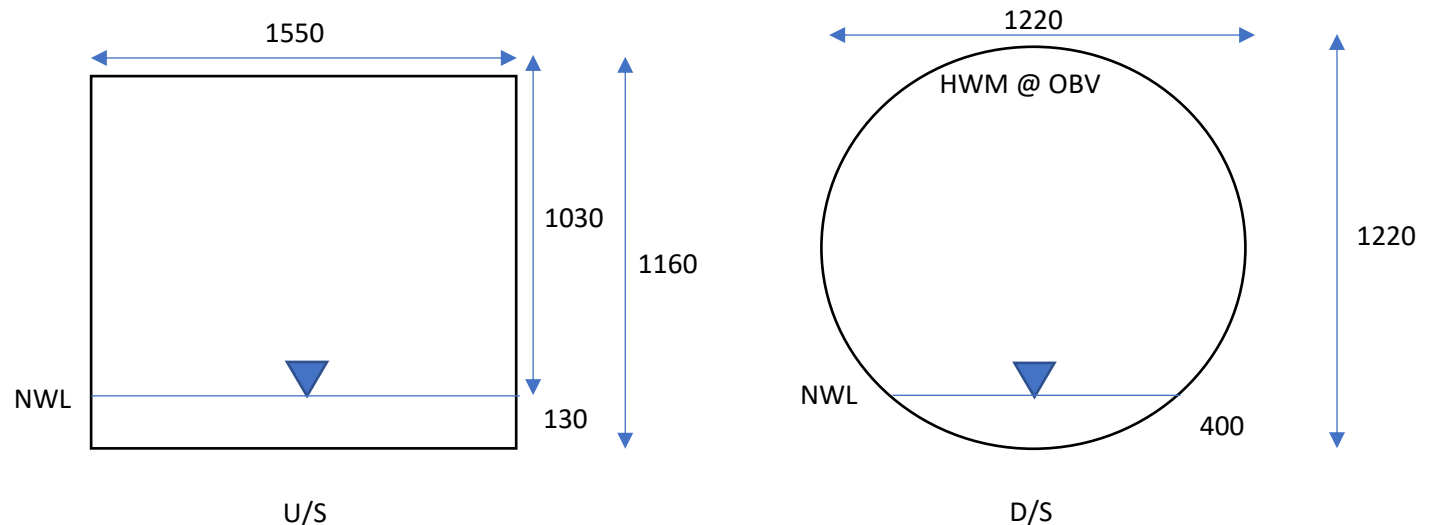
Physical Culvert Condition (rust, damage, etc.) – OK

Culvert Appearance (general comments) – Replace

Creosote Timber Culvert and Corrugated Steel Pipe (Culvert #7) @ 20+375

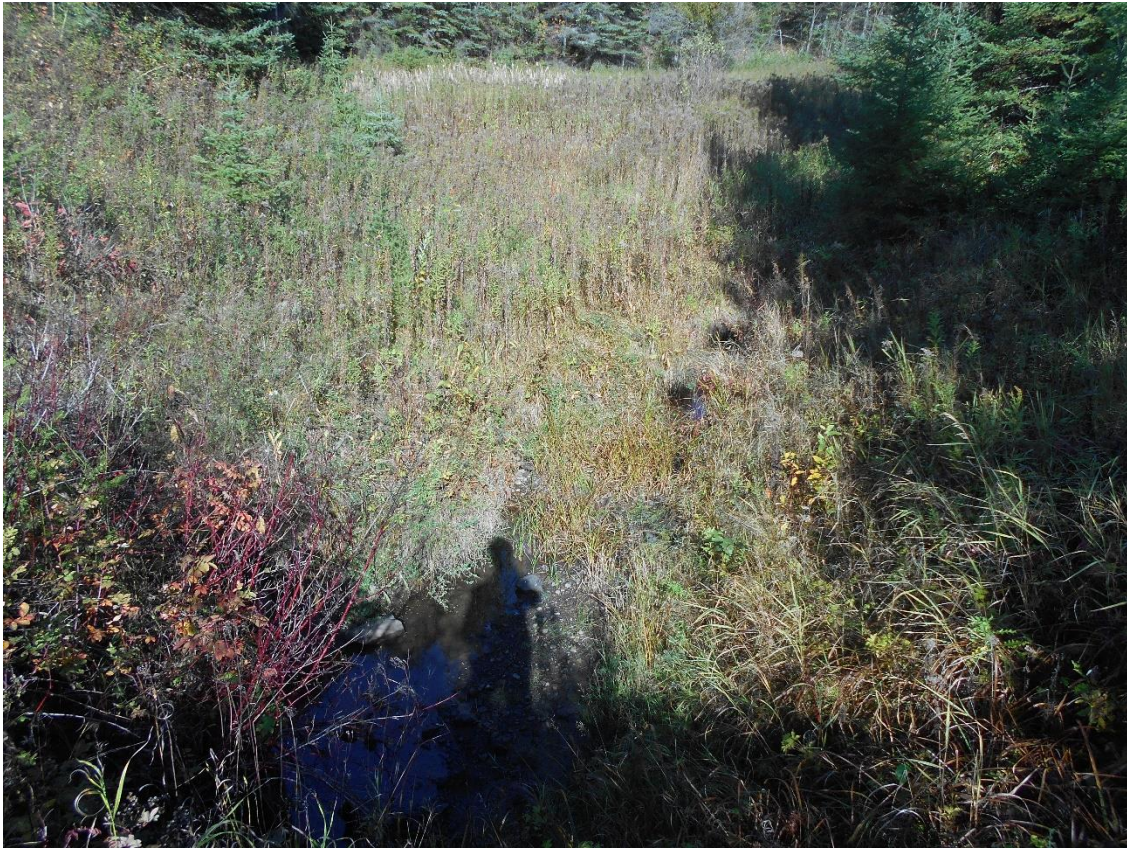
C7 - #1 – Upstream Channel Conditions

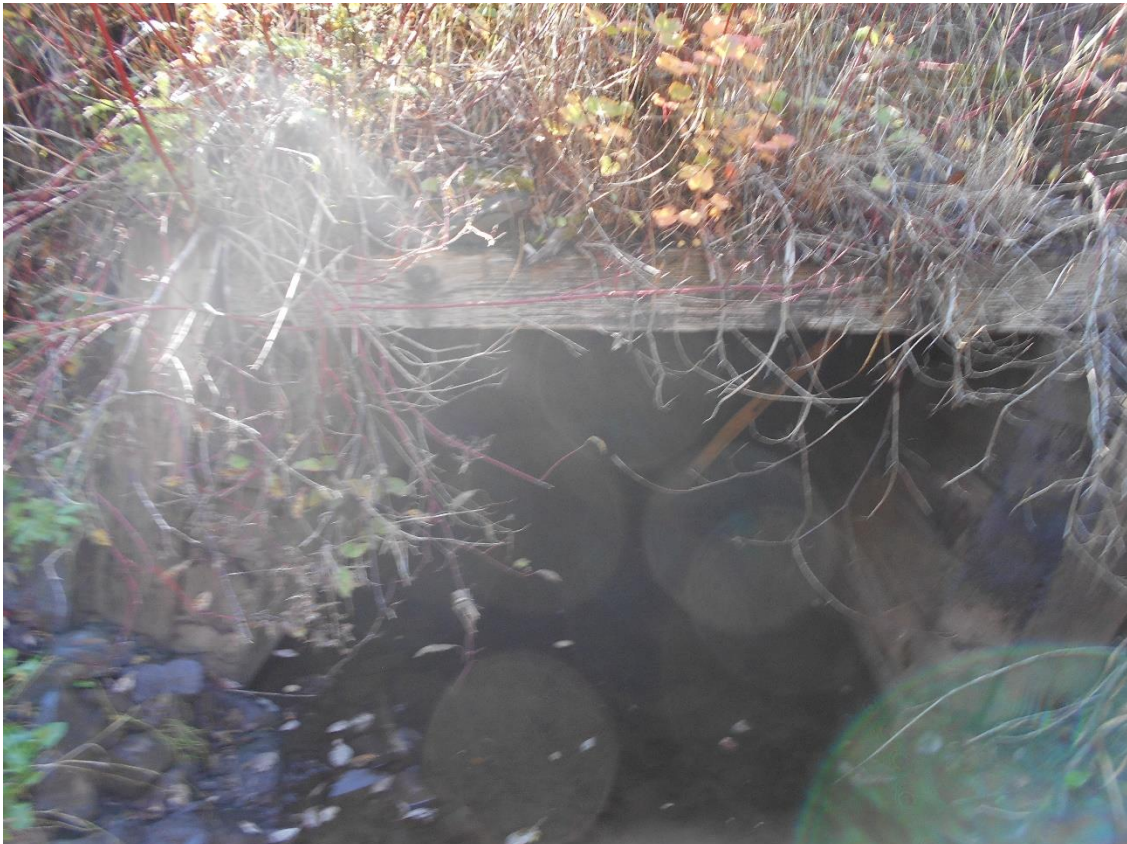
C7 - #2 – Upstream Face of the Culvert

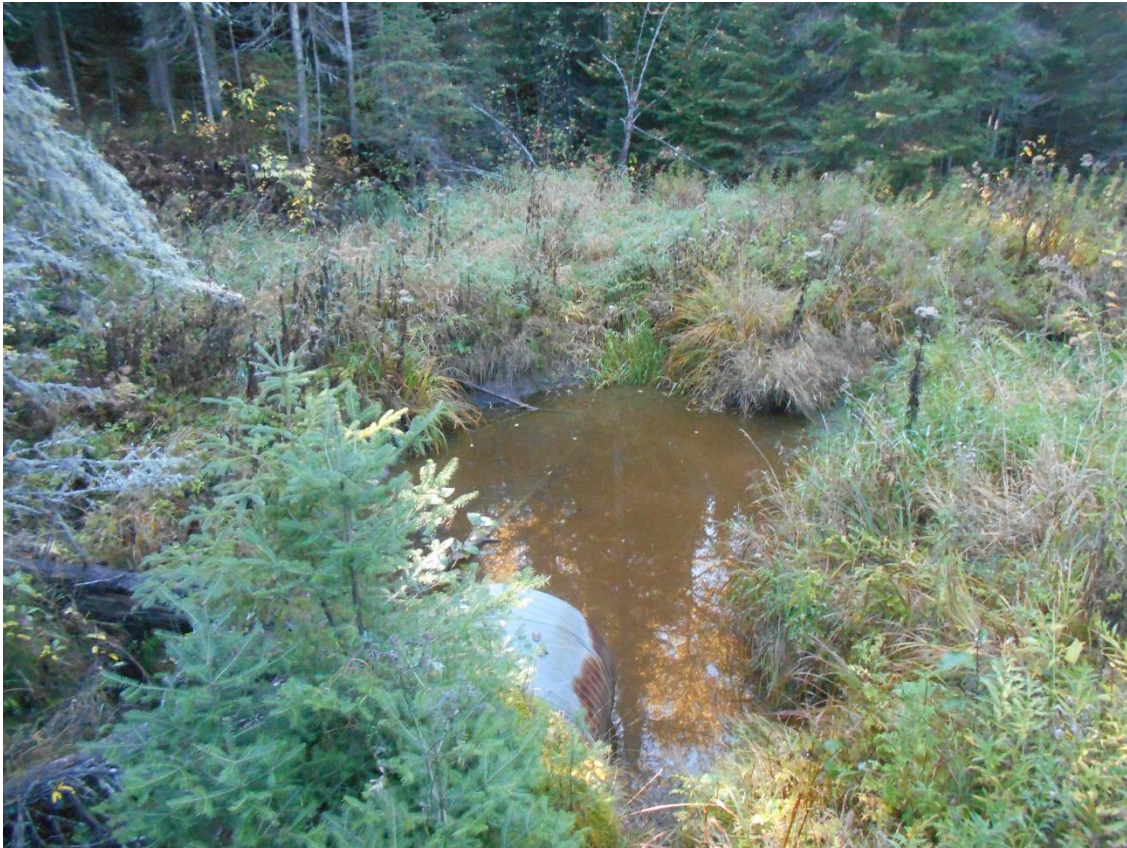
C7 - #3 – Downstream Channel Conditions

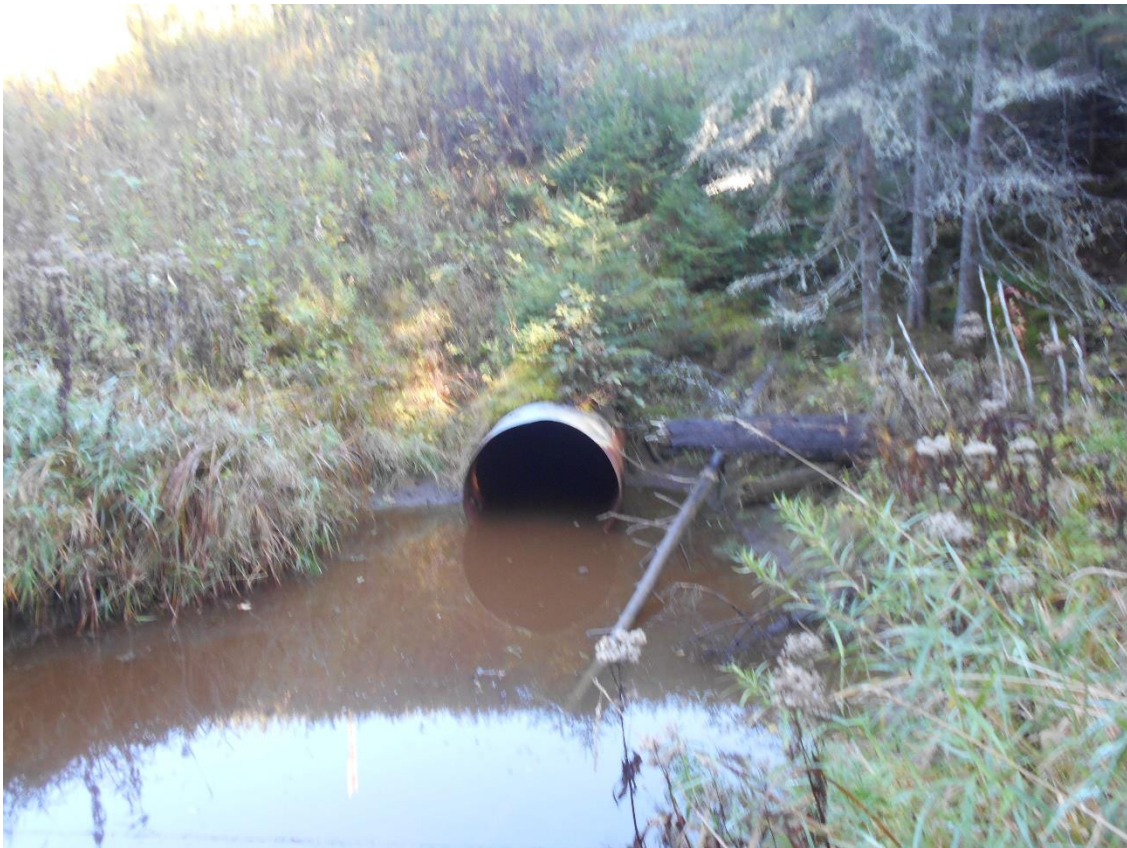
C7 - #4 – Downstream Face of the Culvert

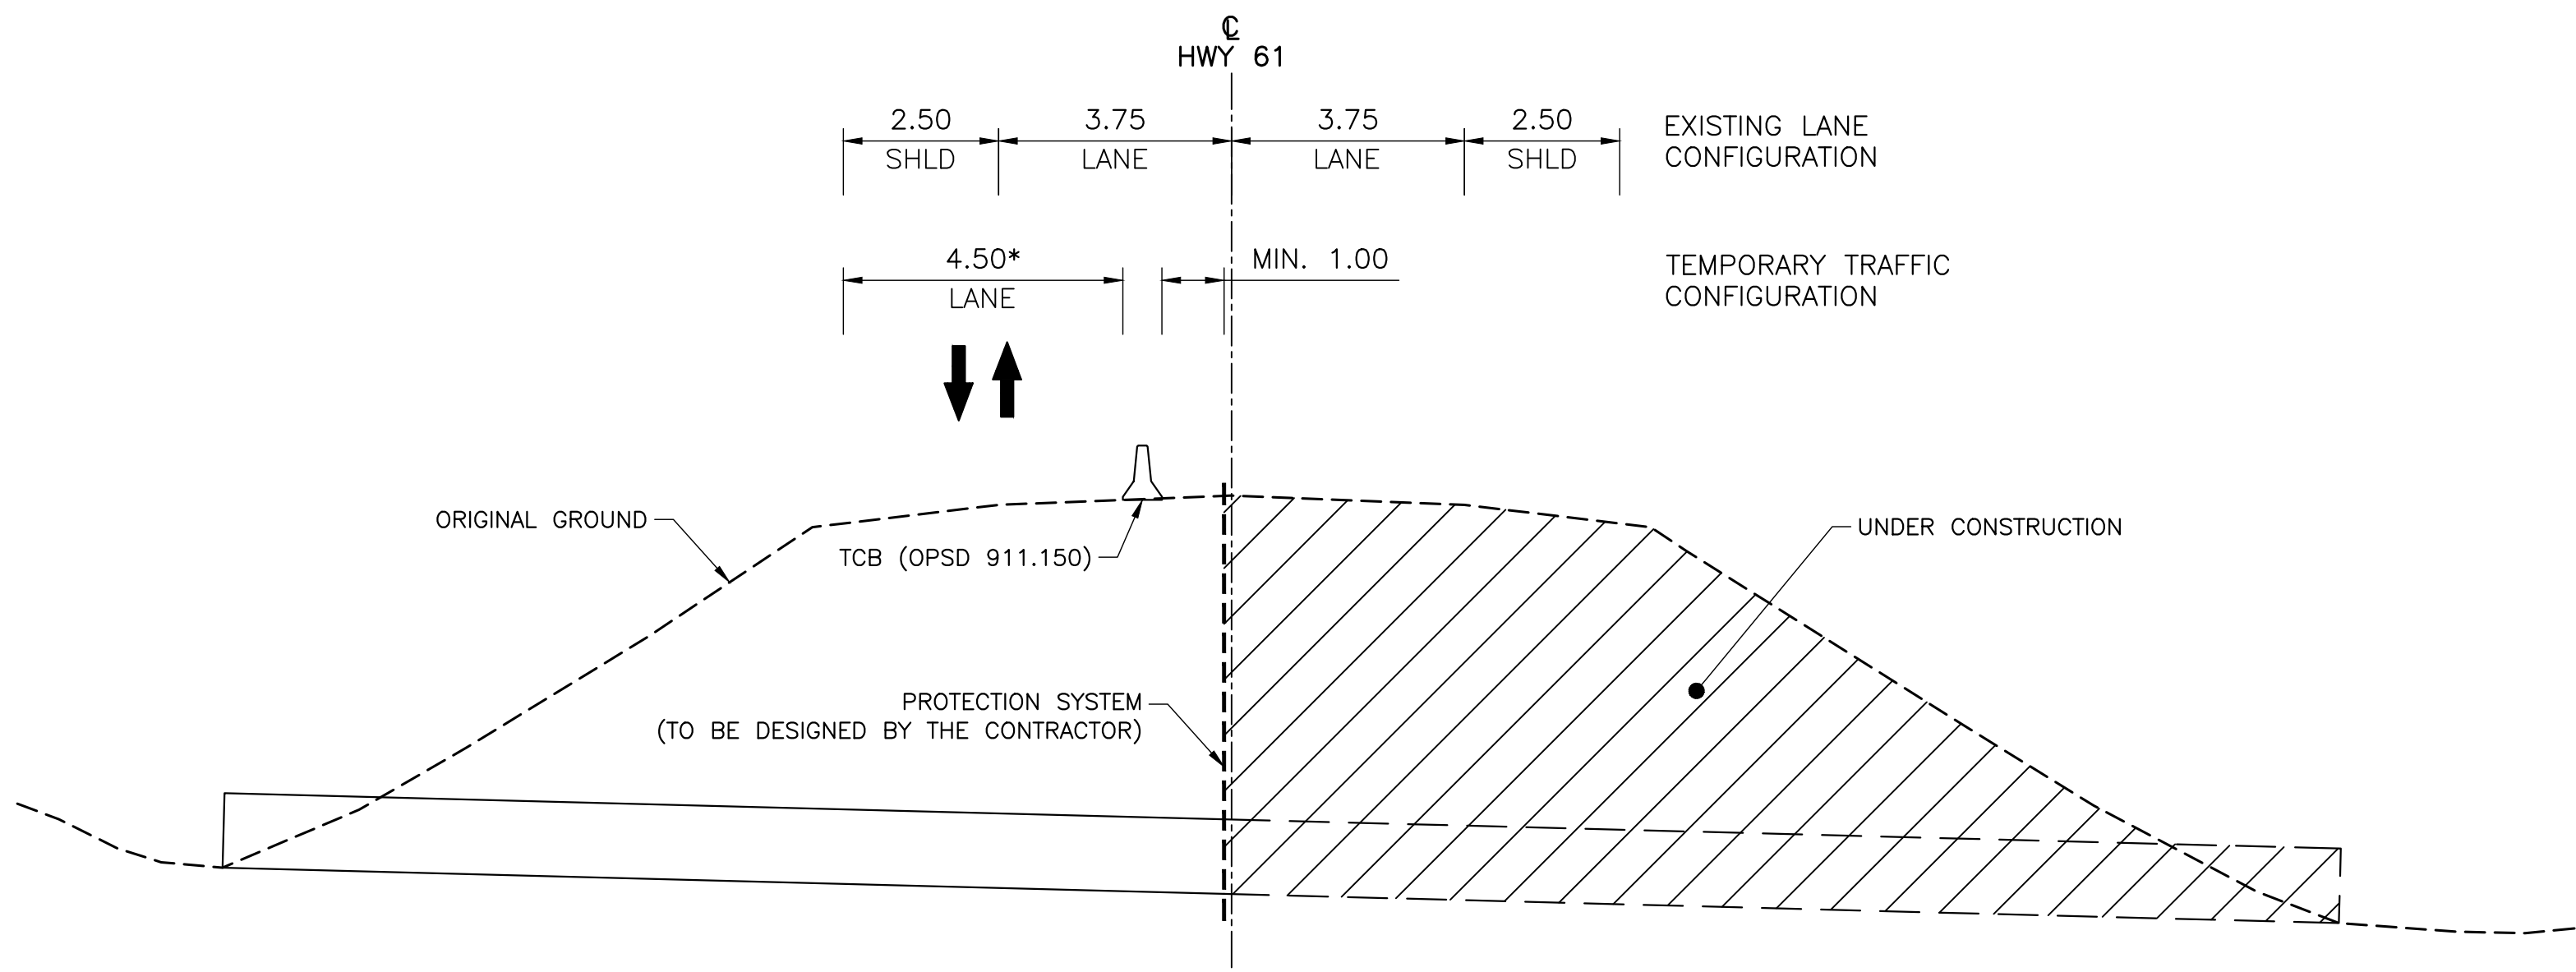
STAGE 1 – TYPICAL SECTION
* 4.50m INCLUDES 3.50m TRAVEL LANE AND 2 X 0.5m PAVED SHOULDERS

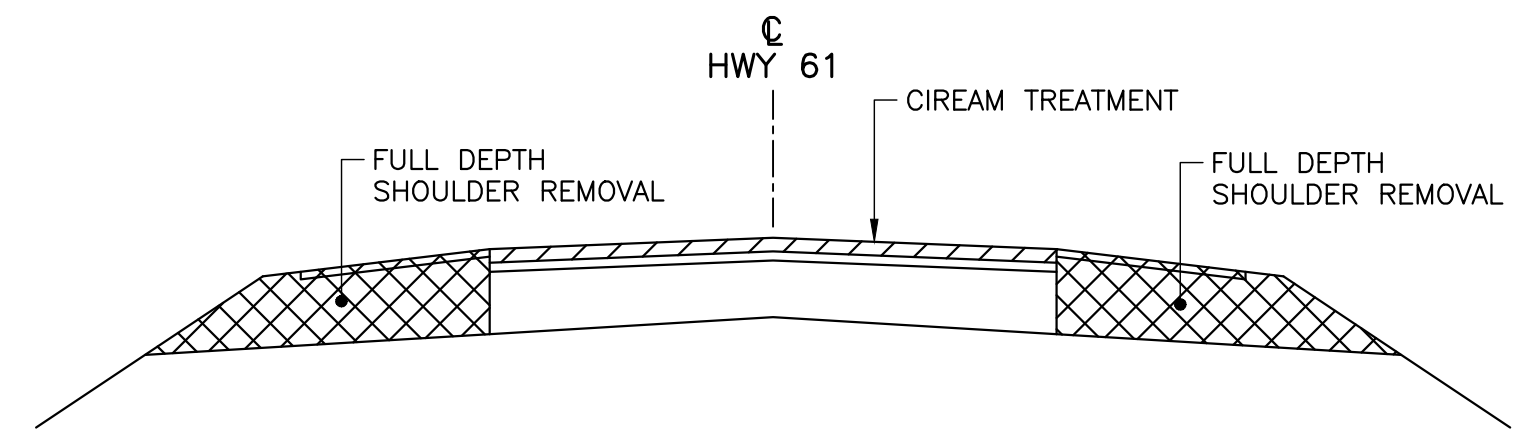
SEQUENCE 1
REMOVAL WORKS INCLUDING CIREAM TREATMENT AND FULL DEPTH SHOULDER REMOVAL. GUIDE RAIL REMOVAL AND STRIPPING WHERE PLATFORM WIDENING IS REQUIRED.
