Final Foundation Investigation Report (FIR)

Highway 61 Culvert Replacement

Station 20+375, Township of Blake

September 15, 2022

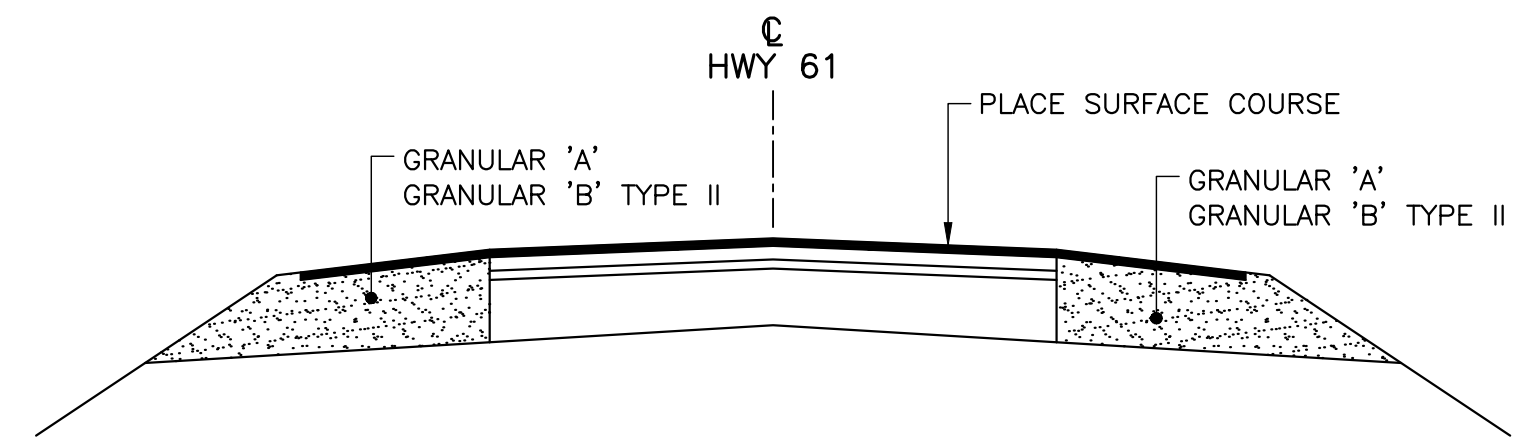
SEQUENCE 2
PAVE TOP LIFT ASPHALT (50mm GRAD RAISE). APPLY GRANULAR SEALING AND INSTALL NEW STEEL BEAM GUIDE RAILS WHERE REQUIRED.
