Final Foundation Investigation Report (FIR)

Highway 61 Culvert Replacement

Station 26+422, Township of Crooks

GWP 6176-15-00

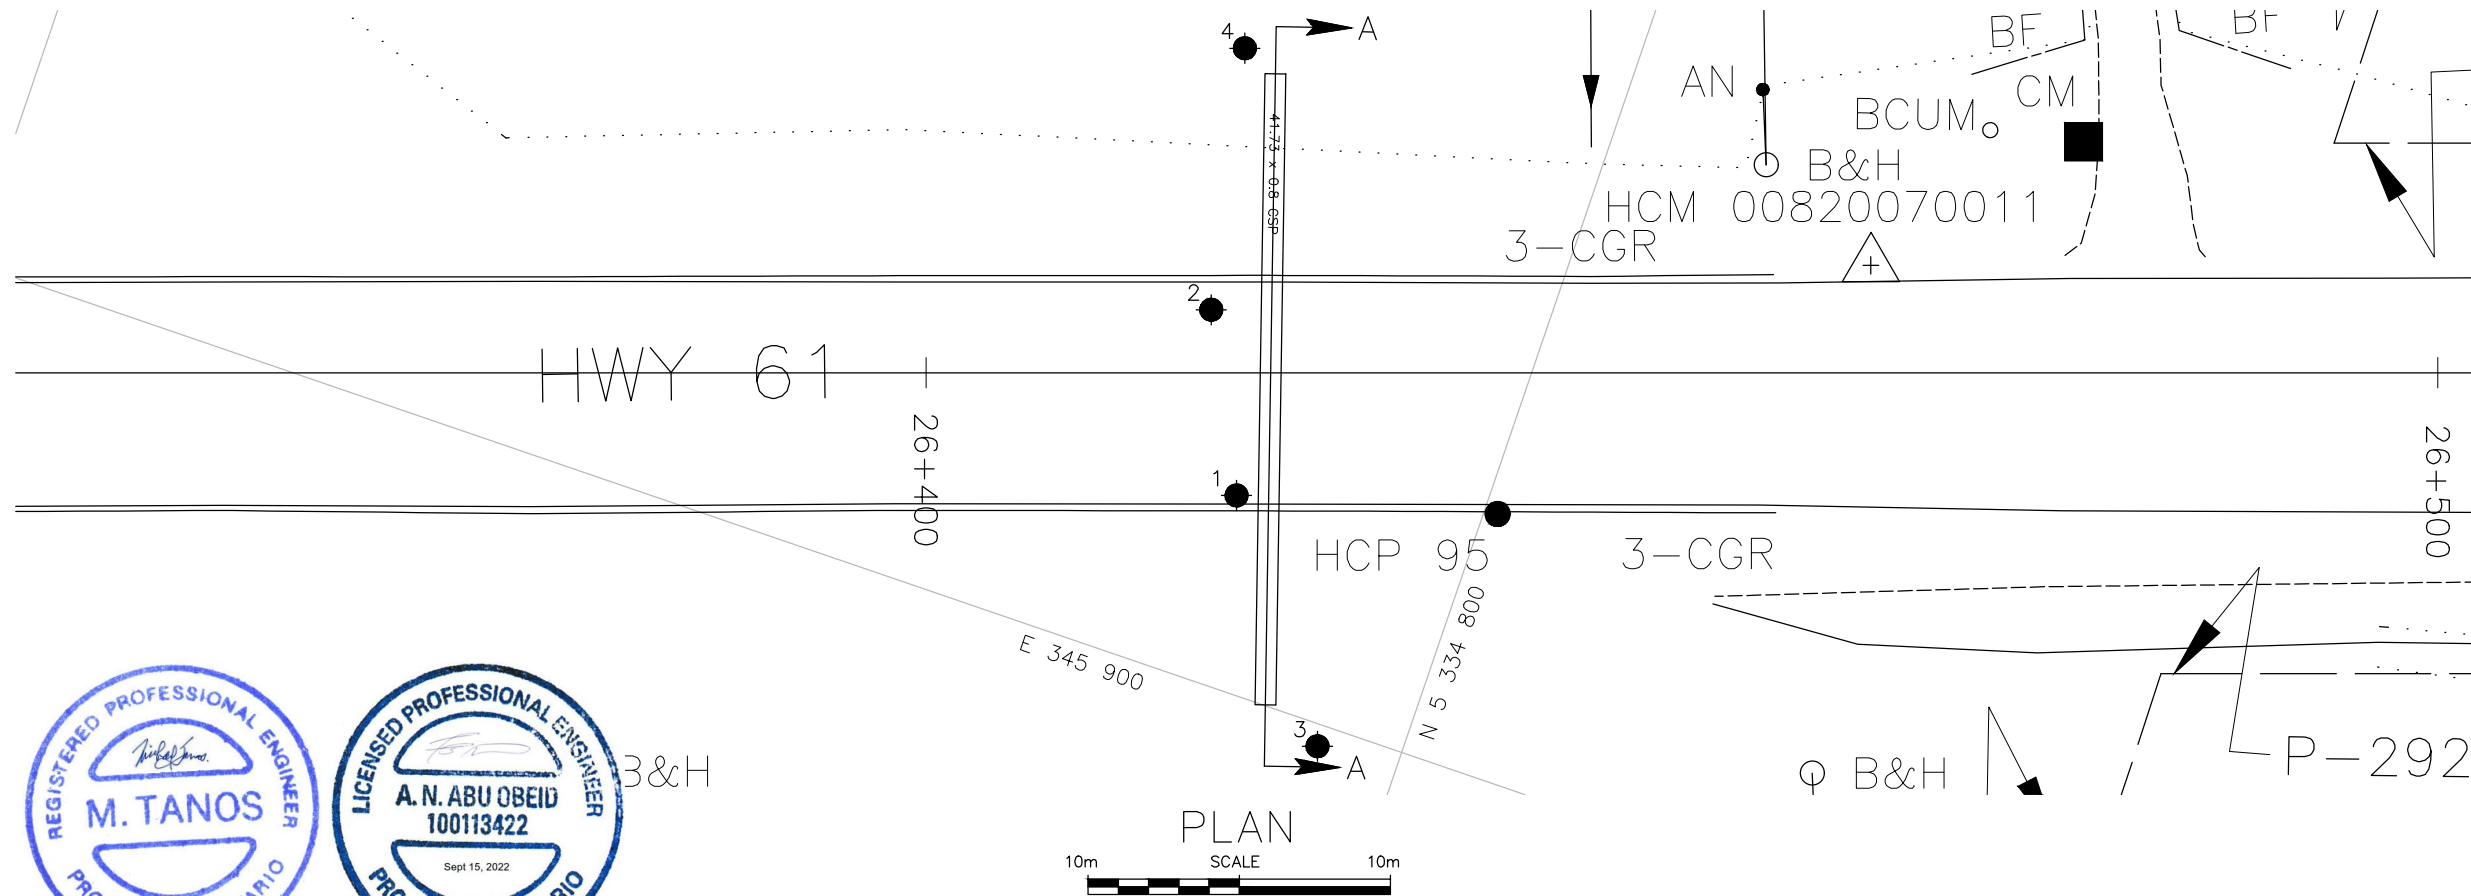
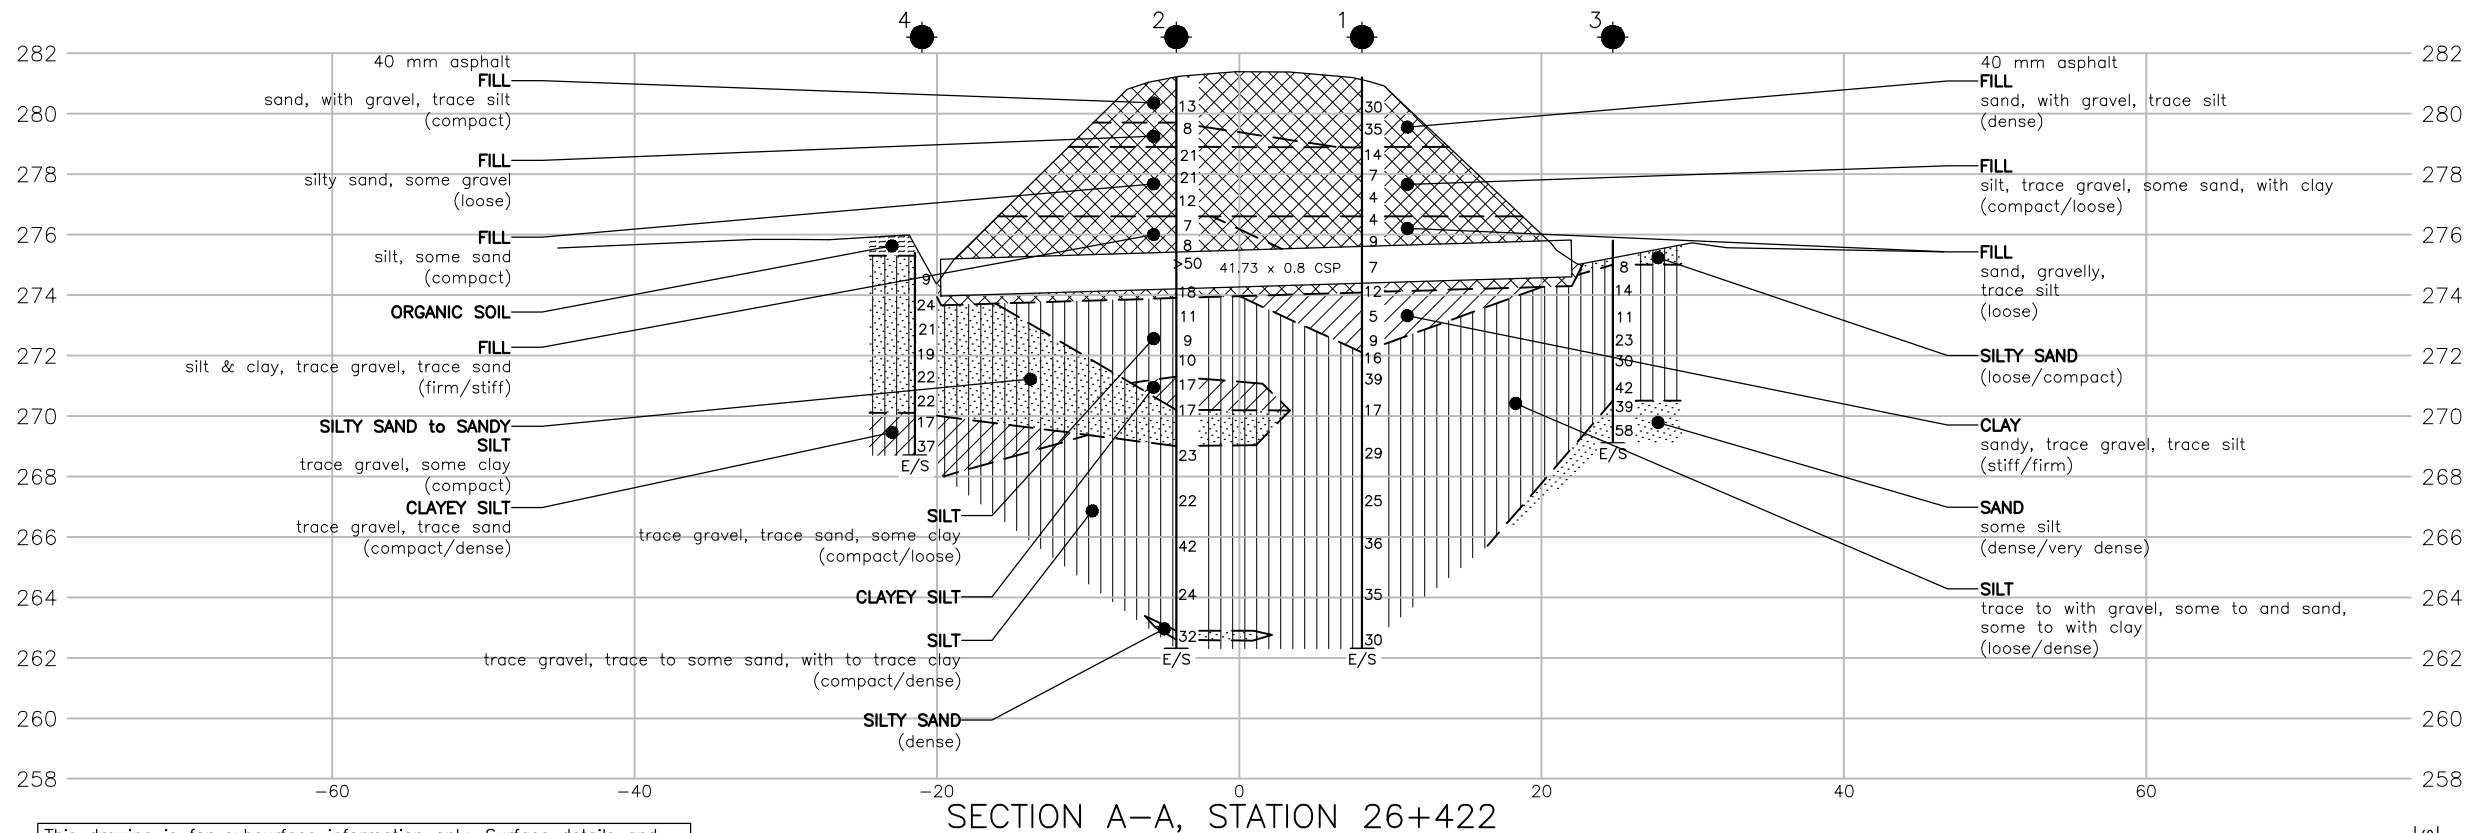
Drawing No. 2 - Borehole Location Plan & Embankment Profile

The existing culvert structure is crossing Highway 61 at almost a perpendicular alignment from east (upstream) to west (downstream). The existing culvert structure is 800 mm wide and 620 mm high at the upstream and 800 mm wide and 650 mm high at the downstream, as shown on Drawing No. 2 in Appendix A and described in detail and shown on the sketches and Figures in GF Culvert Inspection Report in Appendix D. The culvert edges extend out beyond the embankment without wing walls. The CSP culvert barrel at the invert and springline is very severely corroded with total section loss below the springline. The channel dimensions were described by GF in general as 3 m wide channel upstream (US) with banks at 3H:1V and water depth of 80 mm; and 3 m wide dry channel downstream (DS) with banks at 3H:1V. The top of the culvert elevations at the inlet and outlet are El. 275.8 and El. 275.2 m, respectively with clearance of 620 mm and 650 mm (i.e. dry), respectively. Flow through the culvert is from east/right (Rt) to the west/left (Lt) as shown on Drawing No. 2 in Appendix A.

The fieldwork for this investigation included four (4) sampled boreholes (BH). BH Nos. 1 and 2 were advanced in the roadway shoulders through the embankment. BH Nos. 3 and 4 were advanced at the inlet (Rt) and outlet (Lt) ends of the culvert, respectively. The locations of the boreholes are shown on Drawing No. 2 in Appendix A and are provided in the Table below.

The subsurface conditions revealed by the investigation program are summarized in Table 2 below and on the stratigraphic profile presented on Drawing No. 2 (Appendix A) and on the detailed Records of Borehole Logs (Appendix B). It should be noted that the stratigraphic delineation presented on the borehole logs and soil strata plot is interpreted from the results of non-continuous sampling, response to drilling progress, recorded SPT 'N'-values, plus field observations. Typically, such boundaries represent transitions from one zone to another and are not an exact demarcation of specific geological units. Additional consideration should be given to the fact that subsurface conditions may vary markedly between adjacent boreholes and beyond any specific boring location and are shown on the drawings for illustration purposes only.

REHABILITATION OF HWY 61
CULVERT REPLACEMENT
STATION ±26+422

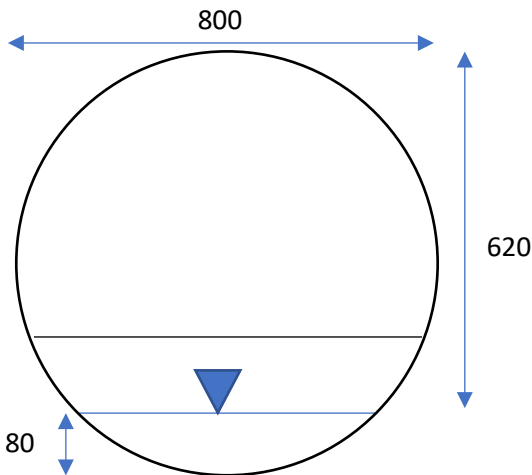
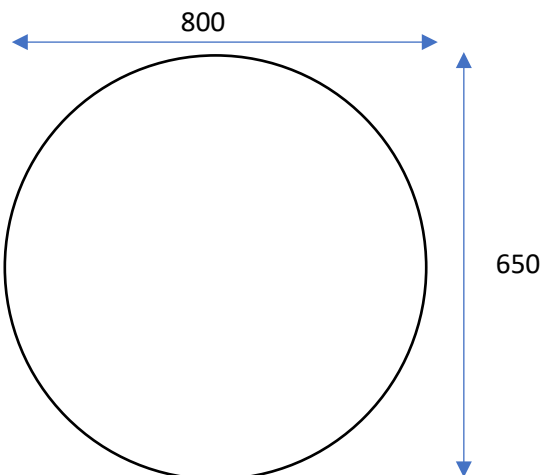
D. ENVIRONMENTAL CONDITIONS			
Watercourse Type and Creek Material – Creek with gravel and stones			
Bank Conditions (stability) – Scour at US end			
Channel Dimensions (width and depth) – 3m, 3:1, 80mm US / 3m, 3:1, Dry DS			
Observed Flow Conditions (ephemeral/permanent) – Permanent – standing water

E. SITE CONDITIONS			
Road Condition (sag, settlement, etc.) – OK			
Physical Culvert Condition (rust, damage, etc.) – Rusted/damaged			
Culvert Appearance (general comments) – Replace			
Site Sketch – <div style="display: flex; justify-content: space-around; align-items: flex-end; text-align: center;"> <div style="position: relative; width: 300px; height: 300px;">

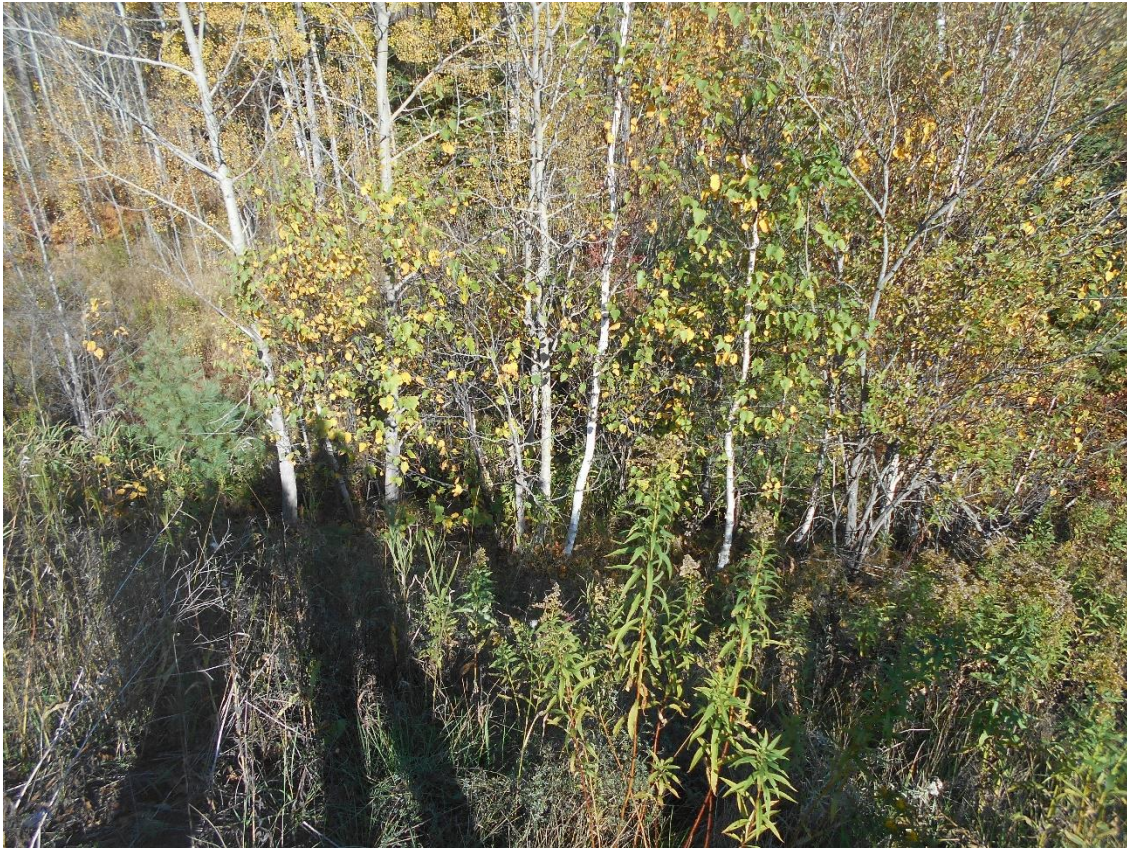
C37 - #1 – Upstream Channel Conditions

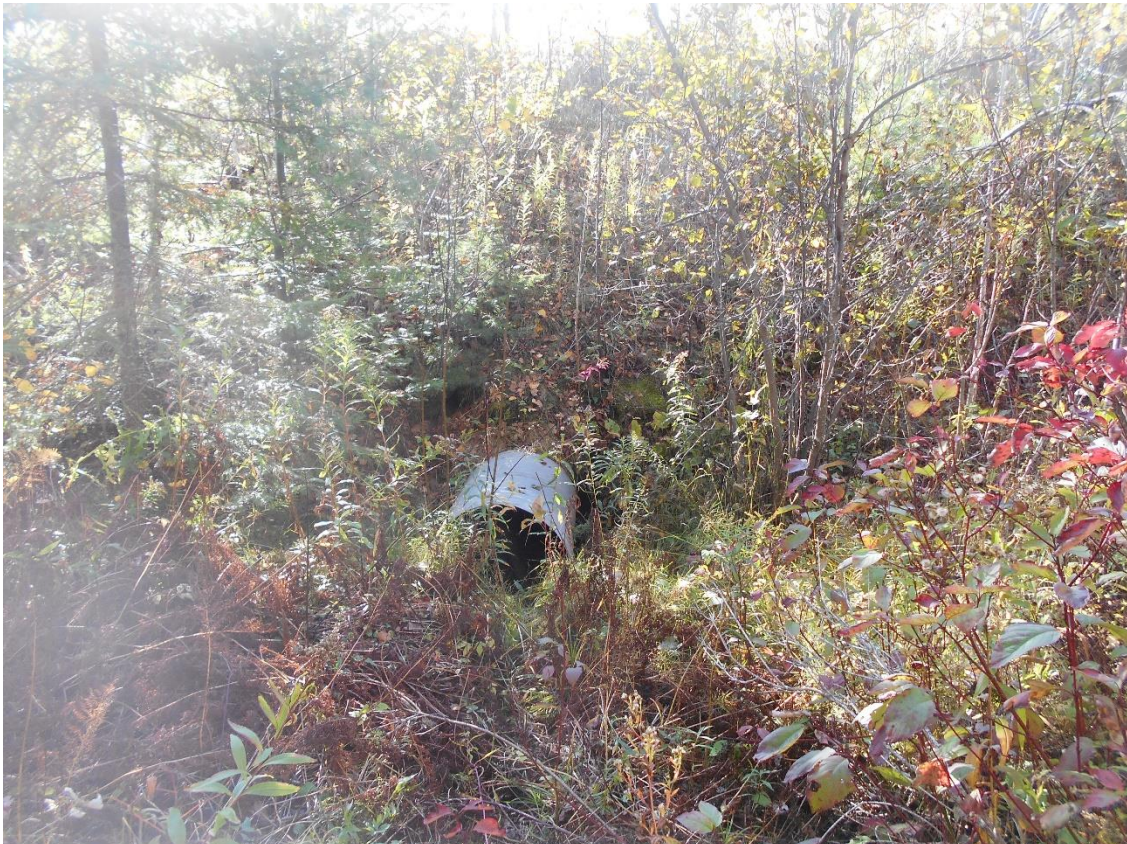
C37 - #2 – Upstream Face of the Culvert

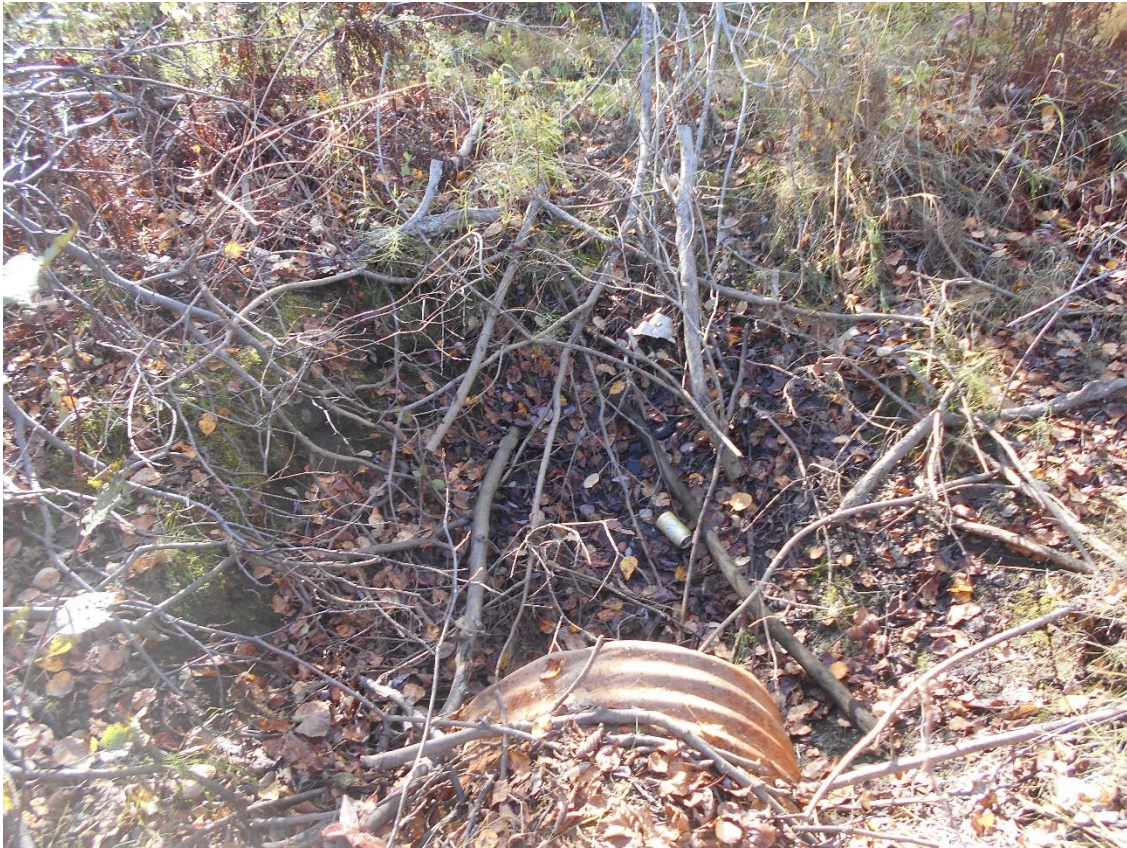
C37 - #3 – Downstream Channel Conditions

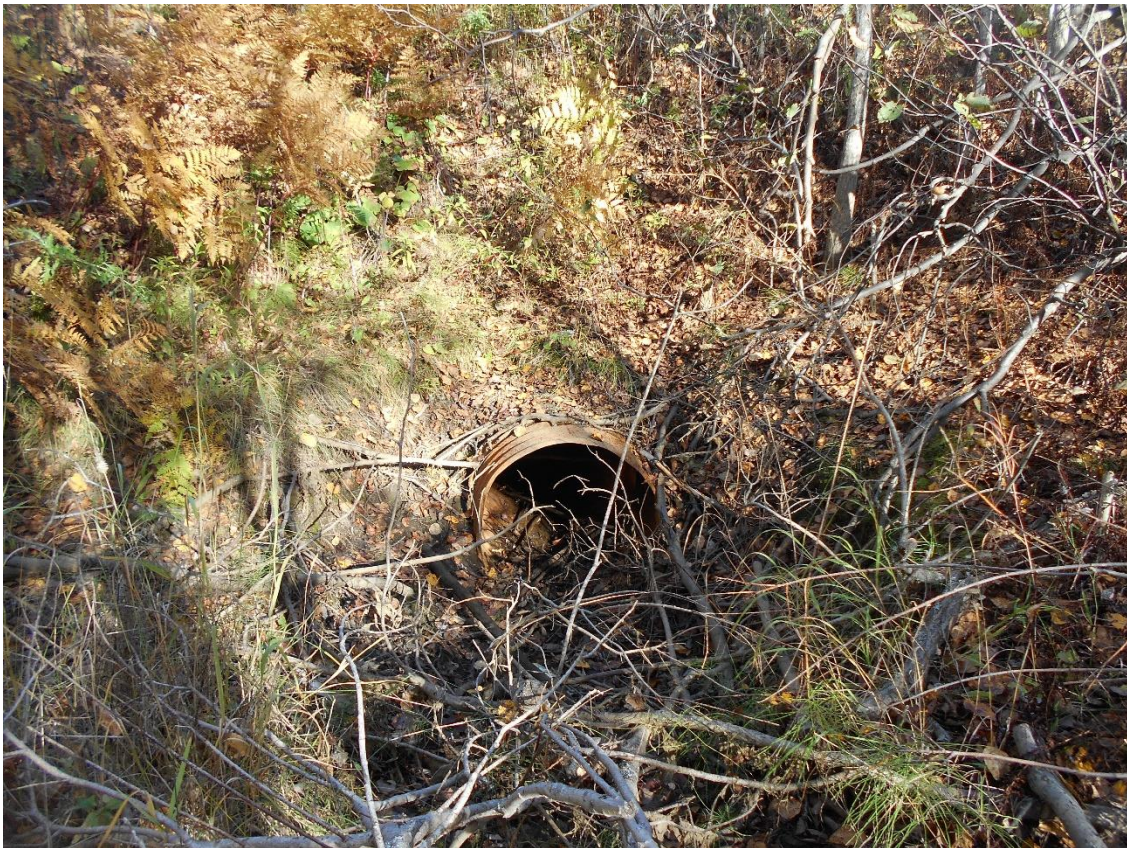
C37 - #4 – Downstream Face of the Culvert
