FOUNDATION INVESTIGATION AND DESIGN REPORT

HIGHWAY 6 / 21

SLOPE FAILURE INVESTIGATION

OWEN SOUND, ONTARIO

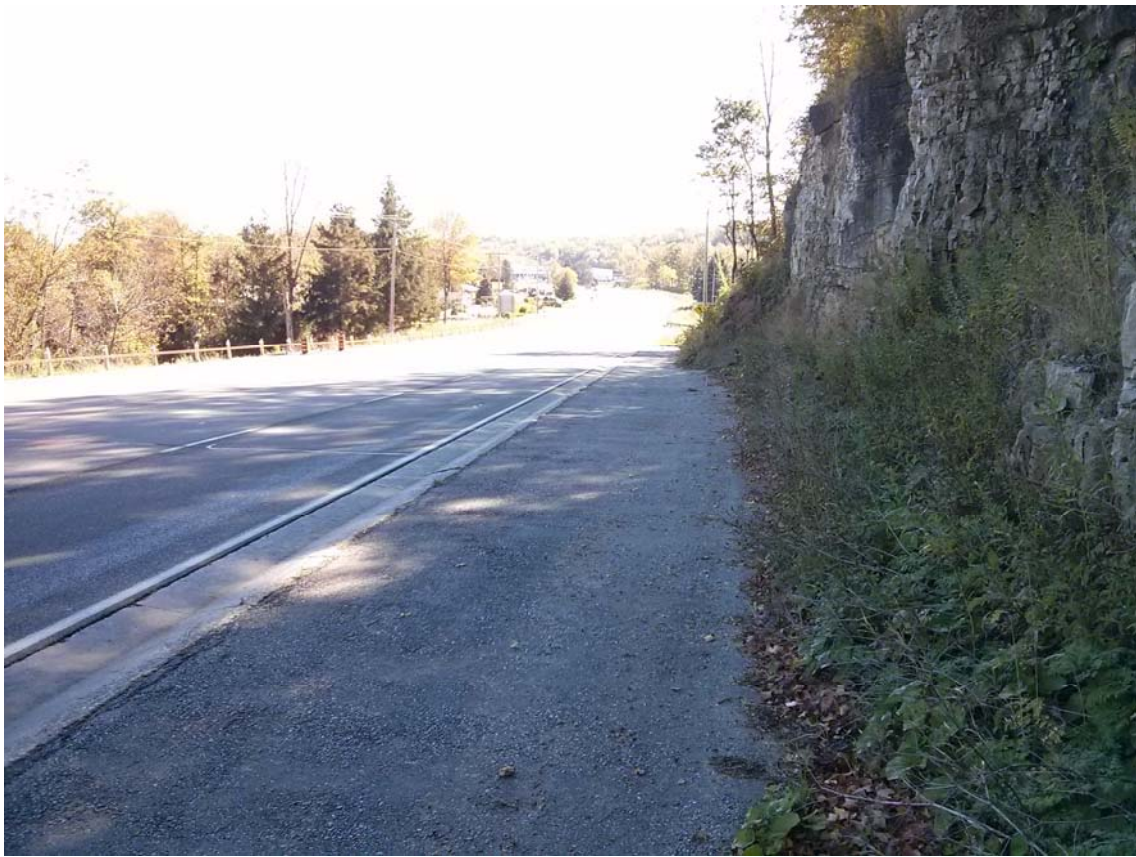
Photo 1: Looking Eastward (toward Owen Sound) from eastbound shoulder showing rock face on south and pylons outlining slope failure on north side of highway

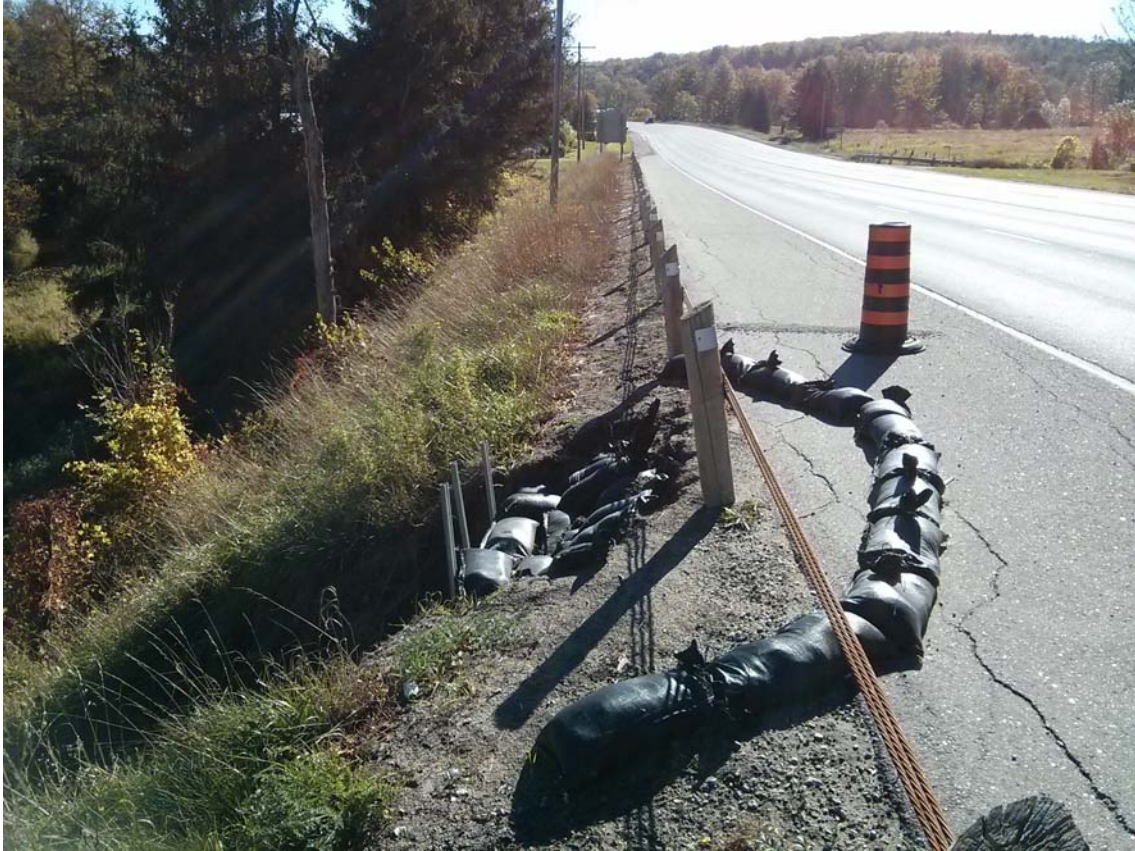
- The absence of any curb or gutter on the highway would allow sheet flow over the embankment crest, which inevitably becomes concentrated in preferred locations due to minor undulations in the pavement.
- Although the surficial erosion and soil deposition downslope has removed the vegetation, the process may have been assisted by an initial loss of vegetation cover.
- Extensive cracking of the asphalt is evident in the paved shoulder and into the driving lane and running parallel to the slope. The pattern of cracking suggests that there is on-going creep in the steep slope.

Photo 2: Looking Eastward (toward Owen Sound) from westbound shoulder showing pylons and sandbags outlining slope failure on north side of highway. Also note longitudinal cracking on shoulder parallel to highway.

In conjunction with regrading, it is recommended that control of surface water runoff be initiated to divert the water away from the embankment slope. This might best be accomplished with the installation of a curb and gutter system along the highway alignment to direct the water to a catch basin or to an area with a flatter slope covered with appropriate erosion protection measures. The approximate extent of this treatment would coincide with the length of highway protected by the cable guardrail running parallel to the westbound lane.

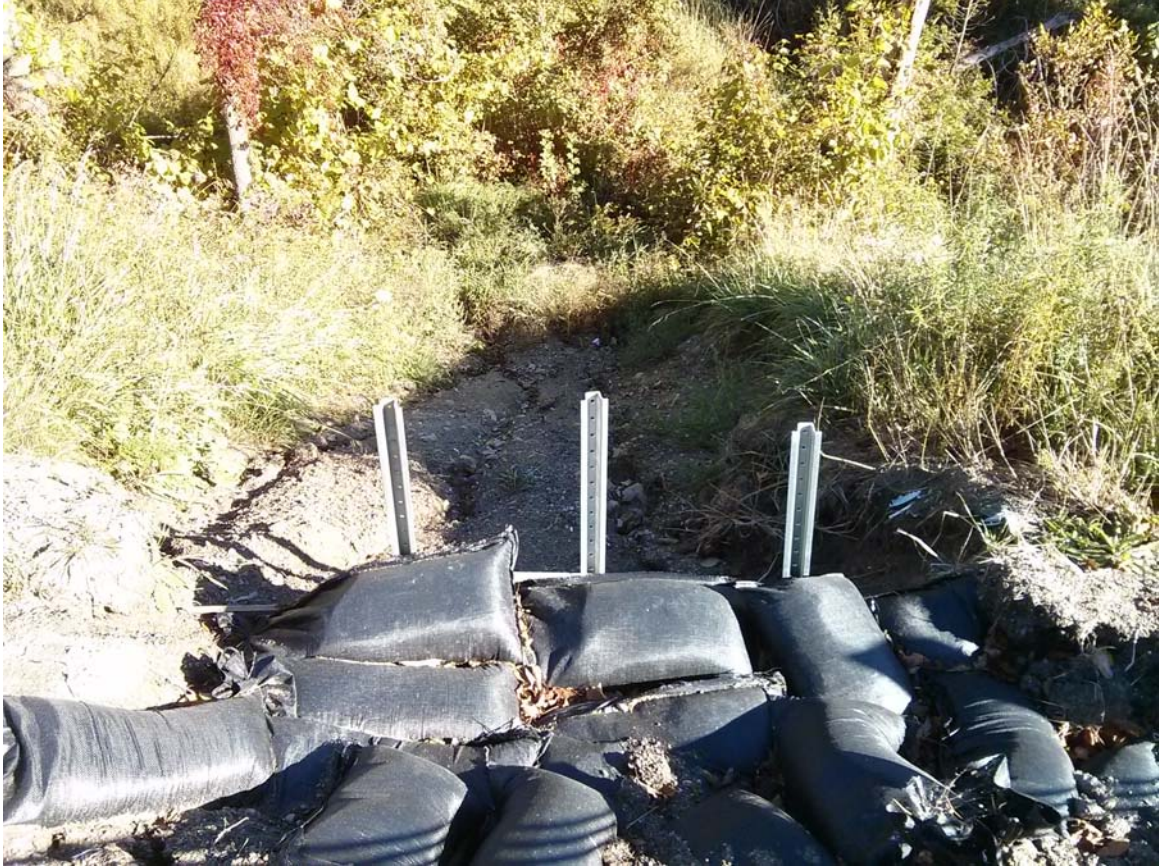
- The observed failure is shallow, which is consistent with such a steep slope in cohesionless soils
- The failure scar suggests that the mechanism may have been more a matter of over-saturation of the soil followed by a small soil flow rather than a classical rotational failure

Photo 3: Looking Northward (perpendicular to Highway) from westbound shoulder showing sandbags and erosion gullies along slope failure on north side of highway

The slope should be reinstated with Granular A or Granular B Type II with minimal disturbance to adjacent areas. These materials are recommended for reinstatement due to their physical properties: relatively high angle of internal friction and comparatively high permeability. Construction methods must be selected to minimize disturbance and loss of vegetative cover in the adjacent area. To achieve this, it may be necessary for the regrading be accomplished by placing the material by bucket with a machine sitting on the highway, possibly supplement by manual placement near the toe. The actual methods can be left to the Contractor but the Contract must contain a constraint to protect the adjacent, vegetated slope. Grading should match the adjacent slope. It is recommended that the regraded slope be protected by an erosion control blanket in accordance with OPSS 804.

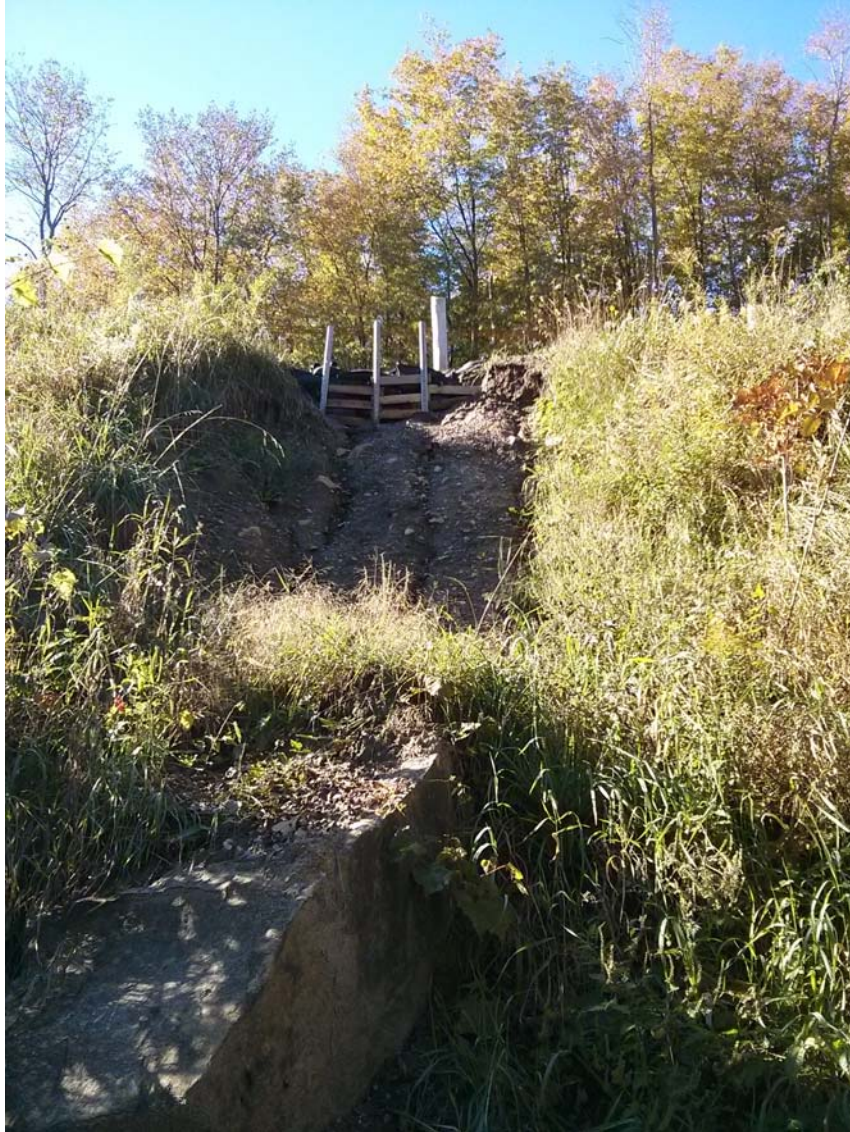
Site observations also noted similar indications of concentrated surface water runoff at additional locations along the north embankment crest where similar erosion and soil deposition may occur in the future if left untreated.

Photo 4: Looking Southward (toward Highway) from north toe of slope showing erosion gullies and soil deposition along slope failure on north side of highway

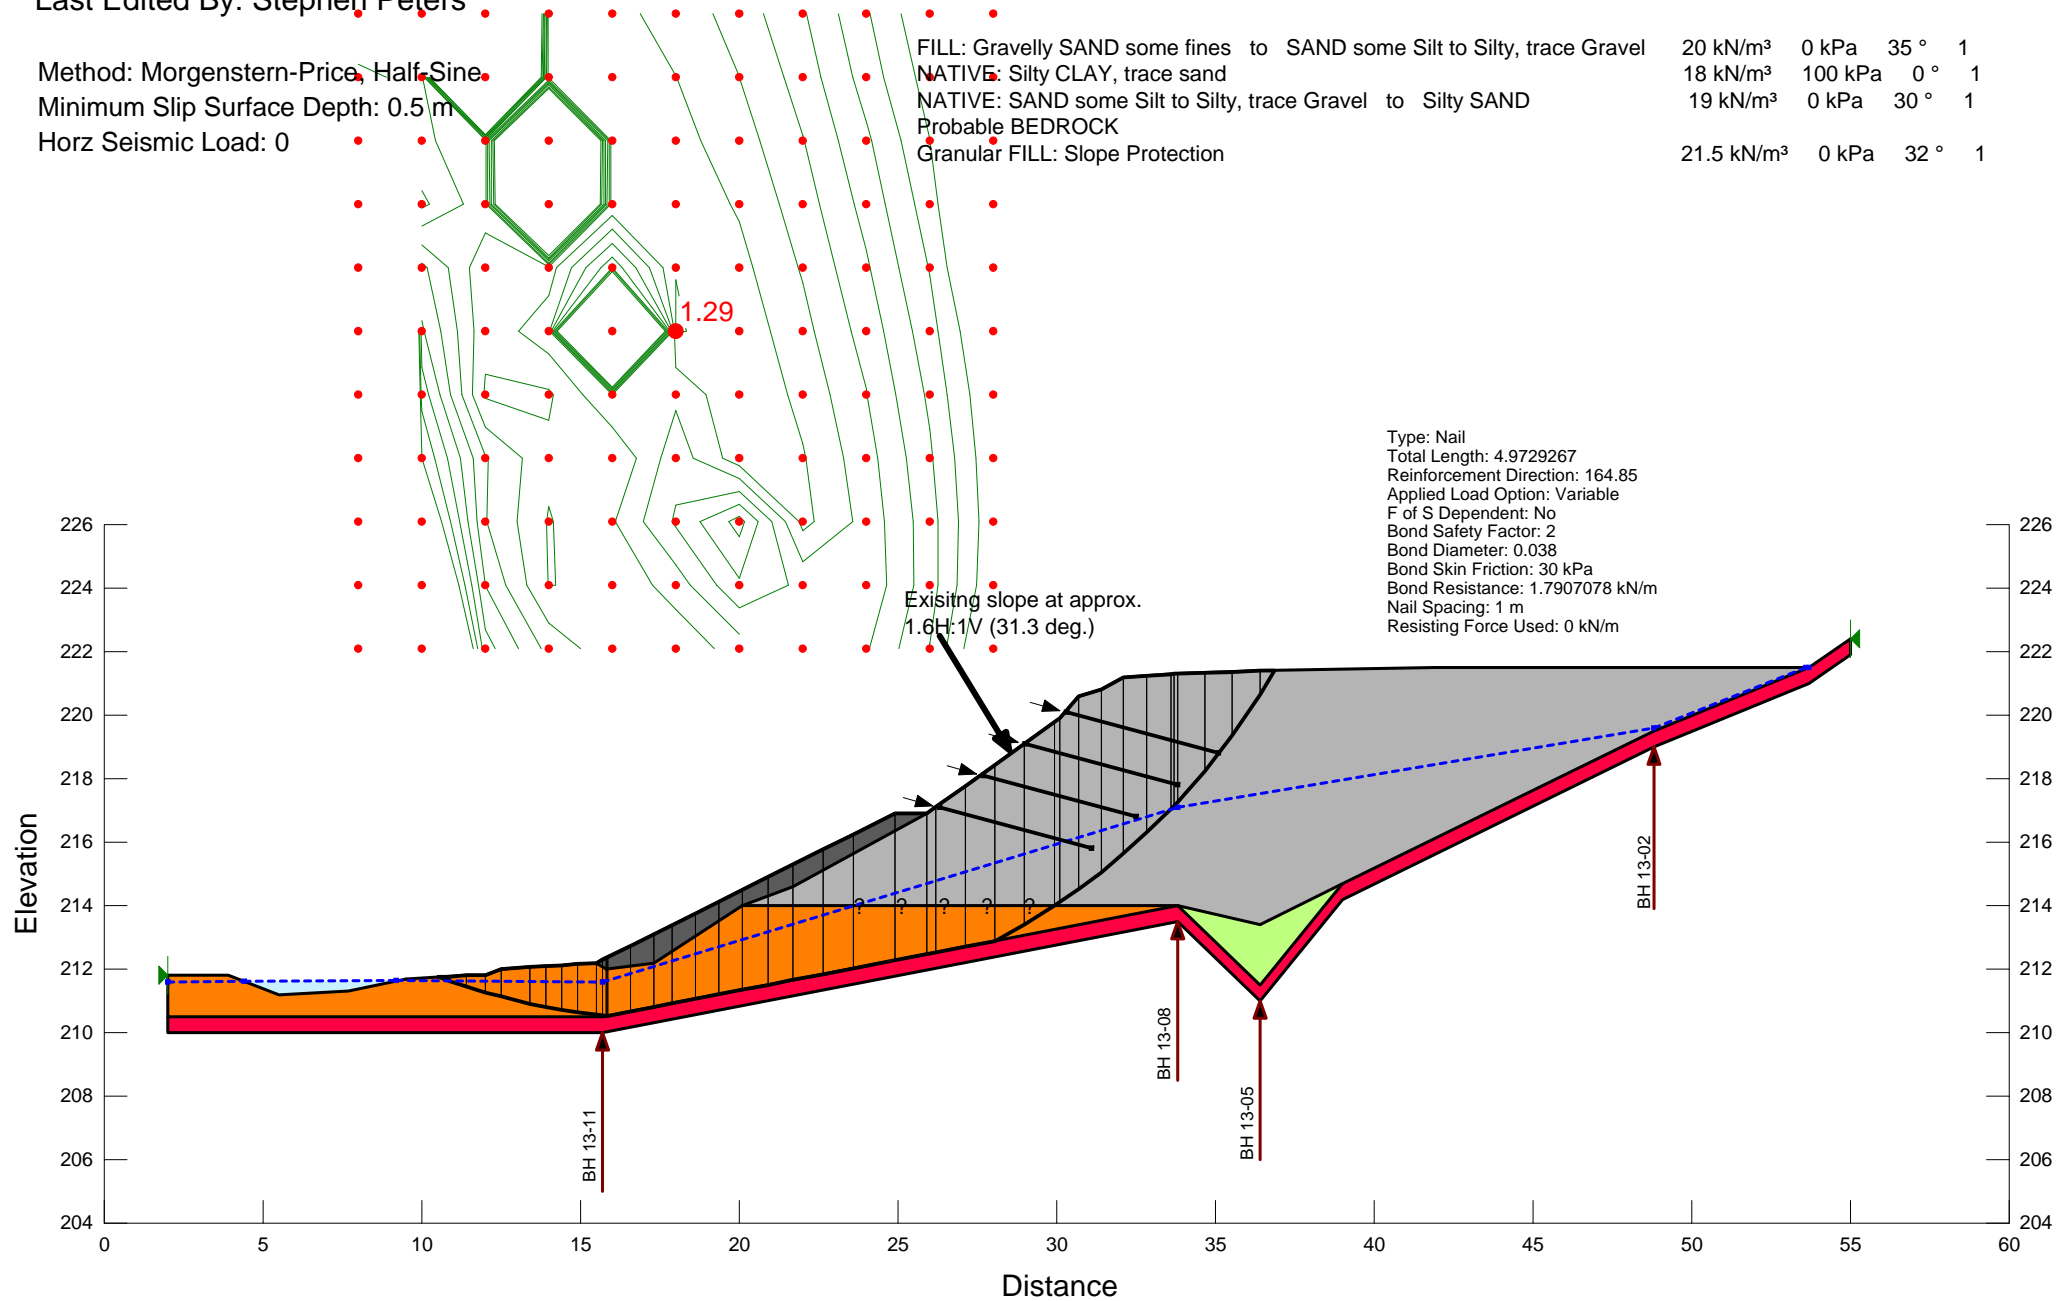
Granular FILL: Slope Protection

21.5 kN/m³ 0 kPa 32 ° 1

The input parameters and soil model used in the stability analyses, including soil stratigraphy, soil properties, groundwater conditions and embankment geometry are shown in figures included in Appendix E. The analysis indicates that the stability of the embankment slope is near marginal with a computed factor of safety near 1.0 (Figure 1, Appendix E). This is below a factor of safety (FS) of 1.3 which is considered appropriate to achieve both short and long-term stability for the embankment slope.
