Hydrogeological Investigation and Design Report

Harris River Rest Area

Highway 69 Four Laning

Prepared For: Ministry of Transportation

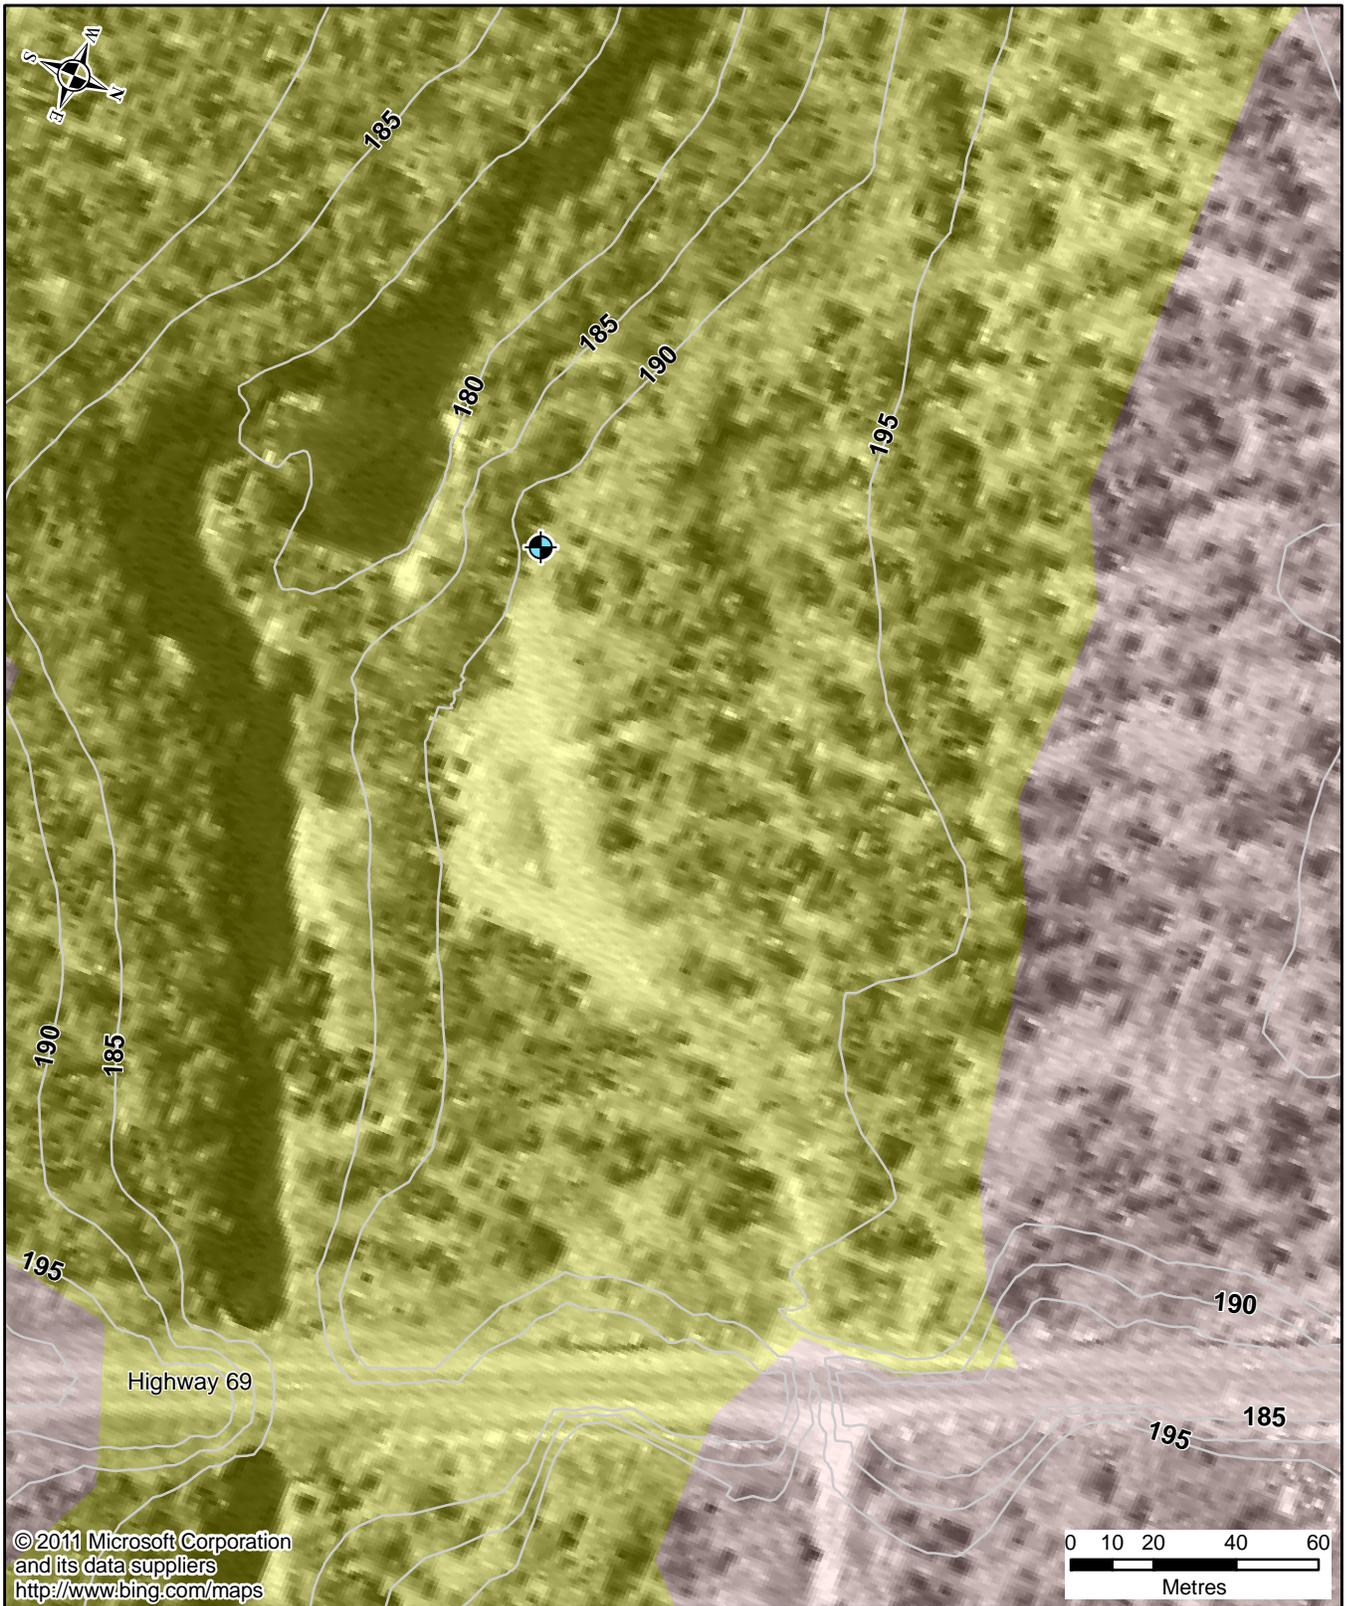
16-07198-001-EN4	Scale as Shown	Review: AL
Date: December 2011		Figure: 2
© Queen's Printer for Ontario

J:\1442 Projects by Job Number\2007_Jobs\16-07198 Hwy 69-529 N (Harris R)\50 Mapping\MXD\Figure 2_Surficial Geology.mxd

The site is situated in an area that is mapped as underlain by coarse-textured glacio-lacustrine surficial deposits (See Figure 2). Based on the elevation contours and the proximity of the site to Harris River, along with observed water levels measured at test holes, local groundwater is flowing towards the south/southwest. Regional groundwater flow is expected to flow westerly towards Georgian Bay.

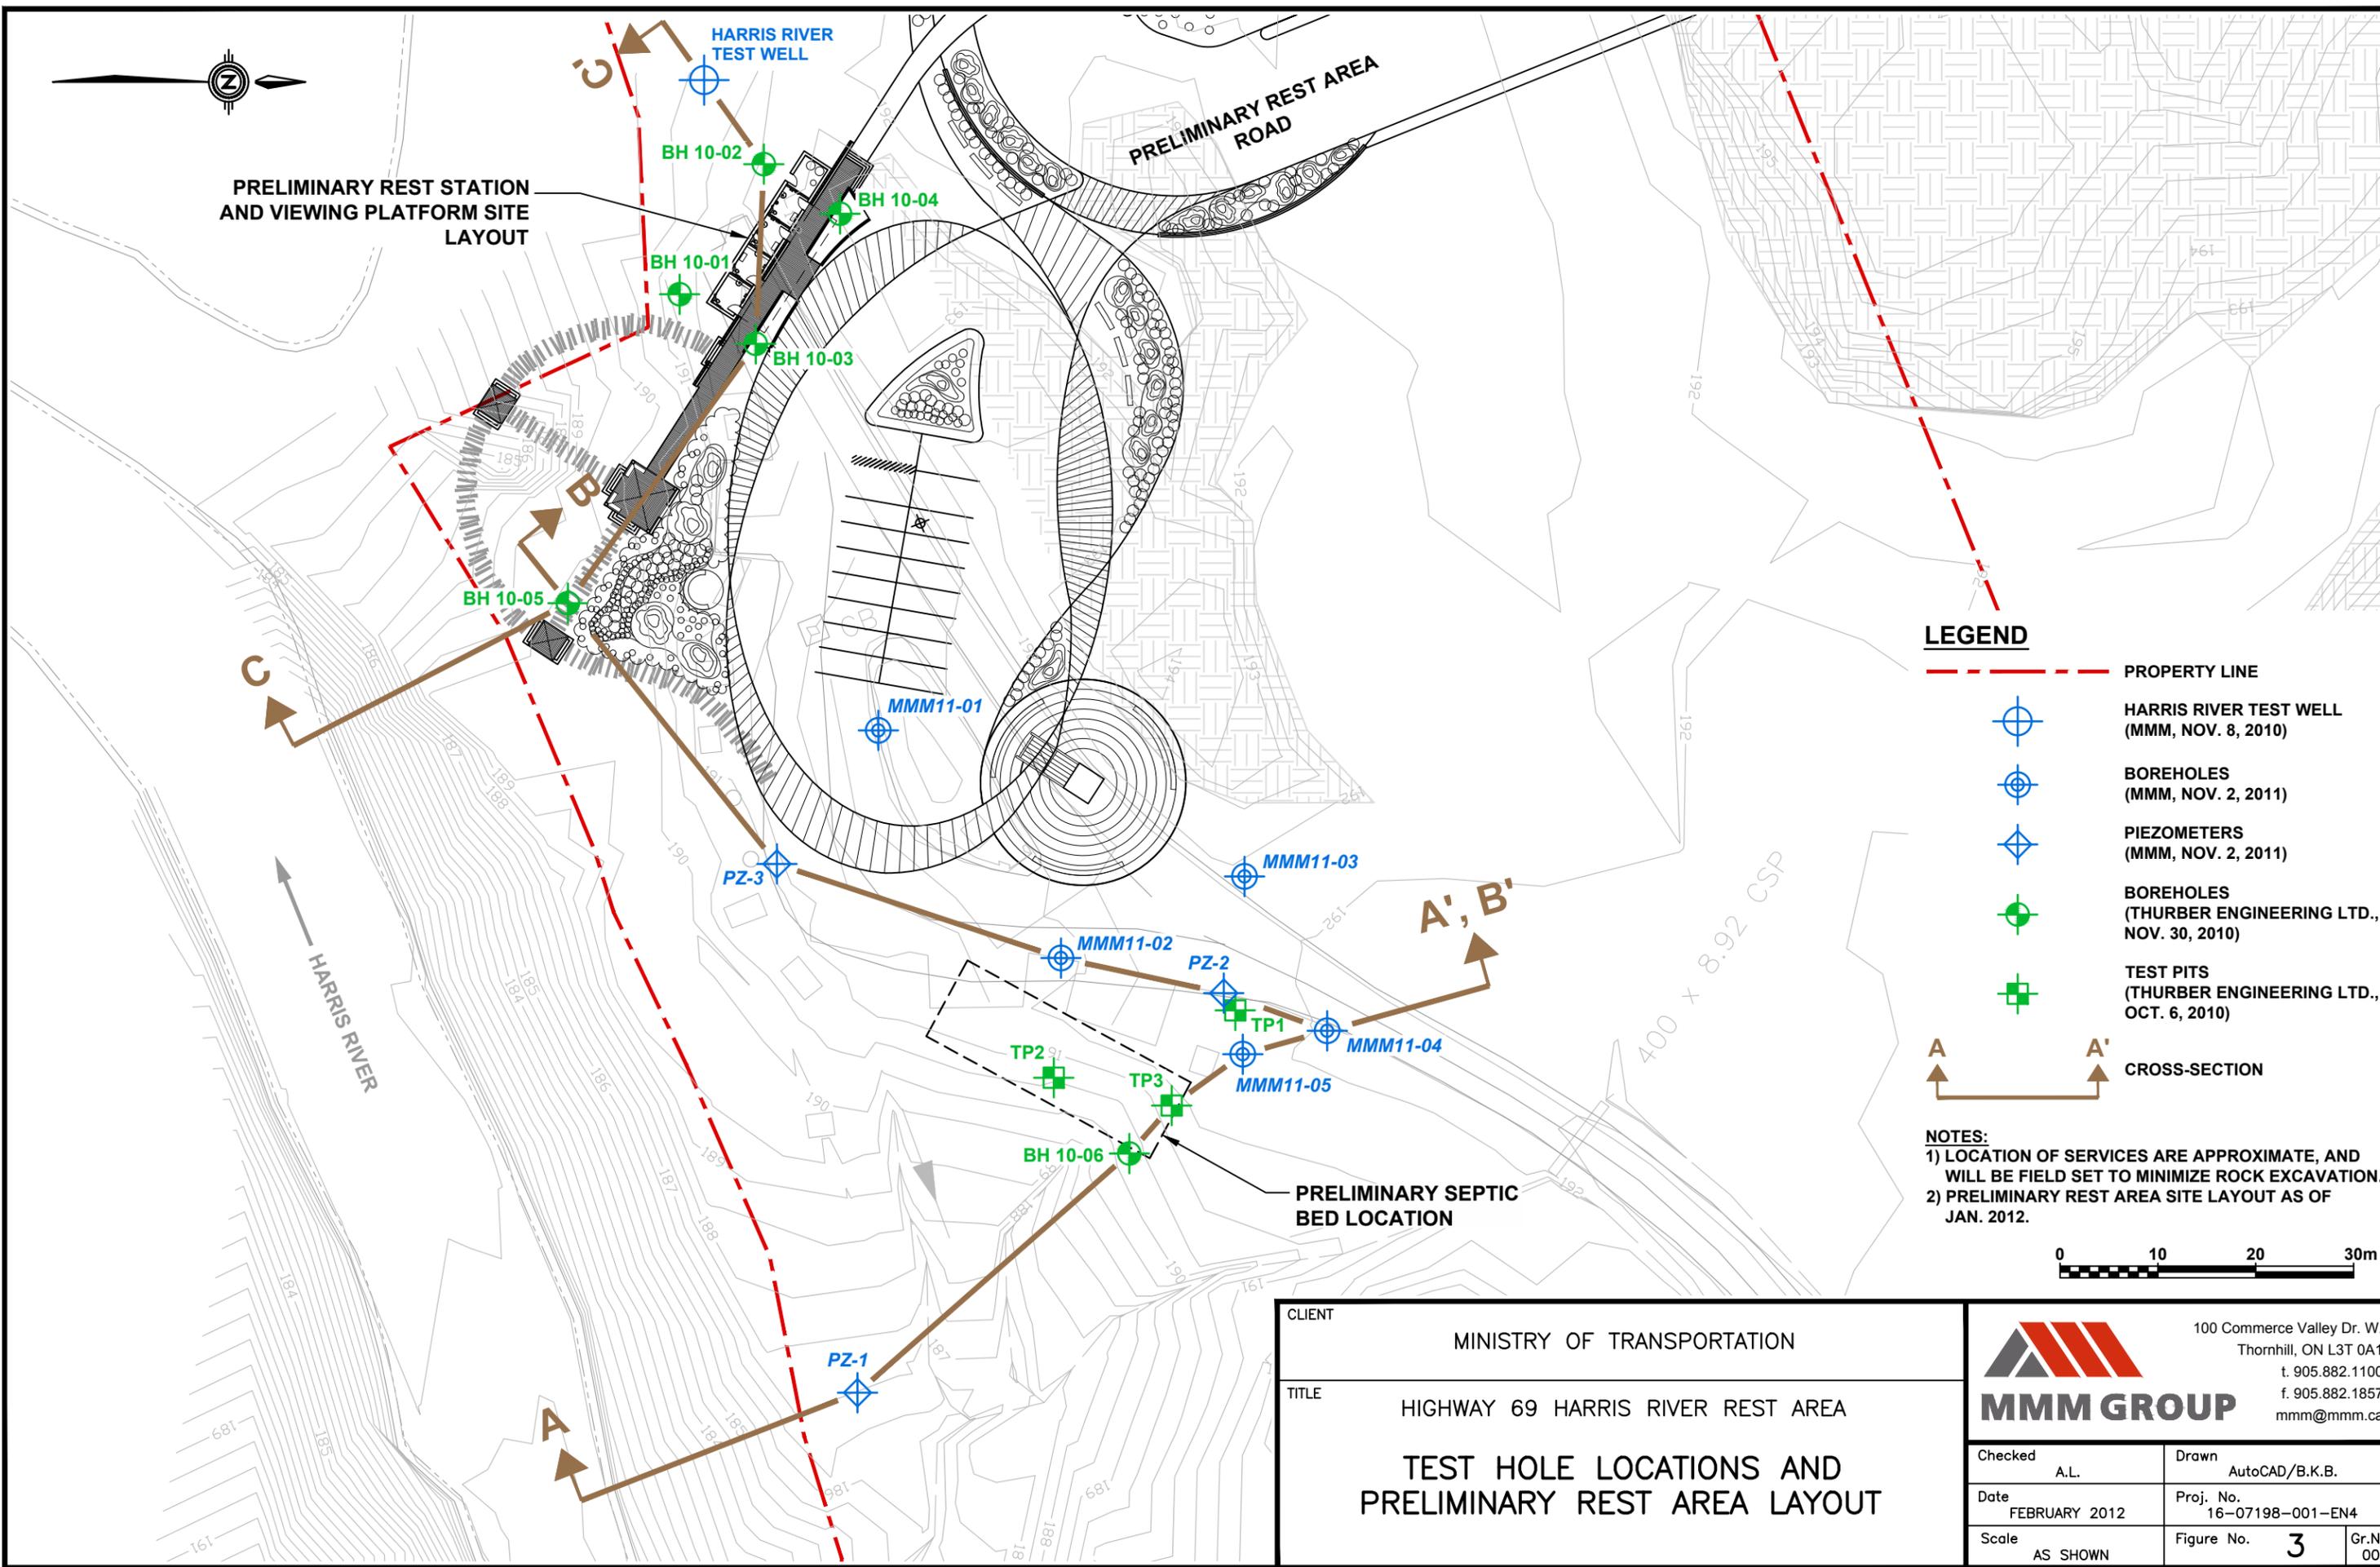
100 Commerce Valley Dr. W. Thornhill, ON L3T 0A1 t. 905.882.1100 f. 905.882.1857 mmm@mmm.ca	
Checked	A.L.	Drawn	AutoCAD/B.K.B.
Date	FEBRUARY 2012	Proj. No.	16-07198-001-EN4
Scale	AS SHOWN	Figure No.	3
		Gr.No.	001

FIGURE 3.dwg Test Hole Locations And Preliminary Rest Area Layout S:\14-4216\07198-001-EN4 Mar 16, 2012 - 9:29am

CLIENT	MINISTRY OF TRANSPORTATION		
TITLE	HIGHWAY 69 HARRIS RIVER REST AREA		
	TEST HOLE LOCATIONS AND PRELIMINARY REST AREA LAYOUT

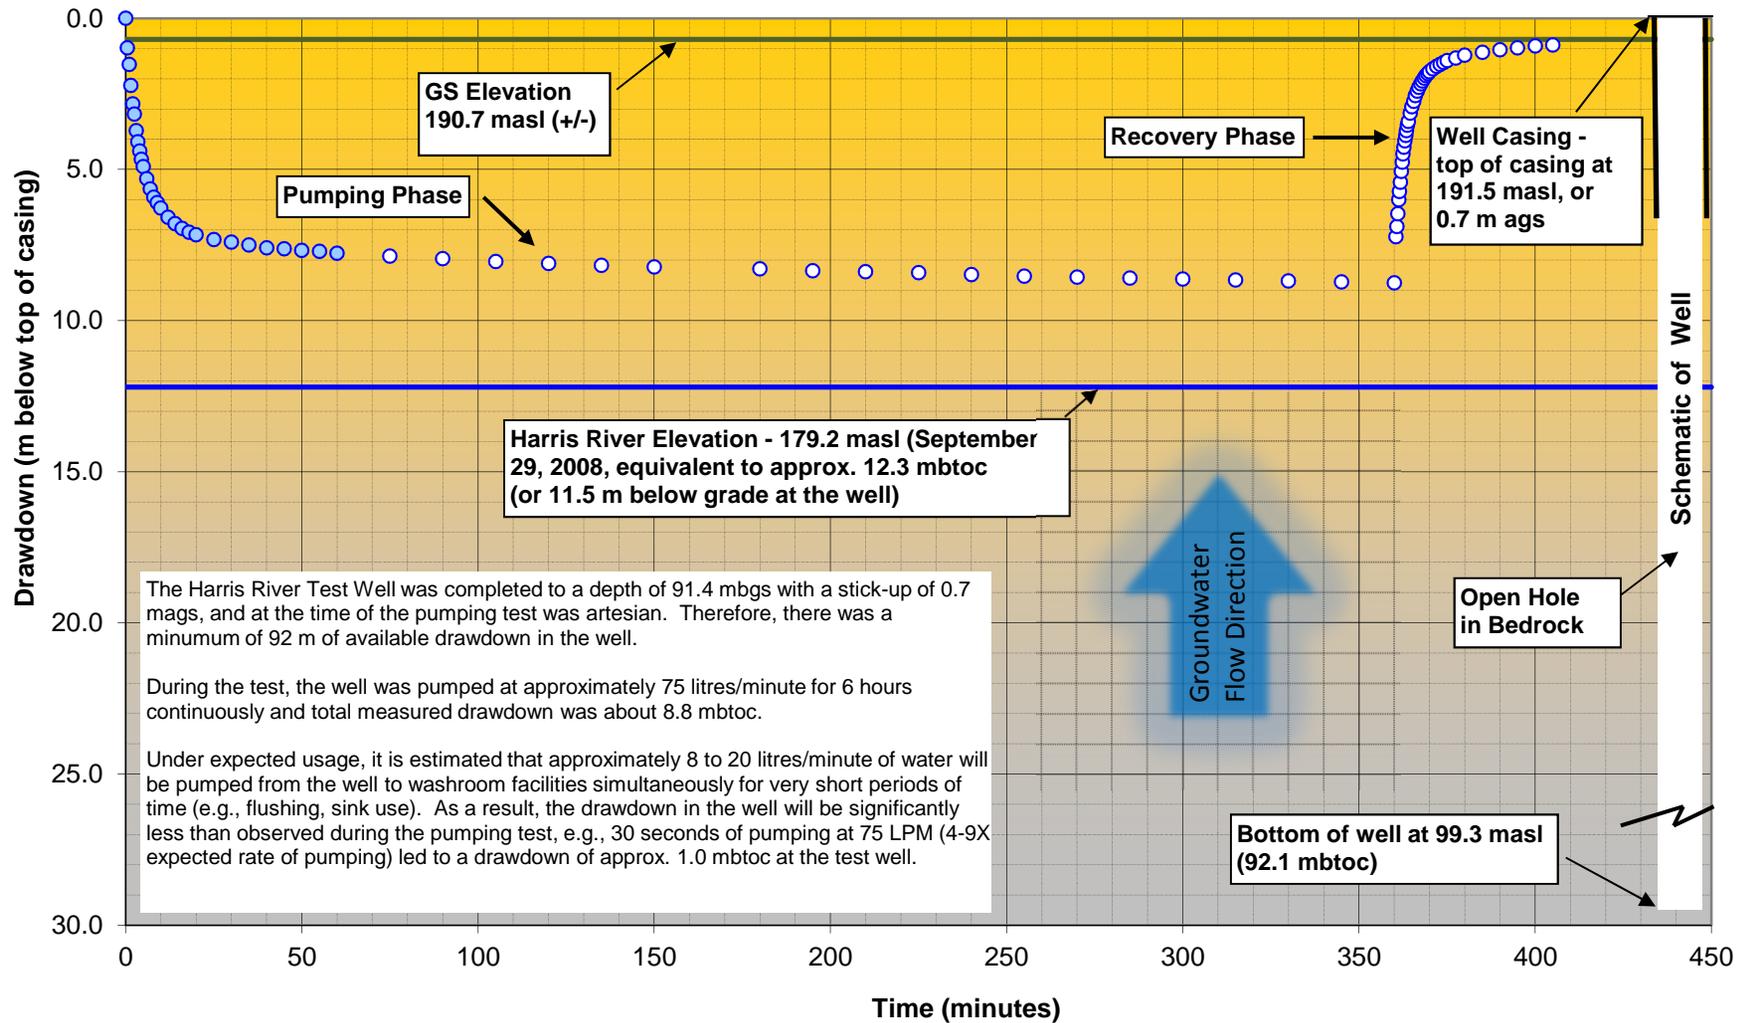
Figure 4: Groundwater Levels in a Test Well during Pumping Test and Recovery
 Harris River Rest Area Pumping Test - November 18, 2010

Groundwater levels monitored in the test well during the pumping test and recovery are presented on Figure 4. The schematic of the well is shown on the right-hand side of the graph. As can be seen on the graph, the water levels declined steadily during the testing, consistent with the pumping rate remaining constant during the pumping phase of the test. The maximum drawdown of 8.8 m in the well below the casing (approximately 182 masl) occurred at the end of the test, which is approximately 3.5 m above the elevation of the Harris River. It is noted that during normal use, infrequent, short term pumping of the well at a lower rate will occur and drawdown at the well will be considerably less than 8.8 m of drawdown recorded during the testing of the well.

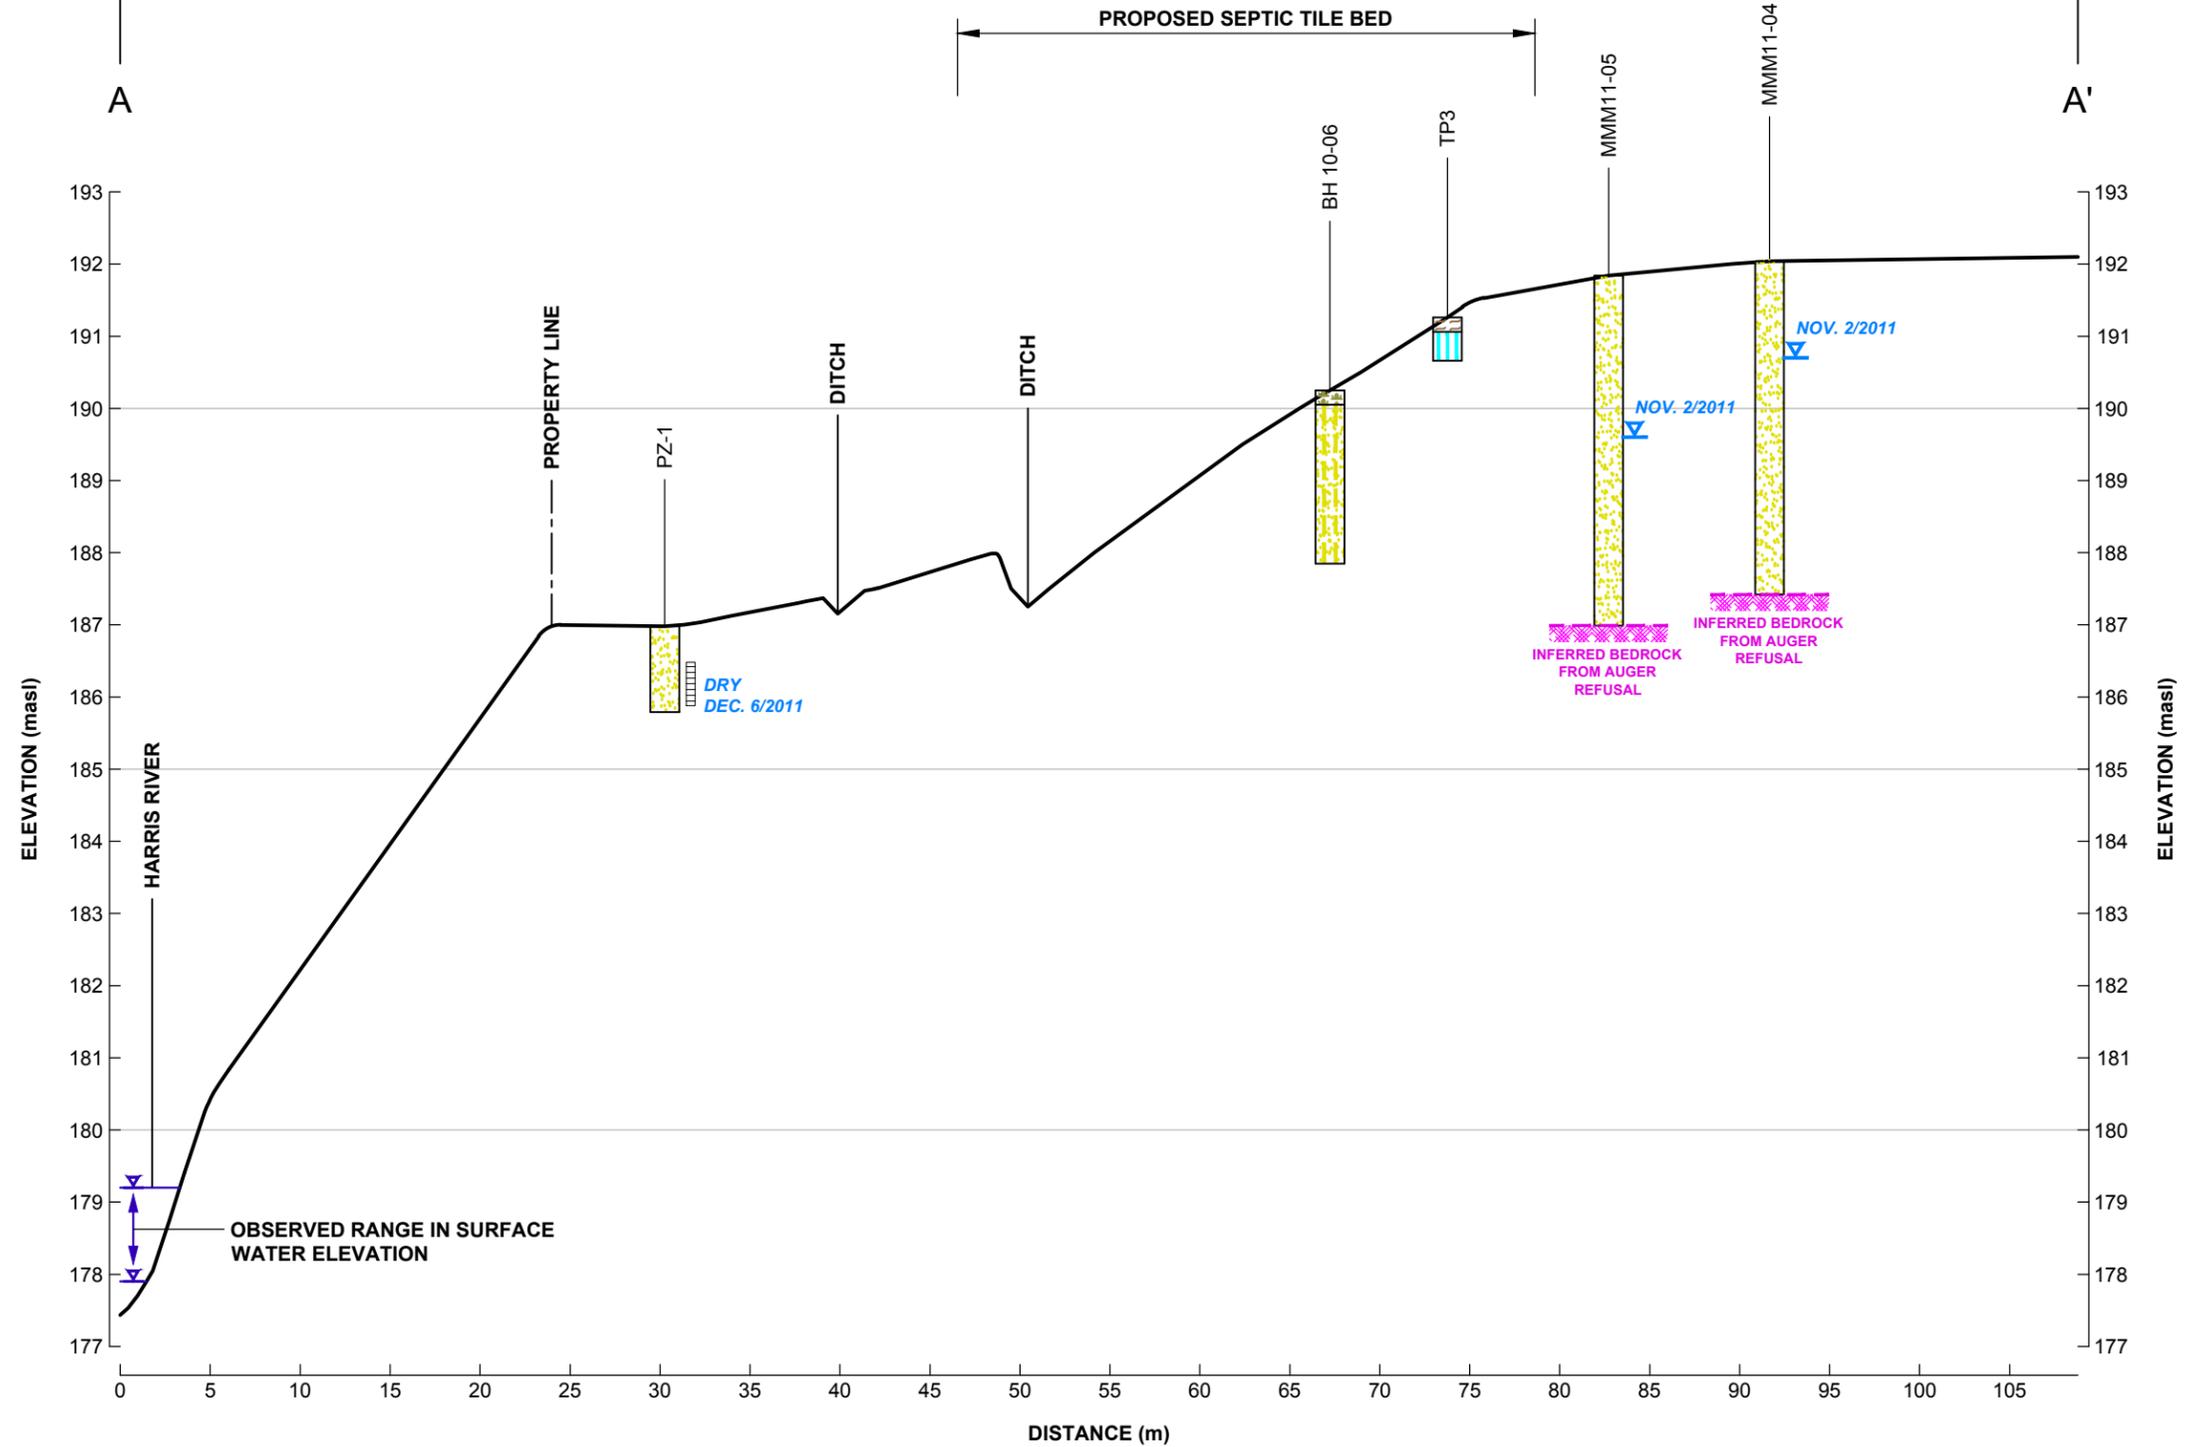
CLIENT	MINISTRY OF TRANSPORTATION		
TITLE	HIGHWAY 69 HARRIS RIVER REST AREA		
	HYDROGEOLOGIC CROSS-SECTION A-A'

FIGURE 5 - FIGURE 6 - FIGURE 7.dwg Hydrogeologic Cross-Section A-A' S:\14-42\16\07198-001-EN4 Apr 22, 2012 - 12:52pm

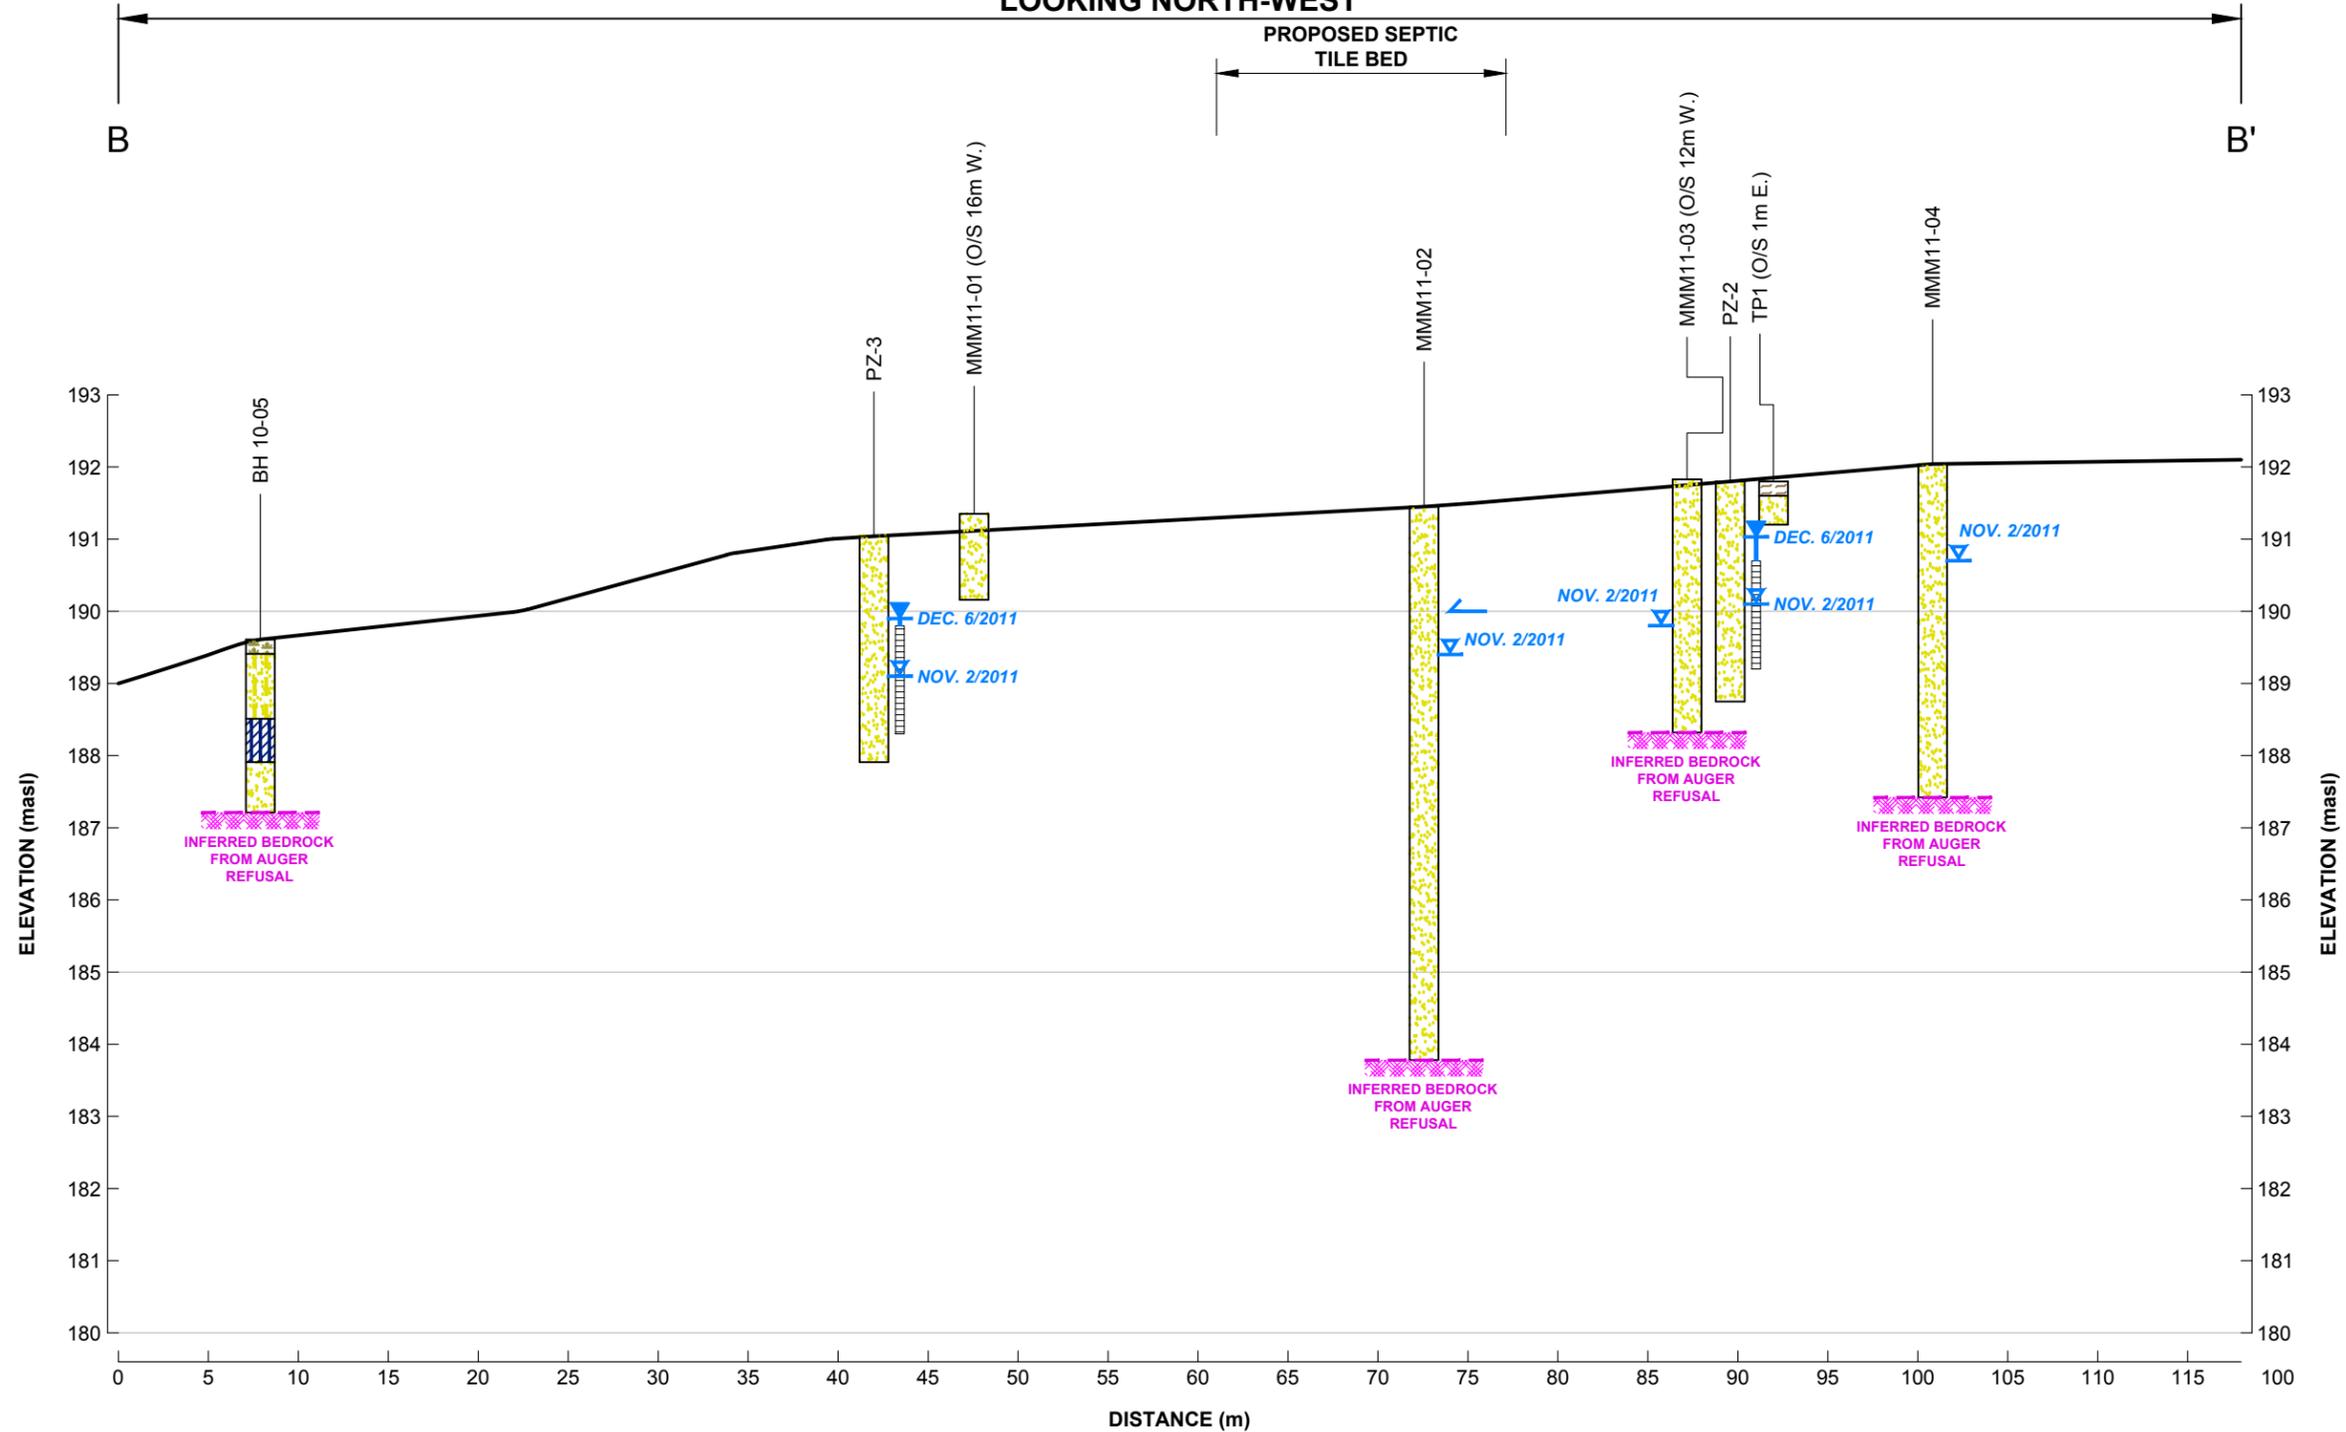
Checked	A.L.	Drawn	AutoCAD/B.K.B.
Date	FEBRUARY 2012	Proj. No.	16-07198-001-EN4
Scale	VERT: 1:100 HORIZ: 1:400	Figure No.	6
		Gr.No.	001

FIGURE 5 - FIGURE 6 - FIGURE 7.dwg Hydrogeologic Cross-Section B-B' S:\14-4216\07198-001-EN4 Mar 15, 2012 - 8:02am

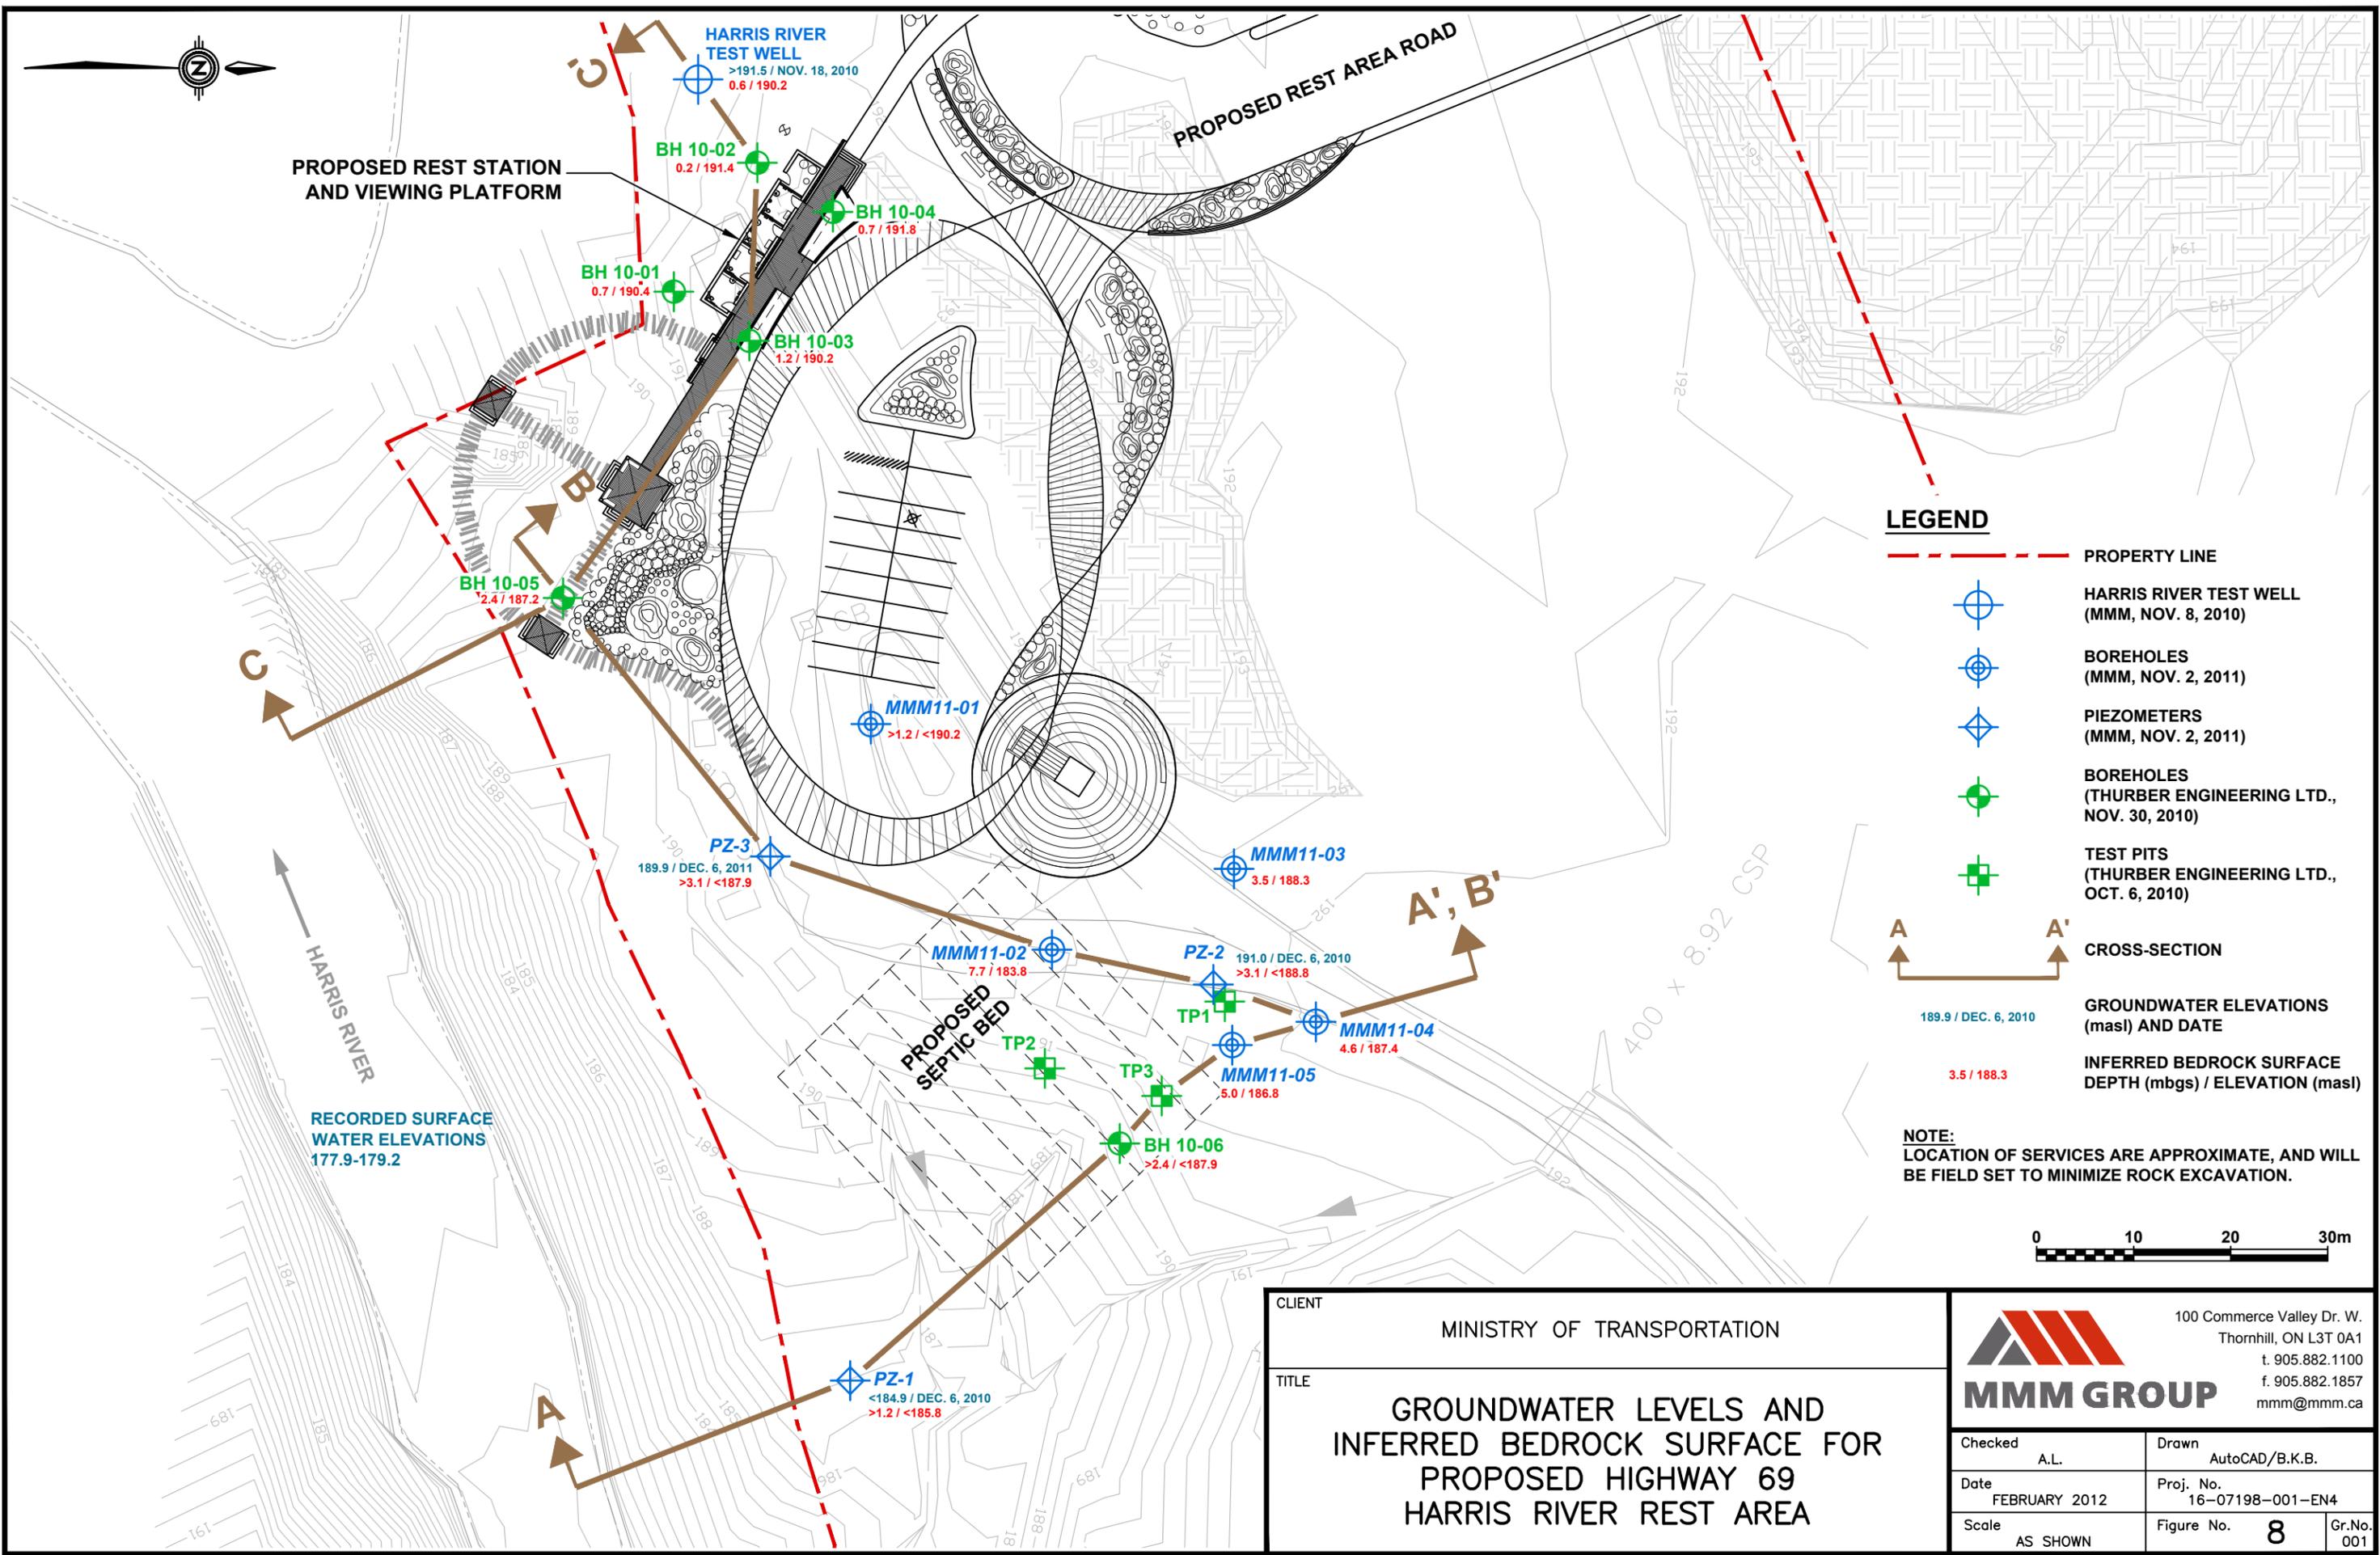
100 Commerce Valley Dr. W. Thornhill, ON L3T 0A1 t. 905.882.1100 f. 905.882.1857 mmm@mmm.ca	
Checked	A.L.	Drawn	AutoCAD/B.K.B.
Date	FEBRUARY 2012	Proj. No.	16-07198-001-EN4
Scale	AS SHOWN	Figure No.	8
		Gr.No.	001

FIGURE 8.dwg Groundwater Levels And Inferred Bedrock Surface For Proposed Highway 69 Harris River Rest Station S:\14-42\1607198-001-EN4 Feb 21, 2012 - 9:29am

CLIENT	MINISTRY OF TRANSPORTATION		
TITLE	GROUNDWATER LEVELS AND INFERRED BEDROCK SURFACE FOR PROPOSED HIGHWAY 69 HARRIS RIVER REST AREA

The test well, constructed at the west end of the site was found to be flowing artesian (November 2010), with a groundwater elevation of at least 191.5 masl (the surveyed top of well casing). This places the water level at the test well between 12.3 to 13.6 m above the recorded water elevations of the Harris River, and above shallow groundwater elevations recorded at monitors to the east in the vicinity of the proposed septic bed area. Groundwater flow from the bedrock aquifer beneath the site is therefore vertically upward from the rock towards the Harris River and not from the river into the rock.

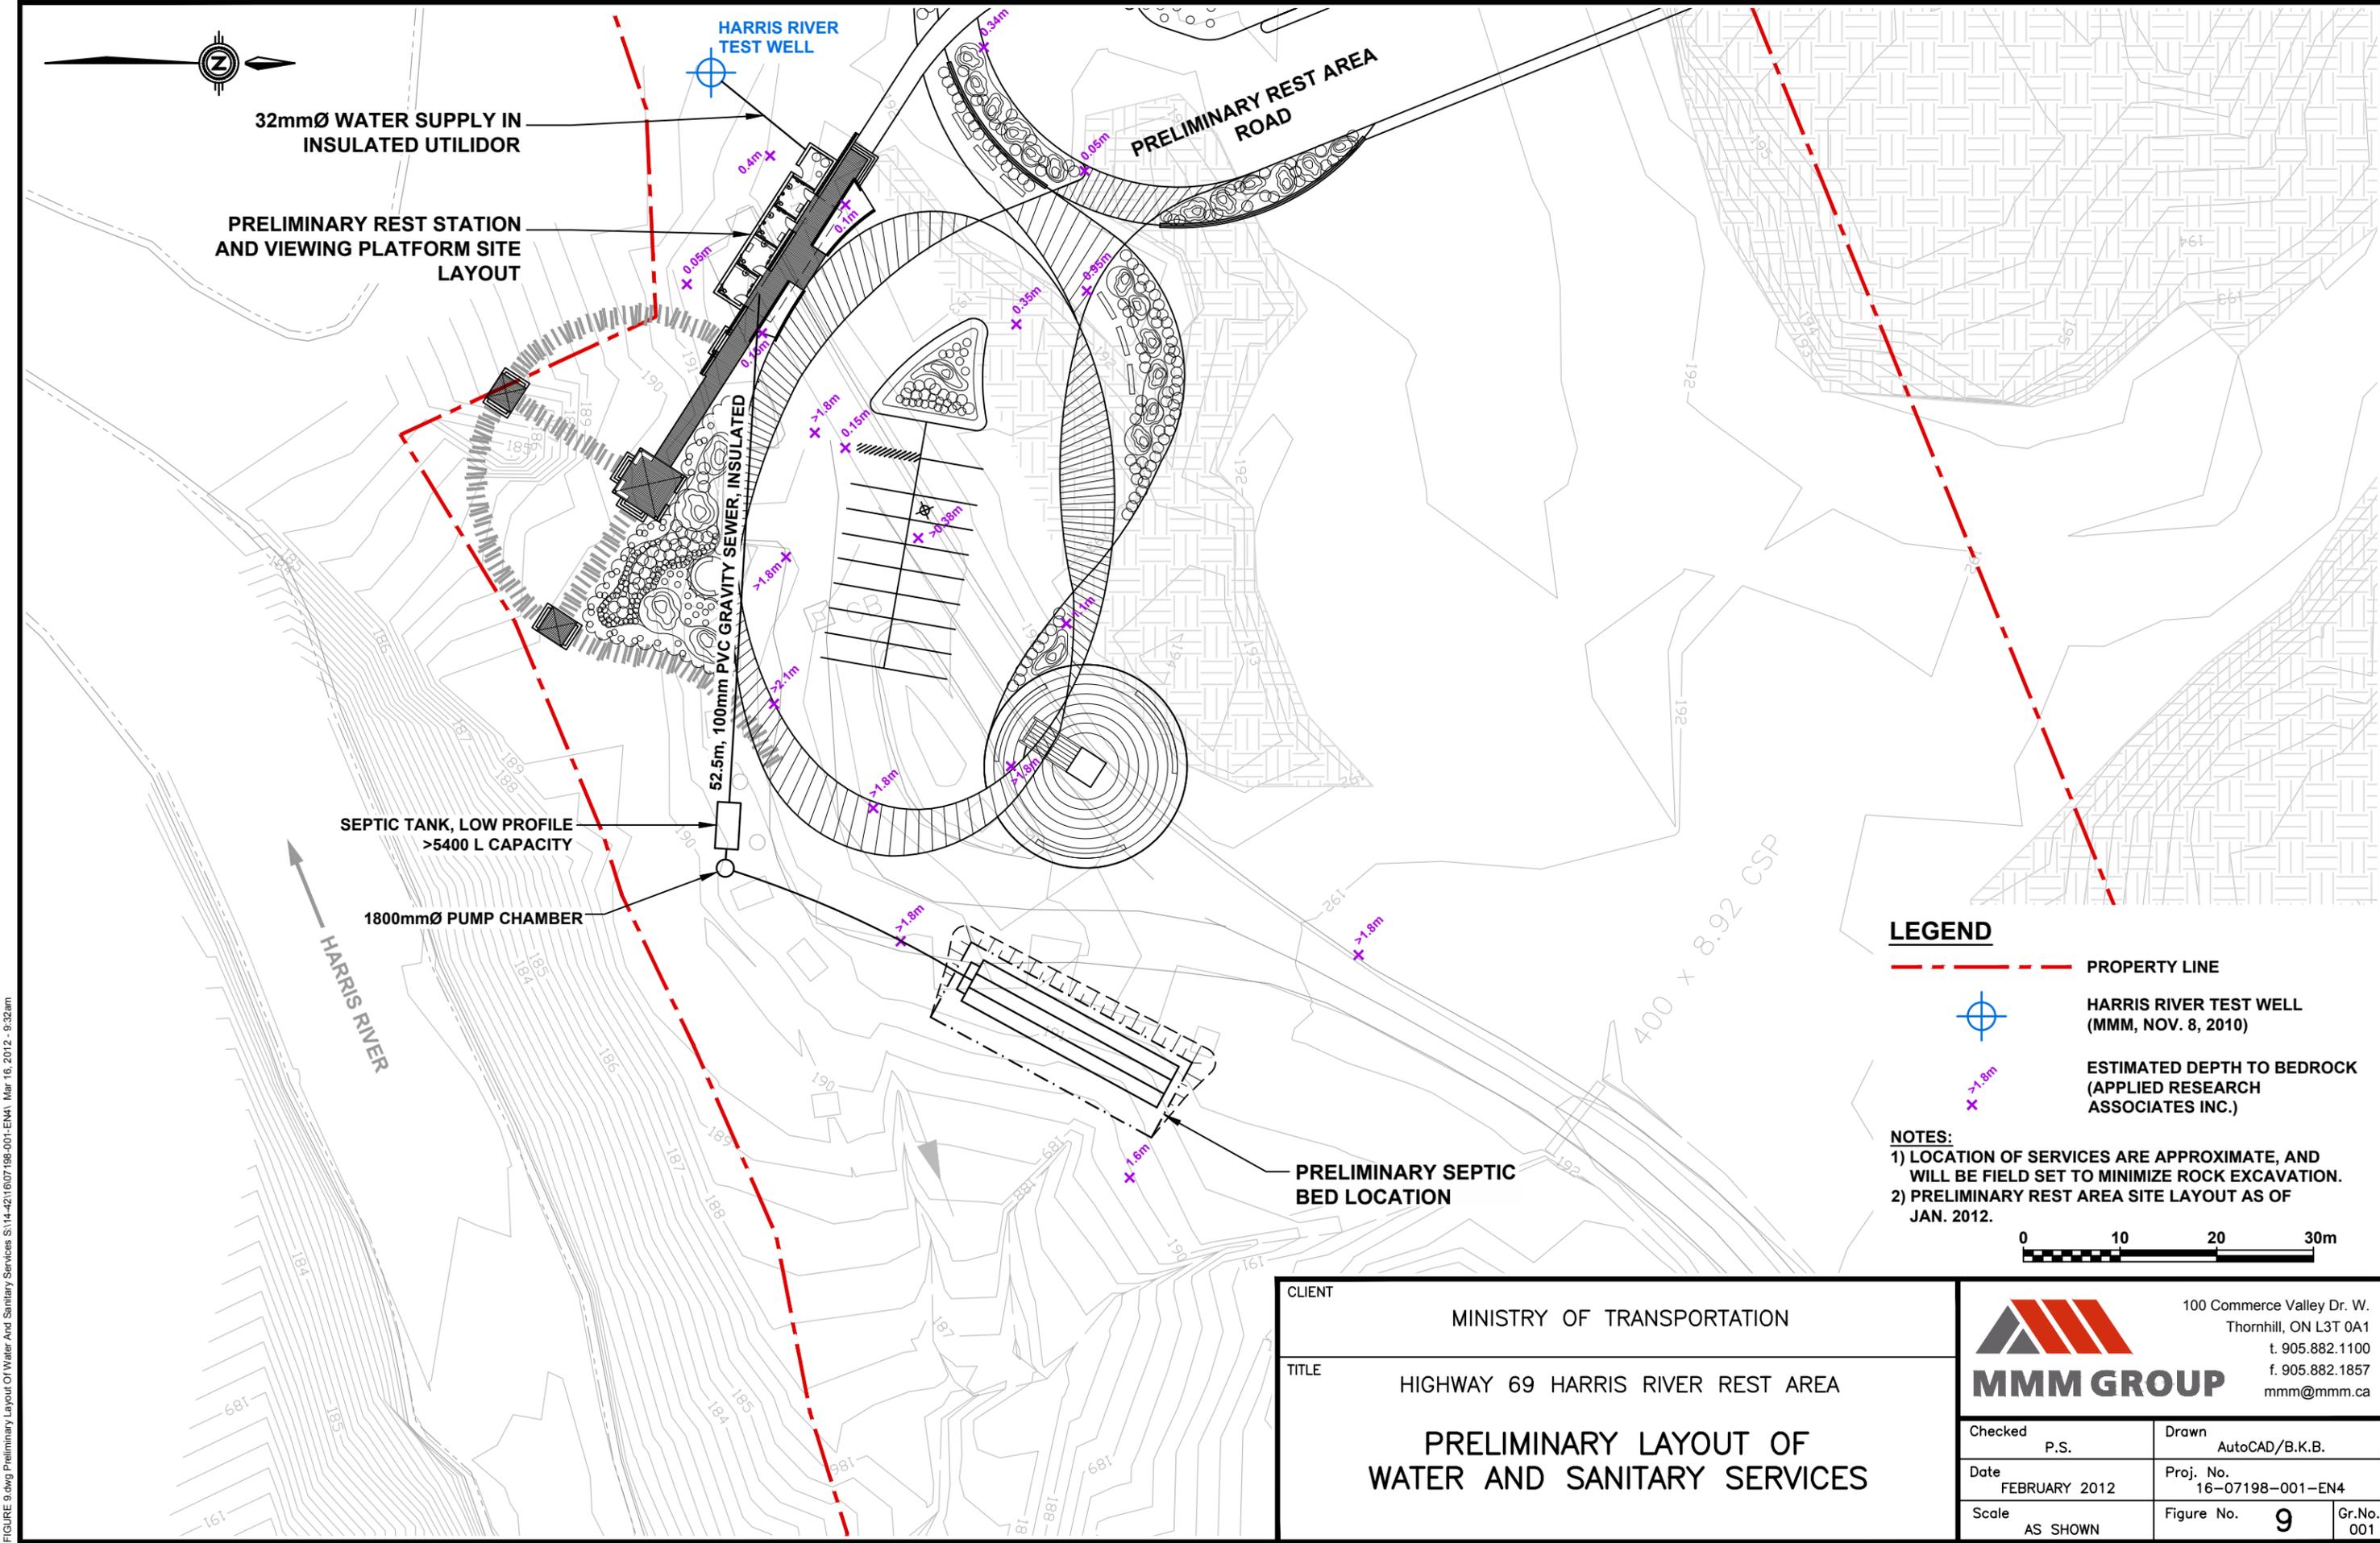
100 Commerce Valley Dr. W. Thornhill, ON L3T 0A1 t. 905.882.1100 f. 905.882.1857 mmm@mmm.ca	
		Checked P.S.	Drawn AutoCAD/B.K.B.
Date FEBRUARY 2012	Proj. No. 16-07198-001-EN4		Gr.No. 001
Scale AS SHOWN	Figure No. 9

32mmØ WATER SUPPLY IN INSULATED UTILIDOR

PRELIMINARY REST STATION AND VIEWING PLATFORM SITE LAYOUT

PRELIMINARY LAYOUT OF WATER AND SANITARY SERVICES
