Hydrogeological Investigation and Design Report

Harris River Rest Area

Highway 69 Four Laning

Prepared For: Ministry of Transportation

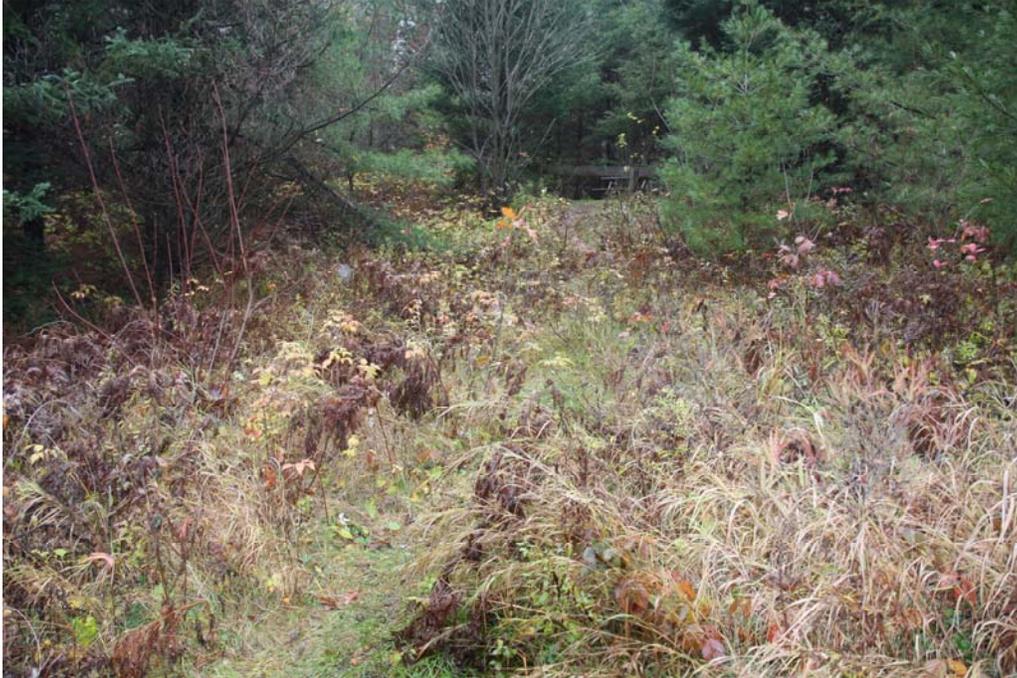
Photograph 1: View looking north towards rest area from north embankment of Harris River (Oct.25, 2010).

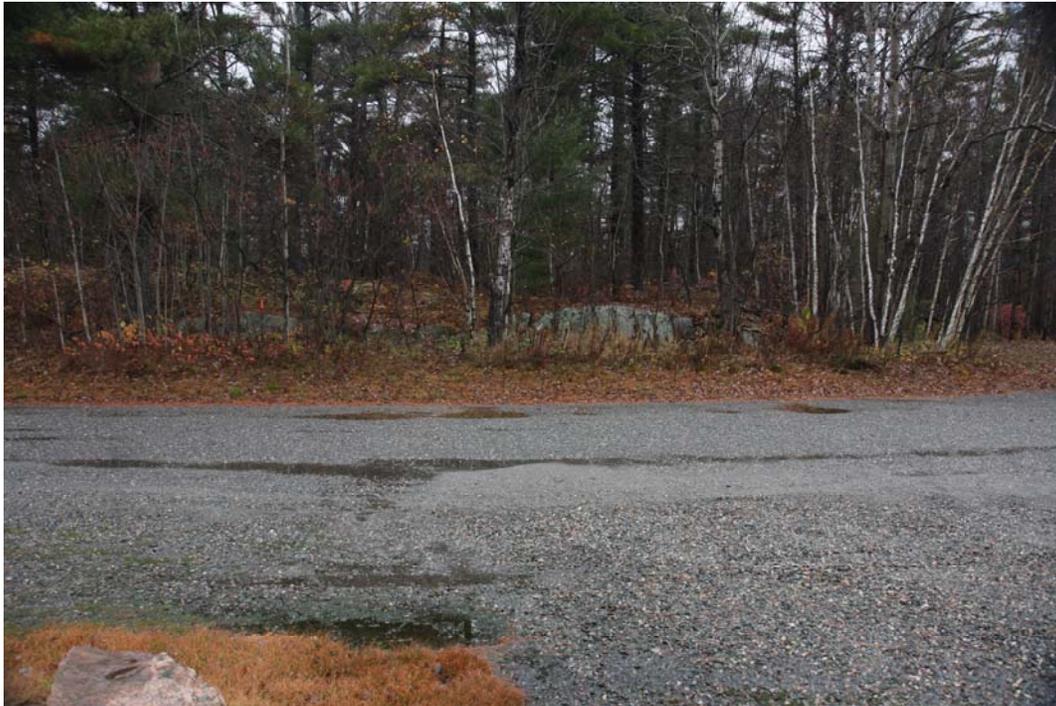
Photograph 5: View of rock outcrop looking north from centre of rest area (Oct.25, 2010).

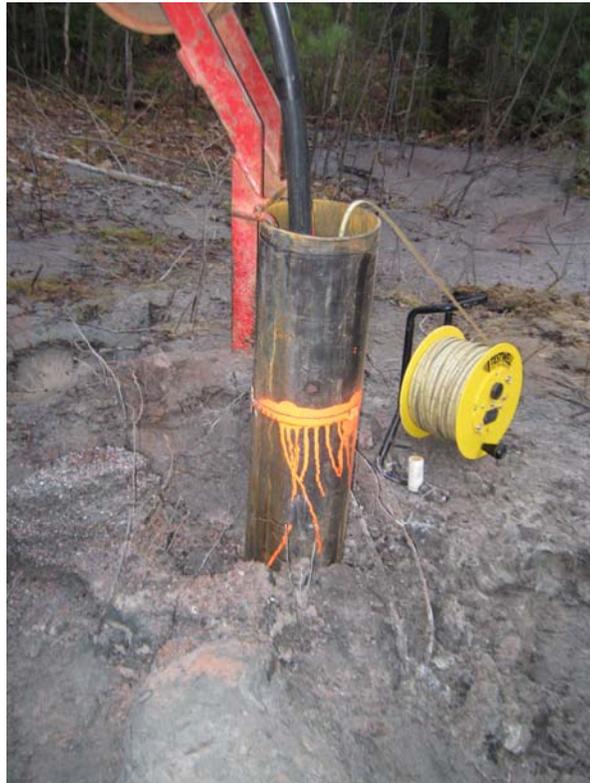
Photograph 6: Pump test on Harris River test well (Nov.18, 2010).

A submersible pump was installed within the well with a rated capacity of 75 litres/min (20 US gal/min) and the pump intake was set to a depth of approximately 73 mbgs. Pumping at the well was maintained at a steady rate of 75 litres/min (20 US gal/min) during the entire testing period, with no variation noted. The pump rate was monitored by using a F452 manual flow meter supplied by the well drilling contractor. The accuracy of the pumping rate was verified by the MMM field technician by measuring the flow at the discharge end of the hose, using a graduated bucket and timer. Water was discharged to the ground surface in the forest, at a point located approximately 20 m to the northwest of the test well. The area was monitored throughout the test to ensure there was no erosion caused by the discharge. In total, 27,000 litres of water was pumped from the well during the test.

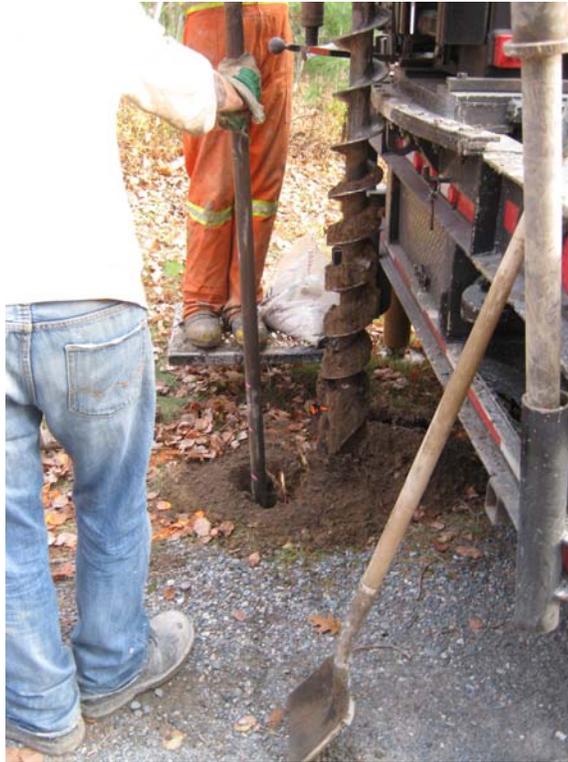
Photograph 7: MMM11-02 borehole drilling (Nov.2, 2011).

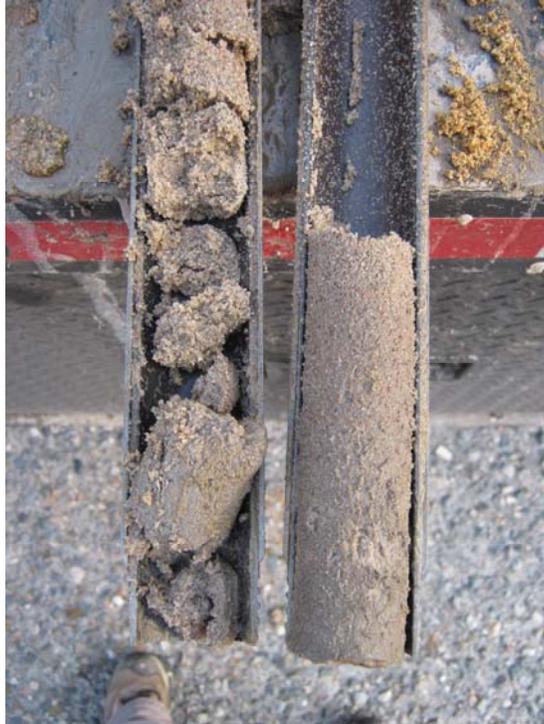
Photograph 8: View of split spoon soil sample from MMM11-04 (Nov.2, 2011).

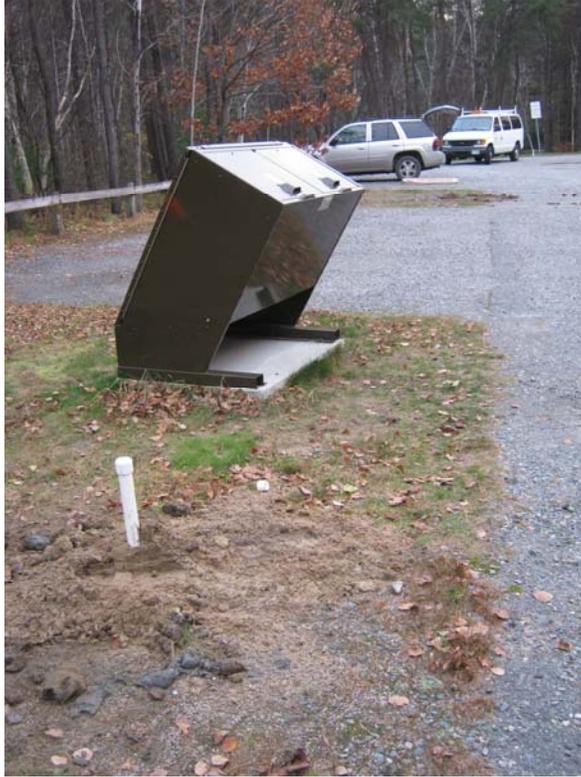
Photograph 9: View of piezometer stickup at PZ-2 looking west (Nov.2, 2011).

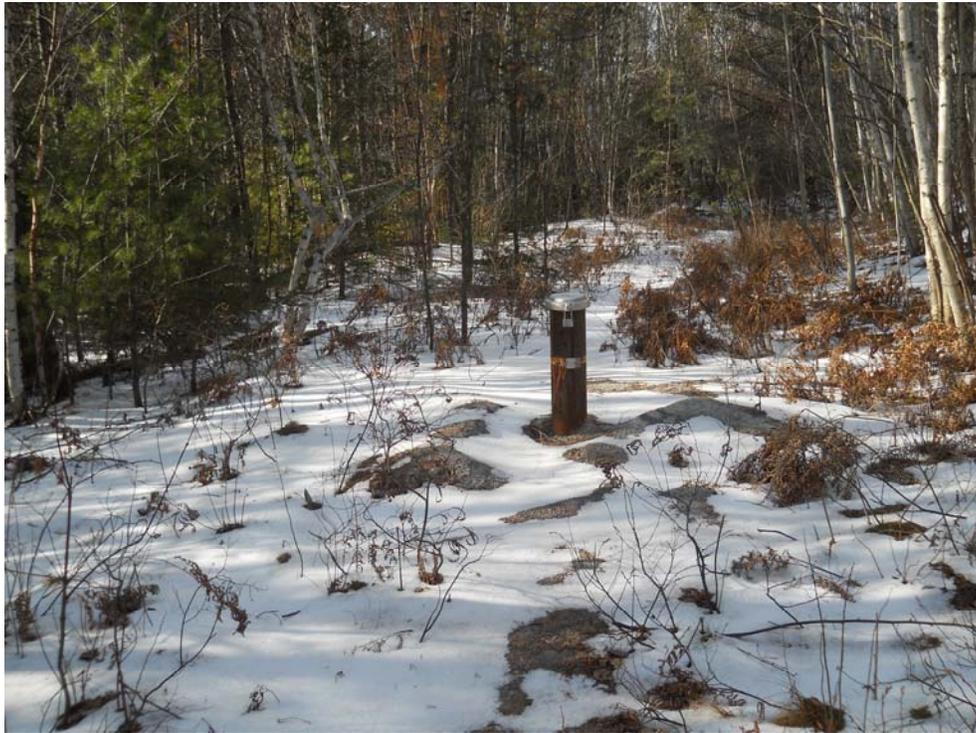
Photograph 10: View of test well looking northwest (Dec.6, 2011).

A preliminary site visit was conducted on October 25, 2010 with representatives from MMM and the water well drilling contractor to review the proposed work plan and to identify the test well location. The test well is located approximately 12 m southwest of the proposed washroom building facility¹. The general location of the test well was chosen to allow for future ease of access to the well for maintenance vehicles (see Figure 3). The test well is located a minimum of 80 m to the west of the proposed septic bed, and approximately 30 m to the north of the Harris River.

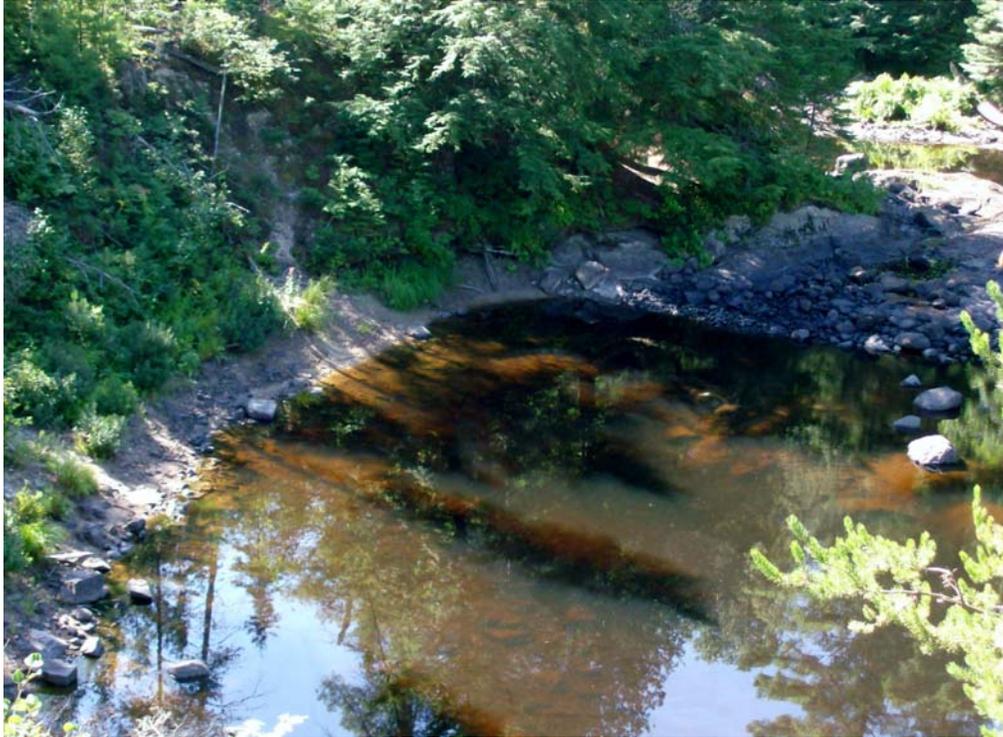
Photograph 11: Close-up view of the south embankment of the Harris River, looking southwest (Aug.16, 2011).

The Harris River is located south of the rest area and flows in a westerly direction. The rest area is on the order of 10 to 15 m higher in elevation than the Harris River (surface water level elevations recorded to range from 177.9 metres above sea level (masl) (on Aug.15, 2011) to 179.2 masl (on Sept.29, 2008)). The river valley is defined by a steep slope/ bluff (approximately 1.5:1 slope) at the southwest part of site. Grade towards the Harris River at the east end of the site is less steep (approximately 2:1 slope) (See Figure 3).

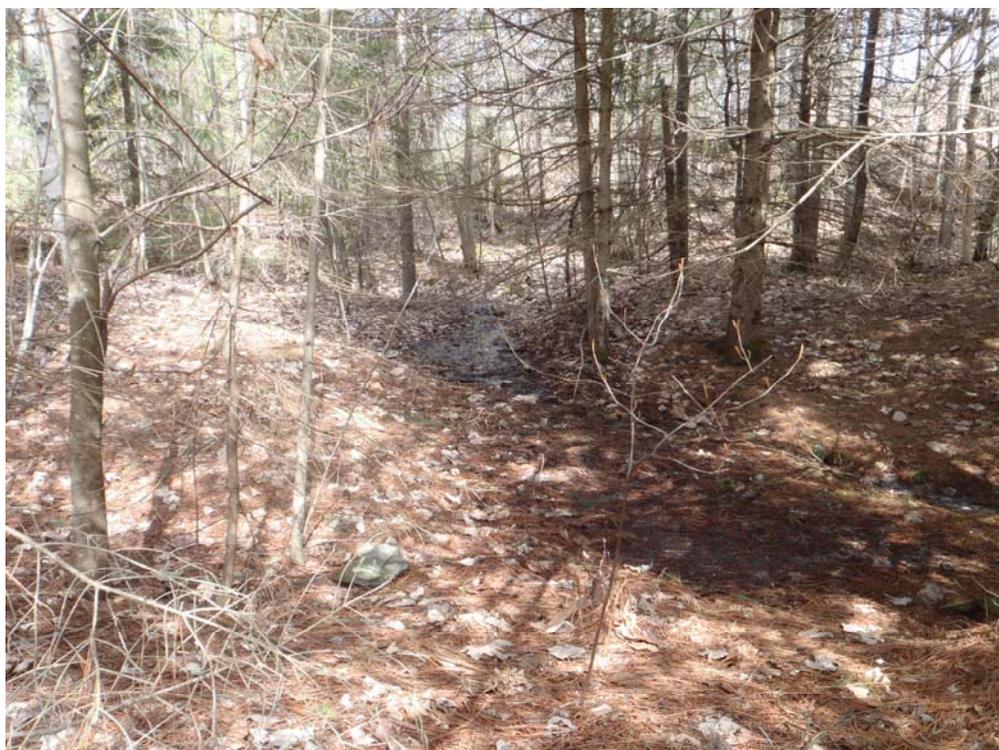
Photograph 13: View of minor wet channel near PZ-1, looking west (Apr.11, 2012).

At the time of the site visit on December 6, 2011, minor water flow was noted at one the two swales located downslope of the proposed septic area, and at the time of the visit on April 11, 2012, the areas was observed in moist/wet condition with pockets of standing water. These swales are situated at topographic elevations that may seasonally intercept the shallow water table.

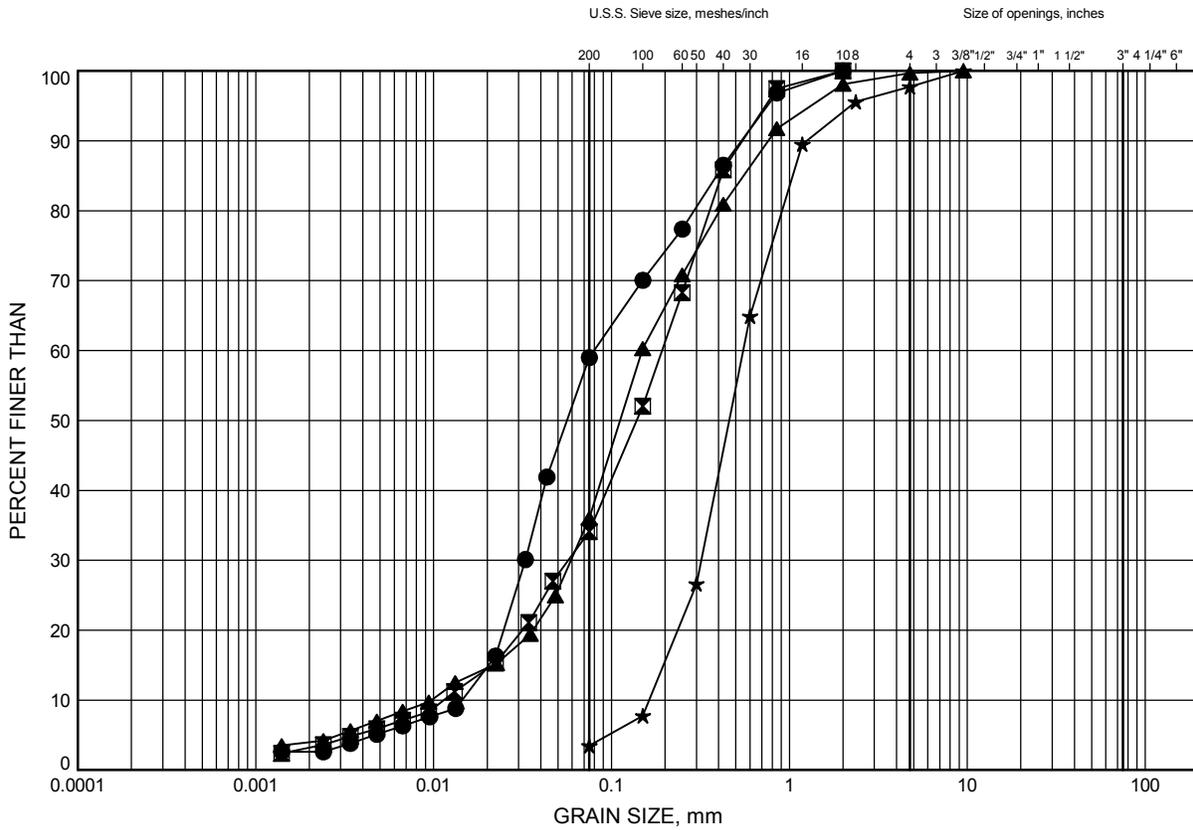
FIGURE B1

SAND & SILT/SILTY SAND

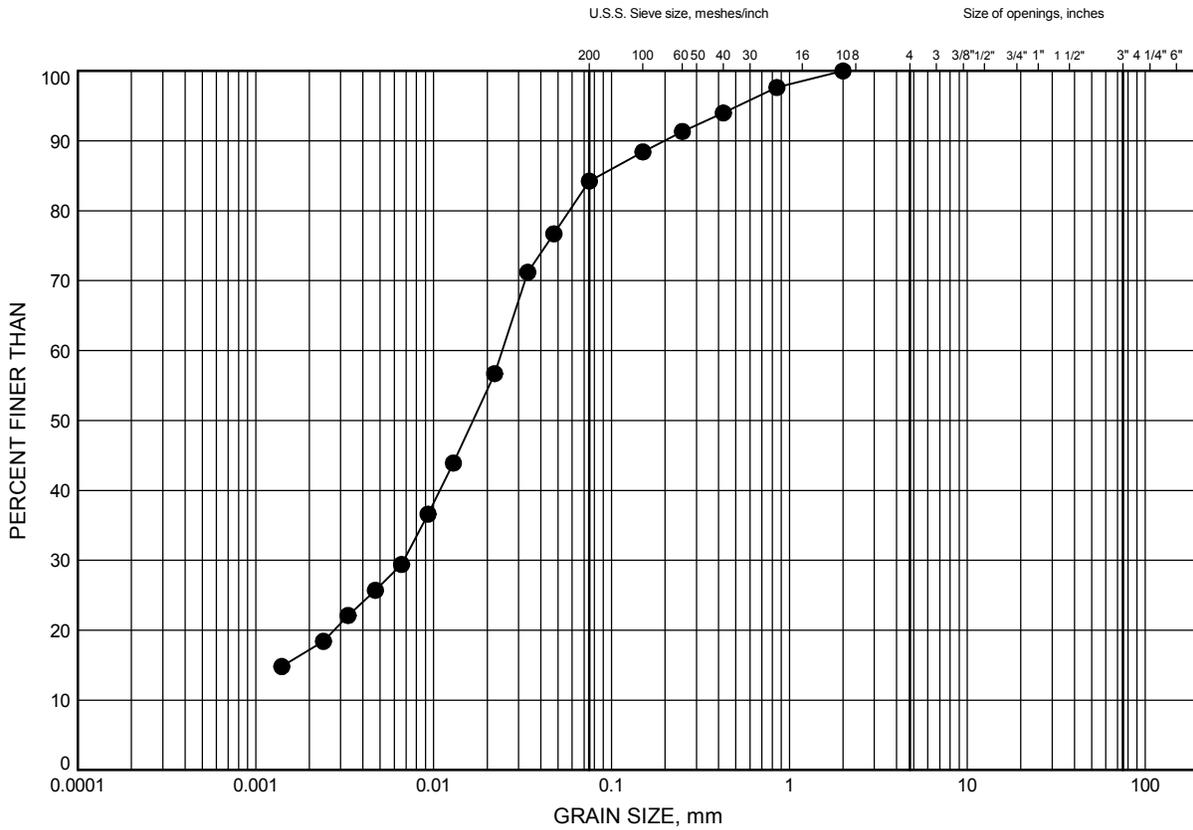
FIGURE B2

SILTY CLAY

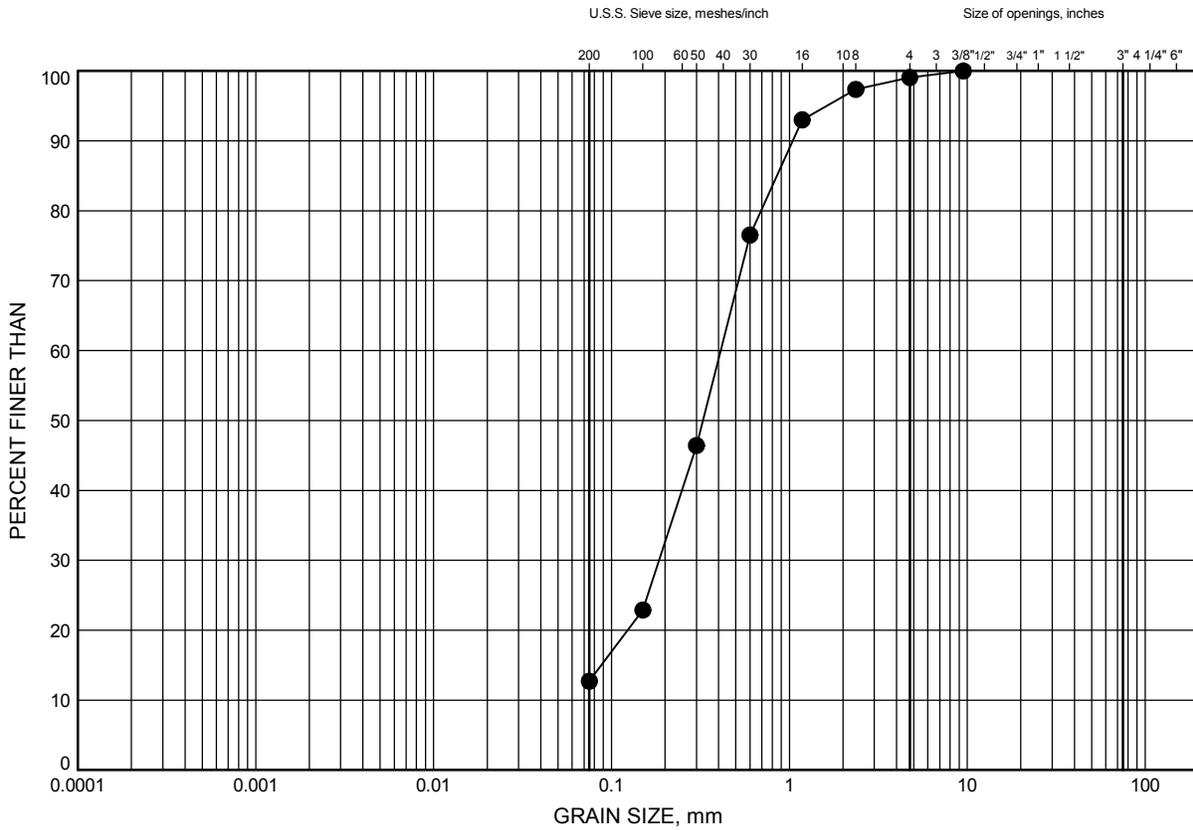
FIGURE B3

SAND

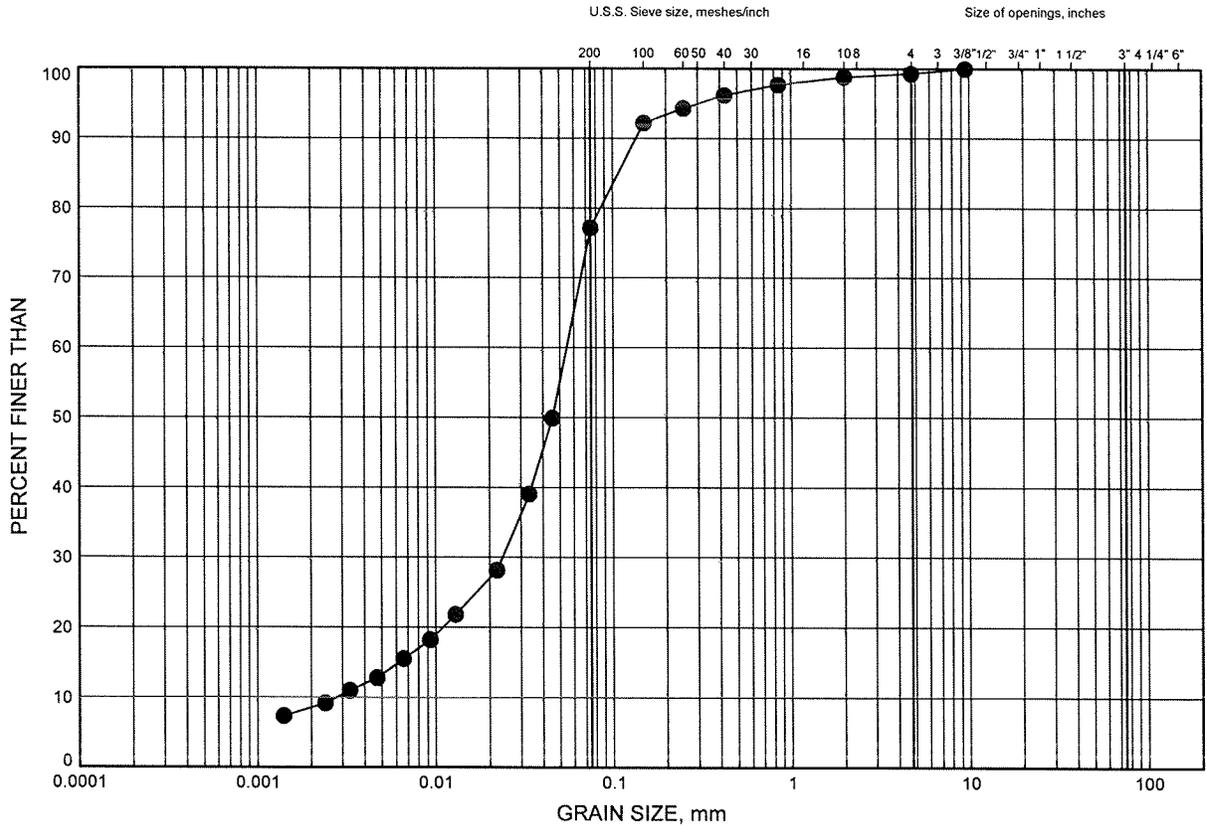
FIGURE 2

Silt, some sand

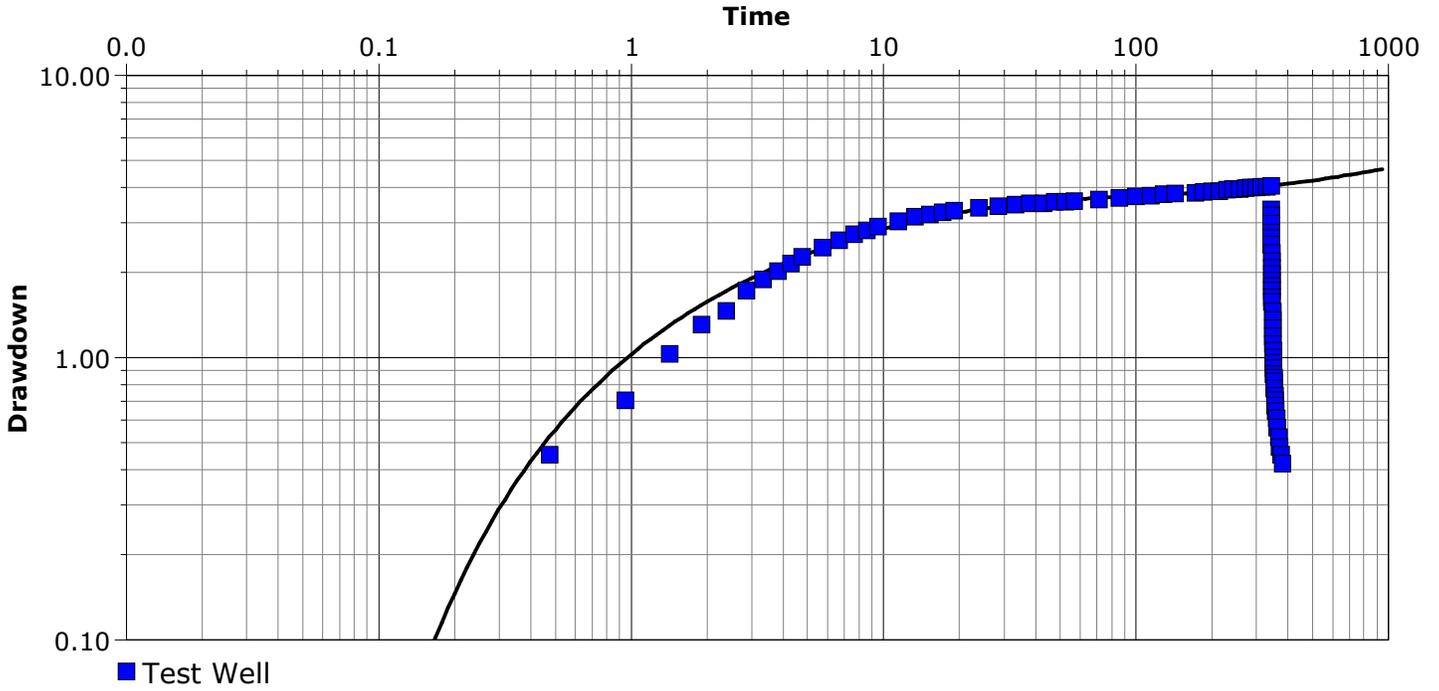
Calculation after Moench Fracture Flow

Observation Well	Transmissivity [m ² /d]	Hydraulic Conductivity [m/d]	Storage coefficient	Sigma	Gamma	SF	Radial Distance to PW [m]
Test Well	3.98×10^0	4.42×10^{-2}	5.00×10^{-1}	2.18×10^1	9.95×10^{-1}	2.81×10^1	0.08

The pumping test and recovery data was analyzed using AquiferTest Pro (version 4.2). Drawdown during pumping was analyzed using the Moench solution for fracture flow and the Double Porosity fracture flow model developed by Warren and Root. Recovery data was analyzed using the Theis Recovery Method. As drawdown and recovery data were obtained from the pumping well only, aquifer Storativity coefficients cannot be estimated. Transmissivity of the bedrock aquifer as calculated by the three approaches was 4.0 m²/day, which is a modest value. Drawdown and recovery data for the pumping test are presented in Appendix D.

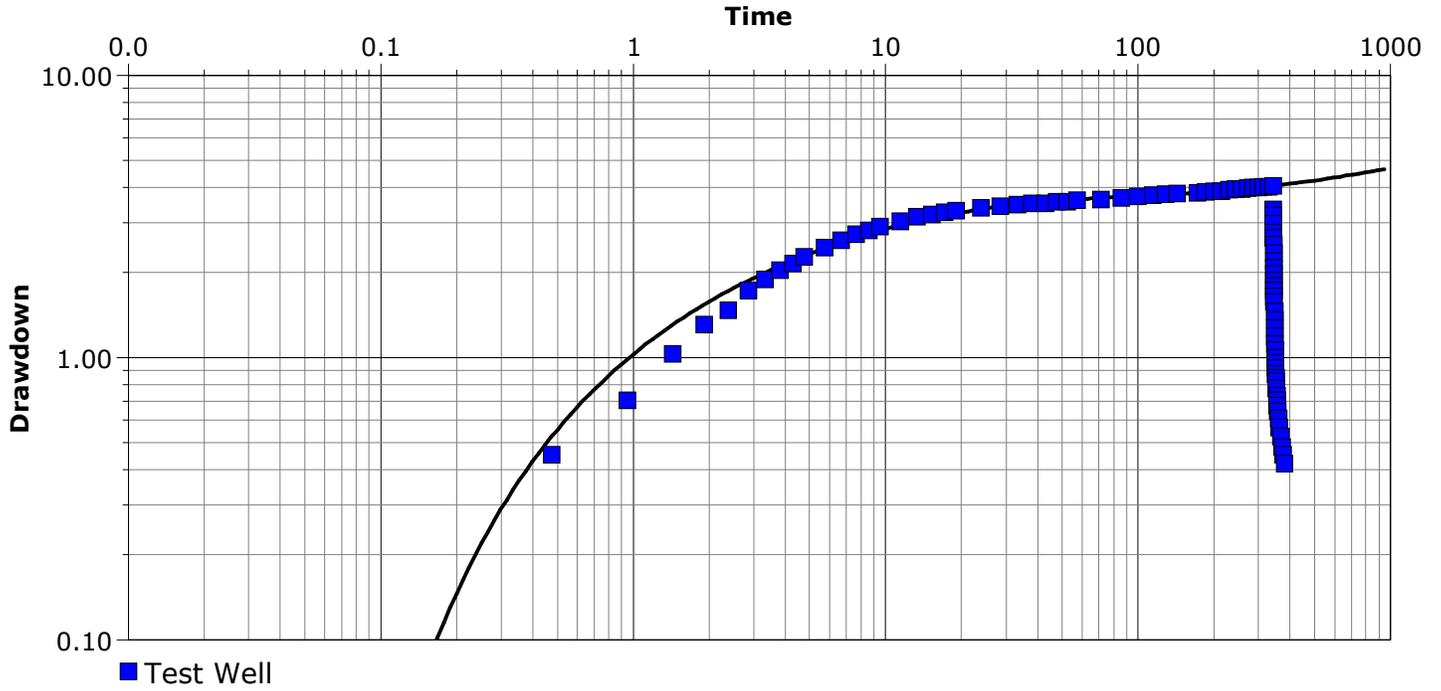
Calculation after Double Porosity

Observation Well	Transmissivity [m ² /d]	Hydraulic Conductivity [m/d]	Specific storage	Sigma	Lambda	Radial Distance to PW [m]
Test Well	3.98×10^0	4.42×10^{-2}	5.00×10^{-1}	2.17×10^1	3.47×10^{-2}	0.08

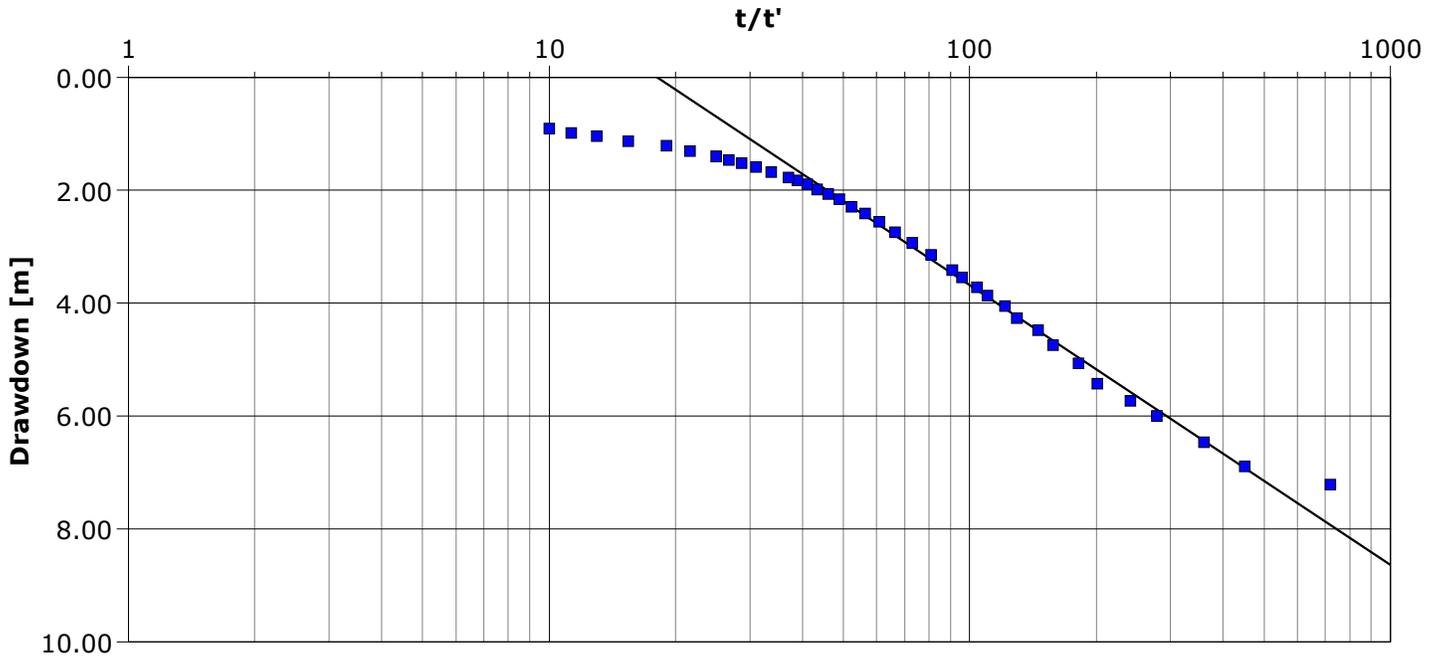
Calculation after Theis & Jacob

Observation Well	Transmissivity [m ² /d]	Hydraulic Conductivity [m/d]	Radial Distance to PW [m]
Test Well	3.99×10^0	4.43×10^{-2}	0.08

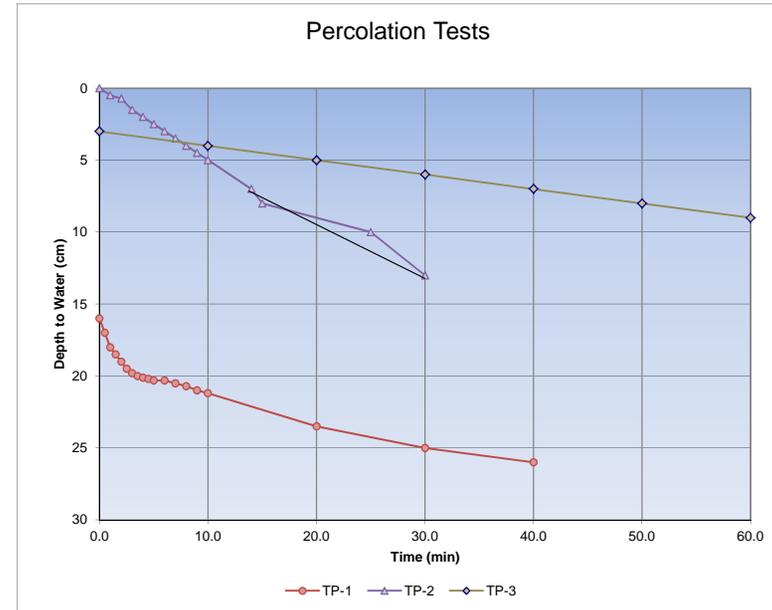
Tests carried out by Thurber Engineering Staff - October 28 2010

At TP-1, T-Time is calculated based on comparison of later water levels beginning at time = 10 minutes
 At TP-2, T-Time is calculated based on comparison of later water levels beginning at time = 14 minutes
 At TP-3, T-Time is calculated based on comparison of later water levels beginning at time = 30 minutes
 Highlighted T-times are used for reporting and analysis.

Percolation tests were carried out by Thurber Engineering at the three test pits hand-excavated in the proposed tile field bed location. At each percolation test location the field technician removed all the topsoil and excavated a 0.3 m deep straight-sided hole (0.3 m x 0.3 m square). Each hole was twice filled to the top with water and allowed to infiltrate. Each hole was then filled with water a third time and the falling water was measured against time. The tabulated measurements of the percolation tests are presented in Appendix D.
