**FOUNDATION INVESTIGATION AND DESIGN REPORT
STATIC PILE LOAD TESTING
PIC RIVER BRIDGE REHABILITATION
HIGHWAY 17, MARATHON, ONTARIO
ASSIGNMENT NO. 6013-E-0012**

G.W.P. No. 6137-13-00 Site No. 48E-025

**Ministry of Transportation Ontario
Northwestern Region**

December 11, 2013
File: 15-64-29

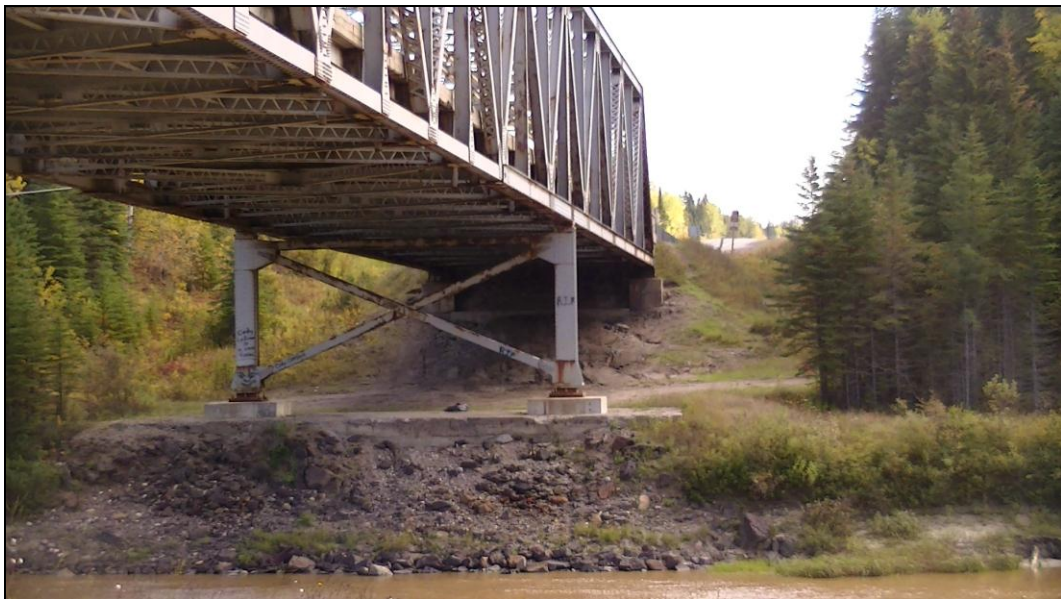
Photograph A2 - East Pier and Abutment

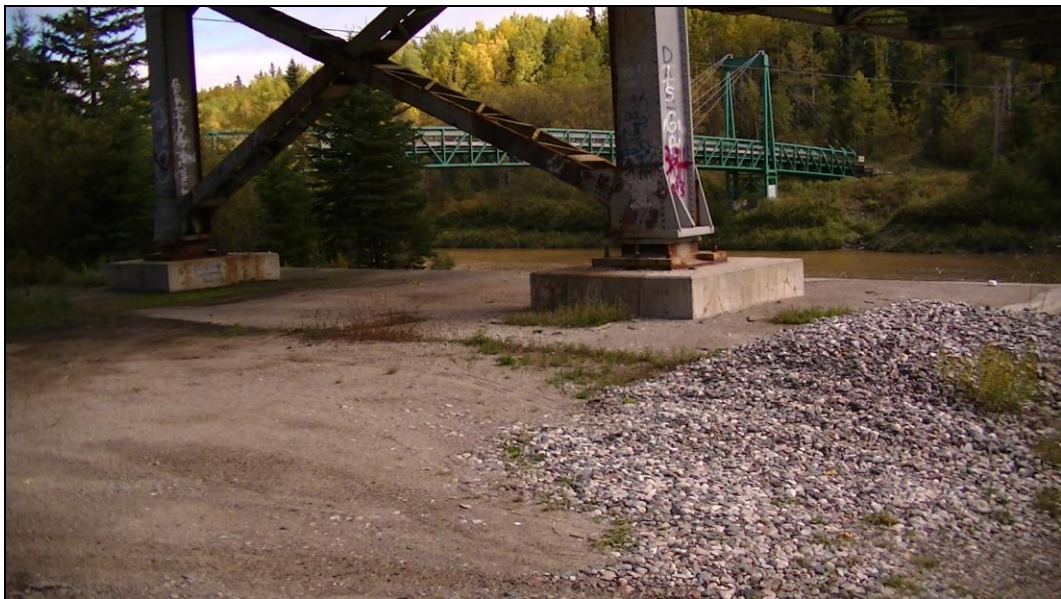
Photograph A4 – West Pier

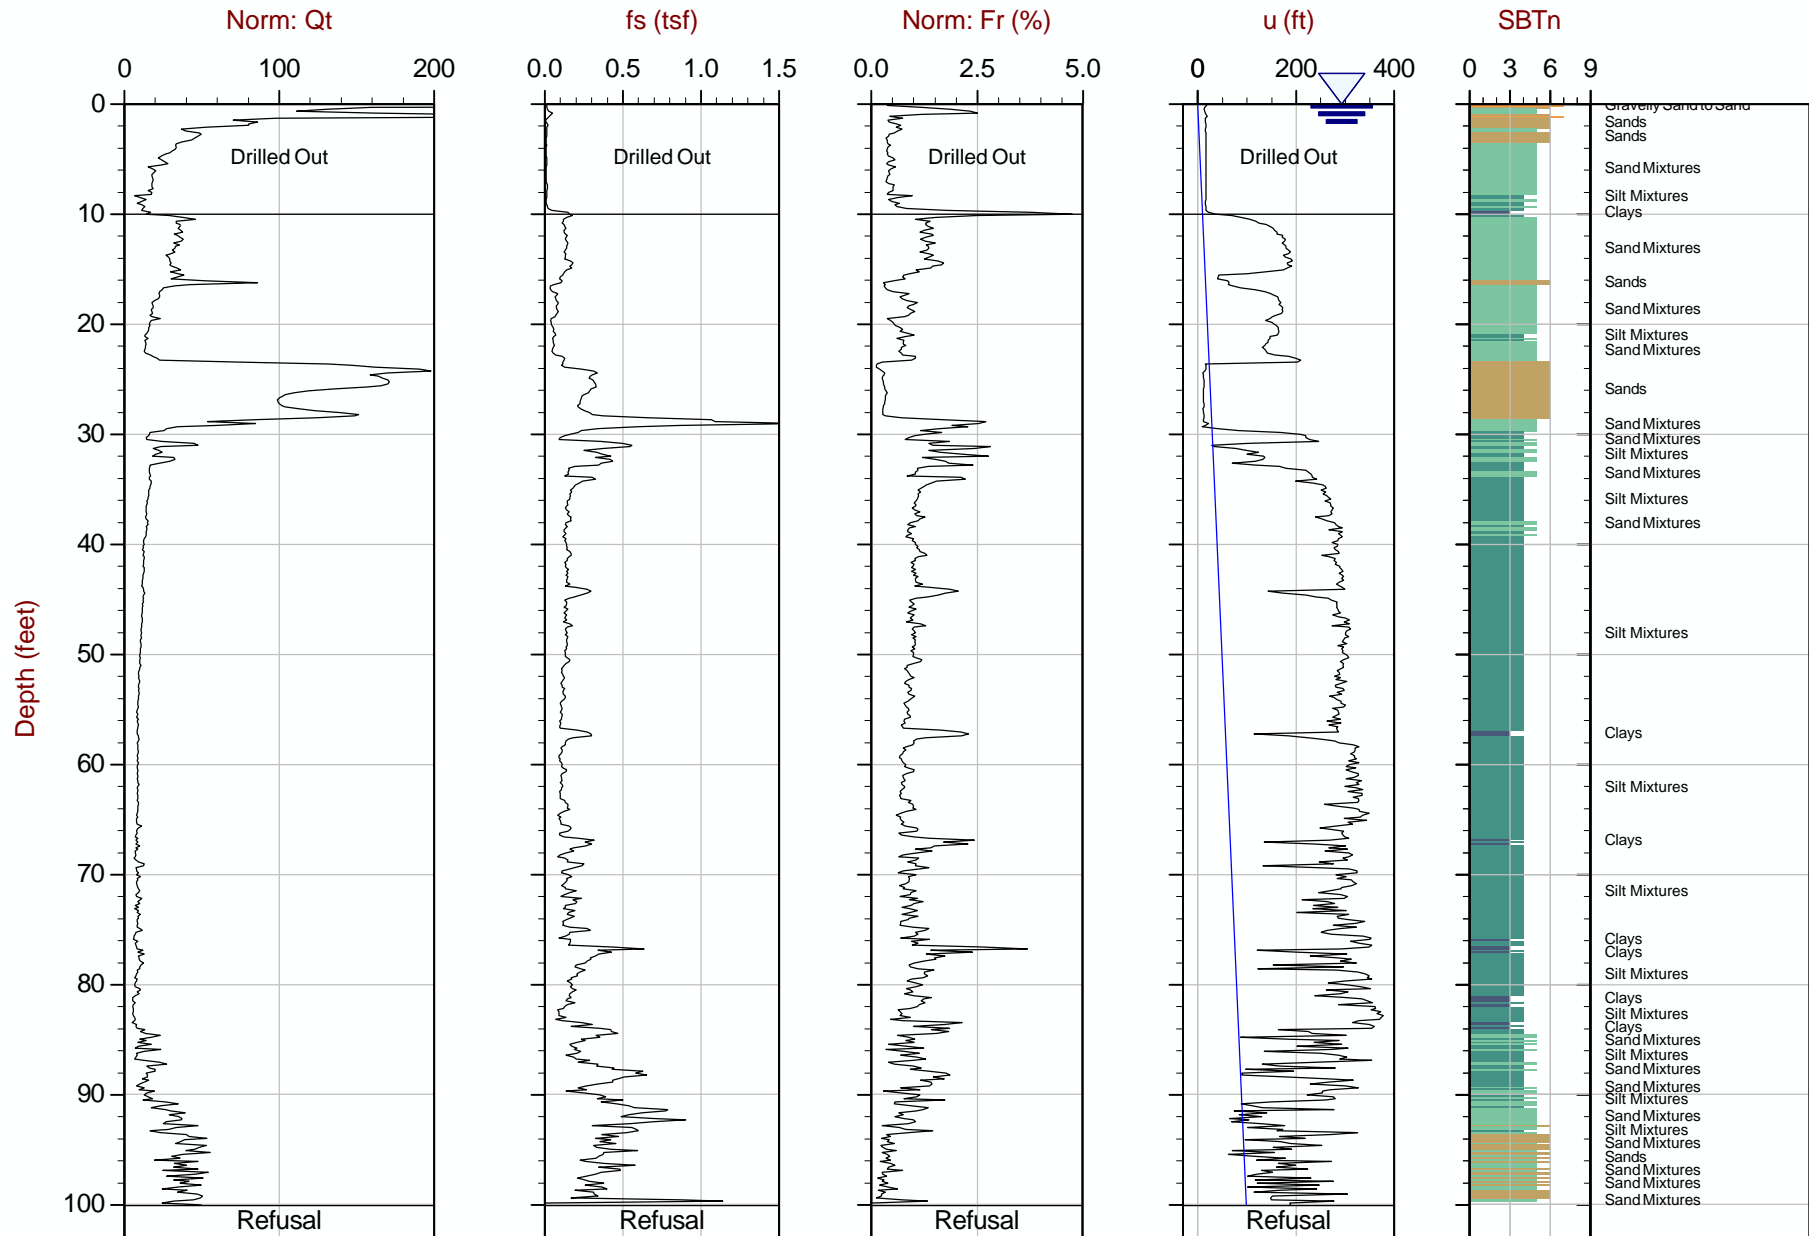
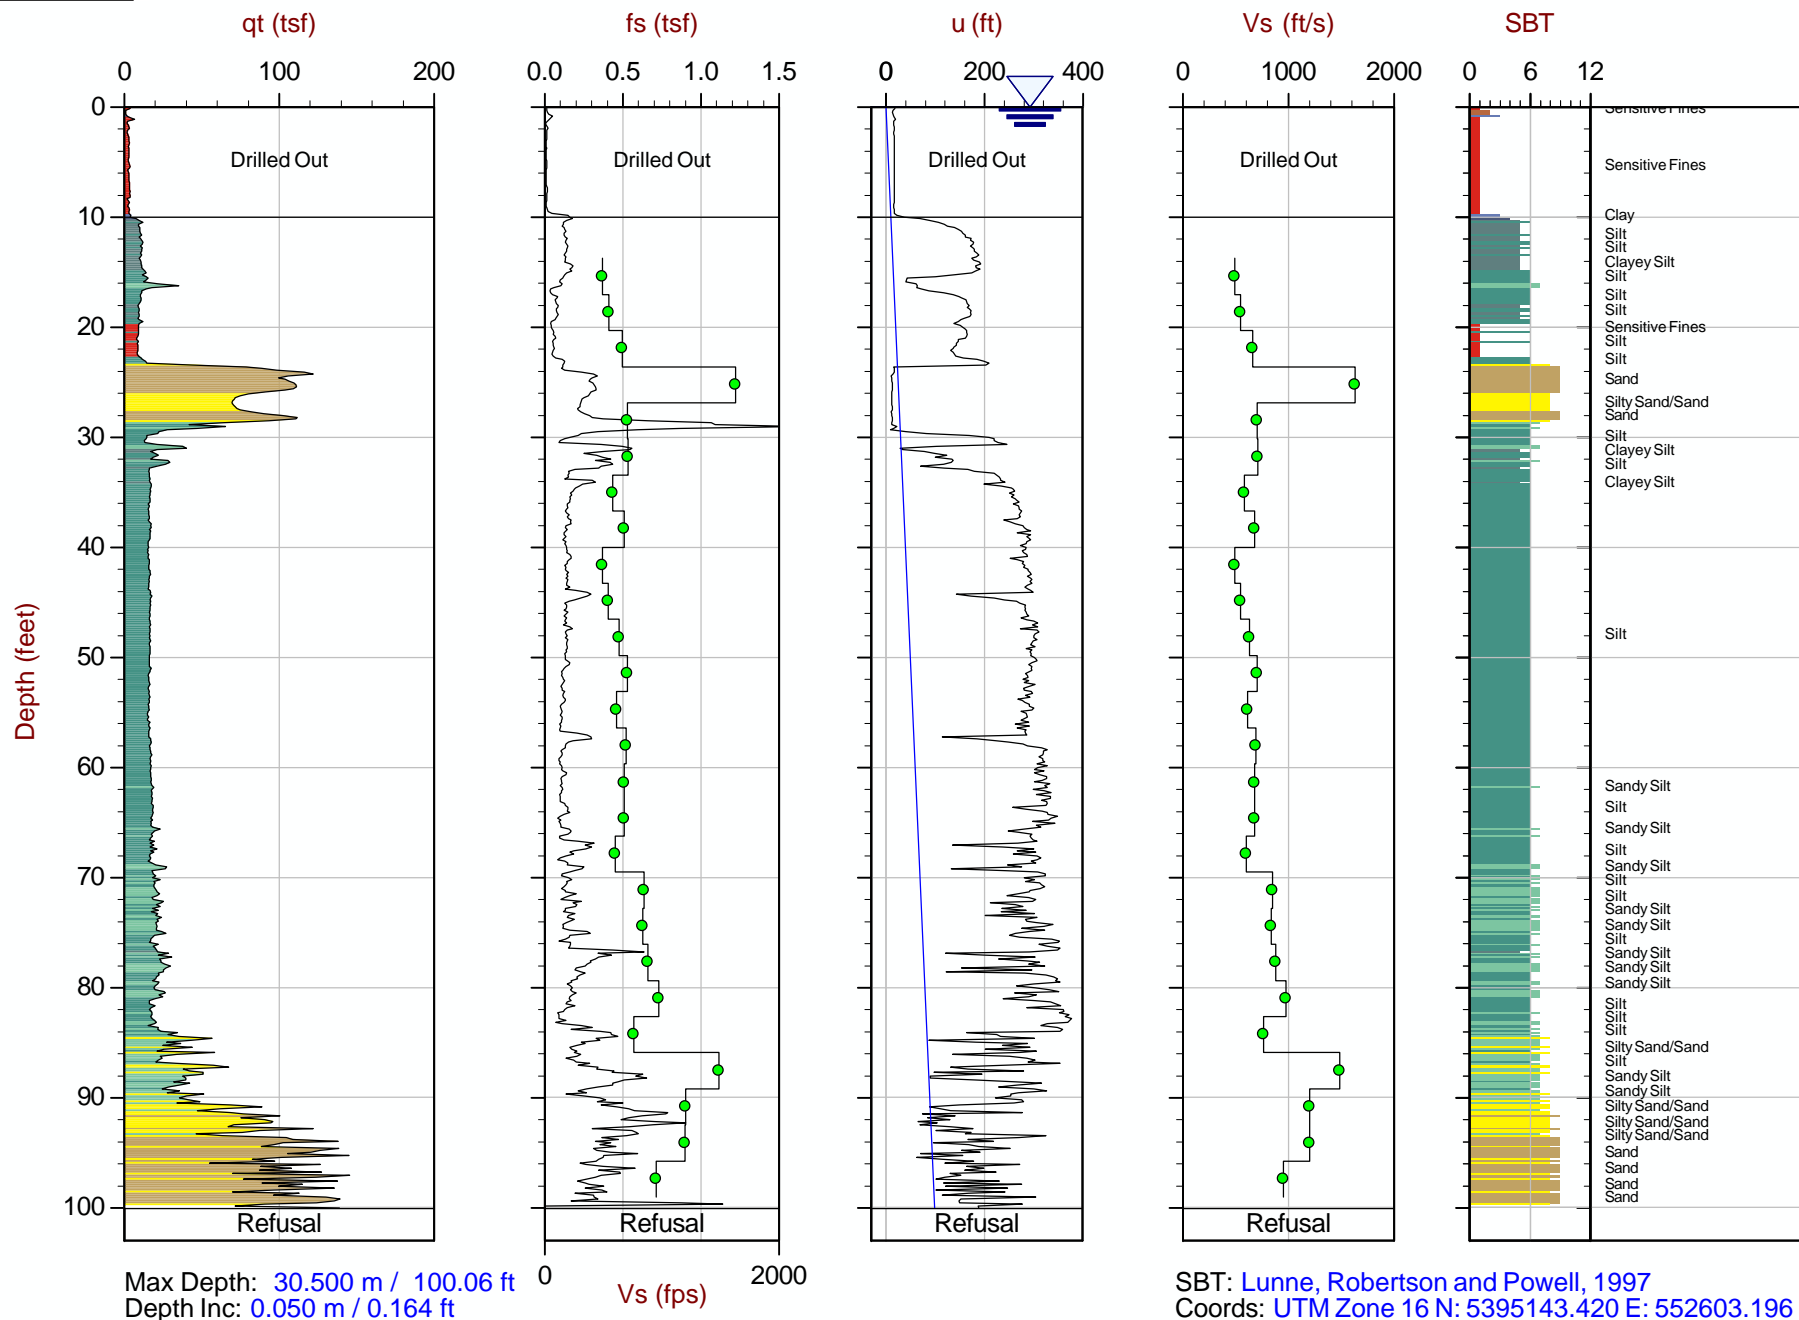
Sounding: CPTU11-1
Cone: 301:T1500F15U500

SBT: Lunne, Robertson and Powell, 1997
Coords: UTM Zone 16 N: 5395143.420 E: 552603.196

In addition to the boreholes, piezocone penetration testing (CPTu) was carried out along the detour alignment, adjacent to each foundation unit. The locations of the piezocone tests are shown on the Borehole Locations and Soil Strata Drawing in Appendix B. The CPT plots provided by the piezocone contractor, ConeTec, are included in Appendix B.

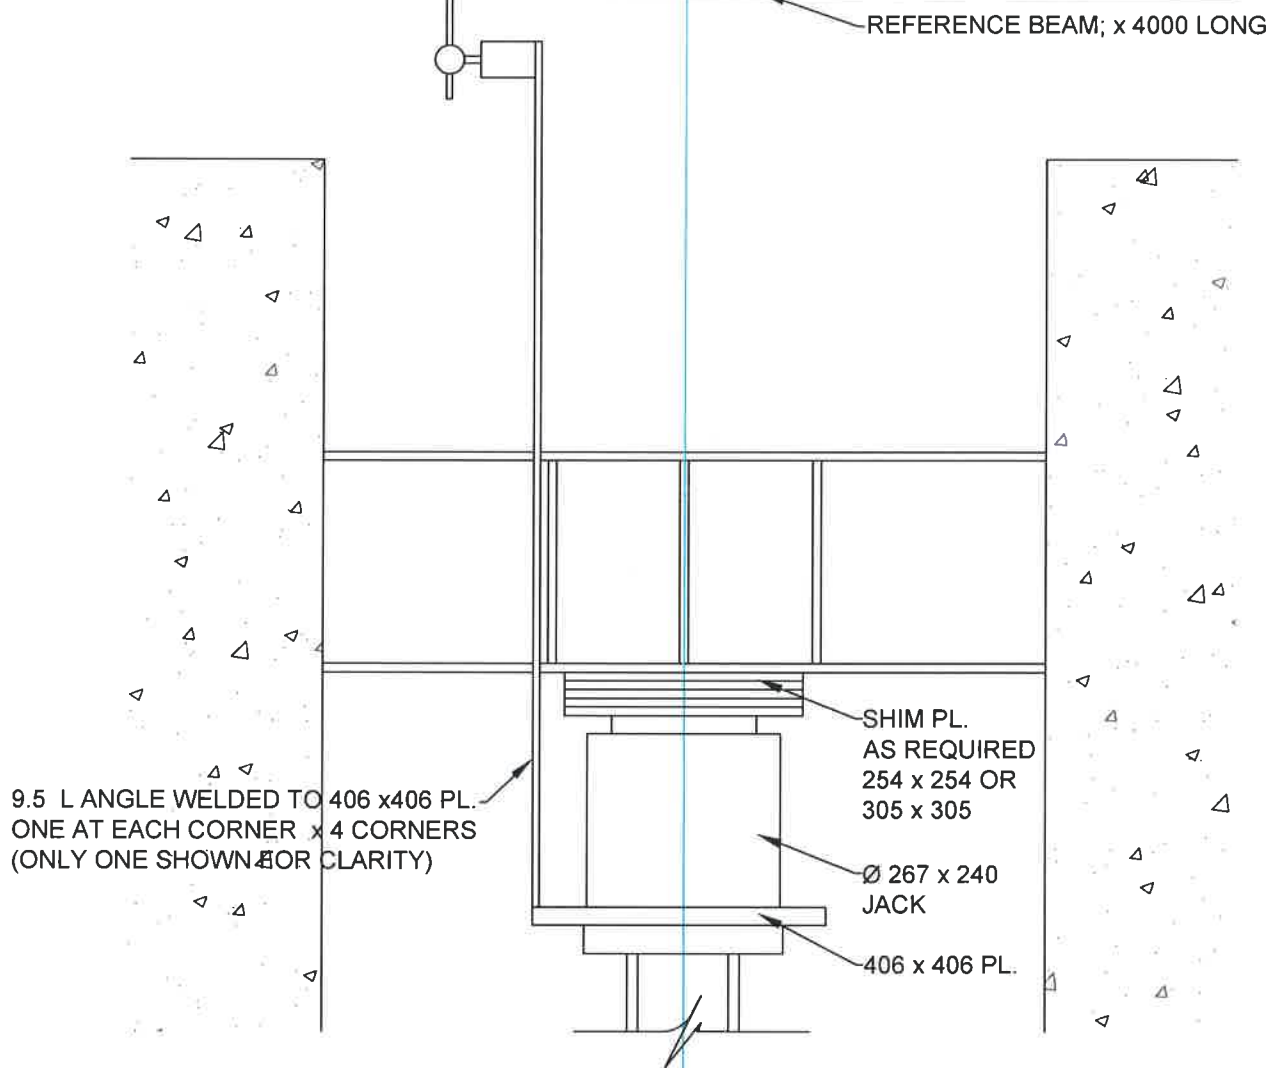
SECTION

1	ISSUED FOR COORINDATION	09/25/2013
No.	DESCRIPTION	DATE
519-853-3216		
  302 MAIN STREET NORTH ACTON, ONTARIO L7J 1W9 GEO-FOUNDATIONS CONTRACTORS INC.		
TITLE: THURBER ENGINEERING LTD. PIC RIVER BRIDGE PILE LOAD TESTING SEPT./OCT. 2013		
SCALE:		DWG NO:
N.T.S		G-13-24-SK1

Geo-Foundations Contractors Inc. provided the pile load test set up, two 1,000 kN jacks, dial gauges and associated equipment. Thurber Engineering Ltd. recorded all load-settlement readings. The load test set-ups are shown in Geo-Foundations' Drawings G-13-24-SK1 and SK2 in Appendix C. Geo-Foundations provided the calibration charts for the jacks.

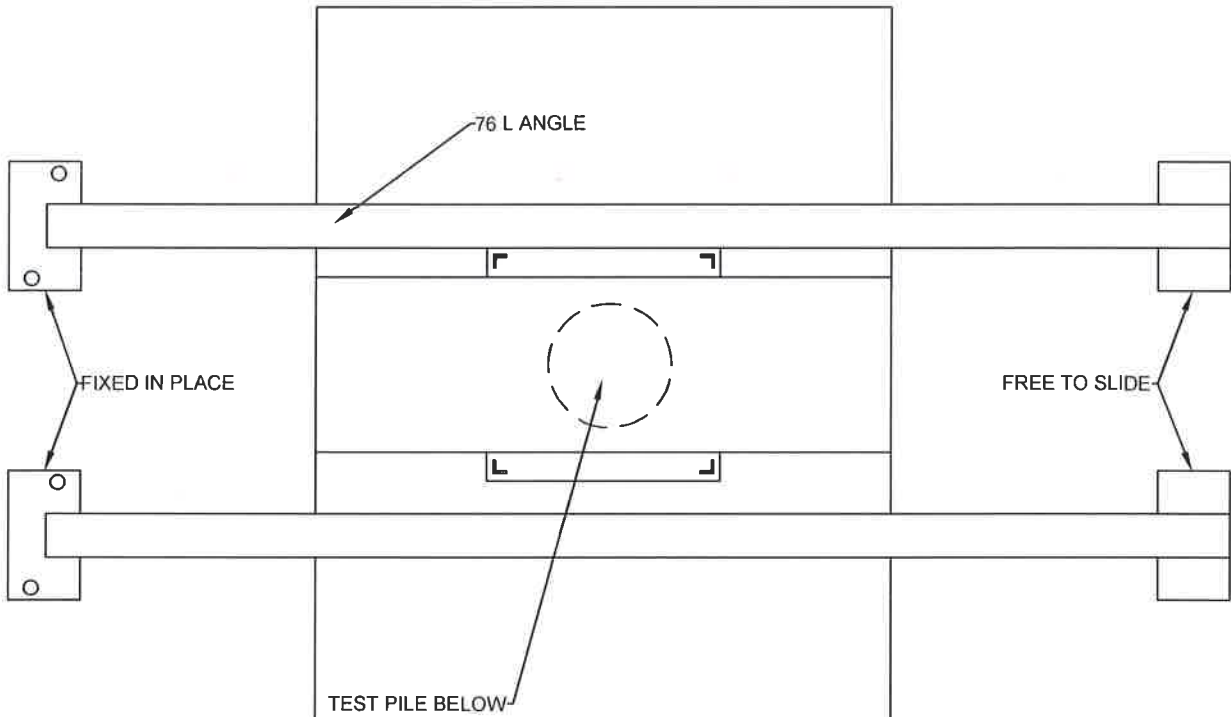
PLAN

302 MAIN STREET NORTH ACTON, ONTARIO L7J 1W9 GEO-FOUNDATIONS CONTRACTORS INC.		
TITLE: THURBER ENGINEERING LTD. PIC RIVER BRIDGE PILE LOAD TESTING SEPT./OCT. 2013		
SCALE: N.T.S		DWG NO: G-13-24-SK2

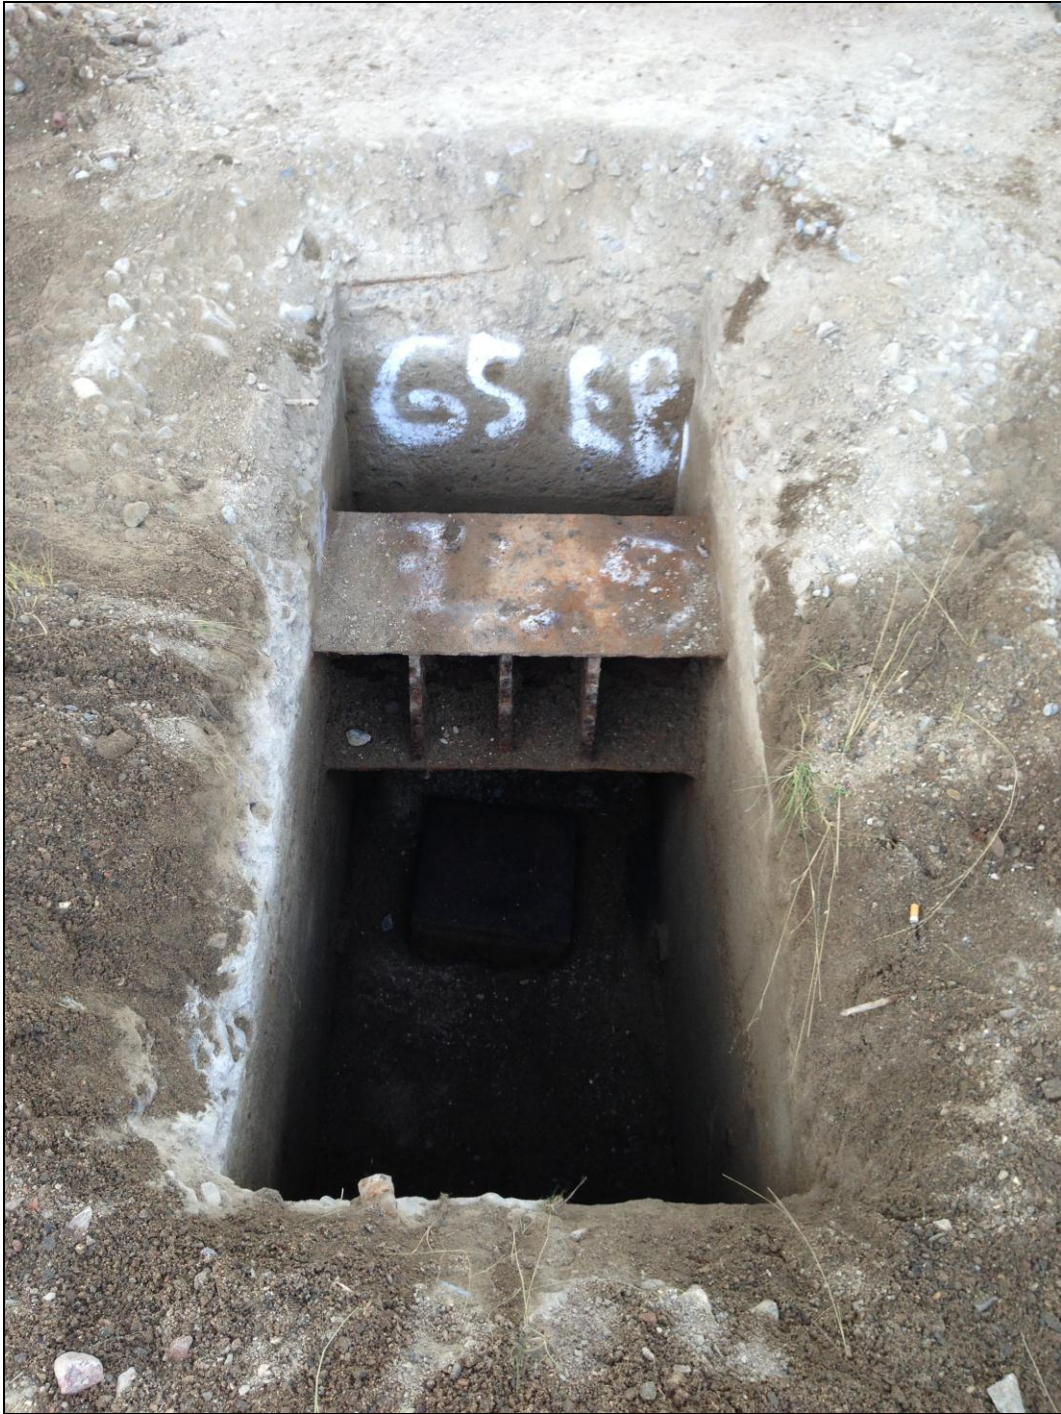
Photograph C1 – Pile Cap Cut-out and Reaction Beam at Pier G-5

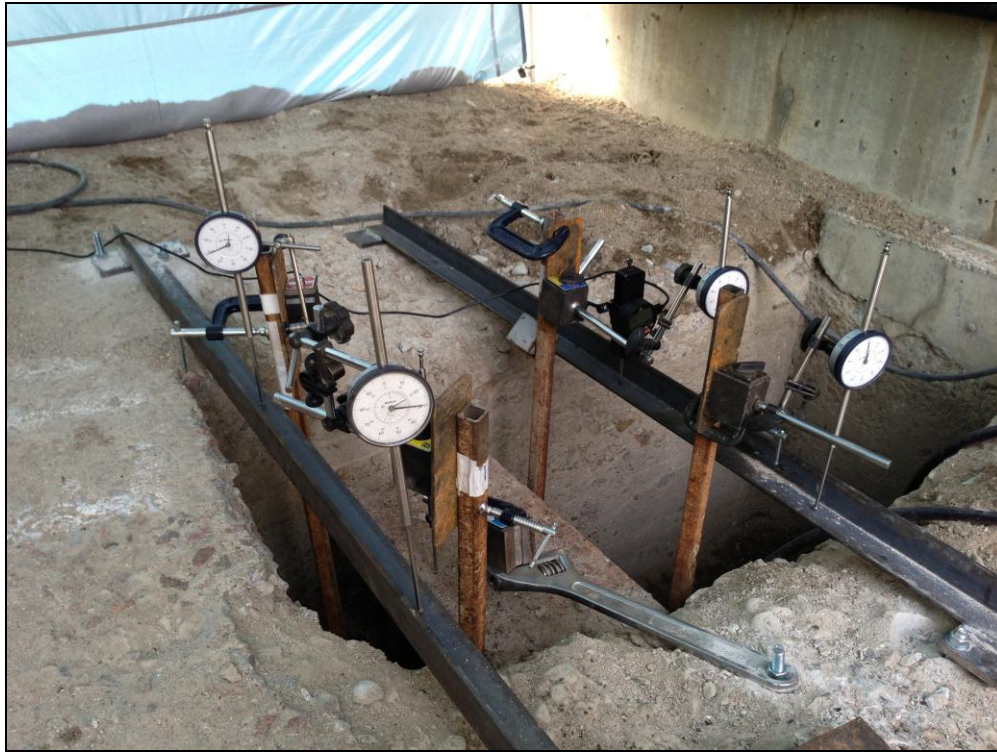
Photograph C2 – Pile Load Test Set-up at Pile E-16, East Pier

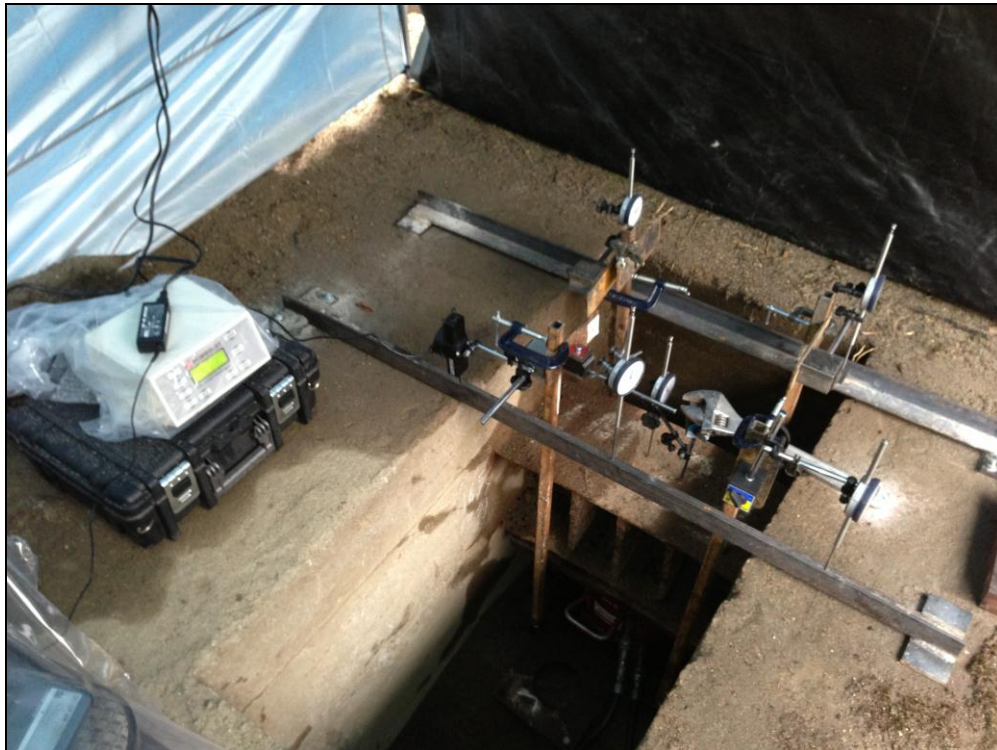
Photograph C3 – Pile Load Test Set-up at Pile E-2, West Pier

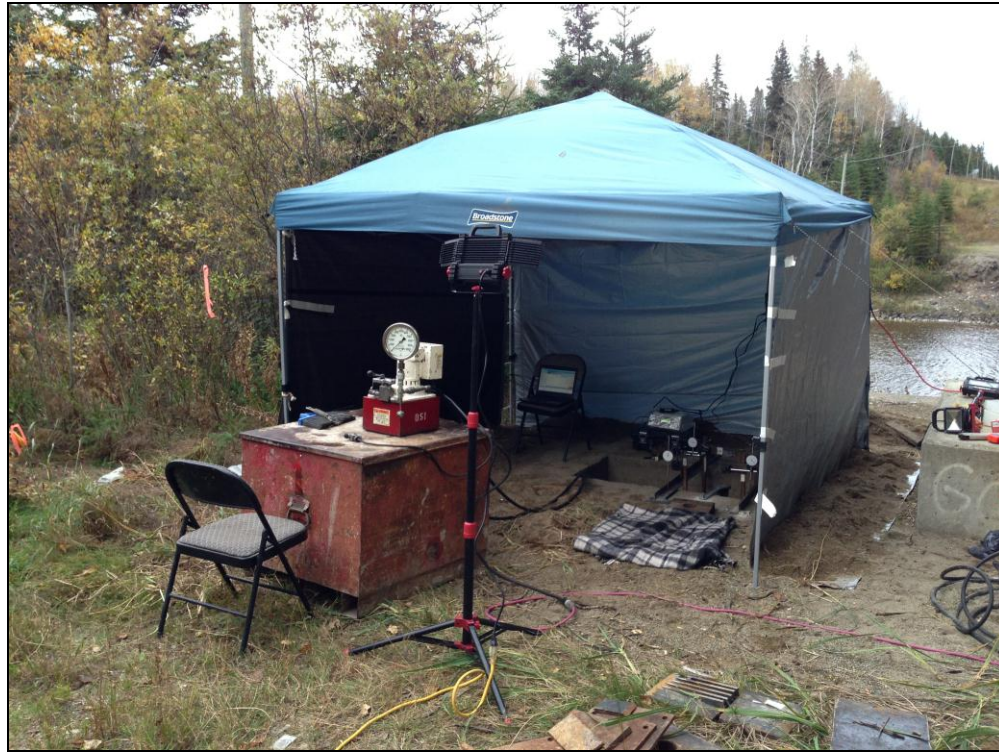
Photograph C4 – Shelter Set-up for Pile Load Test at Pier E-2

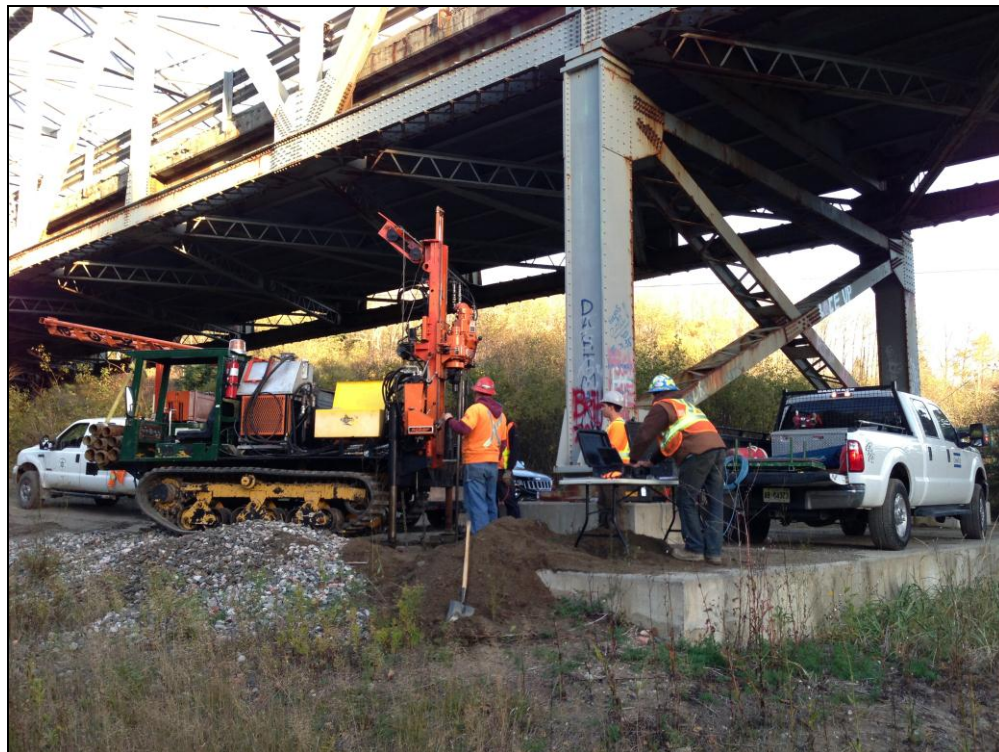
Photograph C6 – Drill Rig Set-up for Piezocone Penetration Testing, Pile E-16

One of the CPT tests at the east pier was pushed as close as possible to the pile (0.23 m from centre of the pile) while the second CPT test was pushed 0.56 m away from the pile in an effort to compare soil properties within and outside the zone of electro-osmotic treatment. At the west pier, the piezocone was pushed 0.3 m north of the test pile. Pore pressure dissipation tests were conducted at selected depths within the foundation clay.

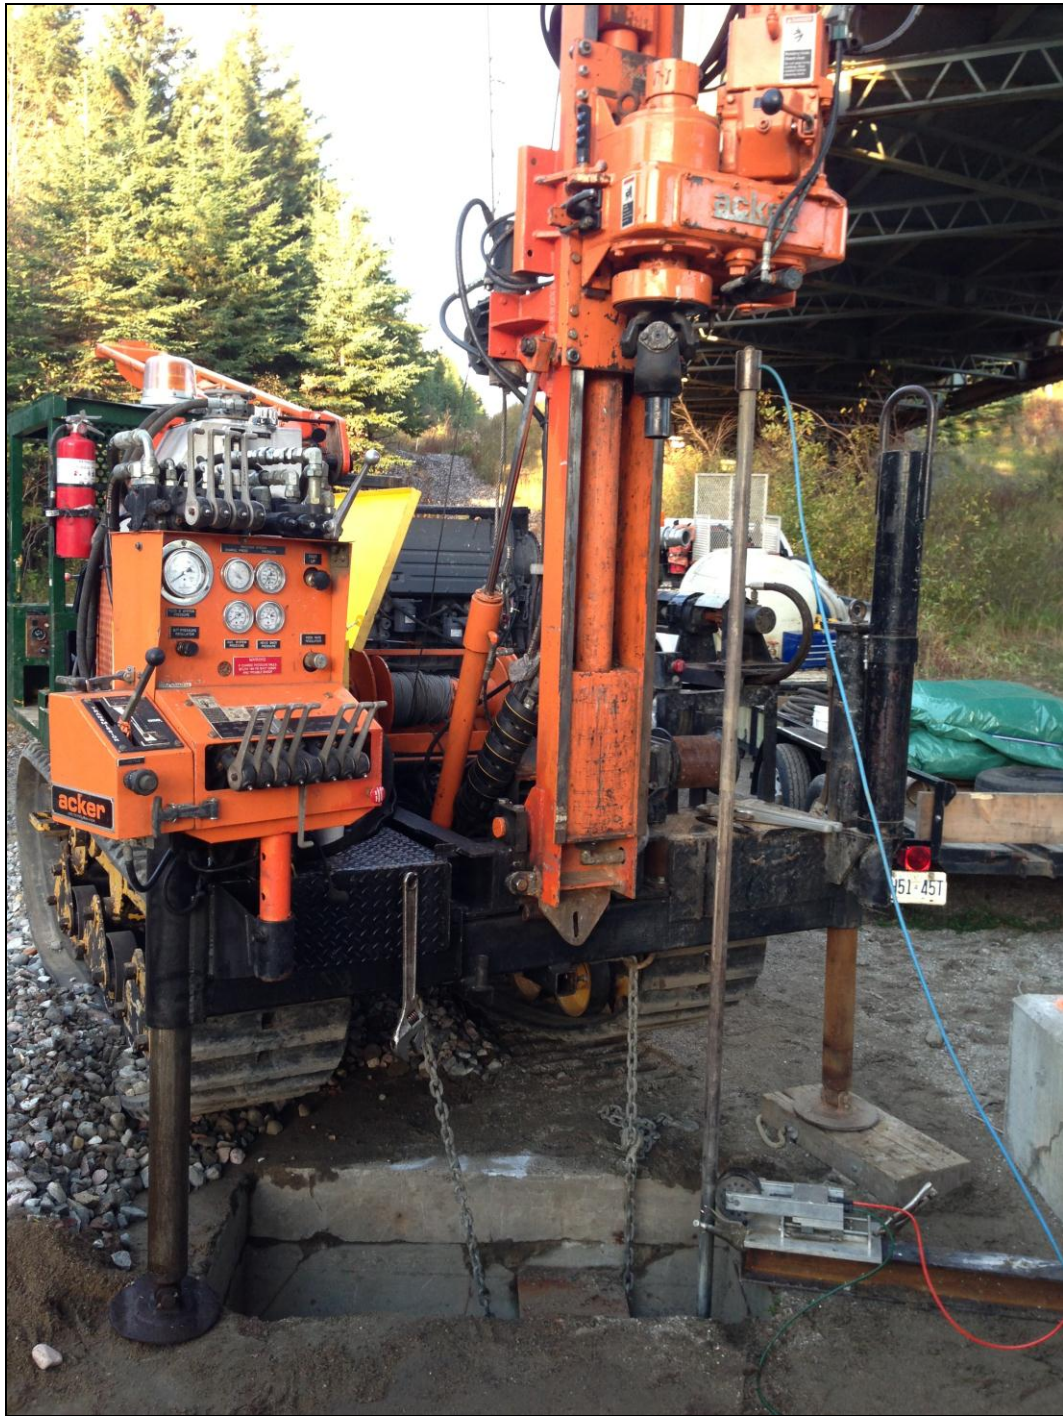
Photograph C7 – Piezocone Testing at Pile E-16

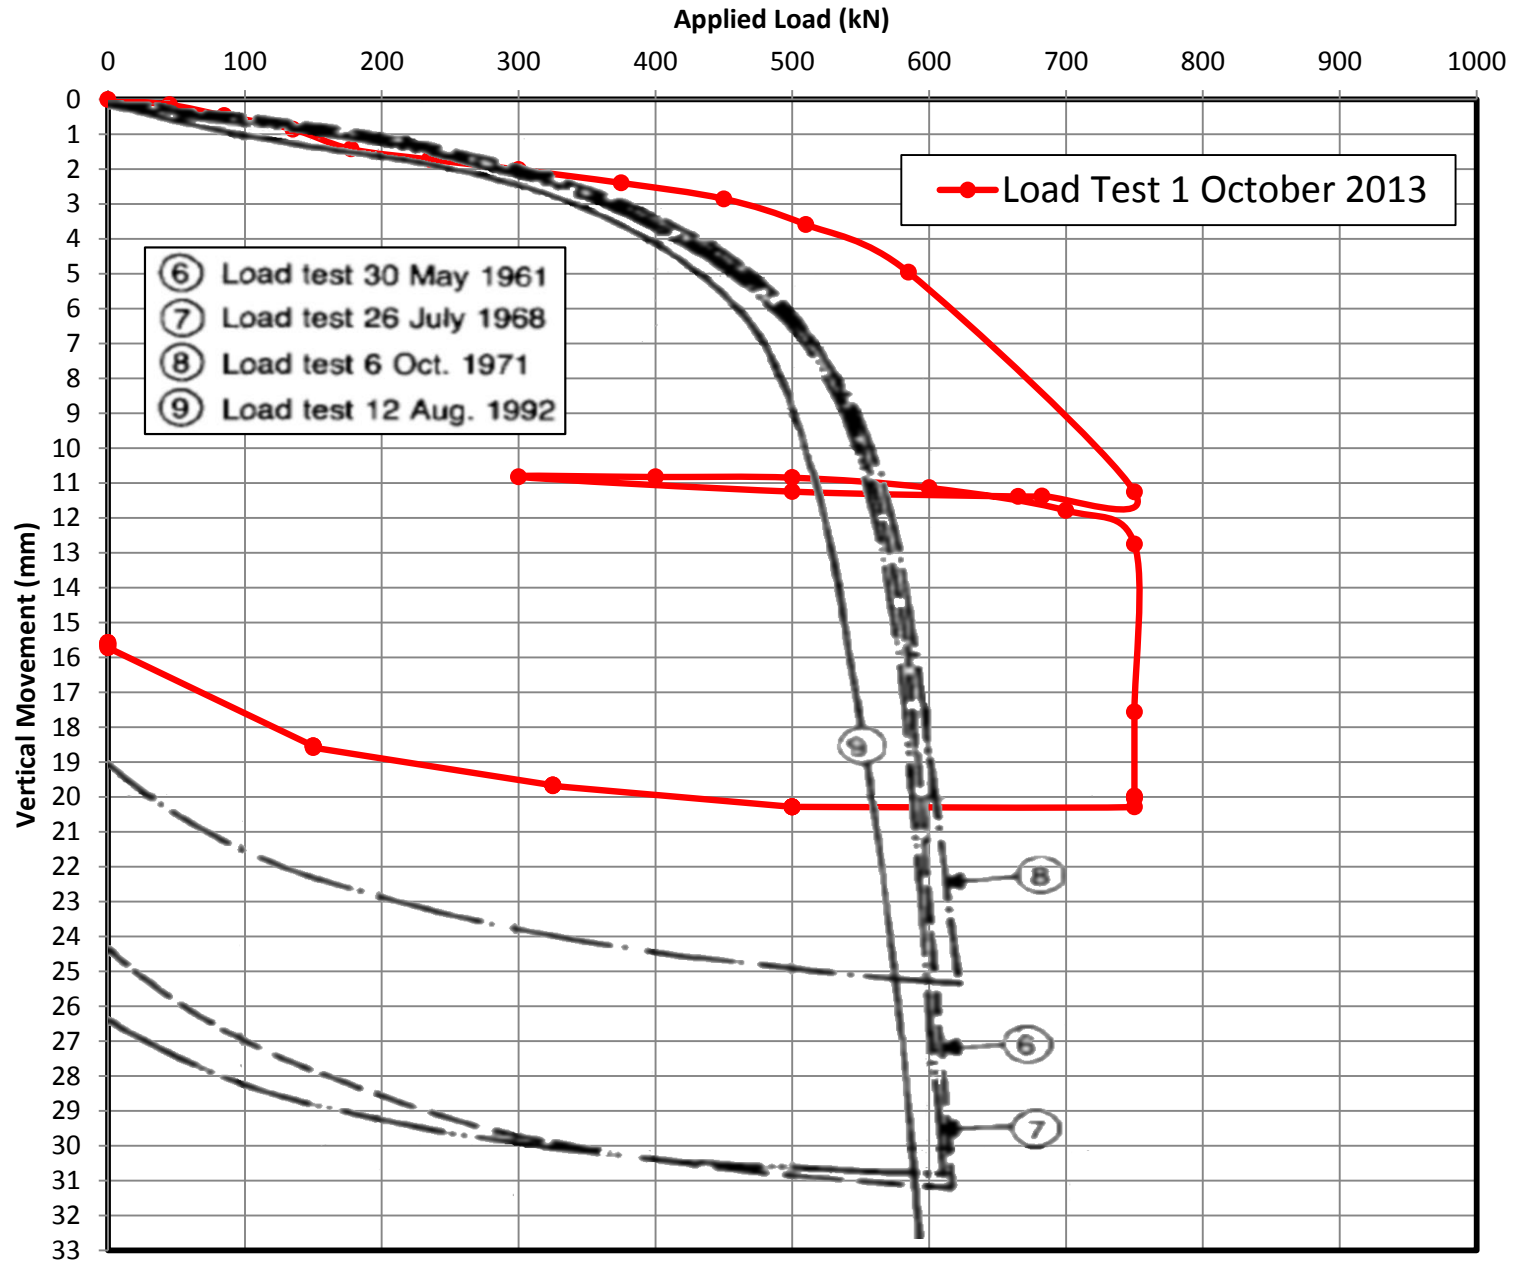
Hwy 17 Pic River Bridge - Pile Load Test Results - East Pier G-5

The factual results of the static pile load tests carried out on Pile G-5 and Pile E-16 at the east pier and Pile E-2 at the west pier were presented in Section 4.2 and the load-settlement plots are provided in Appendix D. The ultimate capacity of Piles G-5 and E-16 from the east pier ranged from about 550 to 600 kPa. Pile E-2 at the west pier did not reach failure at a loading of 900 kN.

The ultimate capacities of the piles tested during the current program are consistent with the capacities determined during the historical load tests on the same piles. As noted above, the ultimate capacities previously determined for the treated piles at the east pier (Piles E-16 and G-5) were in the order of 500 to 600 kN, and the pile at the west pier (Pile E-2) did not fail under the maximum load of 800 kN applied during the historical tests.

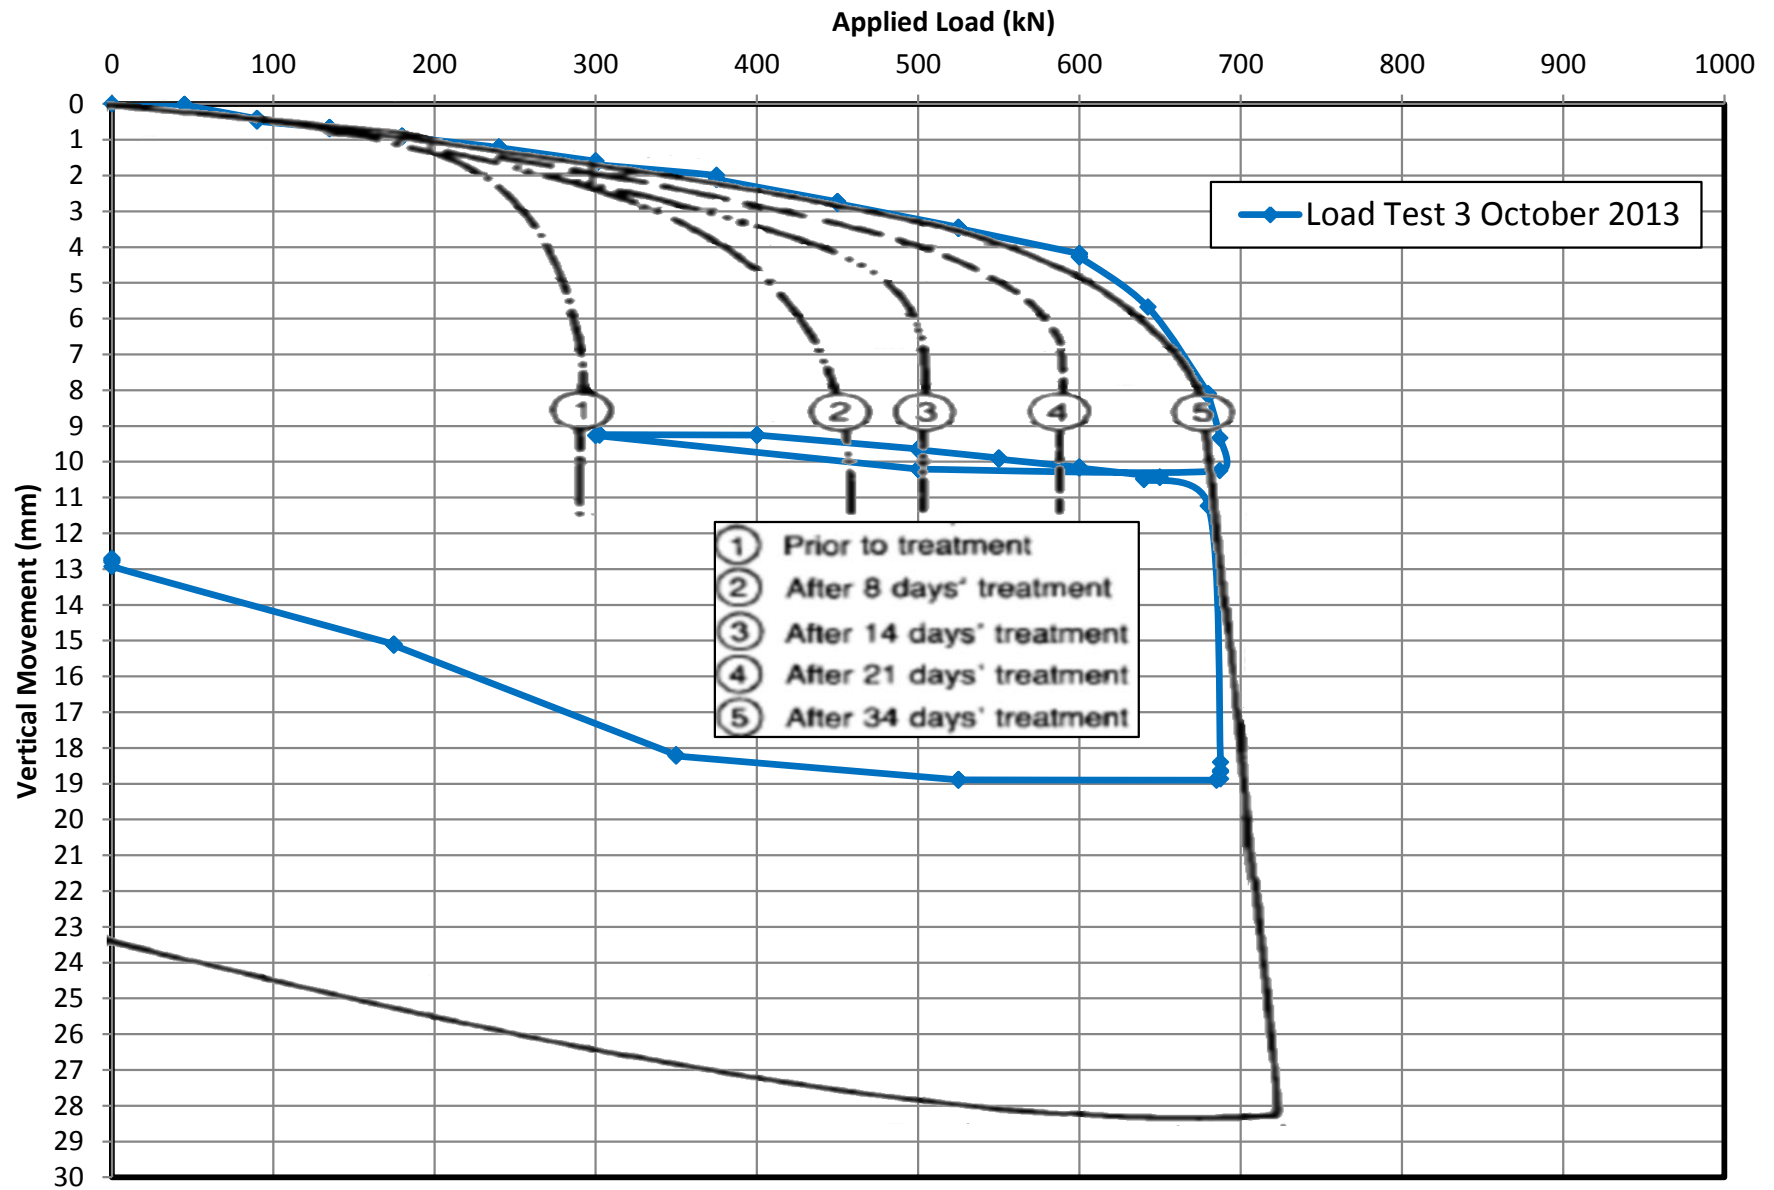
Hwy 17 Pic River Bridge - Pile Load Test Results - East Pier E-16

- During electro-osmotic treatment, static pile load testing was carried out on a selected pile (Pile E-16) at the east pier. The load test results indicated an increase in ultimate pile capacity from about 300 kN for the untreated pile to over 600 kN for the treated pile. Subsequent load testing on another pile (Pile G-5) at the treated east pier indicated an ultimate capacity in the order of 500 to 600 kN. Testing of a pile (Pile E-2) at the west pier after foundation treatment indicated that the pile did not fail under the maximum applied load of 800 kN.

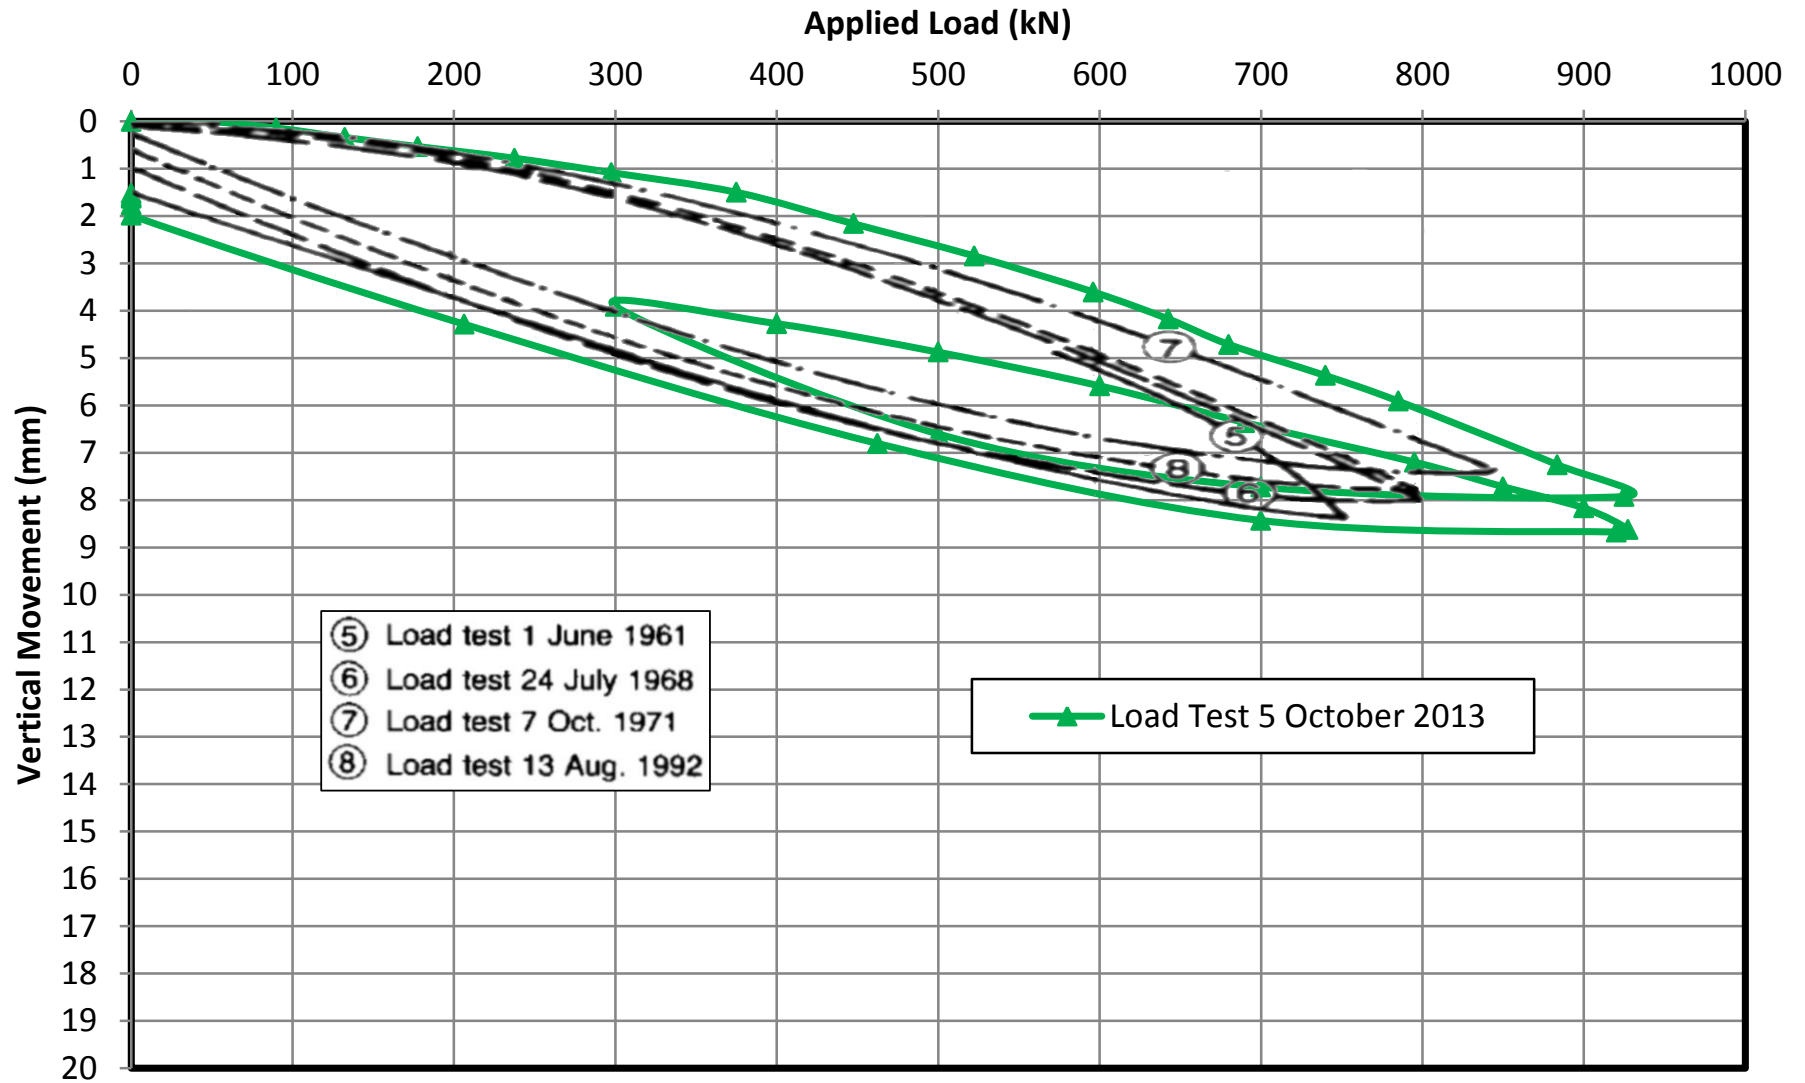
Hwy 17 Pic River Bridge - Pile Load Test Results (West Pier - E2)
