**FOUNDATION INVESTIGATION AND DESIGN REPORT
STATIC PILE LOAD TESTING
PIC RIVER BRIDGE REHABILITATION
HIGHWAY 17, MARATHON, ONTARIO
ASSIGNMENT NO. 6013-E-0012**

G.W.P. No. 6137-13-00 Site No. 48E-025

**Ministry of Transportation Ontario
Northwestern Region**

December 11, 2013
File: 15-64-29

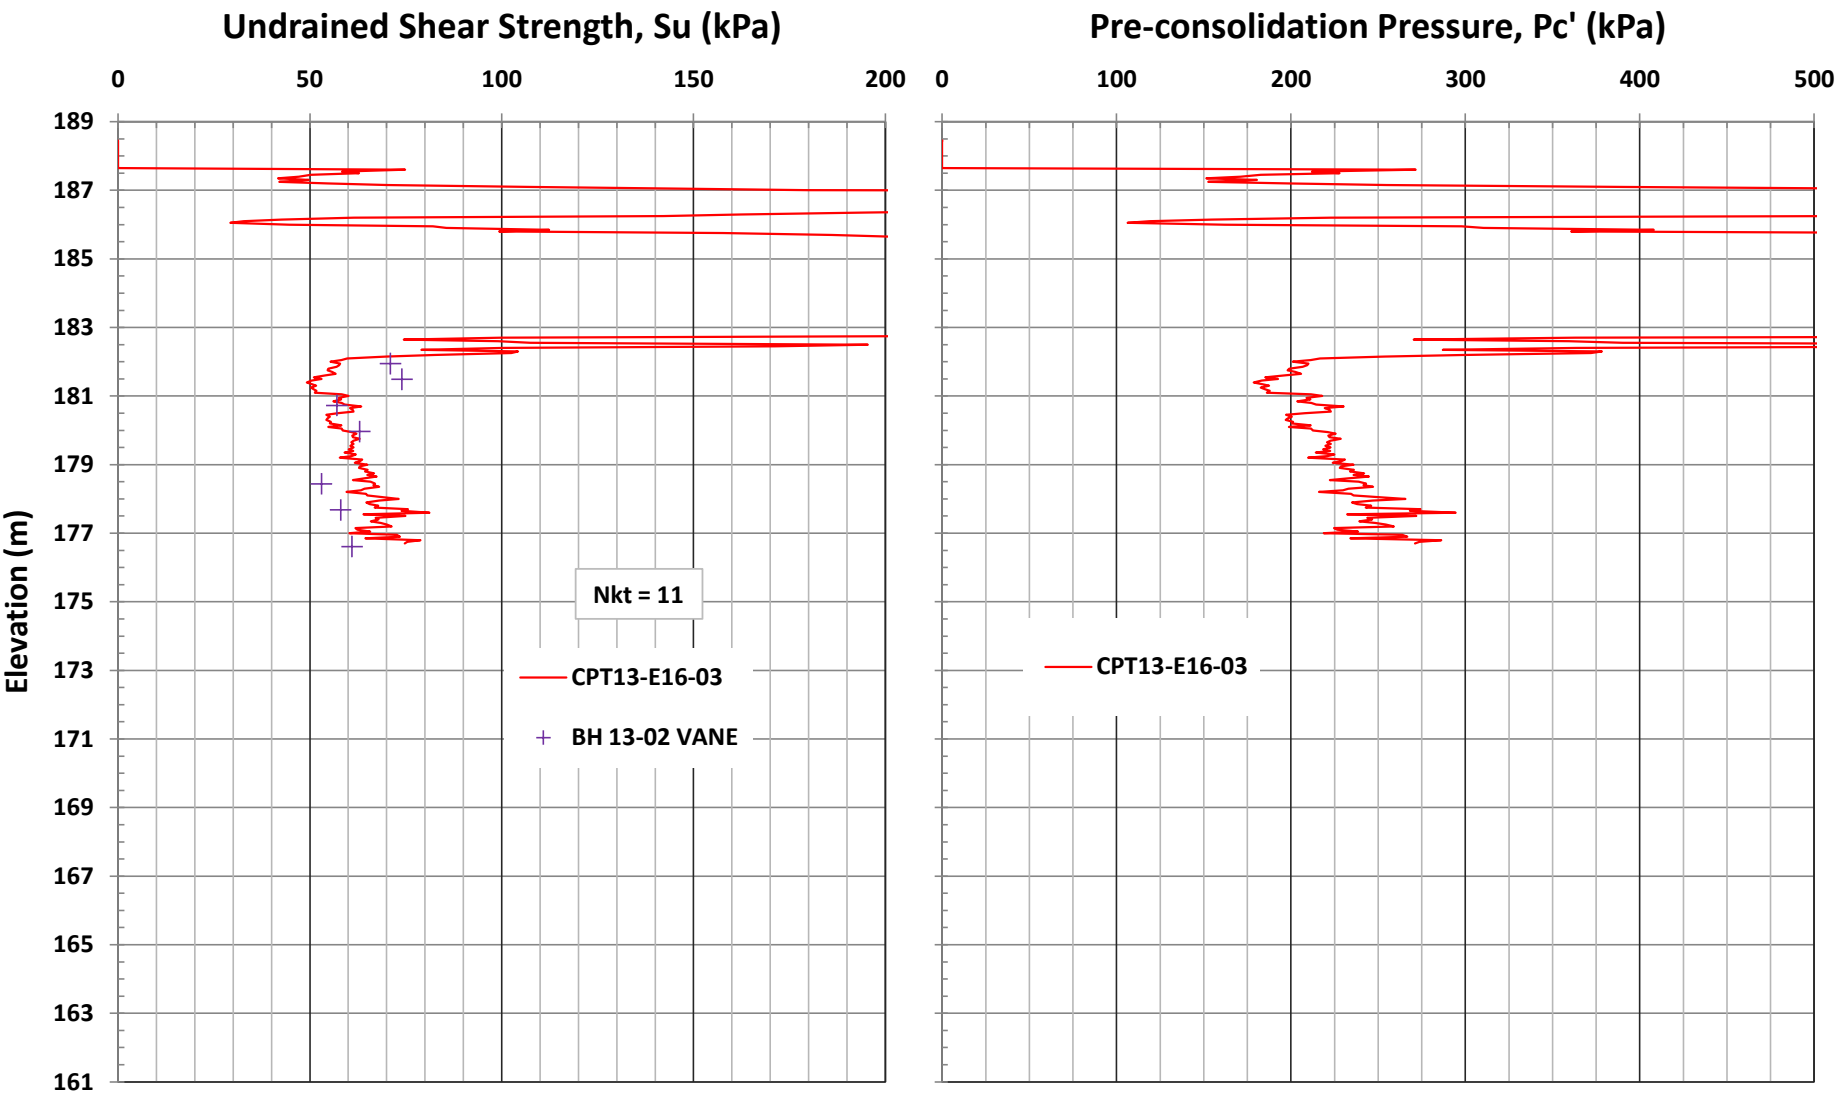
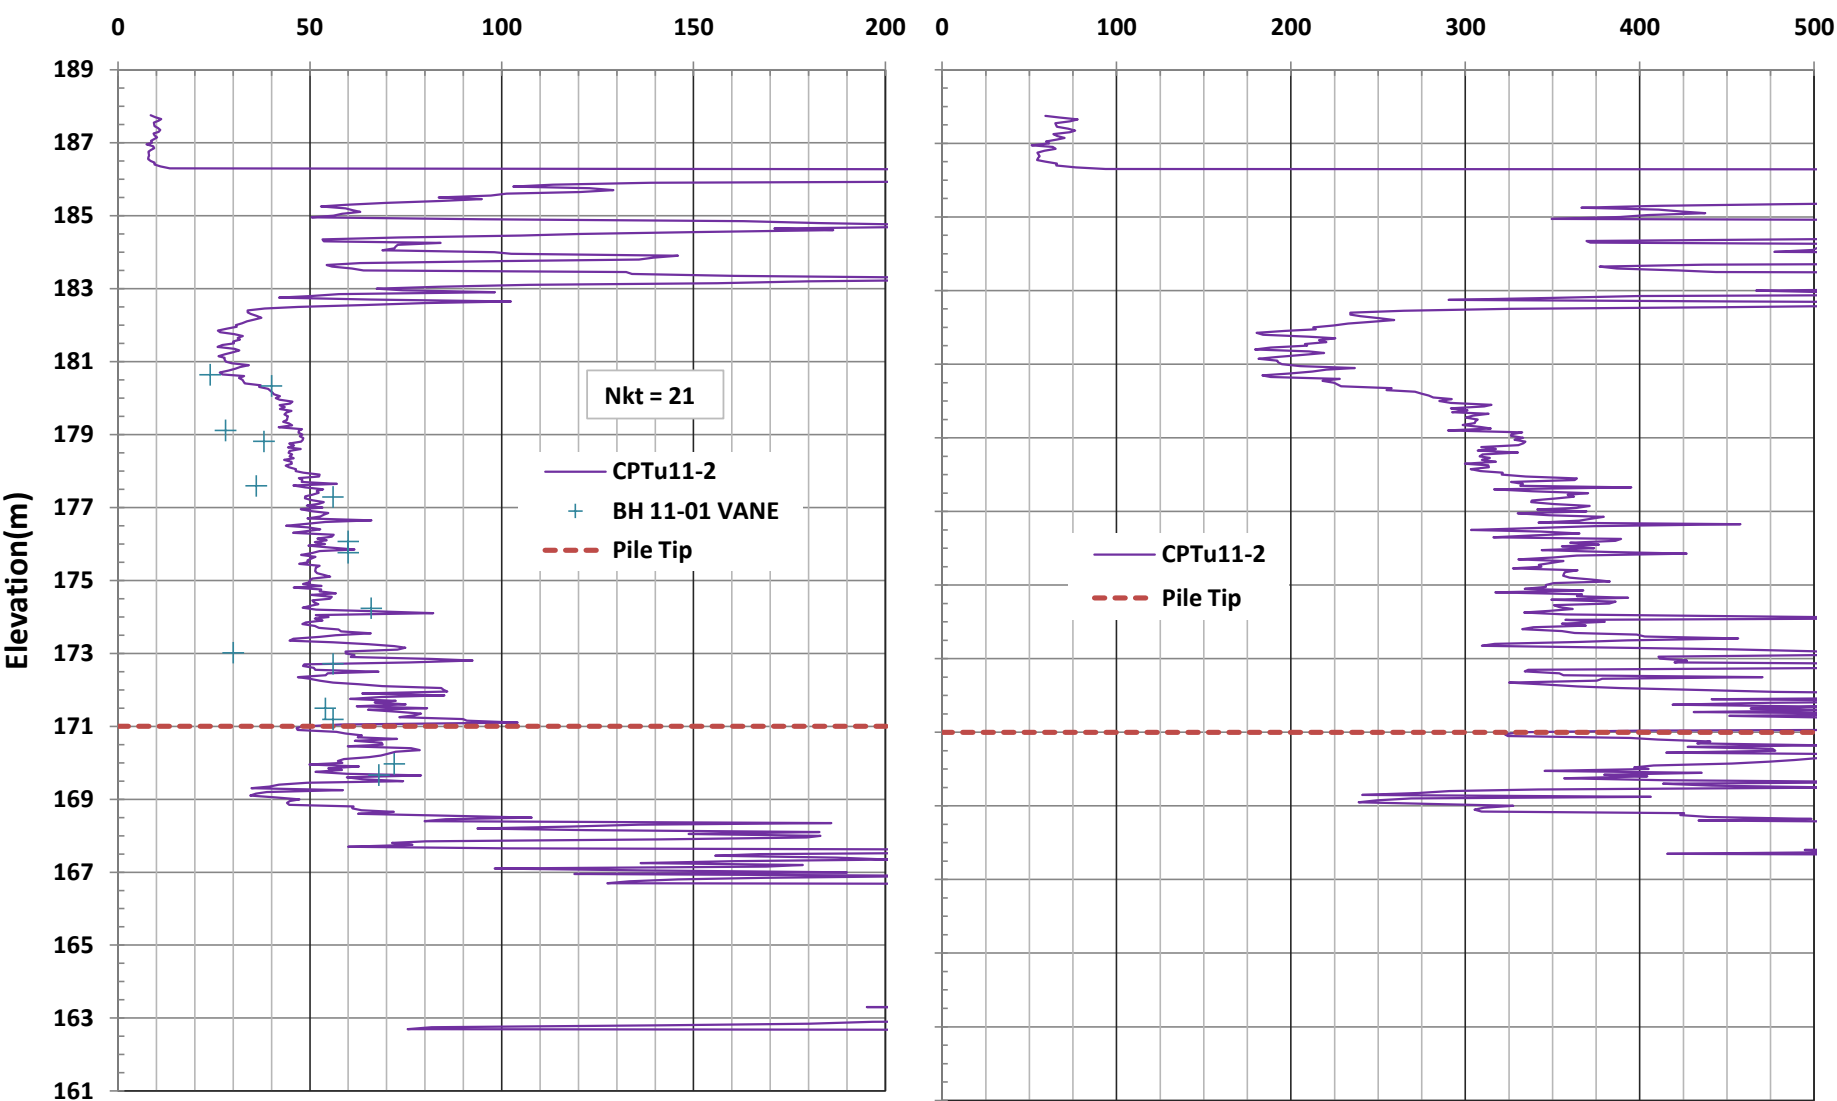
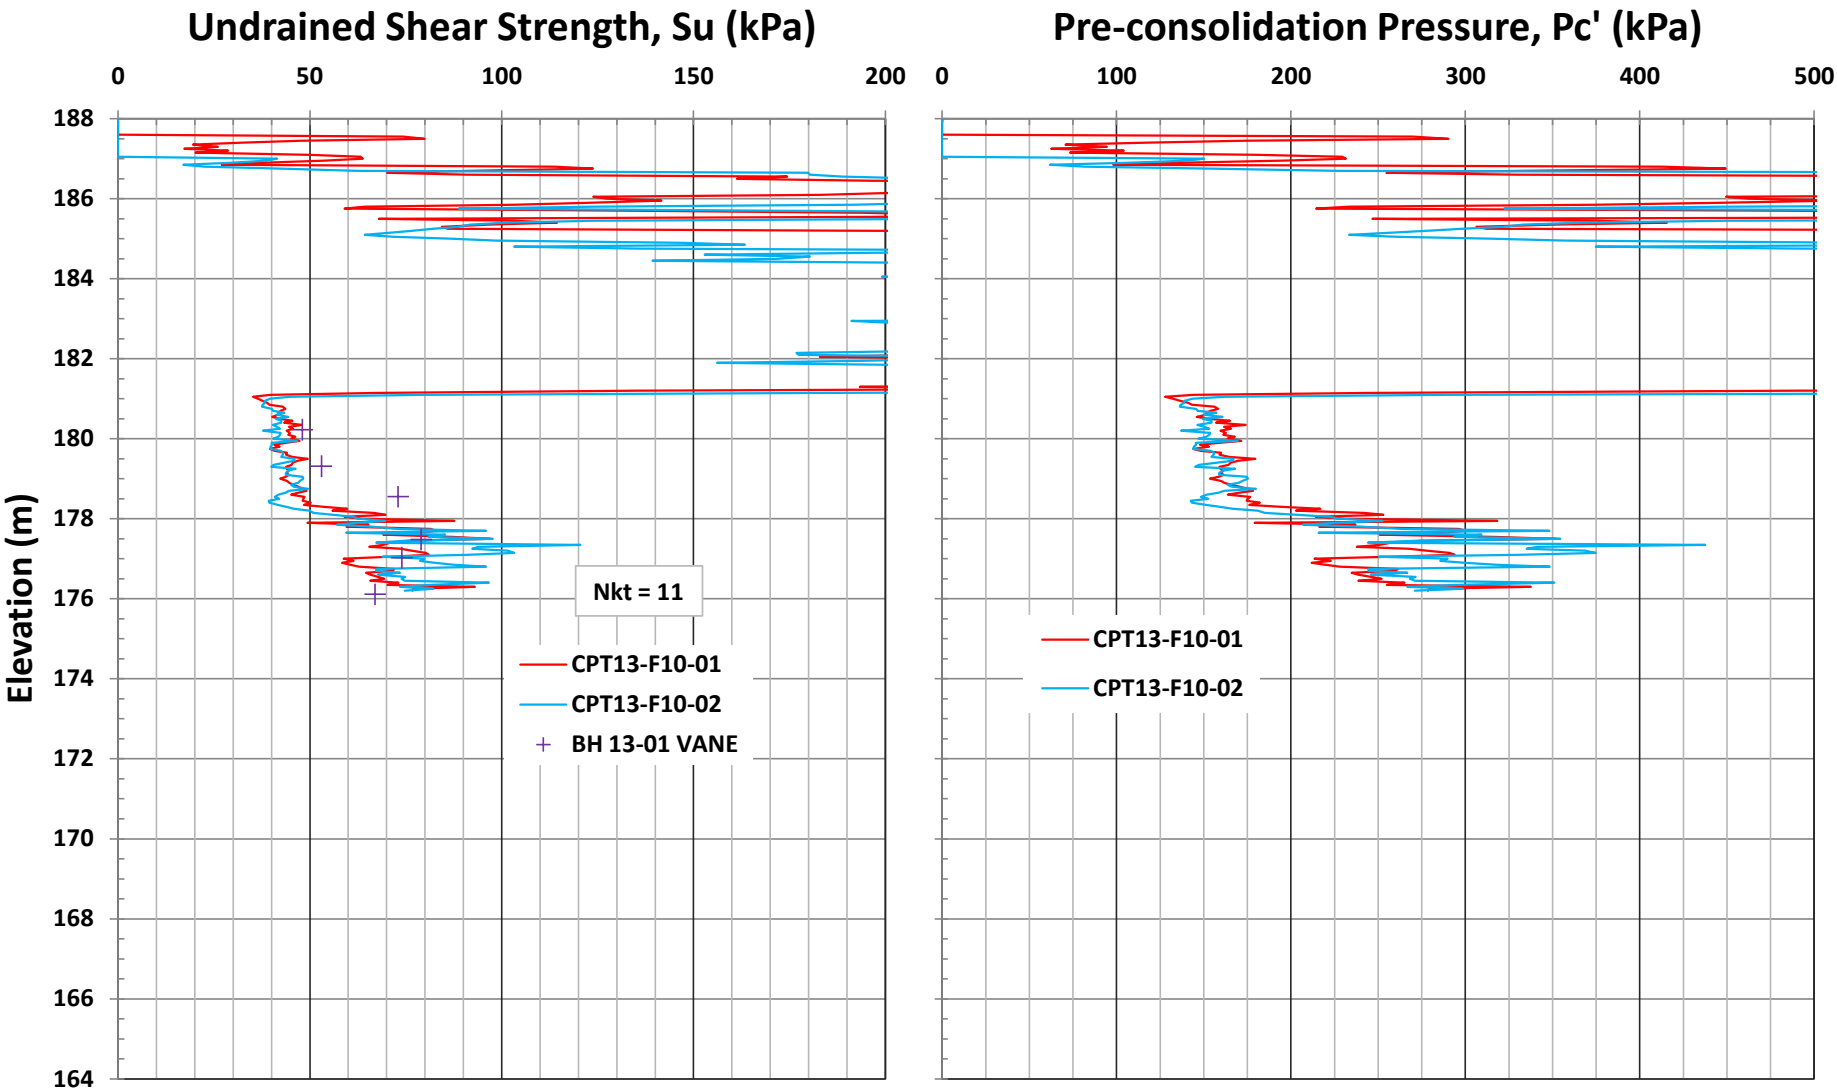
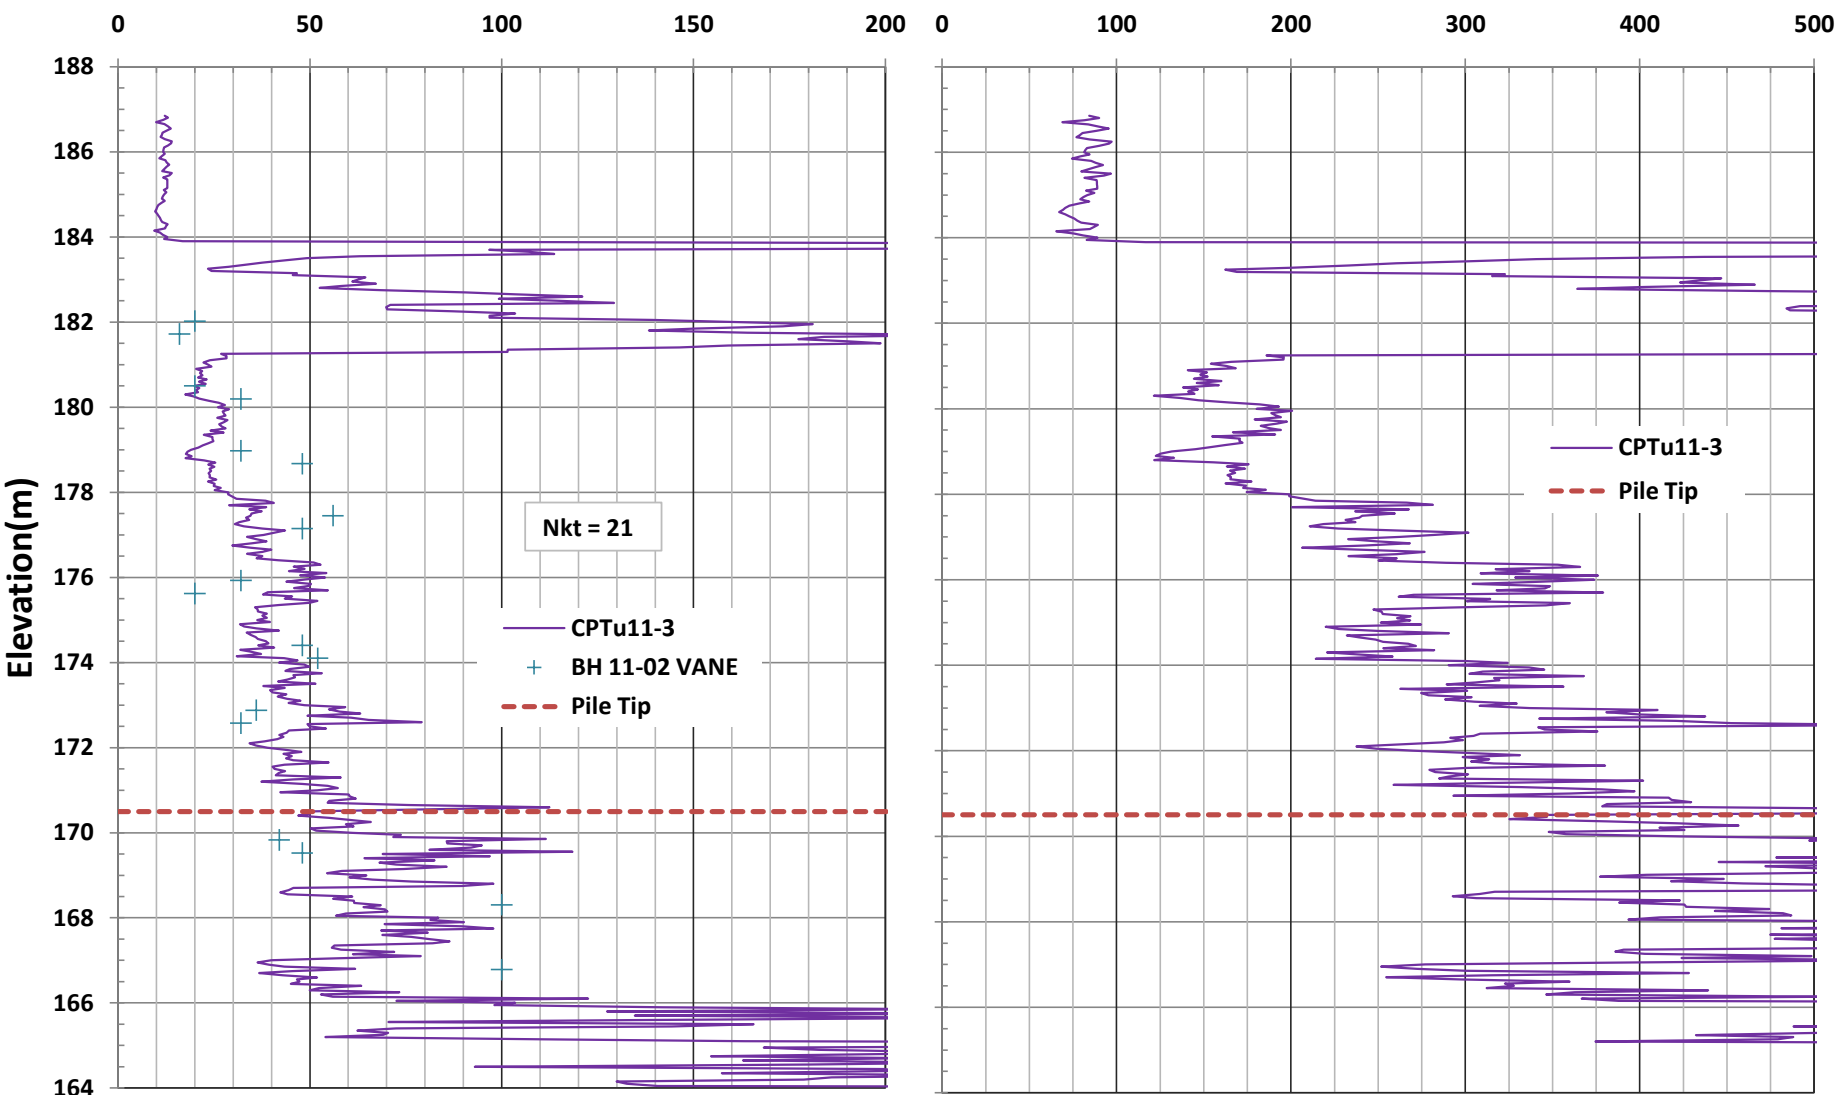
West Pier - Within Pile Group

West Pier - Untreated Native Ground Outside of Pile Group

East Pier - Within Pile Group

East Pier - Untreated Native Ground Outside of Pile Group

3. The above results indicate that the electro-osmotic treatment and extended period of loading from the existing bridge foundations have resulted in an increase in shear strength of the foundation clay under the pile caps.
